AN ARCHAEOLOGICAL
EVALUATION AT PLOT 7,
MASSHOUSE, BIRMINGHAM

13th November 2003

Project 2420
Report 1196
BSMR 20724

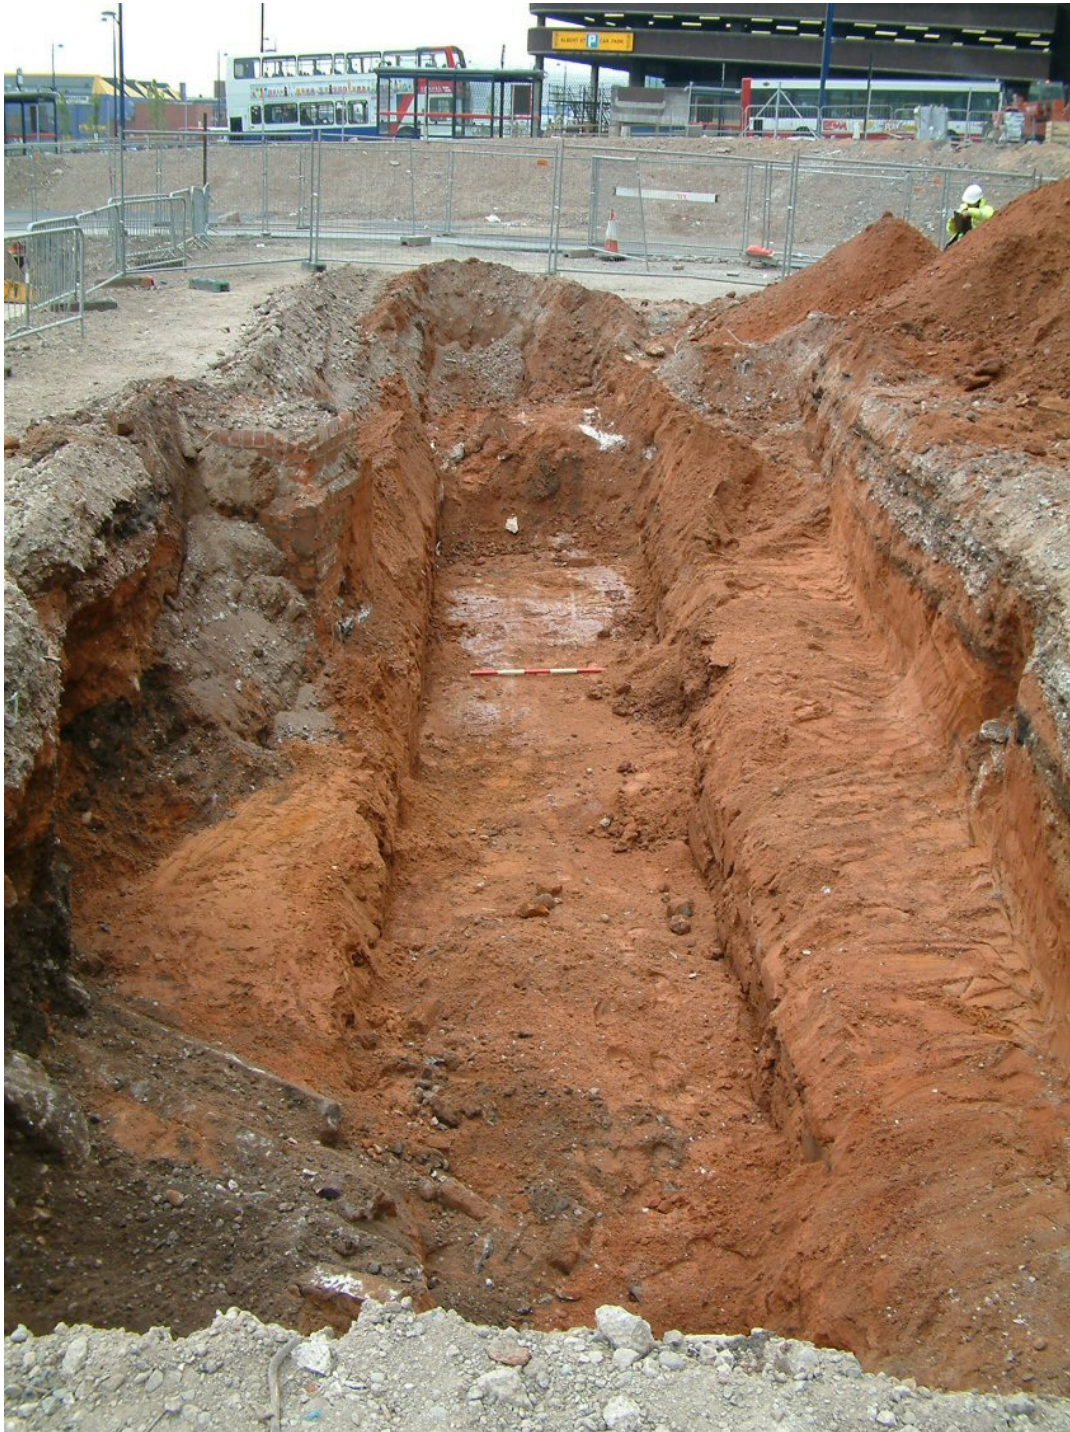
Plate 1: Trench 1, looking south down trench

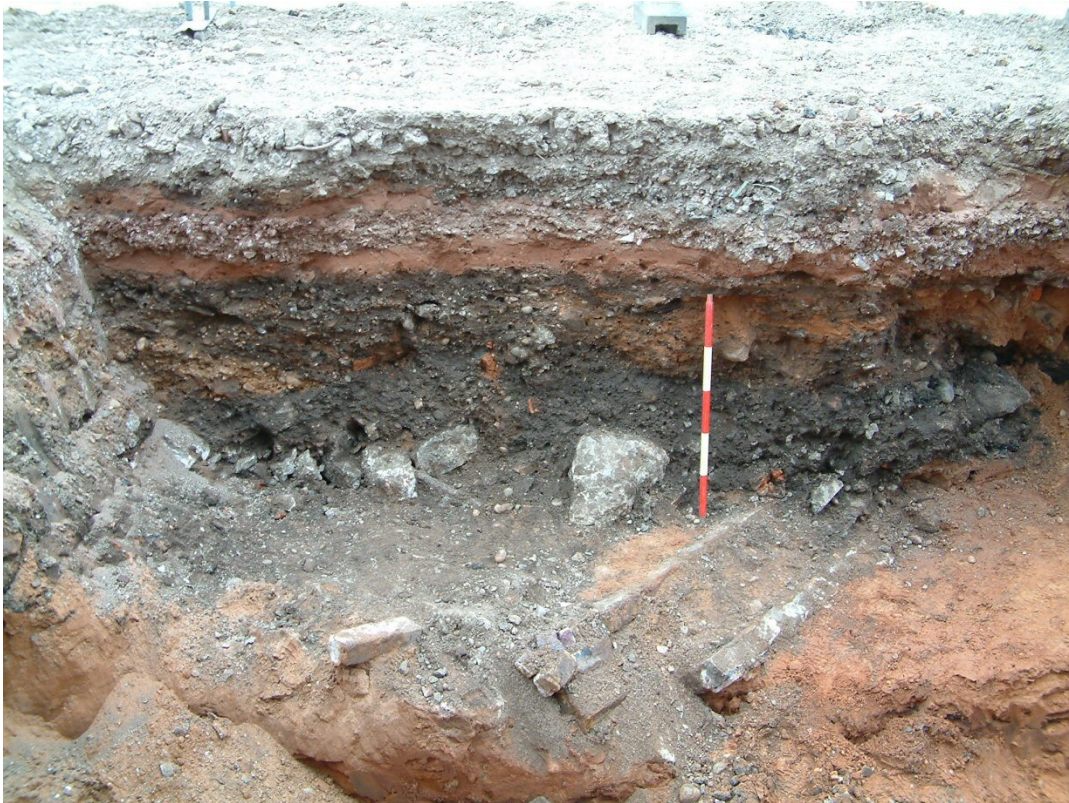
Plate 2: Trench 1, East section, showing modern dumped layers

Both trenches displayed a lot of activity relating to the modern period. Trench 1 was composed of dumped layers of sand and dark grey silty material. The lowest layer present in the section (one of the stratigraphically earliest) was context 121, which lay directly on top of the undisturbed natural. This was a dark grey silty deposit, which contained lumps of modern concrete. These dumped layers of sand and stone were occasionally cut through by services, most of them ceramic pipes laid on top of a concrete bed. The earliest context in Trench 1 appears to be the cut for a culvert of an indeterminate date. Trench 3 had a potential feature in the form of a concave-sided gravelly feature in the south section. No artefactual material was recovered from this though, so it could not be dated. It cut through the natural sand and was sealed by similar dark grey silt and red sand layers as were visible in Trench 1. A large brick service was present at the east end of the trench. This was probably the abandoned sewer visible on Figure 2. It can be assumed that the variety of layers in the trenches relate to the period of groundworks undertaken with the construction of the Queensway roadway, which runs through the site, the adjacent National Westminster Bank building and the levelling required for the car park in 1961.

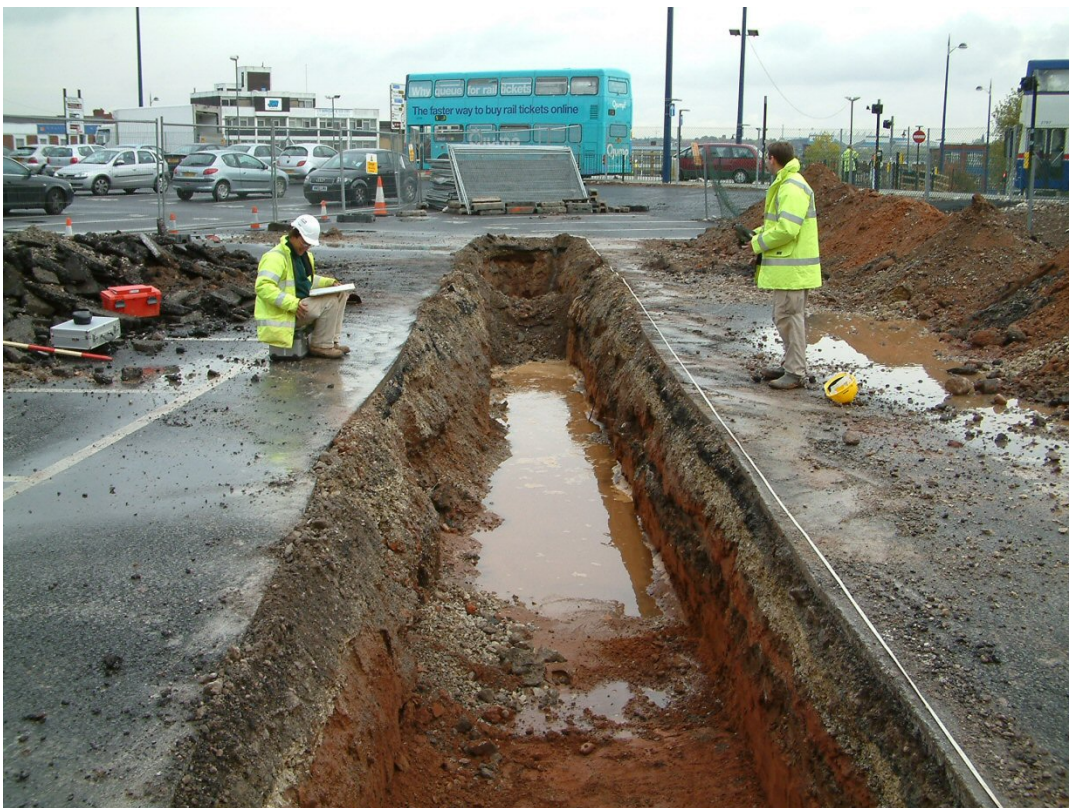
Plate 3: Trench 3. looking east down the trench

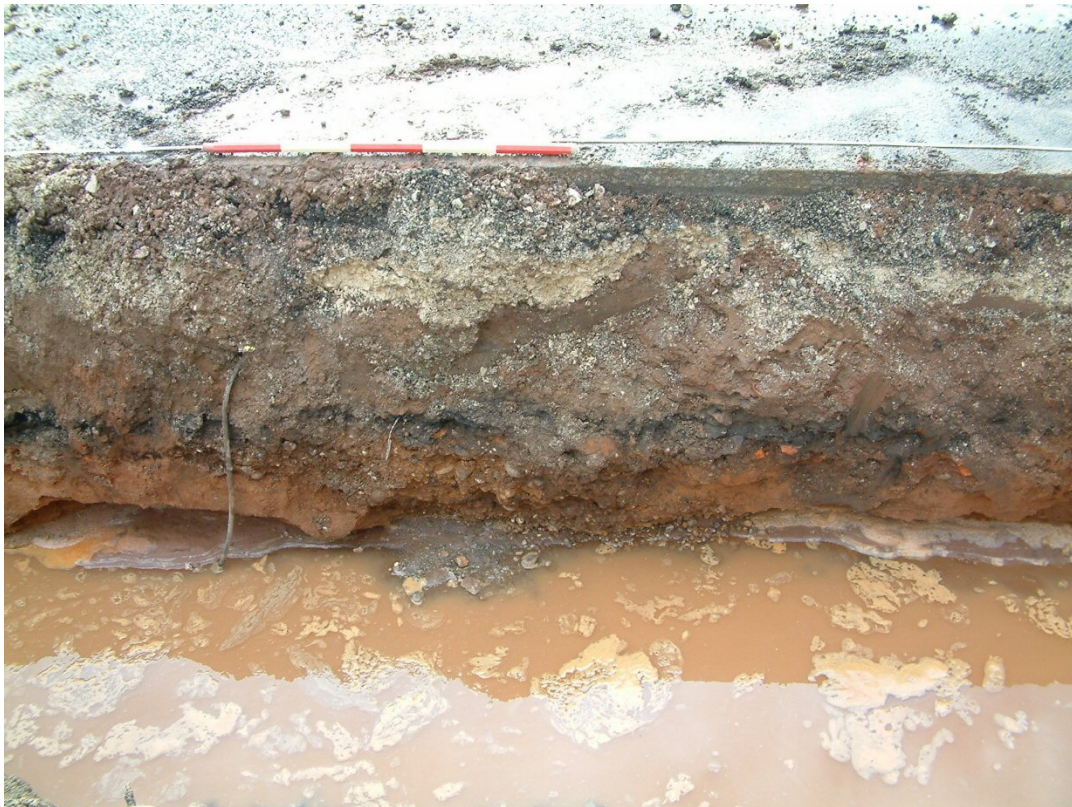
Plate 4: Trench 3, with possible ditch or pit cut visible in the lower portion of the south section

The evaluation did not detect any significant archaeology in either of the evaluation trenches. Traces of a possible ditch was detected in the south section of Trench 3. The feature was not datable. The strata and features visible in the sections of both trenches were modern in date, possibly relating to the construction of the car park and the large-scale development of the area around it.

305	Possible ditch/pit fill of 306	Firm mid greyish brown sand with moderate medium-sized rounded stones	0.90-1.30m
306	Ditch or pit cut, filled by	Shallow concave sides, not visible or detectable in north section due to trench collapse	0.90-1.30m
307	Natural	Natural orangey sand

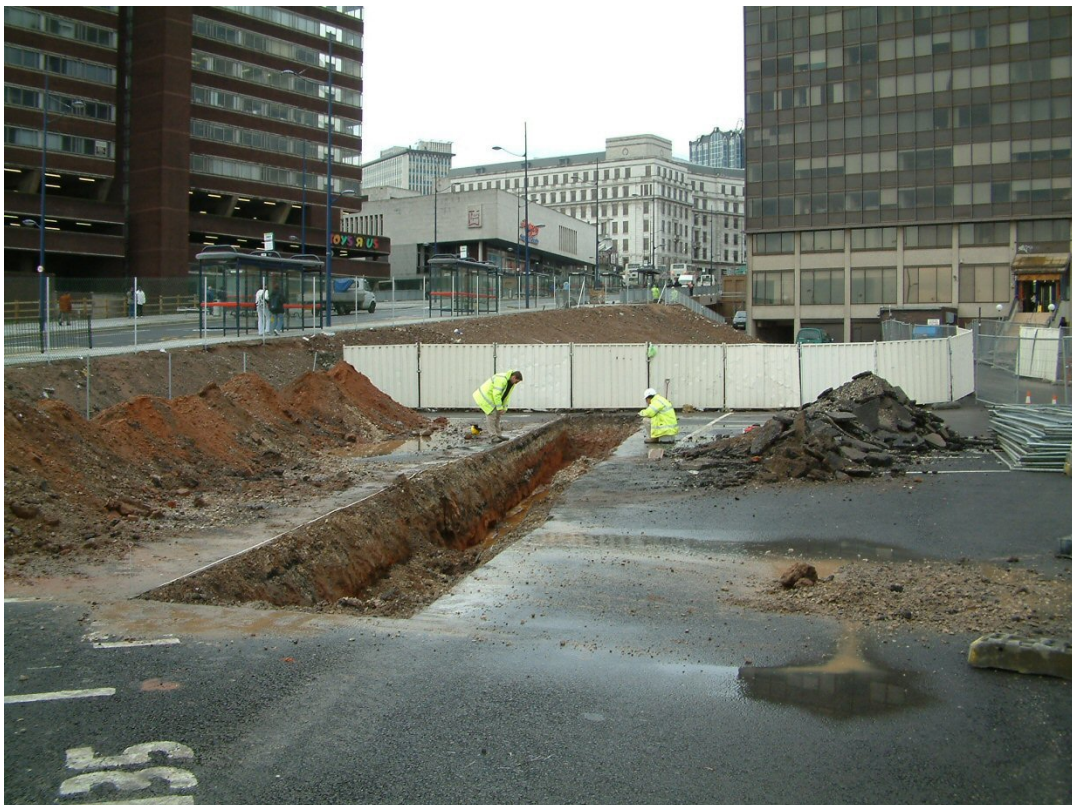
Plate 5: Trench 3, general view of trench, looking west
