ARCHAEOLOGICAL
EVALUATION AT PLOT 3
MASSHOUSE, BIRMINGHAM,
WEST MIDLANDS

14th August 2002

Project 2272
Report 1007

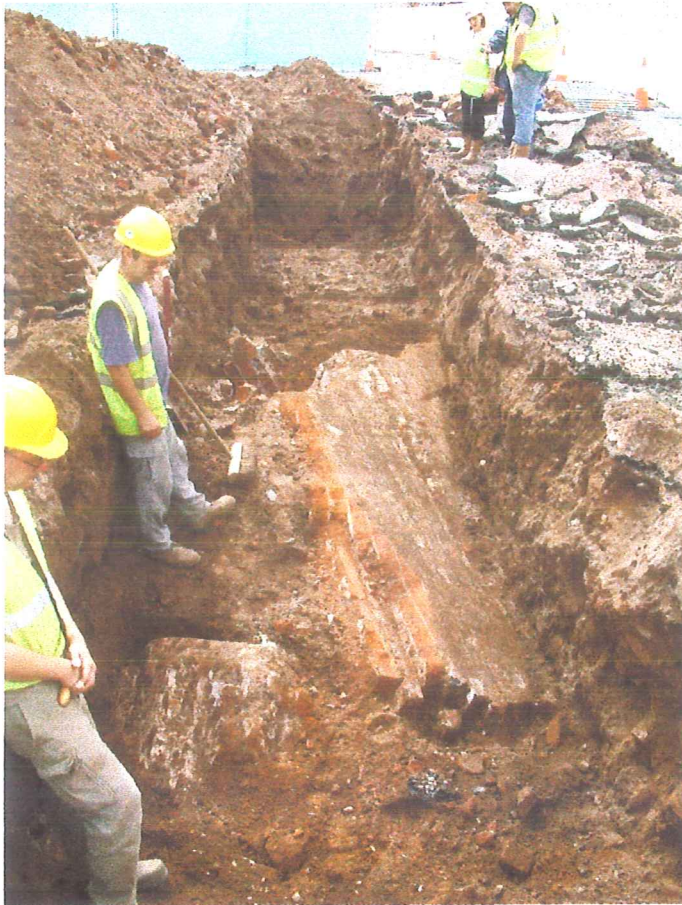
Plate 1, Collapsed wall in Trench 1

The remains of St. Bartholomew's Chapel were located in Trench 1 at the northwest edge of the site close to the Birse Construction compound (Fig 3). The trench was excavated to a depth of 2.4m, through made ground consisting of orange-brown silty sands with a large quantity of loose demolition debris including brickwork, stone and tile. The large quantity of masonry was interpreted as the remains of the chapel and showed that it had been the subject of an extremely thorough demolition job. A large piece of redbrick wall was found lying flat at the northern end of the trench 1.5m beneath the ground surface, measuring approximately 4m long by at least 2m wide and 0.5m thick (Plate 1). The wall appeared to have been pushed into a void in the ground and it may be that the chapel was demolished into an underlying crypt. The wall may have just been re-deposited during later earth moving activity in the area. A small quantity of disarticulated human bone was found close to the northern end of the trench around the collapsed wall. An attempt was made to see what was under the wall but it was not possible due to the size of the masonry and the narrowness of the trench. Several pieces of carved stone thought to be from the chapel were found amongst the rubble (Plate 2).

The quantities of rubble found in Trench 1 confirm the location of the chapel, which had been thoroughly demolished so that nothing remained *in situ*. The chapel may have been demolished to its foundations in the 1940s and any masonry left was then disturbed and re-deposited during the later clearances of the 1960's. This may account for how some large pieces of masonry came to be so deeply buried.

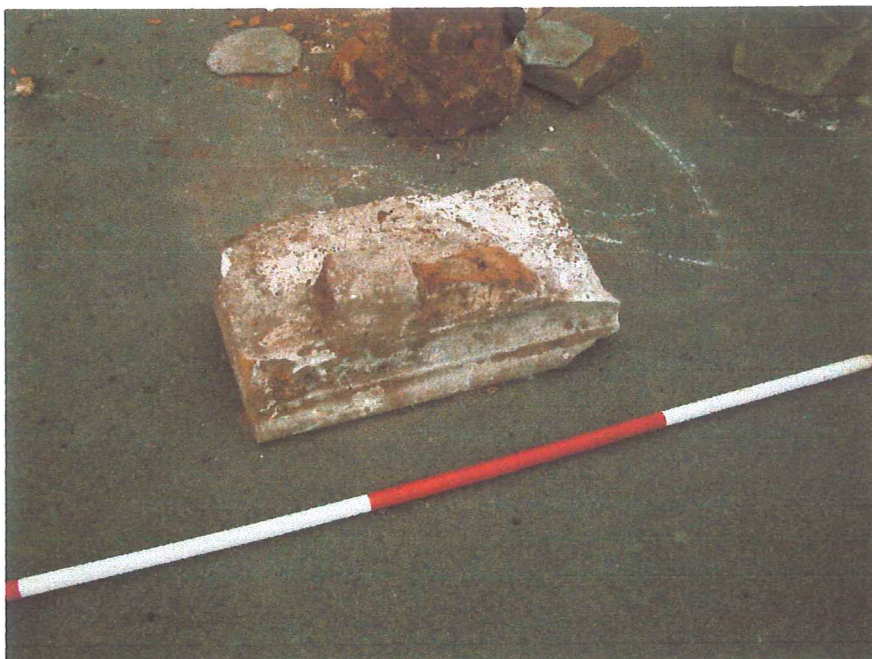
Plate 2, Carved stone from the chapel

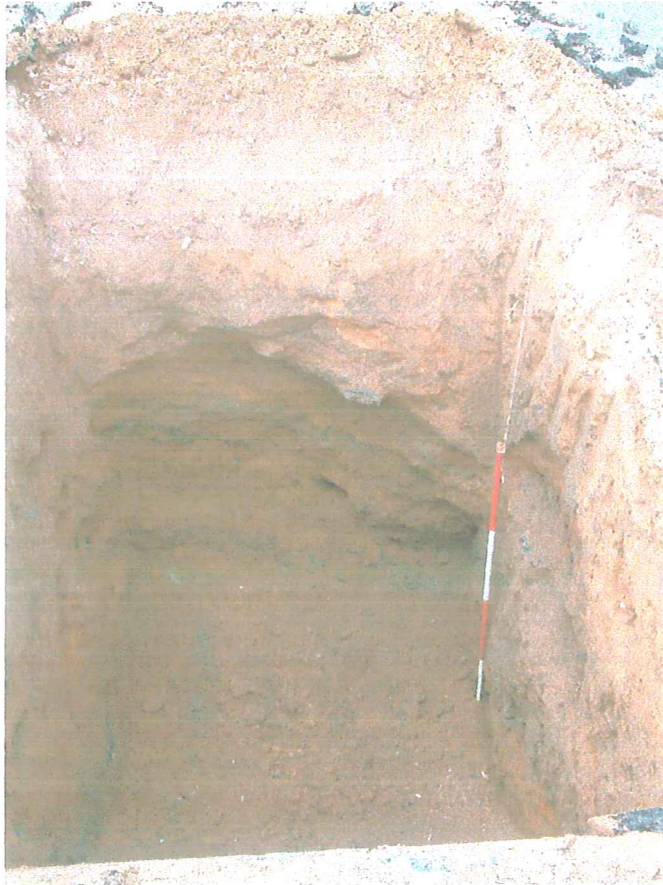
Plate 3, Evidence of tipping in Trench 2

Trenches 2 and 3 were both excavated to a depth of 3m, through a deposit of mixed silty sand to the natural sandstone beneath (Fig 3). The section of the trenches showed banding of material with clear tip lines (Plates 3 and 4). The material all seemed to have been re-deposited from elsewhere and was very clean with no rubble inclusions other than a few fragments of salt-glazed drain-pipe and tar near the base of Trench 2 and several pieces of corrugated asbestos from Trench 3. Very little human bone was recovered, 23 fragments from Trench 3 and only two fragments from Trench 2. A large slab of sandstone was visible in the northeast facing section of Trench 3 was possibly the remains of a grave monument.

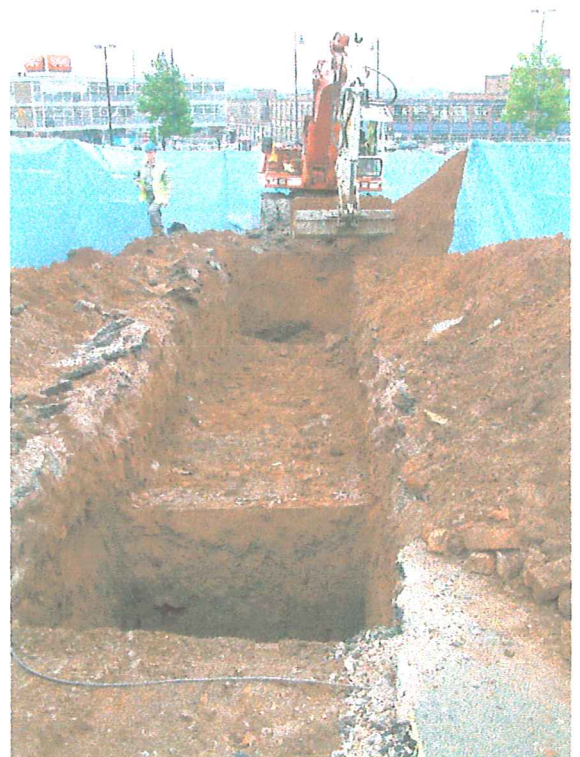
Plate 4, Machining of Trench 3

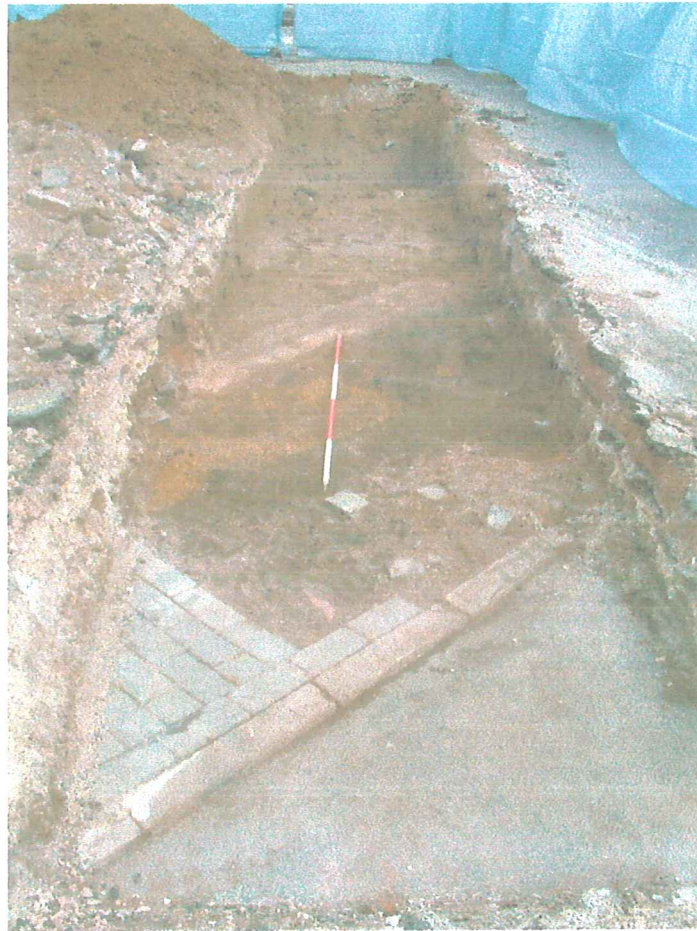
Plate 5, Former Masshouse Lane road surface in Trench 4

The boundary of the graveyard was found in the southwestern end of Trench 4, 0.48m below the car park surface and consisted of the foundation of the former boundary wall and the pavement and road surface of the earlier alignment of Masshouse Lane (Plate 5). The road surface was tarmac and was abutted to the east by a pavement constructed of granite kerb stones and blue bricks. Redundant electrical and water services survived beneath the surface of the pavement. The boundary wall was built of red brick with foundations 2m deep cut into the natural sandstone. Large carved blocks of limestone were found in the demolition debris overlying the former road surface, which appear to be the capping stones of the brick wall on to which the railings were attached (Plate 6). To the east of the wall, inside the former burial ground, the soil had been subjected to the same re-deposition of material that was found in Trenches 2 and 3 to a depth of 2.8m. The material was a mixed orange brown silty sand and again was very clean with no rubble or rubbish, only two pieces of human bone were recovered.

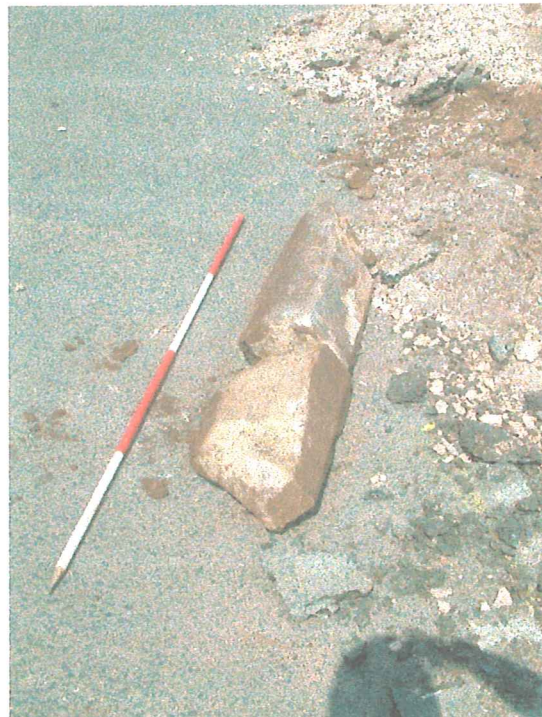
Plate 6, Former burial ground perimeter wall capping stones from Trench 4
