DESK-BASED ASSESSMENT
OF SAINSBURY'S
SUPERMARKET SITE,
THE SMITHFIELD, BRIDGNORTH,
SHROPSHIRE

Project 3079
Report 1555

Part 1 Project summary

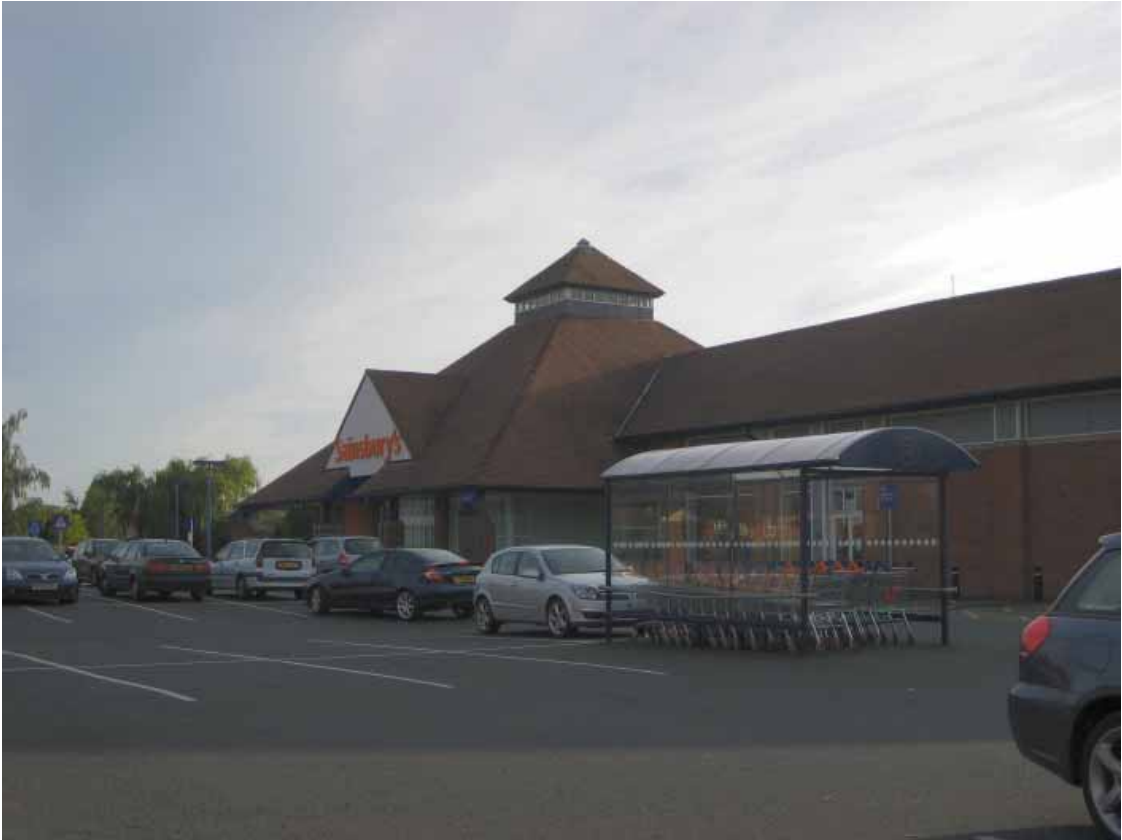
Plate 1. Sainsbury's Supermarket, Bridgnorth. View from north-east.

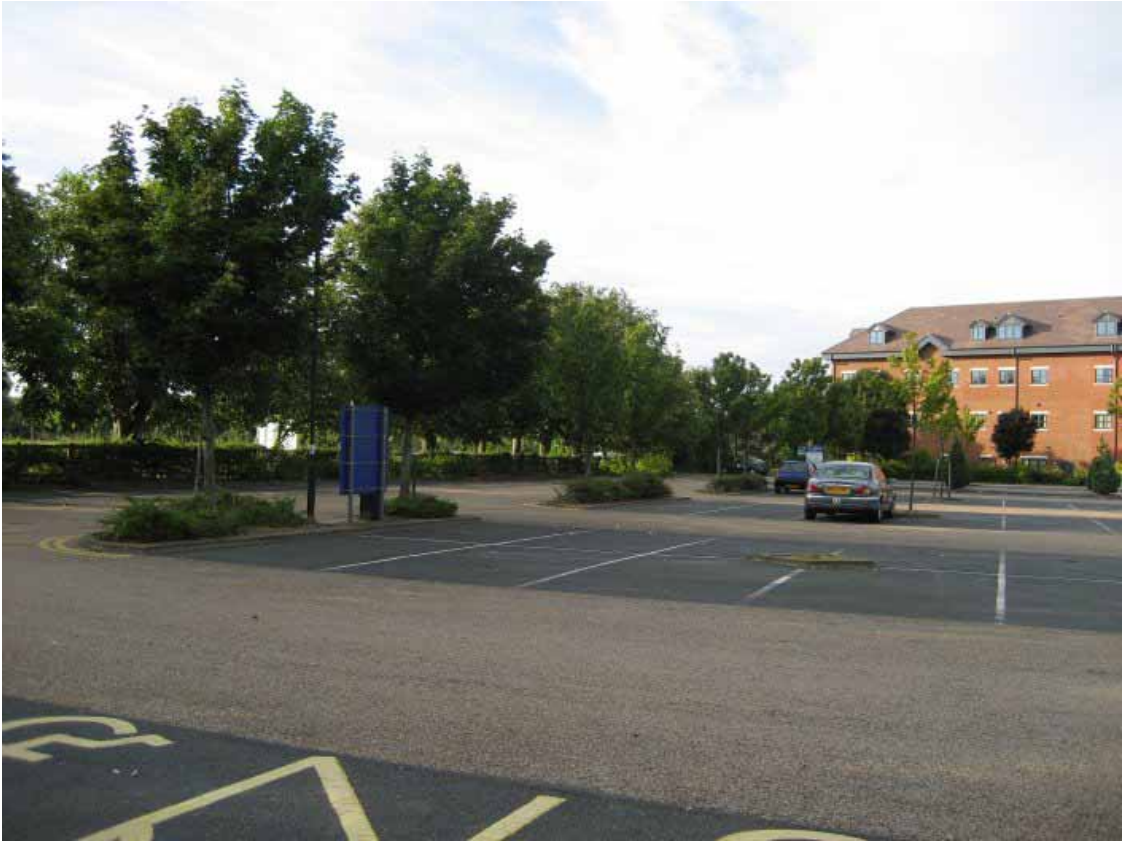
Plate 2. Bridgnorth District Council carpark, north part of study area. View to north.

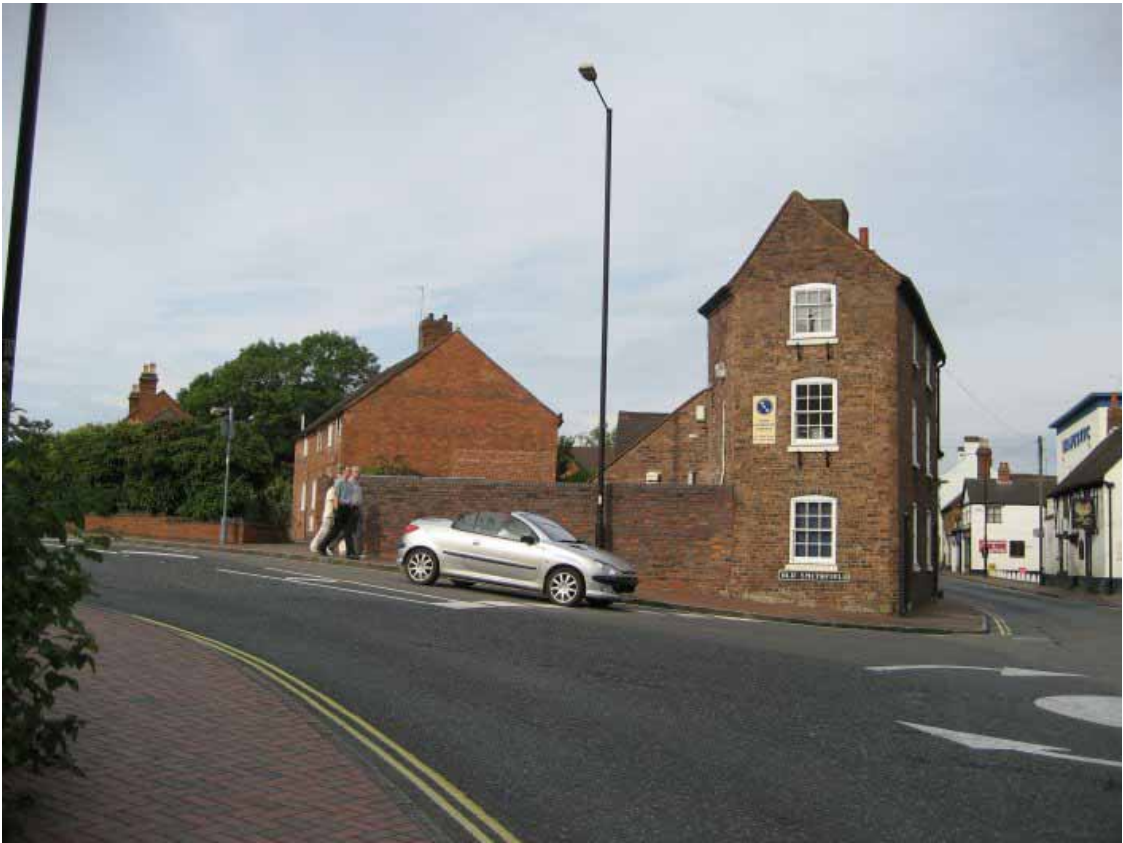
Plate 3. Junction of Whitburn Street (on right) and Old Smithfield (on left). View looking northeast. No. 34 Whitburn Street, on the corner is C19th.

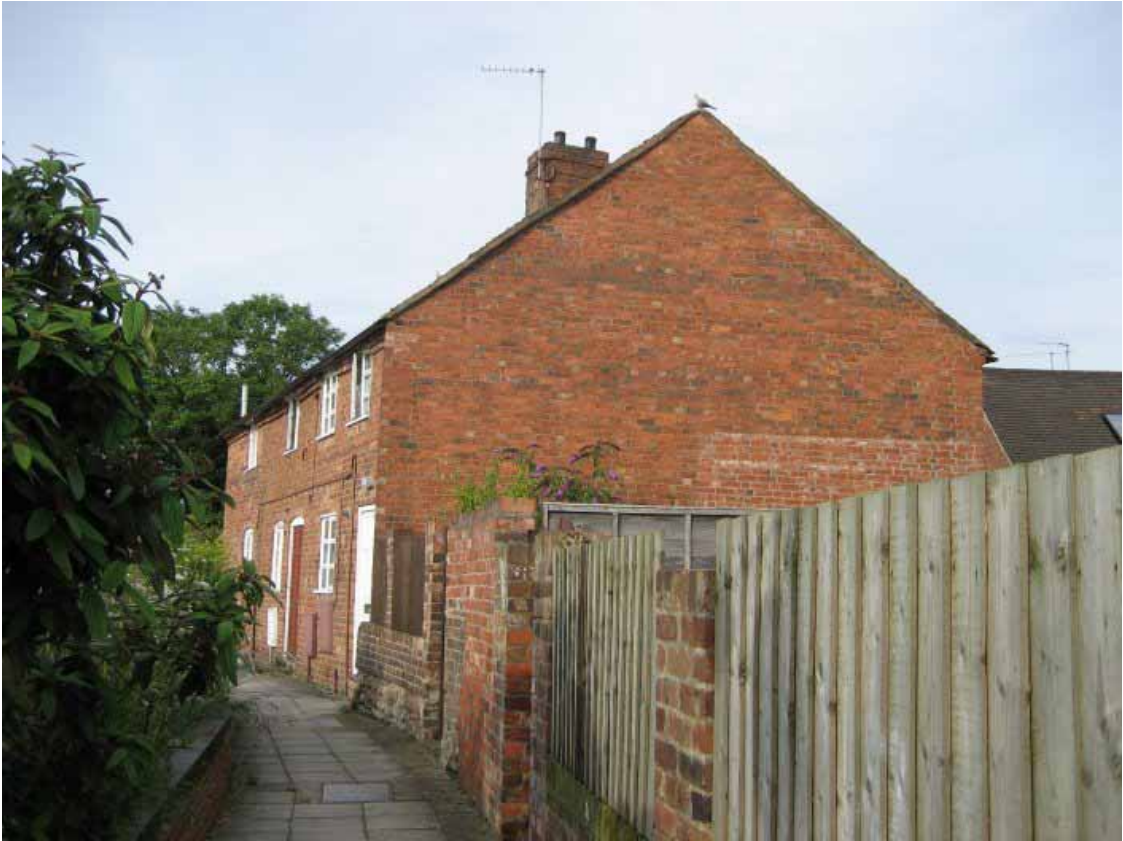
Plate 4. 31 & 32 Whitburn Street, on southern edge of and outside study area. Two small houses, C19th, formerly part of a court called Whitburn Place. View from southwest.

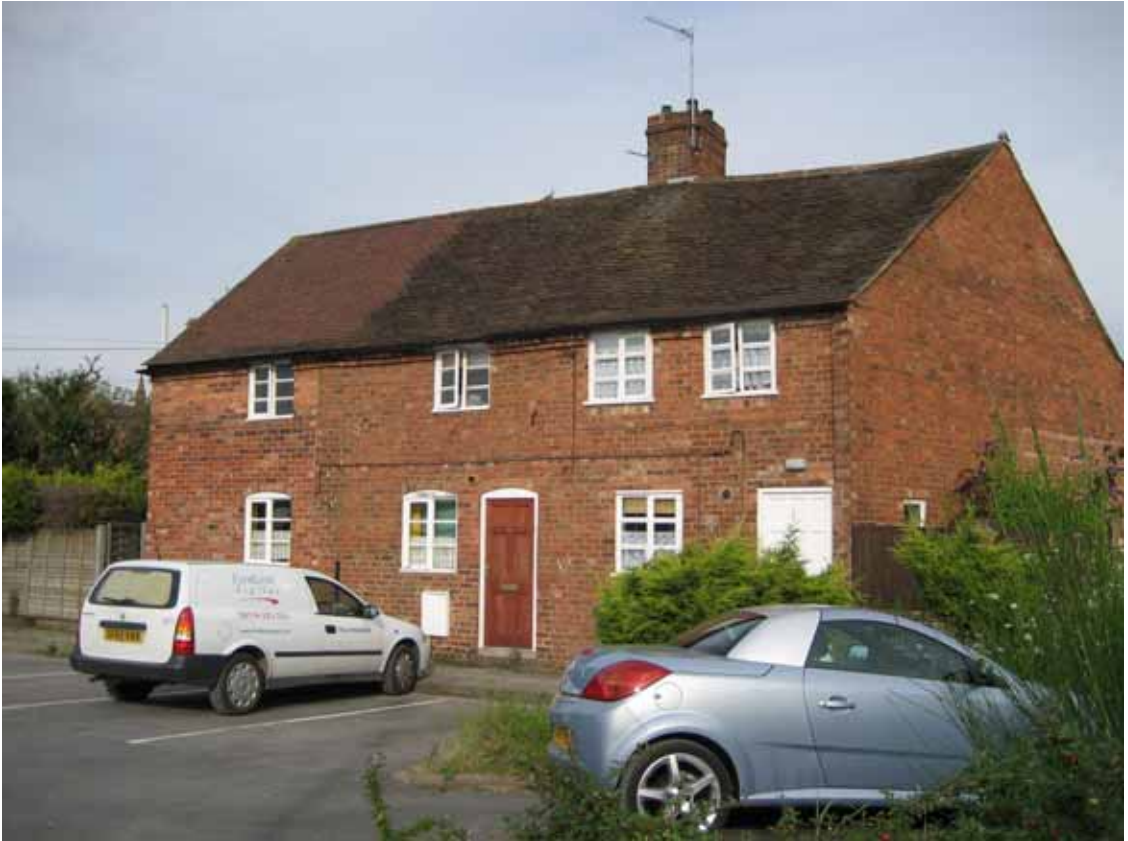
Plate 5. 31 & 32 Whitburn Street, on southern edge of and outside study area. Two small houses, C19th, formerly part of a court called Whitburn Place. Eastern house has extension. View from west.

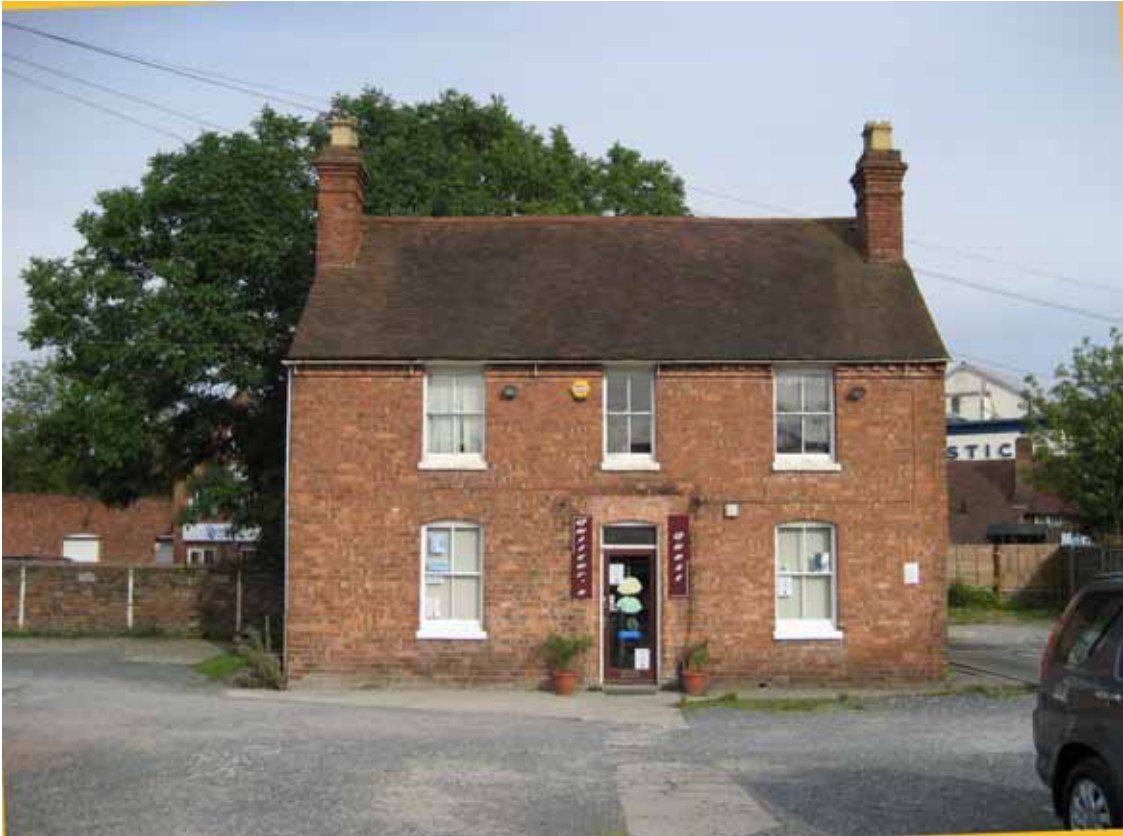
Plate 6. ‘Quilter’s Quest’, commercial premises on south side of the study area. This building is identified for demolition in the planning application. A three-bay, two-storey late 19th century house, this building originally stood at the end of Whitburn Place. View from northwest.

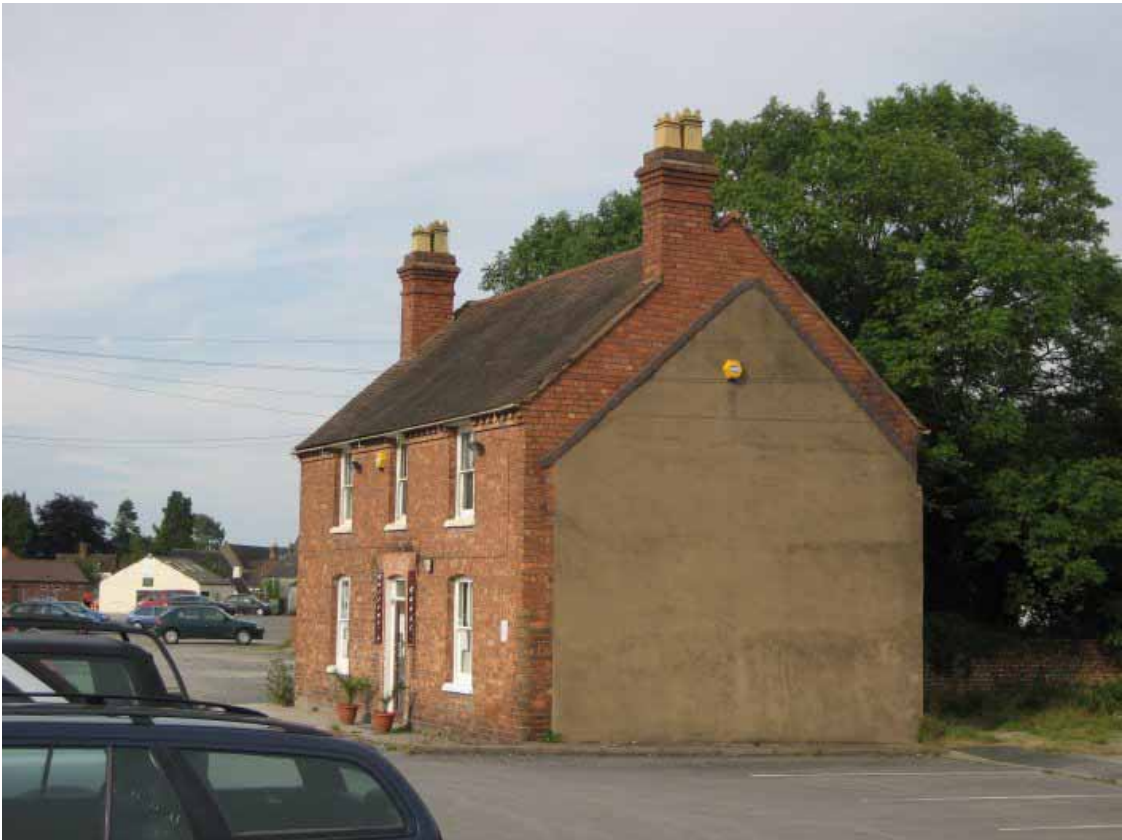
Plate 7. 'Quilter's Quest', commercial premises on south side of the study area. This building is identified for demolition in the planning application. A three-bay, two-storey late 19th century house, this building originally stood at the north-east end of Whitburn Place, and the scar of the adjacent terraced house is clear. View from southwest.

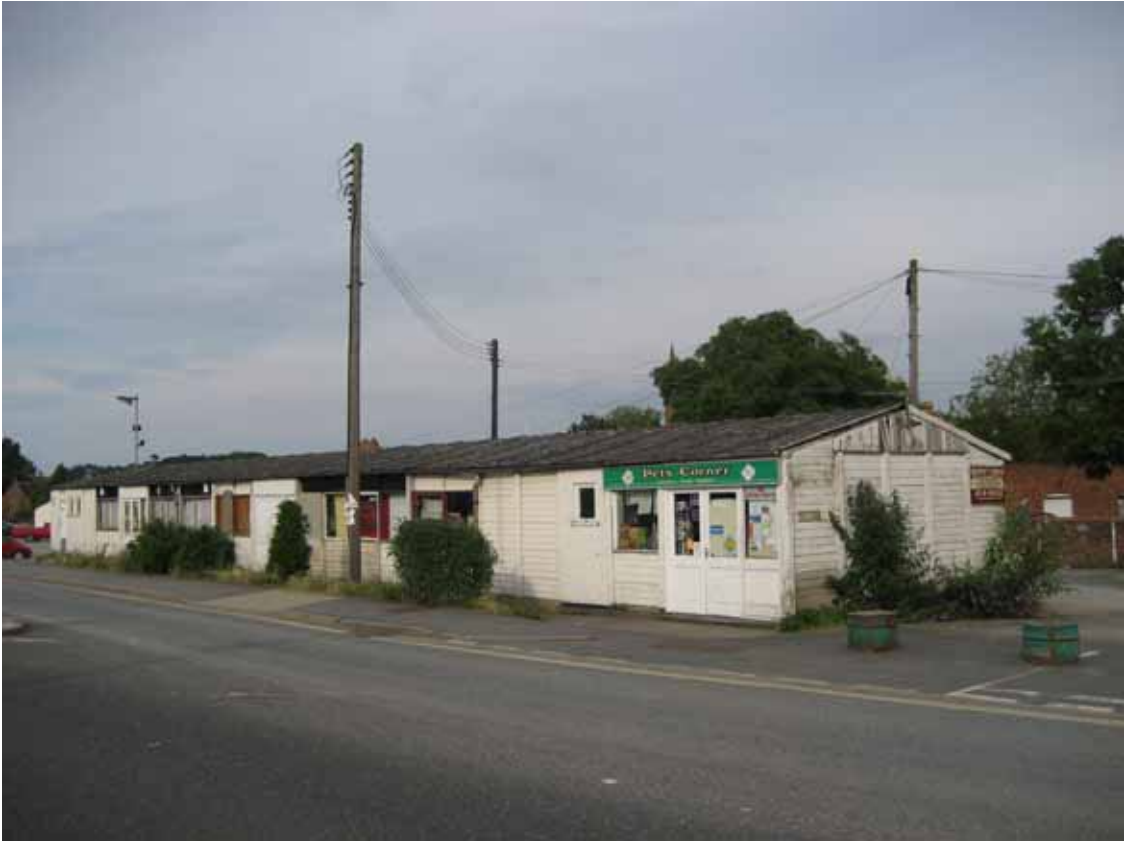
Plate 8. Modern building, currently shops. This building is identified for demolition in the planning application. View from northwest.

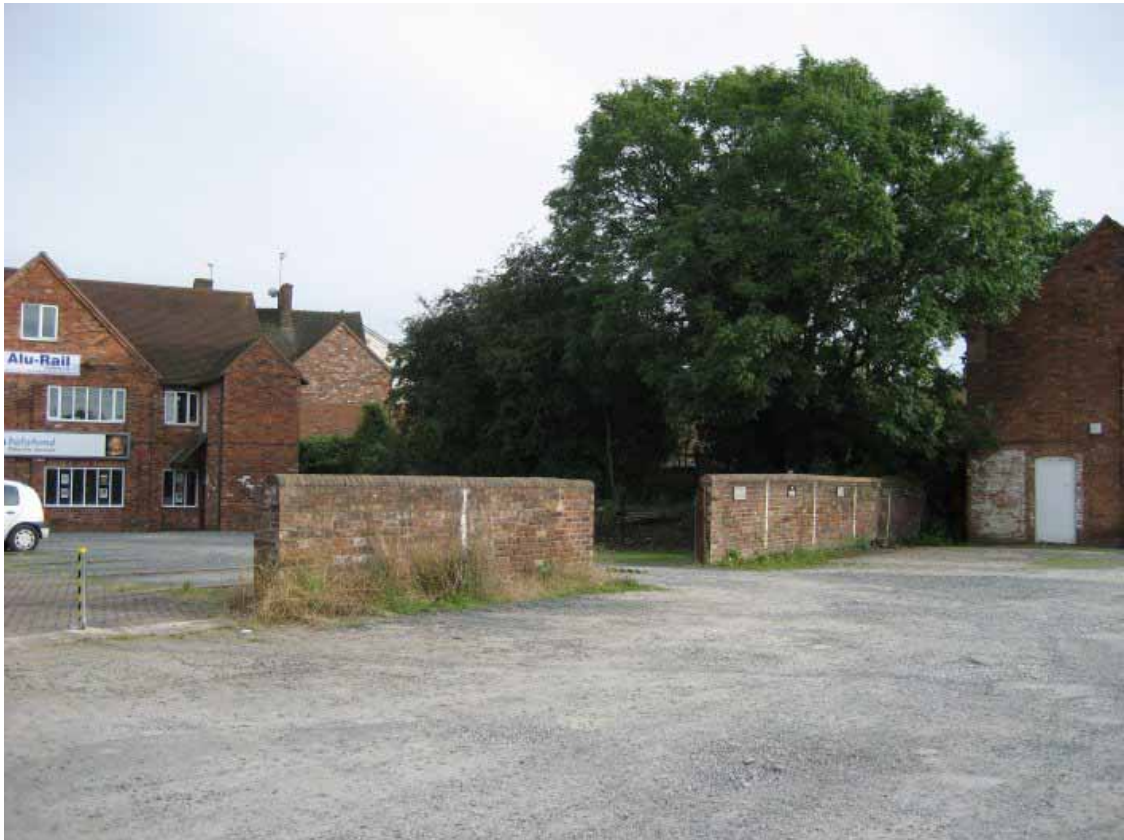
Plate 9. Property boundary, forming edge of application site at rear of Nos. 14-17 Whitburn Street. Brick wall with modern openings, C19th or earlier C20th.

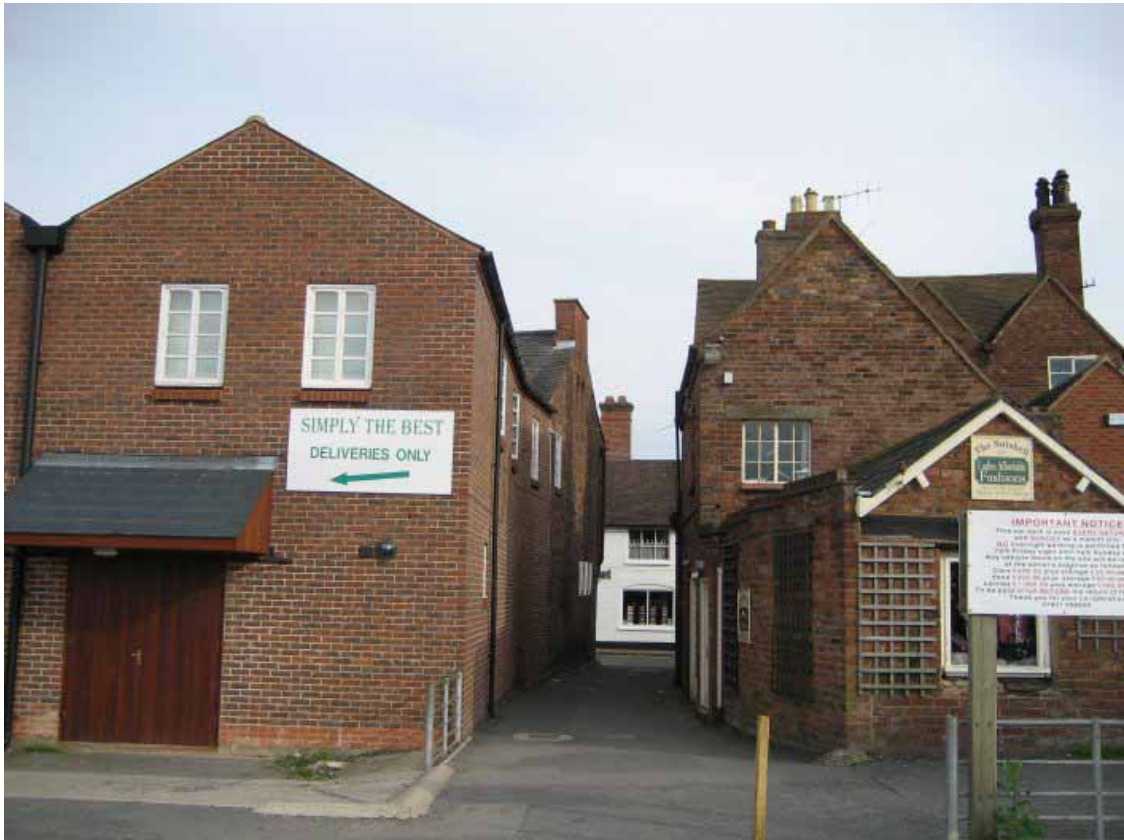
Plate 10. Rear of Nos. 8 & 9 Whitburn Street and the public right of way between the properties, leading from Whitburn Street to the market area. This passageway is identified in the planning application for enhancement as pedestrian access to the carpark, with no demolition of extant buildings.

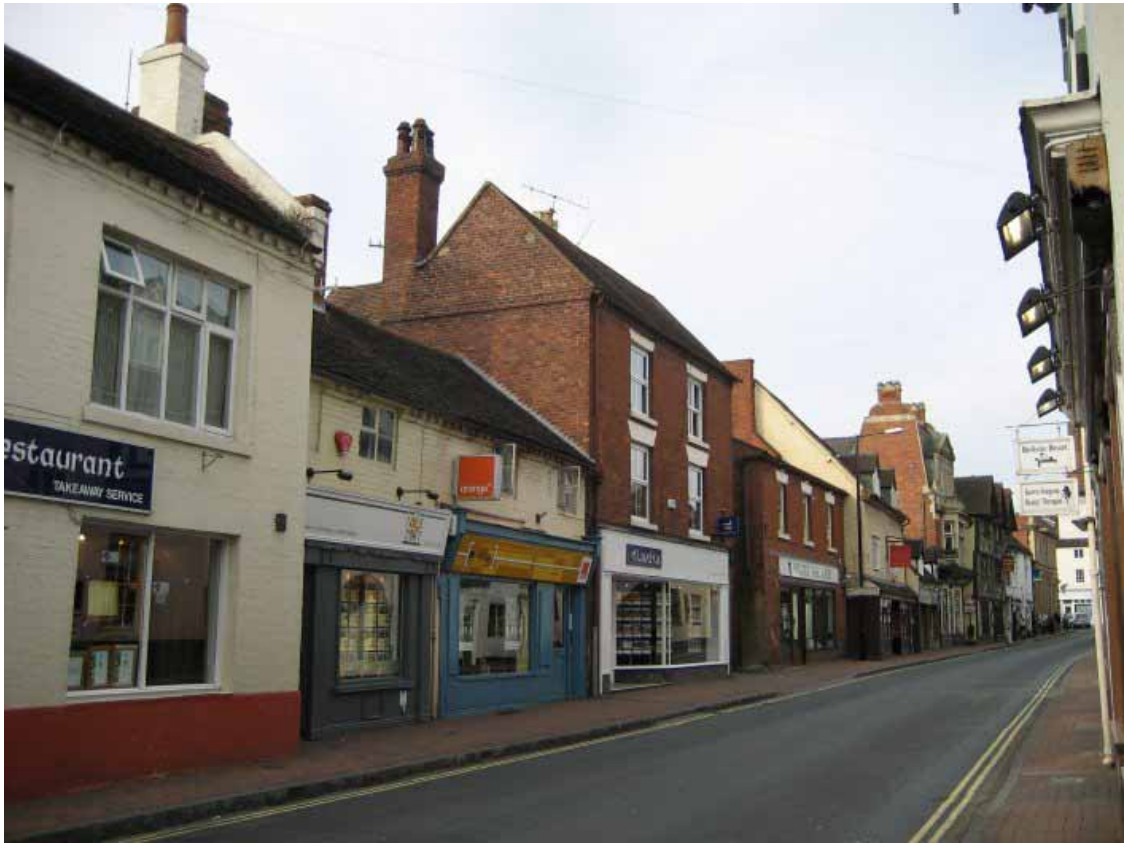
Plate 11. General view of Whitburn Street, north side, showing mix of building fabric.

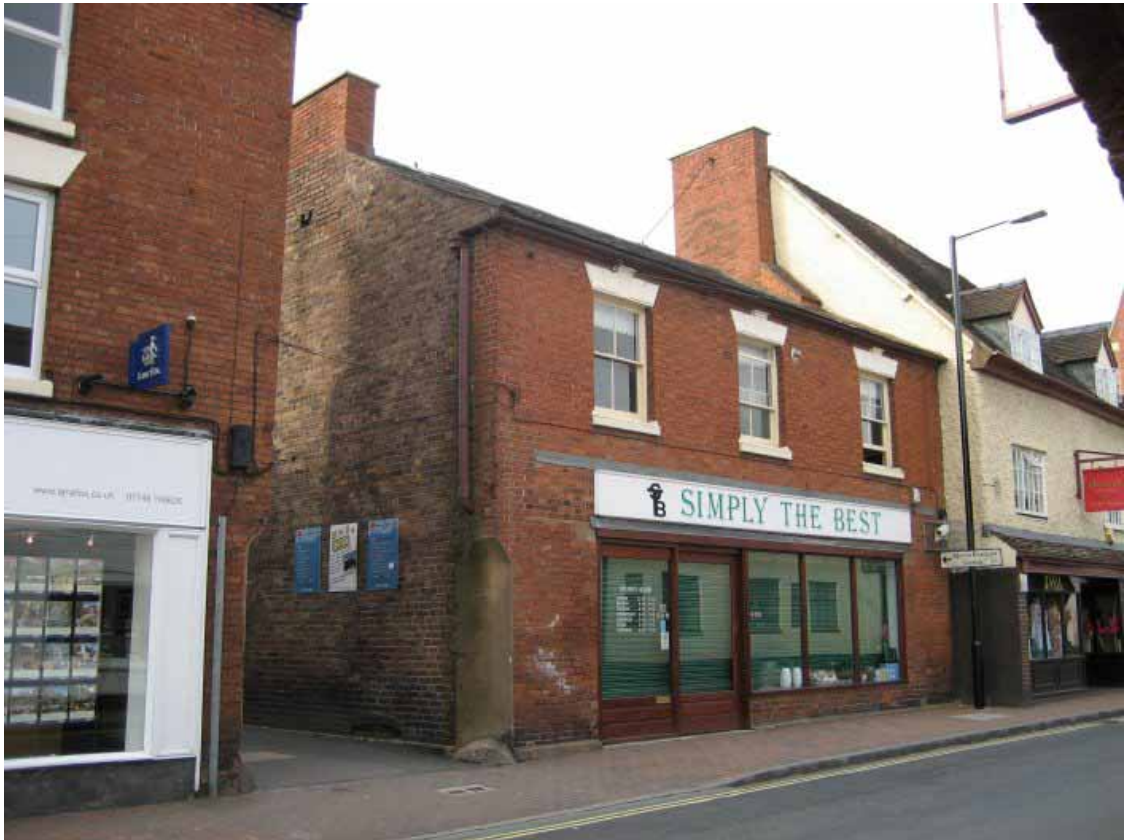
Plate 12. No. 8 Whitburn Street ('Simply The Best'), and adjacent passageway. A 19th century three-bay, two-storey brick building, with cellar.

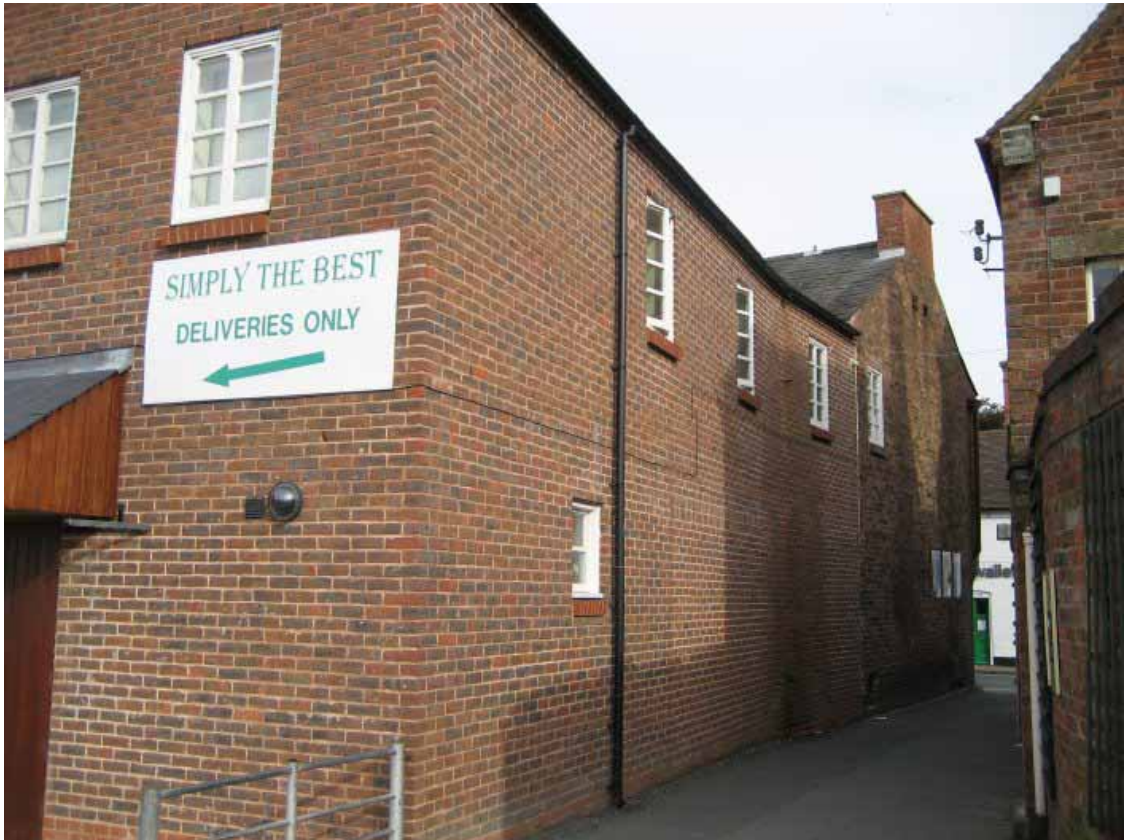
Plate 13. Rear of No. 8 Whitburn Street ('Simply The Best'). A modern brick two-storey extension. It is proposed that two small retail units will be built to the north of this building, with access from the passageway.

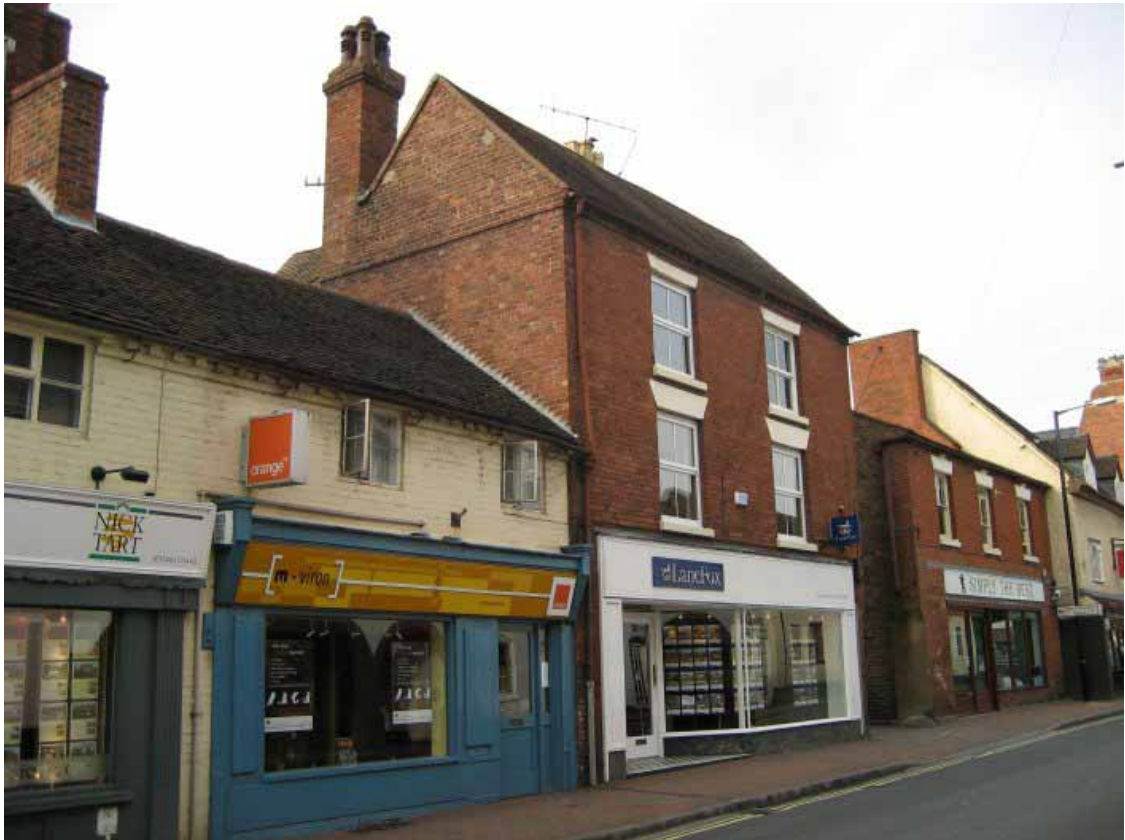
Plate 14. No. 9 Whitburn Street ('Lane and Fox' estate agents). A three-storey, two-bay brick building, 19th century.

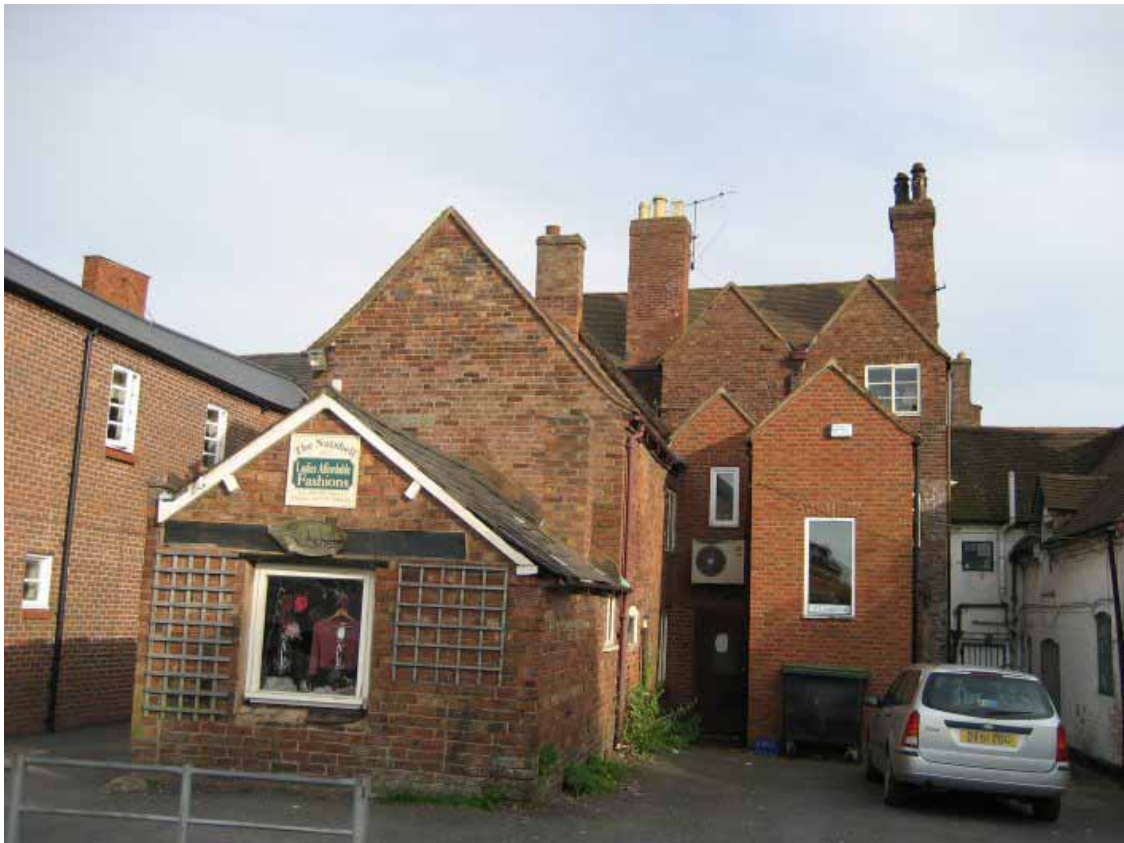
Plate 15. Rear of No. 9 Whitburn Street (No. 9b, 'The Nutshell' clothes shop). Two separate C19th buildings, a two-bay, two-storey building (built as a house) and a small one-storey building adjacent (probably built as a workshop). These buildings are identified for retention in the planning application. It is proposed that two small retail units will be built to the north of this building, with access from the passageway. View to south.

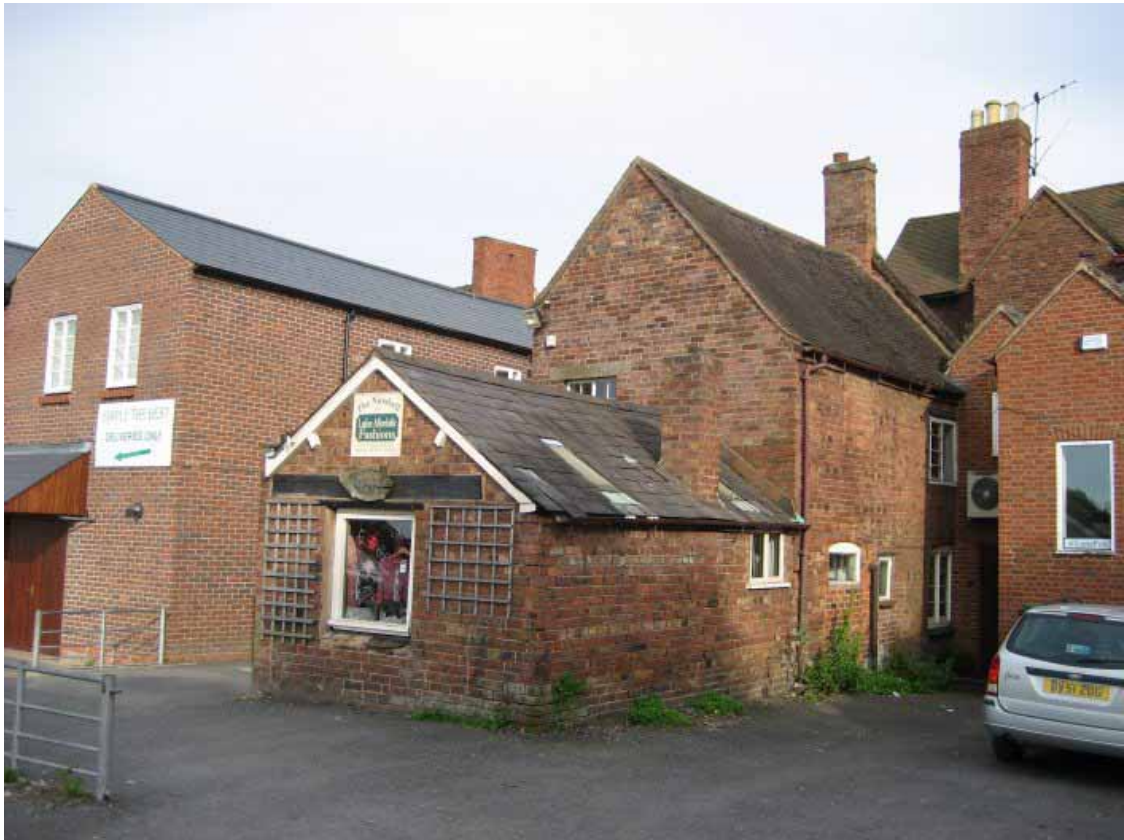
Plate 16. Rear of No. 9 Whitburn Street (No. 9b, ‘The Nutshell’ clothes shop). Two separate C19th buildings, a two-bay, two-storey building (built as a house) and a small one-storey building adjacent (probably built as a workshop). These buildings are identified for retention in the planning application. It is proposed that two small retail units will be built to the north of this building, with access from the passageway. View to southeast.

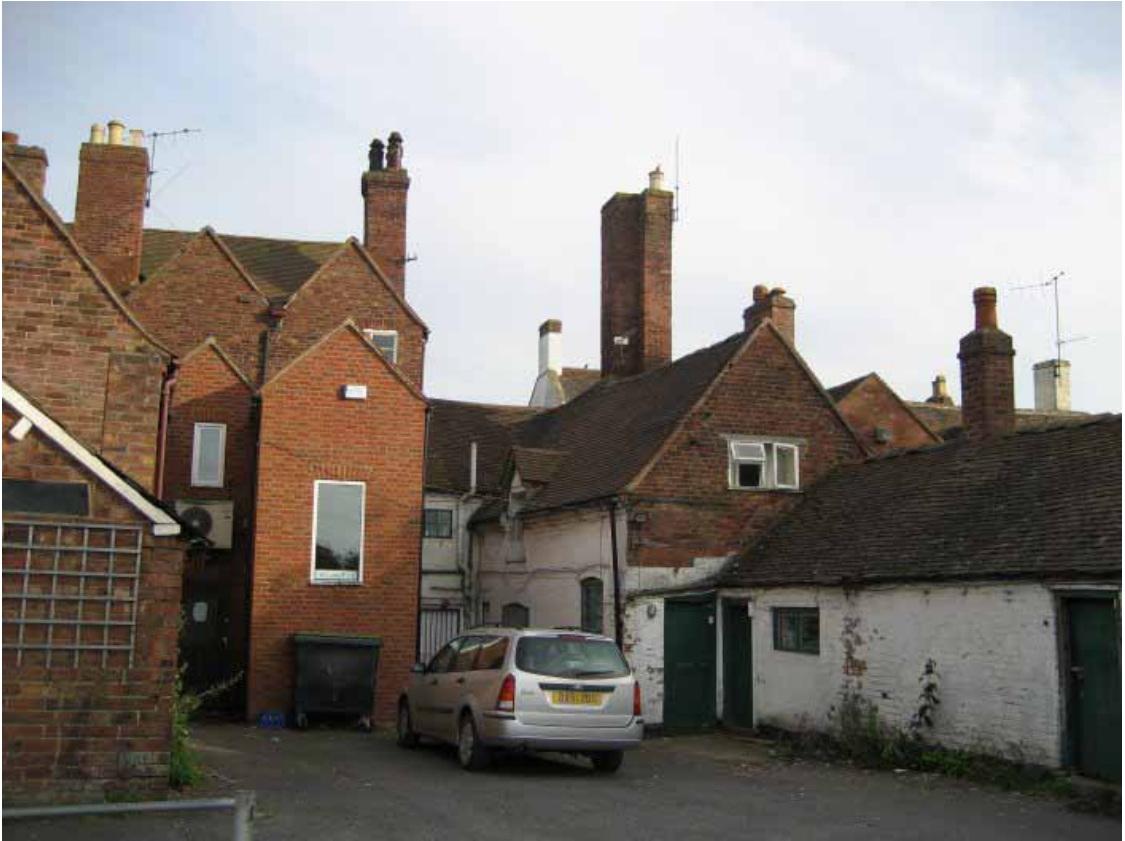
Plate 17. Rear of Nos. 9 & 10 Whitburn Street. This view shows character of rear extensions of properties on Whitburn Street, including domestic accommodation and workshops (see Plate 18). View looking southwest.

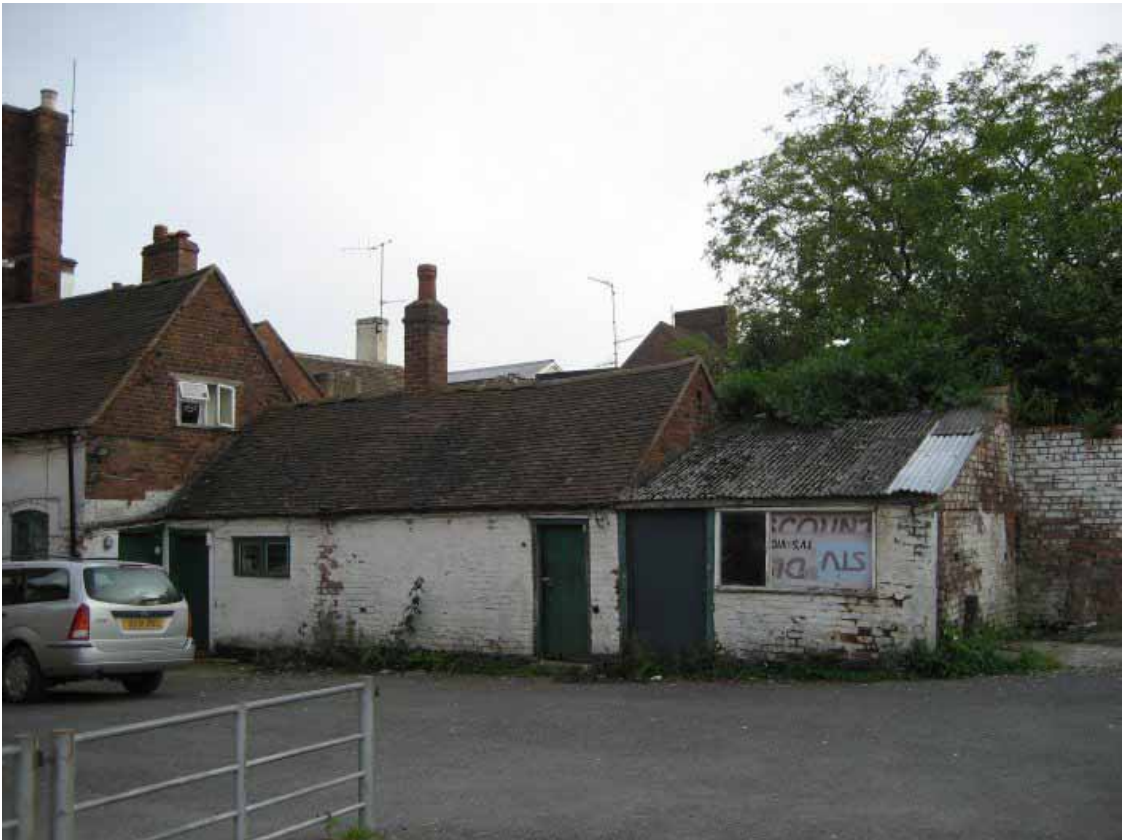
Plate 18. Rear of No. 10 Whitburn Street. A one-storey C19th workshop, with modern window inserted. This view shows the absence of identifiable property boundaries defining rear plots, removed after 1982.

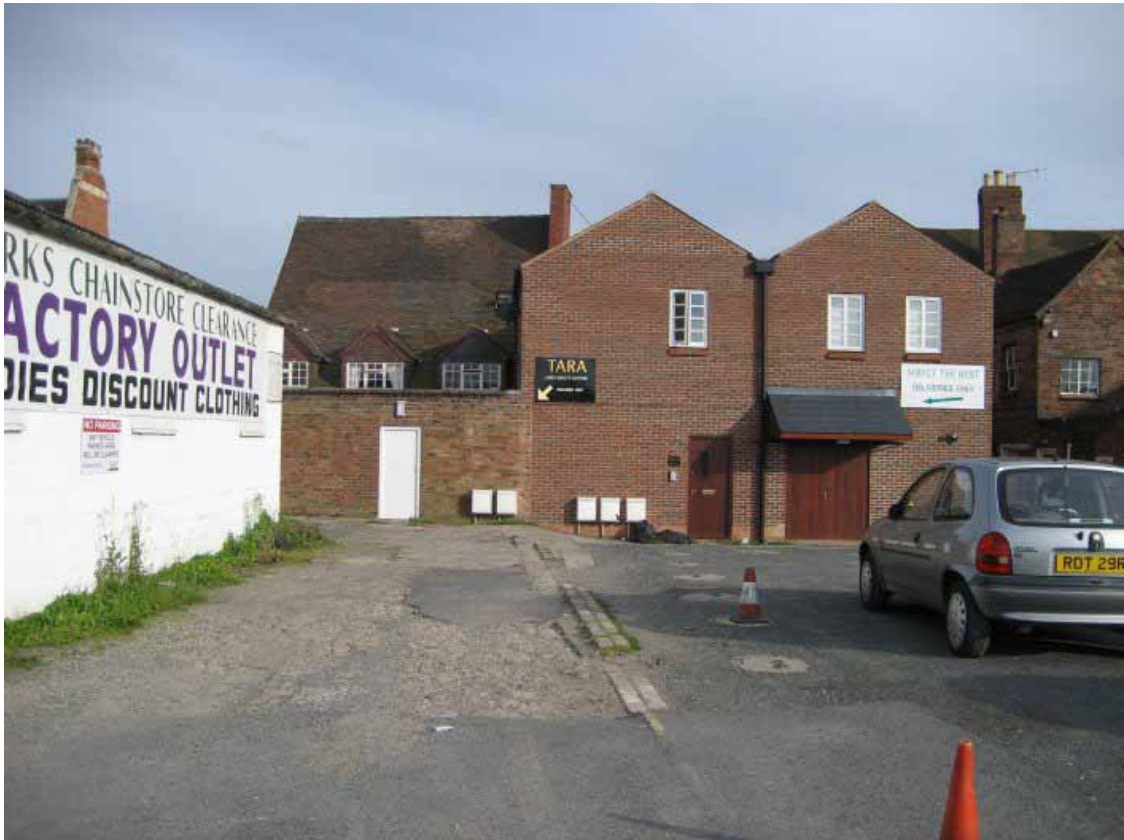
Plate 19. Rear of Nos. 7 & 8 Whitburn Street, view to south. This view shows evidence for property boundaries, formerly brick garden walls, demolished after 1982.

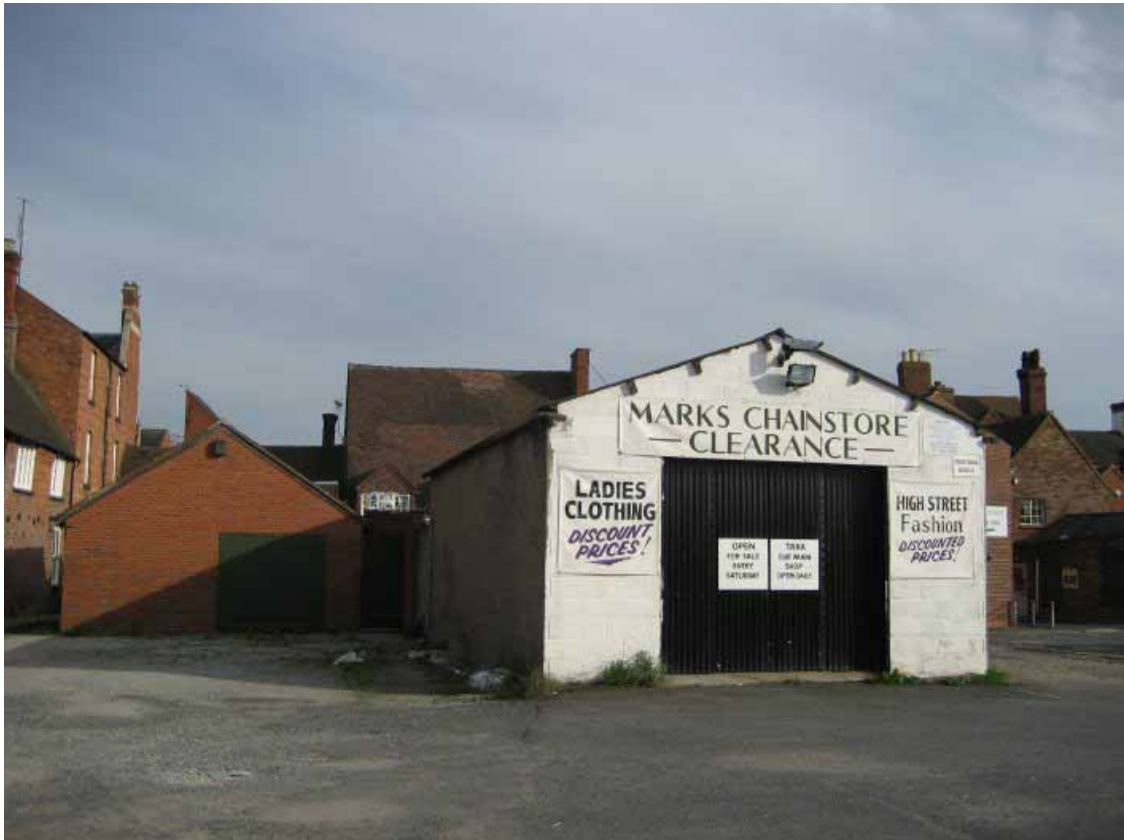
Plate 20. Store building, C20th, rear of No. 7 Whitburn Street.

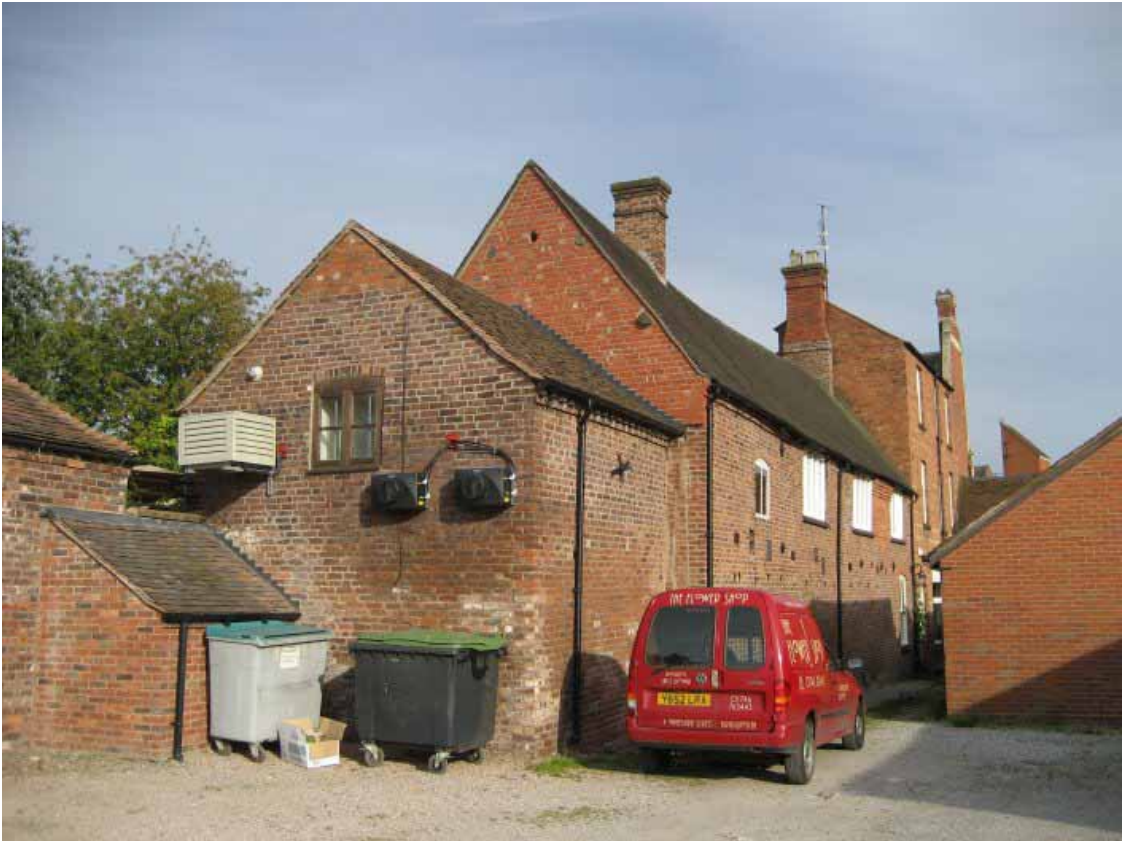
Plate 21. Range of buildings at rear of No. 4 Whitburn Street. A range of brick buildings of late 19th century date, accessed from a passageway leading from Whitburn Street.

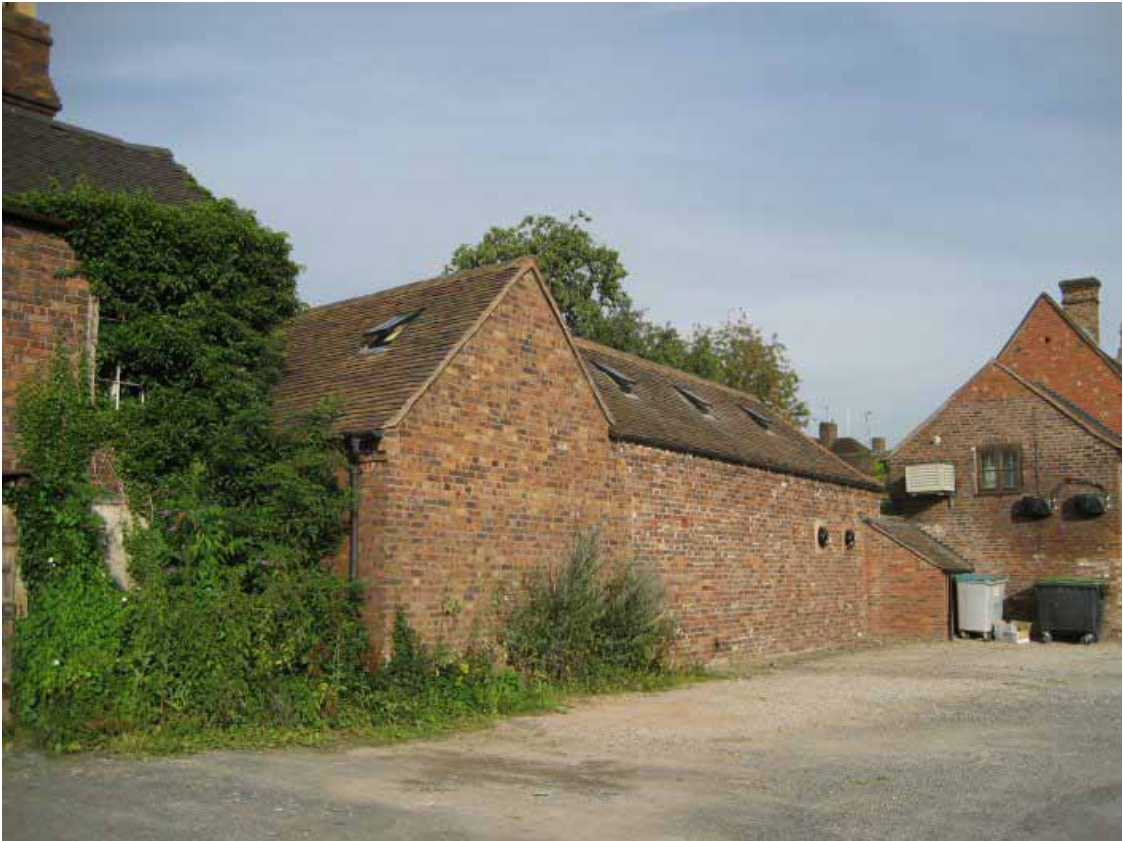
Plate 22. Range of buildings at rear of No. 3 Whitburn Street. These C19th buildings were probably built as stables or workshops, in rear yard of King's Head Inn, as shown on 1884 Ordnance Survey map (see Fig 9).

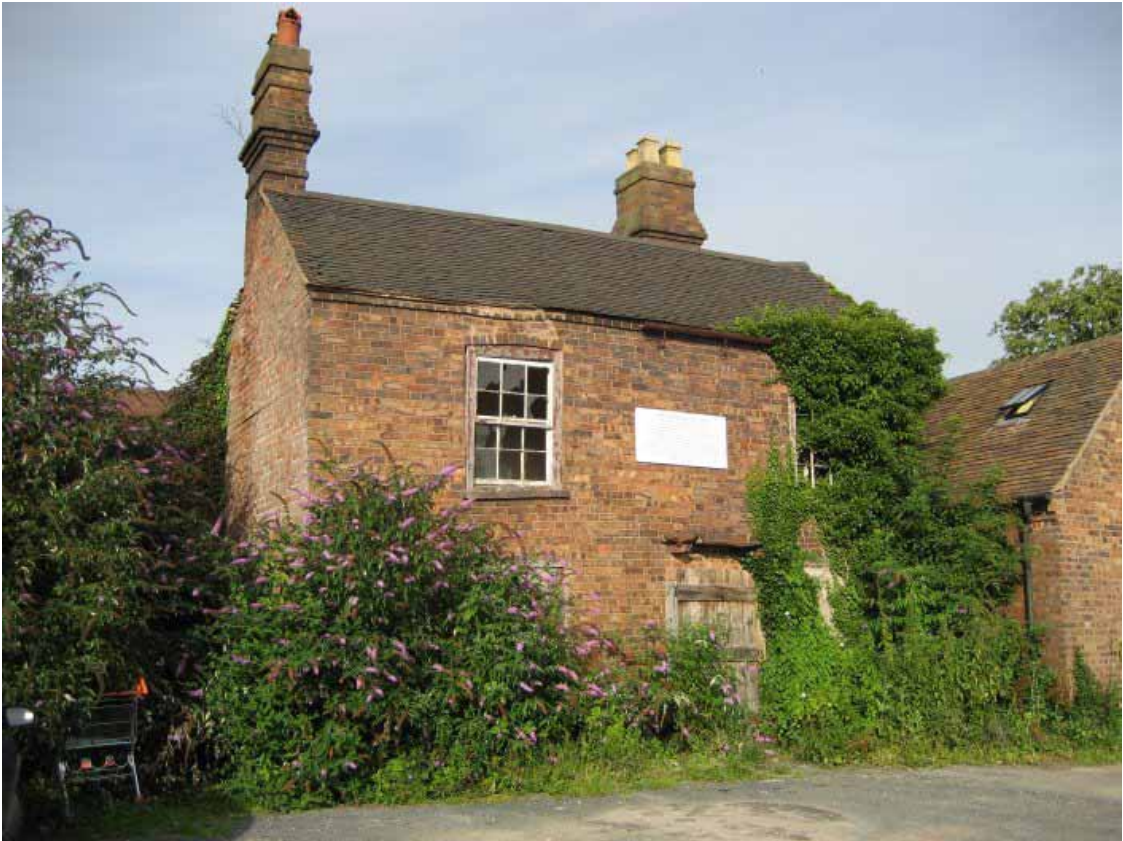
Plate 23. No. 5 Whitburn Street. A 19th century brick two-storey, three-bay house, now uninhabited and derelict. This house was originally accessed by a lane between Nos. 4 and 5 Whitburn Street (see Plate 21), which led to a garden in front of the house, shown on Ordnance Survey map of 1884 (see Fig 9). There is some evidence for subsidence on the north side of building, where it stands over the town ditch (see text).
