DESK-BASED ASSESSMENT
OF SAINSBURY'S
SUPERMARKET SITE,
THE SMITHFIELD, BRIDGNORTH,
SHROPSHIRE

Project 3079
Report 1555

Part 1 Project summary

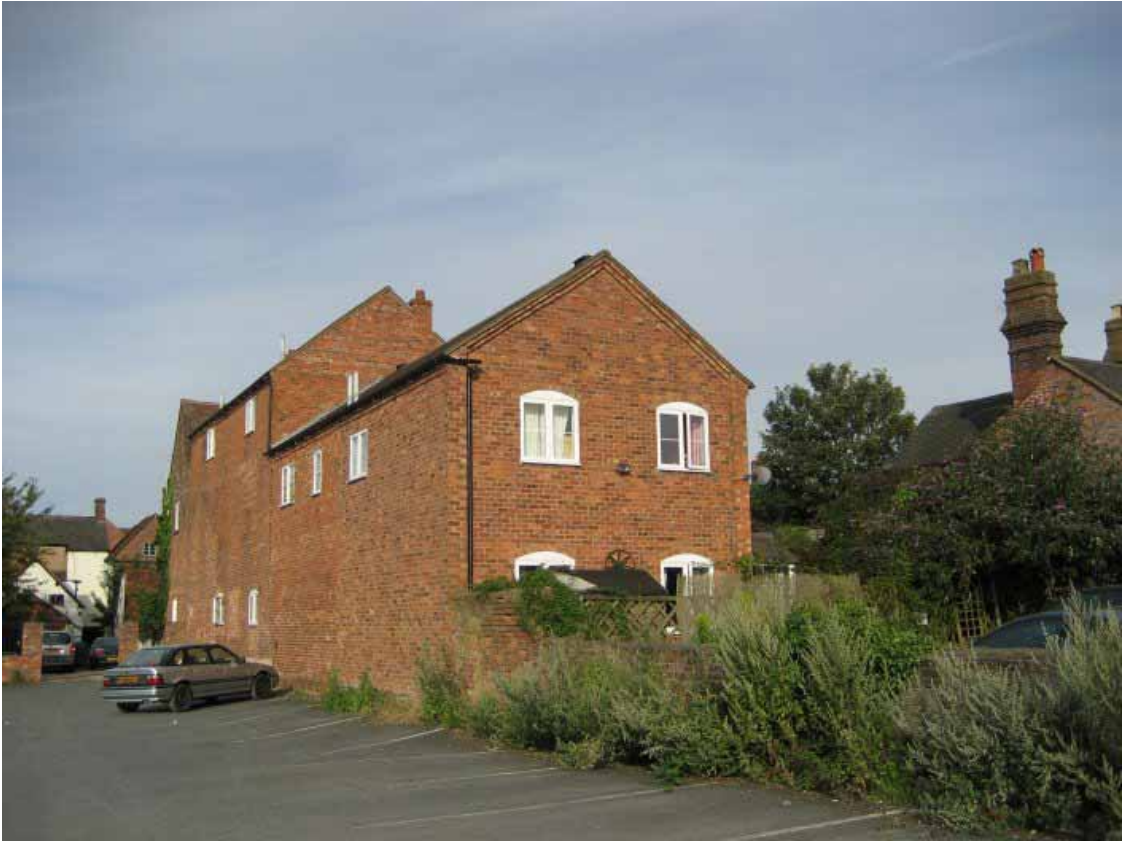
Plate 24. Nos. 3-6 Northgate Mews. Row of 19th century houses (rear elevation).

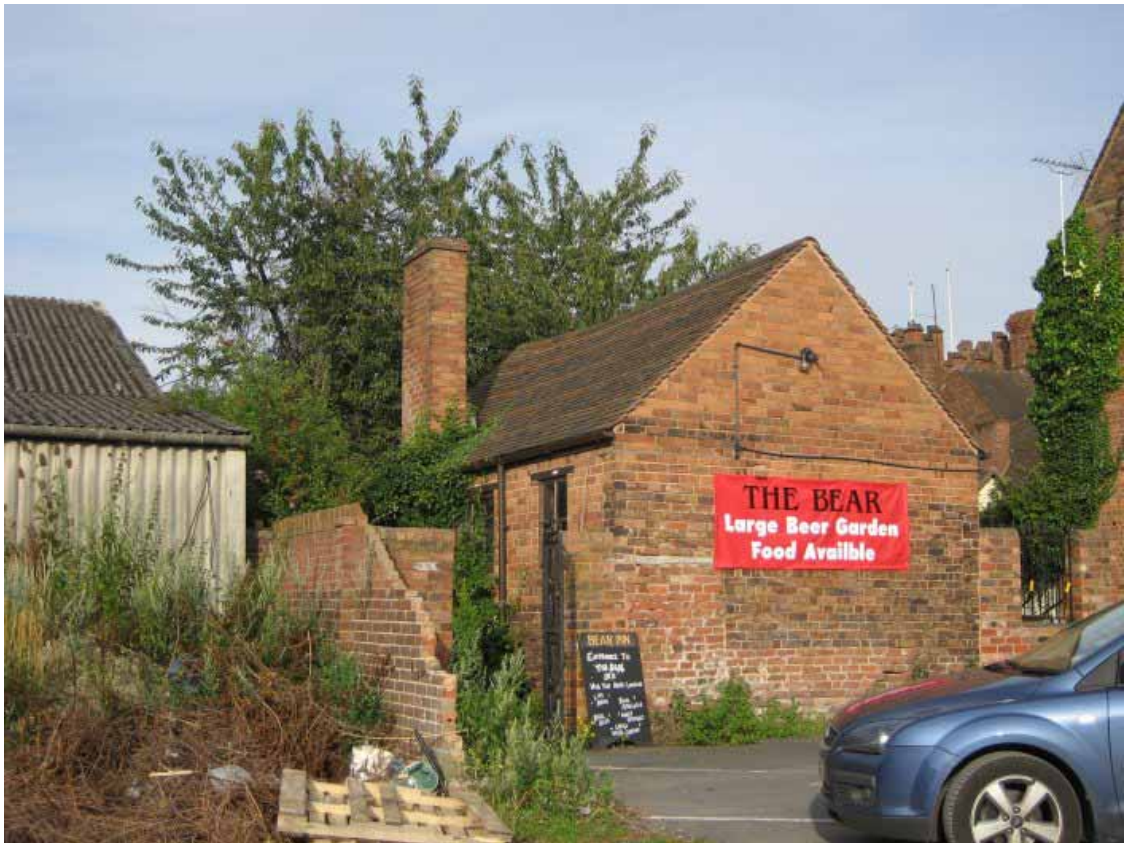
Plate 25. Small C19th workshop building, rear yard of The Bear.

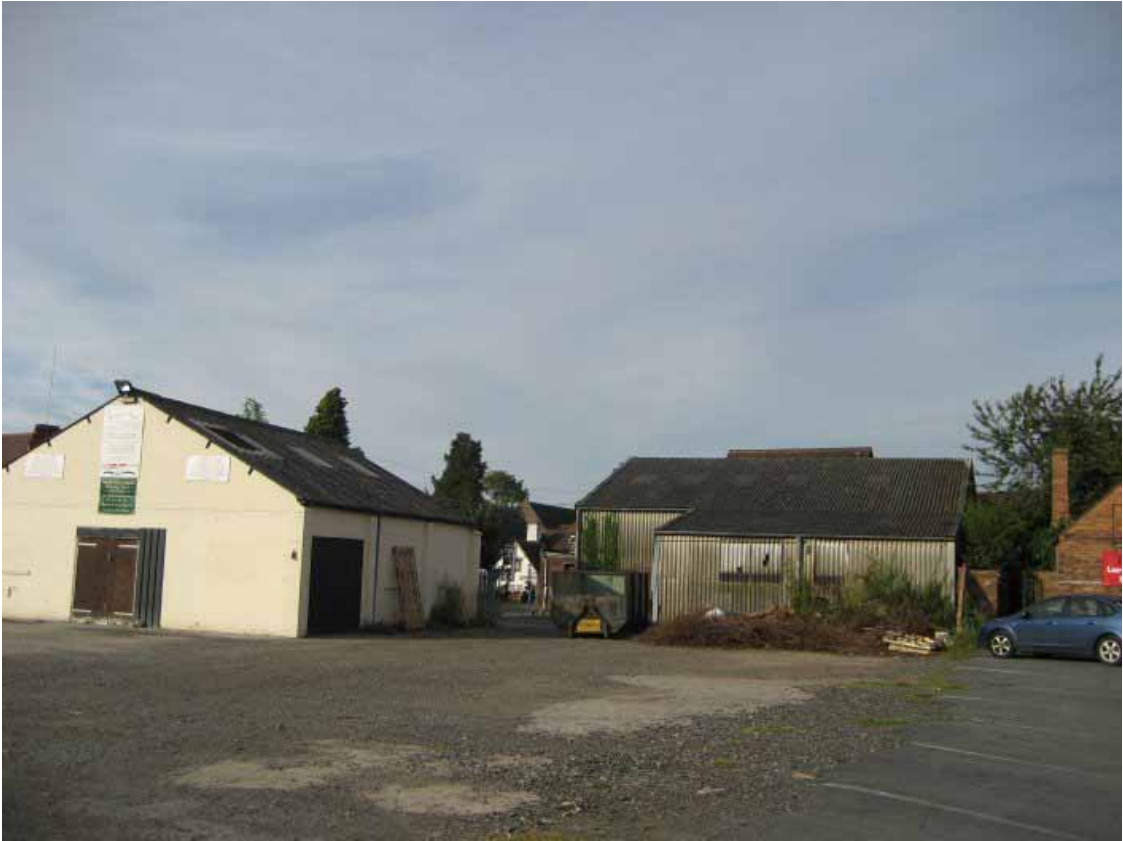
Plate 26. Modern garage buildings, part of Northgate Garage. These buildings are identified for demolition in the planning application.

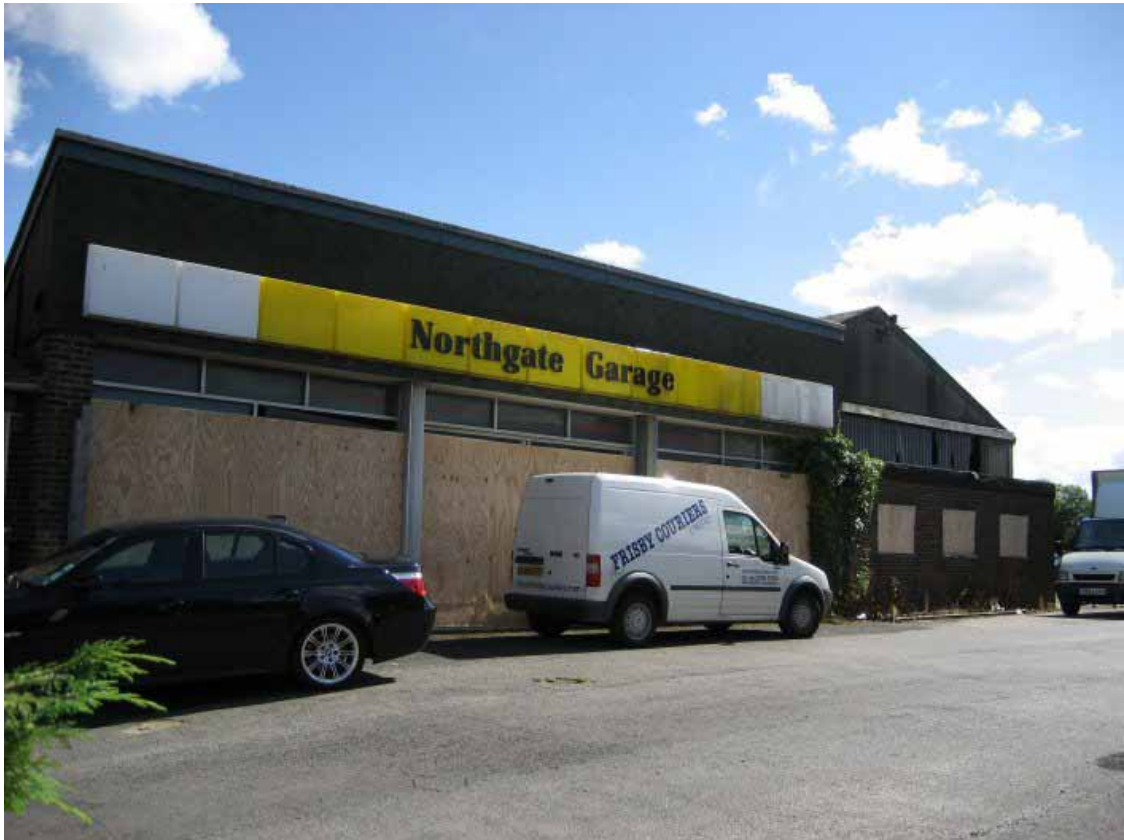
Plate 27. The Northgate Garage, North Gate. A C20th brick building, identified for demolition in the planning application: the new relief road will run through here (see Fig 4).

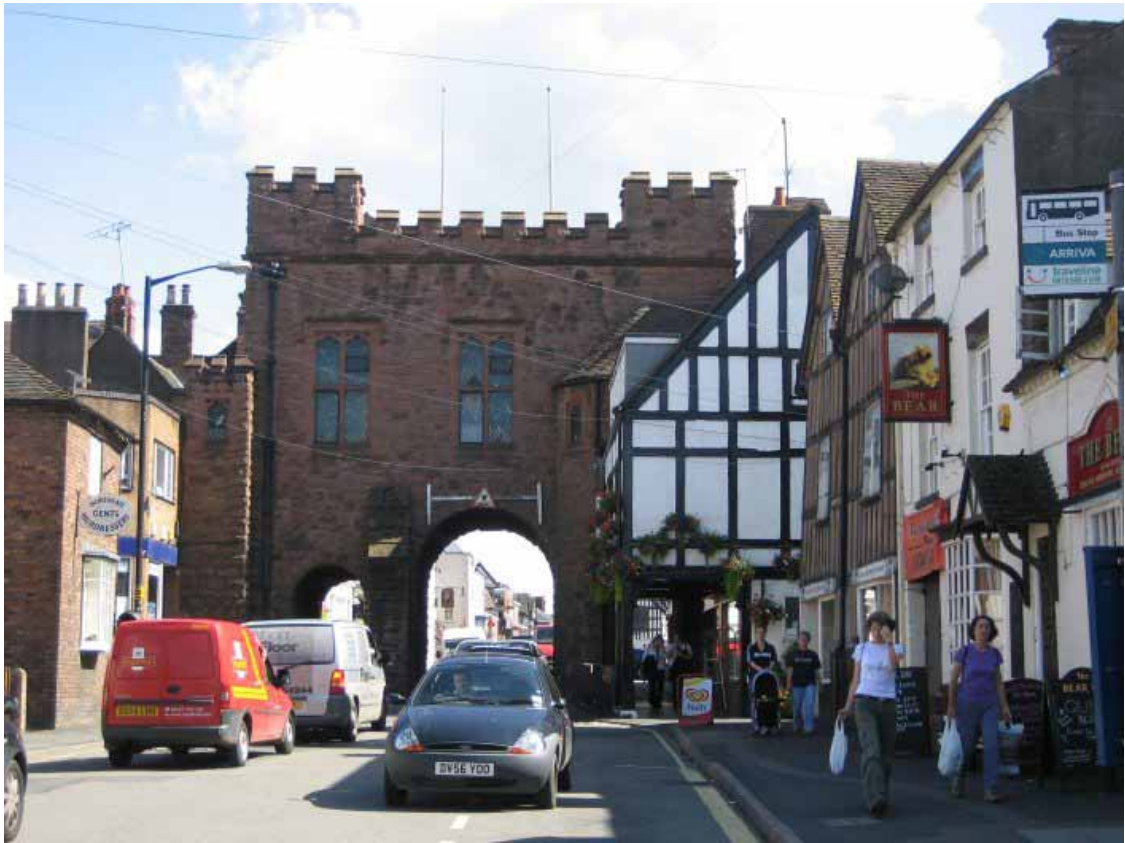
Plate 28. The North Gate, view to south.

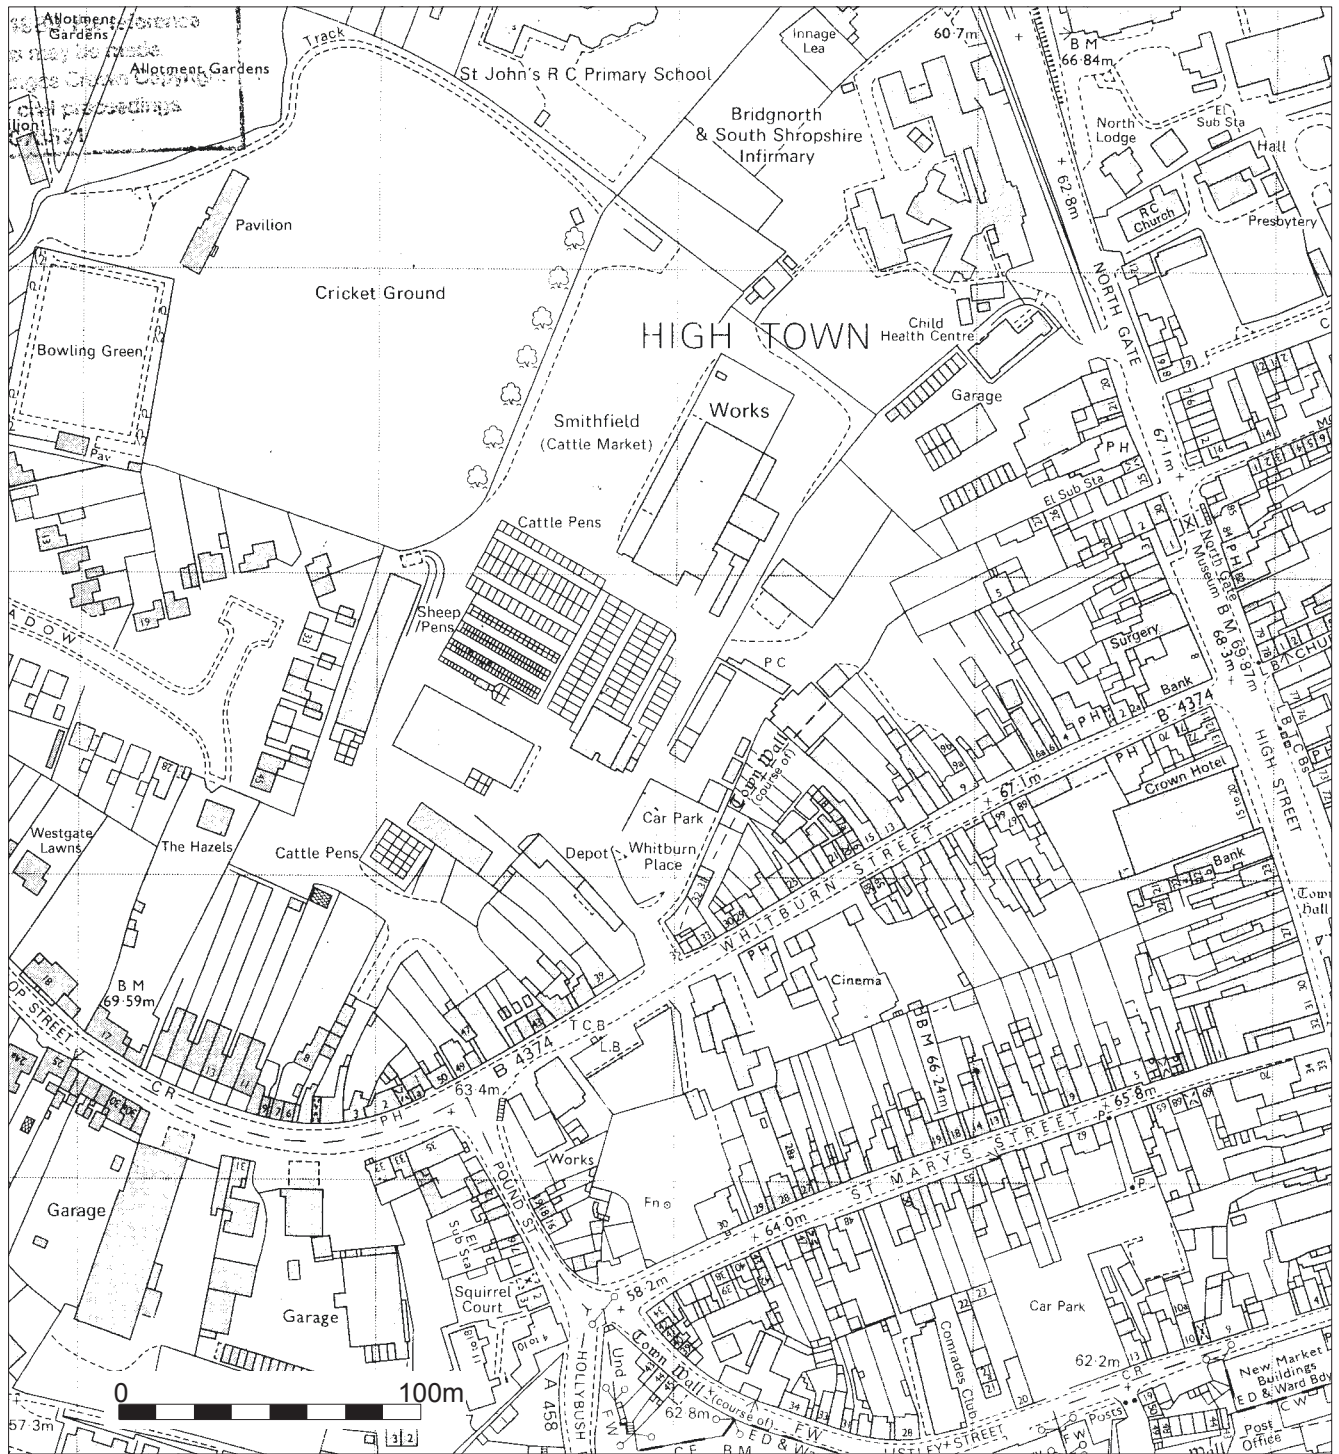
Figure 13

Extract from Ordnance Survey 1:2500 map SO 7193 (1982)
