Archaeological desk-based assessment of a site at Kingsholm Road, Gloucester

Date: 7 October 2014
Author: Elizabeth Connolly, econnolly1@worcestershire.gov.uk
Illustrator: Laura Templeton
Project reference: P4325
Report reference: 2150

Desk-based assessment at Kingsholm Road, Gloucester

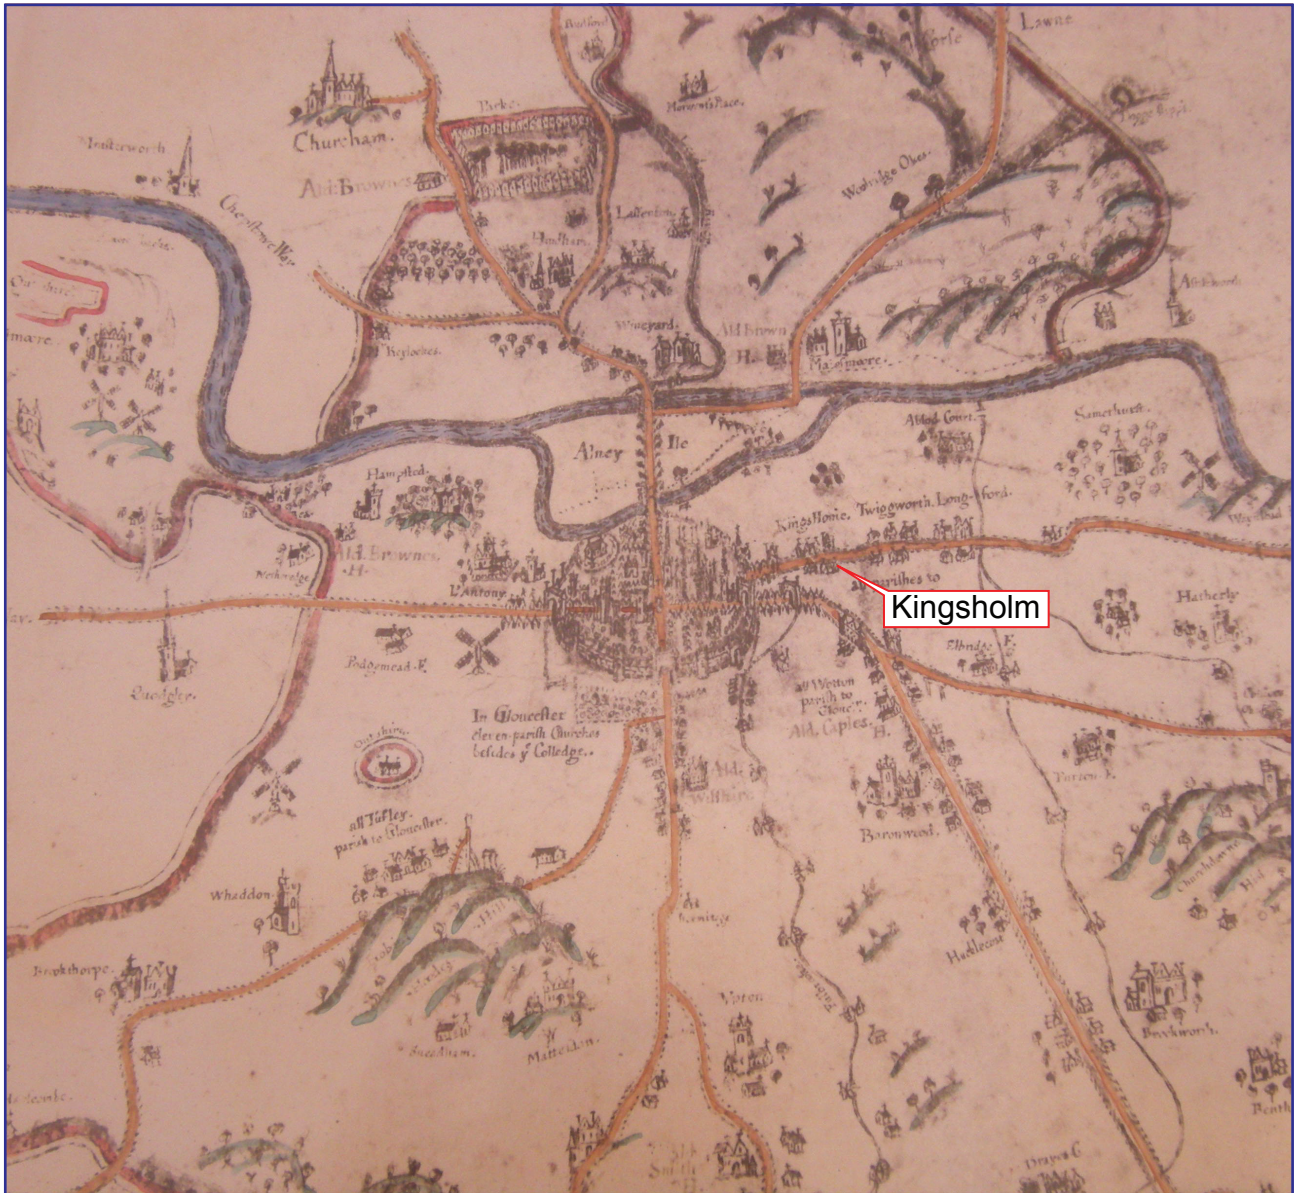
Figure 3

Extract of 1624 Map of Gloucester

On the 1624 map of the inshire of Gloucester (Figure 3), Kingsholm is shown as mainly undeveloped, with some houses fronting onto the road north out of Gloucester. A raised area is depicted which might be the site of the palace, and later the Manor House at Kingsholm Close.

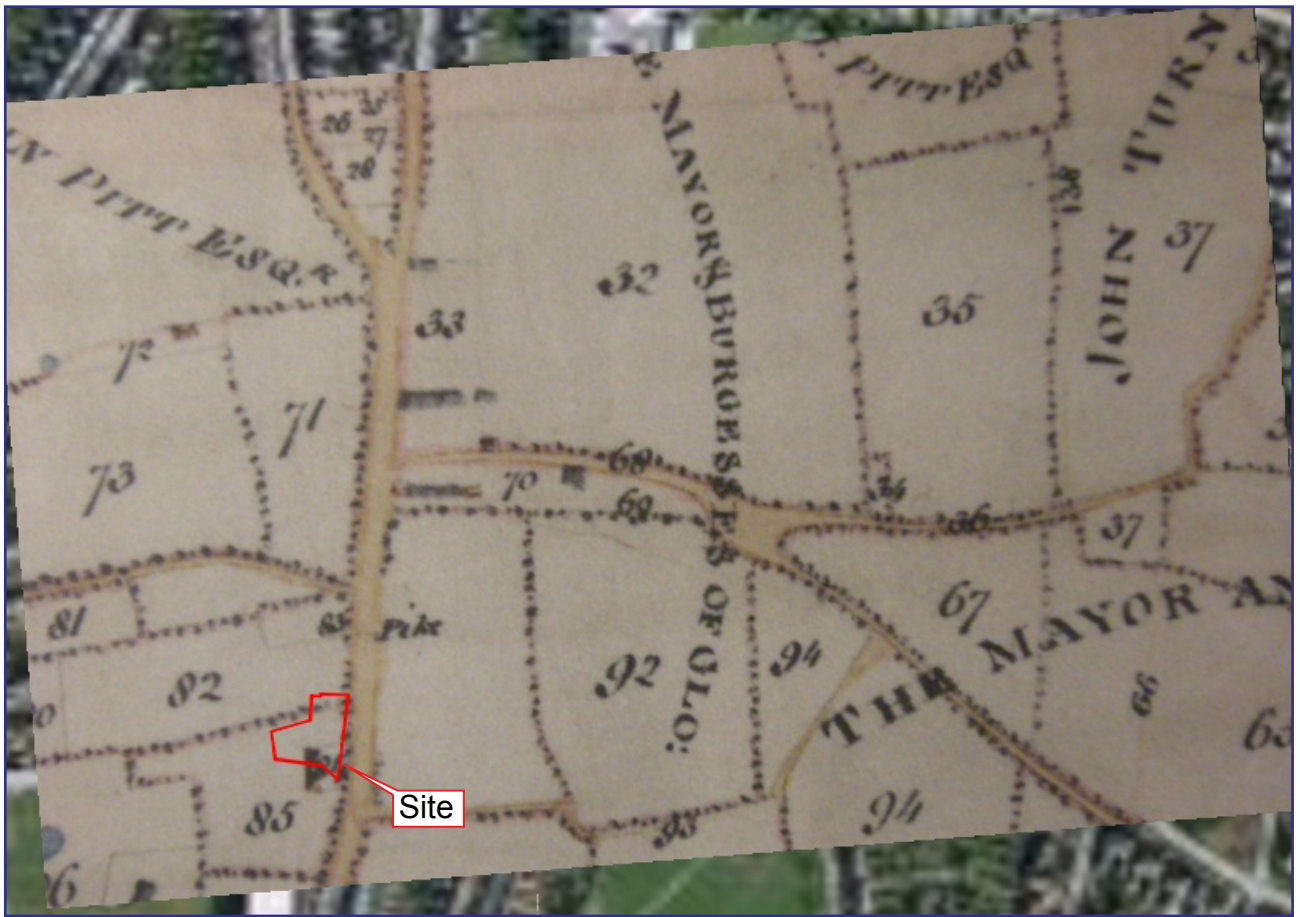
Figure 4

Extract of 1799 Inclosure Map

On the 1799 Inclosure map (Figure 4) the proposed development site is shown as part of two parcels of land, one small, squarish piece, land parcel number 84, described in the apportionment as *messuage garden &c*. The land parcel is small and some shading along its western boundary might in fact represent a building. The term *messuage* generally refers to a dwelling house and appurtenances legally as one. The second land parcel, number 85, is a larger irregular shaped field, described in the apportionment as the *St Pt of the Orchard* (South Part of the Orchard). The road running north is shown as a turnpike. The distinctive curve of Edyw terrace is identifiable to the north of the site but the landscape is clearly mainly agricultural.

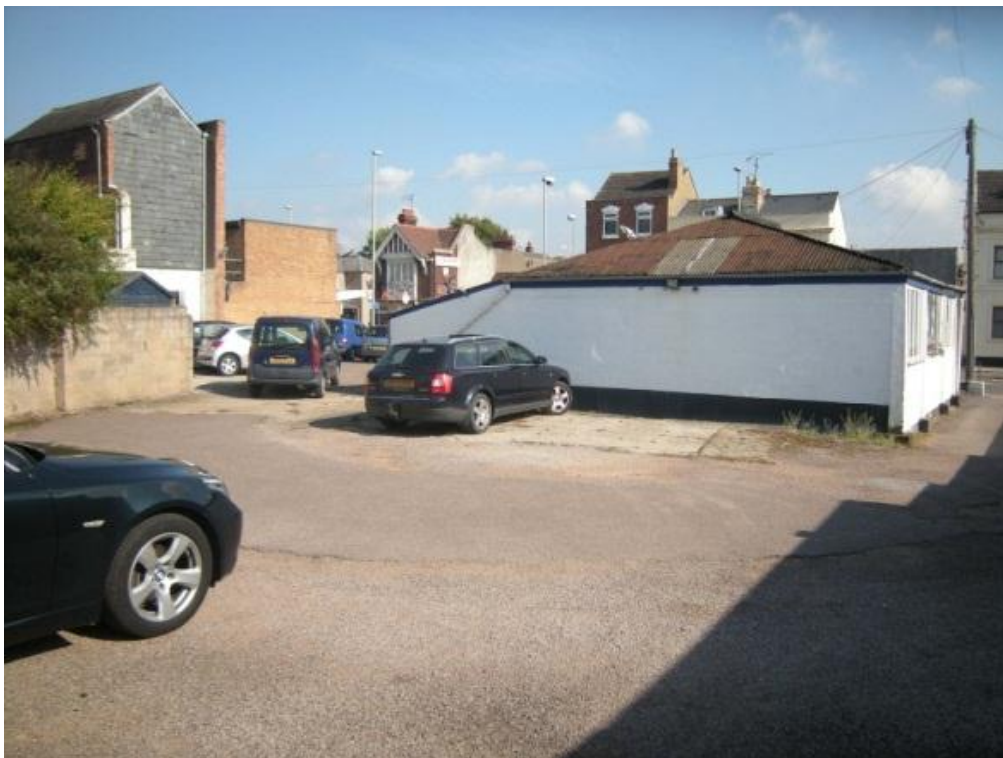
Plate 3 View east from rear of the site showing the car workshop and concrete floor to rear

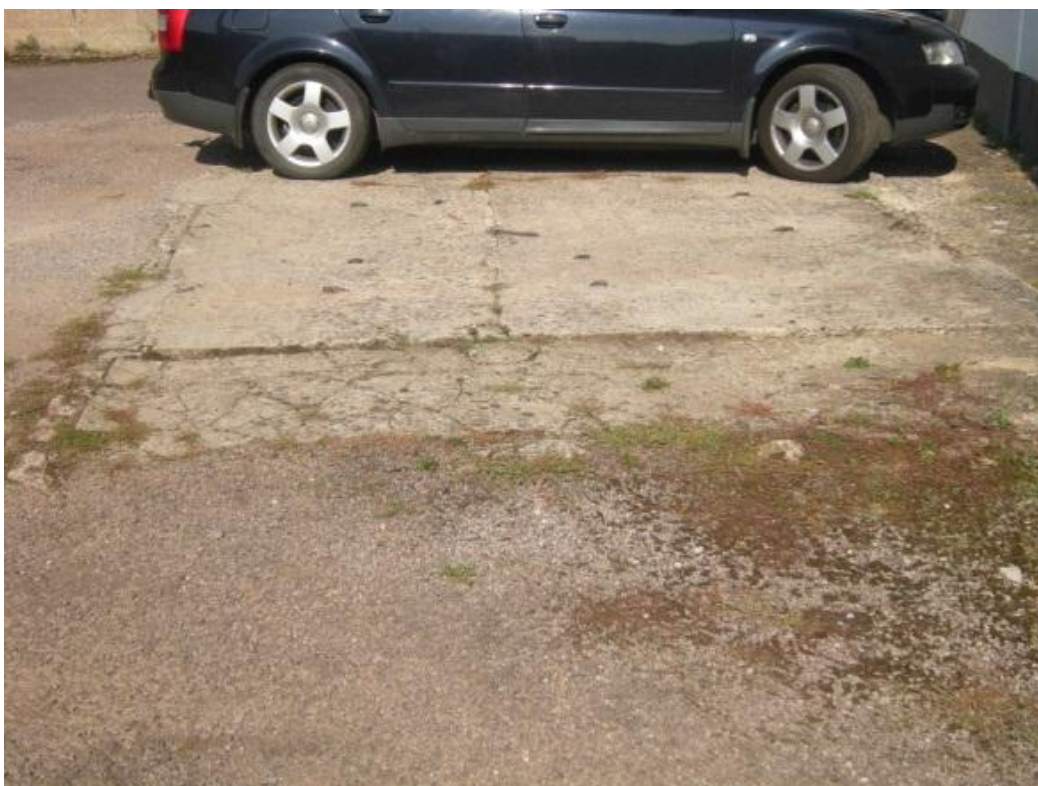
Plate 4 Detail of concrete floor from south

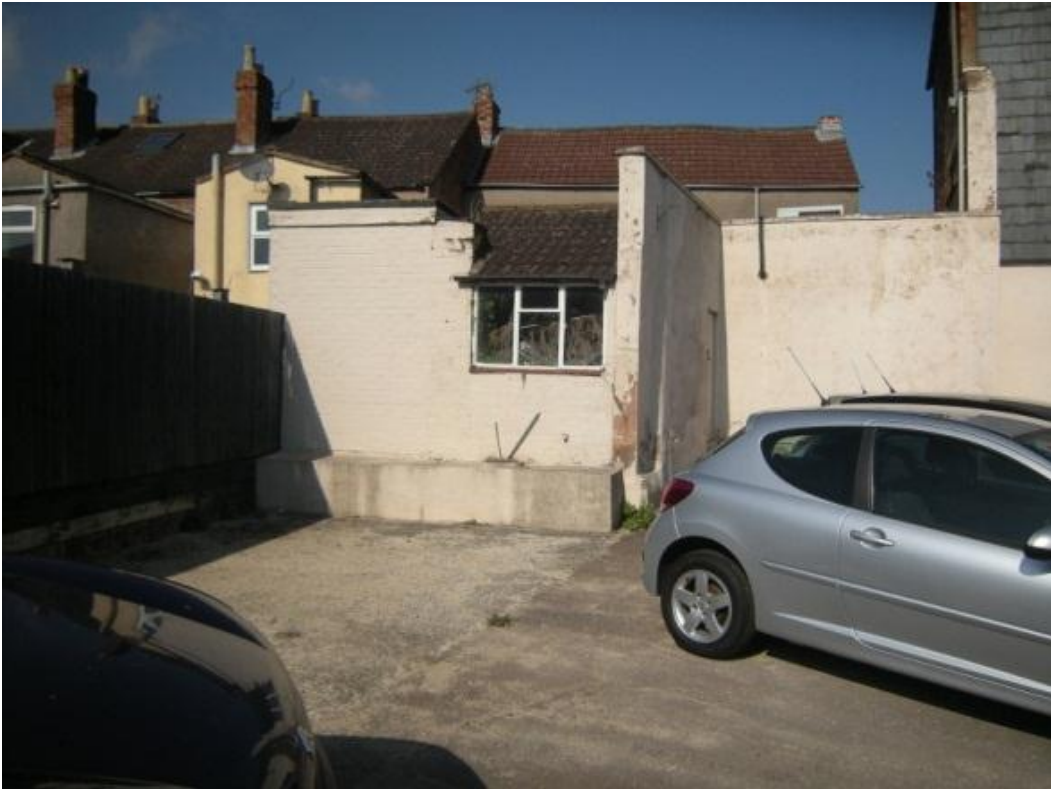
Plate 5 Shed in north west of site

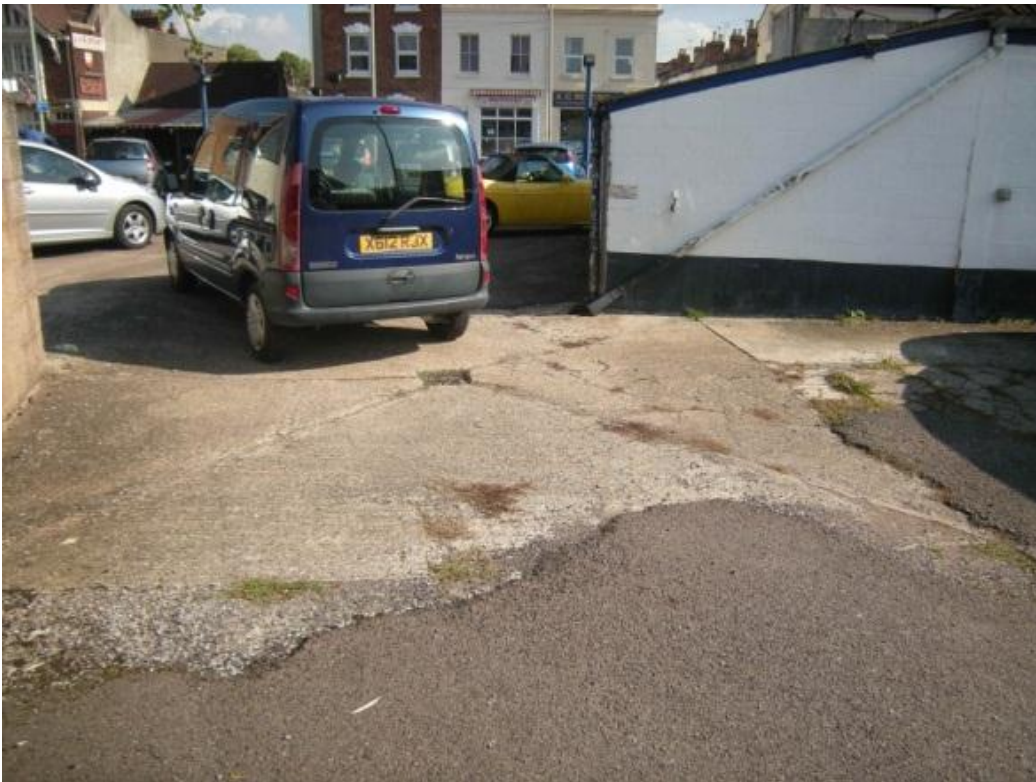
Plate 7 Detail of drainage to north-west of car workshop

A brick built work shop stands in the centre of the site (Plate 2), with the rest of the area being tarmacked for car parking with a low concrete fence between the site and the road. It was established that the workshop does not have a mechanic's pit. The ground slopes gently from east to west. A slightly raised area (7.8m north west by south east; 3.5m south west by north east) of concrete slabs containing projecting ironwork and edged with kerbing, possibly the base or foundation to a floor area of a previous building on the site, is immediately to the rear of the current workshop (Plates 3 and 4). Evidence of drainage runs across the site to the north of the workshop with two drainage grilles and a manhole recorded (Plate 7).
