HISTORIC BUILDING  
RECORDING  
AT TACK FARM,  
HEWELL LANE, TUTNALL AND  
COBLEY, WORCESTERSHIRE

Project 2413  
Report 1228  
WSM 32866

## **Historic building recording at Tack Farm, Hewell Lane, Tutnall and Copley, Redditch, Worcestershire**

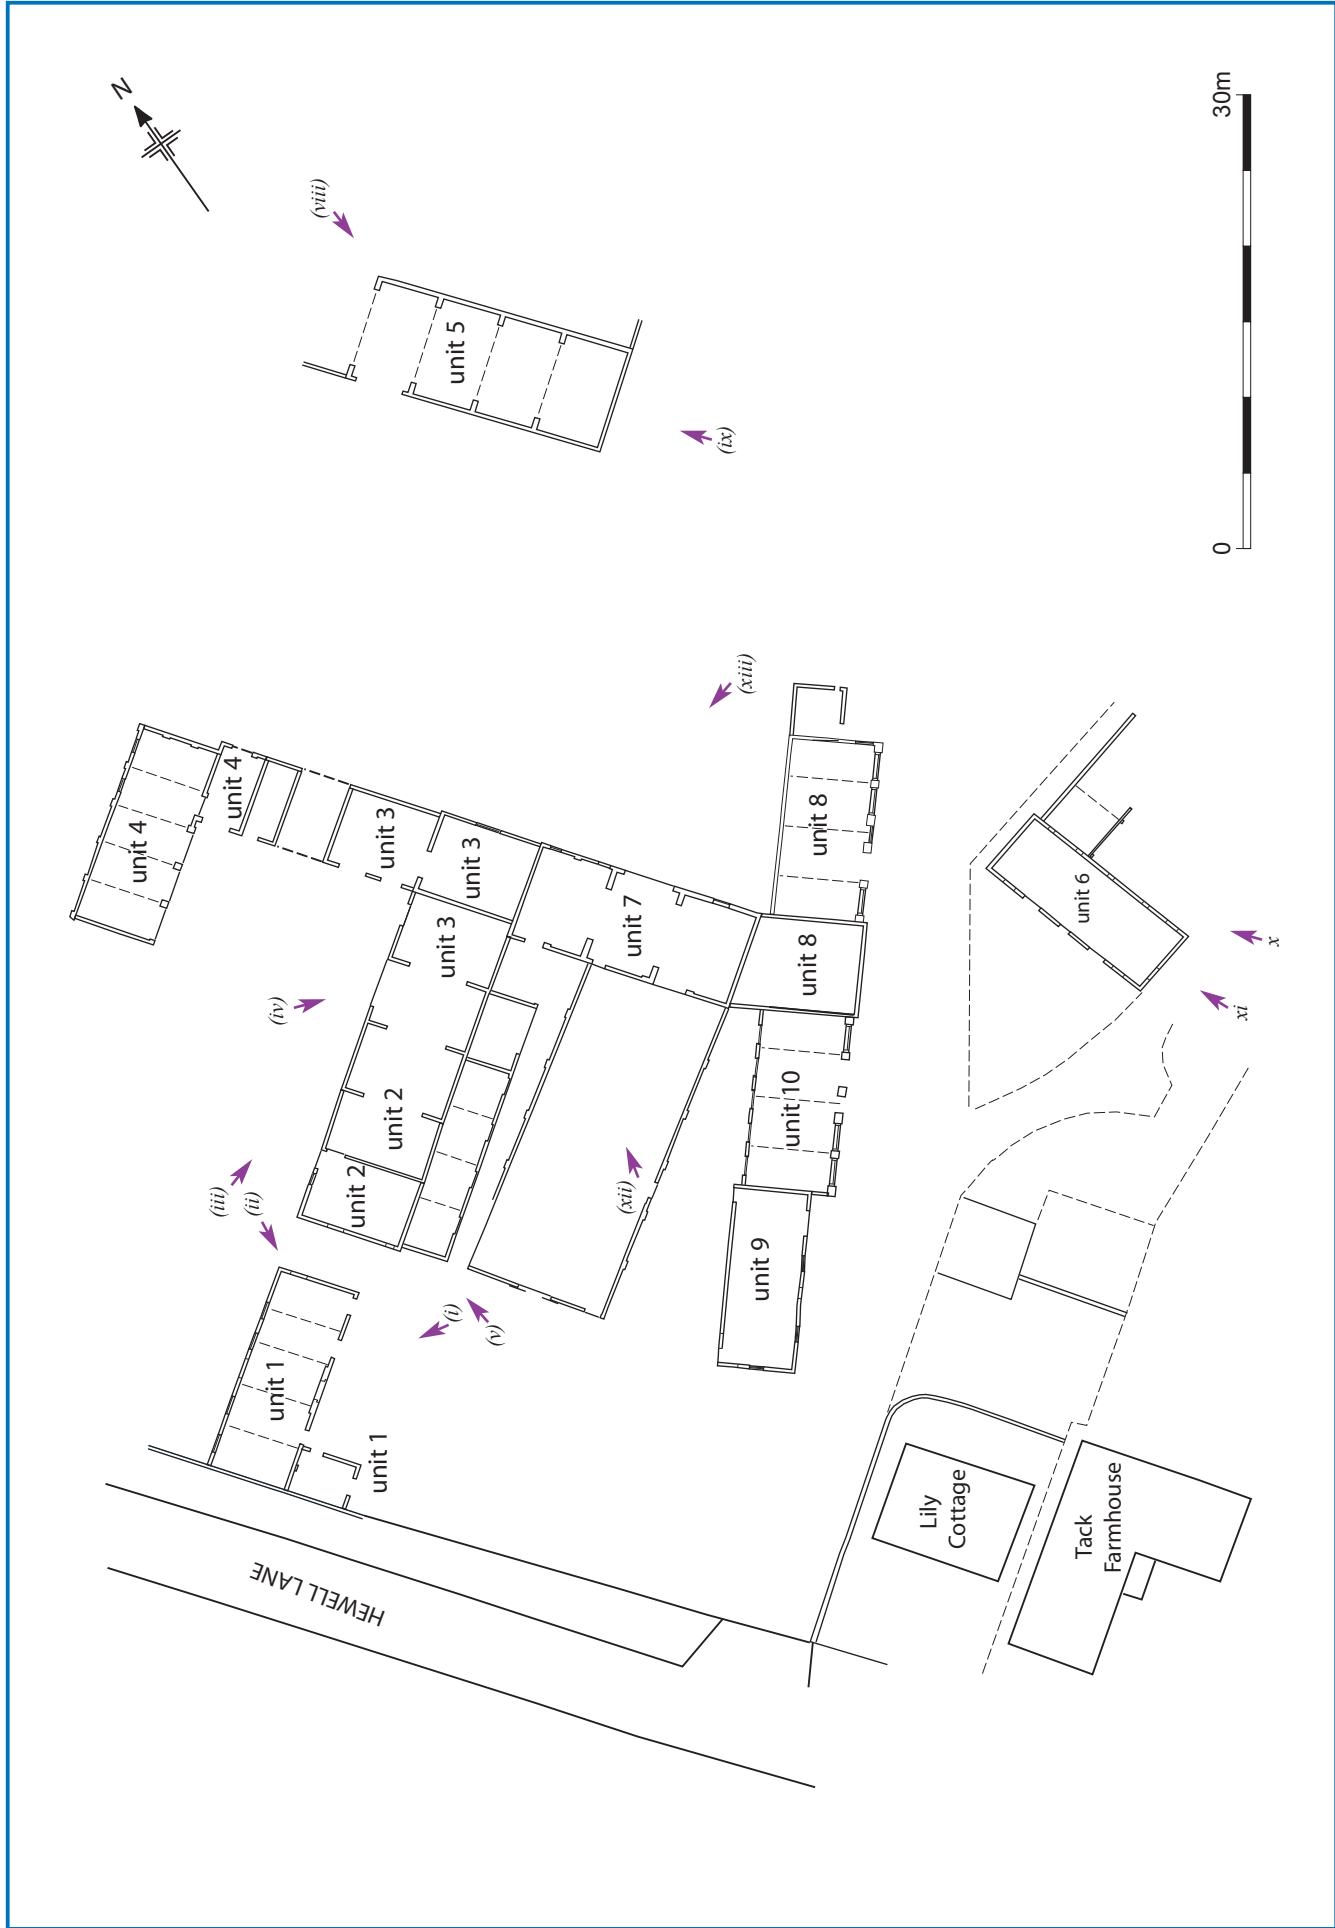
Plan of buildings recorded showing location and direction of plates.

A plan of the buildings recorded is provided in Figure 5 showing the location and direction of the photographs reproduced in this report (Plates i-xx). In addition a phased plan of the buildings is provided in Figure 6.

The main farm buildings (Units 2, 3, 7, 8, 9 and 10) are arranged in a U shaped plan composed of two long ranges running north-east to south-west (Units 2 and 3) and north to south (Units 8, 9 and 10) bridged by a further range running north-west to south-east (Unit 7). This main set of ranges is flanked by Unit 1 to the south-west, to the north-east by Unit 4, to the south-east by Unit 6 and to the north-east by Unit 5.

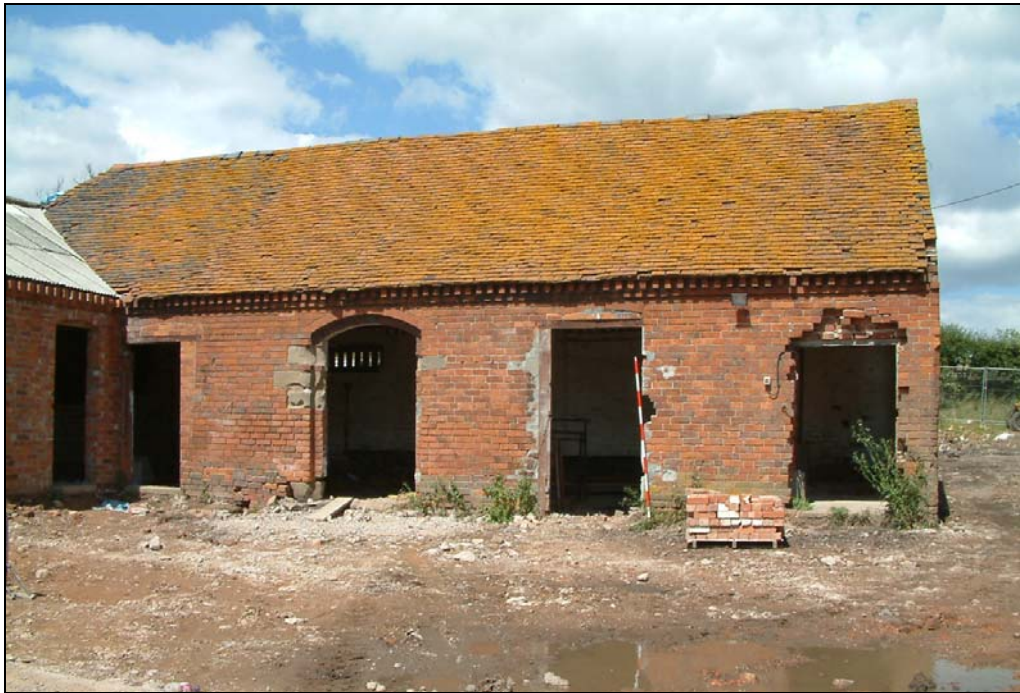
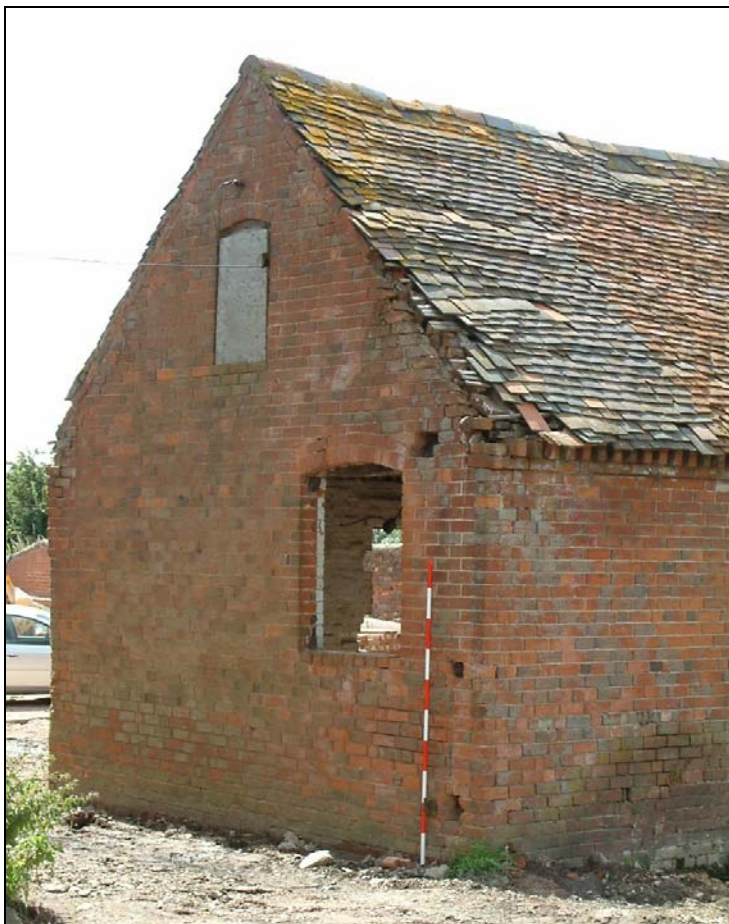
A single storey building with 'L' shaped plan comprising two cells, the lesser of which abuts the south-west boundary wall and appears to be a later addition running south-east from main body of the building. The building is constructed of bricks measuring 9" x 2.75" x 4.25" coursed in Flemish stretcher bond with dentilated eaves and a flat tiled gabled roof supported by three king post trusses. The main south-east elevation (Plate i) contains one original doorway with four blue sandstone blocks inserted into the brickwork of the edges and a semi-circular arch. In addition are three inserted door openings all with flat wooden lintels. One of these is clearly inserted into a former window opening and the remains of flat segmental relieving arch remain extant. The north-west elevation contains an inserted centrally placed door opening with flat segmental arch, flanked by four narrow elongated windows positioned directly below the eaves. The north-east gable end contains an inserted window with flat segmental arch on the ground floor and a tall opening within the loft area (Plate ii). Closers along north-west edge of this opening indicate that it is also a later addition. The smaller cell at the south-west extent of the building contains a door opening in the north-east elevation and a window opening in the south-east elevation, both openings have flat segmental arches.

Internally the floor of the main cell is brick laid in stretcher courses with evidence of a partition wall formerly dividing the north-east end of the building. The floor of the smaller cell is concrete.

*Plate i: South-east facing elevation of Unit 1*

*Plate ii: North-east gable end of Unit 1*

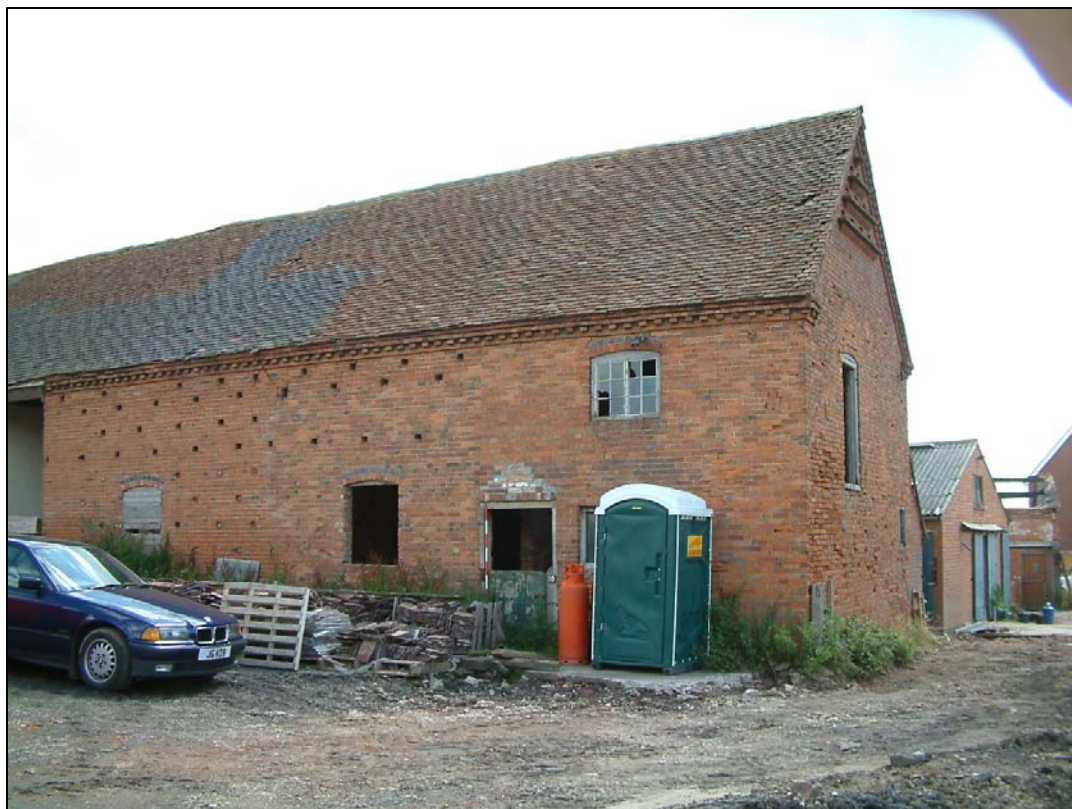
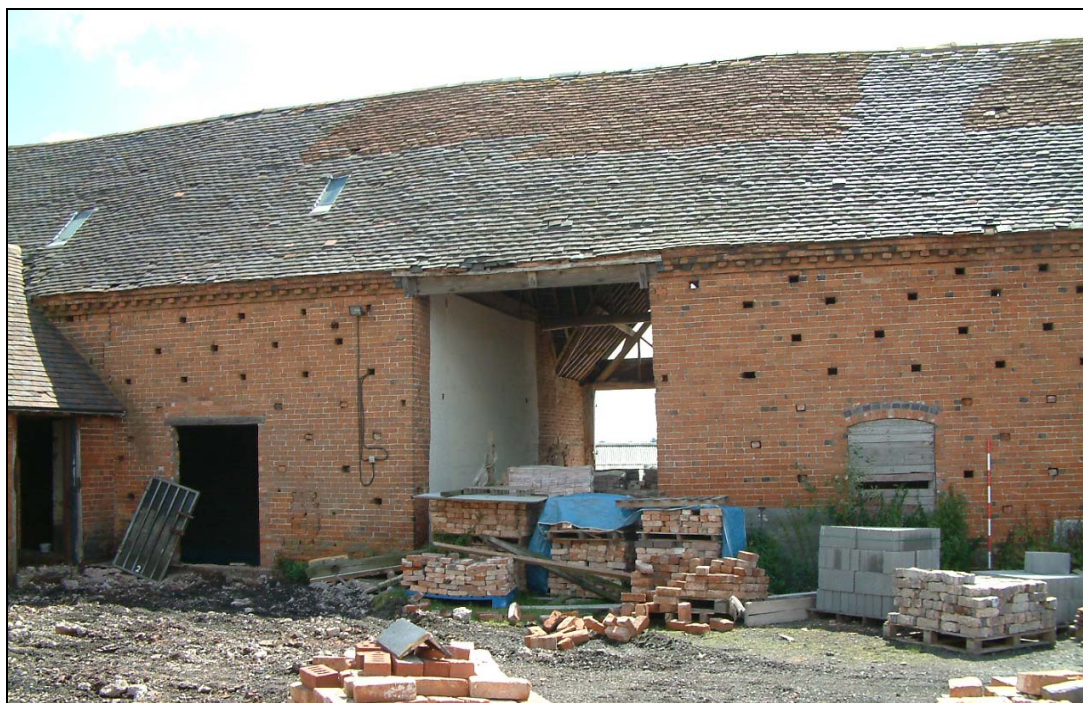
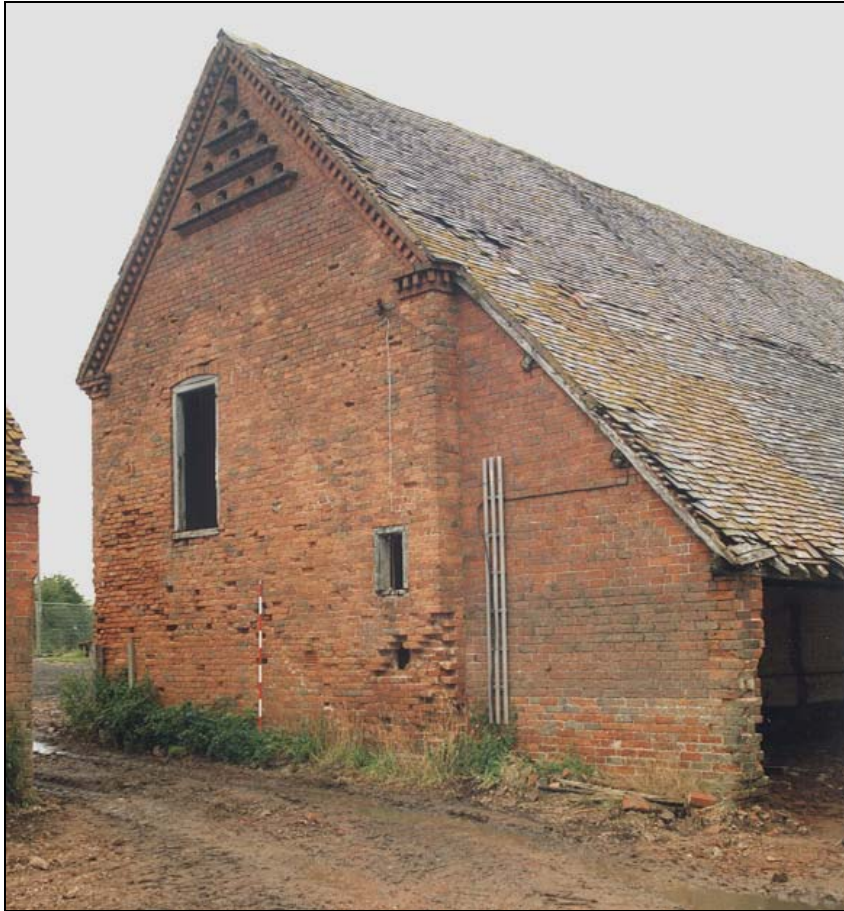
These buildings form an 'L' shaped plan comprising five cells, four of which are the main north-east to south-west aligned range (Units 2 and 3) with a single storey fifth cell running north-west at the north-east end (Unit 3). In addition a long single celled stable block abuts the south-east elevation. The building is built using bricks measuring 8.5-9" x 2.5" x 4.25" coursed in Flemish stretcher bond with dentilated eaves along the two storey main range (Plate iii and iv). The north-west facing elevation contains pierced brickwork which is coursed in English Garden Wall with piercing on the header courses. This piercing is also evident on what is now the south-west internal elevation Unit 2 indicating that this was formerly an external wall, the piercings are now blocked. The buildings have a gabled roof with flat tiles extended to the south-east to cover the single storey 'lean-to' stable block. The roof is supported by four composite trusses within the main range and by mono-pitch trusses

within 'lean-to'. Ventilation piercings in what is now the north-west internal elevation of Unit 3 indicate that it was formerly an external elevation.

The north-west facing elevation of the main range contains three window openings on the ground floor, two of which are rectangular with segmental flat brick arches with the third being square with flat wooden lintel. A fourth window opening with flat segmental arch is present on the first floor. Door openings are present at the south-west and north-east ends of the elevation providing access to Units 2 and 3 respectively. At the junction of the two units is a large rectangular open drift-way, which is also present on the opposite elevation (south-east facing) within a projecting gabled porch. The south-west gable end shows the shadow of a former single storey gable, evidently the original end of what is now a separate building, the stable block (Unit 1; Plate v). The gable also contains openings relating to the use of the loft space as a pigeon loft. Internally the floor is composed of bricks laid in rows of stretchers.

*Plate iii: North-west facing elevation of Unit 2*

*Plate iv: North-west facing elevation of Unit 2 and 3*

*Plate v: South west facing elevation of Unit 2 –showing shadow of former gable*

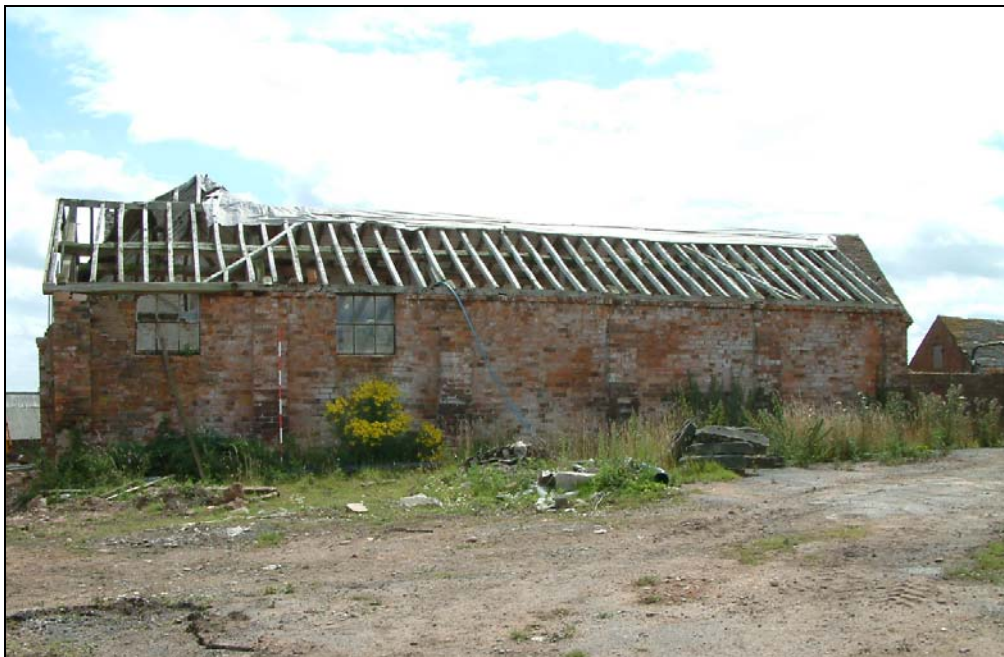
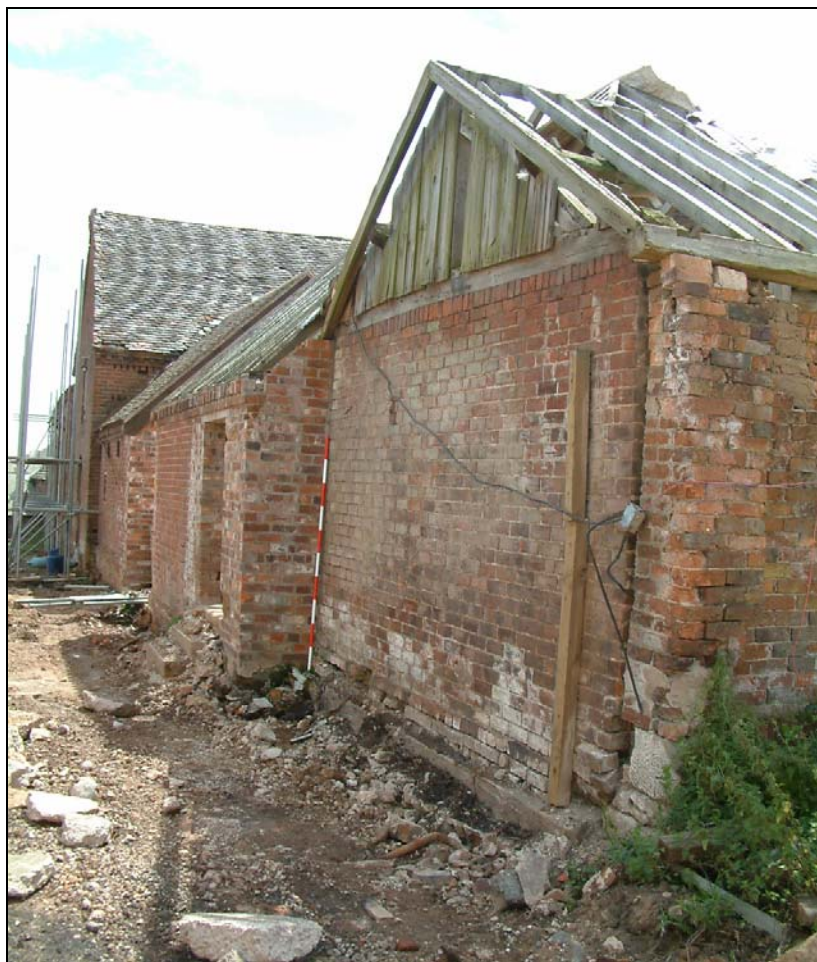
An 'L' shaped single storey brick structure, comprising three cells, coursed in Flemish stretcher bond with the exception of the north-west elevation which is randomly coursed and built up from a stone plinth. The north-west elevation is also distinct due to its brickwork external buttress and dog tooth dentilated eaves (Plate vi). These features were also observed on the internal elevation of the south-eastern cell of the building which suggests that these two elevations represents the only extant elements of an earlier phase. The joint between the north-west and north-east elevation (Plate vii) clearly demonstrates the relationship inferred from structural features. The remaining elevations have been identified as three further phases of 19<sup>th</sup> century rebuilding. The earliest of these, dating to the mid 19<sup>th</sup> century, is the southern half of the north-east elevation, followed by the remaining north-east elevation, the south-west elevation and the open south-east elevation which are all of late 19<sup>th</sup> date. Two elevations have been built using re-used brick (the south-east internal and external elevations of the south-east cell), as such it is not possible to state with any certainty the date of their construction.

The gabled roof is supported by four king post trusses in the north-west cell and one kingpost truss with clear carpenters marks in the south-east cell. Openings comprise rectangular flat headed door openings in the north-east and south-west elevations and two square window openings with 6 casement metal frames in the north-west elevation.

*Plate vi: North west facing elevation of Unit 4*

Plate vii: North-east facing elevation of Unit 4

Only three extant elevations represent this phase of the farms development, comprising the north-west external and south-east internal elevation of the store (Unit 4) and the north-west facing elevation of the shelter shed or cow house (Unit 10). The two extant elevations of this phase within the store (Unit 4) represent an earlier phase of the building at which time it was a single storey rectangular building and was most likely not open to the south-east. The elevations contain regularly spaced external buttresses and dogtooth dentilated eaves. The function of this building is not certain, however given its setting just out of the main yard area it would seem appropriate to suggest that it was a machine store.

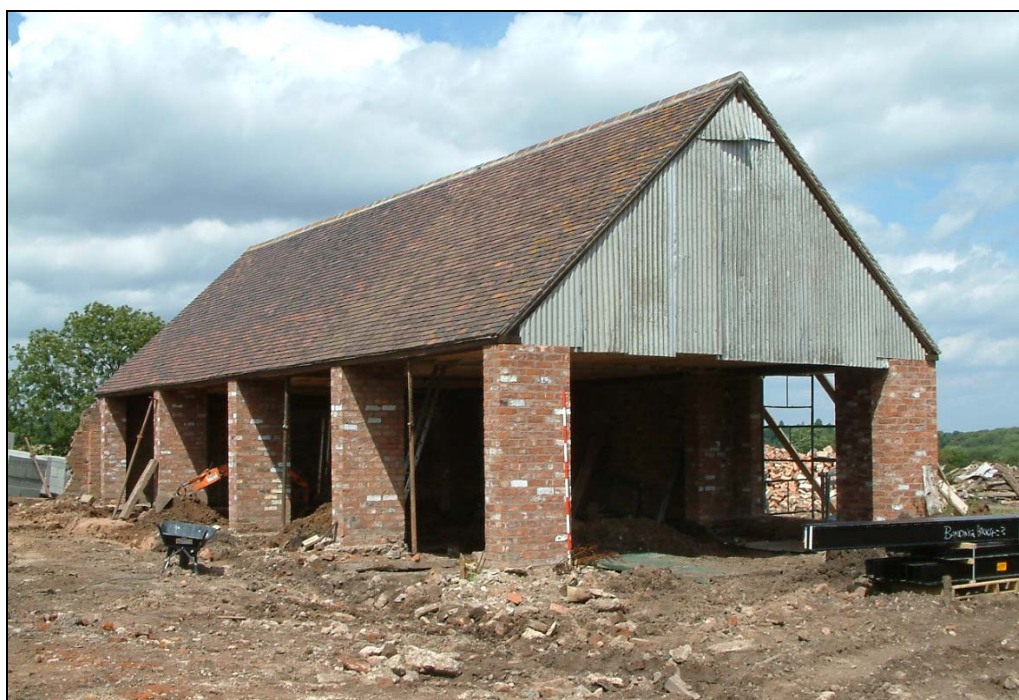
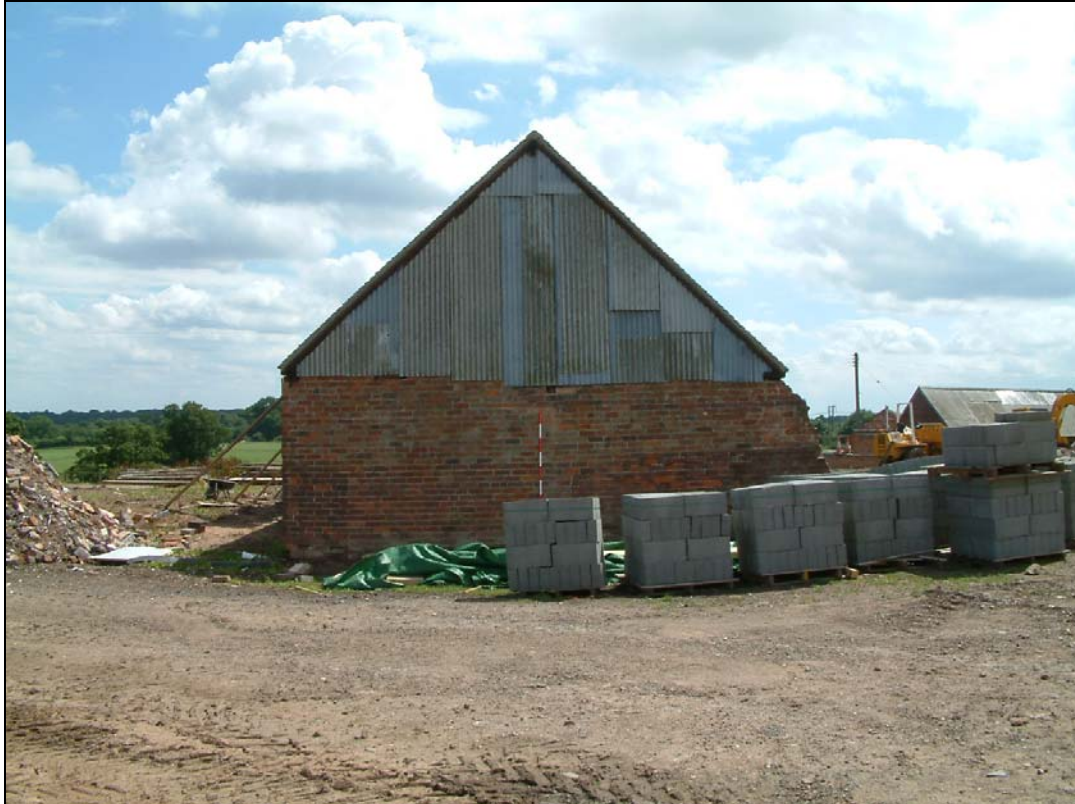
A single celled rectangular structure aligned north-west to south-east. The building is open to south-west with four brick piers forming the elevation, the piers support the wall plate and four trusses which in turn support a gable flat tile roof. The ground floor of the north-east elevation and north-west gable are brick built constructed with handmade bricks measuring 9" x 3" x 4.5", coursed in Flemish garden wall. The gables are clad in corrugated sheet metal. The north-east facing elevation contains a single door opening at the northern end of the building. The floor is of concrete.

Plate viii: Gable and south-west elevation of Unit 5

*Plate ix: North-west facing gable, Unit 5*

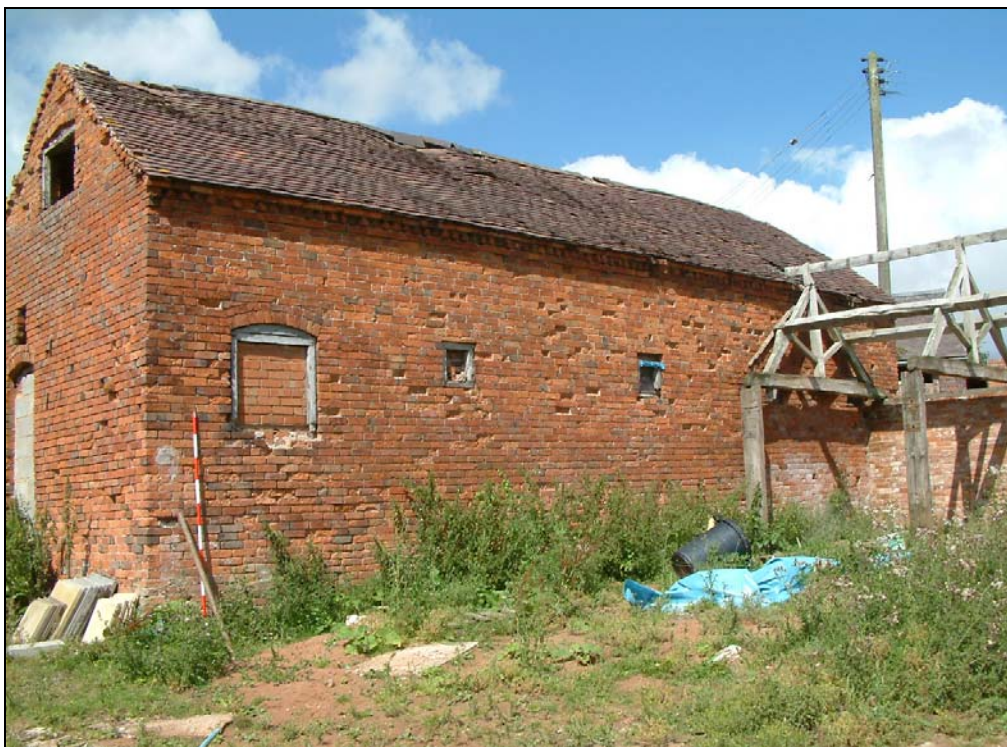
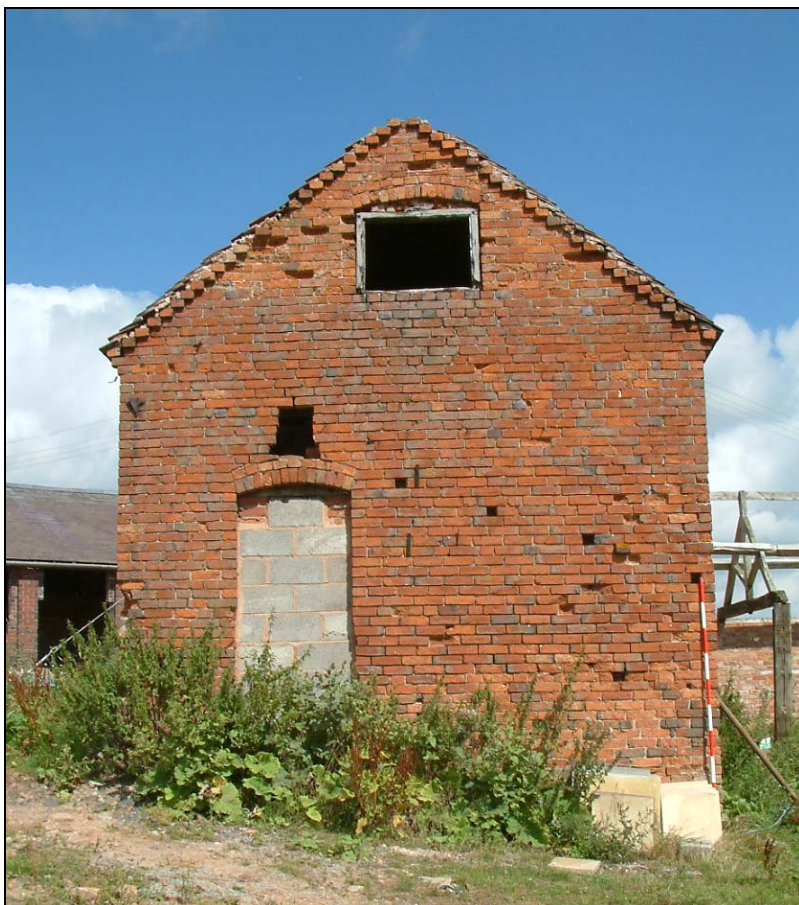
A single celled brick rectangular structure aligned north-west to south-east. The building is constructed with handmade bricks measuring 8.5" x 2.5" x 4", coursed in Flemish garden wall with dogtooth dentilated eaves and a gabled flat tile roof supported by four queen post trusses. Openings in the north-east elevation comprise four small square windows with wooden lintels and a rectangular window opening with flat segmental arch at the south-east end. The south-west elevation contains three door openings, two of which are stable doors.

all have flat segmental arches. Small inserted rectangular windows are present at either end of the elevation, flanking the door openings.

The remains of a gabled shelter shed are attached to the north-east elevation, comprising timber uprights and a brick elevation running north-east, supporting two king post trusses, purlins and a ridge board. Internally the ground floor has a concrete floor and a first floor loft area accessible from both gable end of the building.

*Plate x: North-east elevation facing elevation of Unit 6*

*Plate xi: South-east facing gable, Unit 6*

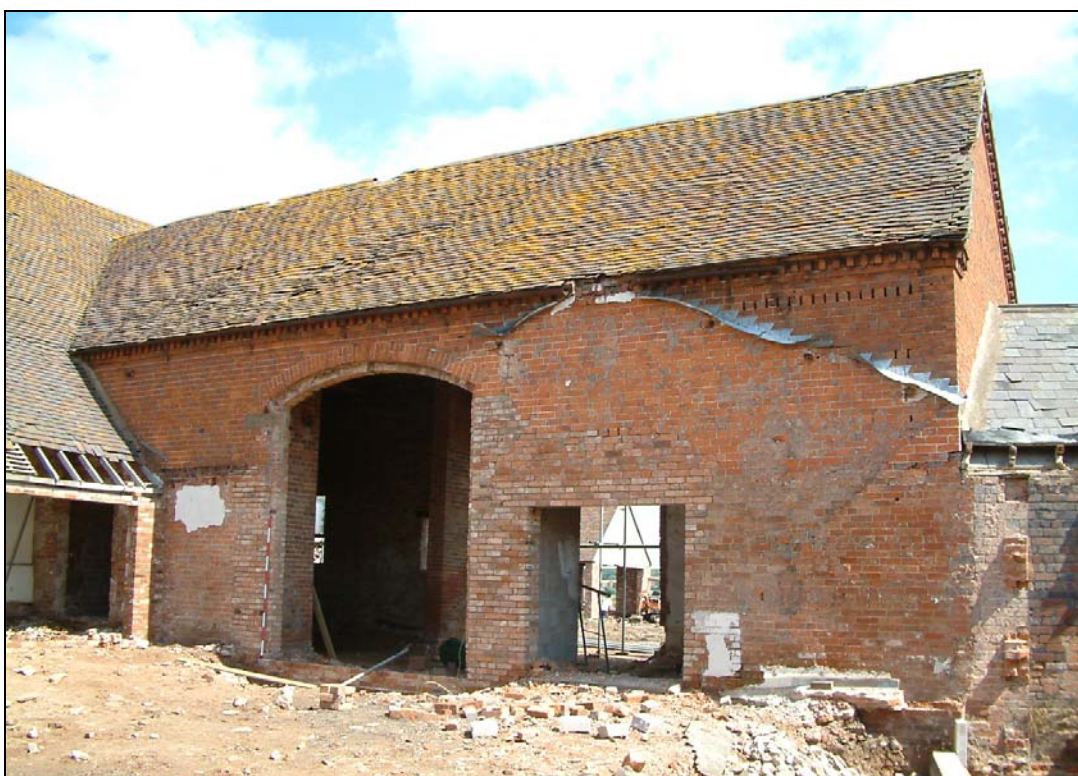
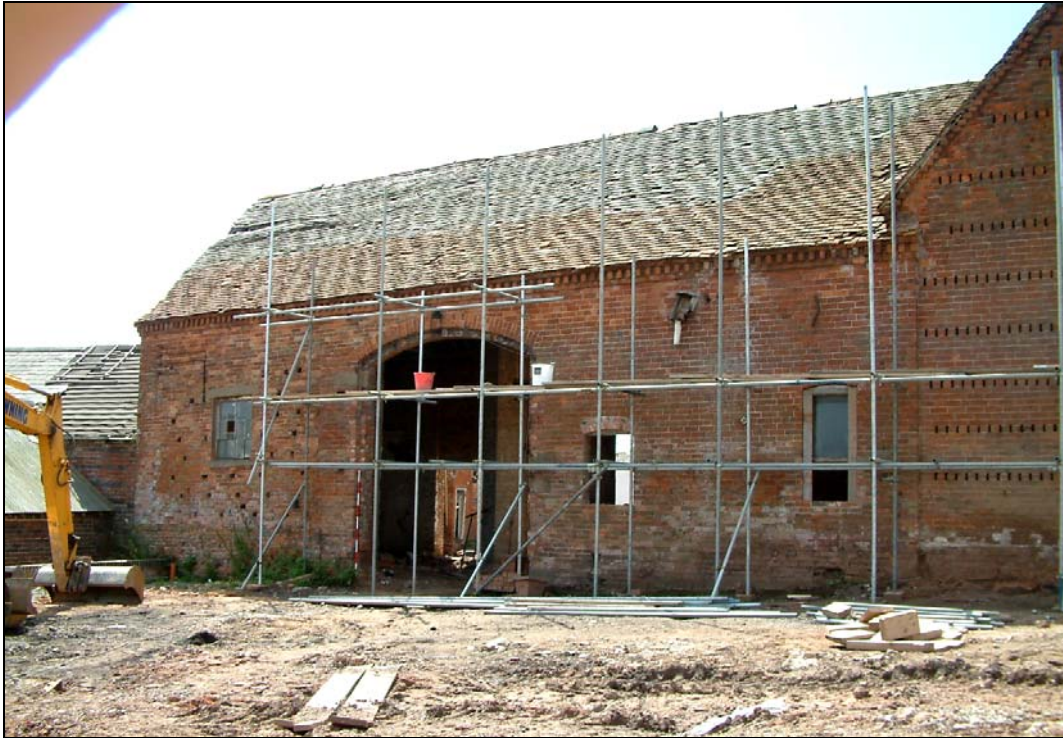
A single celled brick rectangular structure aligned north-west to south-east, adjoining another threshing barn (Unit 3) to the north-west and a shelter shed or cow house (Unit 8) to the south-east. The building is constructed with handmade bricks measuring 9" x 2.25" x 4.25", coursed in Flemish garden wall with dentilated eaves and a gabled flat tile roof supported by four queen post trusses. At the north-east elevation 12 courses of a stone plinth are visible underpinning the brickwork, and are clearly abutted by the shelter shed (Unit 8) to the south-east. The brickwork of the south-east facing gable end contains ventilation piercings on every eighth course, reflecting the units function as a threshing barn. Openings in the yardside south-west facing elevation comprise a wide drift-way door with a flat segmental arch and a single broad rectangular opening with flat lintel, which formerly provided access to the modern built barn to the south-west. The north-east facing elevation contains the corresponding driftway to that of the opposing elevation and three rectangular window openings of various dimensions, all with flat segmental arches. Internally the floor is now concrete but is underlain by two phases of brick flooring (exposed during re-development).

*Plate xii: South-west facing elevation, Unit 7*

*Plate xiii: North-east facing elevation, Unit 7*

The earliest phase of the farm buildings is represented by a threshing barn (Unit 7). The barn was constructed during the mid to late 18<sup>th</sup> century and would have originally been rectangular in plan comprising three bays and stood alone rather than within the range of buildings it is now flanked by. The building has been assigned to this phase on the basis of its coursing and brick form and size, which are both indicative of a construction date of the mid to late 18<sup>th</sup> century. The original function of the building (threshing) is reflected in the presence of ventilation piercings in the south-east facing gable end and the substantial drift ways on the south-west facing yard side elevation.

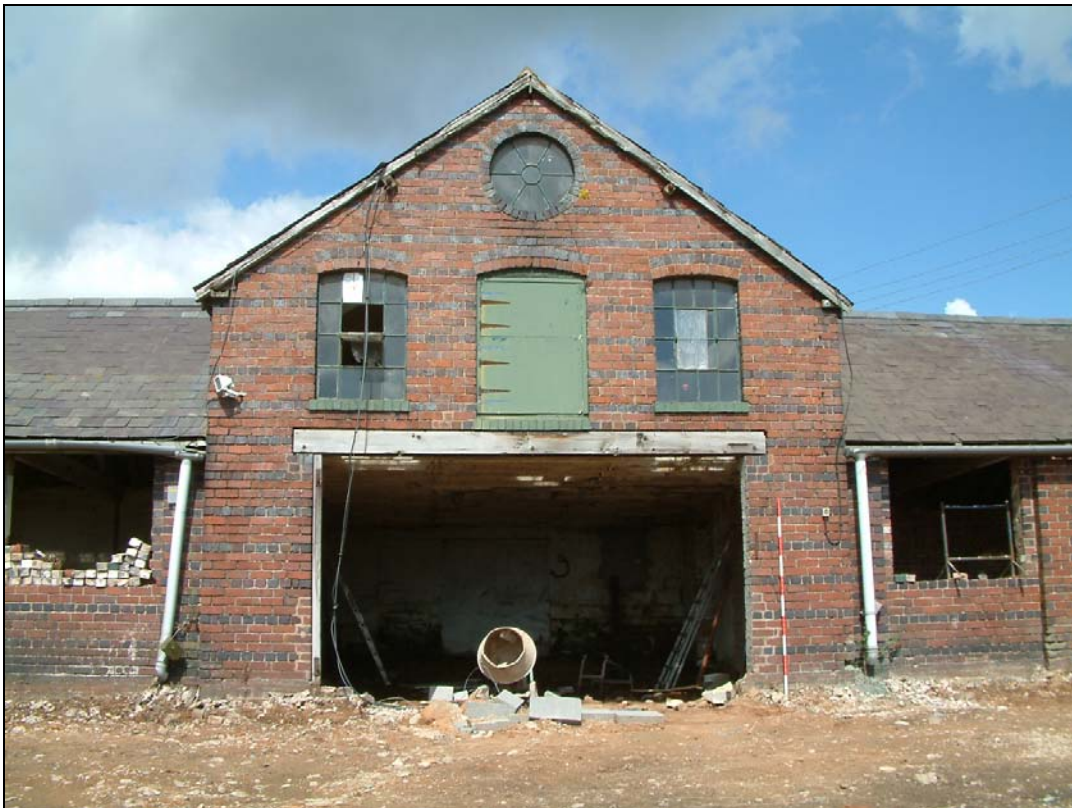
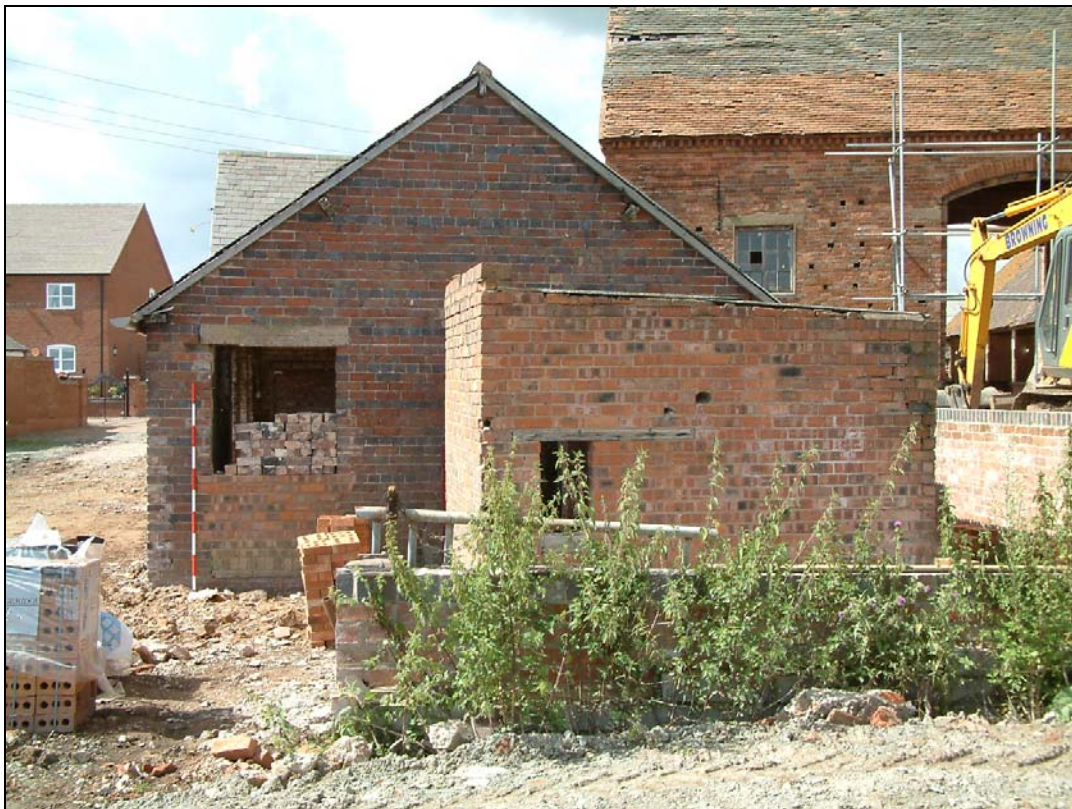
The shelter shed or cow house has two distinct phases, the earliest of these is a two storey single celled brick structure which runs eastwards from the eastern end of the threshing barn (Unit 7). The building is coursed in English garden wall with decorative bands of over fired bricks on the header courses, the bricks measure 9" x 3" x 4". Two king post and collar trusses support the roof, which is gabled and houses flat tiles. Openings in the south-east gable end comprise a wide drift-way with a flat wooden lintel, over which on the first floor are three rectangular window openings with flat segmental arches and above this a circular window with metal frame which sits central to the gables apex. Internally the flooring is concrete.

The later phase of the building abuts the north-east elevation of the principal phase, and comprises a single storey rectangular building running south-west to north-east. The building is constructed with machine made bricks measuring 8.75 - 9" x 2.75" x 4.25 - 4.5" coursed in English garden wall and also has decorative bands of over fired bricks on the header courses. Four king post trusses support the roof, which is gabled and houses flat tiles. The south-east facing elevation is principally composed of five brick piers within which are three areas of brickwork beneath broad square openings, originally there would have been a forth but the infill brickwork has been removed to create a wide opening. In addition is a narrow tall doorway positioned central to the elevation. The north-east gable end contains a single door opening with a flat wooden lintel and the elevation is abutted by a single celled flat roof structure constructed of machine made bricks measuring 8.75" x 2.75" x 4.25" coursed in stretcher bond.

*Plate xiv: South-east facing elevation, Unit 8*

*Plate xv: North-east facing gable, Unit 8*

In the early 20<sup>th</sup> century the spur running east off the north-east end of Unit 8 was demolished and a new building erected. The new structure (Unit 8) was built of machine made bricks, unlike its predecessor, but was constructed to match the existing style with decorated coursing as well as flat rectangular openings. The building also functioned as a shelter shed or cow house.

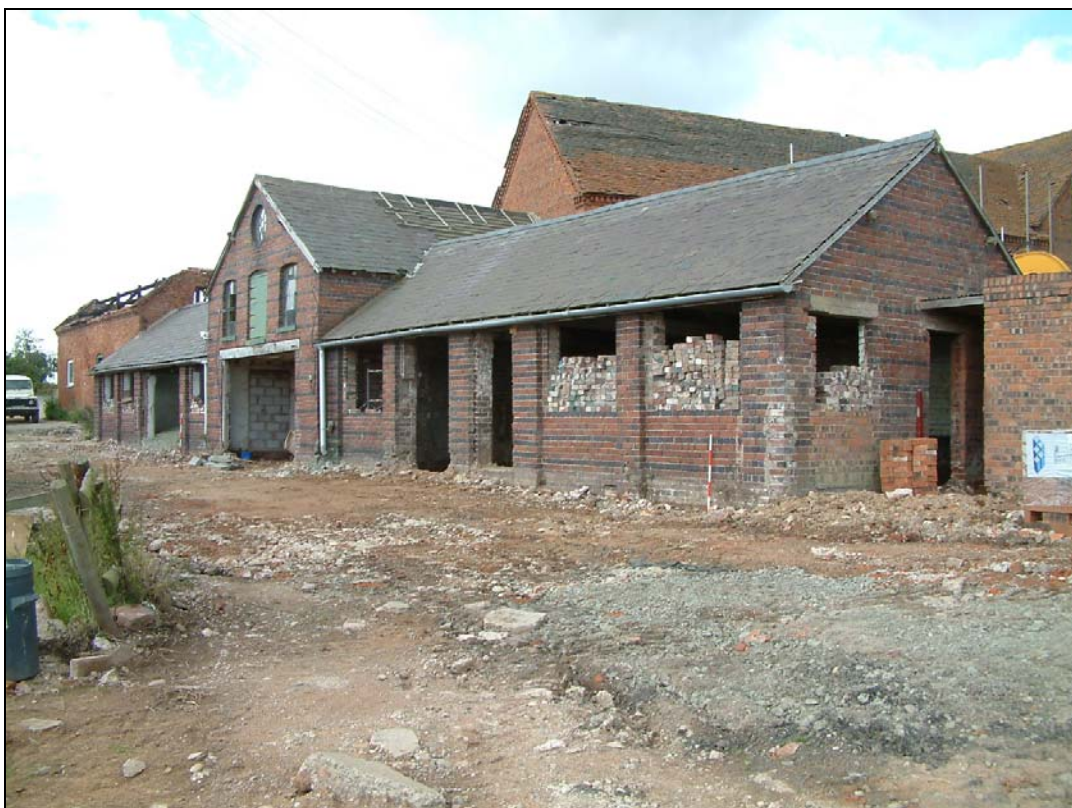
*Plate xvi: South-east facing elevation, Unit 8, 10 and 9*

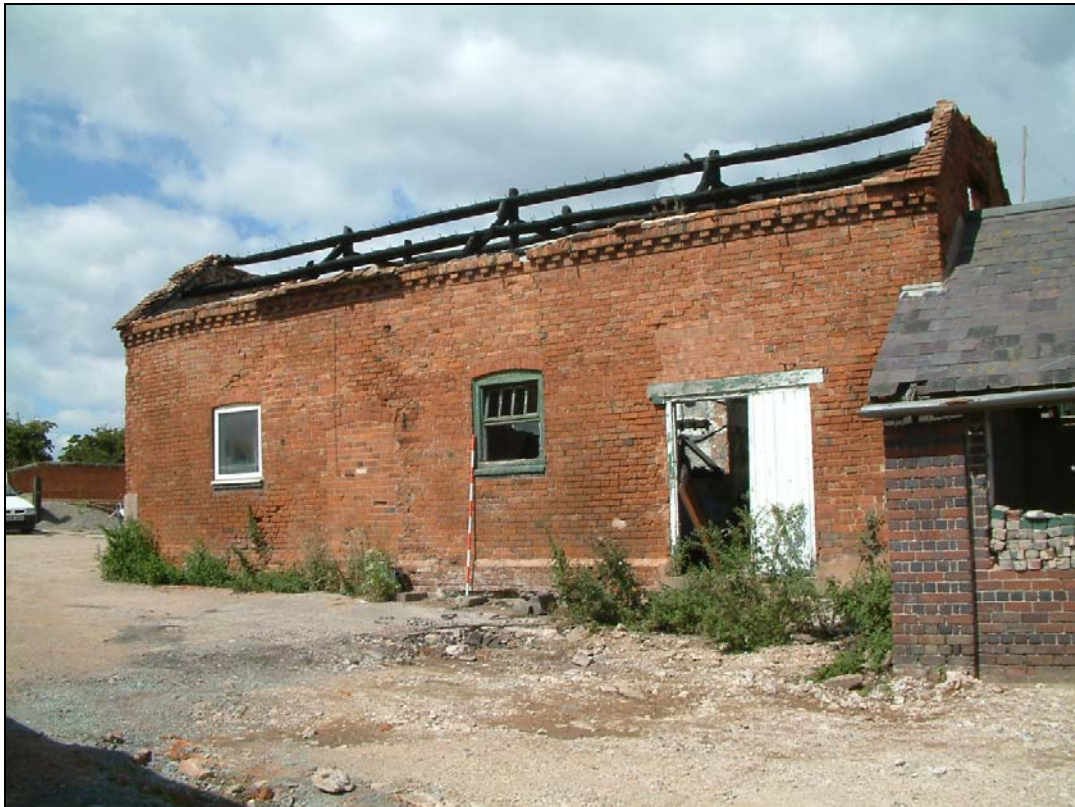
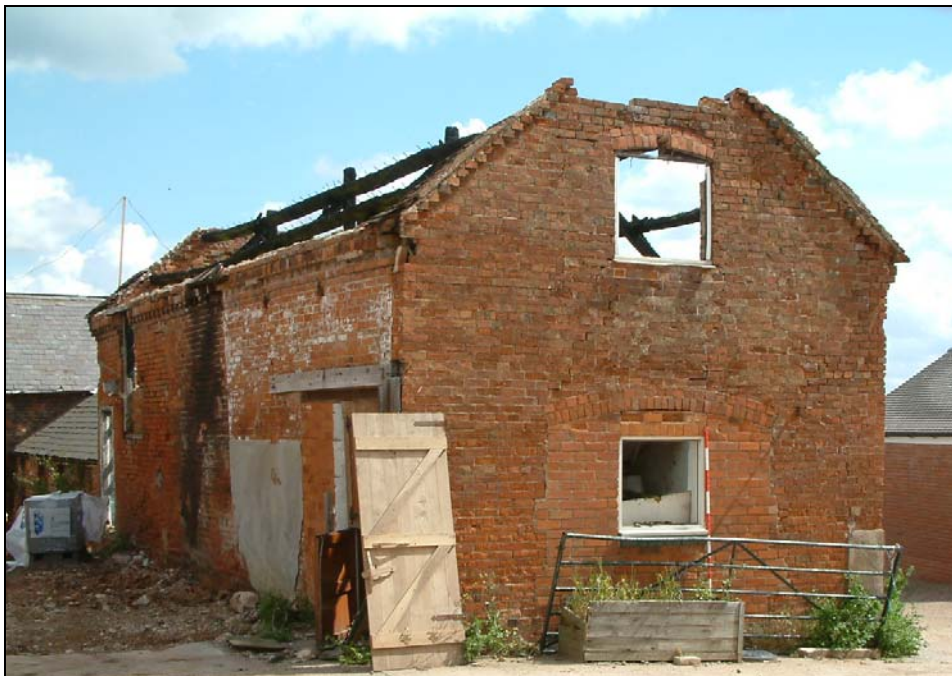
The building has been badly fire damaged however it fundamental structural characteristics remain extant. The building is a single celled two storey brick structure, aligned north to south abutting the southern end of Unit 10, and is constructed of hand made bricks measuring 8.5" x 2.5" x 4.25" coursed in English garden wall with dentilated eaves and the remains of a flat tiles gabled roof. Underpinning the northern elevation are stone foundations and a six

course brick plinth which projects from the face of the main elevation by 56mm. The roof is supported by three queen post trusses.

Openings in the south-east facing elevation comprise two rectangular window openings with flat segmental arches, a wide rectangular door opening with a flat wooden lintel and a blocked doorway with a flat segmental arch. The south-west gable contains two window openings, on the first floor this is original and complete with a flat segmental arch, beneath this the opening on the ground floor has been inserted into the blocking of a wider opening, former doorway, with flat segmental arch. The north-west elevation contains a door opening at either end of the elevation, at the south-west end this consists of a rectangular stable door inserted into the blocking of a wider opening with a flat wooden lintel and at the north-east end a rectangular opening with wooden frame which also appears to have been inserted. In addition to this a long rectangular opening running from the top of the gables to midway down the ground floor is partly open but has been blocked by 7 course of modern machine made bricks. The north-east gable also contains a small square window opening on the first floor. Internally the floor is concrete, but no further observations could be made due to the instability of the roof structure.

*Plate xvii: South-east facing elevation, Unit 9*

*Plate xviii: South-west facing gable, Unit 9*

The brickwork and coursing of the probable shelter shed (Unit 9) is also typical of the late 18<sup>th</sup> century, however evidence of its original function was less clear due to the impact of fire damage. However given its size and location within the farmyard it would seem likely to have acted as a shelter shed and latterly as a machine store. The stable block with accompanying hayloft (Unit 6) has also been assigned to this period on the basis of its brickwork and coursing. The building was not part of the main farmyard but rather stood to the east with access to a large field (Figure 2) which is likely to have been partially used as a paddock.
