HISTORIC BUILDING  
RECORDING  
AT TACK FARM,  
HEWELL LANE, TUTNALL AND  
COBLEY, WORCESTERSHIRE

Project 2413  
Report 1228  
WSM 32866

## **Historic building recording at Tack Farm, Hewell Lane, Tutnall and Copley, Redditch, Worcestershire**

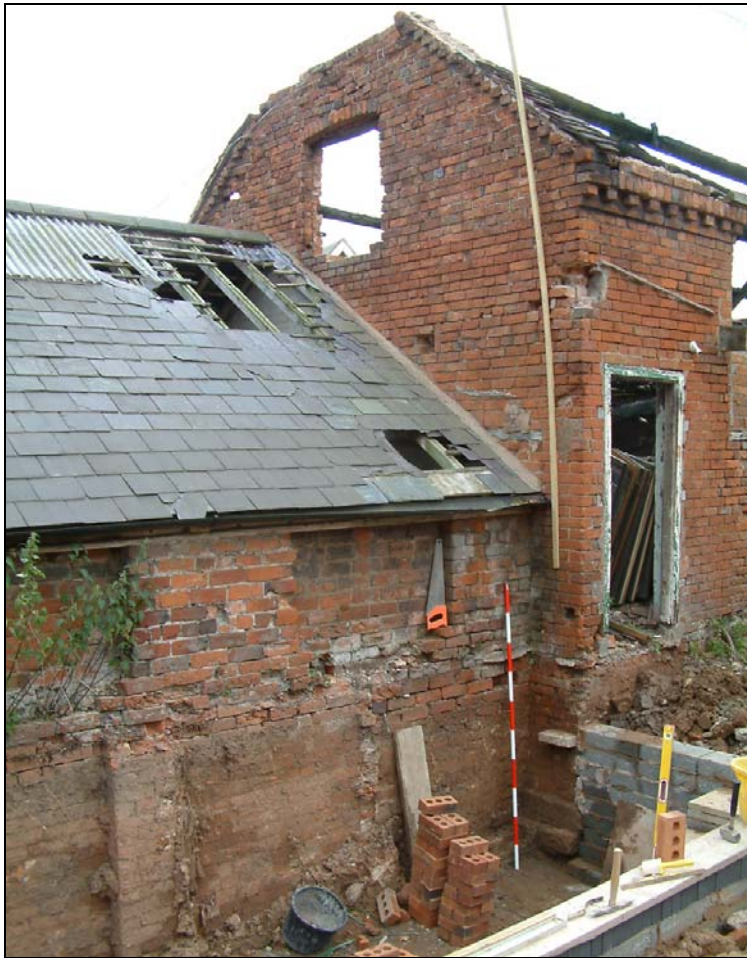
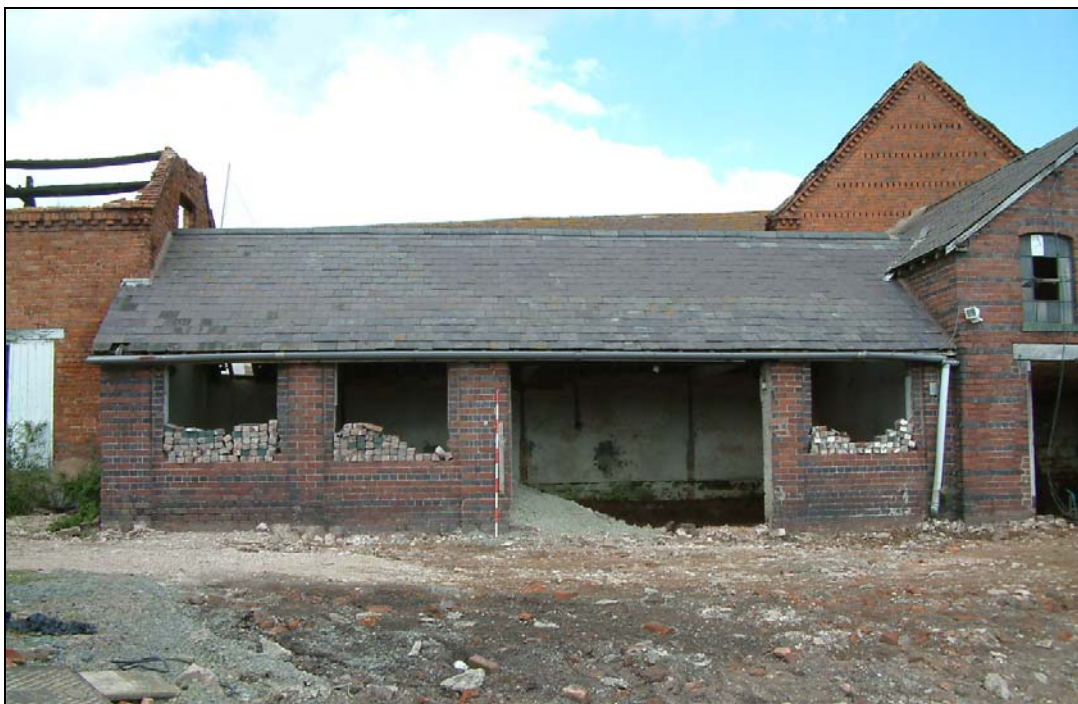
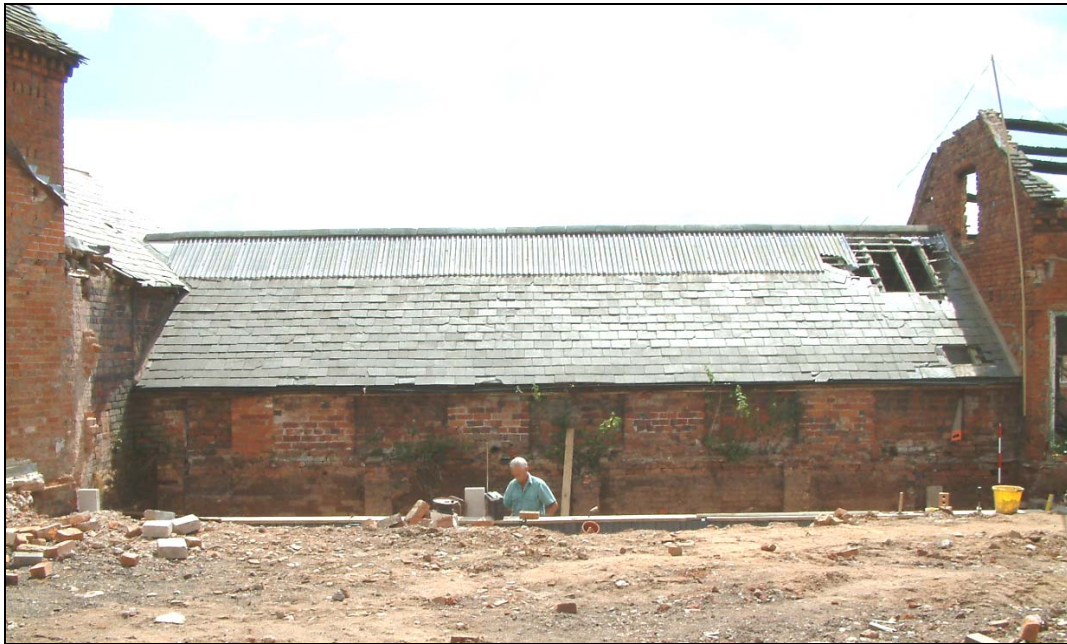
The building is a single celled two storey brick structure, aligned north to south abutting the southern elevation of Unit 8. The roof is gabled and houses flat tiles and is supported by three queen post trusses. The south-east facing elevation is constructed of machine made bricks measuring 8.5" x 2.5" x 4.25" coursed in English garden wall with decorative bands of over fired bricks on the header courses and contains three large square openings which sit between the brick piers which form the main element of the elevation. In addition to this is a wide 'door' opening, which has been formed by the removal of one pier. The north-east-facing elevation contains at least two phases. The earliest phase forms the lower half of the elevation up to the base of the blocked window openings and is composed of bricks measuring 9" x 3" x 4" coursed in English garden wall, whilst the upper element comprises brick piers coursed in English bond with square window openings. The openings of this structure indicate that it functioned as a cow house or shelter shed.

*Plate xix: Junction of Units 9 and 10, looking south-east*

*Plate xx: South-east facing elevation, Unit 10*

*Plate xxi: North-west facing elevation, Unit 10*

The north-west facing elevation of the shelter shed or cow house (Unit 10) is similar in formation to those of the store (Unit 4) and also has buttresses and irregular coursing. It is possible that this elevation represents the only remaining element of an earlier building which was rebuilt in the late 19<sup>th</sup> century, or alternatively it may have formed a boundary wall to the main farmyard, running north from the end of Unit 9.
