AN ARCHAEOLOGICAL  
PROGRAMME OF WORKS  
AT  
HANLEY MEAD, HANLEY  
CASTLE, WORCESTERSHIRE

21<sup>st</sup> January 2003

Project 2212  
Report 1133  
WSM 31924

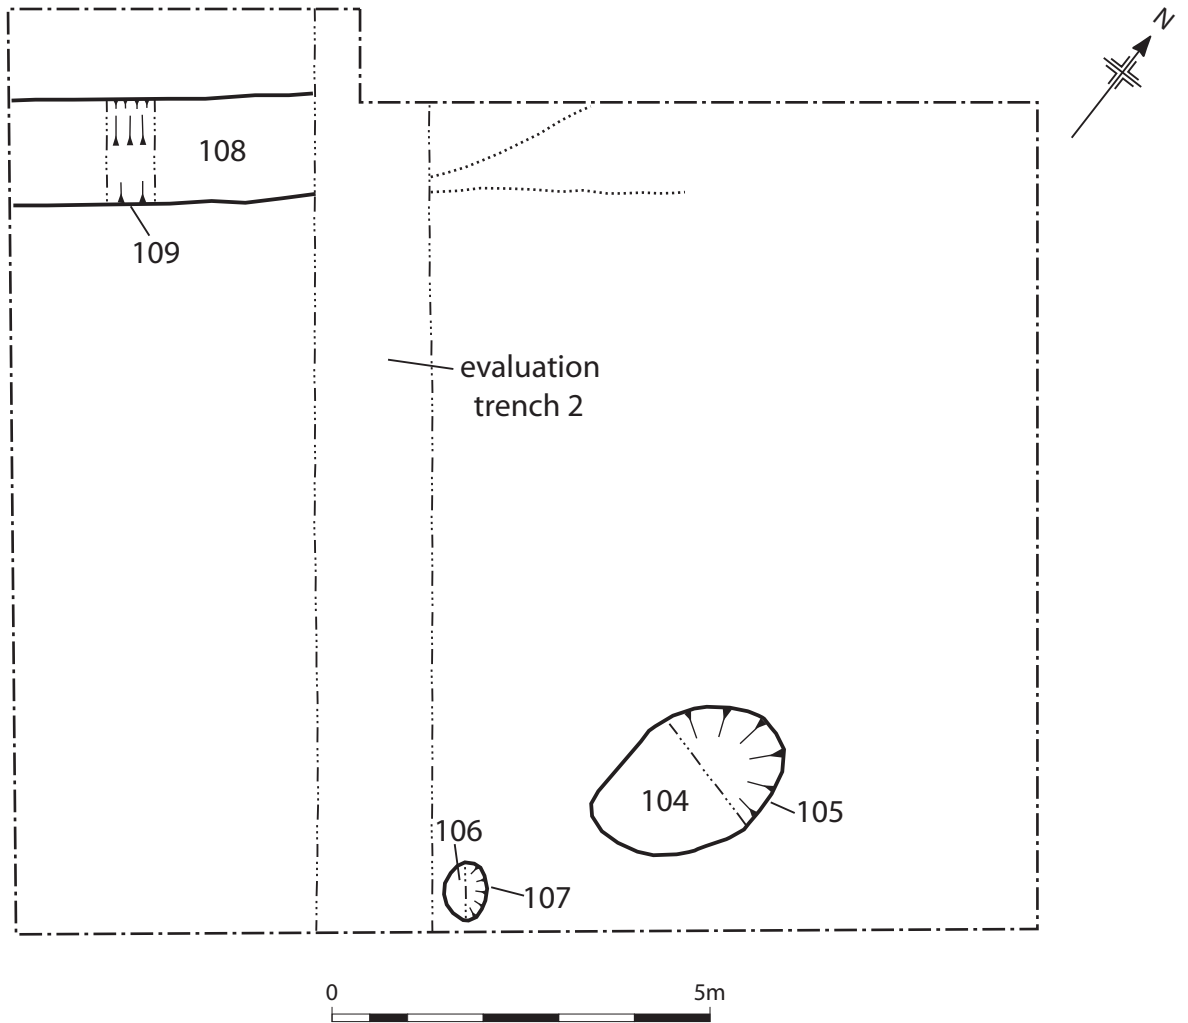
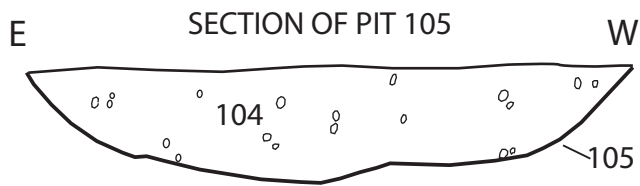
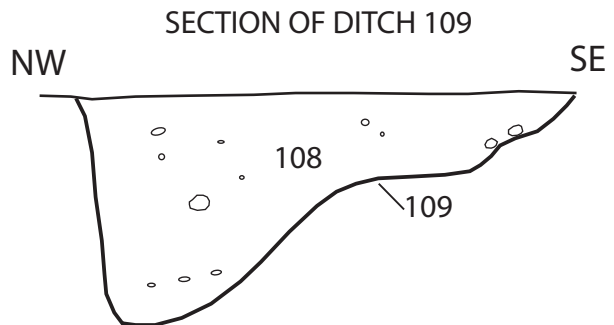
Figure 4: Trench plan and sections.

One feature, a ditch orientated north-east to south-west, was dated to the Roman period by a single sherd of Severn valley ware pottery. Only about 4m of the ditch was clearly visible and its terminus was unclear. It was not detected in the evaluation trench which it appears to abutt in plan. This short length of ditch indicates the possible presence of an enclosure, and seems to be the only indicator of Roman activity in the area which points to the presence of a Roman settlement or field system. Unfortunately, the limited amount of the ditch that was revealed during the strip does not give us very much information as to the form such a settlement might take. The possibility remains that the single sherd of pot could have been redeposited and that the ditch dates to a later period.

An additional posthole (associated with medieval pottery) was discovered, located next to a couple of pits/postholes found during the evaluation of this site. The similarity of these features in the form of a single homogenous fill, and the discovery within one of them of a thirteenth to fourteenth century pottery sherd, indicates there could be a relationship between them. The limited area stripped, however, meant that no definite structure could be defined. A large pit located a couple of metres north of the posthole, could have belonged to this period but no artefacts were recovered from it.

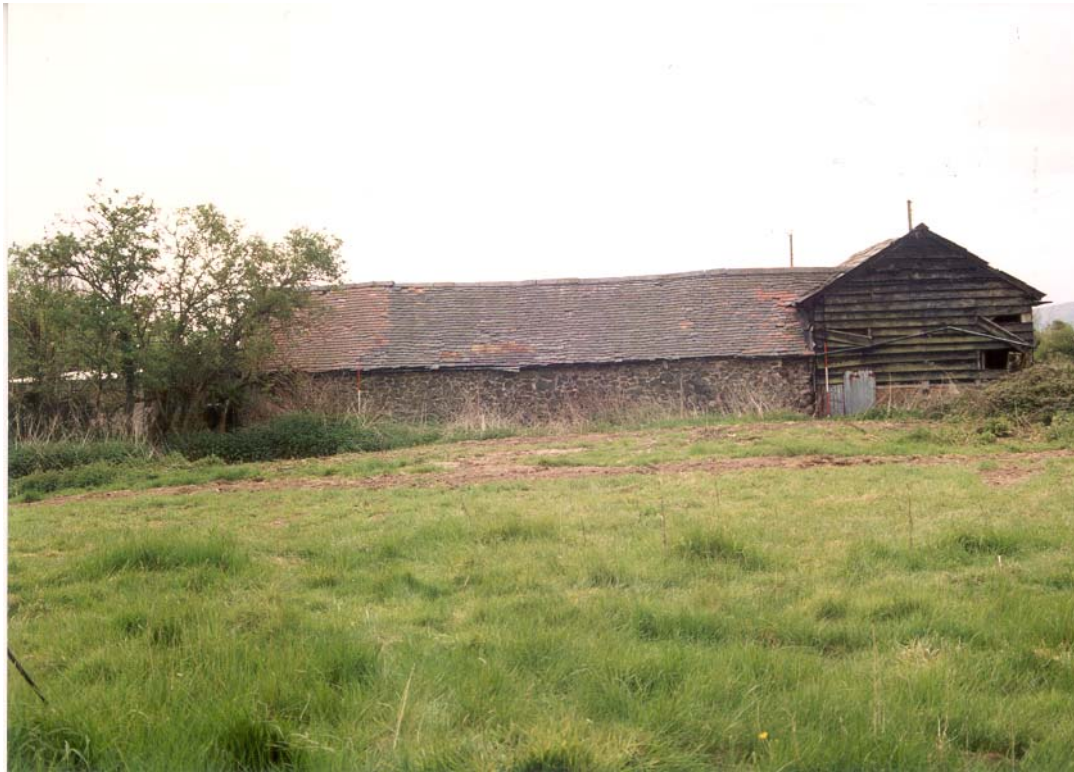
*Plate 1: Animal shelter shed (building 1) and hay storage barn (building 2), northeast elevation.*

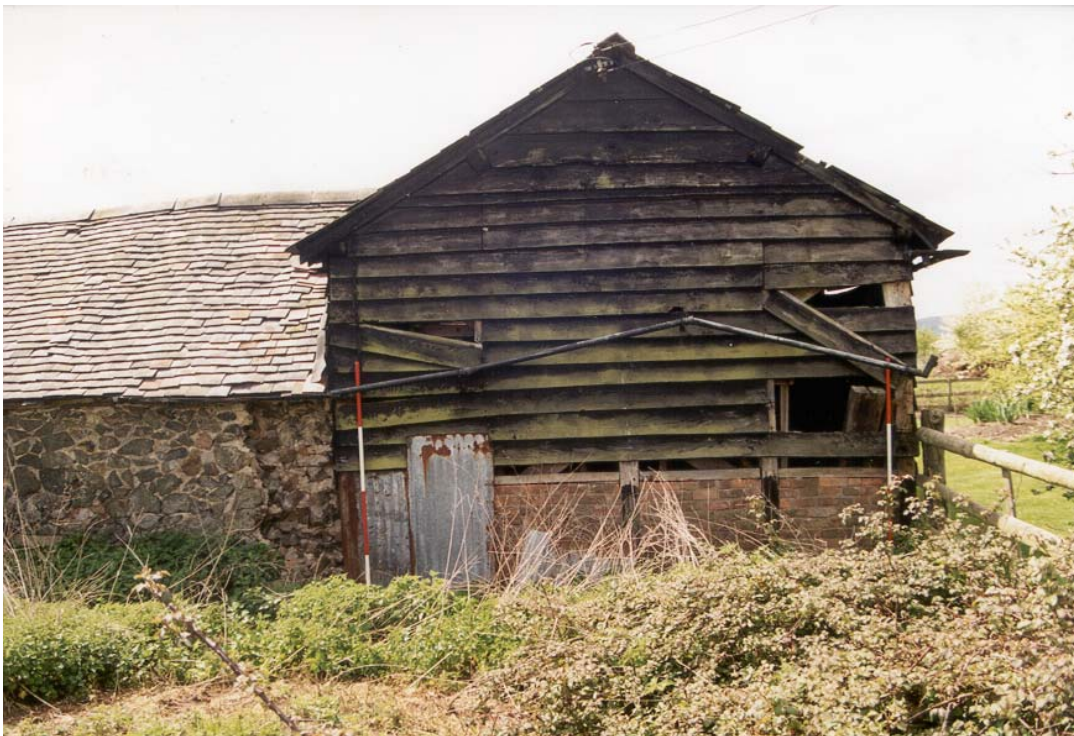
*Plate 2: Hay storage barn (building 2), northeast elevation.*

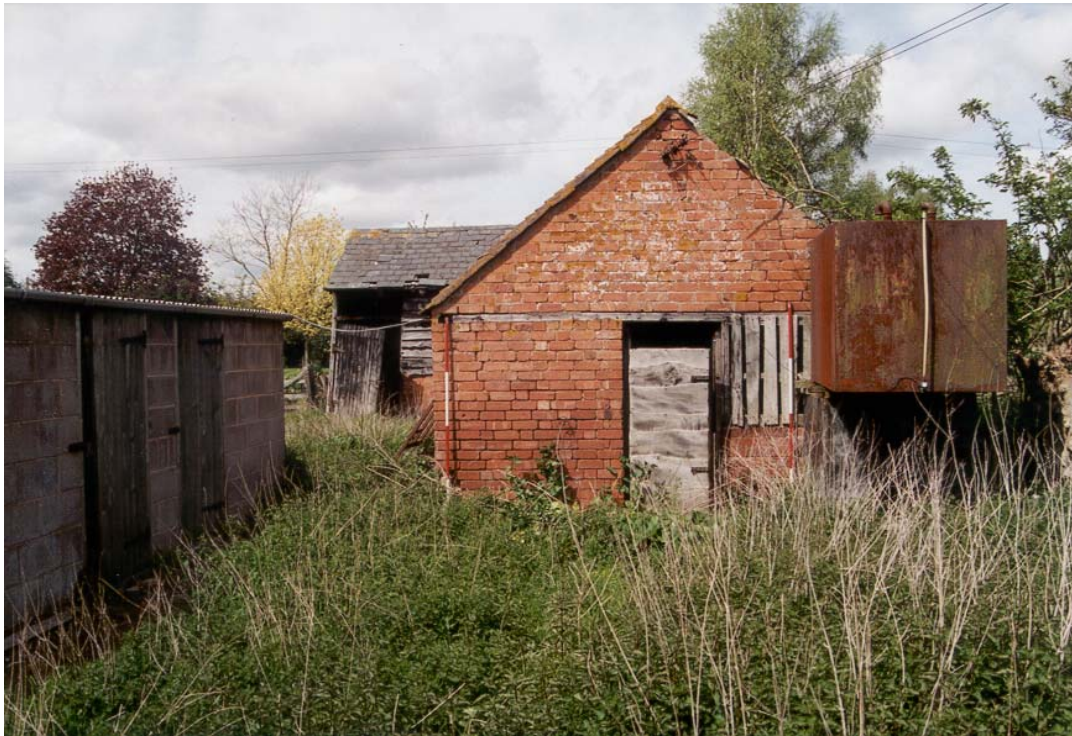
*Plate 3: Workshop (building 3), southeast elevation.*

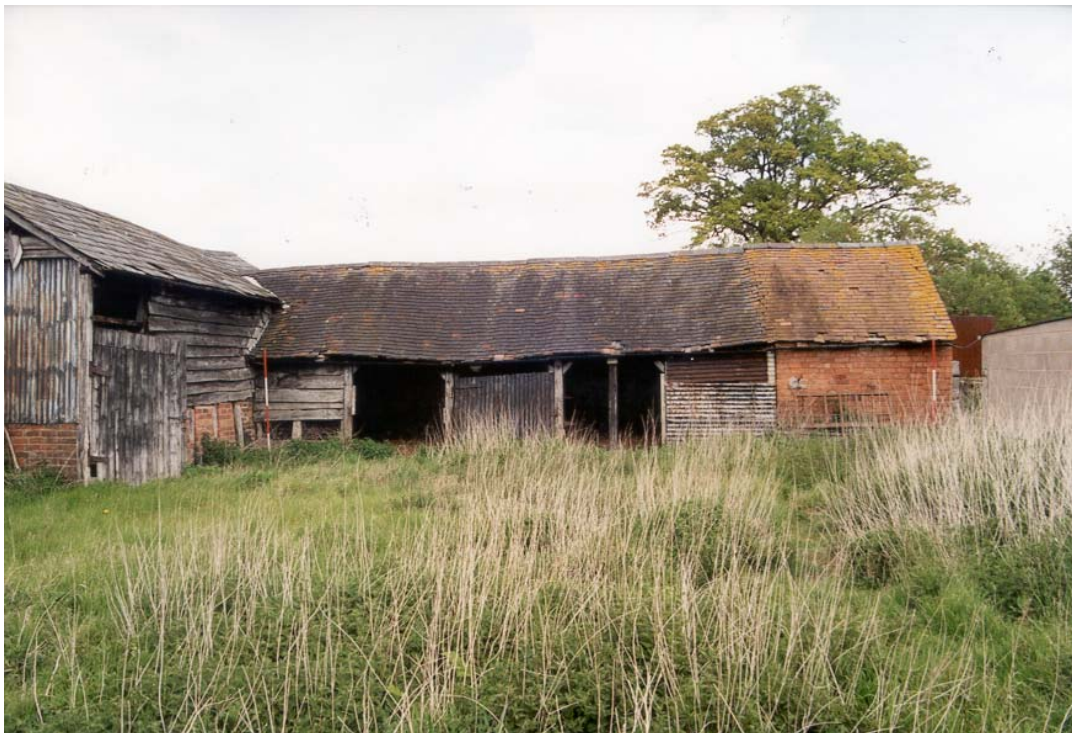
*Plate 4: Animal shelter shed (building 2) and workshop (building 3), southwest elevation.*

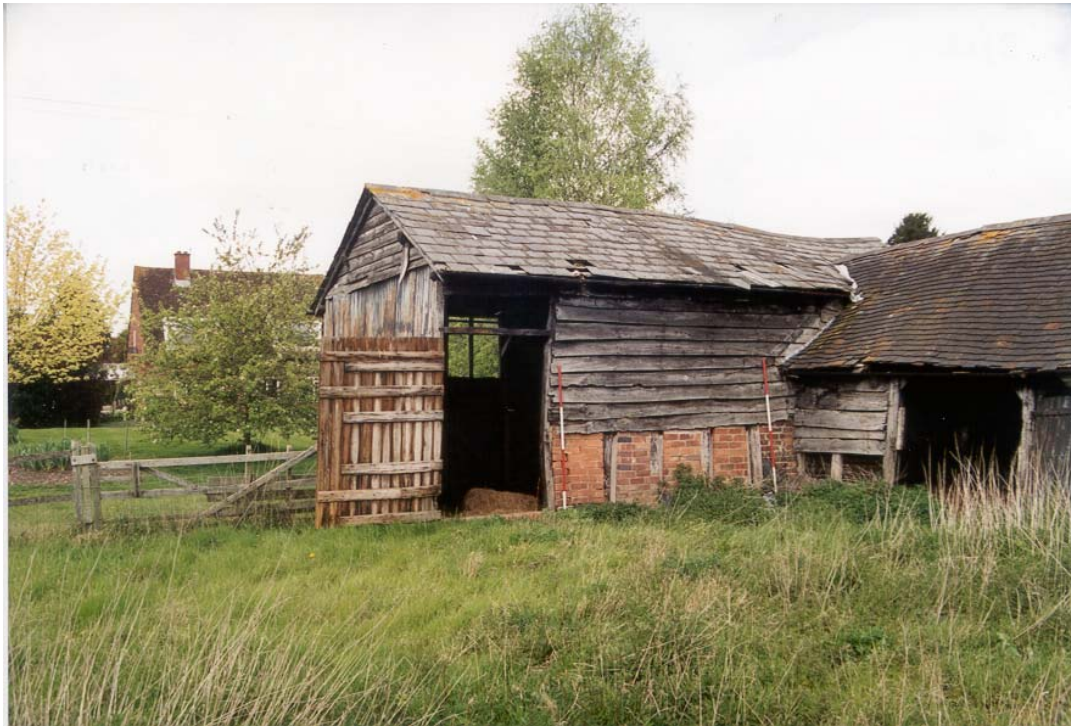
*Plate 5: Hay storage barn (building 1), southwest elevation.*

The south-western gable lower section was rebuilt during the 20<sup>th</sup> century using brick and mortar. This encompassed trimming the original north-western corner post and inserting a new post on the opposite corner. Some internal bracing was nailed to the internal framework sometime during this period. The brick built workshop was also added to the southernmost end of the shelter shed during the 20<sup>th</sup> century.

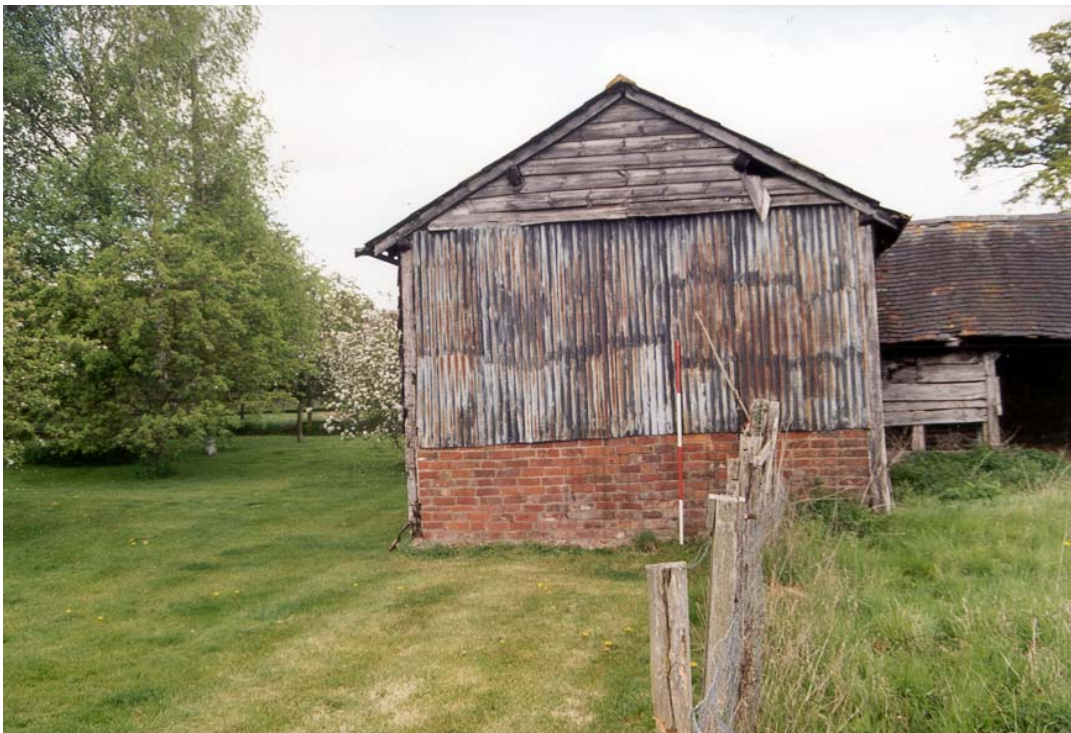
*Plate 6: Hay storage barn (building 1), southwest elevation.*

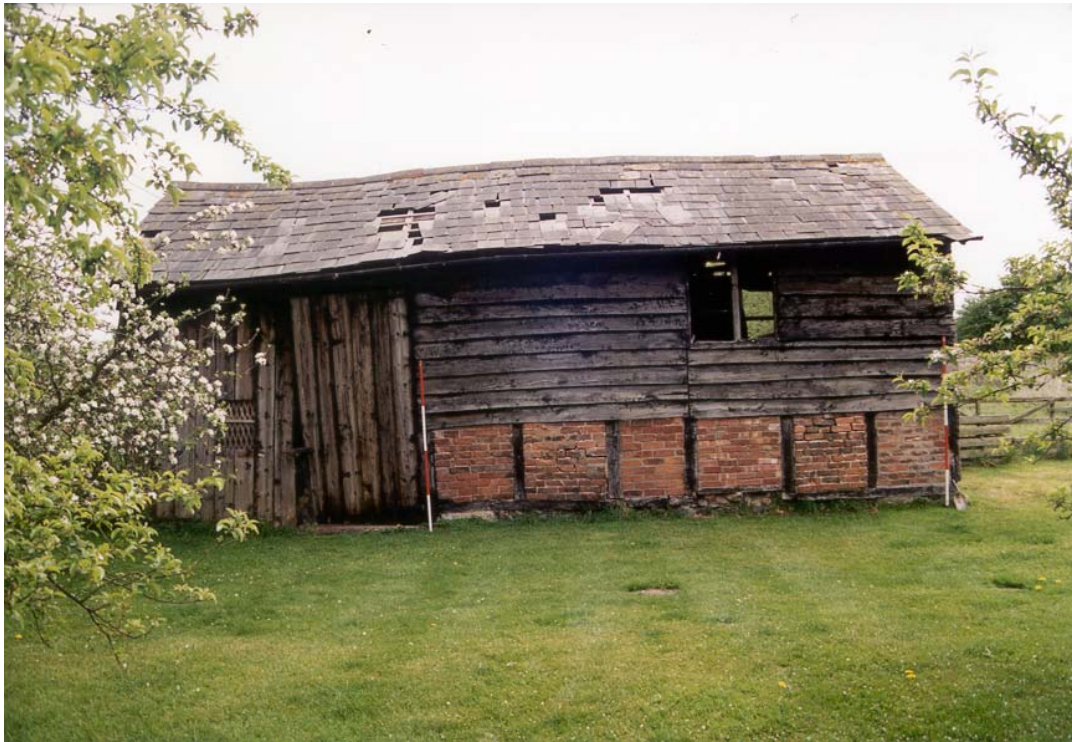
*Plate 7: Hay storage barn (building 1), northwest elevation.*

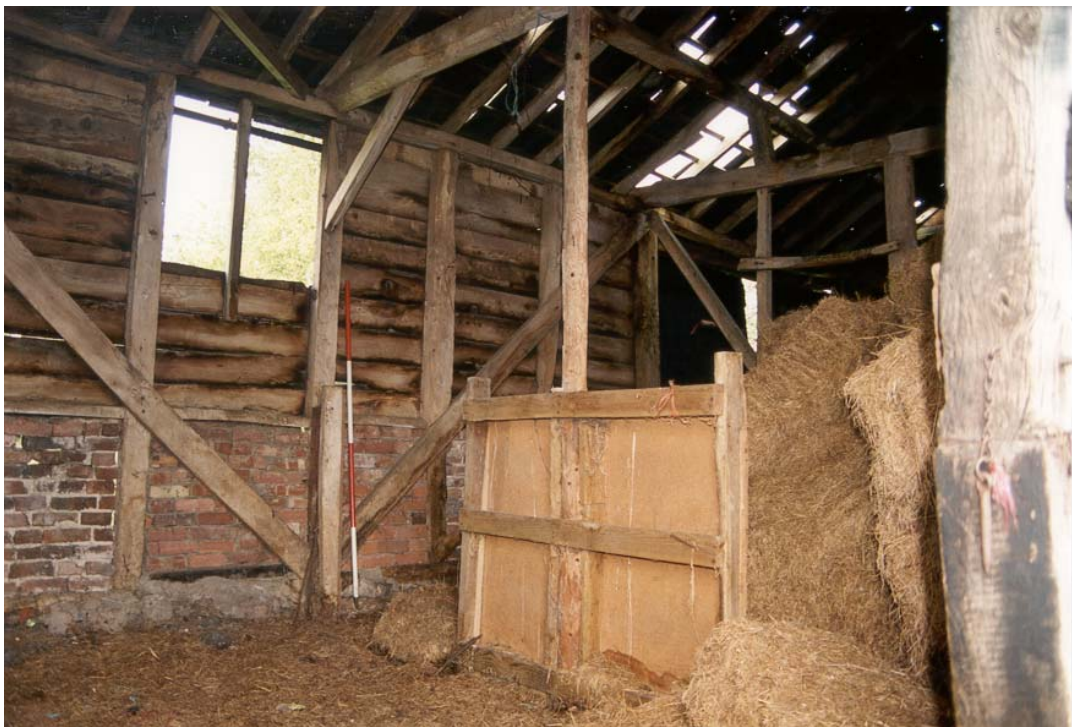
*Plate 8: Hay storage barn (building 1), internal detail.*

Much of the timber structure had been repaired with re-used timber. Notably, one section of purlin had been scarfed in from a former bridging beam, which most likely originated from a domestic building. There were diminished haunch tenons to take floor joists on both faces of this substantial timber, these tenons generally date to the 16<sup>th</sup> century.

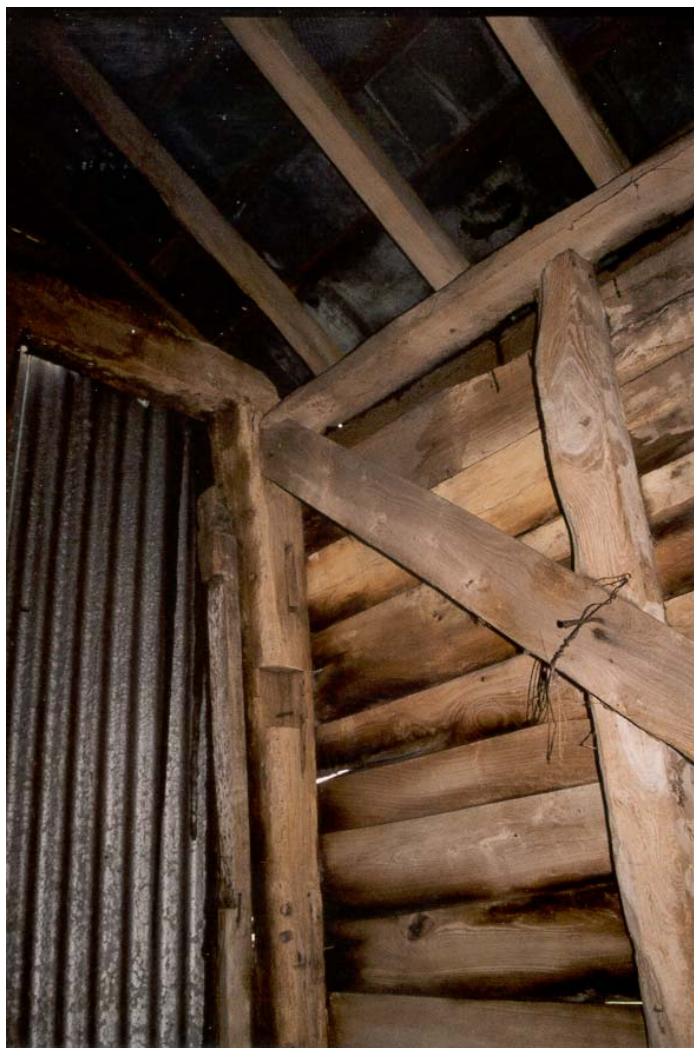
*Plate 9: Hay storage barn (building 1), internal detail.*

The barn was subjected to extensive repairs and alterations during this period. The roof structure and wall plates were all replaced. The purlins were by now supported on short twin queen struts above the tie beams, which also date from this period. The lowered pitch of the roof has dispensed with the requirement for collars and a central ridge-piece carries the common and principal rafters. The panel in-filling from this period was of brick and mortar, there is no evidence of the former in-fill method. A partition of timber-frame was inserted between the cart bay and the remainder of the barn. The external weather board cladding is most likely to come mainly from this period.

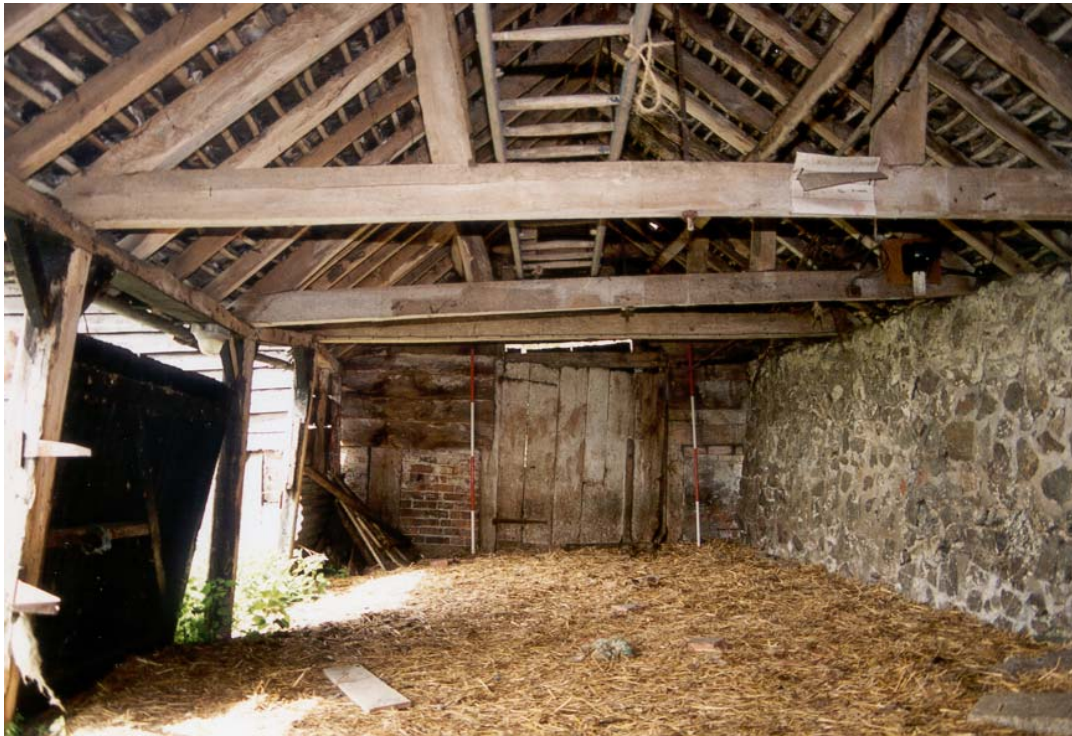
*Plate 10: Animal shelter shed (building 2), internal detail.*

rear wall was constructed of Malvernian stone with occasional half bricks. This building also incorporates much re-used timbers, with open mortises and unused peg holes. The roof structure makes extensive use of steel tie bars. Most of the structure is pegged together with small pegs. The purlins are scarfed together from five individual timber members. The northern ends of the purlins are supported on the wall plate of the hay barn. The floor of the shelter shed was of random brickwork, some laid on end. This showed extensive wear in the areas visible. There were also sections of concrete floor within the structure.
