ARCHAEOLOGICAL DESK-BASED  
ASSESSMENT OF FLOOD  
DEFENCES AT LONGNEY,  
GLOUCESTERSHIRE

Project 2379  
Report 1158

# Archaeological desk-based assessment of flood defences at Longney, Gloucestershire

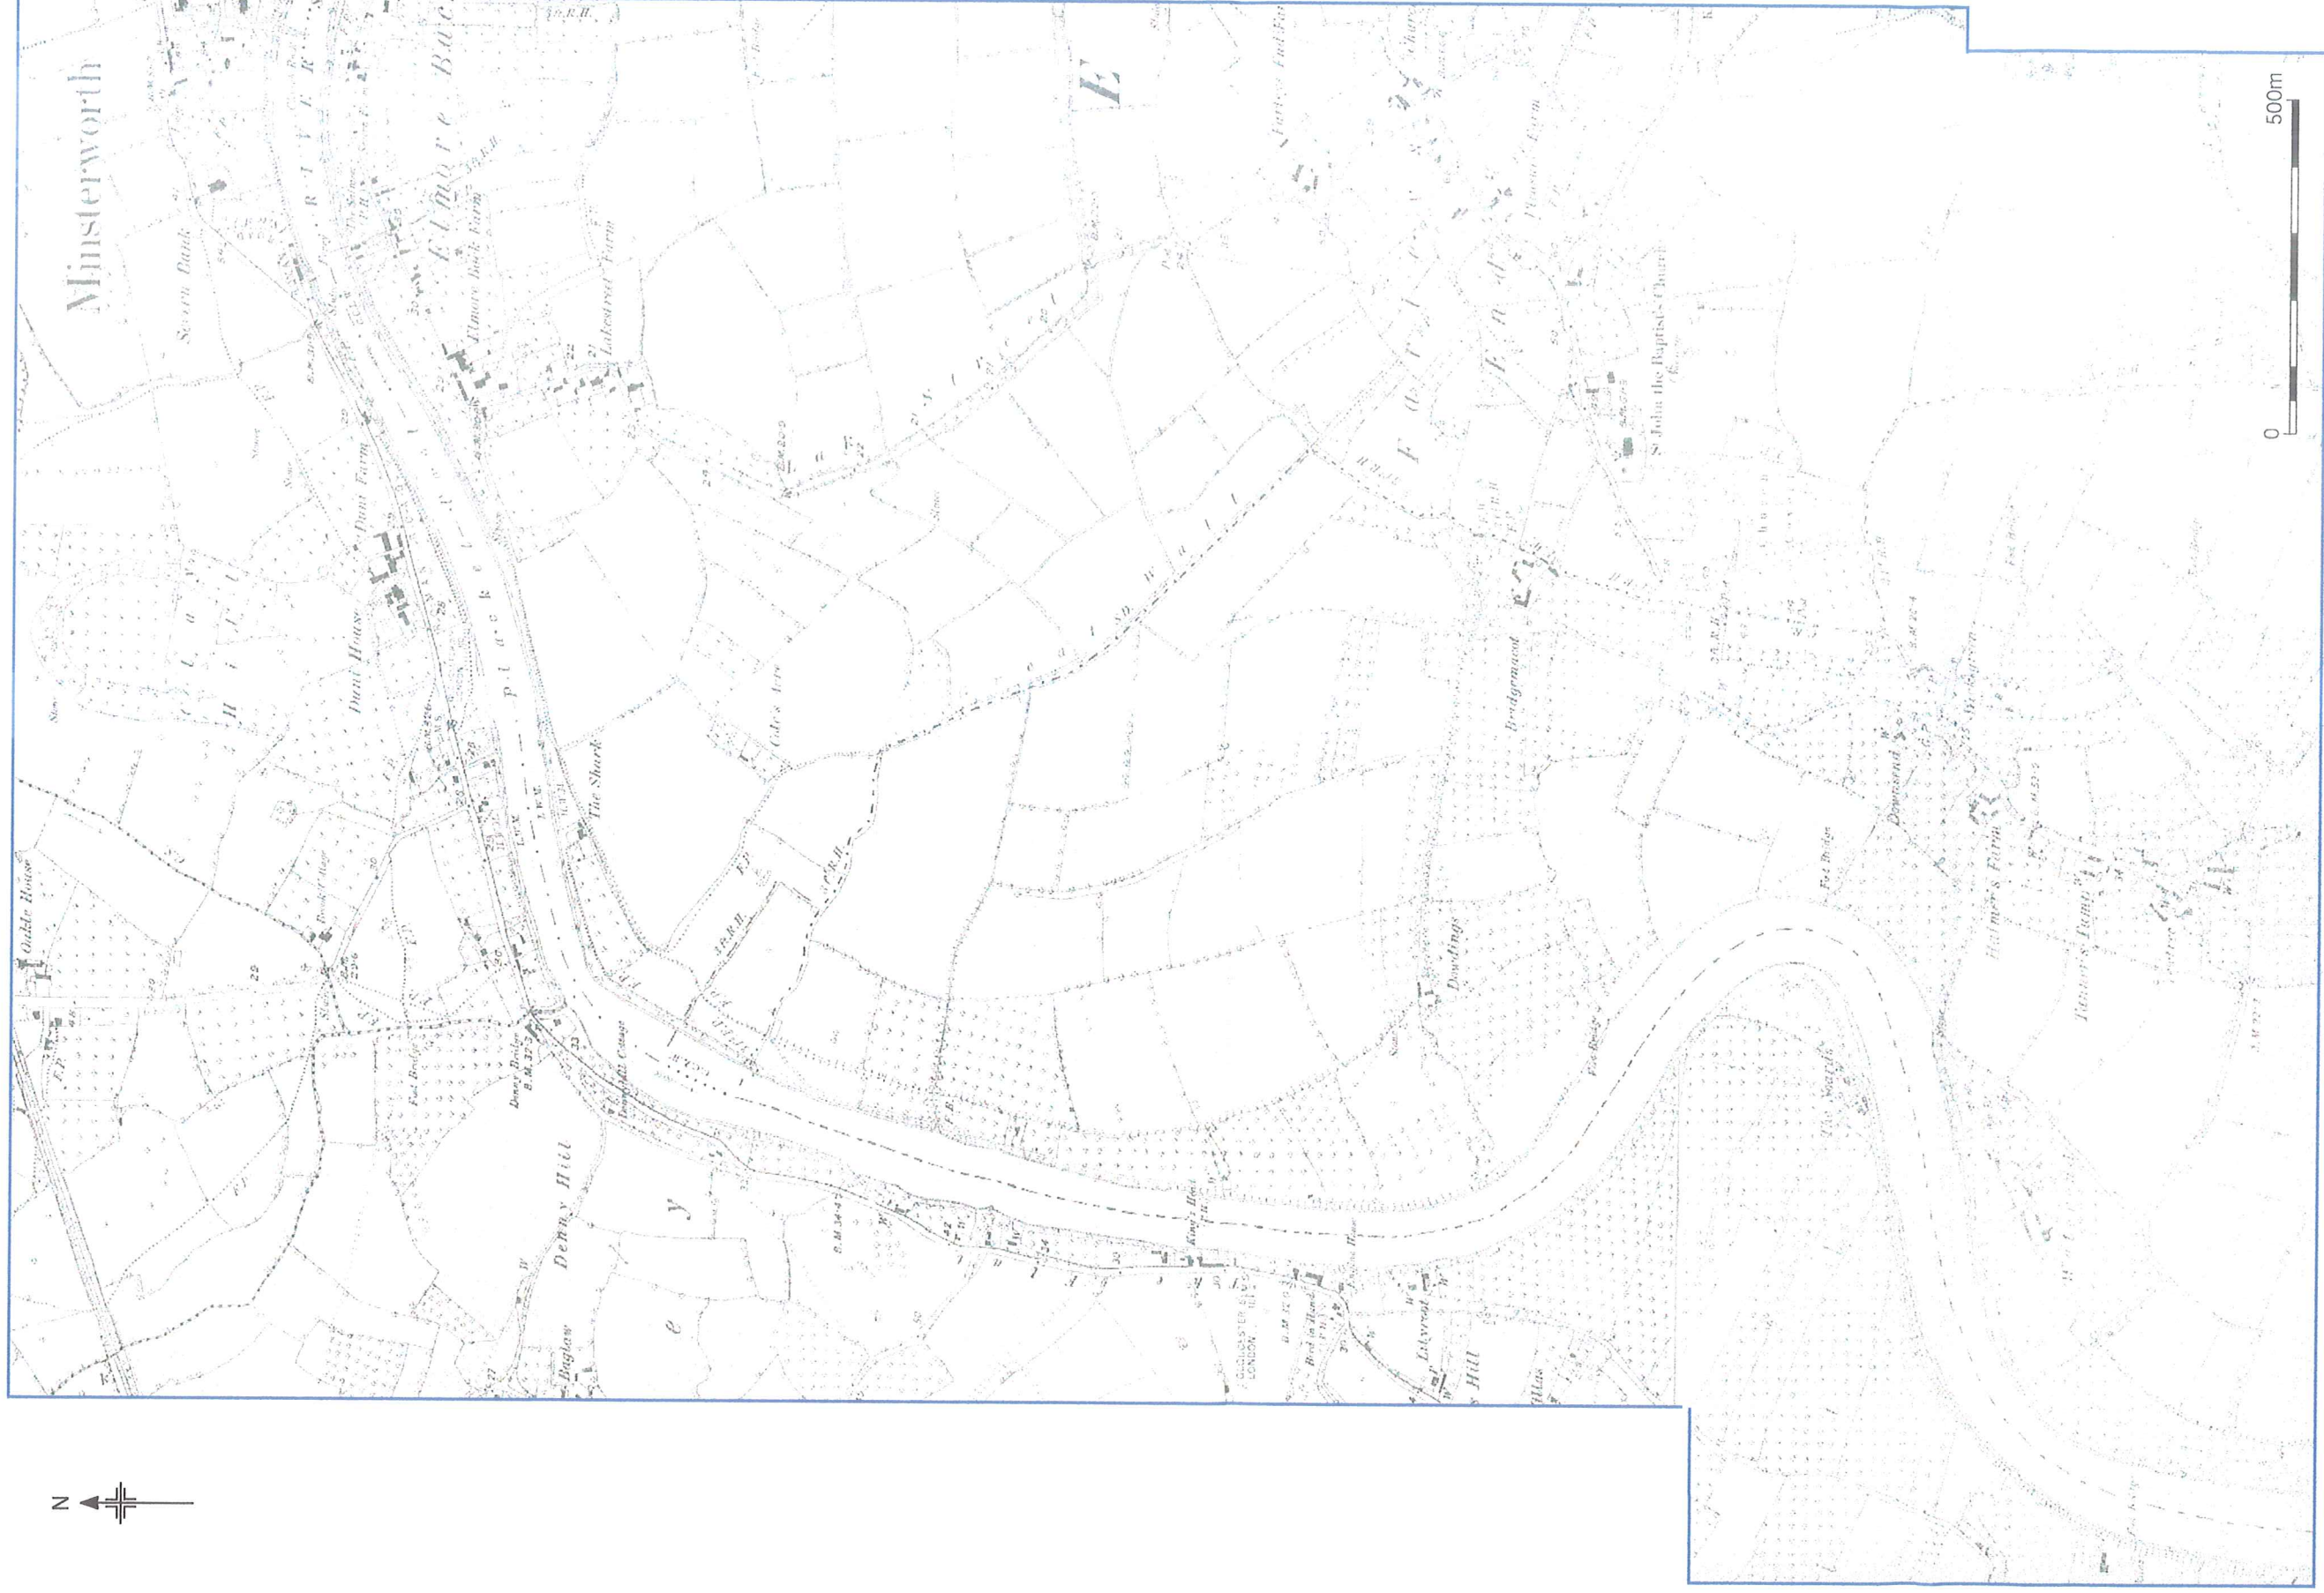
Figure 3

Extract from OS 1888 Sheet 32 NE.

Post-medieval and modern developments along the riverbank can be reconstructed in some detail from a long series of large-scale maps, beginning with the Inclosure map of 1815 (Fig 6). As noted above, this map shows the abandoned *Great Wall*, part of the second set of Roman defences, and the undated, but early bank extending westwards from Hill Farm to the riverbank and on to Watersend. No other flood defences are shown on this map, and none are likely to have been omitted, in view of the high quality of the surveying and draughtsmanship. Much the same situation is shown on several Ordnance Survey maps published in the 1880s (Figs 3 and 7), and in 1902 (not reproduced here), although the bank passing through Watersend appears to have been removed between 1815-1880s (see Figs 6-7). Only on the Ordnance Survey map of 1924 (Fig 8) is a significant change apparent along the riverbank, with lengths of the second set of early flood defences being removed (compare Figs 7 and 8). This gradual decline in the condition of the early (at least partly Roman) flood defences seems to have obtained, until the present flood defences were constructed in 1960-1 (as stated by Allen and Fulford 1990a, 20), as Ordnance Survey maps of 1954 and 1955 show no significant differences from the flood defences of 1924 (Fig 4), while those of 1974 and 1980 show the flood defences almost exactly as they appear today (Fig 5).

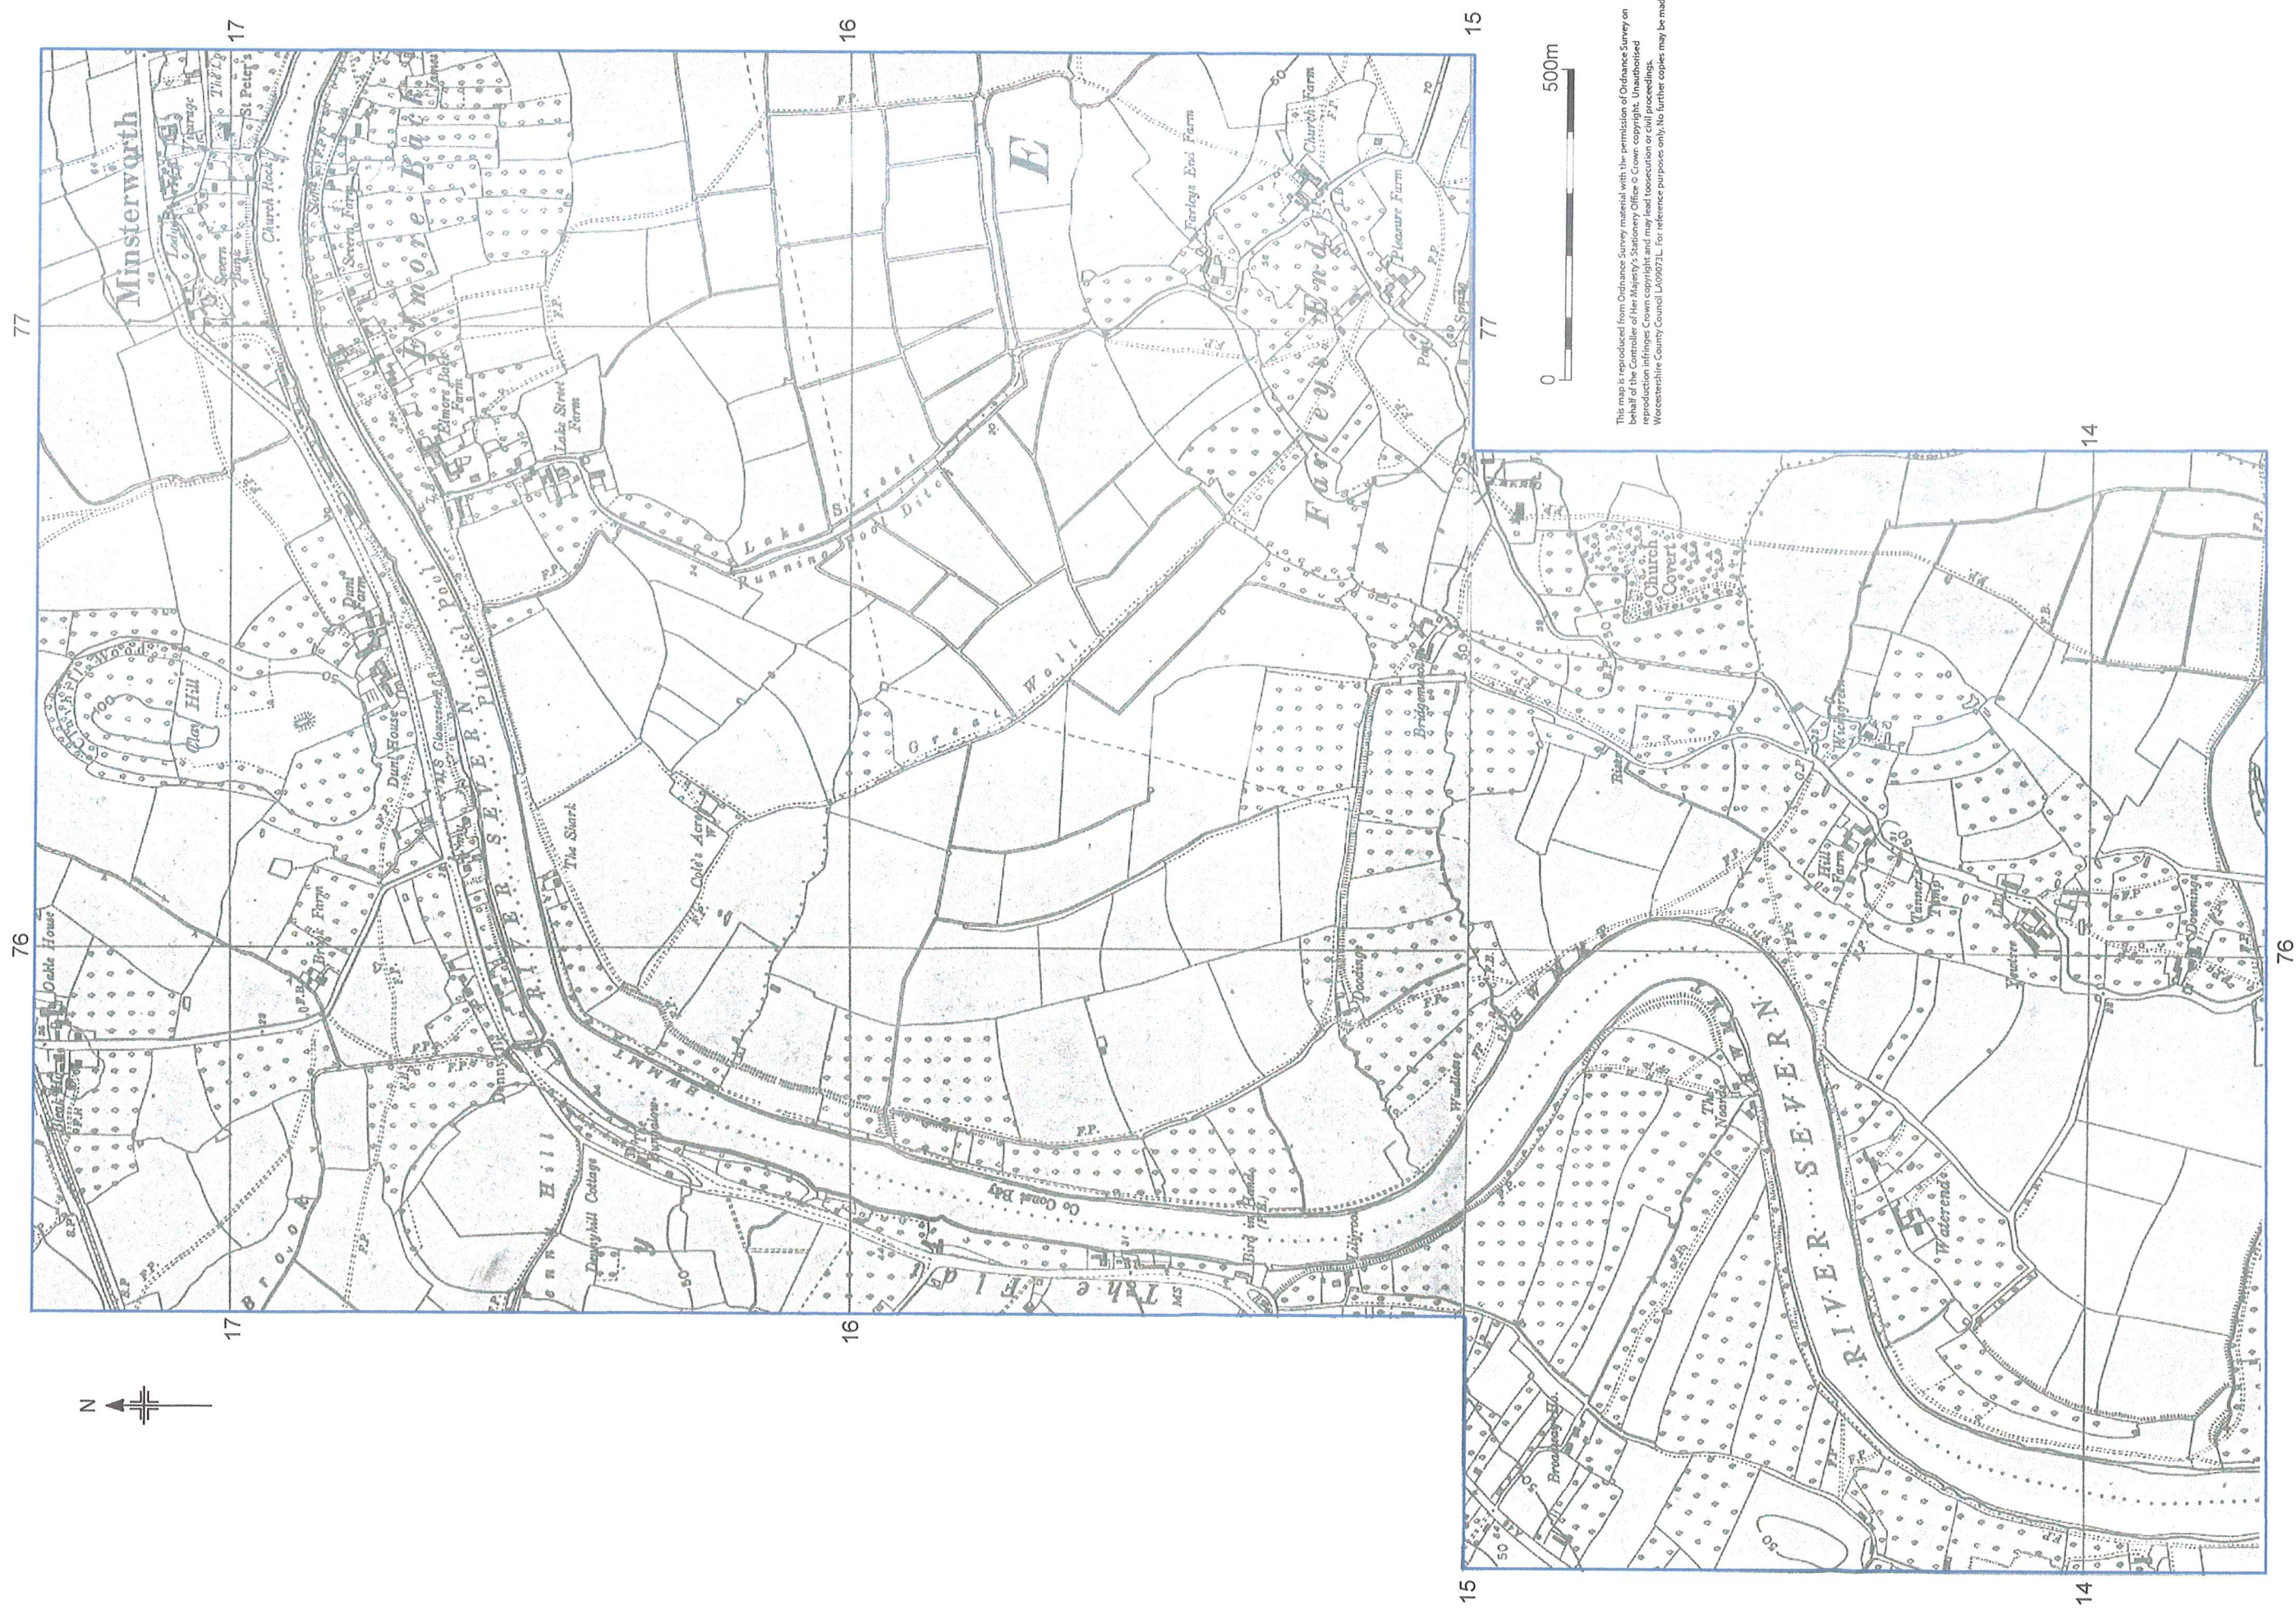
Figure 4

Extract from OS 1955 Sheet SO71 NE, 1:10,000 (top) and OS 1954 Sheet SO71 SE (bottom).

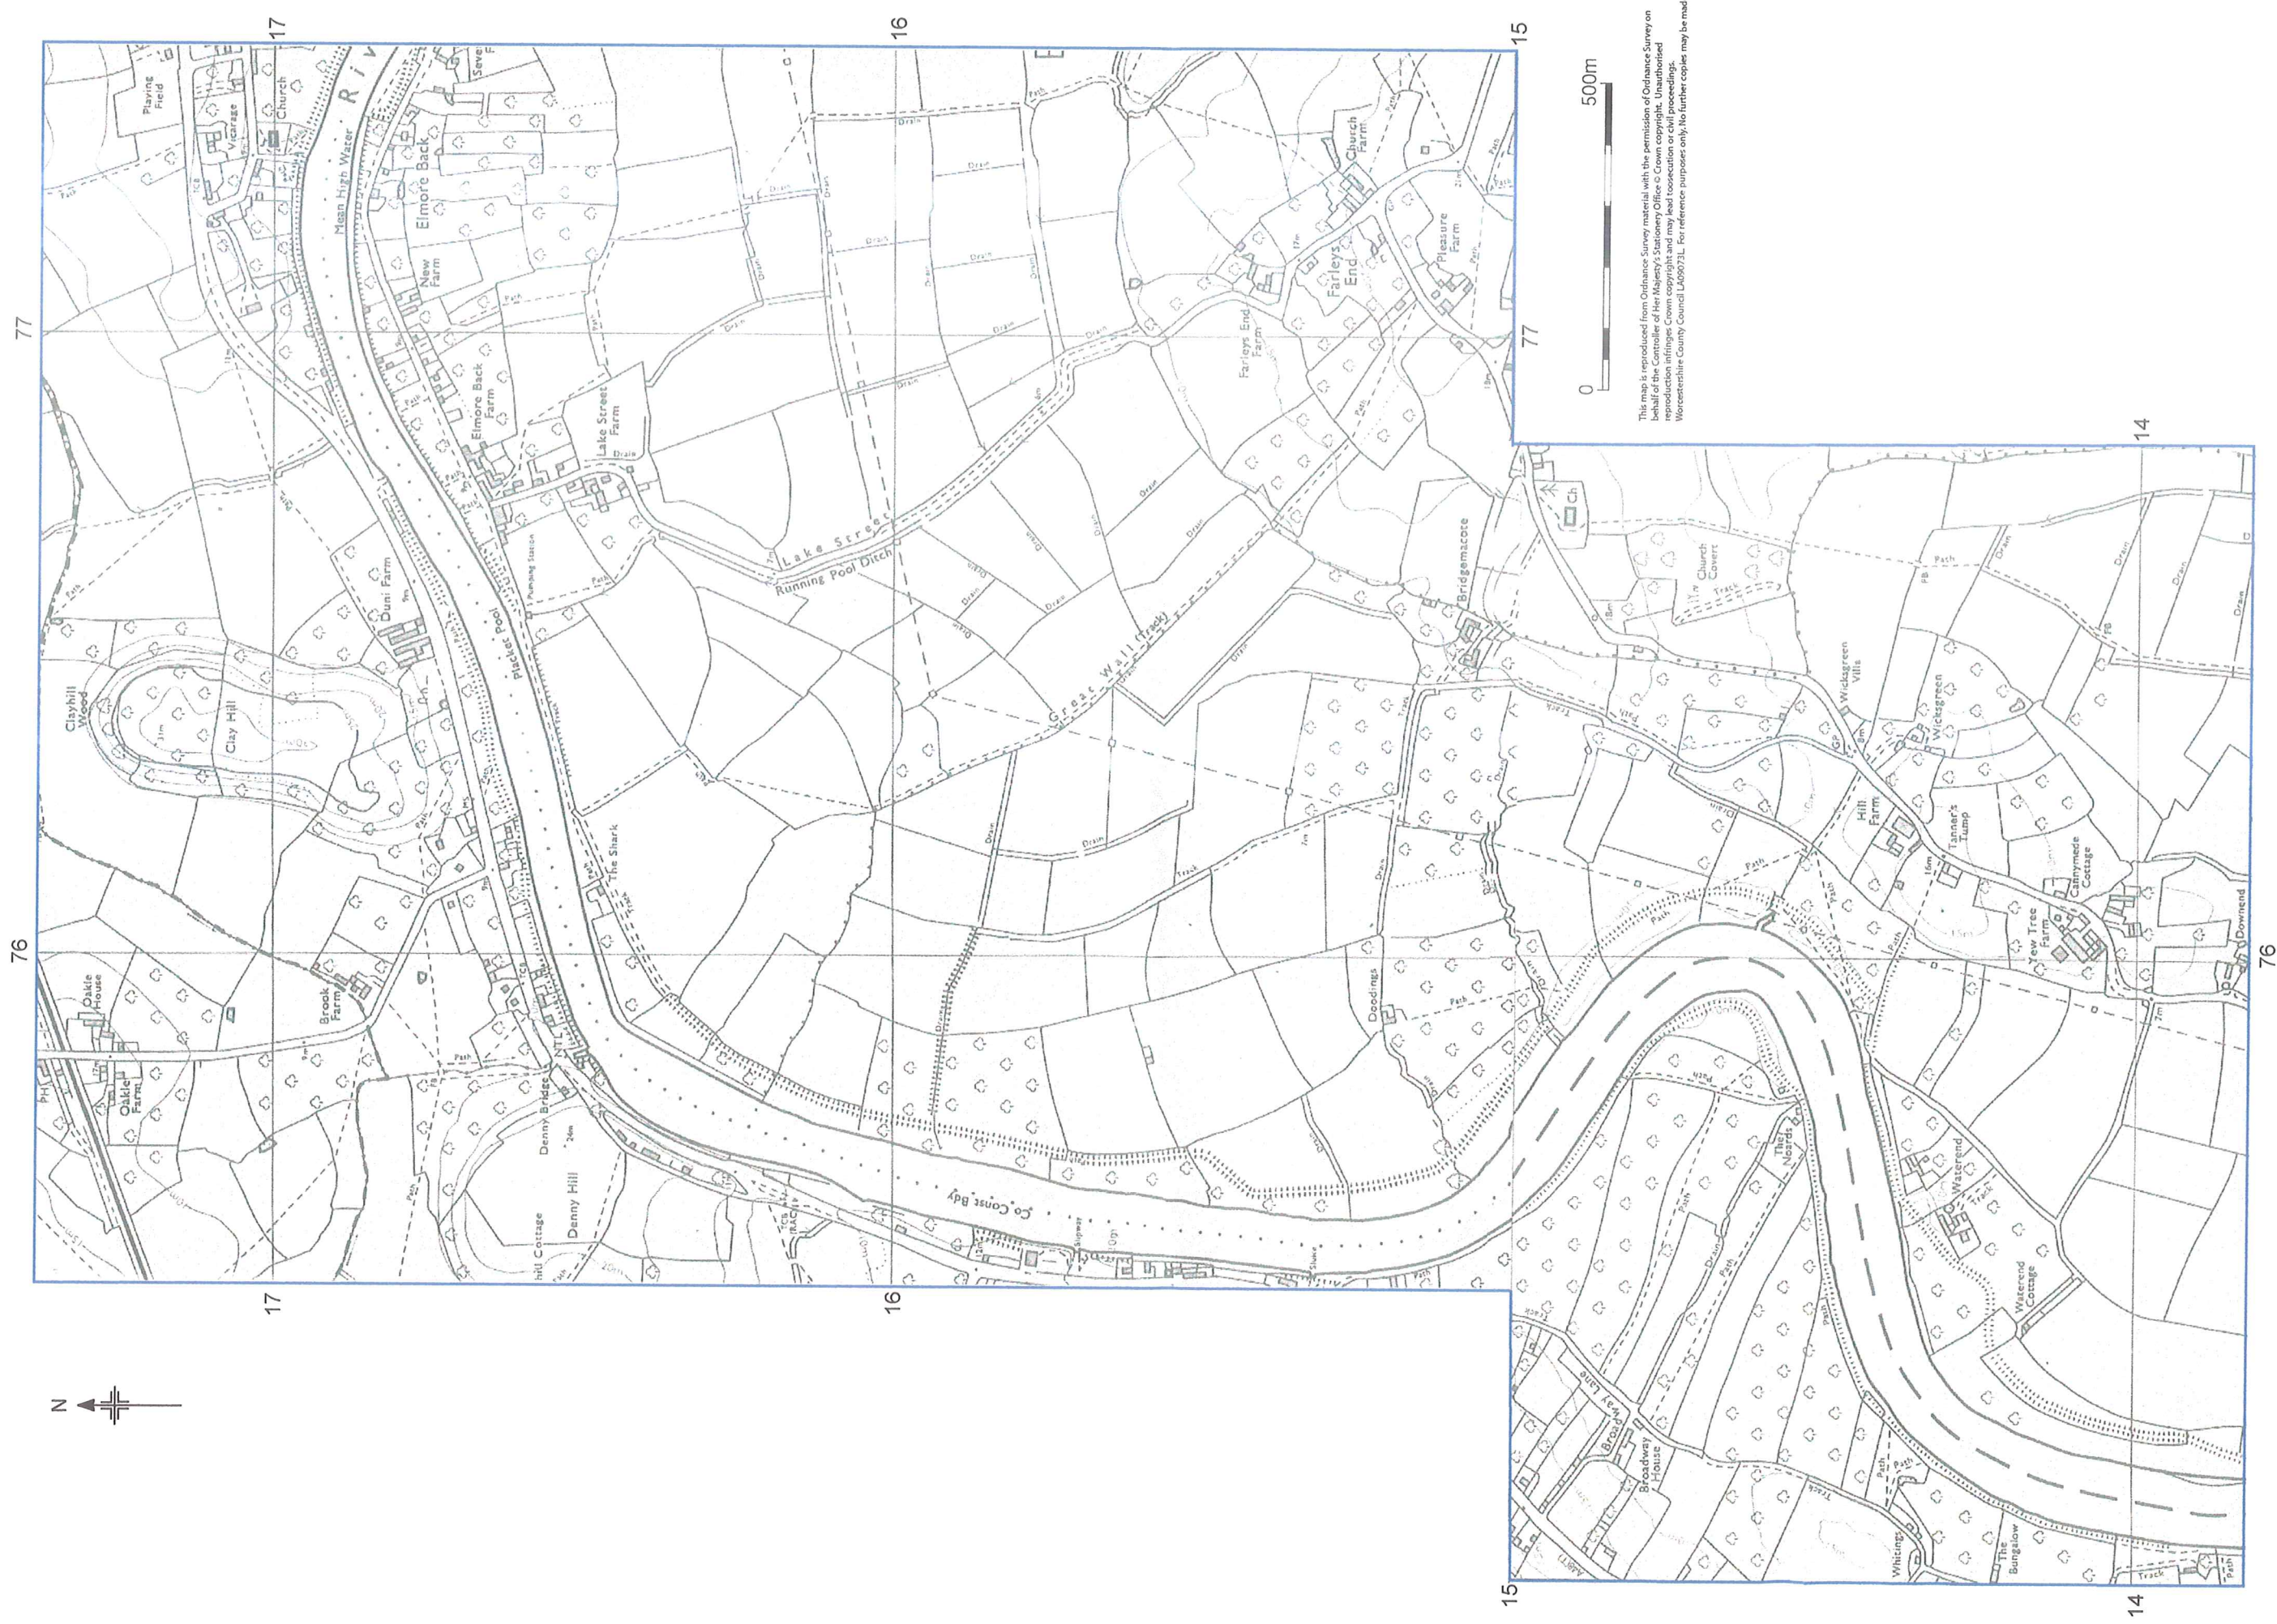
Figure 5

Extract from OS 1974 Sheet SO71 NE, 1:10,000 (top) and OS 1980 Sheet SO71 SE (bottom).
