HISTORIC BUILDING
RECORDING AT
COOKHILL PRIORY, COOKHILL,
WORCESTERSHIRE

Project P2333
Report 1184

Archaeological building recording at Cookhill Priory, Cookhill, Worcestershire

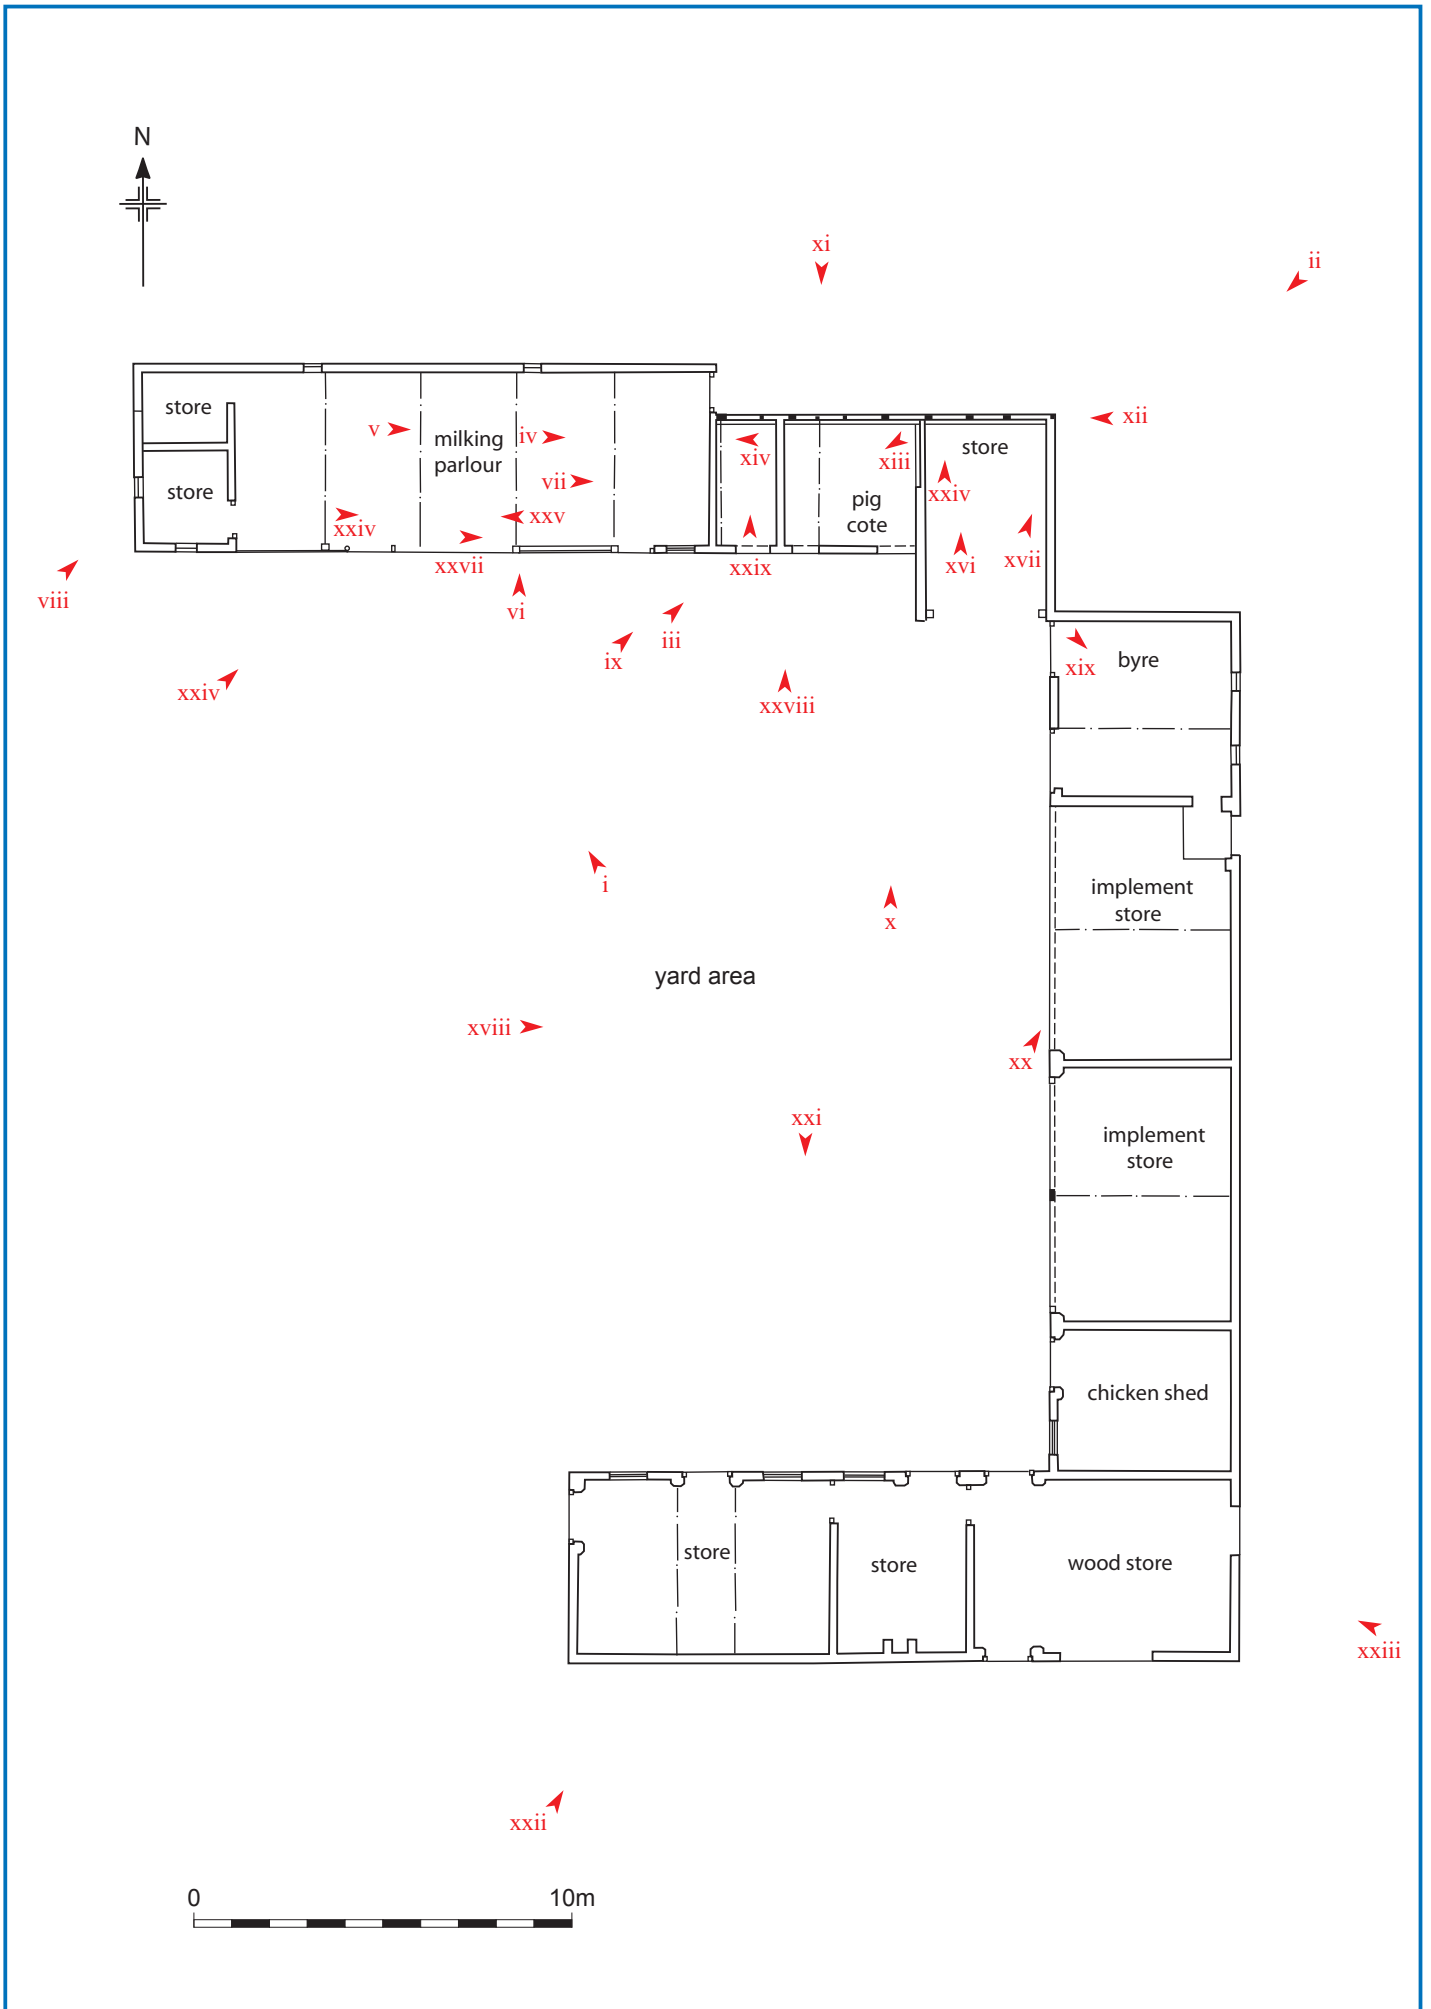
Figure 3

Location of external and internal photographs showing directions of view and plate number.

Further fieldwork was undertaken following the commencement of re-development, comprising the monitoring and recording (photographic and written) of all ground breaking activity within and surrounding the farm buildings. The areas observed are shown on Figure 3.

The location of all groundbreaking activity is shown in figure 3.

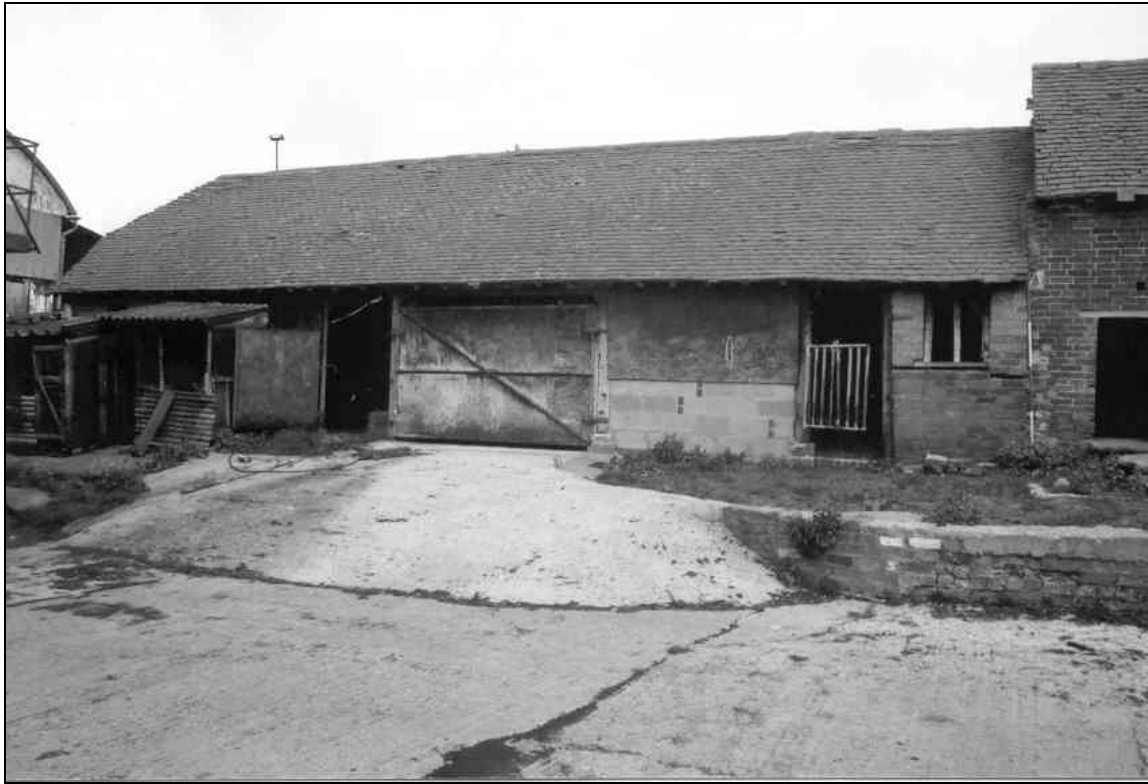
Plate i South facing elevation of milking parlour

The milking parlour is a single storey brick built structure, measuring 15.0metres by 5.0 metres, aligned east-west forming part of the northern range of the farmyard complex (Plate i). To the south lies the yard and to the north a partially infilled ditch which runs the length of both the milking parlour, the pig cote and store C (Plate ii). The brickwork is coursed in Flemish stretcher with bricks measuring 9.5 x 2.75 x 4.5 inches. Openings comprise single casement wooden framed window openings in the south, north and west elevations, three gated openings which provide access at both ends and to the west of centre in the southern elevation and a further door opening in the west elevation, which has been partially blocked to create a window opening. The southern frontage is in a poor state of repair, with the east end dramatically buckling outwards (Plate iii) and the lower portion of the central area partially rebuilt in breeze block.

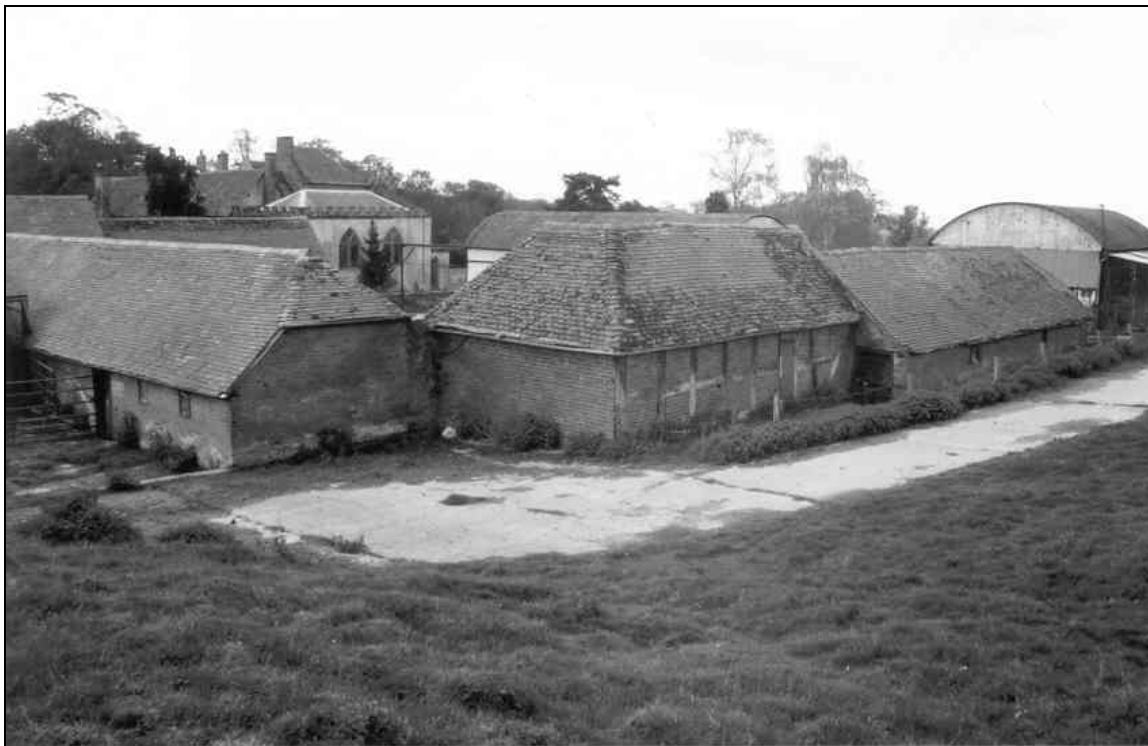
Plate ii Store C, pig cote and milking parlour north facing elevations

The roof is a single build over the pig cote and store C with one pitch running east-west over the pig cote (Plate ii) and a gable to the west (abuted by the gable of the milking parlour; Plate viii). The pitch changes over store C with the ridge turning 90° to run north-south to a hipped roof at the southern frontage of store C (Plate ix).

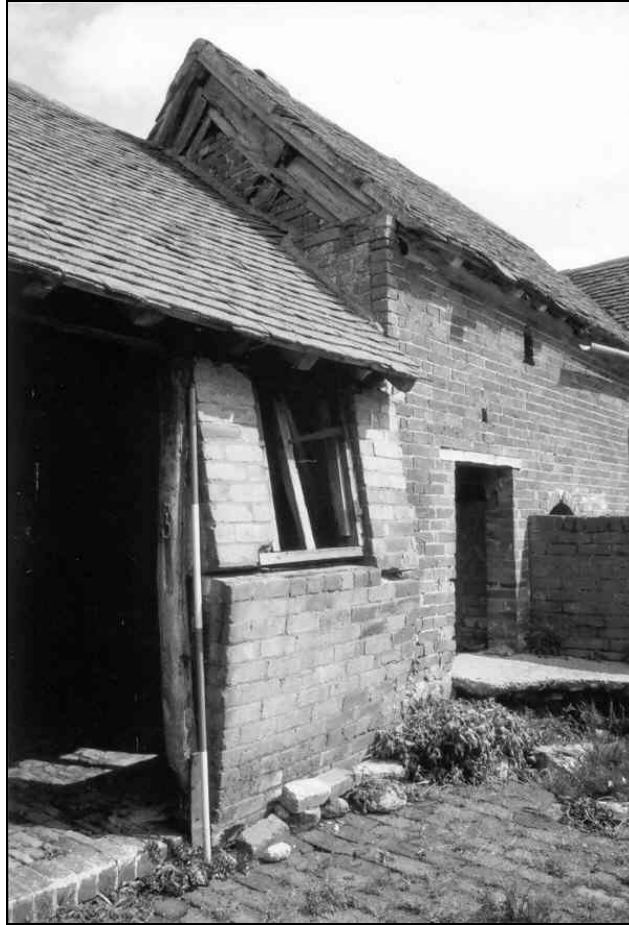
Plate iii *Buckling of wall at southern frontage of milking parlour*

The farmyard was subject to several alterations during this phase, confined to repair or consolidation activities of the existing buildings. A breeze block wall replaced the lower elements of the southern frontage of the milking parlour. Poured concrete floors were laid within all the buildings masking all earlier surfaces - mainly consisting of laid brick floors. Several new buildings were constructed of breeze block with corrugated iron roofs, evidence of an expansion in the size of the farm at this time and a change in the implements and vehicles being used.

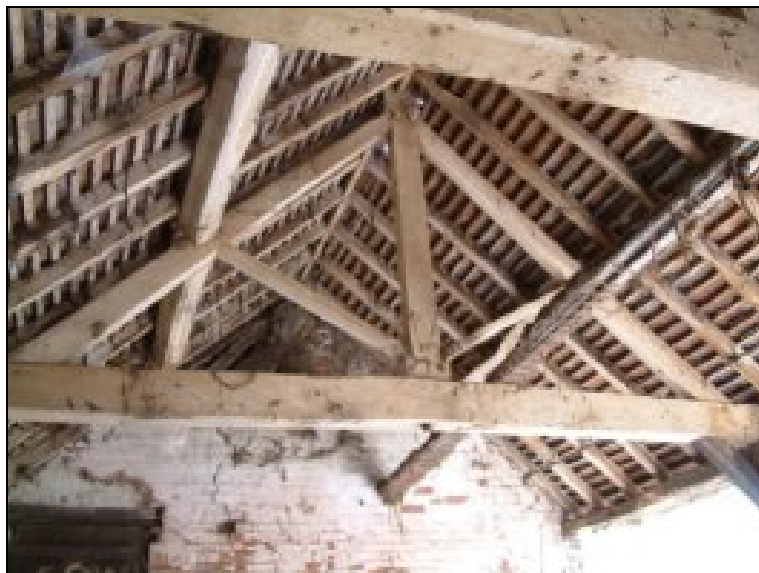
Plate iv *Truss in milking parlour*

Internally the building comprises a long single celled bay (the milking parlour) supported by four king post trusses with through purlins (Plate iv). The trusses sit to the north onto the brickwork and wall plate and to the south onto a wall plate supported by three extant arched brace frontage posts (with the exception of the second truss from the west where the post has been removed to accommodate a wider opening and the truss is supported by the wall plate alone). Carpenters marks were clearly visible on the western face of the trusses and the southern face of the frontage posts indicating that they were assembled on site from ready cut timbers (Plate v). The northern elevation houses a number of tethering rings relating to the function of milking parlour. At the western end of the building are two smaller cells (the stores) separated by a single skin brick wall with two door openings. The floor is principally 20th century poured concrete with an area of stretcher brickwork at the eastern end (Plate vi). The roof has a half-hipped gable end to the west (Plate vii) and a gable to the east, which abuts the west gable of the adjacent pig cote (Plate viii). The roof covering comprises flat rectangular tiles.

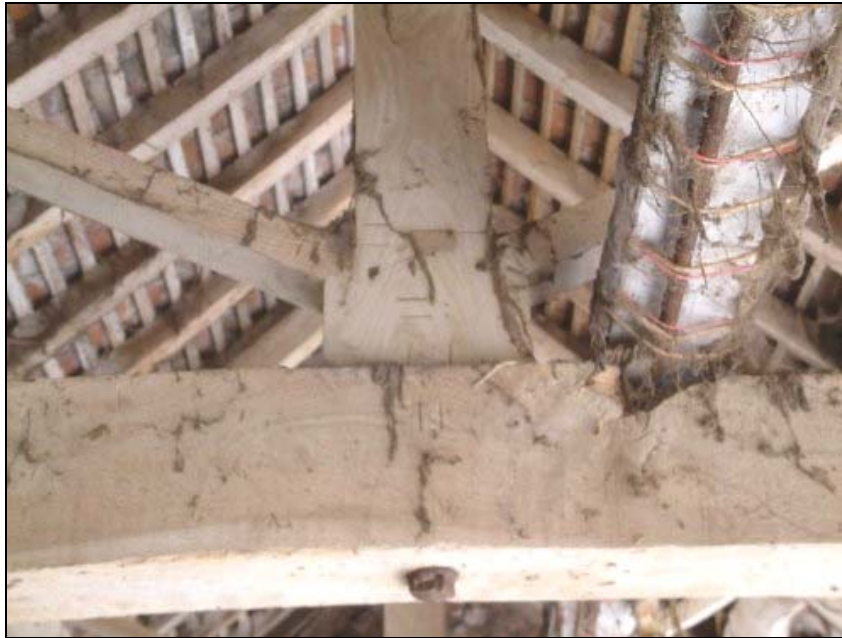
Plate v Carpenters marks on milking parlour truss

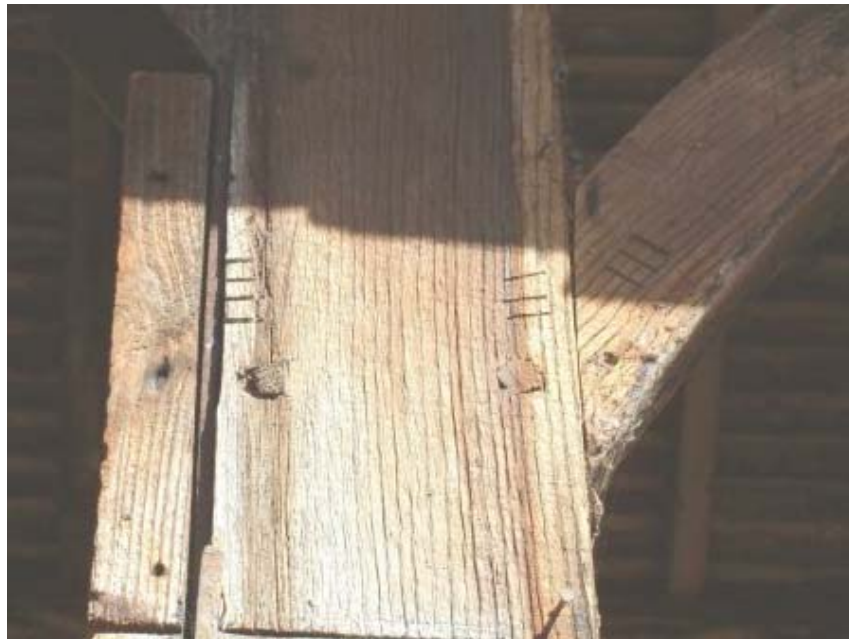
Plate vi Carpenters marks on main support beam of milking parlour south elevation

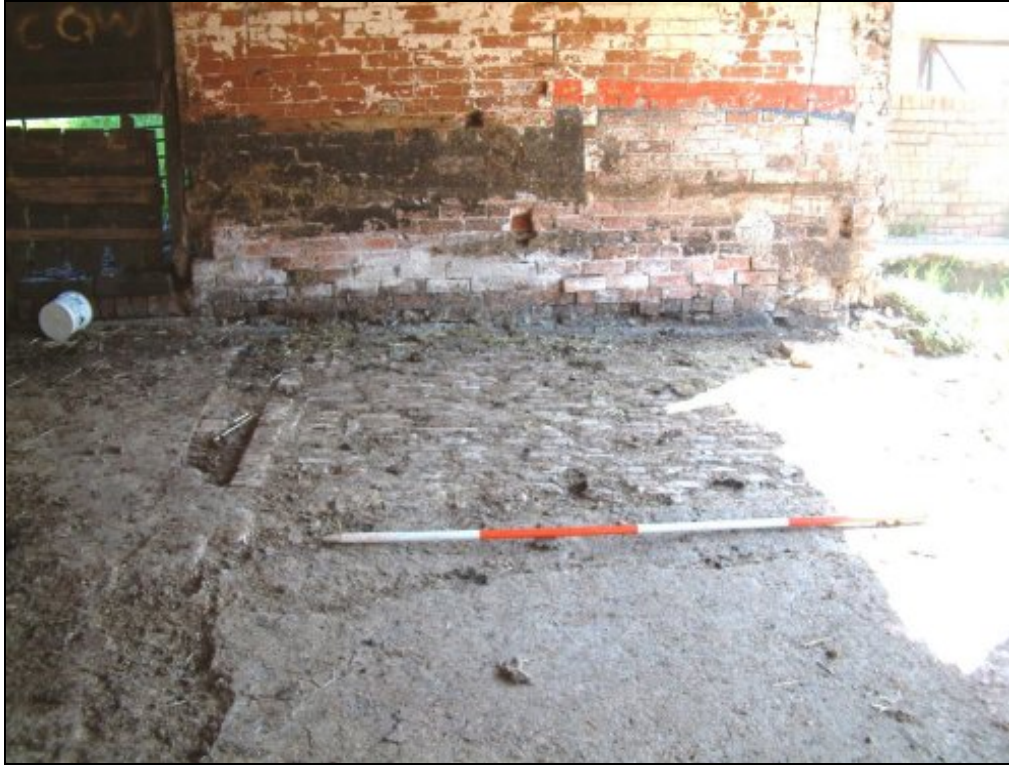
Plate vii Internal floor at east end of milking parlour

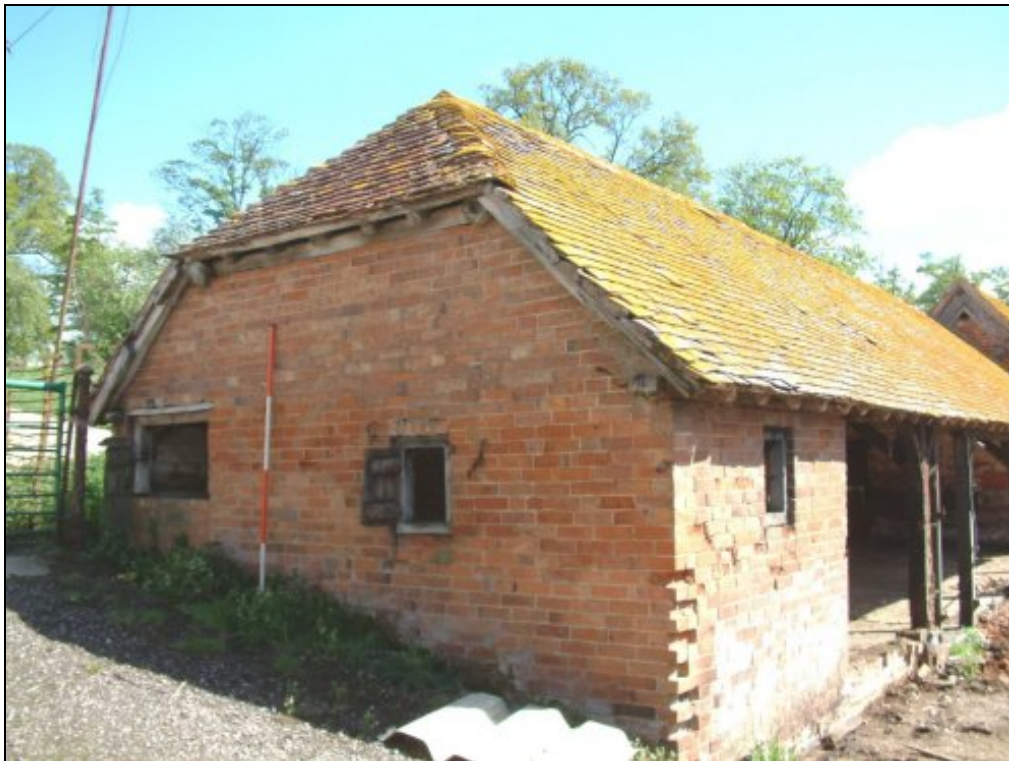
Plate viii West facing elevation of store and milking parlour

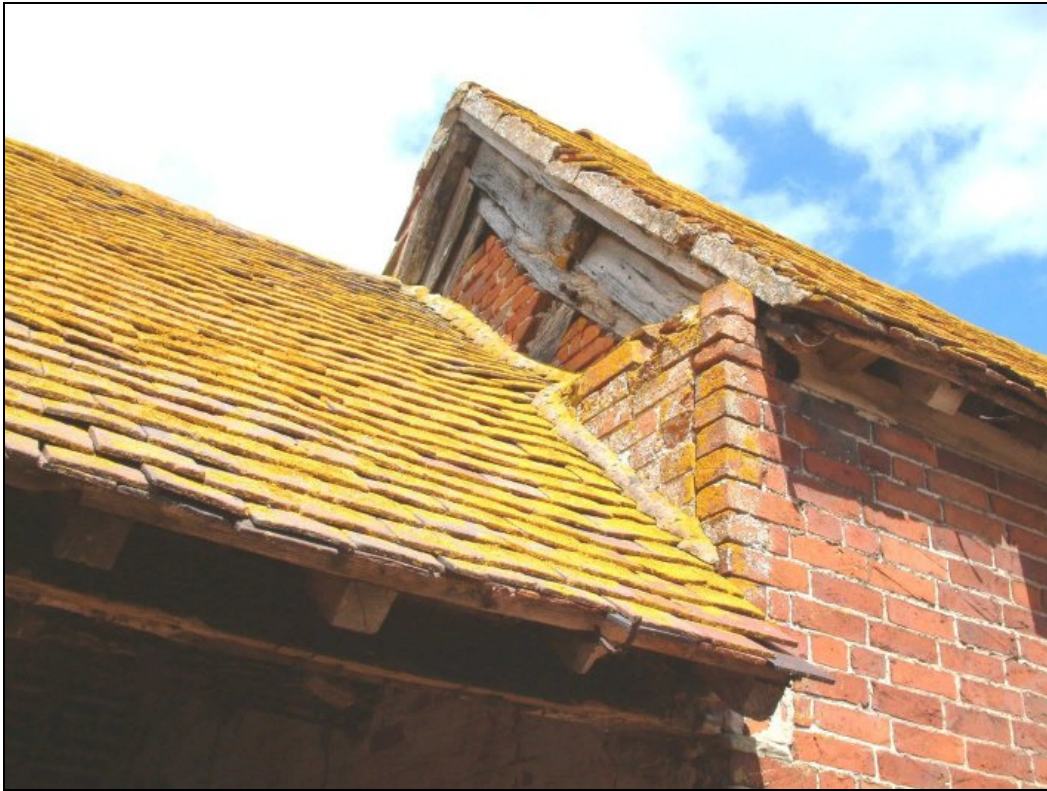
Plate ix *Abutment between pig côte and milking parlour*

The pig cote (pig sty) is a single celled brick structure, measuring 5.00 by 3.75 metres, with remains of brick infilled timber framing in the northern elevation (Plates ix and x). The building forms the central element of the northern range flanked by the milking parlour to the west and store C to the east. The brickwork is coursed in Flemish stretcher with bricks measuring 9 x 2.5 x 4.25 inches. Openings are all located in the southern frontage and comprise a low flat headed opening at the west, a semicircular arched opening at the centre and a taller flat headed opening with segmental arch voussoirs at the east (Plate ix). The timber framing in the northern elevation is of square panelling (Plate x) typical of the Welsh Marshes region and the West Midlands from the 15th century amongst higher status buildings disseminating into wider use by the 17th century (Brown 1986, 49). Grooves evident in the internal faces of the timbers indicate that they would have originally housed wattle and daub rather than brick infill. At the eastern external corner a pronounced groove, undoubtedly to house wattle and daub, is evident in the stud of the framing, above this a mortice joint in the wall plate indicates that the elevation originally continued to the east (Plate xi). As such the east elevation of store C represent a different phase of construction to the northern panelled elevations. A former doorway in the framing, blocked by re-used chamfered bricks provides further evidence of alterations to this elevation. Carpenters marks are clearly visible at the joints between braces and studs or posts. The sill beam is supported by brickwork and stone,

Store C is a single celled brick structure measuring 5.40 by 3.75m forming the eastern extent of the northern range (Plate ix). The brickwork is coursed in Flemish stretcher with bricks measuring 9 x 2.5 x 4.25 inches. The northern elevation is continuous with that of the pig cote. The building is open to the south with wide double gates under a hipped roof. The trusses appear to be reused and have been cut above the collar (Plate xv) in order to accommodate the change in roofline at the northern end and to accommodate the hipped roof at the southern end. Their form, the type carpenters marks employed and the use of round section wooden pegs (Plate xvi) at the joint between the tie beam and principal rafters strongly resembles that of the trusses observed in the pig cote, and implies a contemporary period for their initial use.

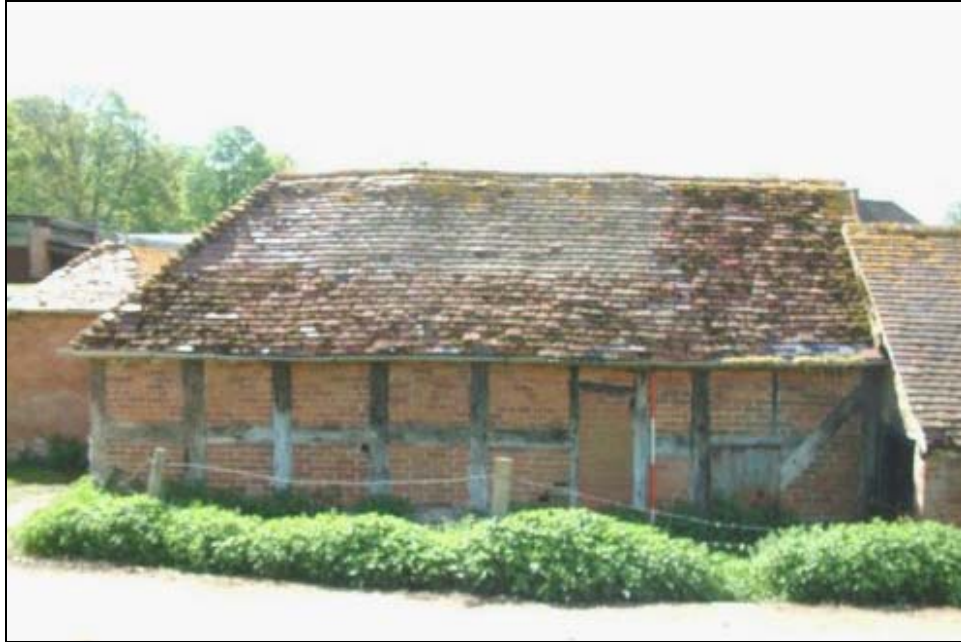
Plate xi North facing elevation of pig cote

The only extant building elements relating to this period are the timber framed northern elevation of the pig cote and store C and possibly the trusses of these buildings. The square panelling shows clear evidence of several alterations. Originally the panelling would have been infilled by wattle and daub, the grooves for which are still evident on the internal faces of the studs. A blocked doorway would have provided access from the north, the dimensions of its height and width indicates it was for human access rather than livestock. At the eastern end the evidence of a groove in the vertical stud and a mortice hole in the wall place indicates that the building originally extended to the east.

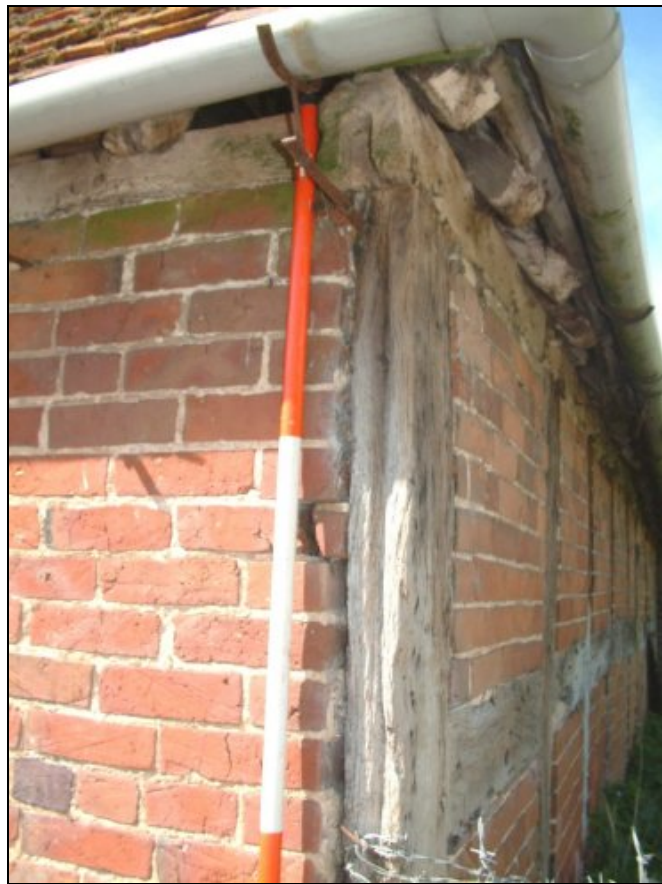
Plate xii Detail of mortice joint and groove at east corner of pig cote

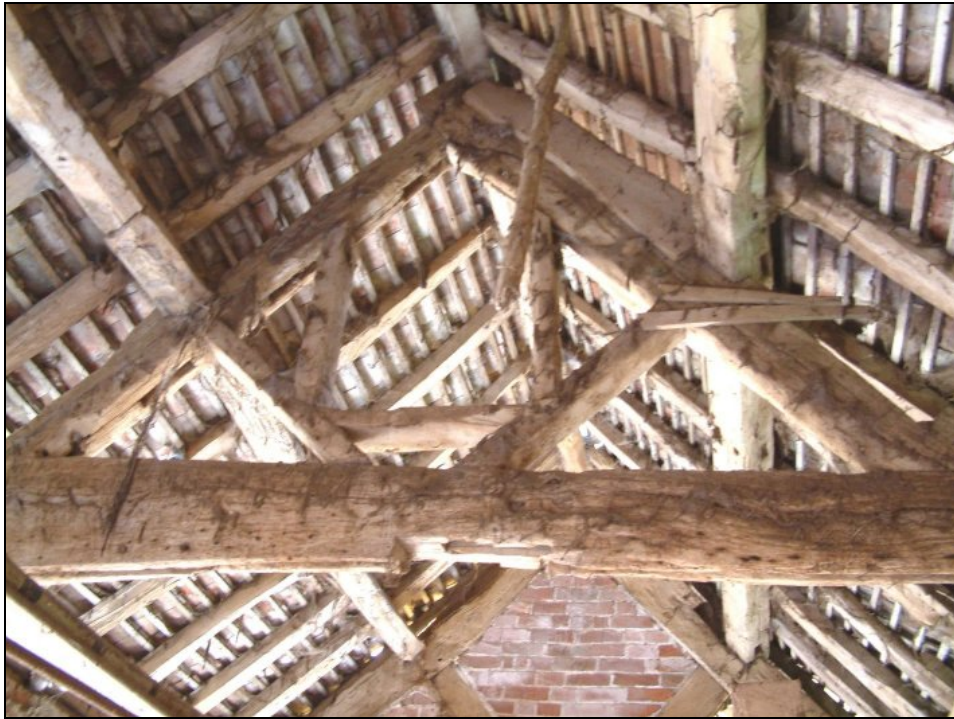
Plate xiii Truss in pig cote

It is not possible to assign a definite date to the trusses present in the pig cote and store C. All are adze cut with wooden pegs which can be dated to a range of between late 17th century to mid 19th century (Wade Martins 1991, 80). However their dimensions and form indicate that they are early and are likely to have been contemporary to the original timber framing. Those in store C have clearly been reused and may have originally been employed in the eastern continuation of building. Numerous mortice holes indicate that the tie beam and principal rafters have been subject to numerous alterations and may even be reused.

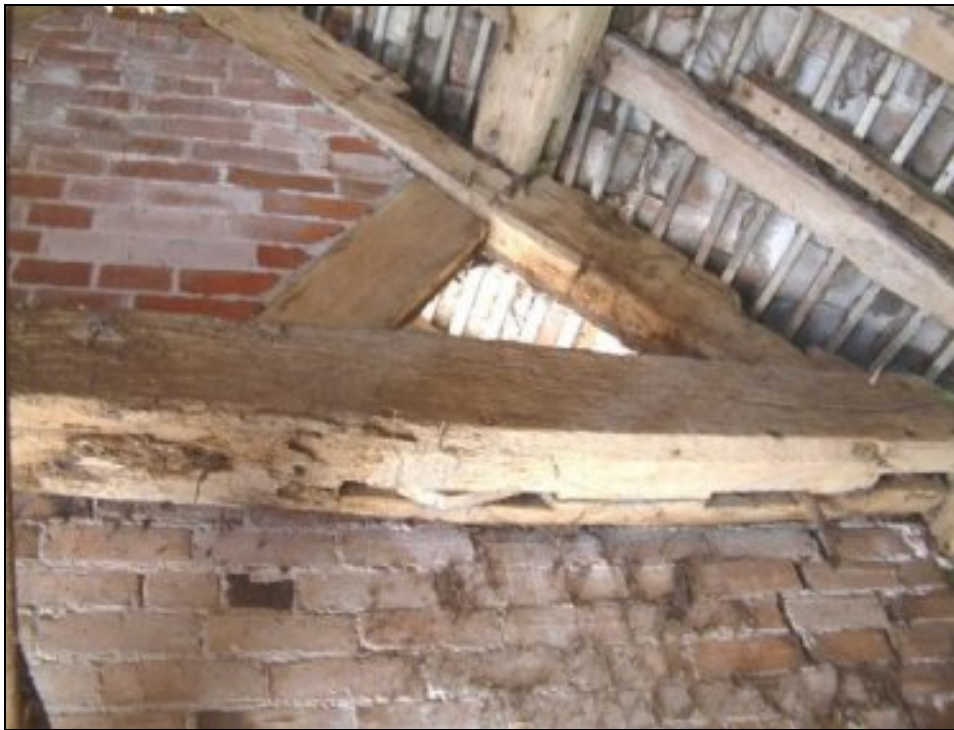
Plate xiv Detail of truss and purlin formation in west elevation of pig cote

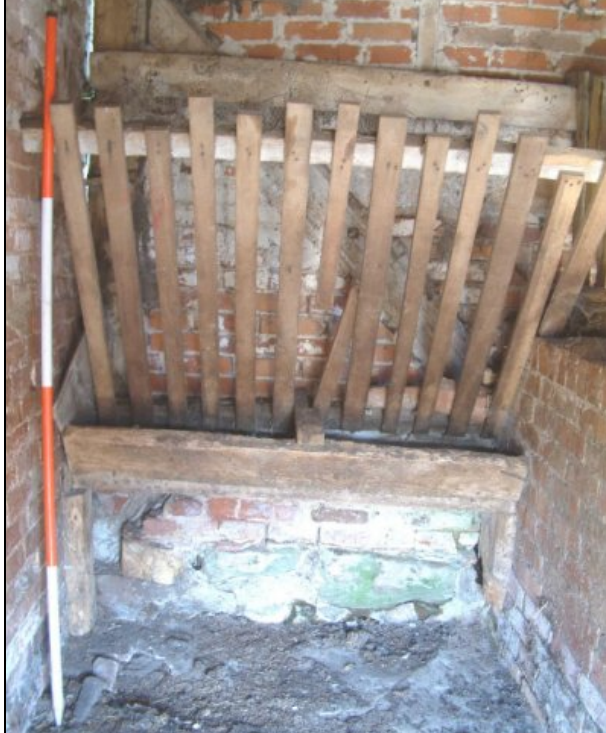
Plate xv *Internal south facing elevation in pig cote showing feeding trough and stone footings*

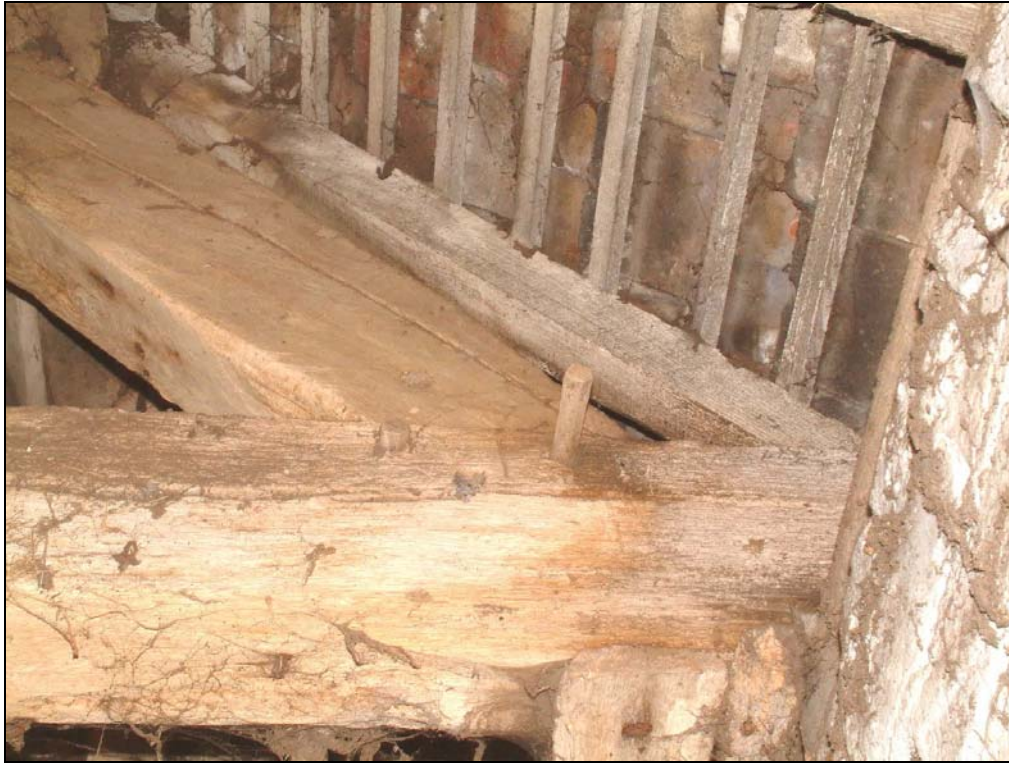
Plate xvii Detail of truss in store C

The eastern range comprises four cells; the byre, two implement stores and the chicken shed (Plate xvii). The brickwork of the eastern and northern elevation is coursed in Flemish

The byre is a single cell brick built structure at the southern end of the east range (Plate xvii), measuring 5.00 by 5.00m. A number of blue lias blocks have been incorporated into the main build at the door opening to the west (yardside) and within the main build at the east and south elevations. Openings are present in both the west and east external elevations and in the south internal elevation (where the byre adjoins the implement store). The western end of the northern elevation clearly abuts store C. Internally there is no extant evidence of the building's function the floor is covered by poured concrete. The kingpost truss (Plate xviii) is of the same form observed in the milking parlour with a slightly longer length of the crown post projecting above the principal rafters and clasped pulins which continue south into the implement stores.

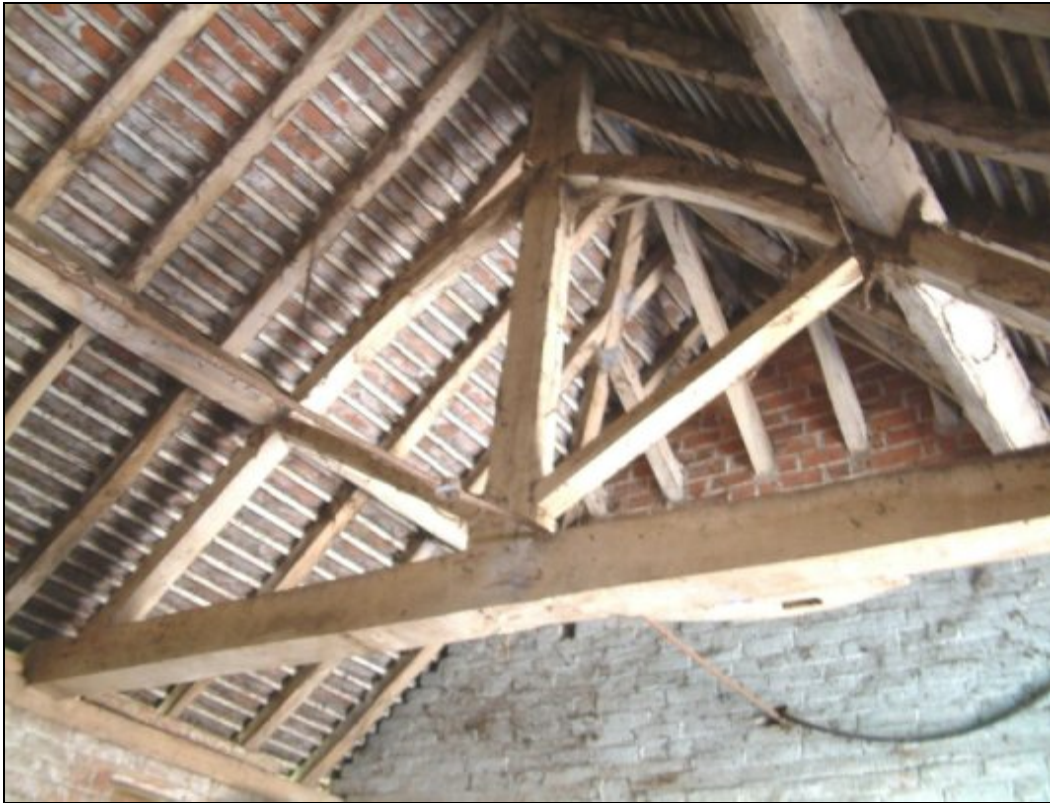
Plate xix Truss in byre

These three bays are all open to the west (Plate xvi) supported by two A-frame trusses (Plate xix) with angled queen struts and through pulins, situated in implement stores A and B. The southern elevation of the chicken shed is of two builds; the lower being keyed into the eastern elevation, and the upper build abutting the east elevation, matching in brick dimensions and coursing that of the other internal walls of the range.

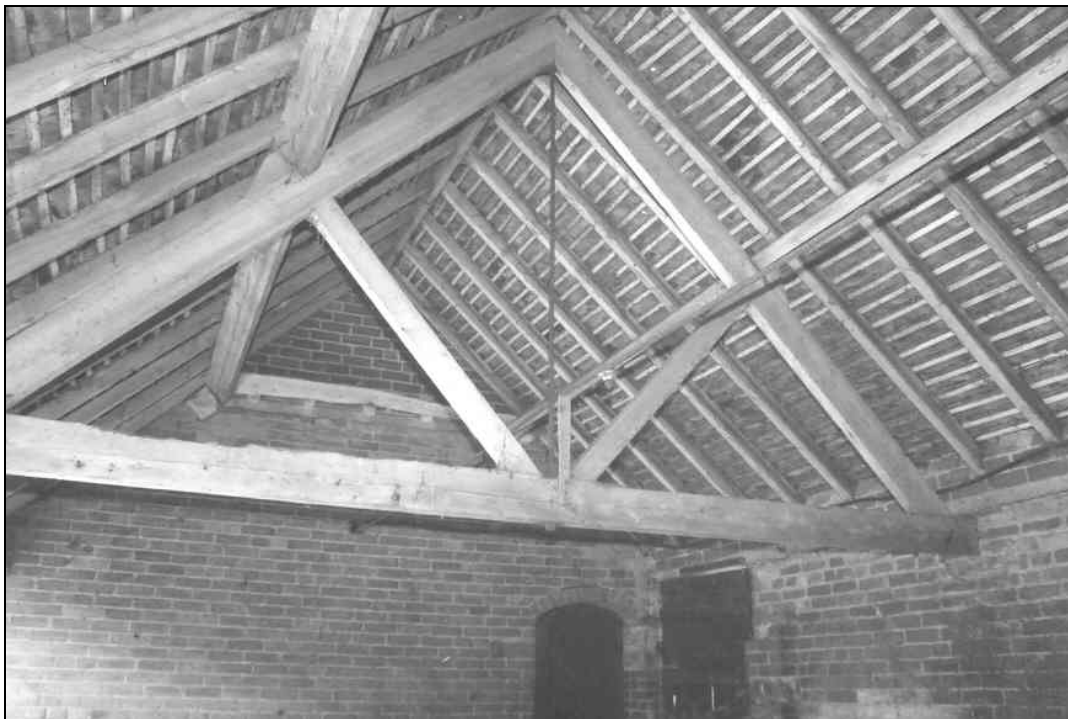
Plate xx Truss in implement store A

The southern range comprising the wood store, stores A and B is two storey, three celled brick structure with door and window openings to the north south and west (Plates xx and xxi). The brickwork of the main external elevations is coursed in Flemish stretcher with bricks measuring 9.25 x 2.5 - 2.75 x 4.5 inches, with the internal elevations and part of the east elevation coursed in stretcher bond in bricks measuring 8.5 x 2.5 x 4 inches. The roof is gable ended to the east and west and supported by A-frame trusses only visible in store A, due to the presence of hay lofts in both the wood store and store B. Openings are present in the north, west and south elevations, all openings have flat segmental arches characteristic of the mid to late 19th century. The west elevation houses a stable door. The internal southern wall of Store A houses a small hearth with an internal brick stack abutting the southern elevation which projects through the roofline. The west and south walls also house tack hooks.

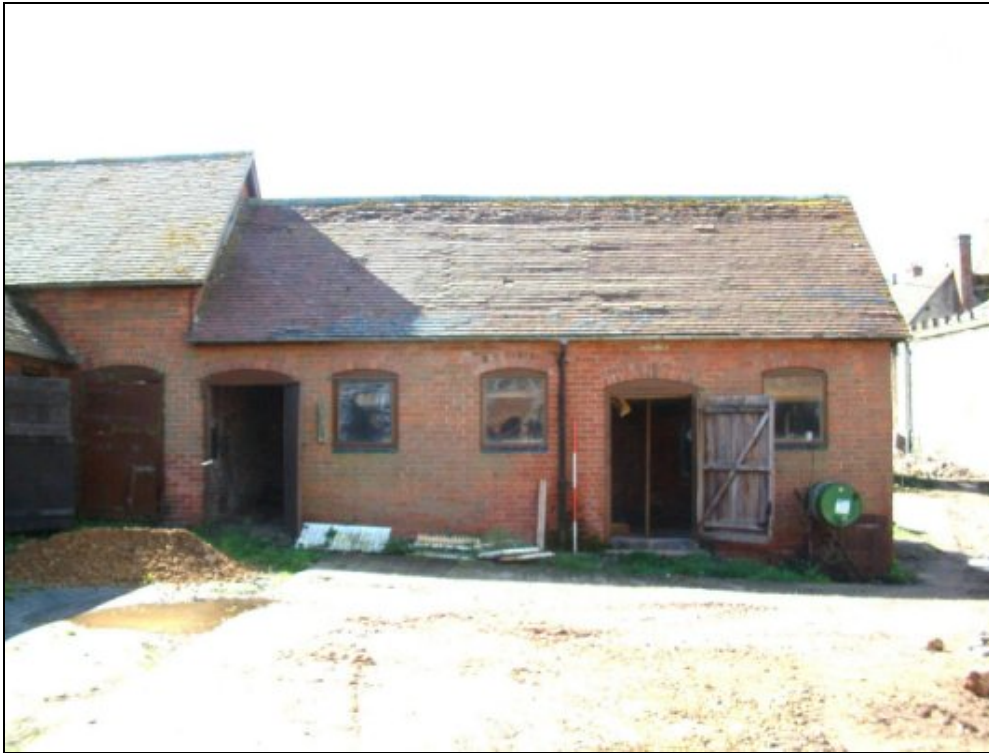
Plate xxi North facing elevation of southern range – wood shed and stores A and B

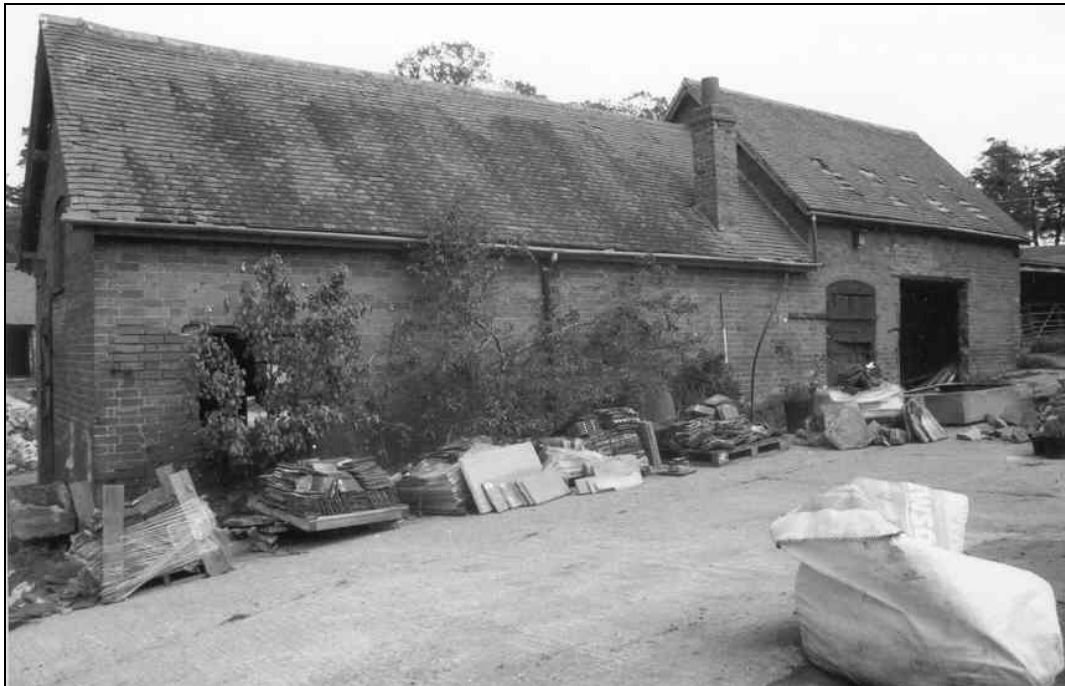
Plate xxii South facing elevation of southern range – wood shed and stores A and B

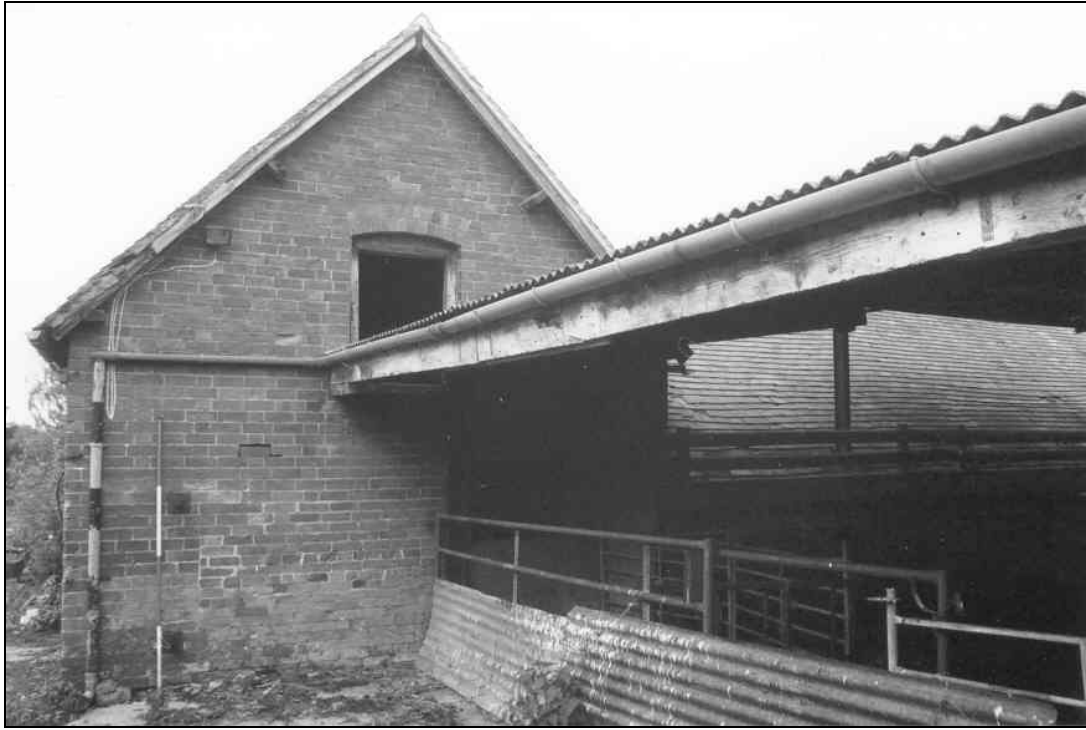
Plate xxiii East facing elevation of wood shed

The eastern elevation of the wood store contains several phases of construction, comprising a continuation of the main build from the eastern range, only present in the lower courses, which abuts the main build of the southern range at the south-east corner (Plate xxii). The joint coincides with two iron gate fixtures one inserted into the main build of the southern range and one in the lower build.

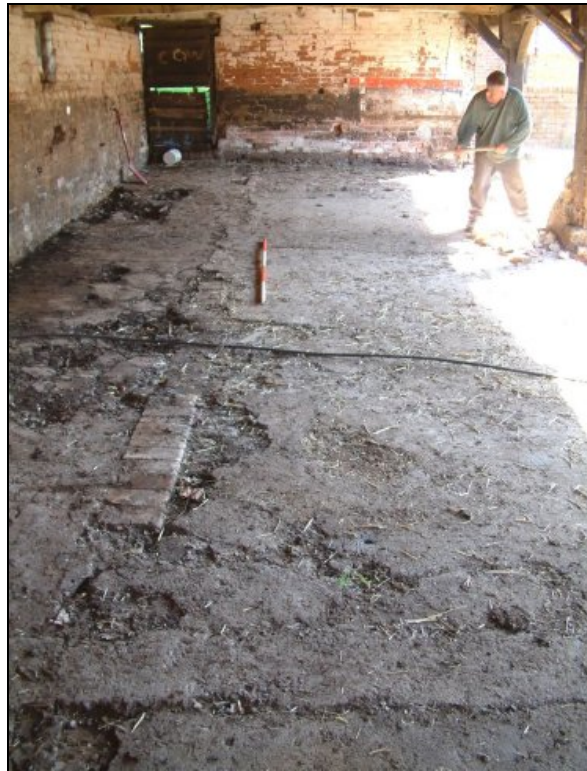
Plate xxiv Floor of milking parlour during ground works

The existing concrete floor a brick floor was removed with a mechanical excavator revealing a brick floor laid in stretcher courses running north-south. The bricks measured 9.25 x 3 x 4.75 inches and were laid directly onto orange sand. Ground reduction was ceased at this level, approximately 0.30m below the former floor surface. No features of archaeological significance were encountered.

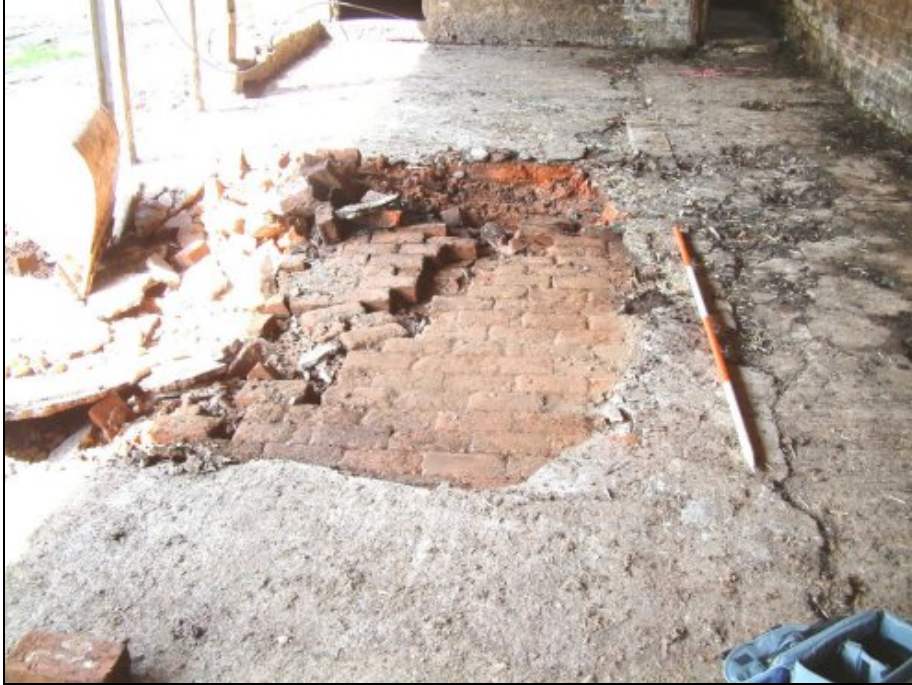
Plate xxv Old brick floor surface revealed in milking parlour

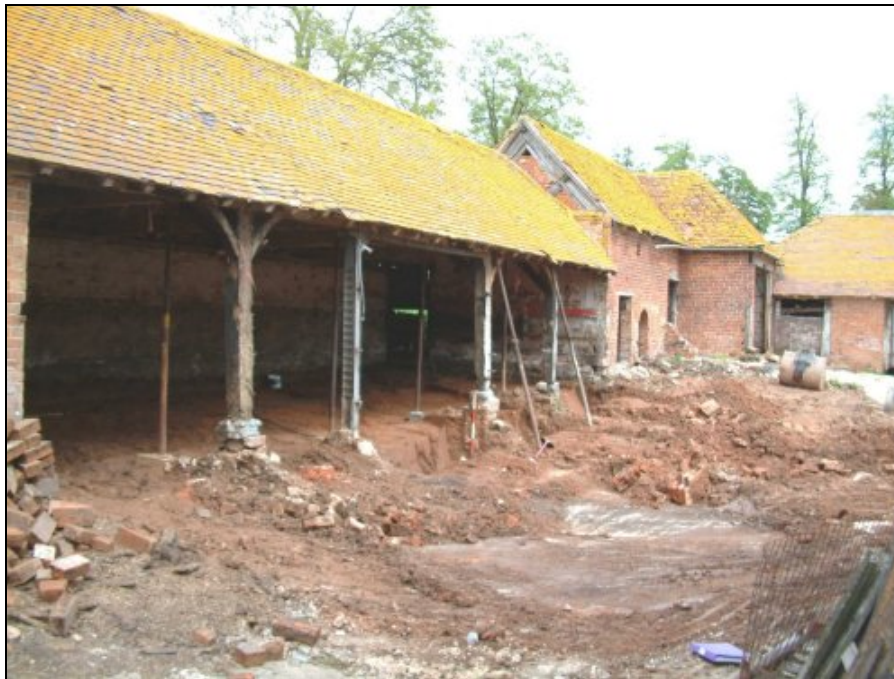
Plate xxvi Milking parlour following ground works

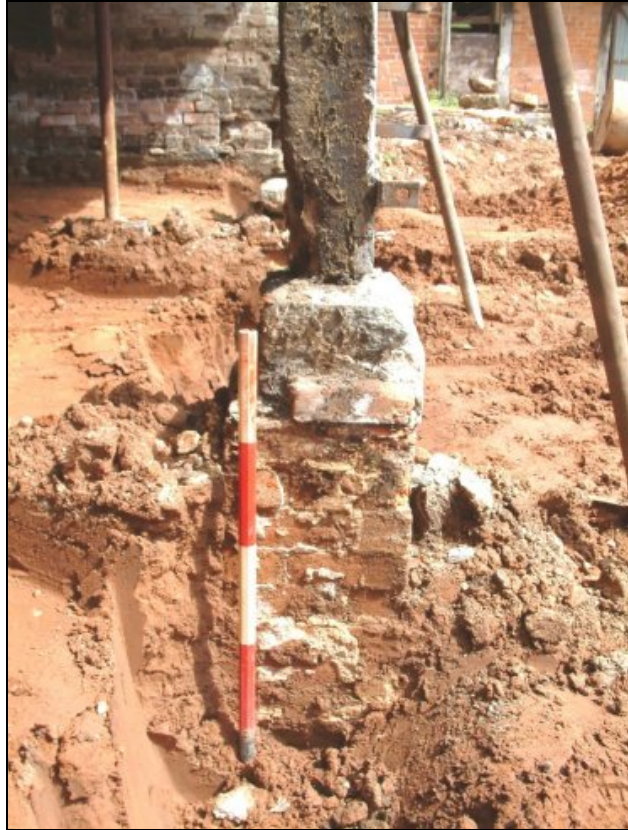
Plate xxvii *Detail of brickwork below frontage beam of milking parlour*
