HISTORIC BUILDING
RECORDING AT
COOKHILL PRIORY, COOKHILL,
WORCESTERSHIRE

Project P2333
Report 1184

Archaeological building recording at Cookhill Priory, Cookhill, Worcestershire

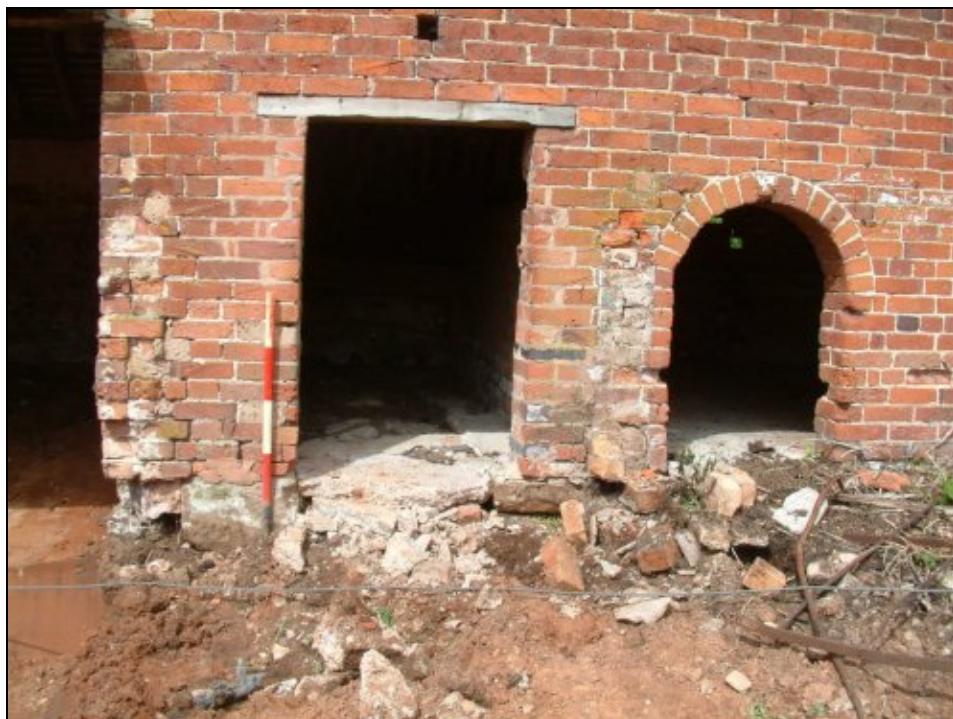
Plate xxviii *Pig côte following ground reductions*

The floor of the pig cote was removed by pneumatic hammer and hand pick. Directly below the existing concrete floor was rubble material (200) including brick, tile and stone rubble acting as a consolidation layer. A single piece of worked masonry was recovered from this material, however no features or structural remains of archaeological significance were encountered.

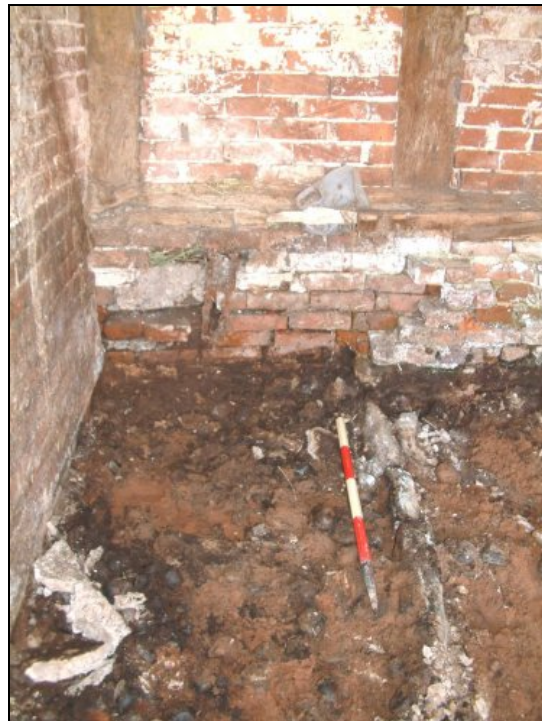
Plate xxix *South facing elevation and ground following ground reduction in store C*

The floor of store C was removed by mechanical excavator, beneath the existing concrete floor the remains of a former floor surface was revealed at a distance of 2.20m north of the present southern elevations. The flooring was composed of a small surviving area of 1.0m wide strip of bricks cut to the west by the western wall of the store. The remaining area was covered by large rounded cobbles (120 – 180mm) divided from the brick by a single row of blue lias stones running north - south. The cobbles had no apparent signs of metalling and appear to represent consolidation or packing material. The relation between the remains of the surface and the northern wall was difficult to ascertain, as it was only partially extant. However the blue lias stones certainly respected the elevation implying that the wall was present before the laying of the floor.

A sondage was inserted next to the northern wall revealing brick footings to a depth of approximately 1.00m (12 courses) below the sill beam. This depth of brickwork below the sill beam may indicate that the original elevation was underpinned at a later date. In support of this supposition is the fact that the underpinning is keyed into the east wall of store C which certainly appears to post-date the original timber panelled building (see 4.2)
