Building recording at
Tanwood Stud
(formerly Woodside Farm),
Tanwood Lane,
Chaddesley Corbett,
Worcestershire

Status: Revision 1
Date: 7 March 2016
Author: Tim Cornah tcornah@worcestershire.gov.uk
Illustrator: Laura Templeton and Tim Cornah
Project reference: P4766
Report reference: 2300
HER reference: WSM67664
Oasis id fieldsec1-240976

Building recording was required prior to the redevelopment of Tanwood Stud, Tanwood Lane, Chaddesley Corbett, Worcestershire.

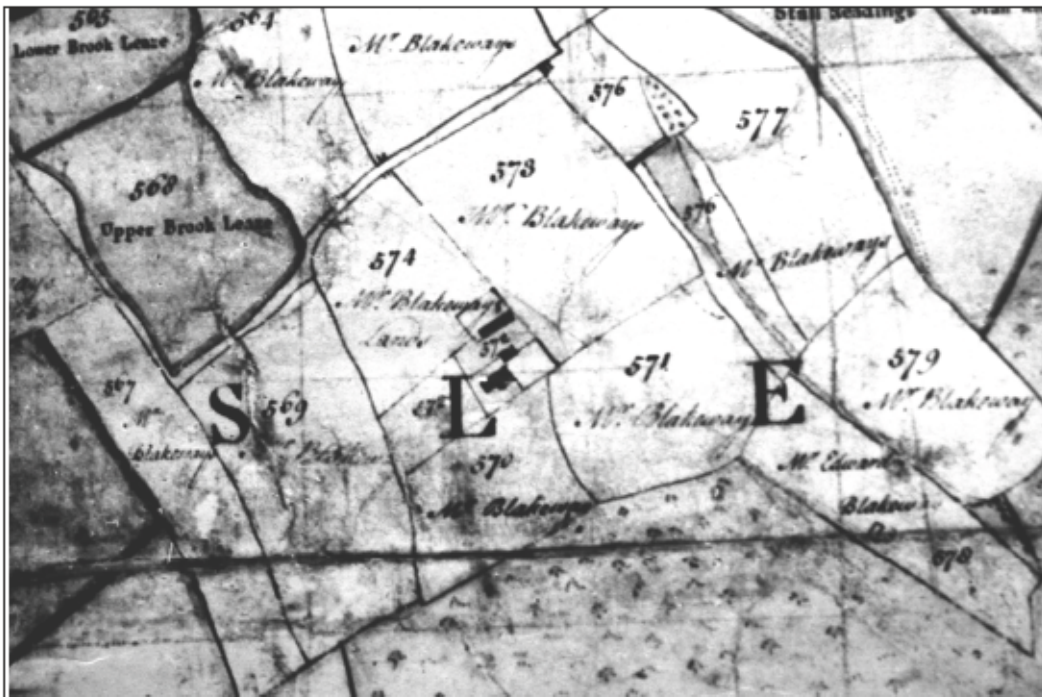
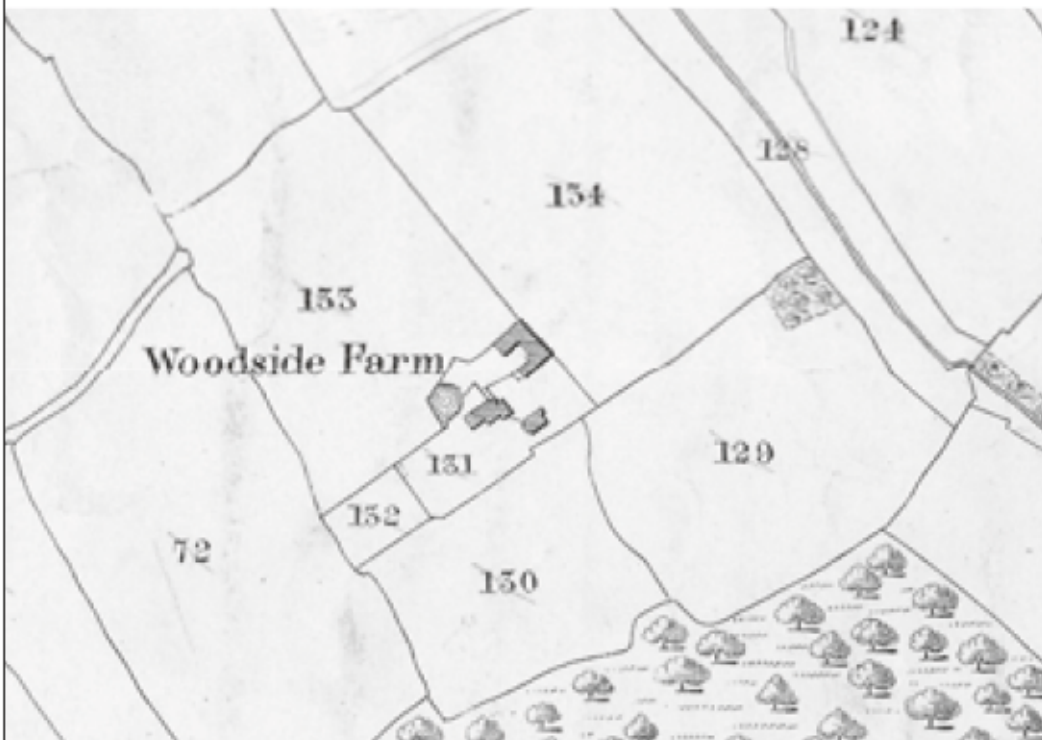
Figure 3

Tanwood (Woodside Farm) shown in 1745 ref. no. f970.5:92(above) and Chaddesley tithe map, 1839, ref. no. S760-178

The earliest cartographic source is a 1745 estate plan (WRO BA844 ref f970.5:92), Figure 3, and shows the house with the extra two bays added to the 17th century bay. A rectangular building is shown to the north of the house and a longer parallel rectangular building, also to the north. This building appears to have been associated with an enclosed area to the north-west, as well as areas to the south and east around the house. The landowner of the house and immediate surroundings is listed as being Mr Blakeway at this time, with no occupier recorded. Mr Blakeway was a large landholder in the parish so the extent of the farm at this time cannot be established. The farm and its immediate environs are named as Homestall and Homestall Close.

The 1839 Tithe Apportionment lists Woodside Farm as occupied by John Turner and owned by "John Amphlett executor under the will of John Page deceased". The apportionments and associated tithe map (WRO ref S760-178), Figure 3, documents the holdings of John Turner in a roughly rectangular area extending to the Hockley Brook on its north-west side and the woods on its south-east side. In total, the area of the farm was about 42.5 acres.

This map shows a significant reorganisation of the farm buildings, with a U-shaped set of structures enclosing a yard to the north-east of the house and a further detached structure to its south-east. These buildings correspond with Phases 1 and 2 as outlined below. Also shown on the map is a pond to the north-west of the house. The former enclosure shown on the 1745 to the north-west of the longer rectangular building has been amalgamated into a wider field by 1839 and is listed as an orchard within the apportionment.

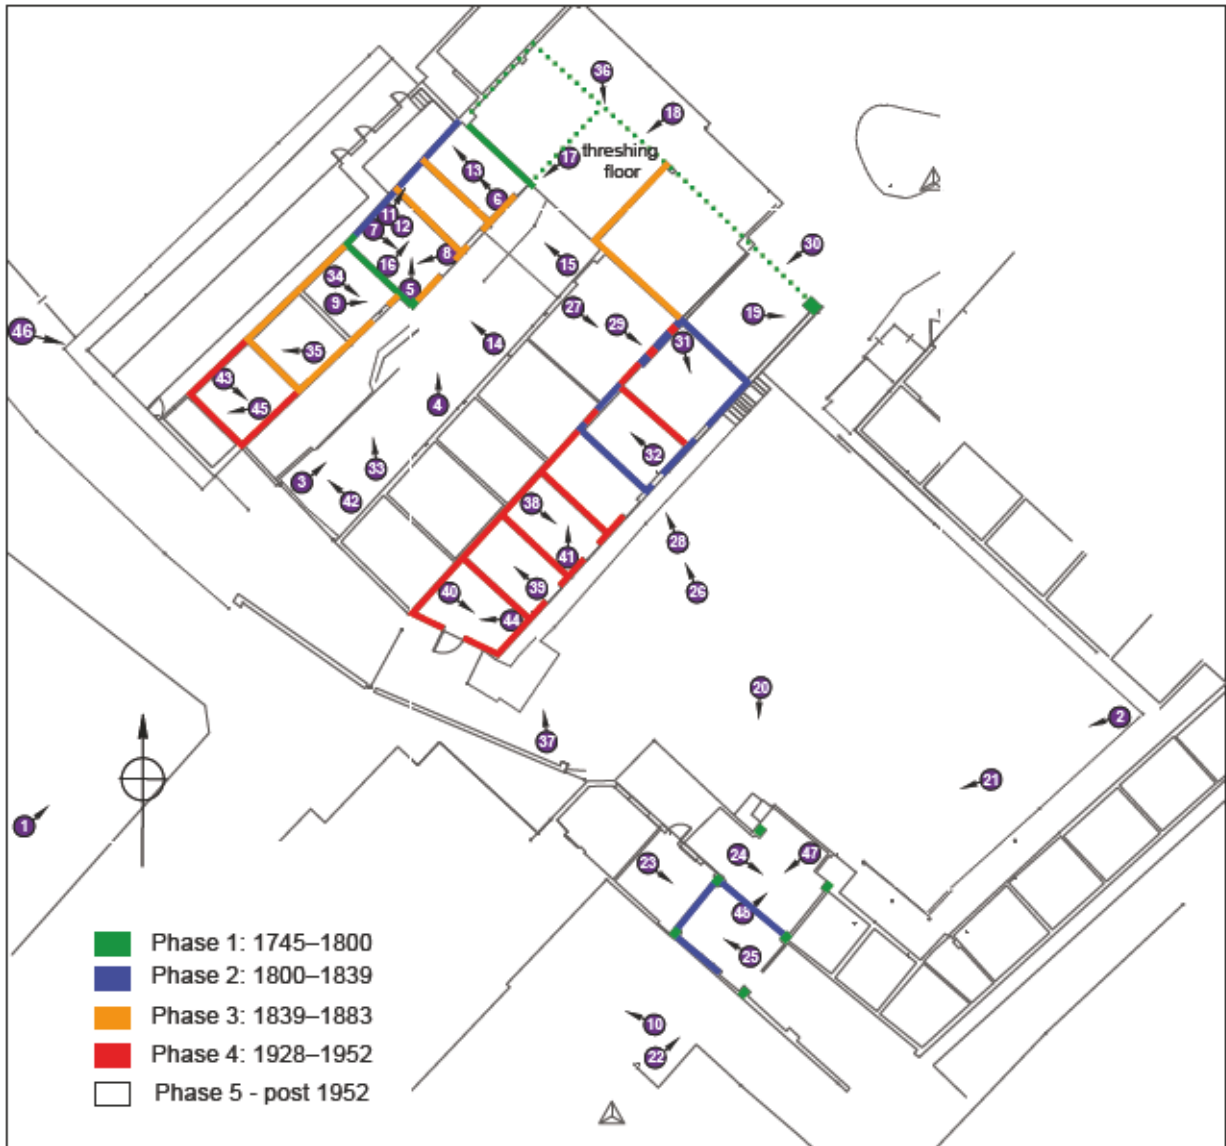
Figure 2

Phase plan with photo locations
 based on Nick Carroll Architects drawing number 1517/02-03

The phases of the buildings and the orientation of the photo plates are shown in Figure 2.

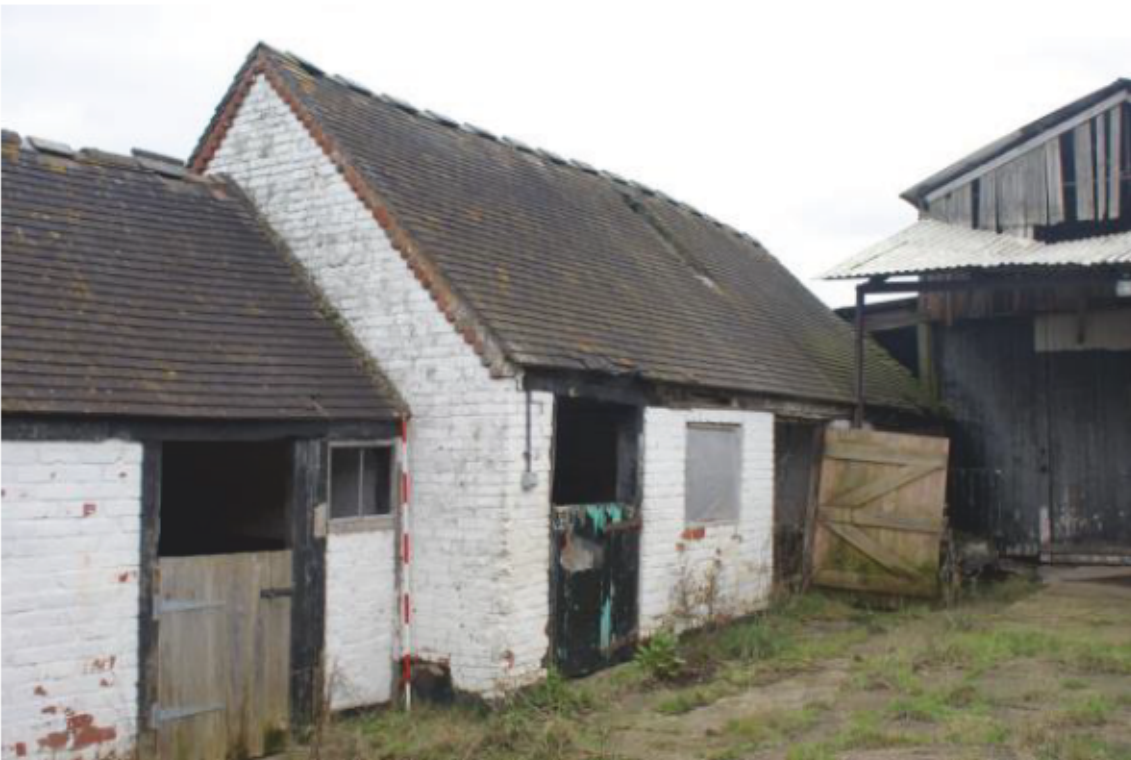
The first was a structure in the northern corner of the farmyard (Plate 4). It was aligned north-east to south-west and split by two oak roof trusses into three bays (Plate 5 to Plate 7). These roof trusses are consistent with a broadly 18th century date. The 18th century phase of the farmhouse had similar roof trusses and their purlins also sat on timbers built into the brick work (Plate 8). This plate also shows a blocked doorway in the south western gable end of the building. The gable end walls were brick built, though with stone foundations (Plate 9). The stepped brickwork detailing (Plate 4) is of the same style to a later 18th century addition to the rear of the house (Plate 10). The carpentry of these trusses also suggested pre-19th century date, as the timbers were converted by both hewing and pit sawing. Carpenters marks were also visible, showing that the trusses were made specifically for this building (Plate 11 and Plate 12), in some cases reusing old timbers (Plate 13) potentially having been part of the structure on this spot on the 1745 estate map. Whilst this was on the same alignment, it was longer and not likely to be the same structure.

Plate 4 Phase 1 shelter shed, looking north

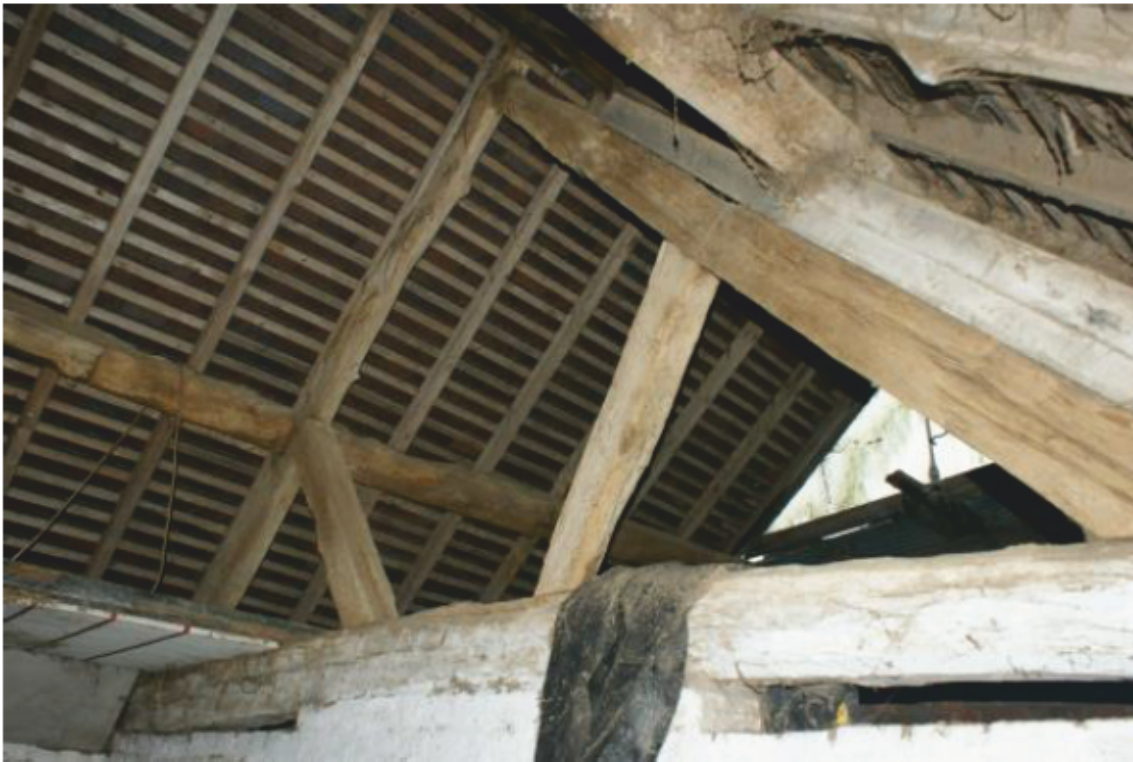
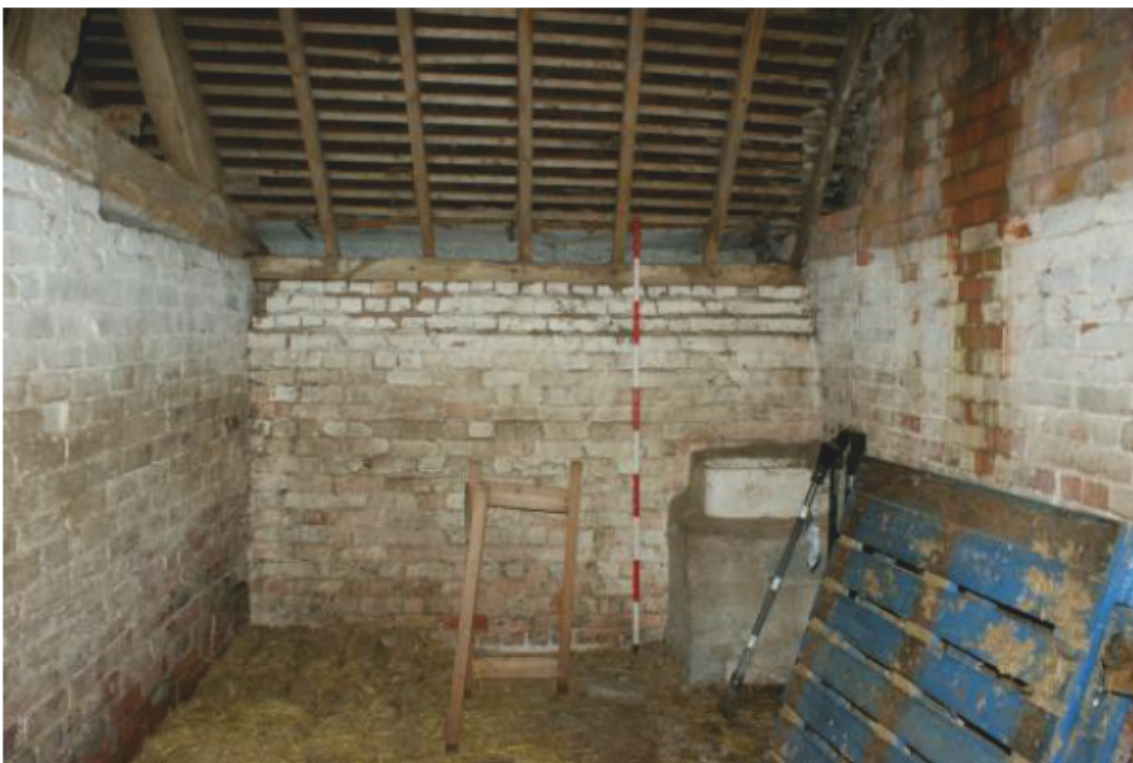
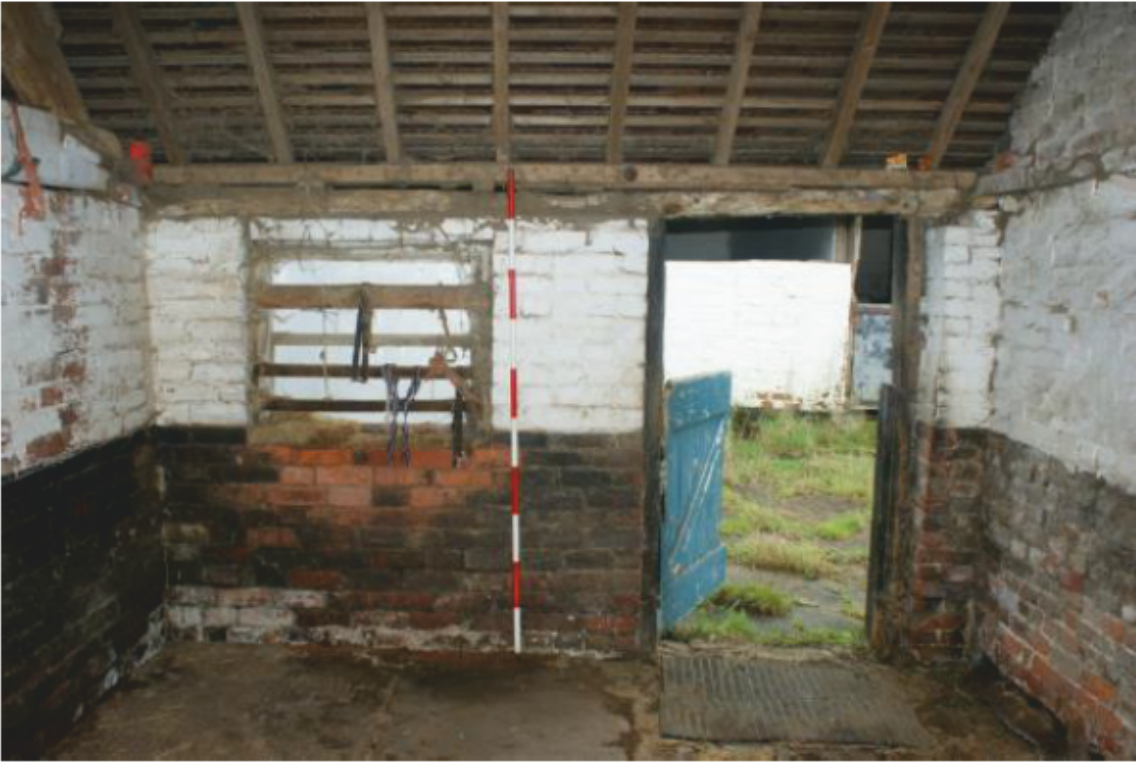
Plate 5 Phase 1 shelter shed, looking north

Plate 6 Phase 1 shelter shed, looking north-west

Plate 7 Phase 1 shelter shed, looking south-east

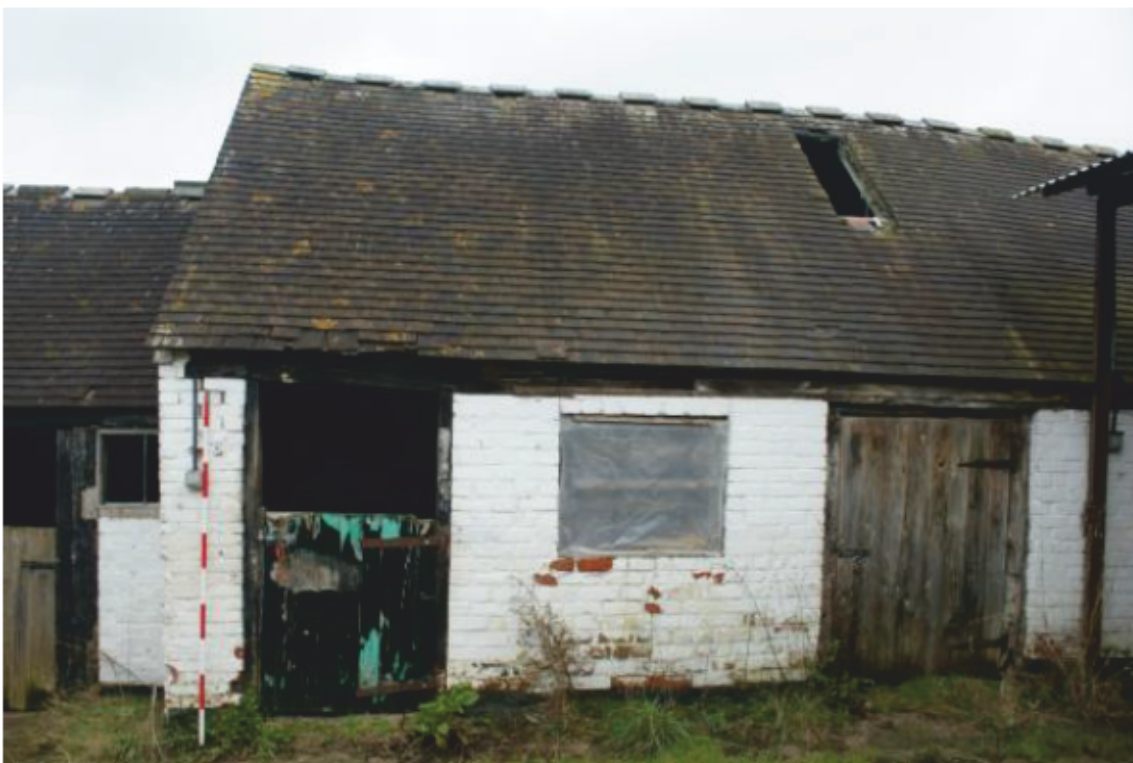
The function of this building may be suggested by the lack of original walling along its longer sides. Two mortices and peg holes could be seen in the wall plate on the south-east side. These may have related to posts to support the wall plate though these would be expected to be located below the bay frames. The evidence for this was obscured by later changes. The two sets of mortice and peg holes seen were located close to the end walls above the later doorways at the north-east and south-west ends. It is possible that the peg holes seen were part of re-used timbers (*Plate 14* and *Plate 15*). An open fronted building such as this would be typical of a shelter shed for cows (Lake 1989), especially as it was constructed without a roof space. It would also be consistent with it facing into the yard as shown in the 1839 tithe map. A light weight temporary roof had been in place at some point, as seen by the wear between the collars on the top of the tie beams (*Plate 16*). The lack of wall on the north-west side of this building is more difficult to interpret; it is likely that this has simply been rebuilt in the later phases.

Plate 14 Phase 1 shelter shed with mortice and peg hole above the left hand door, looking north-west

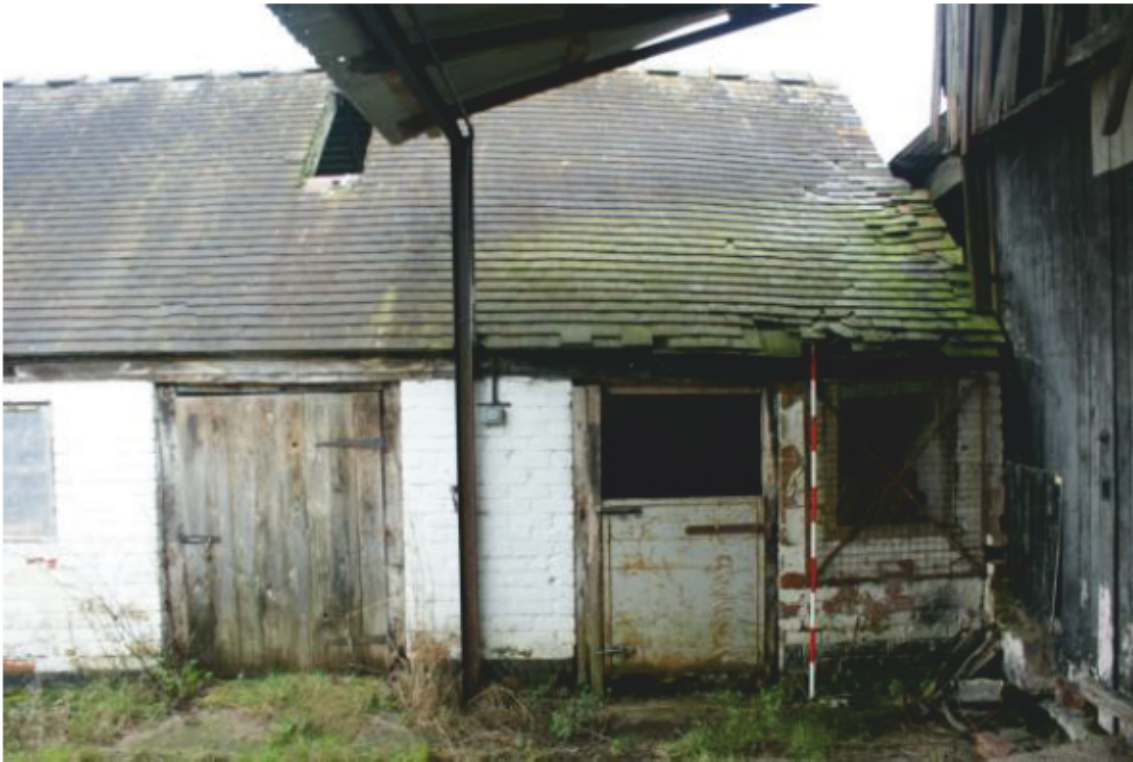
Plate 15 Phase 1 shelter shed with mortice and peg hole above the right hand door, looking north-west

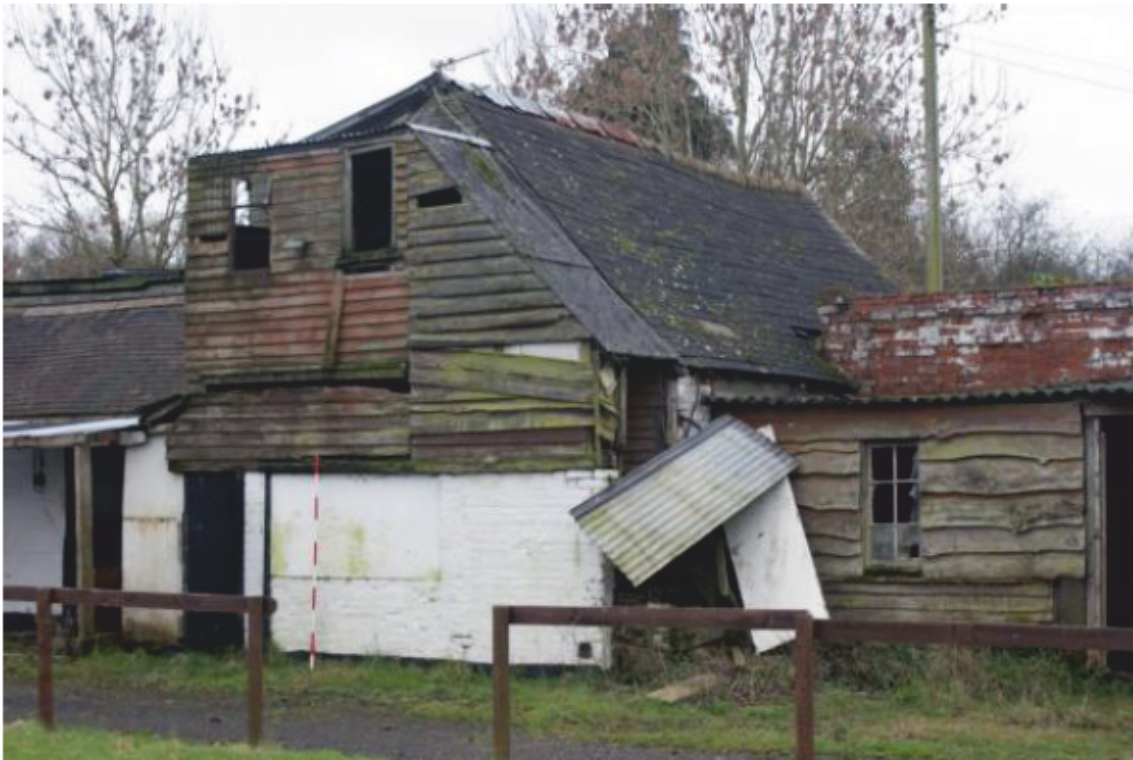
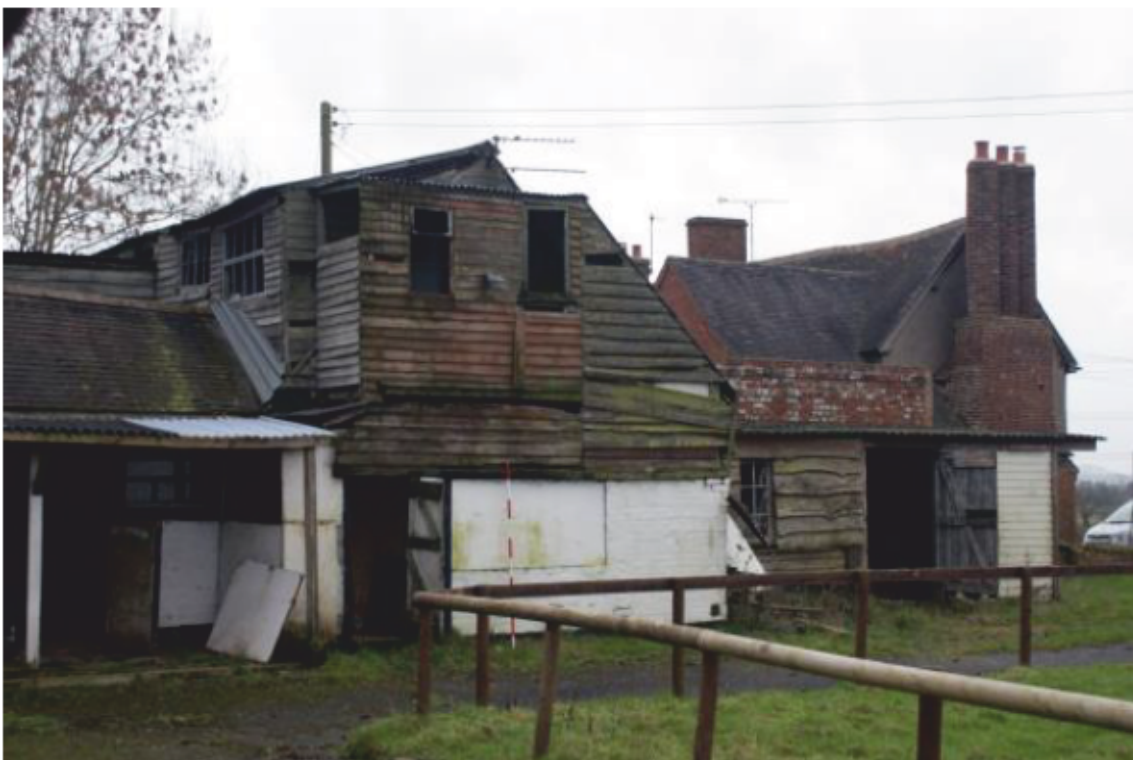
The third surviving structure was located close to the west end of the house and was an isolated structure seen first on the 1839 tithe map (*Plate 20* to *Plate 25*) and *Figure 3*. Its roof trusses were of similar style and construction to that over the shelter shed, and is therefore assigned to this phase as opposed to Phase 2. It was formed of two bays, as divided by three roof trusses. These trusses sat on a wall plate which was in turn supported by six brick pillars, with no walls in between. It was constructed without any first floor and was open to the roof. An interpretation as a cart-shed may be suggested for such an open sided building.

The first of these relates to the former cart shed which was both enclosed in buildings (Plate 20 and Plate 21) as well as having a first floor added. A kitchen, bathroom and living room were added with much of the original roof being removed on the south-east side and the truss at the north-east end being modified to accommodate a doorway (Plate 47 and Plate 48).

Plate 20 Phase 1 Cart shed, looking south

Plate 21 Phase 1 Cart shed, looking west

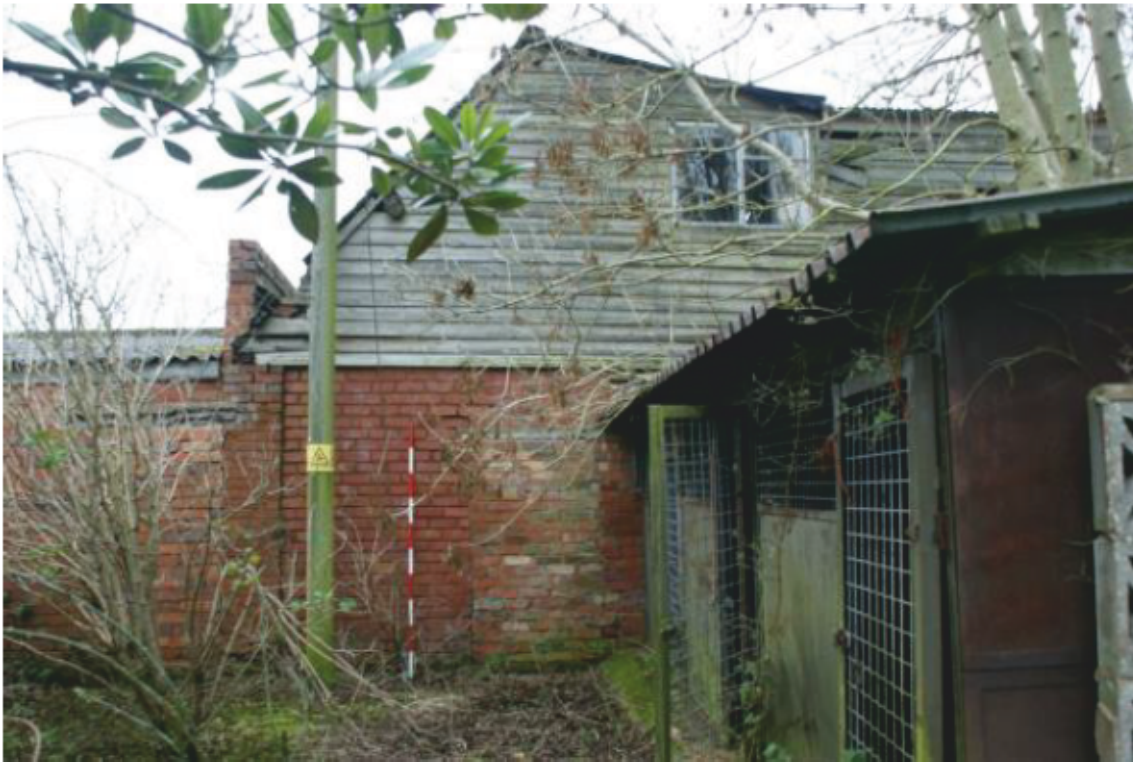
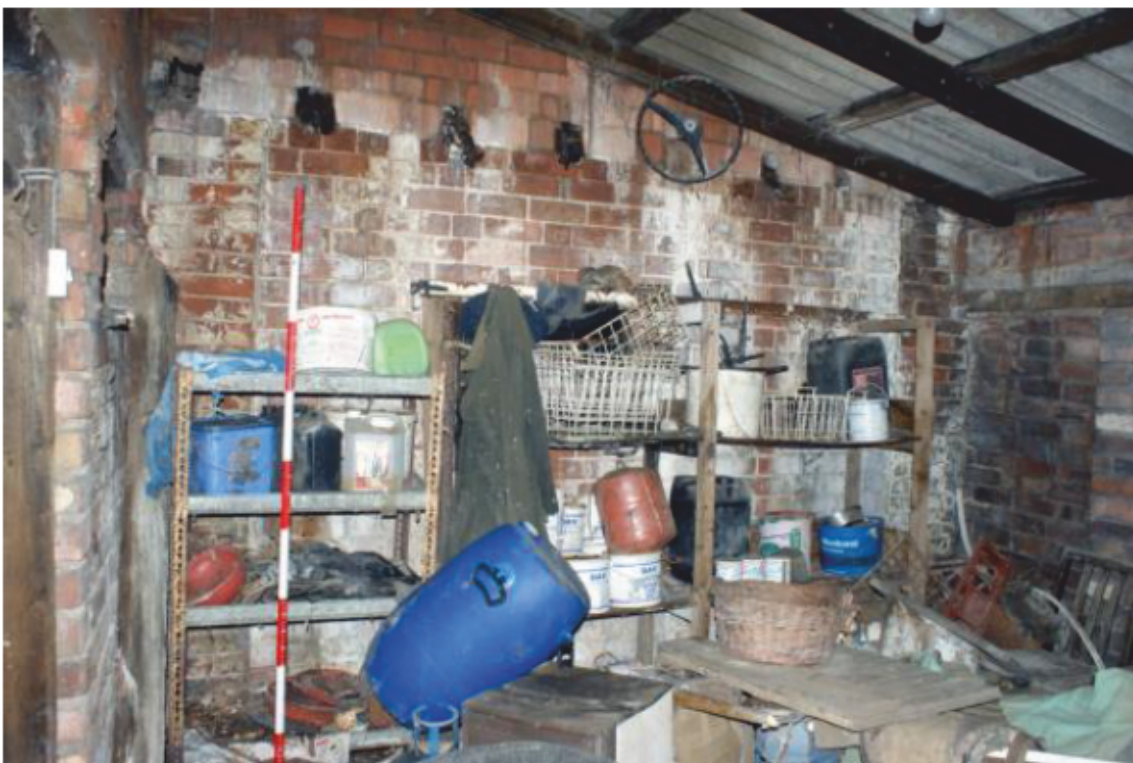
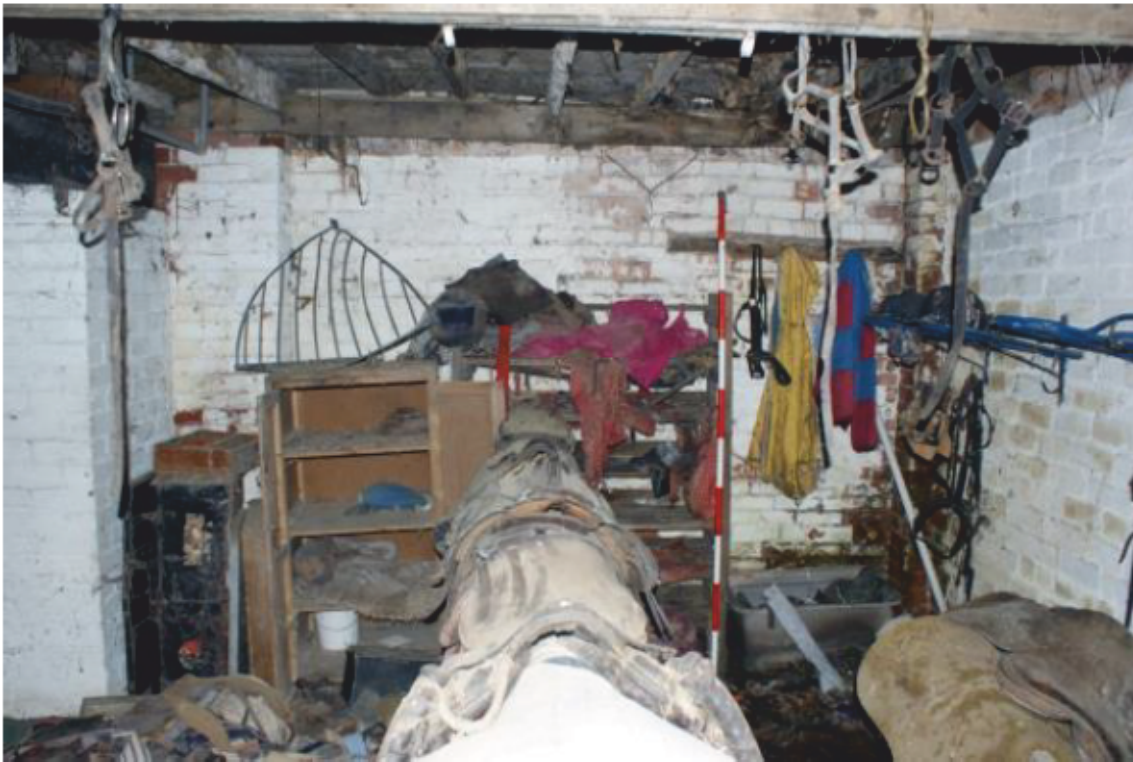
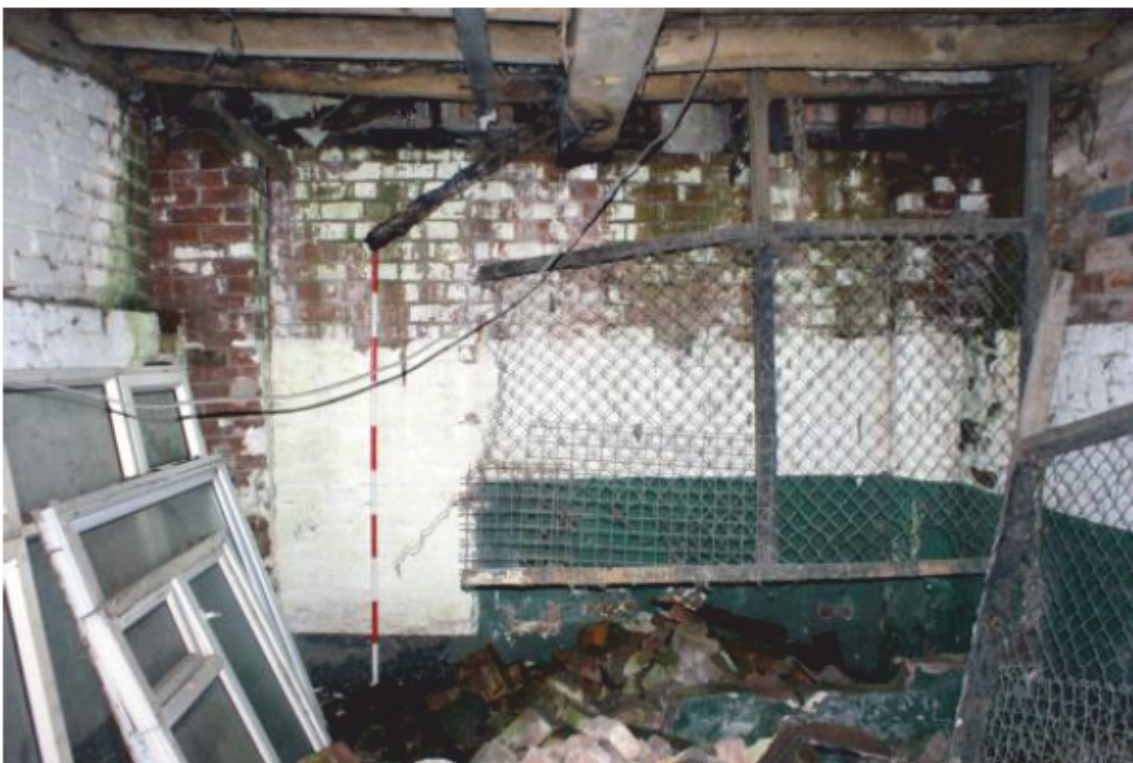
Plate 22 Phase 1 Cart shed, looking north-east

Plate 23 Phase 1 Cart shed, looking south-east

Plate 24 Phase 1 Cart shed, looking south-east

Plate 25 Phase 1 Cart shed, looking north-west

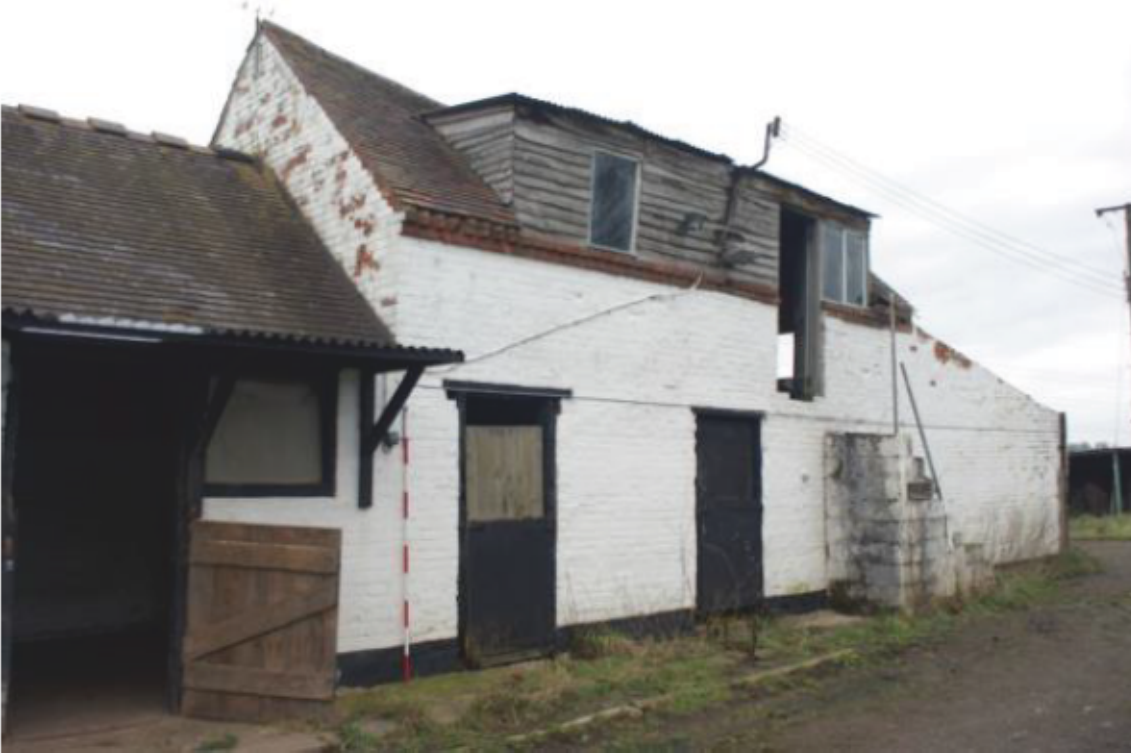
A further structure was built in the eastern corner of the U-shaped farmyard (*Plate 26*). This was constructed with low arch windows and doors (*Plate 27*) and dentilled eaves detailing (*Plate 28*). These features are typical of a 19th century building with the eaves detailing being seen on some early 19th century buildings. The bricks used to construct this were 3 inches in width, as opposed to the Phase 1 structures which were 2½ inch in width, also suggesting a later date. This building is visible on the 1839 tithe map.

The hayloft roof was also rebuilt at this time with all of its original fabric removed. A timber clad element was added with steps leading to a new entrance (Plate 26).

Plate 26 Phase 2 stable and hayloft, looking north

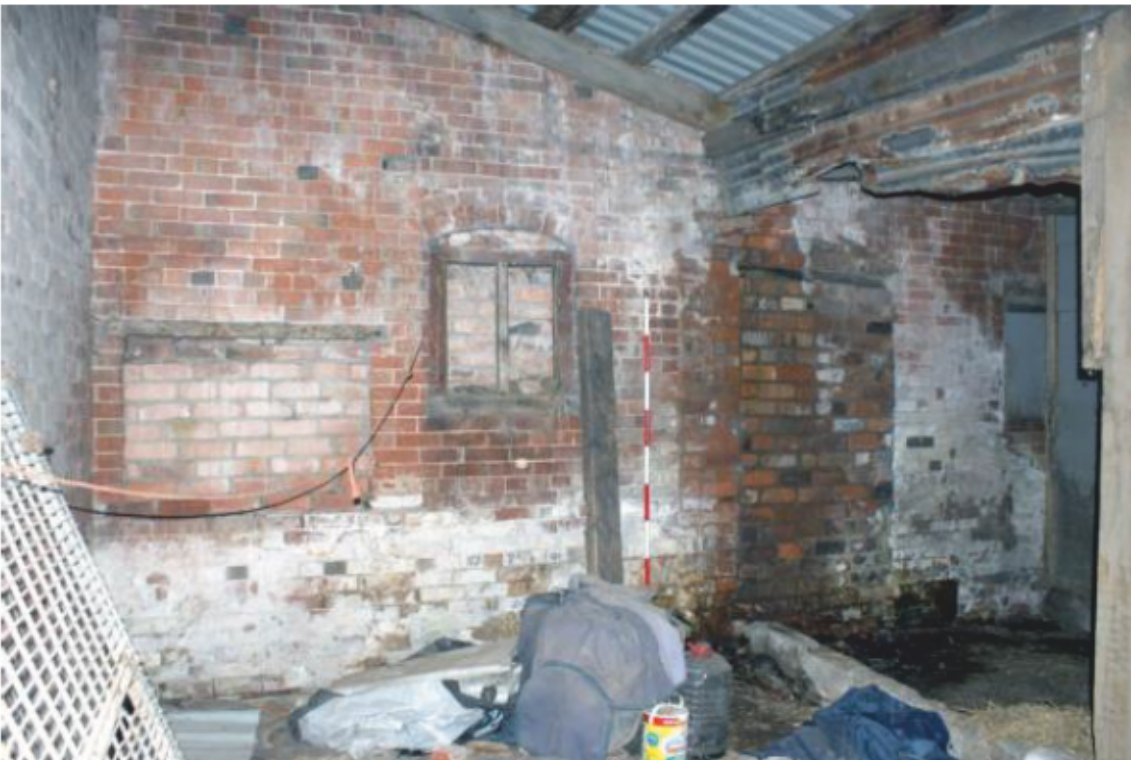
The ground floor of the building was accessed by a wide door in its western side (*Plate 27*) which had an adjacent window, which would suggest stabling. The ground floor was one room which may have been split up into individual stalls, though evidence for this was not seen. An original window frame remained extant (*Plate 29*). Whilst an interpretation of stabling is likely, it may have been used as a cow house, as these often had wider doors (Lake 1989) though those which included windows date to between the mid-19th to early 20th century (Lake, Hathaway and Robson-Glyde 2014).

Plate 27 Phase 2 stable and hayloft, looking south-east

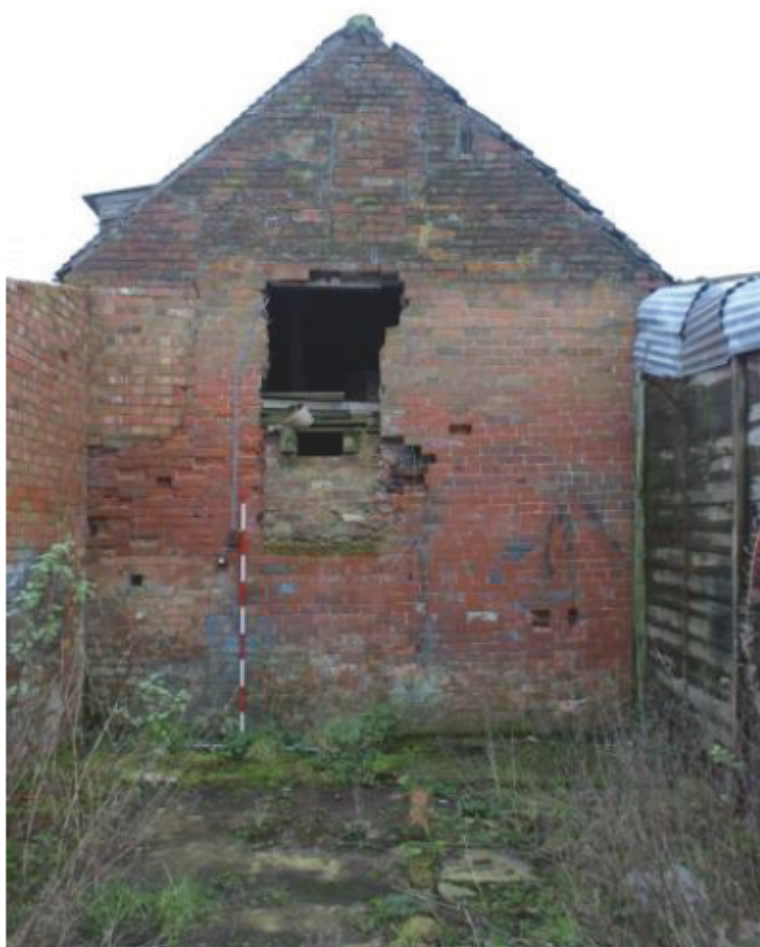
The first floor was accessed from a doorway in the north-east gable end which originally had a window above (*Plate 30*). No original roof trusses remained within this structure, having been removed within the second half of the 20th century (*Plate 26*) as suggested by its replacement roof. The extant floor is also a replacement; the original was slightly lower, as seen by holes for joists in the brickwork. It is likely that the first floor room was used as a hayloft, a layout which is more usual with stabling below as horses were considered to require extra insulation (*Plate 31* and *Plate 32*). Cows generally were considered to require greater ventilation, so were more often housed in open roofed structures.

Plate 30 Phase 2 stable and hayloft, looking south-west

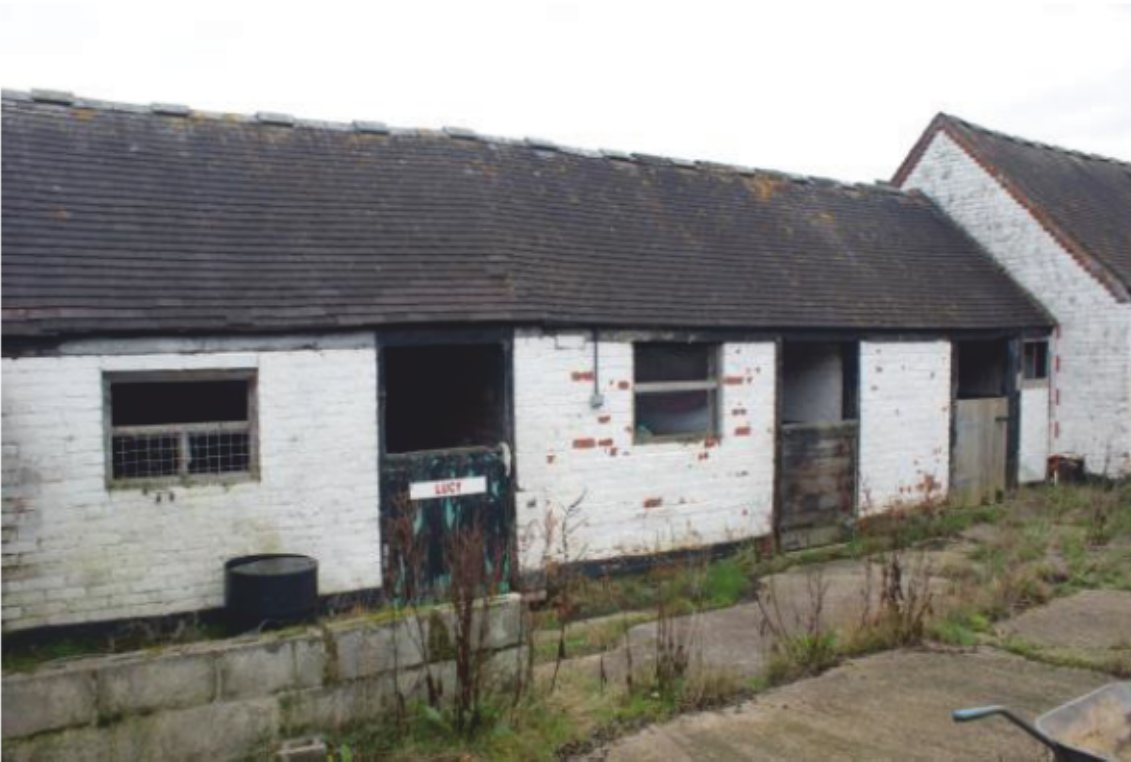
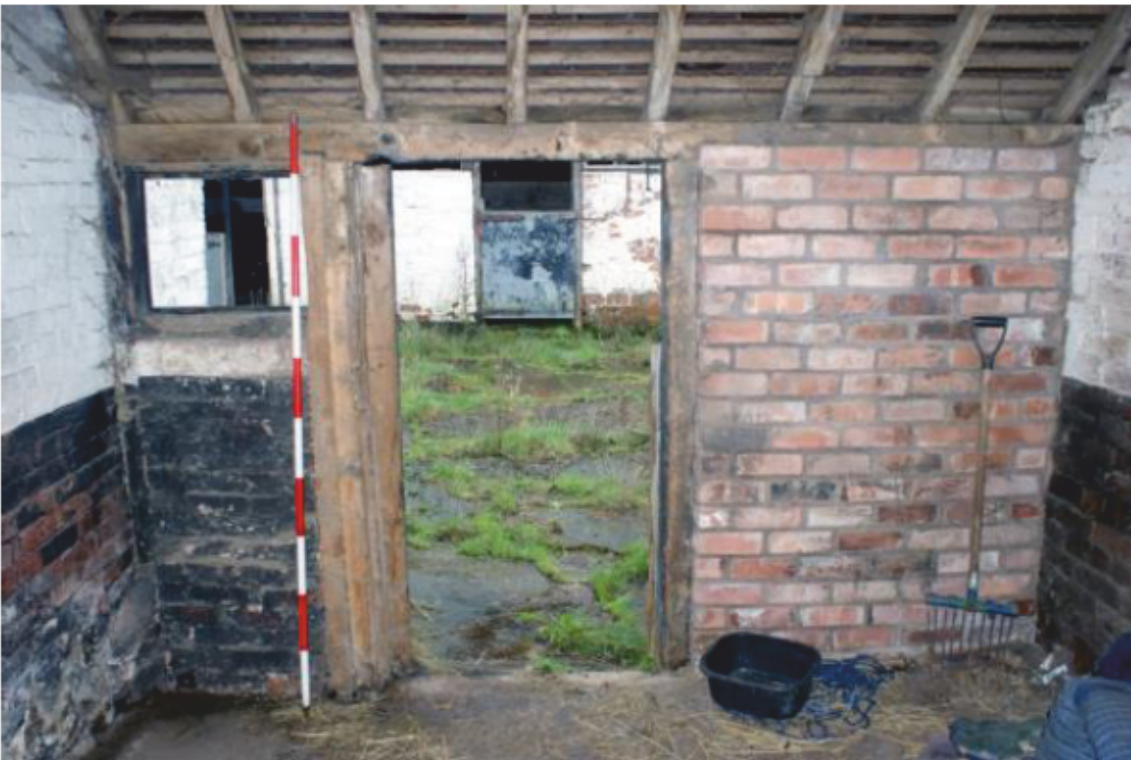
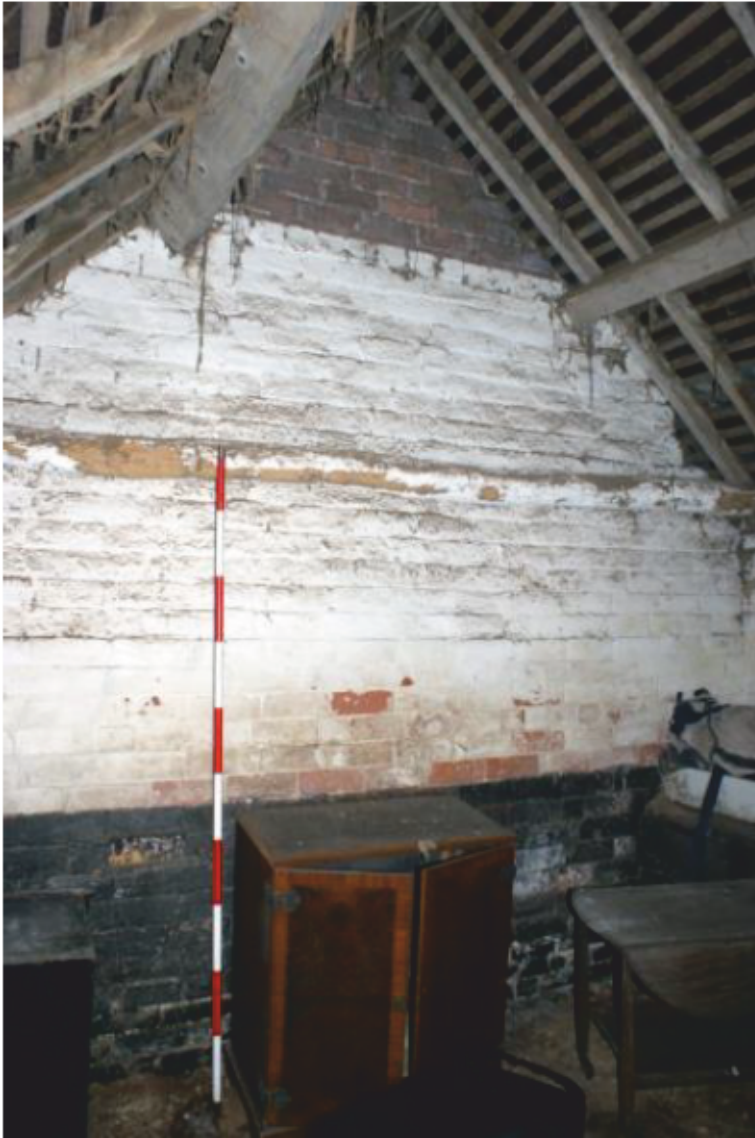
A small additional structure (Plate 33 to Plate 35) is visible on the 1883 OS map constructed on the south-west end of the former shelter shed of a slightly lesser width. It was formed of two rooms with doors and windows facing into the yard and likely also to have been stables. The roof was supported entirely by the brickwork and contained no first floor.

Plate 33 Phase 3 stables, looking north

Plate 34 Phase 3 stables, looking north

Plate 35 Phase 3 stables, looking south-west

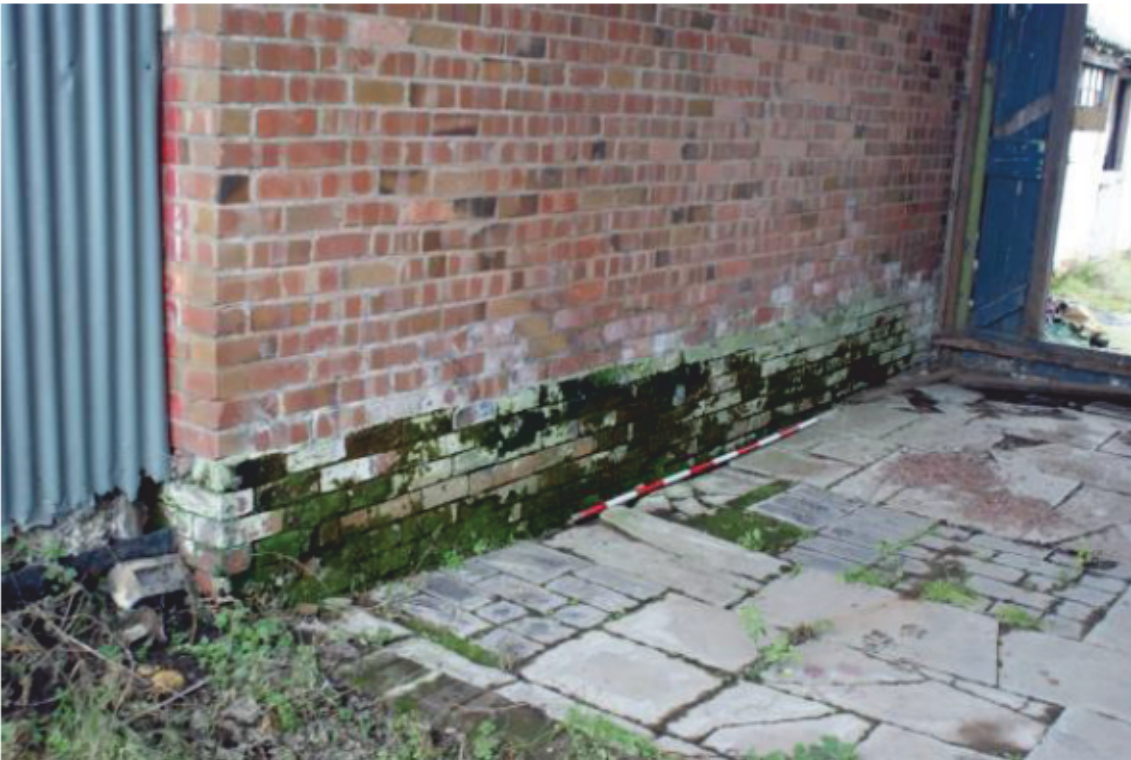
A further L shaped wall was added on the south-eastern side of the Phase 1 threshing floor (Plate 36) that butted the Phase 2 stable and hayloft.

Plate 36 Phase 3 rebuild of the threshing barn, looking south
