Building recording at
Tanwood Stud
(formerly Woodside Farm),
Tanwood Lane,
Chaddesley Corbett,
Worcestershire

Status: Revision 1
Date: 7 March 2016
Author: Tim Cornah tcornah@worcestershire.gov.uk
Illustrator: Laura Templeton and Tim Cornah
Project reference: P4766
Report reference: 2300
HER reference: WSM67664
Oasis id fieldsec1-240976

Building recording was required prior to the redevelopment of Tanwood Stud, Tanwood Lane, Chaddesley Corbett, Worcestershire.

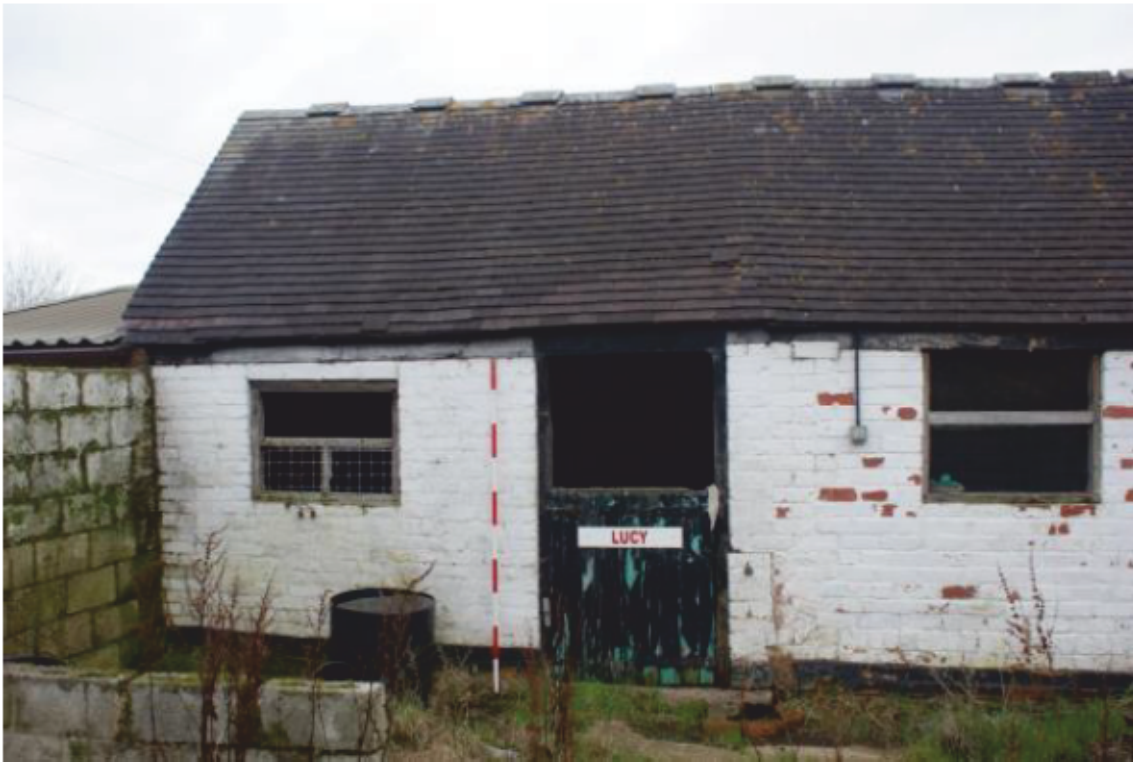
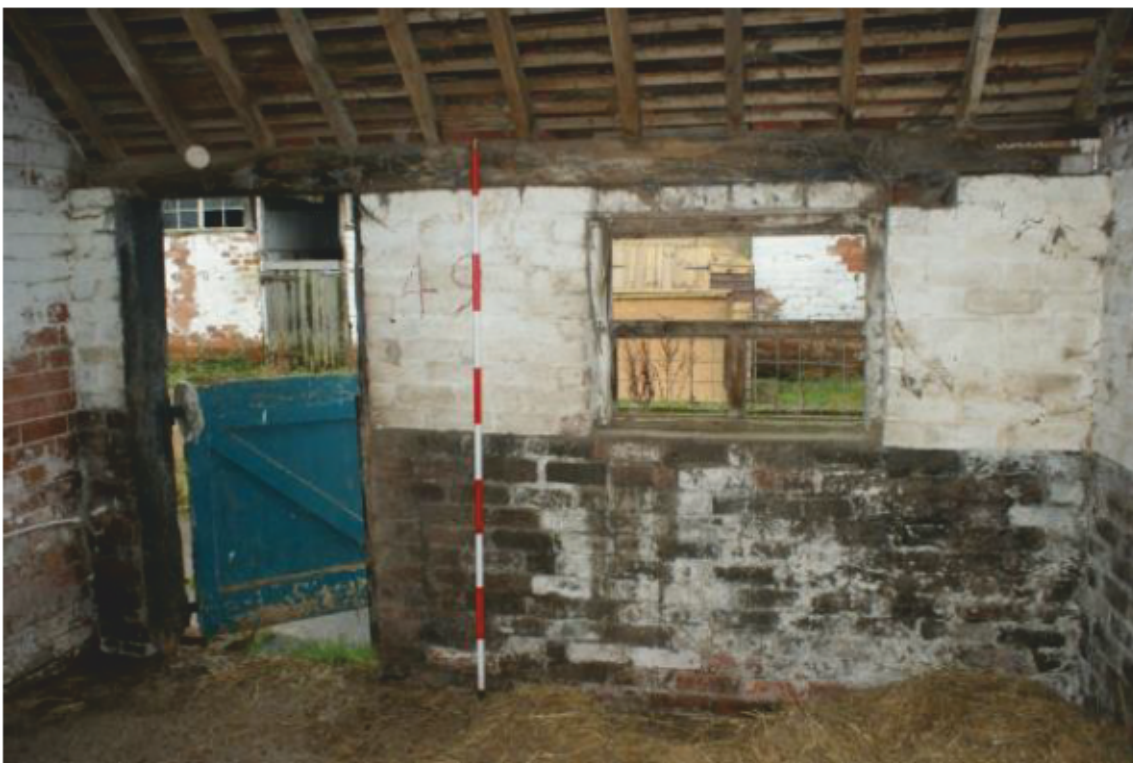
A further single cell stable was added onto the end of the Phase 3 stable block (Plate 42 and Plate 43). This used the same construction materials and techniques as the other building of this phase, including similar interior detailing to support the roof timbers (Plate 44 and Plate 45).

Plate 42 Phase 4 stable, looking north-west

Plate 43 Phase 4 stable, looking south-east

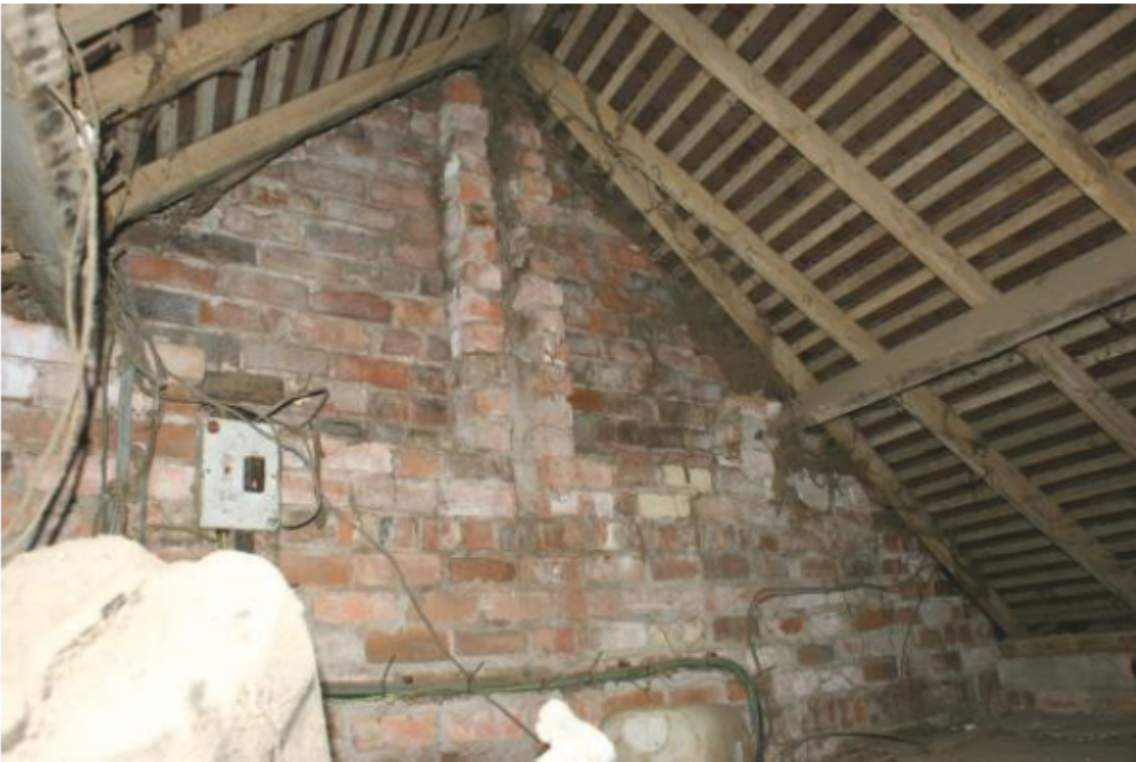
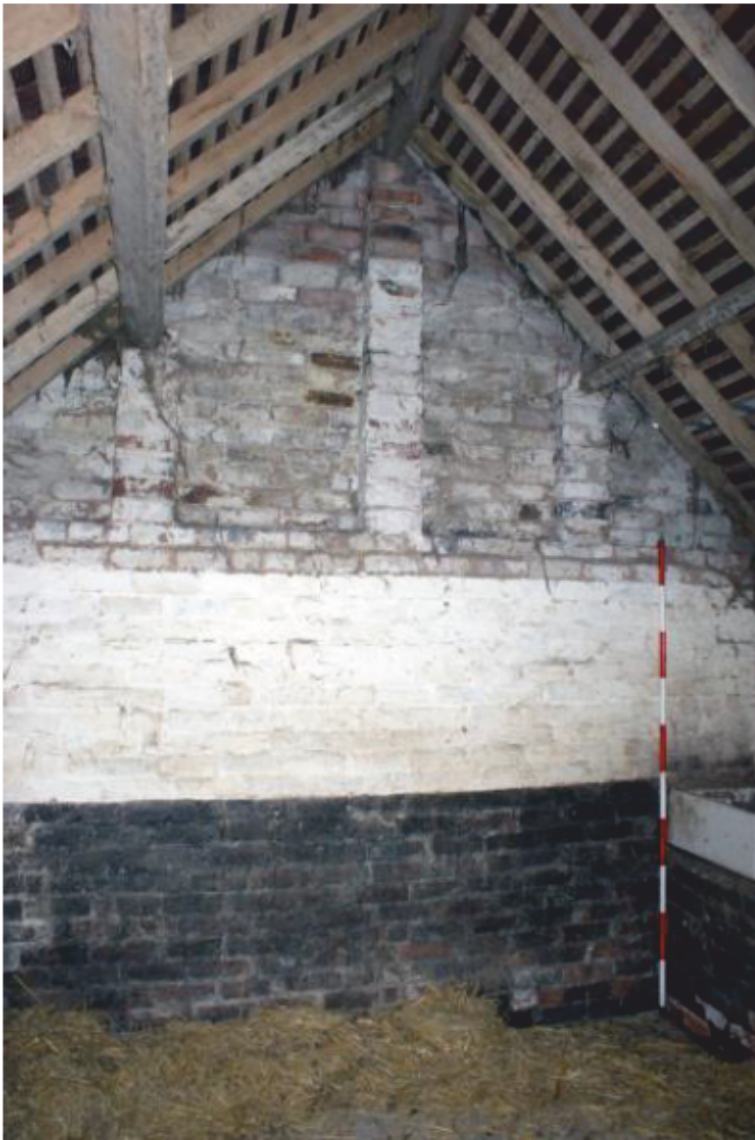
Plate 44 Phase 4 stables, looking south-west

Plate 45 Phase 4 stable, looking south-west

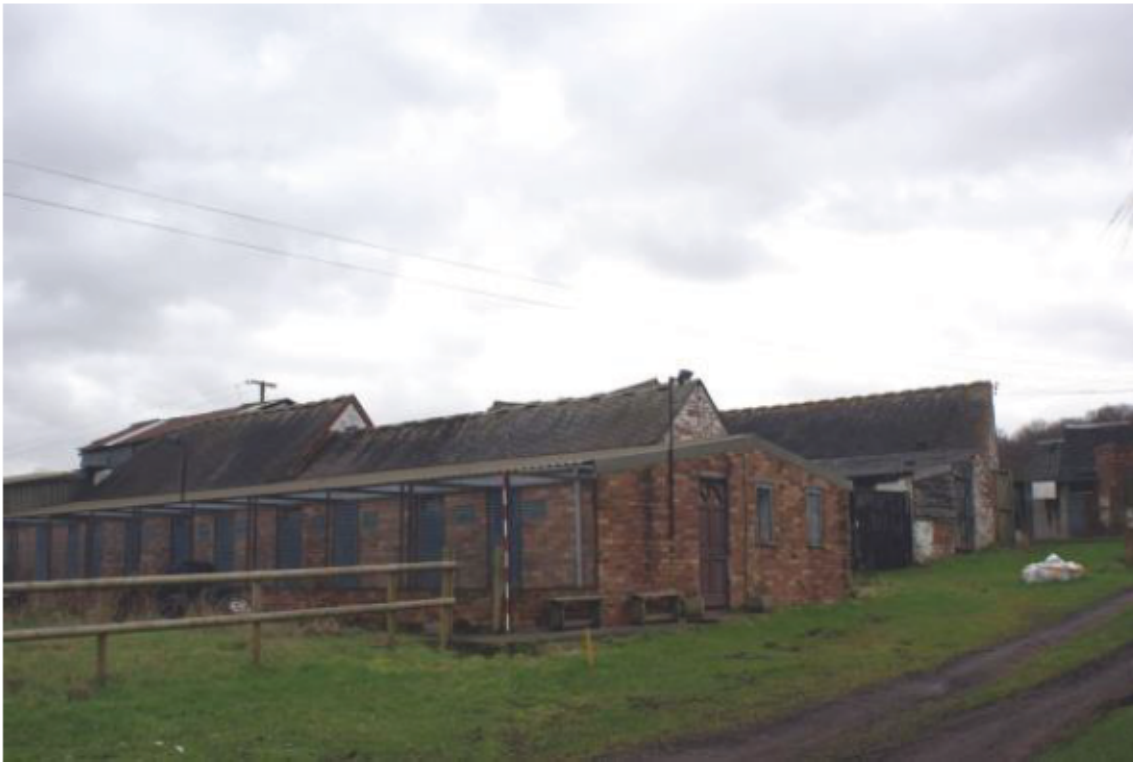
During this phase, common rafters and tiling above the Phase 1 shelter shed and the Phase 3 stables were replaced. These were all constructed using the same materials and techniques. The extent of the reroofing at this time can be seen by the raised ridge tiles that allowed air flow into the roof spaces (Plate 46).

Plate 46 Phase 4 re-roofing, looking east

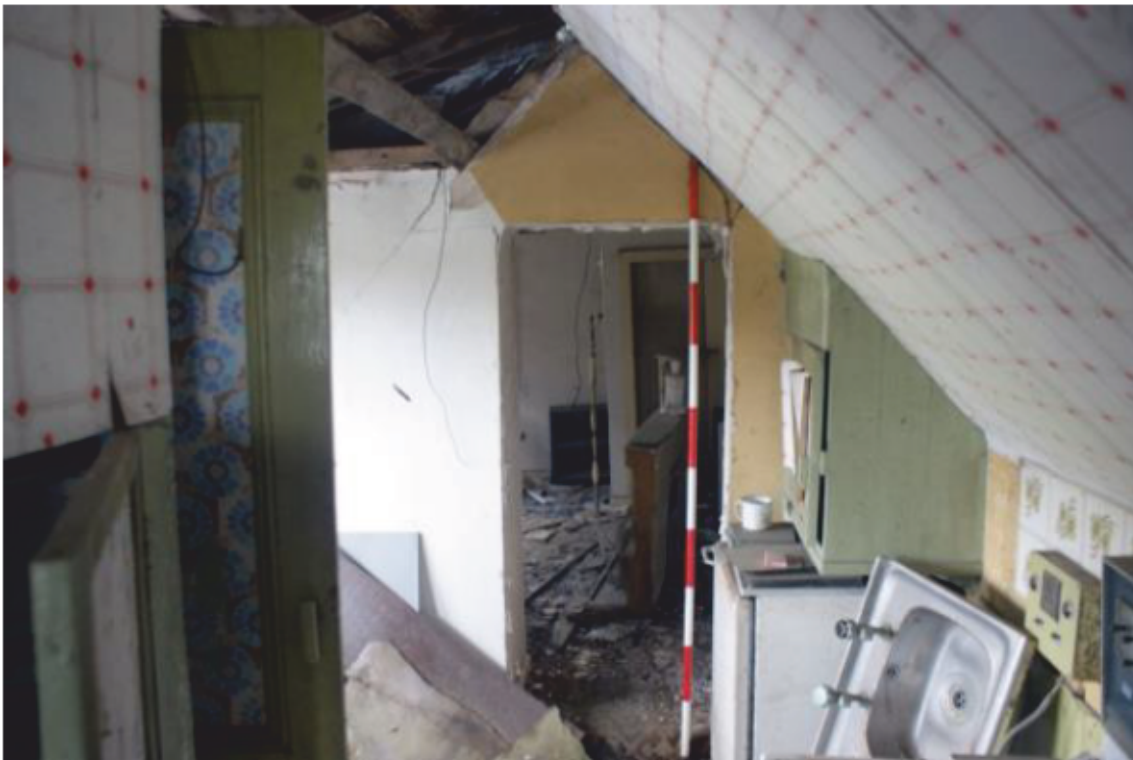
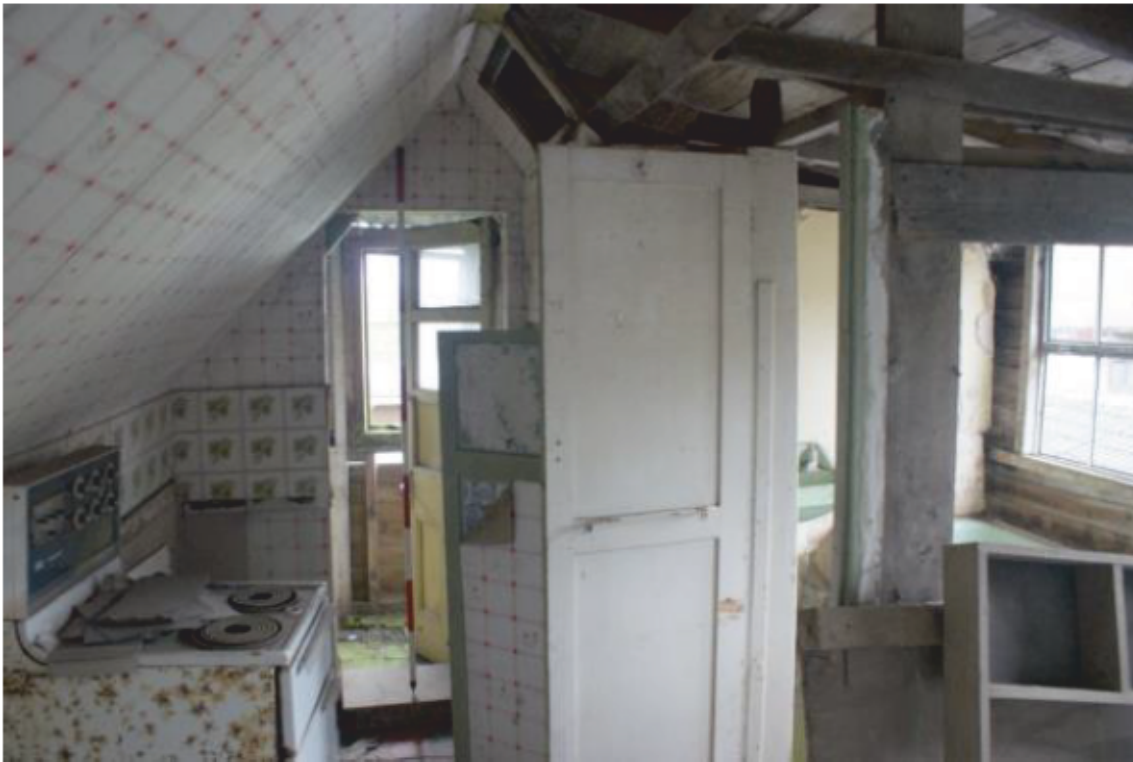
The first of these relates to the former cart shed which was both enclosed in buildings (Plate 20 and Plate 21) as well as having a first floor added. A kitchen, bathroom and living room were added with much of the original roof being removed on the south-east side and the truss at the north-east end being modified to accommodate a doorway (Plate 47 and Plate 48).

Plate 47 Phase 5 first floor conversion of the cart shed, looking south-west

Plate 48 Phase 5 first floor conversion of the cart shed, looking north-east
