ARCHAEOLOGICAL WATCHING  
BRIEF AT SEVERN SIDE NORTH,  
BEWDLEY, WORCESTERSHIRE

Project 2162  
Report 1110  
WSM 31563

## Archaeological watching brief at Severn Side North, Bewdley

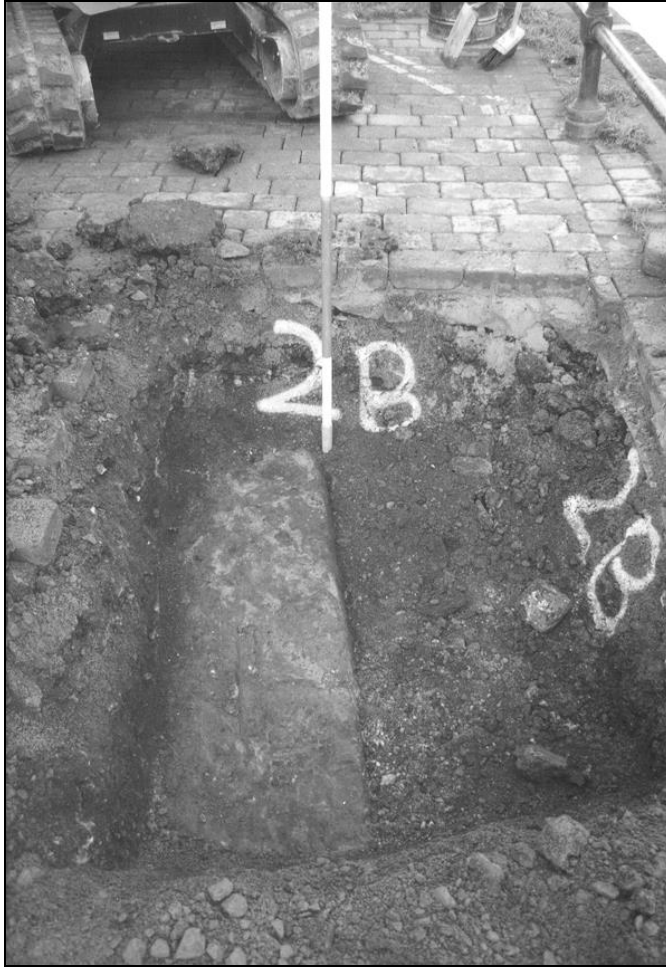
*Plate 1: Top of former quayside wall exposed in test-pit 10*

At a later date, ten test-pits were excavated to locate buried services (Fig 2). Eight of these test pits were recorded archaeologically, two having been backfilled before observation could take place. The test-pits measured up to 4.40m in length by 1.45m in width, and were on average c1.45m deep. Most of the test pits showed recent made ground in section and plan, although Test-pits 2, 9 and 10 exposed further remains of the sandstone wall identified in Trenches 1 and 2 (Plate 2).

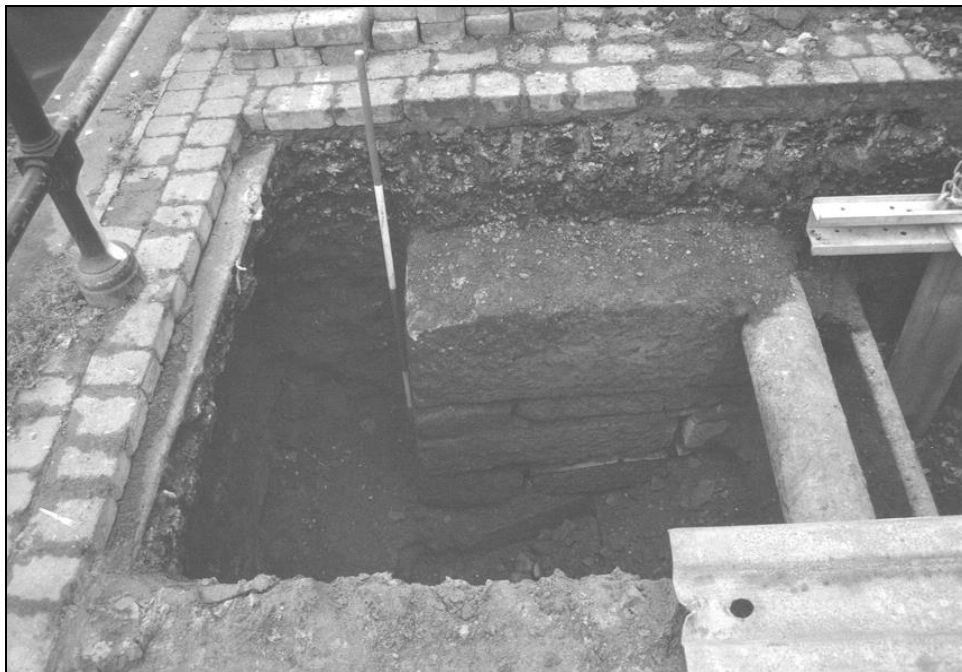
*Plate 2: Break in former quayside wall exposed in test-pit 2*

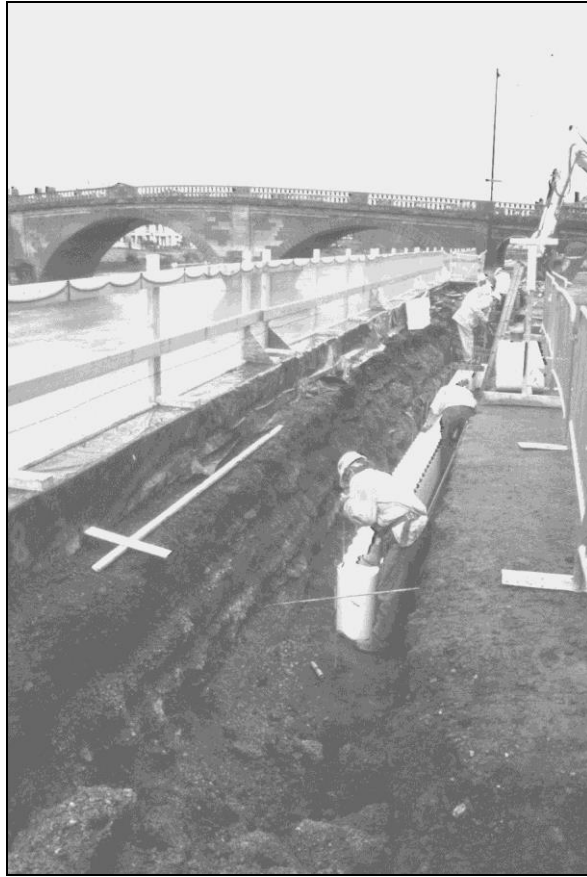
*Plate 3: General view of guide trench showing dumped gravels in west-facing section*

Later groundworks comprised the excavation of a guide trench and piling at close intervals within it. The guide trench extended all the way along Severn Side North and had a width of around 0.90m and a uniform depth of 1.30m (Fig 2). The west-facing section showed successive dumps of small gravels (Plate 3), while the opposite section showed tarmac and roadstone over brown silty sand with common brick rubble (Plate 4).

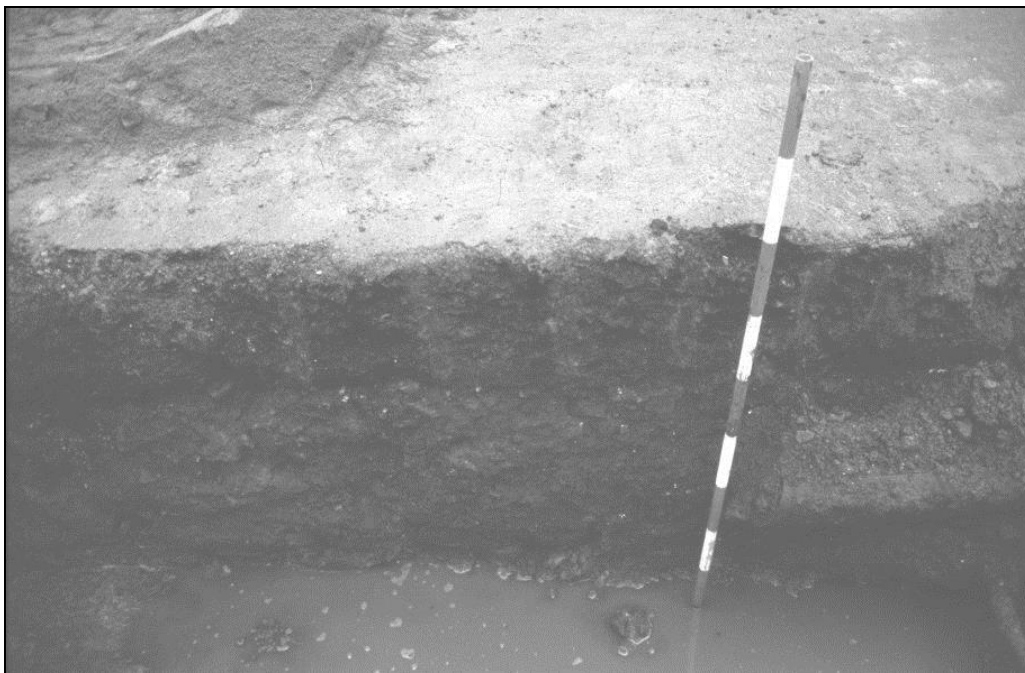
*Plate 4: Made ground exposed in east-facing section of guide trench*

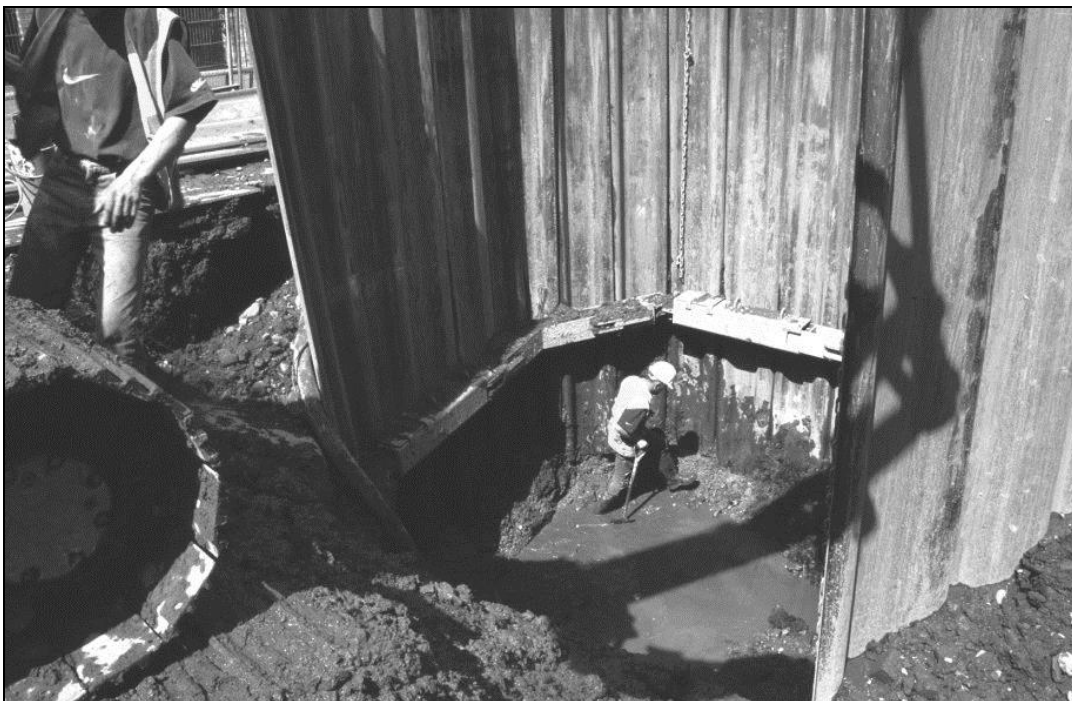
*Plate 6: Deep excavations at foot of Dog Lane*

Further excavation took place within an open ring of steel shutters that largely obscured the sides of the trench (Plate 6). Rising groundwater within the trench also restricted visibility, despite the use of a pump). Nevertheless, it was possible to ascertain the basic sequence of deposits below 1.50m. This comprised a further 1.0m of made ground with fewer stone and brick inclusions (context 1403), around 0.70m of dark grey sand (context 1405), and finally natural orange sand (context 1405). However, it was also noted that both the lower made ground and the dark grey sand abutted the remains of a stone wall which lay underneath the open south side of the trench (Plate 7). The wall itself (context 1407) which comprised 2-3 courses of squared sandstone blocks with occasional tile fragments between courses; it appeared to enter the trench from the east, and run for approximately 1.50m before ending or returning to the south. On top of the wall, but apparently not extending into the trench was around 0.15m of reddish brown silty sand with frequent tile fragments (context 1406). Unfortunately it was not possible to record the wall or this deposit any further, although a fragment of tile was recovered from between two courses of the wall, and one sherd of pot and another fragment of tile were recovered from the overlying layer.

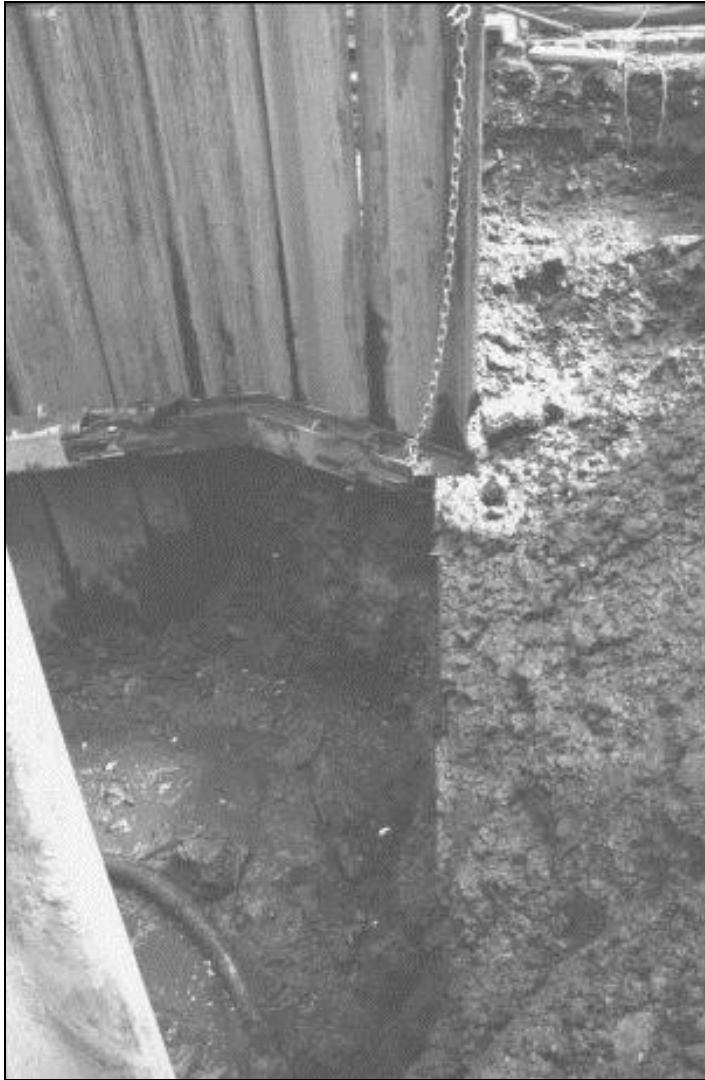
*Plate 7: Location of stone wall beneath open south side of shuttering*

Secondly, it is possible that the wall found in the trench for the pumping station at the foot of Dog Lane is of considerable antiquity, and might relate to an earlier arrangement of tenements and buildings in the area. The depth of the wall, at around 2.5m below the present surface (and 1.0m below the presumed 19<sup>th</sup> century ground level) provides a crude indication of its date, while a fragment of tile from the wall itself is of a type conventionally dated to the 13<sup>th</sup> to 18<sup>th</sup> centuries. These evidences are not in themselves conclusive of an early date, as ground levels in the area have obviously changed significantly, and the tile from the wall may be residual; moreover, the layer immediately above the wall produced sherds of modern pottery and post-medieval tile. However, the location of the wall in the middle of the road, and the lack of any apparent relationship with the late 19<sup>th</sup> or early 20<sup>th</sup> century building immediately adjacent argues most strongly for an earlier date. The road is also in the same position as it occupied in the late 19<sup>th</sup> century, while the building is likely to have replaced an earlier 19<sup>th</sup> or 18<sup>th</sup> century building, occupying the north-west end of a continuous frontage. It is therefore possible that the wall is of pre-18<sup>th</sup> century date, and associated with an earlier frontage, or arrangement of buildings along the quayside. If this were the case, then the wall would date to a period before the 16<sup>th</sup> century, as the line of the present frontage appears to have been established by then (DoE 1986).
