HISTORIC BUILDING
RECORDING
AT THE CRESCENT WORKS,
MOUNT PLEASANT, REDDITCH

Project 2237
Report 1004
WSM 31931

Historic building recording at the former Crescent Works, Mount Pleasant, Redditch, Worcestershire

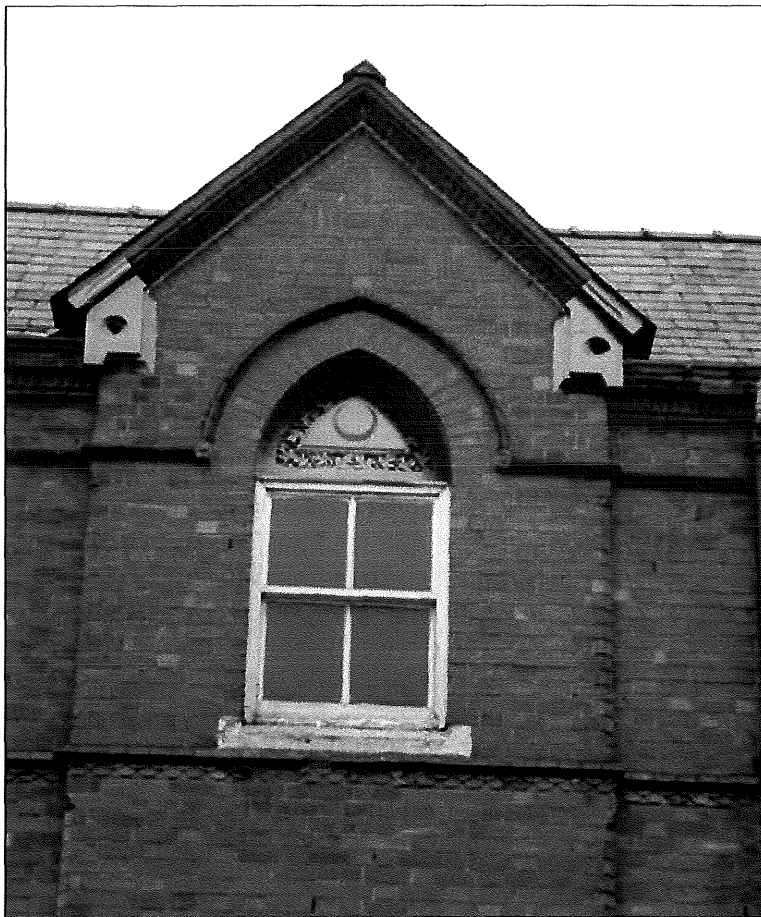
Plate 2: Detail of the Crescent Moon emblem on the northern porch.

storey porches fronting the road. Each has a wagon entrance now enclosed by pairs of timber gates. The front (western) elevation is not quite symmetrical with sets of three windows between the porches and to the south, with only two columns of windows to the north (Plate 1). The windows are typically Victorian balanced four light sashes. The lower two rows of windows are below segmental brick arched lintels with contrasting blue roll moulded narrow brick pediments above. The upper tier of windows has plain segmental arched lintels. There are decorative cornices at lintel and sill level of each of the upper two floors and a decorative plinth, although this was largely obscured by stacked building materials. The eaves, north and porch gables are embellished with dogtooth brickwork with a moulded supporting course. The upper windows here are below gothic style brick arches with rolled mouldings. The tympanums below the arches are carved with a 'crescent' moon and laurels (Plate 2), the emblem of the Crescent Works. The arch above the main entrance in the southernmost porch is carved with a pair of crescent moons and the words 'Crescent Manufacturing Co' (Plate 3).

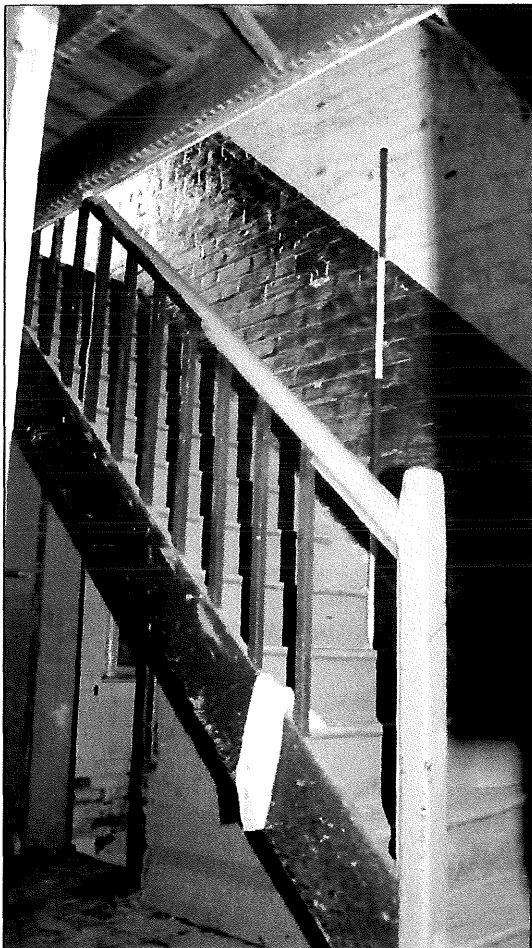
Plate 12: Main staircase from the Crescent Works inserted against the original external wall of the Walton Works. The plinth below the stairs is an indicator that this wall was external when built
