Building recording at Webster/Hemmings Brickworks, Paragon Park, Foleshill Road, Coventry, Warwickshire

Date: 15 February 2016
Author: Tim Cornah tcornah@worcestershire.gov.uk
Illustrator: Carolyn Hunt
Project reference: P4568
Report reference: 2308
Oasis ID: fieldsec1-242166

Summary

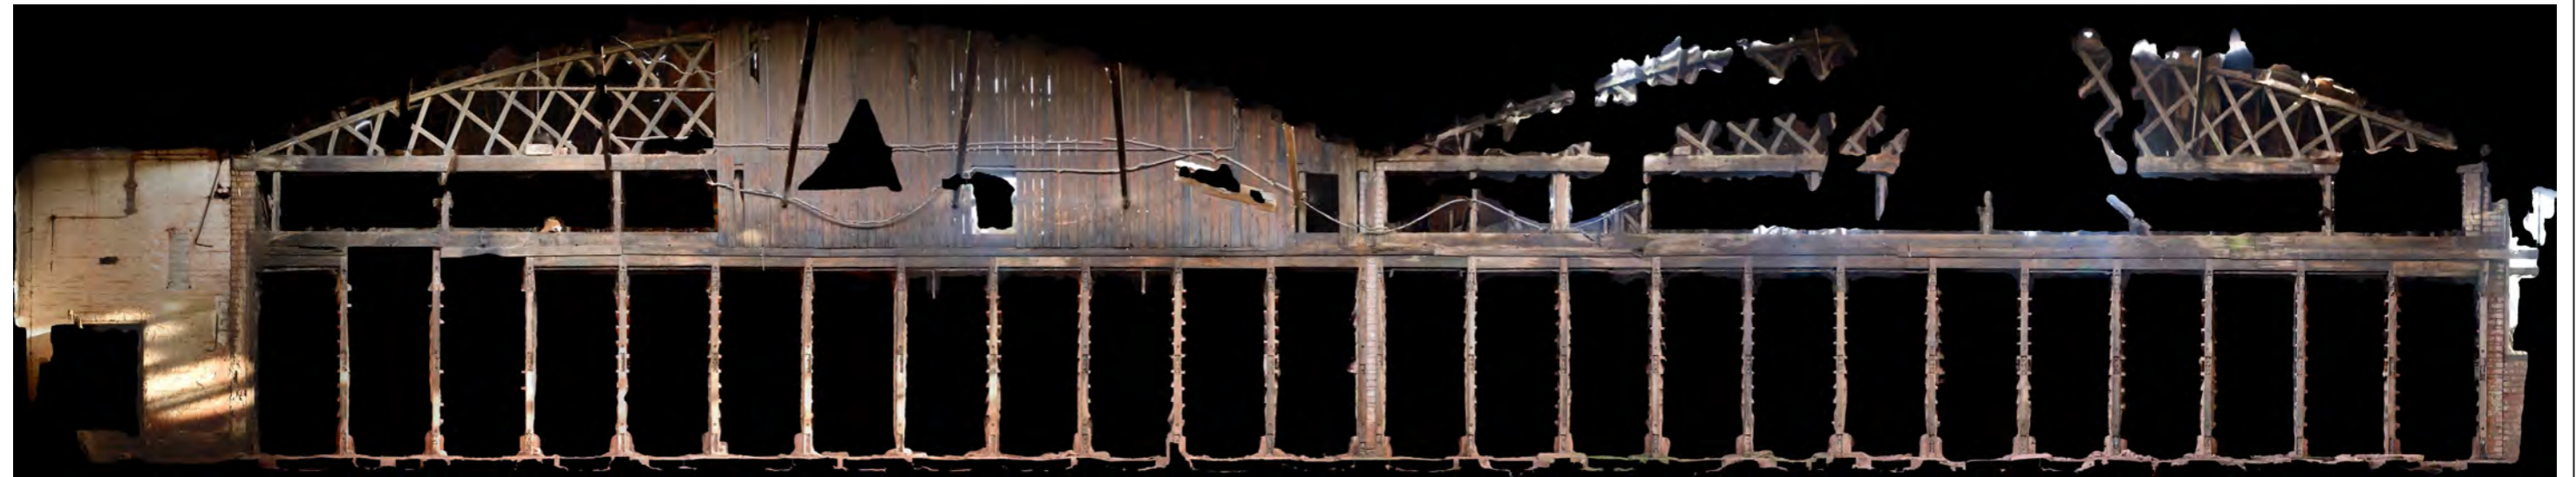
Figure 6

Structure 3 was a rectangular building with a flat concrete steel rod reinforced roof, split into 24 chambers (Plate 33 to Plate 35; Fig 6). This structure finished at the northern wall as it existed (Plate 36), but originally continued further south, as was shown by the brick ledges on this wall (Plate 37). These were seen within each individual chamber and are likely to have been used for stacking bricks.

Rectified photograph of Structure 3 western elevation with later Belfast trusses above

The function of this structure was a drying kiln that appeared to use many of the principles of the Hoffman kiln. Below ground venting structures allowed the movement of air under each chamber, with gaps between the concrete floor slabs. Presumably air flow could be manipulated by chamber appropriate to each phase of heating and cooling, though how this was achieved was unclear. Each bay had wooden doors attached (Plate 38) and would have been loaded and unloaded from either end. No contemporary buildings were seen adjoining this structure so it is likely to have been free standing. The original heat source for this kiln also appears to have been removed. These structures did have some lightweight wooden venting chimneys protruding through the later roof (Plate 39) and originally extended higher (Plate 2). Within the late 20th century, this drying kiln was fuelled by paraffin (WIAS 1999).

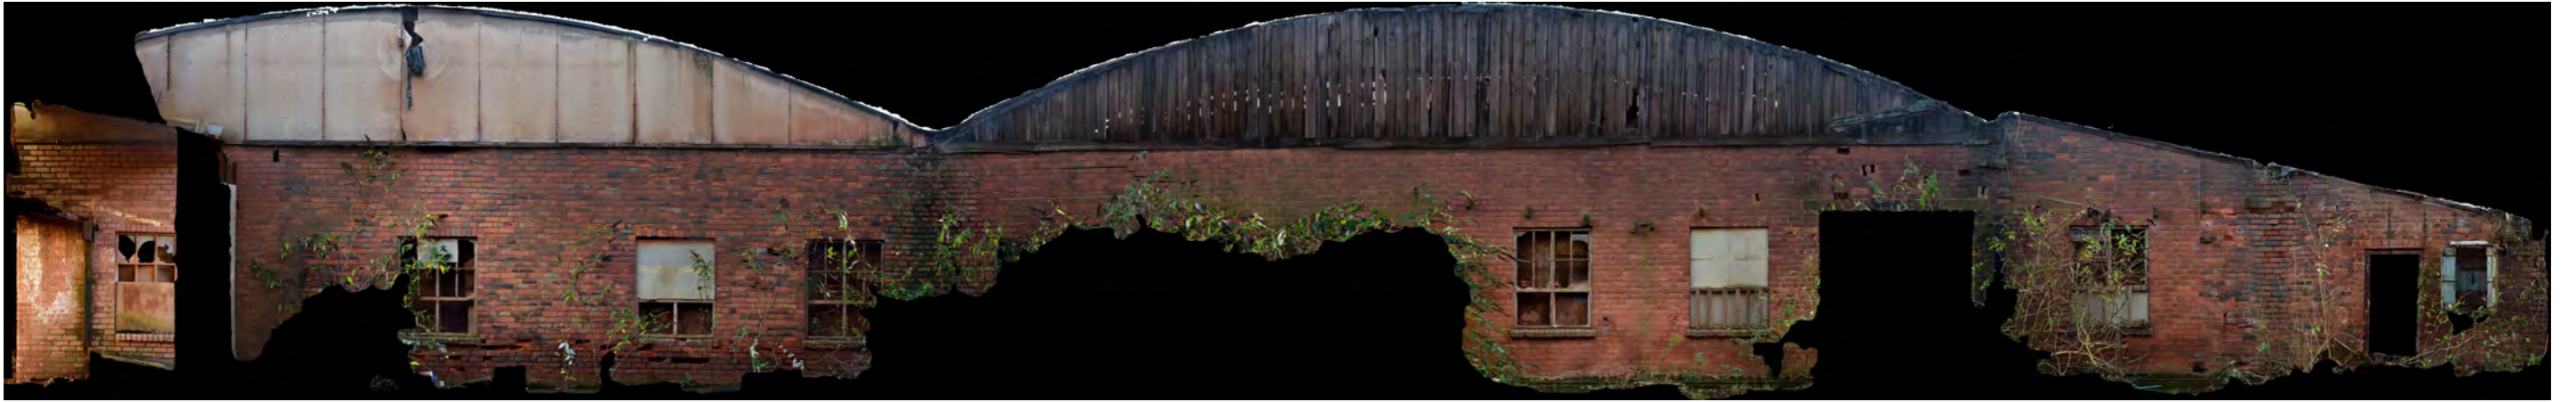
Figure 7

Structures 4, 5 and 8 (Plate 49 to Plate 51) were contemporary in construction, as demonstrated by the wide, shallow arched roof trusses which spanned them. These lightweight roof trusses are known as Belfast trusses, first used in the shipyards of Belfast from the 1860s. Whilst most such trusses date to between the 1860s and the First World War, they continued in construction throughout the 1930s, also being recommended for some military buildings within the Second World War (Gould 2001). They are suggested to date to within the early years of Hemmings take over of the site due to the company name "Hemmings and Sons Ltd" painted onto the gable of Structure 8 (Plate 53 and Plate 2) and the map evidence for Structure 22, as discussed below.

Rectified photograph of Structure 4 exterior elevation

Structures 4 and 5 enclosed Structure 3, the Phase 2 drying kiln, allowing it to be loaded and unloaded within a covered area. Probably at this time, a rail track was added in front of the Structure 3 doors on both ends. On the southern side, these tracks ran through into the later Structure 7, whilst at the northern end they ran into Structure 8 (Plate 54).

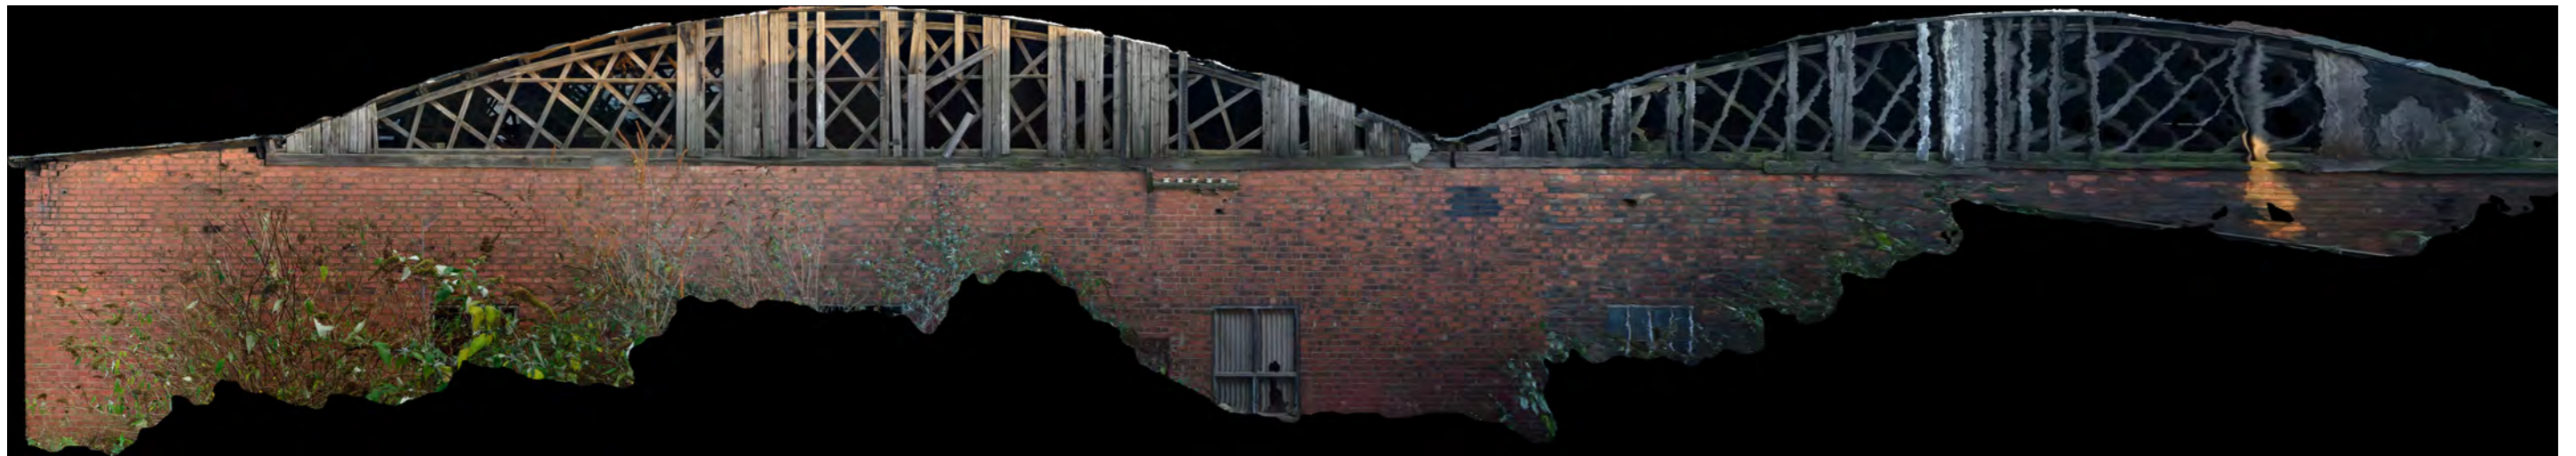
Figure 8

Rectified photograph of Structure 5 exterior elevation

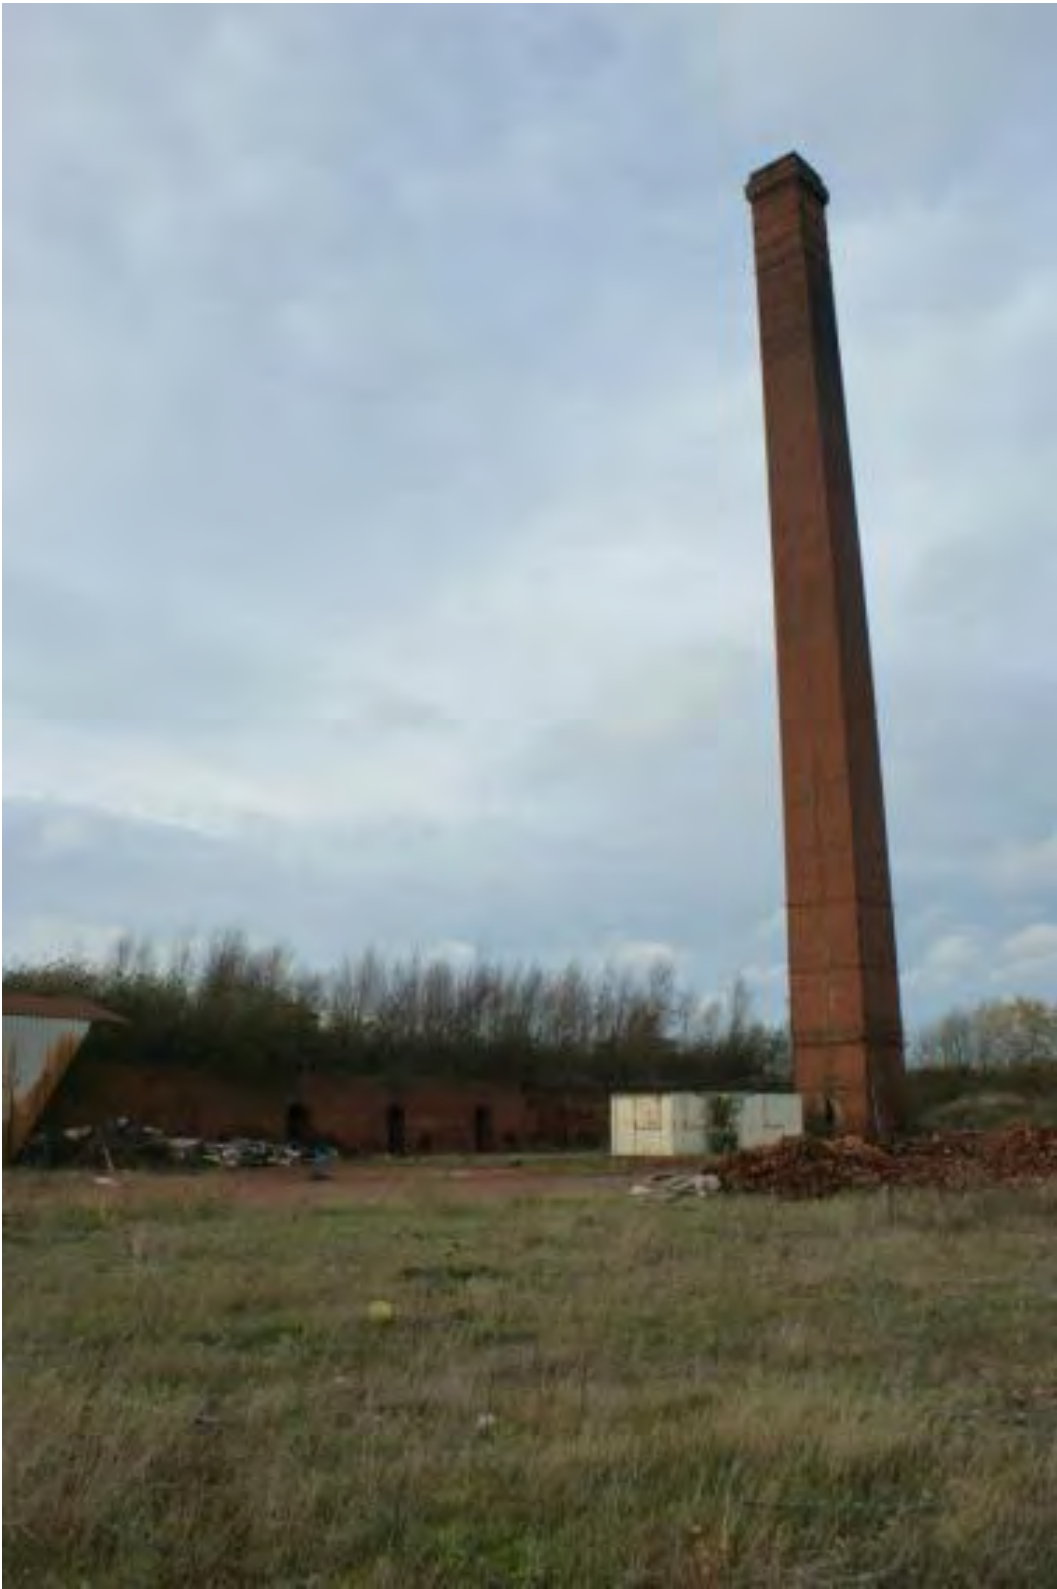
Whilst the earliest Hoffman kilns had a chimney at their centre, later such kilns had a chimney set to one side as is the case with Structure 2 here (Plate 17). Air was drawn through into the chimney from a system of underground vents below the kiln (Plate 18). This chimney stood to a height of about 52m and was 3.70m square at its base. It formerly had an access door at its base and had moulded string course above (Plate 19). The metal strapping was a later addition.

Plate 17 Structure 2, looking north-west

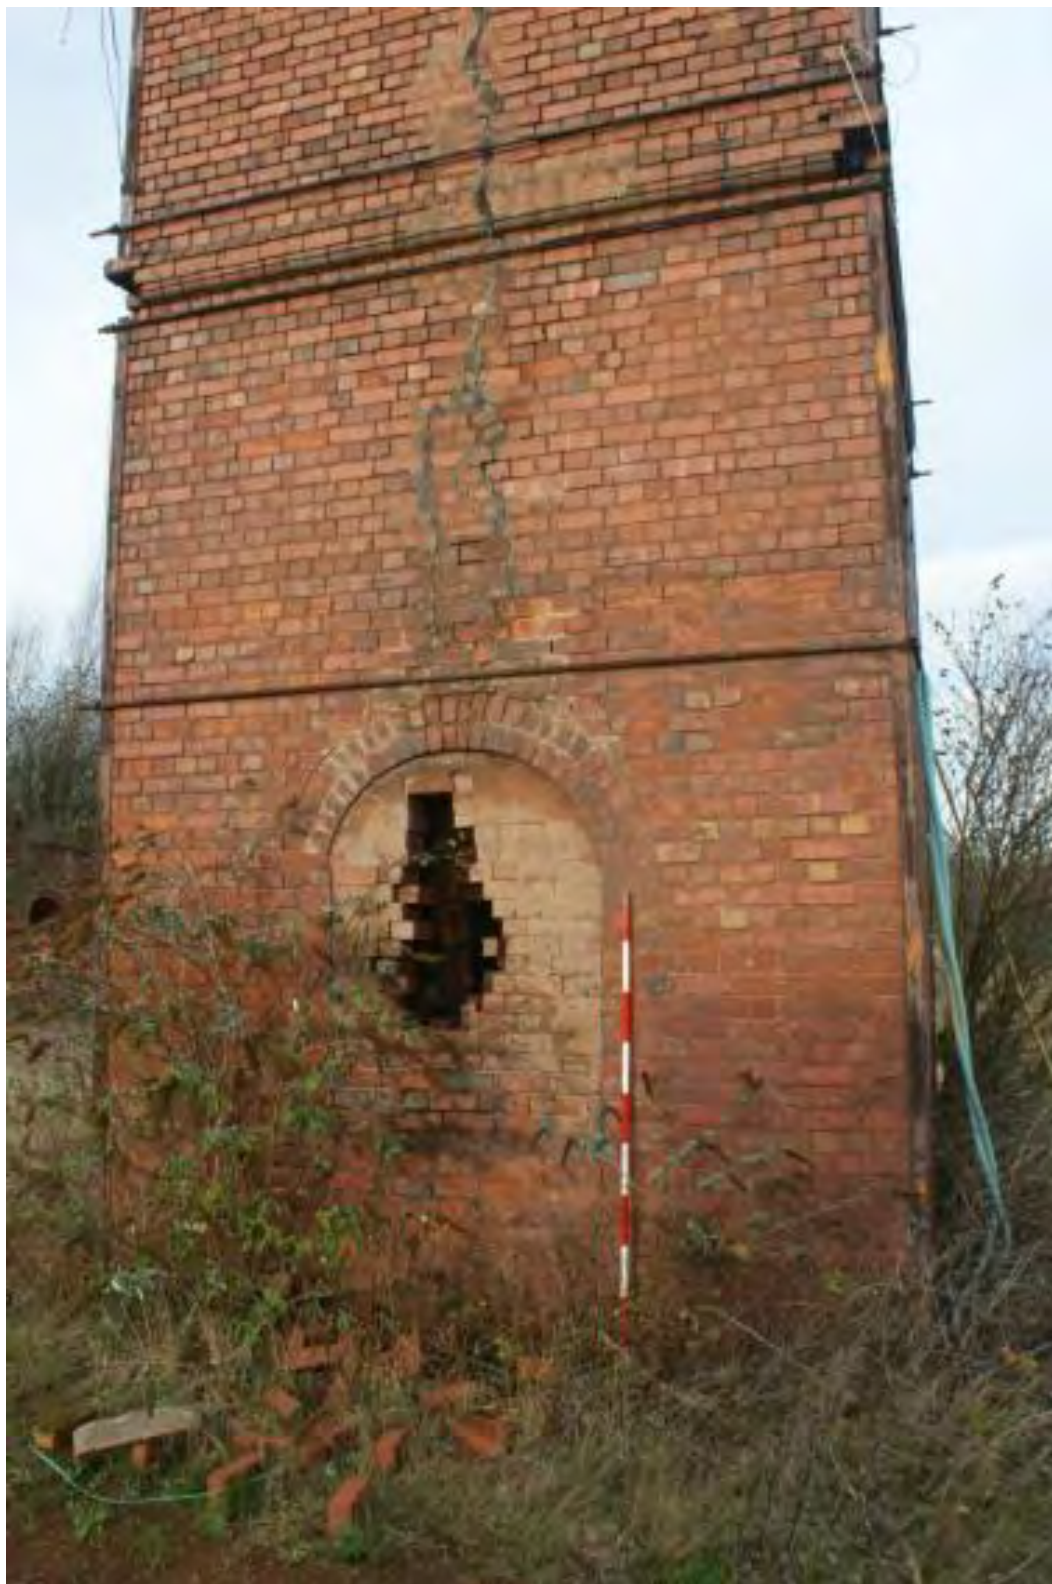
Plate 19 Structure 2, looking north

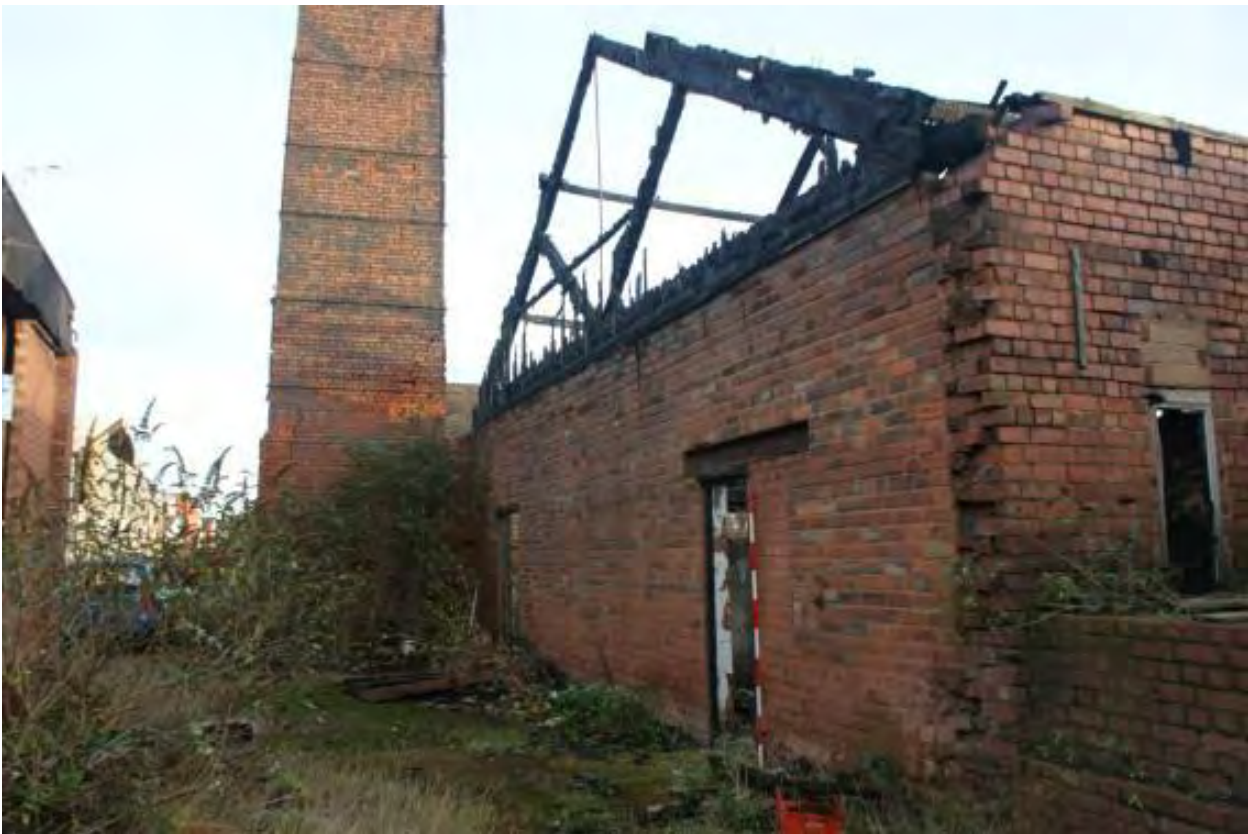
Structure 9 (Plate 20 and Plate 21) was constructed next to Structure 18, possibly replacing an earlier kiln. This consisted of two walls running north to south, spanned by six softwood timber trusses that had raking collars and an iron tie rod instead of a king post. Whilst these may have been original, they are more likely to be replacements dating to a later phase when the building was converted into a warehouse. They maybe contemporary with the gable end walls which are later insertions. The original use of this structure is suggested by two areas of heat affected brickwork internally at the northern ends (Plate 22 and Plate 23). These extended to a height of 1.90m and a length of 9m. It is likely that these represent a kiln, though their general form was unclear.

Plate 20 Structure 9, looking north-west

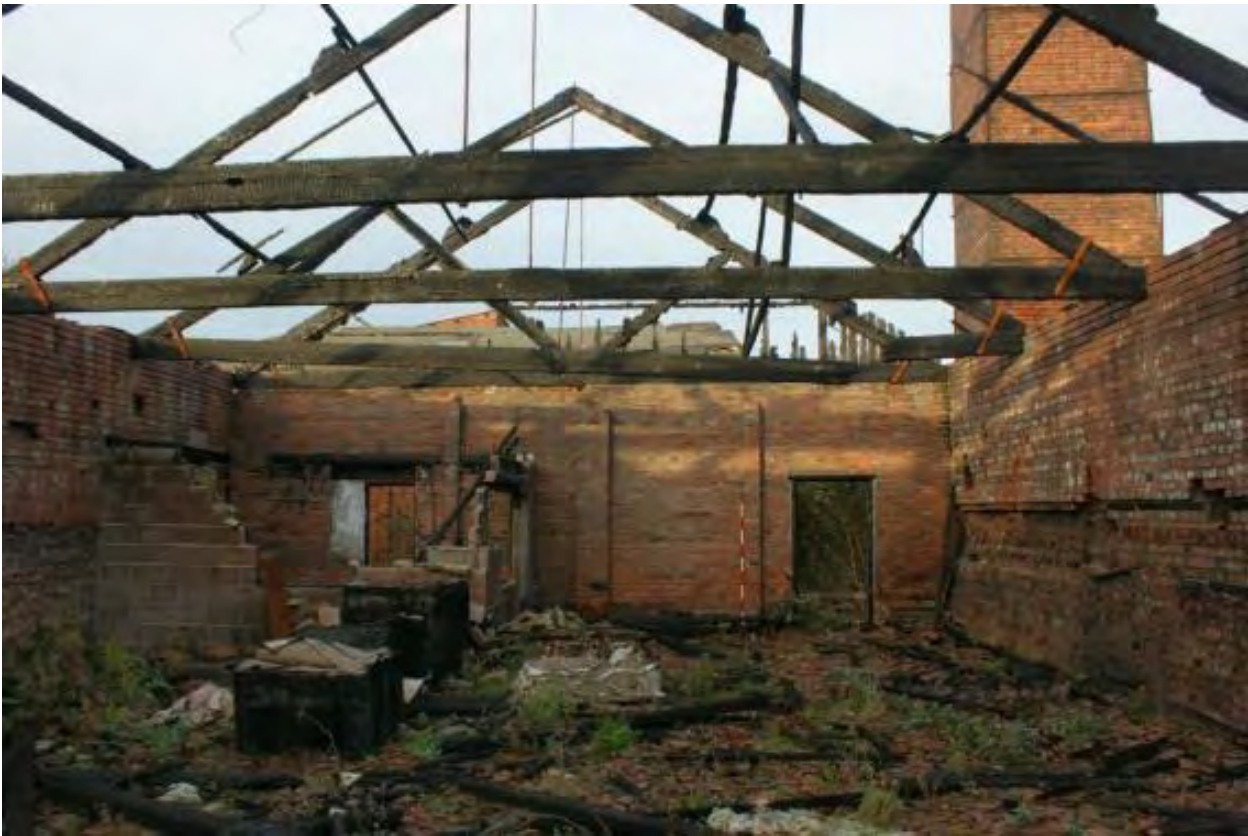
Plate 21 Structure 9, looking north

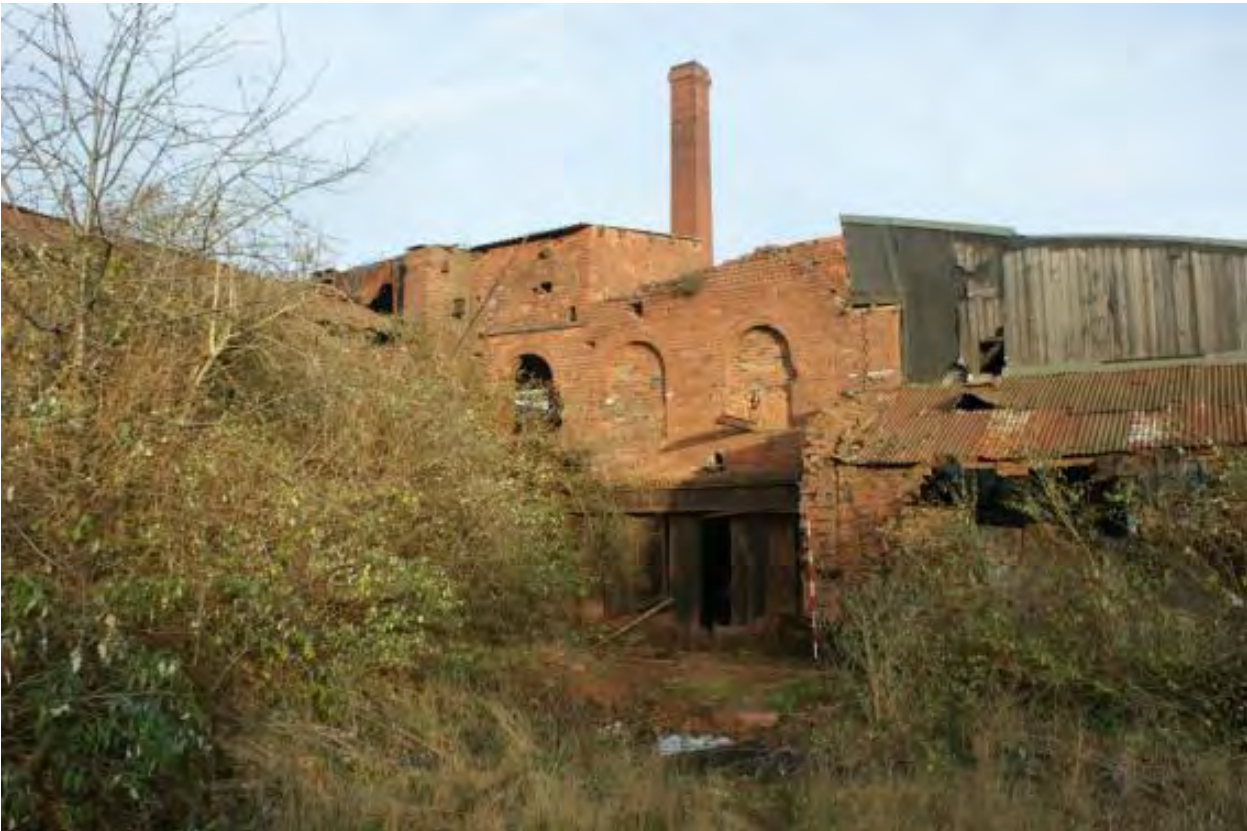
Structures 11 and 12 (Plate 24, Plate 25 and Plate 28) were the same structure linked at first floor level by what is likely to have been a gable end. This had arch headed windows, though two were later blocked and the third had been converted into a door. The configuration of this building at both ground and first floor level is unclear due to it having been truncated on its southern end and eastern side. It does appear to have had a first floor as a platform runs along the interior wall at an appropriate level for joists though this was largely obscured by vegetation. Its function remained unclear.

Plate 24 Structure 11/12, looking north-east

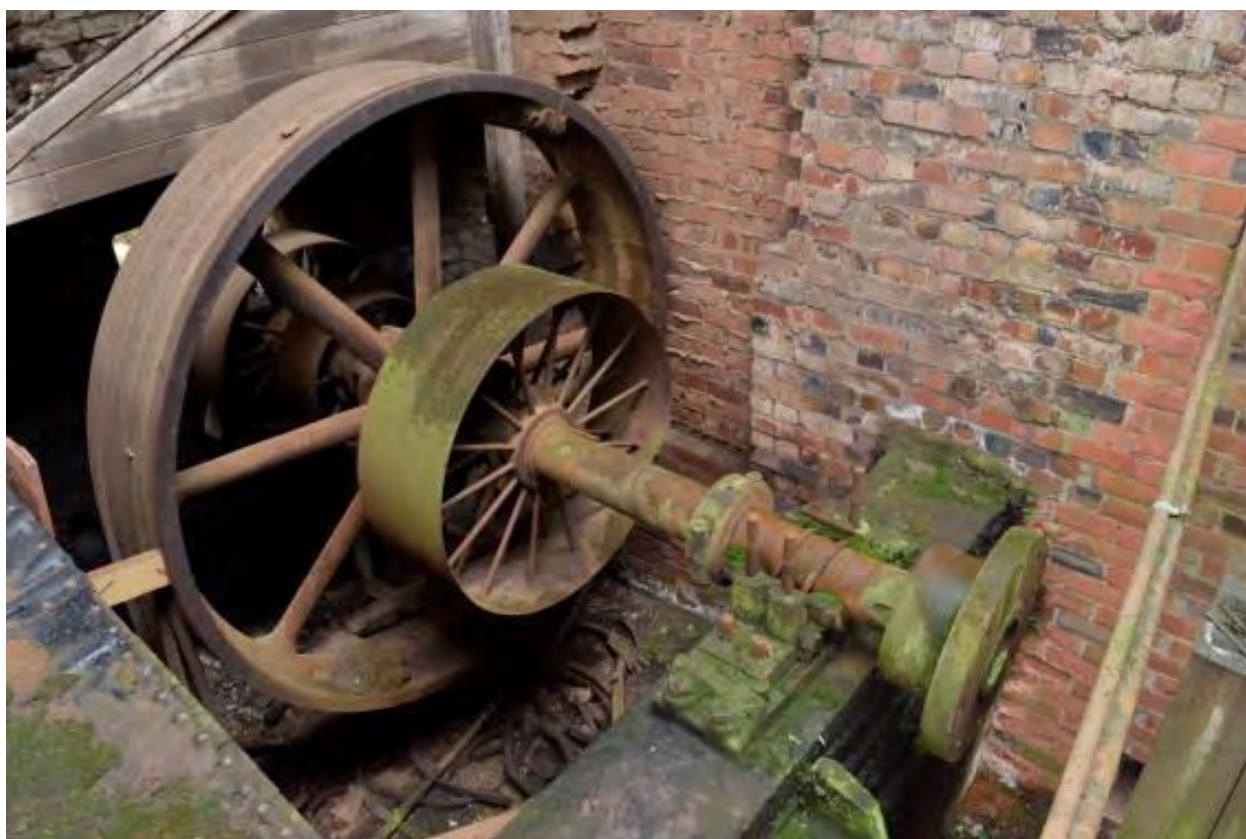
The function of this building was highlighted by a series of fly wheels, all attached to one axle over about a third of the width of the room (Plate 31) as well as the later use of this area. The housing supports for the axle was built into Structure 13 and cut into Structure 12 on the other side of the room, confirming the axle formerly ran across the whole room and the relationship of these structures. How this axle was driven was not clear but it is possible that it was internally driven from within Structure 11/12.

Plate 31 Structure 13, looking north-east

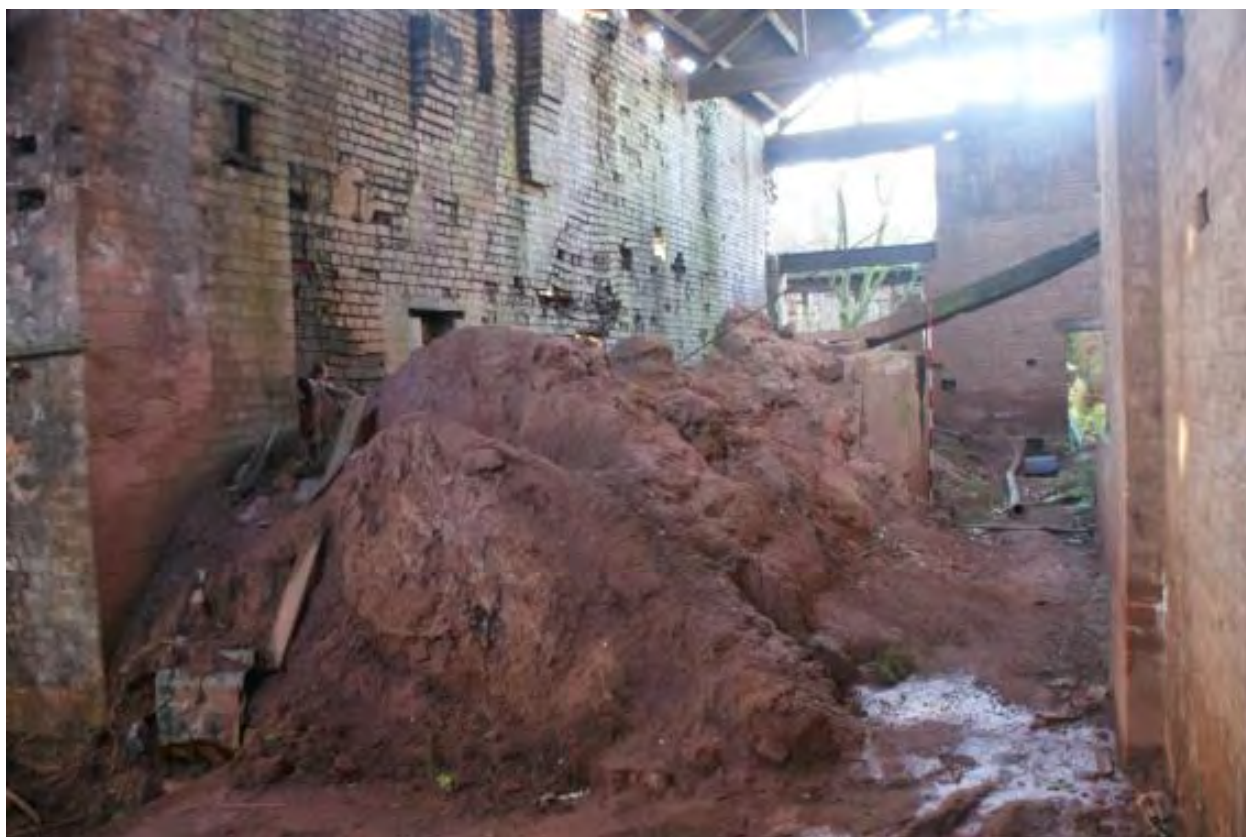
The mounds of clay in this room (Plate 32) and the storage of barium carbonate in the Phase 3 Structure 16, suggests that this room was used for the mixing of clay. Barium carbonate was an additive added to raw clay as a dissolvent of salts that cause efflorescence in the finished brick. This area where additives were mixed in was described in a late 20th century visit as the "pug mill" (WIAS 1999). The 1912 to 1938 OS maps show a railway line running to roughly this area of the buildings from probable extraction pits to the north and west.

Plate 32 Structure 13, looking west

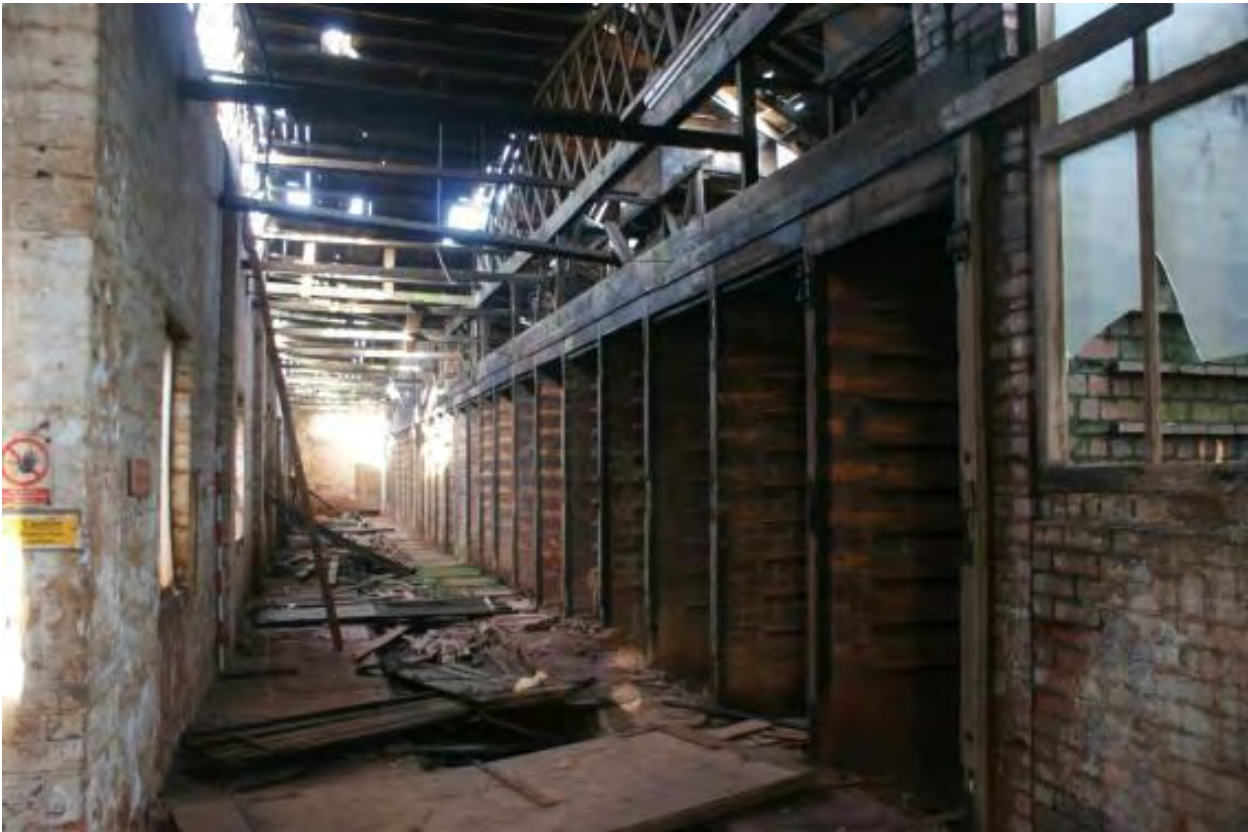
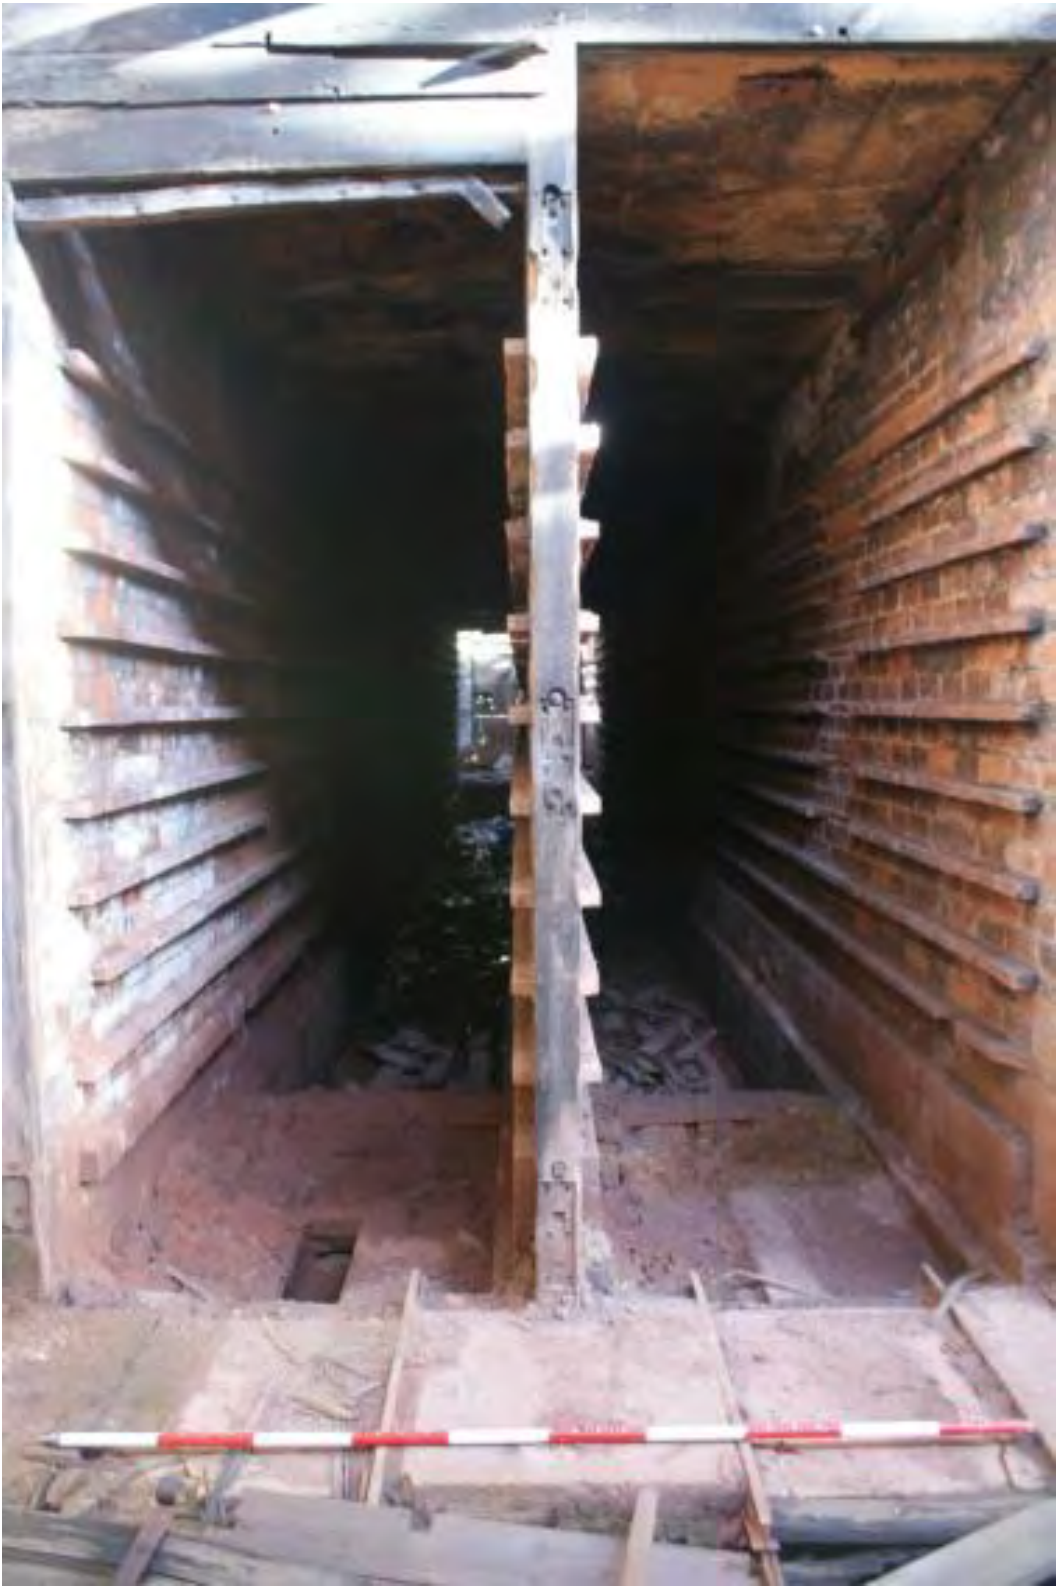
Plate 33 Structure 3, looking north-west

Plate 34 Structure 3, looking north

Plate 35 Structure 3, looking west

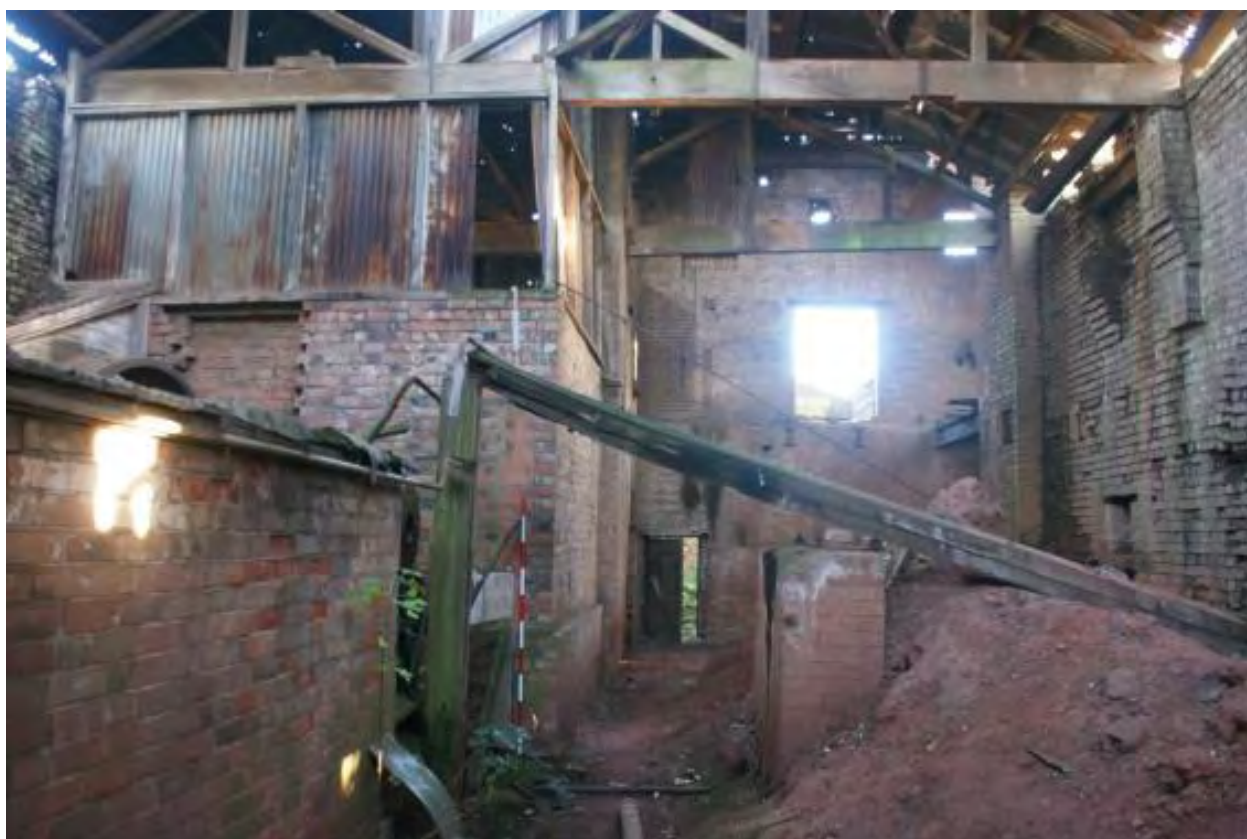
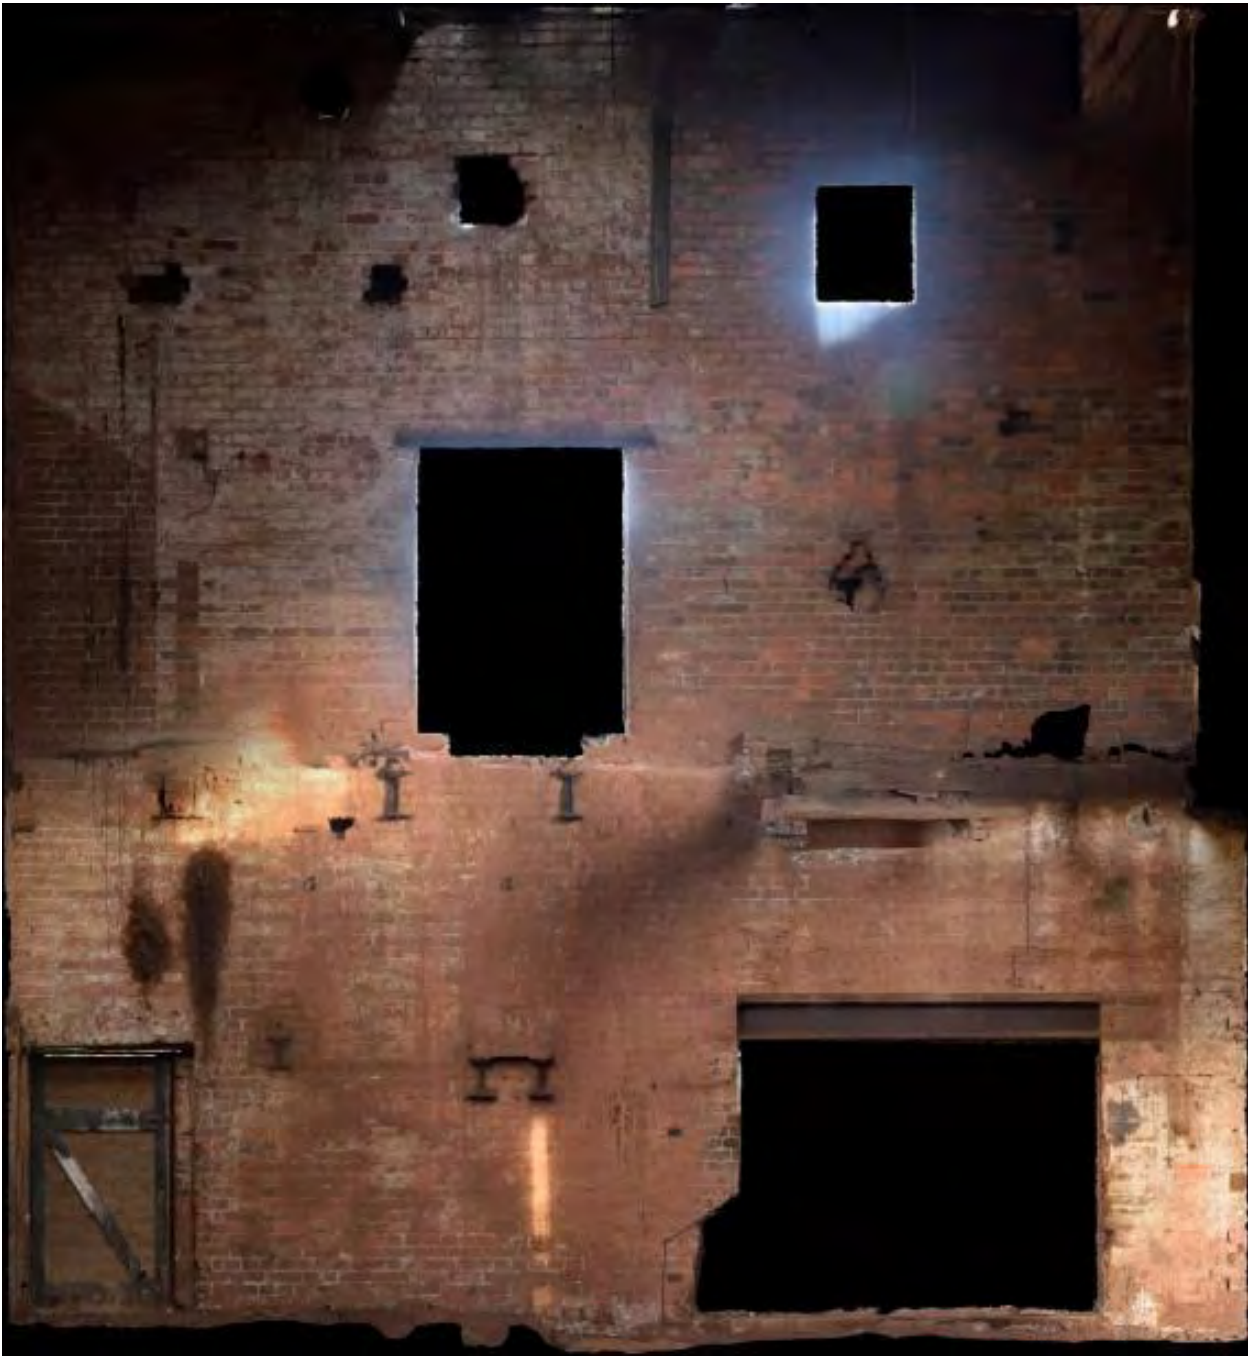
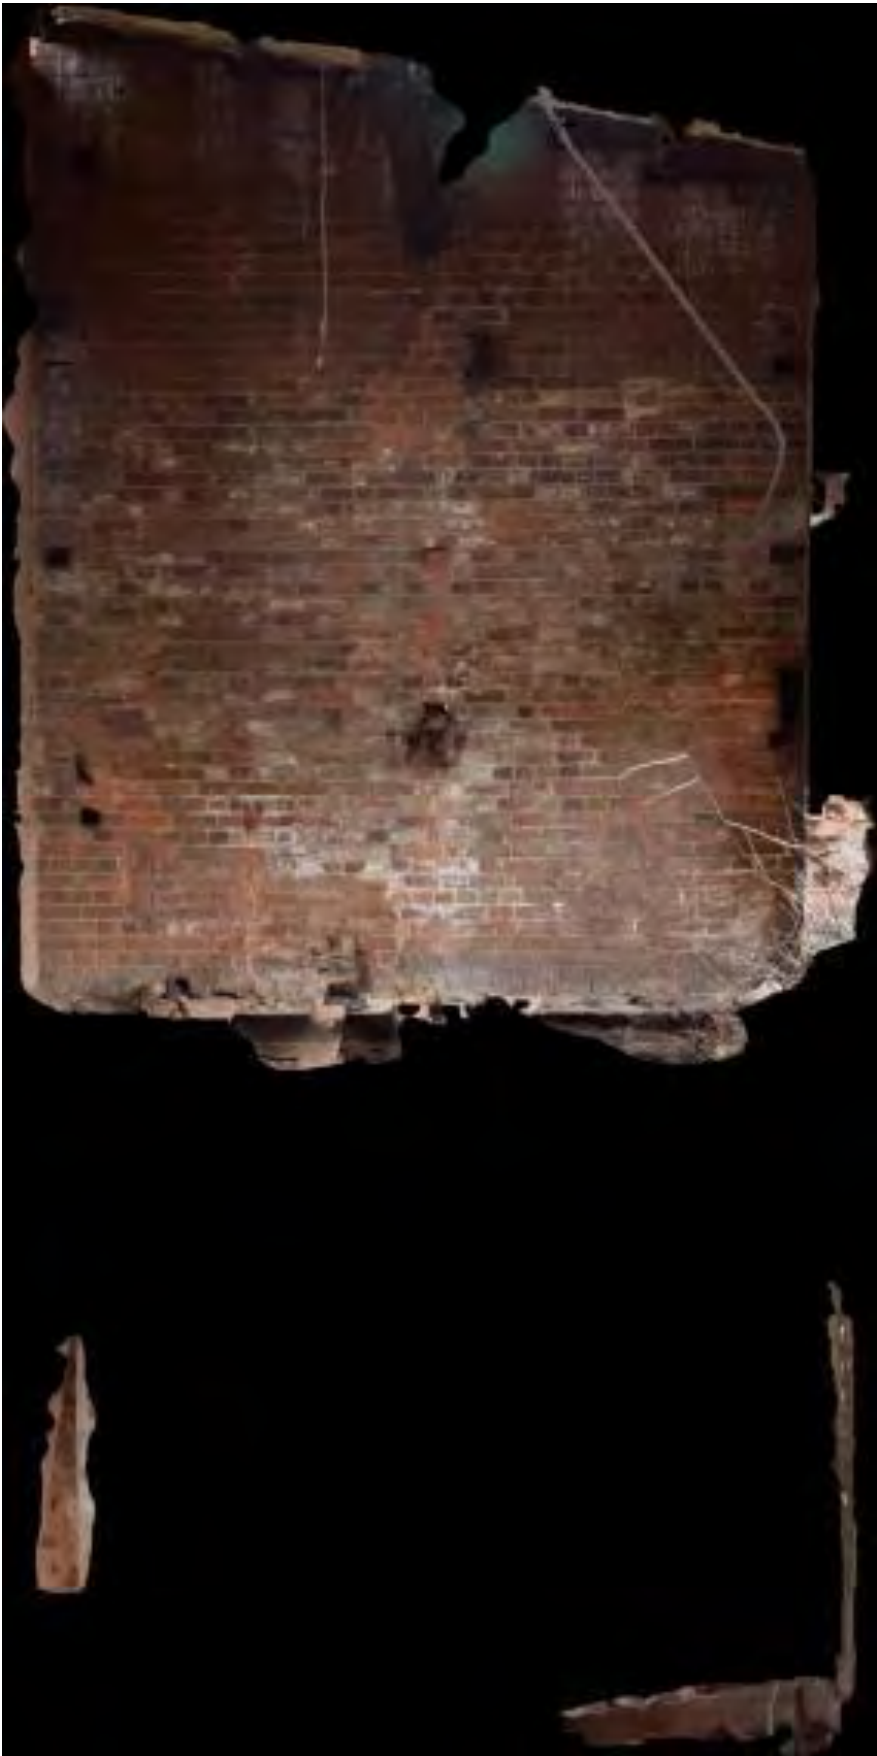
Structure 10 was also added within this phase (Plate 40, Plate 26, Plate 41 and Plate 42), creating a room to its east (Plate 43 to Plate 47) and extending as far as the fly wheels. The wall next to the fly wheel originally had gaps to allow the passage of belts which drove machinery within the extra room, as shown by machine bases in this area (Plate 48). At least one of these machines was likely to have been used for tool sharpening, as some grinding stones remained in the room. This room also had a first floor which also contained machinery based upon axles, as seen by their housing visible in the walls (Plate 26). It is likely that was during this phase that the door through into the first floor of Structure 11/12 was added into the former window, suggesting that this structure remained extant at this time.

Plate 40 Structure 10, looking east

Plate 41 Structure 10, looking east

Plate 42 Structure 10, looking south

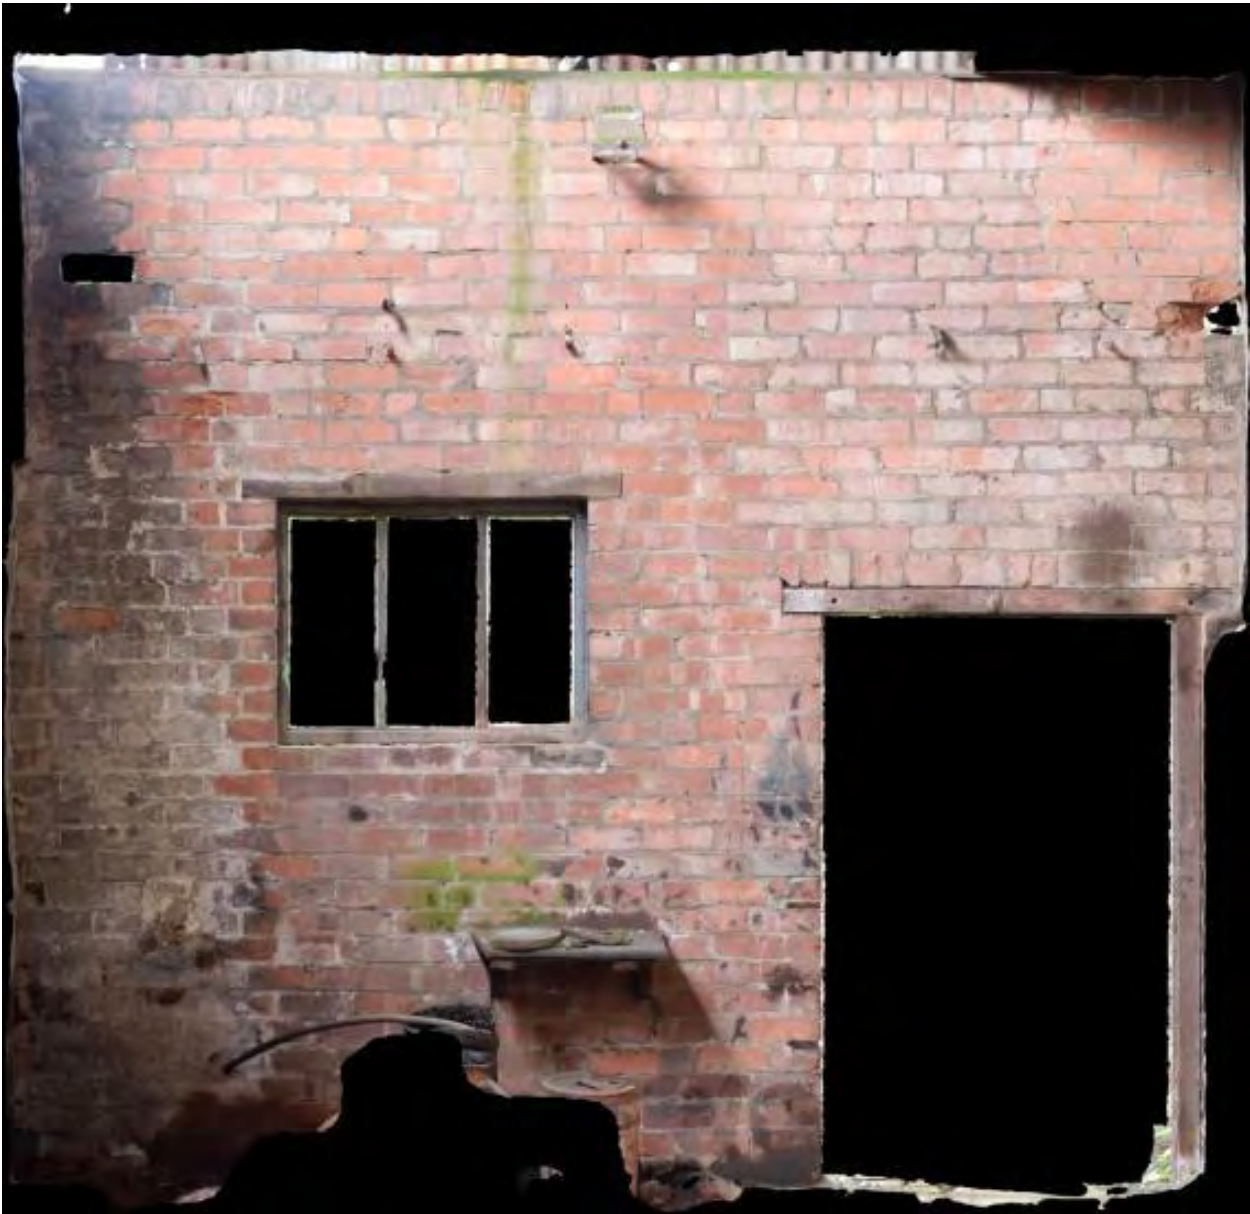
Structure 14 was a rebuild of the probable gable end of Structure 13 (Plate 44 and Plate 45). It could belong to this or the preceding phase.

Plate 45 Structure 14, looking east
