Building recording at Webster/Hemmings Brickworks, Paragon Park, Foleshill Road, Coventry, Warwickshire

Date: 15 February 2016
Author: Tim Cornah tcornah@worcestershire.gov.uk
Illustrator: Carolyn Hunt
Project reference: P4568
Report reference: 2308
Oasis ID: fieldsec1-242166

Summary

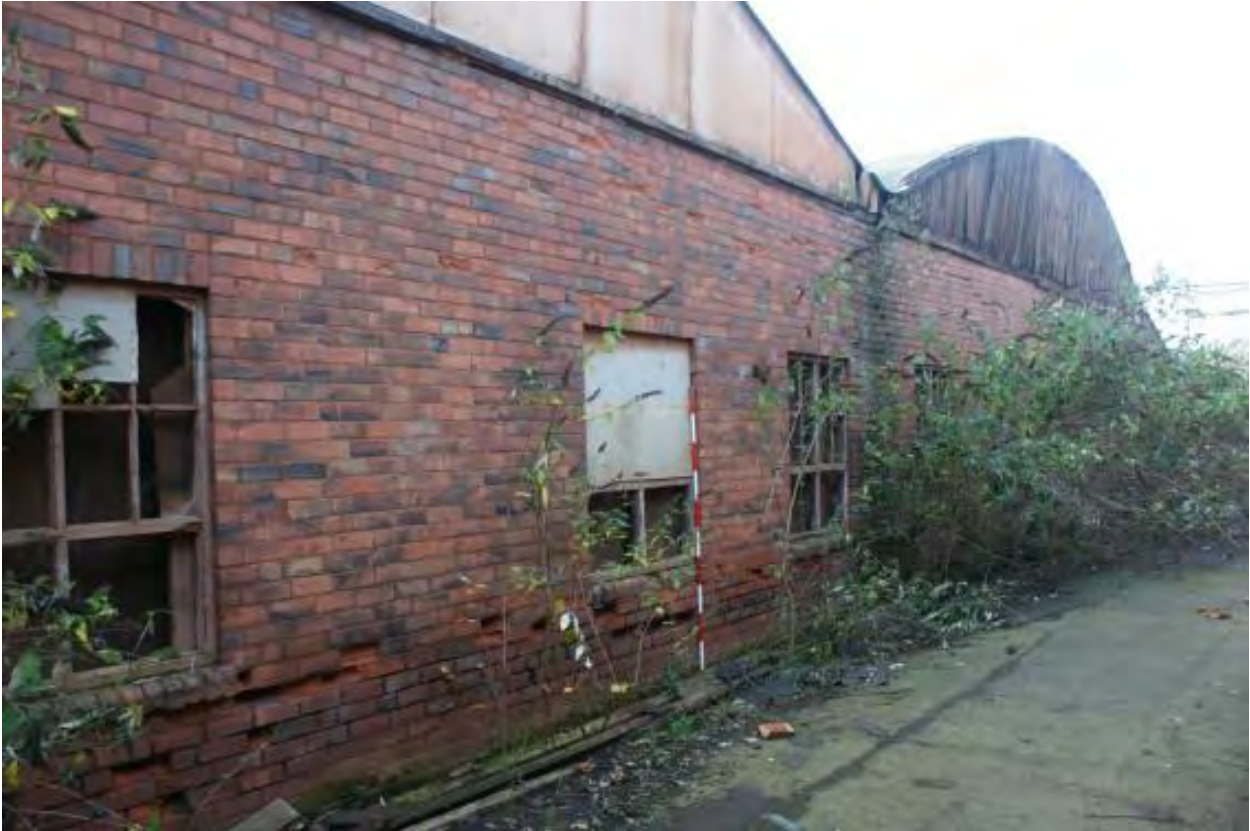
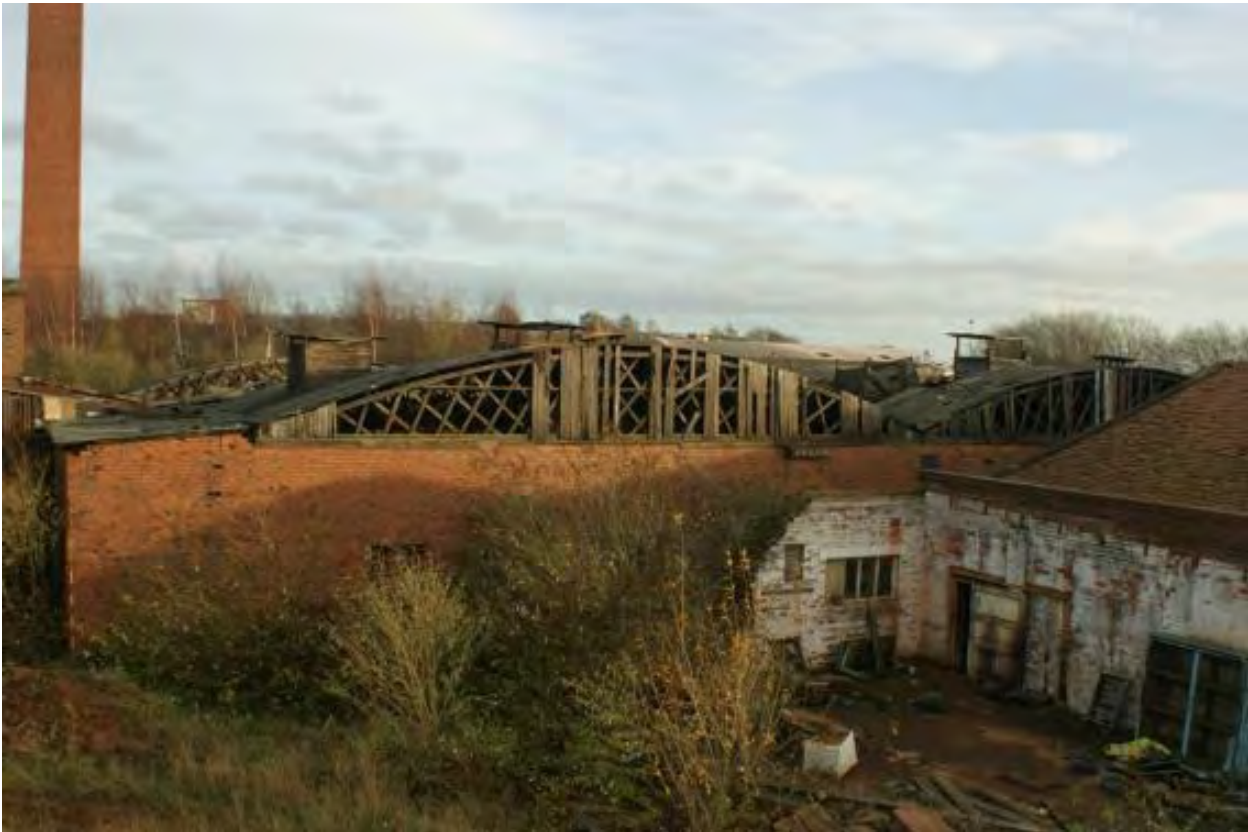
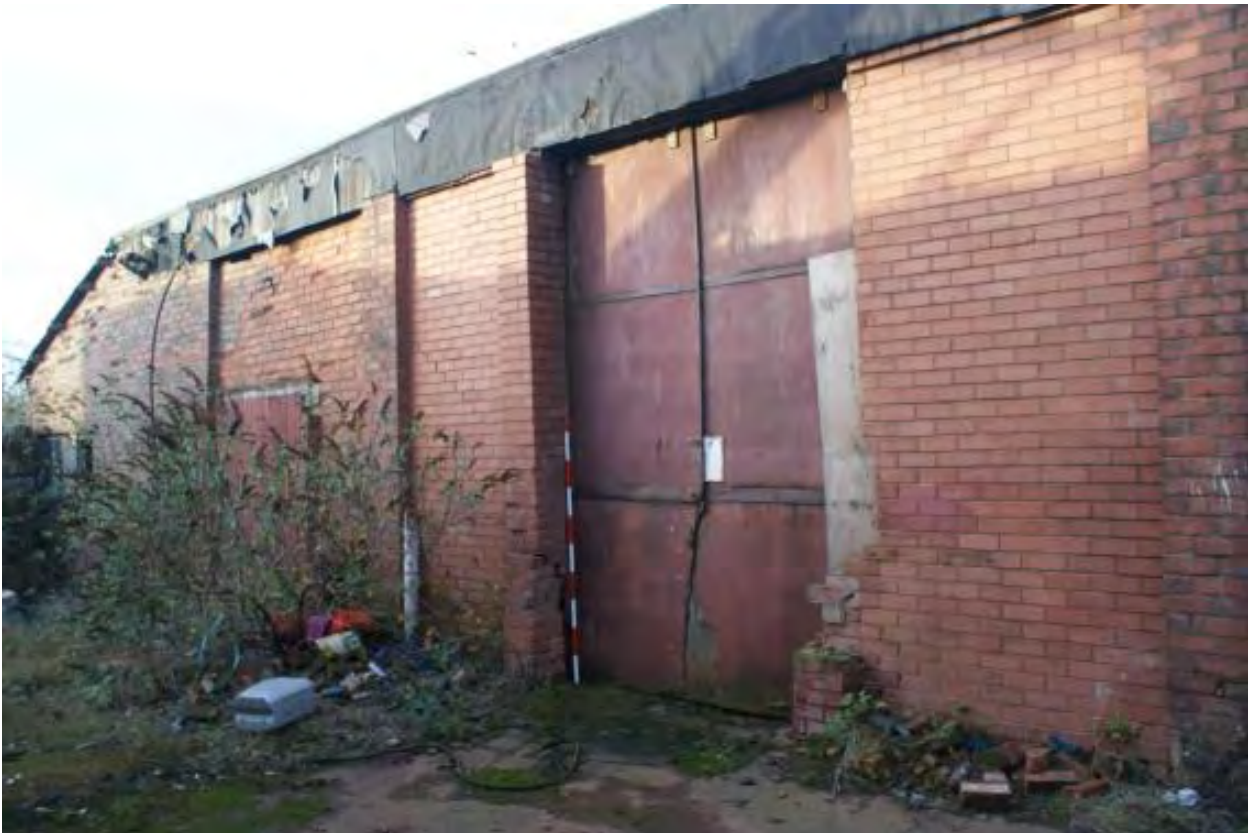
Structures 4, 5 and 8 (Plate 49 to Plate 51) were contemporary in construction, as demonstrated by the wide, shallow arched roof trusses which spanned them. These lightweight roof trusses are known as Belfast trusses, first used in the shipyards of Belfast from the 1860s. Whilst most such trusses date to between the 1860s and the First World War, they continued in construction throughout the 1930s, also being recommended for some military buildings within the Second World War (Gould 2001). They are suggested to date to within the early years of Hemmings take over of the site due to the company name "Hemmings and Sons Ltd" painted onto the gable of Structure 8 (Plate 53 and Plate 2) and the map evidence for Structure 22, as discussed below.

Plate 49 Structure 4, looking north-west

Plate 50 Structure 5, looking north-west

Plate 51 Structure 8, looking north-west

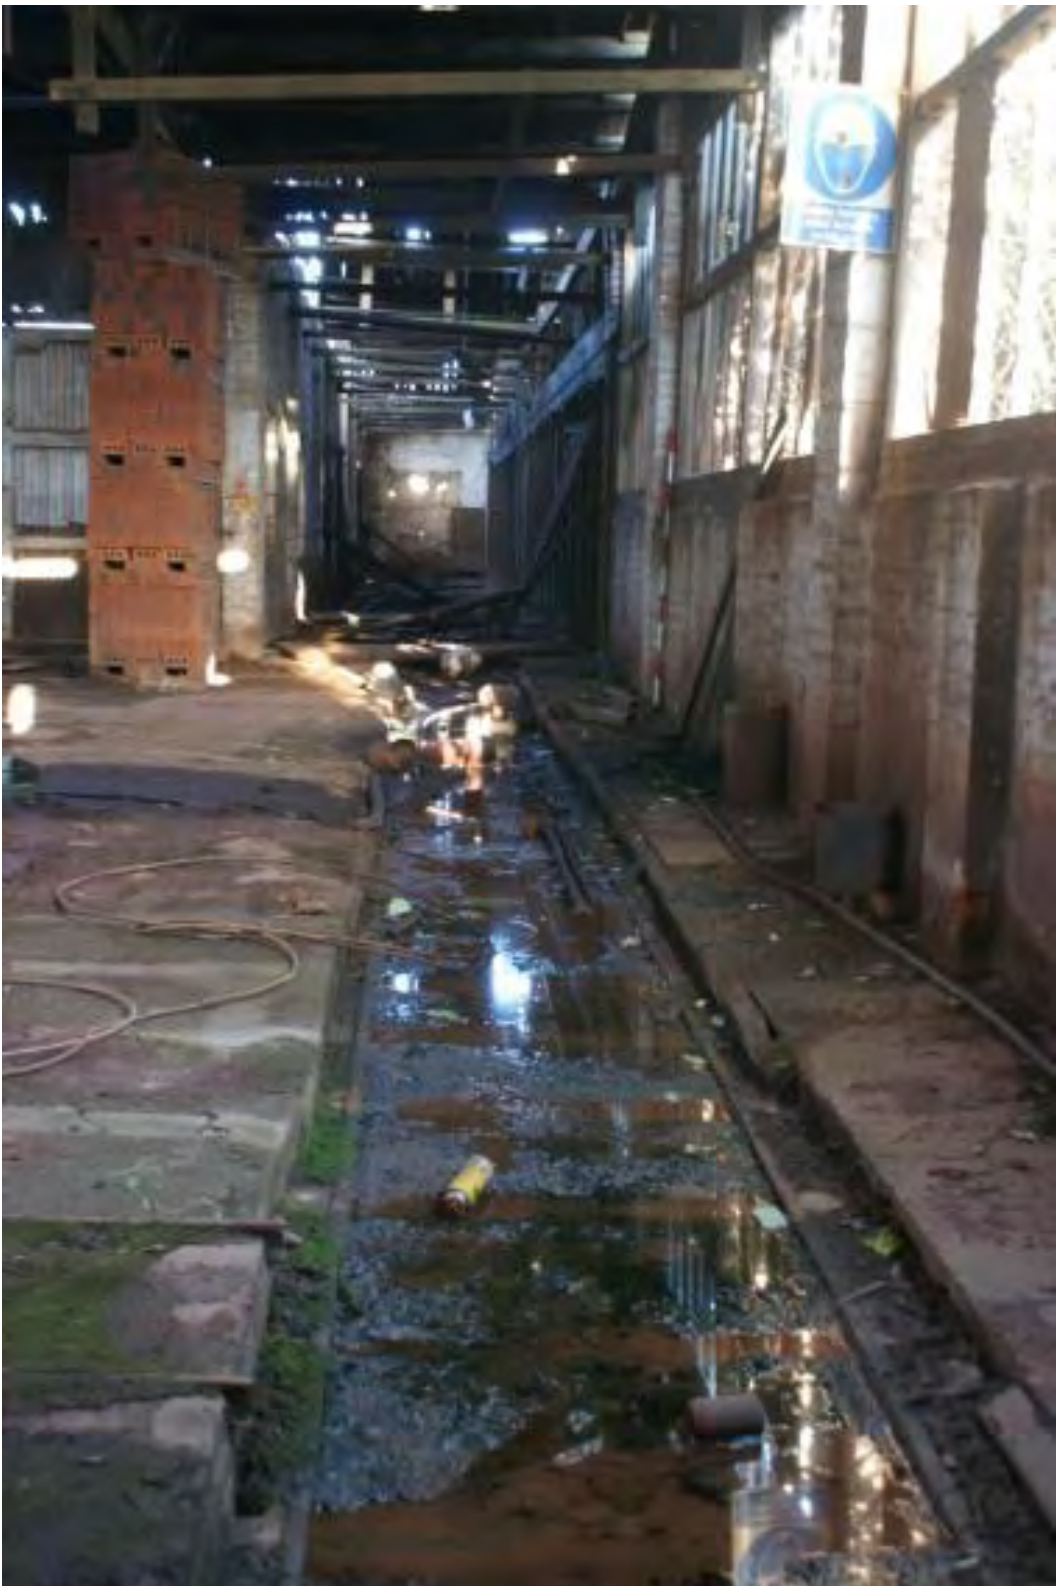
Structures 4 and 5 enclosed Structure 3, the Phase 2 drying kiln, allowing it to be loaded and unloaded within a covered area. Probably at this time, a rail track was added in front of the Structure 3 doors on both ends. On the southern side, these tracks ran through into the later Structure 7, whilst at the northern end they ran into Structure 8 (Plate 54).

Plate 54 Structure 8, looking north

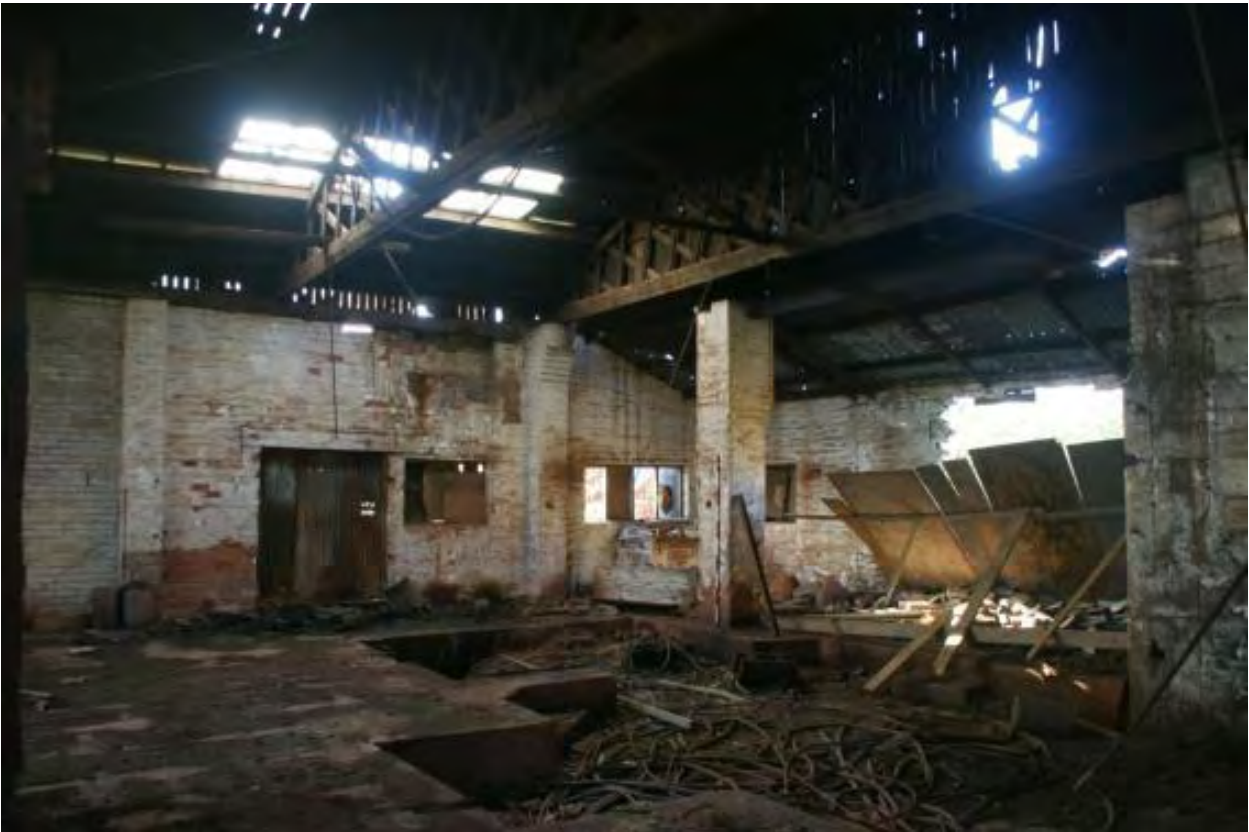
Structure 8 (Plate 55) consisted of a broadly rectangular room without a first floor, abutting Structures 10 and 11. It appears to have had a wide entrance in its south-east corner with additional entrances being cut through Structures 10 and 11 at ground floor level (Plate 56). It was lit by a large metal framed window in its eastern side (Plate 57). A number of machines were shown remaining within the sunken area of this room after its abandonment in 2012 (Jones 2016)

Plate 55 Structure 8, looking south-west

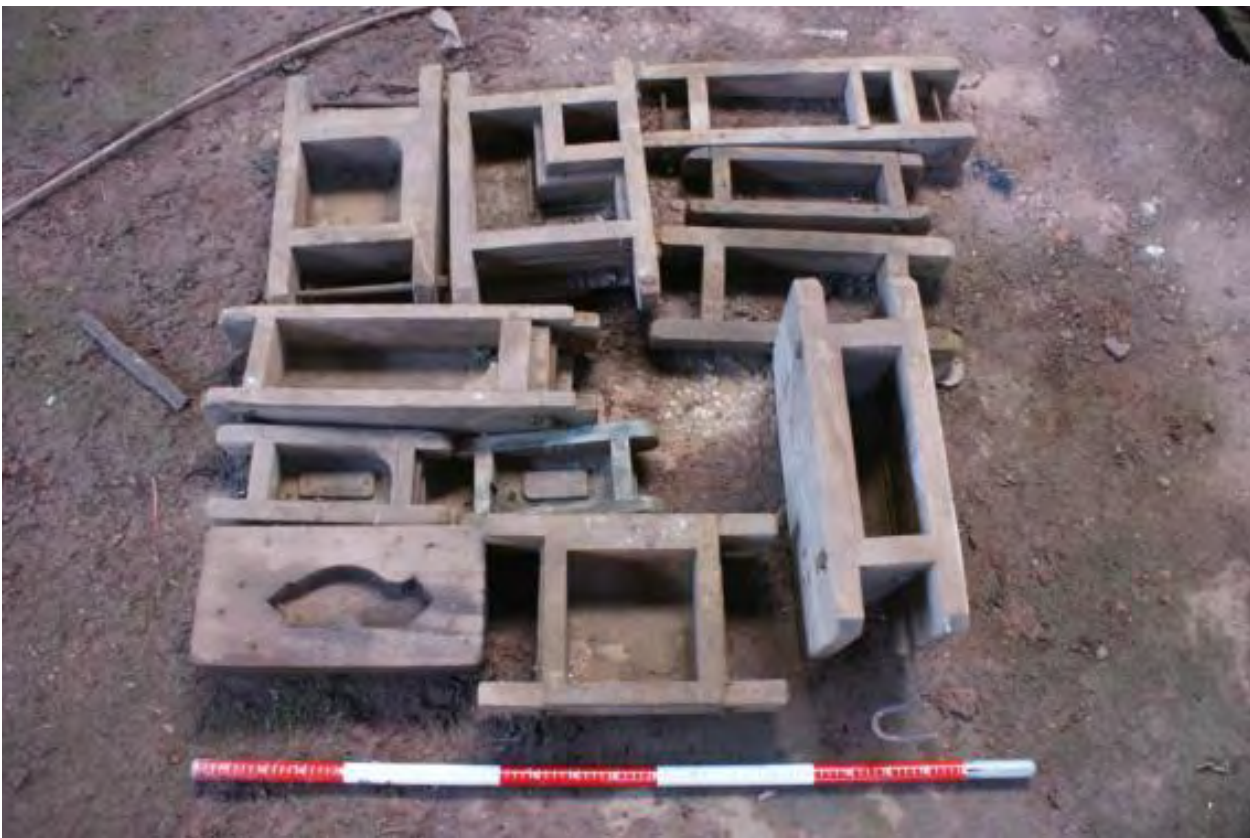
that are likely to have been for the pressing of clay into moulds. An extruder previously existed close to the new opening through Structure 10. These machines no longer remained at the time of recording. A number of the moulds did remain in this room (Plate 58), one showing a Hemmings stamp.

Plate 58 Structure 8, brick moulds

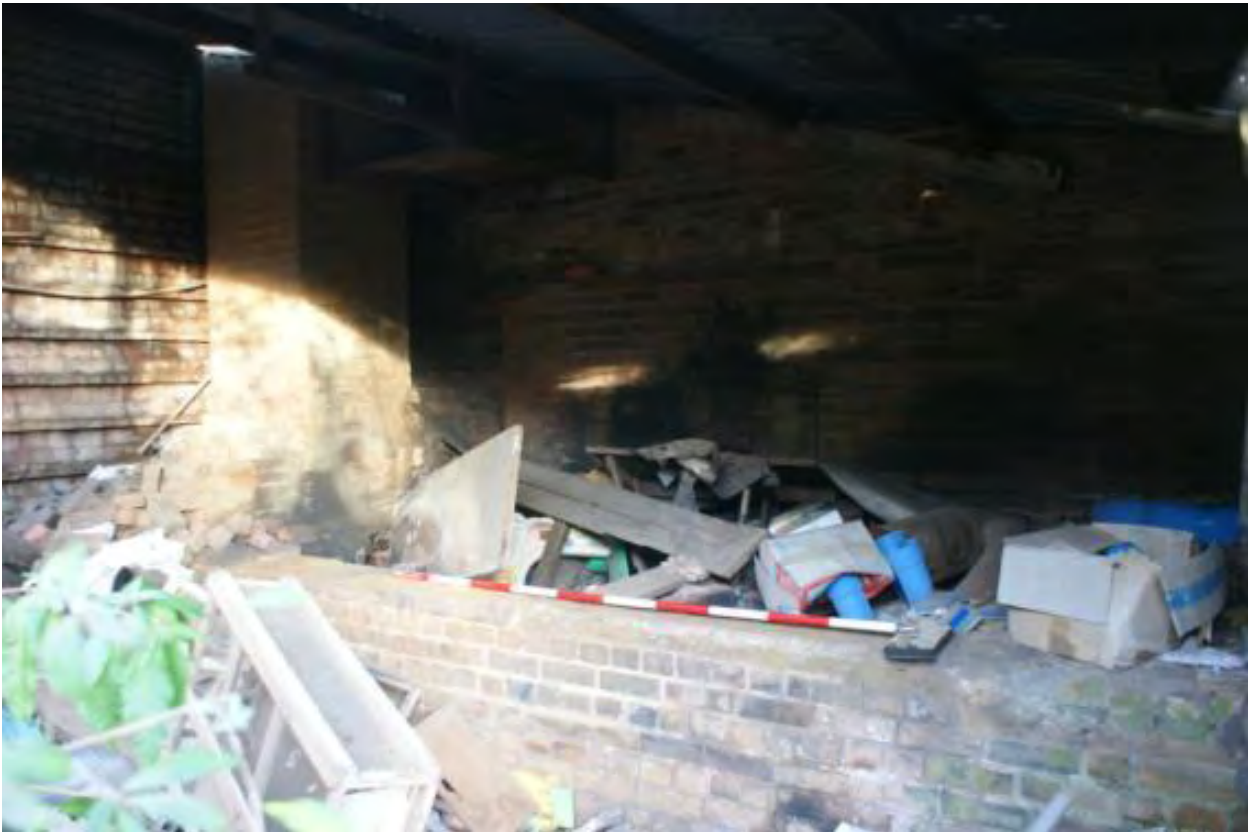
Structure 6 comprised three small single storey structures. One contained a fan which is likely to have fed into the adjacent drying kiln, Structure 3 (Plate 64), whilst a further structure was a storeroom (Plate 65). A small lean-to structure contained a brick structure with a chimney attached that is likely to have been a heat source for Structure 3 (Plate 66).

Plate 66 Structure 6, looking north-east

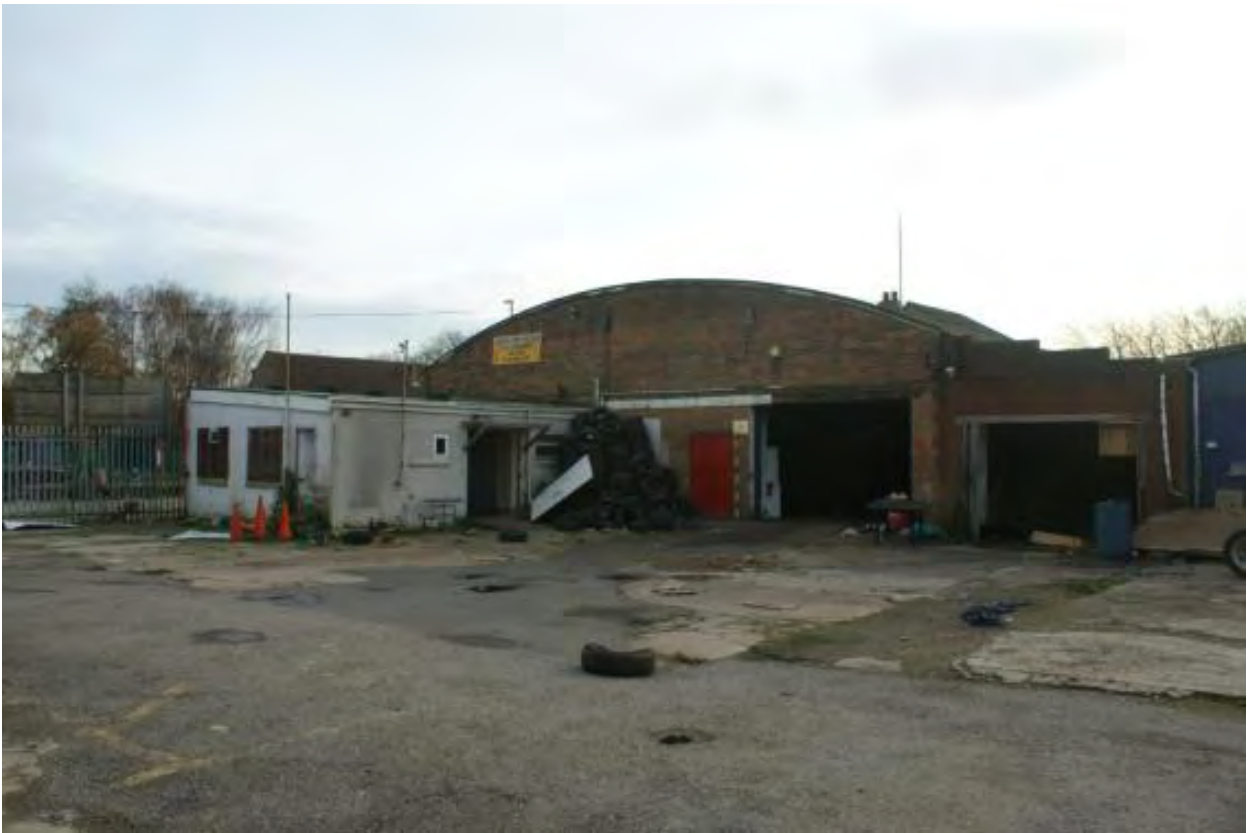
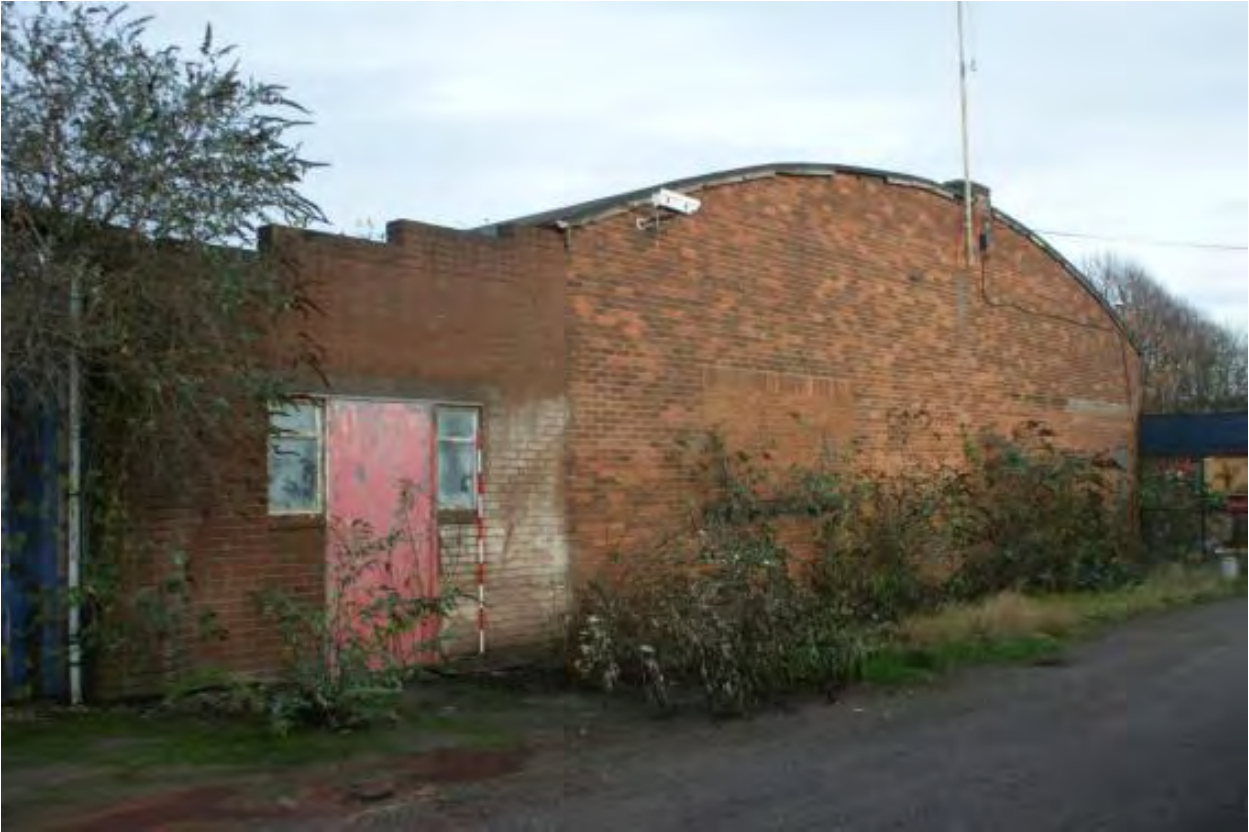
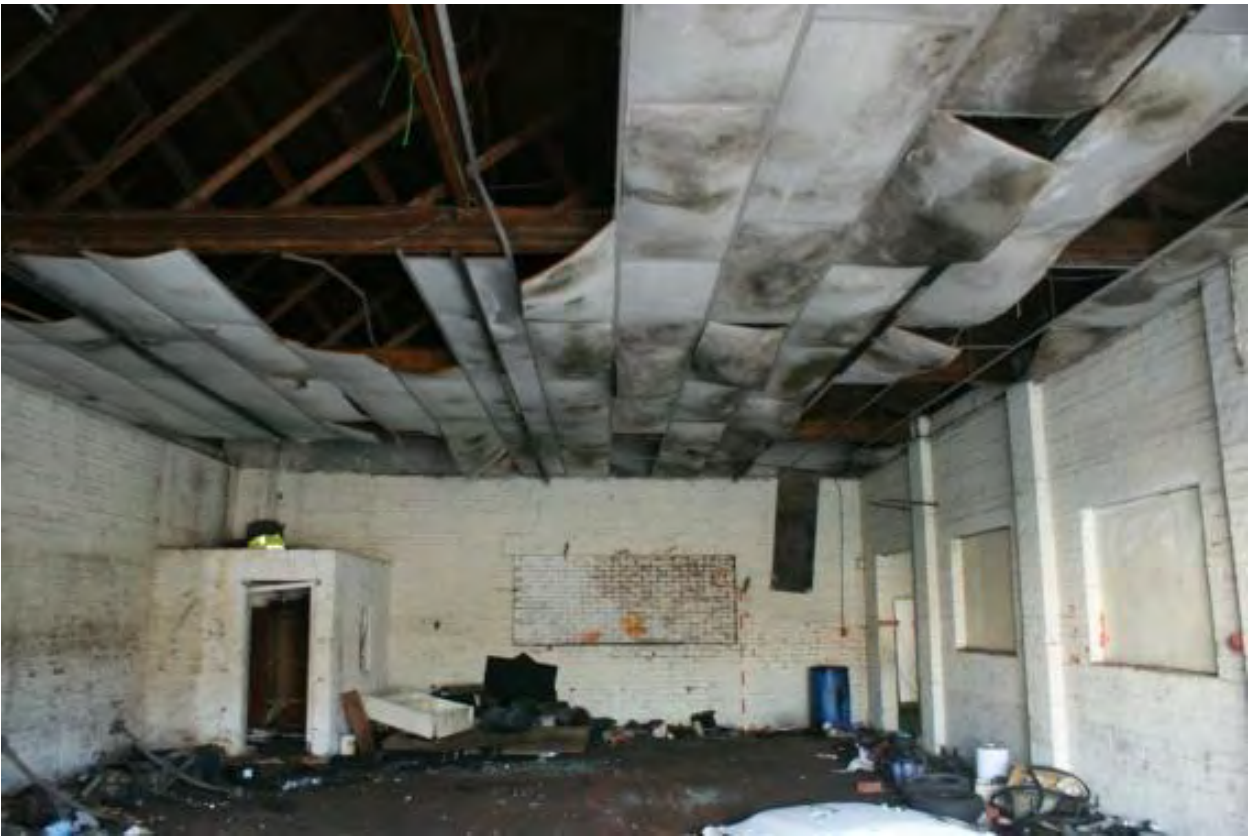
This is confirmed by Structure 22 which was close to Foley Road which appears to have been a warehouse (Plate 67 to Plate 69). It was rectangular in plan and built with the same Belfast trusses as Structures 4, 5 and 8 so is likely to be relatively early in this phase. The structure was accessed primarily by a wide doorway on its northern side.

Plate 67 Structure 22, looking south

Plate 68 Structure 22, looking north-east

Plate 69 Structure 22, looking south

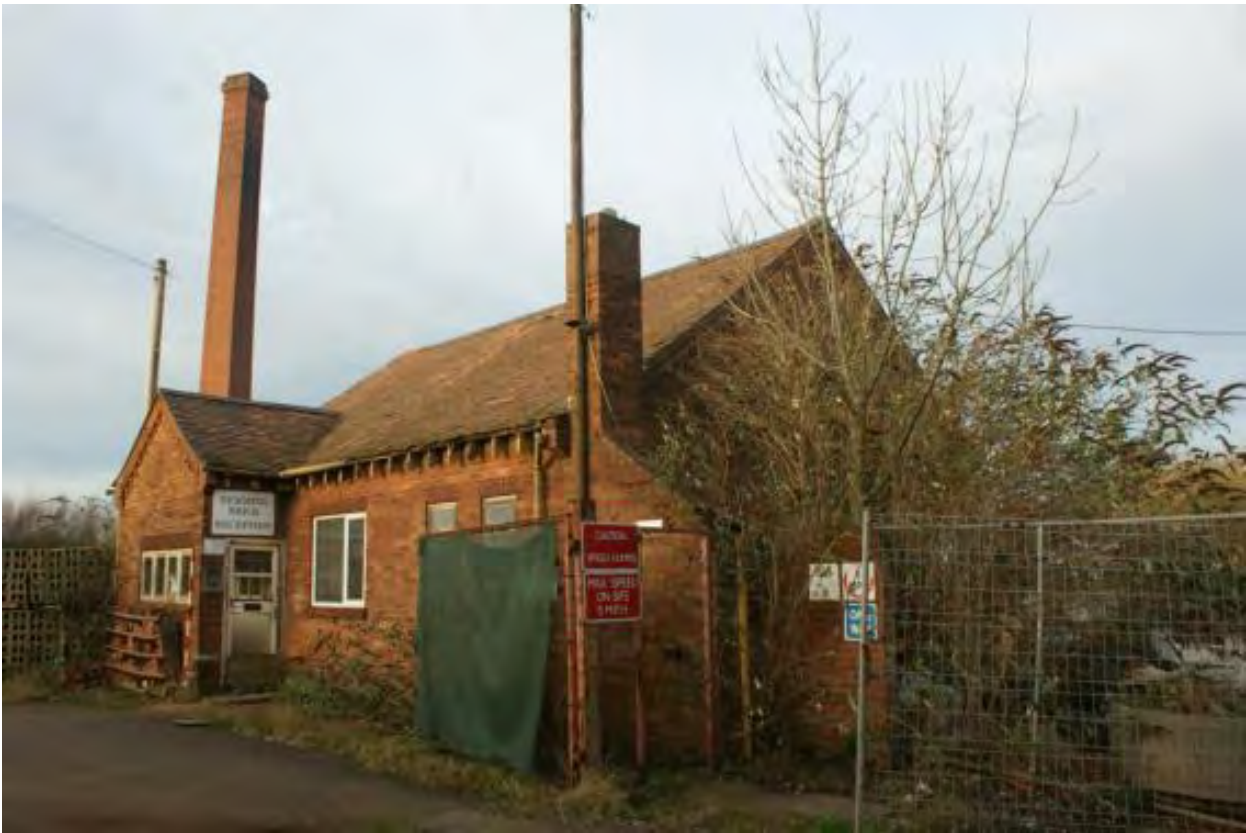
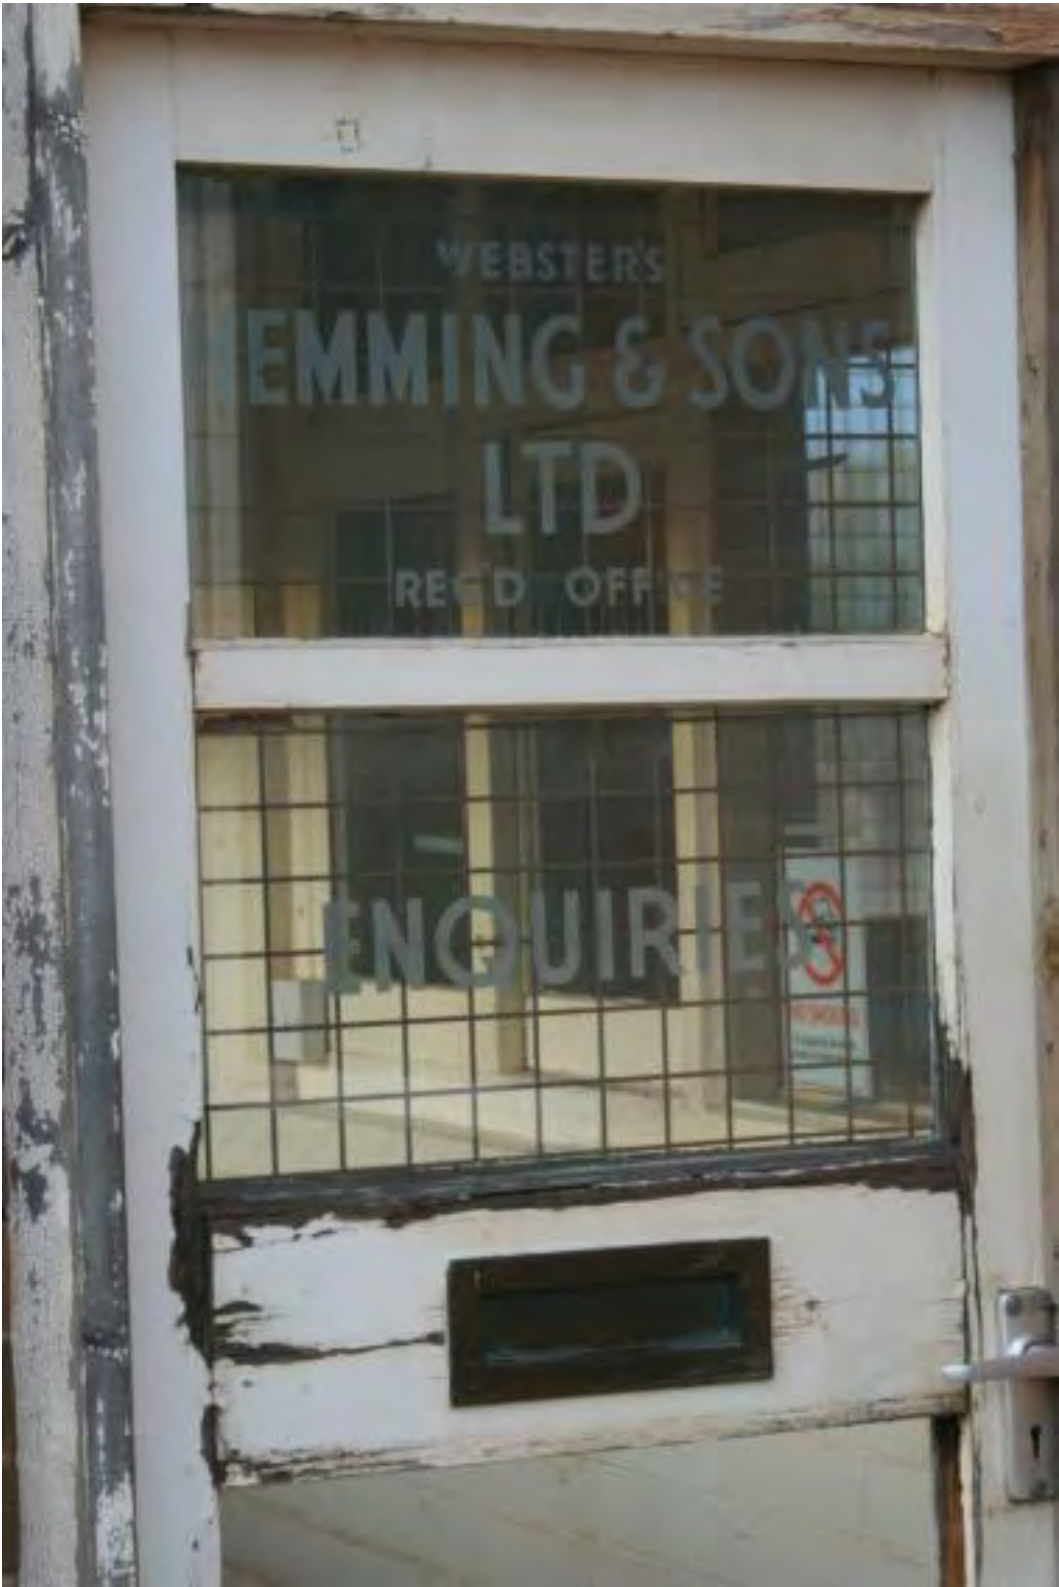
Structure 23, located in the vicinity of the former rail heads, was probably added in the middle of the 20th century (Plate 71). The plaque on the door (Plate 72) shows that it was an office building. This structure was not accessed.

Plate 71 Structure 23, looking north-west

Plate 72 Structure 23, looking west

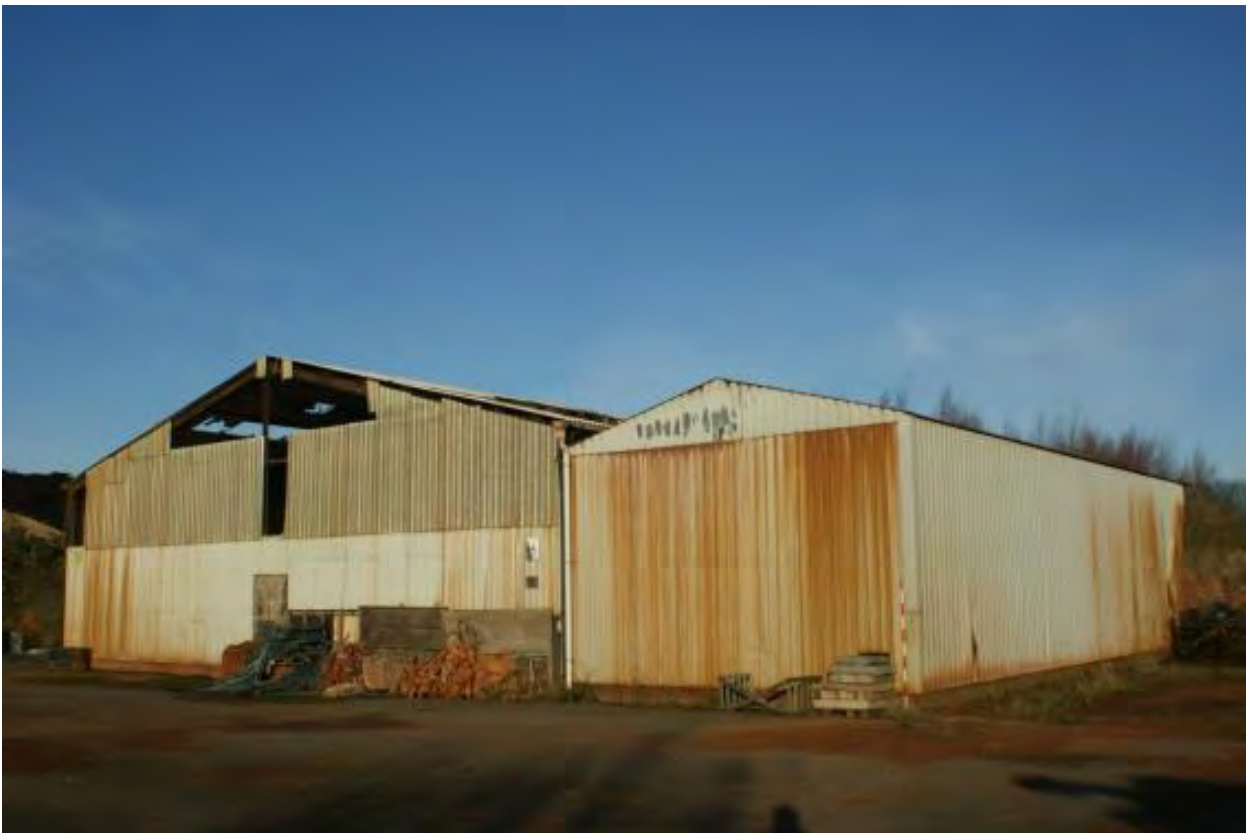
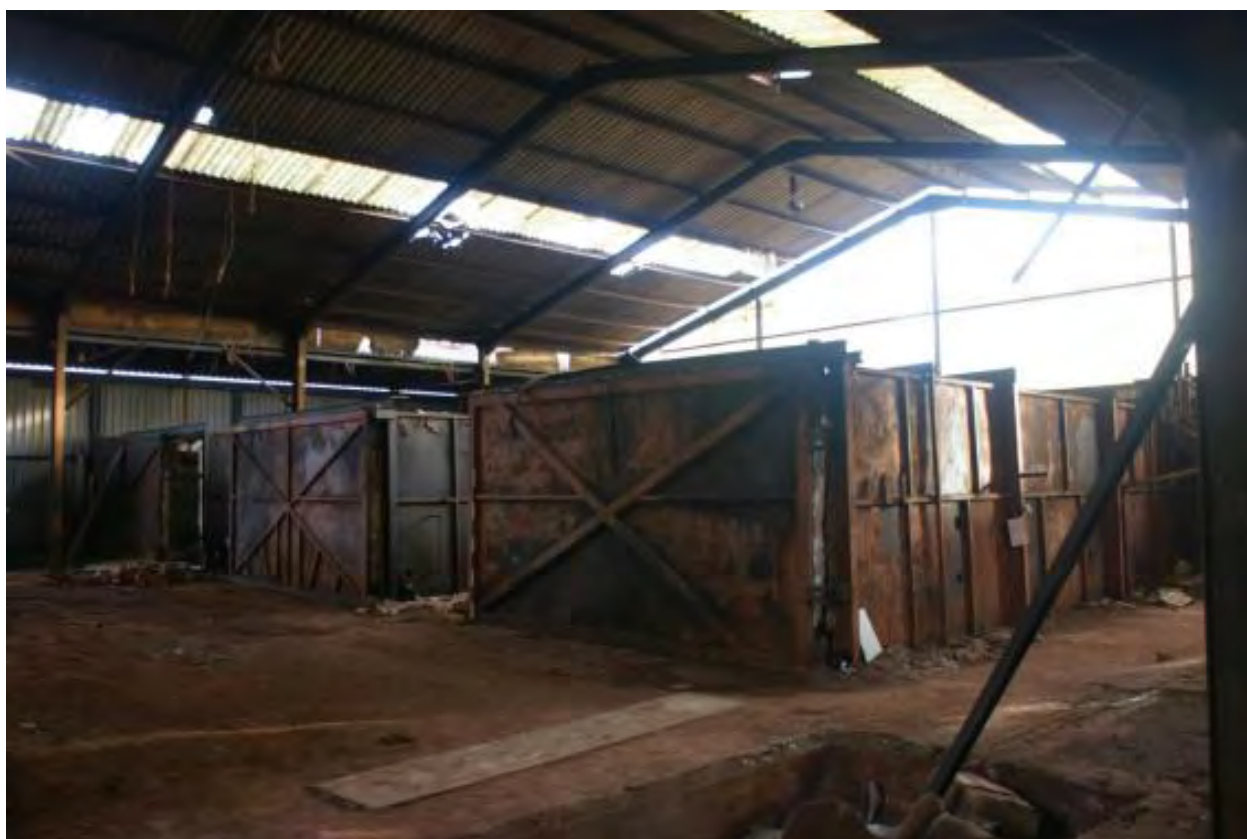
Structure 7 appears to have been the last significant addition to the brickworks. It consisted of two steel framed structures, both covered by corrugated iron sheeting (Plate 80 and Plate 81). Within these, three individual crate sized kilns were added. These were presumably fired by either gas or oil.

Plate 80 Structure 7, looking north-west

Plate 81 Structure 7, looking south-east
