Archaeological Investigations at Pershore Street, Birmingham

Date: 16 February 2016
Status: Revision 1
Author: Andrew Walsh, awalsh@worcestershire.gov.uk
Illustrators: Carolyn Hunt and Andrew Walsh
Contributors: Rob Hedge
Project reference: P4735
Report reference: 2307
Oasis id: fieldsec1-242191

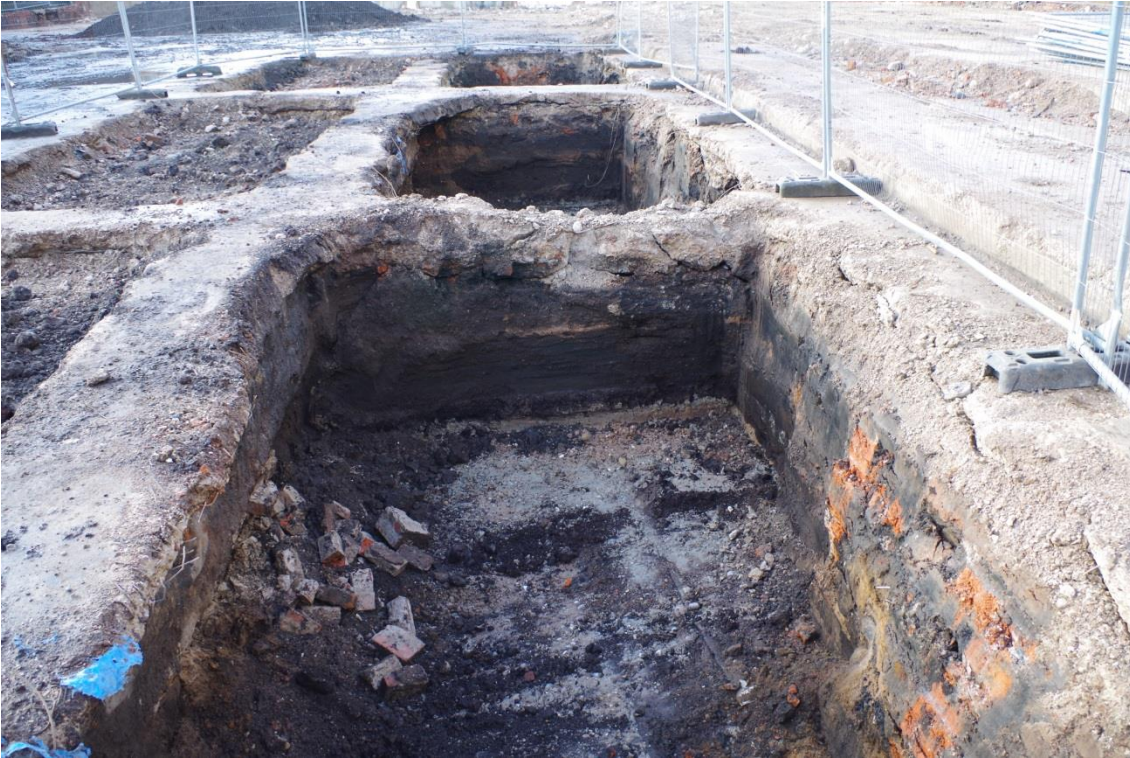
Plate 1. General shot of the excavation area, looking south-west

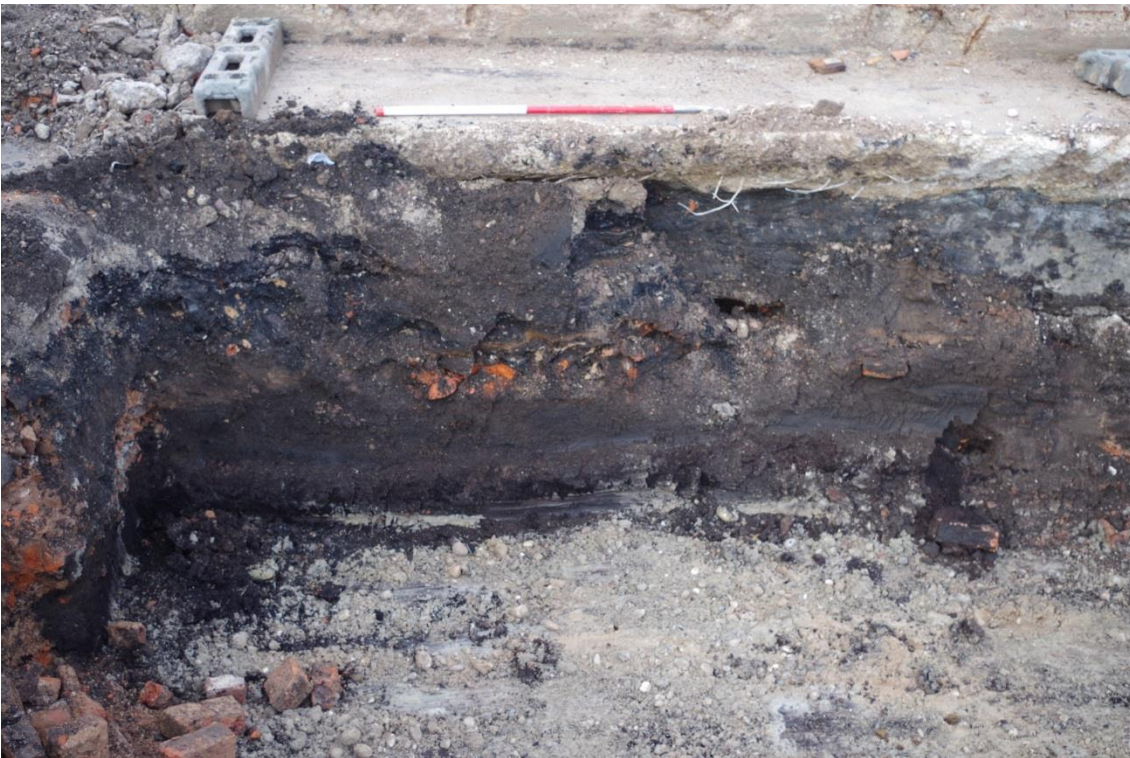
Plate 2. Light grey natural deposits (103) were visible in the base of the trench overlaid by a dark grey brown organic rich silty sand (102). The ring beam (100) is visible to the right, with overburden (101) visible above layer (102). Photo looking north-west

The earliest deposit identified was the same light blueish or brownish grey gravelly clay natural identified in Trench 1 (103). This was overlaid by a firm slightly spongy brownish black silty layer (218), which measured 0.25m in depth and contained organic material. It was sampled for environmental remains but analysis of the deposit showed elevated levels of Lead (Appendix 1). Layer (218) was overlain by a firm dark grey brown sandy silt (217; Plate 5), which measured 0.35m in depth and was in turn overlain by a mid-grey brown sandy silt (216). Layers (216), (217) and (218) appear to correlate with layer (102) which was identified in Trench 1 (Plate 2).

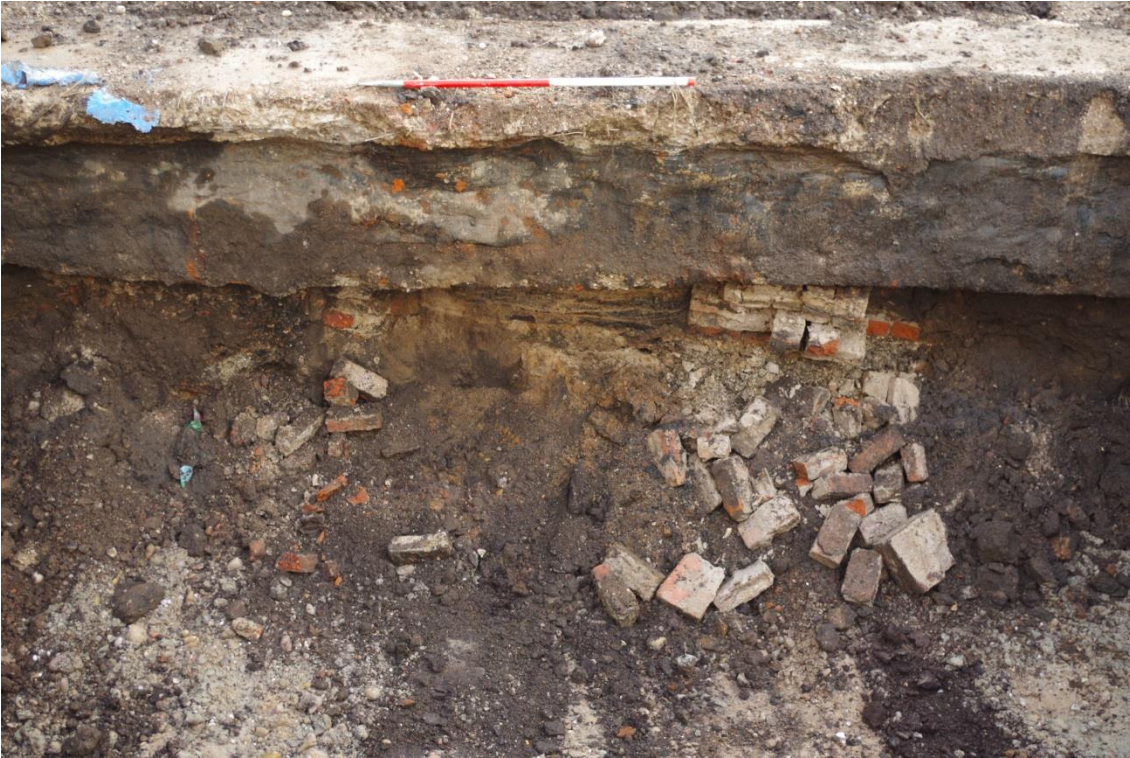
Plate 3. Structure (106) was formed of two parallel brick walls. Between the walls evidence of silting up was clearly visible (107). Photo looking south-east.

Layer (102) was cut by three brick built features (106), (108), (112), a large possible pit visible only in section (110) and the cut for a 20th century concrete basement (104). Feature (106) appeared to represent the remains of a silted up brick lined culvert and, notably, it was located on the same alignment as the predicted course of Dirty Brook (Figures 3 and 4). This feature consisted of a pair of parallel brick walls which were constructed through deposit (103). The walls were approximately 1.25m apart (Plates 3 and 4), and the channel between the walls had been filled with alternating lenses of pale brown or orangey grey sand and dark brown silts (107). The wall on the north eastern side of the channel appeared deeper than the wall to the south west (Plate 4).

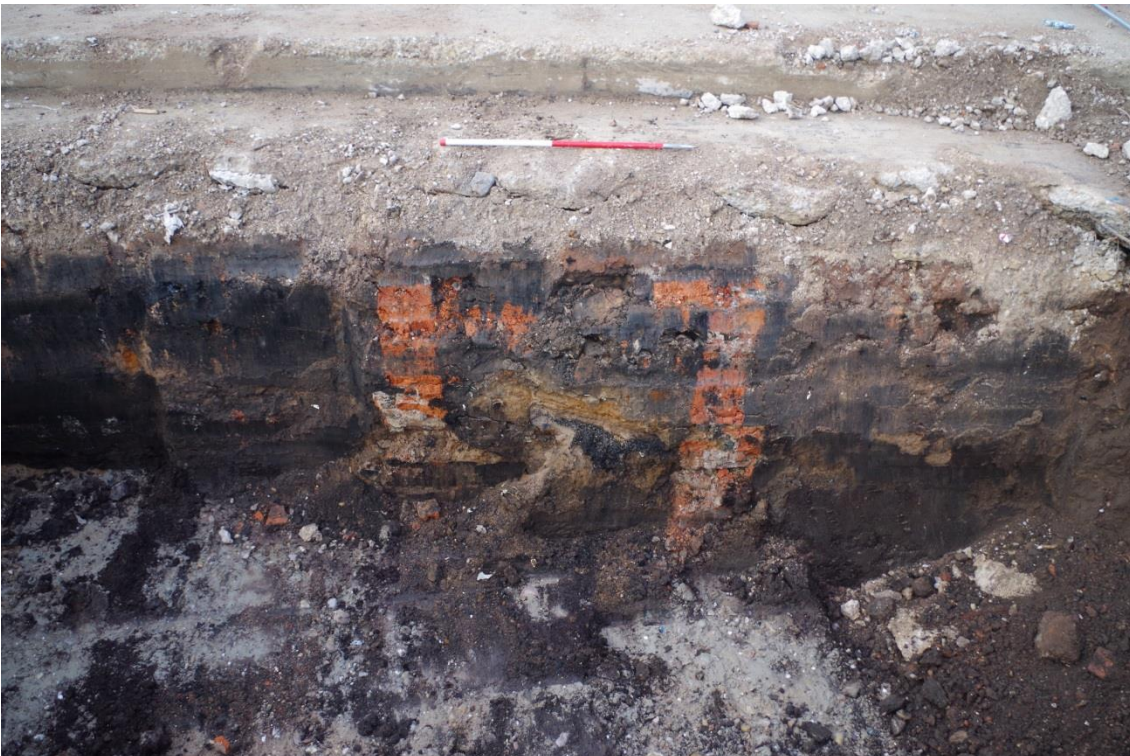
Plate 4. In the opposite section the silting (107) in Structure (106) was less clear although similar deposits were visible. Here the structure was less truncated, and the variation in depth of the walls is visible. Photo looking north-west

Feature (215) was cut by the brick lined channel recorded in Trench 1 as (106). On the north-eastern side it was formed by wall (206) and by wall (208) to the south-west (Figure 3; Plate 6). Wall (206) was approximately 0.4m deeper than wall (208), although there was no reason to suggest why this was the case. This variation in depth was also noted in Trench 1 (Plate 4). There was no evidence of a surviving arch between the two walls.

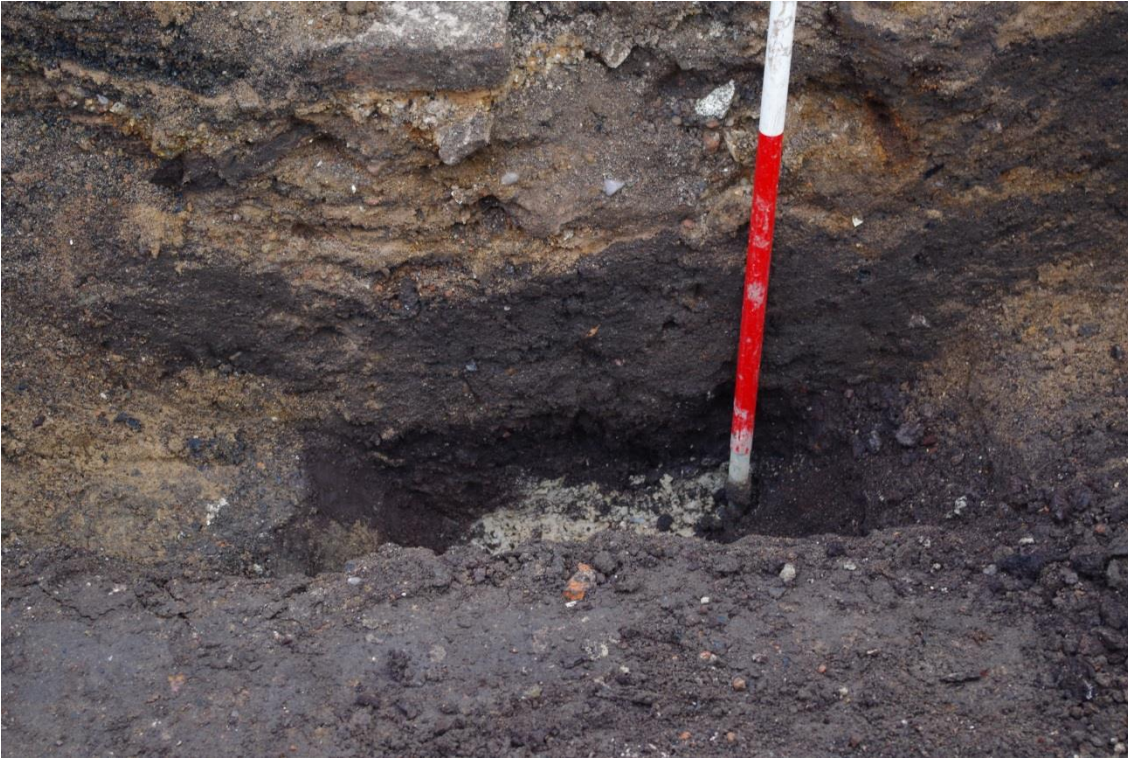
Plate 5. In Trench 2 natural deposits (light grey) were overlaid by an organic rich black silty layer (218), which was overlaid by dark grey brown sandy silt (217). The orangey yellow deposits above are possible channel fill (214). Photo looking south-east

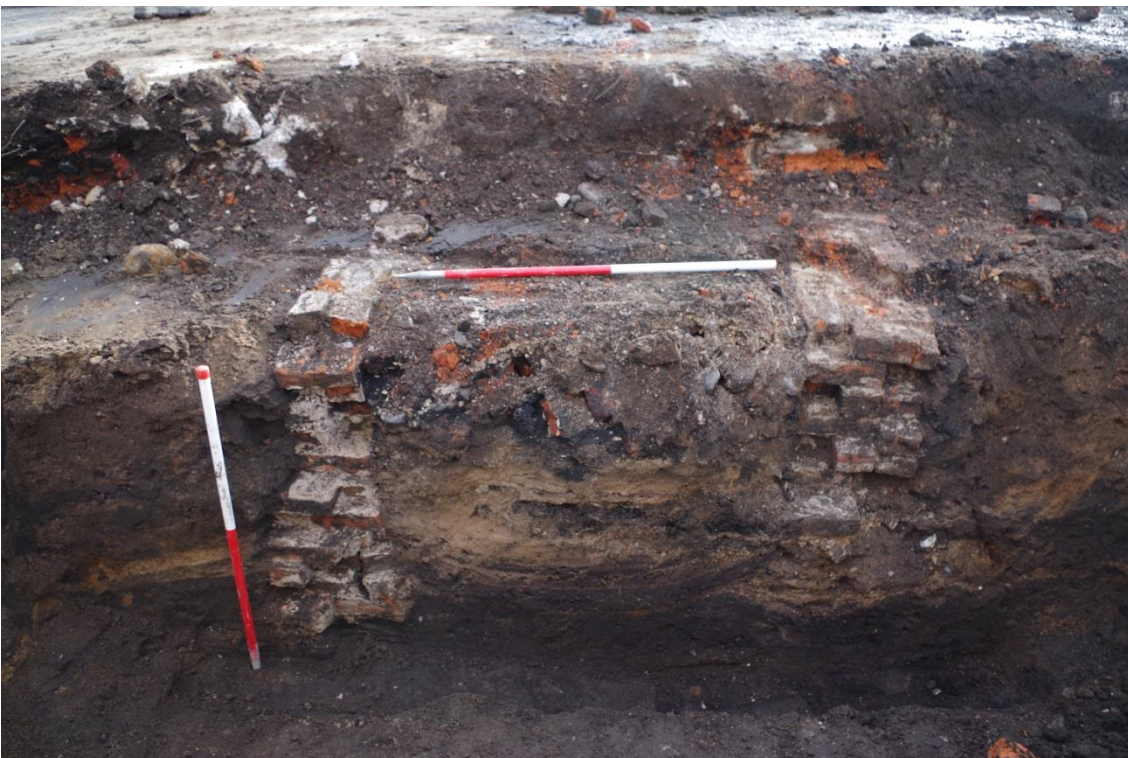
Plate 6. General shot of Trench 2 showing the brick lined channel, and the possible earlier sandy filled channel (215) below the wall to the right.

Layer (216) was cut by feature (215) which was approximately 0.40m in depth and orientated south-east to north-west (Plate 6). It had a shallow U-shaped profile was filled by a greyish yellow sand, which contained lenses of ash, silts and gravel (214). A fragment of rotted out wood was also noted in section.
