Building record of the former Woodcolliers Arms, Bewdley, Worcestershire

Date: 7 March 2016
Author: Tim Cornah tcornah@worcestershire.gov.uk
Illustrator: Carolyn Hunt chunt@worcestershire.gov.uk
Project reference: P4780
Report reference: 2316
HER reference: WSM6777
Oasis id fieldsec1-244570

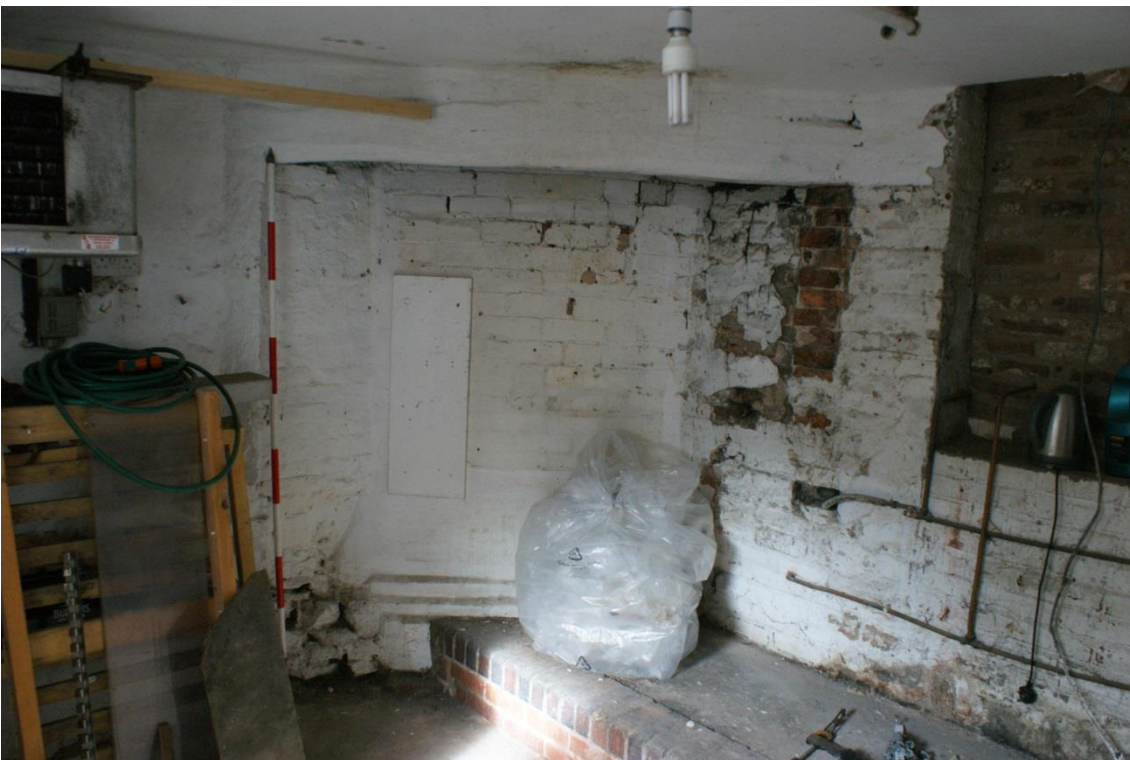
Plate 4 Phase 1 Structure 9, looking north-west

The earliest standing structure within these buildings was Structure 9, [this](#) was a cellar complete with a fireplace within its north-west corner (*Plate 4*). This structure was dated by the dimensions of the bricks which are about 2 and third inches in width and the style of the corner fireplace which is seen in some other buildings of 18th century date in Bewdley. The walls within this room had been refaced within subsequent phases using wider bricks, and in places these coverings were hiding stone constructed elements of wall, particularly in the western wall. It is possible that these stone elements were part of an earlier structure. A raised brick plinth (*Plate 5*) is likely to have been for later barrel storage. This brick plinth partially covered a blocked doorway which led into an open space to the north.

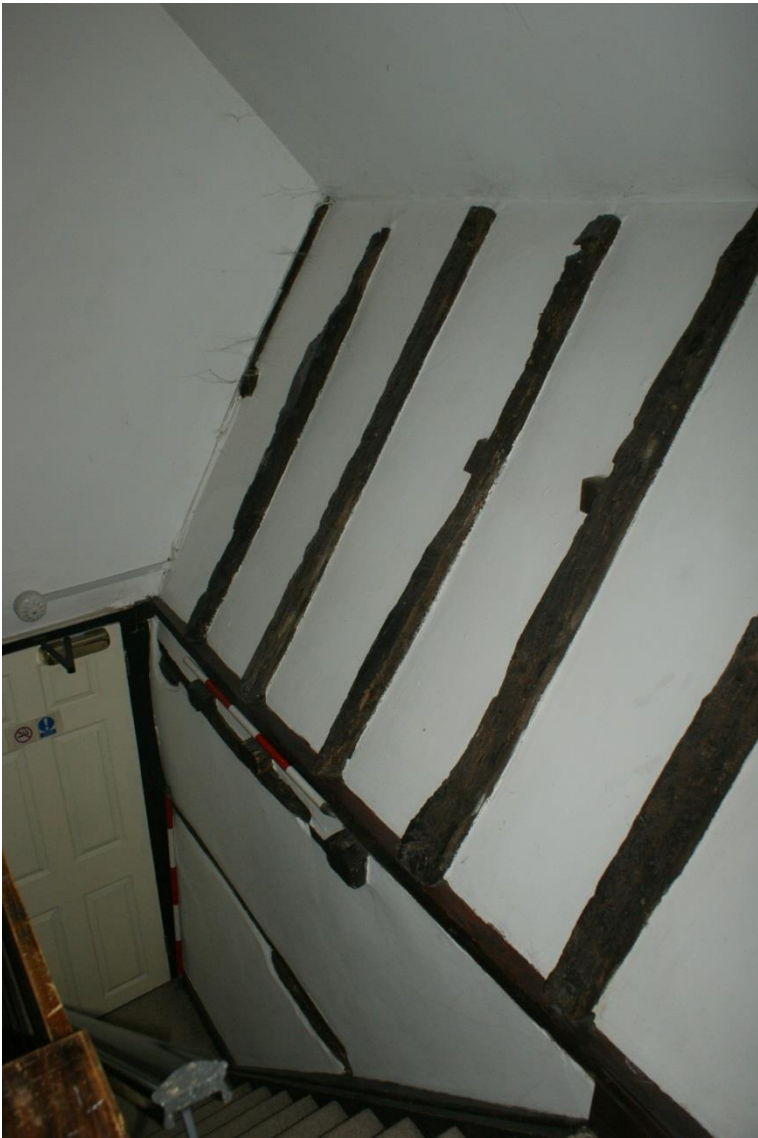
Plate 9 Phase 2 Structure 12, looking north-east

Structure 12 was built to the east of Structure 9, as seen by a set of common rafters (*Plate 9*). This roof ran in a broadly north to south direction, and is likely to have been lower than that of Structure 9. This roof only survived on its western side and no gables remained. An approximate projection of this roof line can be seen on Figure 4. The common rafters were of oak, horizontally set and had been converted by pit saw and hewing. They were originally attached to the wall plate using

Whether the wall on the western side of Structure 12 (*Plate 9*) relates to this or structure 9 is unclear. The timbers visible may relate to a timber framed wall.

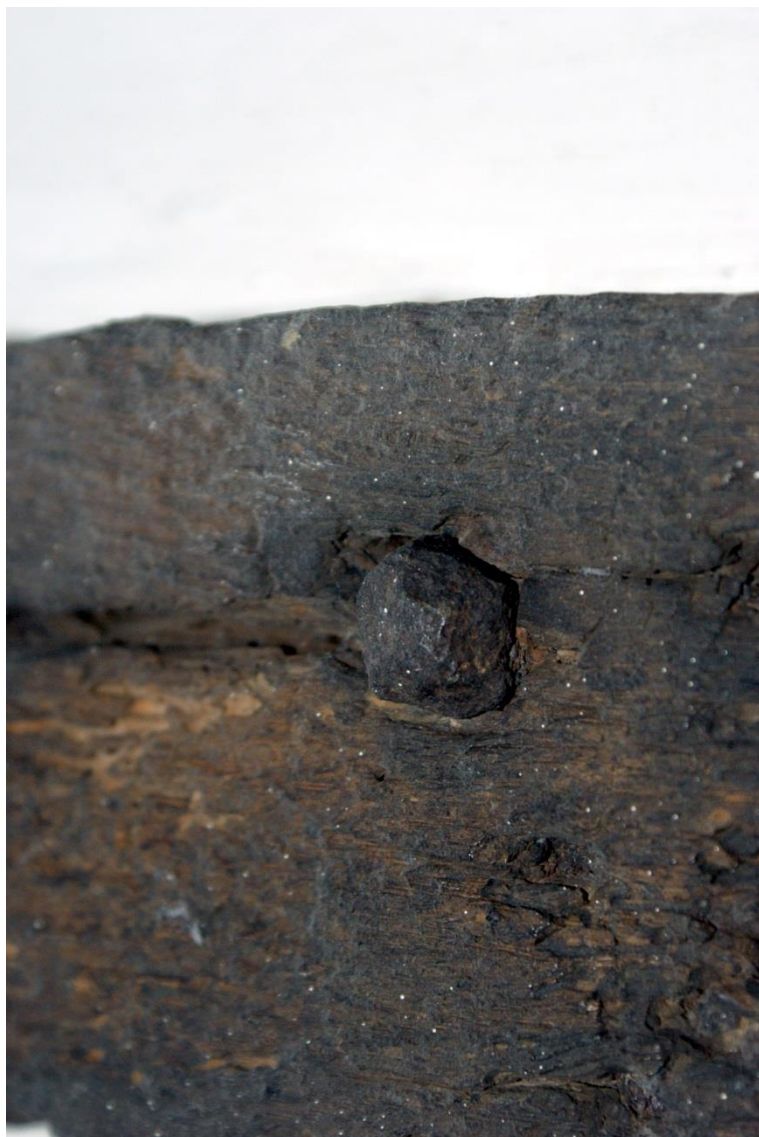
Plate 10 Phase 2 Structure 12, looking east

large square headed nails (*Plate 10*) and were attached to a purlin using the same method. Neither of the original wall plate or purlin survived but the nails show their positions. This type of roof construction is likely to be of an 18th century date, as the common rafters of 17th century buildings were more usually attached using wooden pegs. A 19th century roof is more likely to have had vertically set timber and machine conversion.

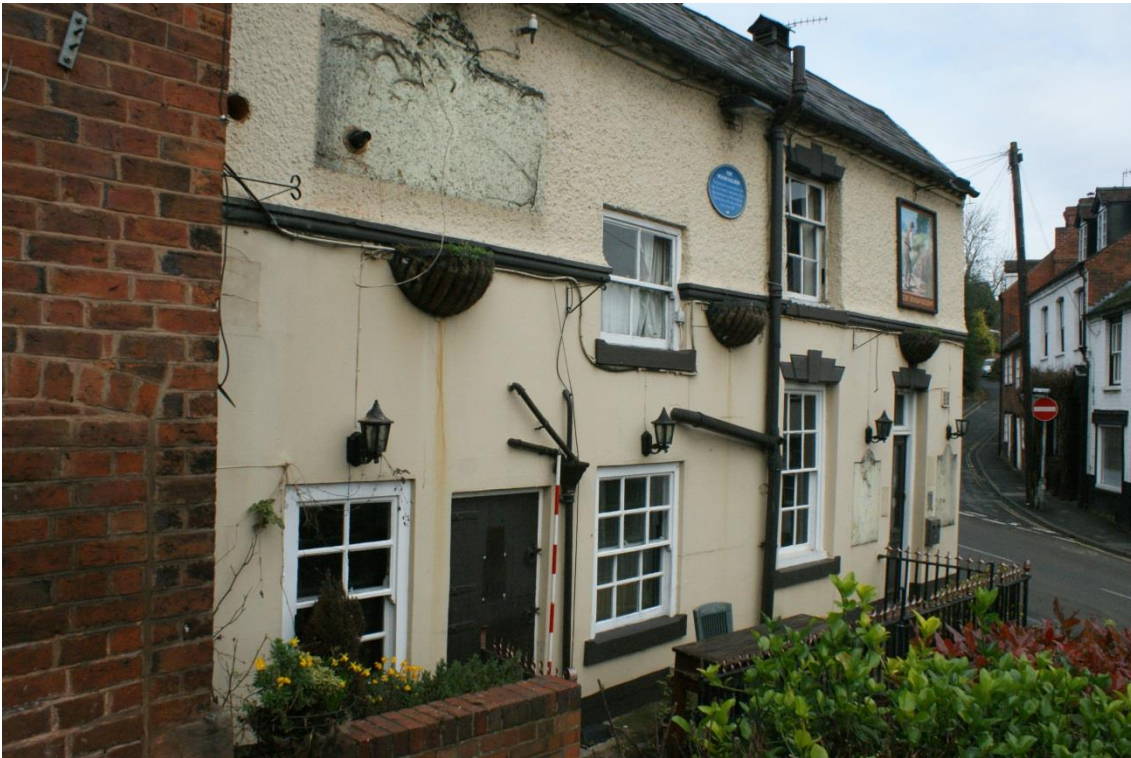
Plate 11 Phase 3 Structure 1, looking north-west

Structure 1 (*Plate 11*) was originally (?) a house that faced east down Welch Gate is likely to have been added within the mid to late 18th century. This was a brick building of at least 1 bay, though may have had more where the later Structures 2 and 3 were constructed. It was aligned broadly north to south with its central doorway being flanked by a window to its north that was of a shape not un-typical of an 18th century house. It had a further first floor window. The windows themselves are 19th century replacements. The window to the south of the door was added later, possibly during Phase 9.

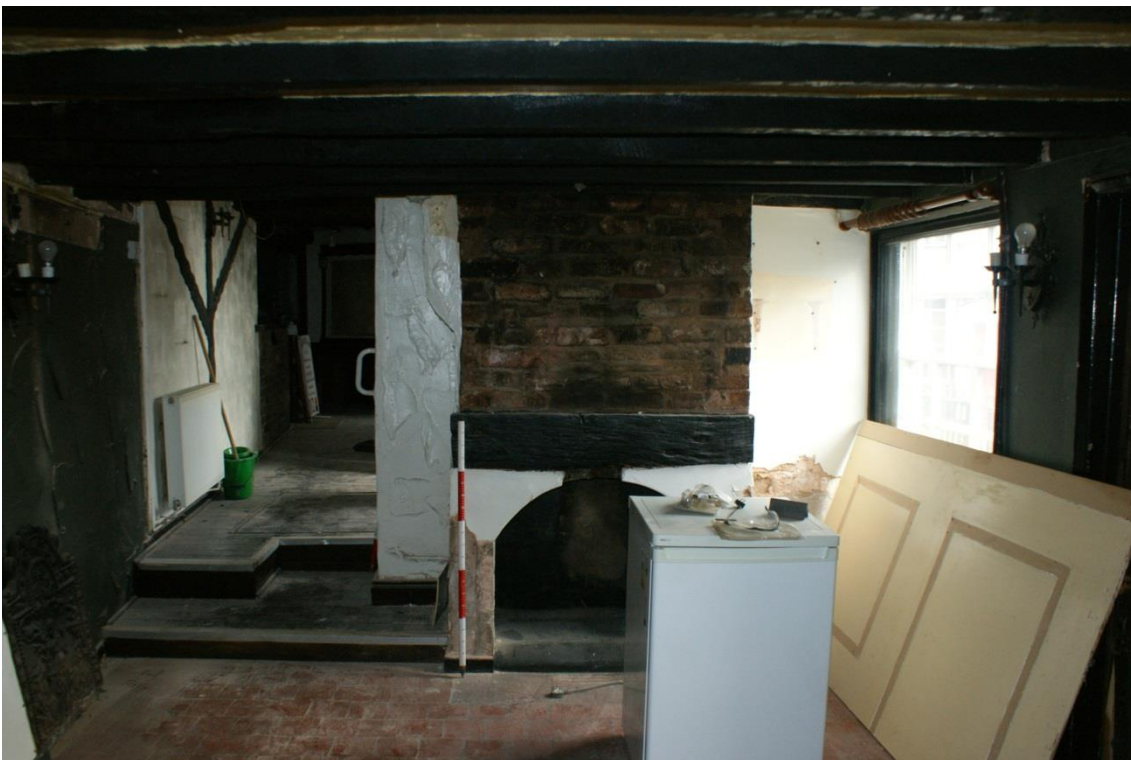
Plate 12 Phase 3 Structure 1, looking north

The extant fire place at the northern end of the ground floor room (*Plate 12*) was an addition associated with Structure 3. It is possible the original fireplace was located at the southern end of this room, where the wall was later removed (*Plate 13*). This position is suggested by a chimney stack visible on a photograph, probably of the late 19th century (Purcell, Purcell and Hobson 1996), and was broadly in this position. The original floor joists were visible within this room (*Plate 14*) though had been truncated on their western end for an unknown reason. A further staircase previously existed at the southern end of this room, though this probably related to Phase 6. How the first floor was accessed was unclear. This structure had one first floor room (*Plate 15*) later divided. It had no known fireplace and had only one known window facing to the east. The floor above this room (*Plate 16*) is likely to have been a Phase 8 replacement as is the roof. It is therefore difficult to assess whether this structure had an attic room. The owner suggests that this building had a slightly lower roof than that of Structure 3 (Coleman pers comm) though the dentilled eaves detailing visible from the outside suggest that they at least had the same wall plate level (*Plate 11*). The overall form and appearance of this building is domestic.

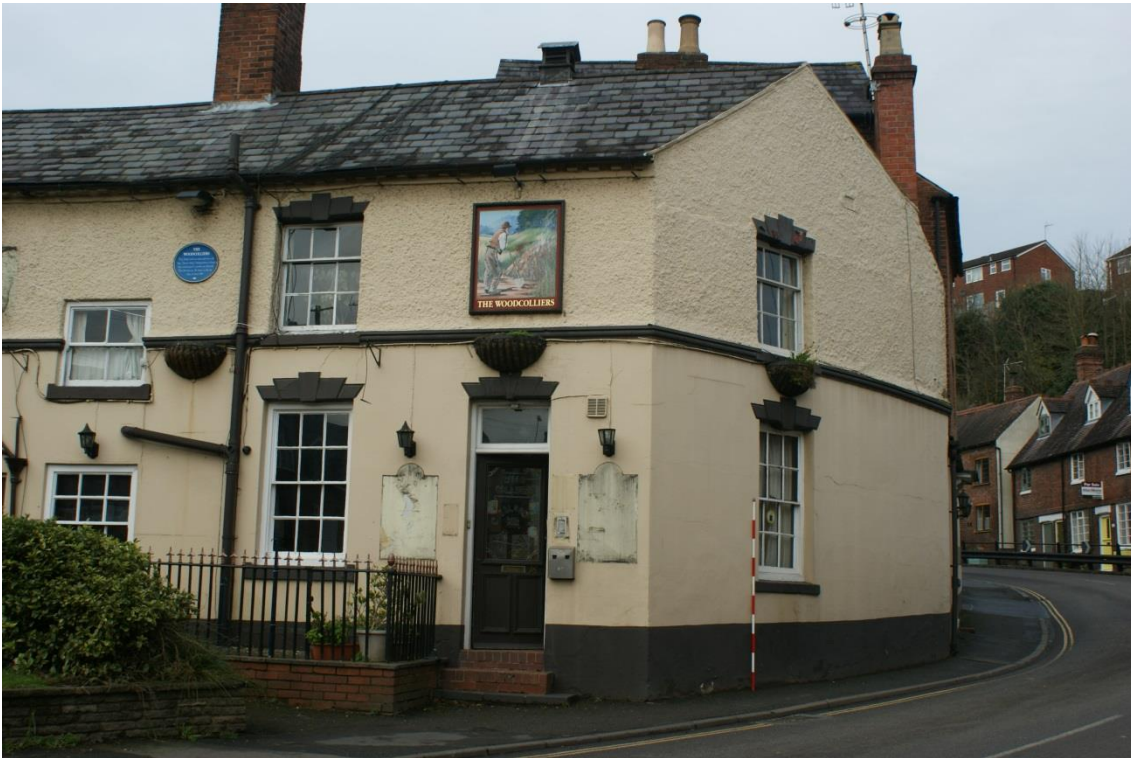
Plate 17 Phase 4 Structure 3, looking west

This building was shown on a photograph dating to the 1880s (Purcell, Purcell and Hobson 1996) and had a central door with sash windows on both sides and further windows above these. It had a chimney on its northern end, is shown un-rendered and constructed with Flemish Bond brickwork and continued the dentilled eaves of Structure 1. The building was truncated in Phase 7 with its corner being cut off from the right hand side of the door (*Plate 17*).

Structure 4 consisted of the destruction and rebuild of the northern end of Structure 3 for the realignment of Welch Gate. This change certainly happened after the 1903 OS map but before a photograph taken in the 1920s (Coleman 2015). It consisted of a curved gable wall (*Plate 39*) with windows that continued the style of Structure 3 on the first and second floors. New fireplaces were added on the first and second floors, replacing that which had been removed (*Plate 40*). The roof of Structure 3 was removed at this time with two new roof trusses being added over a single first floor room which with the earlier divisions having been removed (*Plate 22*). A vent was added in the roof, presumably to allow smoke out, clearly suggesting the use of this space as part of the pub (*Plate 17*).

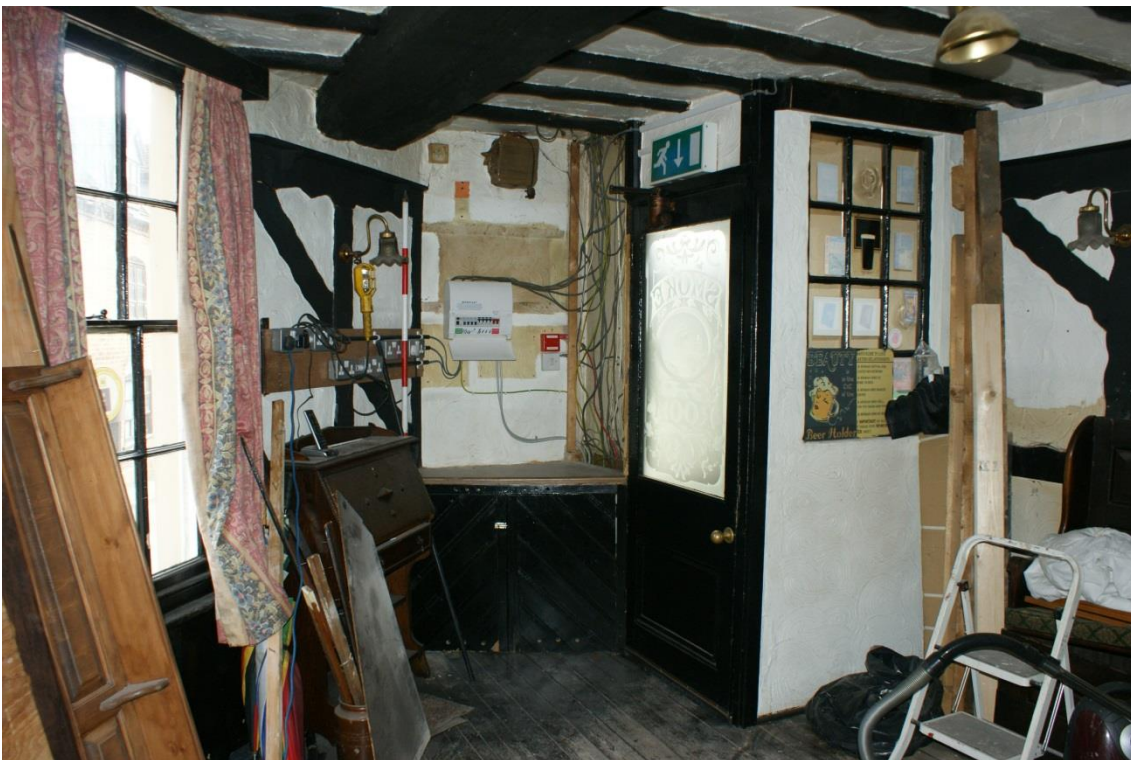
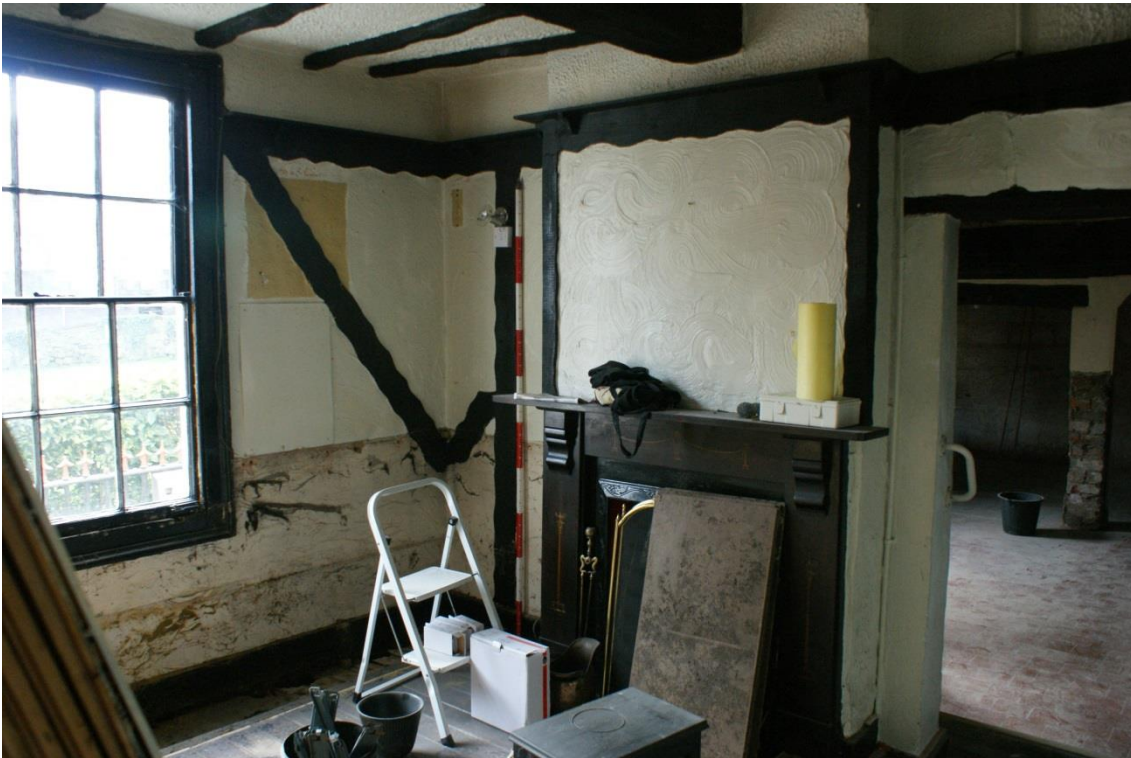
Plate 18 Phase 4 Structure 3, looking south-east

Plate 19 Phase 4 Structure 3, looking south-east

The ground floor was split originally into two rooms, probably either side of a passageway, though this only remained on one side (*Plate 18* and *Plate 19*). Both of these had fireplaces, and a further one was added into Structure 1. Below the southern room was a cellar which was constructed from brick on its east and west walls but stone on its northern and southern walls. The stone walls were later additions to the brick structures (*Plate 21*). The cellar had steps leading up a passage in the north-west corner that probably led into the northern room. It is likely that the original staircase to the first floor was above this.

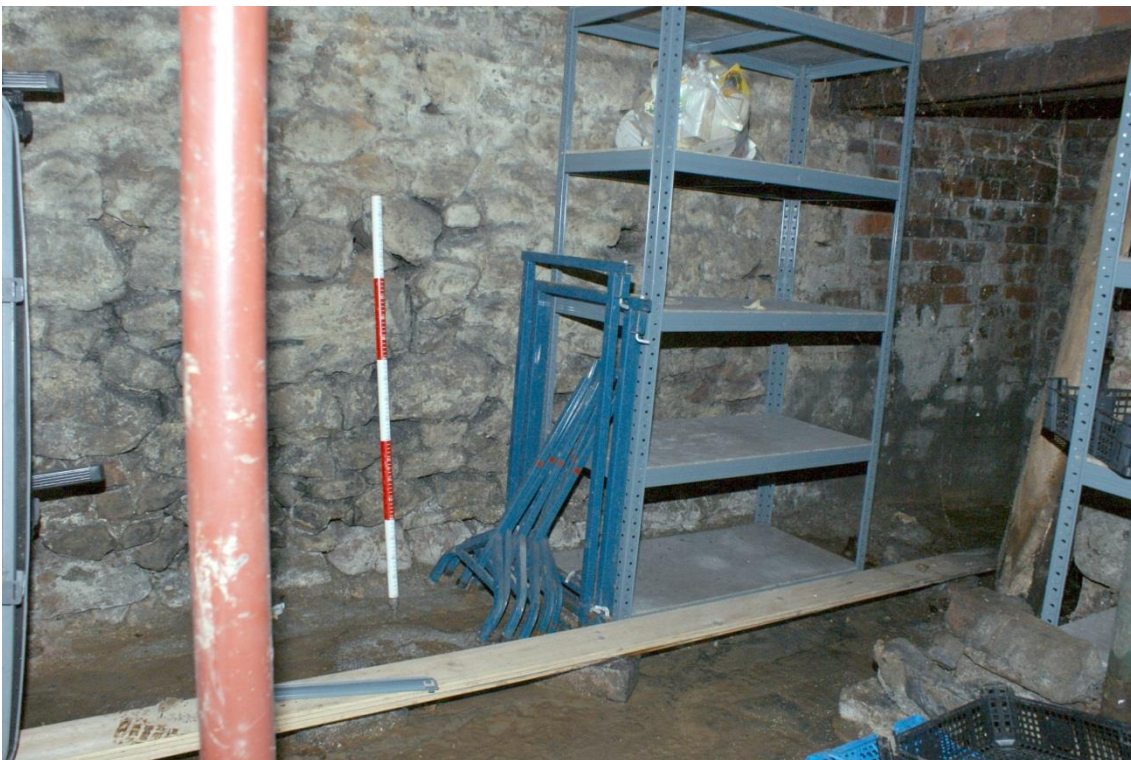
Plate 20 Phase 4 Structure 3, looking north-east

The cellar also had a chute added from the front of the building at a later date (*Plate 20*) and a low wall ran along the southern and eastern sides, respecting the chute. In the context of a pub this

feature is likely to have for keeping barrels off the ground. These barrels were probably lowered in through the chute.

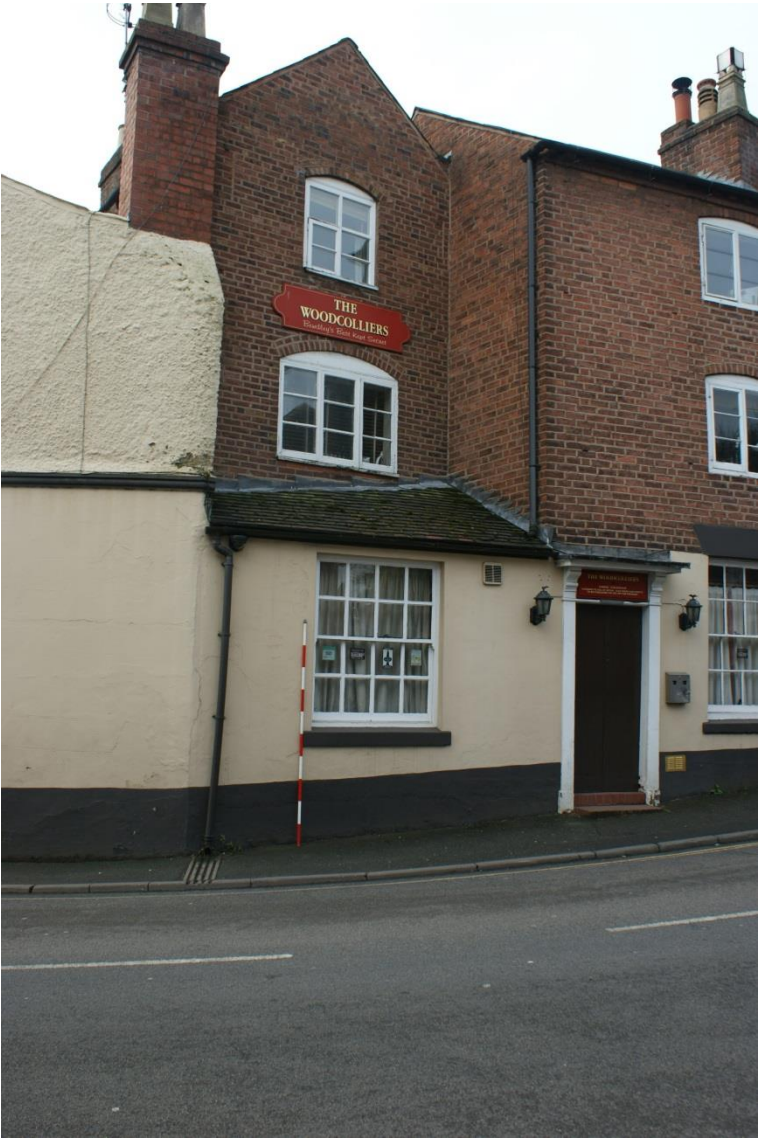
Plate 23 Phase 5 Structure 7, looking south-west

Structure 7 was also aligned north-south, with two low arch-headed windows visible on the first and second floors (*Plate 23*). It was constructed from brick using an English Garden bond and had a tile roof, though this was a Phase 8 replacement. It had one associated chimney stack with two pots visible. Chimney breasts remained on the first and second floors (*Plate 24*). It would therefore appear that the ground floor room had no fireplace and may have been used as storage for the inn. The Phase 8 changes removed much of the evidence of exterior doors, apart from one blocked doorway next to the stairs (*Plate 25*). A formerly exterior window is also visible within this wall. A further doorway led into Structure 10 which was a vaulted brick cellar fitted with raised areas for barrel storage (*Plate 26*). This underbuilt Structure 12 from Phase 2. Whilst this was not closely dateable, it is likely to have been broadly contemporary with Structure 7.

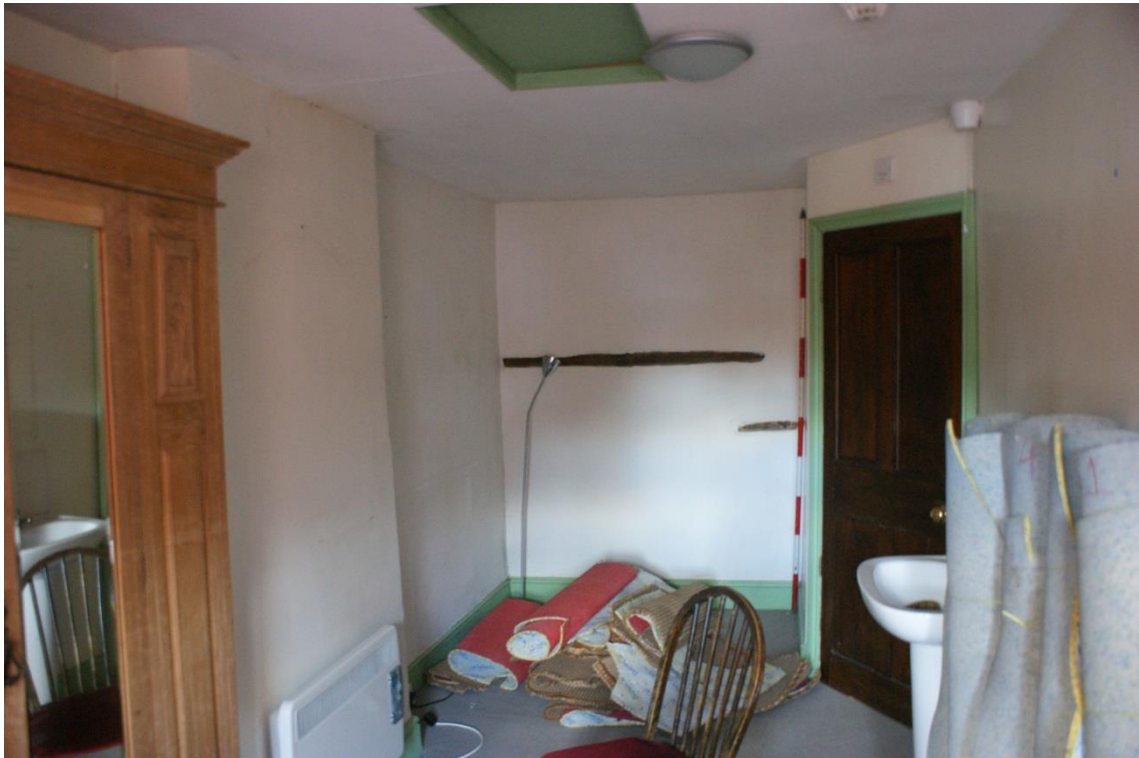
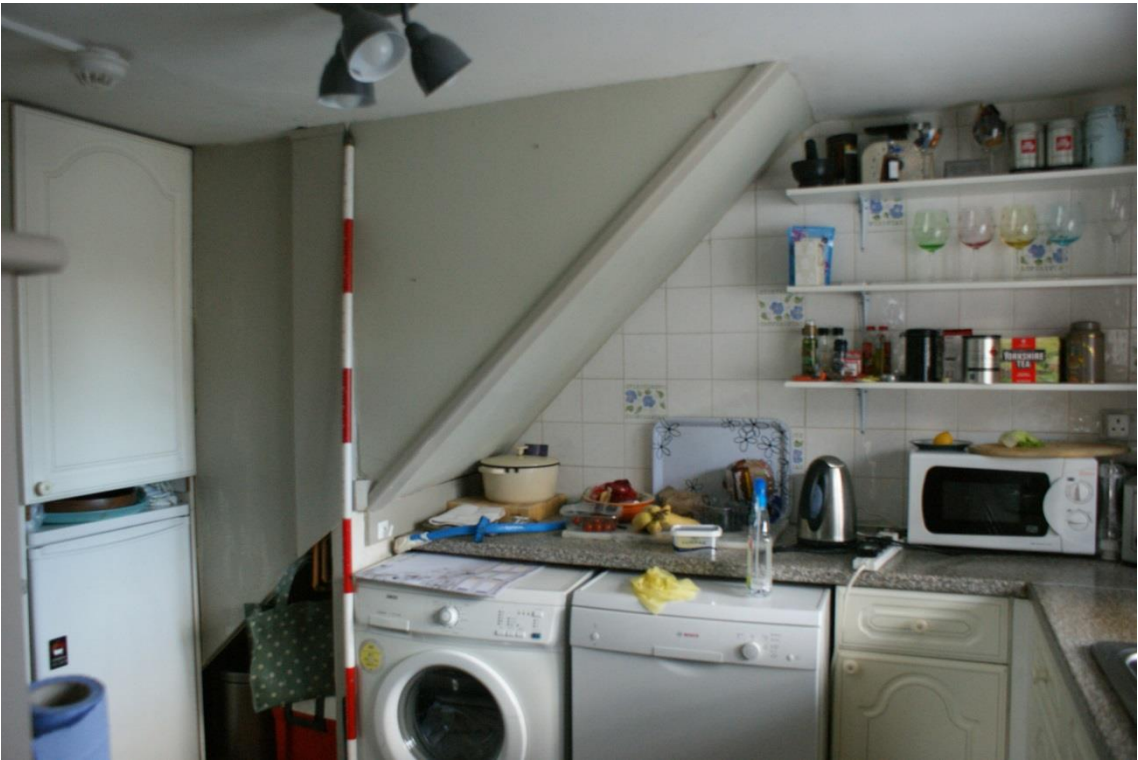
Plate 24 Phase 5 Structure 7, looking south

Plate 28 Phase 5 Structure 7, looking west

How the first floor of Structure 7 was accessed is unclear given later alteration, its staircase was probably close to those seen on the first floor which retained the original position (*Plate 27*). The first floor probably only had one room as the wall next to the extant staircase was of light stud construction. This and the room above are likely to have been bedrooms (*Plate 24* and *Plate 28*).

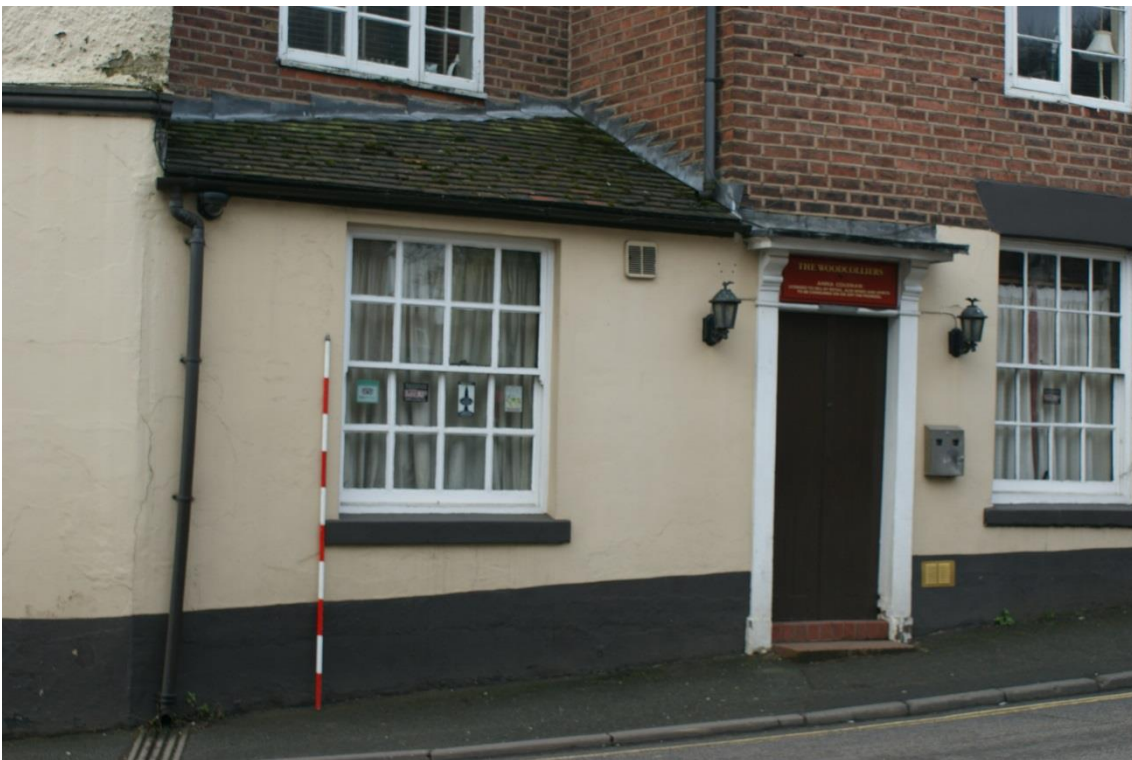
Plate 33 Phase 5 Structure 5, looking south

Structure 5 was a small joining structure was built between structures 4, 7 and 6 (*Plate 33*). How this changed the internal layout is unknown given the Phase 8 changes within this area.

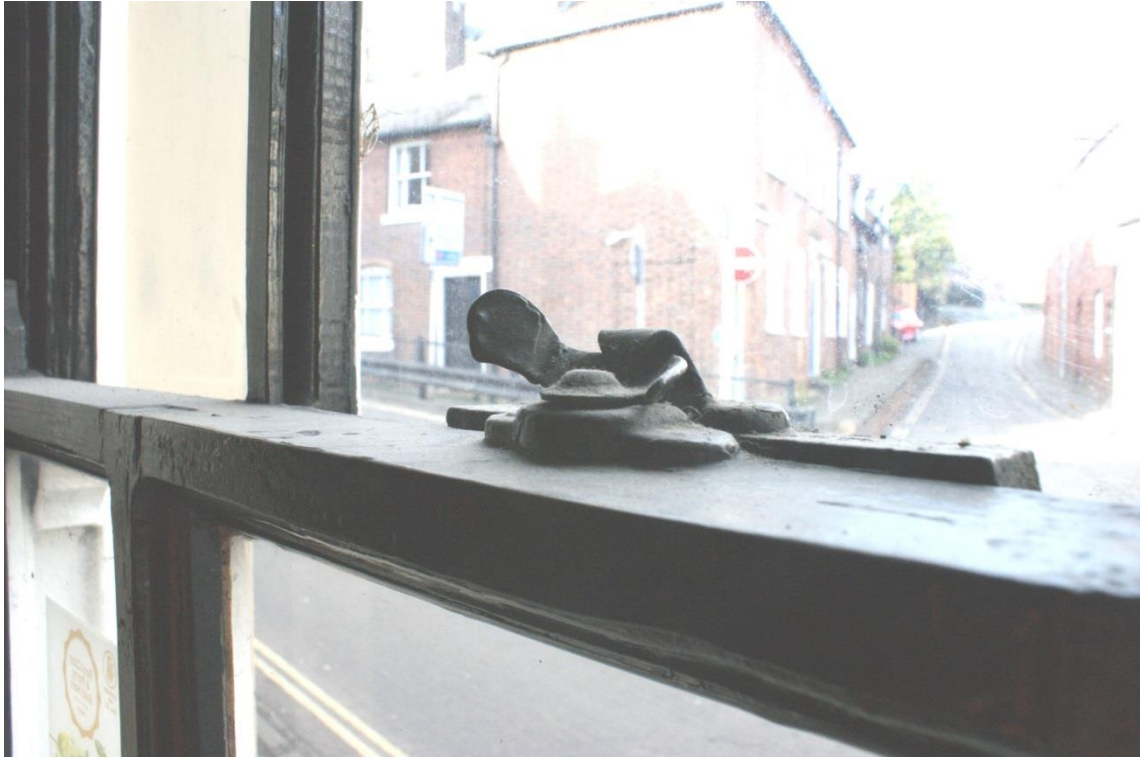
Plate 41 Phase 7 Structure 4, looking north

The sash windows of Structure 3 were also changed at this time given that they are the same style with the same catches (*Plate 41*).

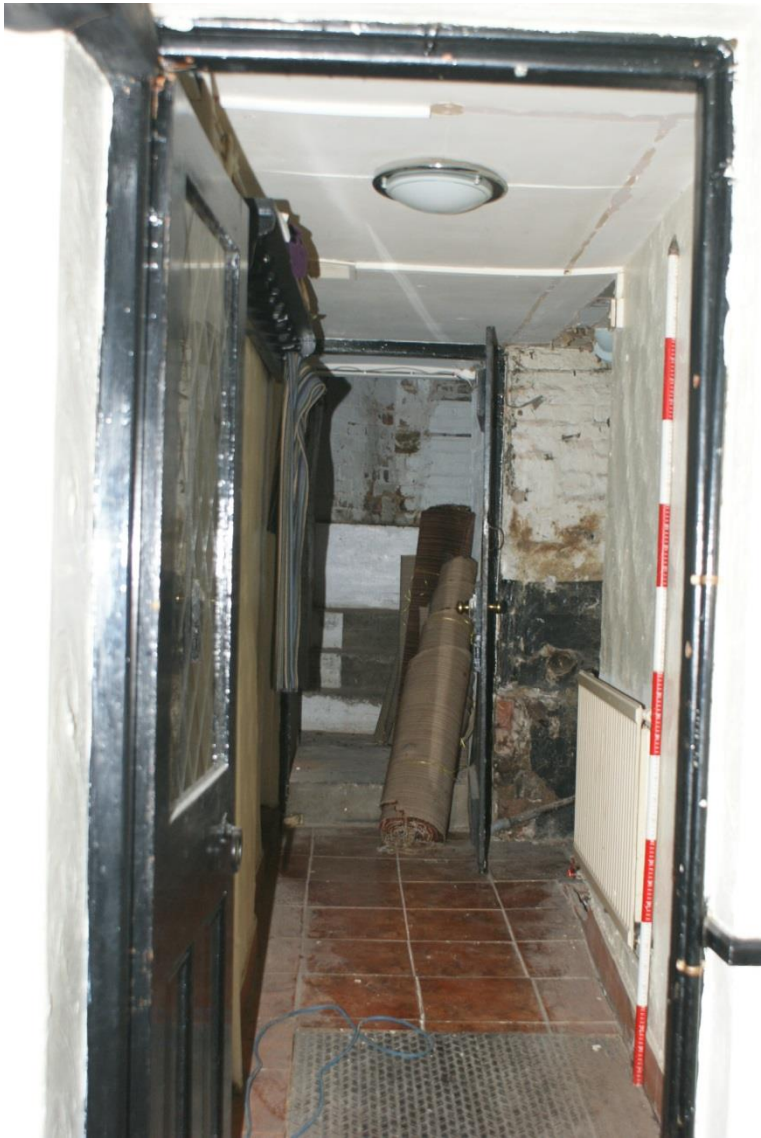
Plate 45 Phase 9 1980s toilet block, looking south

The latter half of the 20th century saw a number of significant changes including the addition of a flat roofed toilet structure that filled in the former yard area (*Plate 45* and *Plate 46*). This probably dated to significant renovations dating to the 1980s (Coleman 2015). Whilst the extant bar area probably remained from an earlier phase, this was extended at this time as seen by the steel joists that were partially covered by imitation woodwork (*Plate 47*). This created a single open space from the doorway of Structure 3, extending as far as Structure 6. The imitation timber framing seen through many of the structures also dates to this time (*Plate 40*). The set of staircase leading away from structure 8 is of this date along with the staircase into the western room of Structure 11 (*Plate 9*). The roofs of Structures 1, 2, 6 and 7 were also changed at this time, as shown by their modern thin scantling timbers.
