Archaeological evaluation at land off the B4399 Rotherwas, Herefordshire

Project reference: P4751 Report reference: 2322

Archaeological evaluation at land off the B4399, Rotherwas, Herefordshire

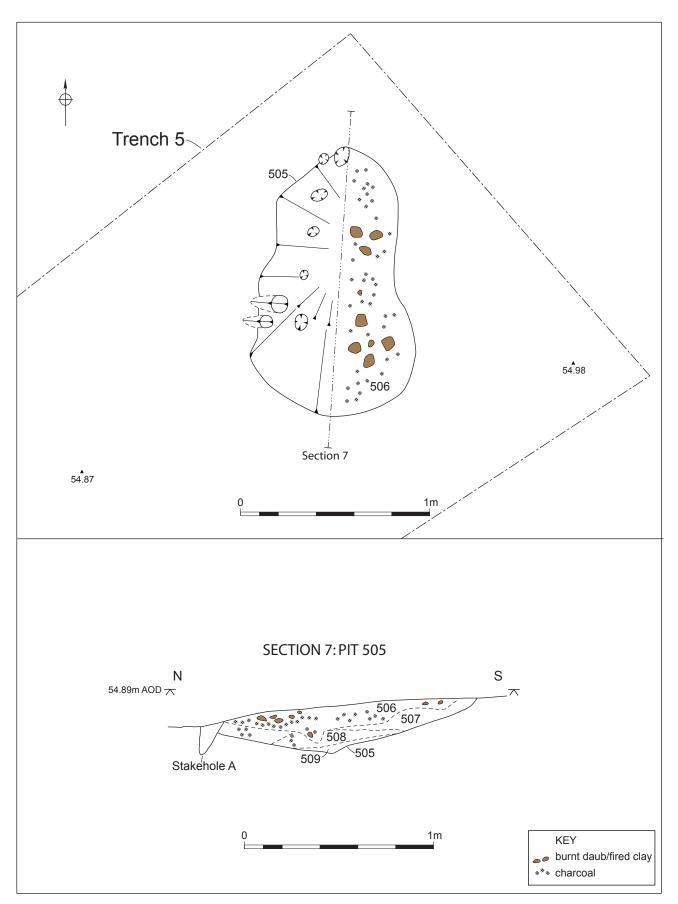
Figure 3

Only one probable prehistoric feature was identified, pit 505, in Trench 5 (Figure 3; Plate 3). The small sub-oval pit contained eleven stake holes in the base that suggest the feature originally had a superstructure (Plate 4), however none of this survived and the original function of the pit has not been established. Subsequently the pit had been filled with a rich charcoal fill, including moderate fired clay fragments. Light firing to the base of the pit suggests that this material may have been deposited in the pit while hot, although as the edges of the pit were not heavily fired it suggests it had not been burnt in-situ.

East end of Trench 5 with plan and section of Pit 505

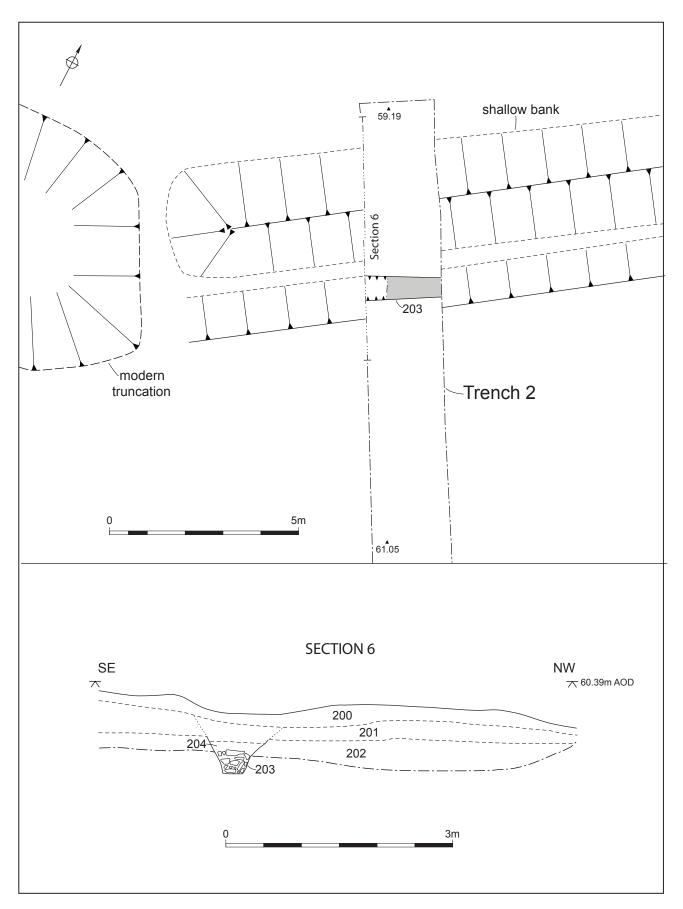
In Trenches 2, 6 and 8 post-medieval drainage ditches and land drains were identified that are related to the extant earthworks visible across the site. In Trench 2 an north-east to south-west aligned land drain (203) was identified (Figure 4; Plate 4), and although not associated with any datable finds it is likely to be of post-medieval date. This lay directly beneath and on the same alignment as an earthwork ditch and bank. Although no relationship could be established between the two features it is likely they were related and excavated at the same time. At the very least it suggests that the earthwork ditch was excavated after the land drain had been inserted, confirming its late date.

Trench 2: plan of north end and section of 203

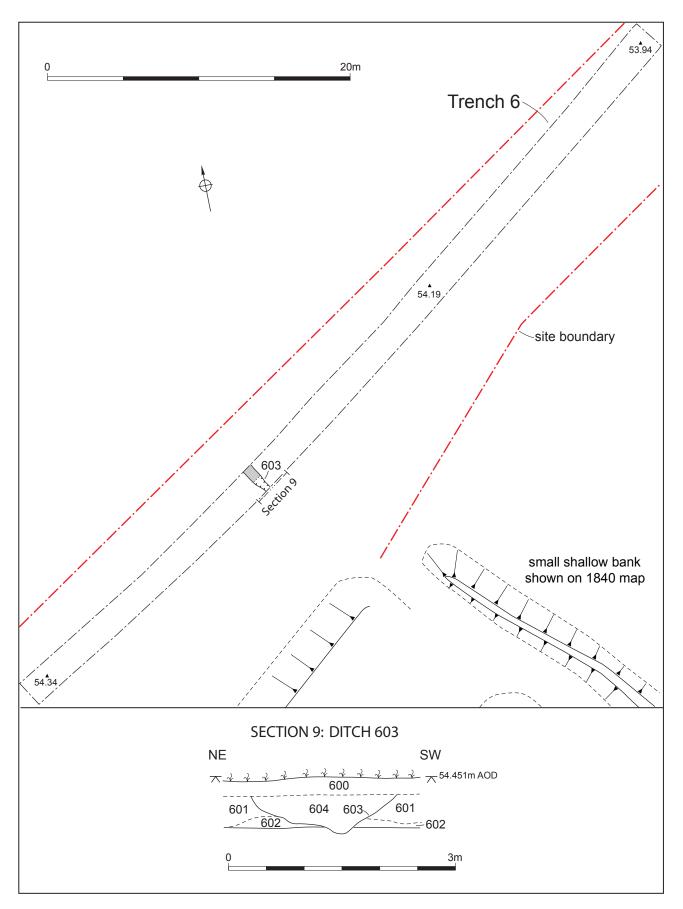
Figure 5

In Trenches 6 and 8 two drainage ditches were identified running approximately north-east to south-west, running downslope of Dinedor Hill (Figures 5 and 6; Plates 5). Both these ditches, 603 and 805 were visible as extant earthworks and both had cut through the subsoil, indicating they were of recent origin. A single tile fragment of probable post-medieval date was recovered from the fill (804) of ditch 805.

Trench 6 plan and section of ditch 603

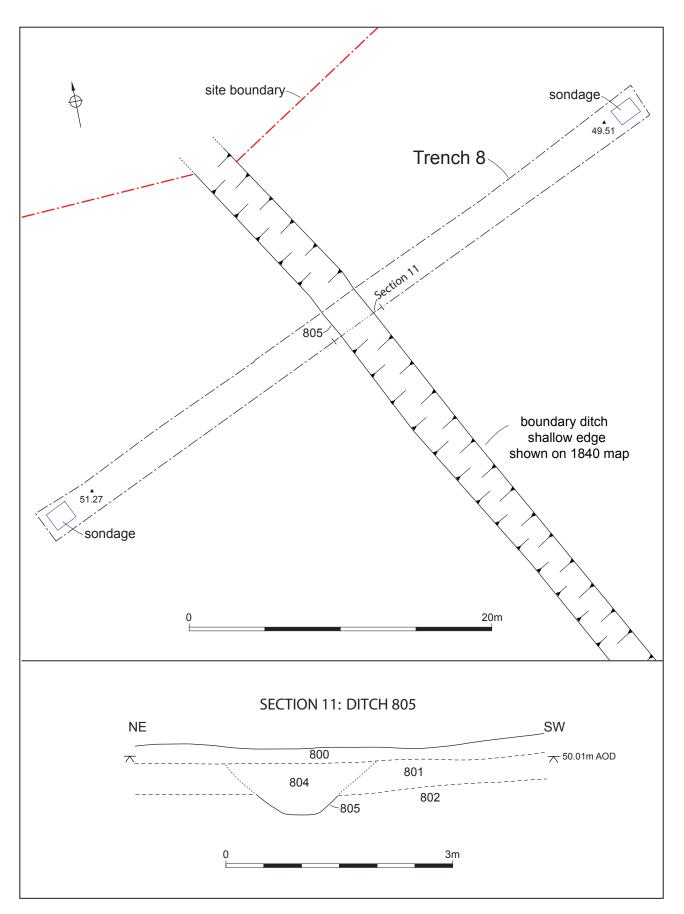
Figure 6

Trench 8 plan and section of ditch 805

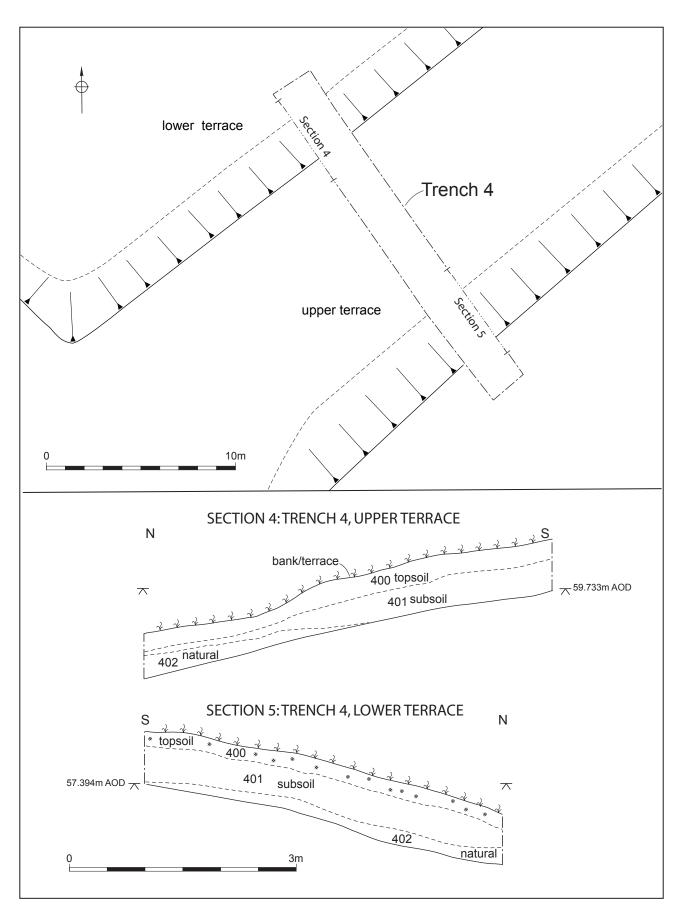
Figure 7

The extant earthwork terraces in the middle of site remain undated but appear to have been truncated by drainage ditch (603). This suggests that they may be of earlier post-medieval or medieval date. The terracing is aligned in a north-east to south-west direction and covers an area of approximately 0.45ha. Two terraces edges survive forming a middle platform 10.0m wide and 96.0m long (Figure 7; Plate 6). There was no evidence to suggest the terraces had been reveted to prevent erosion downslope and it is likely to have been formed by ploughing from the upper side only.

Trench 4 sections

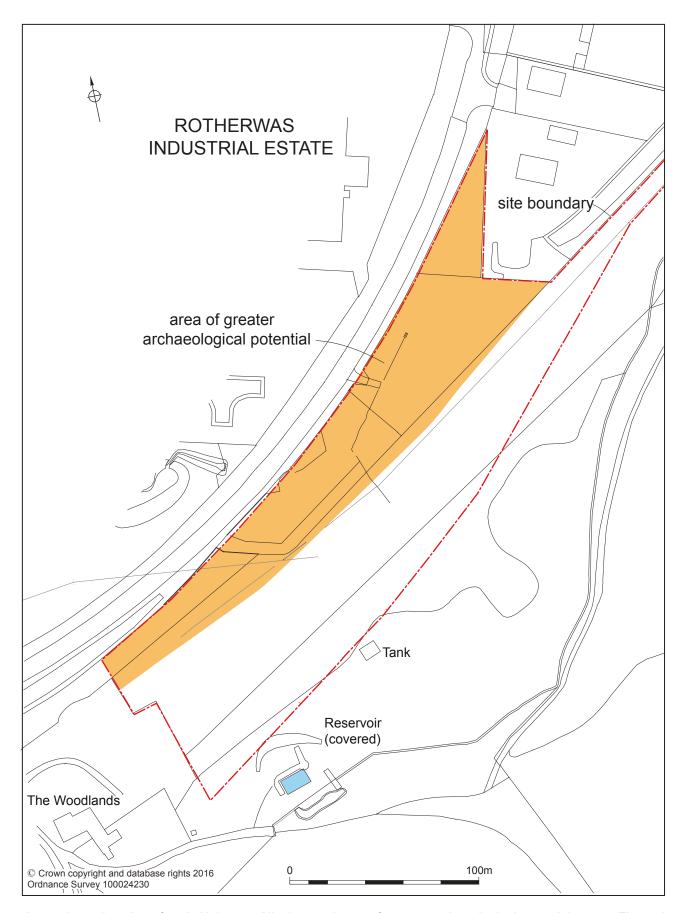
Figure 8

The results of the evaluation suggest that the areas of the site that are hill slope are likely to have little of archaeological interest. Bearing in mind the low sample level that was achievable the evaluation suggests that the lower lying area of the site is likely to contain features of prehistoric date but that this is more likely to be within the northern half of the site (Fig 8).

Approximate location of early Holocene Alluvium and area of greater archaeological potential

The proposed development is very likely to require ground disturbance that will adversely affect significant archaeological deposits within the area indicated on Figure 8.

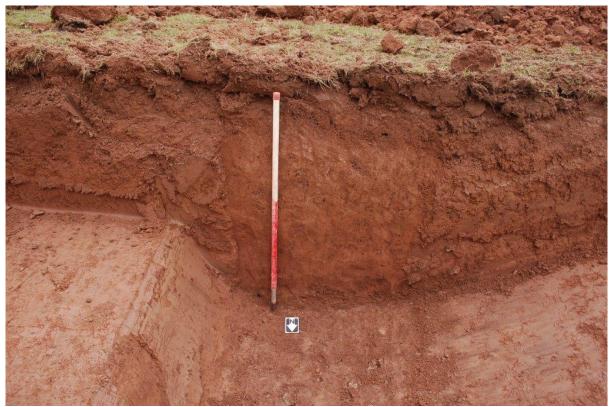
In the lower area of the site (Trenches 3, 5 and 8) firm and cohesive fluvial sand and gravels were identified in sondages that were sealed by firm alluvial clays of orange yellowish-brown colour (Plate 1). This alluvium was of variable depth, being between 0.15-0.60m thick. Although not completely removed during the evaluation, sondages were excavated by machine through this deposit to establish its thickness and identify any other significant horizons or deposits below. No significant deposits were identified but it was established that the alluvium lay directly over sand and gravel terrace deposits.

Plate 1: Trench 5, showing alluvium overlying sand and gravel terrace deposits. 1m scale.

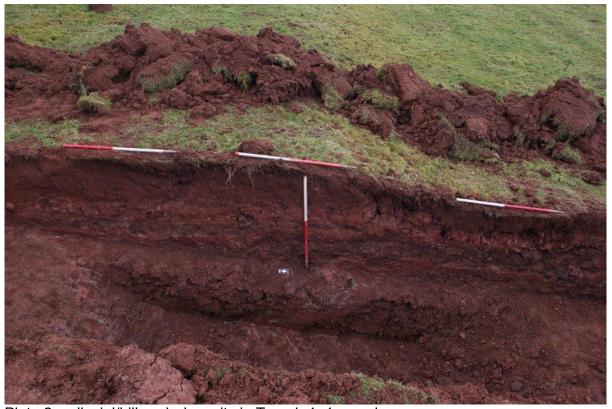
In Trench 1 there were also a number of layers of re-deposited natural (contexts 101-111) that appeared to be hillwash/colluvium (Plate 2). These appeared to sit directly on the sandstone bedrock and were up to 1.33m thick.

Plate 2: colluvial/hillwash deposits in Trench 1. 1m scales.

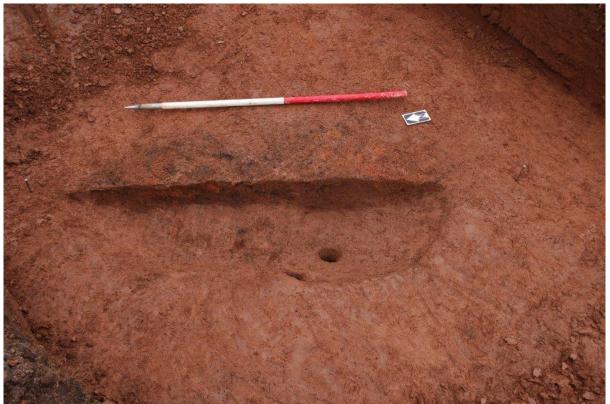
Plate 3: Pit 505 half-sectioned. 1m scale.

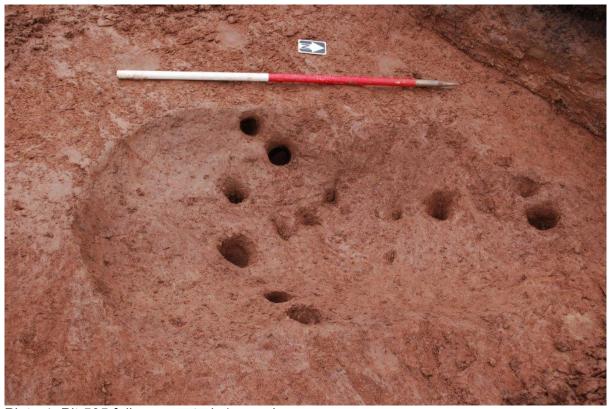
Plate 4: Pit 505 fully excavated. 1m scale.

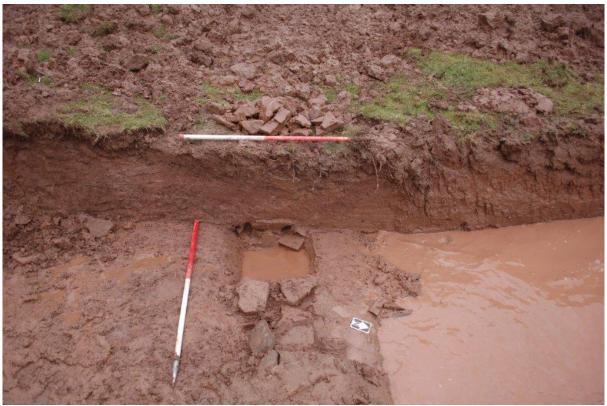
Plate 4: Stone land drain (203), below earthwork depression. 1m scale.

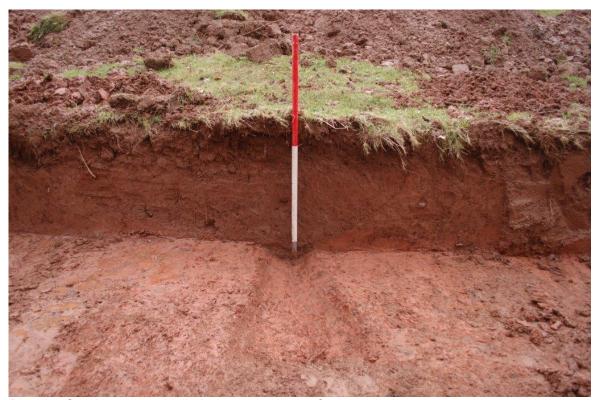
Plate 5: Section through ditch 603, 1m scale, facing south-east.

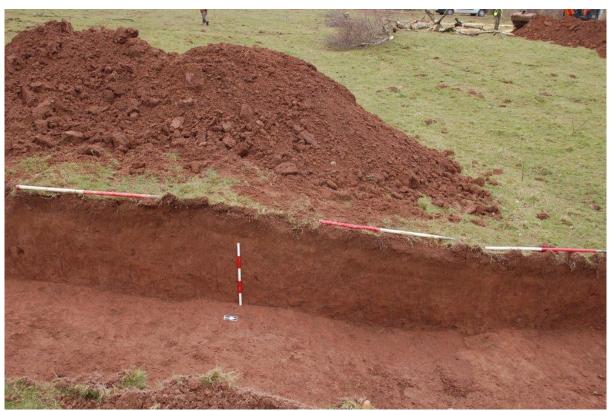
Plate 6: Trench 4, lower terrace facing west, 1m and 0.5m scales
