# Archaeological evaluation at the Sainsbury's and Life Sciences Park, Bristol Road, Selly Oak Birmingham

Status:  
Date: 2 April 2015  
Authors: Tom Vaughan and Jonathan Webster  
Contributors: Robert Hedge  
Illustrators: Steve Rigby  
Project reference: P3006  
Report reference: 2008

## **Archaeological evaluation at the Sainsbury's and Life Sciences park, Bristol Road, Selly Oak, Birmingham**

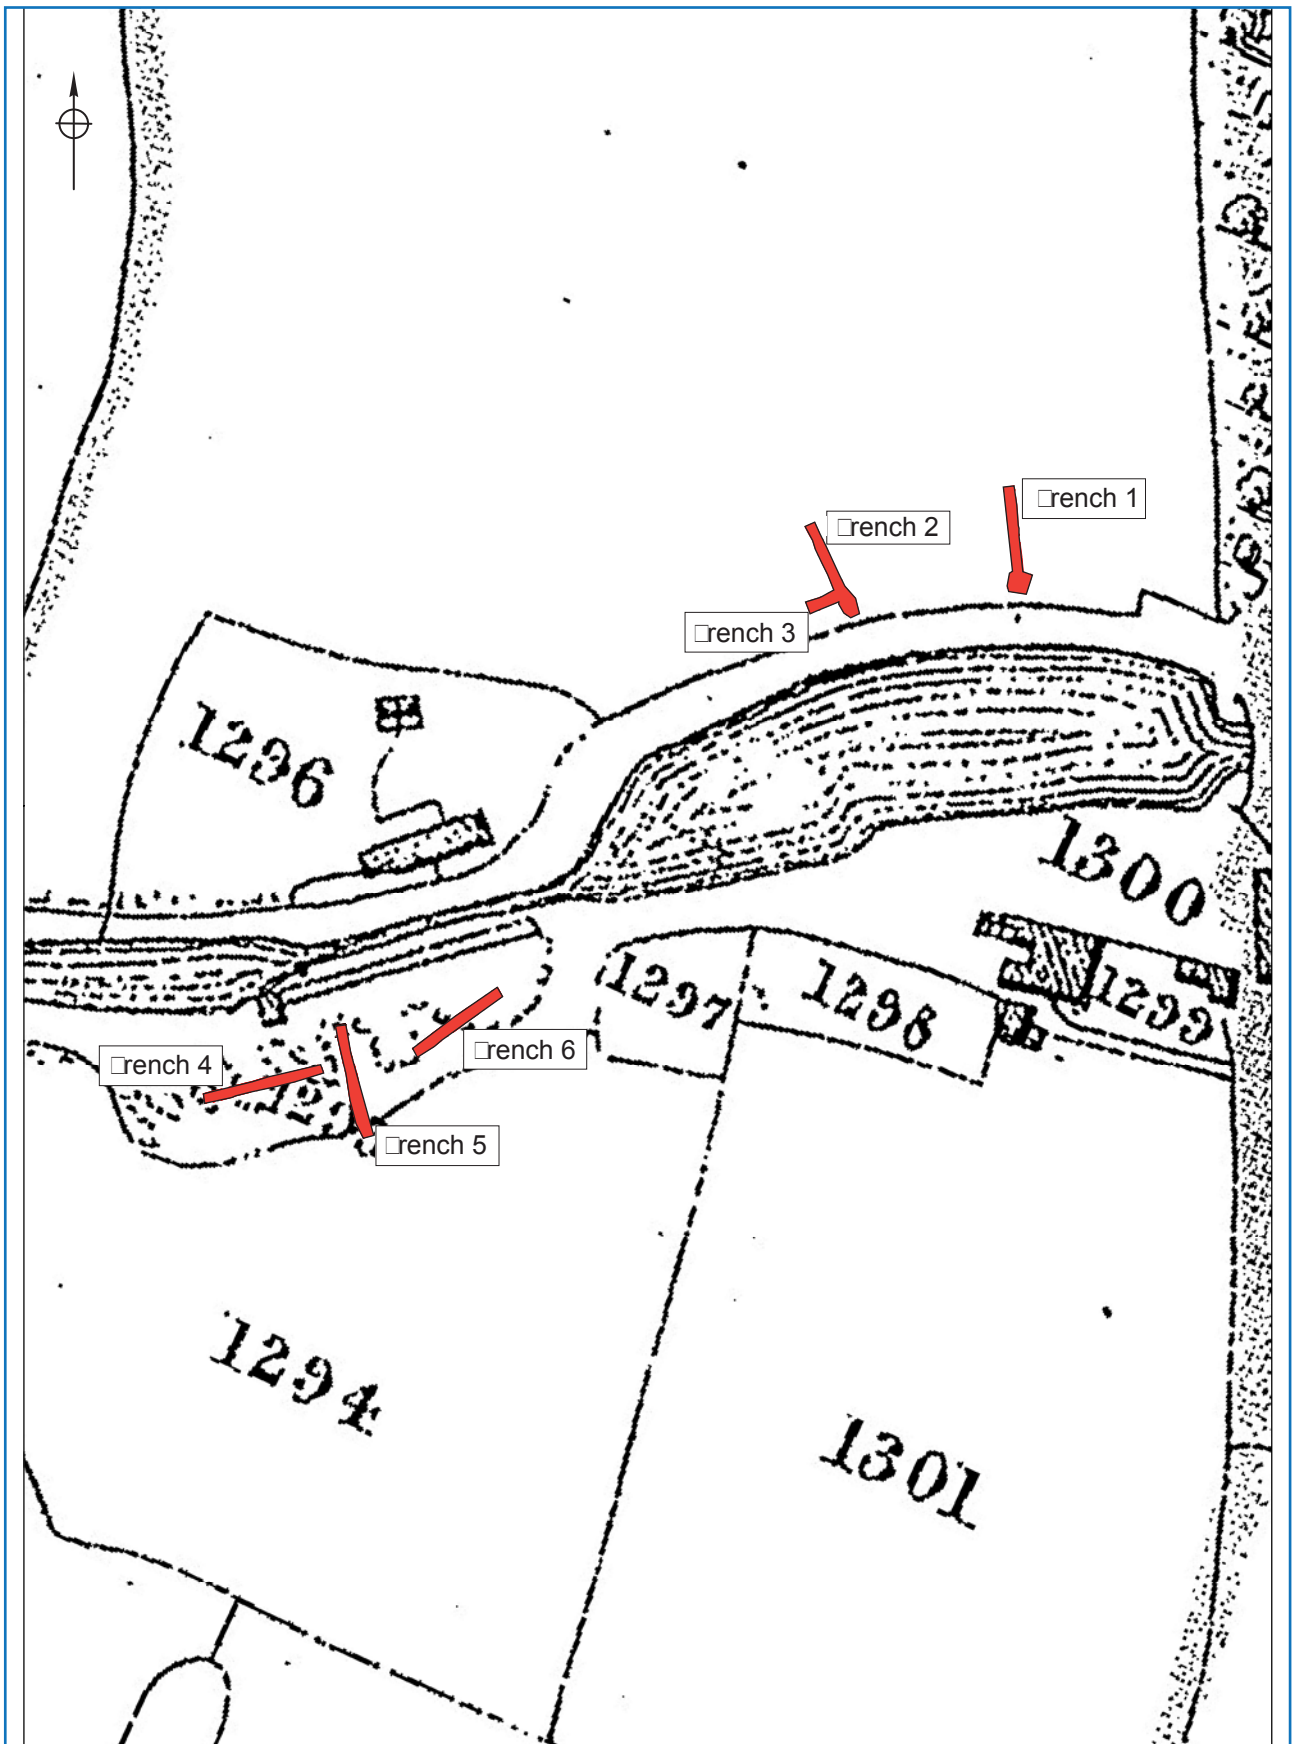
Figure 1

Aerial photograph of trench locations overlain on 1861 tithe map

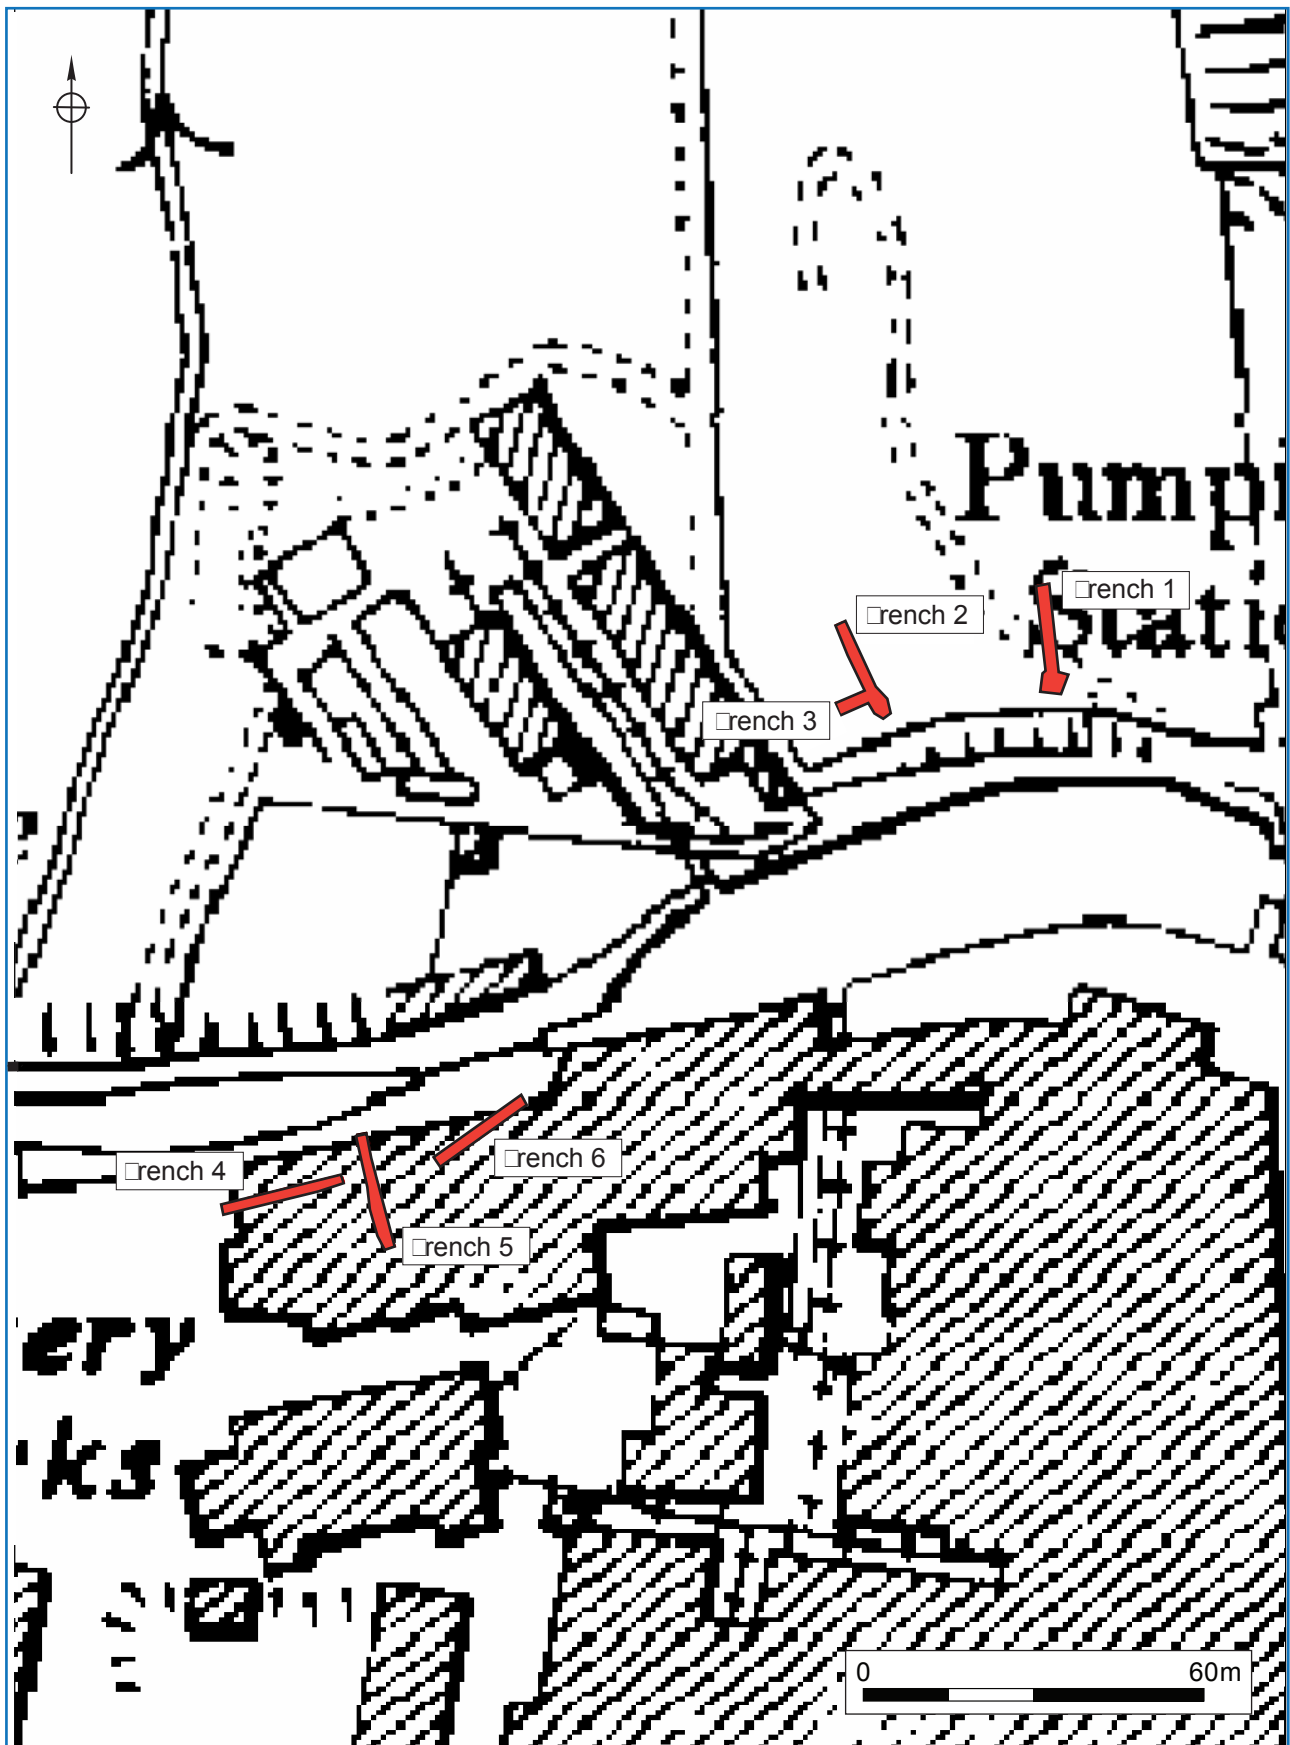
Figure 1

Trench locations overlain on 1999 edition Ordnance Survey map

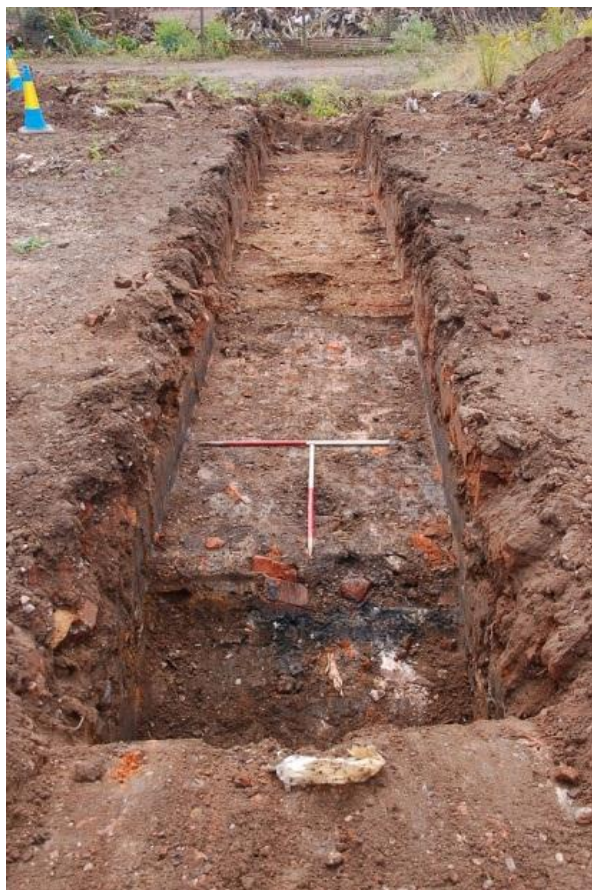
Trench 1 was excavated to the north of the canal basin to investigate the canal side and associated surfaces and structures to the north (Plate 1). It was excavated to an average depth of 1.05m below the present ground surface with additional sondages to a depth of 2m at the south end of the trench (138.56m AOD) and 1.75m at the north end (139.56m AOD).

The trench lay within a substantial modern dump (104) of material (at least 1.33m+ thick) that contained a combination of clinker and ash along with modern brick rubble, wood, plastics and metal fragments, from 0.42m below the current ground surface level in the north down to 1.10m in the south. This was sealed by a dumped band of modern material (103) that averaged 0.32m across the length of the trench and comprised sand and gravels that were mixed with ceramic building material (CBM), plastics and frequent charcoal throughout. This in turn was covered by up to 0.42m of red clay (102) mixed with concrete and brick rubble along with frequent plastics and metal fragments throughout. This was overlain by between 0.28-0.36m of dark brown silty clay topsoil (101) that contained frequent modern artefacts, CBM and domestic waste throughout.

No significant deposits or structural remains were identified. There were no deposits predating the 20<sup>th</sup> century.

*Plate 1: General view of Trench 1 looking south*

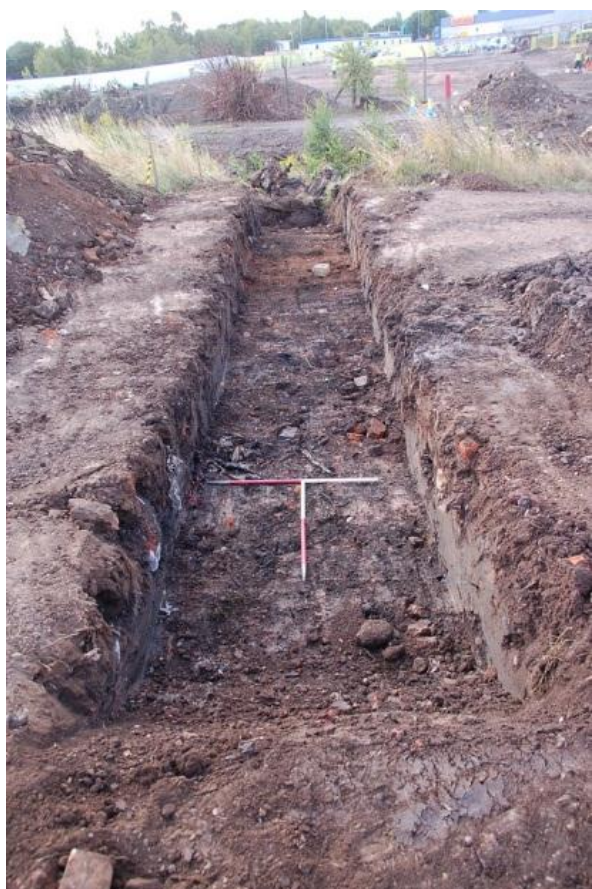
Trench 2 was excavated to the west of Trench 1 to the immediate north of the canal in an attempt to investigate possible structures, deposits and surfaces associated with the construction, evolution and association with the canal (Plate 2). Excavated to an average depth of 1.03m (due to the instability of the trench sides), at the south end a sondage was excavated to a depth of 2m whilst in the northern end a sondage was opened to a depth of 1.64m. The deposits in Trench 2 were similar to those in Trenches 1 and 3, comprising modern dump deposits extending below the limit of excavation.

A loosely compacted silt and sand (204) was seen at the base of the trench that contained very frequent brick and concrete inclusions throughout, along with plastic, cloth, tarmac and metal fragments that indicate a late 20<sup>th</sup> century date. This deposit was seen from an average of 0.83m below the present ground surface level and was overlain by a coarse sand and clay mix (203) that included wood and plastic fragments along with general CBM and domestic refuse inclusions and averaging 0.5m in thickness across the trench. This was in turn sealed by a 0.10m thick deposit of loosely compacted loam (202) that contained frequent glass, plastic, CBM and other items of domestic waste. Finally this was covered by a coarse sand and clay mix topsoil that contained frequent modern detritus and waste throughout the deposit which averaged 0.26m in thickness although was seen to become thicker to the south.

No significant deposits or structural remains were identified. There were no deposits predating the 20<sup>th</sup> century.

*Plate 2: General view Trench 2 looking south-east*

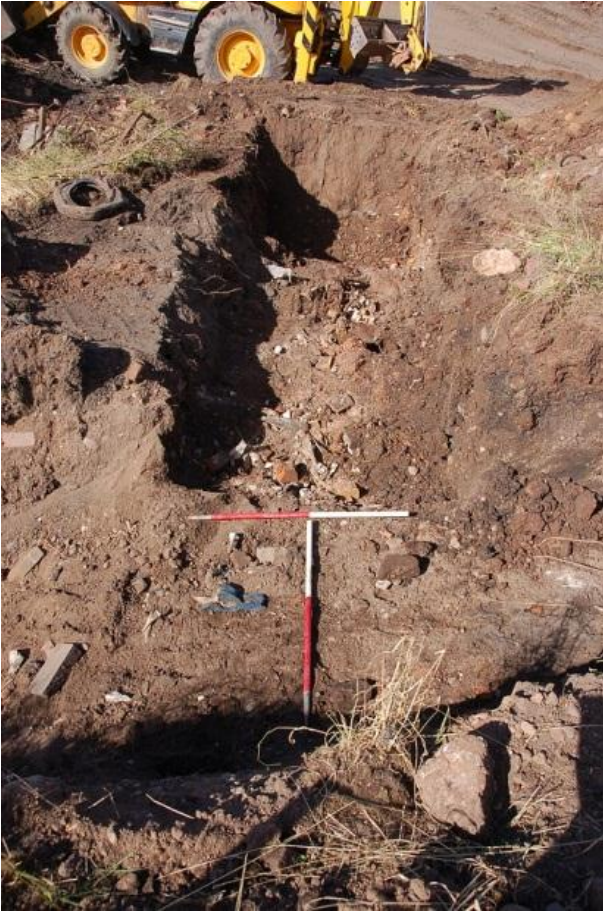
Excavated at a right angle to, and off the south-west side of, Trench 2, this trench was parallel to the canal basin, Trench 3 was placed to identify structures associated with the canal (Plate 3). It contained deposits that were identical to, and with similar depths, as those in Trenches 1 and 2.

No significant deposits or structural remains were identified. There were no deposits predating the 20<sup>th</sup> century.

*Plate 3: General view of Trench 3 looking south-west*

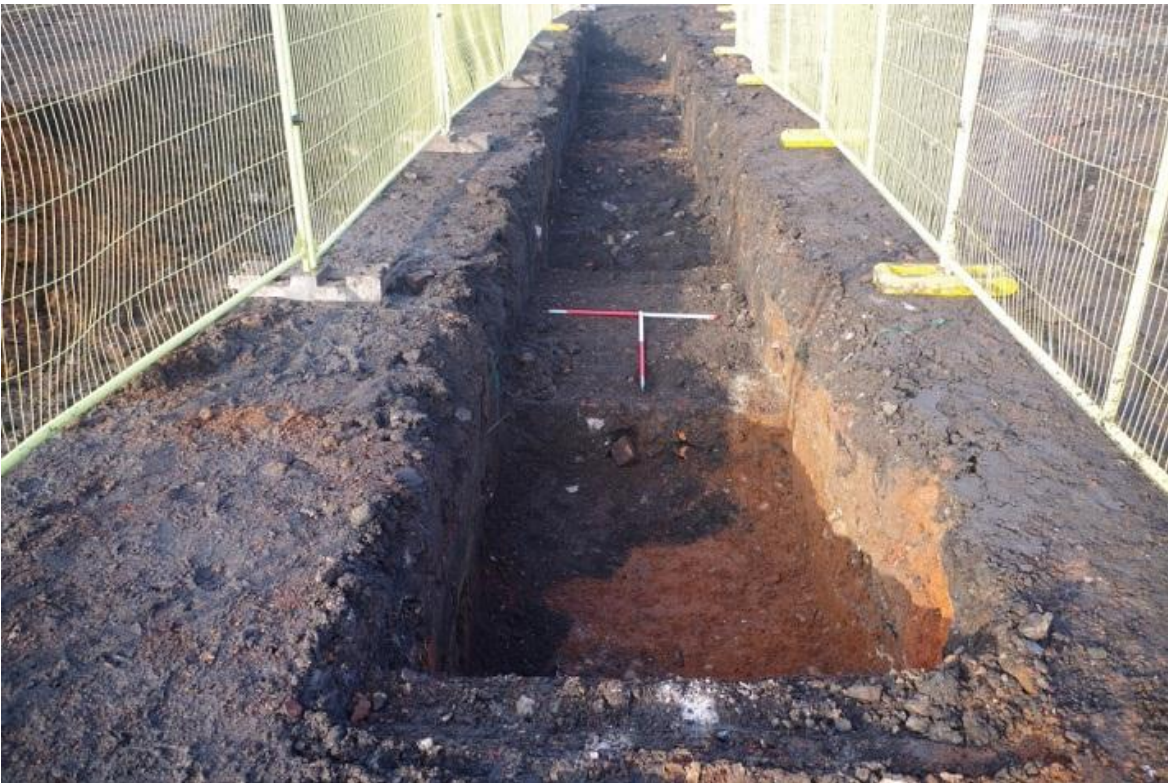
Trench 4 was excavated in the south-west corner of the site and was the westernmost of the second phase of evaluation (Plate 4). It was placed over the postulated westernmost extent of the kilns on a parallel course. It was excavated to an average depth of 1.20m, with sondages at either end of the trench that descended 2.07m below the present ground level (135.54m AOD) at the east end and 2.03m (136.21m AOD) at the west. These sondages were filled in immediately after recording due to health and safety concerns.

The trench contained mixed deposit (402) which comprised a dark sandy grit with frequent CBM, concrete and industrial waste, including ash, charcoal and clinker throughout. This material had multiple tip lines and bandings throughout and appeared to have been the result of a deliberate demolition and deposition of large quantities of material. This material was at least 1.67m in depth and descended beyond the limit of excavation. This deposit sat within a large cut, 403, with almost vertical sides that descended to an unknown depth and appeared to be on a north-west to south-east alignment. At the east end of the trench a thin sandy clay deposit (404) was seen that contained several laminations of charcoal and lime rich bands that measured roughly 0.01m in thickness, dipping from north to south. This deposit measured 1.78m+ in depth and continued beyond the limit of excavation. All of the above was sealed by 0.20m of modern demolition (401) set within a matrix of dark greyish brown silty clay that appeared to have been disturbed during the current redevelopment of the area.

No significant deposits or structural remains were identified. There were no deposits predating the 19<sup>th</sup> century.

*Plate 4: General view of Trench 4 looking west*

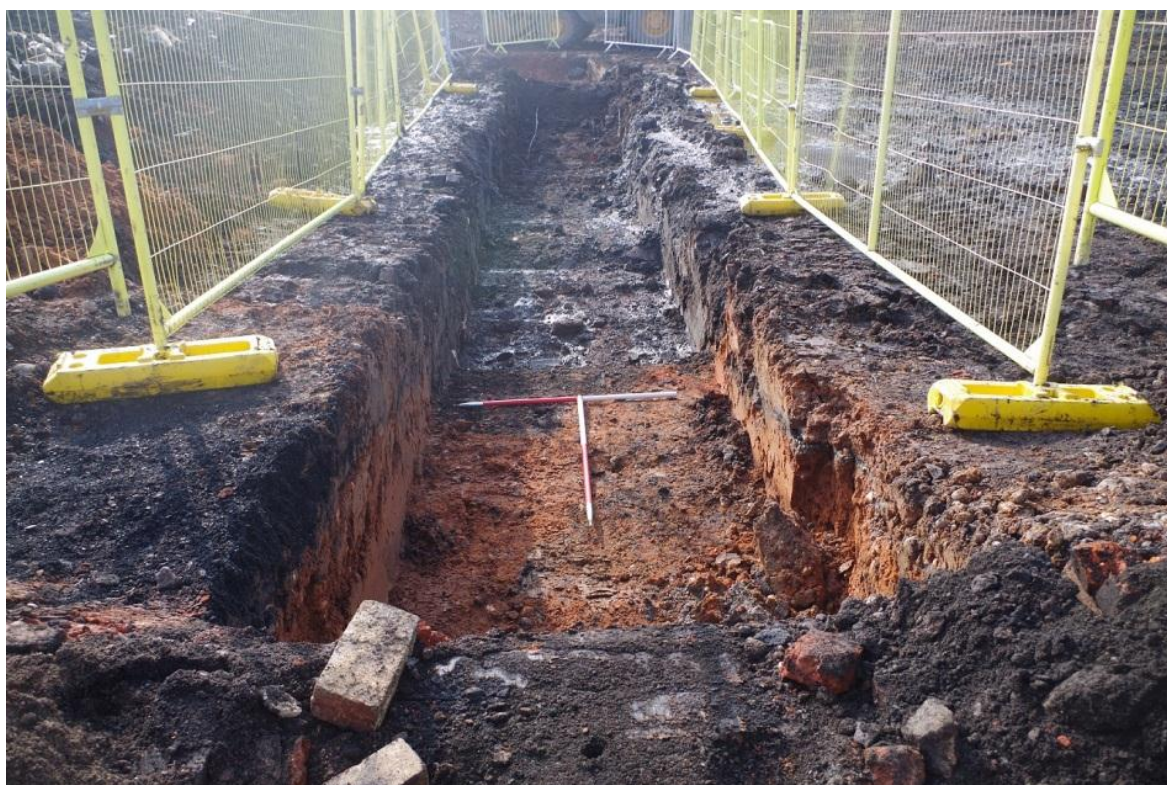
Orientated north-north-west to south-south-east, Trench 5 was placed to the immediate east of Trench 4 and aligned at a right angle to the postulated alignment of the lime kilns (Plate 5).

At the north end of the trench lay a large brick retaining wall (509) that stretched north-east to south-west across the southern quarter of the site. South of this a humic rich loam (508) that contained modern plastics along with a high organic content butted a second smaller brick wall (507) to the south. Two courses thick, this wall was made of well fired machine made bricks that

were unfrogged and bonded with a light greyish yellow lime rich bond. This wall measured at least 0.90m in depth and was seen to extend at least 2m in total before becoming obscured by material to the east and west of the area of investigation. To the immediate south of this wall and butting it was a band of light greyish yellow sand rich clay (504), almost identical in form and make up to deposit (404) in Trench 4 and (505) below. This deposit measured 3.70m in length by at least 1.15m in depth. This material contained a thin band of charcoal and occasional lime inclusions along its upper edge. This was truncated to the south by a large intrusive feature (502). This had vertical sides to an unknown depth, at least 1.70m+ (136.18m AOD) and appeared to have been orientated roughly south-west to north-east. It was infilled by a deliberately deposited dark gritty loam which contained high quantities of CBM, concrete and metal inclusions throughout, along with several fragments of plastic material. This feature also truncated (505; same as 504) and is thought most likely to be part of the same deposit although due to the truncation of [502] it was impossible to prove this. All of the above was sealed by 0.25m of modern demolition (501), set within a silty clay matrix, thought to be disturbance associated with the current redevelopment.

No significant deposits or structural remains were identified. There were no deposits predating the 19<sup>th</sup> century.

*Plate 5: General view of Trench 5 looking north*

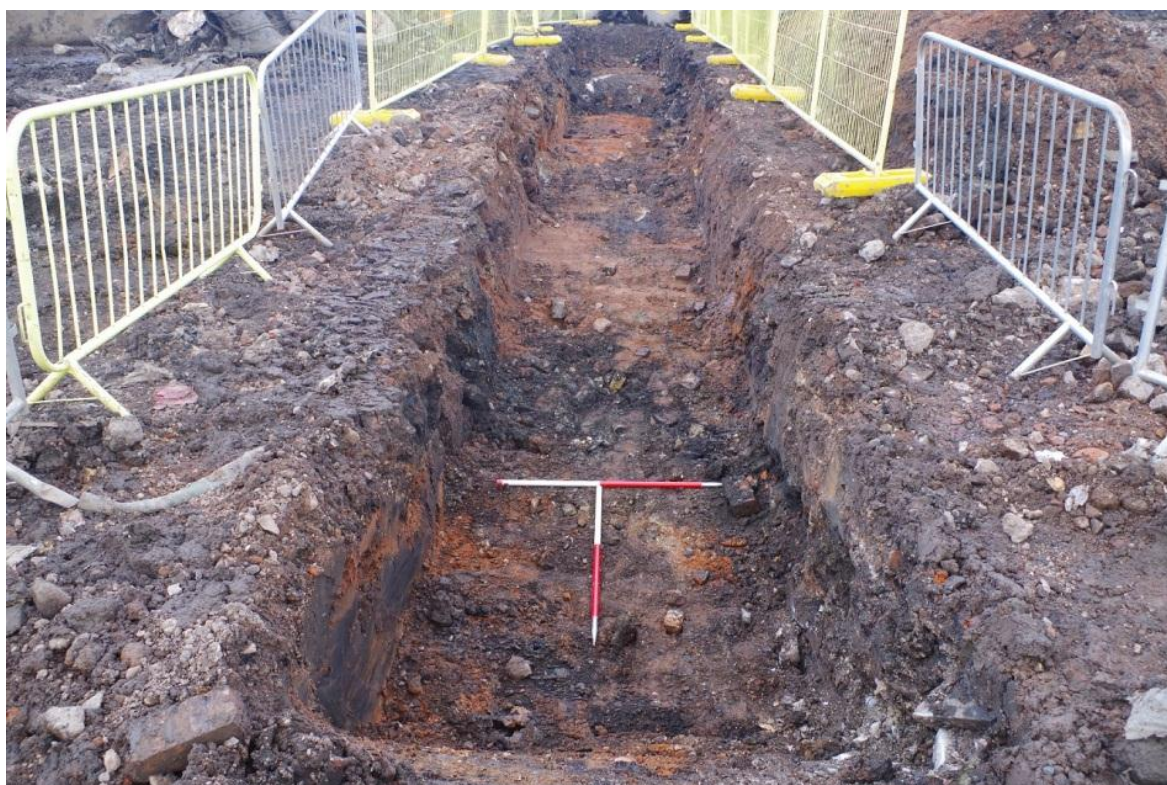
Orientated roughly north-east to south-west this trench was moved 6m to the west of its originally intended position due to the ongoing development works and moving plant (Plate 6). Dump deposit (603) was revealed at 136.21m AOD and comprised a gritty matrix infilled with quantities of CBM, metal and industrial waste throughout. It was truncated by wall (604), a single brick width, of well fired, machine made unfrogged red bricks. It is considered to be an internal wall, and is thought to have been part of the former factory building on the site. This was sealed by an average of 0.75m of mixed deliberately deposited material (602) that included CBM, industrial waste, plastics and metals throughout and was demonstrated to have been associated with the demolition of the factory complex and was itself covered by 0.15 of mixed silty clay (601) similar to that in Trenches 4 and 5.

No significant deposits or structural remains were identified. There were no deposits predating the 19<sup>th</sup> century.

*Plate 6: General view of Trench 6 looking north-east*
