Archaeological Evaluation of Aylesbury House, Hockley Heath, Warwickshire

Status: Revision 1
Date: 1st June 2016
Author: Tim Cornah tcornah@worcestershire.gov.uk
Contributors: Elizabeth Pearson and Laura Griffin
Illustrator: Carolyn Hunt
Project reference: P4809
Report reference: 2344
Oasis id fieldsec1-253031

Archaeological evaluation at Aylesbury House, Hockley Heath, Warwickshire

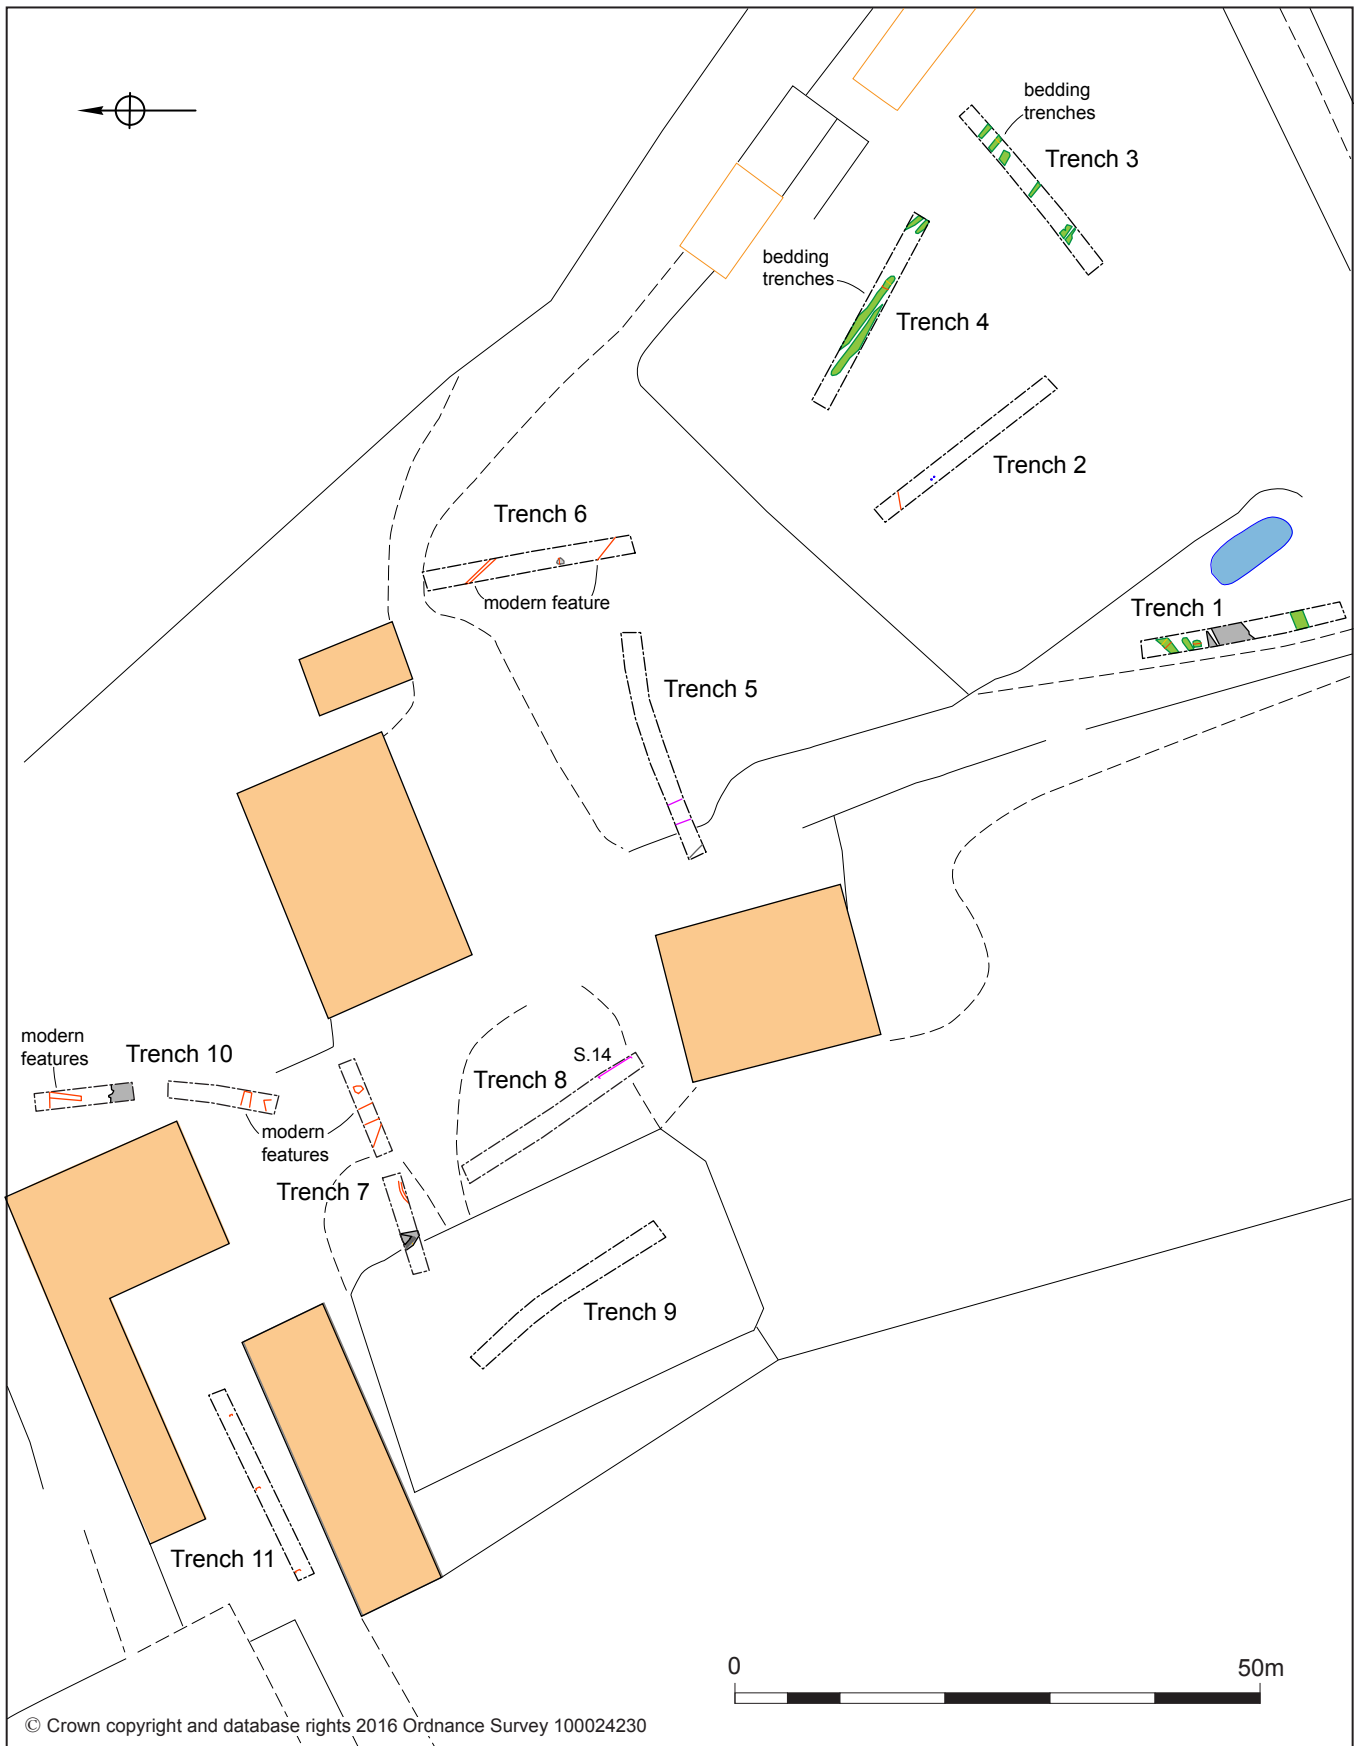
Figure 2

Eleven trenches, amounting to just over 222m² in area, were excavated over the site area of approximately 1.7ha, representing a sample of about 1.3%. The location of the trenches is indicated in Figure 2.

Trench location plan

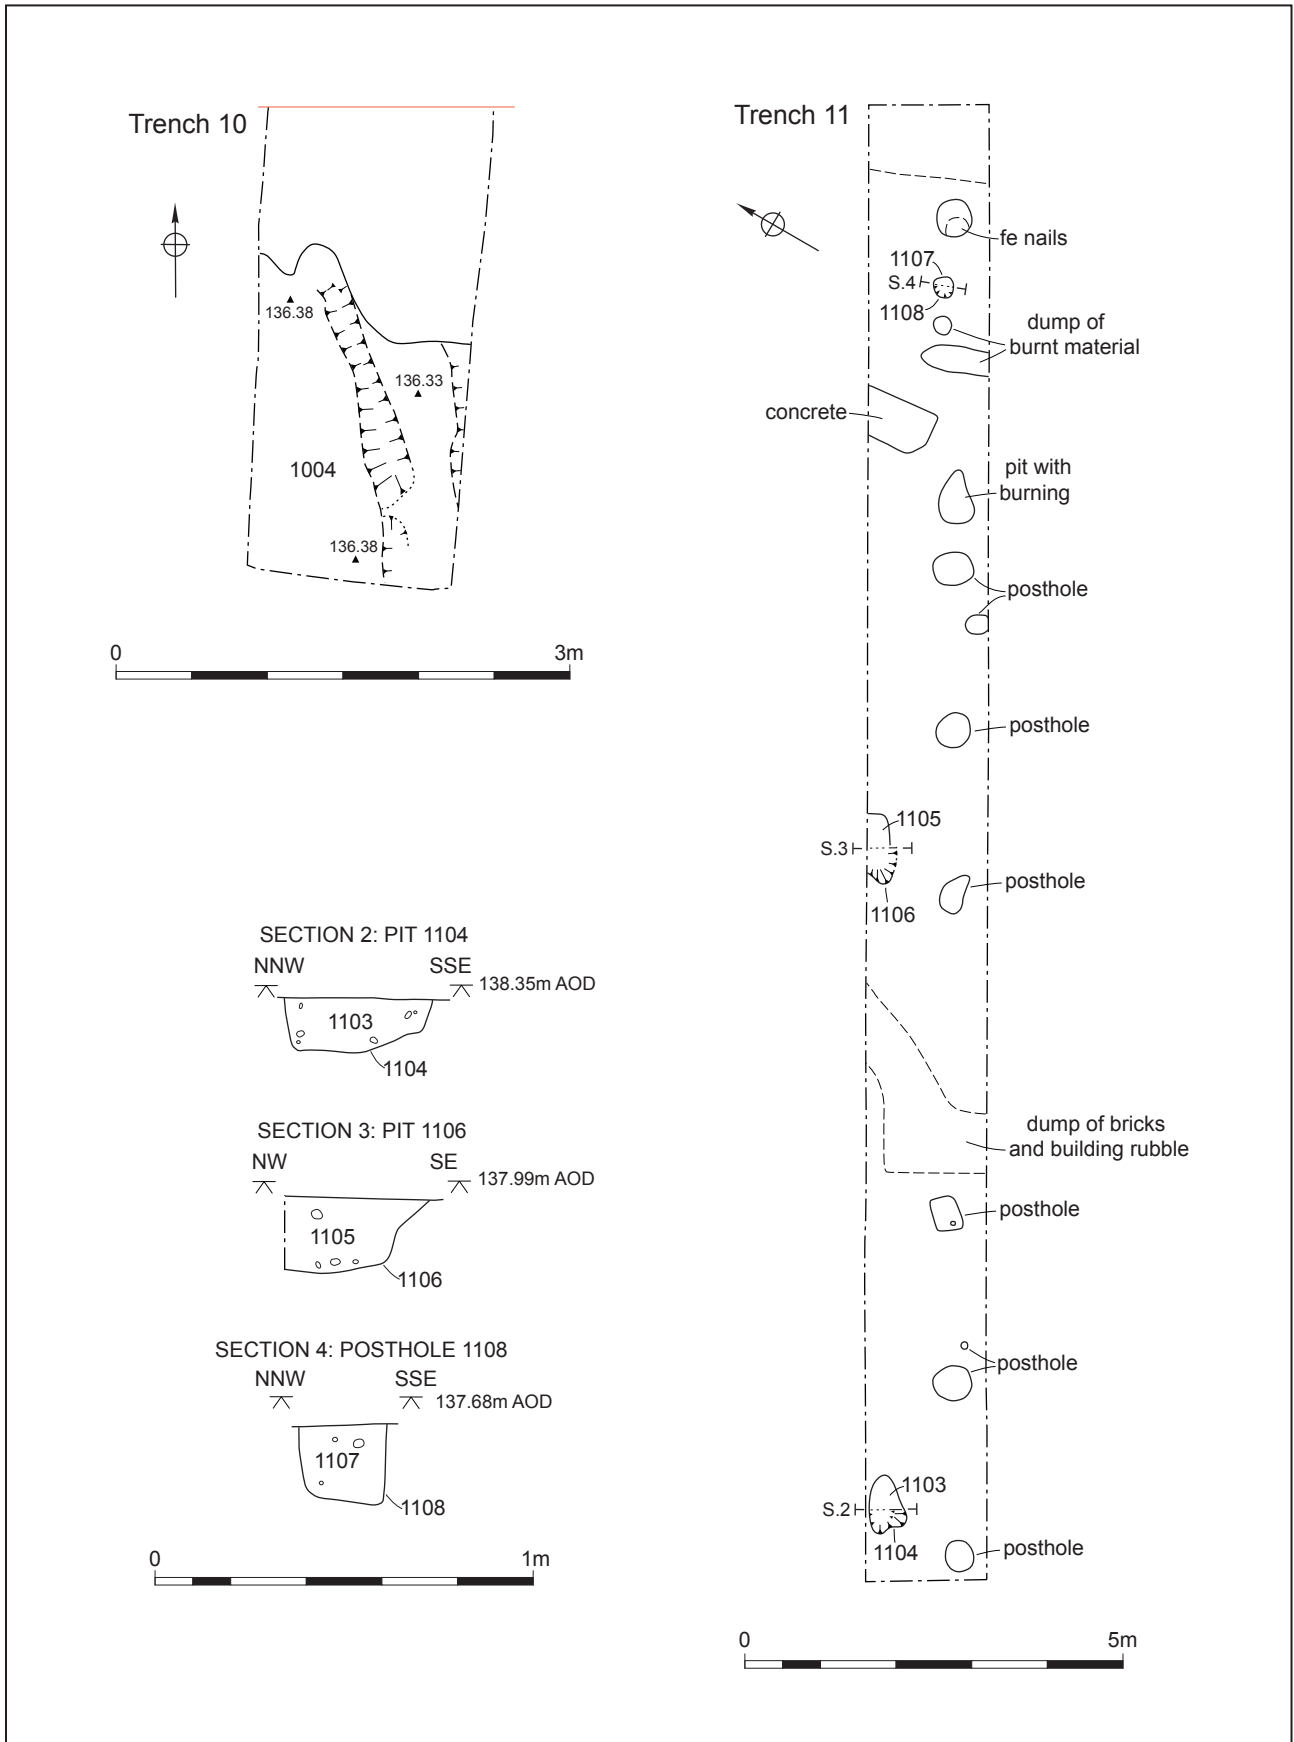
Figure 6

A further cobbled surface was recorded within Trench 10 (1004) that was sealed by a deposit (1003) containing material of this date. This had a rut running roughly north to south, with another possible one parallel to it at its east (Plate 5). The surface had no clear alignment, so it is likely to have been an area of hard standing, as opposed to a track.

Trench 11 contained two small pit features [1104, 1106], the function of which was unclear. A further small pit was recorded in Trench 6 [605] which was within the garden of the house and appears to have been for planting (Plate 6).

Trench 10, plan of 1004; Trench 11, plan and sections

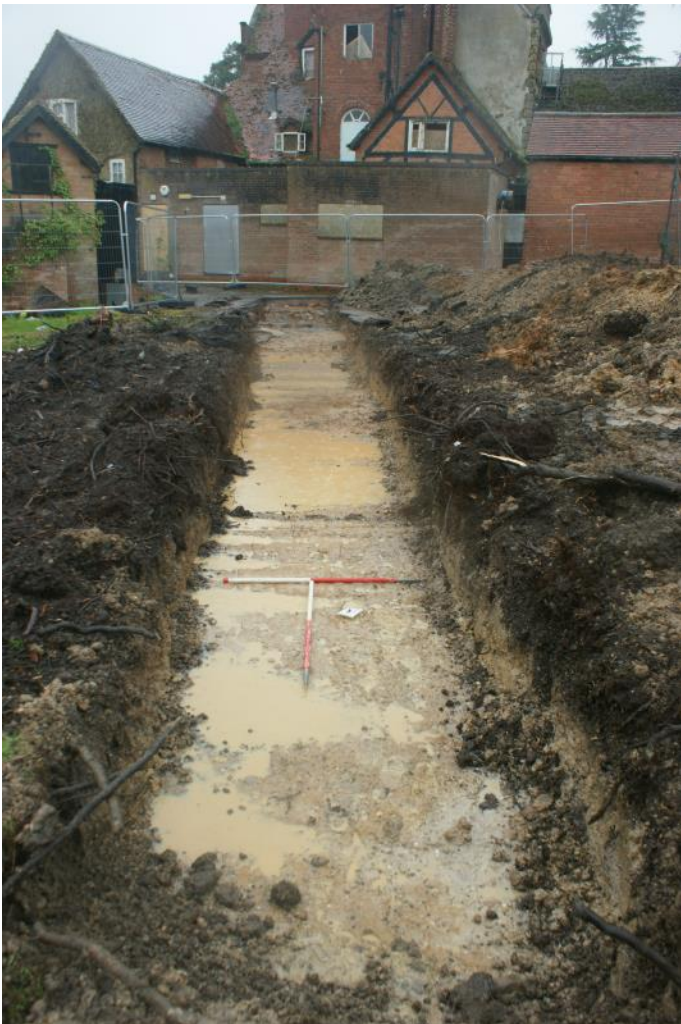
Plate 1 Trench 8, looking south

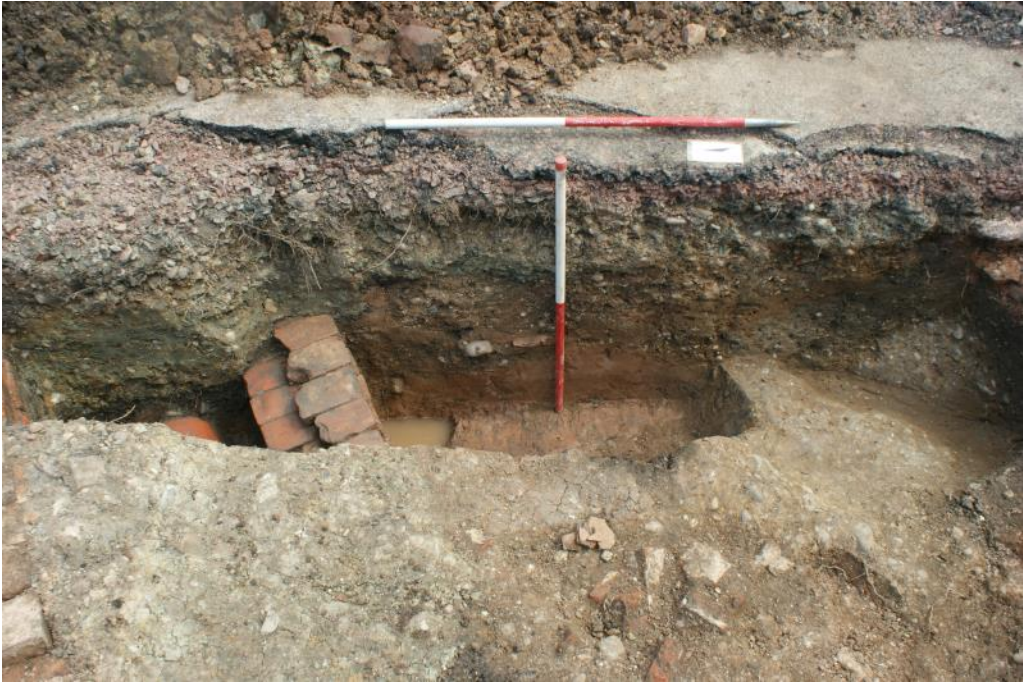
To the north of this possible ditch and on broadly the same alignment a brick wall (834) was recorded constructed of bricks of dimensions 255mm by 125mm by 60mm and a minimum of ten courses deep (Plate 2, Figures 4 and 5). No other features clearly related to this wall or possible ditch [825] and they remained as the earliest stratigraphic elements in the area.

Plate 2 Ditch [825] and wall (834) within sondage, looking east

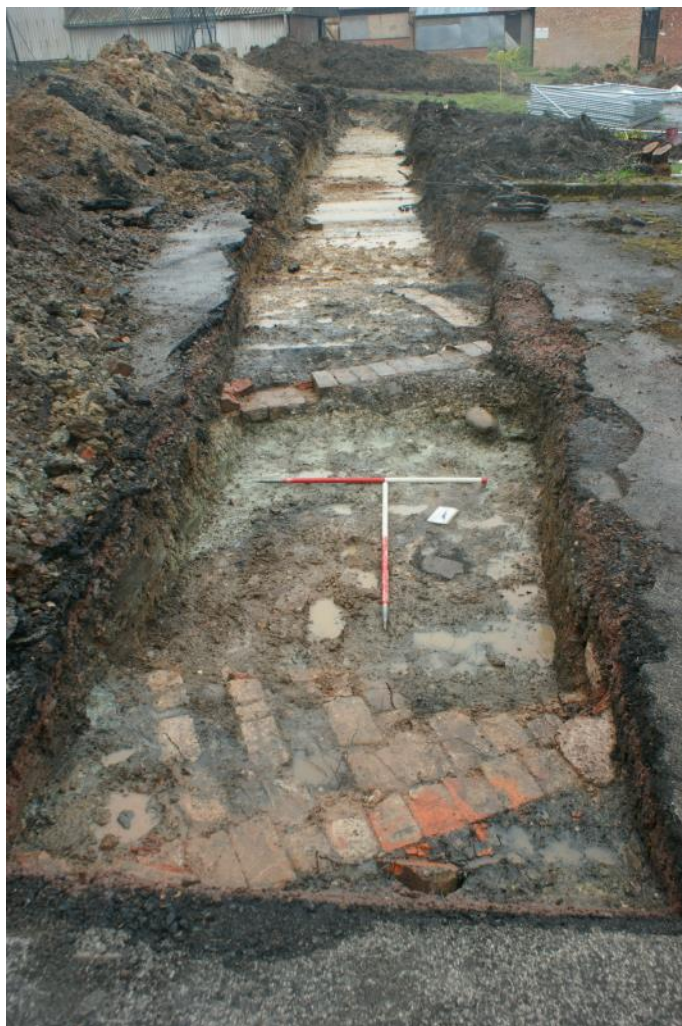
Wall (811) (Figure 4, Plate 3) was recorded at the southern end of the Trench 8 (Plate 3). This was constructed with bricks measuring 230mm by 110mm by 80mm and was parallel to wall (834). It had three single brick-width spurs running from it at 90 degrees on its north-west side, the function of which is unclear. Associated with this on its north side were a series of deposits (842, 843, 841, 808 and 823) which may have been levelling deposits from a former surface at least partially cut against wall (834). These deposits were in turn cut by three postholes [810, 822 and 839]. These deposits and features were sealed by blue grey clay deposits (806, 804 and 837) upon which structures (805) and (815) were built with bricks of 230mm by 100mm by 70mm in dimension (Plate 3). It appeared that these were part of an external structure, as they had a layer of cobbles to the north (813).

Plate 3 Walls (811, 805, 815) within Trench 8, looking north

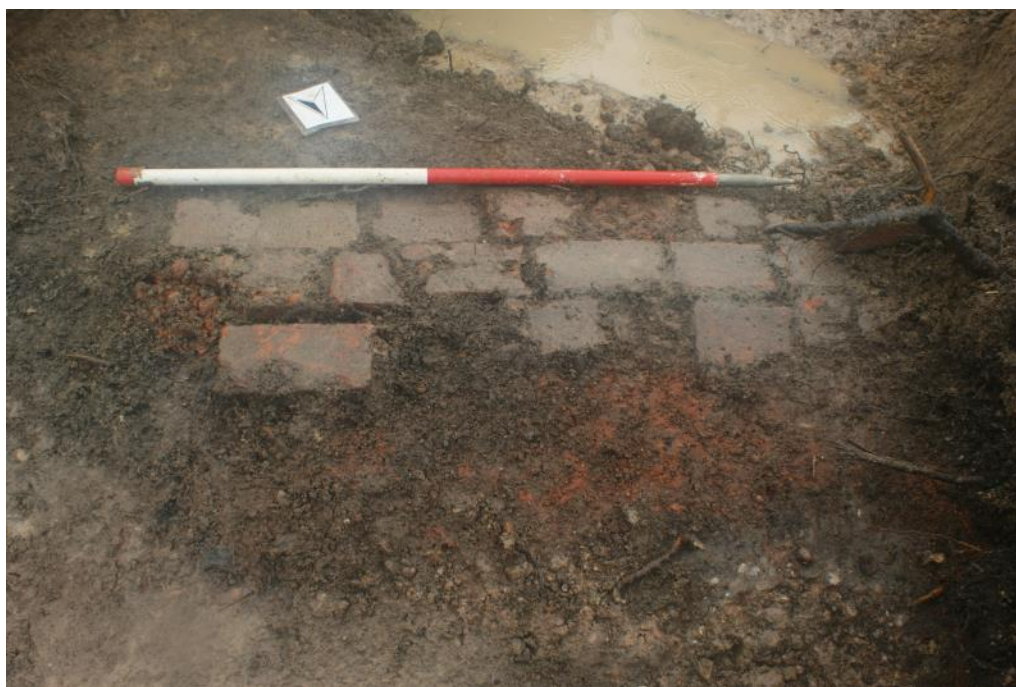
Probably also of the same broad date was a small area of brick (703) and gravel stone (704) surface in Trench 7. The bricks were laid flat and likely to have been an edging to the compact gravel surface and constructed with bricks of 220mm by 110mm by 55mm in dimension. This was not associated with any other features (Plate 4).

Plate 4 Surface (703), looking south-west

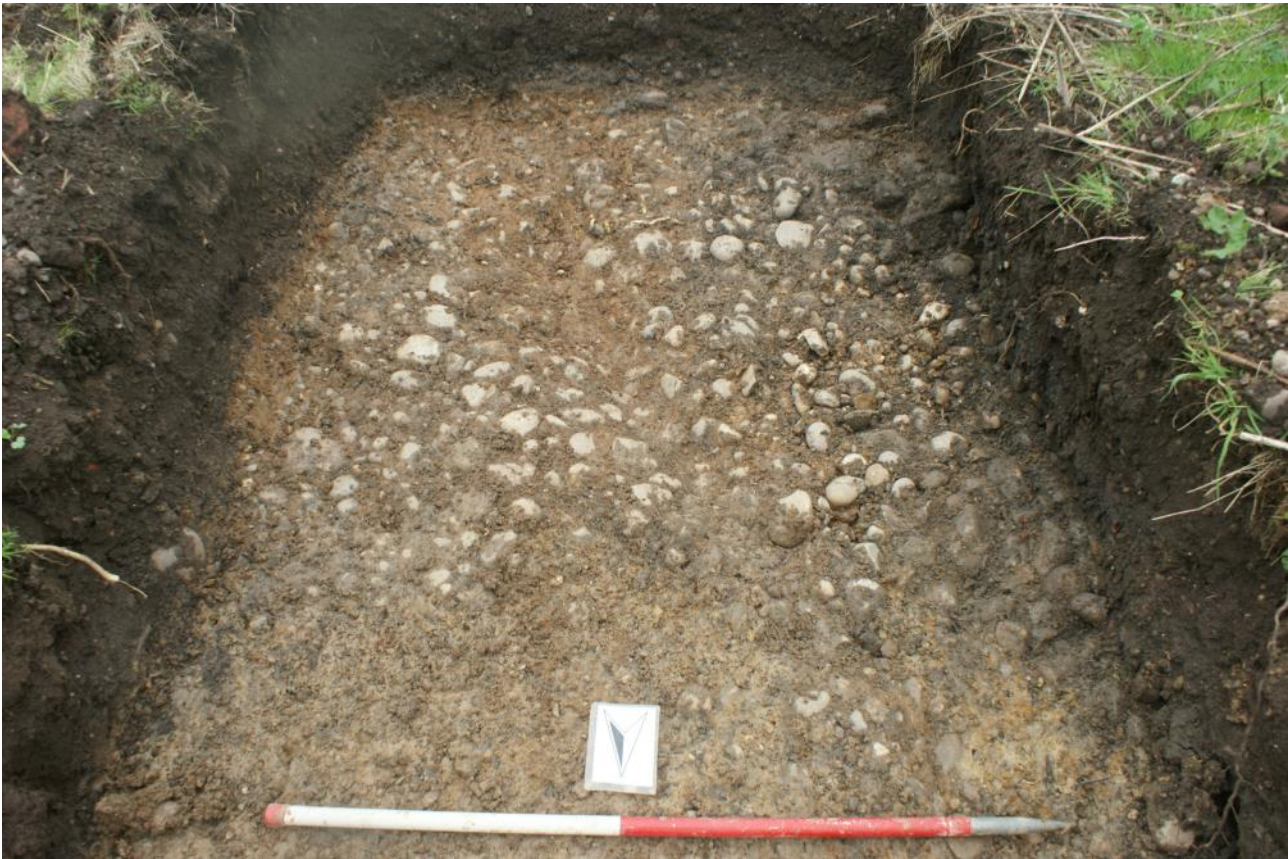
Plate 5 Cobbled surface (1003), looking south

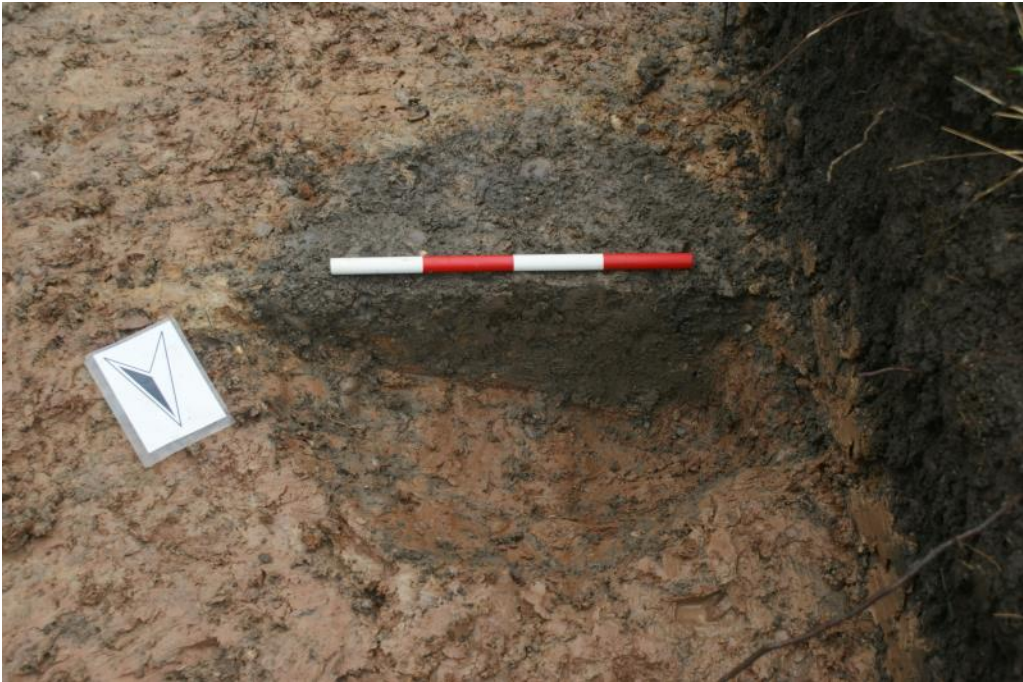
Plate 6 Pit feature [605], looking south-west

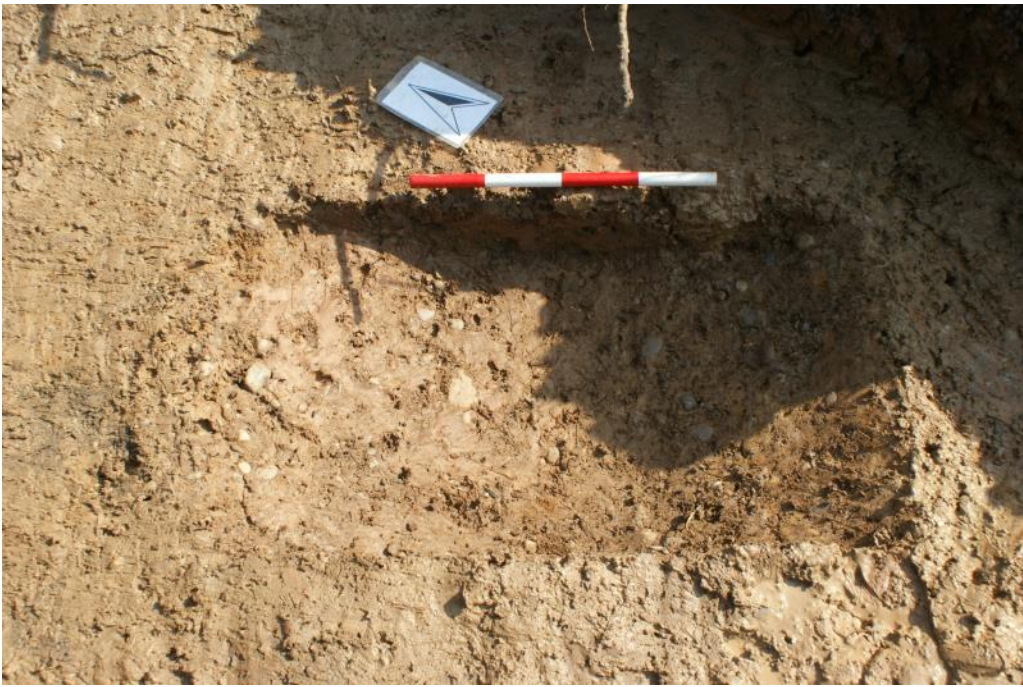
Within Trenches 1, 3 and 4 a number of shallow linear features were recorded which are interpreted as bedding trenches. Four of these survived within Trench 1 and were aligned north-east to south-west. Two of these [103, 108] were excavated (Plate 7). Trenches 3 and 4 contained nine of these features and were aligned north-west to south-east. Of these, 3 were excavated [304, 306, 402] (Plate 8).

Plate 7 Bedding trench (103), looking north-east

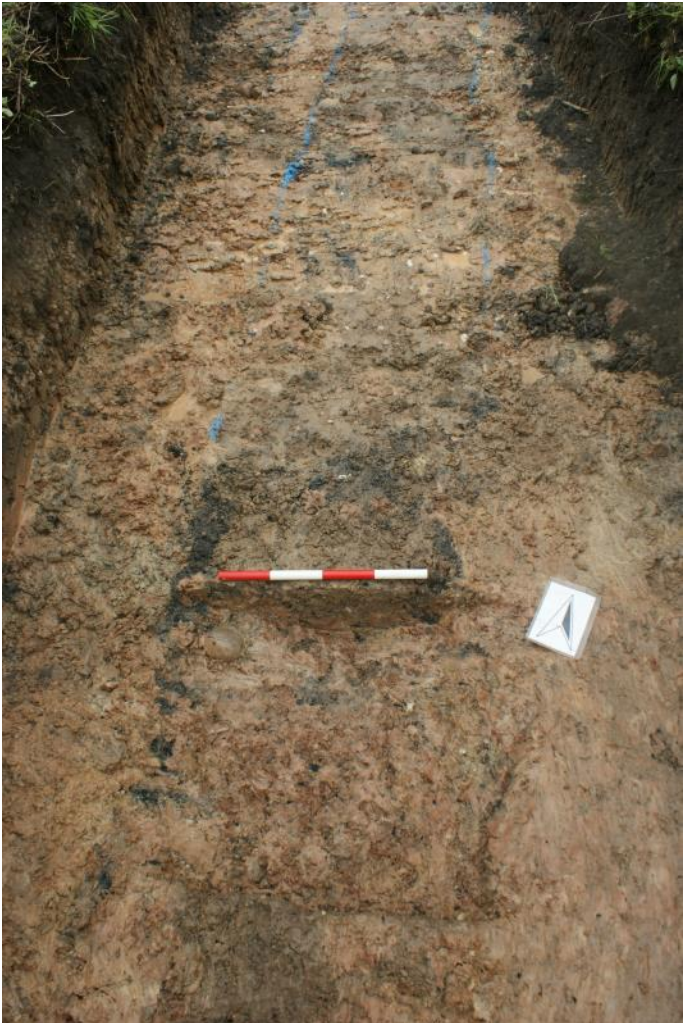
Plate 8 Bedding trench (402), looking north

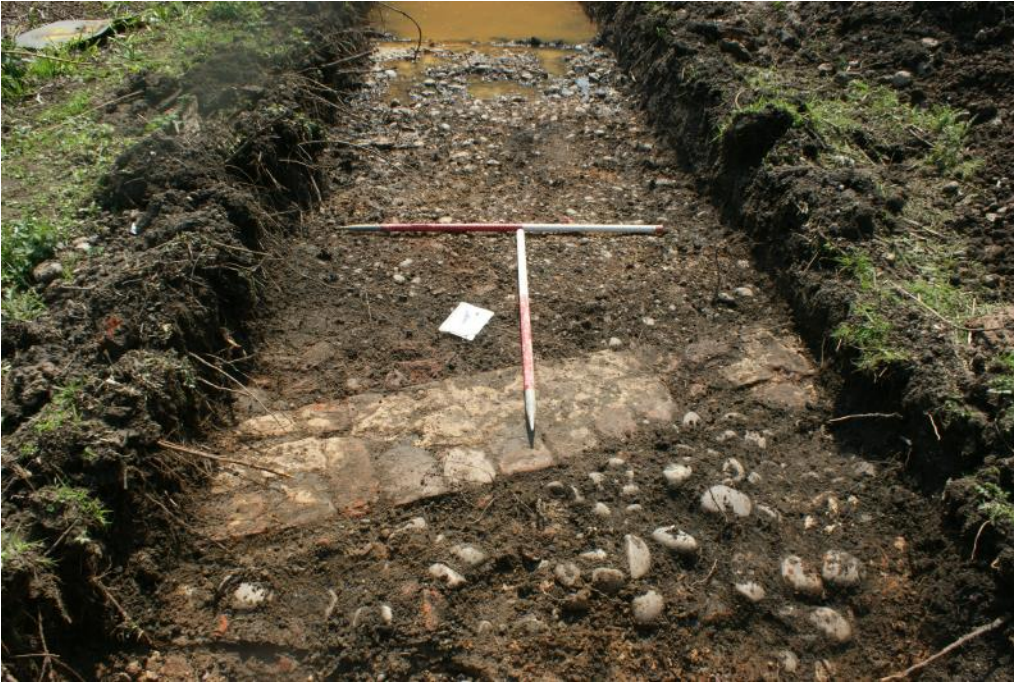
A further wall associated with surfaces was recorded in Trench 1 (Plate 9). The wall (106) was aligned parallel with the bedding trenches and constructed of bricks with dimensions of 240mm by 120mm by 60mm. The surfaces were numbered (104, 105) and comprised of both cobbles and some brick rubble content.

Plate 9 Wall (106) and surfaces (104 and 105), looking south-west

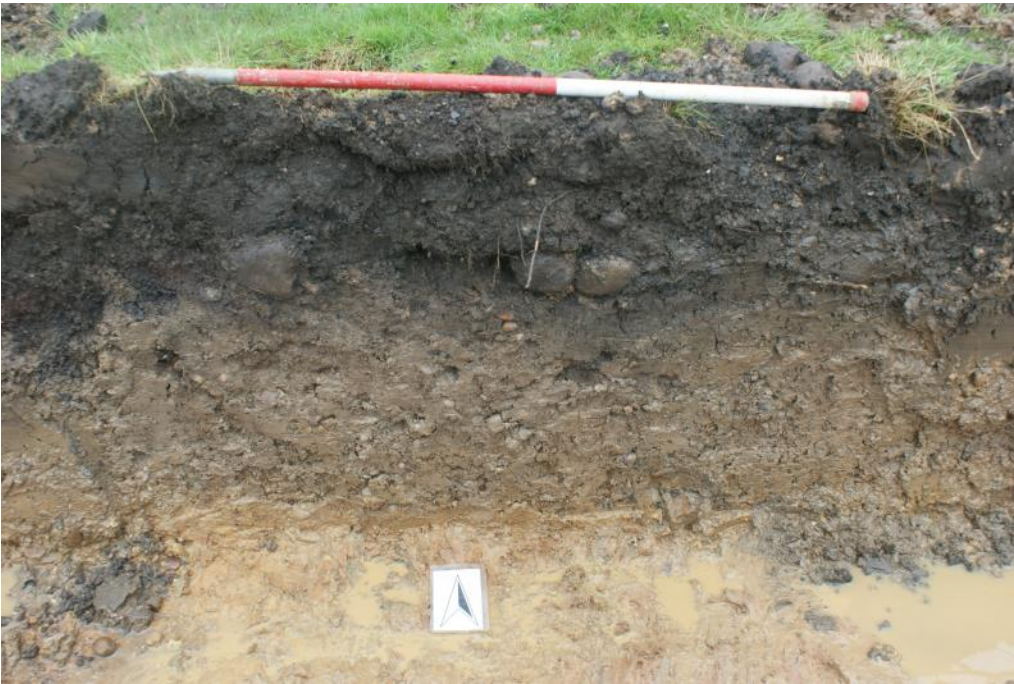
Within Trench 5, a levelling deposit (501) was seen throughout and deepening from 0.21m at the west end to 0.37m at the east end (Plate 10). This formed part of an extant garden terrace and contained a single piece of pottery of medieval date, though this is likely to be residual.

Plate 10 Terrace deposit (501), looking north

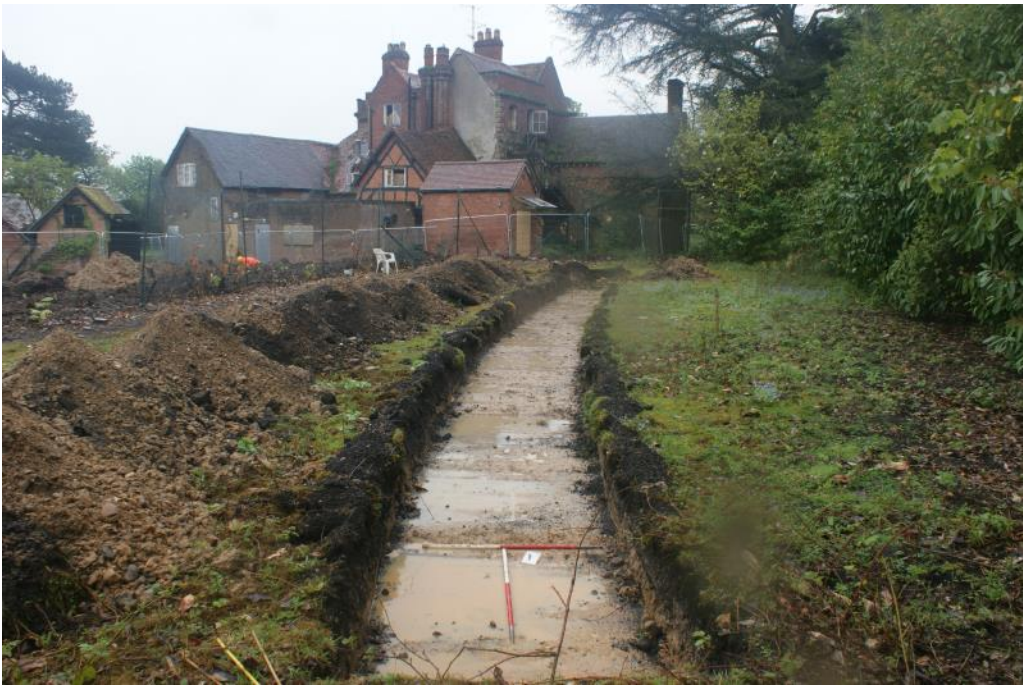
All the trenches excavated contained a number of post-medieval and modern archaeological features excepting Trench 9, where the area had been previously lowered and truncated for a tennis court.

Plate 11 Trench 9 looking south-west
