Building recording at The Granary, St Martins Quarter, Worcester

Status: Version 1
Date: 12th October 2016
Author: Tim Cornah tcornah@worcestershire.gov.uk
Illustrator: Carolyn Hunt chunt@worcestershire.gov.uk
Project reference: P4852
Report reference: 2368
HER reference: WCM102201
Oasis id: fieldsec1-259747

Building recording was required to meet a planning condition relating to the redevelopment of The Granary, St Martins Quarter, Worcester.

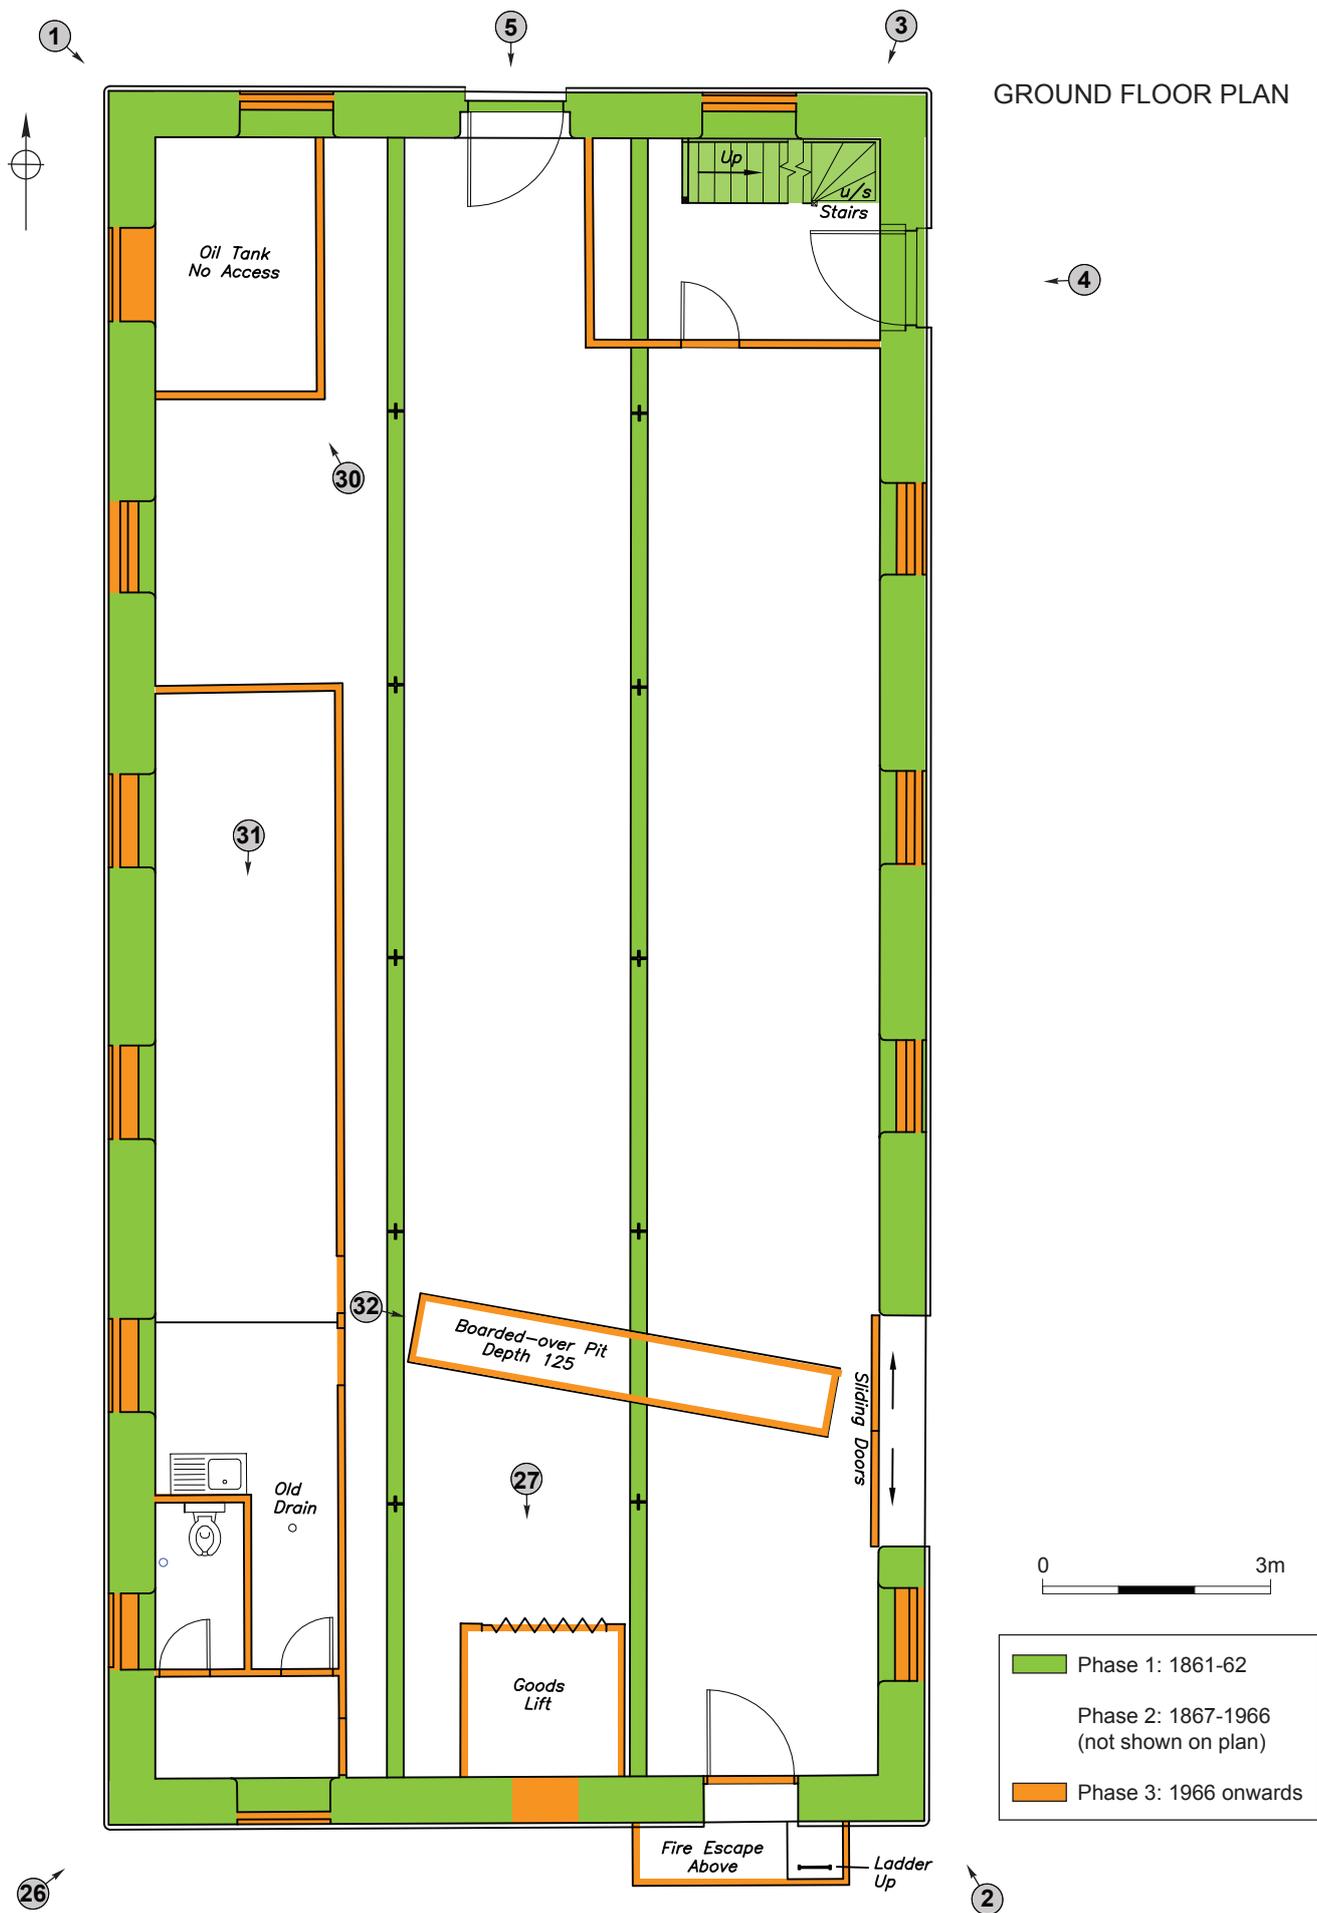
Figure 2

Ground floor plan with phasing and photolocations
(based upon BB Architecture + Planning Dwg. No.011)

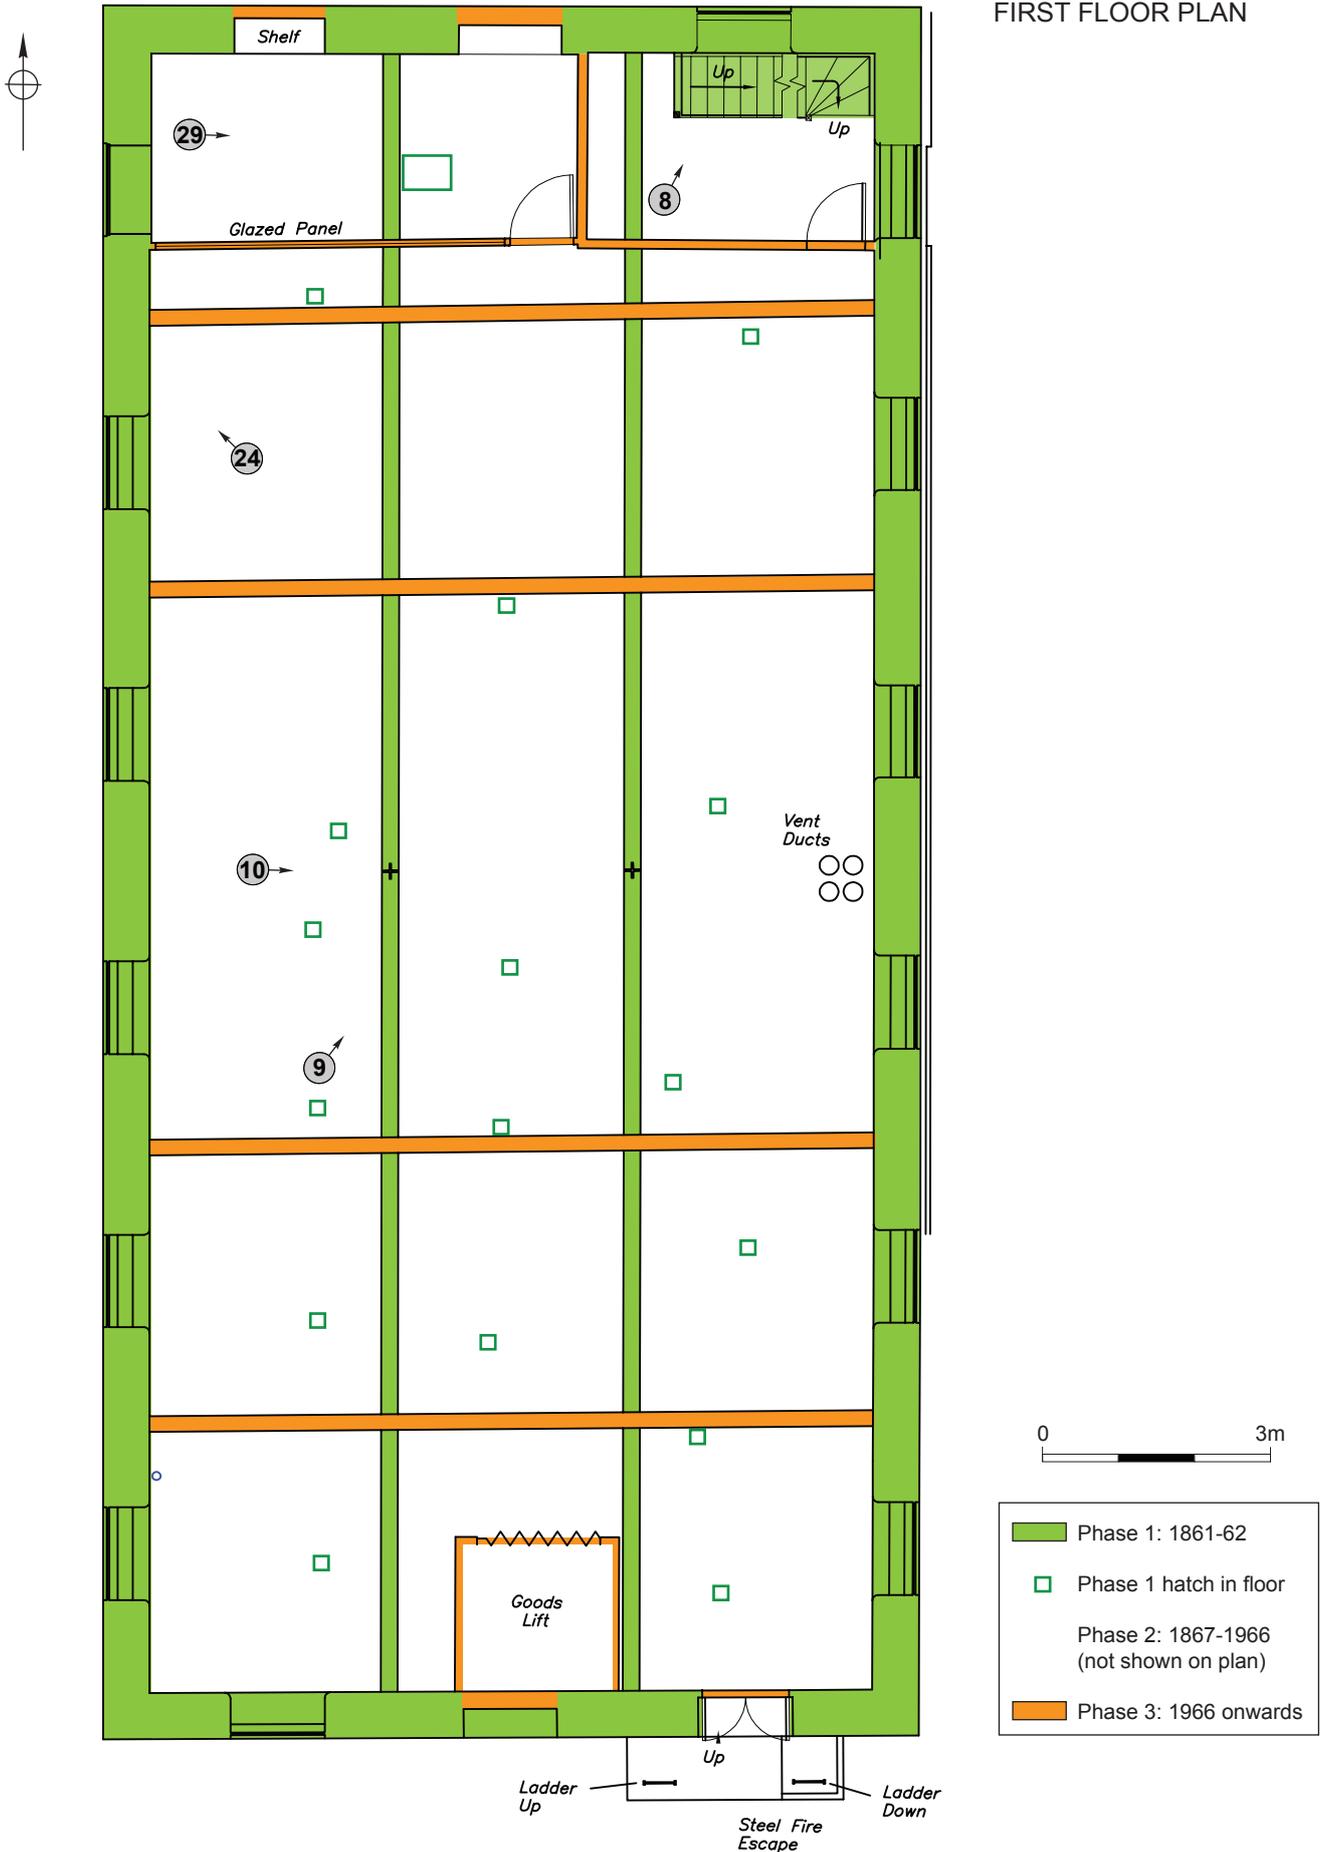
Figure 3

First floor plan with phasing and photolocations
(based upon BB Architecture + Planning Dwg. No.011)

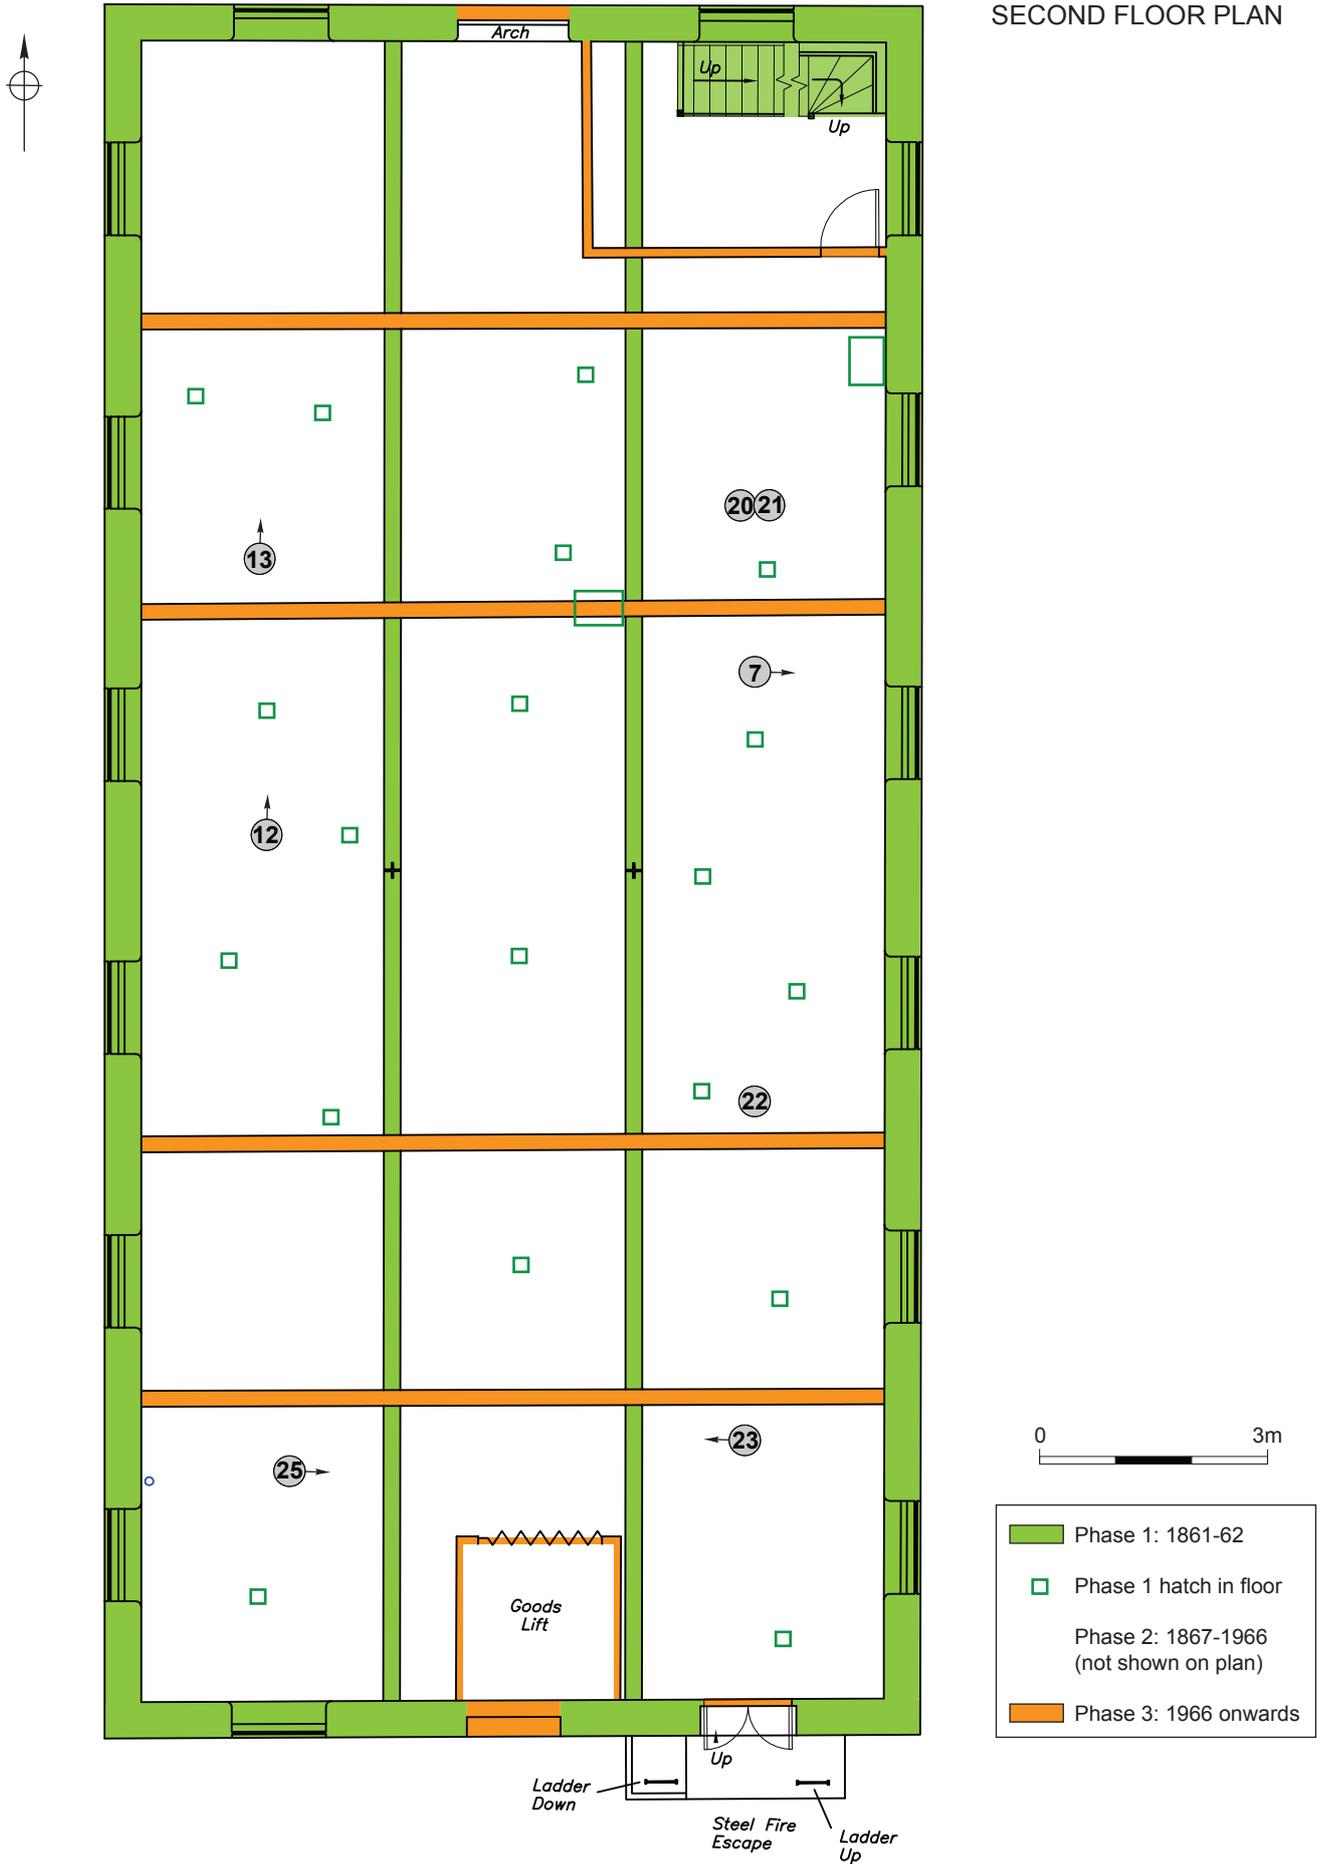
Figure 4

Second floor plan with phasing and photolocations
 (based upon BB Architecture + Planning Dwg. No.011)

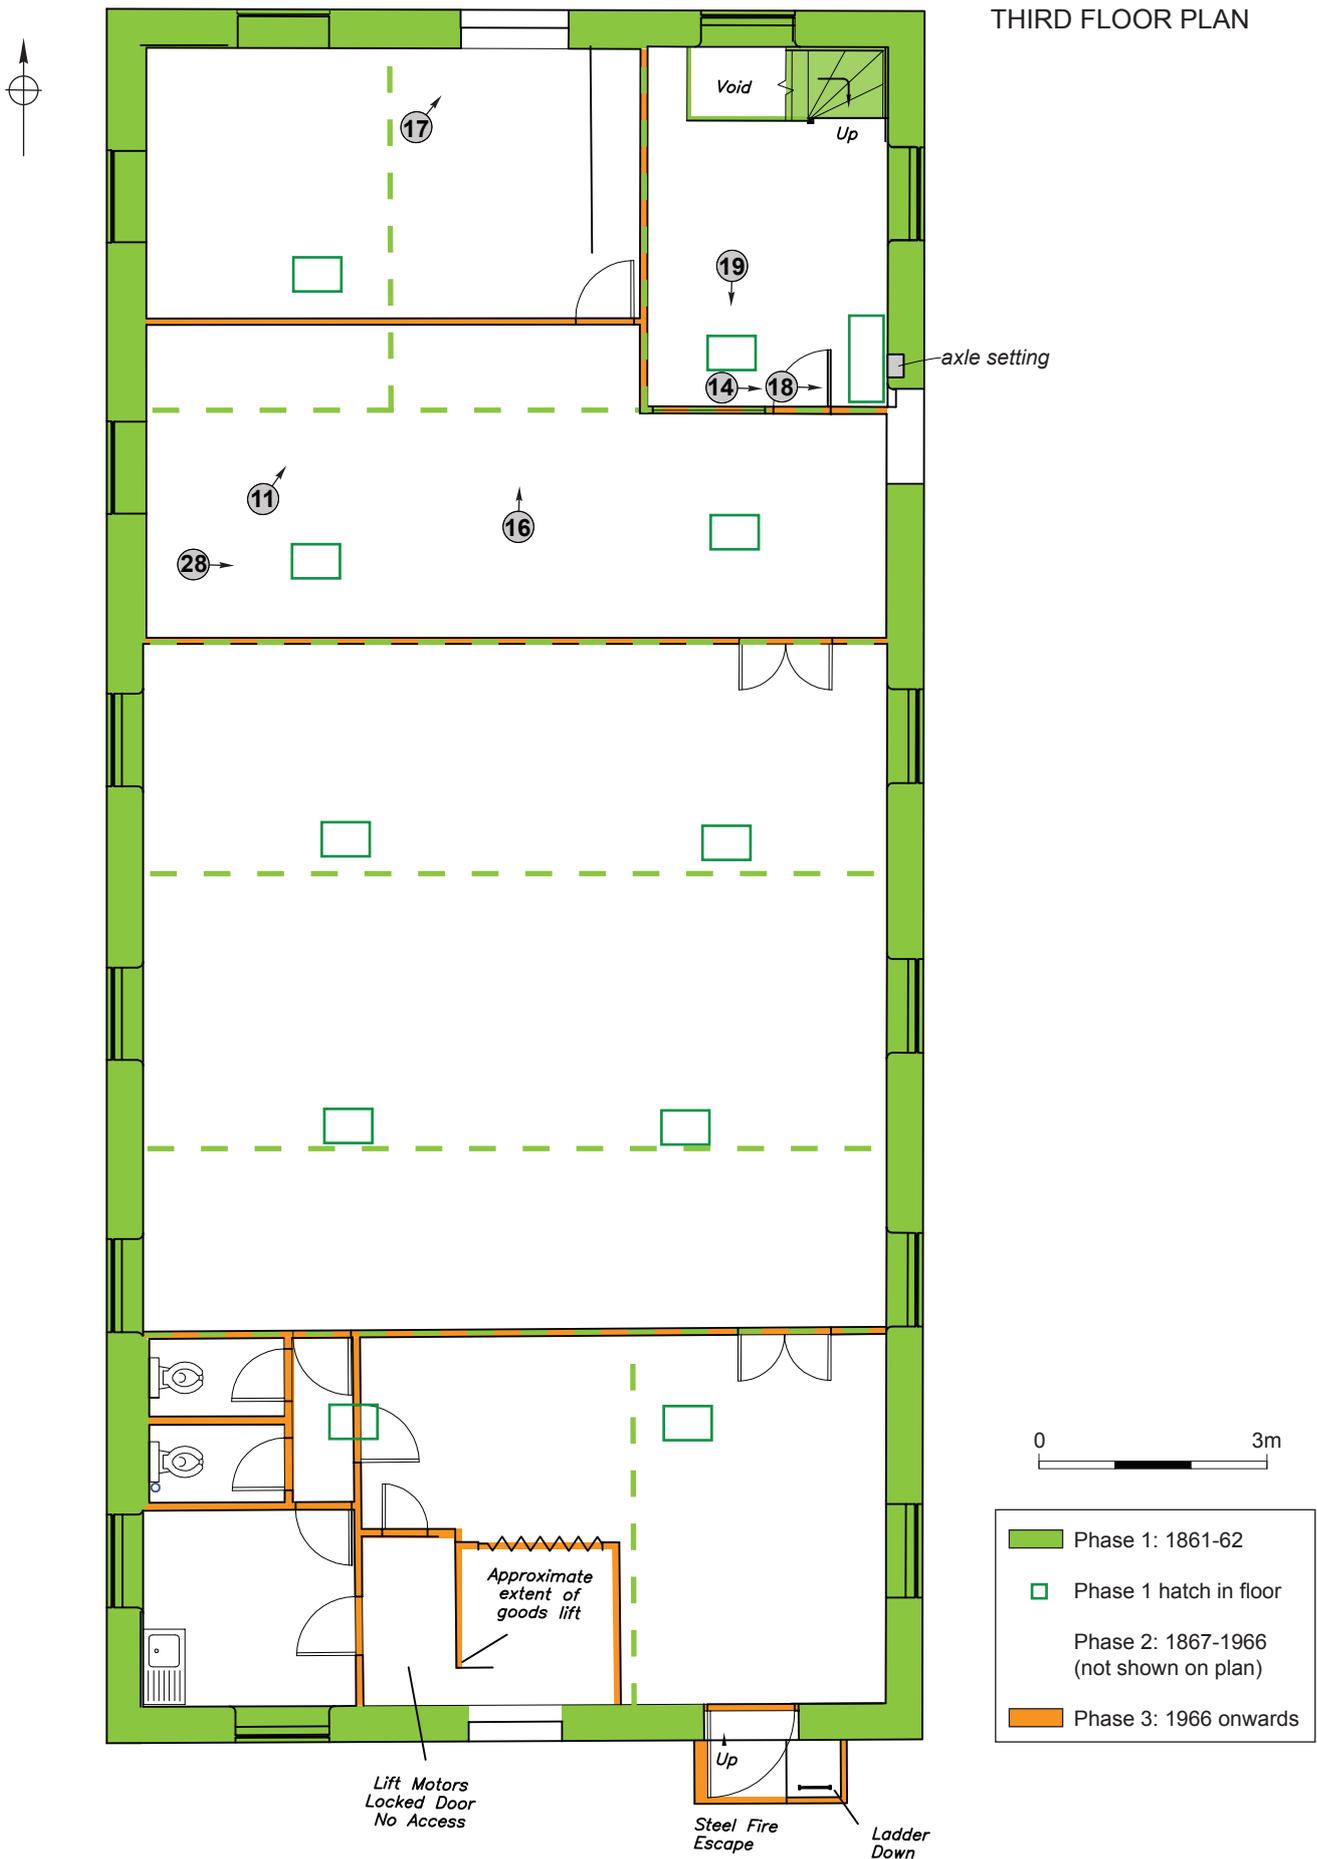
Figure 5

Also on the third floor, a few hatches were visible within the floors (Plate 18 and Plate 19). They were more clearly visible from their underside and are located on (Figure 5). One of these (Plate 20) was marked with the word "barley" in paint. Other paint marks are present but are not

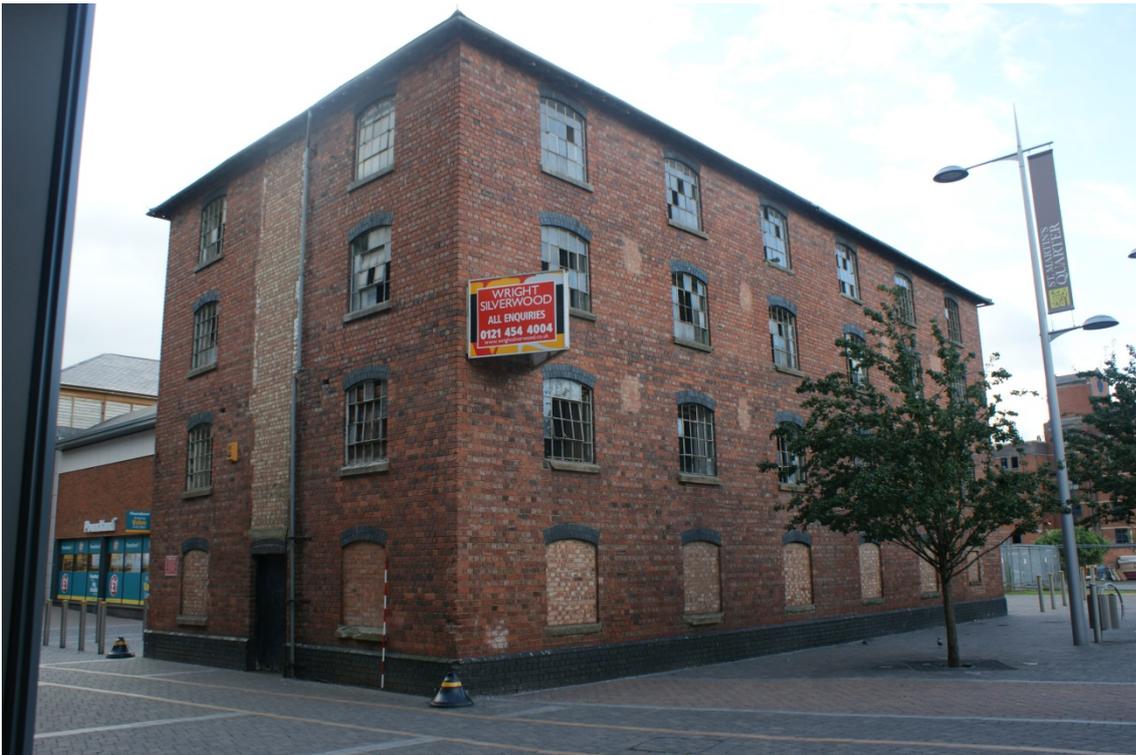
The Granary building was a rectangular brick built structure, had a hipped roof and was built with four floors, as clearly visible from the windows externally (Plate 1 and Plate 2). The brickwork was of English bond with purple engineering bricks used for the both the low foundation sill wall and the segmental arch heads of the windows. A small amount of stone was used within the building of the window sills and stones set into the walls internally used to support the end of structural timbers such as tie beams.

Plate 1 The Granary, looking south-east

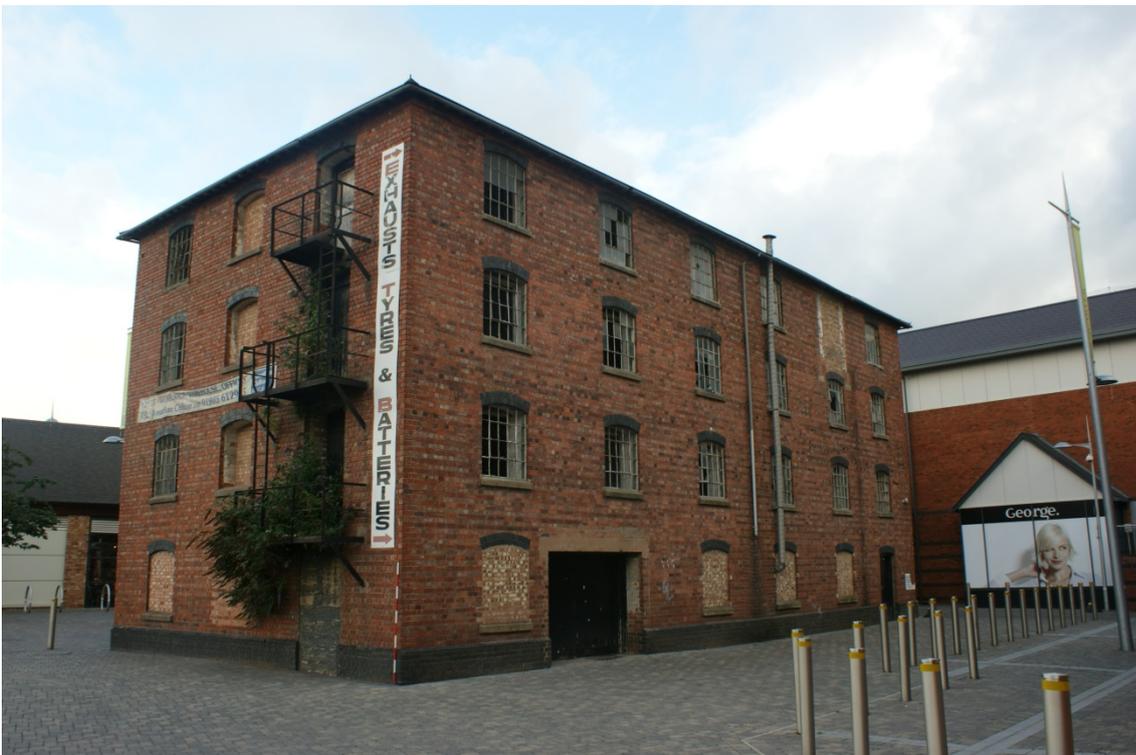
Early within this phase a goods lift was added internally at the southern end of the building (Plate 27) and the earlier hoists presumably removed. A fire escape was added on the south-east corner of the building, with the former windows being cut through for doors. Various internal divisions were erected for offices, work spaces, toilets and storage (Plate 28 to Plate 31), as well as a space separating off the stairs through the full height of the building. On the ground floor, a wide garage doorway was added on the eastern side (Plate 2) and a vehicle inspection pit added (Plate 32).

Plate 2 The Granary, looking north-west

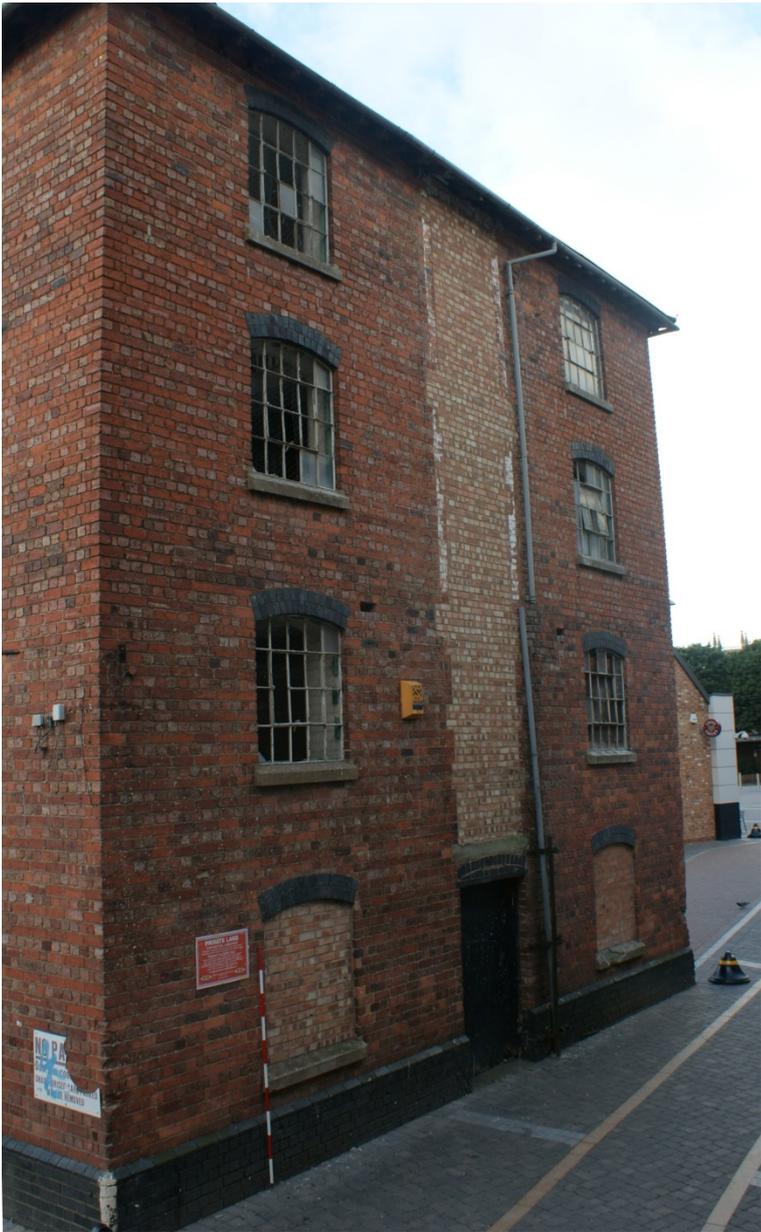
The fenestration was regular around the building, apart from the north elevation which had a central section of replaced brickwork (Plate 3). This is known to have had a wooden structure for hoisting materials. A further such hoist position also existed on the third floor (Plate 4) and was also later blocked. On the northern elevation was a central original door at ground floor level (Plate 5). A further door existed on the north-east corner (Plate 6). The majority of original windows remained and were iron framed with small panes and a centrally opening panel (Plate 7).

Plate 3 The Granary with former central hoist position, looking south-west

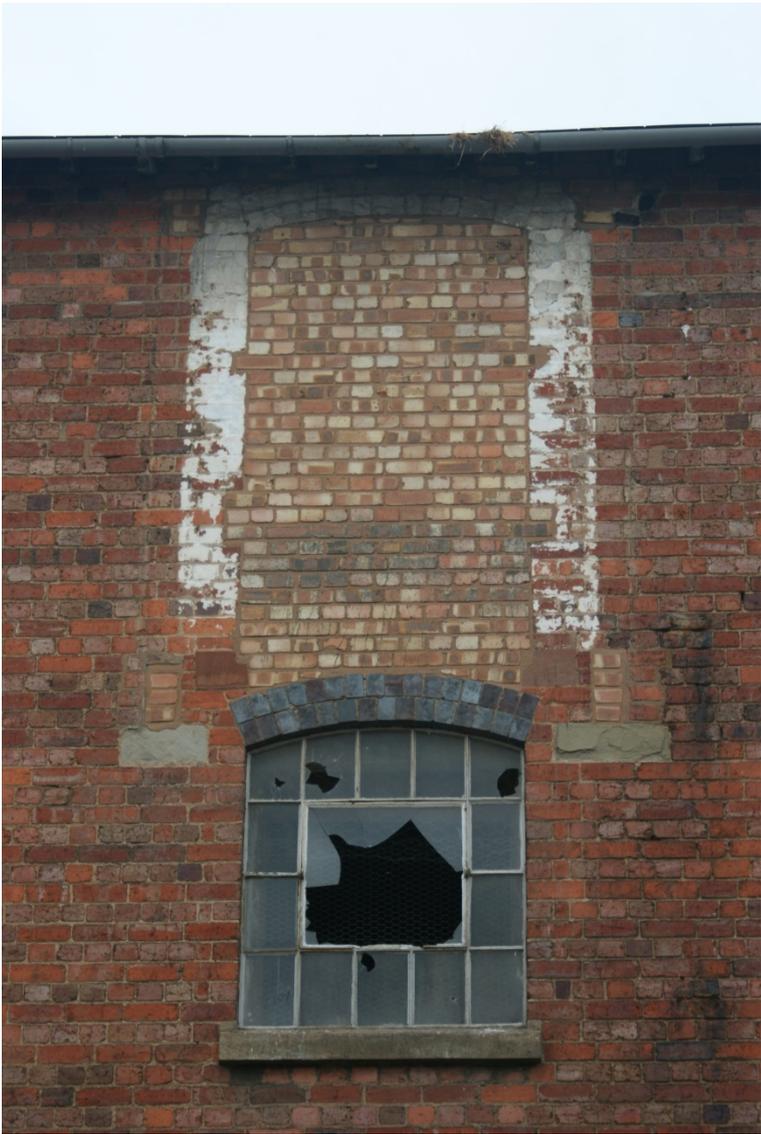
Plate 4 Former hoist position, looking west

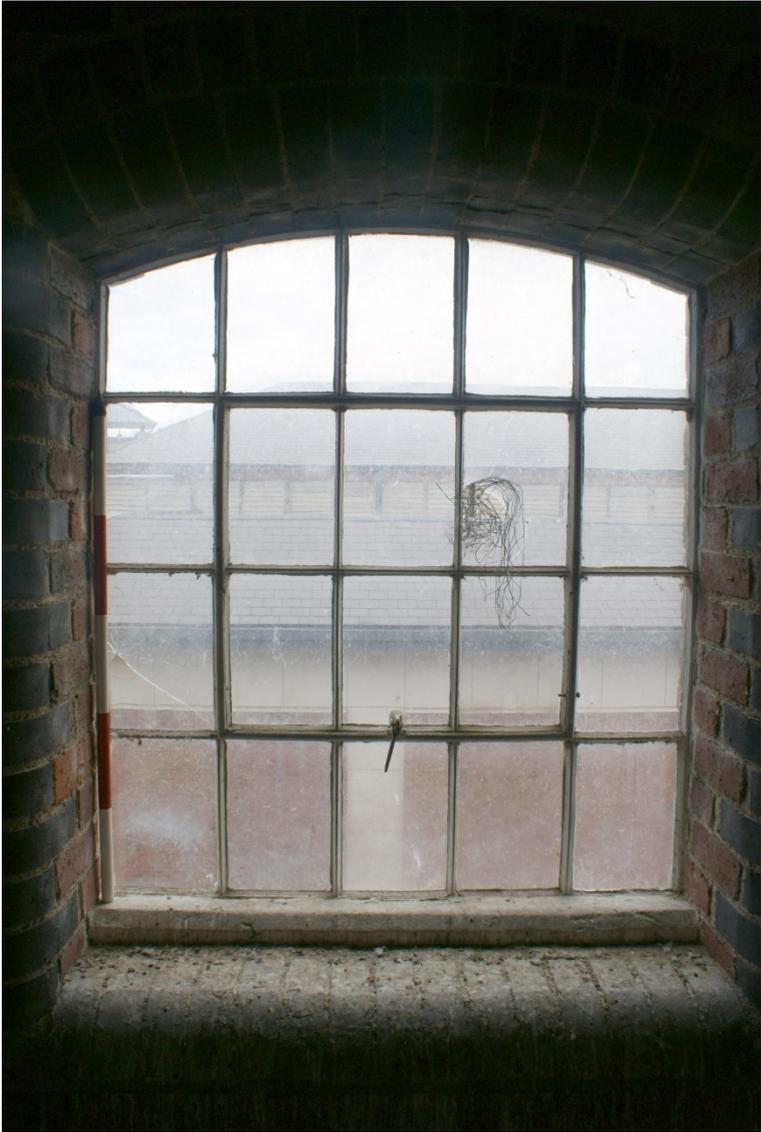
Plate 7 Window example, looking east

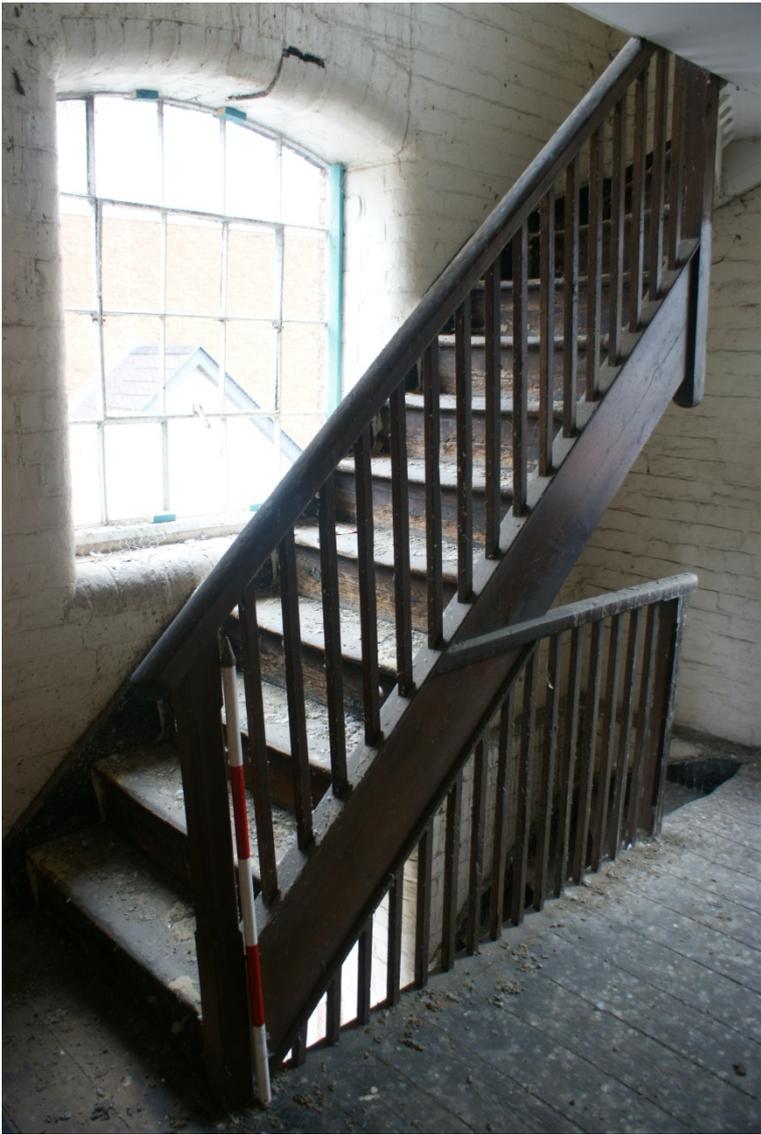
The north-west door led to a staircase which ran the full height of the building (Plate 8). Each floor was supported by two rows of cast iron cruciform posts aligned along the building and in turn supporting beams upon which the floor joists sat (Plate 9 and Plate 10). Many of the cruciform posts were removed within later phases.

Plate 8 Staircase, looking north-east

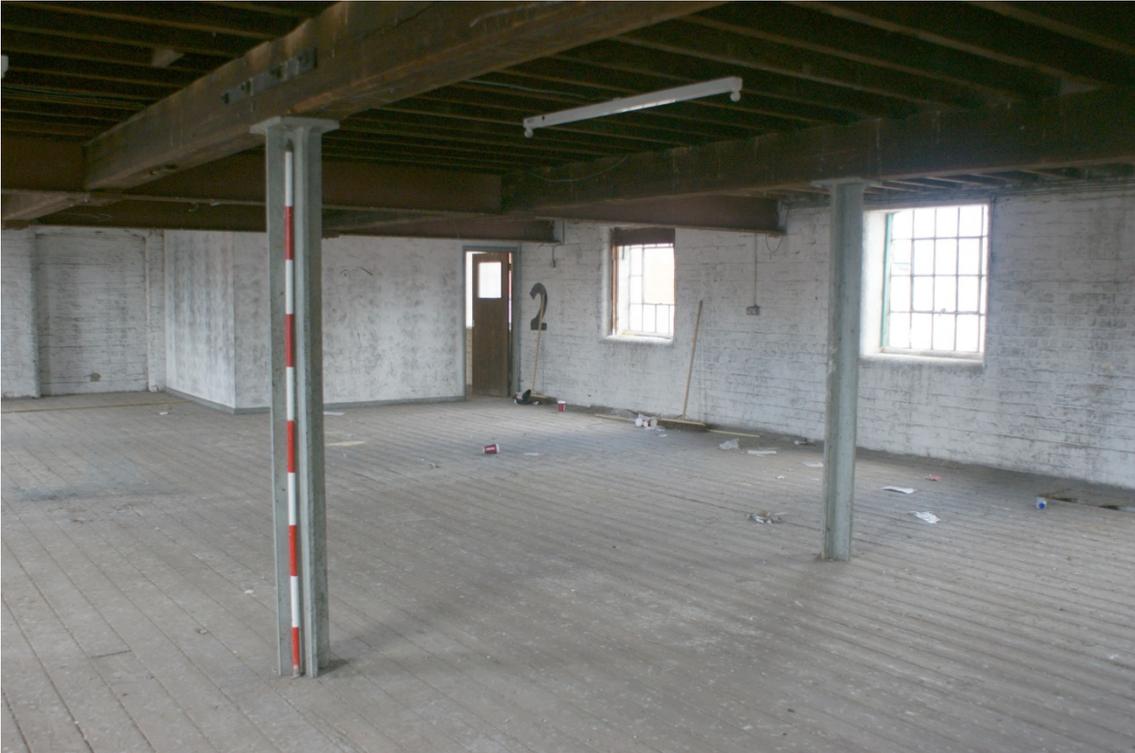
Plate 9 Cruciform posts remaining on the first floor, looking north-east

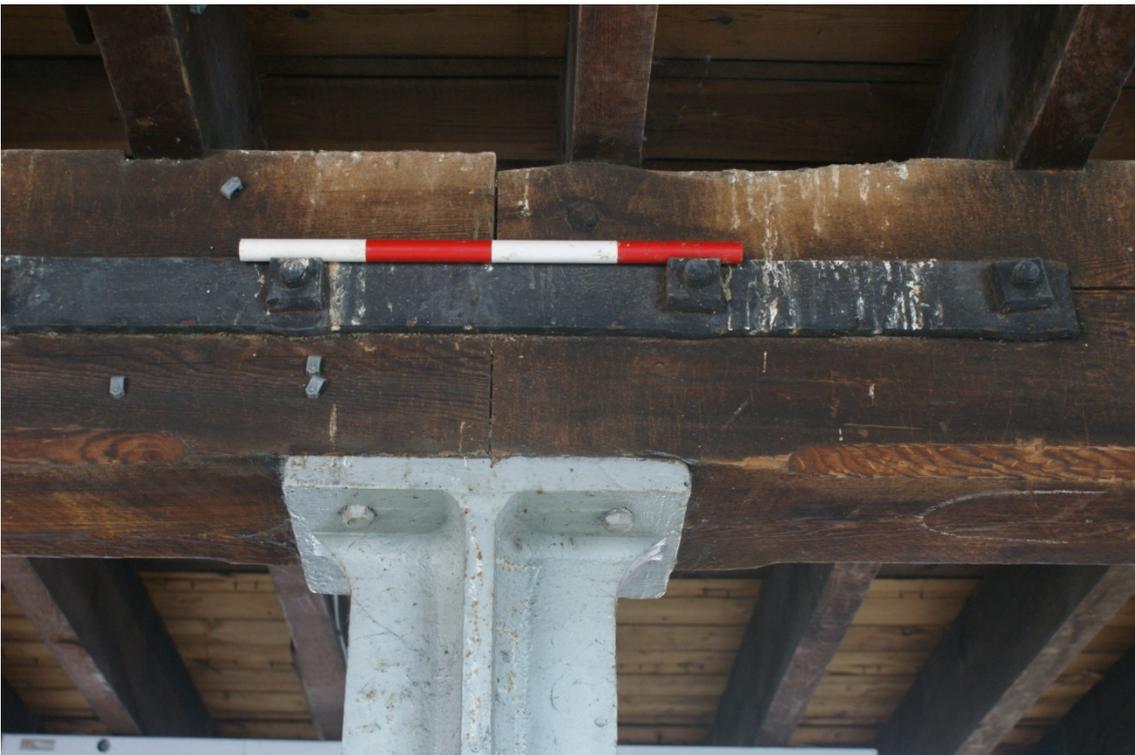
Plate 10 Cruciform posts and joints details with run out chamfers visible on the beams., looking east

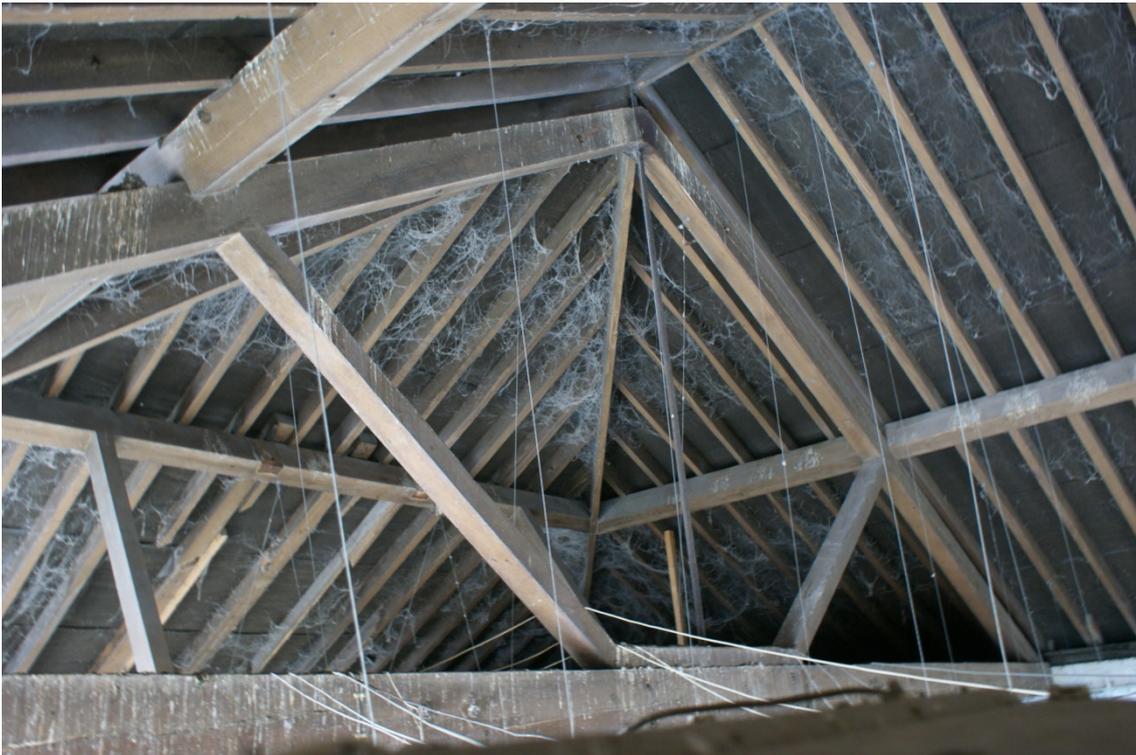
The roof was supported upon five trusses, with the two end trusses having two further longitudinal beams under the hips. The trusses had a central iron tie rod taking the place of a king post and raking queen struts (Plate 11). This truss type was also seen in the Bottom Cooperage, which is thought to have been built at broadly the same time.

Plate 11 Roof truss with tie beam, raking queen struts and central tie rod visible, looking north-east

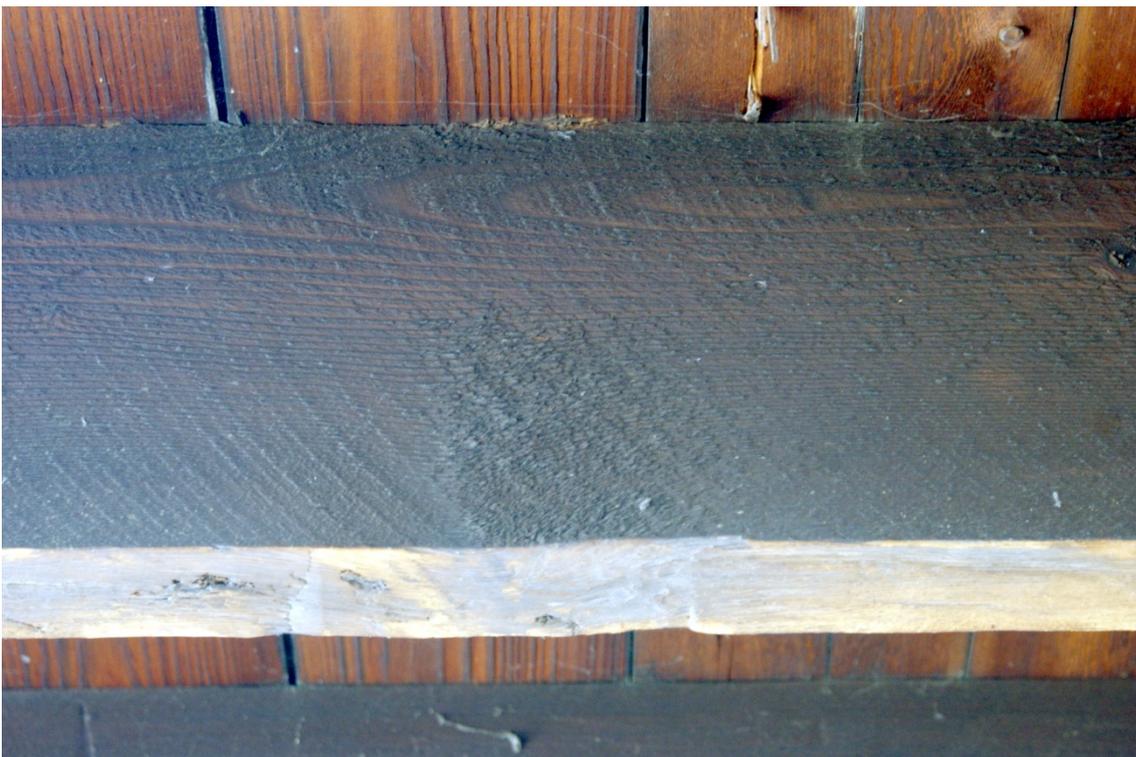
All of the timbers present within the building were of softwood. They had all been converted using a mechanical circular saw (Plate 12), though some timbers showed evidence of being hand hewn. This is likely to have taken place at or before the port of origin, as shown by marks upon the timbers which are widely considered to have been cut onto Baltic softwood before it was shipped (Plate 13).

Plate 12 Evidence of timber conversion by circular saw, looking north

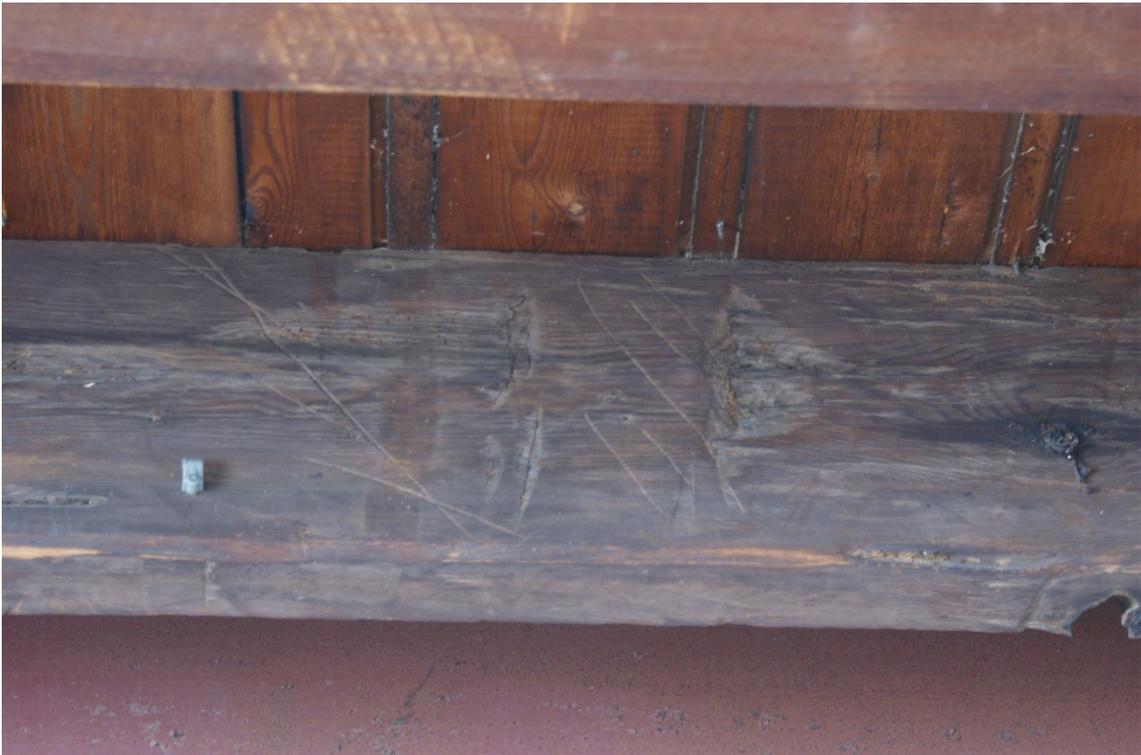
Plate 13 Evidence of timber conversion by hewing and Baltic timber marks, looking north

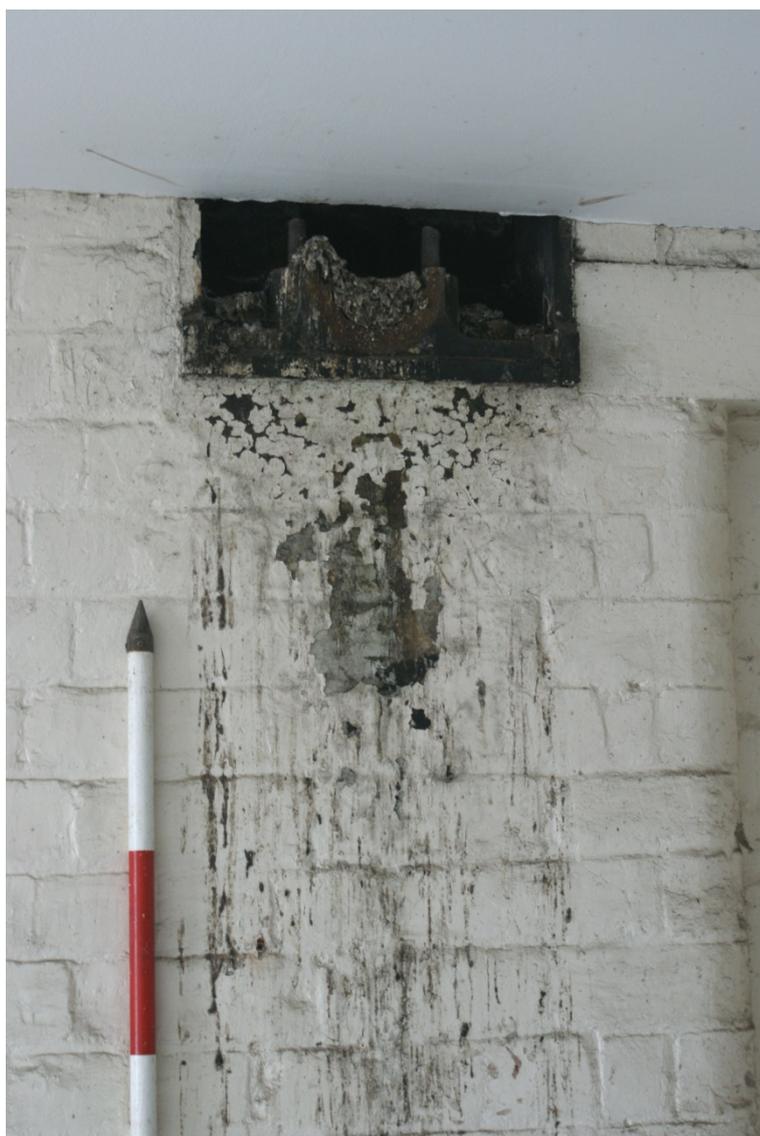
Some clear evidence of the use of the building remained. On the third floor was the setting for an axle in the wall, with the stain of oil running from below it, though most of that visible internally resulted from pigeons using it as a roost (Plate 14). This stain was also visible externally on the north-west corner and clearly showed its position next to a former entrance (Plate 15). The historic mapping would suggest that this was a former raised walkway. On the tie beam of the closest roof truss there was evidence for the former position of a machine or part of a mechanism (Plate 16). This was central and aligned with the former hoist position on the northern side. Above the blocked hoist entrance was a cross beam with two further beams mortised into it (Plate 17). These were clearly part of the removed hoist structure and were also seen on lower floors.

Plate 14 Former machine axle position, looking east

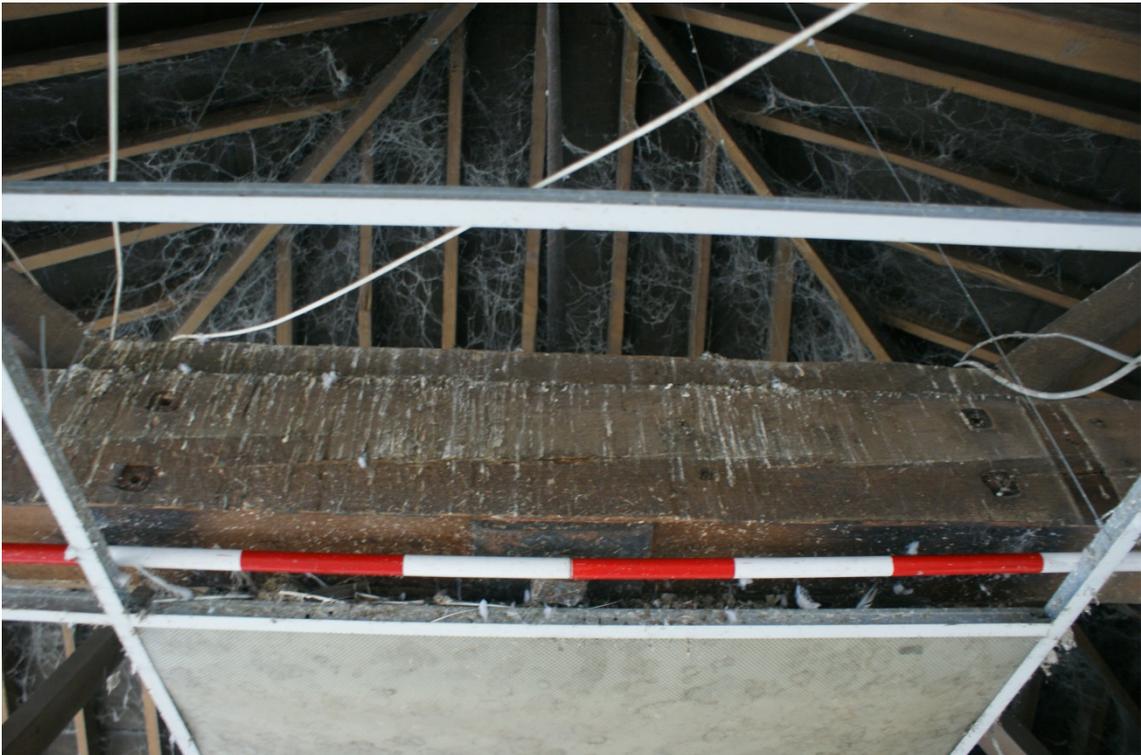
Plate 16 Evidence of a former machine position on the tie beam, looking north
