Building recording at The Granary, St Martins Quarter, Worcester

Status: Version 1
Date: 12th October 2016
Author: Tim Cornah tcornah@worcestershire.gov.uk
Illustrator: Carolyn Hunt chunt@worcestershire.gov.uk
Project reference: P4852
Report reference: 2368
HER reference: WCM102201
Oasis id: fieldsec1-259747

Building recording was required to meet a planning condition relating to the redevelopment of The Granary, St Martins Quarter, Worcester.

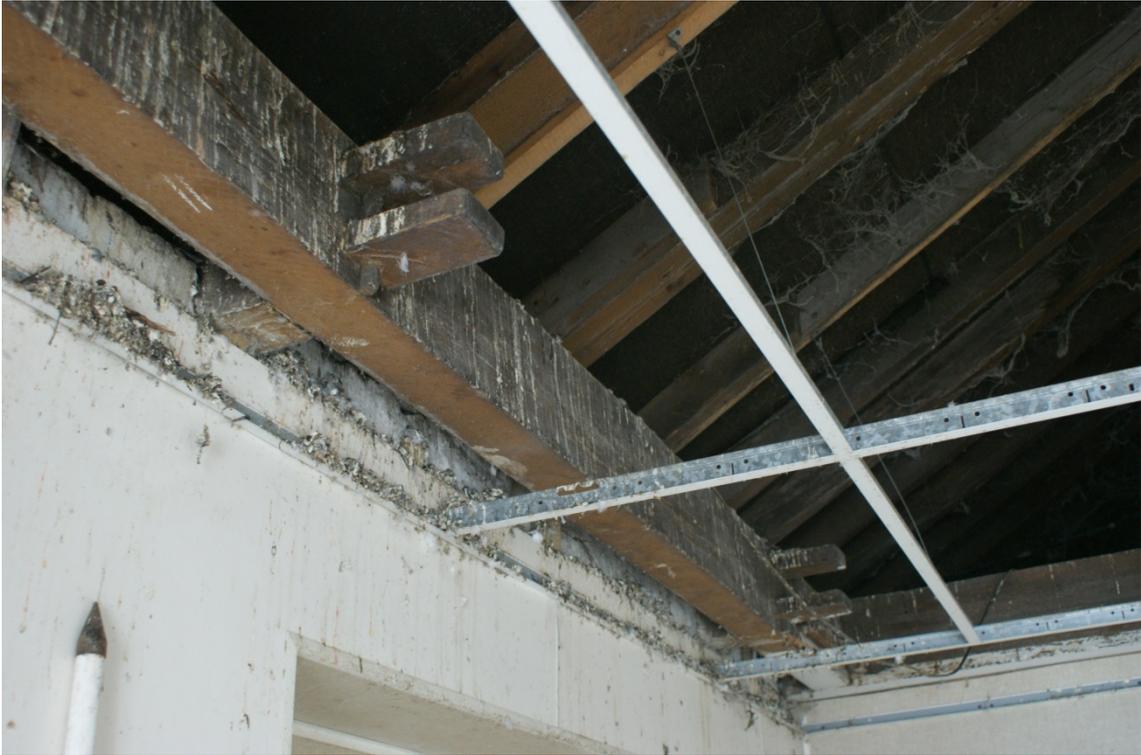
Some clear evidence of the use of the building remained. On the third floor was the setting for an axle in the wall, with the stain of oil running from below it, though most of that visible internally resulted from pigeons using it as a roost (Plate 14). This stain was also visible externally on the north-west corner and clearly showed its position next to a former entrance (Plate 15). The historic mapping would suggest that this was a former raised walkway. On the tie beam of the closest roof truss there was evidence for the former position of a machine or part of a mechanism (Plate 16). This was central and aligned with the former hoist position on the northern side. Above the blocked hoist entrance was a cross beam with two further beams mortised into it (Plate 17). These were clearly part of the removed hoist structure and were also seen on lower floors.

Plate 17 Jointing for the former hoist, looking north-east

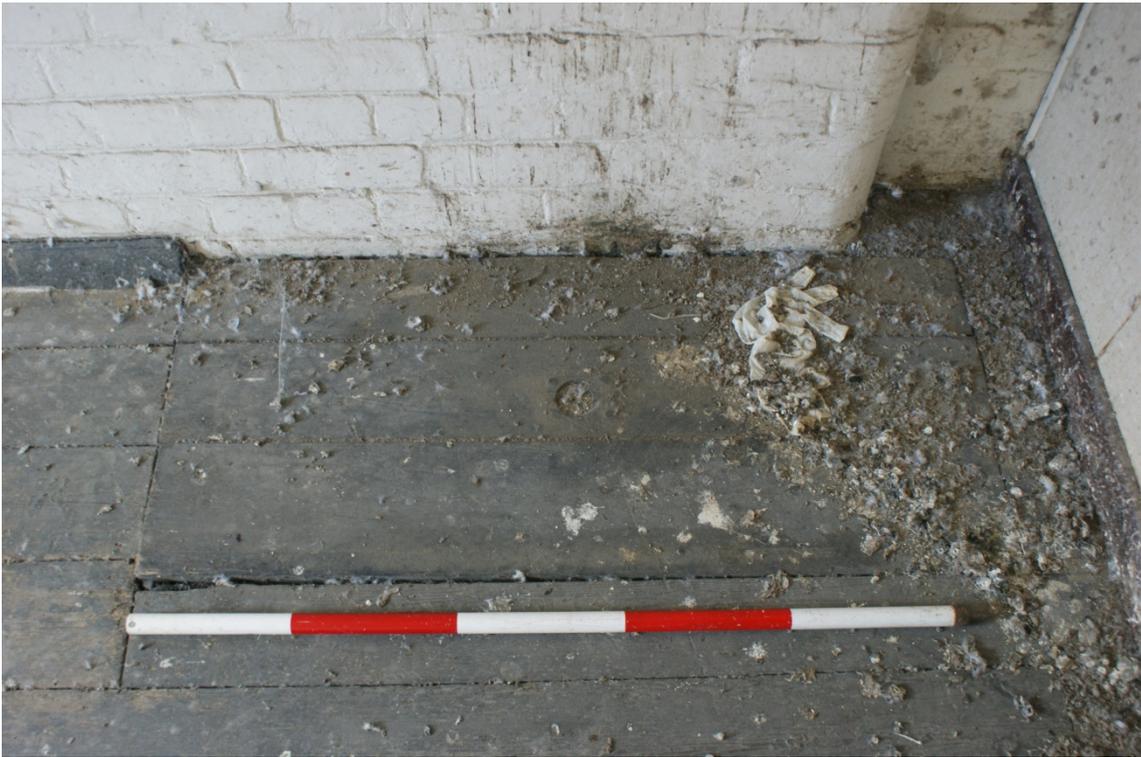
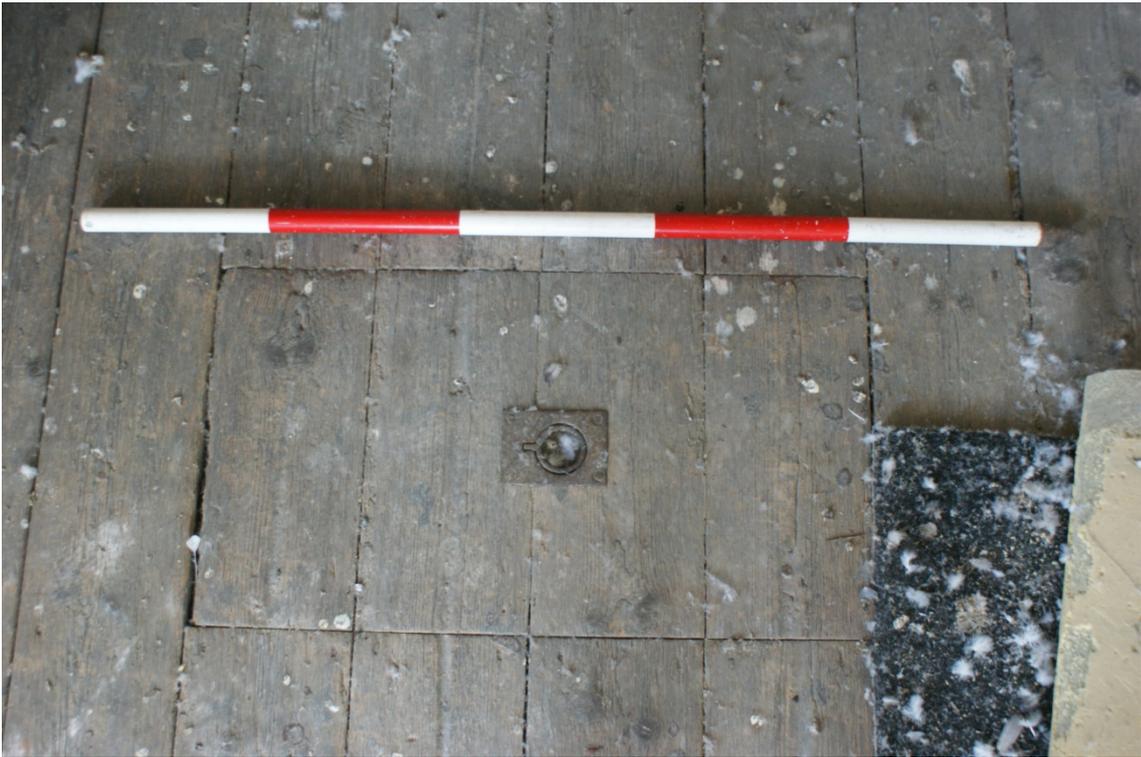
Also on the third floor, a few hatches were visible within the floors (Plate 18 and Plate 19). They were more clearly visible from their underside and are located on (Figure 5). One of these (Plate 20) was marked with the word "barley" in paint. Other paint marks are present but are not

Plate 18 Floor hatch, looking east

Plate 19 Floor hatch, looking south

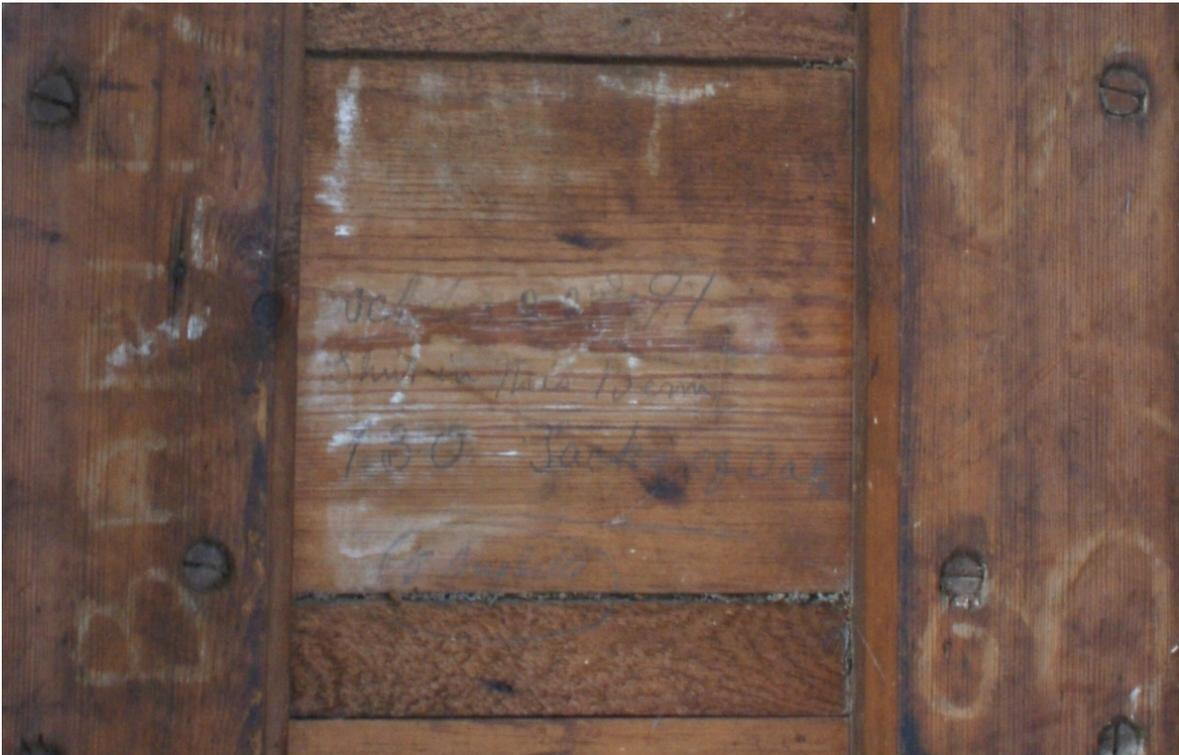
decipherable. A closer view (Plate 21) shows words in pencil. The word appears to be "October" and the last characters of the line make the number 91. The third line clearly says "130 sacks of oats". Further writing was visible on other such hatches, though none were clear (Plate 22 and Plate 23). There were in total 10 such hatches with a slightly larger one next to the hoist position.

Plate 21 Writing detail on the floor hatch, looking vertically

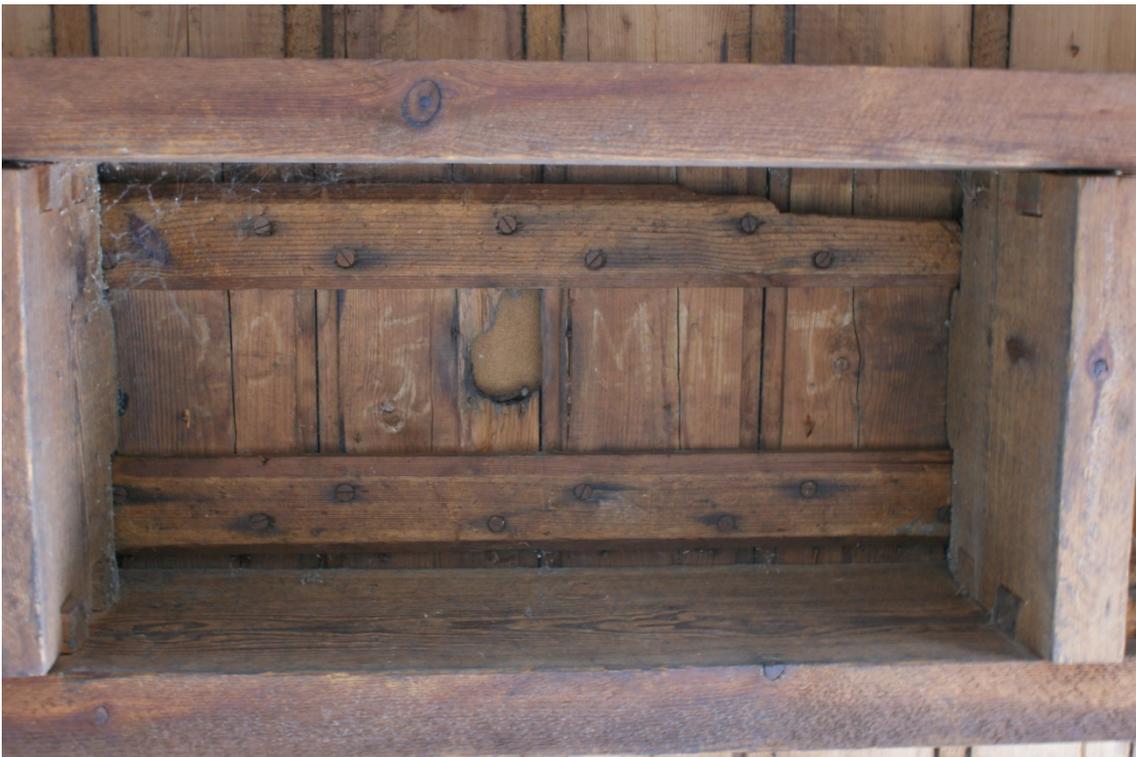
Plate 22 Floor hatch possibly with the word Malt written on the right, looking vertically

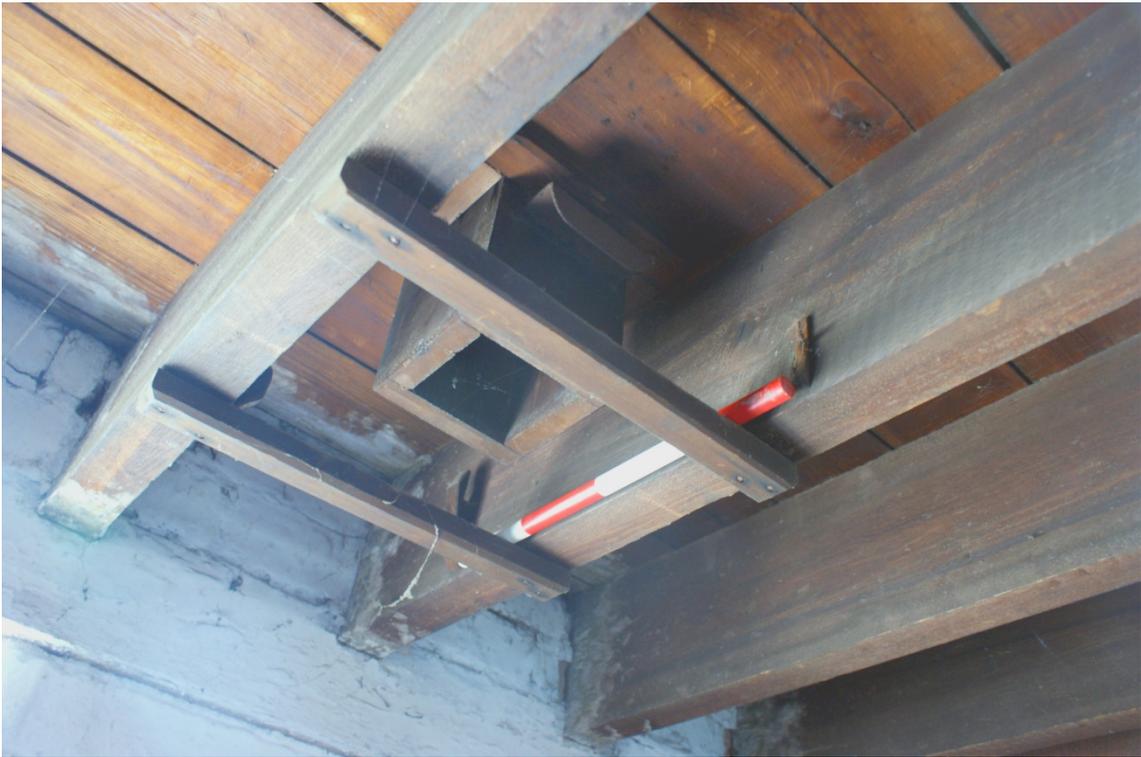
The first and second floors also had holes in them. These were not clearly visible from above as they had been covered over or patch repaired later, but the underside of many of them had small rectangular structures below, complete with a metal plate in order to control the flow of that passing through (Plate 24). The function of the bars and wooden hooks was not obvious, but may have related to bagging the crop as it came through. There were at least 20 such features through the second floor and at least 18 through the first floor. Some may have been removed by later alterations. A larger hole or chute was visible on both the first and second floors, but the boards had been replaced above them so little could be said of their function.

Plate 24 Example of a former chute as seen on the bottom of the ground and 1st floors, looking north-west

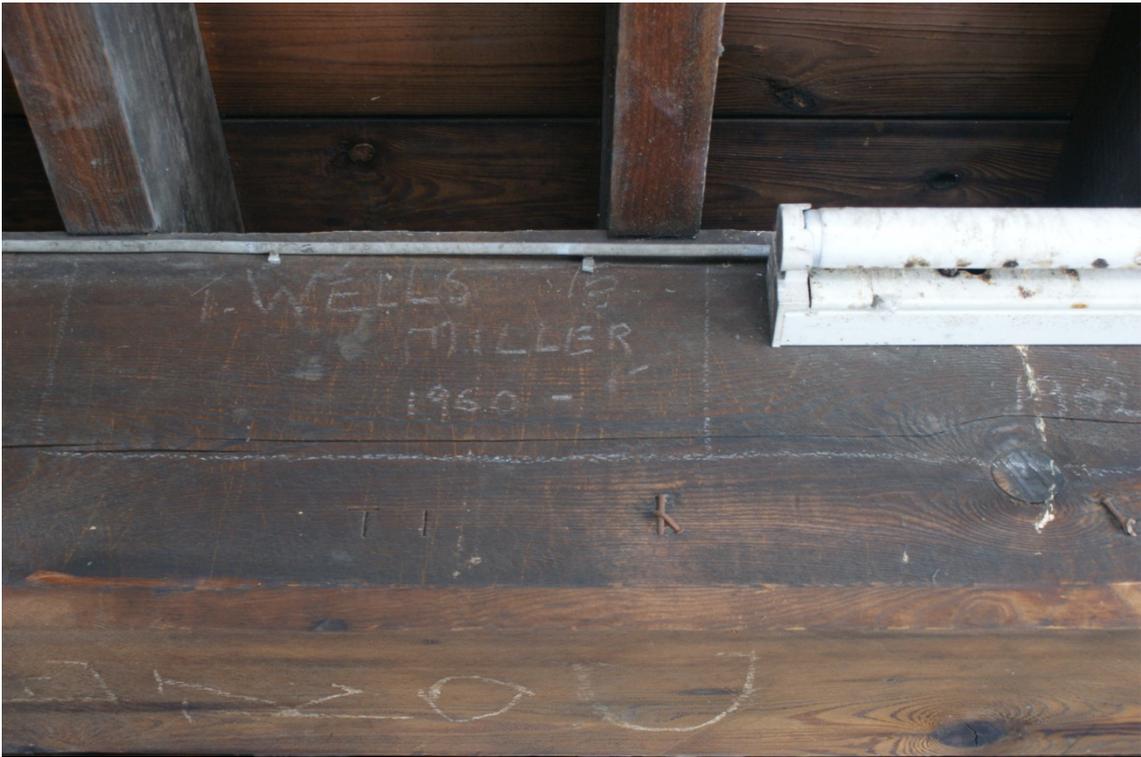
The building was certainly used in 1960 as seen by the inscription of "T.Wells miller 1960" (Plate 25) with a further date of 1962 visible next to it.

Plate 25 Graffiti on a Phase 1 beam, looking east

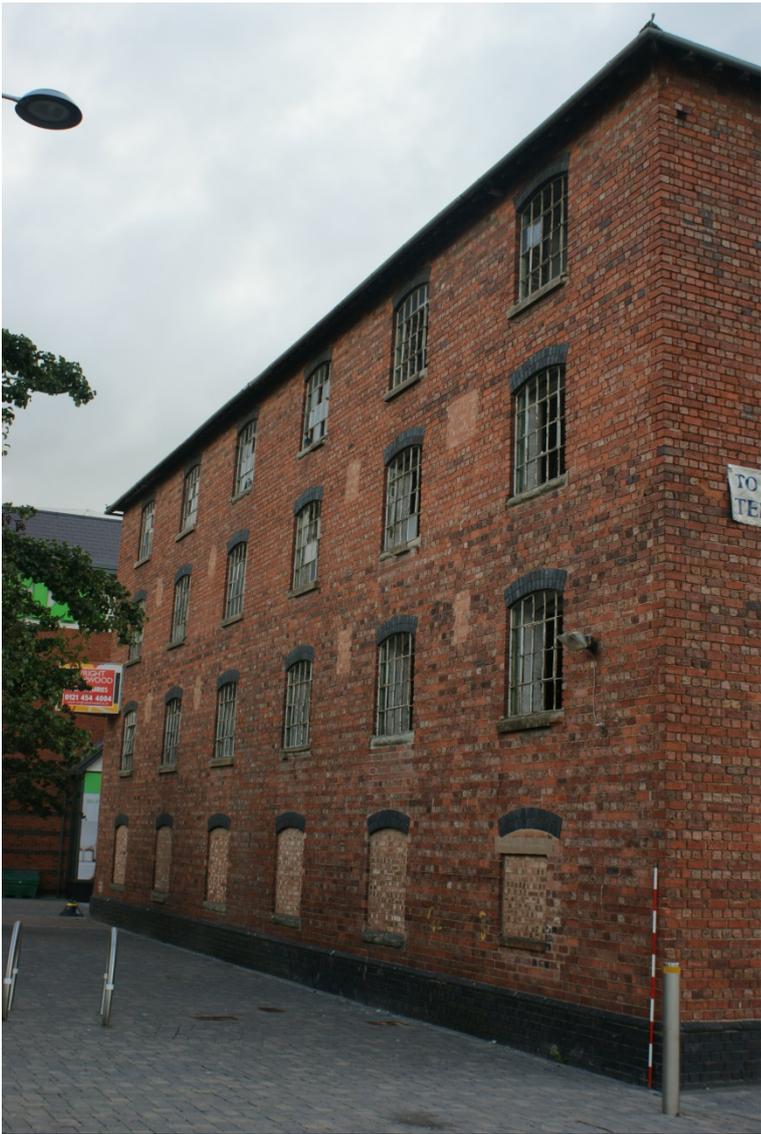
One major change soon into this phase was the clearing of many of the cruciform post on the first and second floors in order to create a less interrupted space. This was achieved by the insertion of new steel joists across the building. To this end, eight holes were cut through the western elevation (Plate 26) and the joists passed through, presumably by crane. The joists rested in the walls at these positions on these sides and the holes blocked. Some graffiti on these joists confirms they were in place by the 1970s.

Plate 26 Holes for the insertion of joists visible on the western elevation, looking north-east

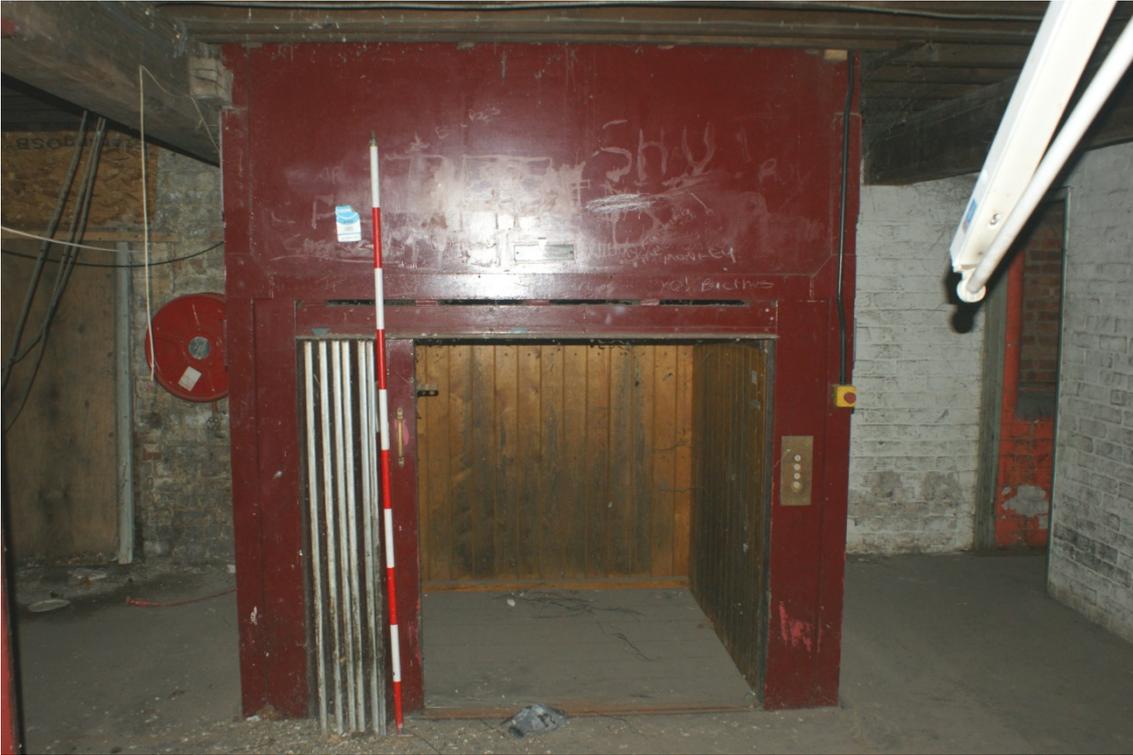
Early within this phase a goods lift was added internally at the southern end of the building (Plate 27) and the earlier hoists presumably removed. A fire escape was added on the south-east corner of the building, with the former windows being cut through for doors. Various internal divisions were erected for offices, work spaces, toilets and storage (Plate 28 to Plate 31), as well as a space separating off the stairs through the full height of the building. On the ground floor, a wide garage doorway was added on the eastern side (Plate 2) and a vehicle inspection pit added (Plate 32).

Plate 27 Inserted goods elevator, looking south

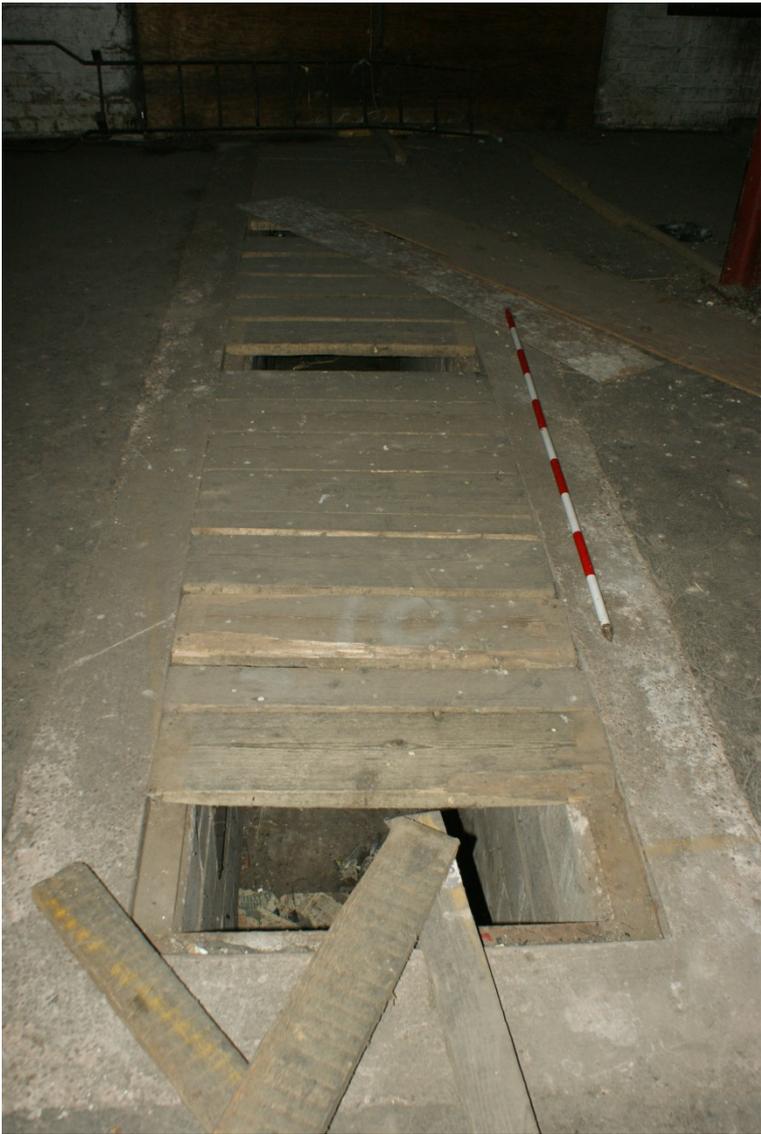
Plate 32 Vehicle inspection pit in the ground floor, looking south-east
