Building recording at Obelisk Farm, Hockley Heath, Warwickshire

Status: Version 1
Date: 10th August 2016
Author: Tim Cornah tcornah@worcestershire.gov.uk
Illustrator: Carolyn Hunt chunt@worcestershire.gov.uk
Project reference: P4720
Report reference: 2306
Oasis id: fieldsec1-259774

Building recording at Obelisk Farm, Hockley Heath, Solihull

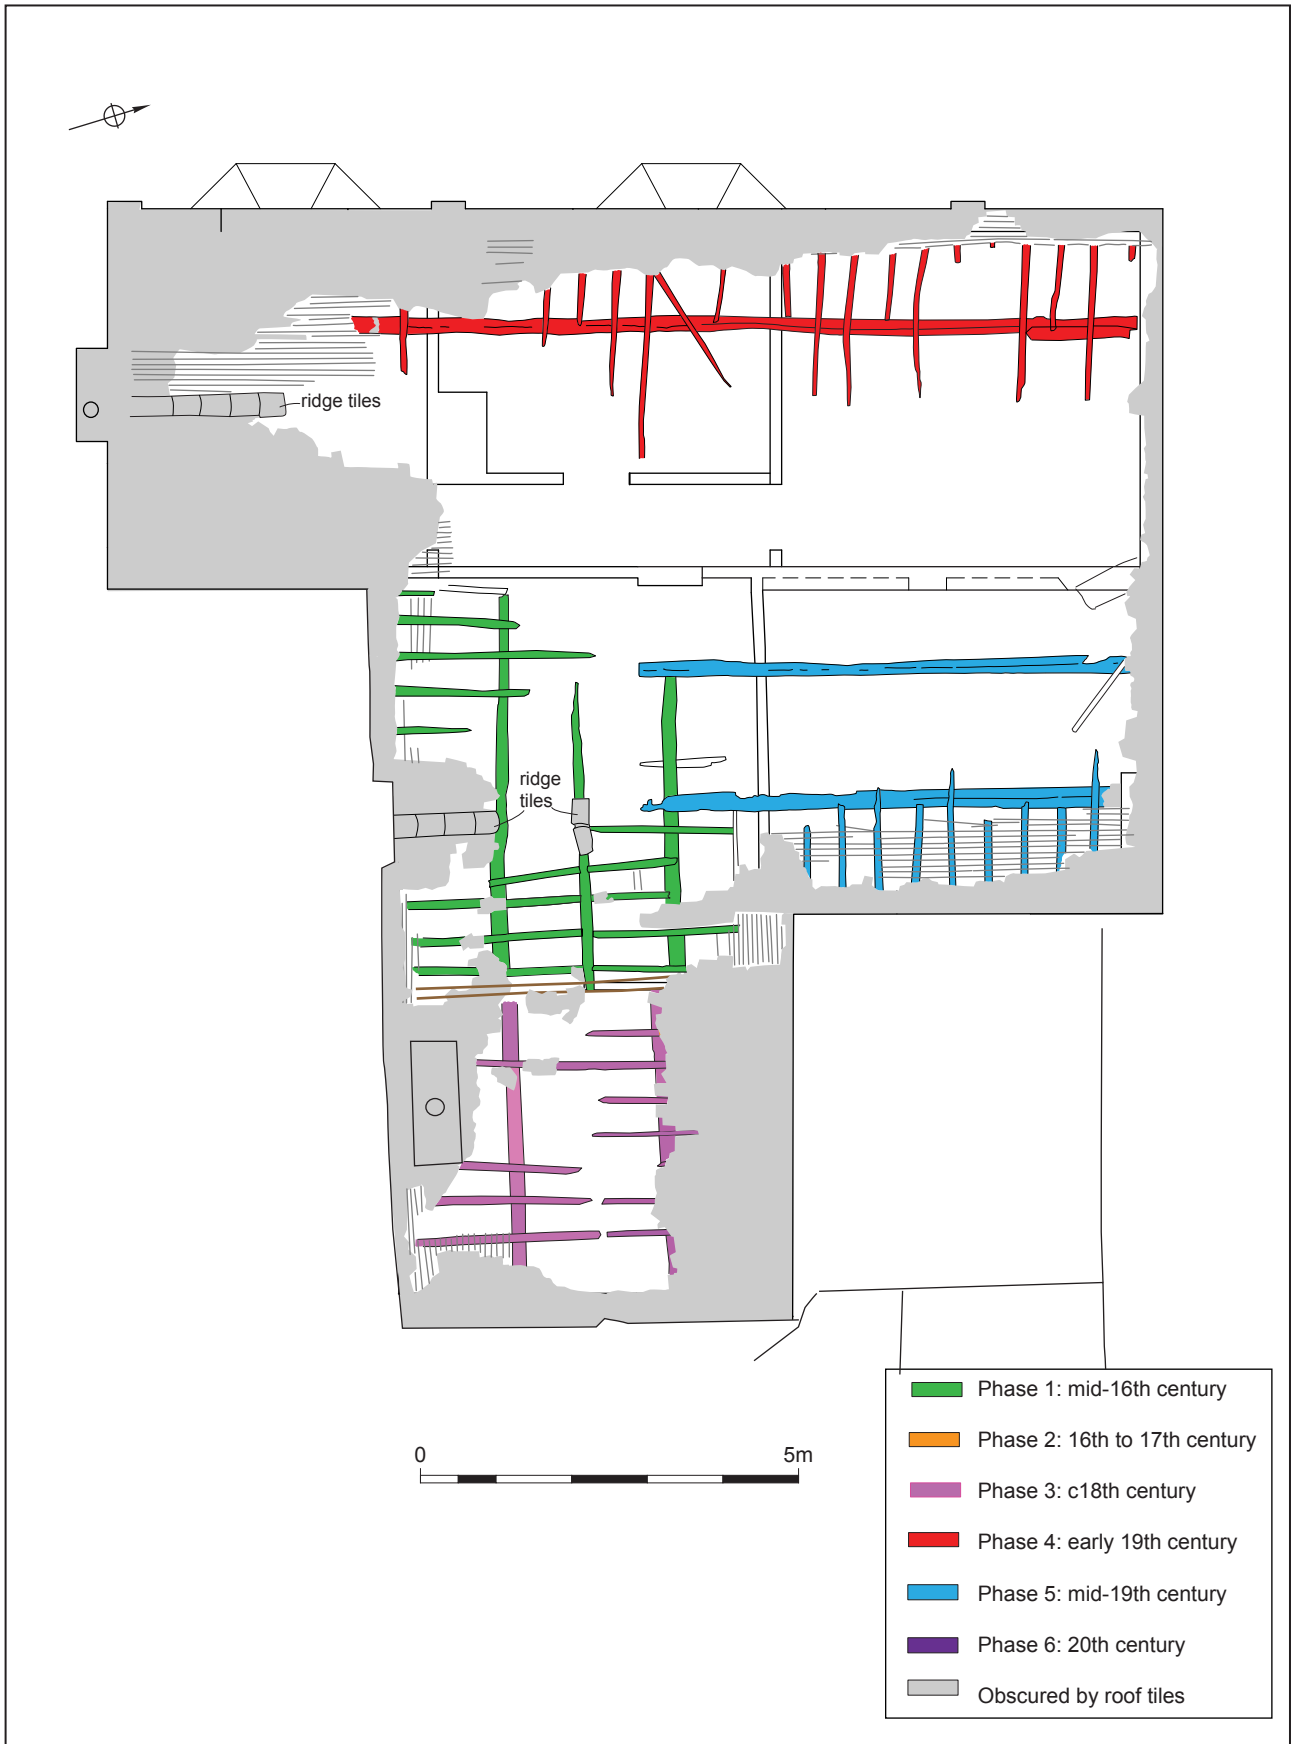
Figure 3

Plan of roof timbers

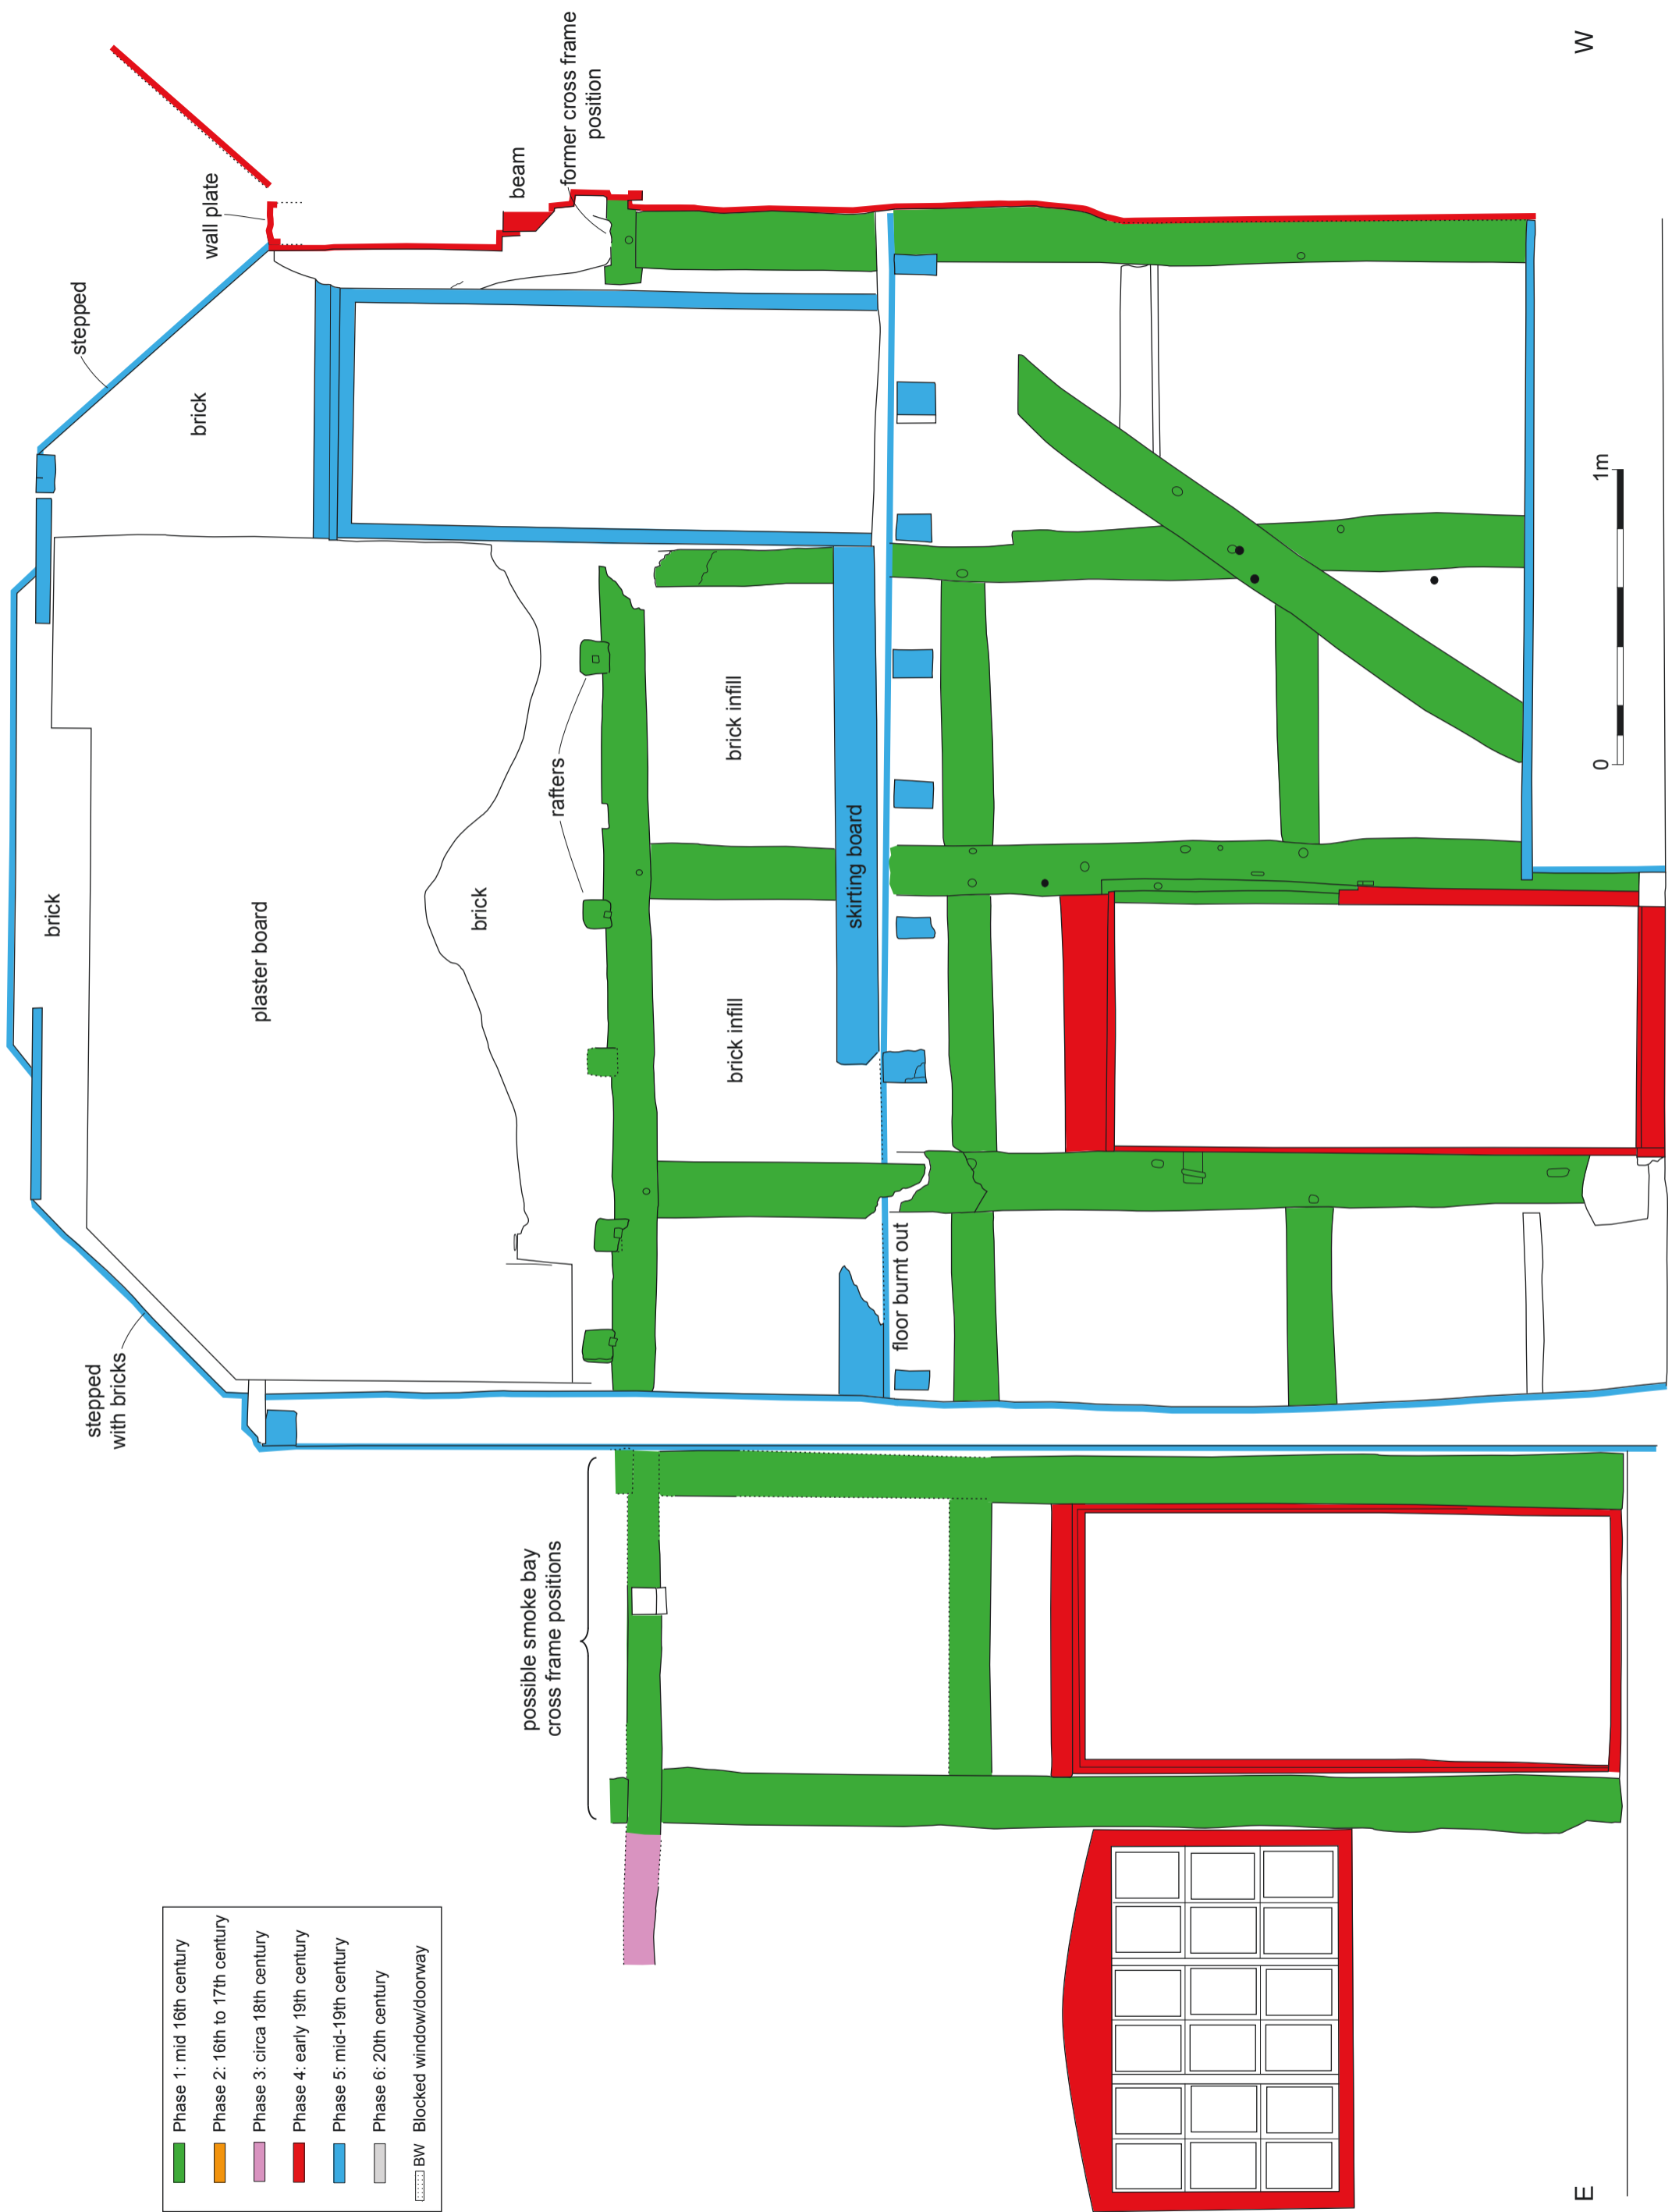
Figure 5

North facing elevation visible within the Phase 5 dairy and bedroom and Phase 6 passage

The wall framing was visible on three sides of the structure, though most complete on its northern side (*Plate 6, Plate 7* and Figure 5). The posts of the wall frames ran the full way from the cill beam, no longer extant, to wall plate and were braced by long straight braces which ran from the cill beam to bay posts. This type of framing is more typical of a 17th century building than 16th, but not enough absolute dating has been undertaken to state this with certainty. A possible door position was visible in the northern side (Figure 5) which would have led into the hall, as outlined below. No windows were seen throughout this building though a timber re-used within Phase 4 could have been taken from this structure (*Plate 8*). Two mortices are visible with at least two small rectangular cuts for mullions. Peg holes along its rear may relate to a sliding shutter.

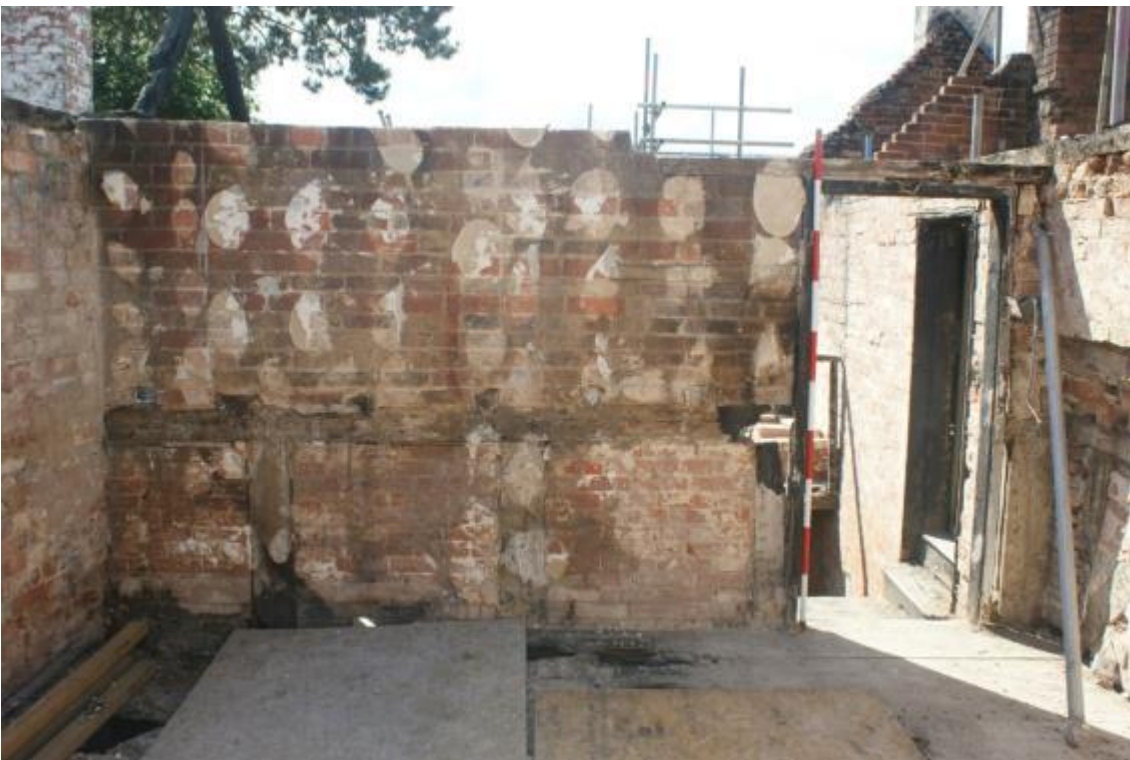
Plate 6 Phase 1 Wall frame with common rafters ends visible above the wall plate, looking south

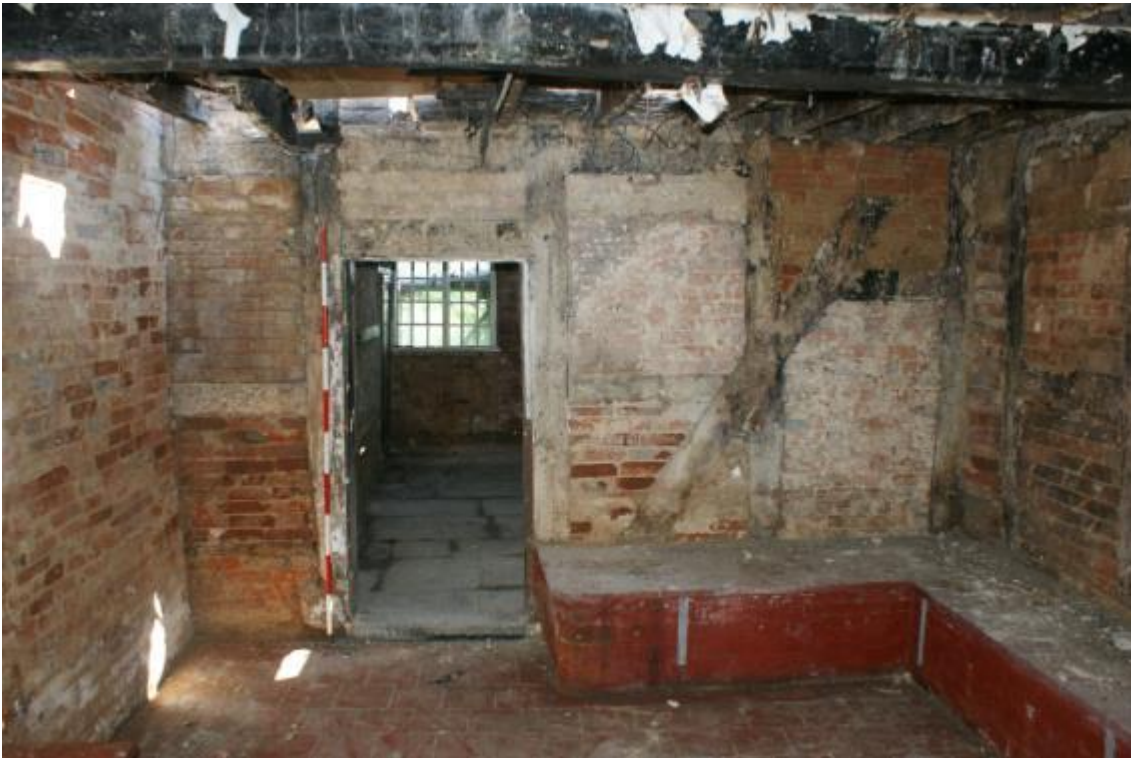
Plate 7 Phase 1 Wall frame visible at ground floor level, looking south

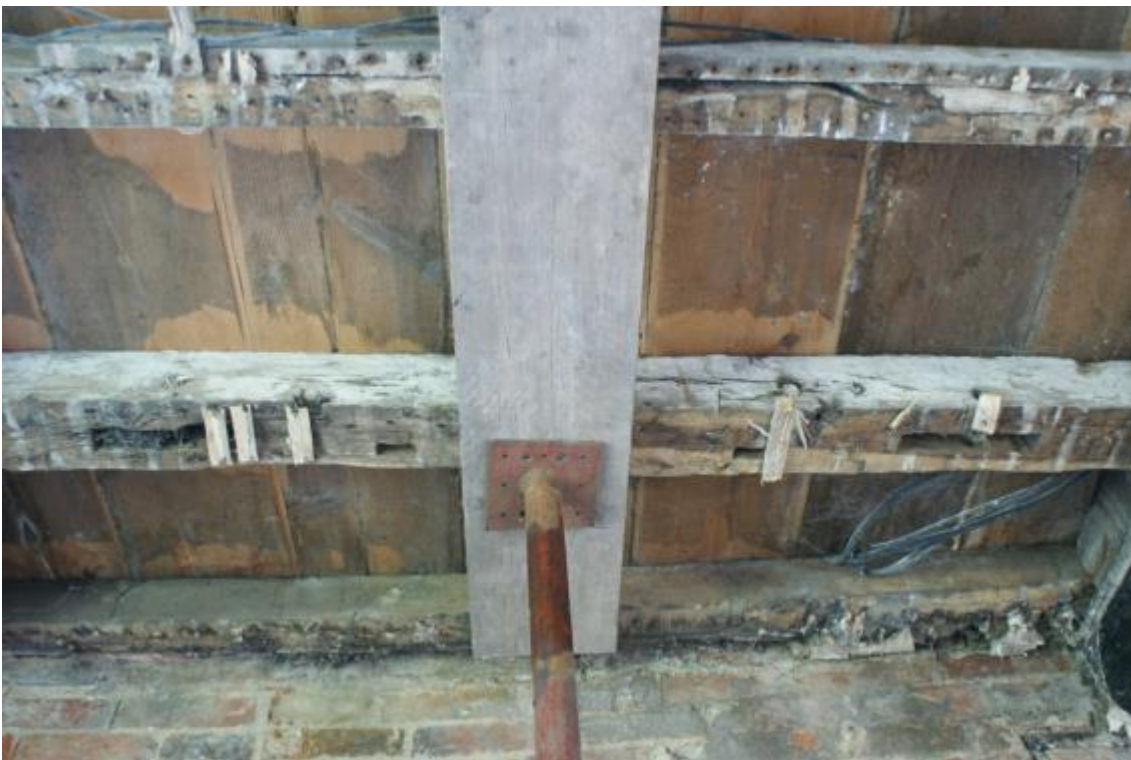
Plate 8 Timber reused as a Phase 4 floor joist showing evidence of window framing, looking north

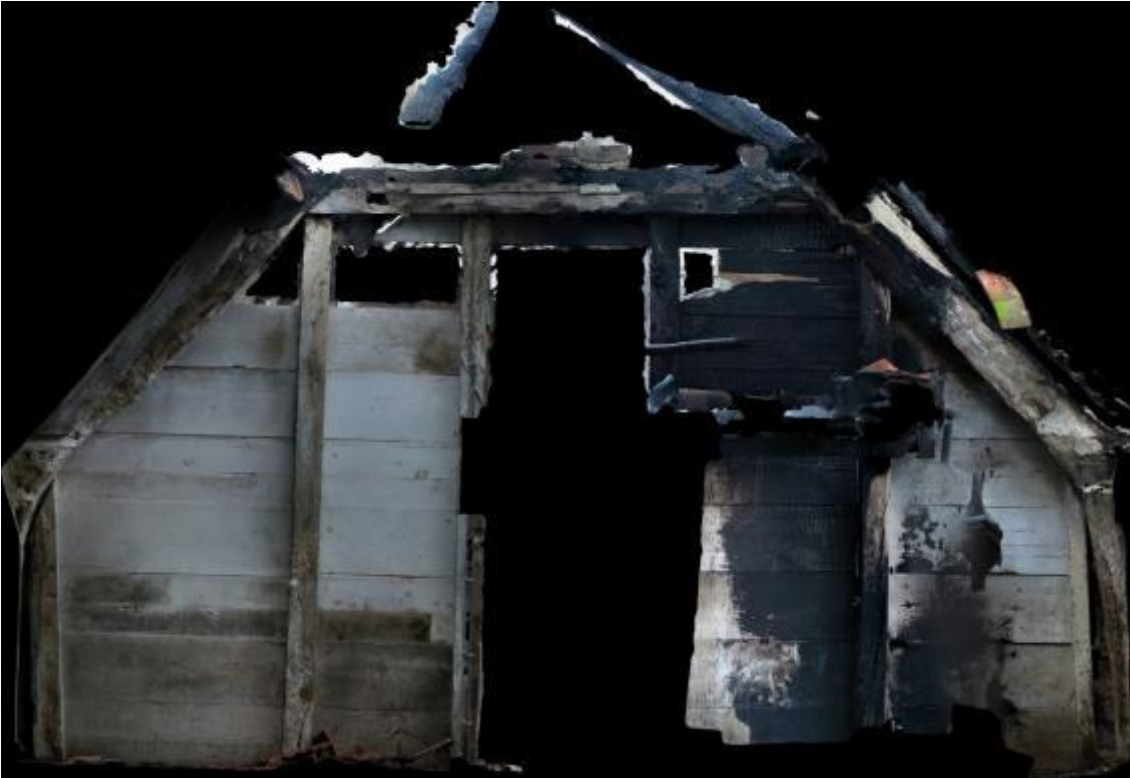
Plate 9 Rectified photograph of cross frame A Phase 1 fireplace interior (Figure 4), looking east

Both of the A frames of the thin bay (Figure 4, Plate 9 and Plate 10) were closed, as seen by grooves for wattling closest to the faces of each frame. The eastern frame was also closed below the tie beam, as seen by studs below, though evidence for this in the form of grooves and mortices and pegs for studs was missing on the base of the tie beam of the western frame.

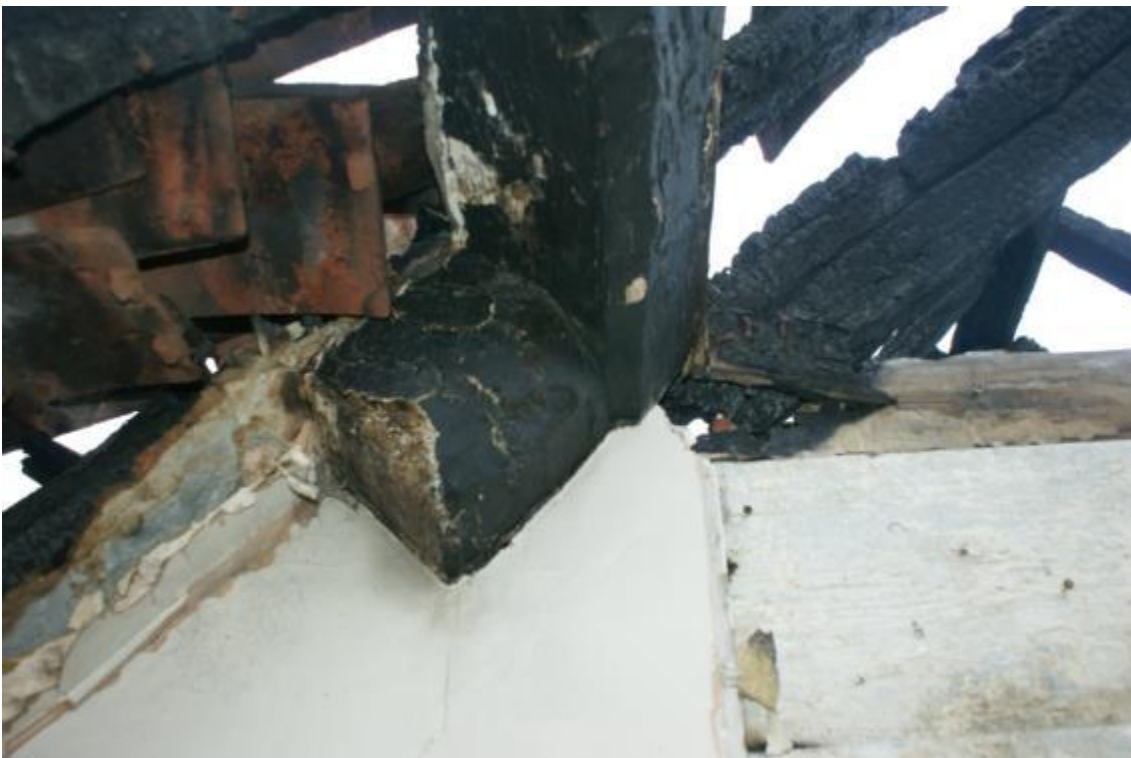
Plate 15 Phase 1 chamfered purlin end, looking west

The structure during this phase appears to have had a gable end to the east of the thin bay as the purlins are chamfered at this point and did not extend through the Phase 2 structure (Plate 15). Some remnants of the end wall frame were visible within the later kitchen below (Figure 6 and *Plate 16*). This frame is reconstructed on (Figure 7)*Plate 4*. To the west of the thin bay was the widest of the remaining bays which extended as far as two jowl posts visible at its western end on the first floor (Plate 17). The tie beam and roof truss associated with this were removed during subsequent phases although it is clear that its carpentered side faced east (*Plate 18*), meaning that it was an internal frame. This bay measured about 4 metres (13 feet) in length. This is likely to have been the hall of the house, and been open to the roof similar to its medieval predecessors. No evidence for floor joists was seen internally throughout any of the remaining wall frames.

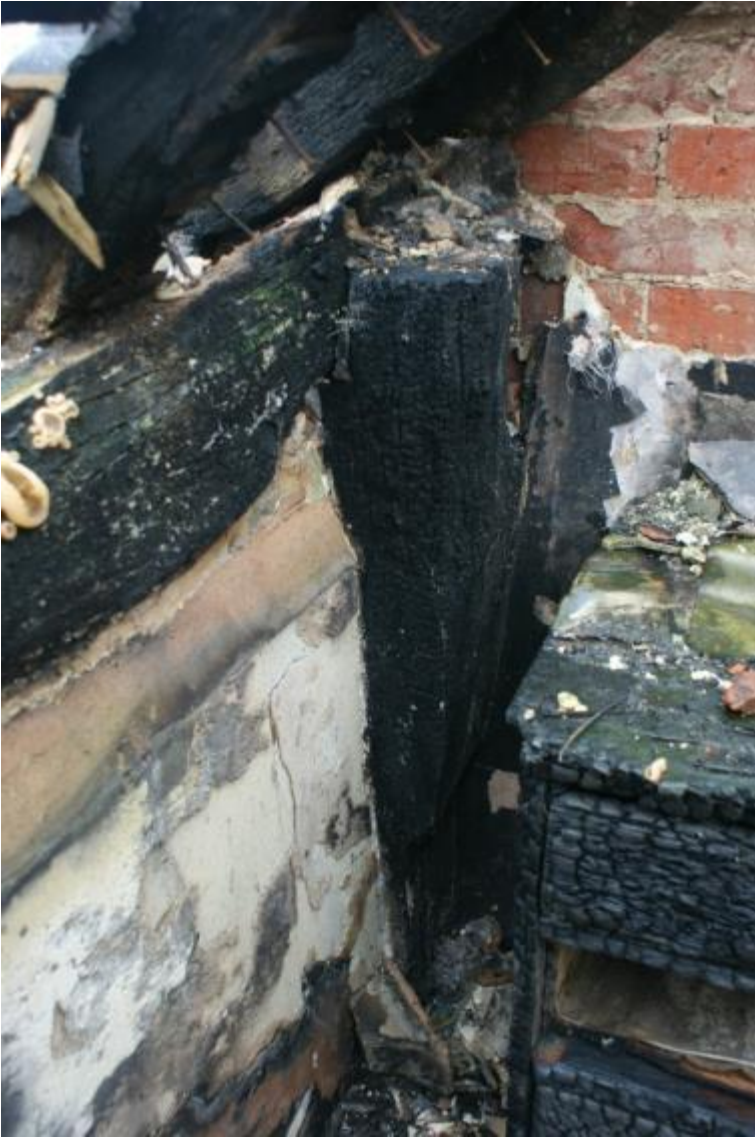
Plate 17 Phase 1 jowl post, looking south-west

The bay at the western end of the hall is only suggested by the presence of the jowl heads at that point (Plate 17) and the continuation of the wall plate through the Phase 4 wall on the northern side. There are no grooves for wattling on the jowl posts to suggest that this was a closed bay frame so the possibility remains of the building having a two bay hall. However, this evidence is slight so such an arrangement cannot be clearly suggested. A single bay hall is more likely with a fireplace at its "lower" eastern end.

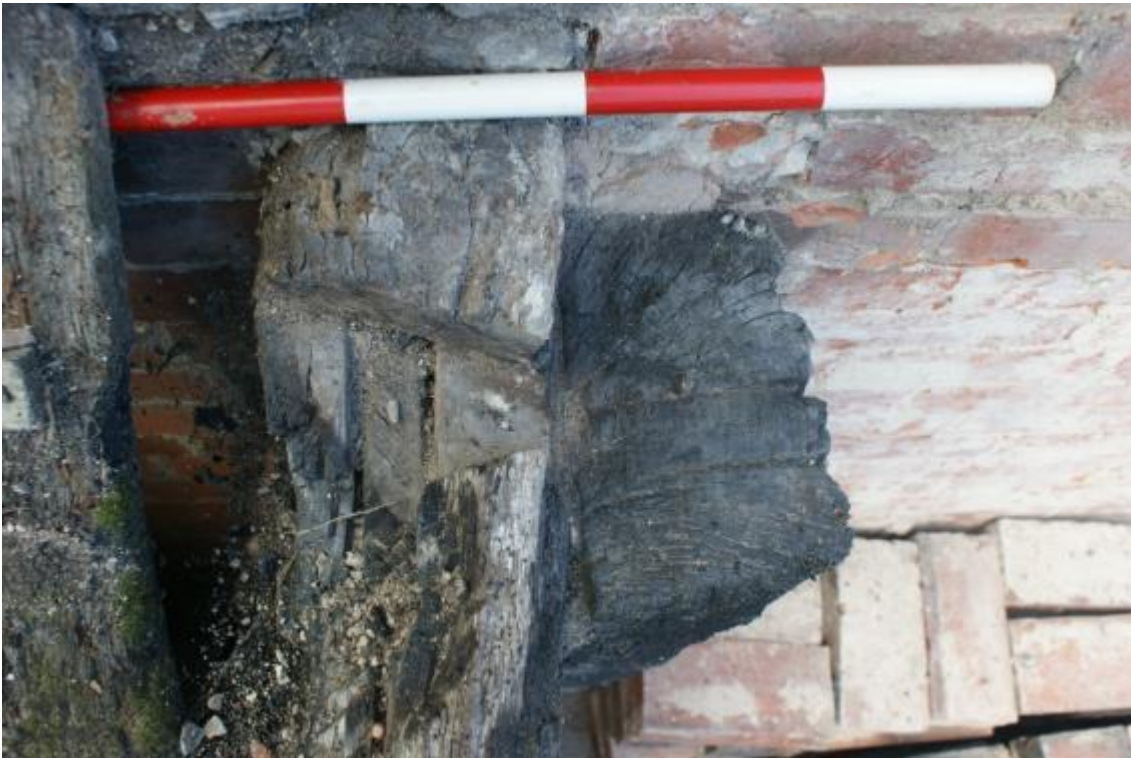
Plate 18 Detail of the Phase 1 jowl post head showing the dovetail joint and sawn off tenon on the eastern side of the frame, looking west, scale 0.40m

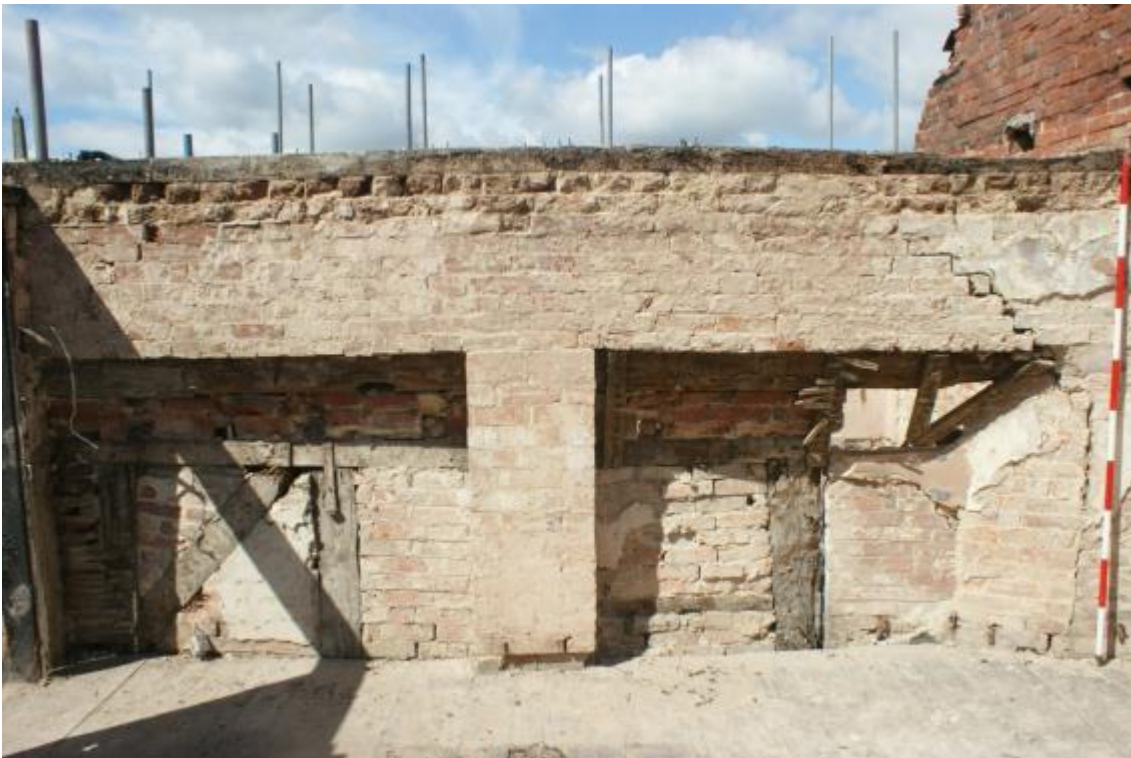
Plate 19 Phase 2 wall frame, first floor looking west

The style of the framing is similar to the previous structure, though with a small straight brace running from the bay frame to the wall plate (Plate 19 to Plate 21). This style is not closely dateable but would be consistent with a building of the second half of the 16th century or the 17th century.

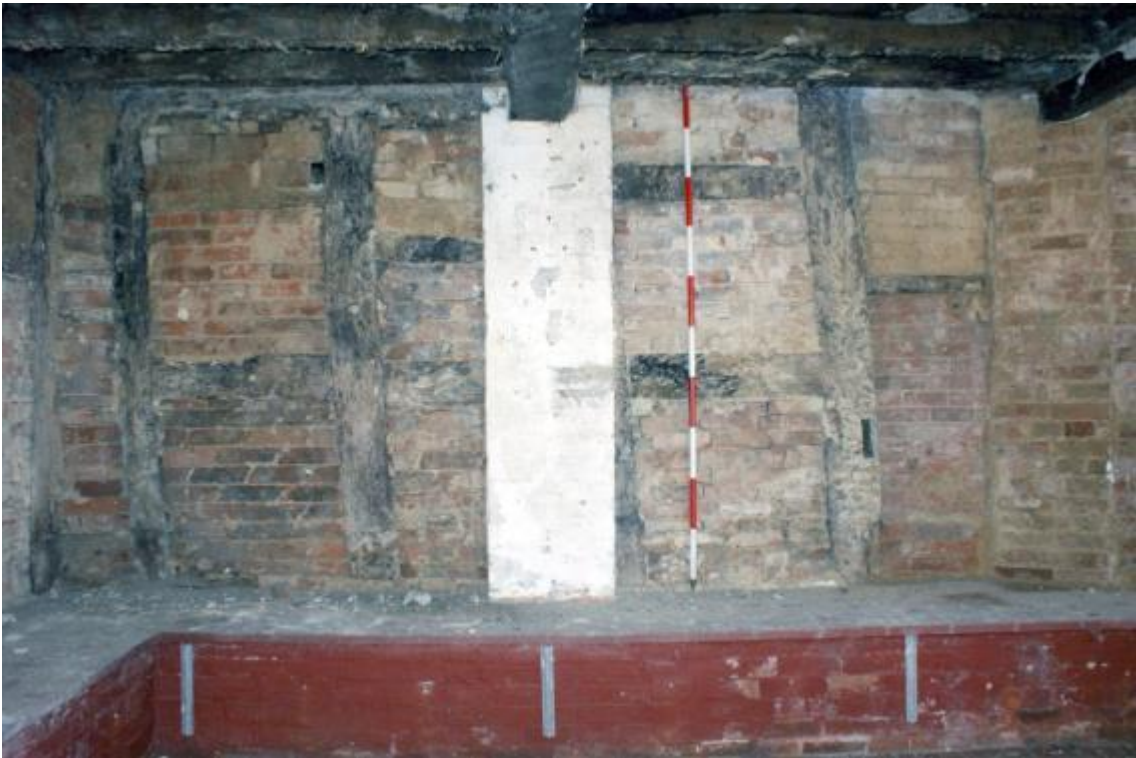
Plate 20 Phase 2 wall frame, ground floor looking west

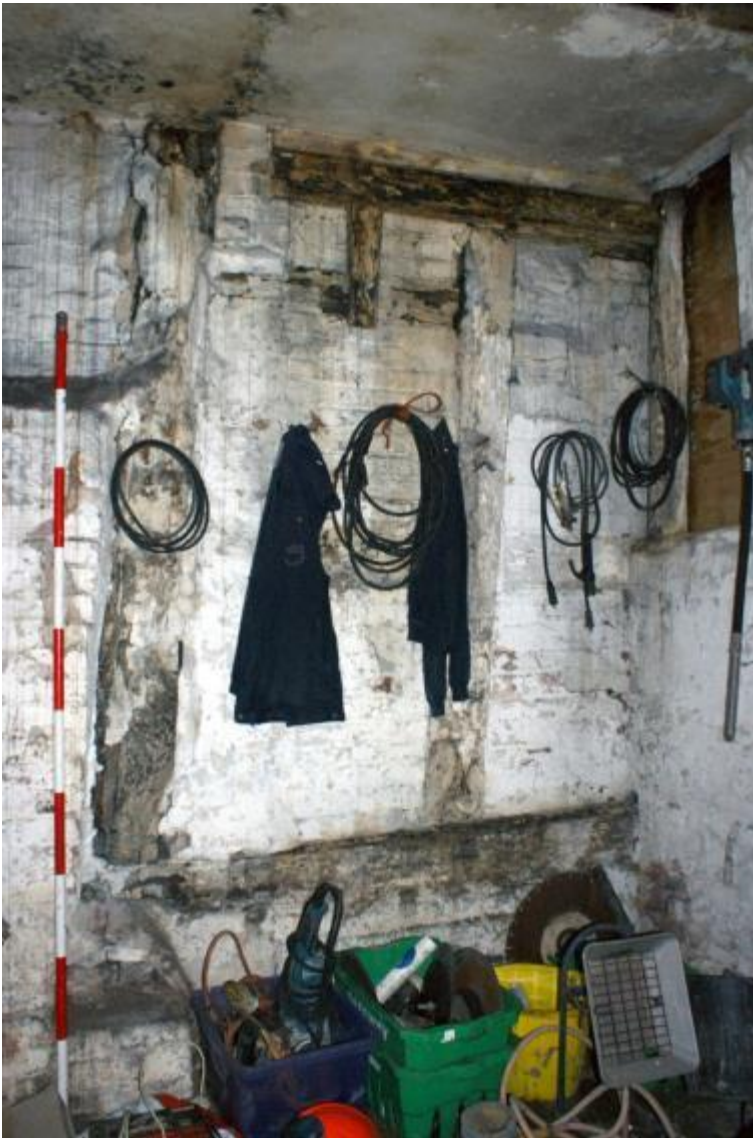
Plate 21 Phase 2 wall and cross frame post, looking east

The carpentered face of the northernmost bay frame appears to have been on its northern side as suggested by the presence of a groove on the northern side of the post, suggesting that this was an external frame. This is supported by a lack of pegging visible on the opposing face. No mortices for the gable end wall frame or internal floors were visible on its rear (Plate 21), but may be covered by paint and later finishes.

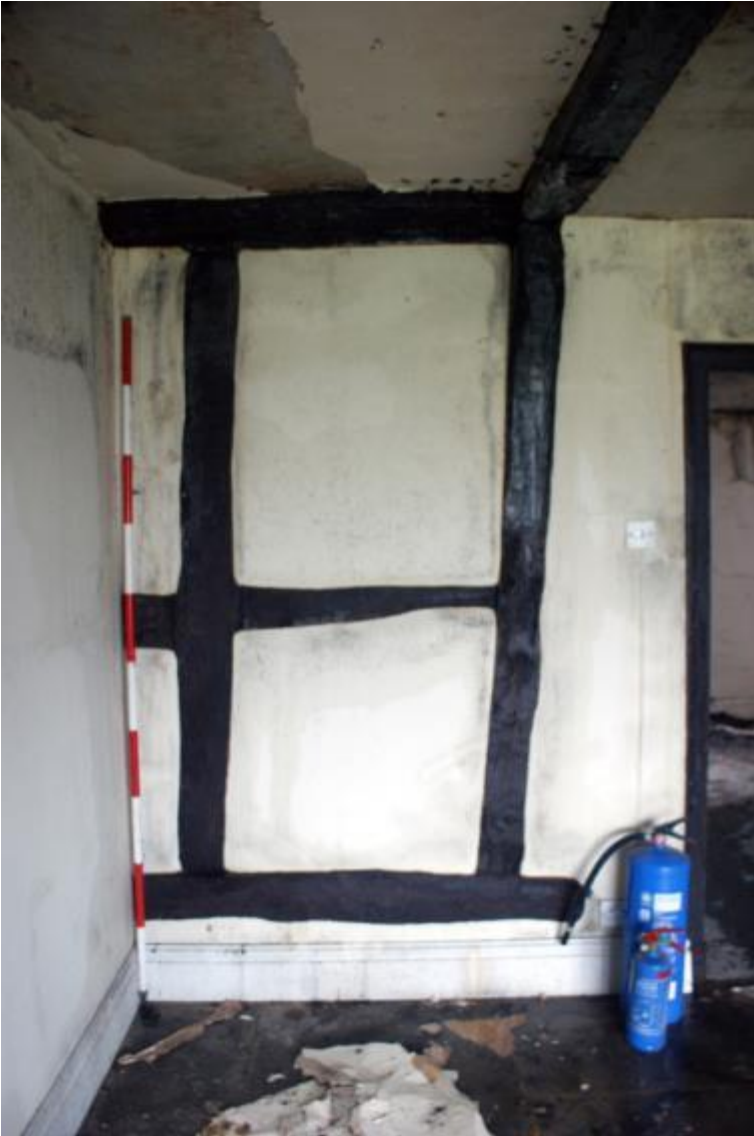
Plate 22 Phase 2 wall and cross frame post, looking east

The northernmost bay potentially extended as far as a post standing in the Phase 4 sitting room and dairy (Plate 22). This would make a bay of about 3m in length. The floor joists visible in the Phase 4 sitting room (Plate 23) are in a position that is consistent with the framing of this phase but are likely to be later replacements. They had a groove to hold wattling on their underside that ran their entire length, not leaving any gap for an internal doorway. One had two mortices which have been reduced in depth, suggesting that this timber has been re-used twice.

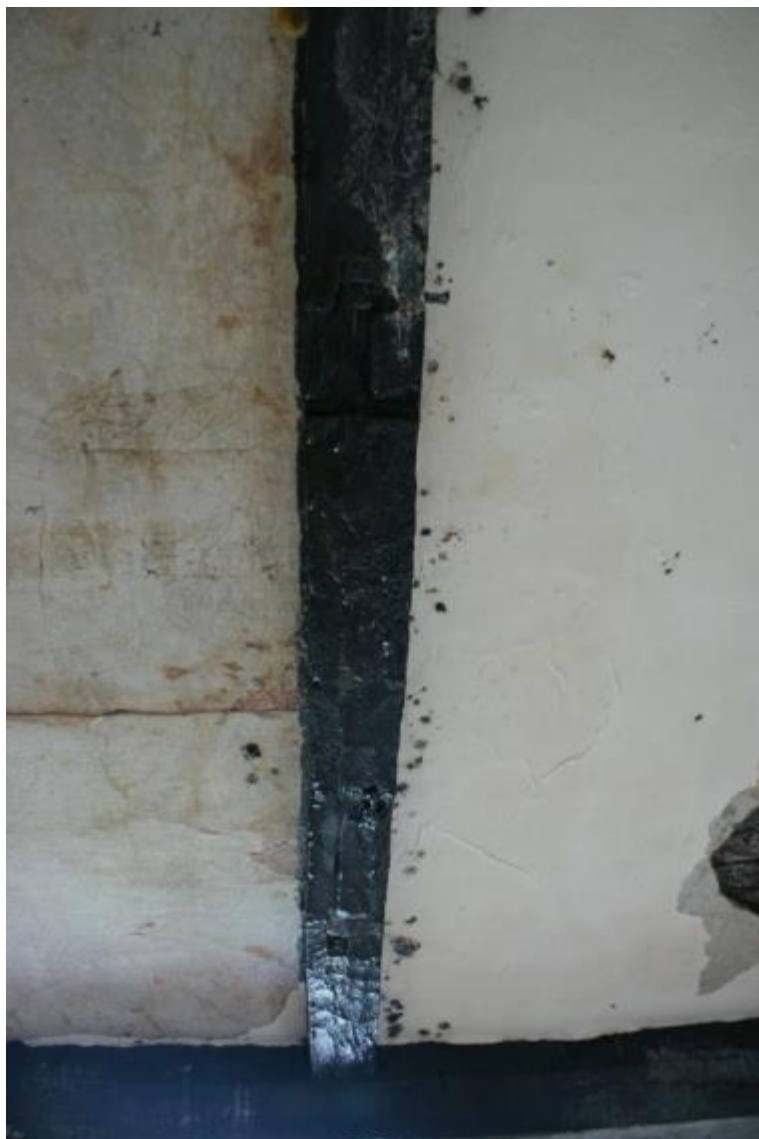
Plate 23 Possible Phase 1 timber, looking west

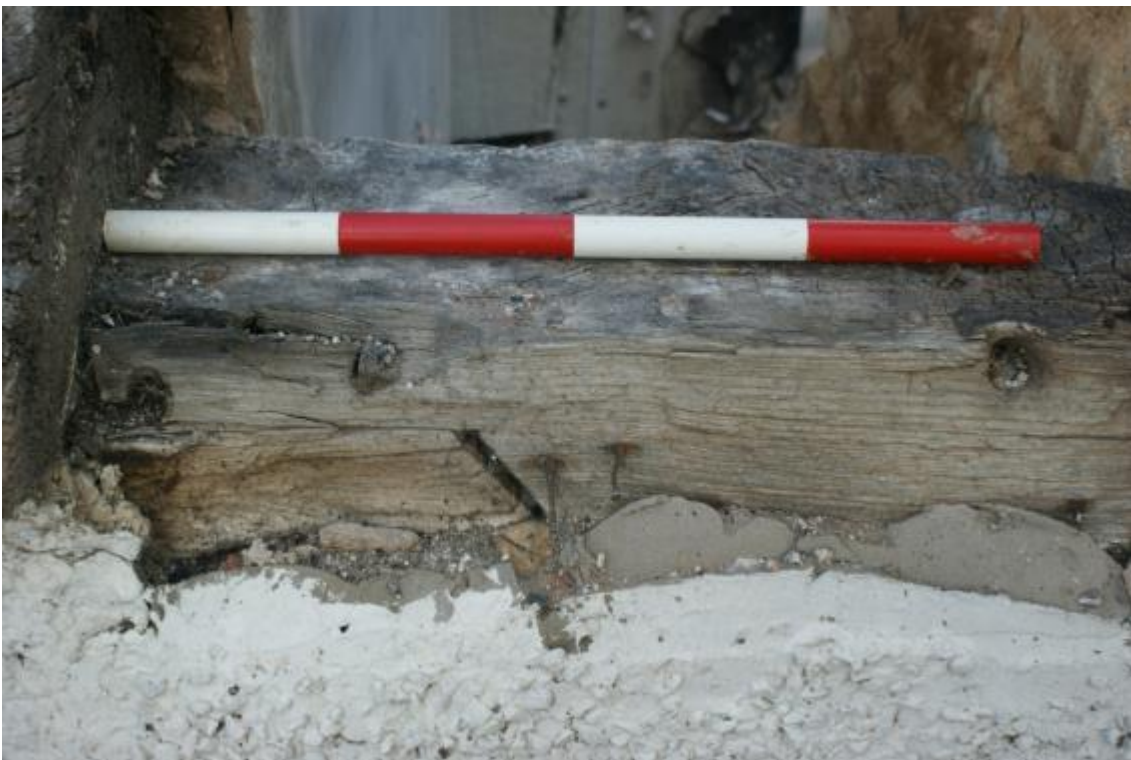
Plate 28 Phase 3 scarf joint in the wall plate to the east of the Phase 1 gable, looking north

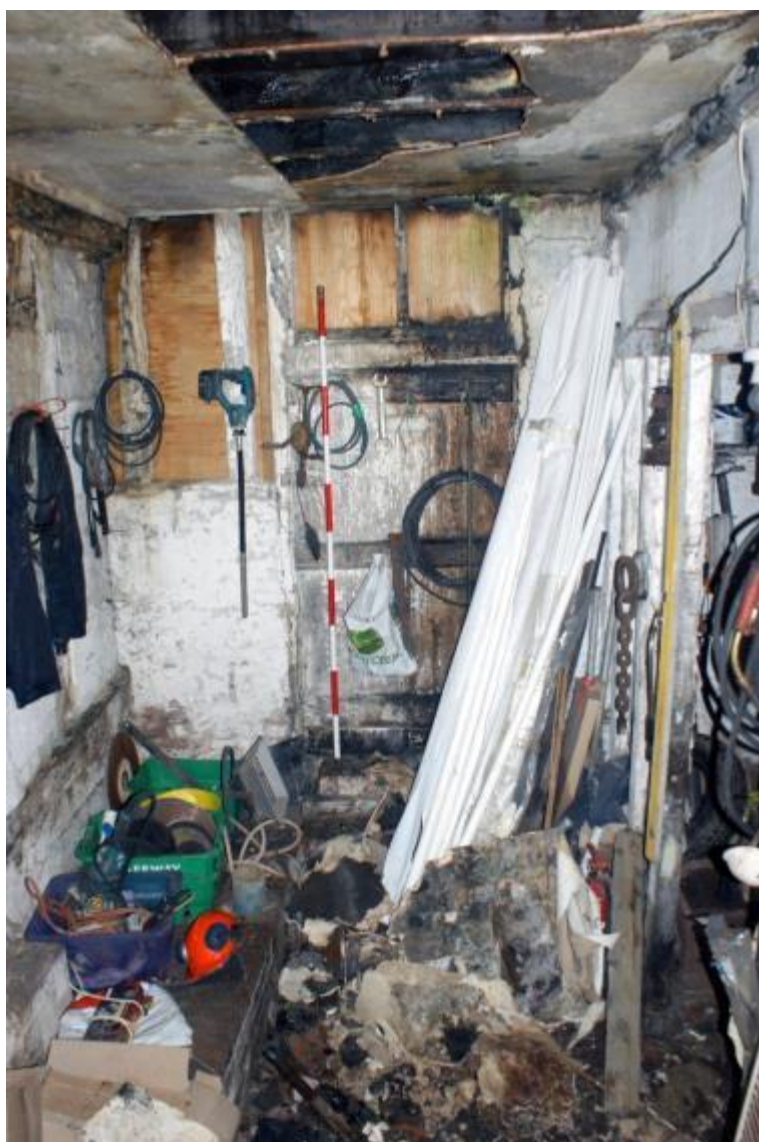
Plate 44 Phase 4 cellar, looking south

The northernmost room (Plate 44) was accessed originally from the central living room, as well as from the northern gable. This was a cellar and appears to have been used for cold storage as it has a brick plinth running around its wall. This would have kept goods such as cheeses from contact with the ground, therefore preventing decay.
