# Archaeological watching brief at Dodford Priory, Dodford, Bromsgrove, Worcestershire

Status: Addendum to report 2337  
Date: 28 October 2016  
Author: Graham Arnold – [garnold@worcestershire.gov.uk](mailto:garnold@worcestershire.gov.uk)  
Contributors: Rob Hedge and Tom Vaughan  
Illustrator: Carolyn Hunt  
Project reference: P4955  
Report reference: 2397  
HER reference: WSM 68325  
Oasis id: Fieldsec1- 261803

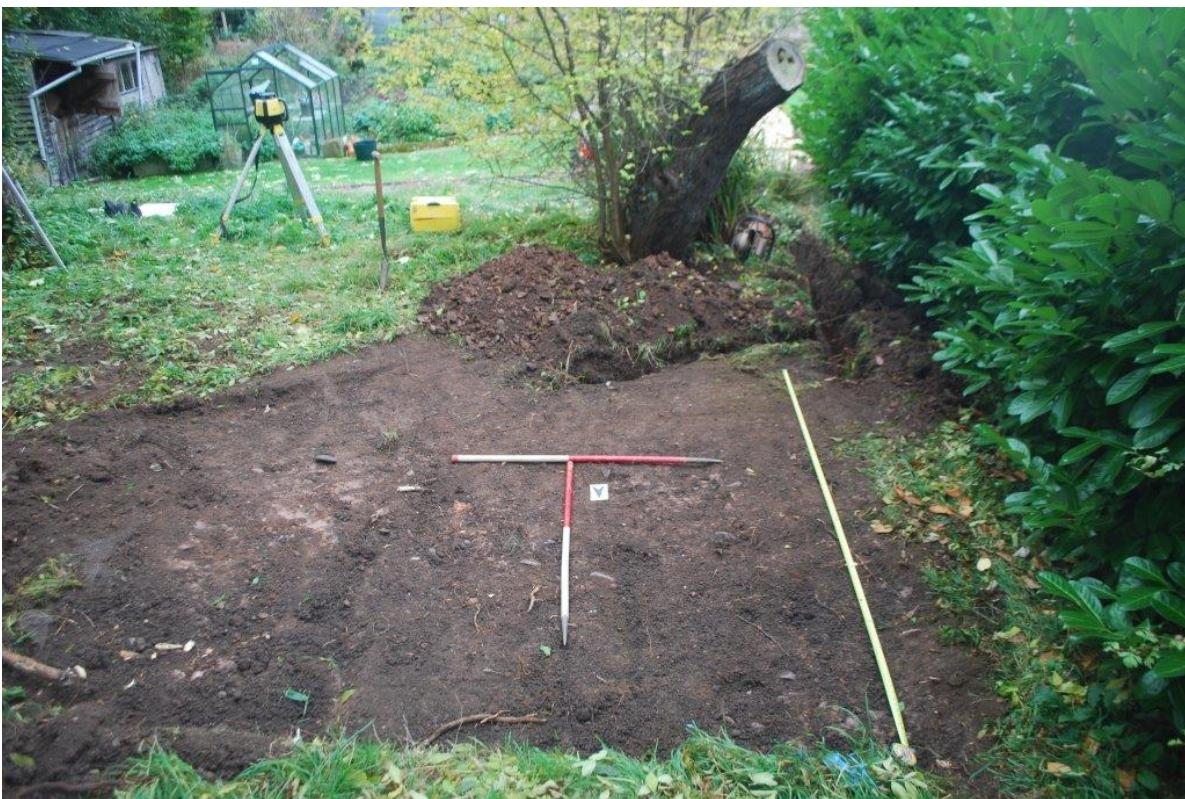
*Plate 2 The excavation for the foundation pad, looking south*

Modern garden soils 100, 104, redeposited natural 105 and type 1 gravel underlay (101) for the driveway and compact bedding for modern paving (103) were recorded in the rest of the trench. The excavation for the foundation pad for the oil tank at the north end of the trench only removed turf and topsoil from the upper garden.

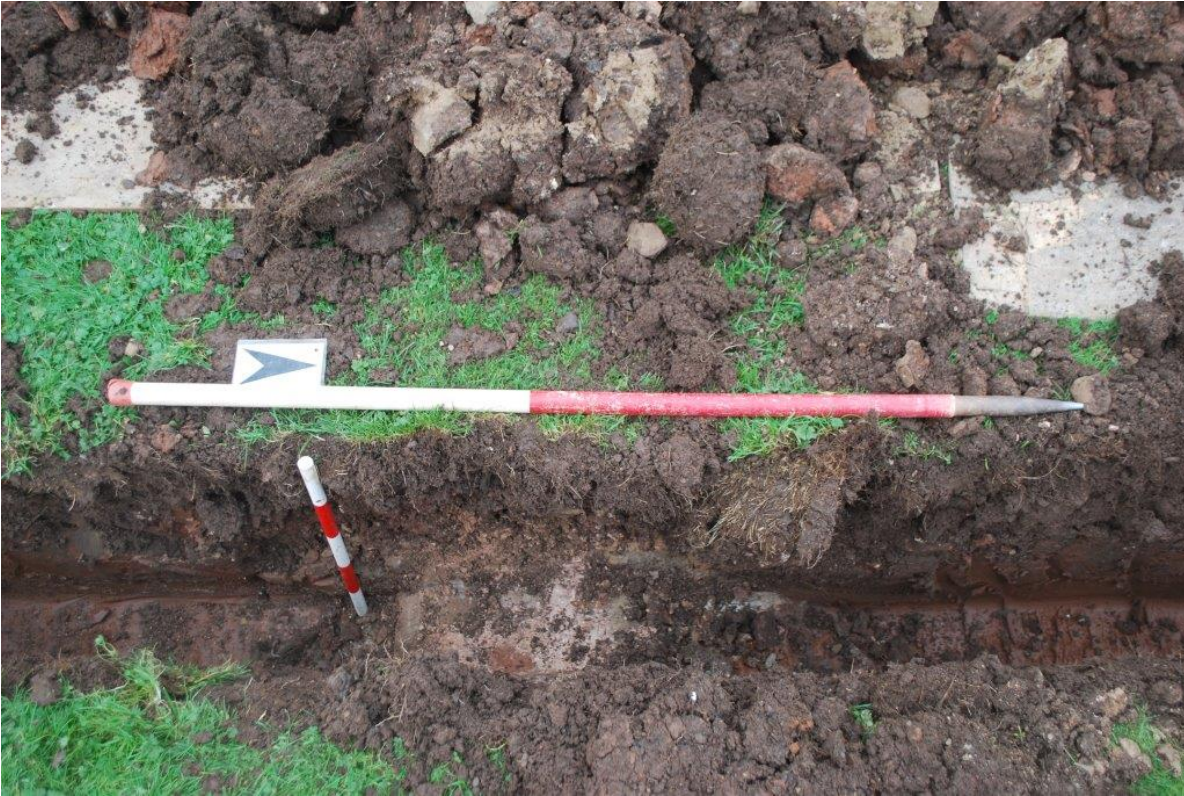
*Plate 3 Wall foundation 105, south wall footing of building, view west*

Three wall foundations were recorded in the central part of the trench, between the present house and the garage, each of red and grey sandstone. Wall 105 (Plates 2 and 3) was 0.60m wide and 0.25m high and lay directly on the surface of the natural clay at a depth of 0.55m below the present ground surface. A red sandstone recovered from the rubble adjacent was roughly moulded with curving chamfered sides and a flat top. It appears to have been reused from an earlier structure, but was worn and undiagnostic (Plate 4).

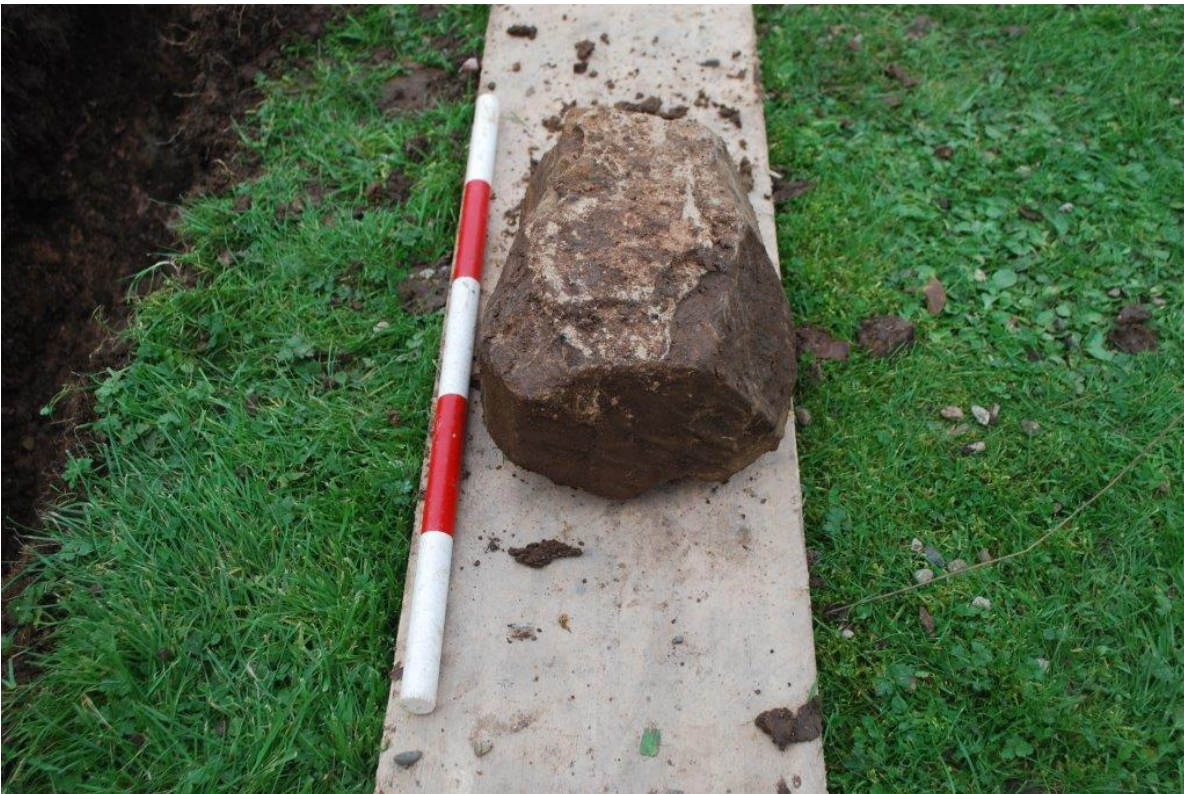
*Plate 4 Sandstone masonry block from 105*

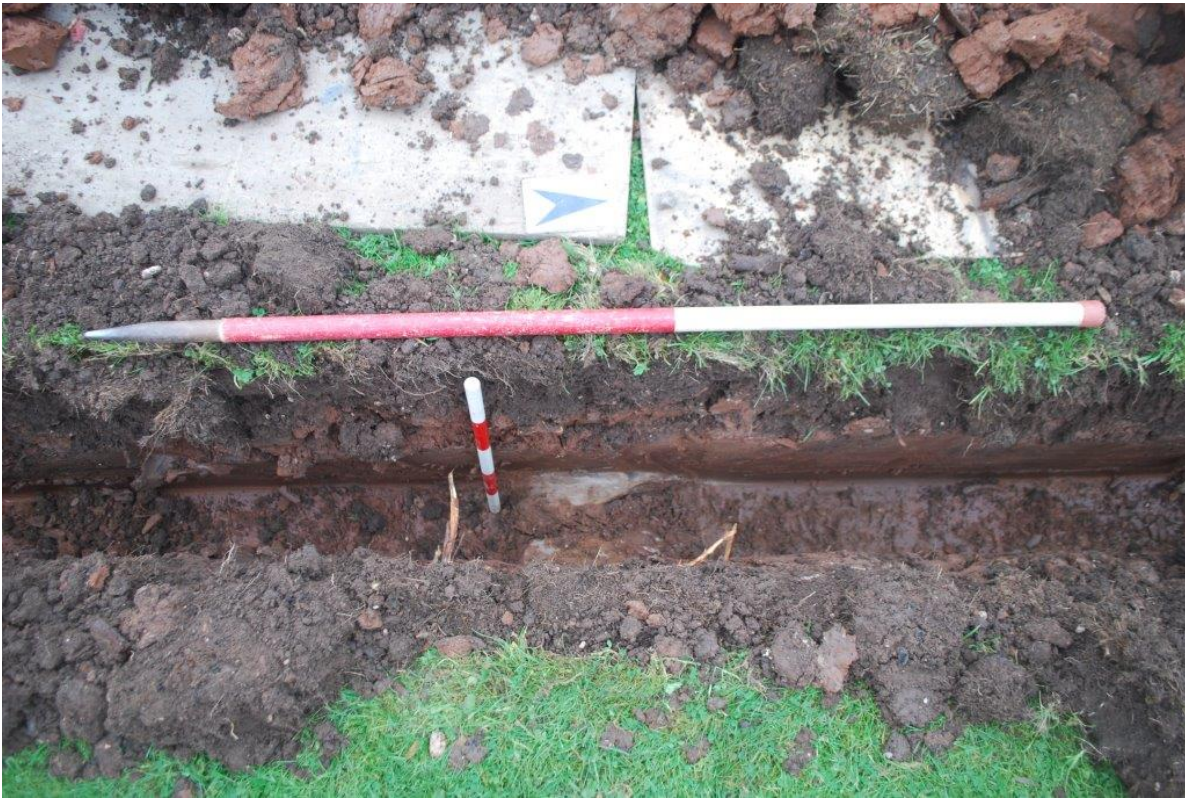
*Plate 5 Sandstone wall footing 106, view west*

Wall 106 (Plate 5) was 0.30m wide and recorded at 0.40m below the present ground level. It is interpreted as an internal wall of the building. It extended beyond the full depth of the excavation within a trench cut into the natural clay. It was overlain by redeposited natural clay, with occasional lime mortar and brick inclusions.

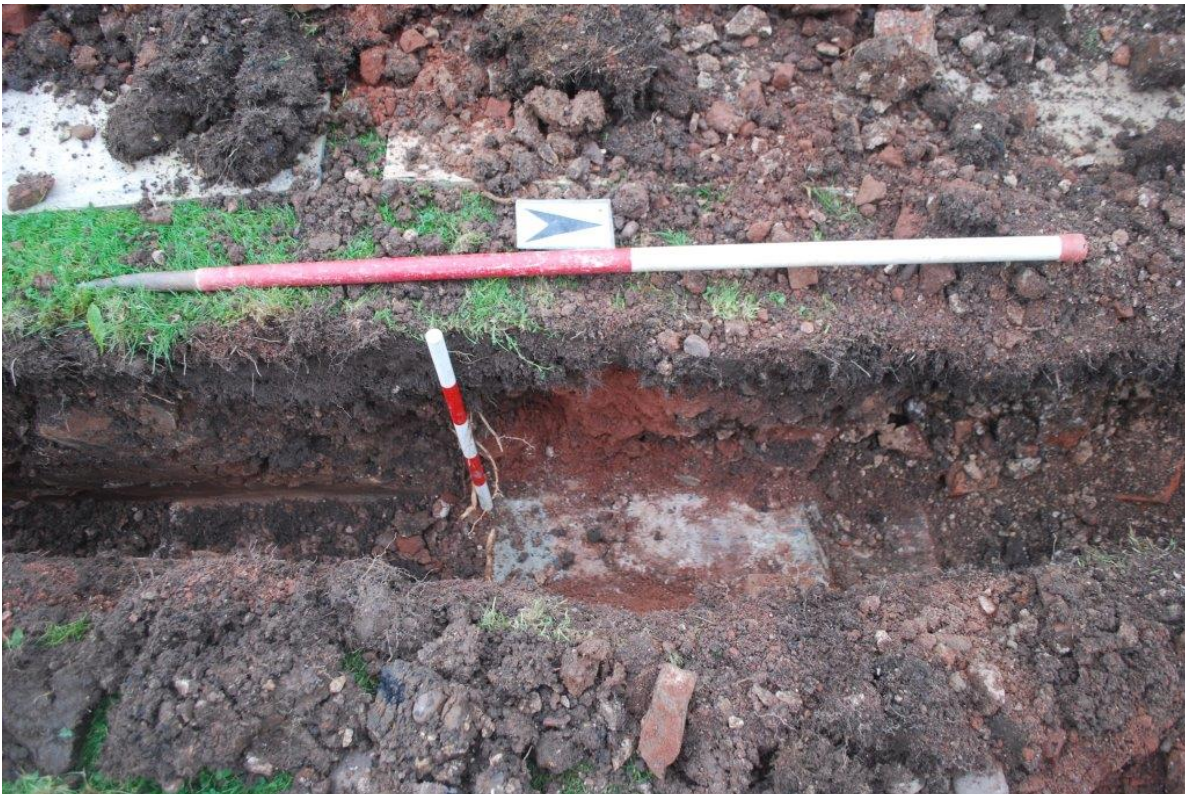
*Plate 6 Sandstone wall footing 108, showing red sandstone upper and grey sandstone base, looking west*

Wall 108 (Plate 6), also 0.60m wide, was topped by loose red sandstone and had grey sandstone below. The base extended below the full depth of the excavation, within a trench cut into the natural clay. Rubble along its northern side extended northwards to the edge of the garden. The rubble also contained large stone cobbles and iron metal hinges (Plate 7). These are interpreted as external walls of a building recorded on the 1<sup>st</sup> edition Ordnance Survey map.

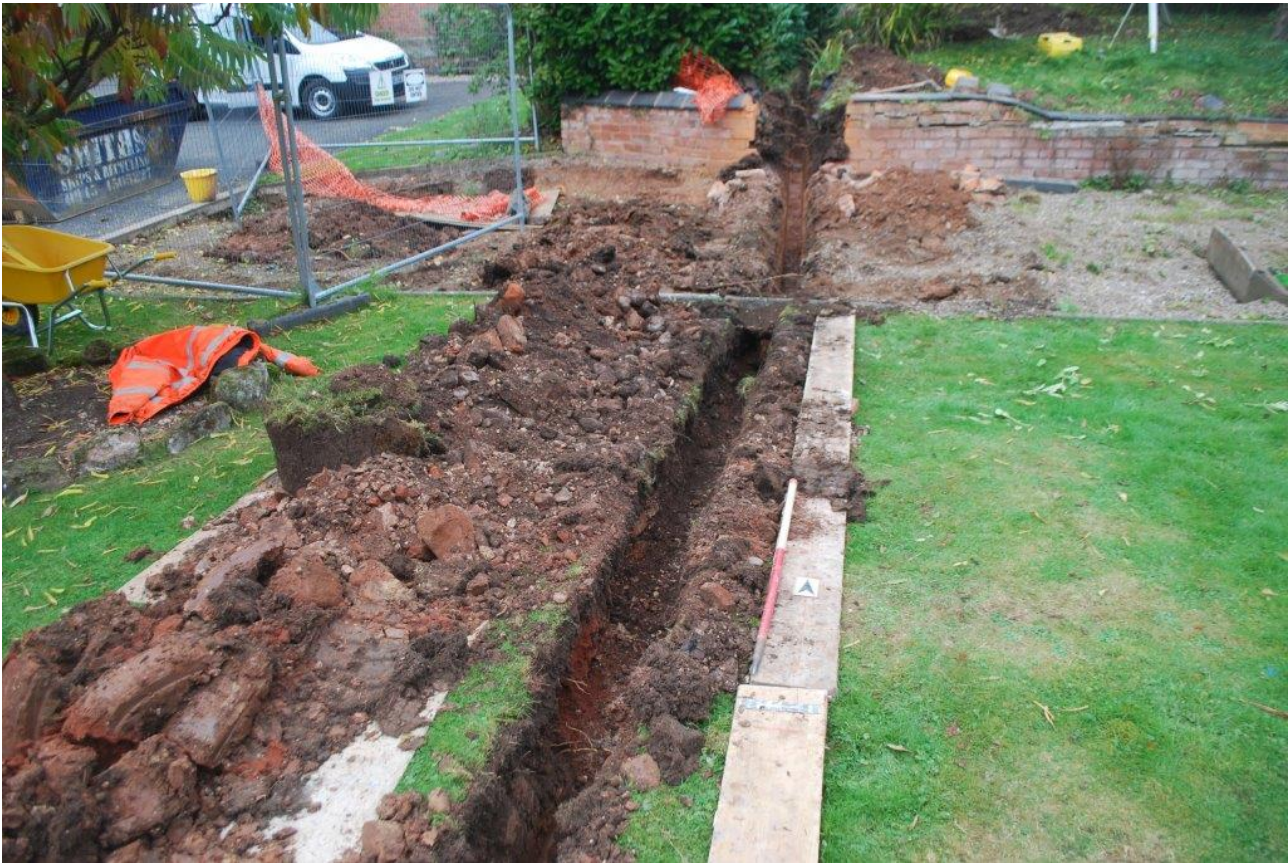
*Plate 7 Demolition deposit 109 to the north of wall 108 and trench across driveway*

107	Layer	Redeposited natural clay with frequent lime mortar, red sandstone and charcoal, demolition deposit or levelling.	0.20–0.40m
108	Wall foundation	Grey Sandstone wall foundation 0.60m wide, 0.10m high, with loose red sandstone blocks and mortar above	0.10-0.45m
109	Layer	Bricks (9" x 4 ½" x 2 ½"), mortar, cbm, large cobbles and iron hinges. Rubble demolition deposit on Northern side of wall 108, probably related to building on 1 <sup>st</sup> edition OS map.	0.20–0.45m
