# Building recording at 20-23 Horsefair, Kidderminster, Worcestershire

Status: Version 1  
Date: 11<sup>th</sup> October 2016  
Author: Tim Cornah [tcornah@worcestershire.gov.uk](mailto:tcornah@worcestershire.gov.uk)  
Illustrator: Carolyn Hunt [chunt@worcestershire.gov.uk](mailto:chunt@worcestershire.gov.uk)  
Project reference: P4635  
Report reference: 2371  
HER reference: WSM67954  
Oasis id fieldsec1-262671

Recording of a historic building was undertaken at 20-23 Horsefair, Kidderminster, Worcestershire (NGR SO 8334 7720). It was commissioned by Worcestershire Building Preservation Trust who have obtained planning permission and Listed Building Consent for refurbishment of 20-23 Horsefair Kidderminster to bring them back to sustainable use as dwellings, for which planning permission was granted by Wyre Forest District Council (WF/12/0760 and WF/12/0761).

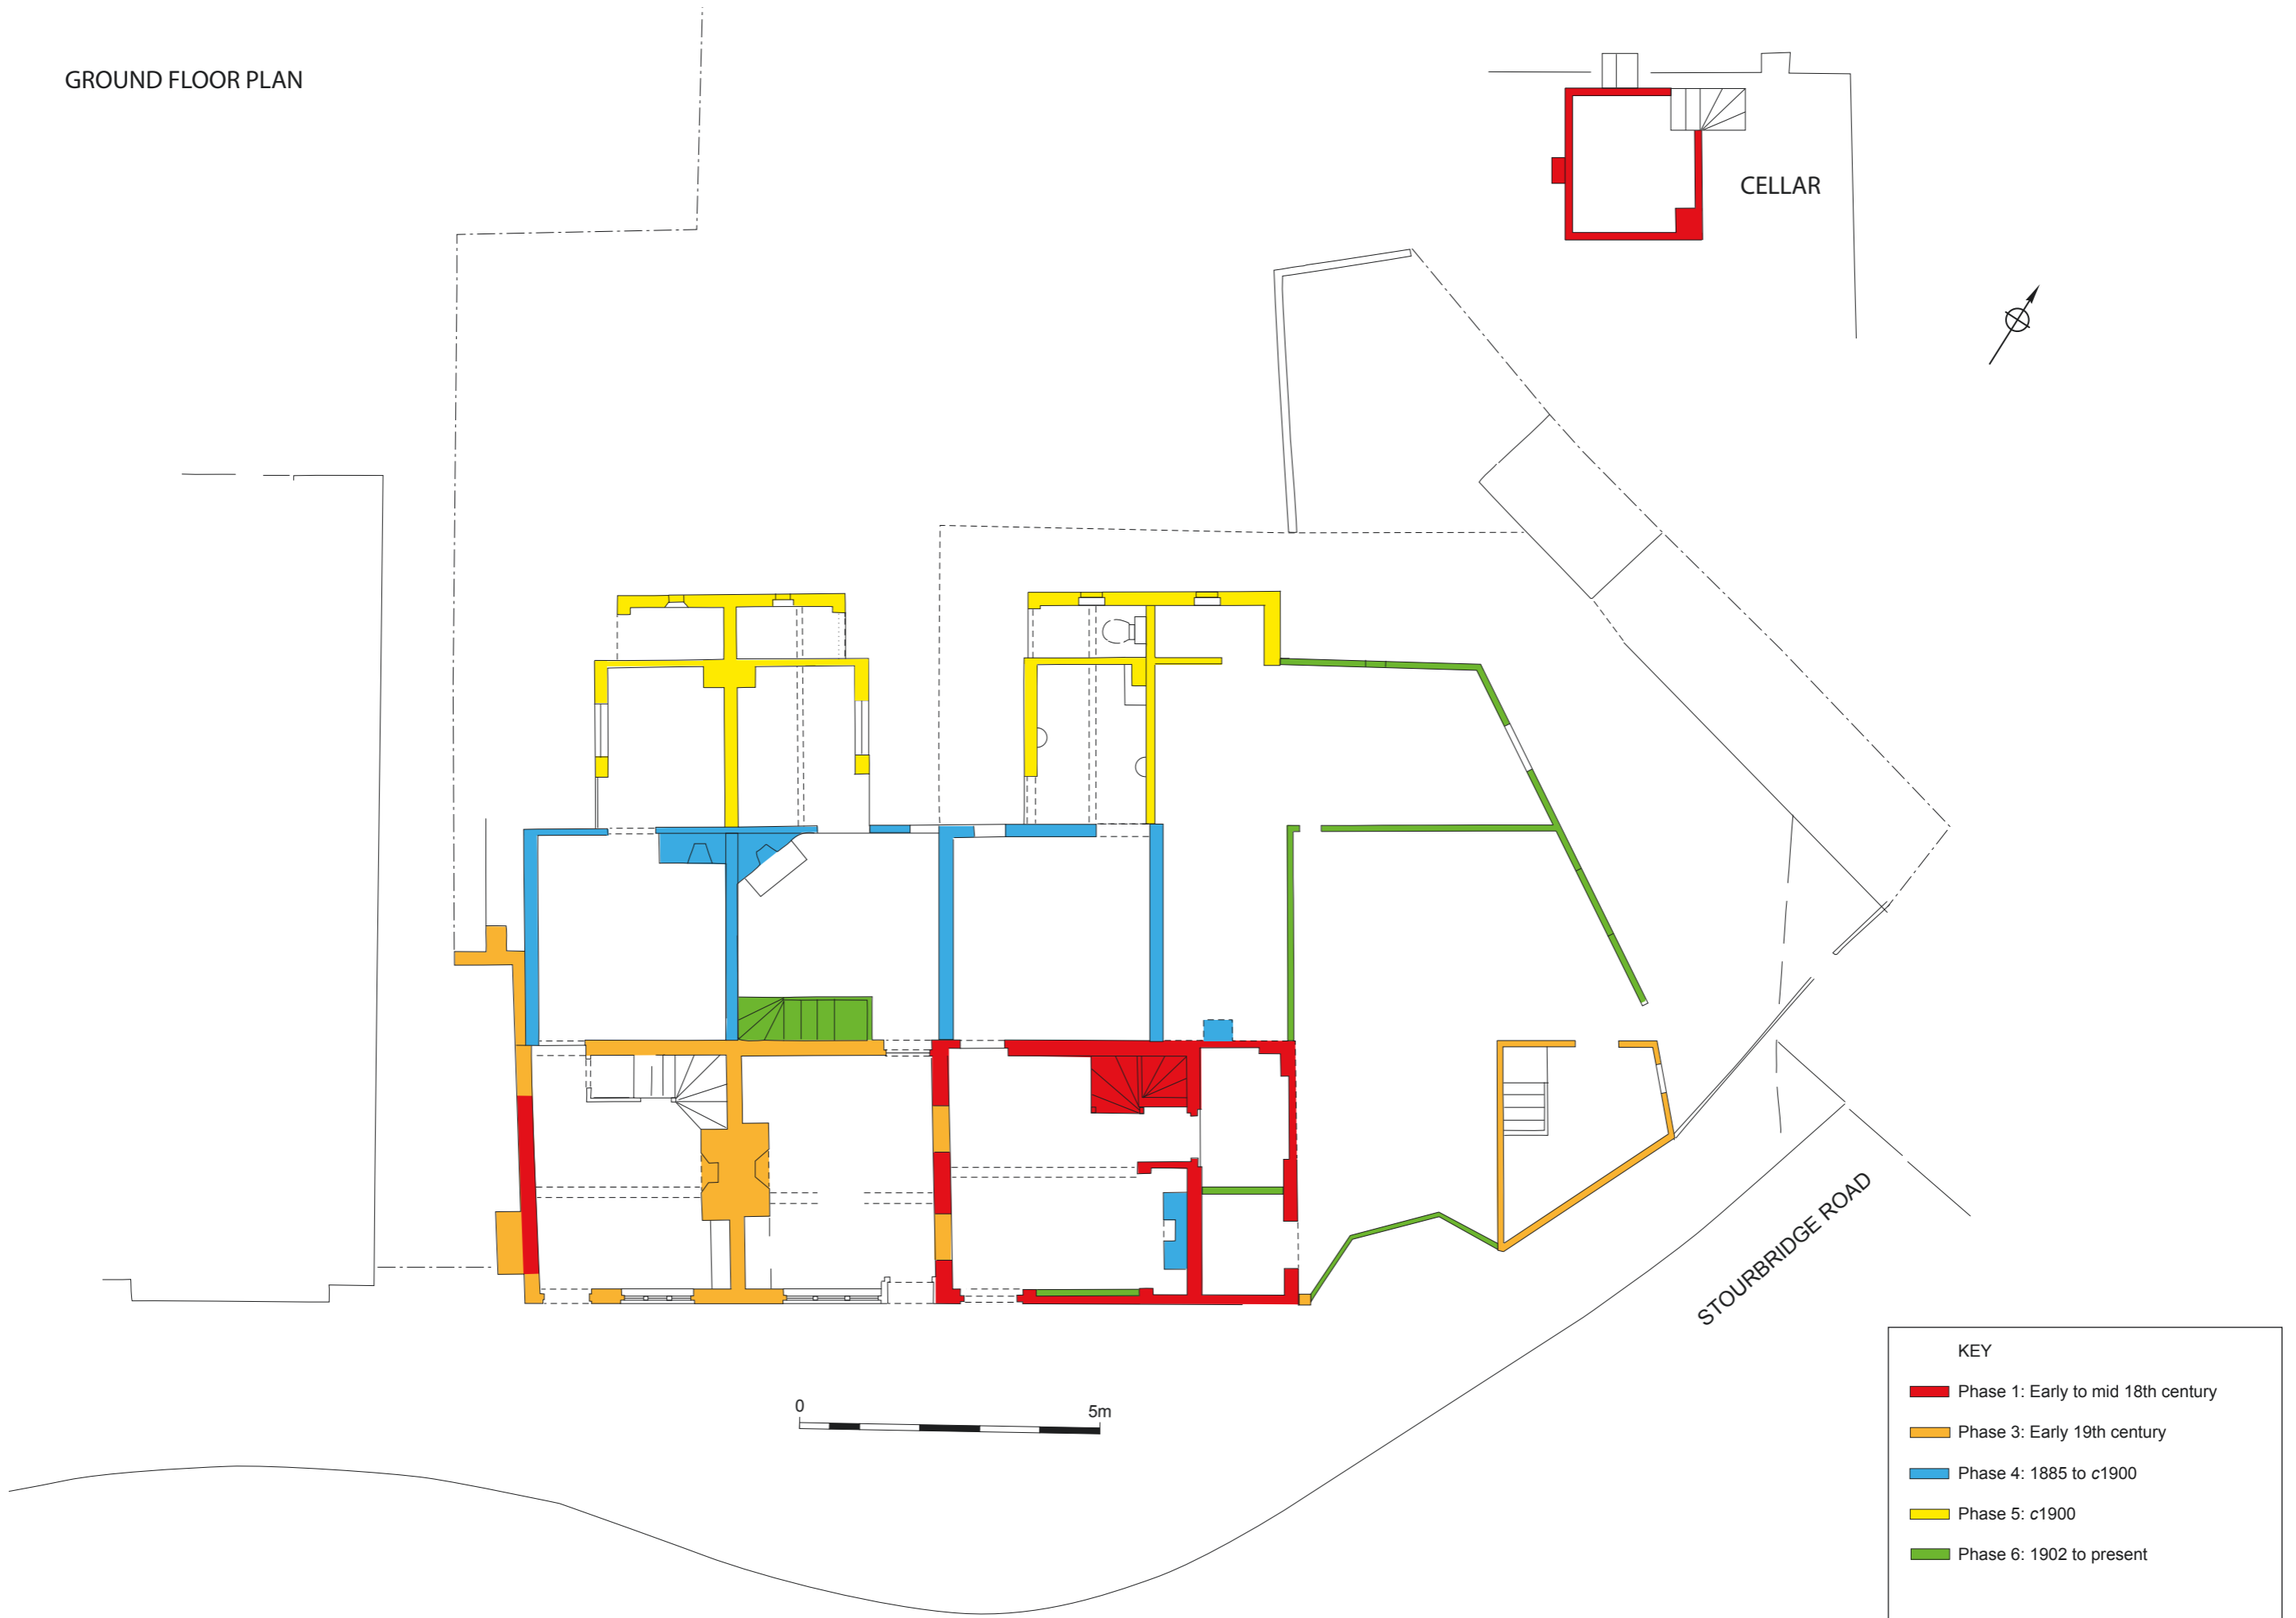
Figure 2

Ground floor plan with phasing (based upon Rodney Melville + Partners Drg No 11)

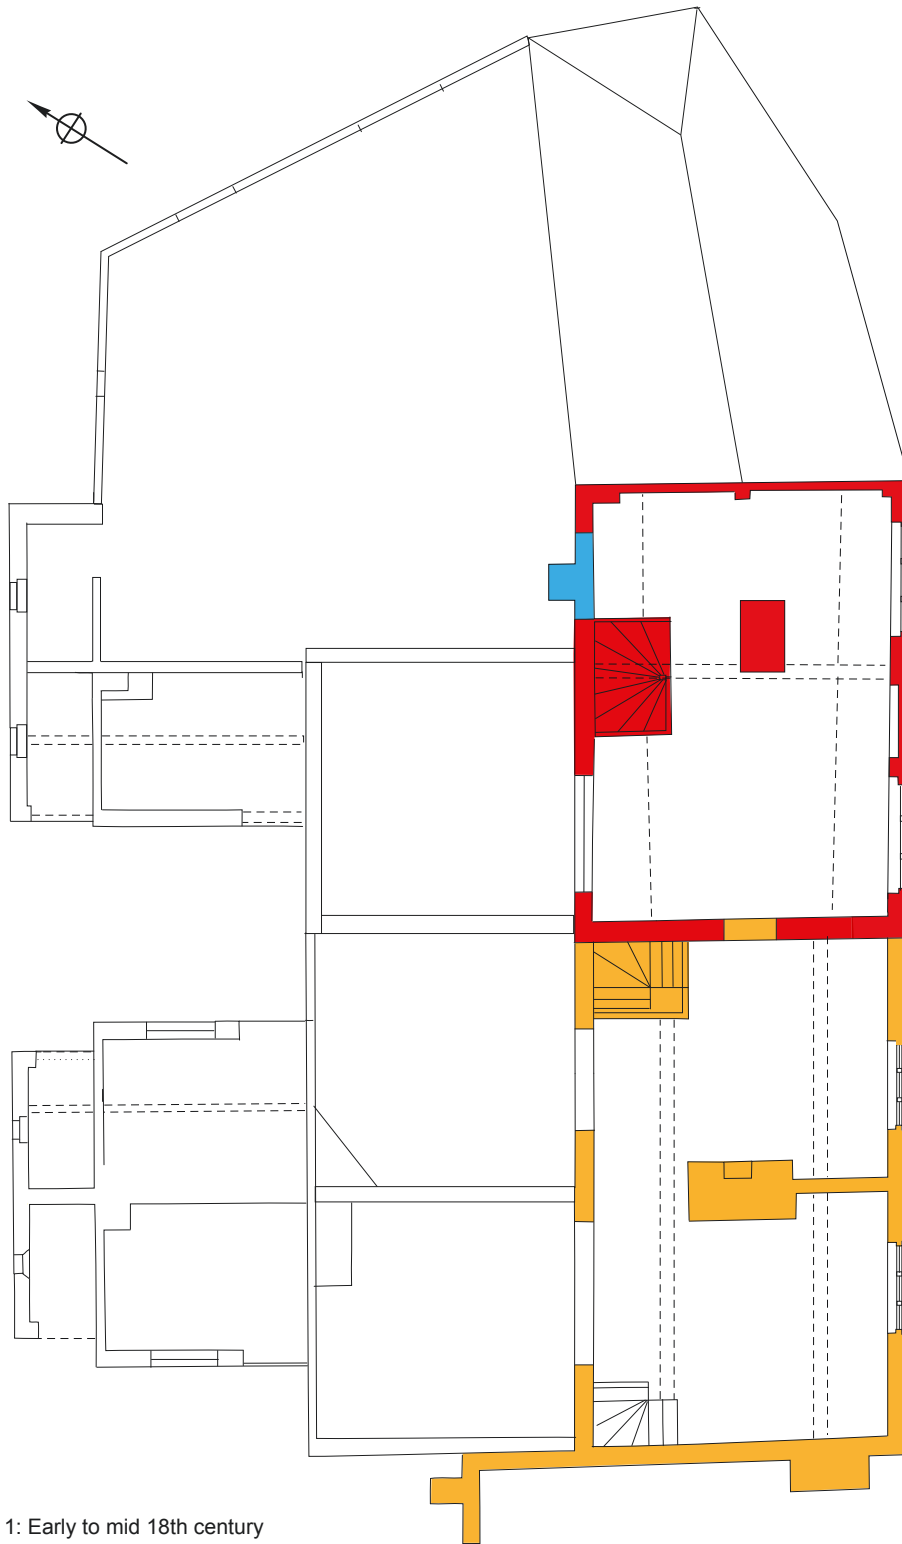
Second floor plan with phasing (based upon Rodney Melville + Partners Drg No 12) Figure 4

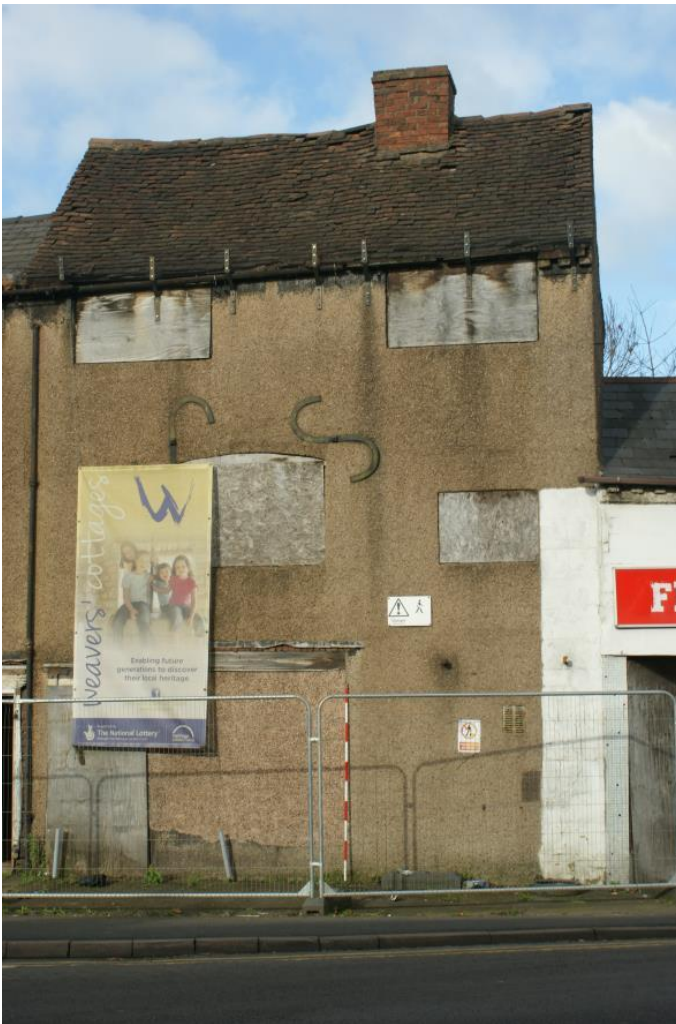
*Plate 1 The Phase 1 cottage, looking north-west*

The earliest construction within this set of buildings was a two bay brick built structure (**Plate 1**) that contained two rooms on the ground and first floors with one large room on the second floor. These rooms were accessed from a staircase located internally in the centre of the north-west wall. This staircase also led to a cellar below the ground floor.

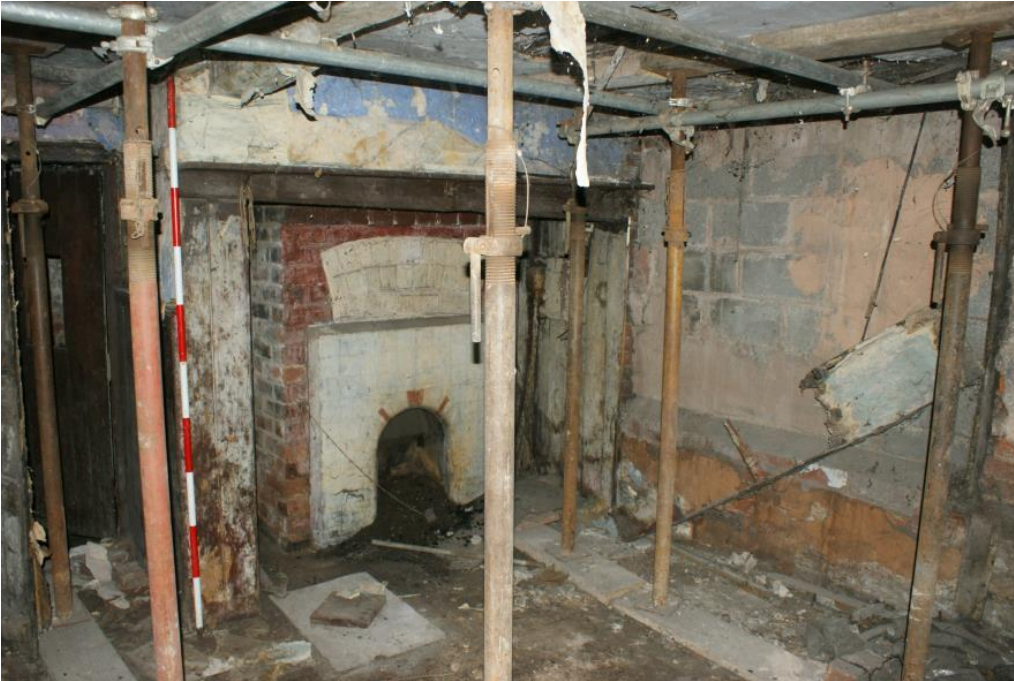
*Plate 2 Phase 1 living room, looking east*

The ground floor room was accessed from the street from a door in the southern corner of the room, and had an opposing door in the north-western corner of the room (**Plate 2**). This room was probably lit by a window facing the south-east, though this has been removed by later changes. It also had a low window facing south-west (**Plate 3**). The function of this is difficult to ascertain, though it is unlikely to be for lighting, given its height. There is some suggestion, as outlined below, that there was an existing earlier structure in the position of number 21 when this phase was built, so this window may have been internal. This room had a large fireplace within its north-east corner of a scale consistent with cooking functions. This room is likely to have combined as both a kitchen and living room.

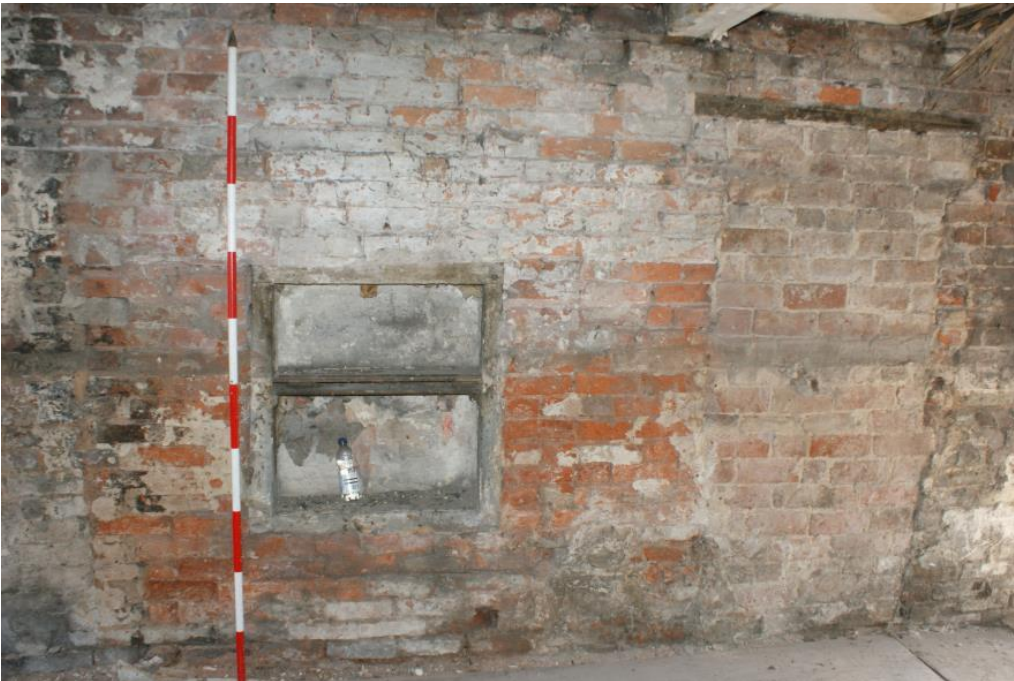
*Plate 3 Blocked window in Phase 1 gable end, looking north-east*

hypothesised building outlined above which it may have replaced. It is possible that a door inserted through the south-west gable of number 22 at ground floor level relates to this building (Plate 3), though it may relate to Phase 3.

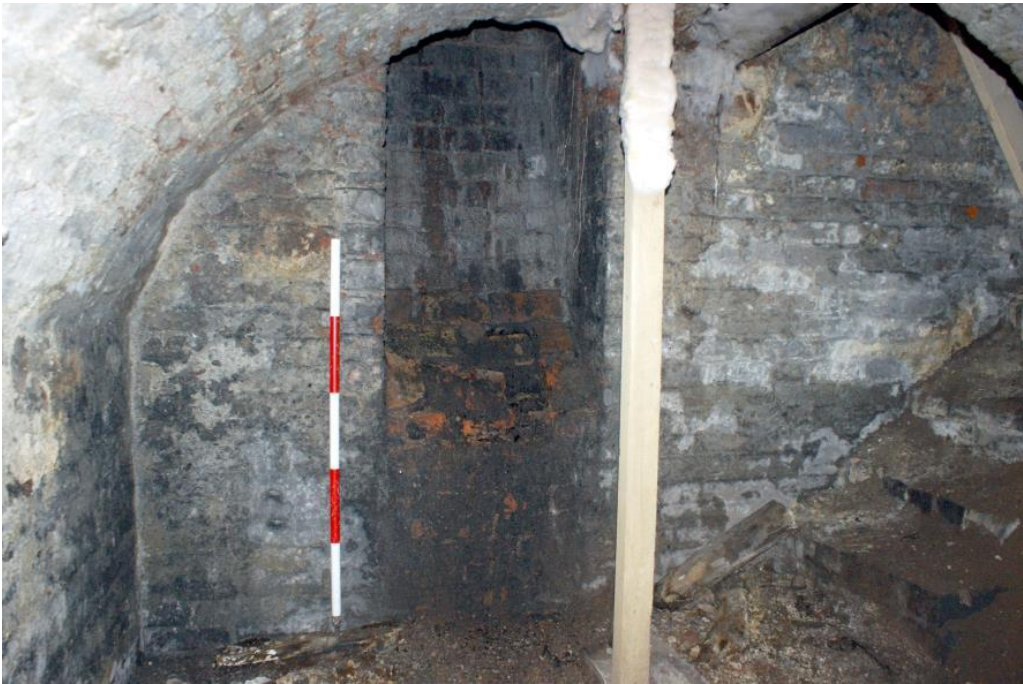
*Plate 4 Phase 1 cellar, looking north-west*

The staircase led down to a brick vaulted cellar which had a coal chute (**Plate 4**) and a further chute below the front of the fireplace in the room above (**Plate 5**), though this may be a later addition.

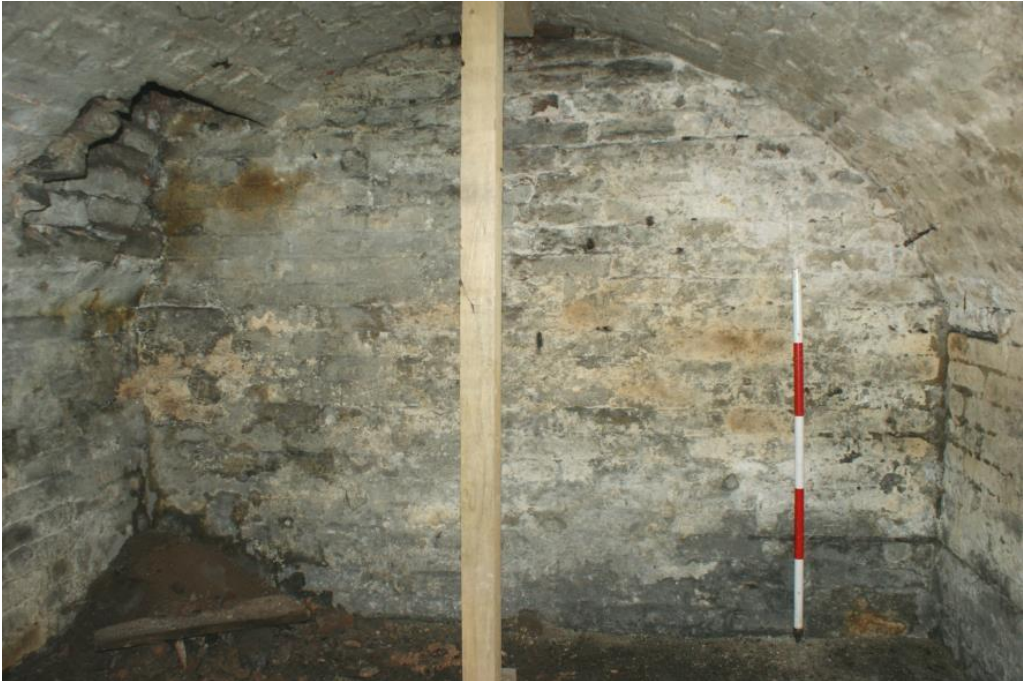
*Plate 5 Phase 1 cellar, looking south-east*

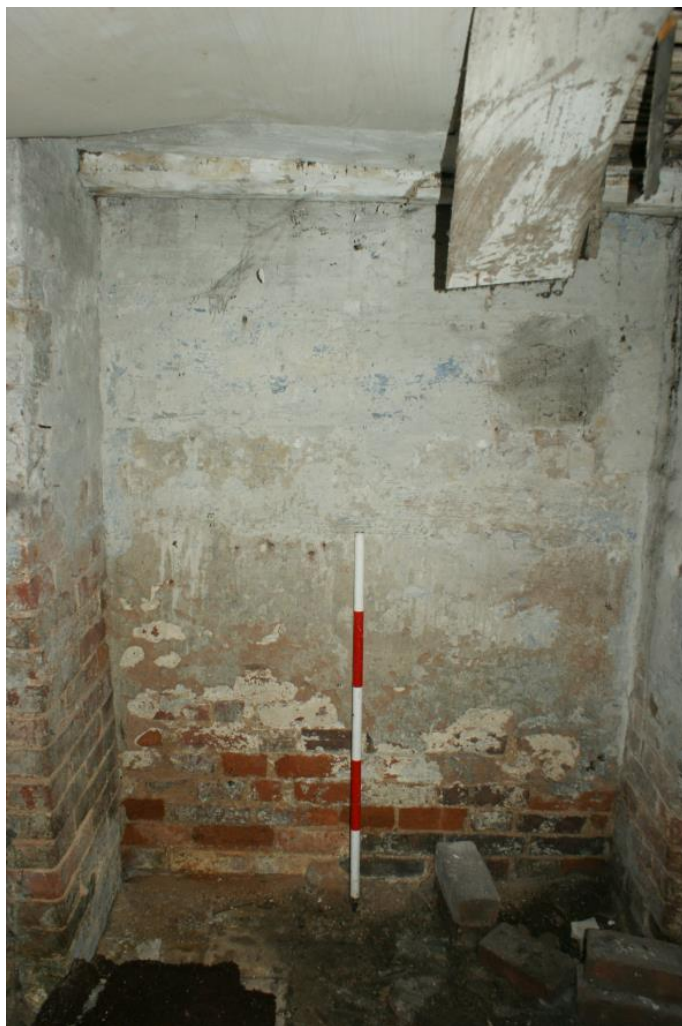
*Plate 6 Phase 1 groundfloor storage room, looking north-west*

The further small ground floor room was accessed from the living room/ kitchen and had a slightly lower floor level (**Plate 6**). The room had no windows and is likely to have been for storage.

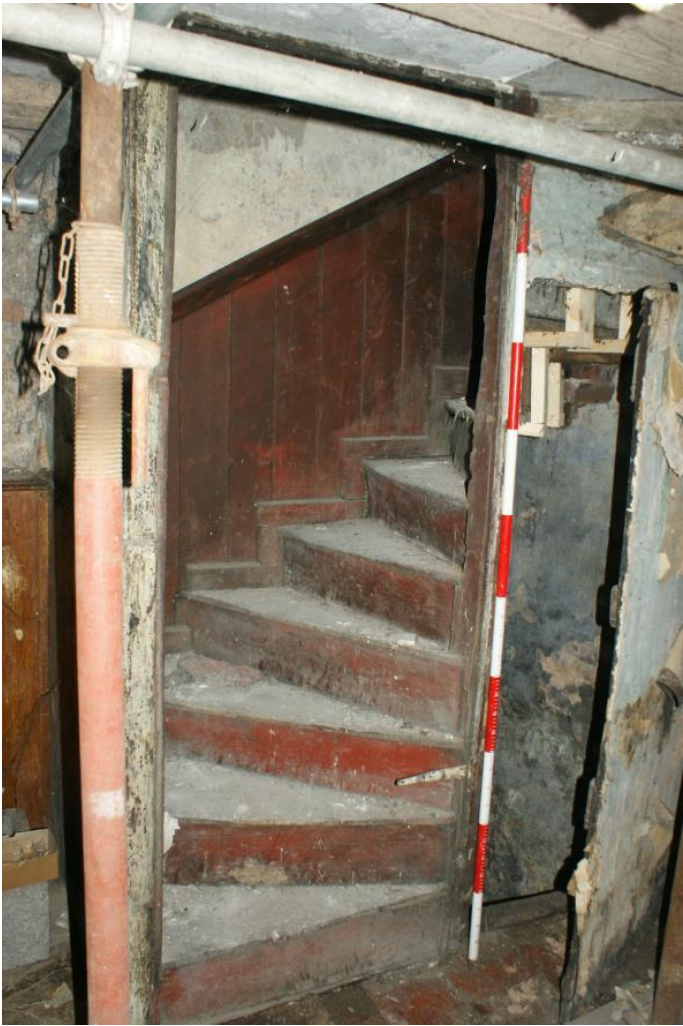
*Plate 7 Phase 1 staircase, looking north*

The original staircase remained extant (**Plate 7**), though the enclosing boarding and timber work may be a Phase 2 or 3 additions. The staircase was lit by a small window (**Plate 8**) and led firstly to the smaller of the two rooms on the first floor. This had a window facing the south-east and is again likely to be for storage (**Plate 9**). The larger first floor room had a smaller fireplace than the kitchen or living room below and is of a scale sufficient for a bedroom (**Plate 10**). It had a window facing south-east, though this was altered at a later date to include a low arch lintel (**Plate 1**). It had a further window facing north-west (**Plate 11**) which was later blocked but contained an original frame similar to that seen in the ground floor room (**Plate 3**).

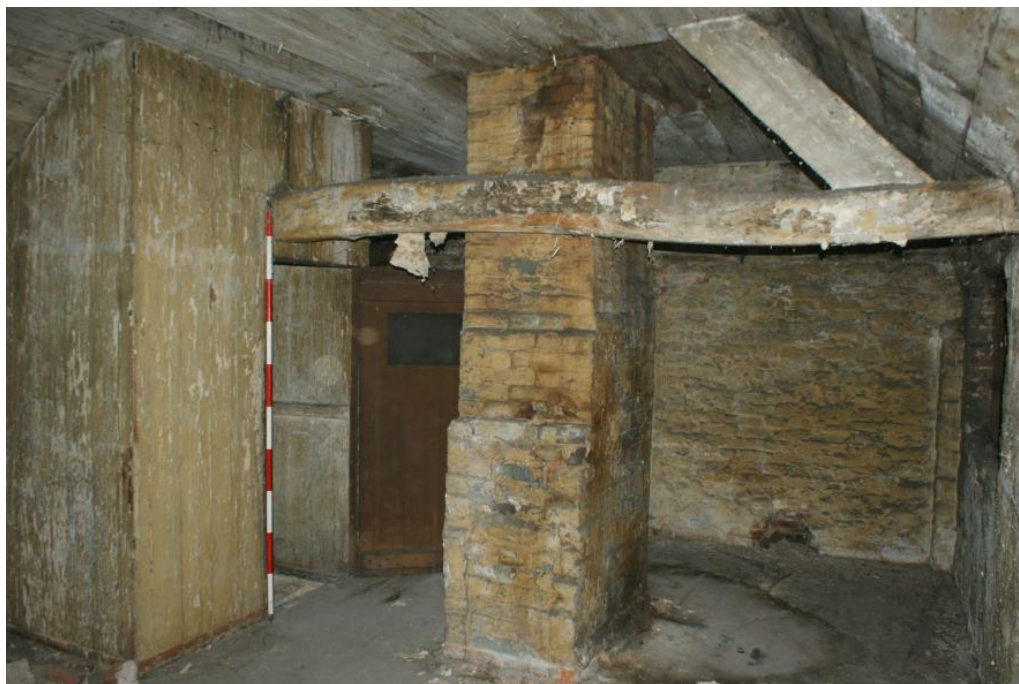
*Plate 12 Phase 1 second floor room, looking north-east*

The second floor consisted of one room only (**Plate 12**) which had direct access around the chimney breast in the middle of the room. This chimney breast may have had a small fireplace on

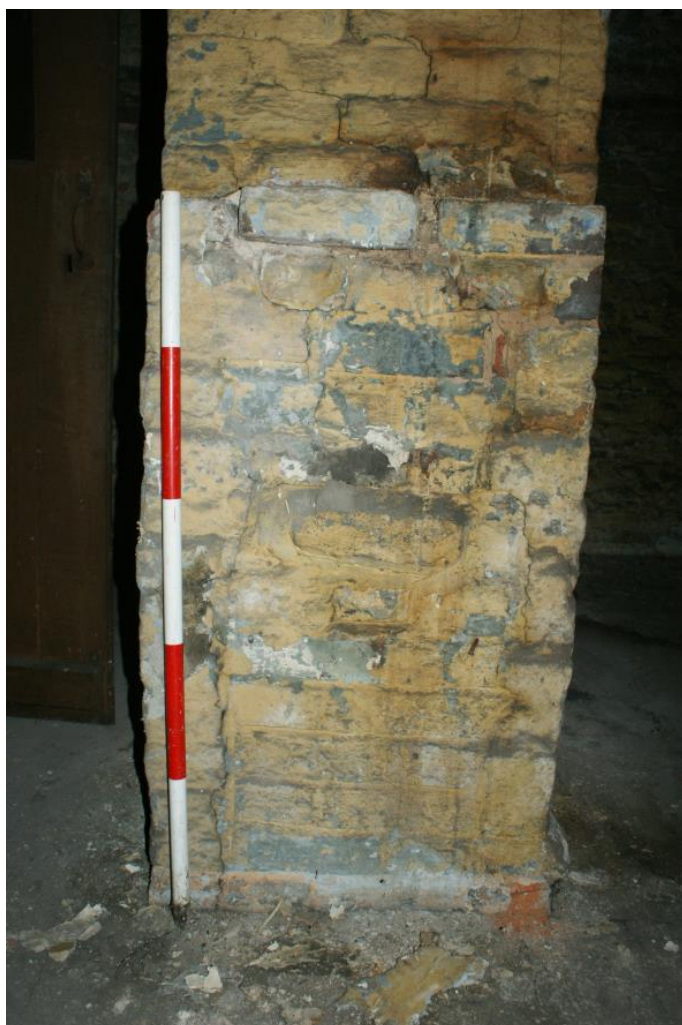
*Plate 13 Possible Phase 1 former fireplace, looking north-east*

its south-west facing side (**Plate 13**), as seen by changes to the brickwork at this point. This room was lit by four windows (**Plate 14**) which were noticeably larger than those seen elsewhere, though the two on the north-west side were later blocked. The boarding on the ceiling is likely to date to Phase 2 or 3 so it is probable that this room was originally open to the roof, giving a large, well lit room for weaving. A high roof would have been essential for the accommodation of a hand weaving loom.

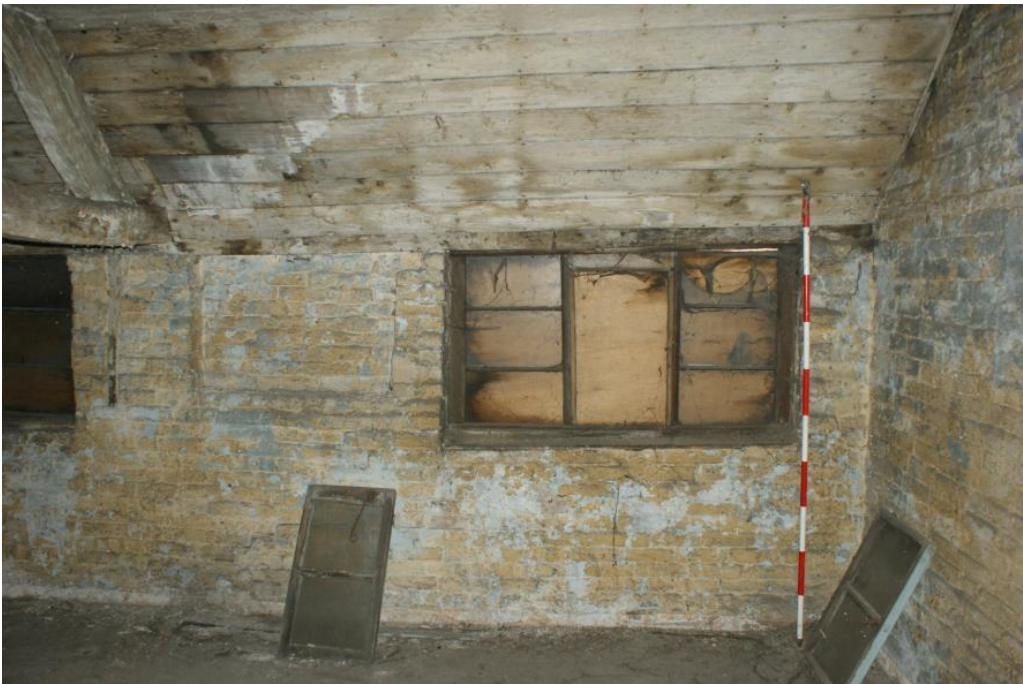
*Plate 14 Phase 1 second floor room, looking south-east*

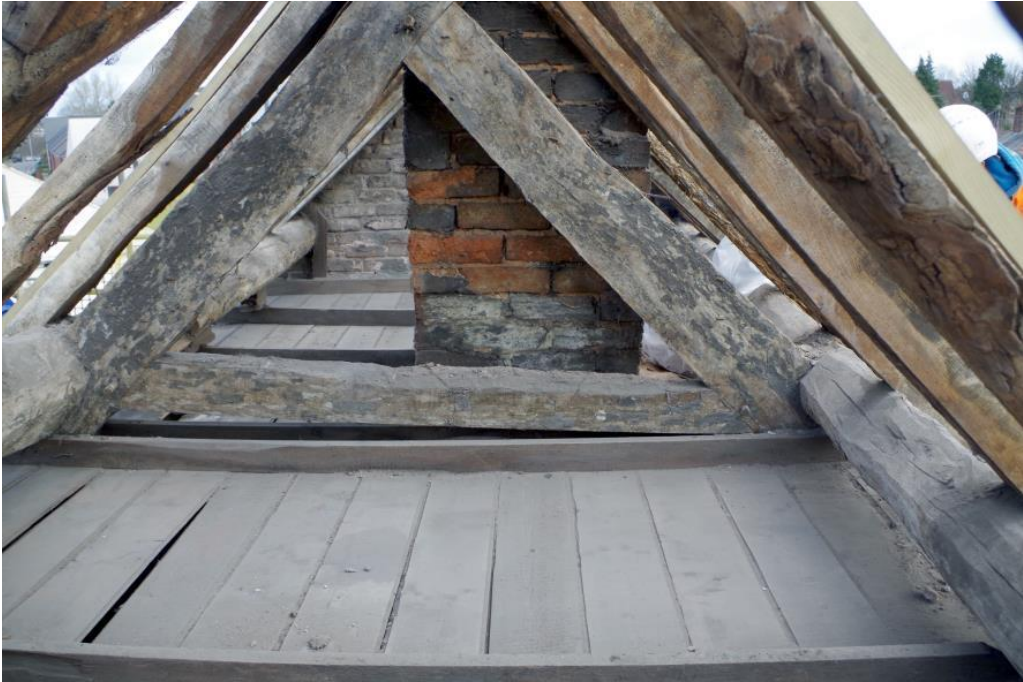
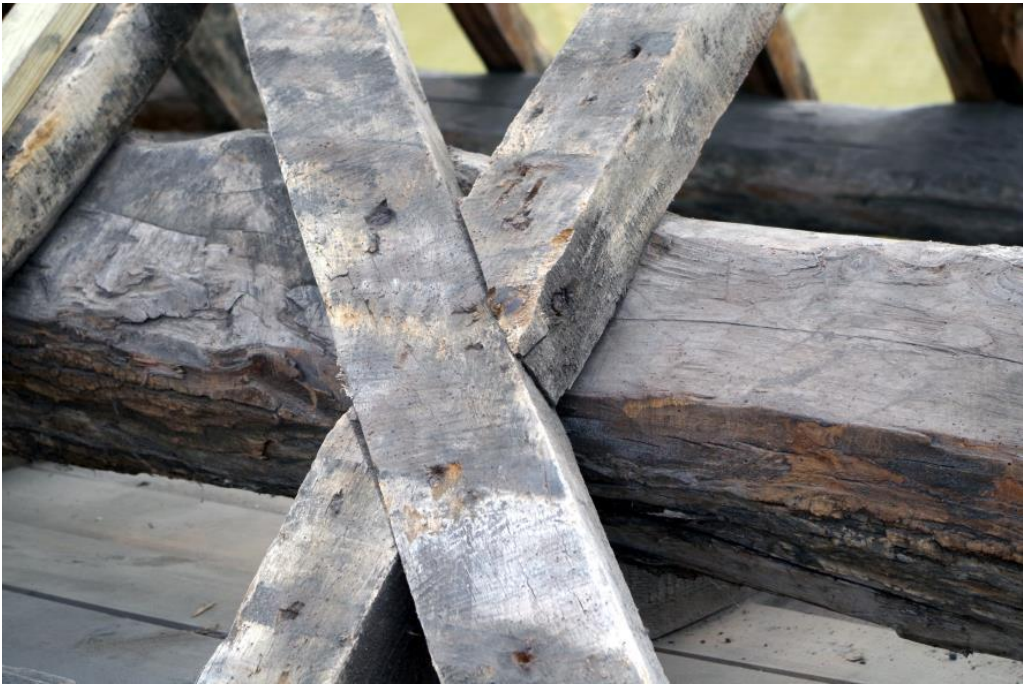
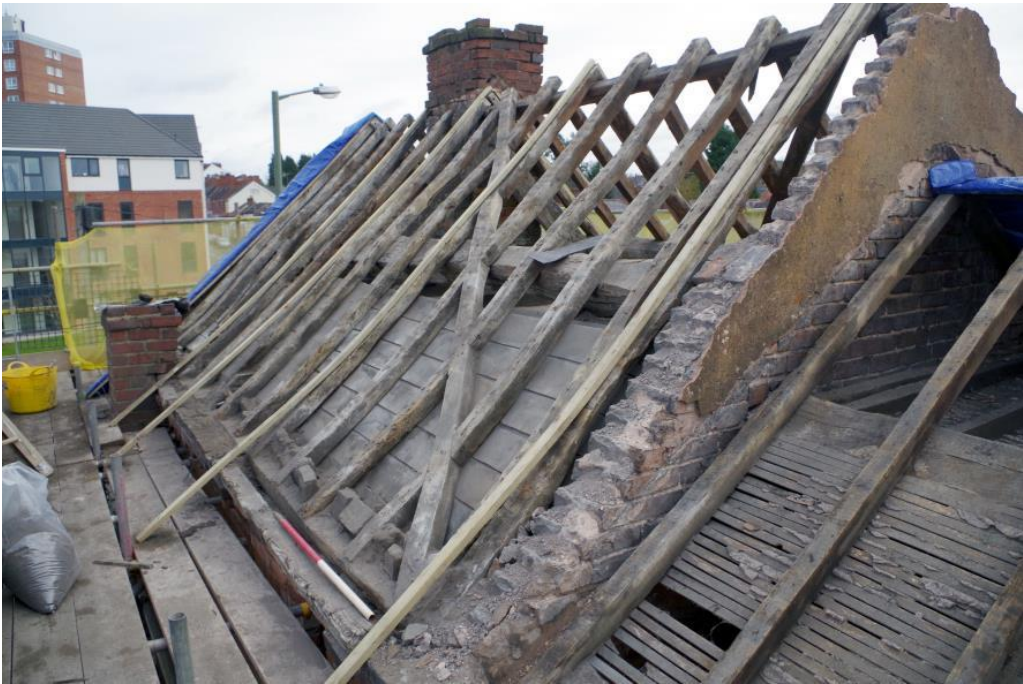
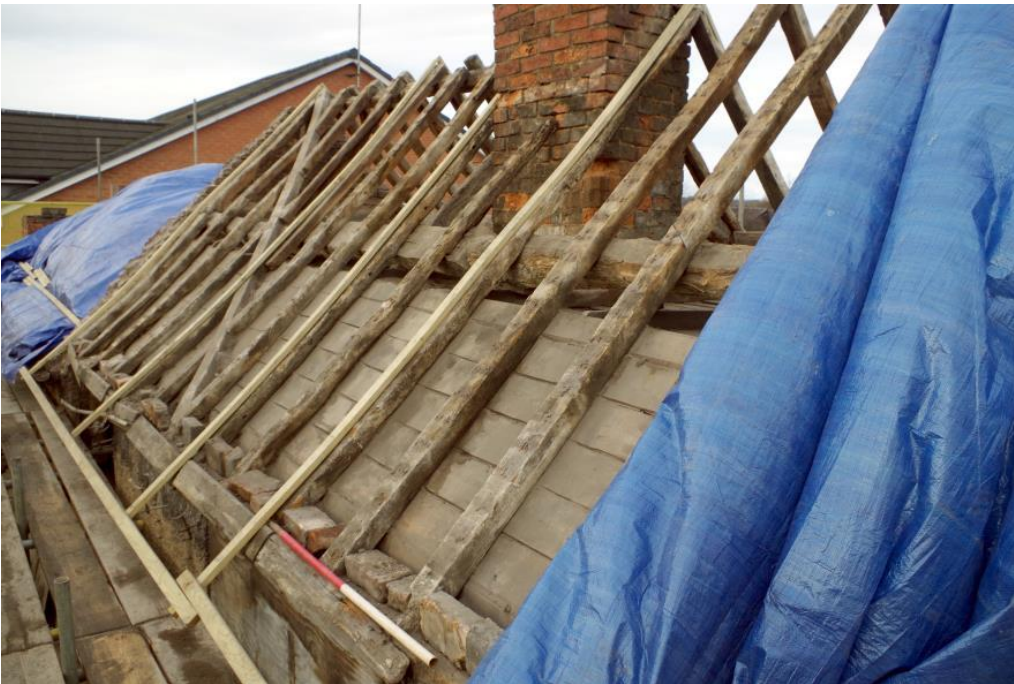
*Plate 15 Phase 1 roof structure, looking north-east*

*Plate 16 Phase 1 roof structure, looking north-east*

*Plate 17 Phase 1 roof structure, looking north-east*

*Plate 18 Phase 1 roof structure, looking south-west*

The roof structure, constructed entirely from elm, was supported by a tie beam truss which sat upon a wooden plate along the walls. The principle rafters were set well back from ends of the tie beams as is typical of a 17<sup>th</sup> century or later building and the main joints were pegged together with wood, as seen on the trusses collar (**Plate 15**). The purlins were trenched to the back of the principle rafters and the common rafters nailed to these (**Plate 16**). This combination of both wooden and metal fixings is much more typical of a building of 18<sup>th</sup> to 19<sup>th</sup> century date than a 17<sup>th</sup> century date.

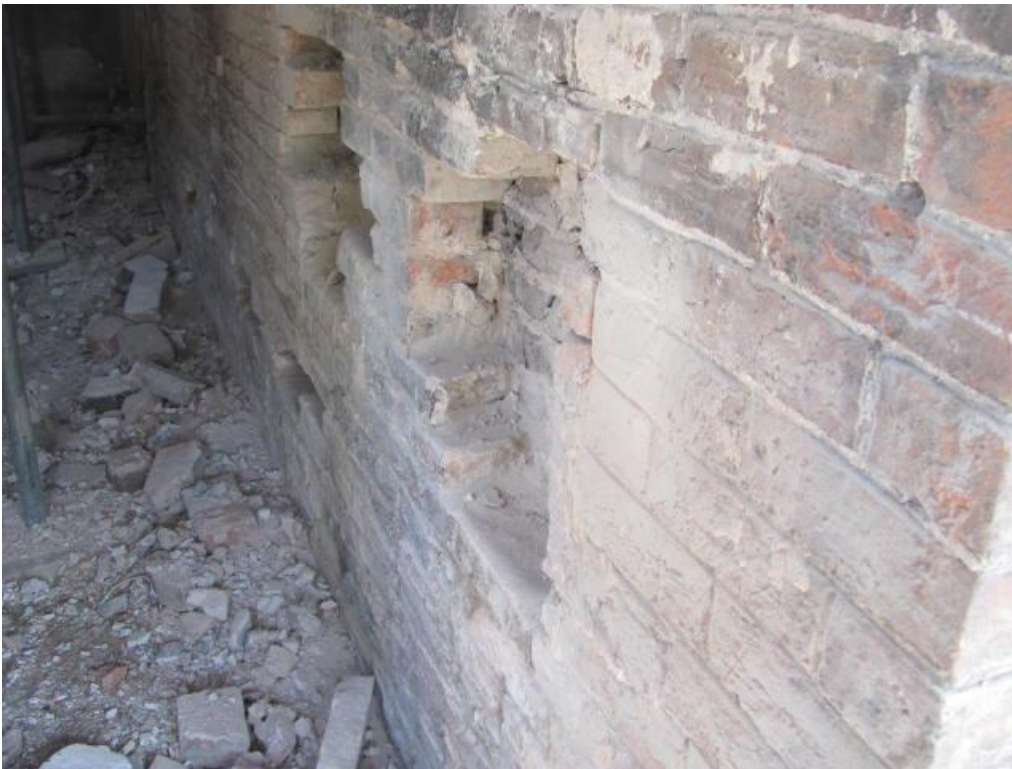
*Plate 22 Bricks visible in the gable end of Number 20, suggesting the presence of an earlier structure, looking north*

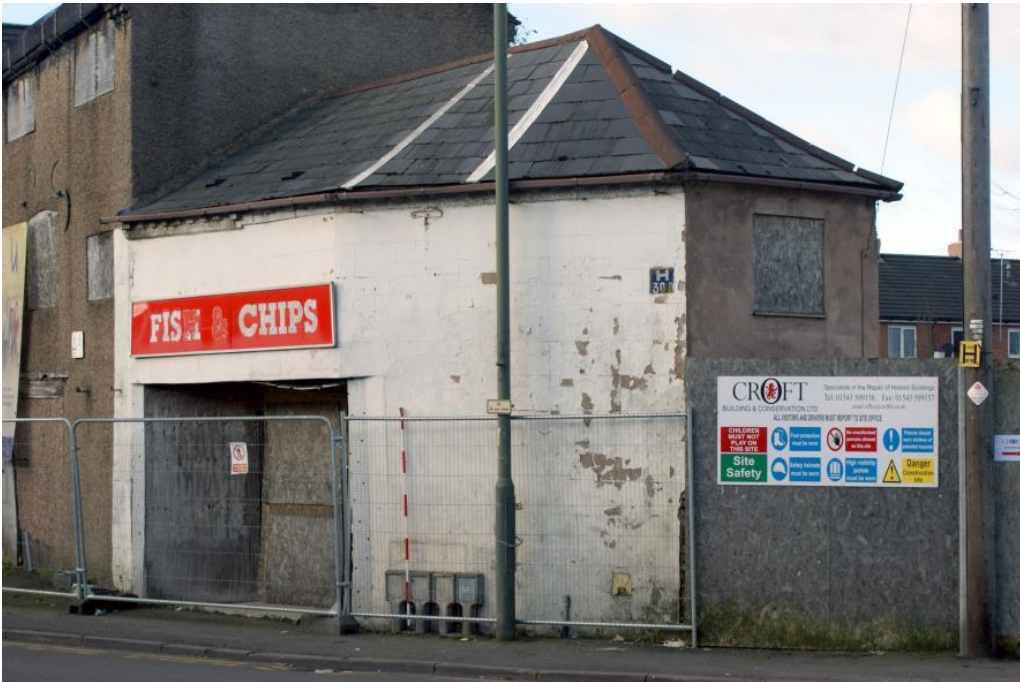
*Plate 39 Phase 3 Number 23, looking south-west*

It is not clear when No 23 (Plate 39 and Plate 40), was added to numbers 20 and 21. The building has the character of a 19<sup>th</sup> century building with its dentilled eaves and low pitch roof. However, the roof was a Phase 5 replacement. The ground and first floors had two rooms each with the first floor being accessed from the northern room. The northern room (**Plate 41**) was itself accessed from a doorway in its north-west wall, with a window in the north wall. The ground floor configuration of the southern room was heavily altered in Phase 5 (**Plate 42**), leaving no trace of original doors or windows. There was no direct evidence of access between these rooms. The first floor rooms were both accessed from the top of the stairs (Plate 43 to Plate 45). It is noticeable that none of these rooms contained any evidence of a fireplace, though a chimney with three pots is visible on an undated photograph of this building (Gilbert 2014).

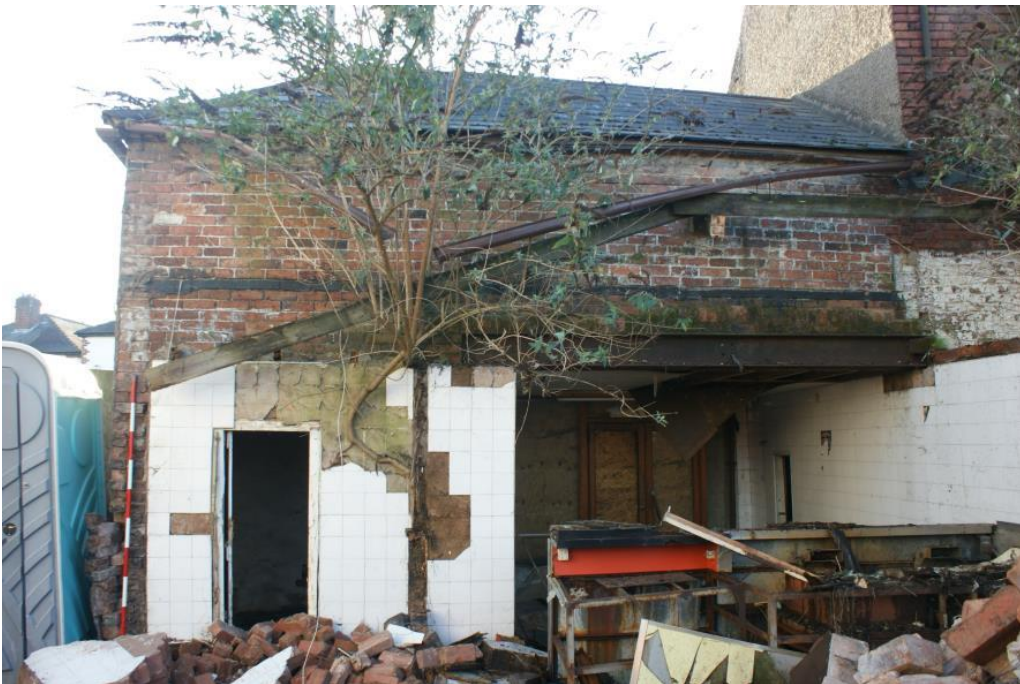
*Plate 40 Phase 3 Number 23, looking south-east*

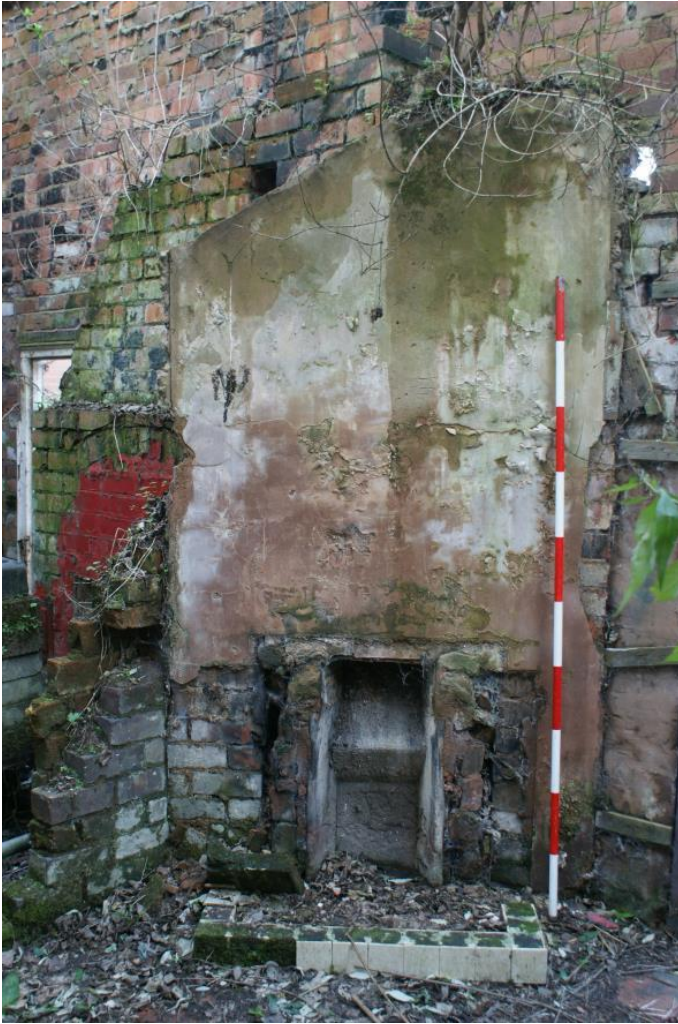
*Plate 51 Phase 5 fireplace added into Phase 4 room, Number 21, looking west*

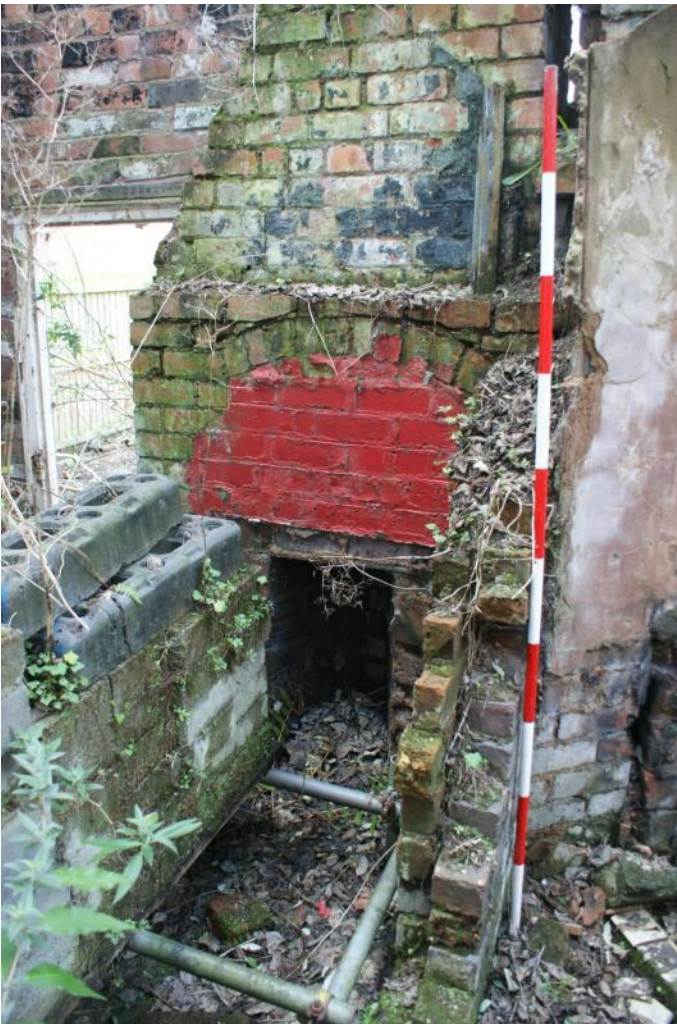
*Plate 52 Phase 5 fireplace added into Phase 4 room, Number 20, looking west*
