## BUILDING RECORDING

**67 AND 68 HONEYBROOK LANE,  
FRANCHE, KIDDERMINSTER,  
WORCESTERSHIRE**

# Building recording at 67 and 68 Honeybrook Lane, Franche, Worcestershire

Status: Revision 2  
Date: 17<sup>th</sup> February 2017  
Author: Tim Cornah [tcorah@worcestershire.gov.uk](mailto:tcorah@worcestershire.gov.uk)  
Illustrator: Carolyn Hunt [chunt@worcestershire.gov.uk](mailto:chunt@worcestershire.gov.uk)  
Project reference: P4935  
Report reference: 2398  
HER reference: WSM68330  
Oasis id: fieldsec1-266896

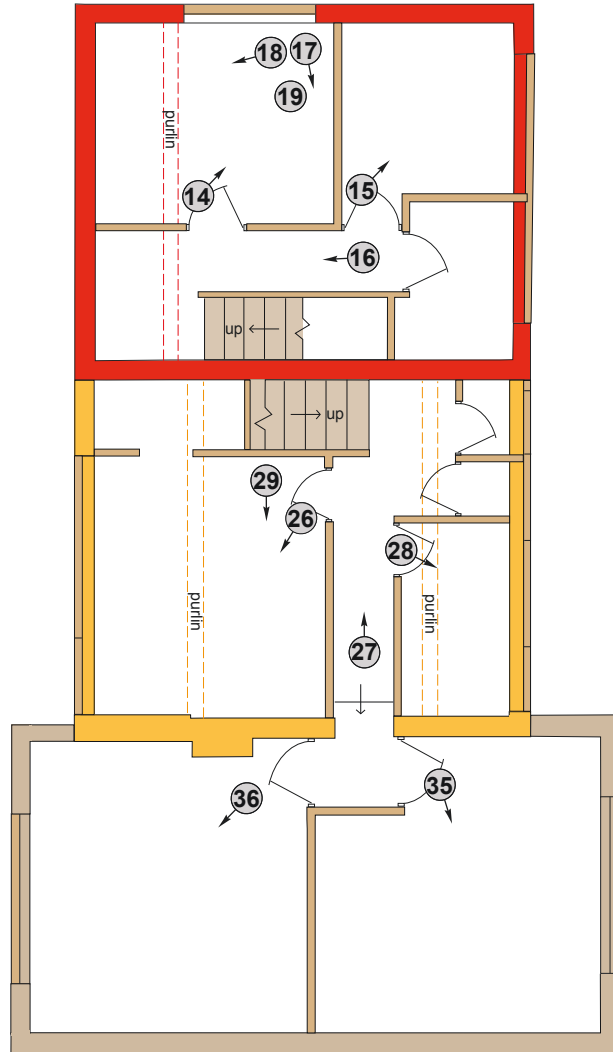
Figure 3

# FIRST FLOOR PLAN

KEY	
<span style="color: red;">█</span>	Phase 1: first half of 18th century
<span style="color: orange;">█</span>	Phase 2: second half of 18th century
<span style="color: tan;">█</span>	Phase 5: second half of 20th century

First floor plan with phasing and photolocations

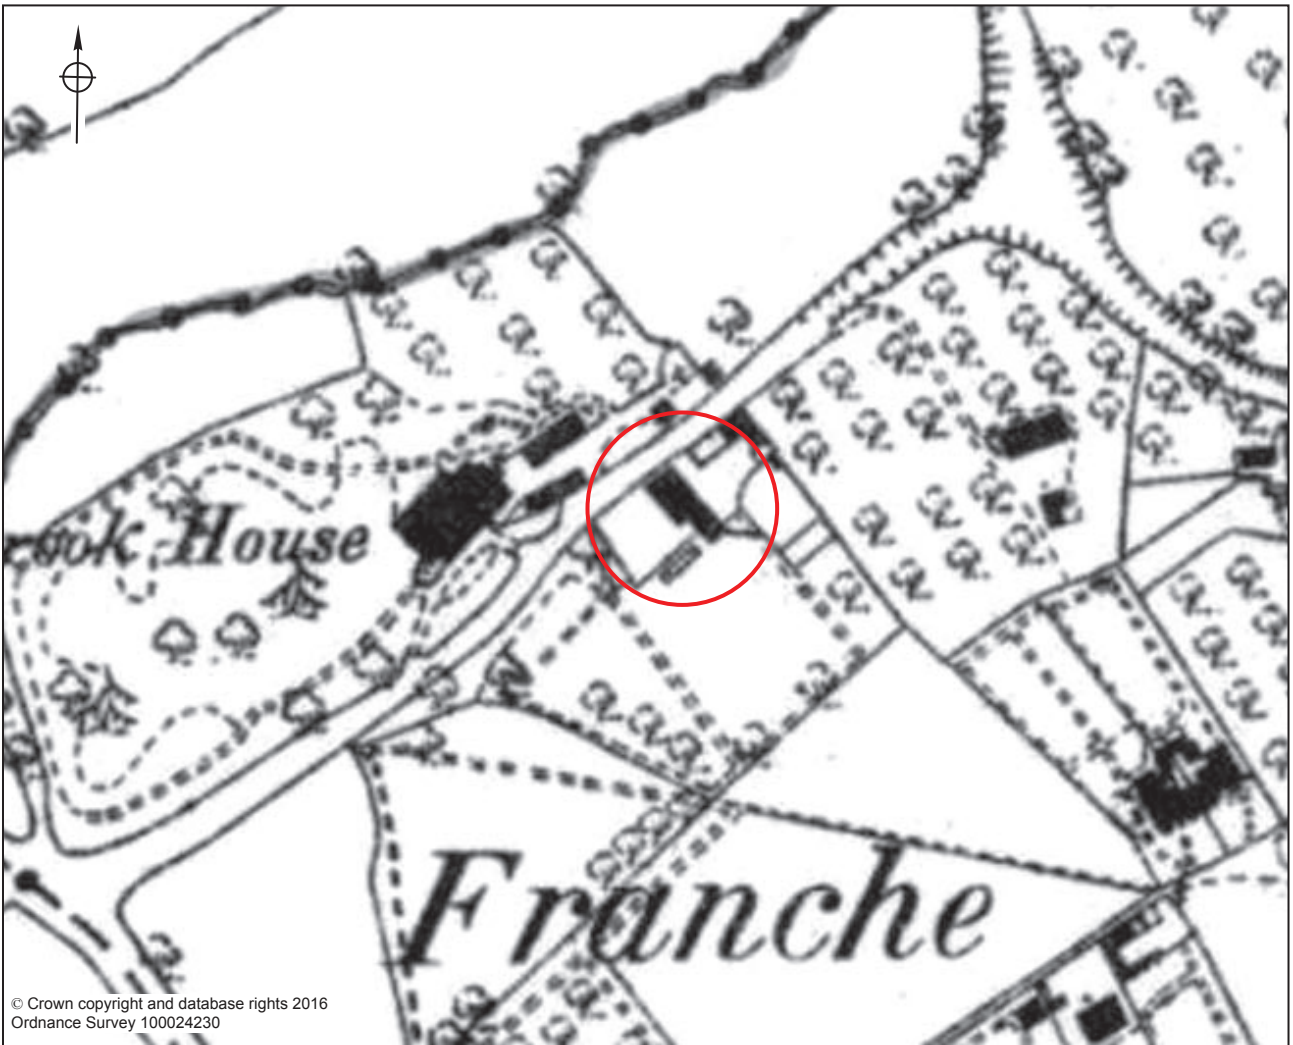
Figure 5

Extract of 1st edition OS, 1884

At least one further building was added to the south of the Phase 2 structure, with two doors added through its southern gable at ground floor level. This building is shown as single storey on the photographs of the 1930s and 1970s, though little remained. A single wall is likely to remain, though this was covered by modern surfaces. The current owners suggest these were used as a washhouse. A chimney position, as would be required for a boiler or copper, is also visible on the western side in the 1930s. This building is depicted on the OS map of 1884.

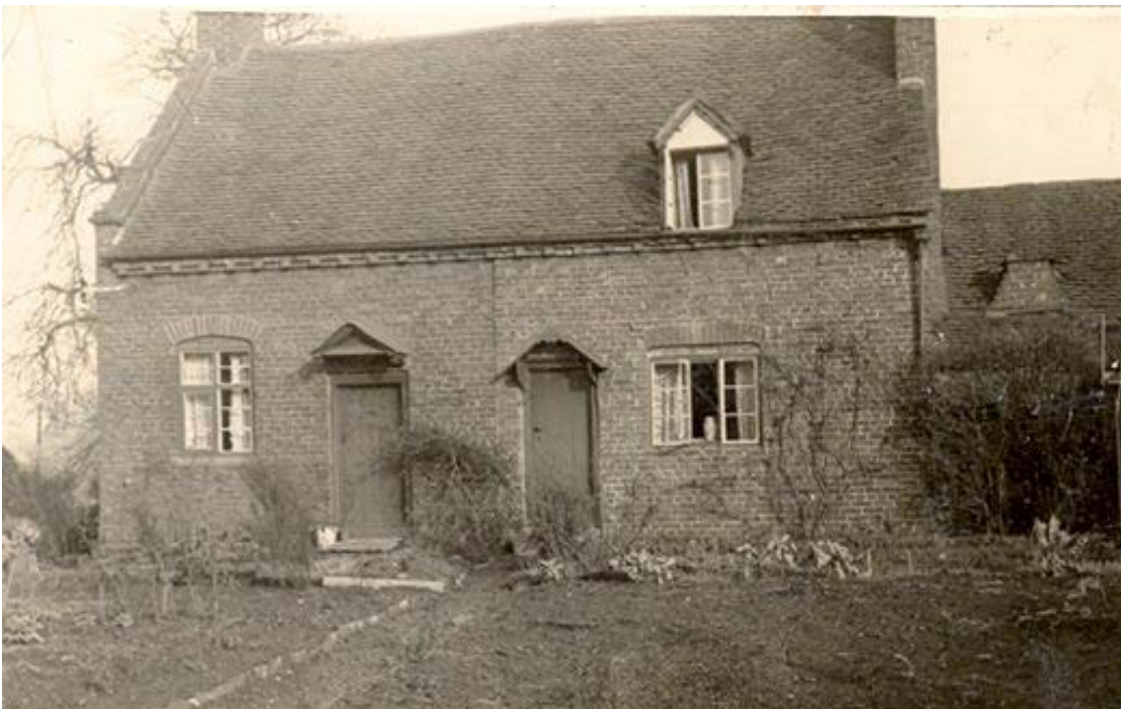
*Plate 2 The cottages pictured c1930, looking east (Courtesy of Peter and Christine Doncaster)*

The building consisted of a rectangular brick structure, the front of which was originally on its western side. This was shown by the doors and windows recorded in (**Plate 2**) and altered in Phase 5 (**Plate 4**). The window was a segmental arch-headed window, another of which was visible on the eastern side alongside a further doorway (**Plate 5**), though some evidence of alteration was visible around these, particularly the door. A further ground floor window previously

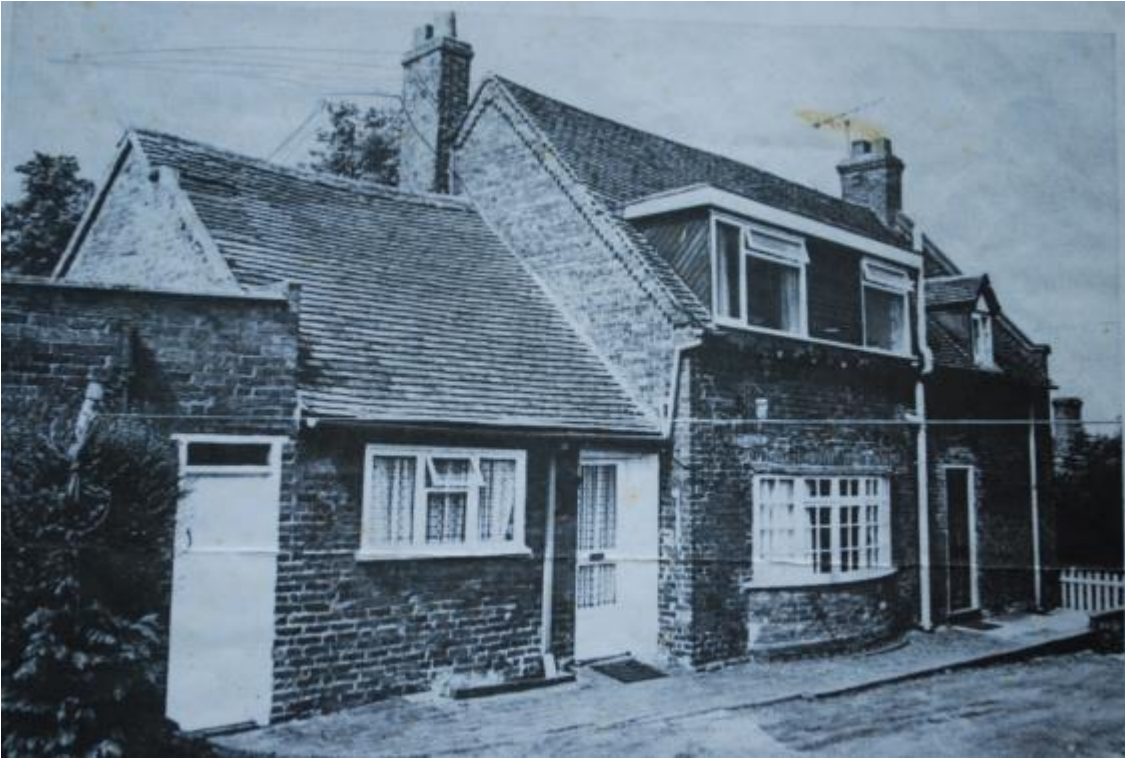
*Plate 3 The cottages pictured c1970s, looking north-west (Courtesy of Peter and Christine Doncaster)*

The earliest building that made up these cottages was Number 68, situated closest to Honeybrook Lane. This and Number 67 are shown in a largely unaltered state in photographs taken in the 1930s (**Plate 2**) and again in the later 20<sup>th</sup> century (**Plate 3**).

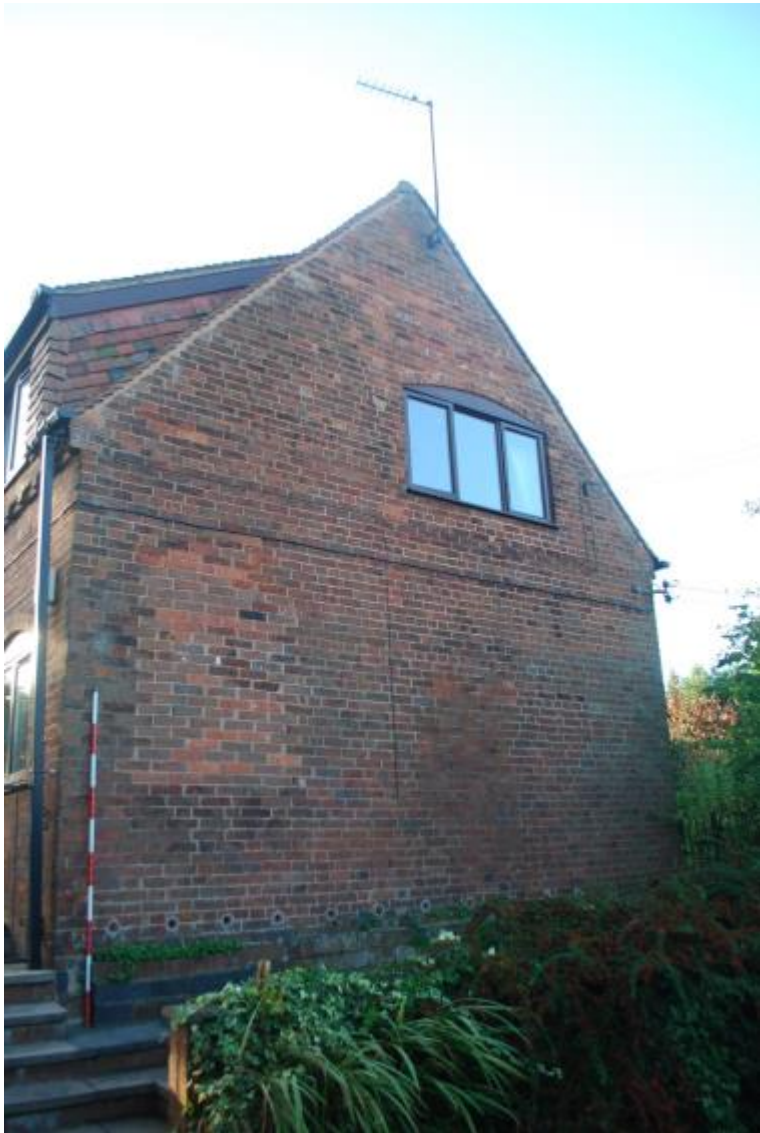
*Plate 6 Phase 1 building, looking south*

existed on its gable, but was later blocked, along with another segmental arch-headed window at first floor level (**Plate 6**).

All of the timbers visible of this phase were converted by pit sawing, a technique which broadly remained in use until around the middle of the 19<sup>th</sup> century, along with some axe conversion by hand. The bricks used throughout this phase were not particularly diagnostic in terms of date, though having brickwork on stone footings is common through the 18<sup>th</sup> century. The brickwork style is certainly unusual with Flemish bond for least the base eight courses, followed by a three course deep English bond, though with alternative header and stretcher bricks for what would usually only be the header only course. This is followed by a four course, deep English bond with the same style and then above these a more normal English bond consisting of a header-only course (**Plate 6**).

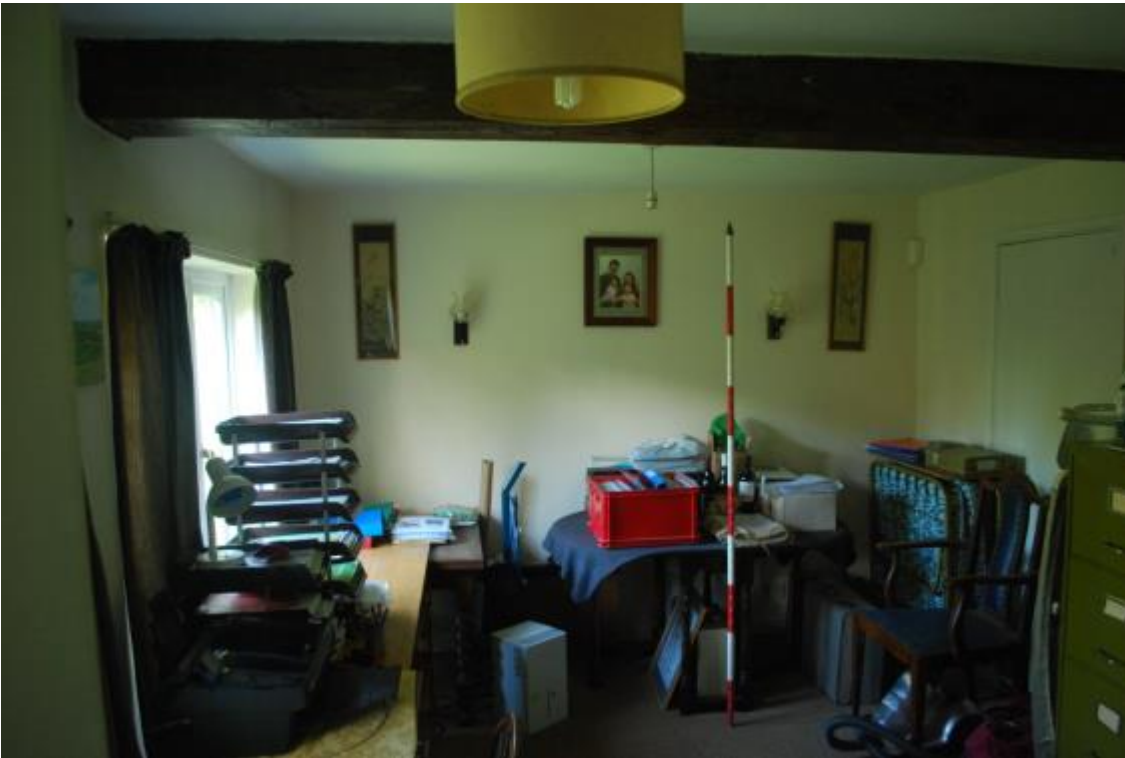
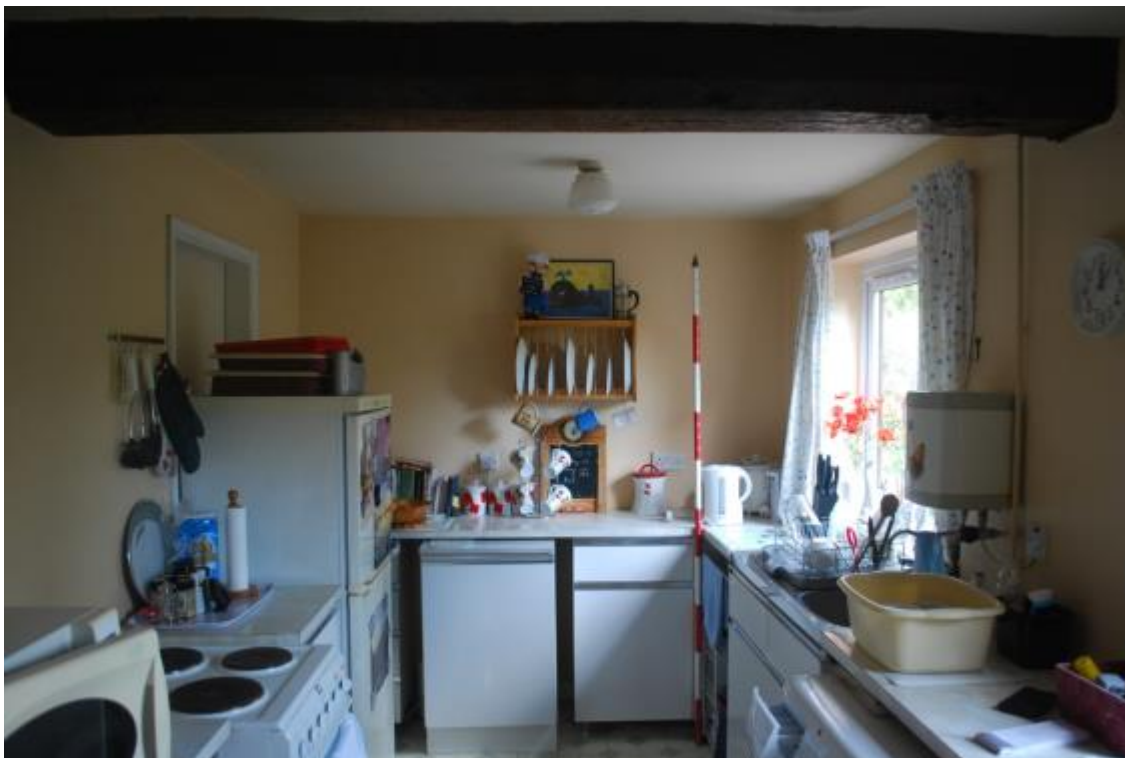
*Plate 7 Phase 1 ground floor room, looking north*

*Plate 8 Phase 1 ground floor room, looking north*

Internally, the ground floor room (**Plate 7** and **Plate 8**) is likely to have been a single living room as no mortices for internal partitions were observed in the base of the central beam for timber partitions (**Plate 9**). It is possible that such evidence remains obscured by the Phase 5 partition but this seems unlikely given that the northern end of this would run across the former fireplace position. A building of this period is likely to have had a wide fireplace such as an inglenook suitable for cooking.

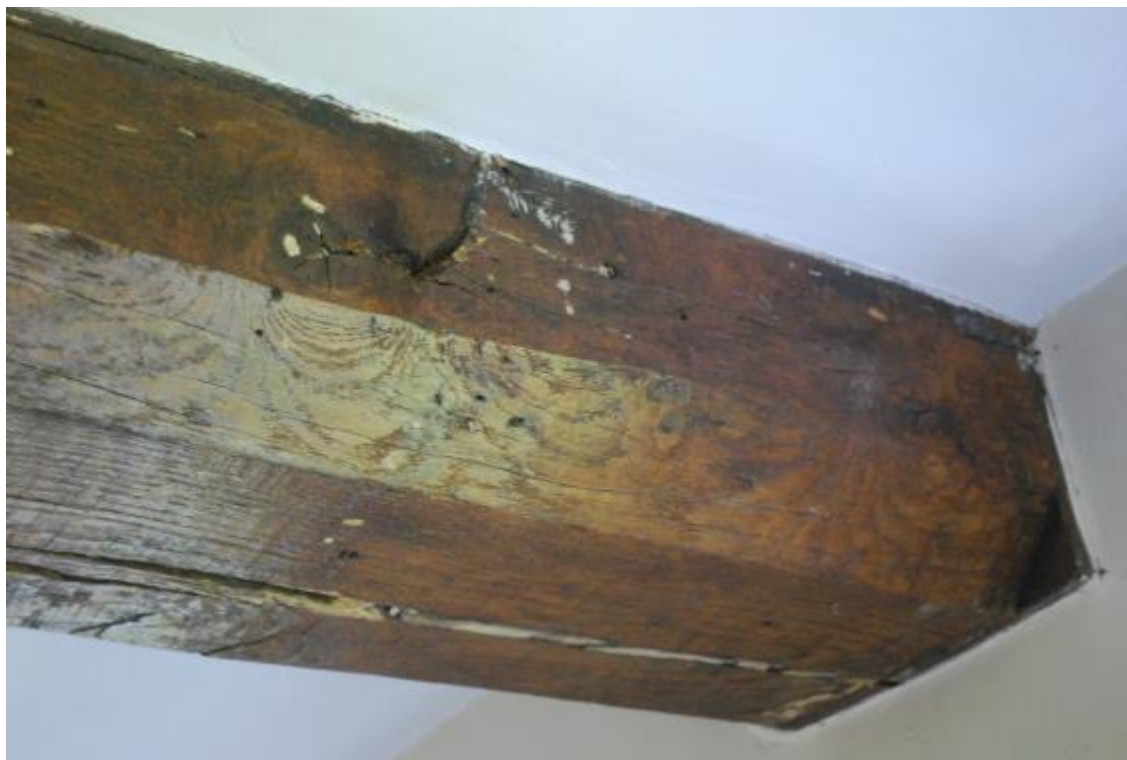
*Plate 9 Phase 1 ground floor room with simple chamfer on the central beam, looking south-west*

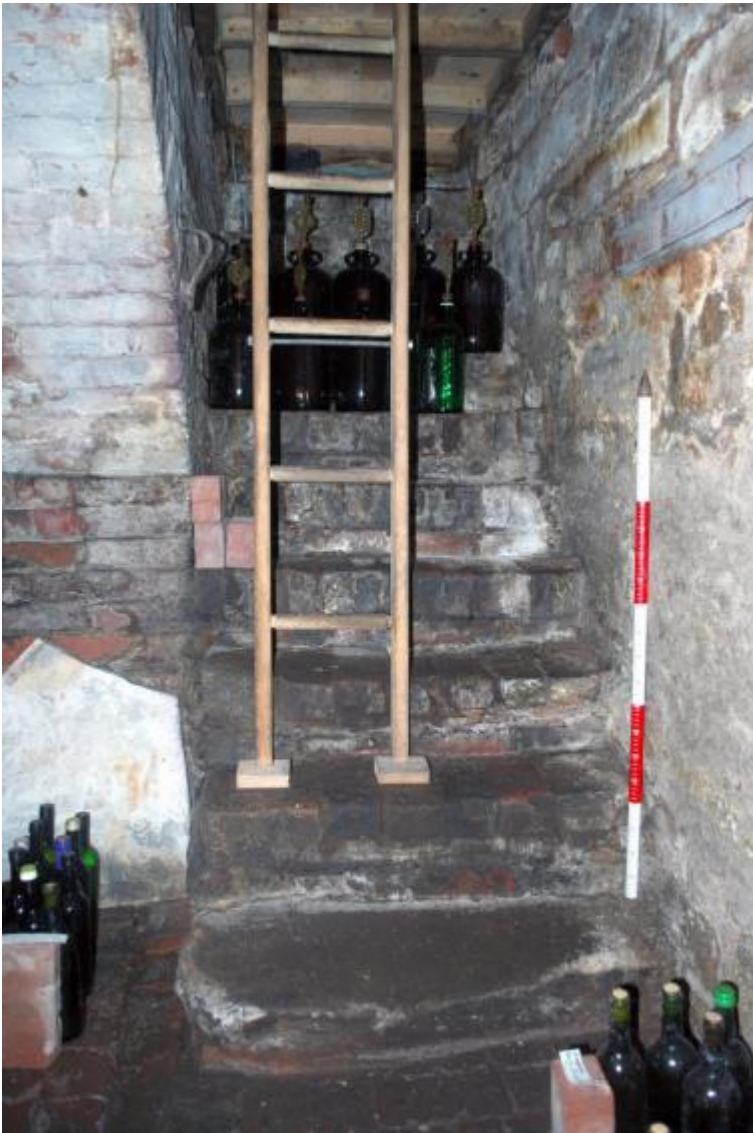
*Plate 10 Phase 1 blocked cellar stairs, looking east*

Below the western half of the building was a cellar, originally accessed from its south-east corner, evident from the survival of a flight of blocked steps (**Plate 10**). The cellar (**Plate 11** and **Plate 12**) was sandstone-built on all external walls, but brick-built on its eastern wall and covered by a brick arch. It had a coal chute at its northern end, though a brick rebuild may suggest this was a later addition. The brick floor contained a channel running around its centre (Figure 2 and **Plate 13**) and draining under the eastern wall. Whilst this may have been purely to allow ground water out of the cellar, it is more likely to relate to the function of drainage for spillage within a beer cellar, with gaps left next to the walls for a raised platform on which barrels would be located.

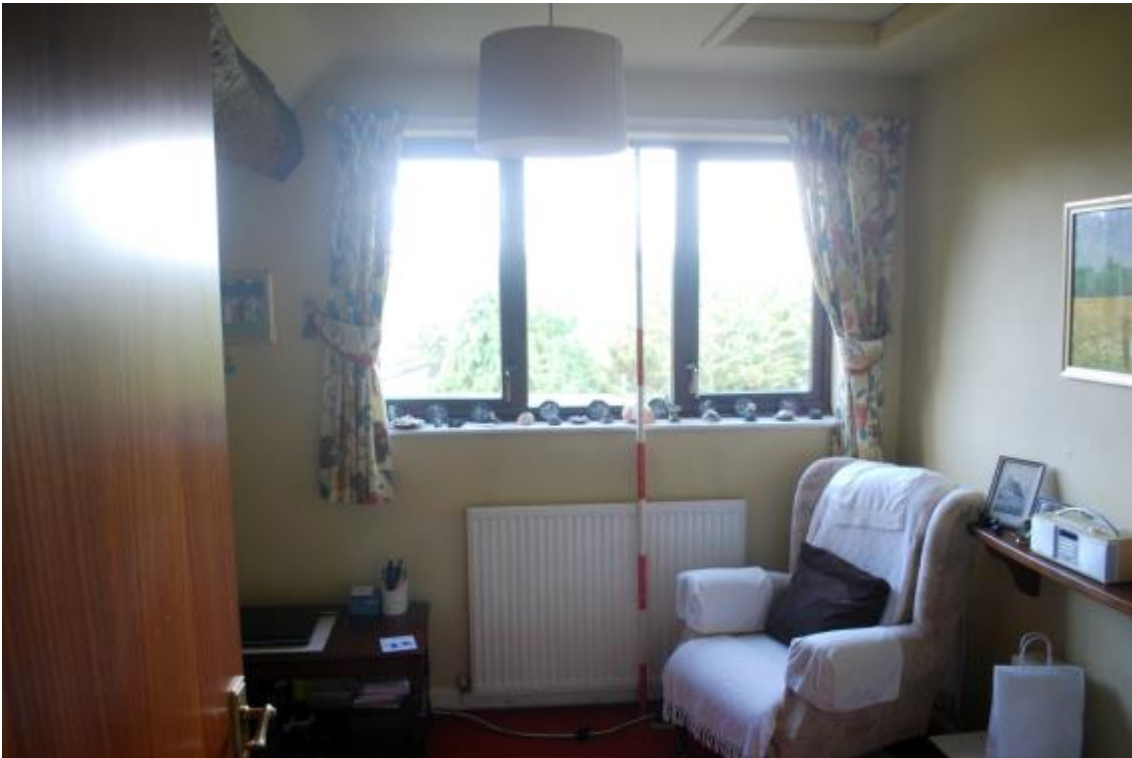
*Plate 14 Phase 1 first floor room, looking north*

It is likely that the original staircase from the ground floor to the first floor would have been directly above those to the cellar and accessed from the front door. Whether the first floor (**Plate 14** to **Plate 16**) was originally partitioned into smaller rooms is again unclear as no evidence for this remained.

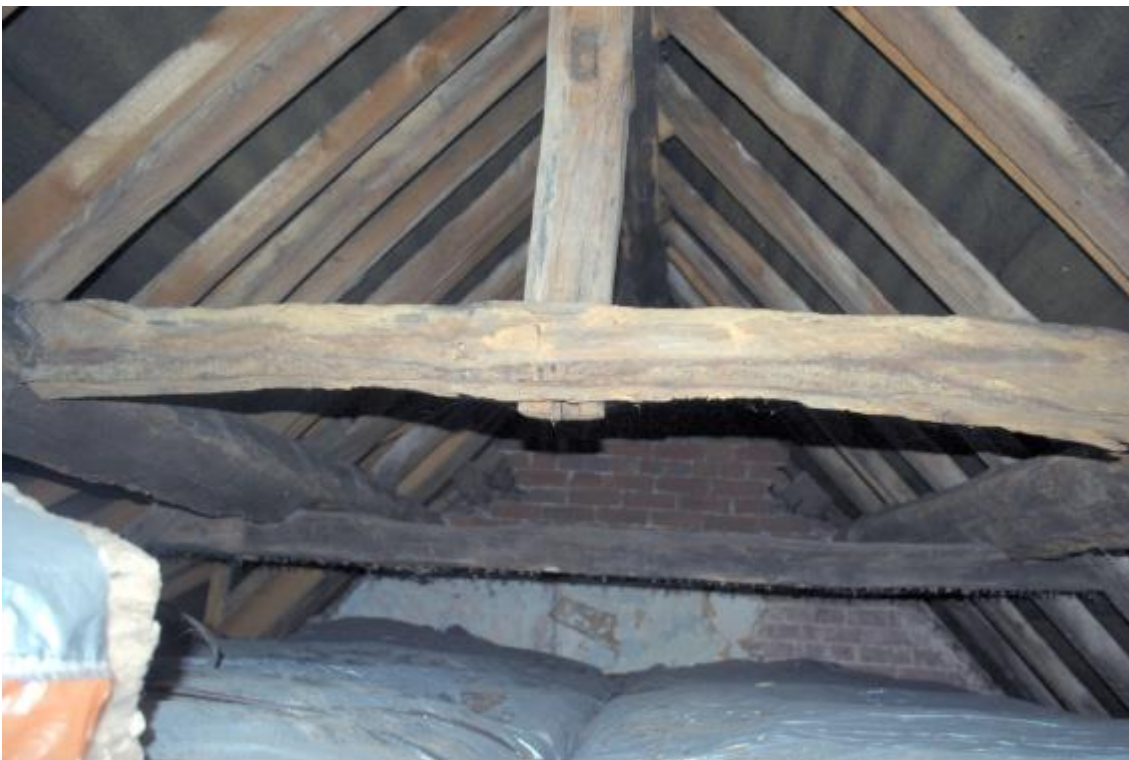
*Plate 17 Phase 1 roof structure, looking south*

A side purlin of the roof structure is visible on the first floor, with a second set of side purlins, the ridge purlin and the rafters visible in the roof space (**Plate 17**). A central collar with a king strut above was placed in the centre of the roof and fixed to the side purlins using wooden pegs. The common rafters (**Plate 18**) were square and fixed together with square-headed nails. On the western side of the roof was a long brace that presumably ran from wall plate level to the ridge purlin. This common rafter arrangement is remarkably similar to Weavers Cottages at the Horsefair in Kidderminster, which can be dated by map evidence to the first half of the 18<sup>th</sup> century. A combination of both wooden and metal fixings is also typical of many 18<sup>th</sup> century roofs. The top end of this brace was attached to the end of the ridge purlin, which was noticeably short from the northern gable wall. This discrepancy is likely to have been caused by the removal of the chimney breast from this position (**Plate 19**).

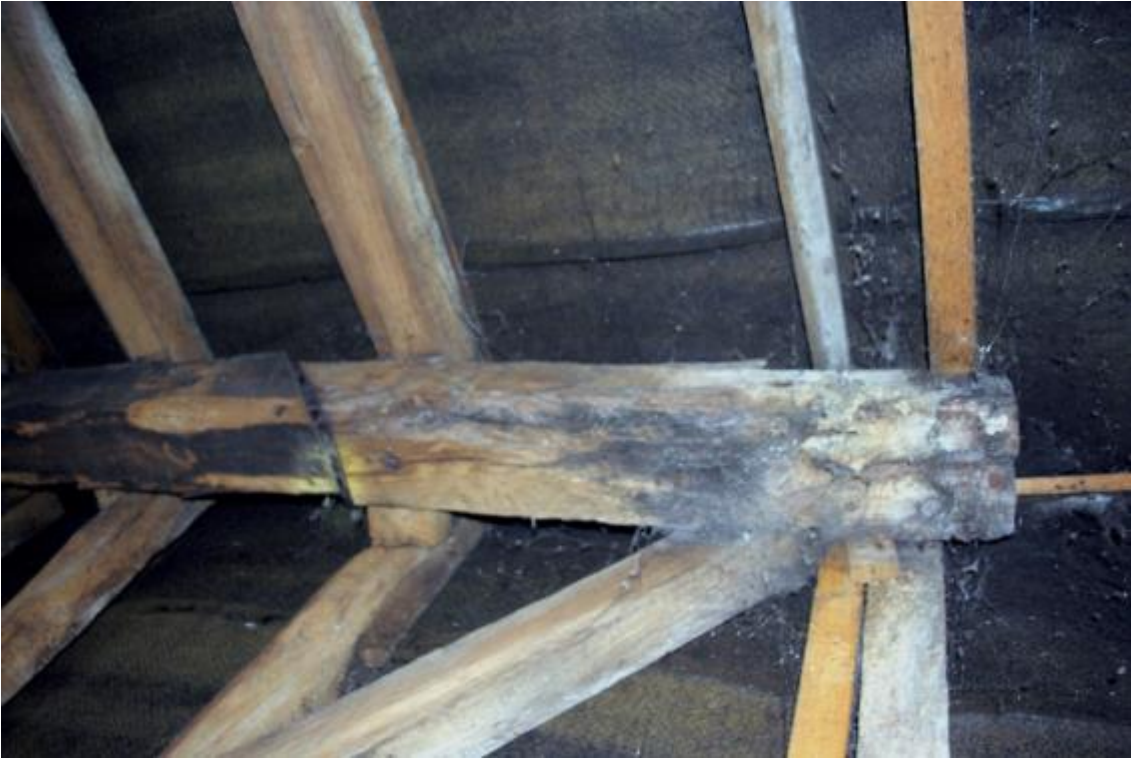
*Plate 19 Phase 1 roof structure, looking upwards*

The details of the building shown on the photograph of the 1930s suggest a building consistent with an 18<sup>th</sup> century date. The dentilled eaves details are of a type common from the 18<sup>th</sup> century onwards and became common after timber eaves were banned following London fire regulation acts of 1707 and 1709. The northern gable raised over the height of the roof tiles with a step at its base is also a common feature of 18<sup>th</sup> century buildings in Worcestershire. This detail was presumably removed from the southern end of the structure during Phase 2. The historic photographs also show a chimney stack rising centrally from the gable. No evidence for this remained internally, apart from a shortened ridge purlin (**Plate 19**).

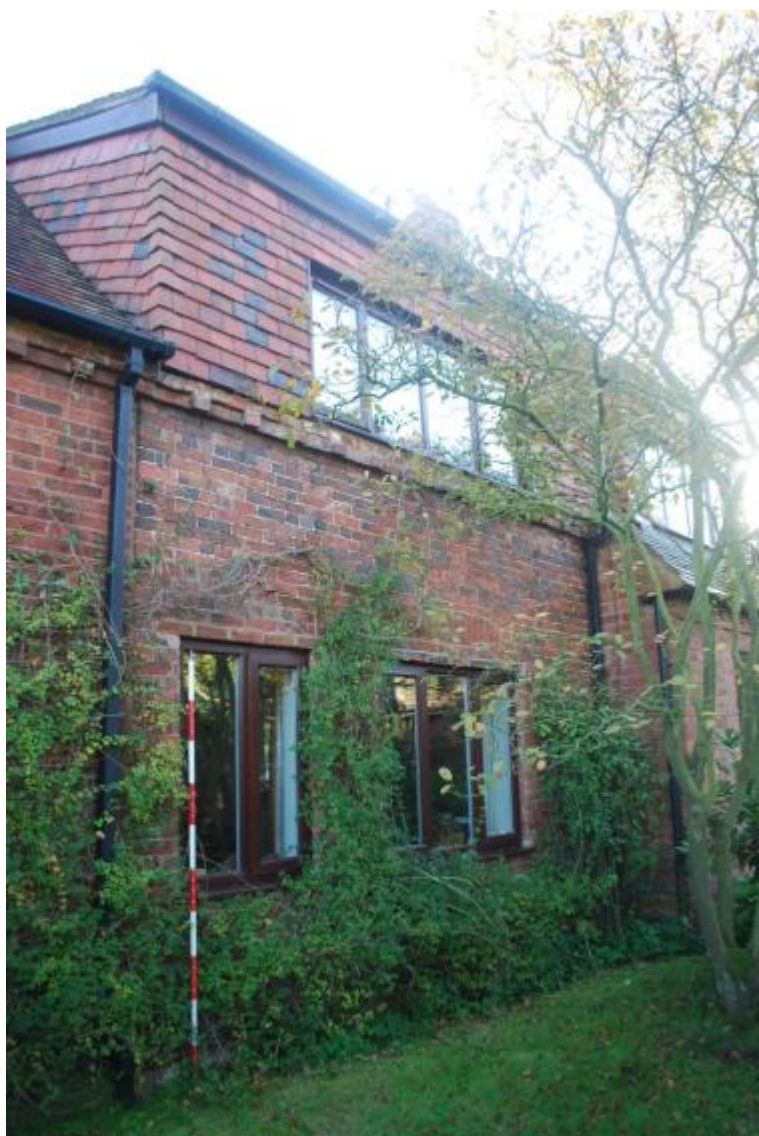
*Plate 20 Phase 2 building, looking south-east*

Number 67 was added onto the southern side of the Phase 1 structure. This was another brick built structure that continued the dentilled eaves detail of the previous building (**Plate 20**). Its front was also on the western side, as seen on the 1930s photograph. Its door on its western side has been blocked and the window changed in Phase 5, though the details of its rubbed brick window arch were visible (**Plate 21**). Any windows on the eastern (**Plate 22**) side have been removed through later alterations though the apex of a former is visible on the brickwork at the northern end of the extant window.

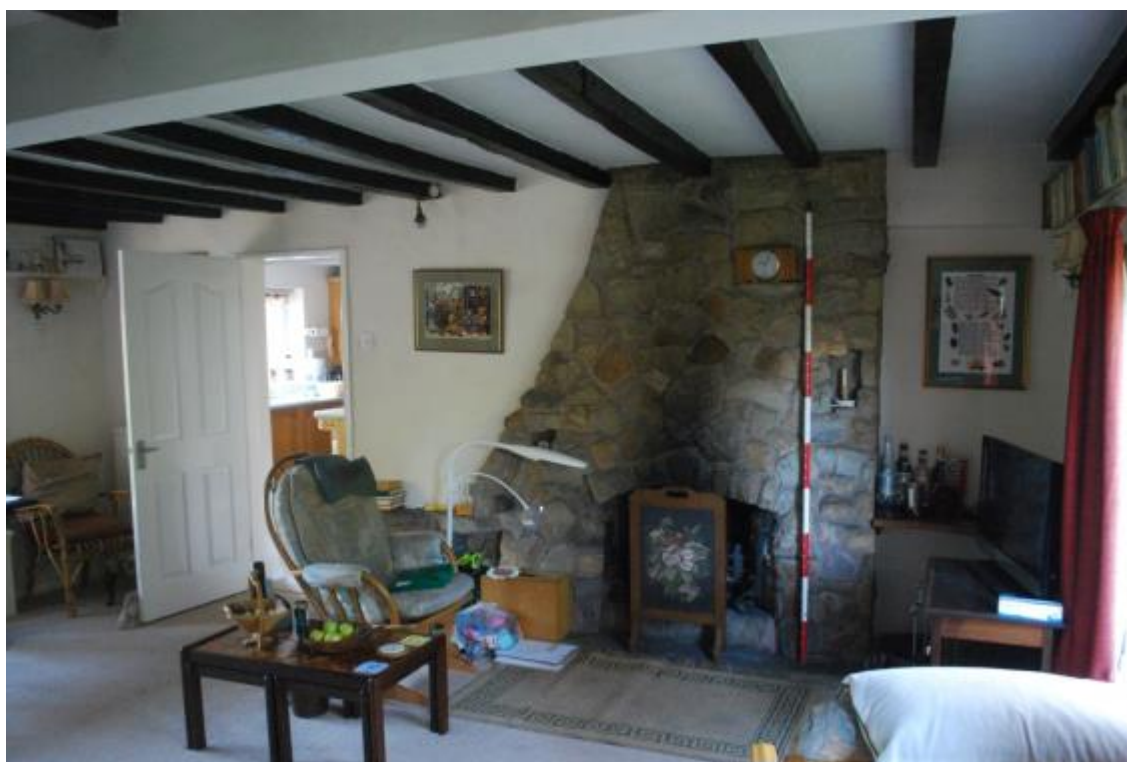
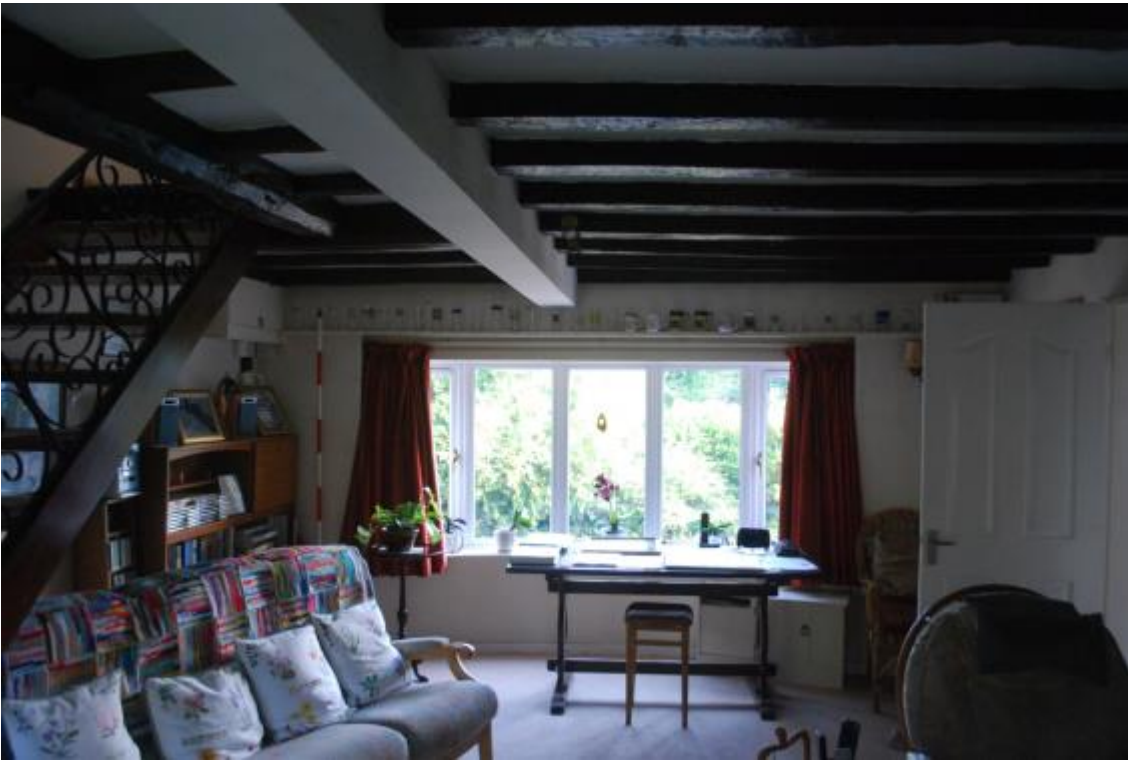
*Plate 23 Phase 2 ground floor room, looking south*

*Plate 24 Phase 2 ground floor room, looking west*

The ground floor room of this phase (**Plate 23** and **Plate 24**) is again likely to have been one room, though it could have been divided below the now boxed-in or replaced central beam. This room is noticeably missing a large fireplace. That in the south-west corner dates to Phase 5, though clearly using an earlier position. A building such as this would again have had a wider fireplace suitable for cooking.

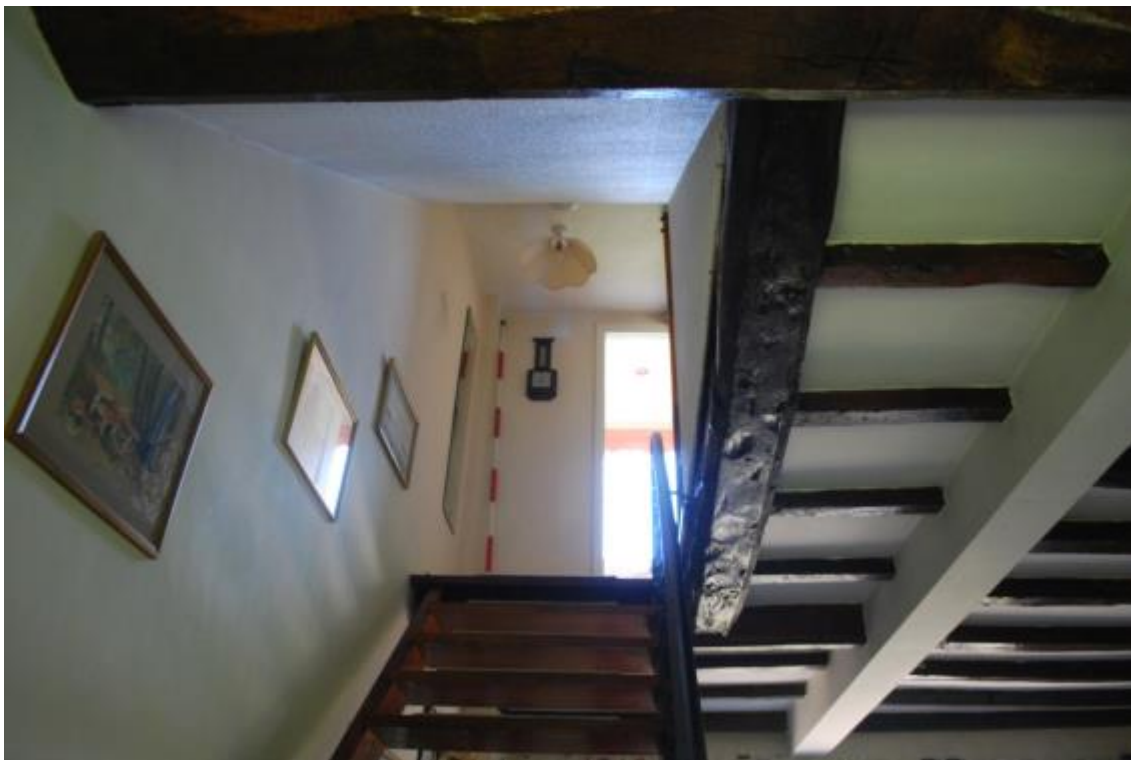
*Plate 25 Phase 2 floor joists, looking east*

The first floor was accessed from its current position, as shown by the position of the floor joists (**Plate 25**), though many of the common floor joists appear to be later replacements. As with the Phase 1 structure, there was no remaining evidence of the first floor room having been divided (**Plate 26** to **Plate 28**). The ceiling was higher than that remaining, as seen by a lath and plaster ceiling within the roof space (**Plate 29**).

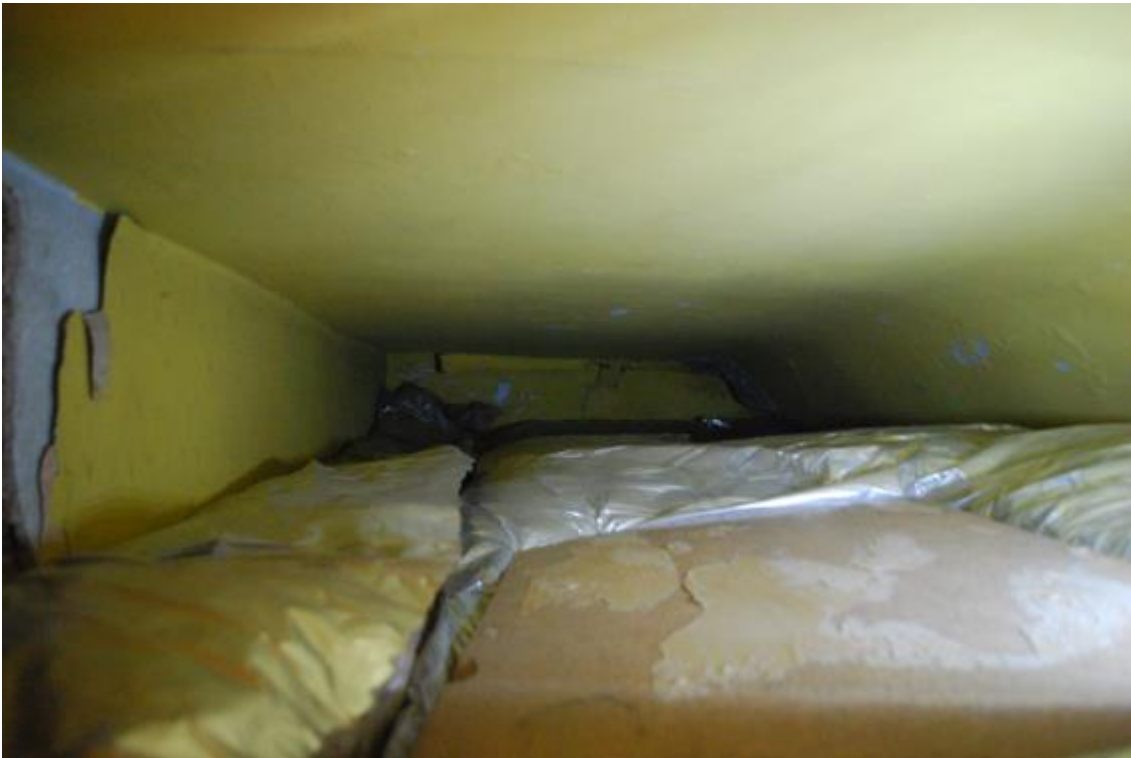
*Plate 29 Phase 2 first floor room, looking south*

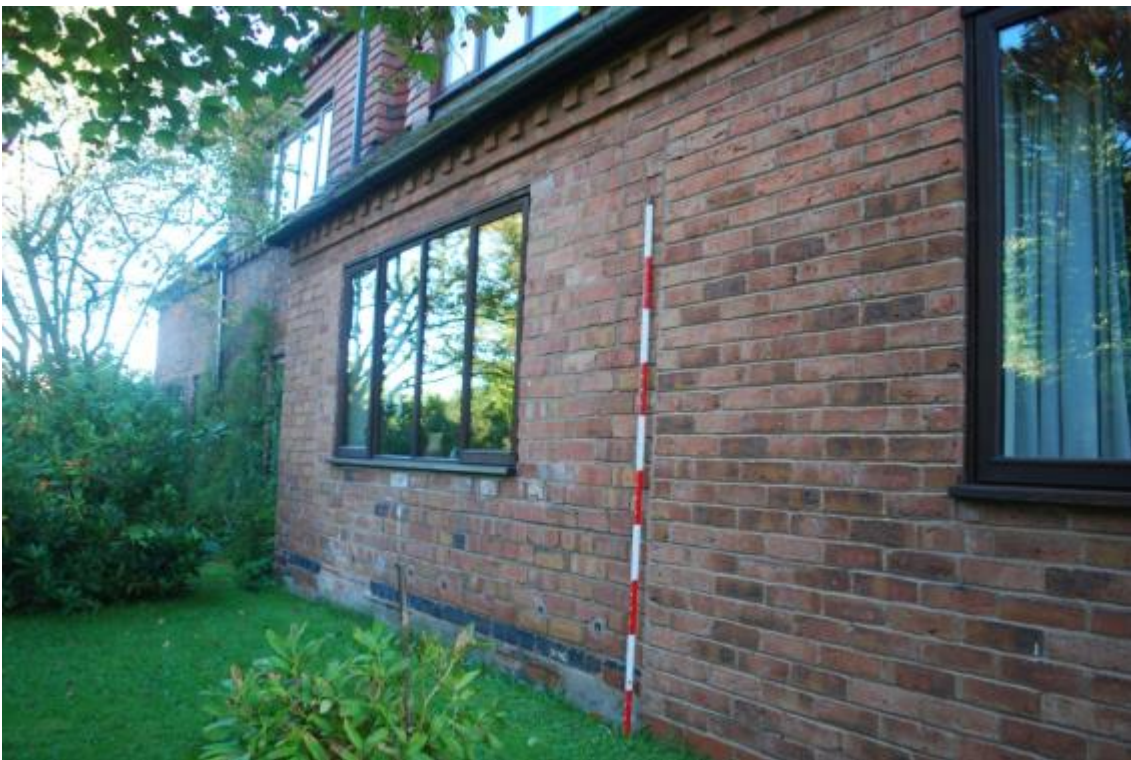
*Plate 30 Phase 4 structure, looking north-east*

At least part of the Phase 3 structure on the southern end of the Phase 2 structure was demolished and rebuilt using machine-made bricks (**Plate 30**). This was itself largely demolished and rebuilt in Phase 5.

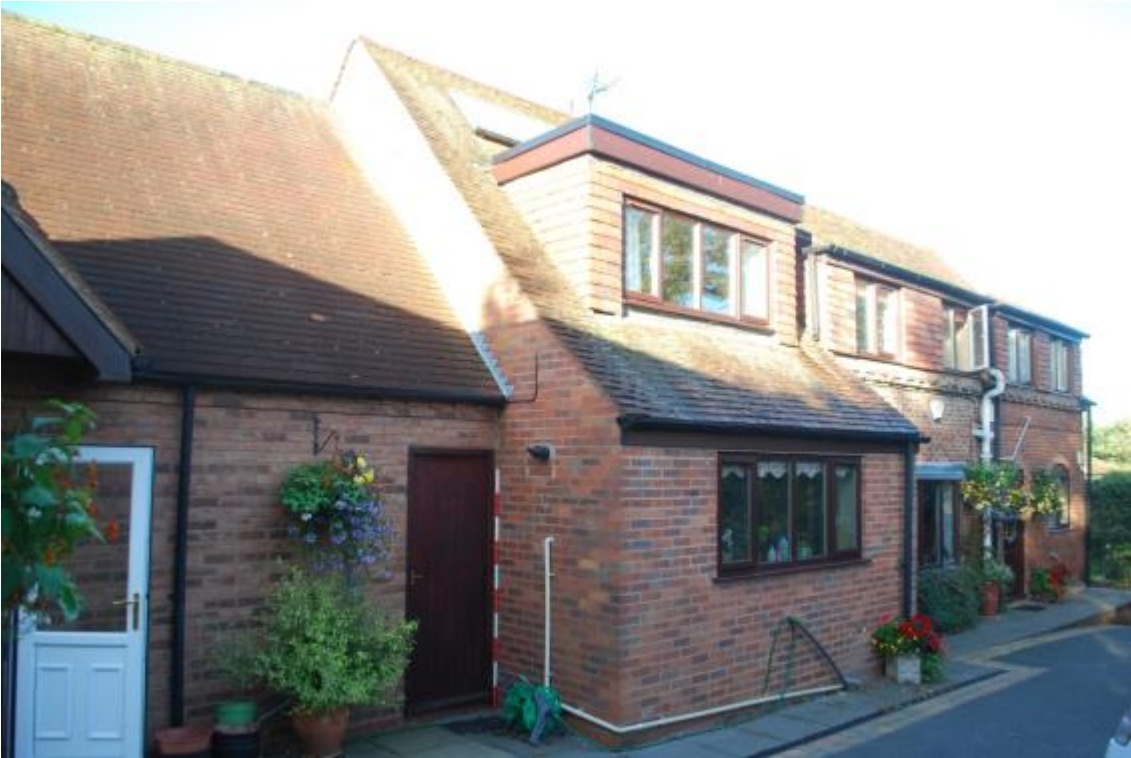
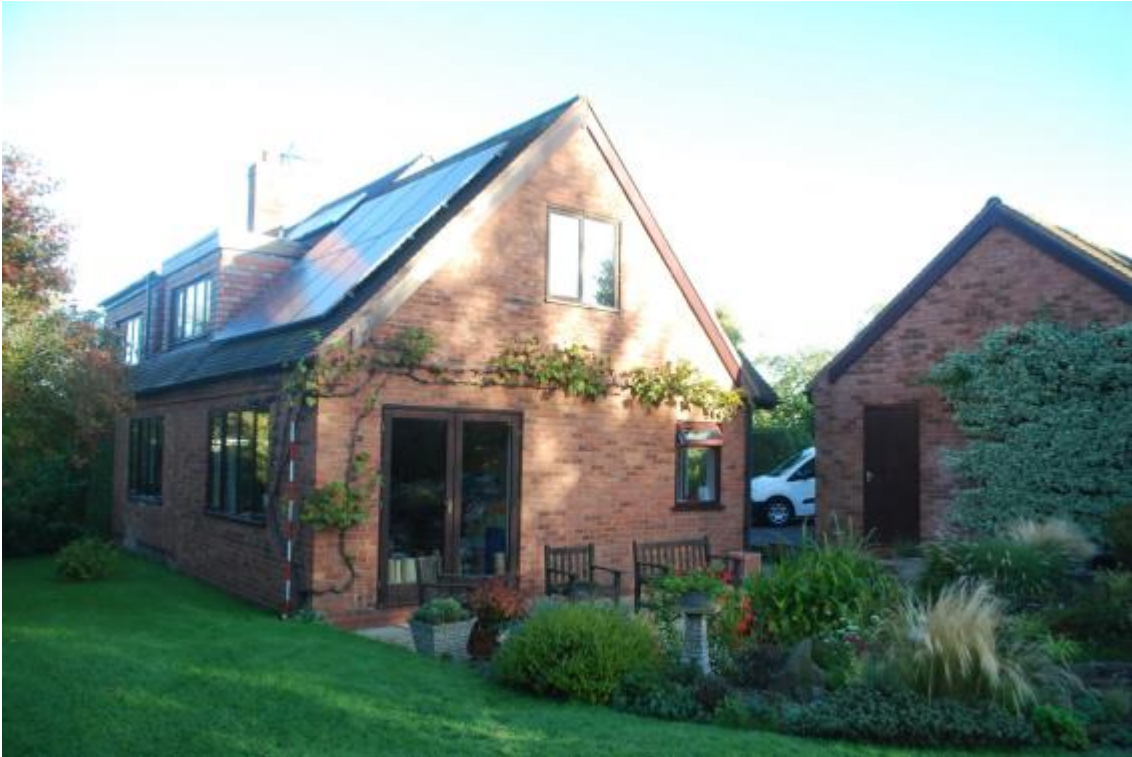
*Plate 37 Phase 5 extension, looking north-west*

*Plate 38 Phase 5 extension, looking north-east*

The Phase 3 and 4 buildings were largely removed at this point and an extension added, creating five further rooms on the ground floor consisting of a kitchen, a dining room, a living room, a utility room and a toilet (**Plate 31 to Plate 34**). Two further bedrooms were also added on the first floor which required a door to be knocked through at this point (**Plate 35 and Plate 36**). These extensions are visible externally on (Plate 37 and Plate 38).
