Building recording at Tower Barn, Broadway Tower Country Park, Broadway, Worcestershire

Status: Version 1
Date: 27th January 2017
Author: Tim Cornah tcornah@worcestershire.gov.uk
Illustrator: Carolyn Hunt chunt@worcestershire.gov.uk
Project reference: P5011
Report reference: 2417
HER reference: WSM68388
Oasis id: fieldsec1-273797

Building recording was required to meet a planning condition relating to the redevelopment of Tower Barn at Broadway Tower Country Park, Broadway, Worcestershire.

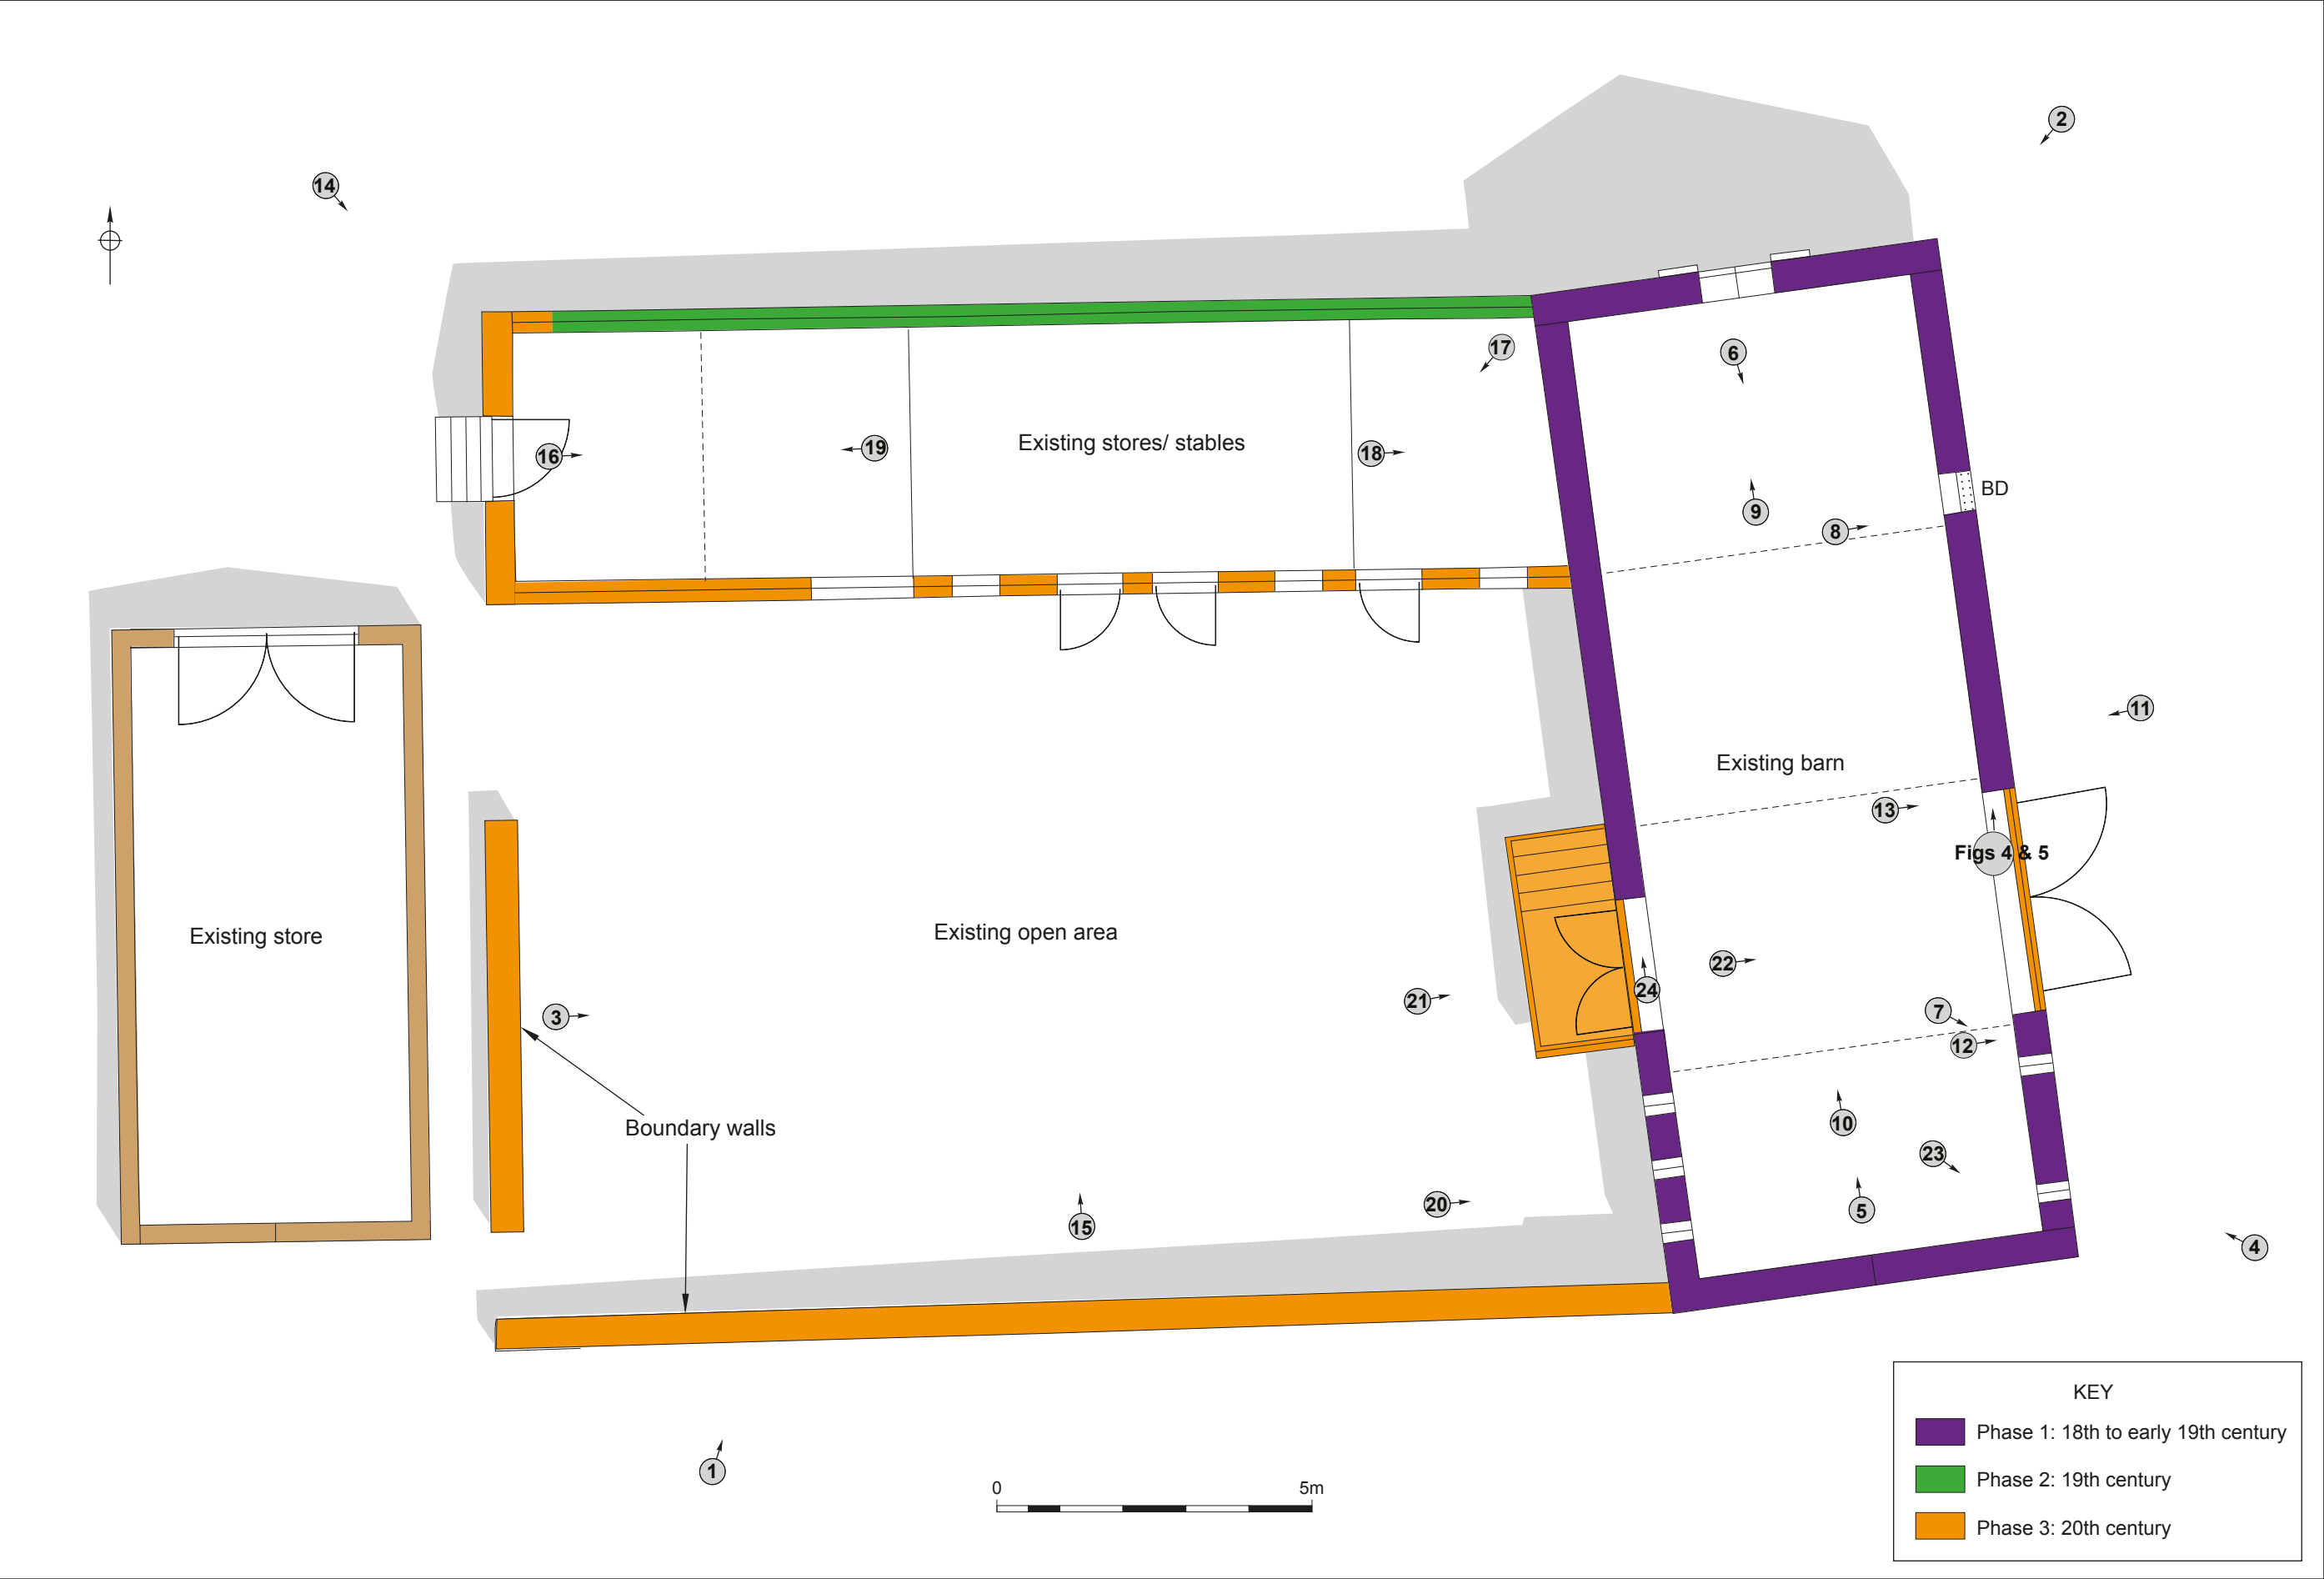
Figure 2

Phased floor plan (based upon AIN Designs Drg AIN077/007) with photolocations

The building as recorded is depicted in Plates 1-24. A ground and phase plan has been reproduced as Figure 2.

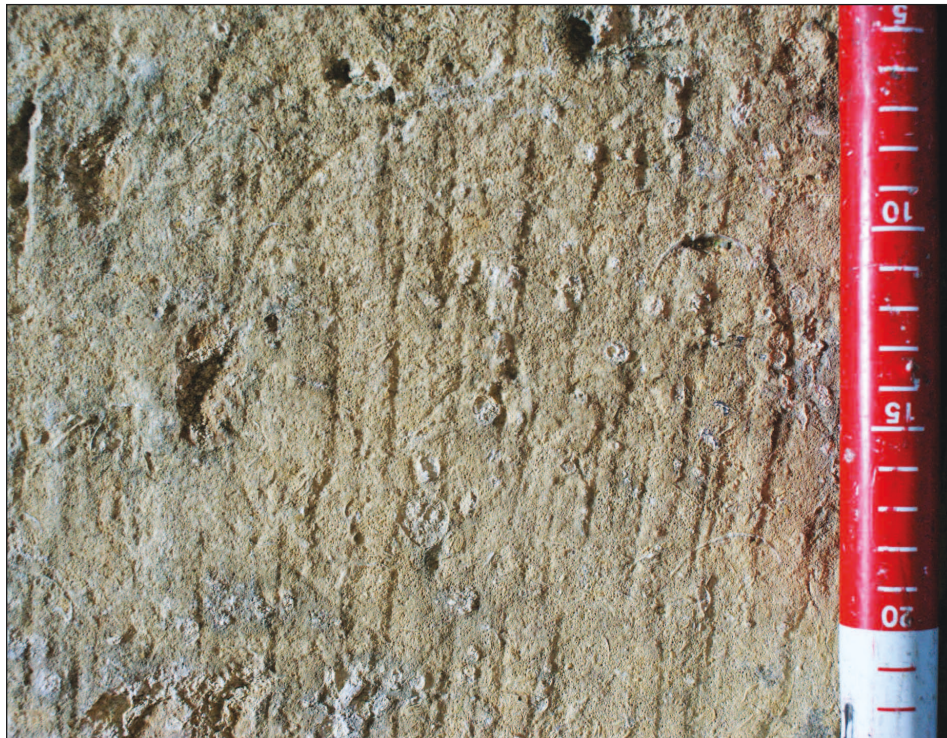
Figure 4

Traces of 'daisywheel' inscription on masonry

Some interesting details were located around the door onto the threshing floor on the eastern side. These took the form of marks cut into the stone. The first of these (Figure 4) was circular and 0.16m across, with a central indent and at least one arc transecting the middle of the circle. There are likely to have been further of these arcs creating a symbol generally known as a daisy wheel. Above this are another set of even fainter marks (Figure 5). It is possible that that these represent either double inverted V or M symbols. Such marks are not uncommon on the door jambs in threshing barns (Jordan 2006) with the double inverted Vs possibly representing *Virgo Virginum* or *Virgin of Virgins* and M representing *Mary* and invoking her projection.

The meaning of daisy wheels is broadly unknown; they were once thought to represent a setting out of Vitruvian geometry principles but are now commonly thought to also invoke protection and have an ecclesiastical origin (Meeson 2005). On the southern side of the door way was a possible saltire cross (*Plate 12*) the type of which has cropped up on what are known as 'witch-posts' in Yorkshire and there it is associated with an itinerant catholic priest who would use it as a 'secret' mark to identify a place where a church was held. A simpler explanation may be that it was a crude blessing to the barn (Brian Hoggard pers comm). The use of protection marks became common through the 17th century and continued to be used into the 18th century and later. There is an example from Bretforton, Worcestershire, of protection marks continuing to be created into the 20th century (Meeson 2005). Two further sets of marks were also visible on the western door jambs of the threshing barn. A further set of marks (*Plate 13*) are likely to have been tally marks for numbering crop loads.

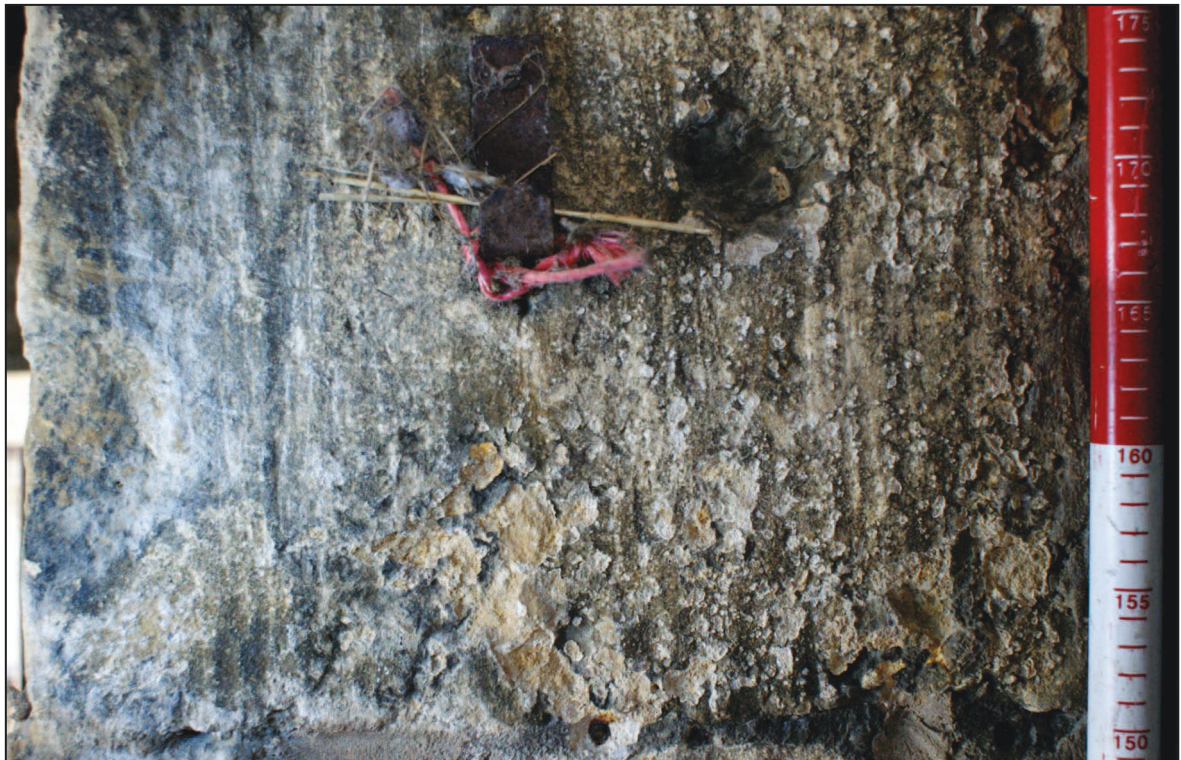
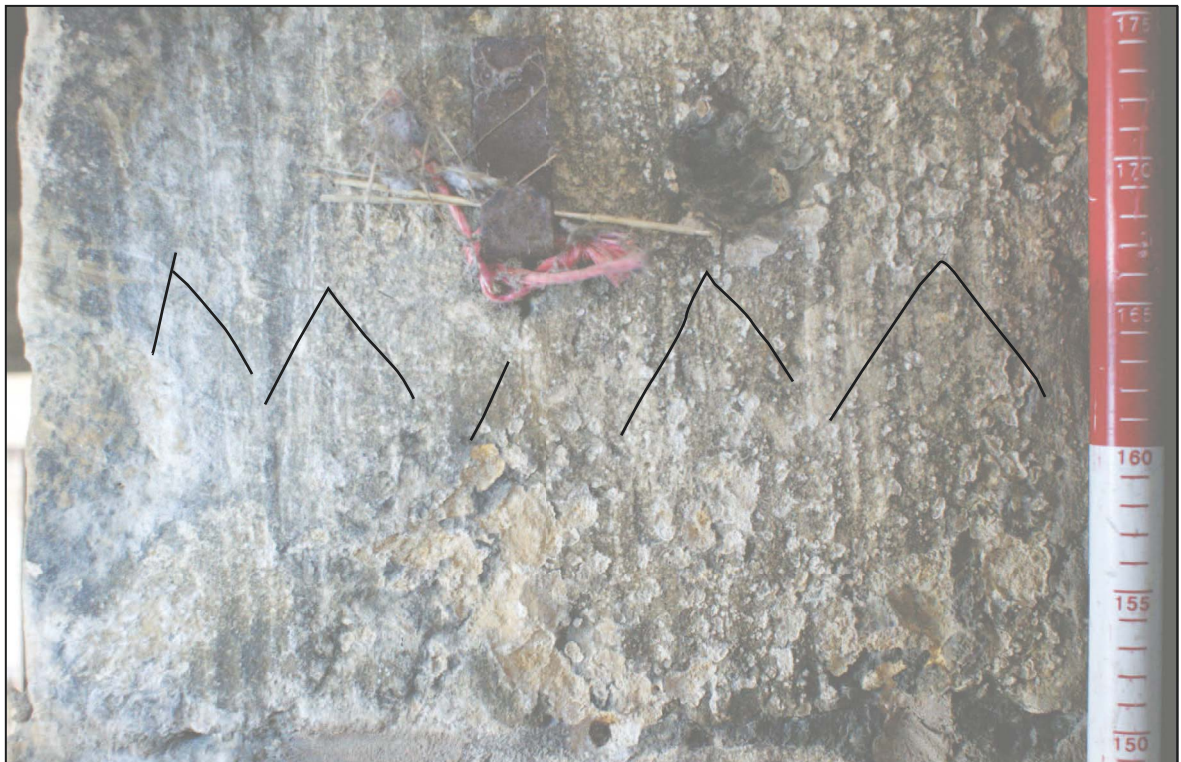
Figure 5

'M' inscription on masonry

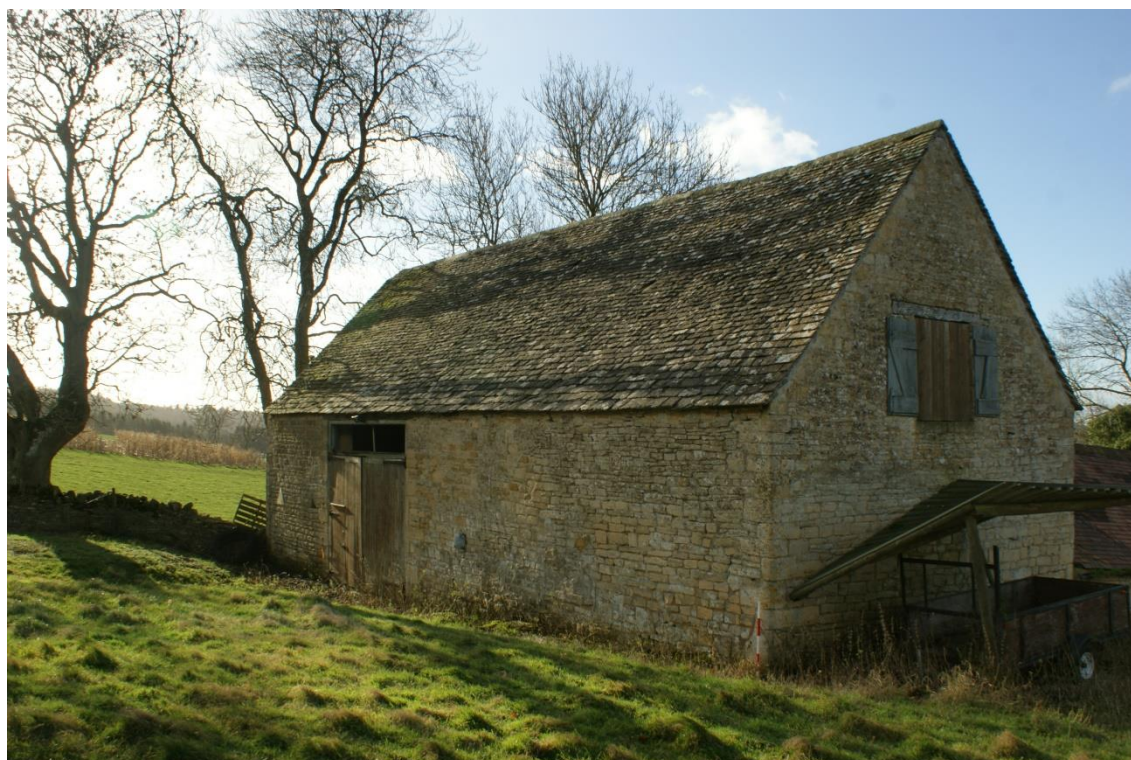
Plate 2 Phase 1 barn, looking south-west

The earliest building on the site is the barn (Plate 2 to Plate 6) which forms the eastern side of the courtyard. It is rectangular, of rough limestone construction with a stone tiled roof divided into four bays divided by three roof trusses. The long axis of the barn is orientated approximately north-south. No original floors remained, having been replaced by concrete.

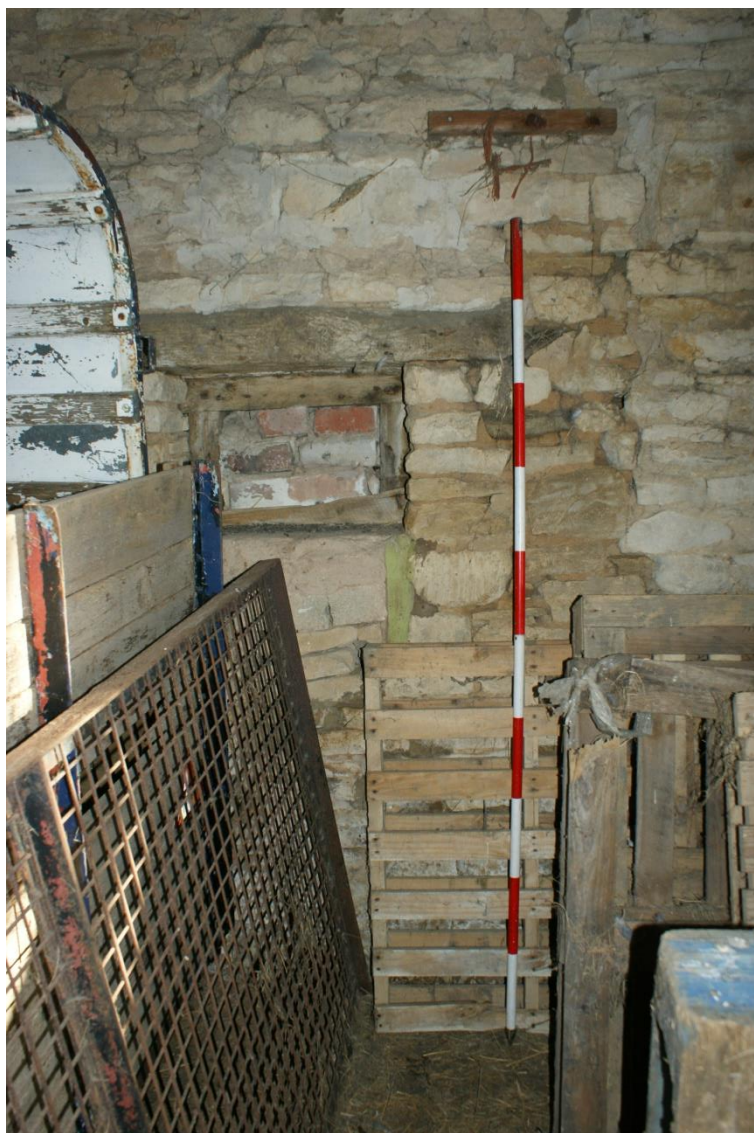
The use of the two northern bays is less obvious given the reduced amount of ventilation holes within the walls. A blocked door was present in the eastern wall, which later became a window which was in turn blocked (Plate 8). It is possible that a window formerly existed in the northern gable at ground floor level, though this was not clear (Plate 9). Above this was a further window (Plate 2 and Plate 5) which may originally have been used as a hatch to allow crop to be placed into the building. This would suggest the presence of a former first floor at the northern end of the building. No clear evidence for floor joists remained, though this may have been obscured by later repointing. The possibility of joists or temporary timbers resting on the walls at wall plate level remains though is speculative. The roof truss type would allow access through the roof space, though the northern truss is a later replacement so will not display wear patterns to suggest this. No such wear was visible on the remaining two trusses.

Plate 8 Phase 1 barn blocked window and door, looking east

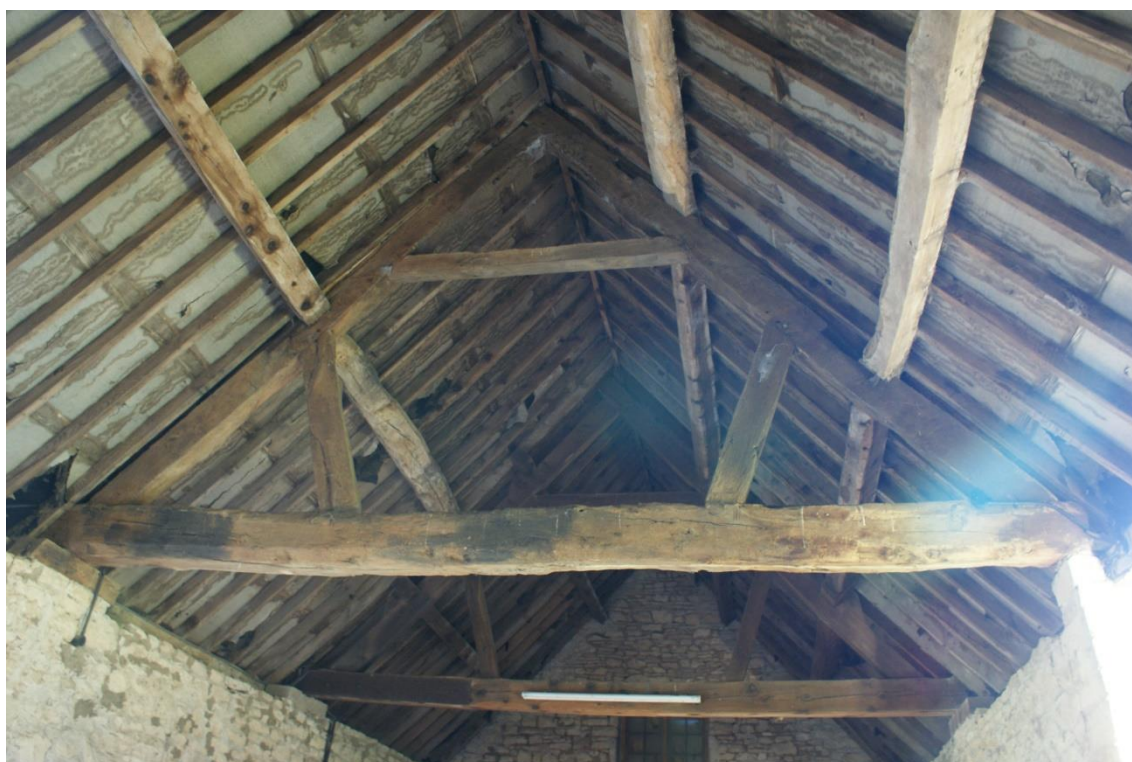
The two intact roof trusses are constructed of oak and converted by hand. Above the tie beam, raking struts supported the principle rafters, with a high collar above (*Plate 10*). This truss type characteristic of an 18th century date, though a later 19th century date cannot be discounted. This broad range is supported to some degree by other features on the building, such as the slight flare at the base of the roof visible from the exterior. This feature is common of buildings of the region from the late 17th century onwards.

A detail of the carpentry of the roof trusses is that their carpentered faces, as seen partially by the presence of carpenters marks, both faced southwards. It is far more typical for these to both face towards the threshing floor, suggesting that the timber framing cultural norms were being eroded by this point.

Plate 10 Phase 1 barn roof trusses, looking north

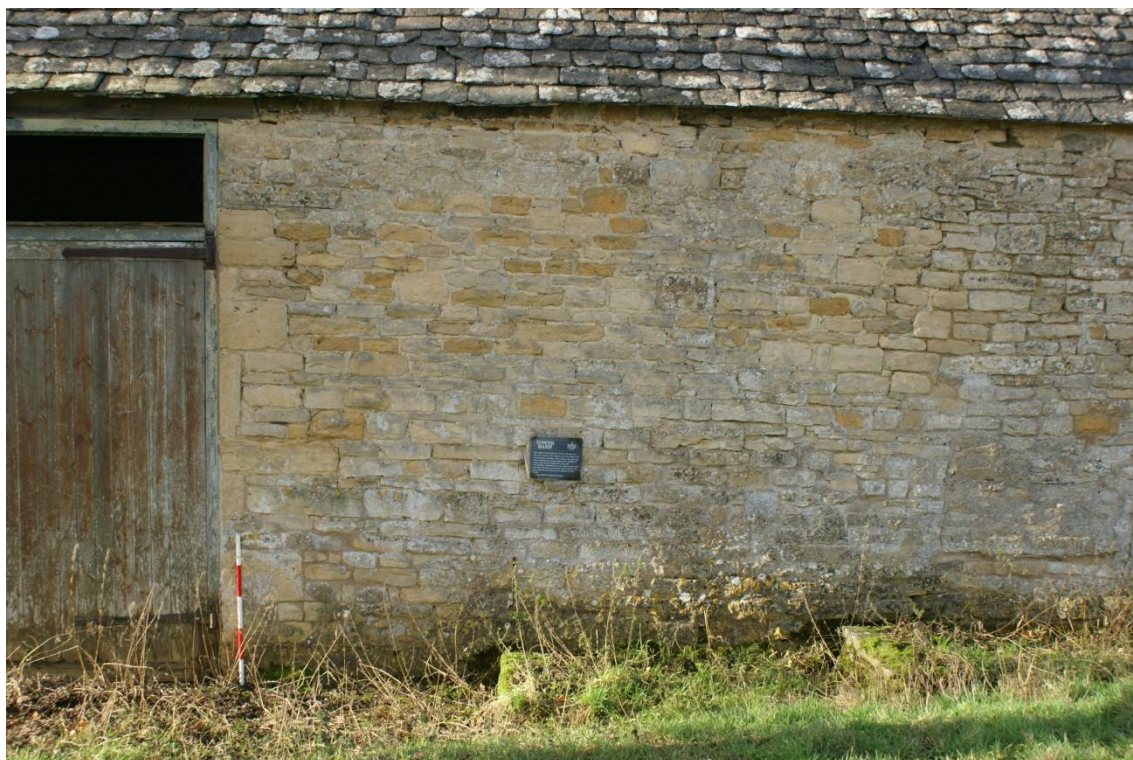
The principle rafters supported a single purlin on the western side and two purlins on the eastern side. All of the common rafters are replacements, as they are of machine cut softwood. A layer of roofing felt suggests a 20th century date for these replacements. The stone roof tiles are likely to be the replaced originals. A further area of visible repair to the barn was on the eastern side next to the door (*Plate 11*).

Plate 11 Phase 1 barn repairs at wall plate level at the top of the door jambs, looking west

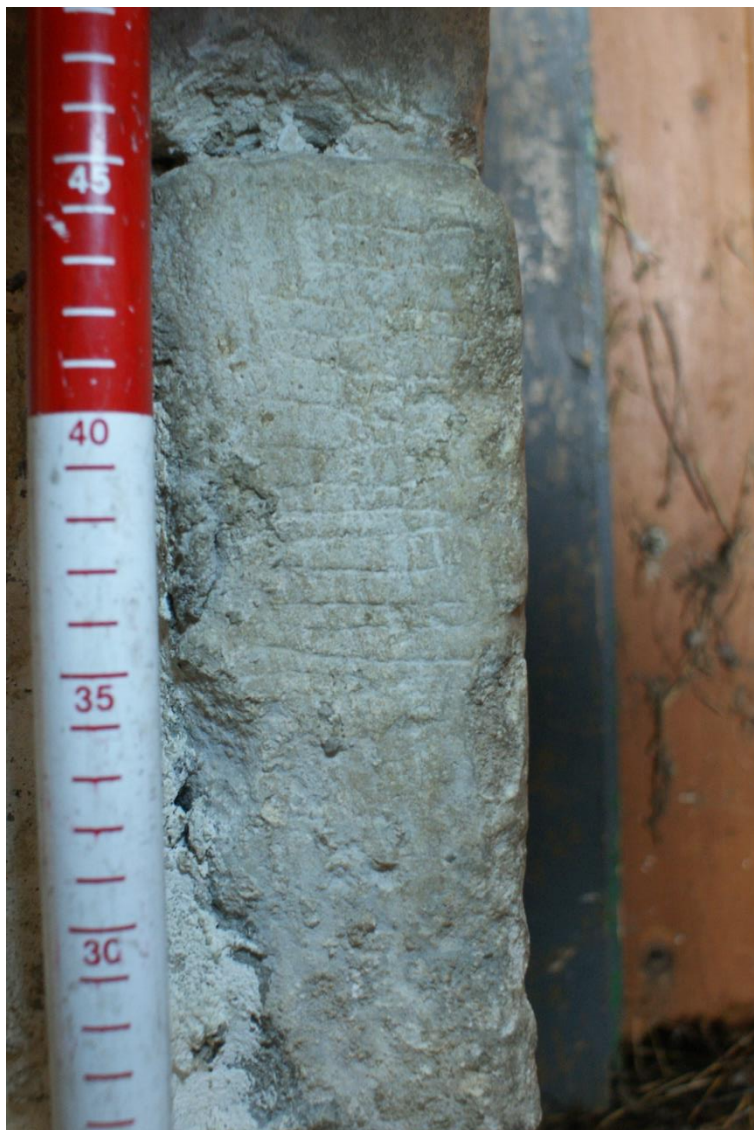
Plate 13 Phase 1 barn possible tally marks, looking east

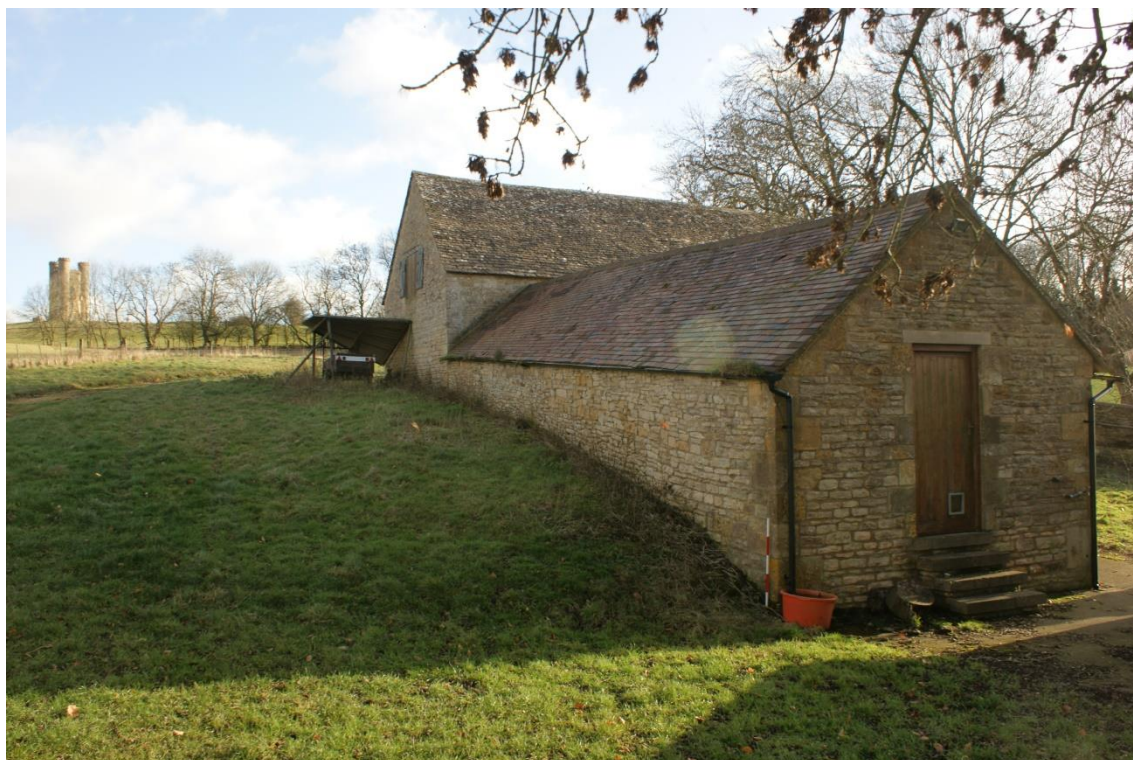
In the 19th Century, a further structure was added onto the north-west side of the barn (*Plate 14* and *Plate 15*). This remains as a five bay east to west aligned structure built of limestone, with a tile roof. However, very little of the original structure remains, potentially only the northern wall. The western and southern walls displayed a more regular coursing and are known to have been at least partially rebuilt and repointed in the second half of the 20th century. The four king post trusses which divide the building into four bays (*Plate 16*) may be replacements of an earlier roof structure. The style of these trusses is broadly consistent with a 19th century date. They were constructed using softwood with metal fixings and show evidence of having been converted mechanically by circular saw. Whilst mechanical circular saws started in use in the late 18th century, they were much more widely used throughout the 19th century (Jones and Simons 1961).

Plate 14 Phase 2 possible stabling, looking south-east

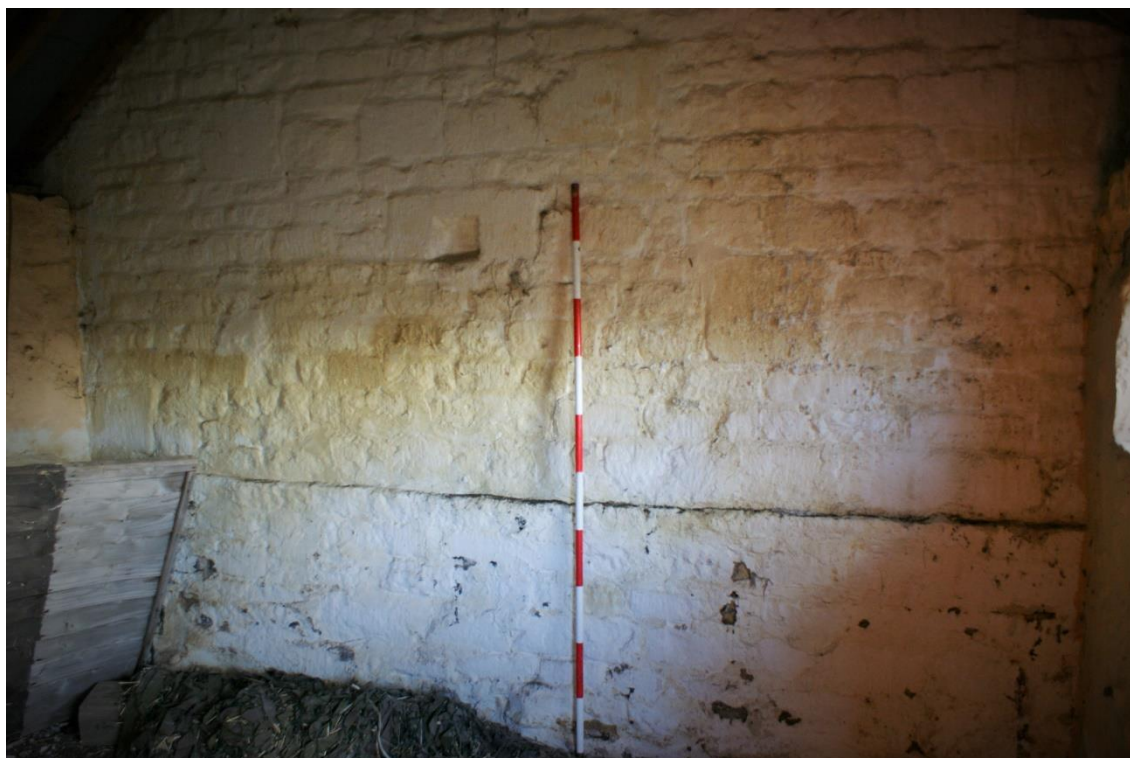
The positioning of the doors and windows on the southern side of the building are entirely consistent with stabling for the eastern three bays. No original internal divisions remained to confirm this and the floor levels had been raised using concrete in the 20th century. A single hole cut into the wall of the threshing barn at the eastern end of this building (*Plate 18*) may have held a longitudinal joist used as part of a ceiling. This arrangement would also be typical of stabling as

Plate 18 Phase 2 possible stabling with a scotch for a ceiling beam, looking east

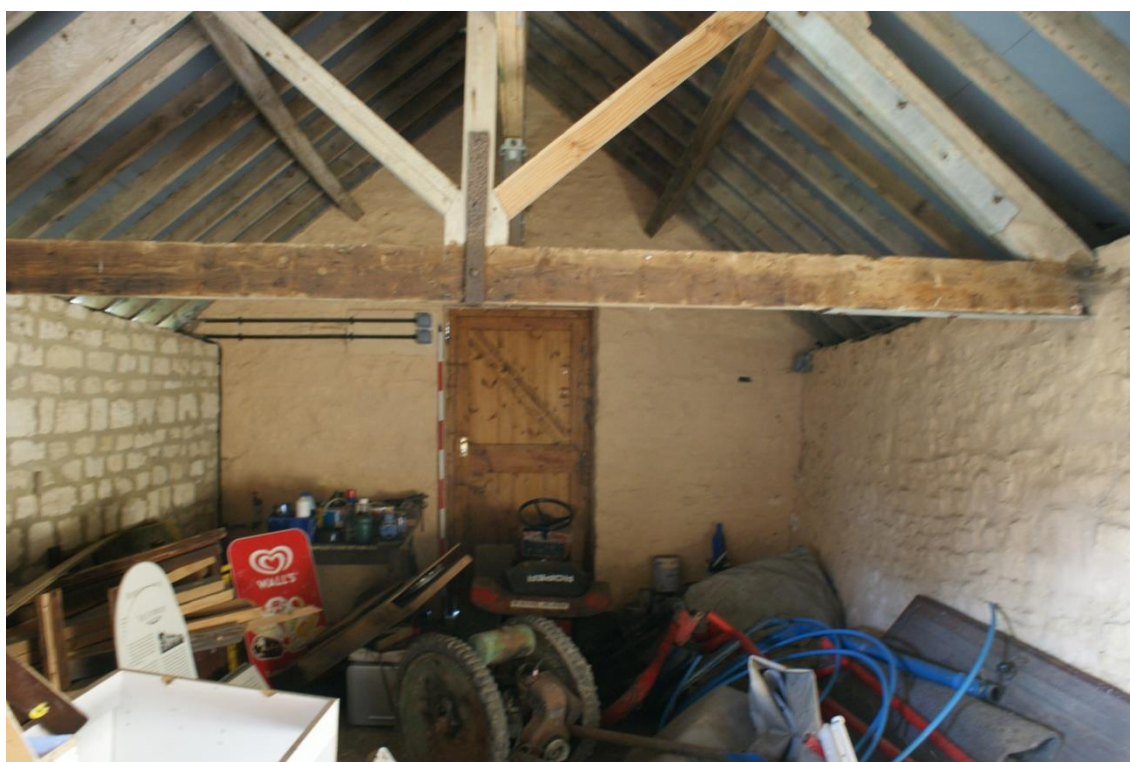
The use of the western two bays of the building is unknown, but storage for equipment related to the keeping of horses is likely. These bays contained further doors on the western and southern sides (Plate 19).

Plate 19 Phase 2 possible stabling, looking west

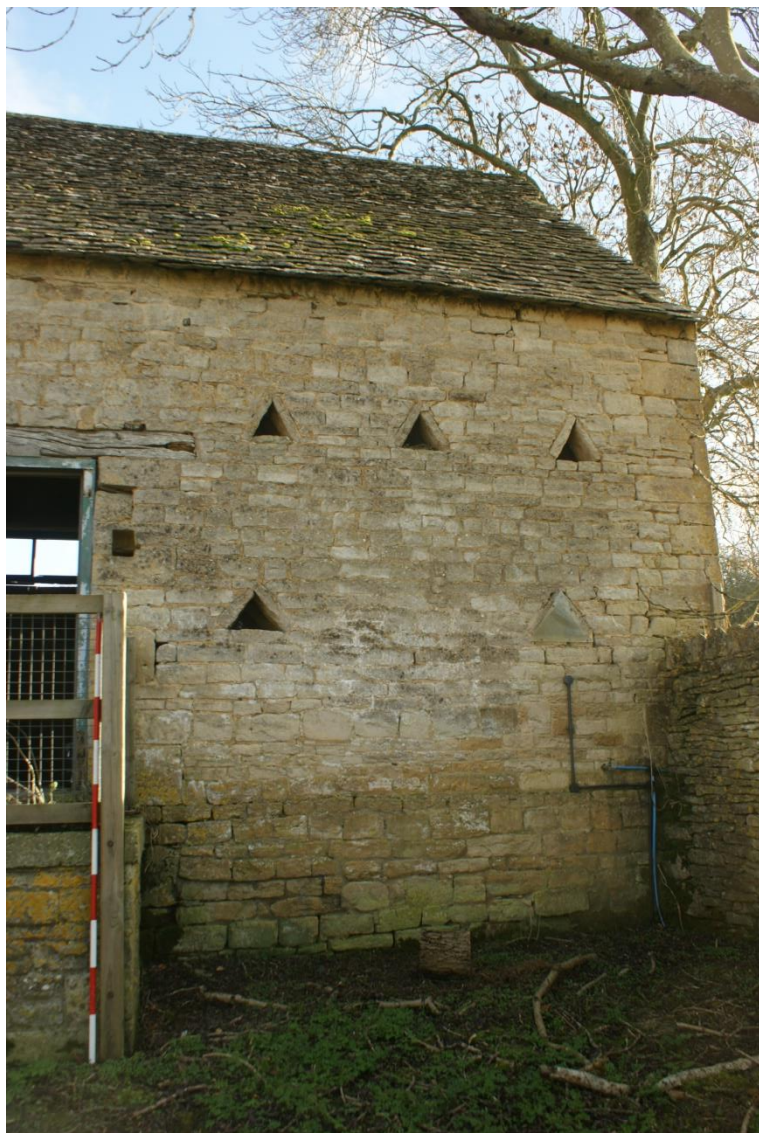
A hole likely to have held the wall plate of the demolished southern range of building was visible cut into the western side of the barn, immediately next to the door (Plate 20). This would suggest a single storey structure, probably used as animal housing. It is clear that this structure pre-dates the 1884 mapping, but no more accurate date can be suggested.

Plate 20 Phase 2 with sotch form a wall plate of a former building next to the threshing door jamb, looking east

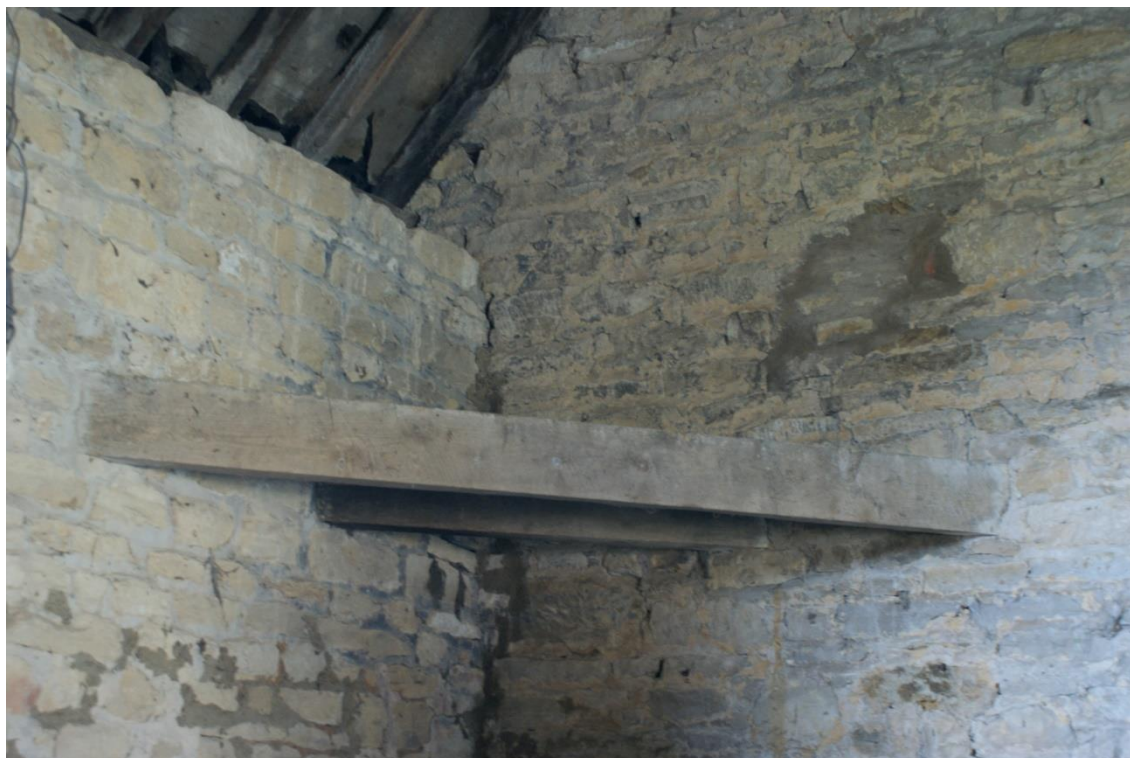
Some suggestions of 20th century use of the barn were visible from painted areas of walls, suggesting the former presence of temporary partitions (Plate 22). Timbers inserted in the south-east corner of the building relate to the insertion of a tank at this point (Plate 23).

Plate 23 Phase 3 tank support, looking south-east

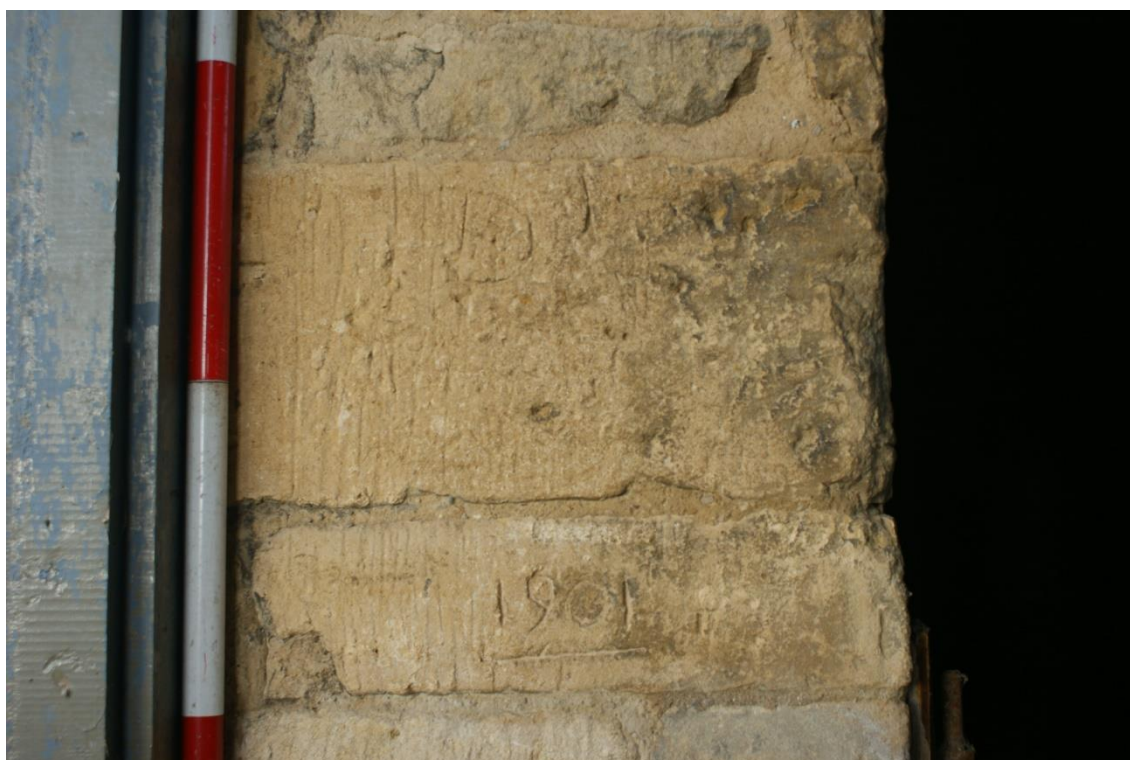
On the doorway on the western side of the threshing floor (Plate 24) the date "1901" was inscribed with a "D" above, possibly being an initial.

Plate 24 Phase 3 marks on door jambs, looking north
