# Archaeological watching brief at Land at Pershore Cottage Hospital, Defford Road, Pershore, Worcestershire

Status: Version 2  
Date: 7<sup>th</sup> April 2017  
Author: Graham Arnold – e-mail address [garnold@worcestershire.gov.uk](mailto:garnold@worcestershire.gov.uk)  
Illustrator: Carolyn Hunt  
Project reference: P4804  
Report reference: 2442  
HER reference: WSM 68513  
Oasis id: Fieldsec1-278990

## **Archaeological watching brief at Pershore Cottage Hospital, Defford Road, Pershore, Worcestershire**

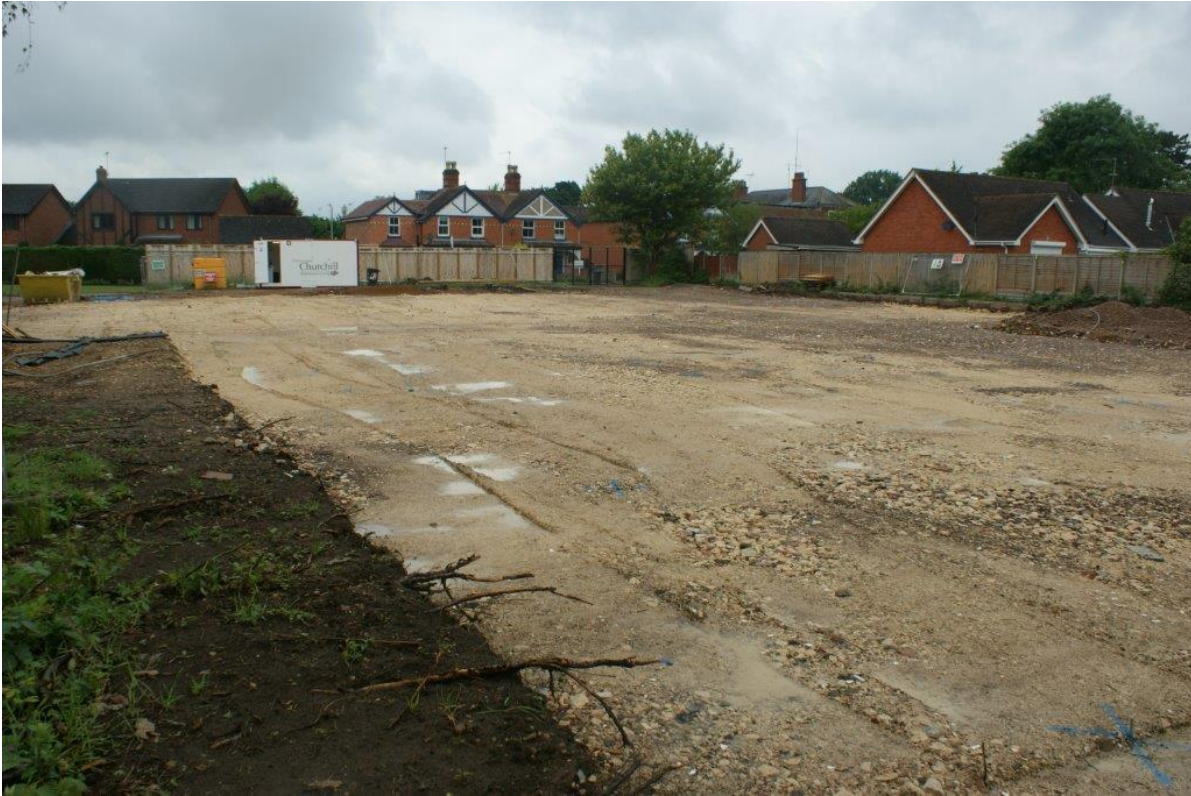
*Plate 1 The site after demolition works, prior to groundworks, with a piling mat hardcore surface. View west*

Prior to the commencement of the watching brief, the hospital buildings were demolished, foundations removed and the area was stoned and vibro-compacted. This process involved piling of about 0.30m in diameter across the stoned area (Plate 1) at a distance of no more than 1m apart and extending to a depth greater than 0.80m. The significant impact of these works are shown in Plate 2 depicting Trench 1.

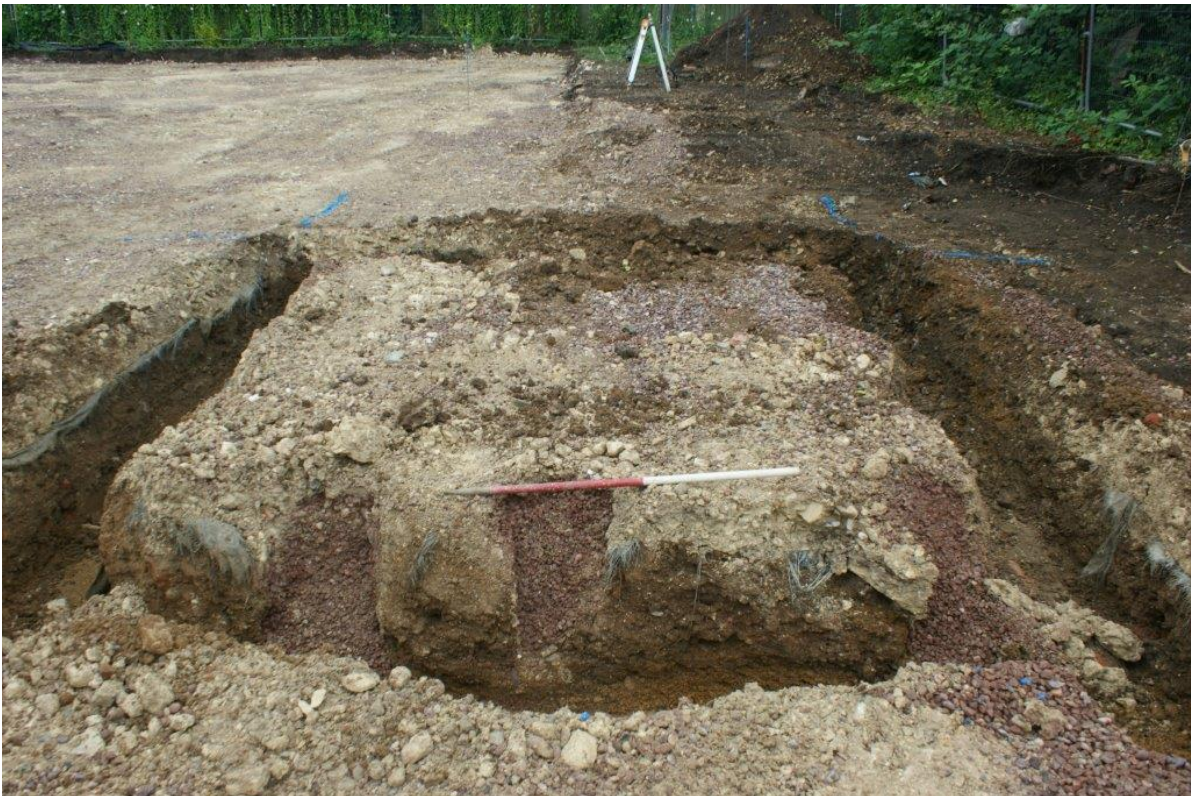
*Plate 2 Trench 1 showing purple gravel filled piles and natural sand at base of trench. View west*

Context	Classification	Description	Depth below ground surface (b.g.s) – top and bottom of deposits
100	Modern hardcore made ground	Mixed stone, topsoil, rubble and sand from demolition levelling. Piles filled with purple gravel	0.00m - 0.70m
101	Natural	Compact yellow sands with sub-rounded gravels.	0.60 – 0.80m

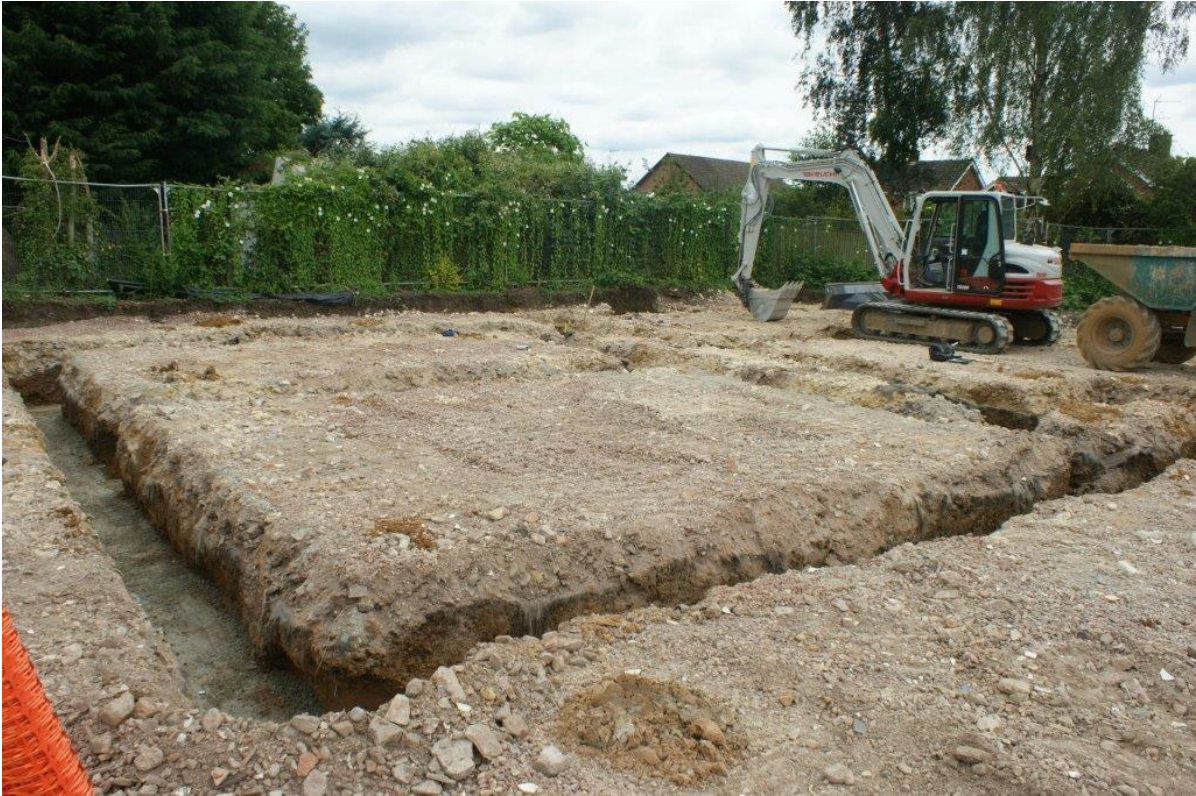
*Plate 3 Trench 2 showing modern made ground and natural sands. View southwest*

Context	Classification	Description	Depth below ground surface (b.g.s) – top and bottom of deposits
200	Modern hardcore layer	Modern hardcore below topsoil at east end of trench	0.00 – 0.30m
201	Topsoil	Dark grey brown silty sand with frequent round and sub-rounded stones and rooting. Both this and (202) only seen in one area to the east end of trench.	0.00 – 0.25m
202	Subsoil	Mid orangey brown silty sand with frequent sub-rounded stones.	0.25m - 0.55m
203	Mixed made ground	Mixed modern deposit such as topsoil and rubble depth below surface 0.30 – 0.60m.	0.30 – 0.60m
204	Natural	Yellow sand and sub-rounded gravels seen throughout trench.	0.60m +

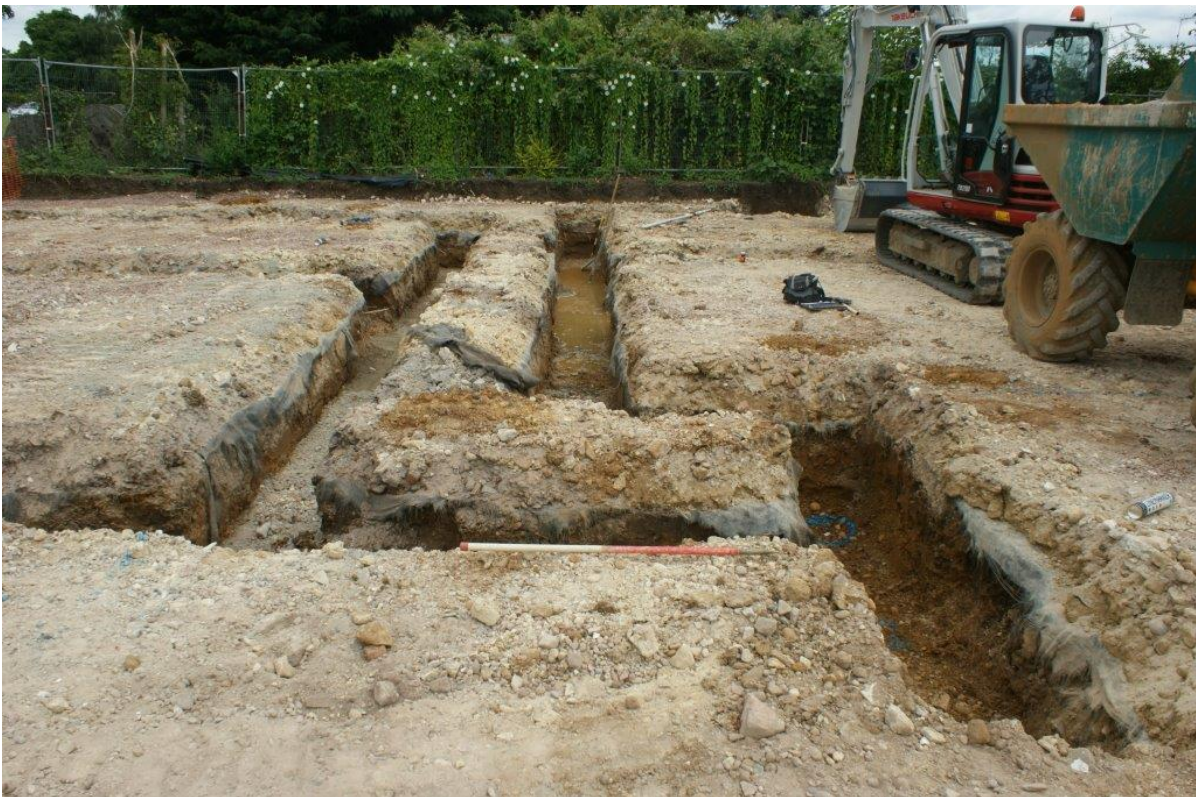
*Plate 4 Trench 2 footings showing natural sand and gravel. 1m scale, view south*

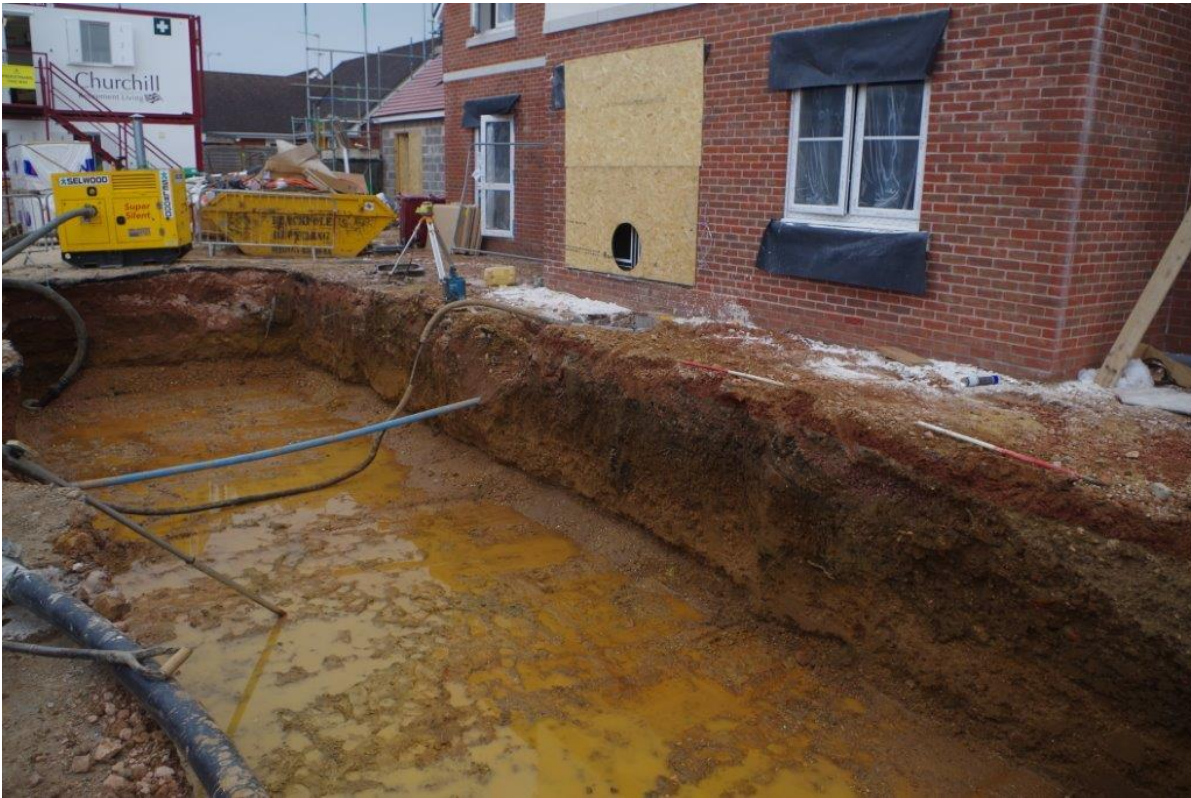
*Plate 5 The attenuation tank (trench 3) view northeast*

Context	Classification	Description	Depth below ground surface (b.g.s) – top and bottom of deposits
300	Tarmac surface	Hardstanding of existing car park	0.00 – 0.10m
301	Hardcore	Modern red pink gravel levelling make up for car park	0.10 – 0.52m
302	Made ground	20th Century made ground of moderately compacted mid grey brown silty sand with frequent brick rubble.	0.35 – 0.95m
303	Former subsoil	Firm mid orange brown silty sand with gravels and pebbles. Heavily truncated former subsoil	0.60 – 0.92m
304	Natural	Compact yellow sand and sub-rounded gravels	0.92 – 1.50m

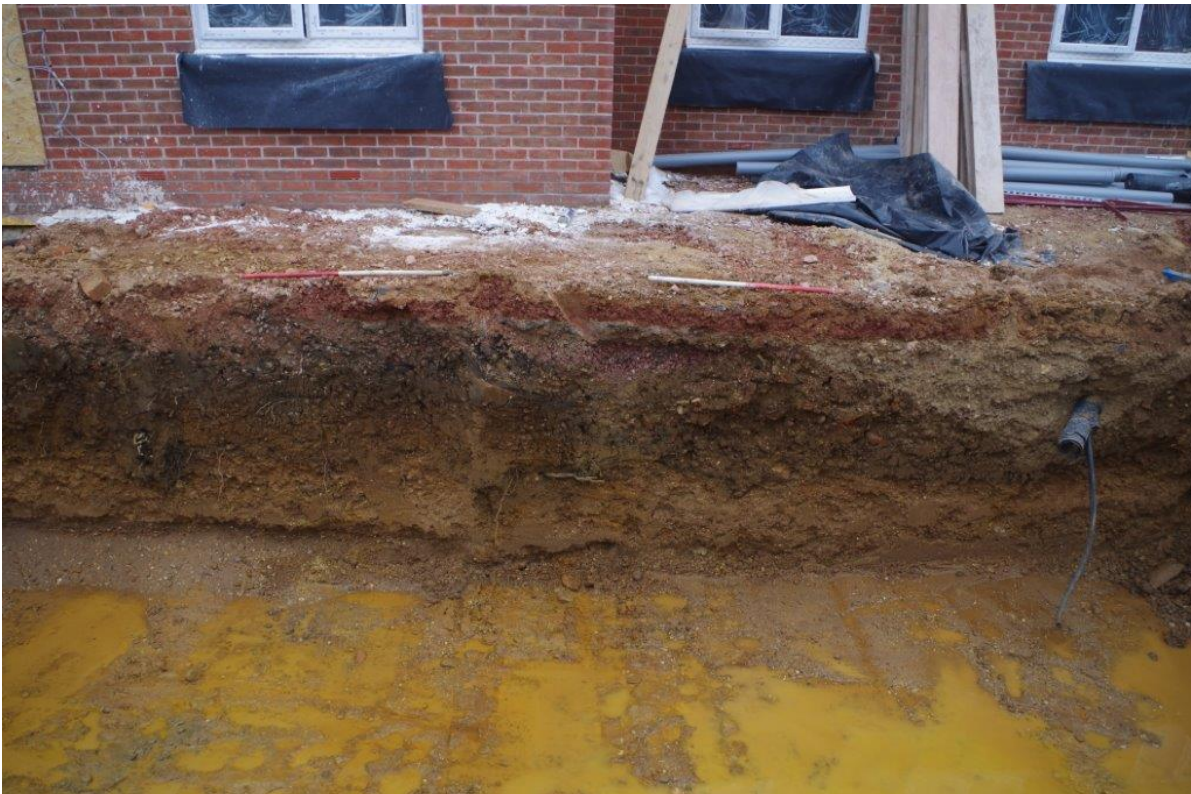
*Plate 6 West facing section of Trench 3 attenuation tank showing general stratigraphy. 2 x 1m scales. View east*
