Archaeological watching brief at St John's Church, Bromsgrove, Worcestershire.

Status: Version 1
Date: 17 March 2017
Author: Andrew Mann, amann@worcestershire.gov.uk
Contributors: Jane Evans
Illustrator: Carolyn Hunt
Project reference: P5015
Report reference: 2422
HER reference: WSM 68499
Oasis id: Fieldsec1-279632

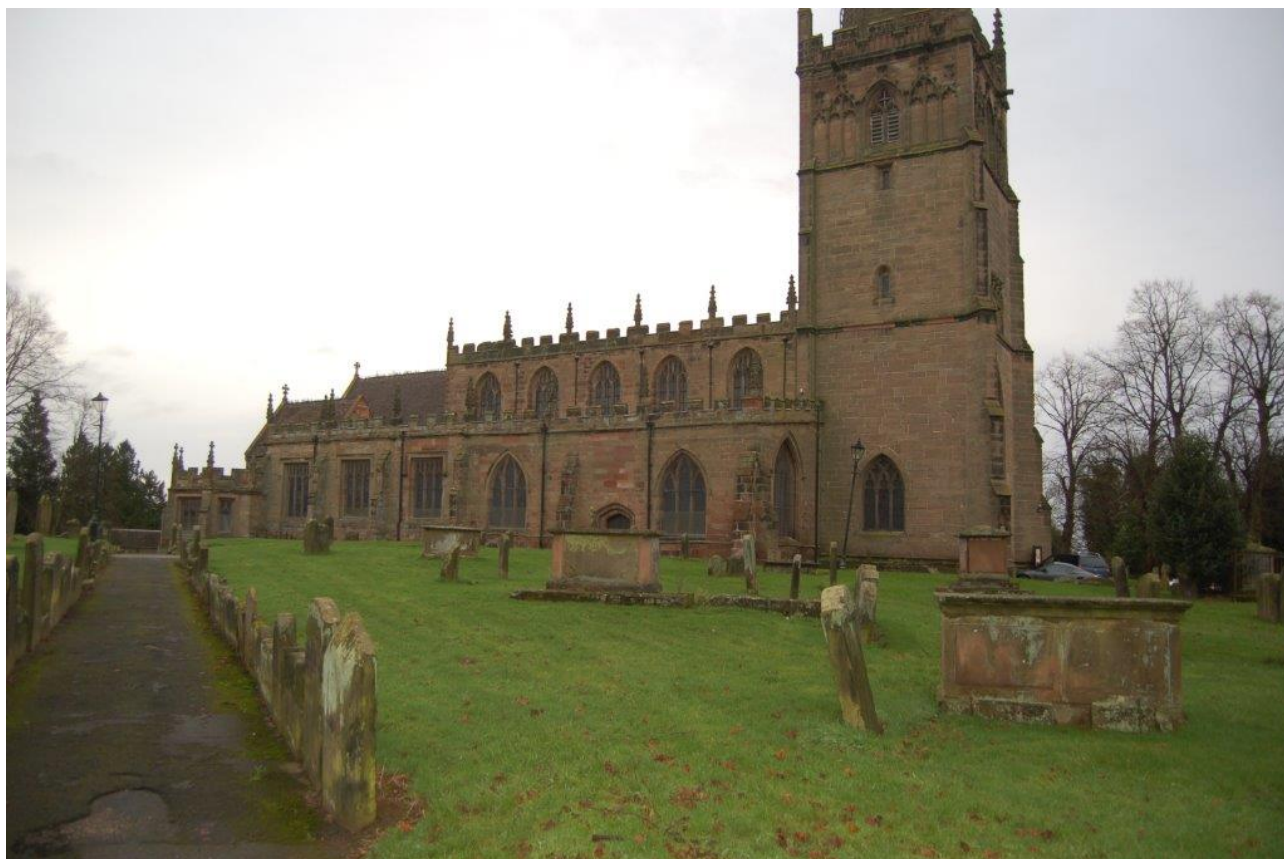
Plate 1: The north side of St John's Church

The church (Plate 1) sits at c 95m AOD on a sandstone hill (Bromsgrove Sandstone Formation) overlooking the town to the east at c. 85m AOD. Around the base of the hill on the east, south and west are alluvial and superficial sand and gravel deposits of the Holt Heath Member.

The watching brief also confirmed that earlier remains of the church (the northern transept), which roughly aligns to the 1250 plan of the church (Henderson 2015, Fig 3) survive below the building in its current form. The western side of the northern aisle, the foundations of which were recorded in bays 3 and 4 are of 14th century date, while the eastern side of the northern aisle (bays 1 and 2) was built c 1478 (Henderson 2015). These alterations are visible in both the foundations and structure of the church, with the joint between the western and eastern sides of the northern aisle still visible on the upper wall in bay 3. The different window styles of the western and eastern sides of the northern aisle are however the more striking indication of the buildings phasing (Plate 1).

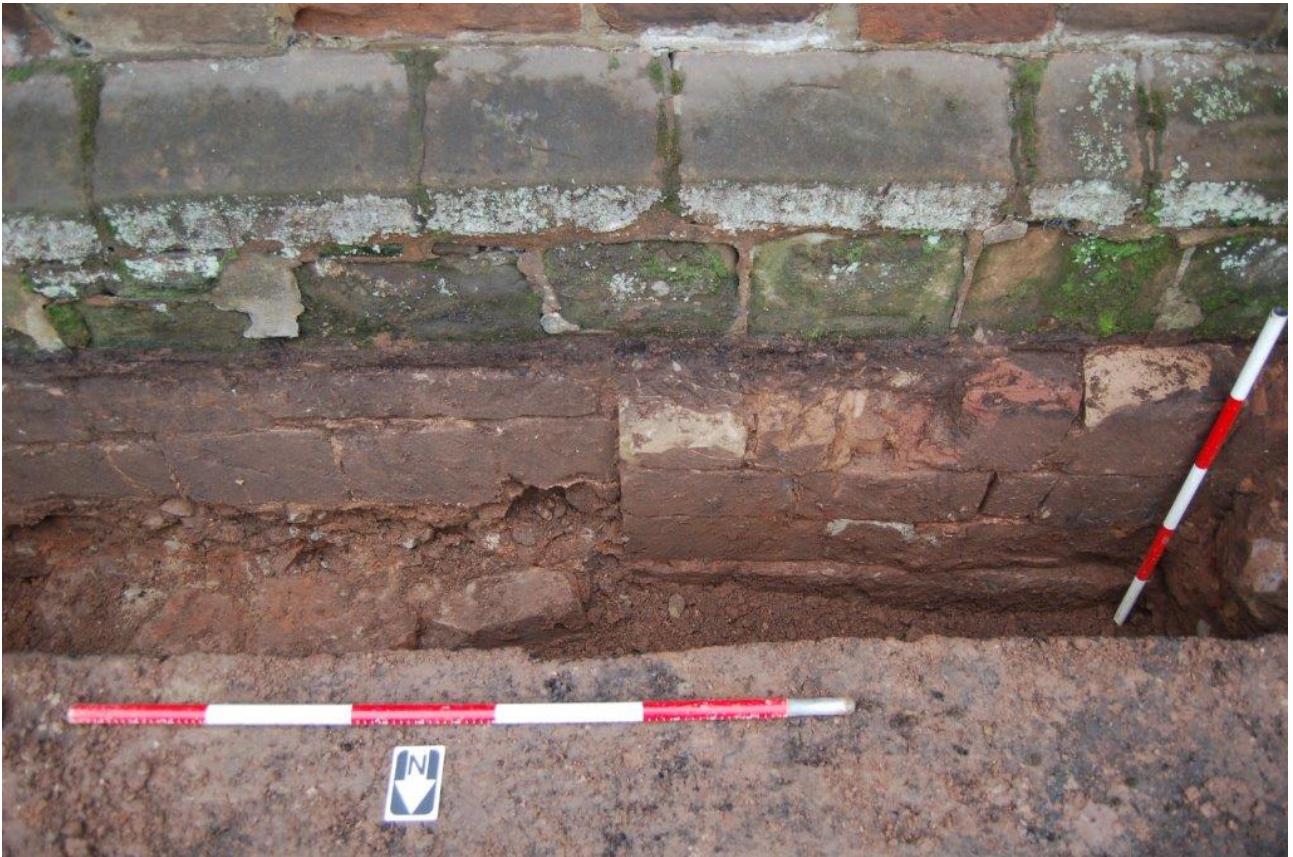
Plate 2: Northern transept wall (110) in the western side of bay 2, 2x1m scales

In bays 1 and 2, to the east of the northern transept the foundations (104 and 109) and lower courses (106) of the eastern wall of the northern aisle were recorded. These varied in composition to bays 1 and 2. In bay 2 the foundations and wall butted up against and overlay the transept wall (110; Plate 2) and the wall of the northern aisle to the east did not contain the lower chamfered course seen to the west (Plates 2 and 5). One to four courses (below current ground surface), of flat faced sandstone blocks (regularly coursed), sat directly on the sandstone rubble foundations. These were overlain by large sandstone blocks which had been chamfered along the upper half and appeared to be at a similar height, although slightly higher, to the string course to the west of the aisle. In bay 1 the foundations rose considerably so that halfway along the bay the wall (106) lay directly onto a buried soil (113) only 0.12m below the current ground level (Plate 5).

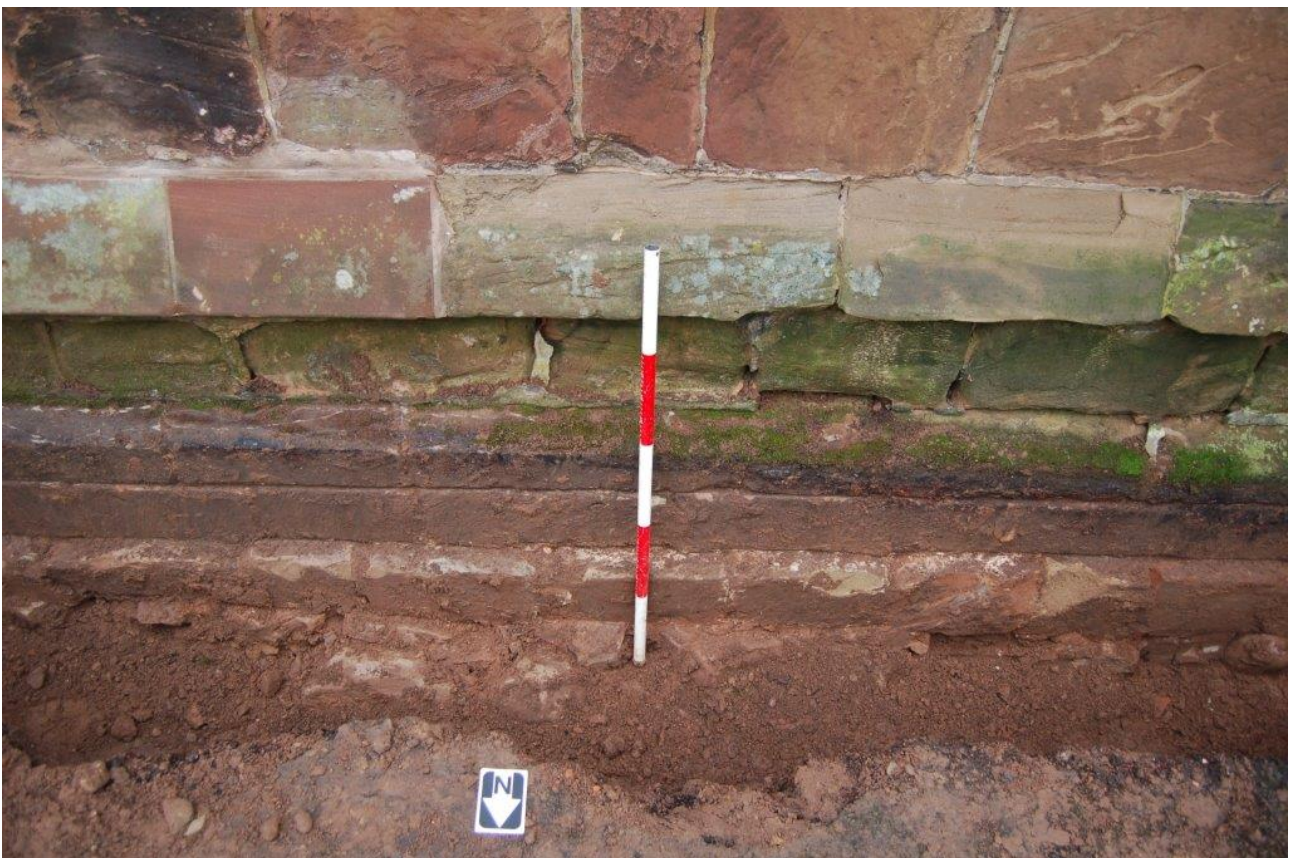
Plate 3: Wall (107) and foundation rubble (108) in bay 4, 1m scale

To the west of the transept the foundations (105) and lower courses of the western side of the northern aisle (107) were recorded in bays 3 and 4. These consisted of large sandstone rubble blocks over which were lain regularly coursed sandstone blocks bonded with gritty cream lime

mortar 20–50mm thick (Plates 3 and 4). The depth of the foundations was not established during the watching brief, but they were a minimum of 0.40m thick and extended a maximum of 0.32m out from the northern face of the wall. The lower two courses of wall consisted of lower course of flat faced blocks (0.20m thick) sitting on the rubble foundations overlain by a chamfered course of sandstone blocks (0.18m thick). Above the chamfered course was another course of sandstone blocks (0.26m thick) which was in turn overlain by a sandstone string course which protruded from the face of the wall by 80mm. This arrangement of courses was consistent in both bays 3 and 4, however due to the natural topography of the site a second course of sandstone blocks had been added below the chamfered course in bay 4 to keep the coursing level. The current external floor level around the northern side of the church was at the same level of as the top of the chamfered course of sandstone. This suggests that, as the lower chamfered stone course would have originally been visible, the ground level has risen over time and that the original ground level would have been between 0.18-0.38m lower. This also suggests that only the lower course of stone was originally below ground level.

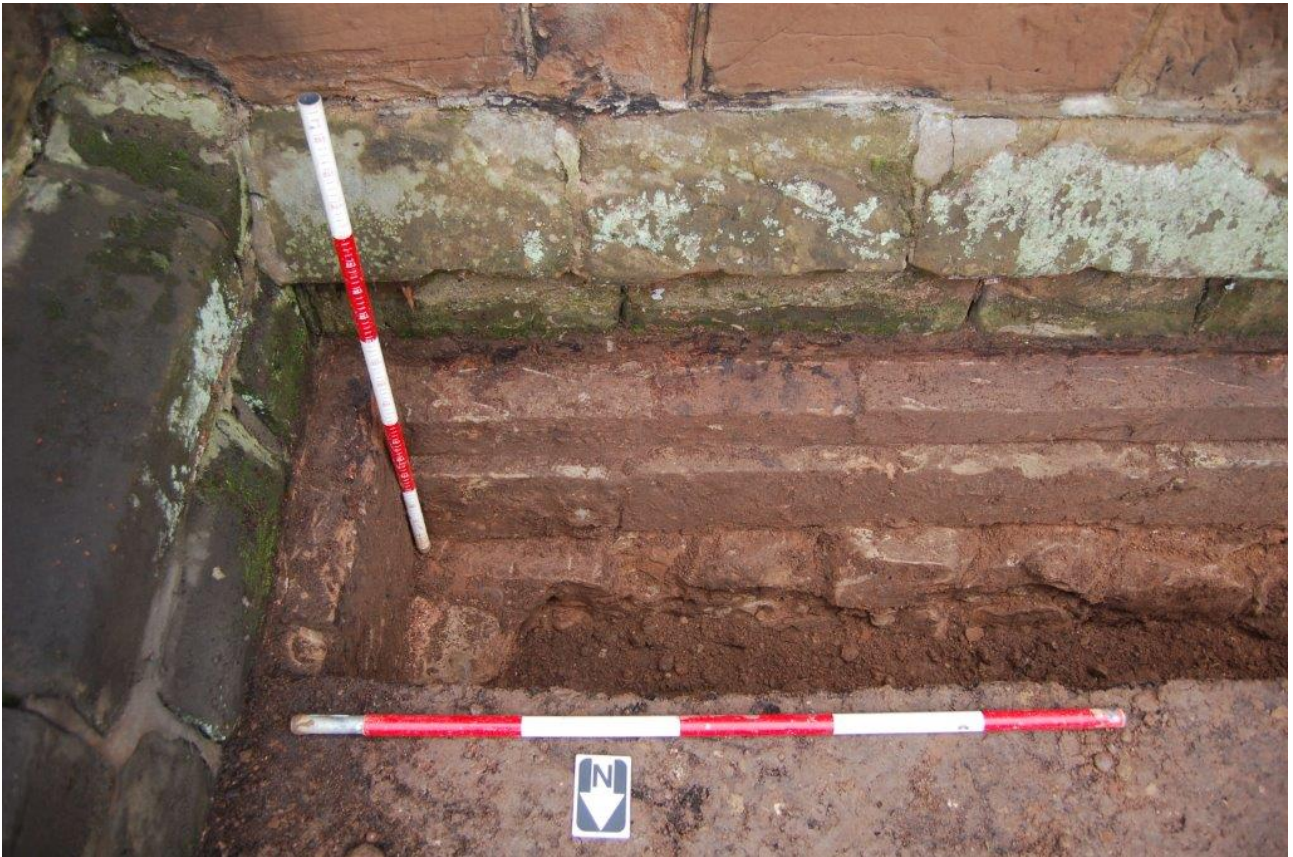
Plate 4: Wall (107) and foundation rubble (105) in bay 3, 2x1m scale

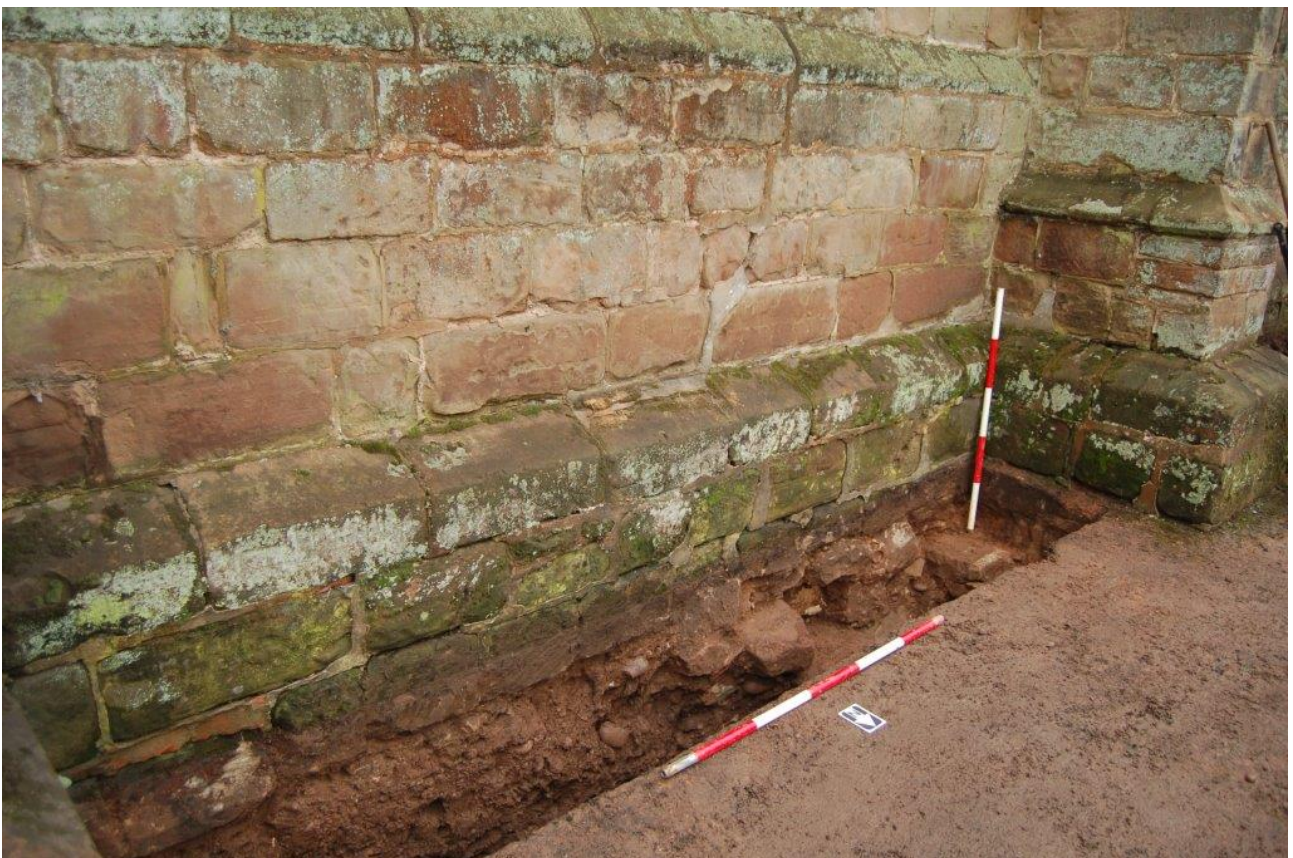
Plate 5: Wall (106) and foundation rubble (109) in bay 1, 2x1m scale

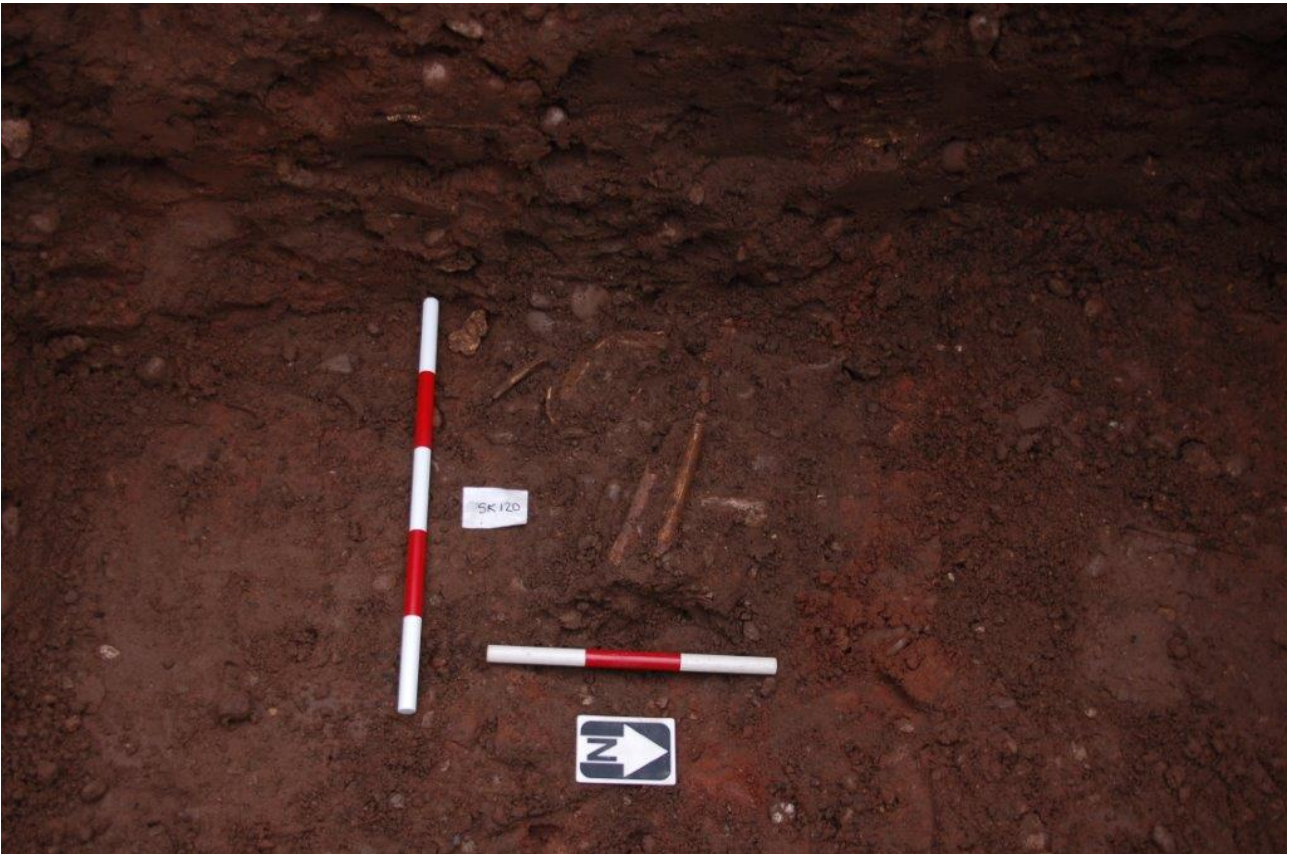
Plate 6: Skeleton 120, 0.50m and 0.30m scales

Articulated skeletons and disarticulated skeletal remains were more common inside the soakaway trenches in the grassed area to the north of the church. Approximately five boxes (45x27x18cm) of disarticulated skeletal remains were recovered from the soakaway trench and articulated remains were encountered at around 1.00–1.10m bgs. Only four partial skeletons (120, 128, 135, 138), were excavated during the watching brief before it was decided to alter the drainage design (Fig 2, Plates 6–9). All of the excavated skeletons were aligned roughly east to west and overlay each other within the lower 0.30–0.40m of the graveyard soil. Based on that density it was estimated that a minimum of 25 other articulated skeletons would be identified in the footprint of soakaway 2. It is difficult to date the skeletal remains as there was no associated coffin furniture or finds, although iron coffin handles (displaced) were found in the graveyard soil suggesting at least some of the skeletons were of post medieval date.

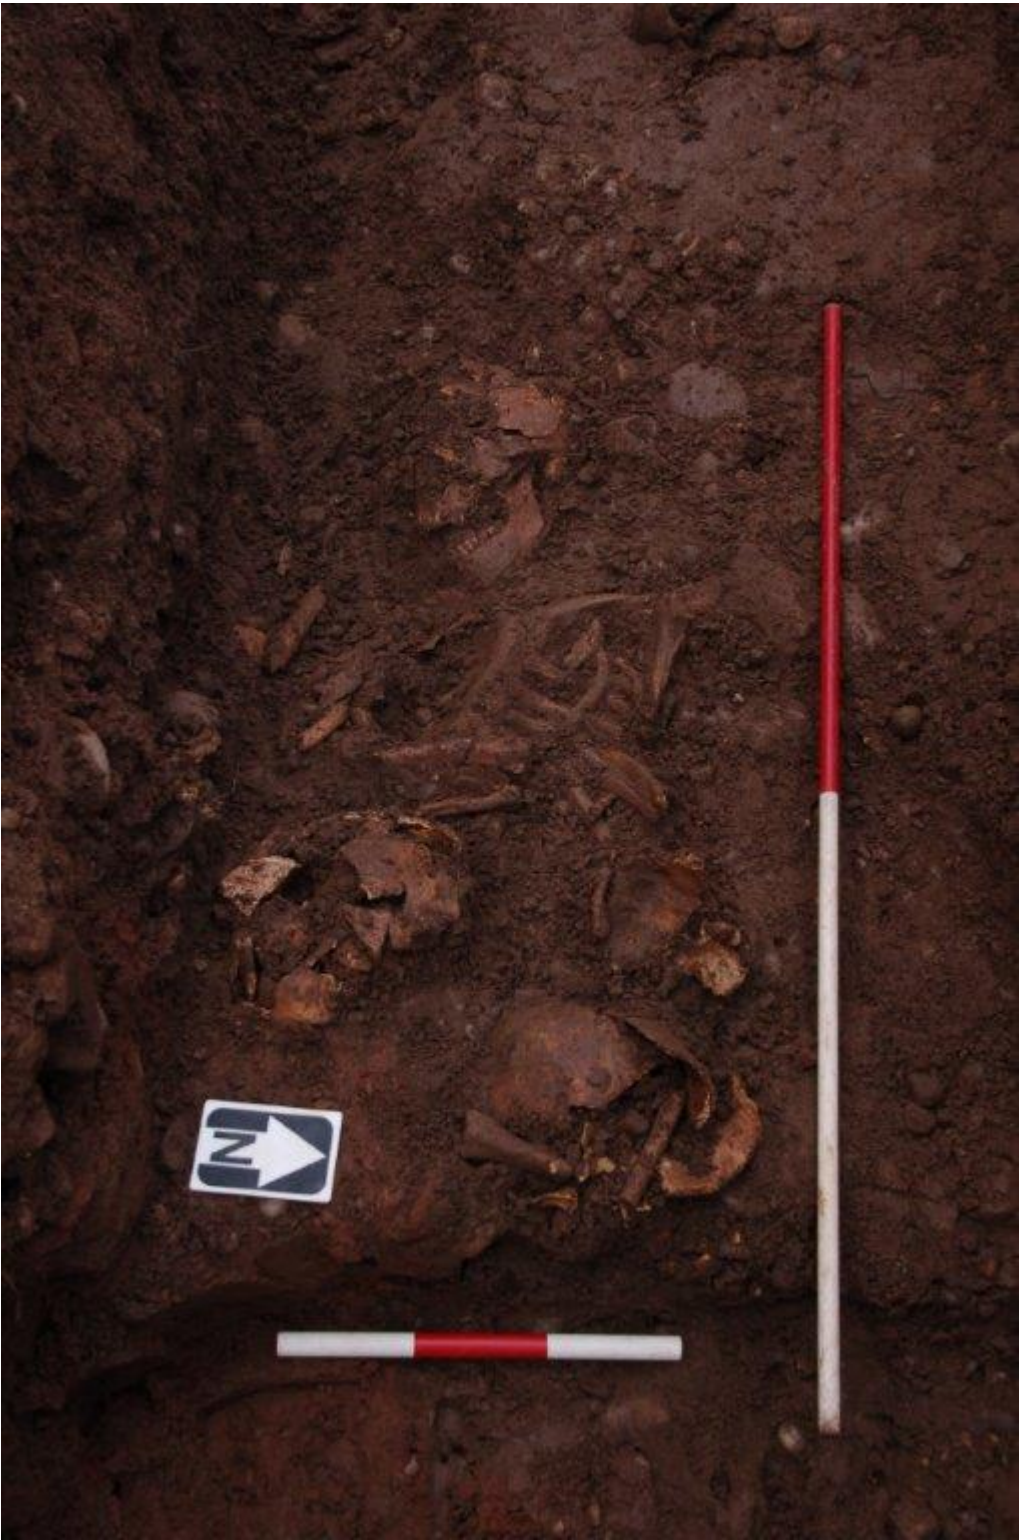
Plate 7: Skeleton 128, 1.30m scales

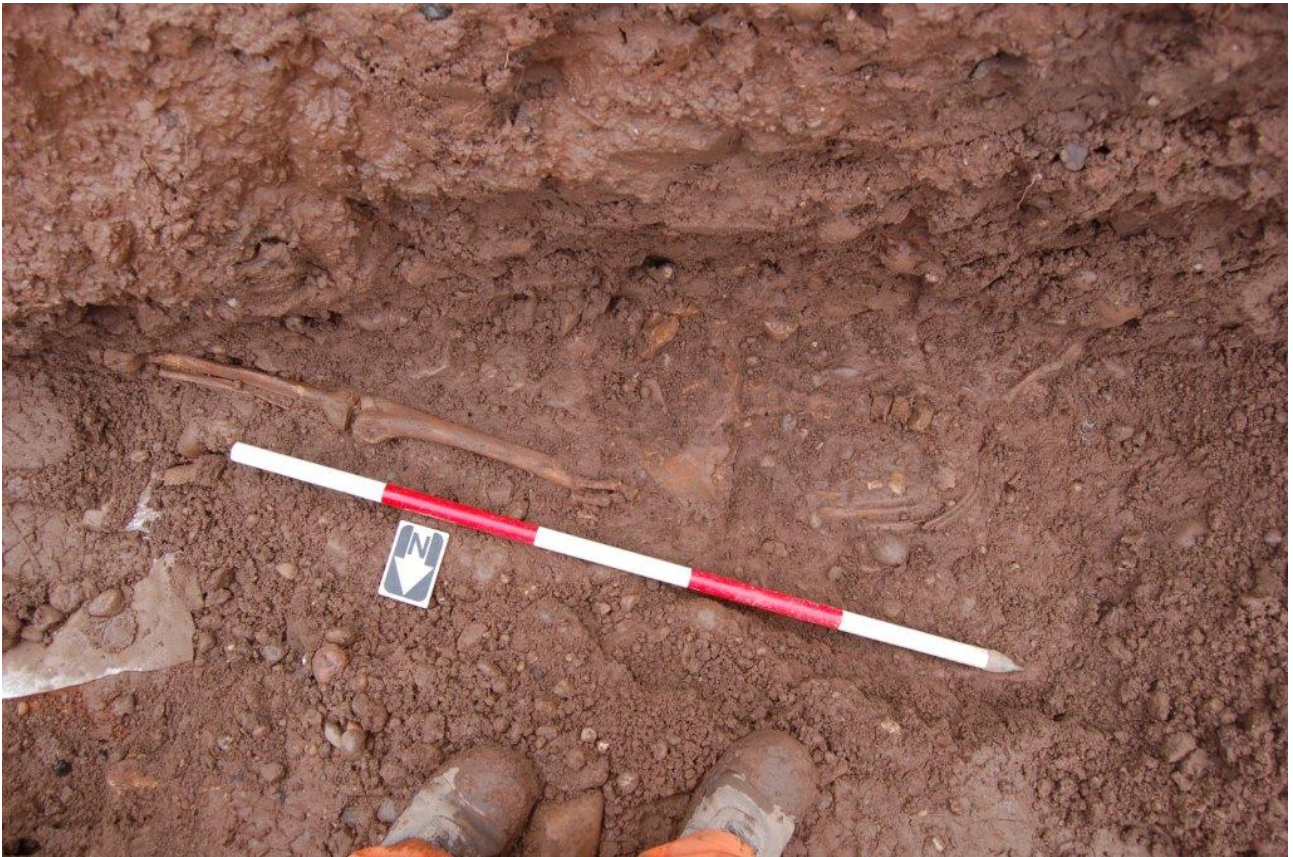
Plate 8: Skeleton 135, 1m scale

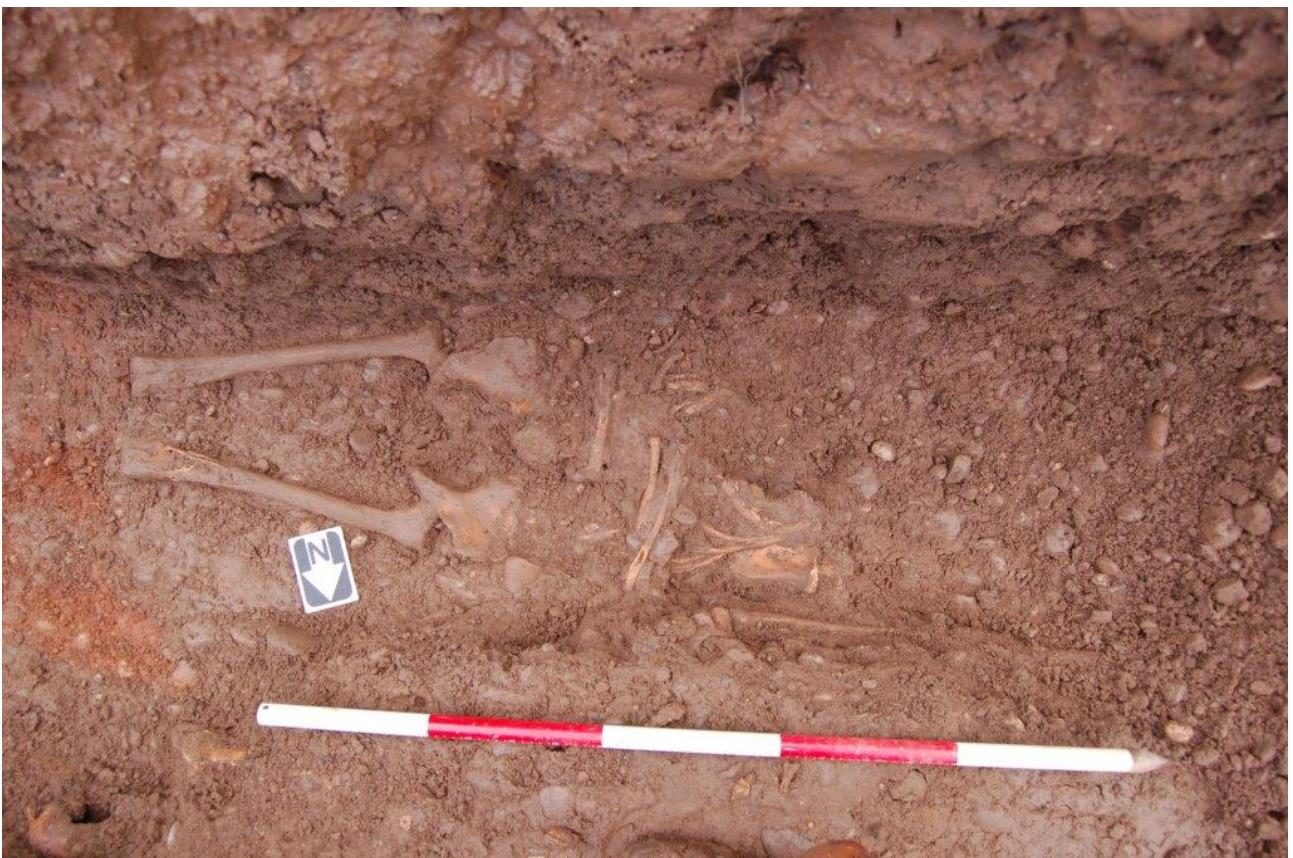
Plate 9: Skeleton 138, 1m scale

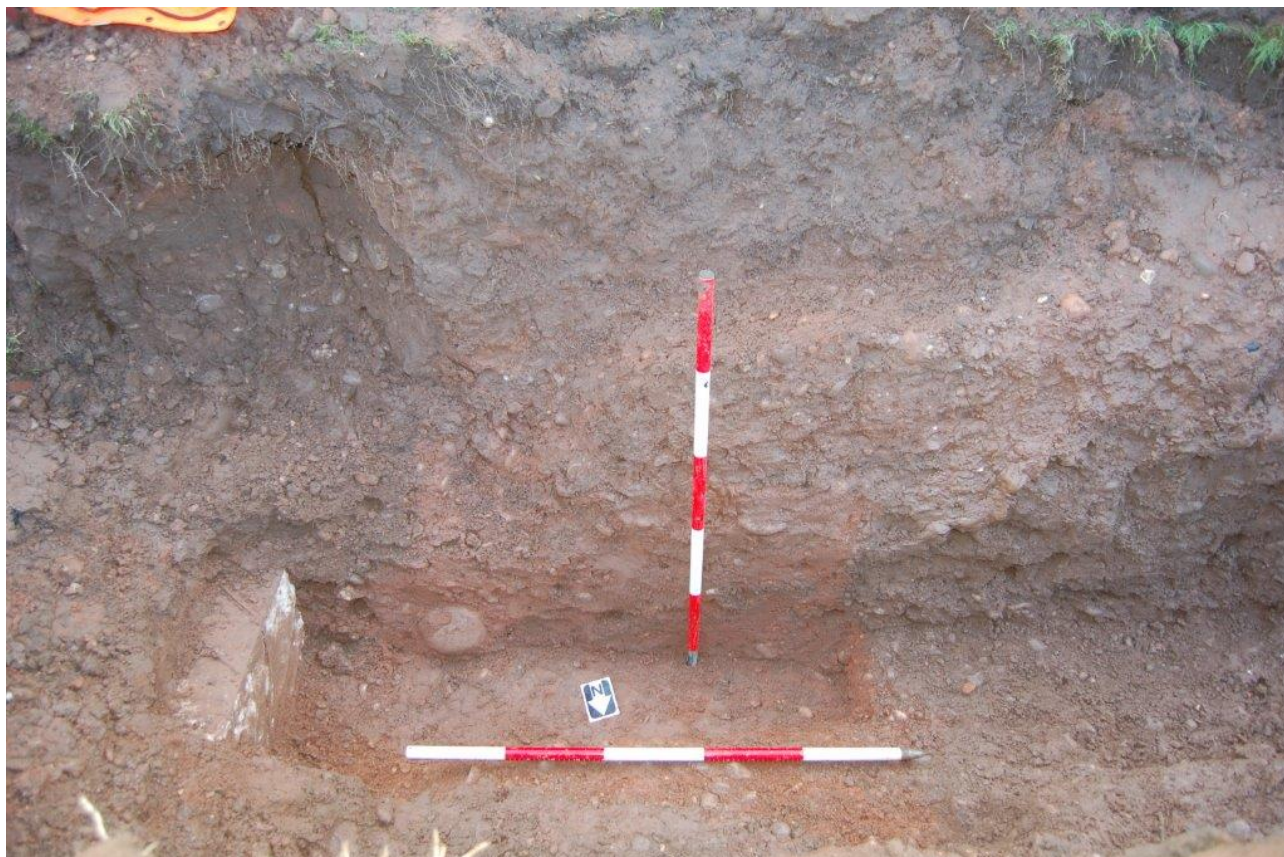
Plate 10: Grave cut 143 to the east of SKs 120, 128, 135, and 138, 2x1m scales.

The eastern ends of the excavated skeletons had been truncated by a later grave cut (143) which had cut through the natural sands and gravels (Plate 10). The burial inside the cut was not encountered and was therefore a minimum of 1.50m bgs.
