Archaeological watching brief at Beechwood Arcade, Cheltenham, Gloucestershire

Status: Version 2
Date: 30th March 2017
Author: Andrew Walsh and Andrew Mann
Illustrator: Carolyn Hunt
Project reference: P4799
Report reference: 2452
HER reference: Assigned after submission
Oasis id fieldsec1-280656

An archaeological watching brief at Beechwood Arcade, Cheltenham, Gloucester

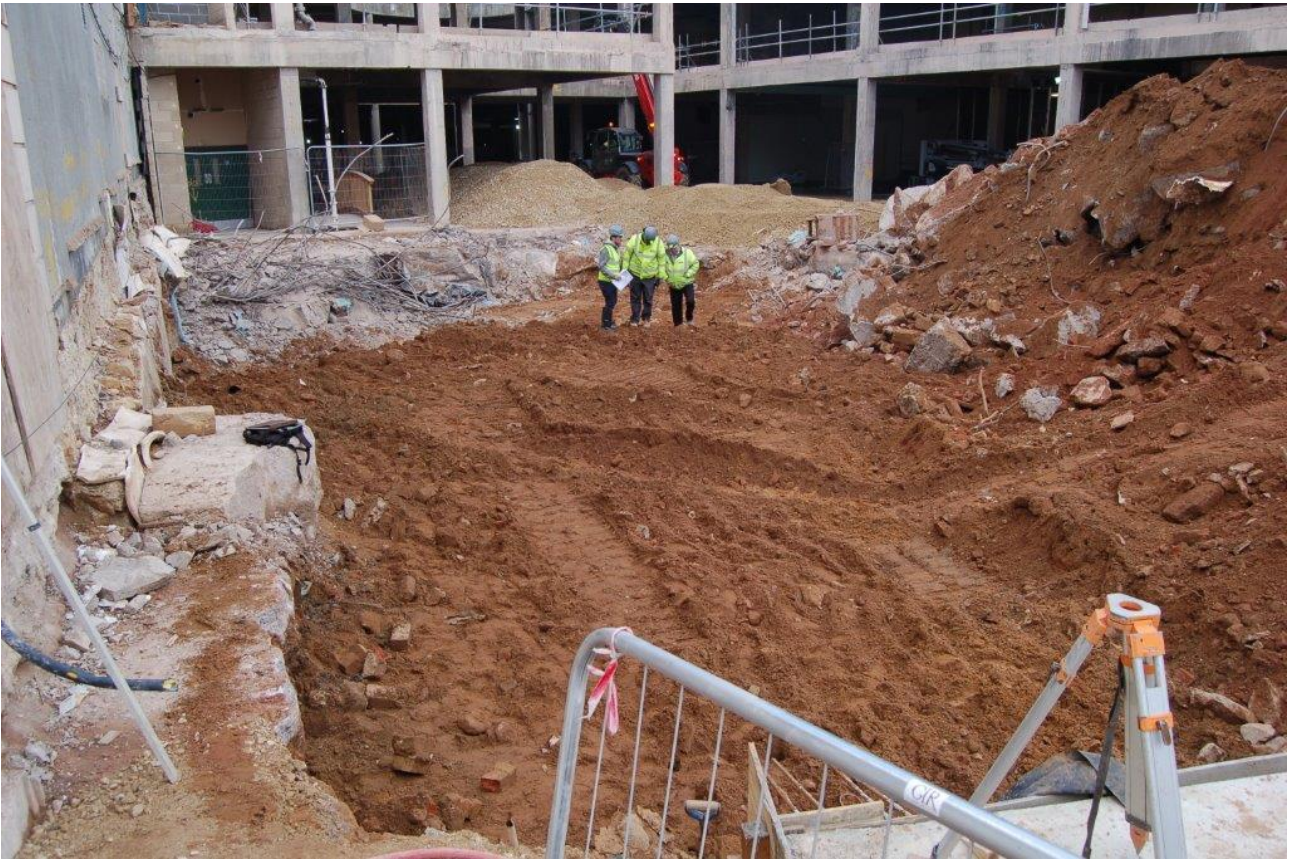
Plate 1: general view of site, facing NNE, showing sand layer (201)

Natural deposits were only observed occasionally during the watching brief as the impact level of the new foundation trenches was higher than the level of the natural. These consisted of soft pinkish red sand (202) overlain by orangey yellow sand upto 0.50m deep. Across much of the site these had been overlain by a layer of soft brownish yellow sand between 0.20-0.50m thick, containing moderate amounts of demolition rubble (201) (Plate 1). It is unclear whether this layer reflects disturbed natural which was mixed with demolition rubble during the construction of the Beechwood arcade or was levelling material brought on to site during construction.

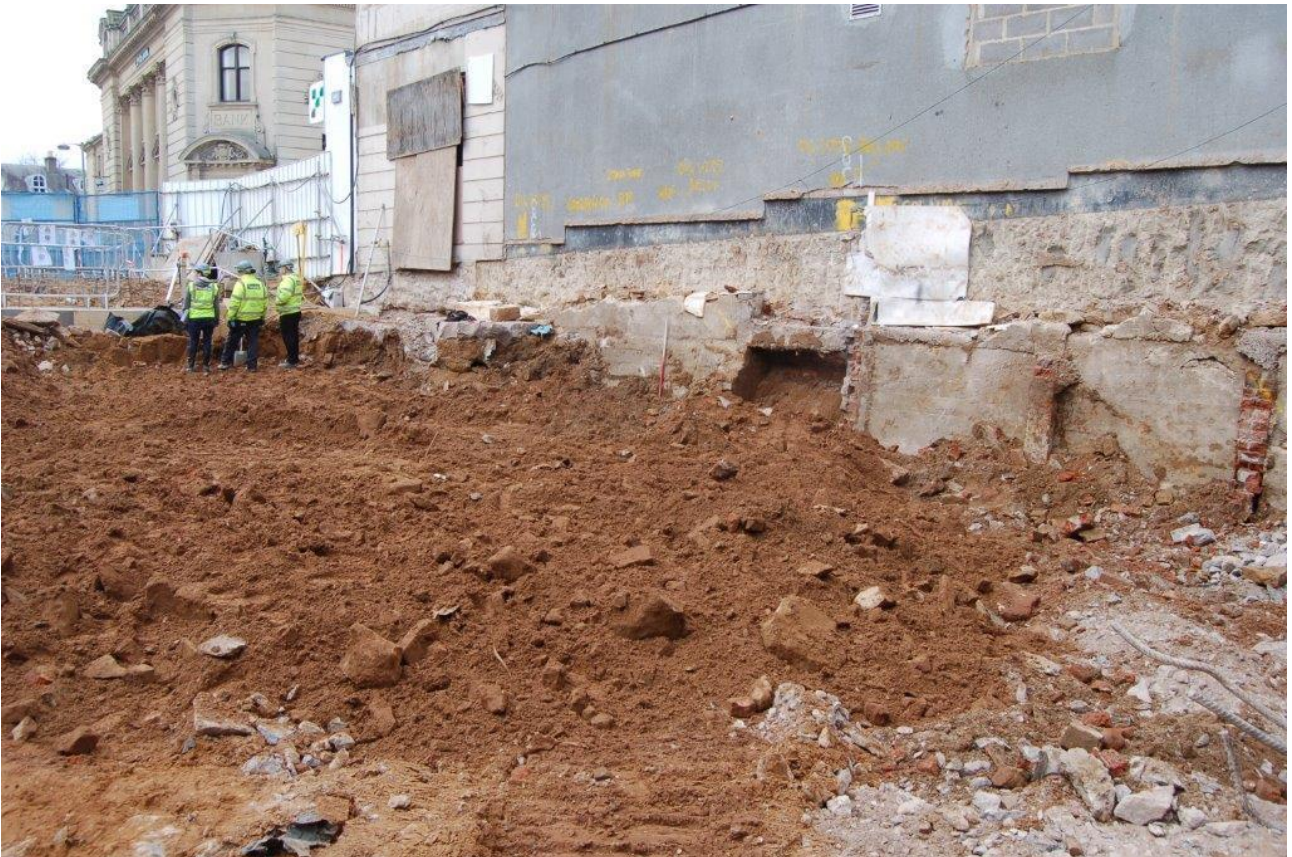
Plate 2: walls 300-306 along western boundary of the site

The only archaeological features identified were limestone and brick walls, that are likely to be of post-medieval date and were probably associated with the Royal Hotel, which used to occupy the site. Along the western side of the monitored area were seven brick walls aligned north-east to south-west (Plates 2-3). Between walls, (300), (301) and (302) was a soft yellowish brown sand (307) containing frequent demolition rubble, thought to be the backfill of a cellar, the lime wash of wall (305) also suggests these walls were exposed and formed cellars. Walls (302) and (305) were butt-ended suggesting they were cellar partitions or doorways. All of the walls along the western edge were bonded with lime mortar except walls (303) and (304), which were bonded with cement mortar.

The majority of the archaeological remains are likely to be associated with the Royal Hotel which had previously occupied the site. The walls along the western side of the site suggest that cellars extended from the street frontages to the rear of the property and had been partitioned internally. Parts of these had been lime washed.

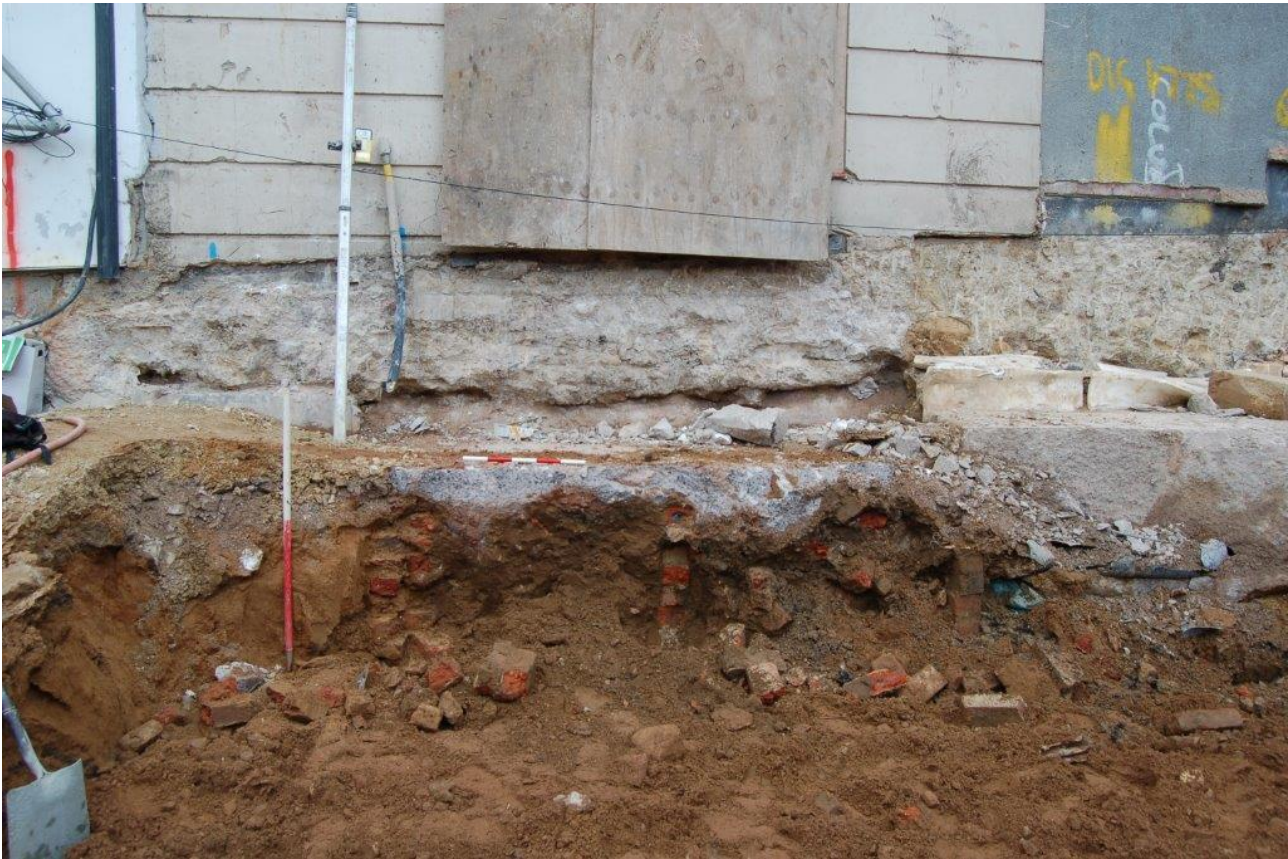
Plate 3: walls 300, 301 and 302 along the western boundary of the site. 1m and 0.5m scales

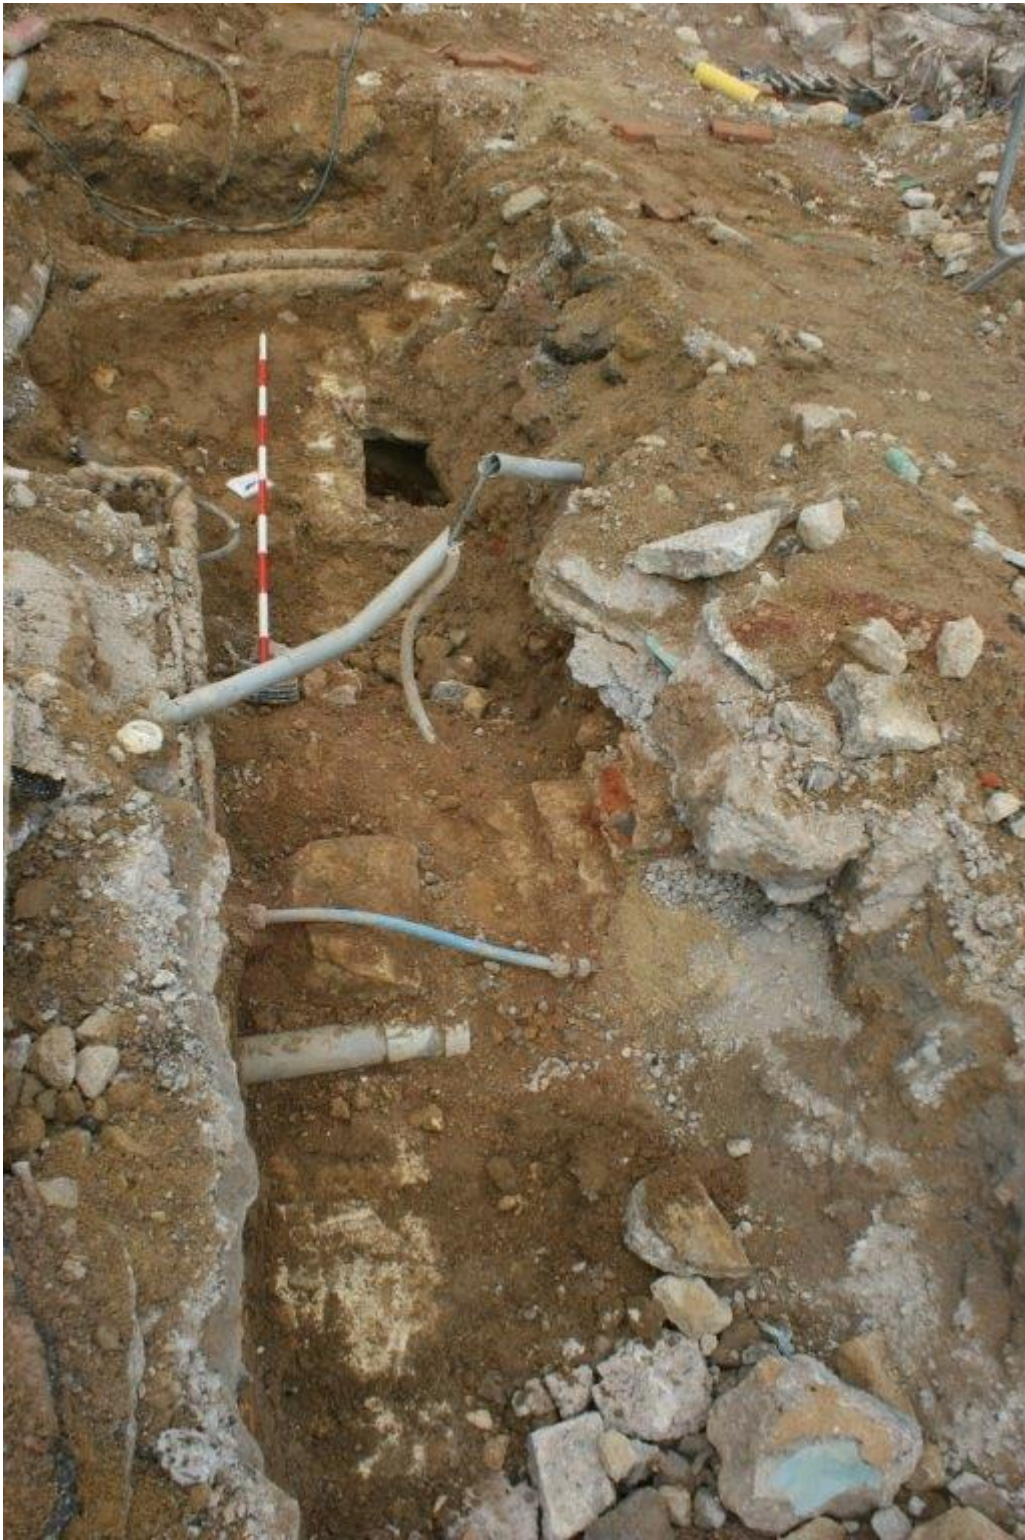
Plate 4: limestone wall (102) facing northwest, 2m scale.

Along the street frontage a limestone wall (102) appeared to form a cellar aligned north-east to south-west (Plates 4-5). Along the top of the wall a brick wall (101), probably a later addition had been built. In the south-west corner of the structure a number of flag stones c.0.15m thick had been built into the limestone wall and appeared to cap the feature. The structure was not excavated further as the impact level of the new footings had been reached so it remains unclear if this formed part of a cellar or a drain. The limestone parts of the wall also remain undated and it is possible they are earlier than the post-medieval brick wall on top.

The limestone wall along the street frontage is either a cellar or drain and at present is undated. However the different method of construction, being of limestone rather than brick, suggests it may be earlier (possibly medieval) in date.

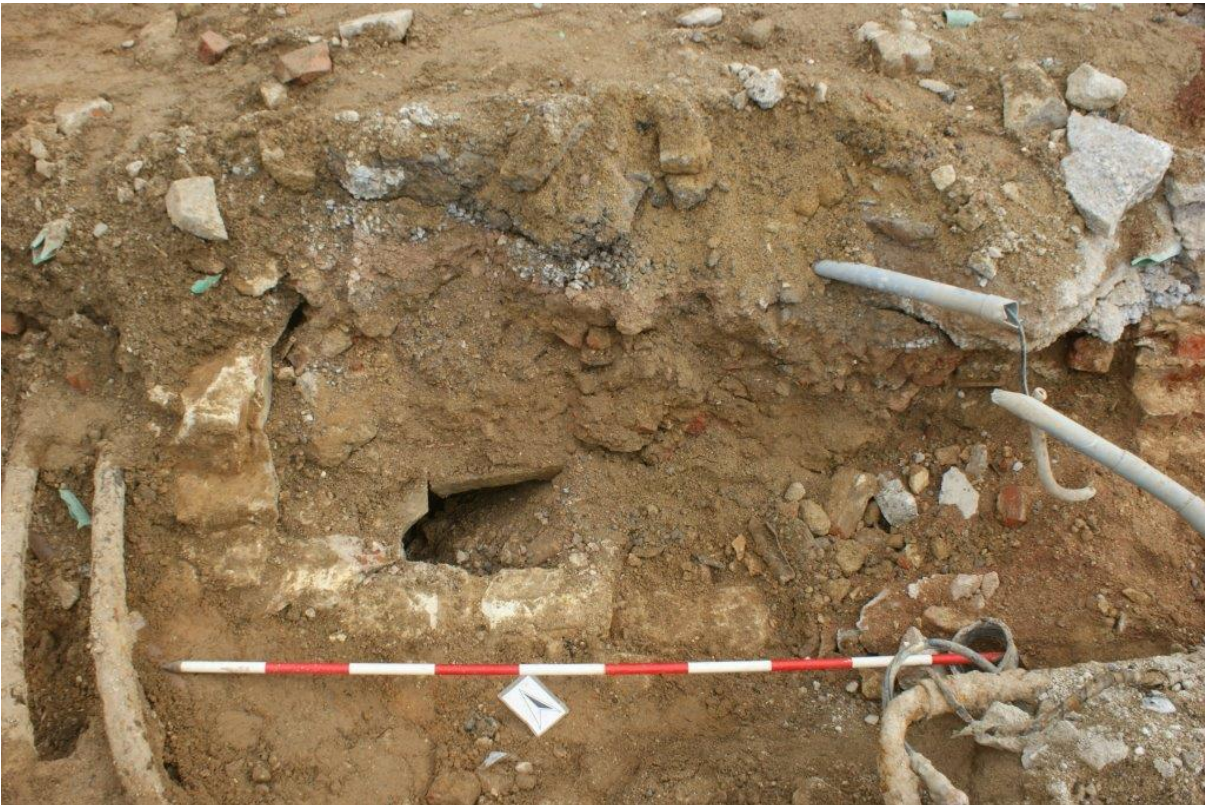
Plate 5: limestone wall (102) facing northeast, 2m scale.

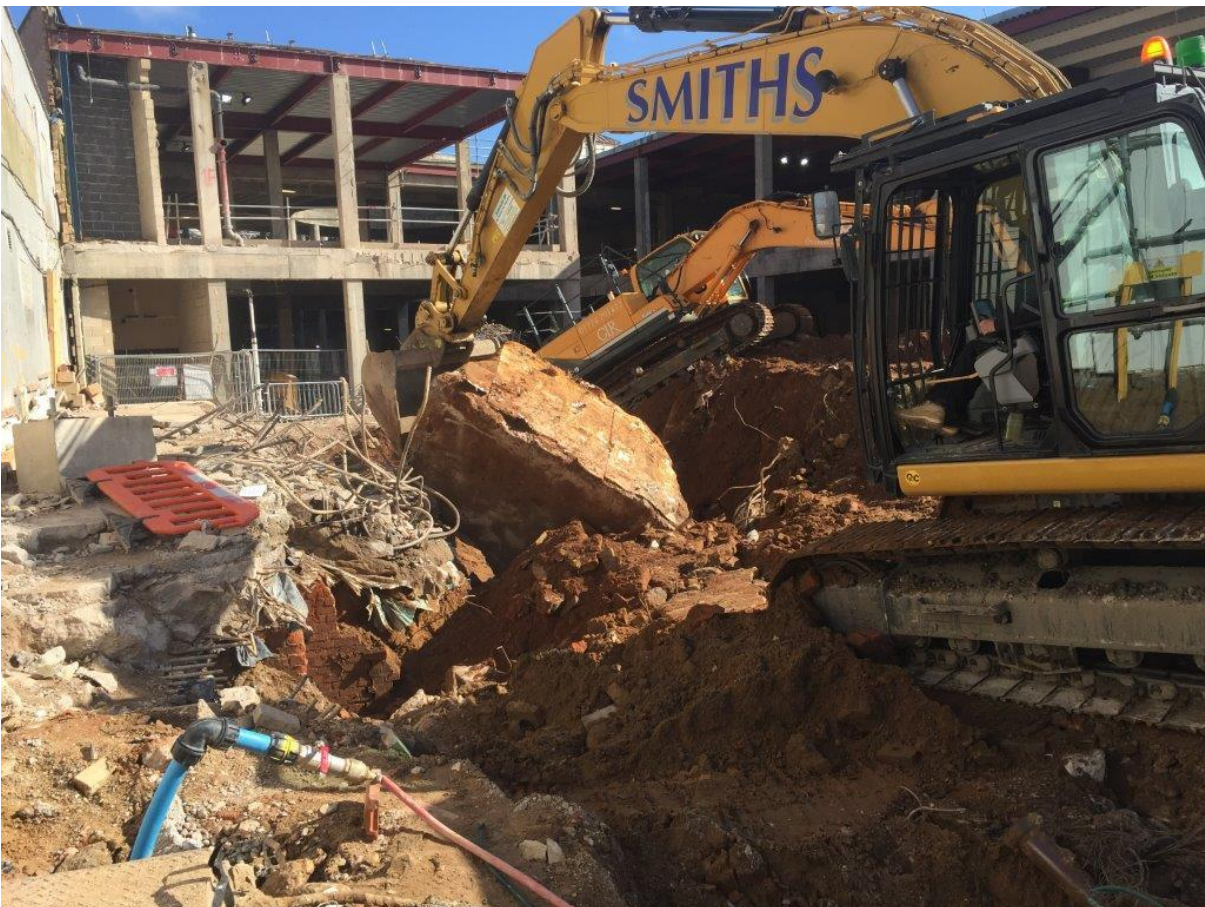
Plate 6: photograph illustrating the amount of concrete used to construct the Beechwood Arcade.

Concrete foundations and floors reinforced with rebar were present across the whole site. These lay directly over the walls discussed above and as a result when they were removed it caused considerable damage to the earlier remains. The concrete footings and floors were between 0.90-1.70m deep and are likely to have truncated most archaeological remains (Plates 6-7).

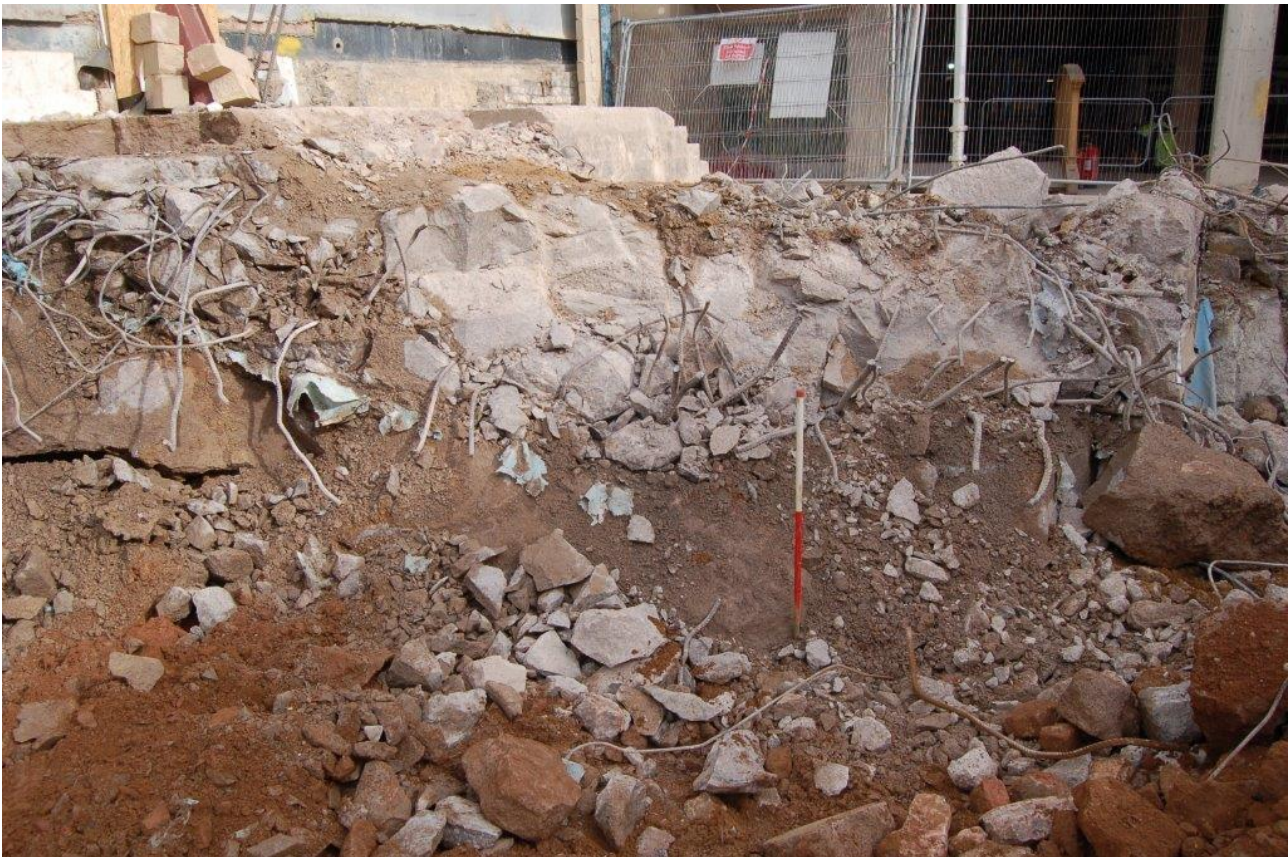
Plate 7: photograph illustrating the amount of concrete used to construct the Beechwood Arcade.
