# Archaeological evaluation of land to the rear of the Shamrock public house, Grove Street, Cheltenham, Gloucestershire

Project reference: P5062 Report reference: **2465**

An archaeological evaluation was undertaken on land to the rear of the Shamrock public house, off Grove Street in Cheltenham, Gloucestershire (NGR SO 394421 222836). It was commissioned by Andrew Marsh of Dawson and Marsh Building Contractors, who intends residential redevelopment, for which a planning application has been submitted to Cheltenham Borough Council.

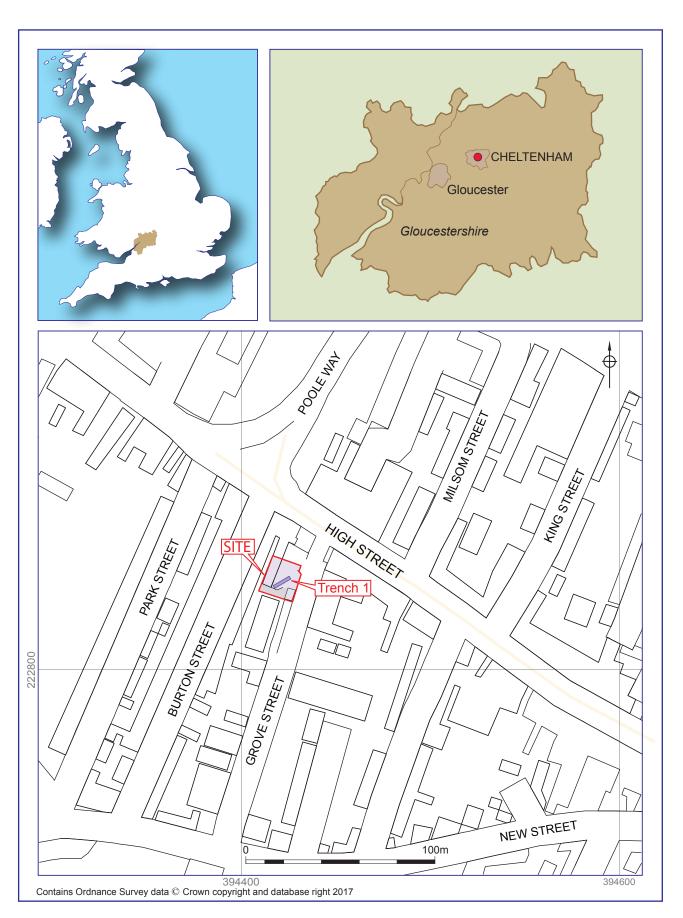
Figure 1

Location of the site and Trench 1

A single trench, 10m in length and amounting to just over 17m<sup>2</sup>, was excavated on the site area of 411m<sup>2</sup>, representing a sample of just over 4%. The location of the trench is indicated in Figure 1. It was positioned with consideration for numerous practical constraints, including live service routes, spoil storage, parking and access to the site (Plate 1).

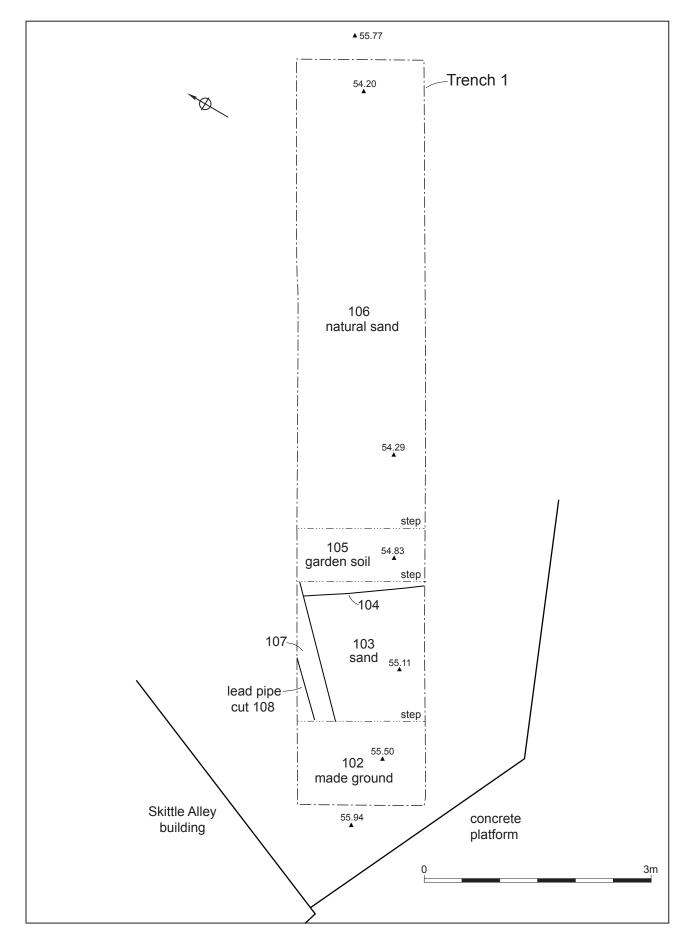
Plan of Trench 1

The trenches and features recorded are shown in Figure 2. The results of the structural analysis are presented in Appendix 1.

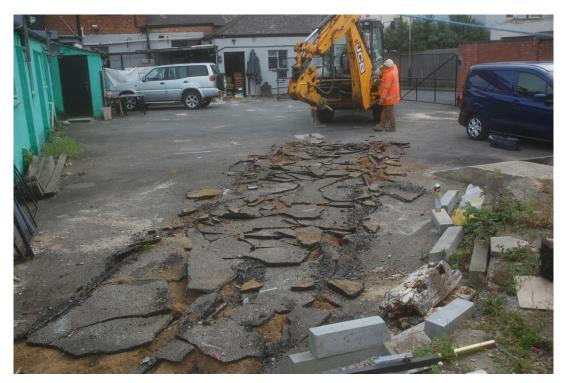
Plate 1: Trench 1 location to rear of public house during initial surface removal

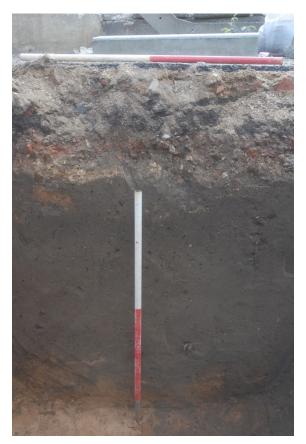
A substantial humic silty sand soil deposit directly overlay the natural sand for the majority of the trench (continuing at least 7m in length); this was up to 1.05m in depth and included frequent charcoal flecks, as well as a few fragments of clay tobacco pipe and pottery dispersed throughout the deposit (Plate 2). The artefacts dated it to the 18th century and it is probable that this represents a reworked garden soil (105).

Sealing the modern features was a layer of loose rubble in a silty sand matrix (102), 0.22m in depth (Plate 2). This included pottery of 19th-20th century date and was probably a demolition or levelling layer of made-ground, deposited prior to construction of the car park surface, which consisted of tarmac (100) bedded onto soft light yellow gravel-rich sand (101).

Plate 2: Post-medieval soil deposit (105) below made ground (102)

Natural deposits were encountered 1.45m-1.65m below the car park surface, at around 54.29m AOD. This comprised soft light yellowish-orange sand with occasional small gravels (106; Plates 2 and 3), consistent with natural deposits previously identified locally (see, for example, Walsh and Mann 2017).

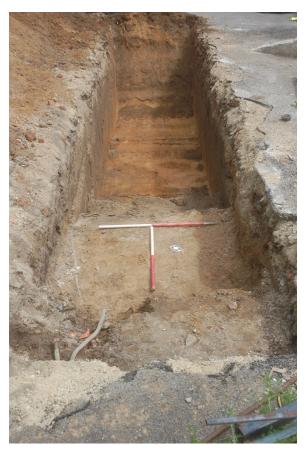
At the south-west end of the trench, the post-medieval soil was cut through by a large feature of modern date [104], possibly a construction cut, that included numerous pieces of glass, brick and tile in the loose sandy fill (finds not retained). Both the humic garden soil and the modern feature were cut by a service trench [108] that included a lead water pipe (capped off but still live). This effectively stopped excavation in the first 3m of the trench, other than locating the route of the pipe (Plate 3).

Plate 3: Overview of Trench 1, with live service in foreground and natural sand below post-medieval soil
