Building recording at Top Barn, Middle Lane, Hadzor, Droitwich Spa

Status: Version 2
Date: 20th June 2017
Author: Tim Cornah tcornah@worcestershire.gov.uk
Illustrator: Carolyn Hunt chunt@worcestershire.gov.uk
Project reference: P5101
Report reference: 2471
HER reference: WSM69252
Oasis id: fieldsec1-286434

Building recording was required to meet a planning condition relating to the redevelopment of Top Barn at Middle Lane, Hadzor, Droitwich Spa.

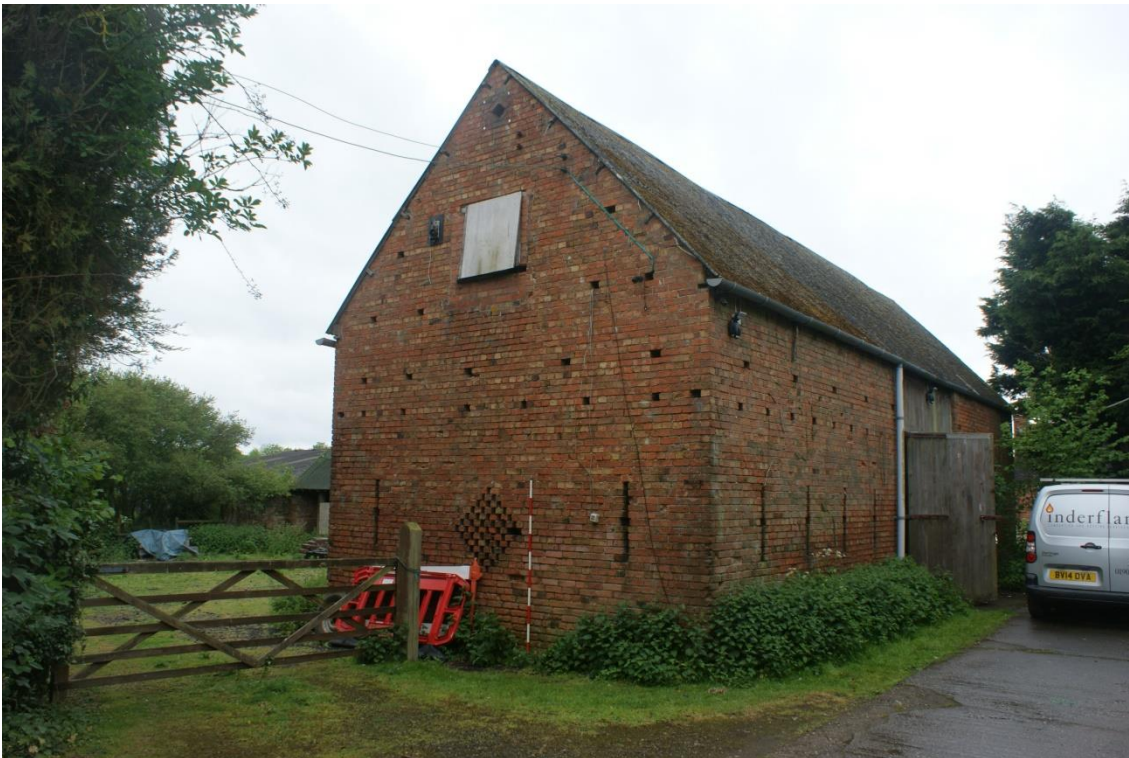
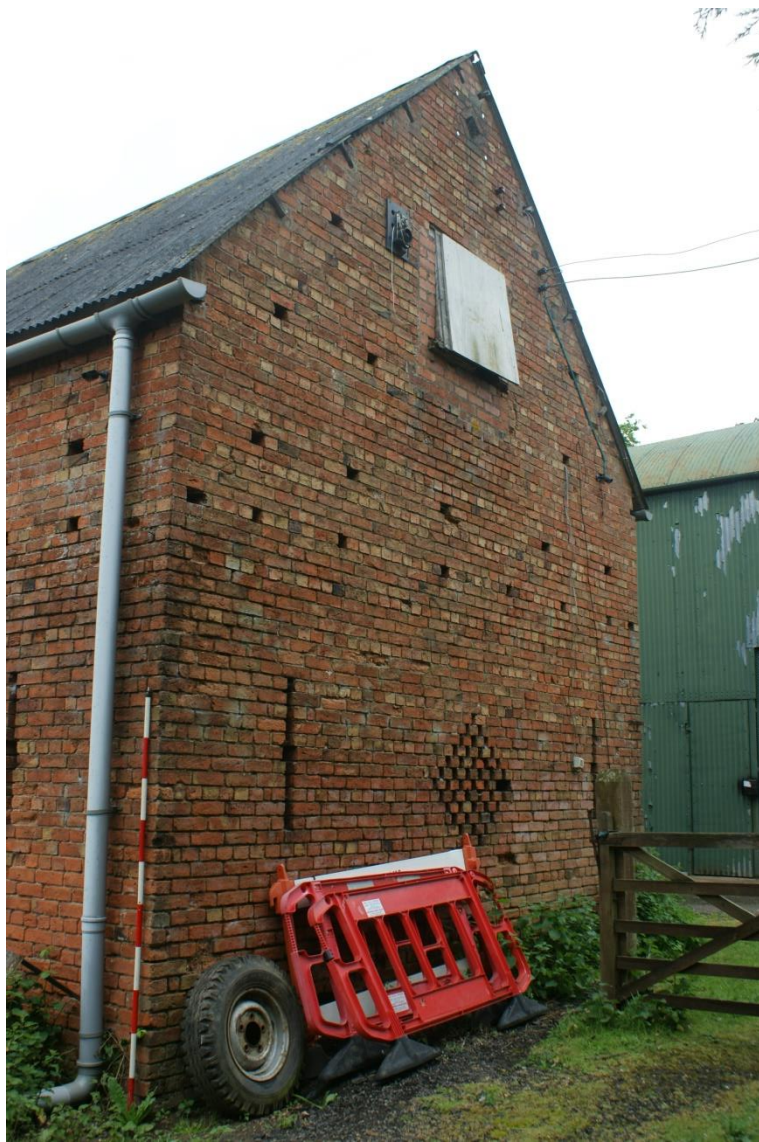
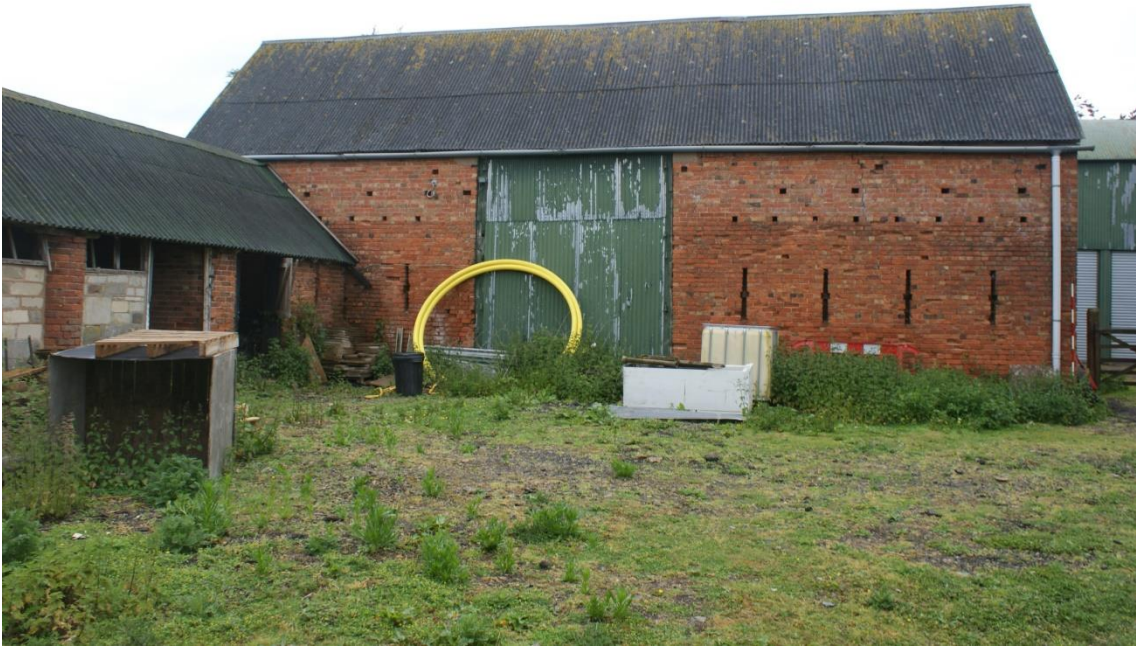
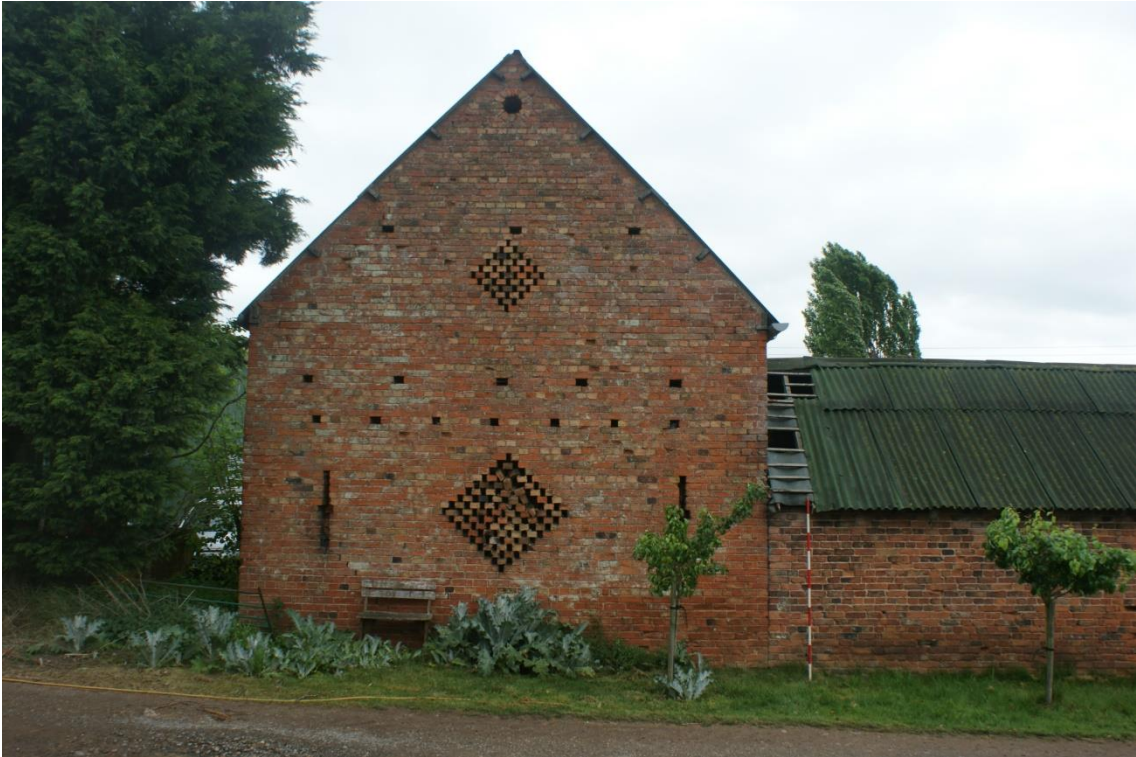
Plate 1 Phase 1 barn, looking south-west

Plate 2 Phase 1 barn, looking south-west

Plate 3 Phase 1 barn, looking north

Plate 4 Phase 1 barn, looking east

The initial building on the site was a brick built threshing barn, aligned east to west (Plate 1 to Plate 4). Vertical ventilation slits were present around the building above the ground, with further

diamond pattern vents at the gable ends. Vents the size of individual bricks were present across the upper half of the building with further small round vents below the apex on either gable. On the eastern gable was a blocked window that may have been used to hoist crops to above the tie beam level internally.

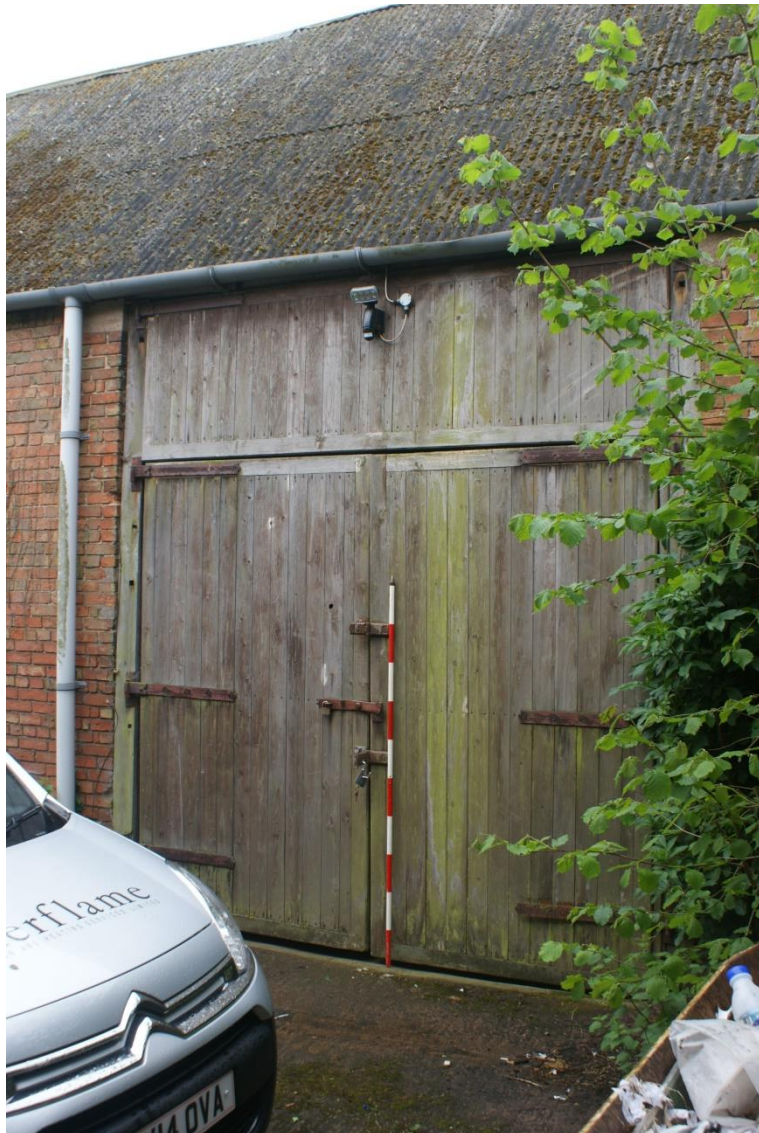
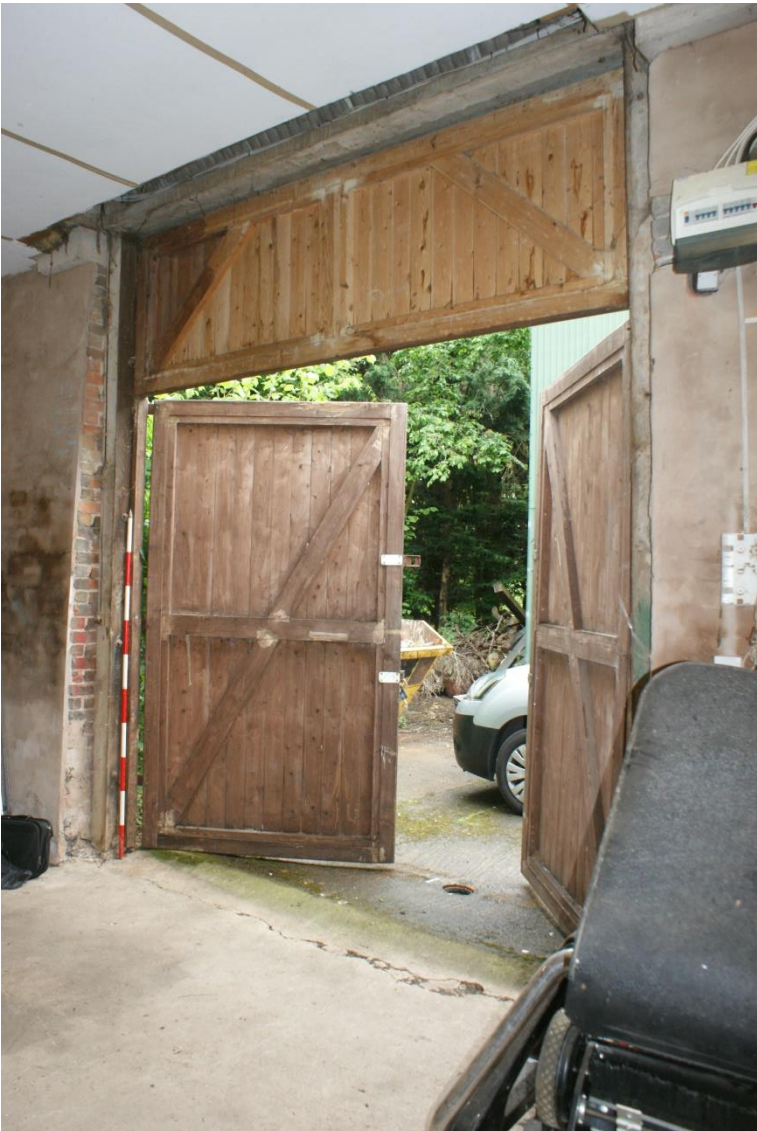
Plate 5 Phase 1 barn, looking south-east

Plate 6 Phase 1 barn, looking north-west

At the centre of the building were opening for two full height doors, one either side with that on the south blocked within Phase 3. The door on the northern side is probably an early Phase 3 replacement (Plate 5 and Plate 6). The building was fitted with internal cladding and false ceiling added during Phase 3 (Plate 7 to Plate 9), obscuring much of the internal historic detail.

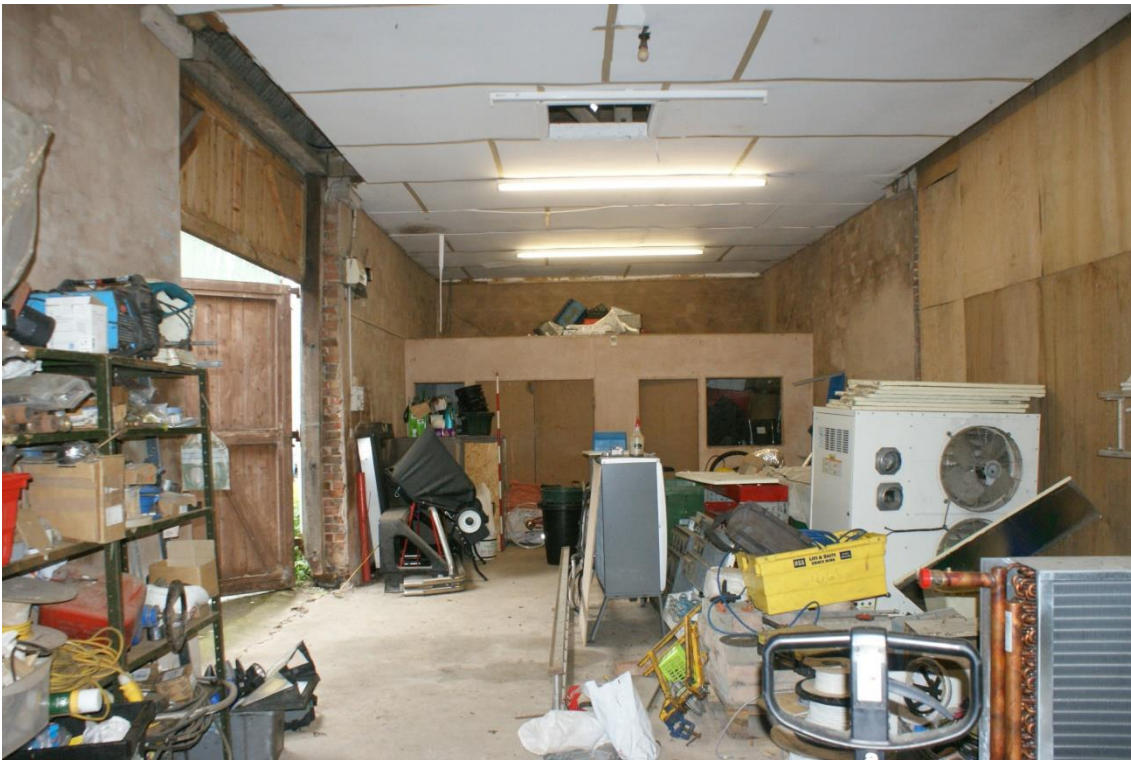
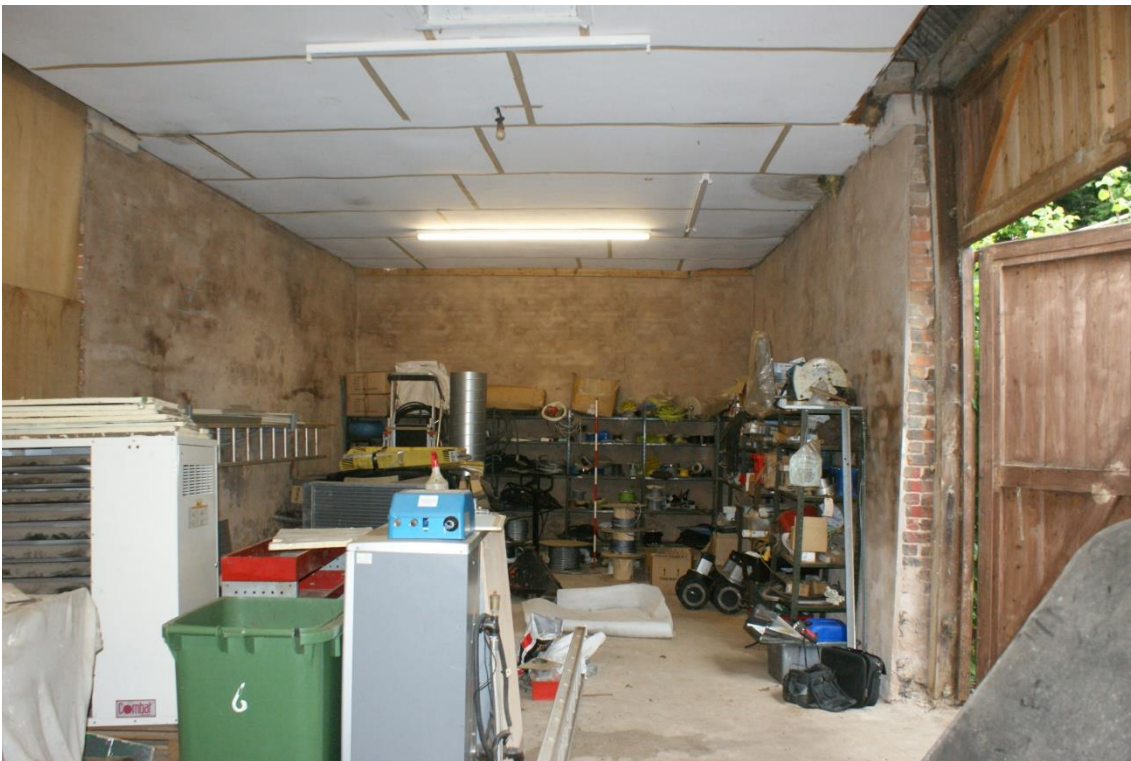
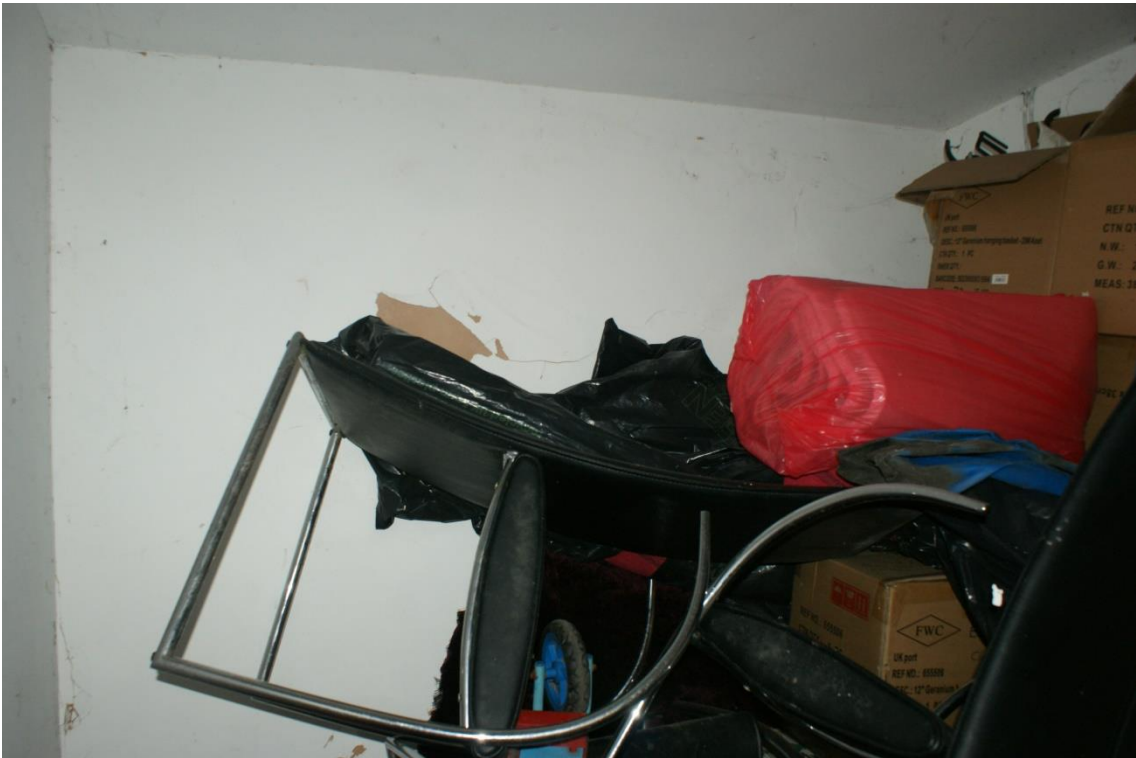
Plate 7 Phase 1 barn, looking east

Plate 8 Phase 1 barn, looking west

Plate 9 Phase 1 barn, looking north-east

Within the Phase 1 barn, the southern door was blocked with internal cladding added to the walls and a false ceiling added. As part of this, two small rooms were added internally at its eastern end. The roofs of both the Phase 1 and 2 buildings were replaced.

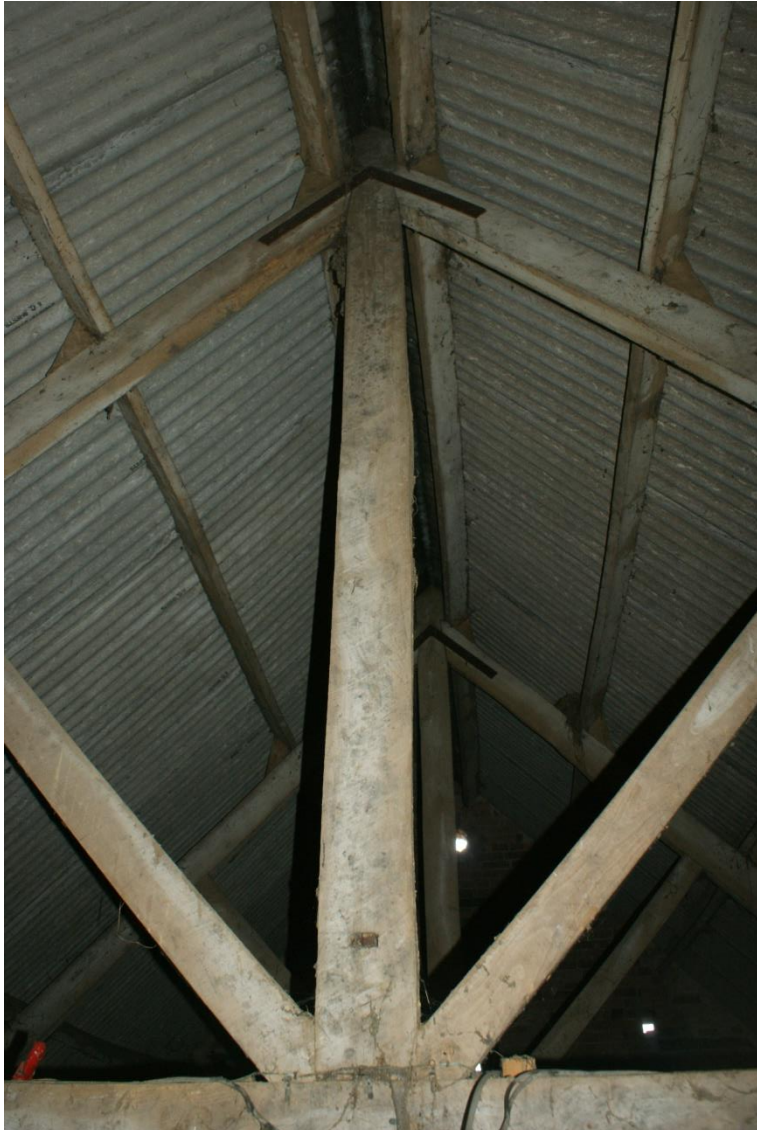
Plate 10 Phase 1 barn, looking east

The roof structure was of five bay construction with four intermediate softwood King Post trusses (Plate 10) that supported purlins set at 90 degrees to the common rafters. The trusses were constructed with iron fixings and fastenings with the conversion of the timbers having been undertaken mechanically using both a vertical band saw and circular saw, suggesting a mid-19th century date at earliest. No visible evidence for a floor above the tie beams remained.

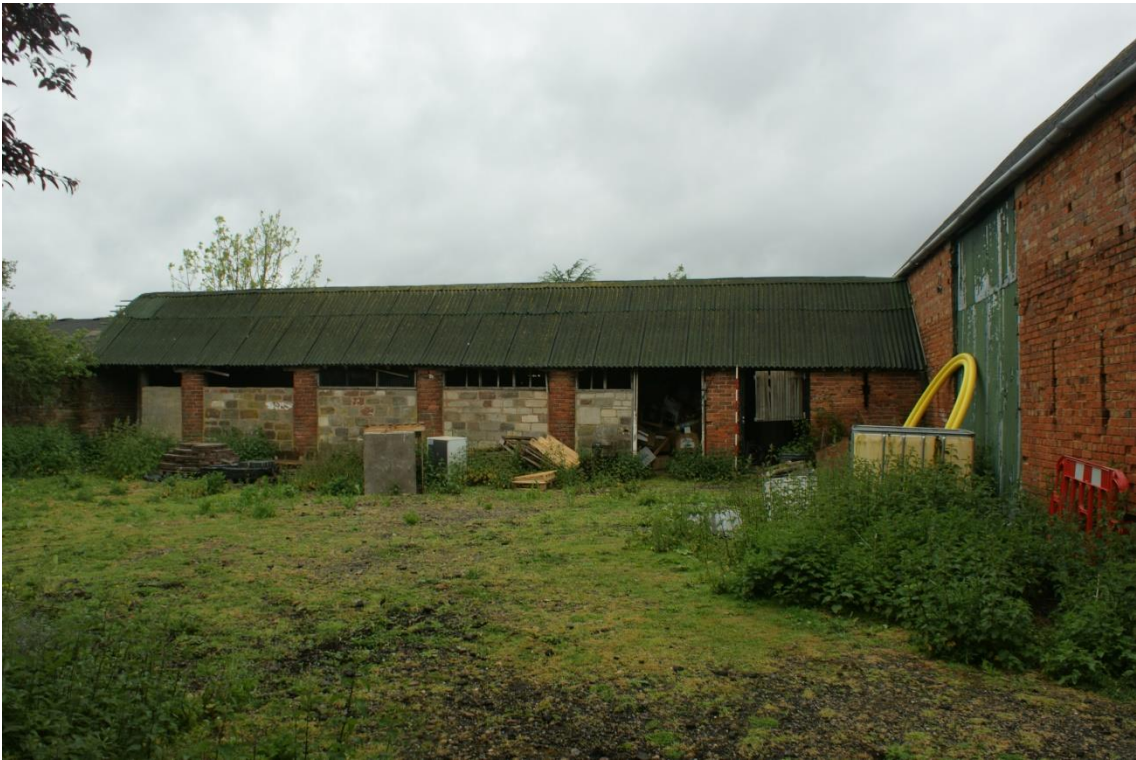
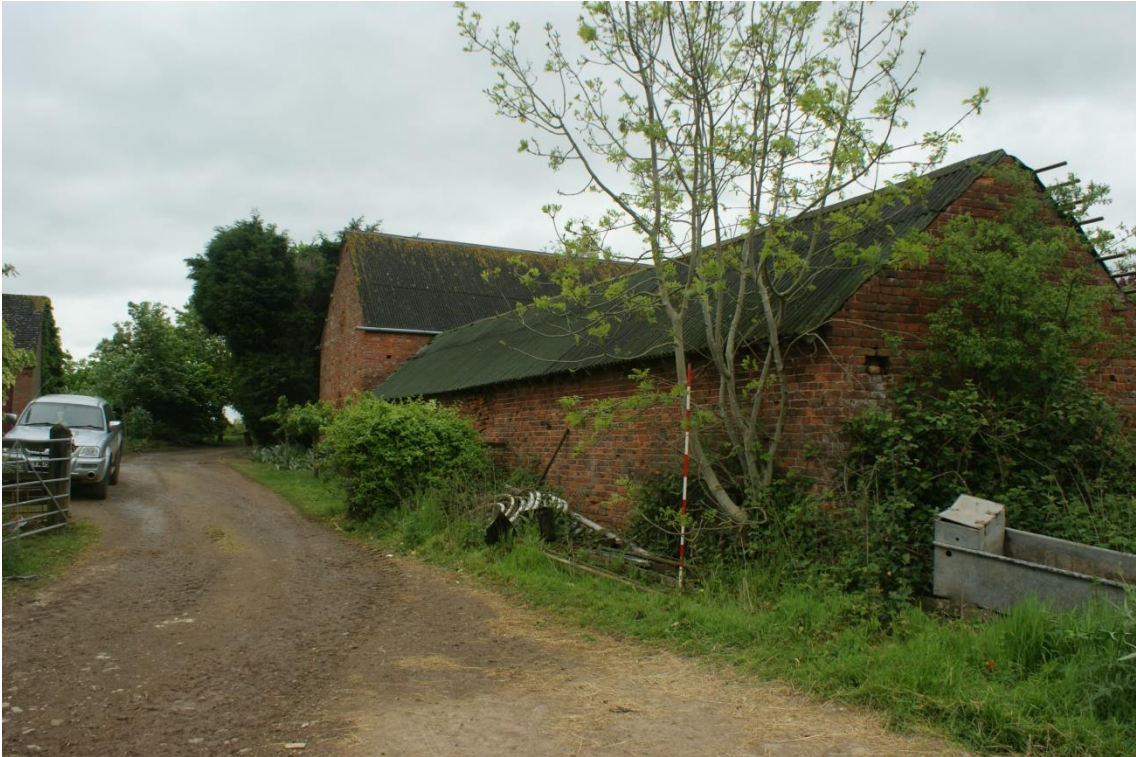
Plate 11 Phase 2 cow shed, looking west

Plate 12 Phase 2 cow shed, looking north-east

Butted on to the Phase 1 barn and was a north-south aligned low structure split into seven bays (Plate 11 and Plate 12). The northern two bays former a single room with a door on its eastern side (Plate 13) with a roof truss spanning its centre. This is likely to have been a feed room with the further five bays to the south (Plate 14 and Plate 15) having formed part of a shelter shed open fronted to the yard on the eastern side. The fact that it was open fronted was visible from four round brick columns at its frontage in line with the interior roof trusses. In the south-west corner was a remnant of an original feed trough which would have extended along the back wall (Plate 16).

The roof trusses were also of softwood king post construction, similarly using metal fastenings and mechanically converted. Some hardwood elements were present, including the wall plate and post heads at the front of the building. These would have been designed in due to their weather durability.

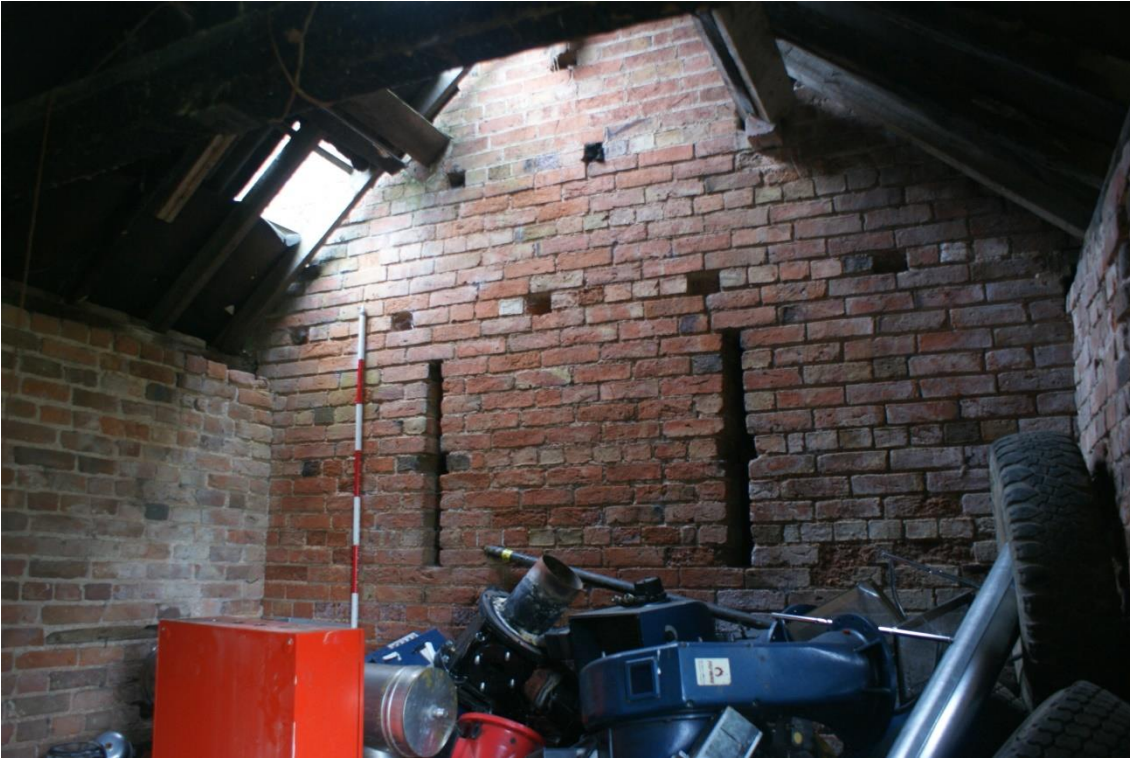
Plate 13 Phase 2 cow shed, looking north-west

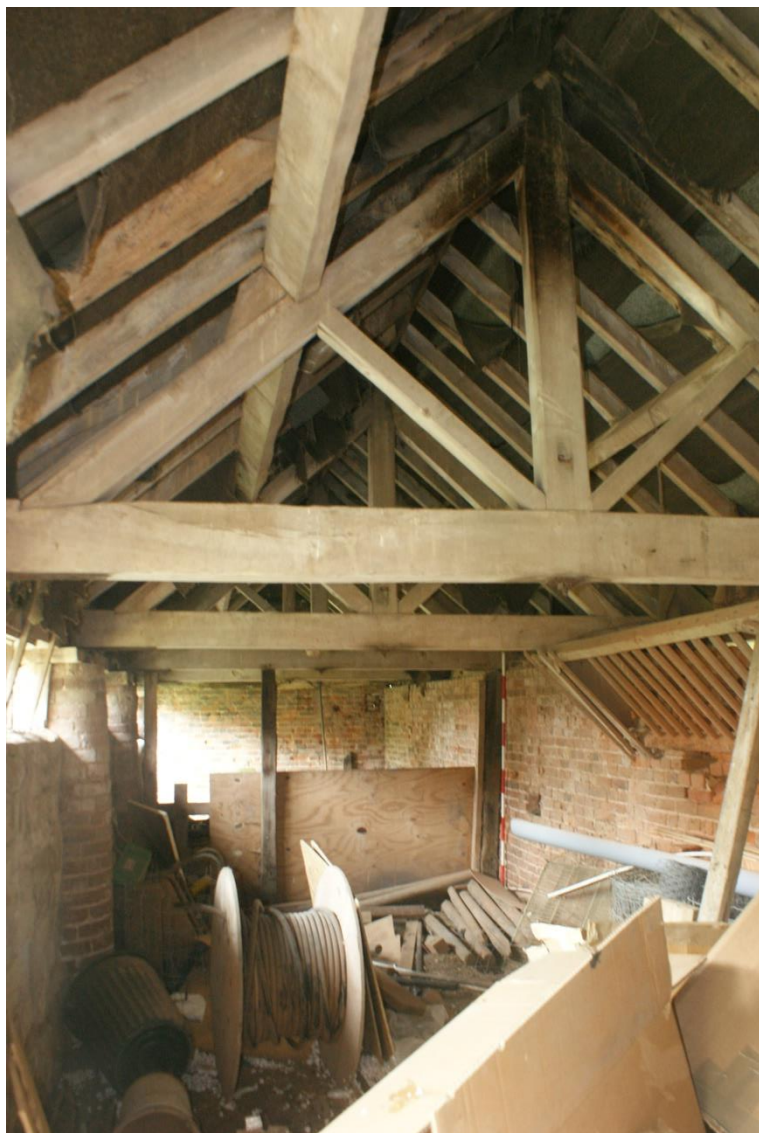
Plate 14 Phase 2 cow shed, looking south

The Phase 2 shelter shed had sandstone inserted between the columns at the frontage and the building used for stabling, as seen by an inserted hay rack (Plate 14).

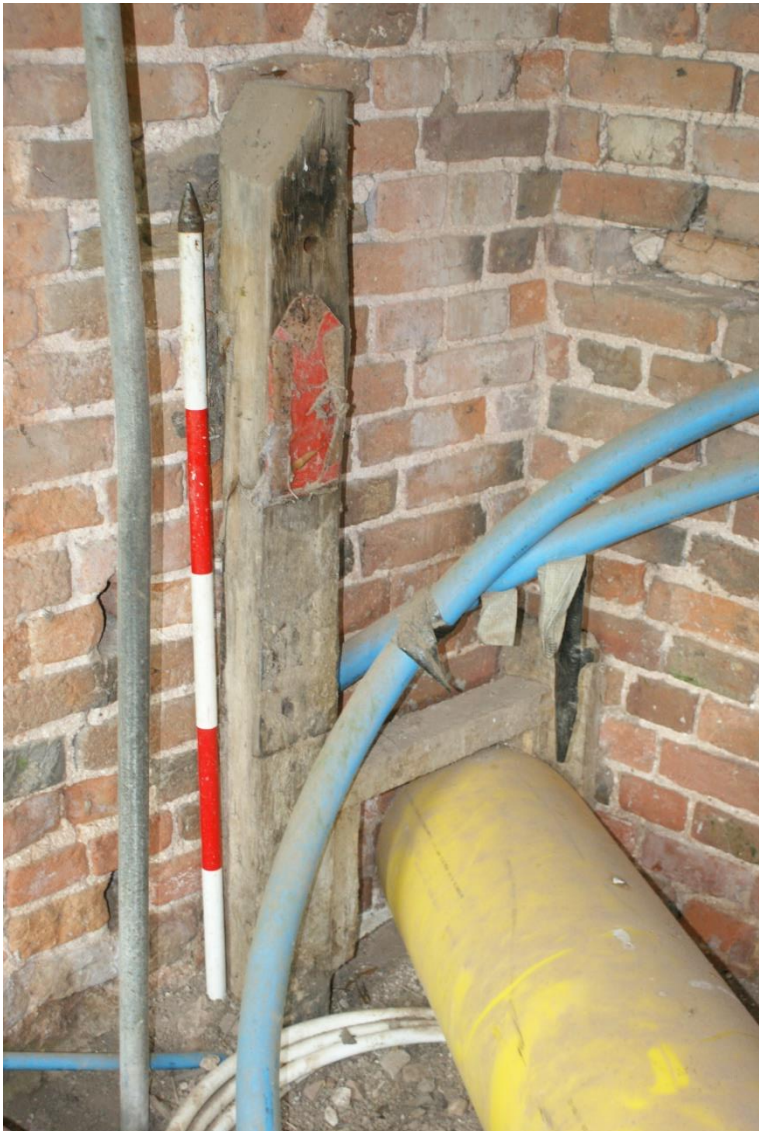
Plate 16 Phase 2 cow shed, looking south-west
