Archaeological investigations at Powick Old Bridge, Powick, Worcestershire

Status:
Date: 13 January 2018
Author: Jamie Wilkins jwilkins@worcestershire.gov.uk
Illustrator: Carolyn Hunt
Project reference: P5174
Report reference: 2504
HER reference: WSM69393
Oasis id: fieldsec1-299025

Archaeological Investigations at Powick Old Bridge, Powick, Worcestershire

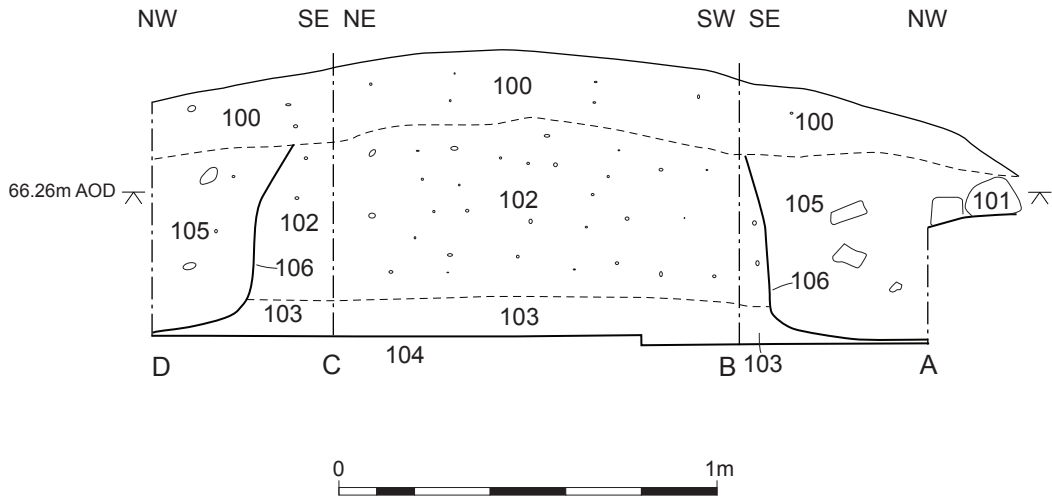
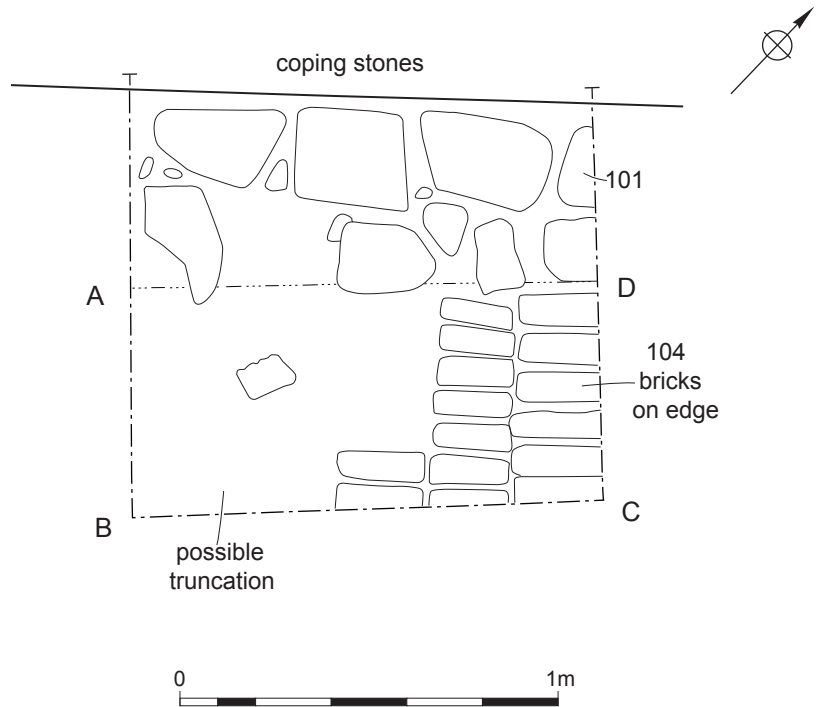
Figure 3

TEST PIT 1: SECTION

PLAN OF TEST PIT 1

Test Pit 1 section and plan of Test Pit 2

The trenches and features recorded are shown in Figures 2 and 3. The results of the structural analysis are presented in Appendix 1.

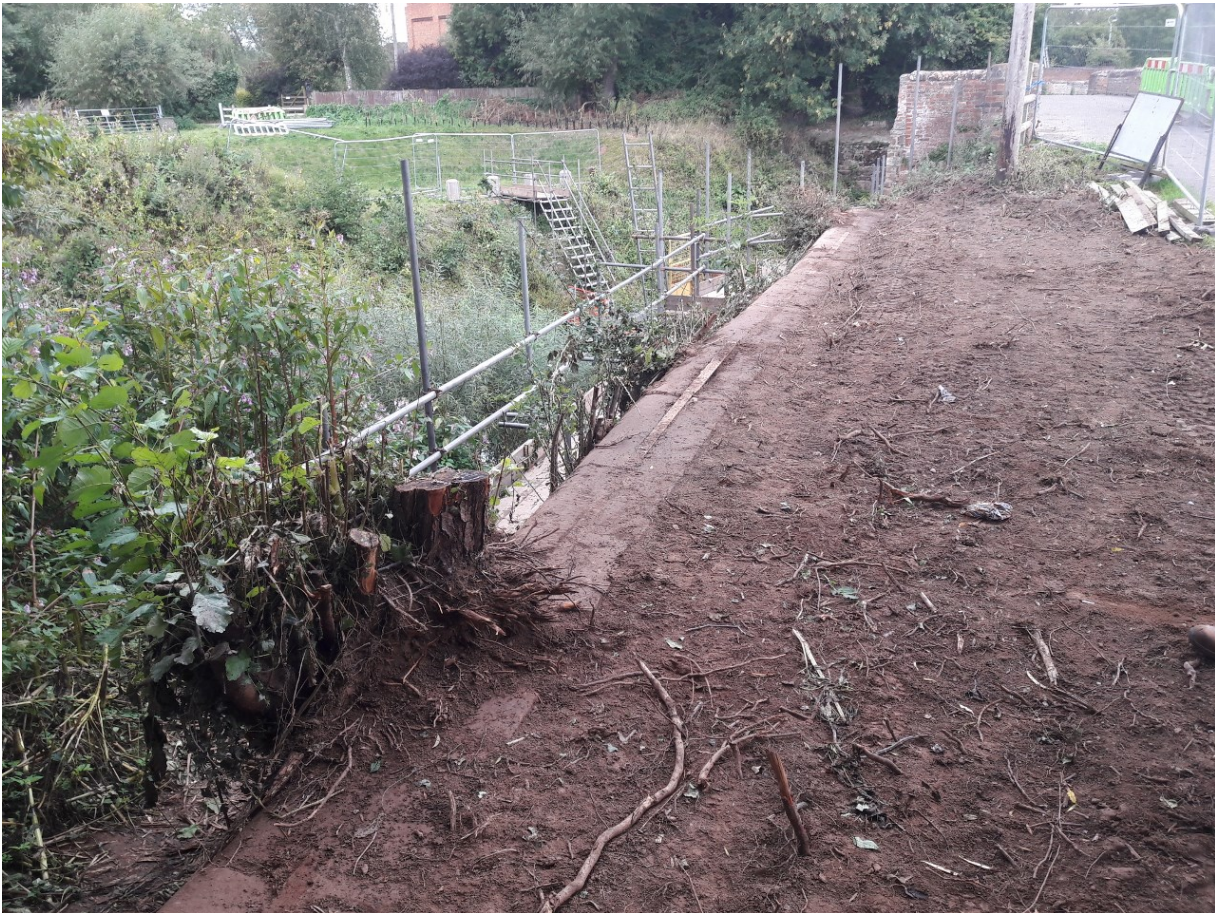
Plate 1. The site after the vegetation was removed, view north

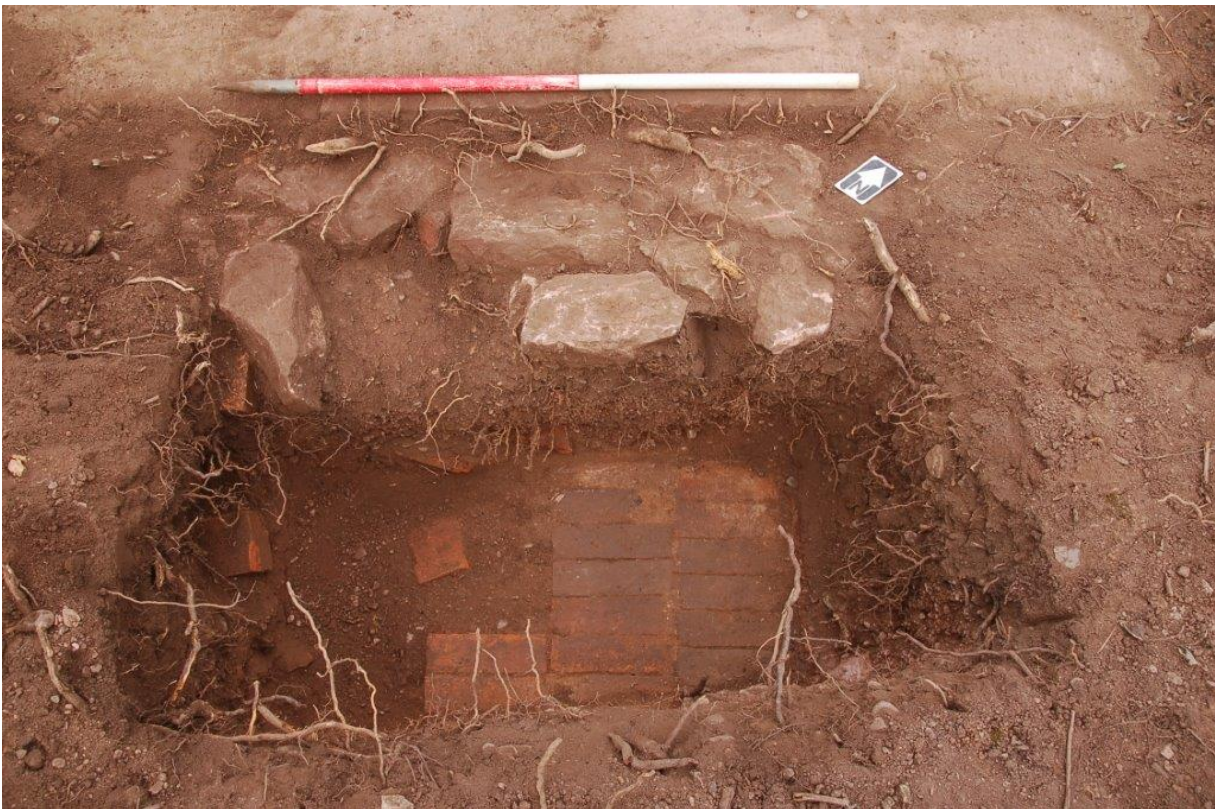
Plate 2. Sandstone structure (101) and wall (104) in Test Pit 1, view north-west, scale 1m

A construction cut [106] was observed to truncate layers (102) and (103) in the west of Test Pit 1. The cut had steep convex sides, a flat base, and was visible to a depth of 0.50m. It appeared to be associated with a crude sandstone structure (101) which abutted the coping stones of the flanking wall. Structure (101) comprised roughly hewn green and red sandstone blocks. The largest of these blocks measured 500mm by 300mm and 260mm deep. The structure was just one course deep and two courses wide, and abutted the coping stones of the flanking wall for the entire length of Trench 3. Additionally, these stones were located directly above the earlier wall (104). The sandstone blocks had no bond, and no clear bonding material, though they were contained within a topsoil-like matrix (105). The sandstone is considered to be the result of earlier remedial works to the bridge, but the function remains unclear. It may be discarded construction material, related to drainage or a surface of some kind.

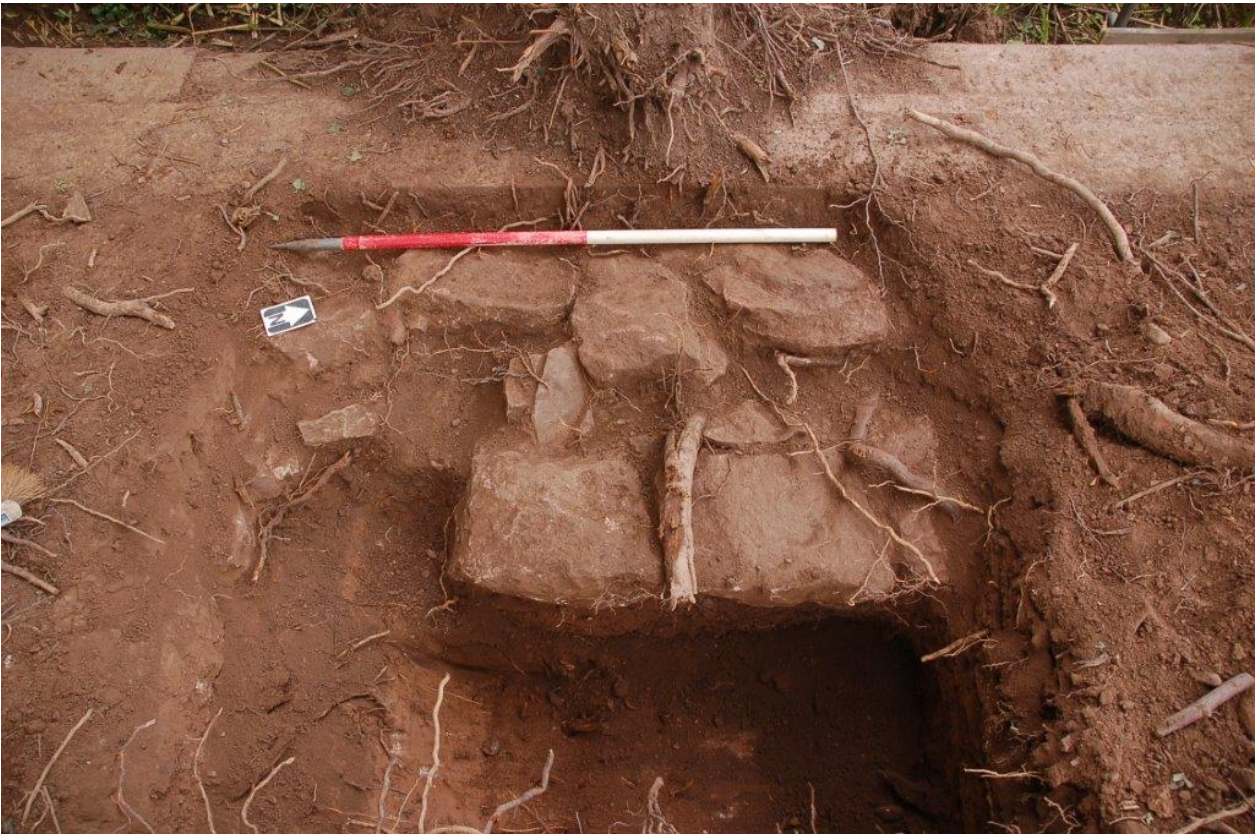
Plate 3. Deposits (102) and (103) above wall (104) in Test Pit 1, view south-east, scale 0.4m

In Test Pit 1, wall (104) was overlain by a compact, orangey brown, silty sand deposit (103). The deposit was 0.12m in depth and was visible in the entirety of the test pit. It contained frequent fragments of sandstone, orange brick, and mortar. Deposit (103) was overlain by a layer (102) comprised of loose, brownish pink sand and gravels, observed to a depth of 0.49m. This deposit (102) was a layer of redeposited natural, and both layers (103) and (102) are likely to be deliberate made ground deposits, intended on building up, or levelling the area around the old road.

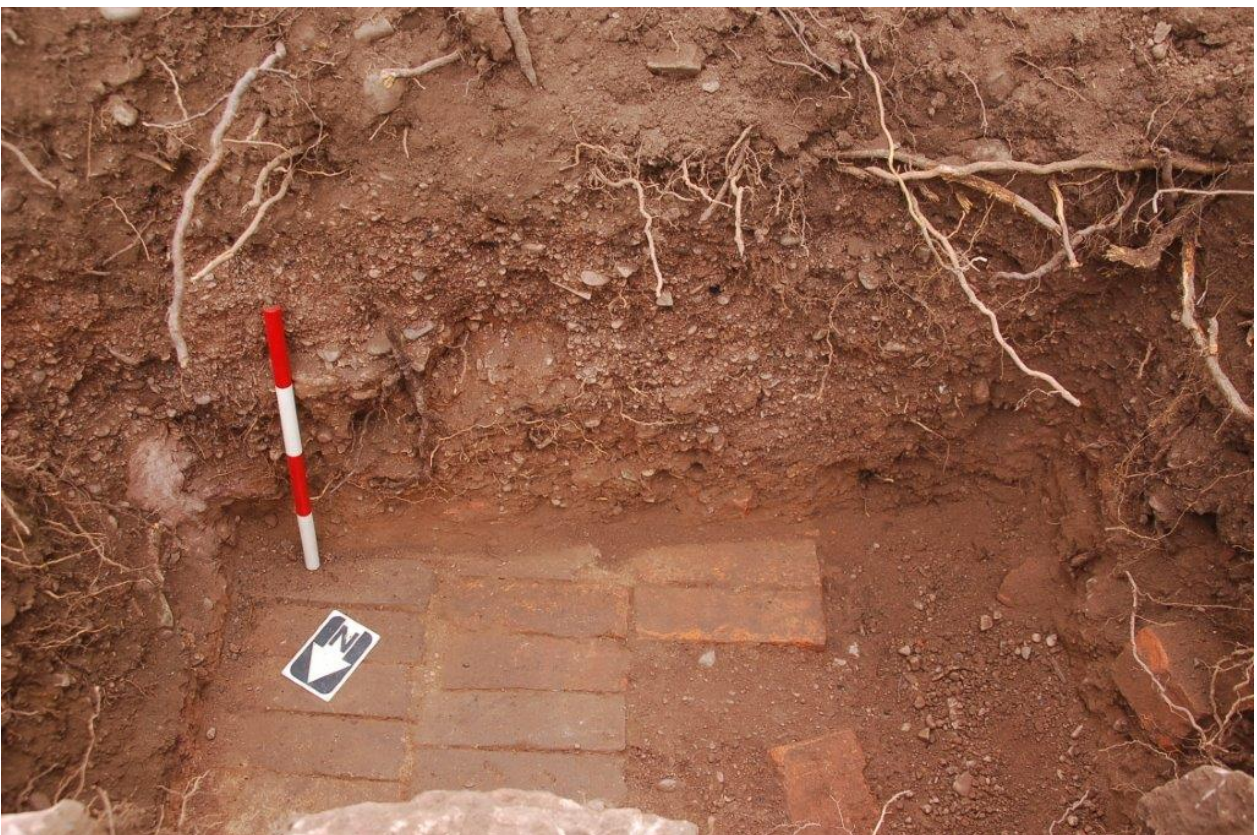
Plate 4. Sandstone structure (202) in Test Pit 2, view north-west, scale 0.4m

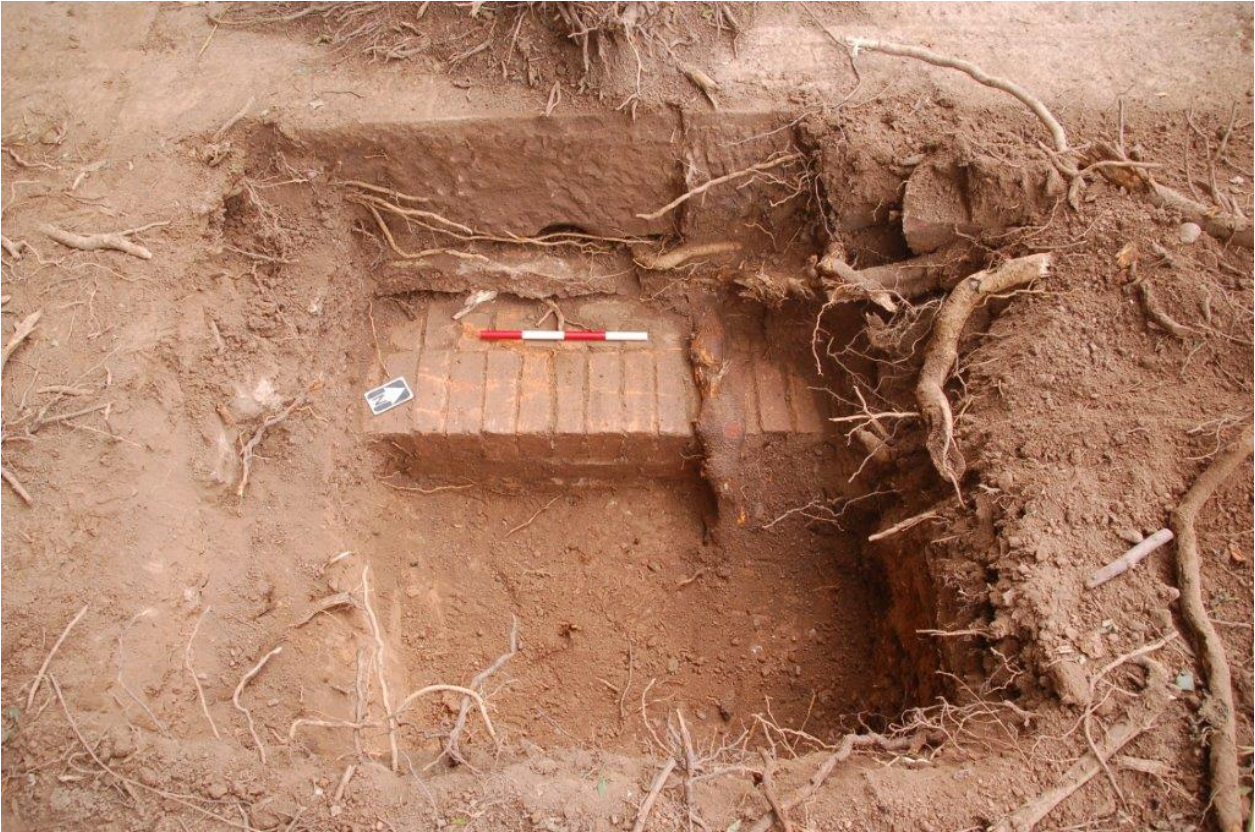
Plate 5. Wall (204) within Test Pit 2; visible below sandstone structure (202), view north-west, scale 0.4m

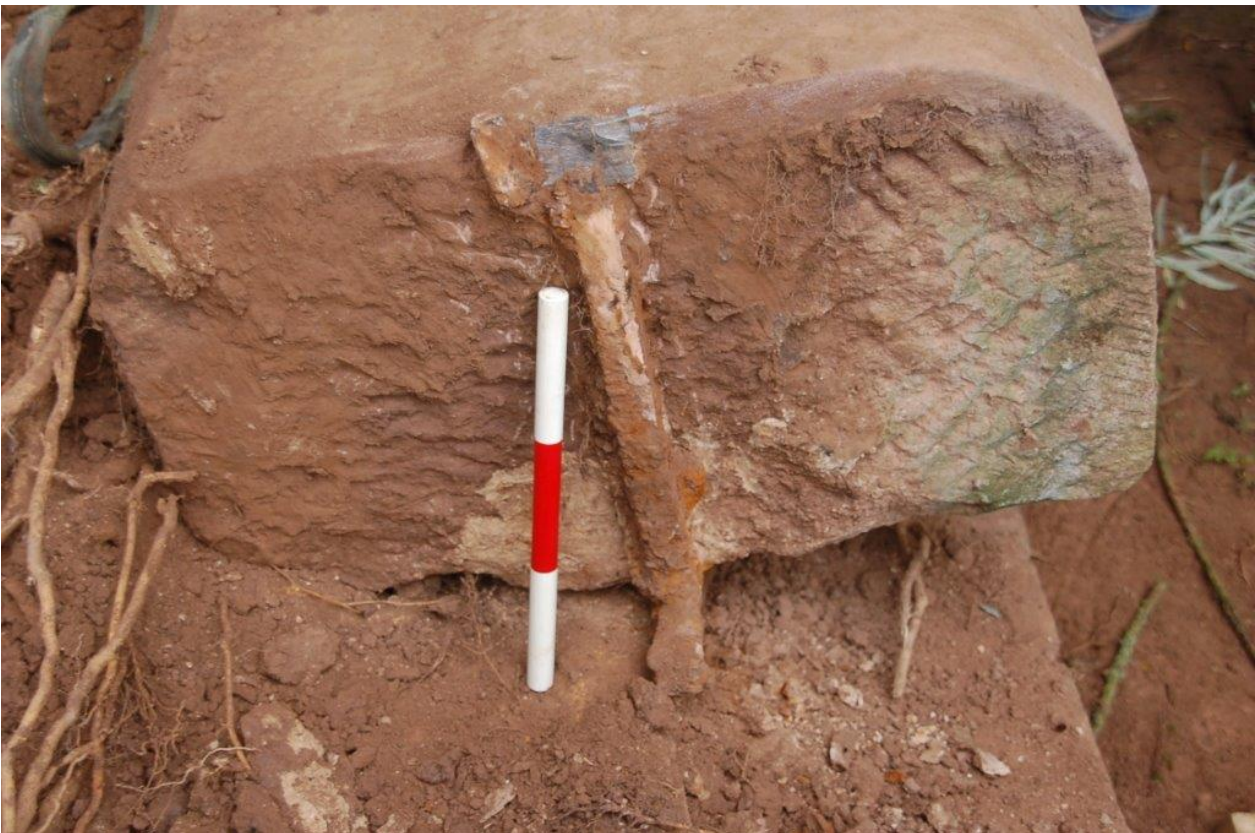
Plate 6. Iron bar within the joins of the coping stones, welded to both upper and lower iron strapping, scale 0.3m

Following the removal of vegetation, the coping stones of the south-west flanking wall were exposed (108). The largest coping stone measured 1.80m long, and the smallest 0.70m. All of the stones measured 0.57m wide and 0.40m thick. Iron strapping was present along the entire length of the stones (c 15.60m) and was located both on the top and underneath the stones. The strapping was 7cm wide and 2cm thick and was welded together via iron rods in between the joints of the stones (Plate 6). Furthermore, the strapping was leaded into a chiselled-out cavity in the centre of each of the stones, to provide structural support to the stones, to prevent sagging or movement.

The iron strapping on the coping stones is unlikely to relate to a form of iron railing or fencing. The strapping was present on both sides of the stones, and was welded together by iron bars in the joins between stones. The form of this iron strapping is indicative of structural support, rather than a foundation for railings. The ironwork was intended to support, and clamp the coping stones together, thereby preventing any potential sagging. This is supported by 20th century photographic evidence, though limited in quality, which shows no evidence of iron railings on the southern approach (Plate 14). No 19th century photographic evidence was identified.

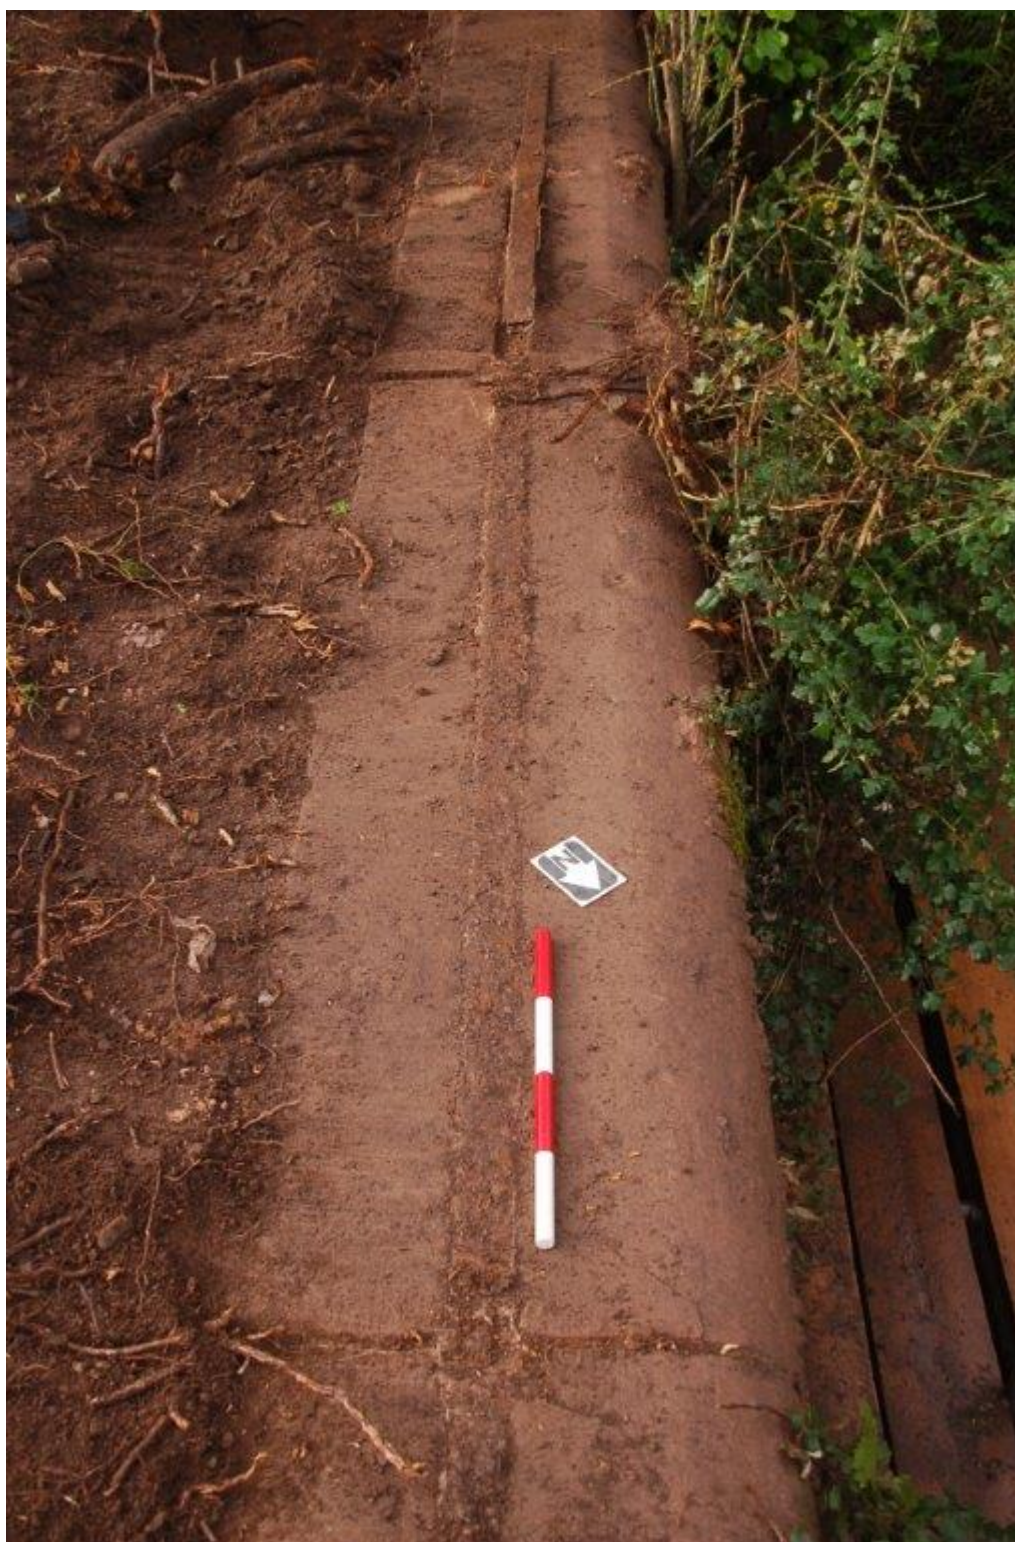
Plate 7. Upper iron strapping which ran the length of the coping stones, led into chiselled-out cavities, view south-west, scale 0.4m

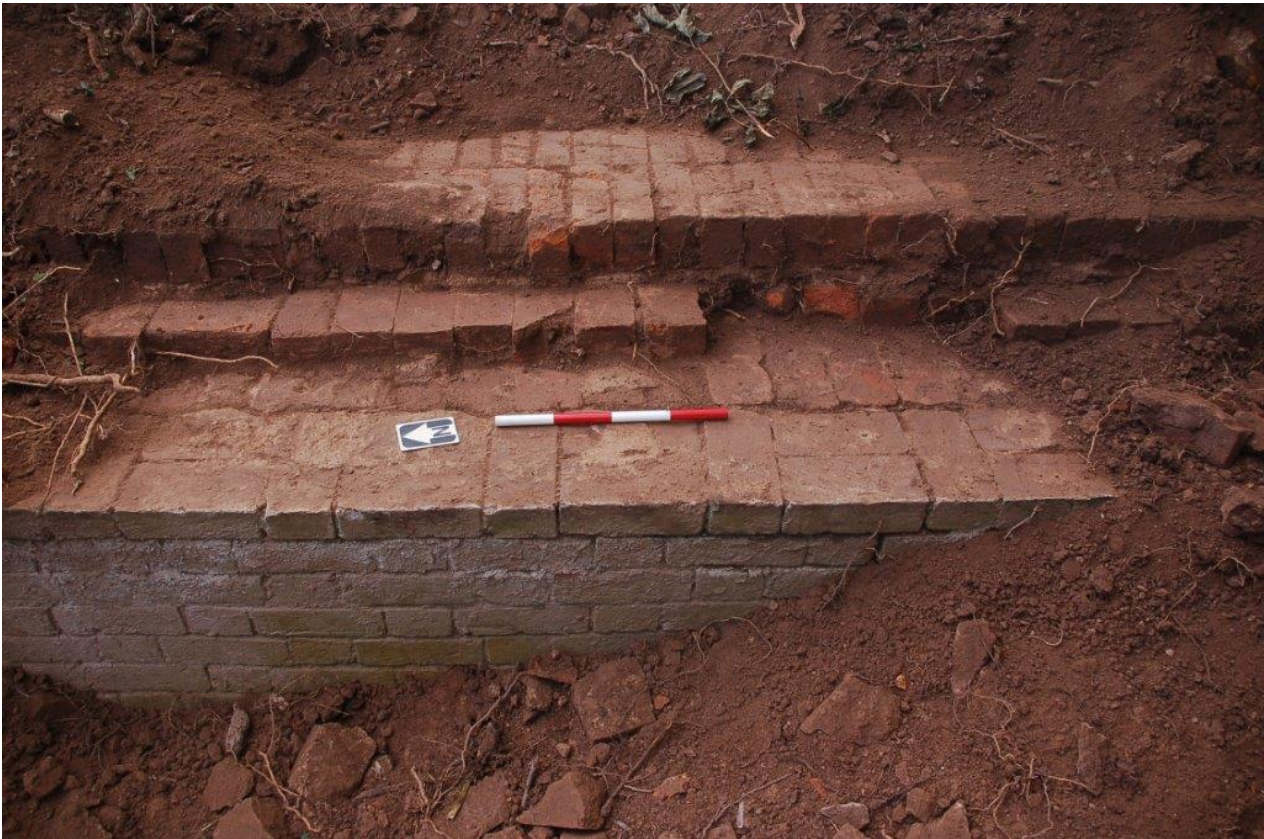
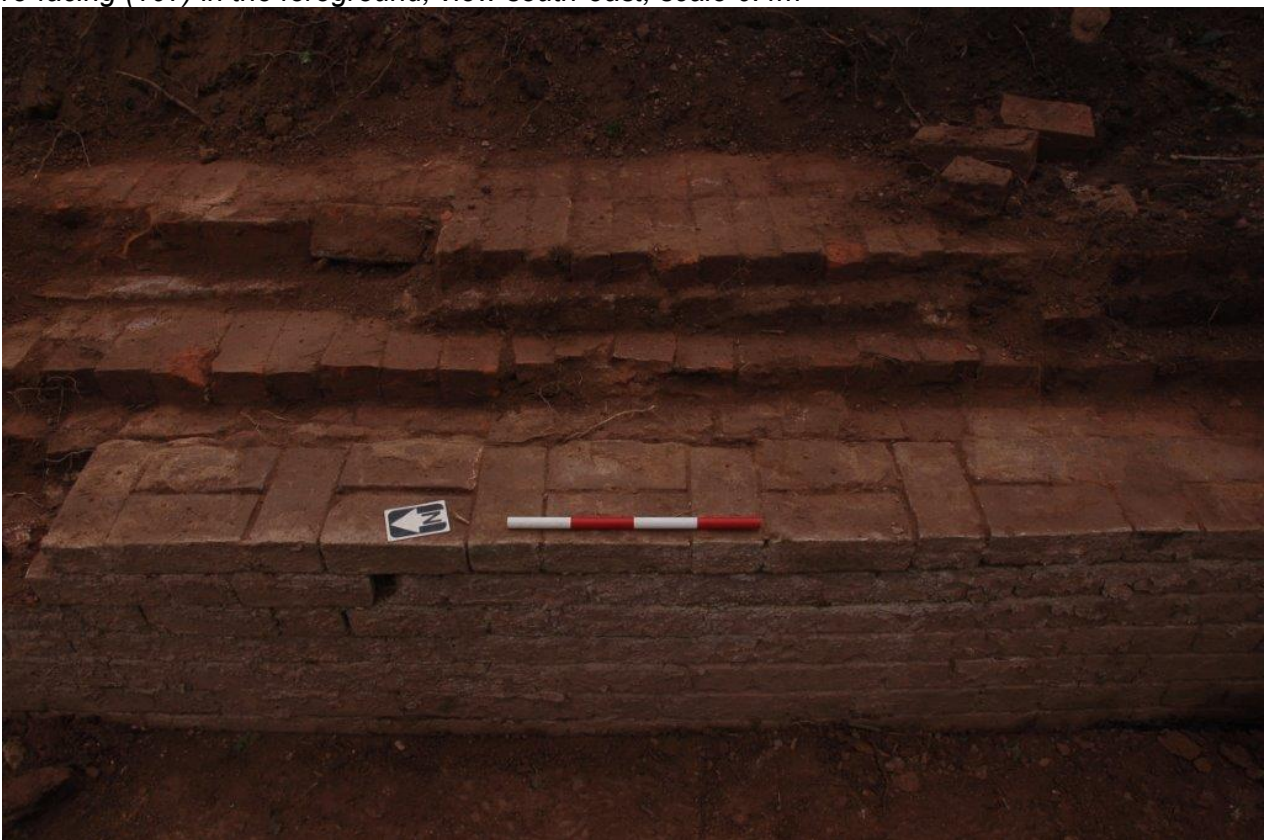
The west (outer) face of the south-west flanking wall was comprised of 14 visible courses of machine-made blue engineering bricks below the coping stones, laid in Flemish bond (107). The bricks measured 240mm by 110mm by 70mm. After the removal of the coping stones, it was identified as just two courses in width (0.24m), and abutting the west face of an earlier brick wall with some areas also block tied into it (Plates 8 and 9).

Plate 8. The original flanking wall (104), in the background, abutted by the later engineering brick re-facing (107) in the foreground, view south-east, scale 0.4m

Plate 9. The original flanking wall (104), in the background, abutted by the later engineering brick re-facing (107), in the foreground, view south-east, scale 0.4m

The remedial works and watching brief indicate that the existing south-west flanking wall is of 19th to early 20th century date and represents a repair to an earlier structure. The later wall, constructed of blue engineering bricks, is just two courses wide, and is a re-facing or cladding on the western face of earlier wall (104). This later construction generally abuts wall (104) but is occasionally block tied in too.

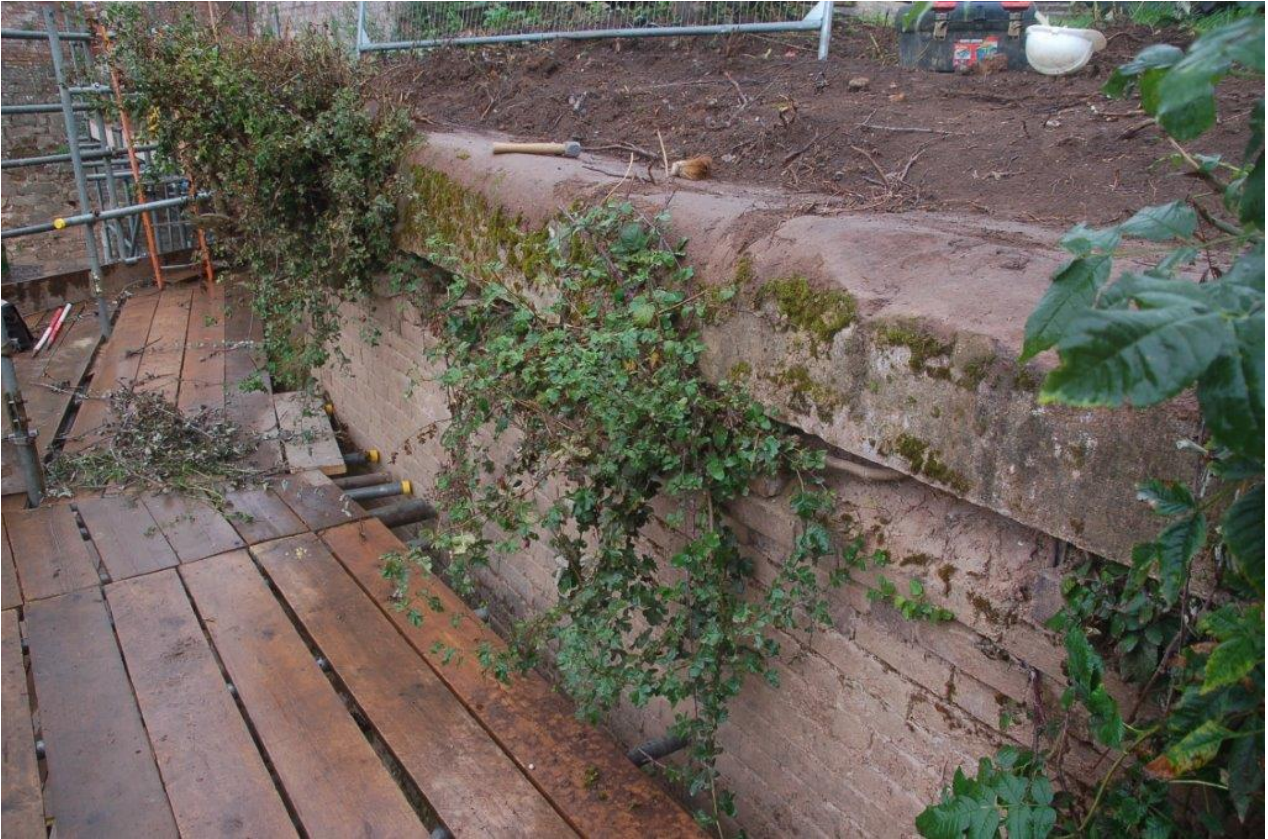
Plate 10. *The damage caused to the flanking wall (107) and the coping stones (108), view north-east*

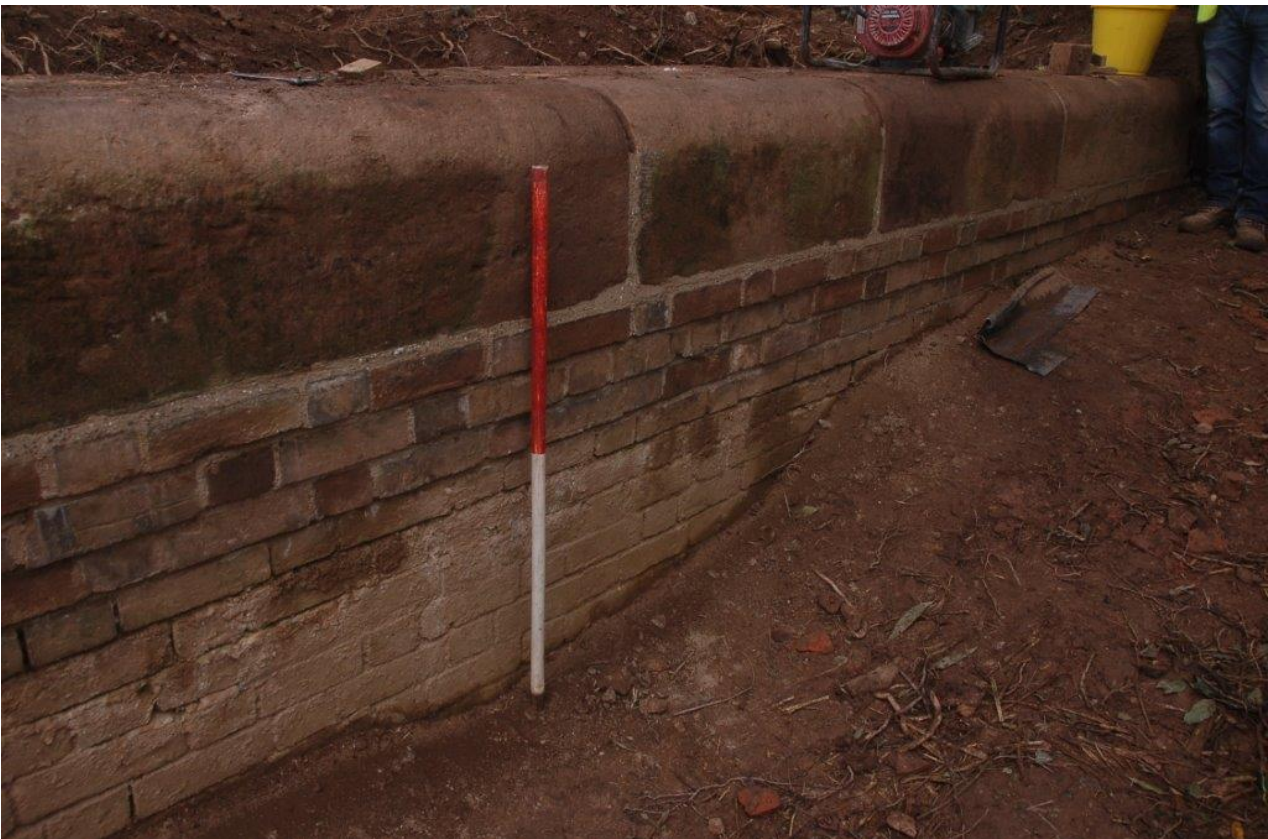
Plate 11. *The repointed and repaired flanking wall (107) with reinstated coping stones (108), view south-south-east, scale 1m*

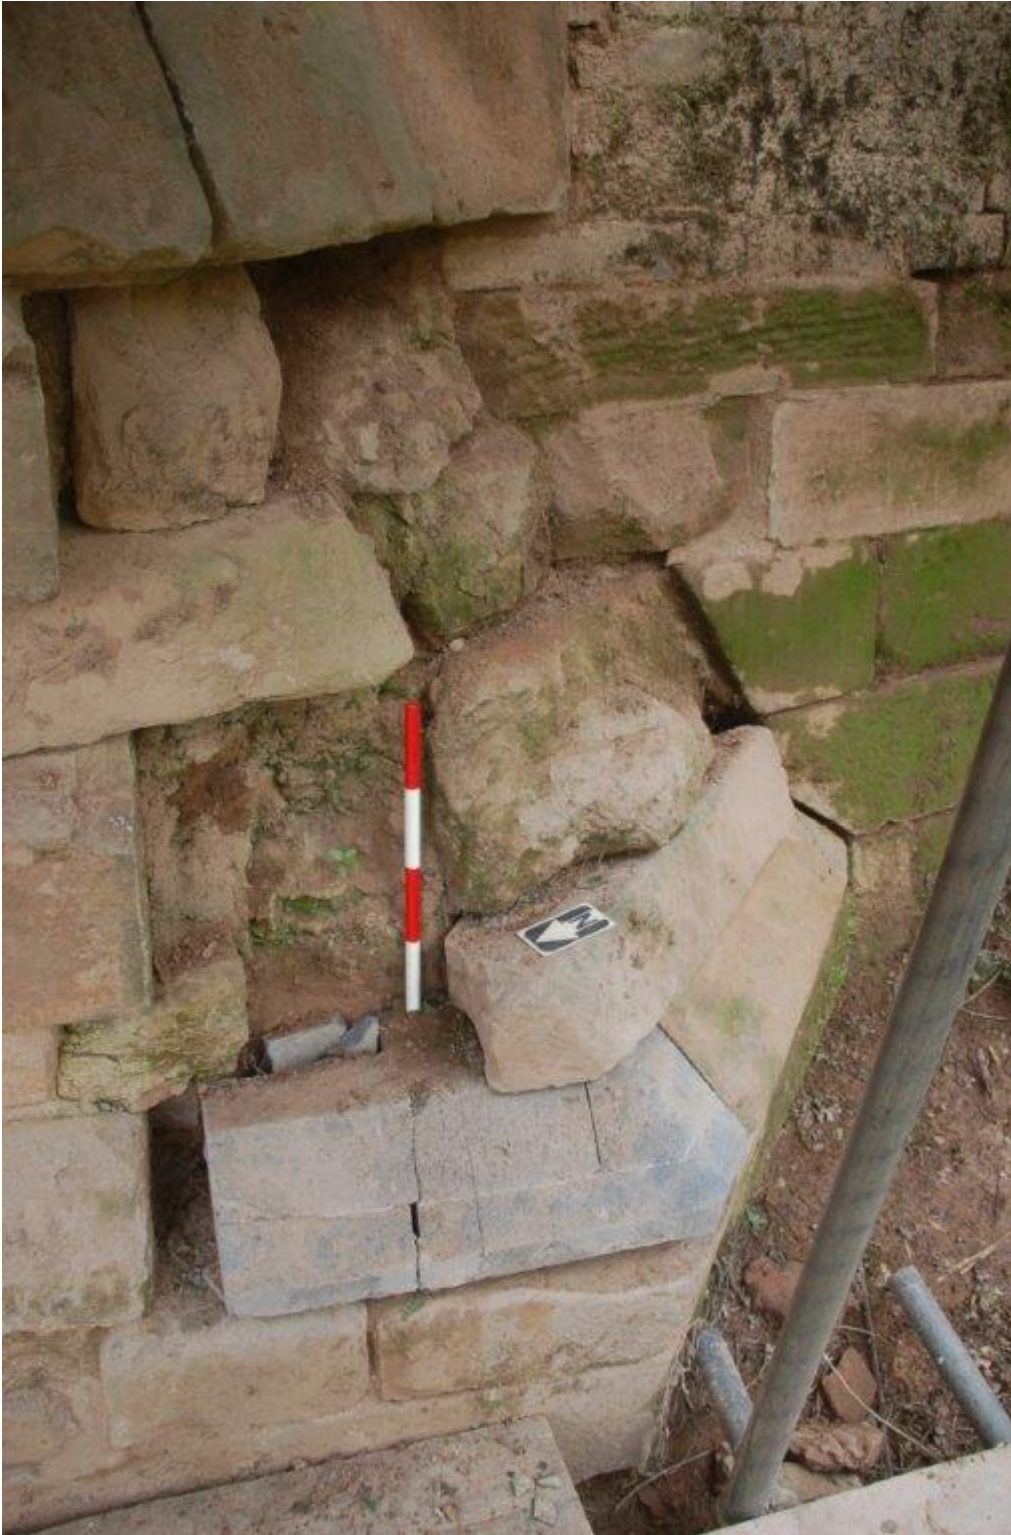
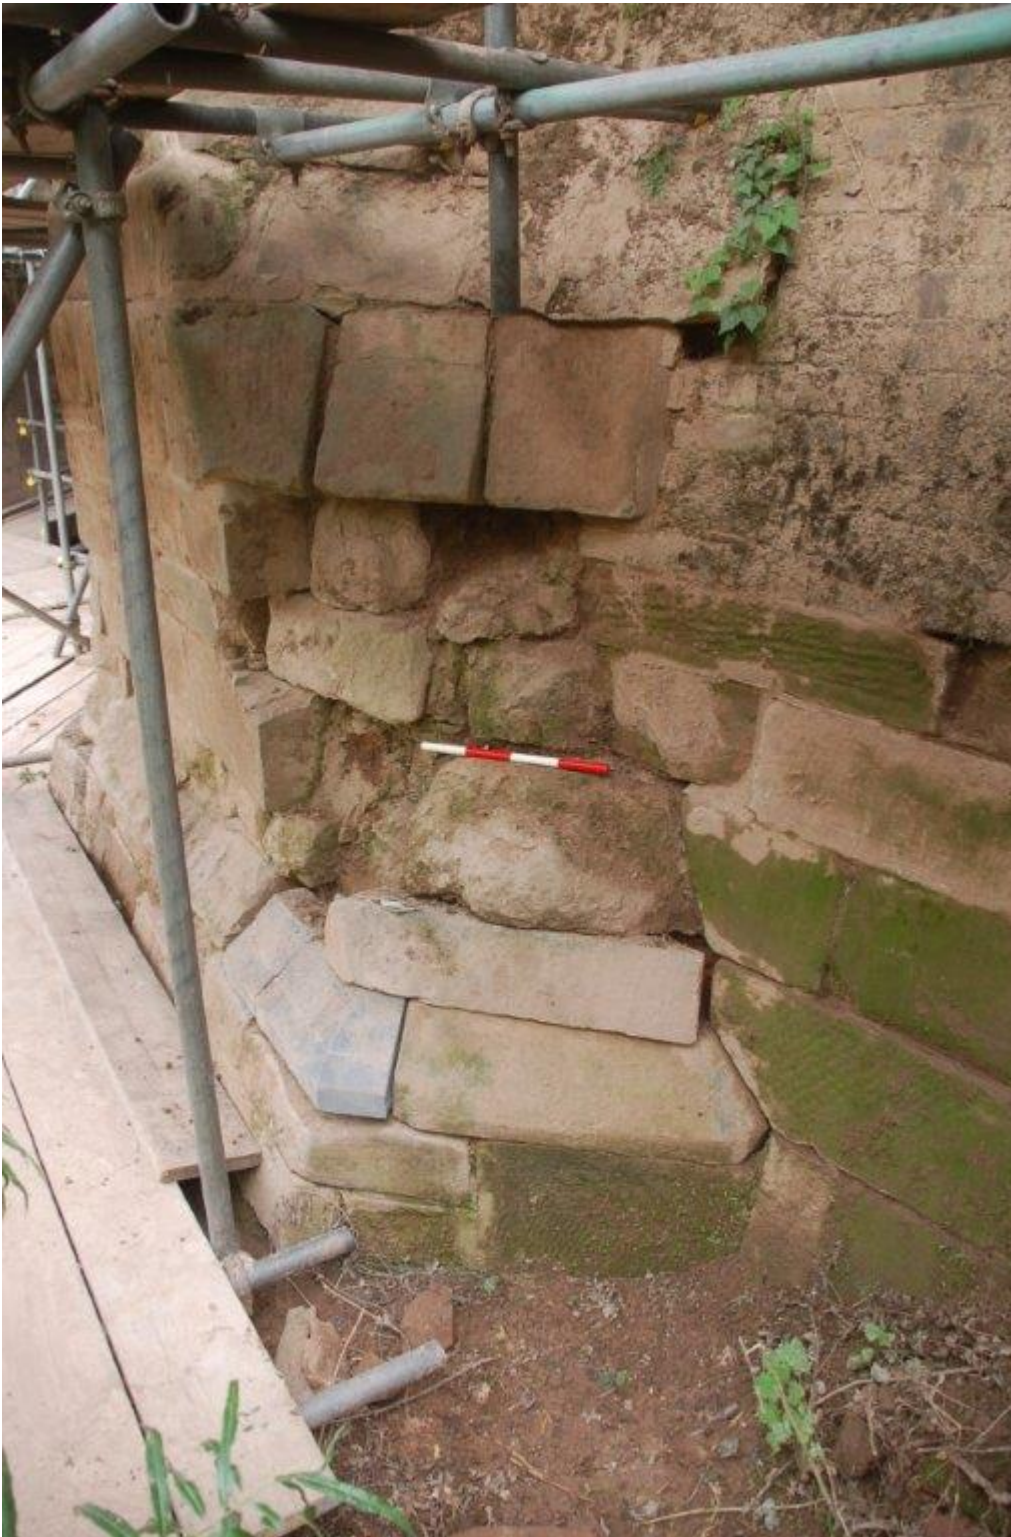
At the request of Dr Neil Rimmington a rapid photographic record was made of a small area at the base of the south-west buttress, in advance of repairs to a patch of heavily eroded blockwork with new masonry (Plates 12 and 13). The masonry had been eroded by repeated flooding. The area comprised eight sandstone blocks and measured 1.10m in height, and 1.50m in width.

Plate 12. *The heavily eroded masonry due to be replaced, at the foot of the south-west buttress, view south-east, scale 0.4m*

Plate 13. *The heavily eroded masonry due to be replaced, at the foot of the south-west buttress, view north-east, scale 0.4m*

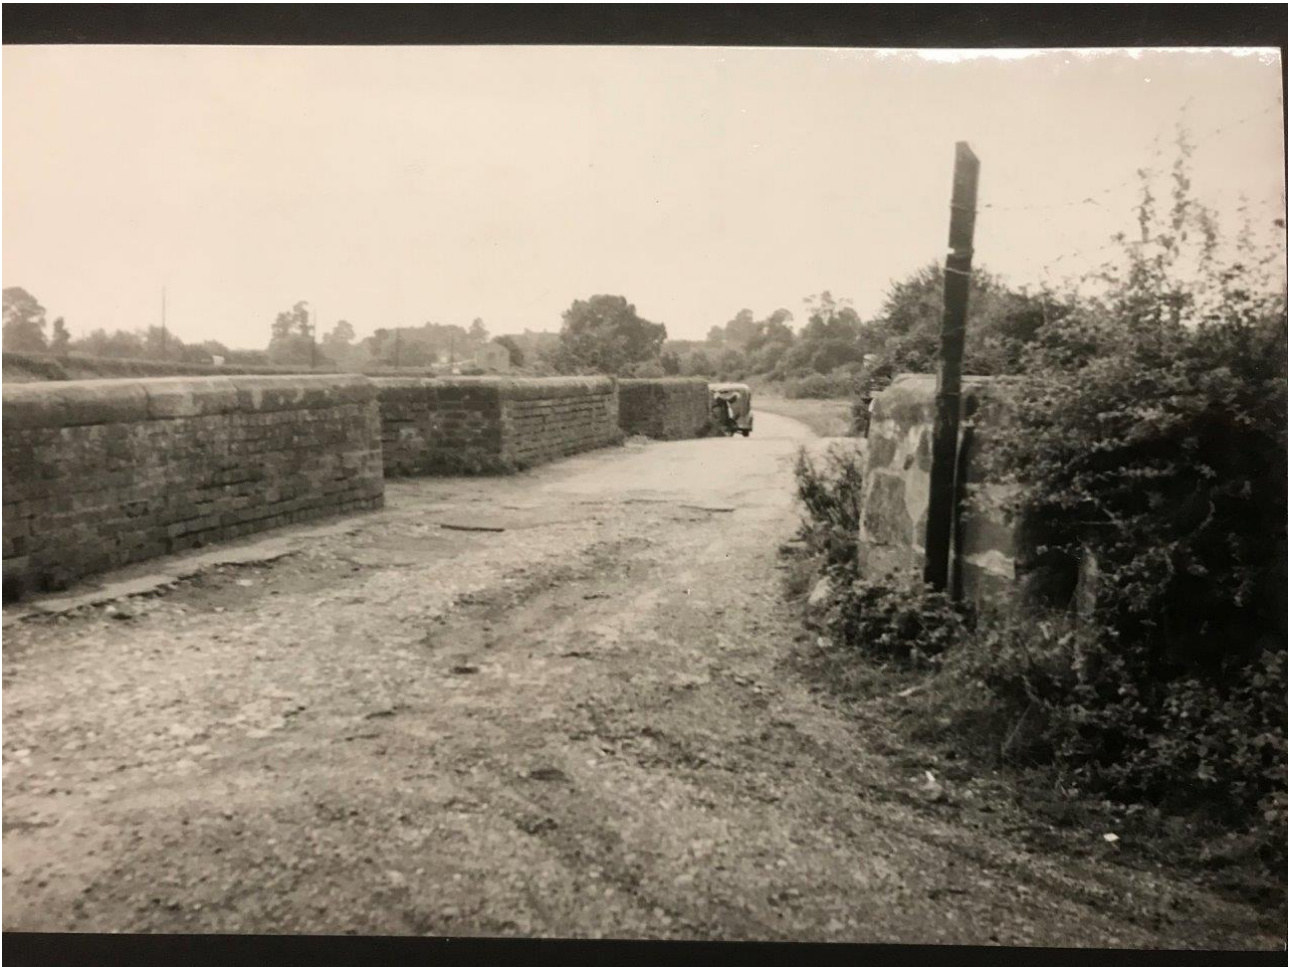
Plate 14. *View south across Powick Old Bridge; the photograph indicates that the site of the flanking wall was overgrown by vegetation in the mid-20th century (copyright Mrs W R Young, 1953, Worcestershire Photographic Survey (WPS) Register number 4283; original held by Worcestershire Archive and Archaeology Service)*
