Archaeological Watching Brief at Exchange Square, Birmingham

Status: Version 1
Date: 17-3-17
Author: Andrew Mann (amann@worcestershire.gov.uk)
Contributors: C Jane Evans
Illustrator: Carolyn Hunt
Project reference: P4878
Report reference: 2424

An archaeological watching brief was undertaken at Exchange Square, Birmingham (NGR SP 07473 87124). It was undertaken on behalf of Sir Robert McAlpine Ltd, who intend to construct a mixed use development at Masshouse Plot 7, for which a planning application has been approved (ref 2014/06135/PA and 2016/06135/PA). The majority of the site had been heavily truncated by the construction and demolition of an elevated roadway (Masshouse Circus) that once crossed the development area. Archaeological features, mostly brick walls and cellars of late 19th and early 20th century date, survived to the north east of the former Masshouse Circus which had belonged to the industrial buildings and factories that once occupied the development site. These mostly comprised elements of the former pork processing plant belonging to Marsh and Baxter Ltd, Morley and Newey glass and lead works and to Gaskell and Chambers bar fitters.

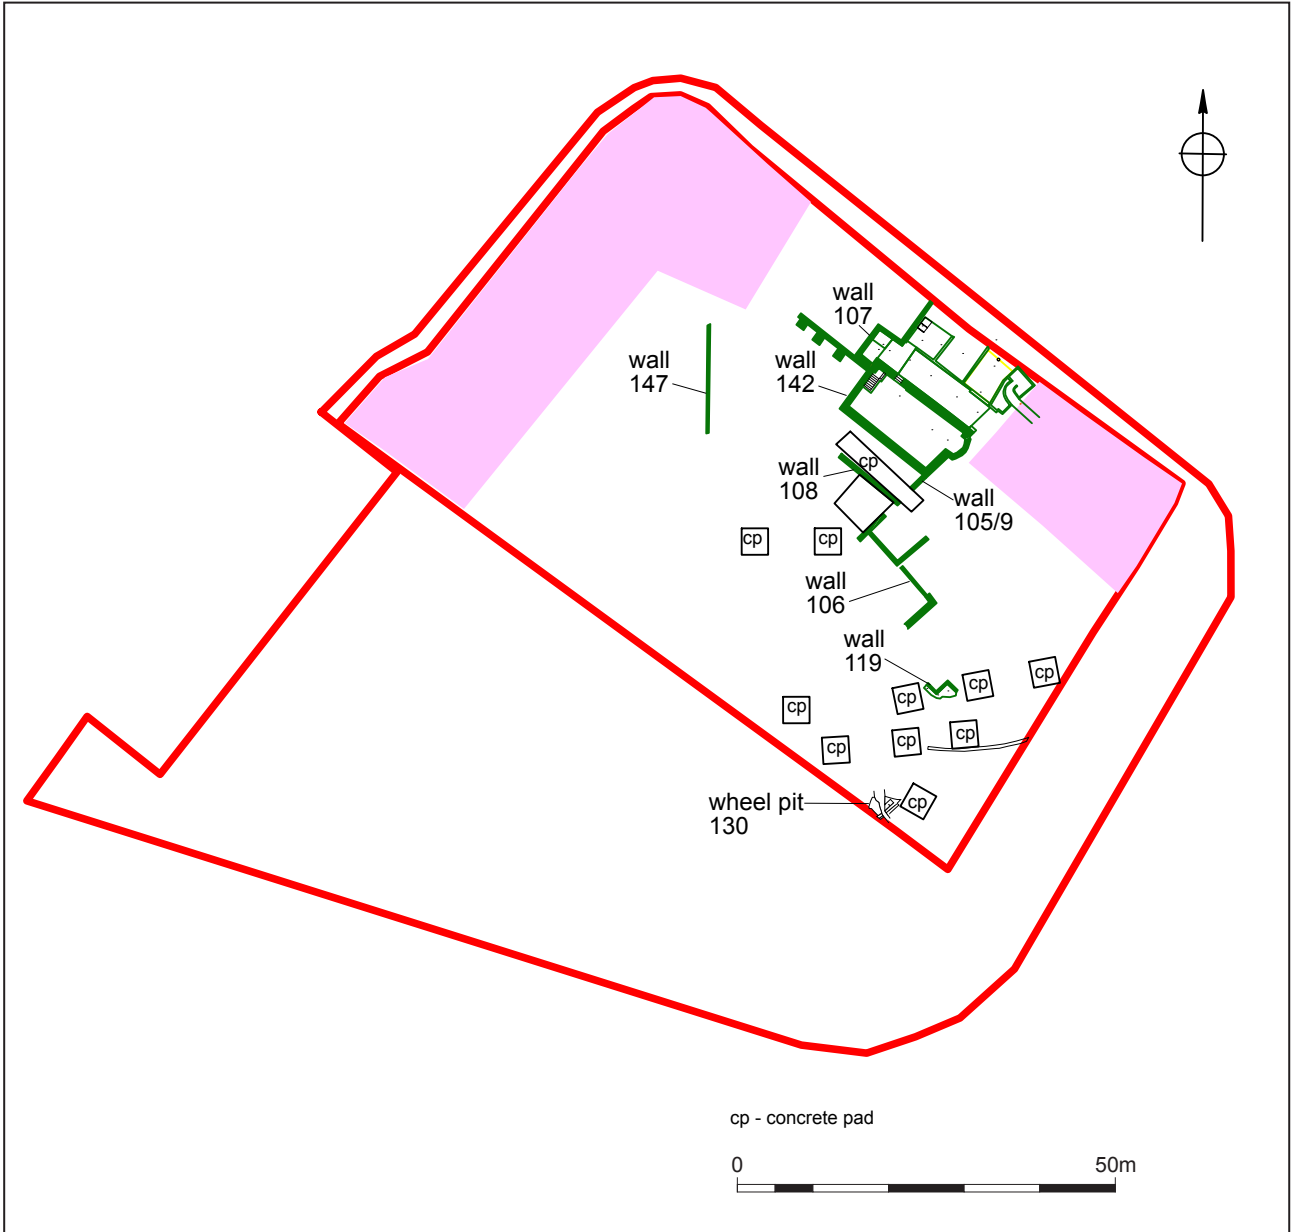
Figure 4

The site, monitored areas and features recorded are shown in Figs 4-7.

Plan of all features

Two other isolated brick foundations were also seen in the more truncated parts of the site. The first (wall 119) was located c.16 m to the west of the wheel pit and the other (147) c. 56m to the north (Figure 4). Wall (119) had been heavily truncated by surrounding concrete pillars and only a 4m length survived (Plate 4). This wall, probably the corner of a building or entrance to a building, was 0.60m wide and 0.70m thick of English Garden Wall bond. The bricks measured 23.5 x 11 x 8 cm and had been bonded with a pale brown cement mortar, overlying a concrete foundation. On their upper surface a slate tile damp proof membrane had been laid. Wall (147) was only partially exposed during demolition and was constructed using modern frogged bricks measuring 21 x 11 x 7 cm. bonded with a light grey, cement mortar. It ran for c.15m and was 0.25m thick.

The cellars of Buildings 1 and 2 had become filled with demolition rubble following their slighting and demolition rubble was found regularly across the site. A number of large concrete pillars or walls were still present across the site that once formed elements of the elevated road (Figure 4).

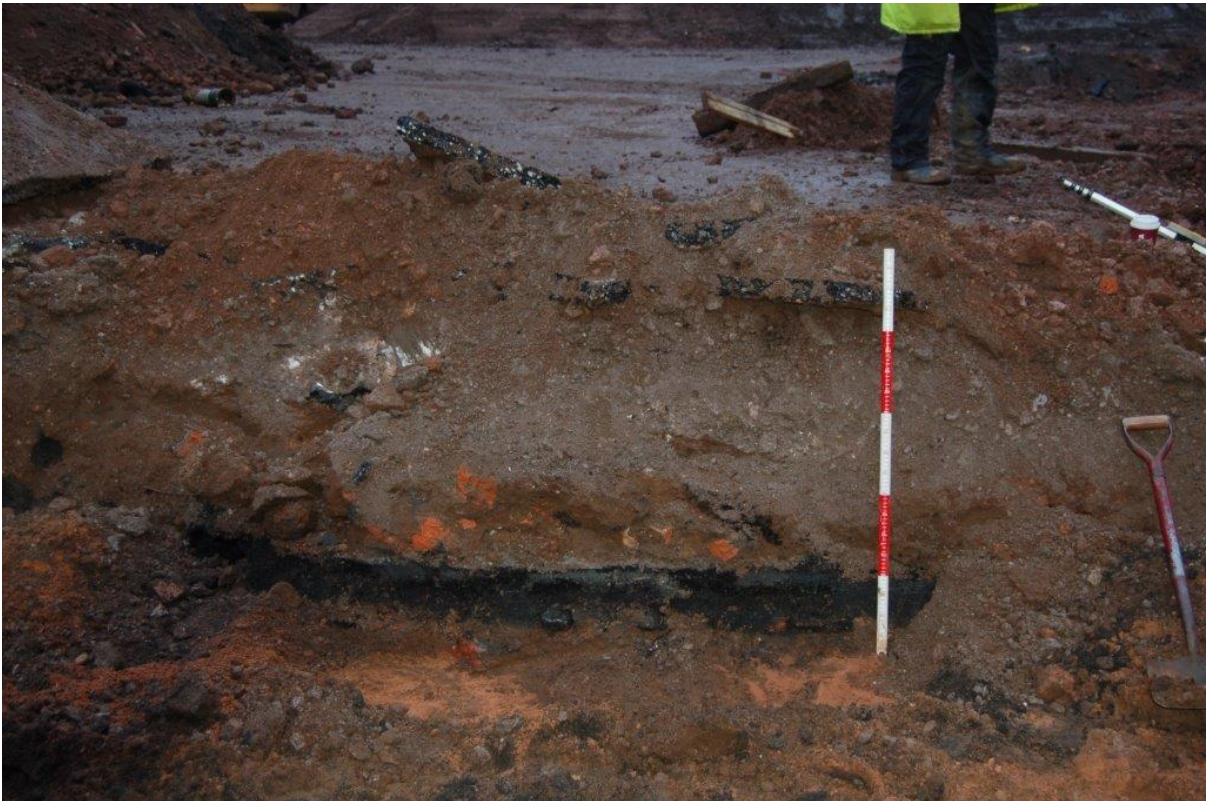
Natural deposits, soft, yellow and orange sands (110 and 152) were observed across most of the investigated area. Across the majority of the site these were overlain by landscaping layers and tarmac of the former car park. To the south-east these layers were up to 0.80m thick, and lay directly on the natural, indicating that the site had been cleared and levelled during the construction of the elevated road and after its demolition for the construction of the car park (Plate 1).

Plate 1: typical deposits across the majority of the site, 1m scale facing north west.

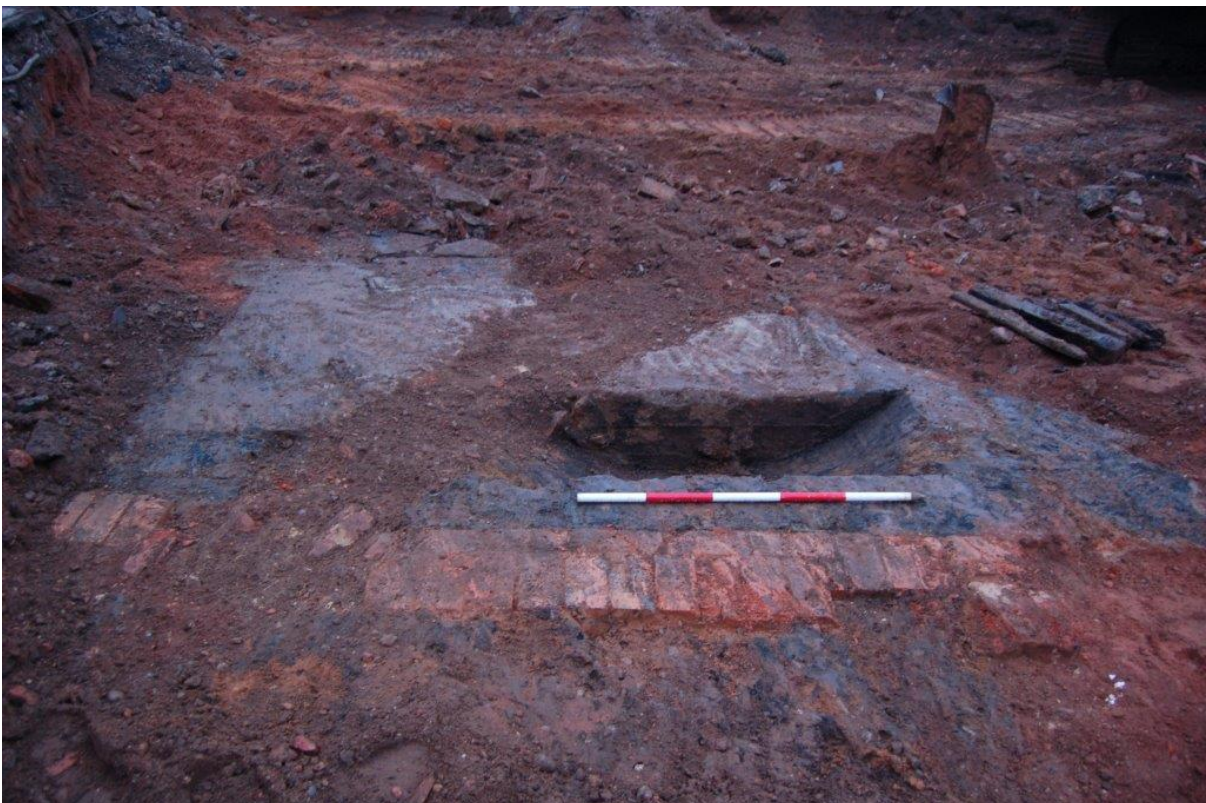
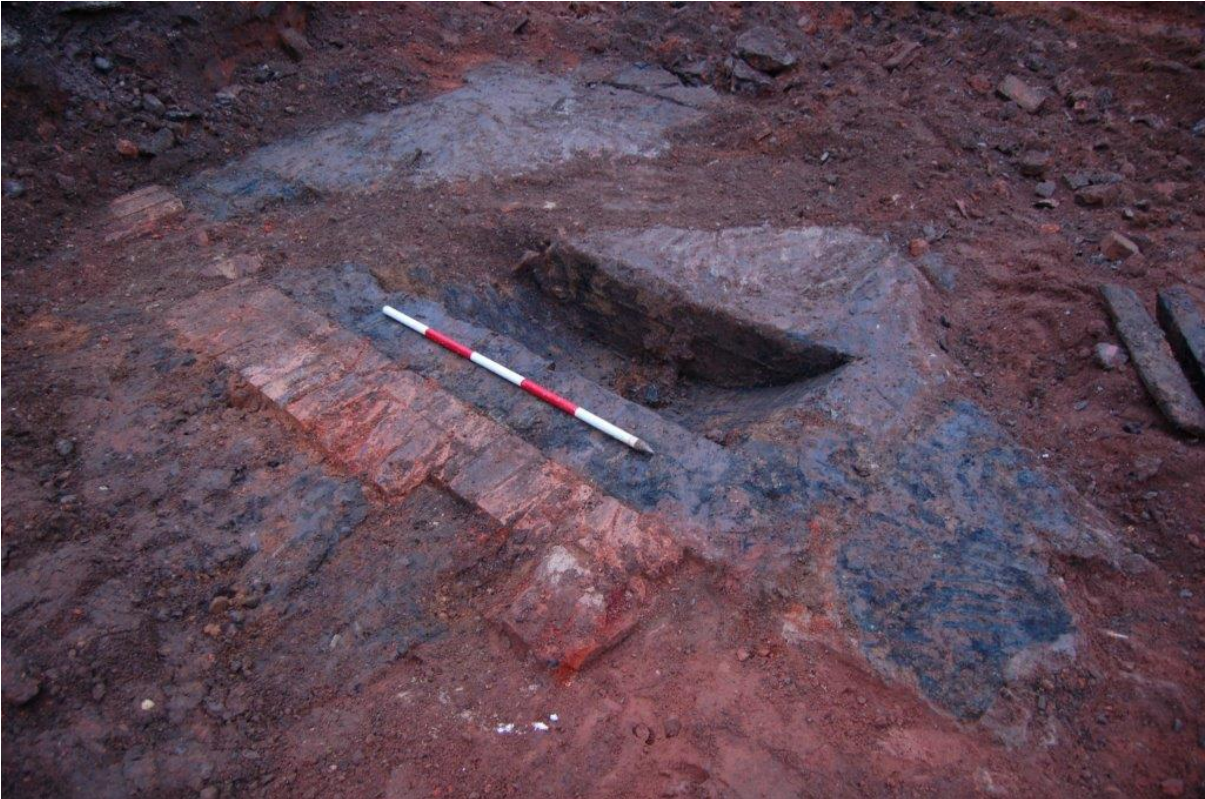
In the south east corner of the site a small area of floor surface survived at c. 118.20m AOD (Figure 4, Plates 2 and 3). The concrete floor surface (124) was between 10-15cm thick and lay directly on the natural sands (152) and abutted a brick wall (126) to the south. Wall (126) was only 3.09m long, 0.33 wide and a minimum of 0.50m deep and had been considerably truncated. It is likely to have originally extended to the north east, but had been cut by a modern concrete pillar associated with Masshouse Circus. The brick wall (126) was of English bond, but had been faced to the west with a single brick stretcher bond. The bricks were 23 x 11 x 7 cm in size and had been bonded with light brown cement mortar.

Wall (126) was abutted to the west by another wall (128) which was only partially visible beneath the concrete floor (124) which appeared to form a render over the wall, preserving the individual shape of the bricks below. It is believed this was constructed to form a trench to contain a wheel pit (129), which was visible in the middle of the concrete floor. The wheel pit (129) was 1.50m long, 0.55m wide and 0.28m deep with 45° concave sides and a flat base. In the wheel pit and across much of the concrete floor was a thin layer of dark greyish blue silty clay containing frequent mineral concretions (153) that is thought to have been deposited in wet conditions.

Two vertical metal rods in the concrete floor are believed to have been anchor points for a machine to the north west of the wheel pit. The latter is likely to have contained a fly wheel associated with a steam engine or perhaps a grinding wheel, either of which could have used water during use.

Plate 2: wheel pit and associated structure (130), 1m scale facing north west.

Plate 3: wheel pit and associated structure (130), 1m scale facing west.

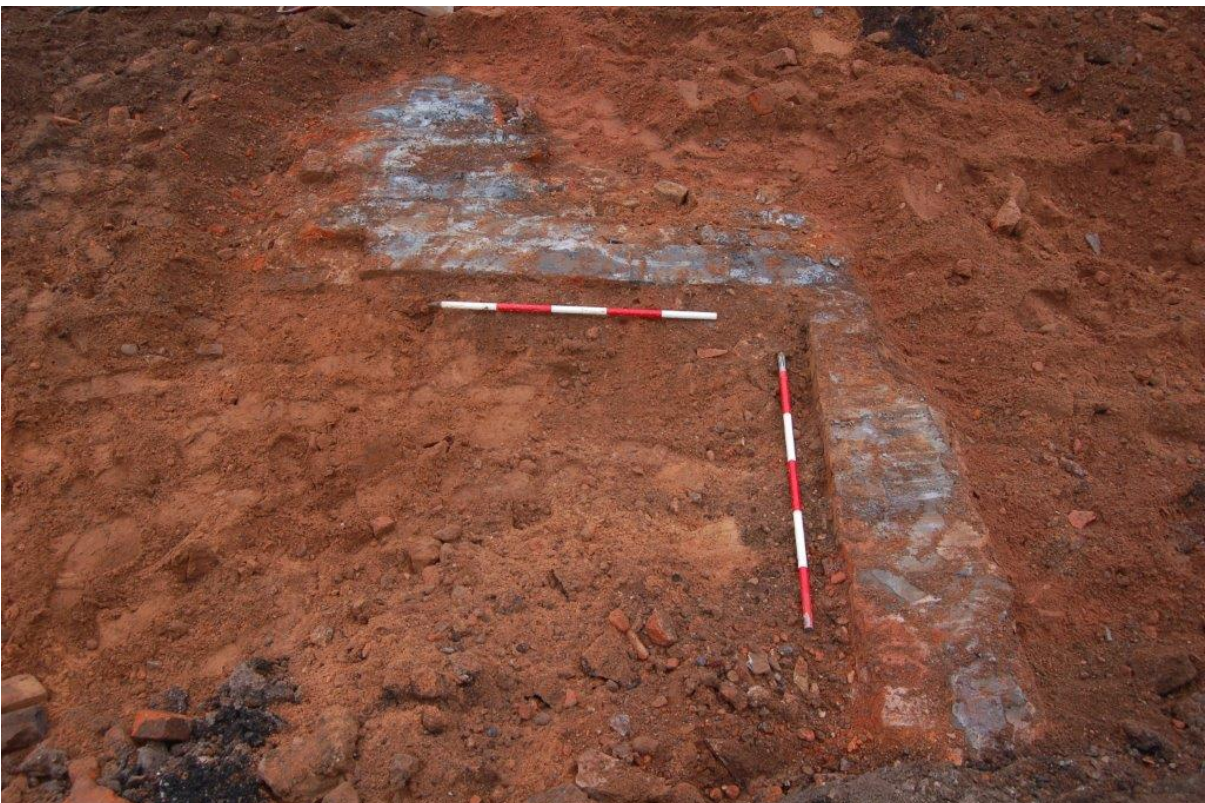
Plate 4: brick wall (119), 2 x1m scales, facing south east.

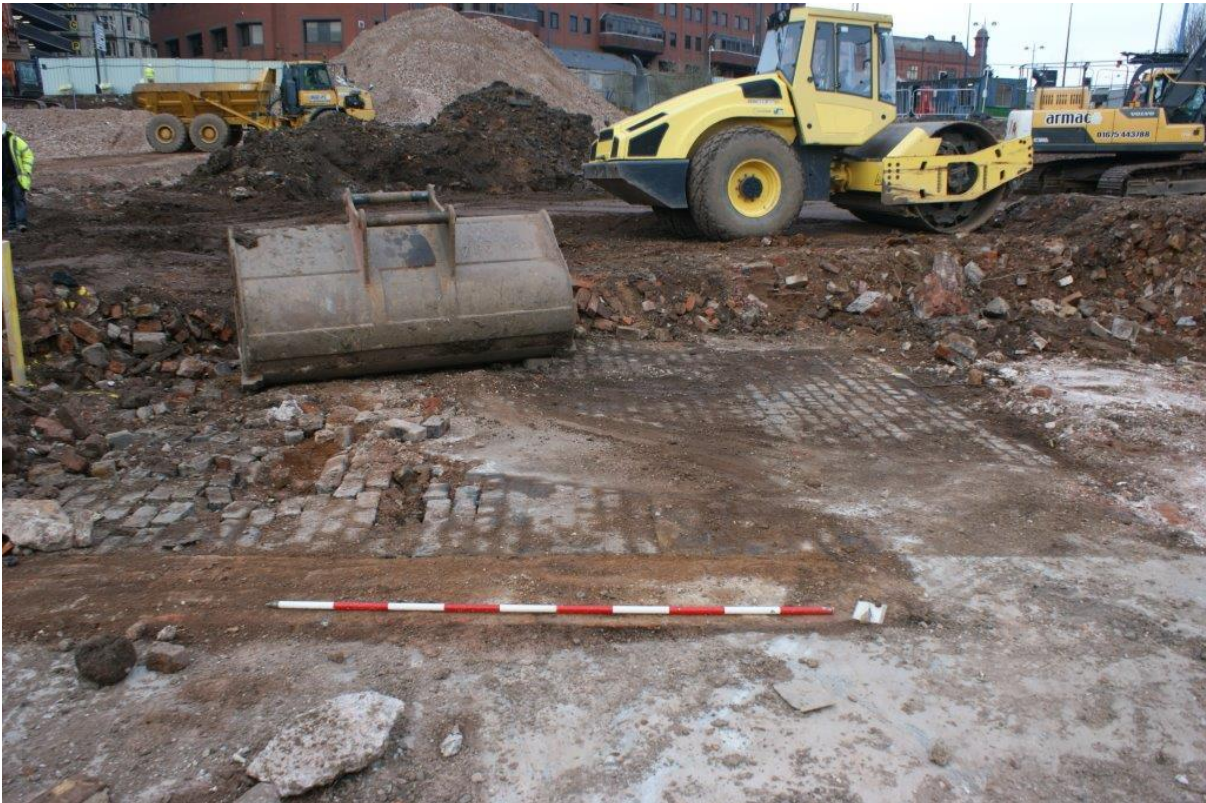
Building 4 was aligned north east to south west between Buildings 2 and 5 (Figures 5 and 6). It was constructed from 3 walls around 0.60m thick (105, 108 and 109). It had been heavily truncated by a concrete wall that had formed part of Masshouse Circus. The walls of the building used red machine made, unfrogged bricks measuring 22.5 x 11.25 x 7.5 cm (9 x 4.5 x 3 inches) bonded with pale brown cement mortar. The northern and western sides of the building had been heavily truncated by cement pillars for the former elevated road but the remaining walls suggest the building was at least 13.50m long and 12.0m wide. It appears to have been split into two rooms with the southern room containing an engineering brick floor (104) a minimum of 5.0m x 5.20m in area. This was accessed through a 2.0m wide door way between walls (108) and (105) (Plate 5).

Plate 5: brick wall (108), with brick floor (104) beyond 2m scale, facing north

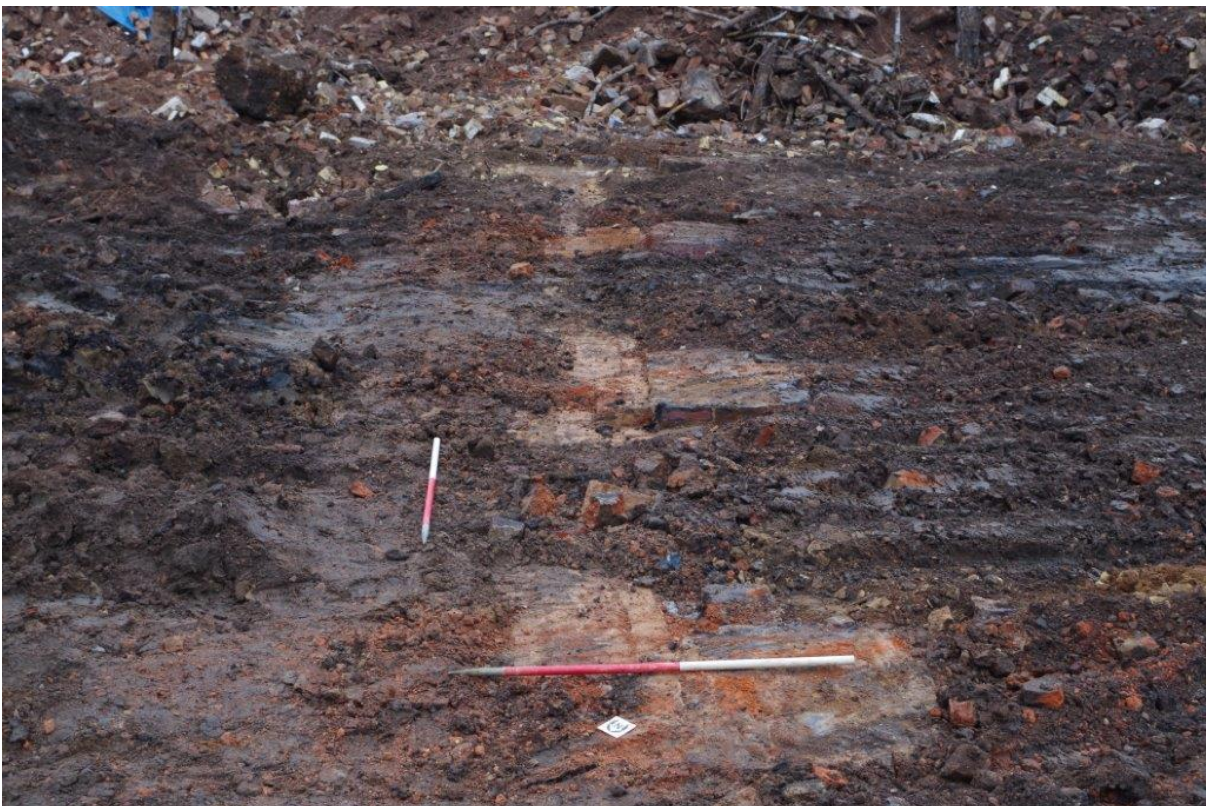
Building 4 was the northern most building to be recorded. Only the north eastern end of the structure survived, which abutted Buildings 1 and 2 (Figures 5 and 6). It consisted a brick wall (150) aligned north west to south east, constructed of red, machine made, unfrogged, bricks measuring 22.5 x 11.25 x 7.5 cm (9 x 4.5 x 3 inches) and bonded with cement mortar (Plate 6). The internal core of the wall, which was also of brick had been faced with a single brick thick stretcher bond on both the external (north) and internal (south) sides of the wall. No associated floor surface survived, however three internal brick buttresses (151), 1.5 x1.5m in size abutted the wall.

Plate 6: wall (150) and buttresses (151), 2 x 1m scales, facing south east.

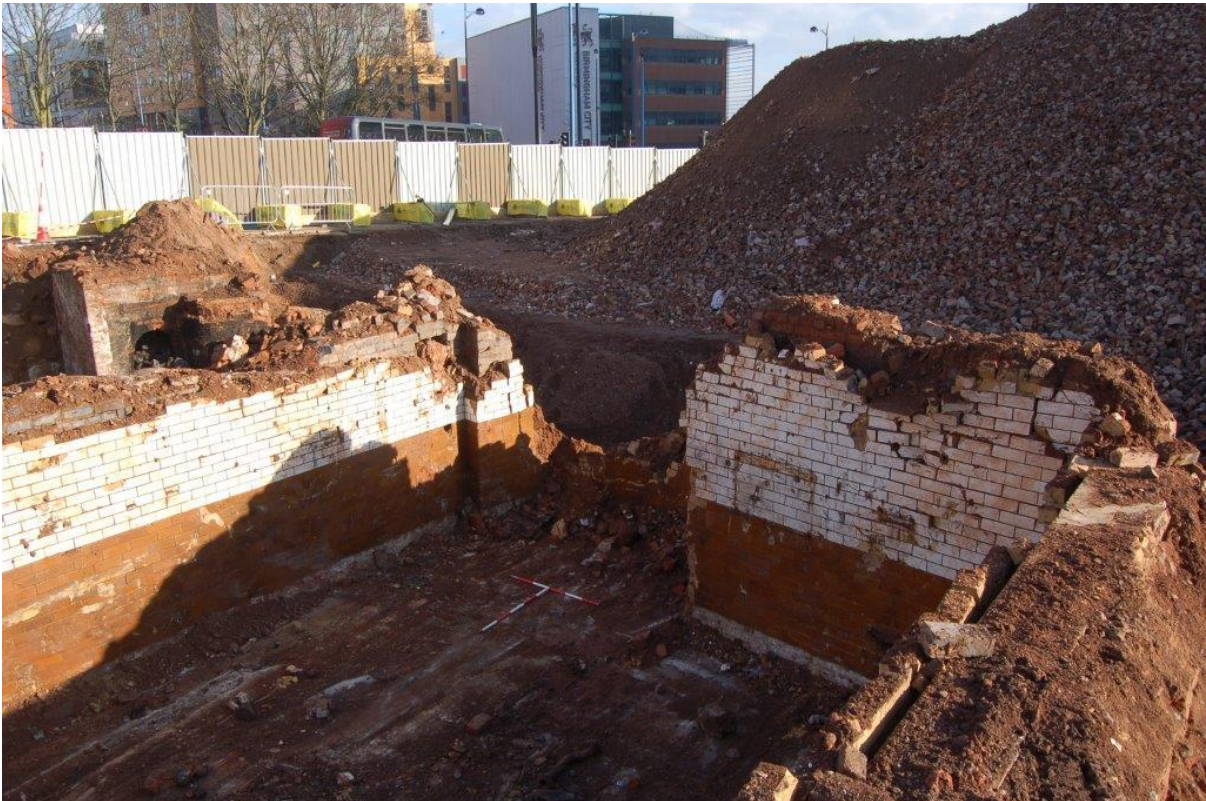
On the south eastern end of the building a bay protruded c. 2.50m out from the wall (Plate 7, Figures 5 and 6). As this level of the building was subterranean it may have acted as a light well or supported bay windows above on the upper floors. Internally at the north western end there were steps up to the ground floor and a door through to Building 1. A concrete floor had been laid in the building and the lower 30cm of the walls had been rendered and painted. Above the wall had been covered with ceramic faced bricks (22.5 x 11 x 8 cm), the lower 104cm in brown and the upper 90cm white (Plate 8).

Plate 7: bay in south eastern end of building 2, 2 x 1m scale, facing east.

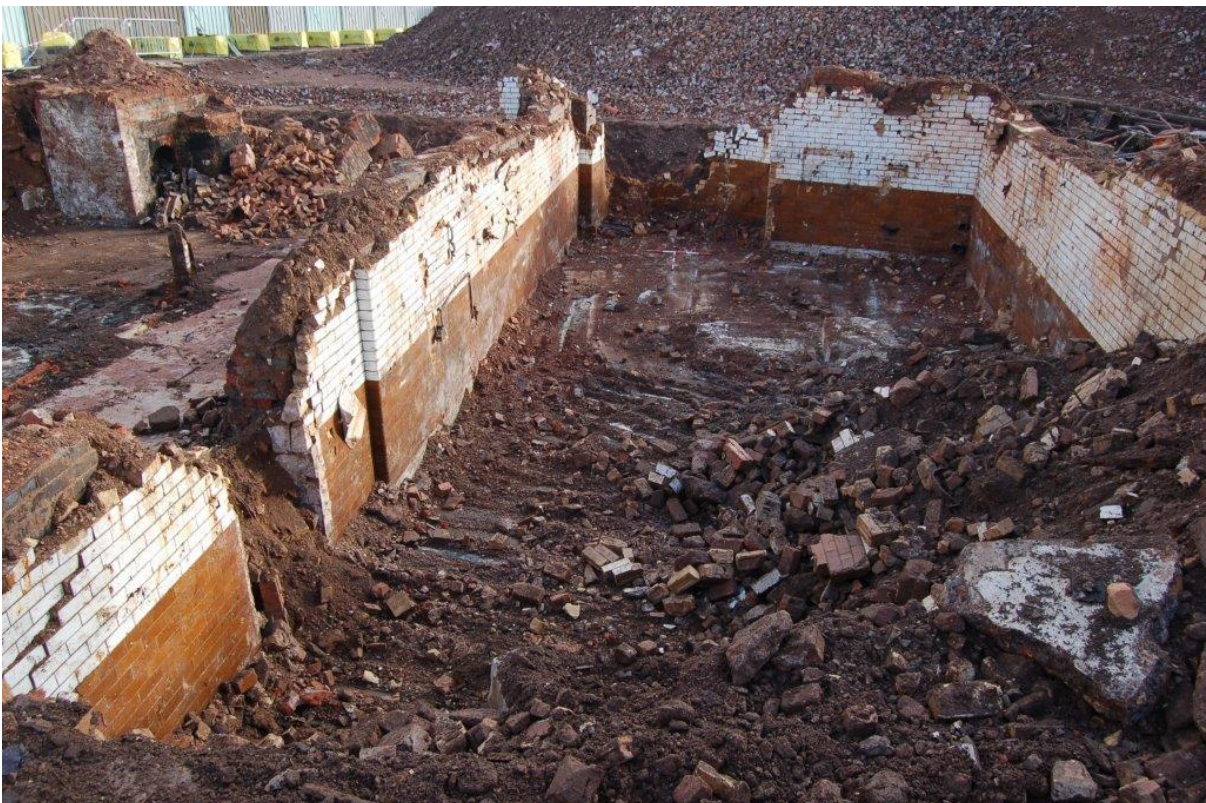
Plate 8: Building 2, facing south east.

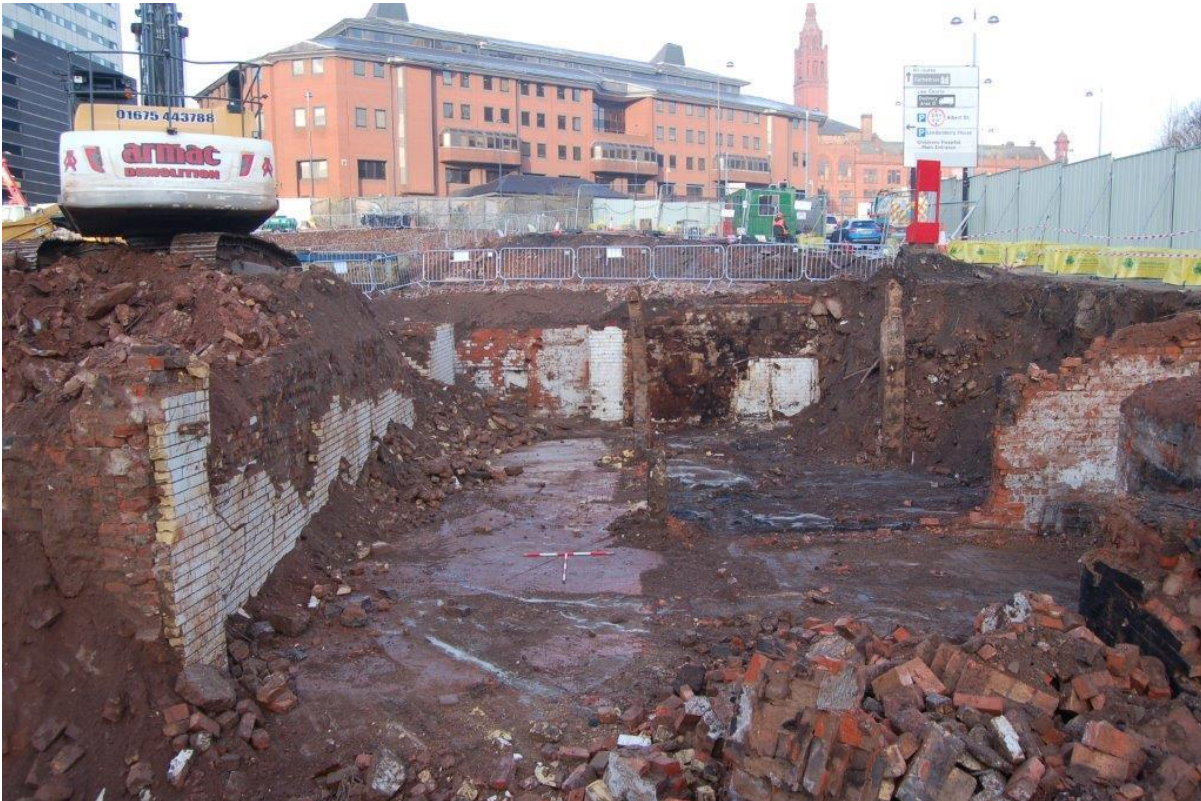
buildings. The dividing wall (156) between the two buildings had been faced ceramic (white) bricks of the same type used inside Building 2 (Plate 9), while the remaining walls (142) and (145) were either whitewashed or cement rendered.

Plate 9: Building 1,2 x 1m scales, facing north west.

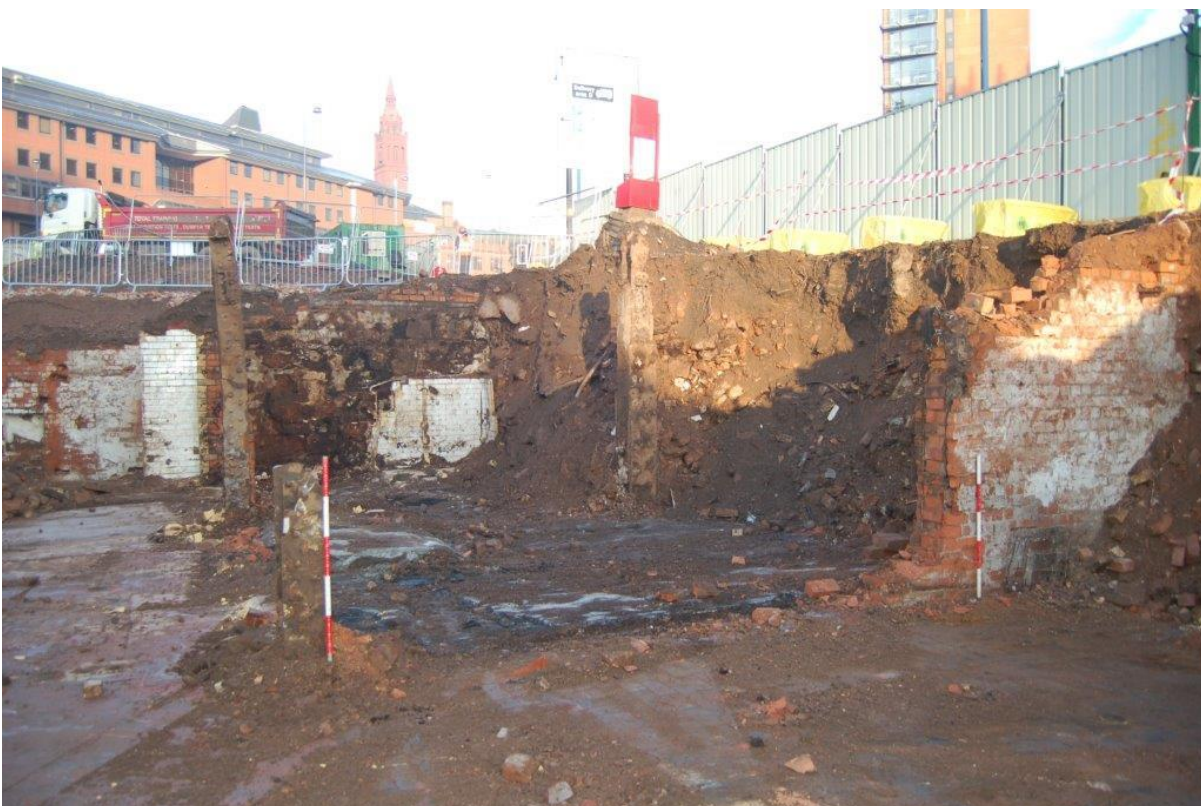
Internally the building appears to have been subdivided into four rooms, using a brick wall (140) that was constructed of machine-made red bricks, 23.5 x 11.25 x 7.5 cm (9.5 x 4.5 x 3 inches) bonded with a pale brown cement mortar of English Bond. Vertical H-shaped steels had been incorporated in to the wall, similar to Building 5 (Plates 9 and 10).

Plate 10: building 1, rooms 1B, 1C and 1D, showing wall (140) and its vertical steels, 2 x 1m scales, facing north.

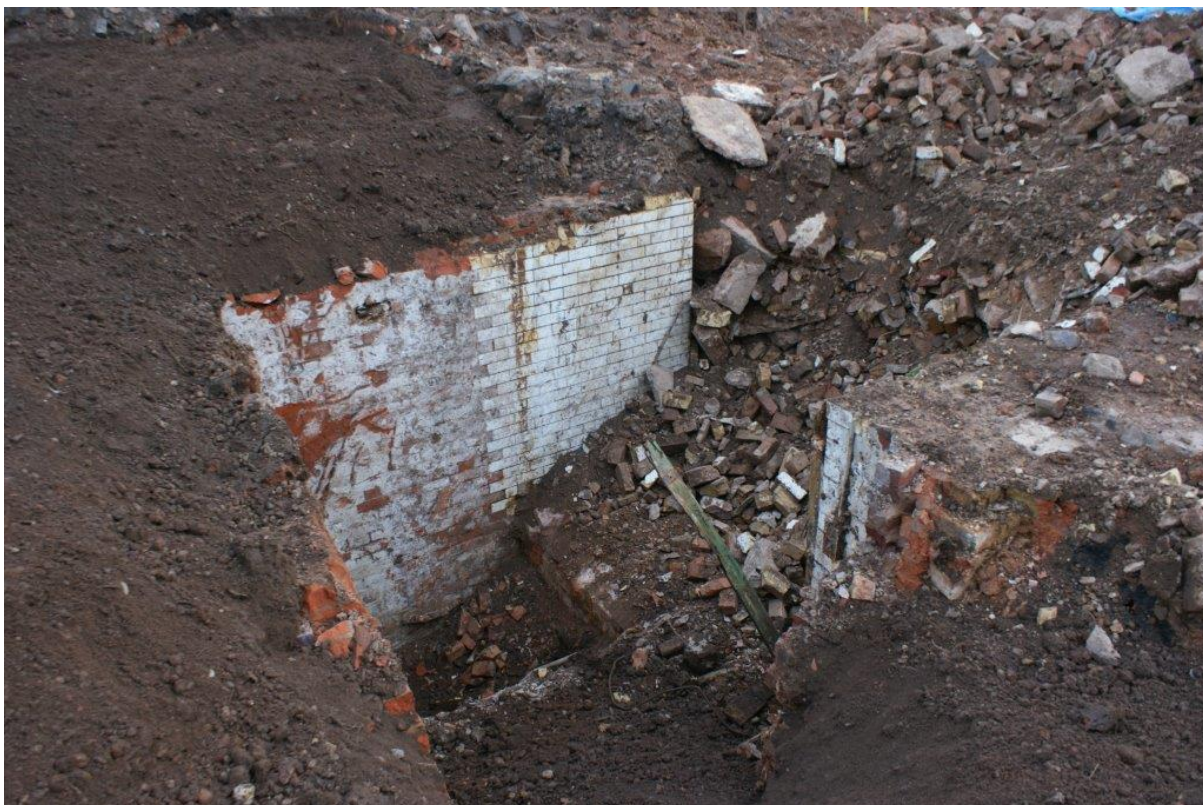
Plate 11: base of lift shaft in Building 1, facing north east.

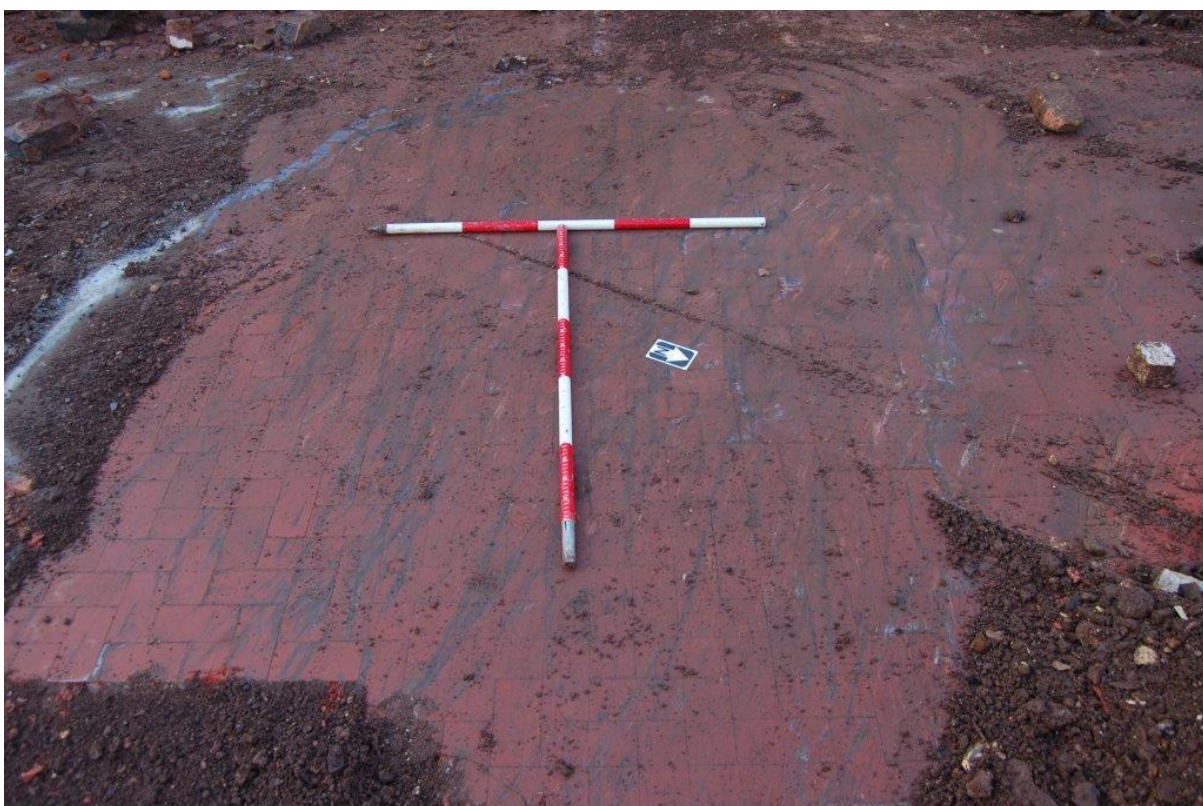
Plate 12: tiled floor (139) in room 1A, Building 1, 2 x 1m scales, facing south east.

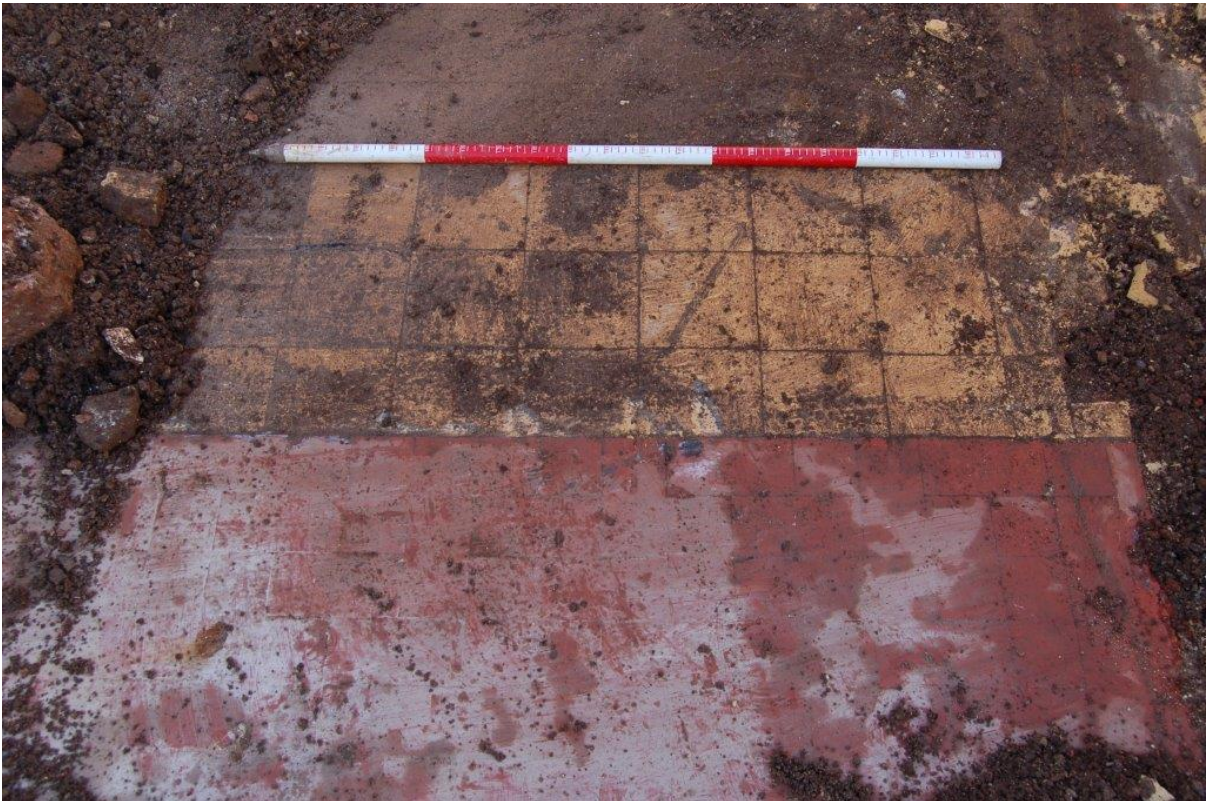
The largest room (1a) ran the length of the building and was 18.0m long and 4.0m wide. The southern wall (156) was faced with ceramic bricks, and the northern wall (142) was whitewashed. At the north western end of the room was the base of a lift shaft 2.0 long and 1.60m wide (Plate 11). Three floor surfaces were present across the room, dark red (139) herringbone ceramic brick shaped tiles (Plate 12), square yellow ceramic tiles (146) (Plate 13) and a concrete floor around the lift shaft.

Plate 13: tiled floor (146) in room 1A, Building 1, 1m scale, facing north west.

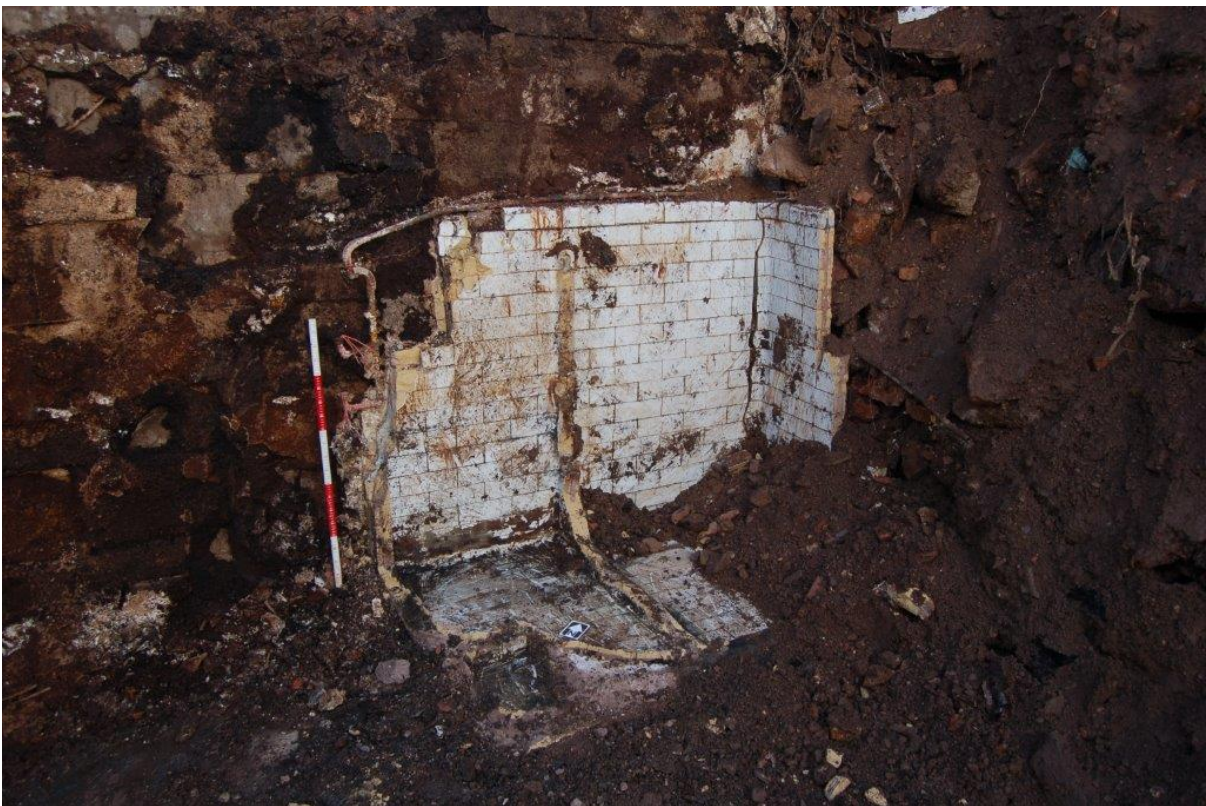
Plate 14: ceramic showers (148) in corner of Building 1, 1m scale, facing north.

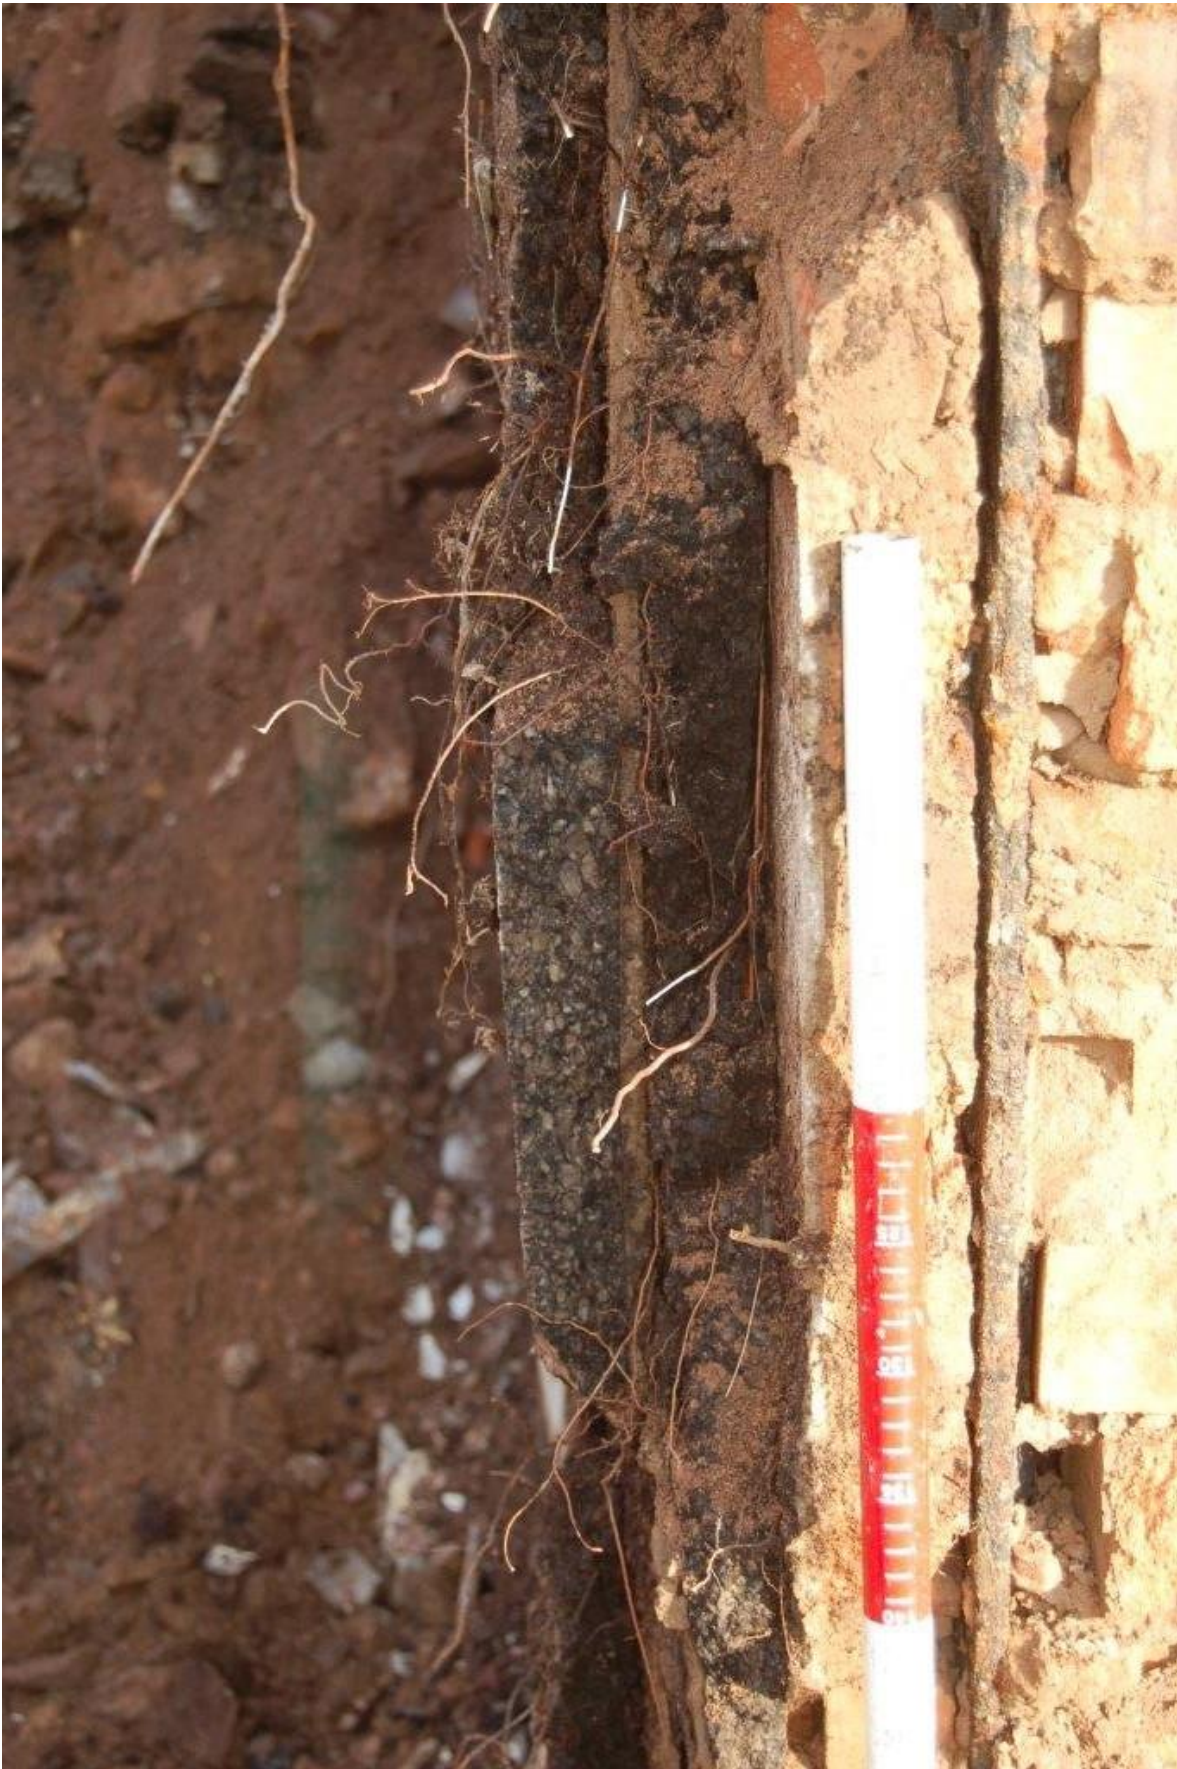
Building 2 at this time is listed as the slaughter house and drying room. To the north Building 1 appears to be a refrigeration plant and cold store, which explains the presence of the cork insulation in rooms 1C and 1D. To the west a lift is plotted in the corner of the room, as located at the end of room 1A and to the west a chimney is recorded is the position of chimney base (144), forming part of the refrigeration plant. It remains unclear however whether this was a recent addition or a reuse of an older chimney associated with the foundries or glass benders originally in this part of the site. Given the size of structure (144) and the heat probably produced during its use, it would seem unlikely that structure (144) was associated with the refrigeration plant at this time. The building was aligned north to south and fronted on to Chapel Street to north and measured c. 26.0m long and 17.0m wide, much larger than had been recorded on site.

Plate 15: Cork insulation inside rooms 1C and 1D.

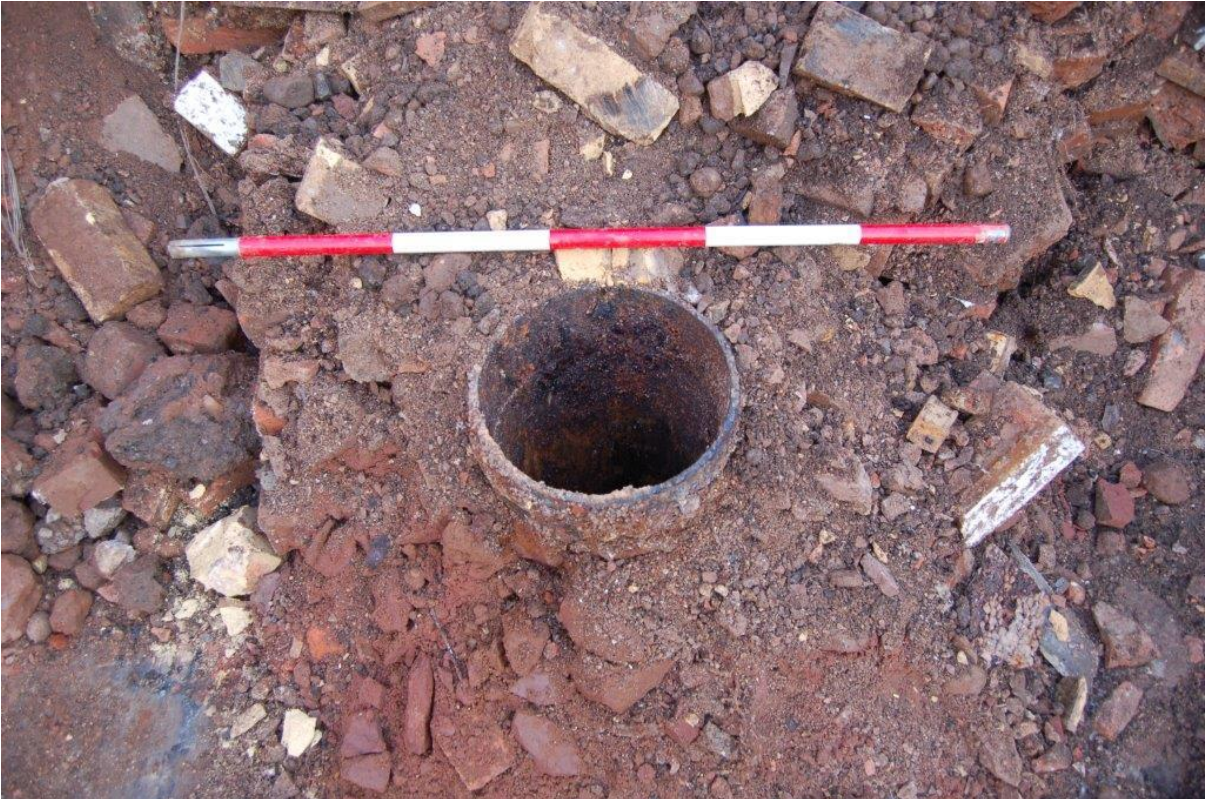
Room 1D was located in the north west corner of the building and measured around 6.0m x 4.30m. A concrete floor had been laid in the room and along wall (145) what appeared to be ceramic shower blocks had been installed (Plate 14). Room 1C was around 6.00m x 4.40m in size and also had a concrete floor. The internal walls of both rooms 1C and 1D had also been lagged with two layers of cork 5cm thick, acting as insulation (Plate 15). Room 1A measured around 6.0m x 5.40m and had an engineering brick floor. At the northern end of the room was a vertical metal pipe (143), 0.35m in diameter that had been sunk a number of metres into the ground and is thought to have been a well (Plate 16).

Plate 16: metal pipe (143) in room 1B, 1m scale, facing north east.

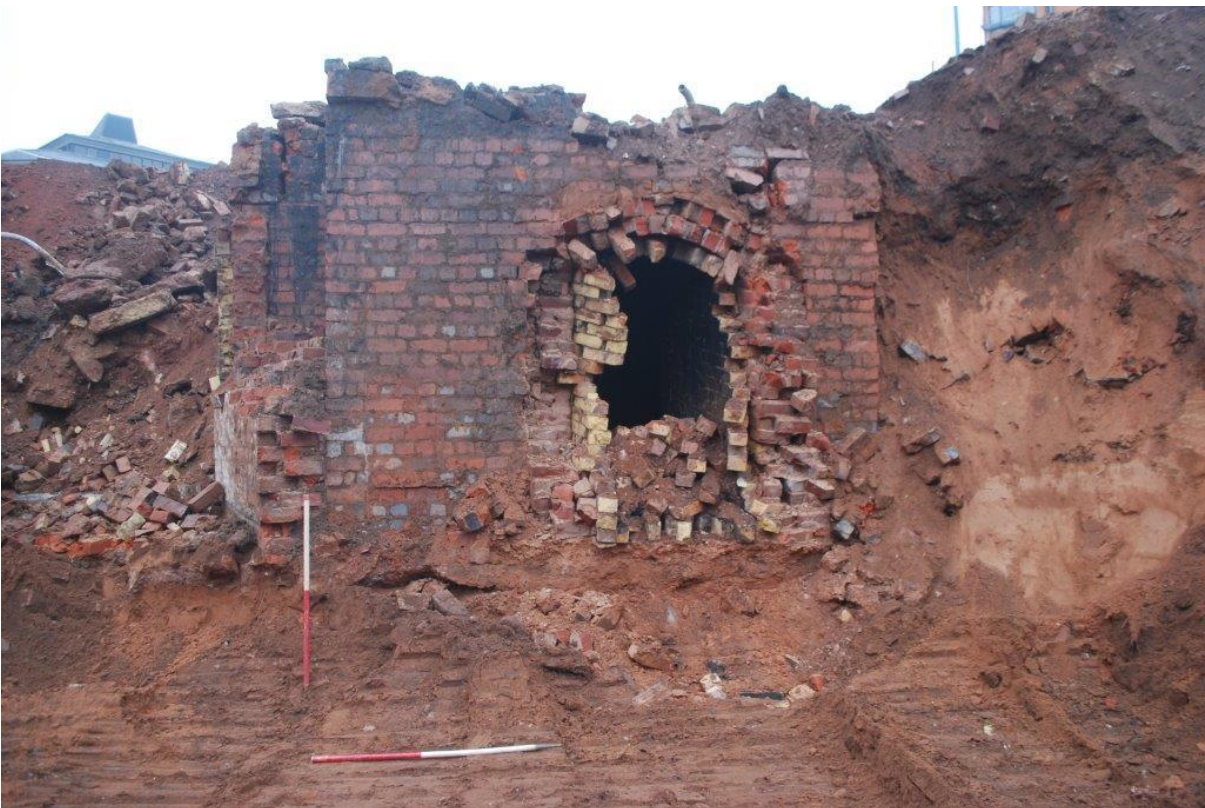
Plate 17: vaulted archway running towards Building 1, 2 x 1m scale, facing north west.
