Archaeological Watching Brief at Exchange Square, Birmingham

Status: Version 1
Date: 17-3-17
Author: Andrew Mann (amann@worcestershire.gov.uk)
Contributors: C Jane Evans
Illustrator: Carolyn Hunt
Project reference: P4878
Report reference: 2424

An archaeological watching brief was undertaken at Exchange Square, Birmingham (NGR SP 07473 87124). It was undertaken on behalf of Sir Robert McAlpine Ltd, who intend to construct a mixed use development at Masshouse Plot 7, for which a planning application has been approved (ref 2014/06135/PA and 2016/06135/PA). The majority of the site had been heavily truncated by the construction and demolition of an elevated roadway (Masshouse Circus) that once crossed the development area. Archaeological features, mostly brick walls and cellars of late 19th and early 20th century date, survived to the north east of the former Masshouse Circus which had belonged to the industrial buildings and factories that once occupied the development site. These mostly comprised elements of the former pork processing plant belonging to Marsh and Baxter Ltd, Morley and Newey glass and lead works and to Gaskell and Chambers bar fitters.

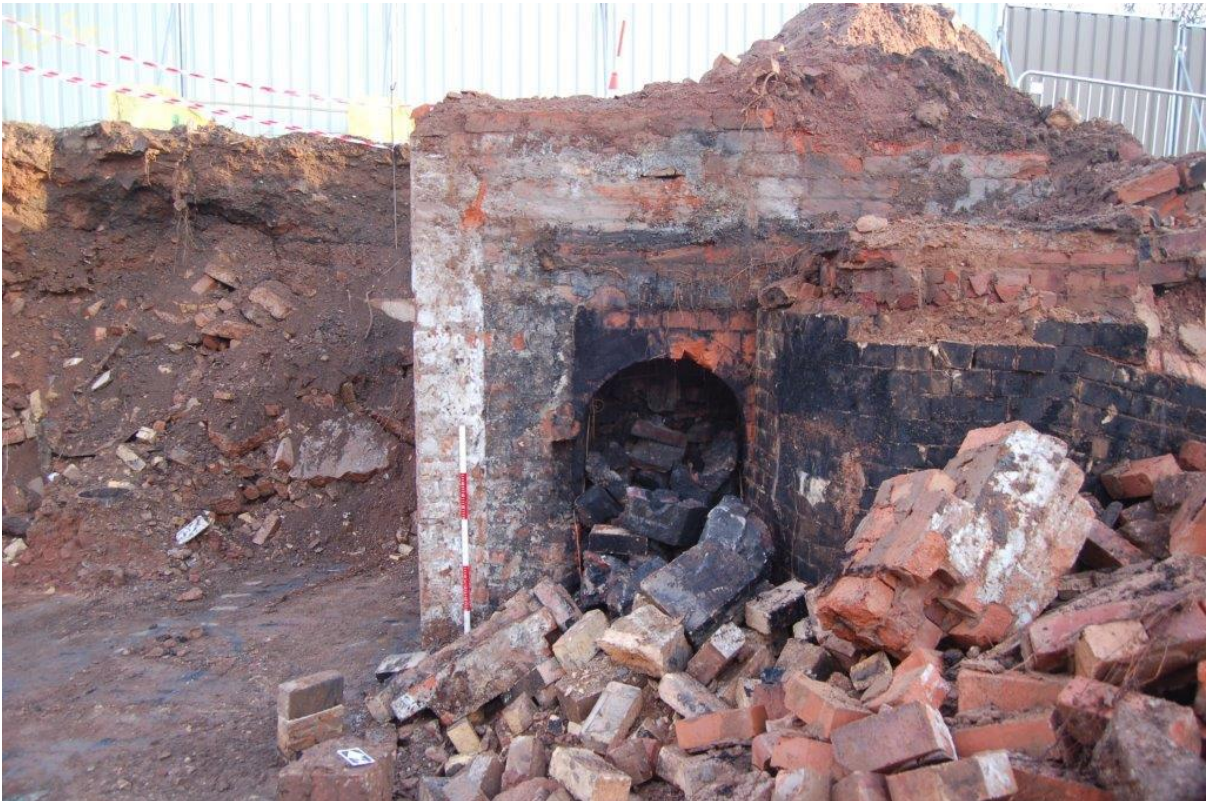
The eastern side of the room butted up against what is thought to be a chimney stack base (144). The arrangement of the structure was difficult to establish but it appears to have incorporated a vaulted arch (2m high and 1.80m wide) lined with yellow fire bricks (Plates 17 and 18, Figs 6 and 7). These had become heavily sooted, suggesting the arch had acted as a flue although from where is unclear. It had been suggested by the demolition team that the archway (which would have been below ground level) ran through the unmonitored area of the site to the east, potentially for another 25m. The structure was made from red, machine-made bricks (21 x 11 x 7 cm), in an English bond, using light brown cement mortar.

Plate 17: vaulted archway beneath chimney base. Taken after the demolition of part of the structure, 1m scale, facing north east.

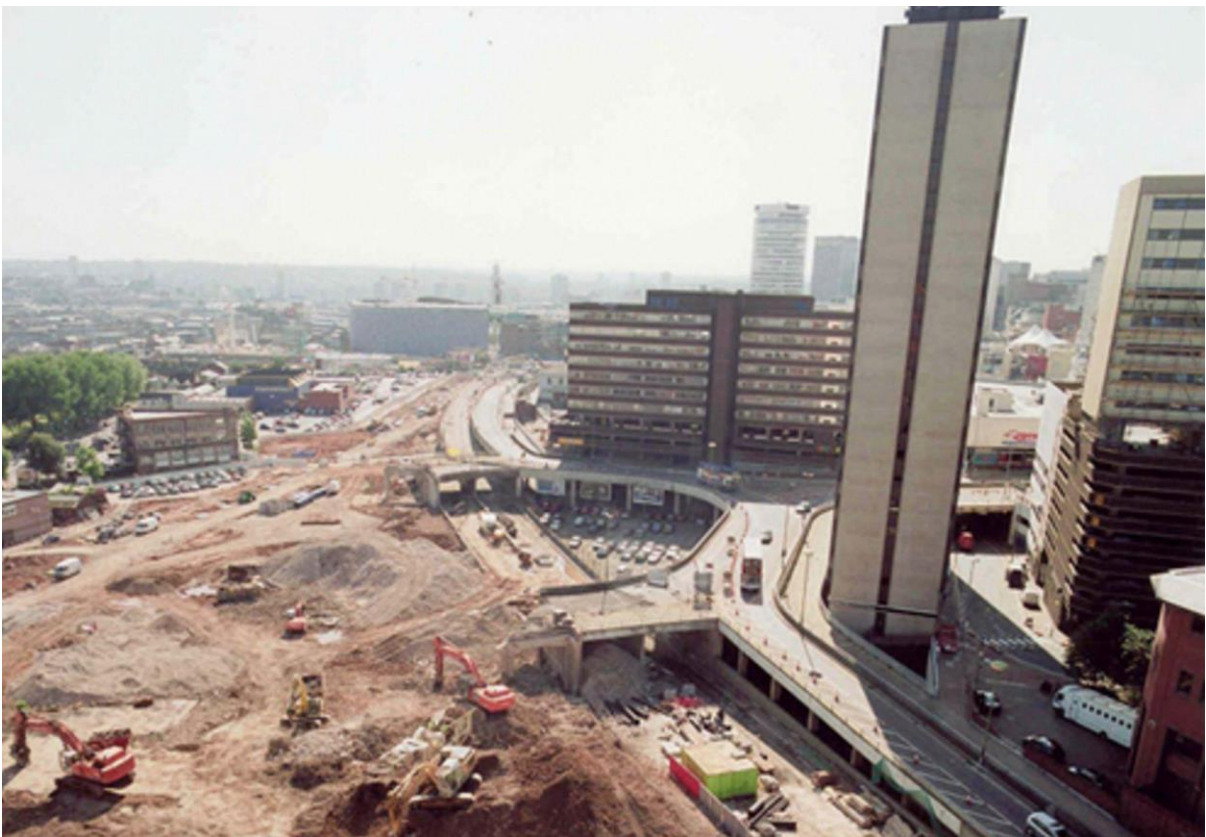
Most of the modern deposits and structures recorded on the site had formed part of Masshouse Circus or were either associated with the demolition of buildings or landscaping of the site prior to its construction. Some were also associated with the landscaping of the area after the demolition of the elevated road in the 2002 (Plate 18).

Plate 18: demolition of the elevated road (Masshouse Circus) crossing the site in 2002, facing south.
