ARCHAEOLOGICAL WATCHING
BRIEF
AT
GROVE FARM, KNOWLE,
WARWICKSHIRE

Project 3135
Report 1657

Archaeological watching brief at Grove Farm, Knowle, Solihull

Part 1 Project summary

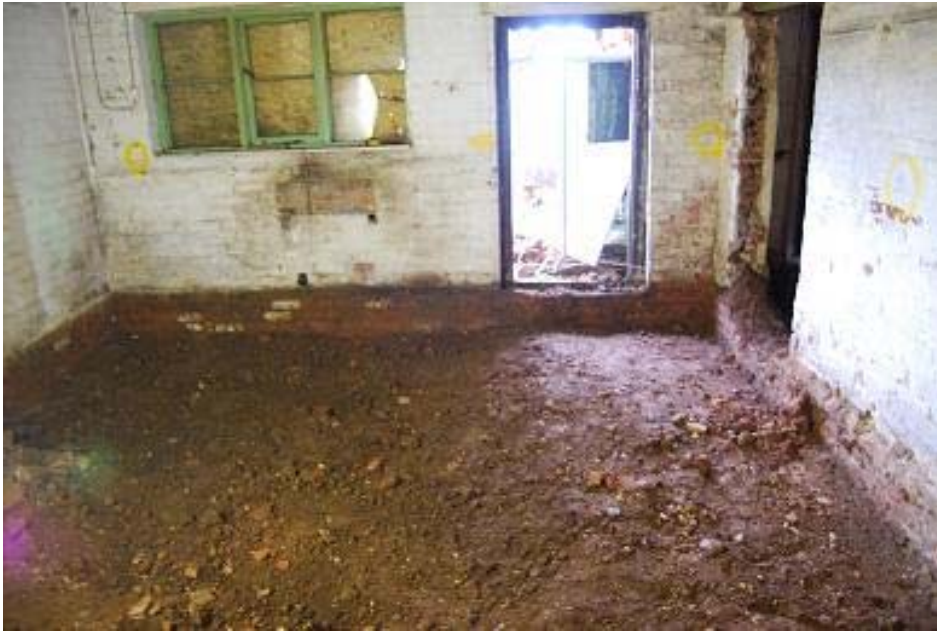
Trenches 1, 2, and 3 were dug within Grove House to a depth of 0.40m and at no point did these trenches reach natural deposits. Deposits 101, 201 and 301 were sealed by the paved floors and comprised of sandy silt. The fill appeared to be made ground, containing fragments of red brick and tile. This is likely to be as a result of the alterations to the building in the 19th century.

Plate 1: Trench 1 in Grove House, looking north

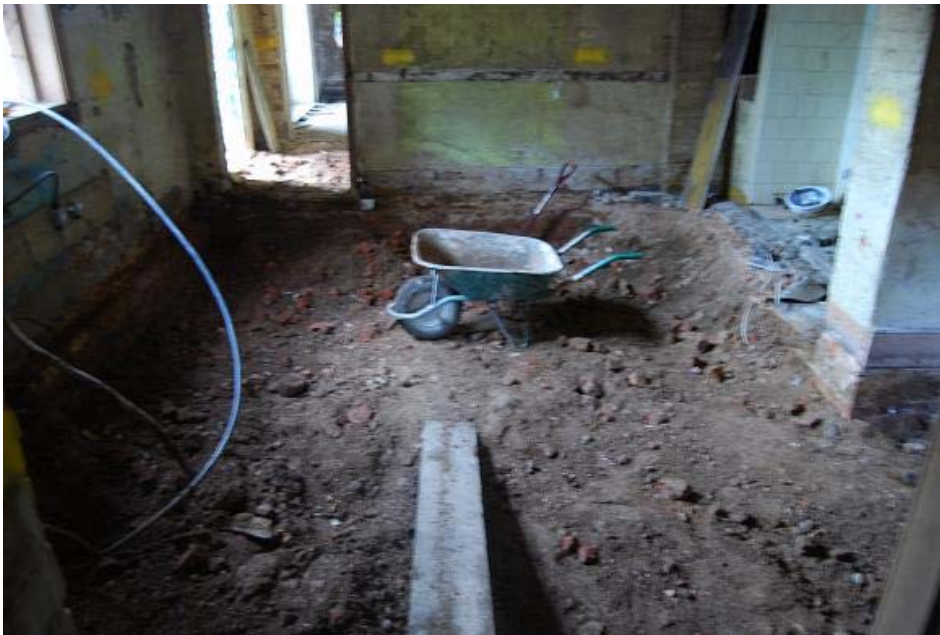
Plate 2: Trench 2 in Grove House, looking south west

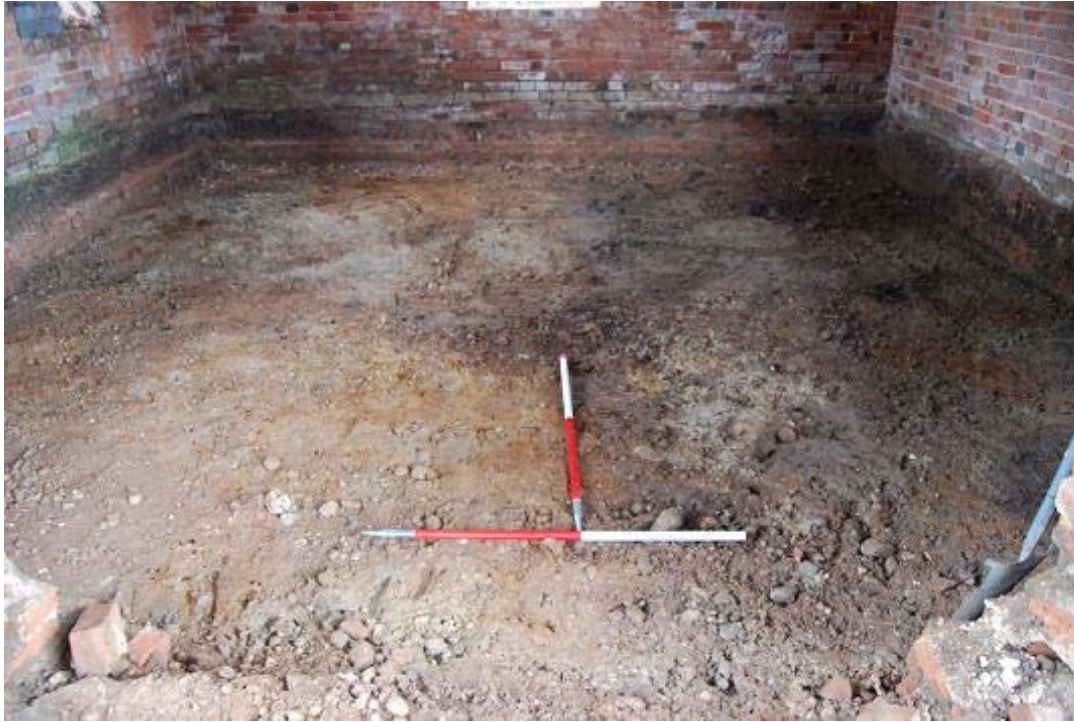
Trenches 4 and 6 observed within the Barn were dug to a depth of 0.50m and did not reach natural ground. Deposit 401 was of coarse gravely silty sand, similar soils were found in the adjacent trench, 601. Trench 7 within the Dairy was only required to be dug to 0.45m and contained one sandy silt deposit. The fill appeared to be of made ground containing glass bottles, red brick, and 19th century pottery. In the adjoining area of the Dairy, Trench 10 was excavated much deeper at about 0.70m; here the sandy silt deposit had rare inclusions of red brick.

Plate 3: Trench 4 in the Barn, looking east

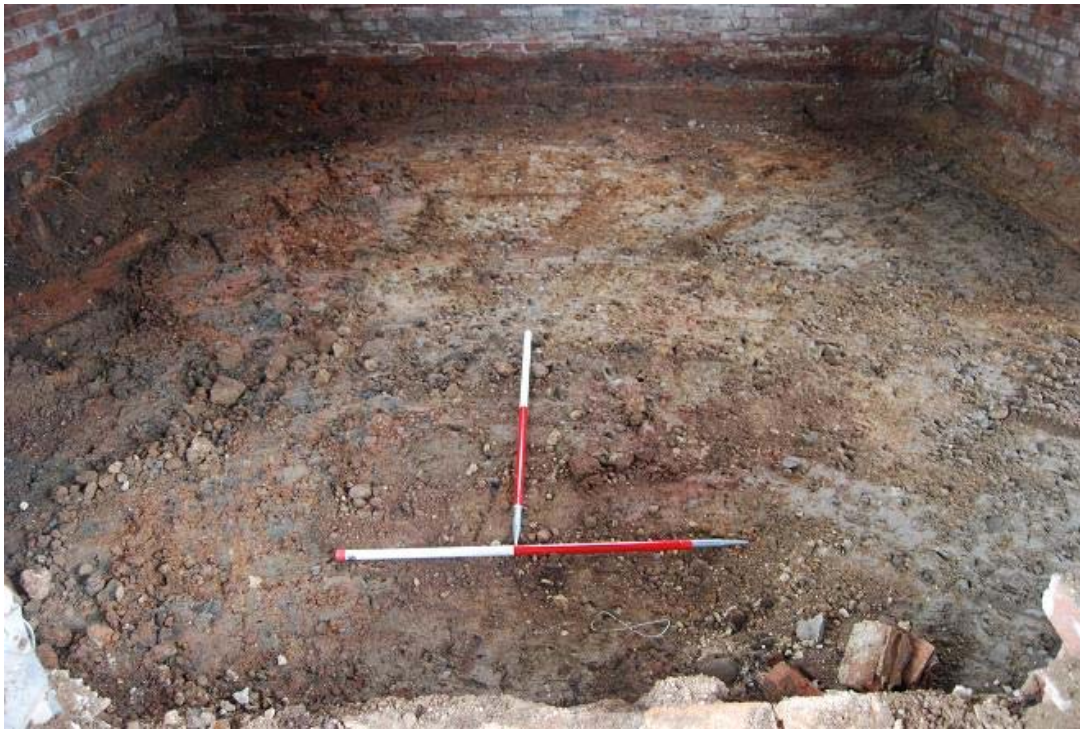
Plate 4: Trench 6 in the Barn, looking west

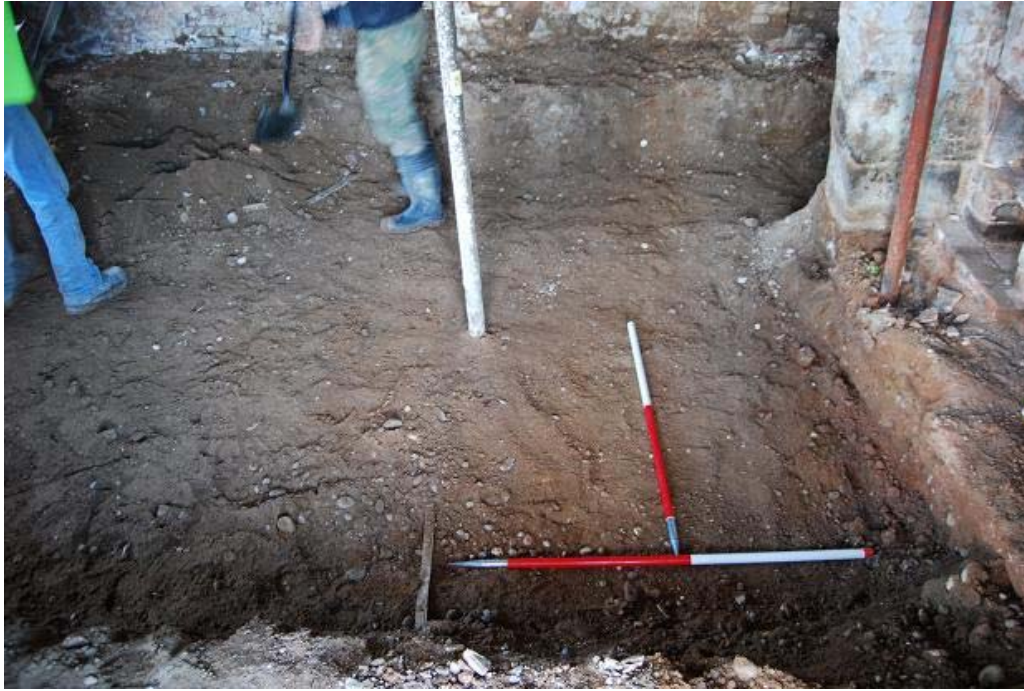
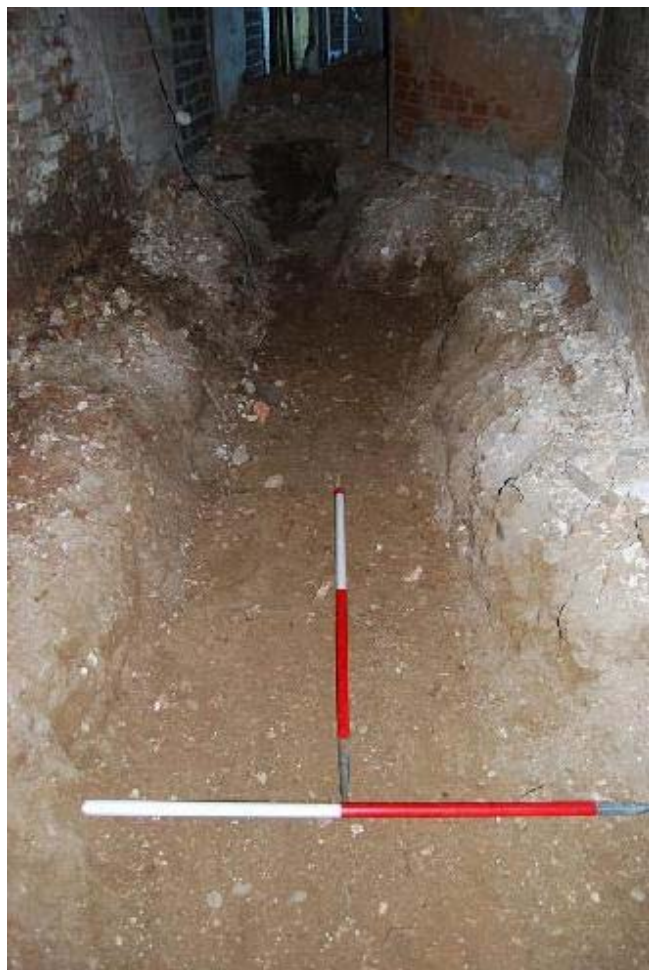
Sealed by the paved floor within the Cottage 501 comprised of sandy silt with a few fragments of red brick. This trench was dug to 0.375m and in places was deeper than the surrounding walls, which suggests the substrate is broadly contemporary with the building.

The majority of the site has been subject to redevelopment from the 19th century onwards. However such activity did not appear to affect the deposit (context 501) found within the Cottage; this suggests it is contemporary or near contemporary with the phase of construction.

Plate 5: Trench 5 in Grove Cottage, looking south west

Plate 6: Trench 5 looking north west

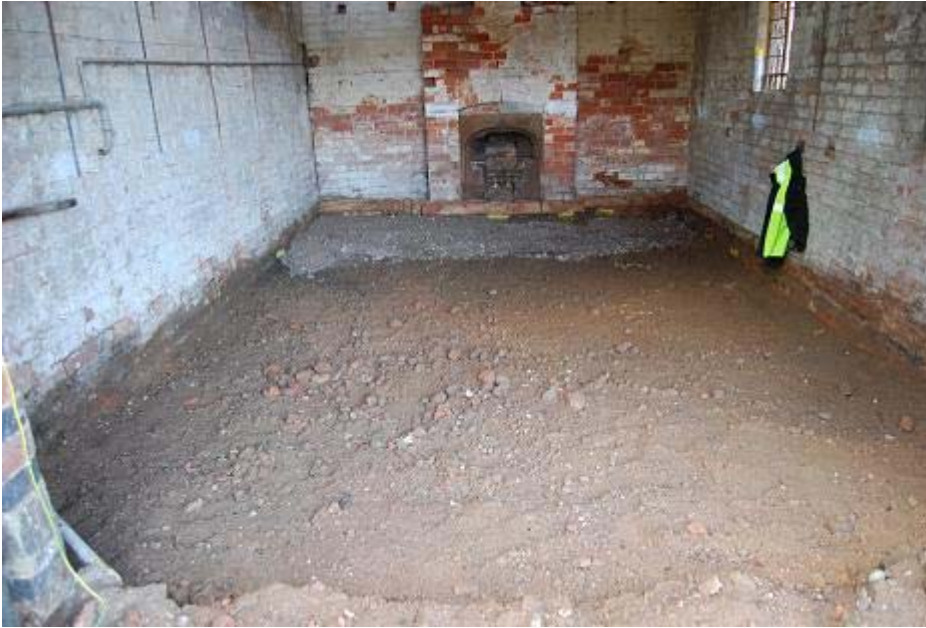
Inside the Coach House the sandy silt deposits 801 and 901 were both dug to a depth of 0.60m and contained rare inclusions of red brick.

Plate 7: Trench 8 in the Coach House, looking west

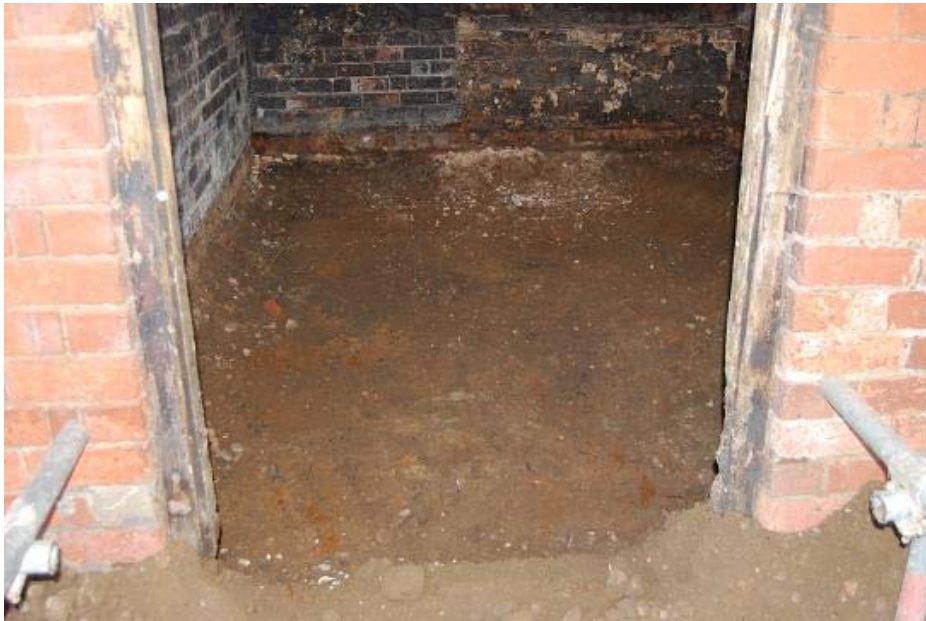
Plate 8: Trench 9 in the Coach House, looking south west

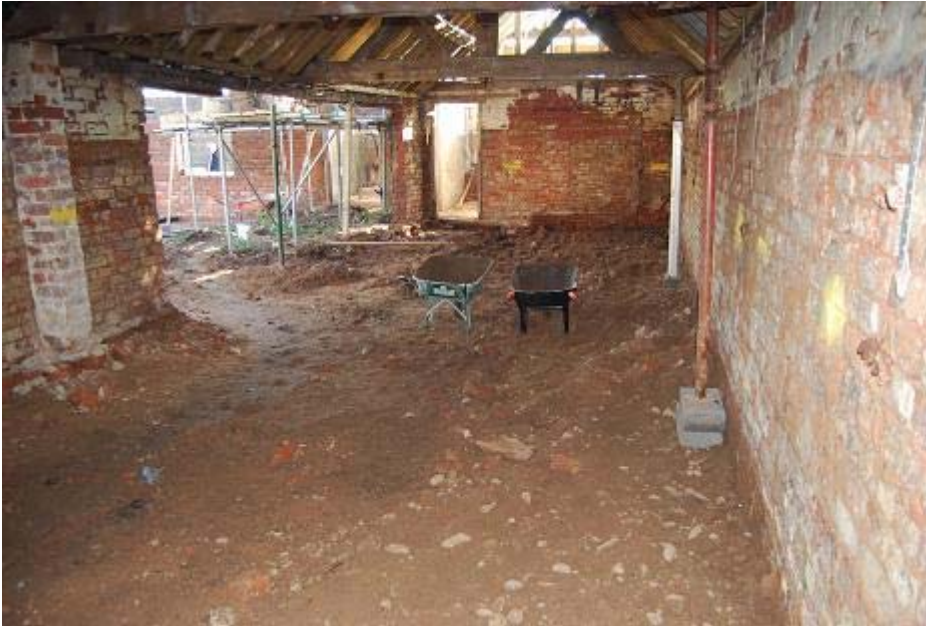
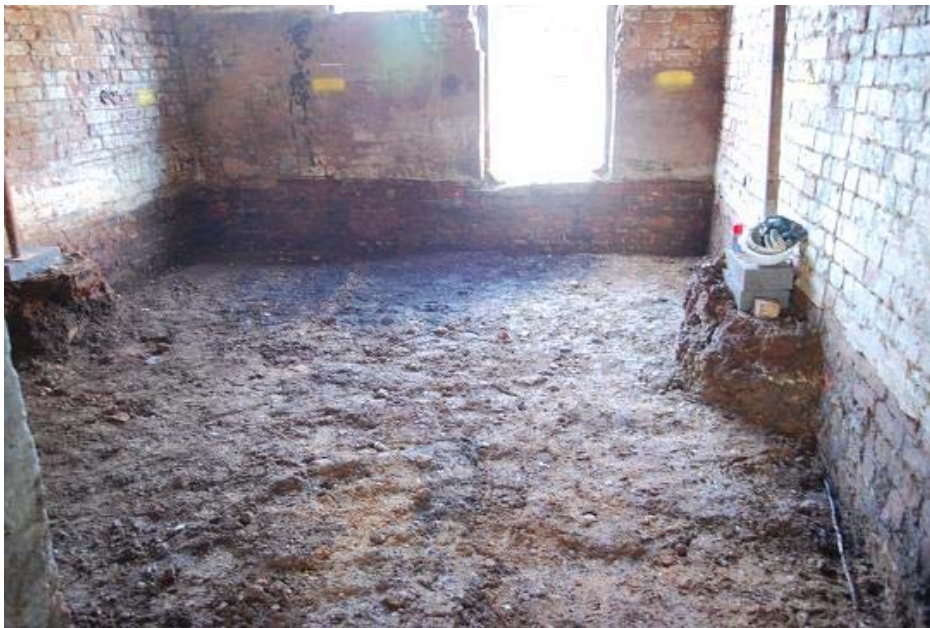
Few artefacts have been recovered from the deposits apart from an assemblage of glass bottles recovered from 701. These have been provisionally dated to the early 20th century and were of no archaeological significance (Angus Crawford pers. comm.). Glassware from the fill of pit 2104 was dated to the 19th century.

Plate 9 Trench 7 in the Dairy, looking south east

Plate 10: Trench 7 looking south west

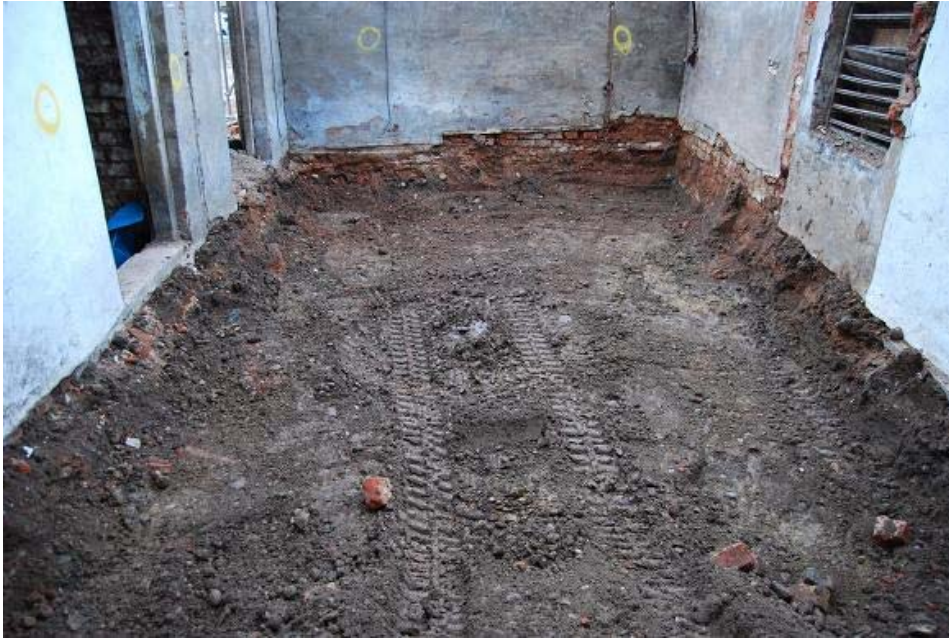
Plate 11: Trench 10 in the Dairy, looking north east

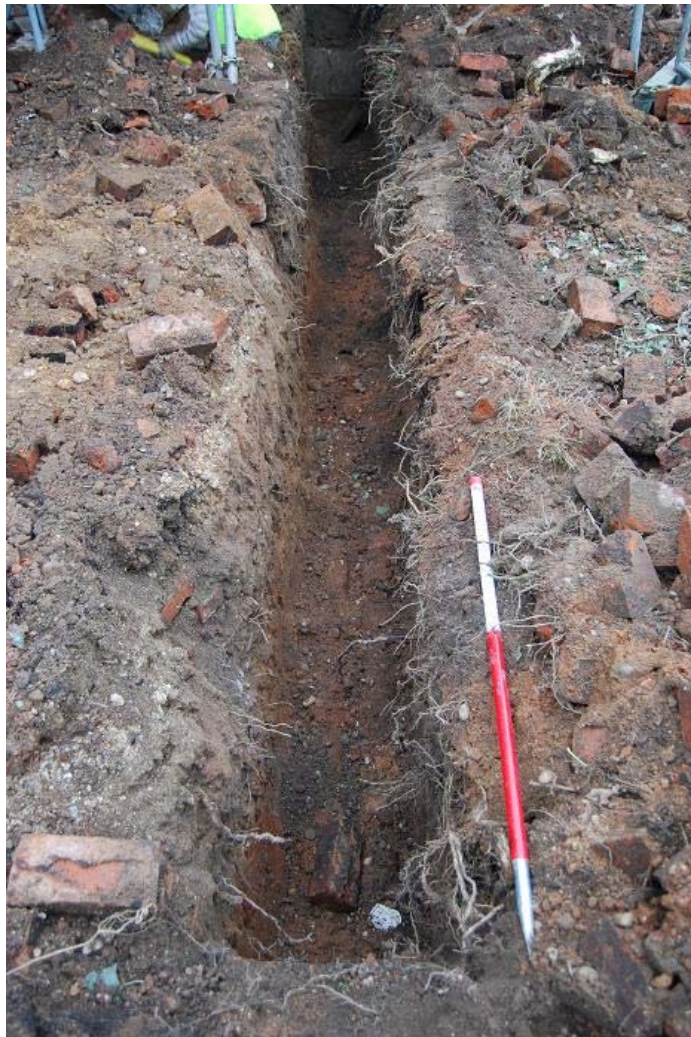
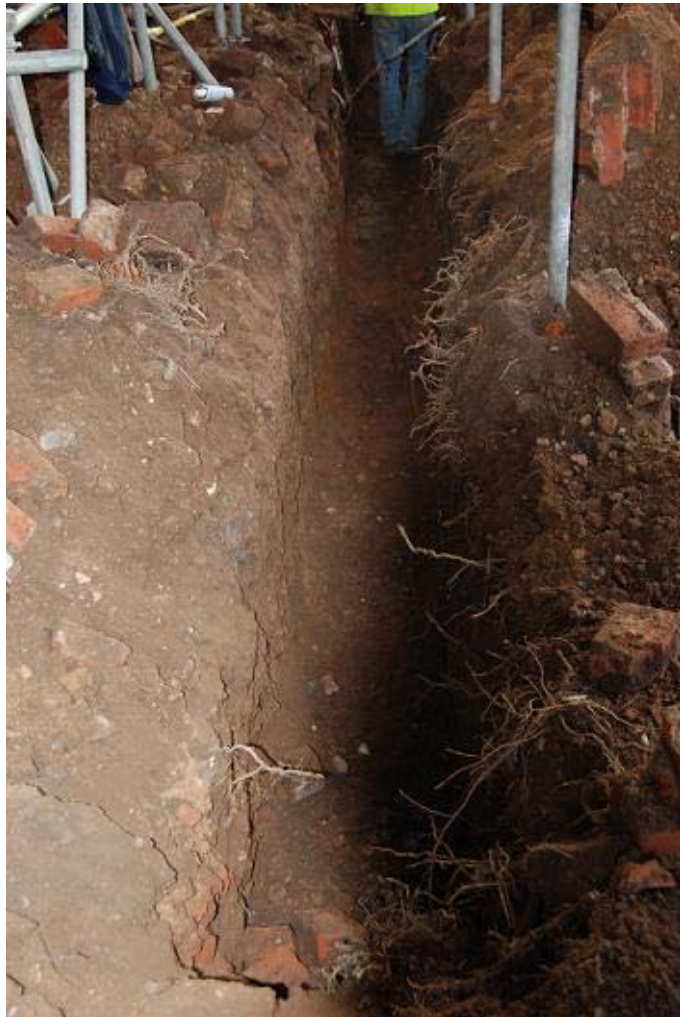
Trench 12 and 13 were dug 1m deep. Context 1201, the red brick footing for the former wall of the Farm House sealed 1202. Contexts 1202 and 1203 comprised of brown sandy silts, with 1203 containing more gravels.

Plate 12: Trench 12 outside the rear of Grove House, looking south west

Plate 13: Trench 12 looking south east

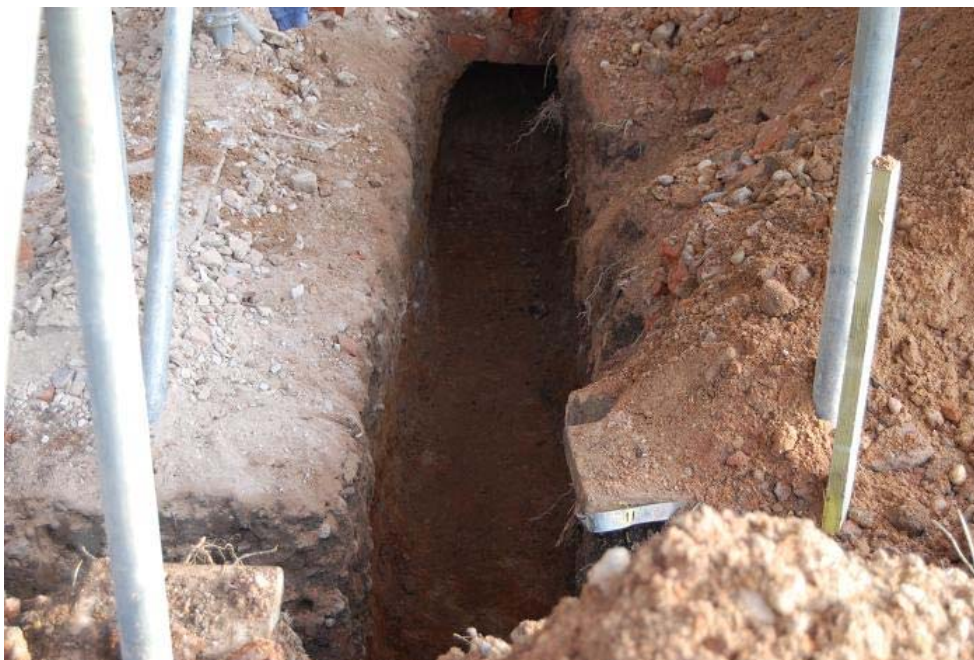
Plate 14: Detailed view of Trench 13, looking south

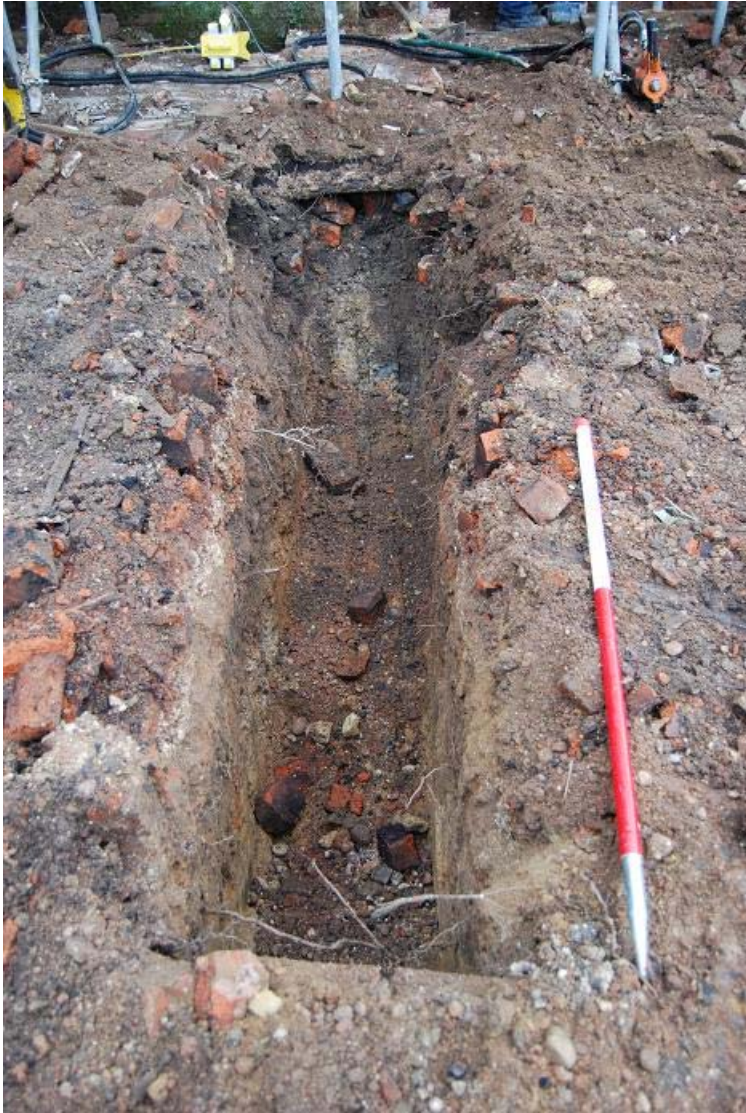
Trench 14 contained red brick shuttering 1m deep filled by concrete and did not contain any further deposits. The deposits within Trench 15 were similar to those within Trench 12. Sealed by a blue brick floor, 1502 was brown silty sand deposit which was above the gravely deposit of 1503.

Plate 15: Detailed view of Trench 15, looking west

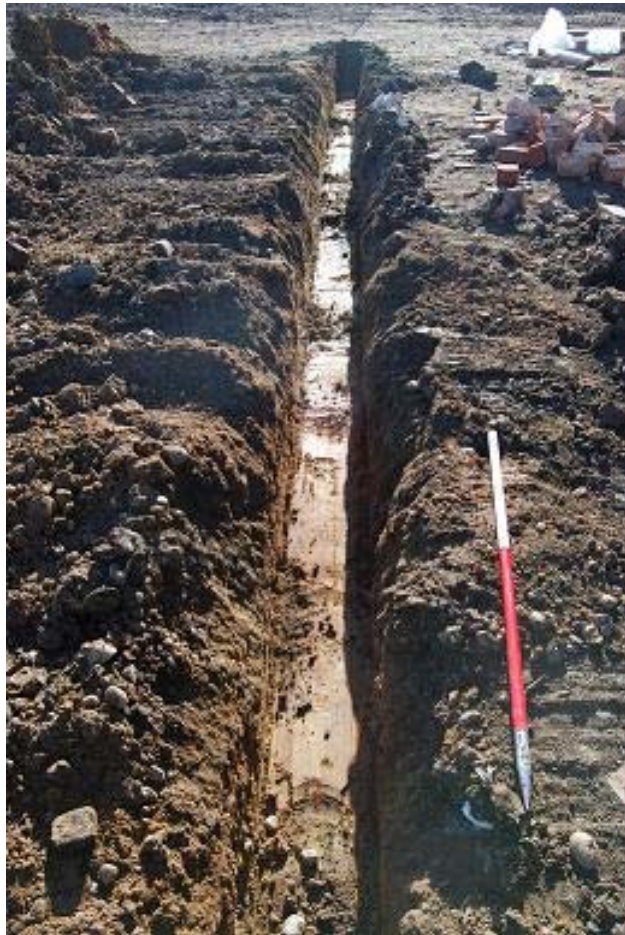
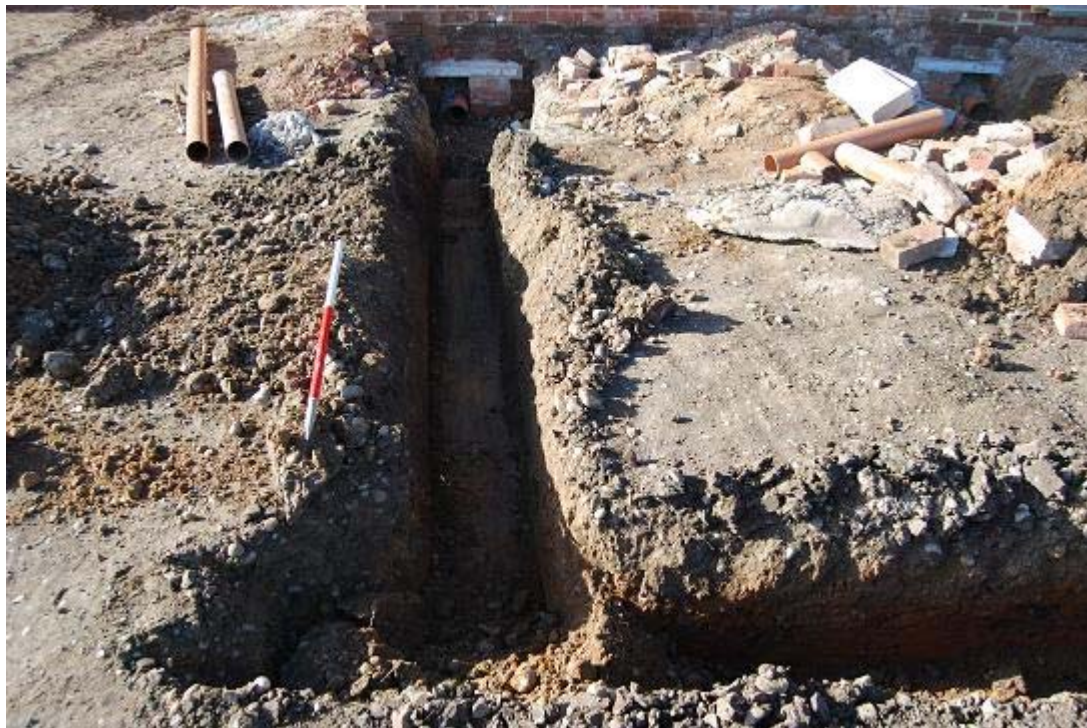
Trench 16 was excavated 38m long, 0.56m wide to a depth of 0.62m. The mid blackish brown sandy silt topsoil was recorded as 0.26m deep. Below the topsoil the observed subsoil was of compact mid to light orangey brown gravely sand, with occasional patches of orangey red clay and frequent sub rounded pebbles and sub angular stones. Similar deposits were revealed within Trench 17, 18 and 19, these trenches were excavated running from the rear of the Barn to Trench 16 and were dug 0.62m below the existing ground level.

Plate 16: Detailed view of Trench 16, looking south

Plate 17: Detailed view of Trench 16, looking south west

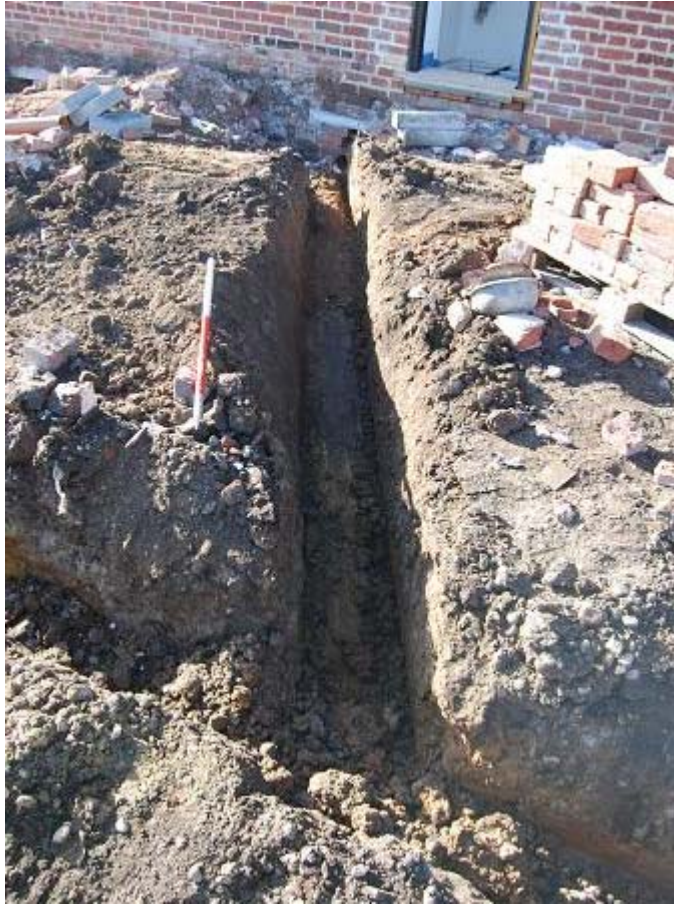
Plate 18: Detailed view of Trench 17, looking south west

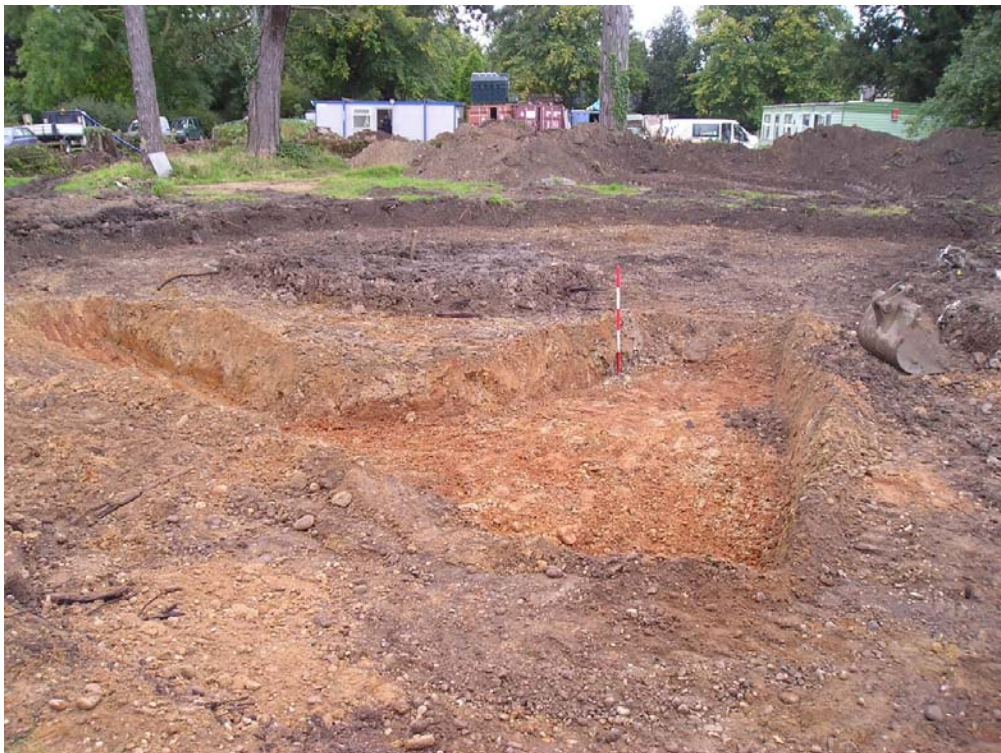
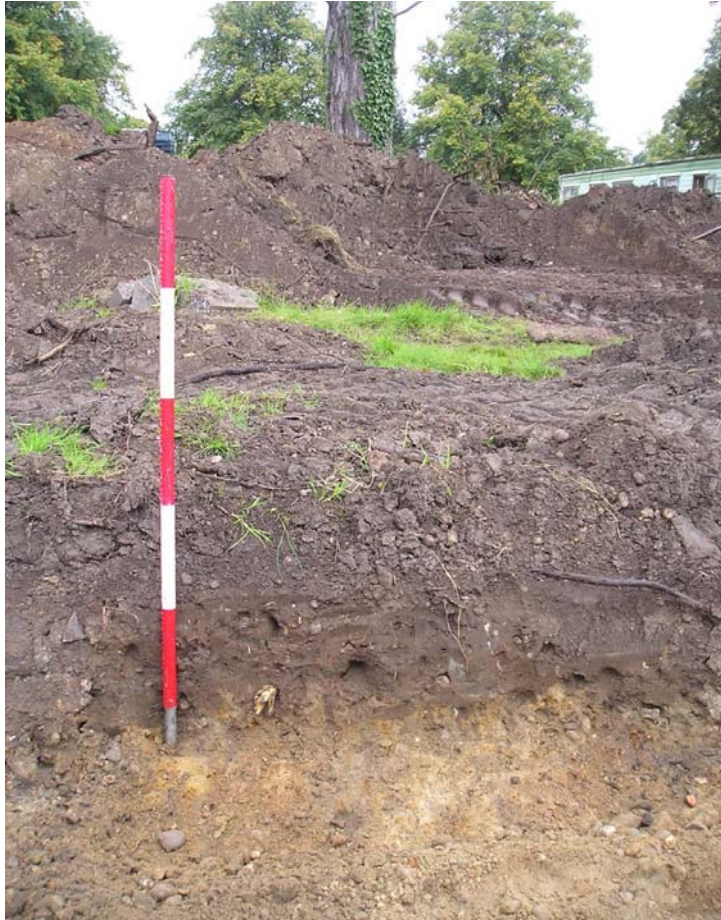
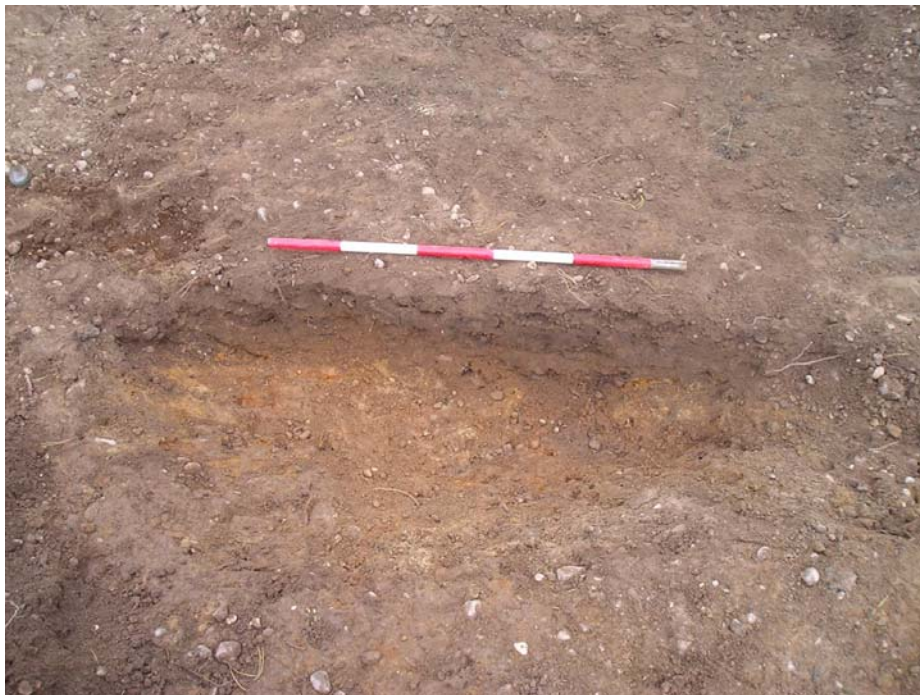
Trenches 20, 24, 25 and 26 were drainage and service lines in the vicinity of the farmhouse and here topsoil, medium brown sandy soil with moderate pebbles overlay natural clay and gravels and no features or finds were recorded. Within Trench 21, the footprint for a proposed duck pond an oval pit (2104) 2.34m x 2.1m was recorded cut into the natural sand and gravel (2102). A section was excavated through the pit, which was found to contain a light brown sandy silt with occasional charcoal, animal bones and 19th century glassware.

A pit recorded in the area of the proposed duck pond, to the south of the farmhouse is probably a refuse pit which lay to the west of the main farm yard.

Plate 19: View of Trench 21 the Duck Pond looking west

Plate 20: East facing section of Trench 21, the Duck Pond looking west

Plate 21: East facing section of Trench 21, the Duck Pond looking west
