Archaeological Watching Brief at 7 Beales Corner, Bewdley, Wyre Forest, Worcestershire

Status: Version 1
Date: 18th June 2018
Author: Andrew Mann (amann@worcestershire.gov.uk)
Contributors: Laura Griffin
Illustrator: Carolyn Hunt
Project reference: P5324
Report reference: 2579
HER reference: WSM 70373
Oasis id fieldsec1-322786

An archaeological watching brief was undertaken at 7 Beales Corner, Bewdley, Wyre Forest, Worcestershire (NGR 378821, 275433). It was undertaken on behalf of the Environment Agency, during construction of flood defences around the property for which listed Building Consent has been granted (Application ref: 17/0788/LIST) by Wyre Forest District Council.

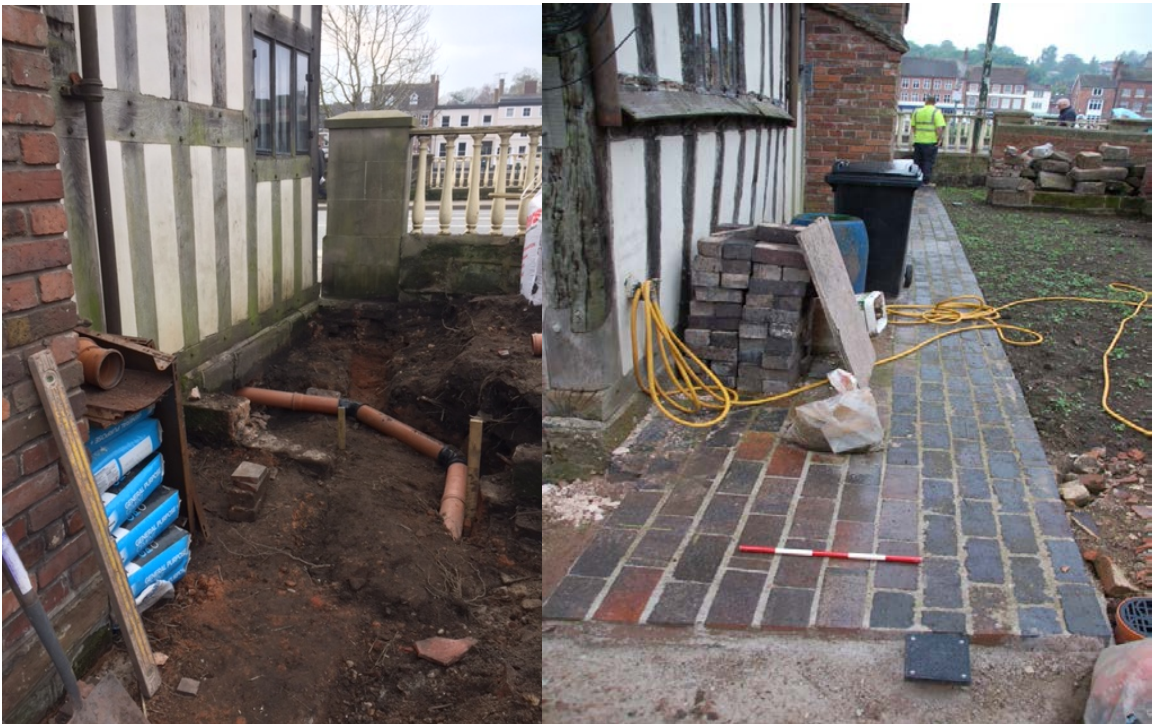
Plate 2: North-western side of the property during groundworks (left) and as seen during the archaeological watching brief (right). Facing south-west.

A single trench amounting to just over 16.18² in area, was excavated around the southern, western and eastern sides of the property as shown in Figure 2 (Plates 3-6). A trench along the north western side of the property was also meant to be monitored but this had already been completed by the home owner prior to the watching brief commencing (Plate 2).

Surrounding the building and visible in all monitored trenches was a compact garden soil consisting of dark reddish brown silty sands containing frequent ceramic building material (CBM) fragments, charcoal flecks and late post-medieval and modern ceramic fragments. The soil had been heavily reworked recently by numerous services (gas, water, electric and drainage) and presumably during the reconstruction of the property in the 1960s and 1970s as frequent cement and lime mortar fragments were also identified. The soil was a minimum of 0.50m deep but its full depth was not established before the impact level of new footings was reached. Although the trench along the northern side of the property was not monitored photographs taken at the time of show the continuation of this soil and do not show any other archaeological features (Plate 2).

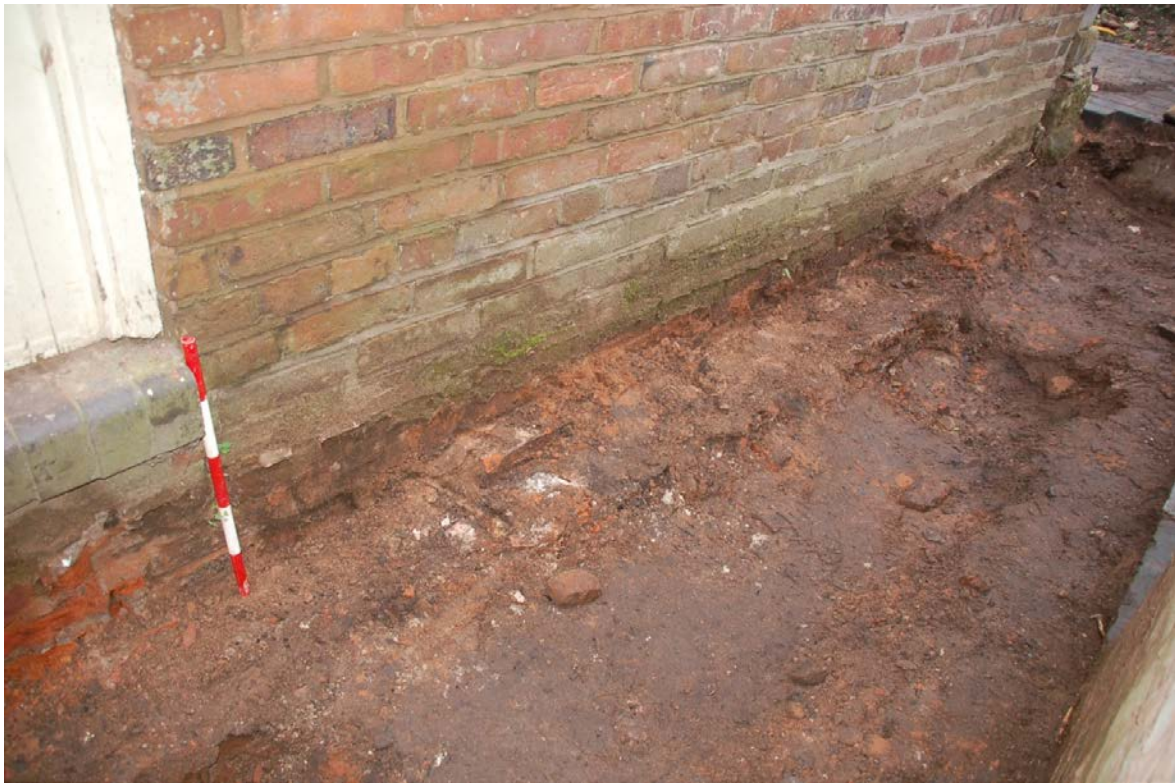
Plate 3: Trench dug to the rear of the property, 0.5m scale, facing north-west.

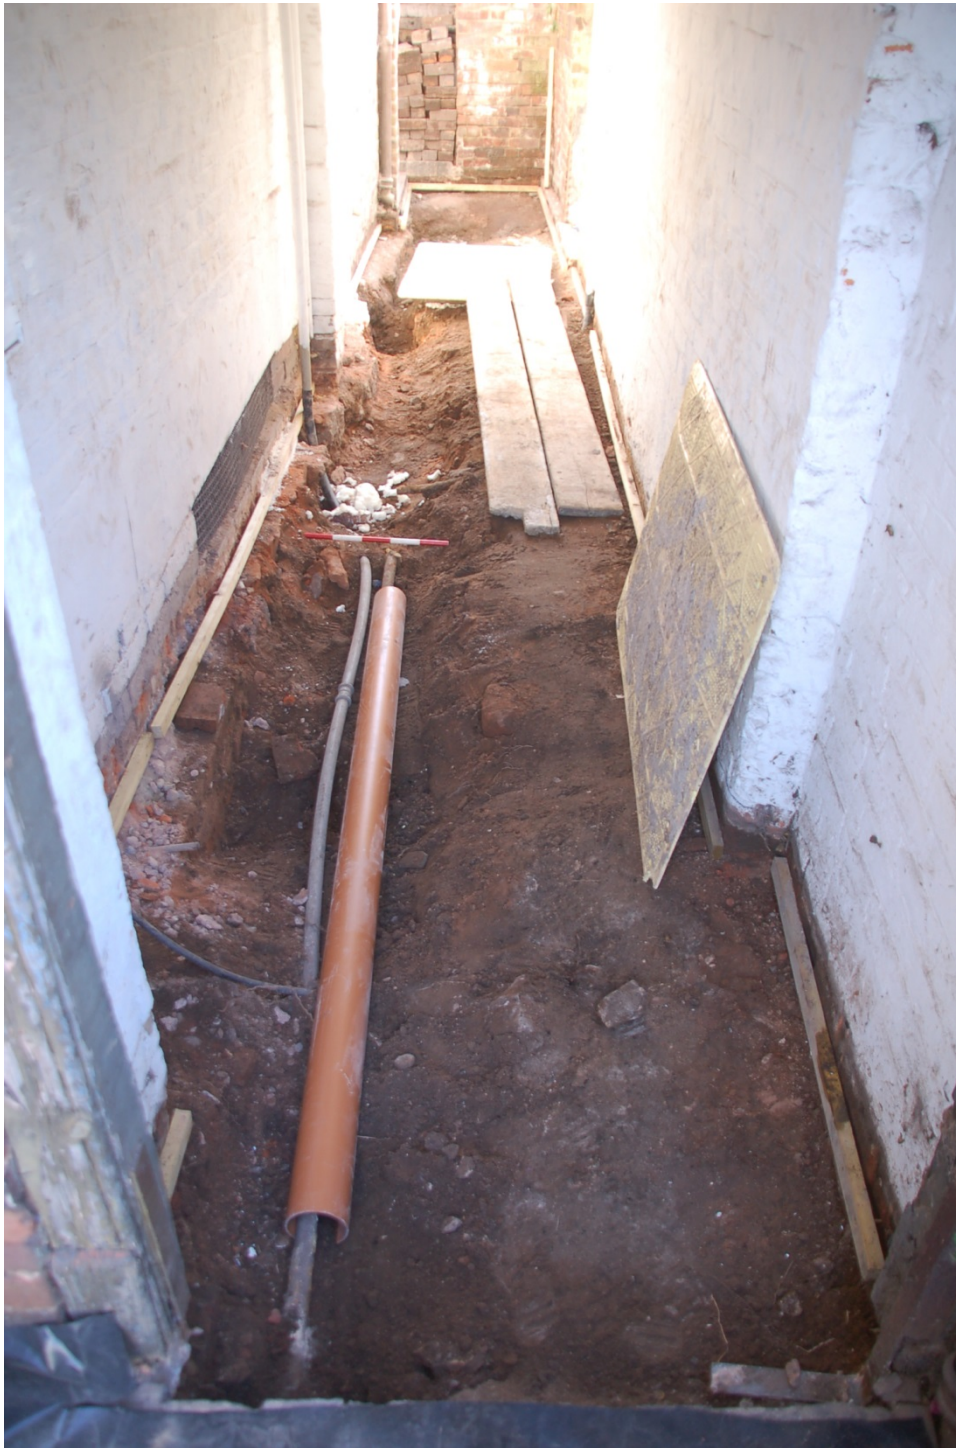
Plate 4: Trench dug along the side corridor of the property, 0.5m scale, facing south-west.

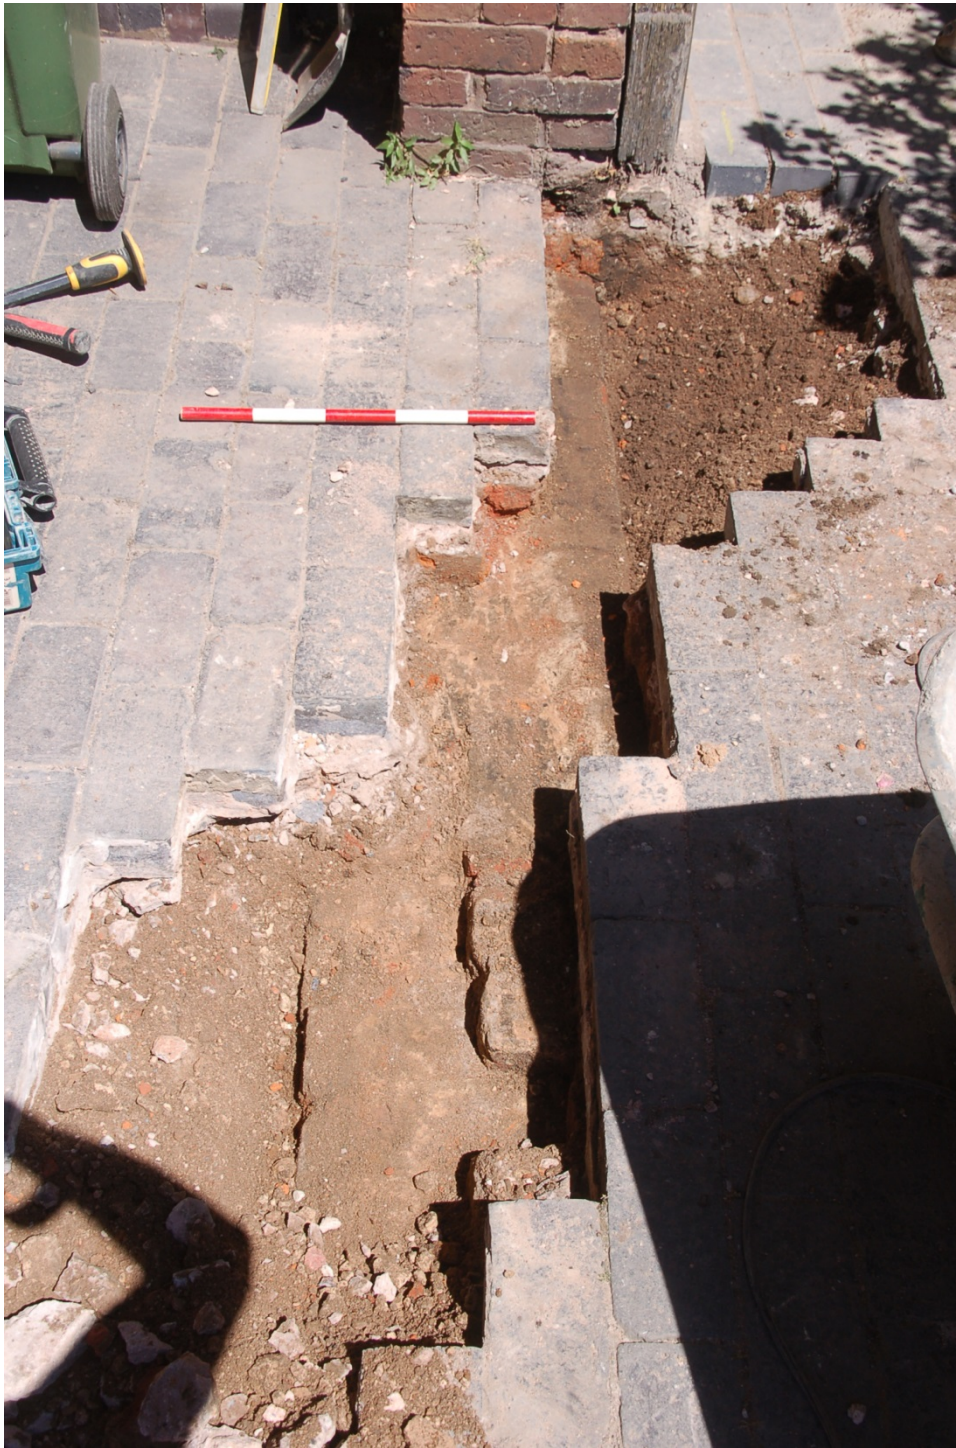
The earliest structures on site were two brick walls (contexts 3 and 5) running across the southern and gable (western) ends of the property (Plates 5 and 6). The walls were constructed of orange, handmade bricks measuring 24cm x 11cm x 6cm and bonded with a creamy yellow gritty lime mortar. The bricks were in English bond and sat on large, unbonded, blocks of red sandstone. Three courses of brick survived which measured 0.35m high and 0.50m wide. The depth of the sandstone blocks foundations were not established as they were located at the impact level of the footings for the new flood barrier.

Plate 5: Brick wall (3) on the south-east corner of the property, 0.5m scale, facing north-east.

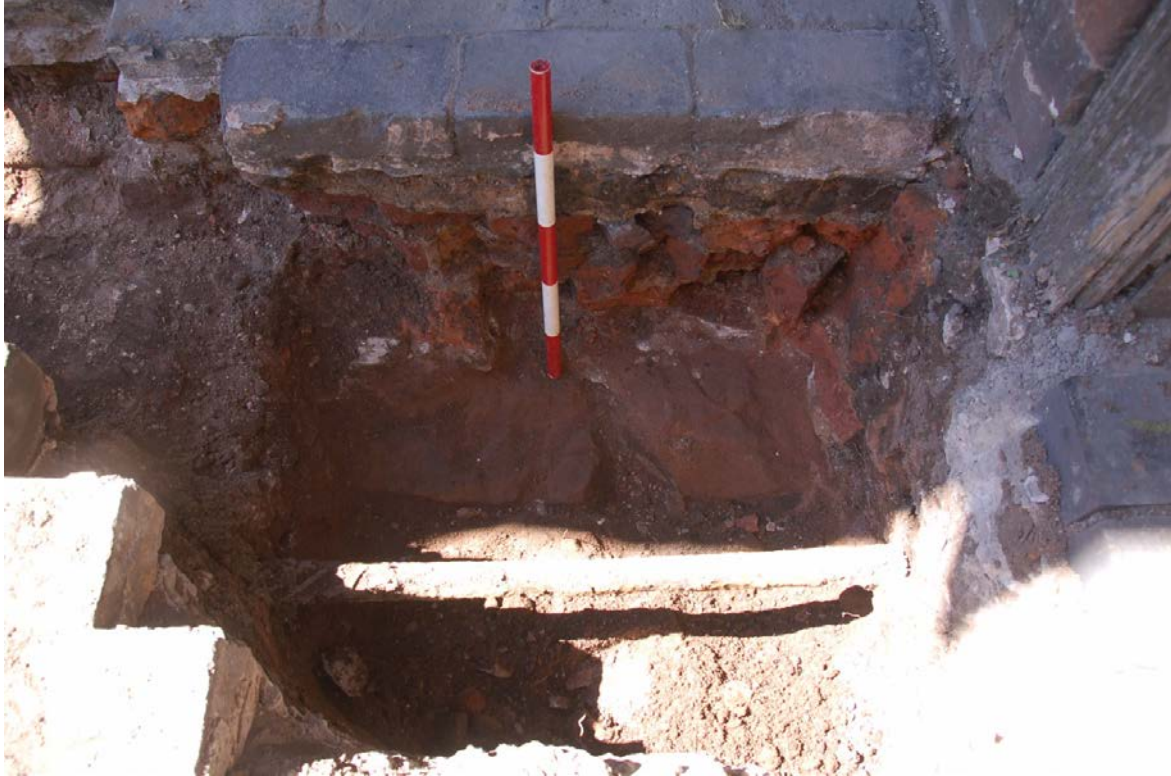
Plate 6: Brick wall (3) and sandstone footing (4) on the south-east corner of the property, 0.5m scale, facing north-east.

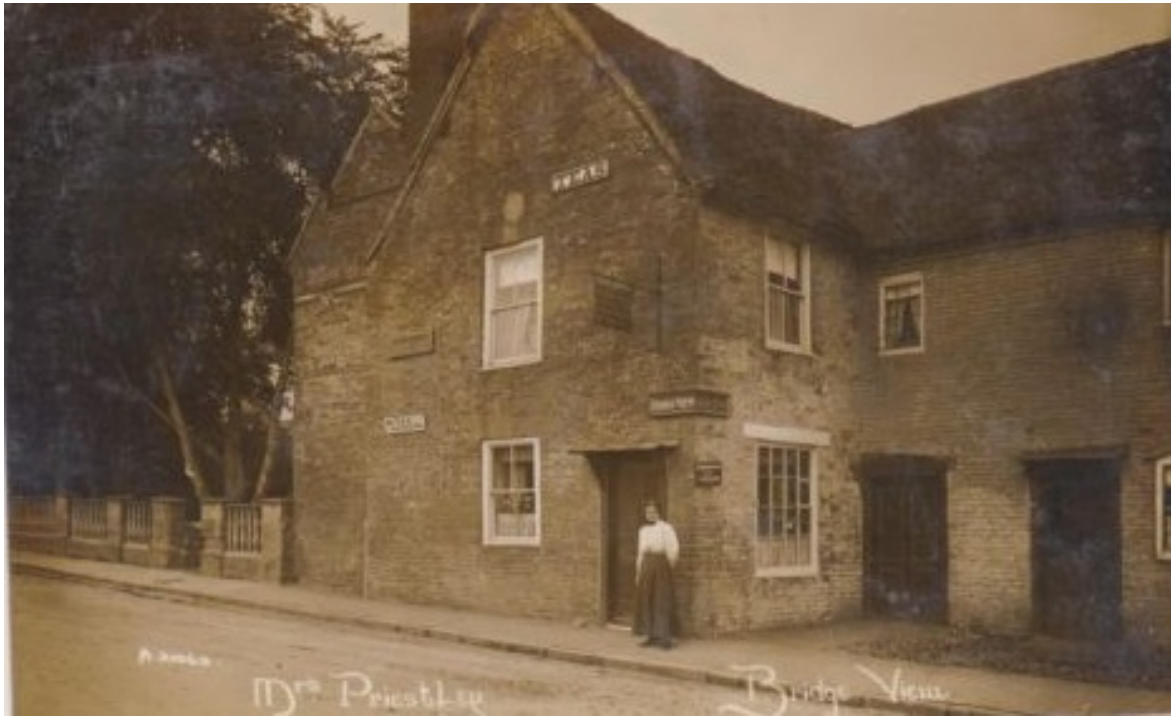
The brick walls recorded to the front of the property represent the remains of the brick cladding which had once encased the timber building (Plates 7 and 8). The timber house was probably encased when the three cottages to the south (Numbers 4, 5 and 6 Beales Corner) were erected in the mid-18th Century. The brick cladding is visible in a number of photographs of the property and is thought to have been removed when the house was rebuilt in the 1960s and 1970s. The walls and photographs indicate that the covered porch, currently present at the entrance to the property was once enclosed and formed part of the original internal space to the property.

Plate 7: Undated photograph showing the property encased in brick walls. Facing north.
