Recording of Bewdley Bridge, Stourport Rd, Bewdley, Worcestershire

Status: Version 1
Date: 29th August 2018
Author: Tim Cornah tcornah@worcestershire.gov.uk
Illustrator: Carolyn Hunt
Project reference: P5358
Report reference: 2600
HER reference: WSM70504
Oasis id: fieldsec1-326294

Building recording was required to meet a planning condition relating to the repair of a damaged section of Bewdley Bridge, Stourport Rd, Bewdley, Worcestershire.

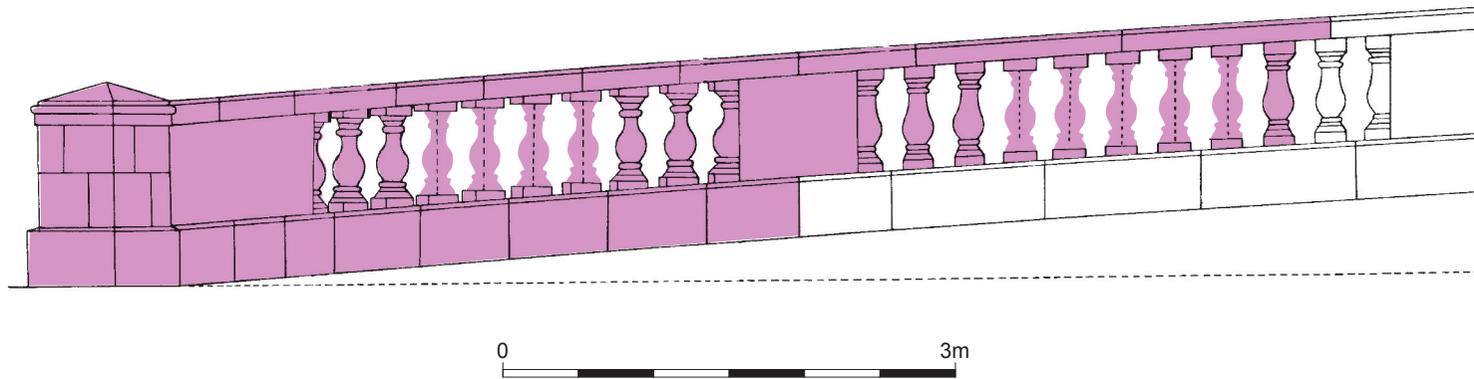
Figure 2

Extent of modern damage (based upon Dr Martyn Heyes Drg No.82182/48)

The collision of the HGV had the effect of misaligning the pillar attached to the reconstructed elements of the toll house along with its capping, all of the rail stones within the first two bays were dislodged along with all except two of the ballusters, the latter of which survive at the south-west end. The stretch of wall which originally attached to the pillar was also dislodged, along with the curbing stones below this, though those below the ballusters remained (Plate 10 to Plate 14). The extent of the damage is shown on Figure 2.

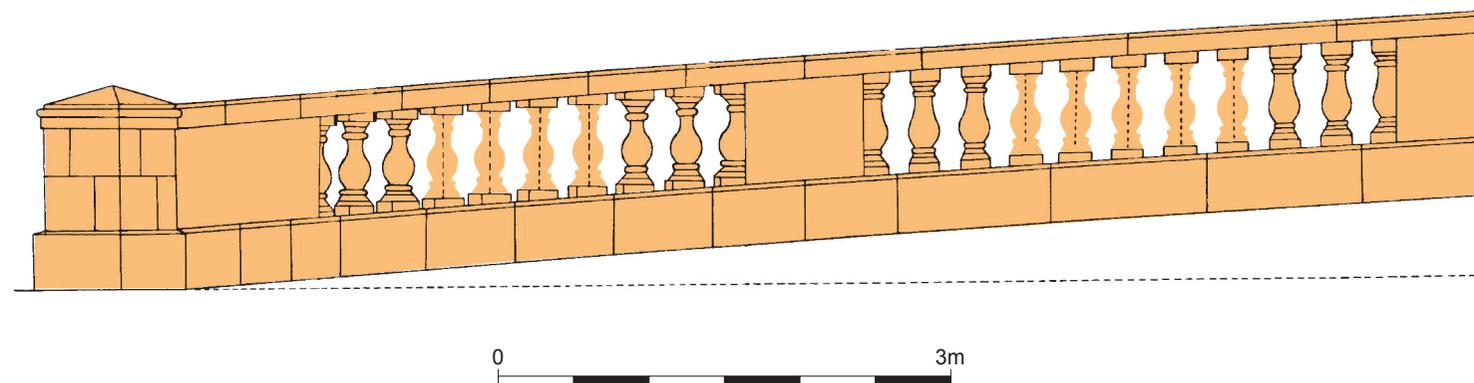
Figure 3

Extent of 1950 replacement and repair (based upon Dr Martyn Heyes Drg No.82182/48)

This period in the bridges history is a catalogue of damage, repair and replacement of the parapets, starting with an entire removal and replacement of the north parapet of the bridge to below road level in early 1950, probably to the depth of the cornice. Whether the parapet was damaged or simply degraded is not clear, but it is clear from the contemporary picture that it was entirely removed and rebuilt at least, all the way to the toll house. Un-weathered and fresh looking stone is visible within the rebuild, suggesting there was a high degree of replacement of the original materials (Plate 7) (Bewdley Historical Research Group 2005). The likely extent of the rebuild and probable replacement is shown on Figure 3.

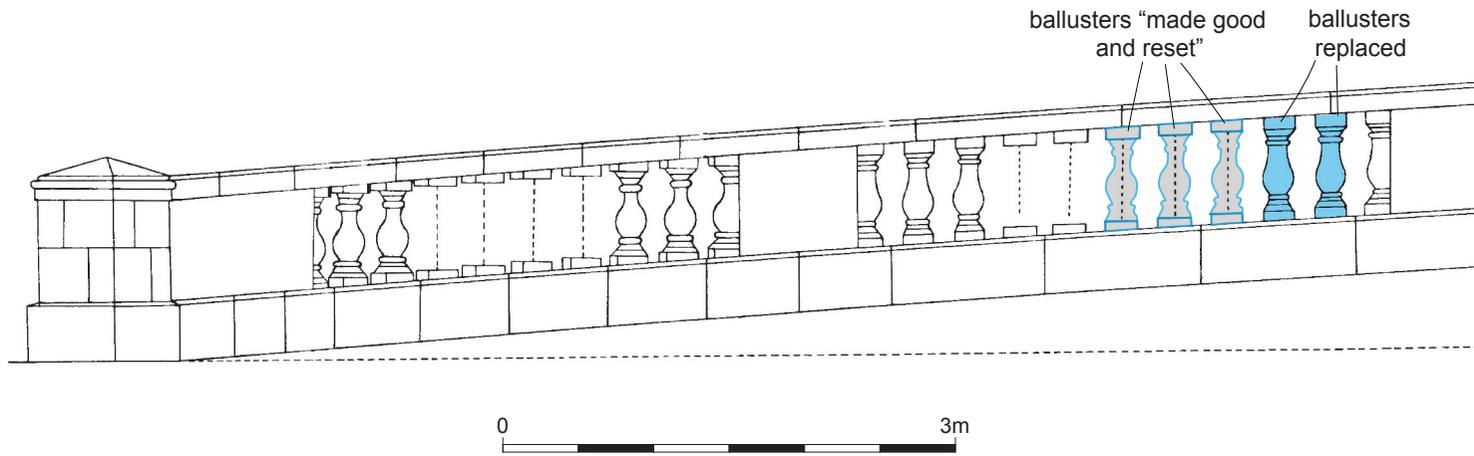
Figure 4

Extent of 1967 repair and replacement (based upon Dr Martyn Heyes Drg No.82182/48)

A survey drawing of the northern parapet in 1965 (Plate 8) details replacement of two balusters with one of those scheduled for replacement shown on the left of plate (Plate 14), with those in the centre of the bay, and now damaged, to be "made good". It must be stated that this is an initial survey drawing and does not detail that which was actually removed or replaced, nor does it give the reasons for undertaking the works. The likely extent of the rebuild and probable replacement is shown on Figure 4.

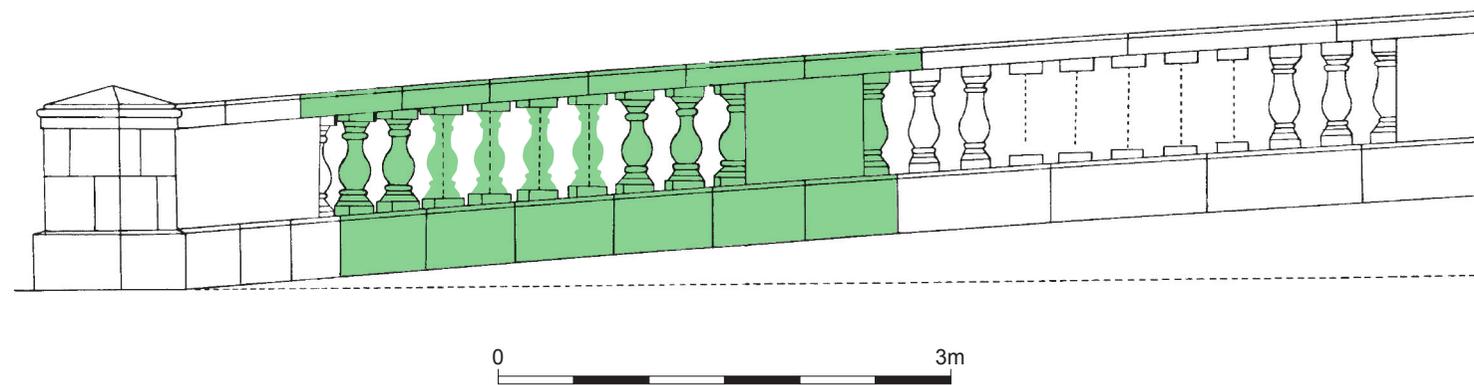
Figure 5

Extent of damage in 1993 (based upon Dr Martyn Heyes Drg No.82182/48)

A drawing of 1993 (Plate 9) details areas of damage to the northern and southern parapets at the eastern end of the bridge. The damage extended for the entire first bay of balusters, the second pillar and the first baluster of the second bay. The drawing is stated as indicative only but that some stone is re-usable, implying a high level of replacement. The section drawing shows that the parapet was replaced as far as, and including, the cornice as slate dowels grouted in cement mortar were added. The likely extent of the rebuild and probable replacement is shown on Figure 5.

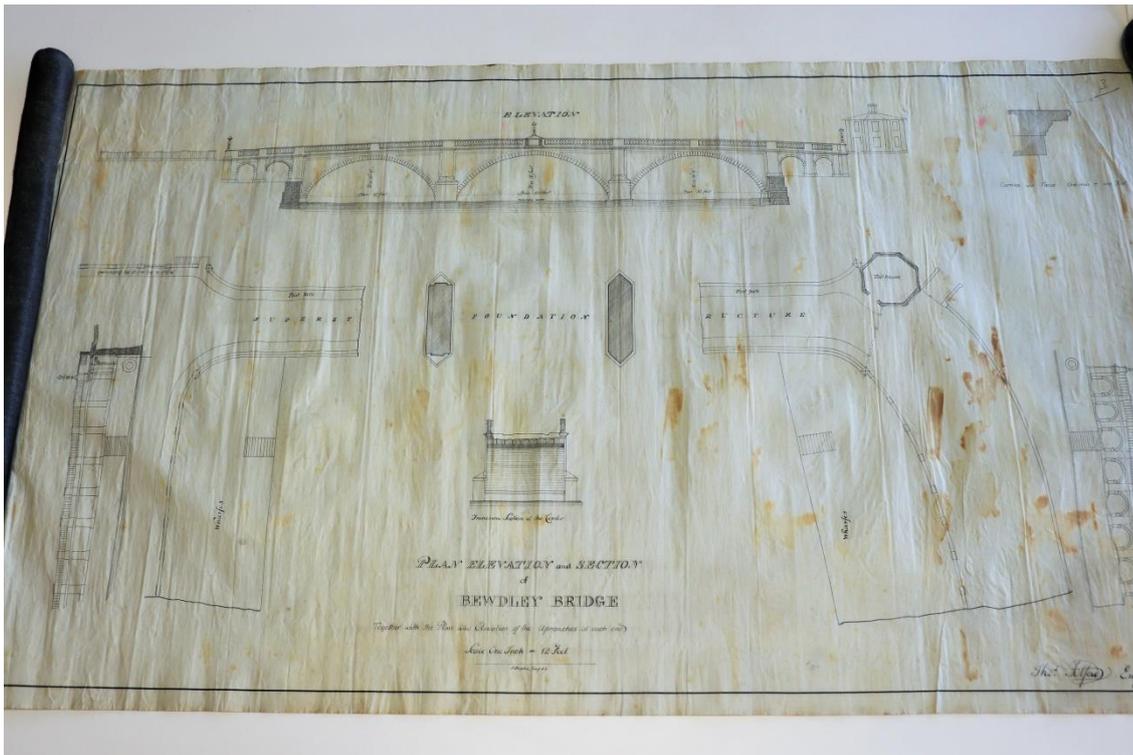
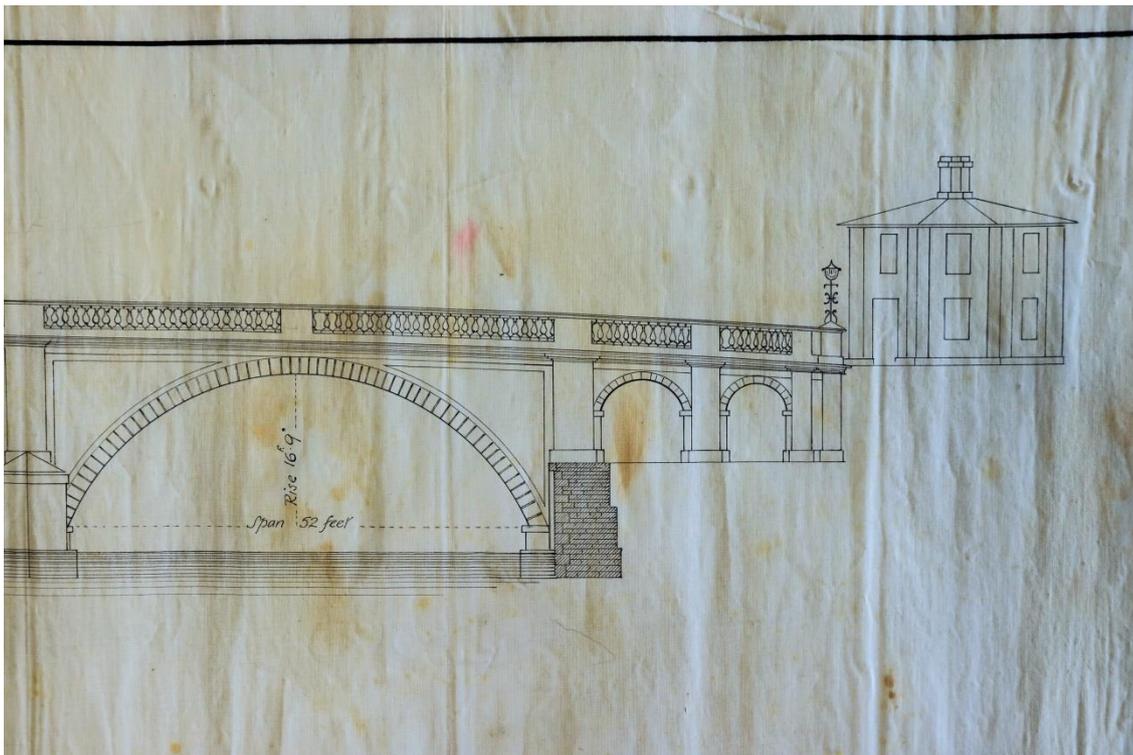
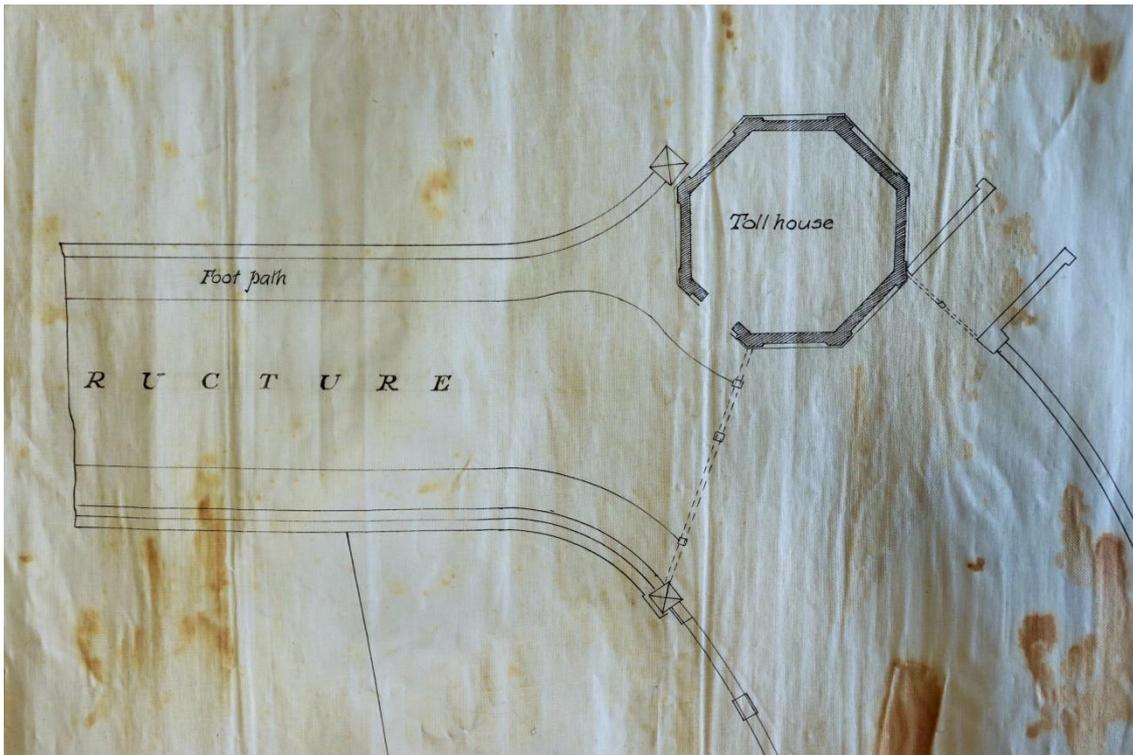
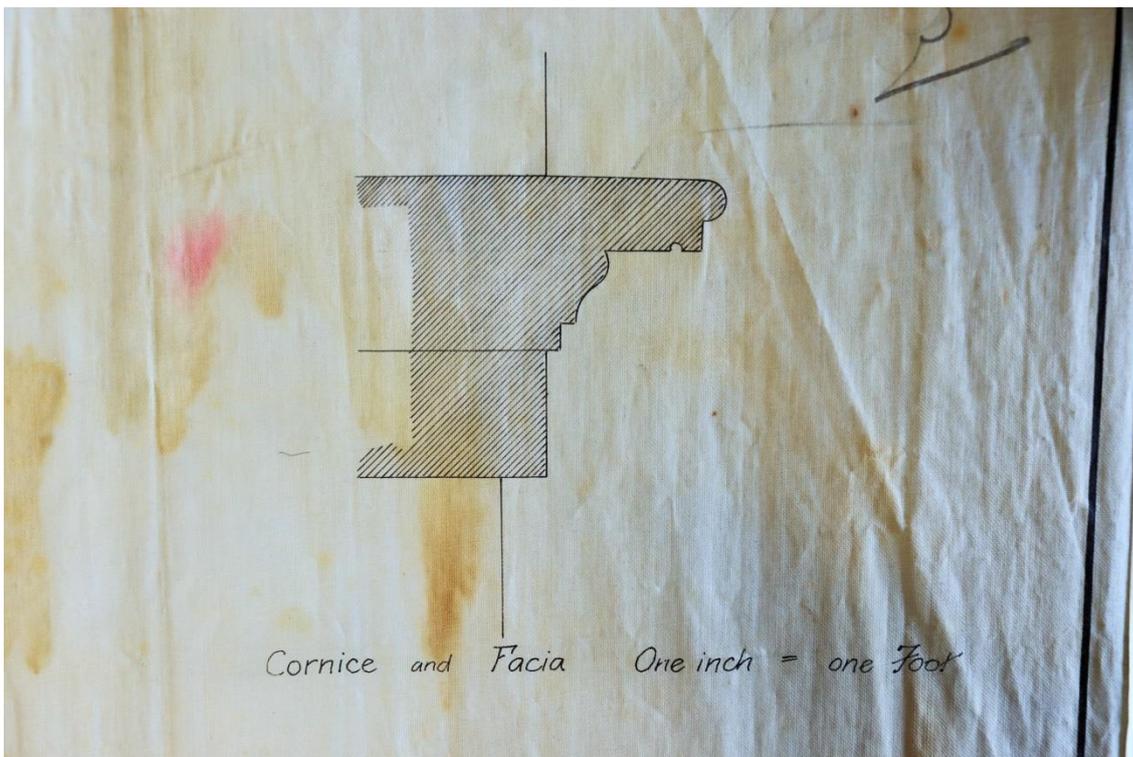
Plate 3 1797 illustration of the original bridge (WRO BA3905 s250.1)

Plate 4 1797 illustration of the bridge original (WRO BA3905 s250.1)

Plate 5 1797 illustration of the original bridge (WRO BA3905 s250.1)

Plate 6 1797 illustration of the of the original bridge (WRO BA3905 s250.1)

An original drawing of the bridge, tollhouse and abutments remain (Plate 3 to Plate 6) and are signed by Thomas Telford. These show the bridge broadly as remaining. The mapping also shows the bridge as remaining, though the 1883 Ordnance Survey map shows the toll house. Subsequent mapping up to 1947 does not show the toll house, despite it having been demolished in the 1960s.

The original bridge was constructed to closely match the plans, elevation and section as drawn in 1797 (Plate 3 to Plate 6). This is as described within the listing information as three arches over river, two towpath arches on south bank, 14 arches on north bank extending about 50 metres to south-east; balustrades on river part of stone, cast iron on land. South front: three segmental arches with rusticated voussoirs, triangular cutwaters with pyramidal caps, above which pilasters rise to the moulded cornice below the balustrade which has bulbous balusters; central pedimented tablet in balustrade bearing the arms of Bewdley.

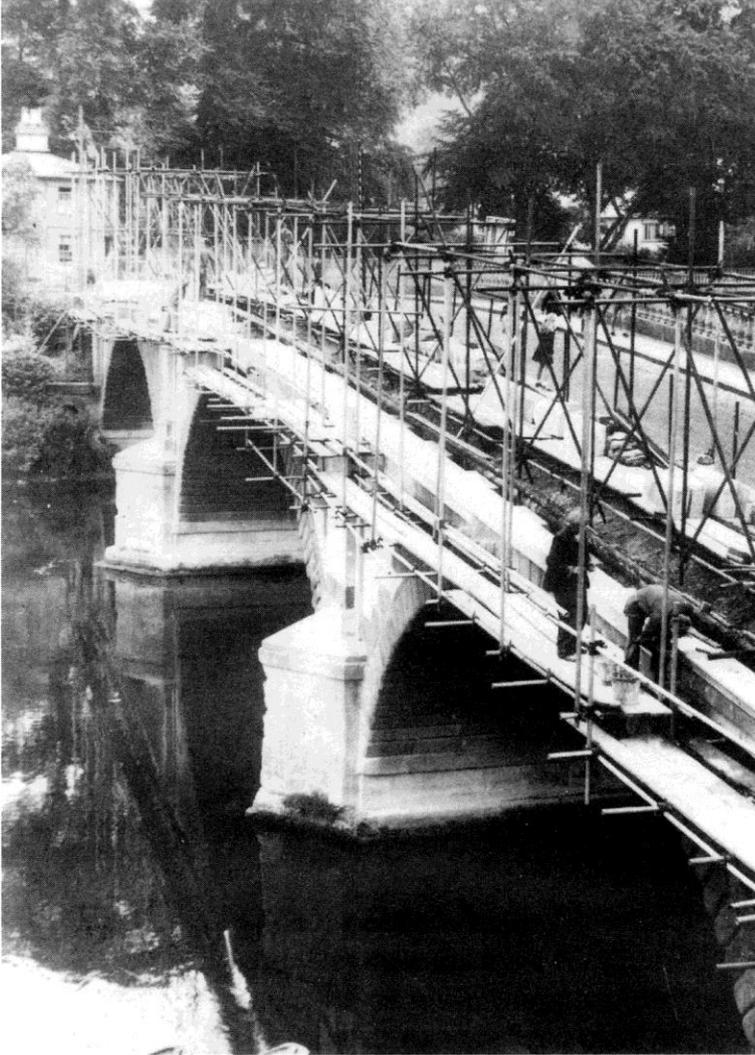
Plate 7 Entire removal and possible complete replacement of the north parapet of the bridge as photographed in 1950. New stone is clearly being used for the reinstatement (Bewdley Historical Research Group 2005)

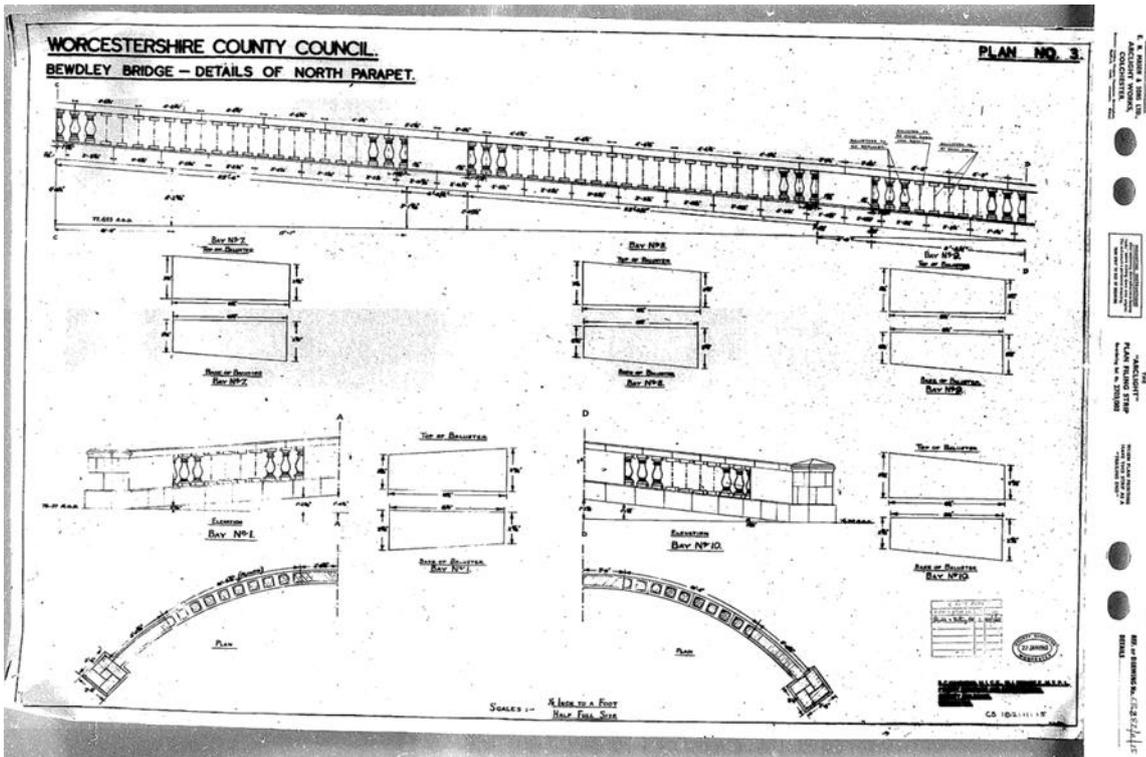
Plate 8 1965 plan of the north parapet, scheduling some replacement.

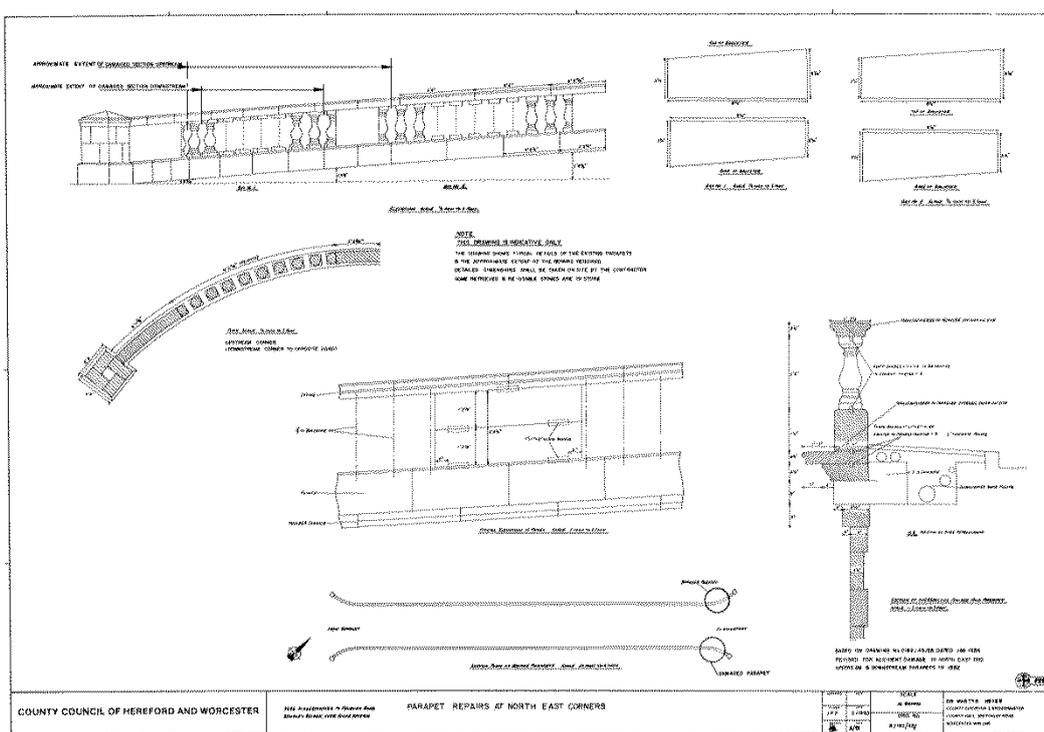
Plate 9 1993 plan of the north parapet, scheduling some replacement and detailing the area of damage.

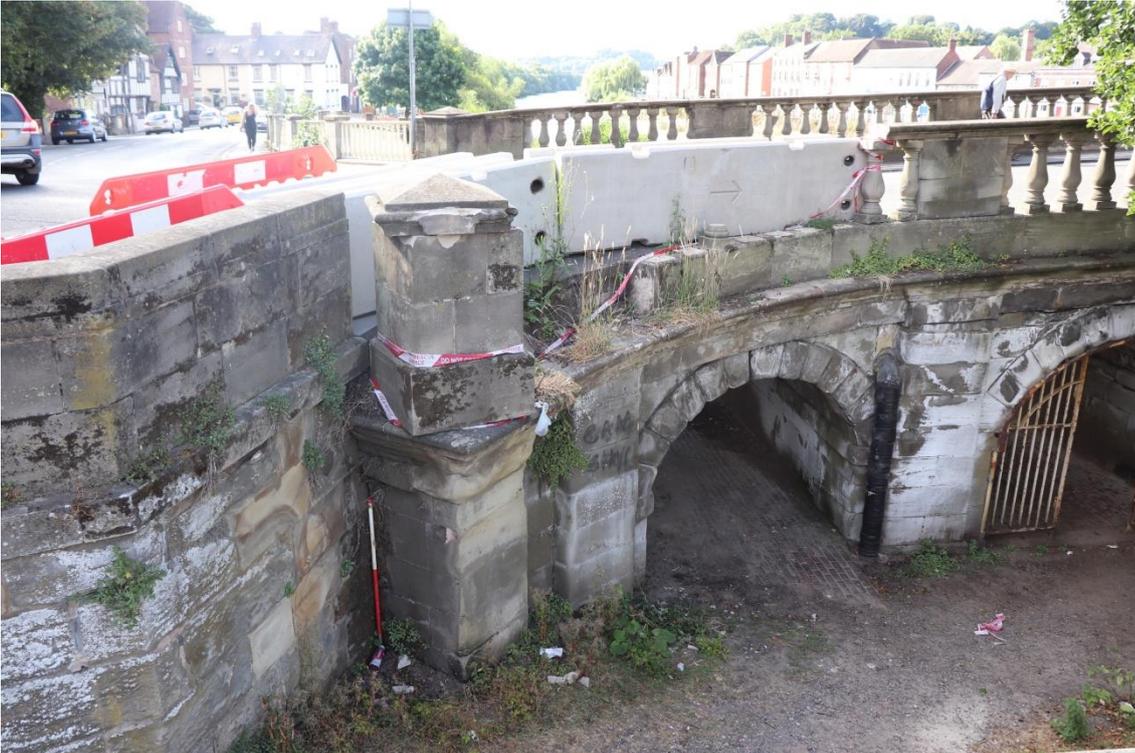
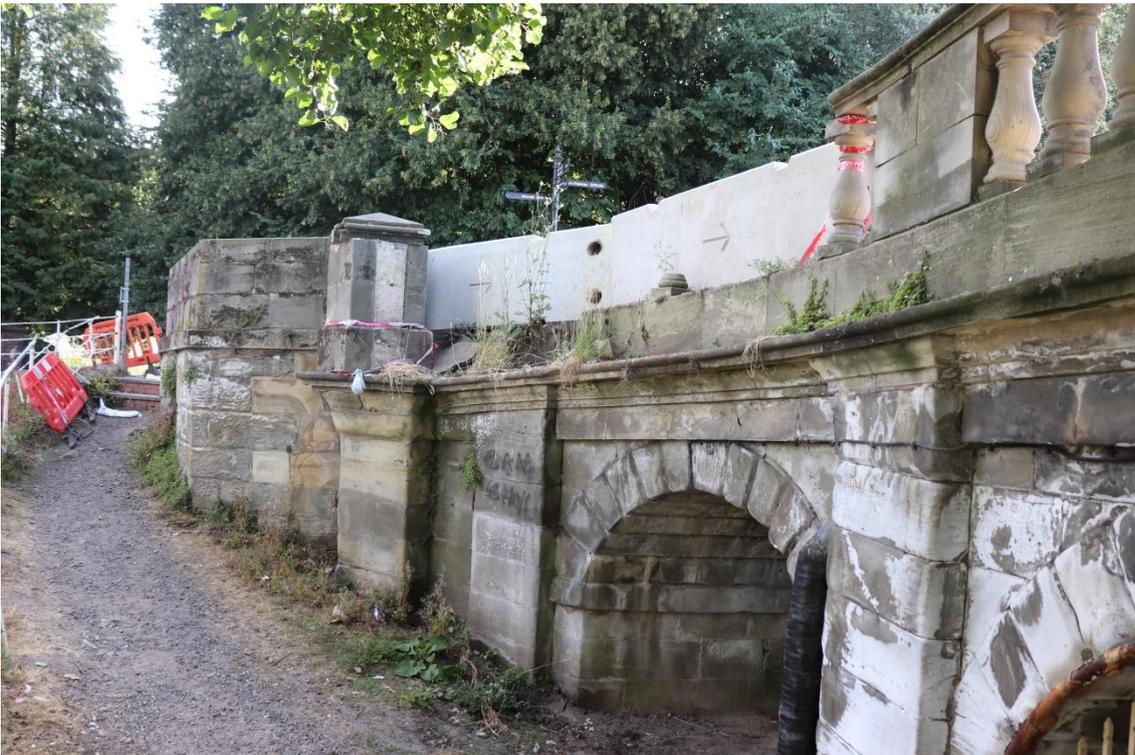
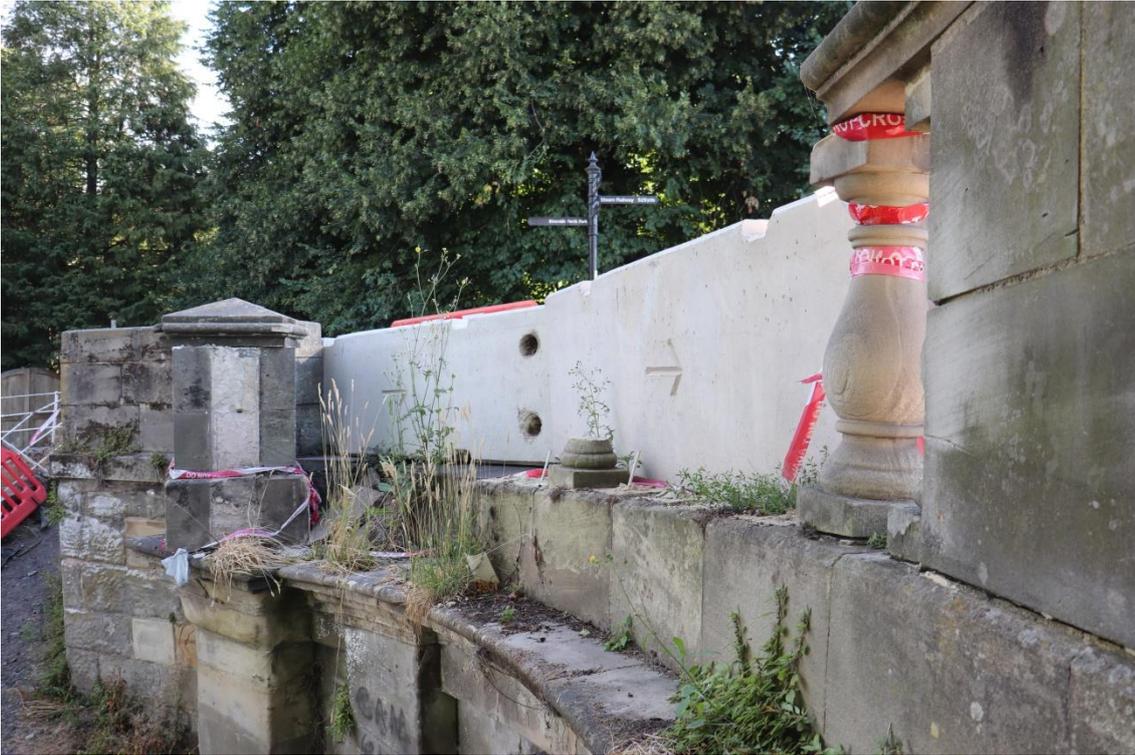
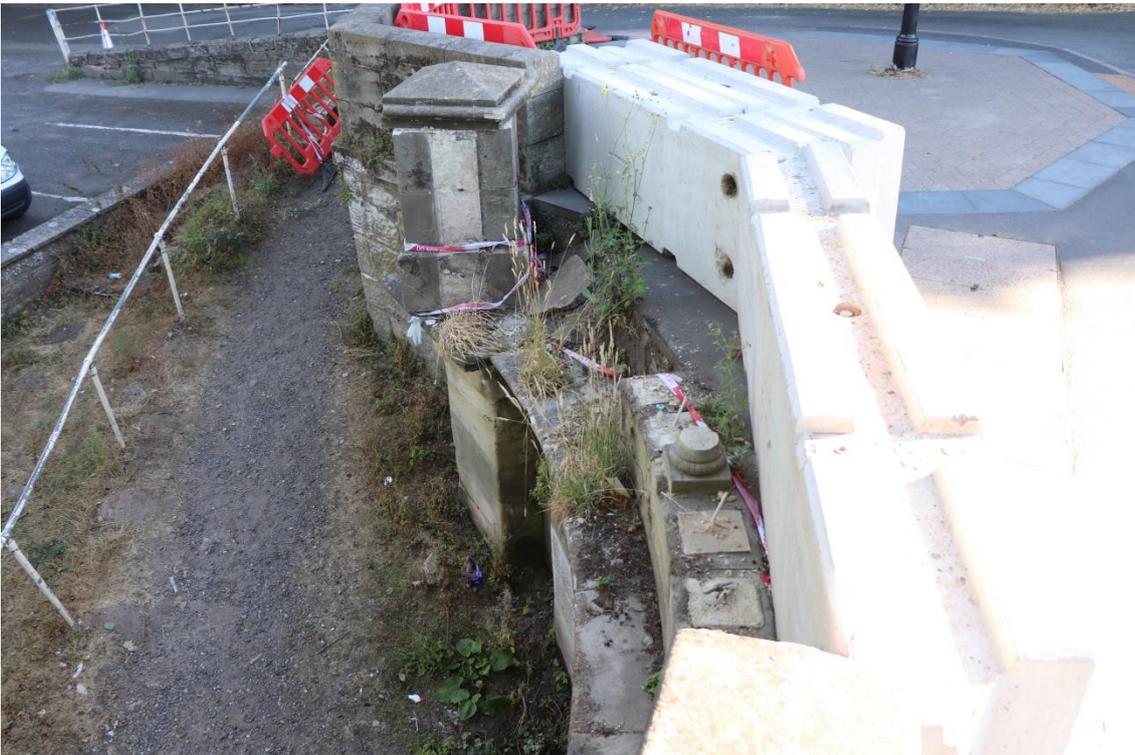
Plate 10 Damaged area of the north parapet, looking south, scale 1m

Plate 11 Damaged area of the north parapet, looking north

Plate 12 Damaged area of the north parapet, looking north

Plate 13 Damaged area of the north parapet, looking north

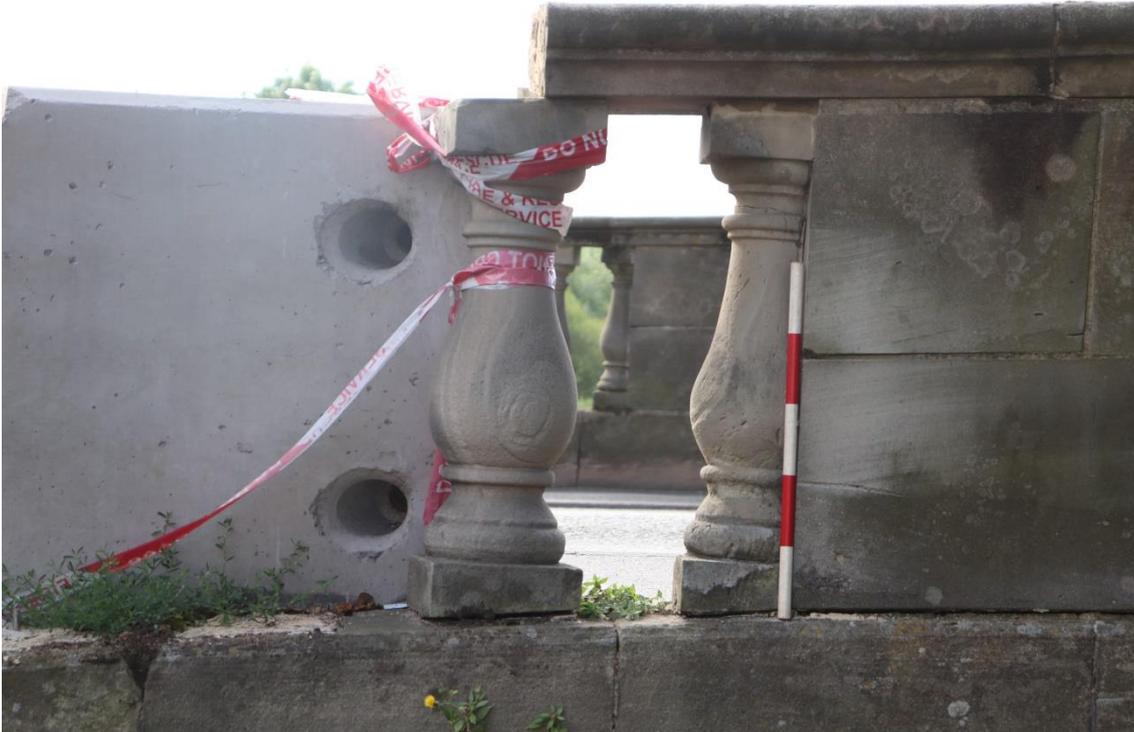
Plate 14 Damaged area of the north parapet, baluster detail, looking east

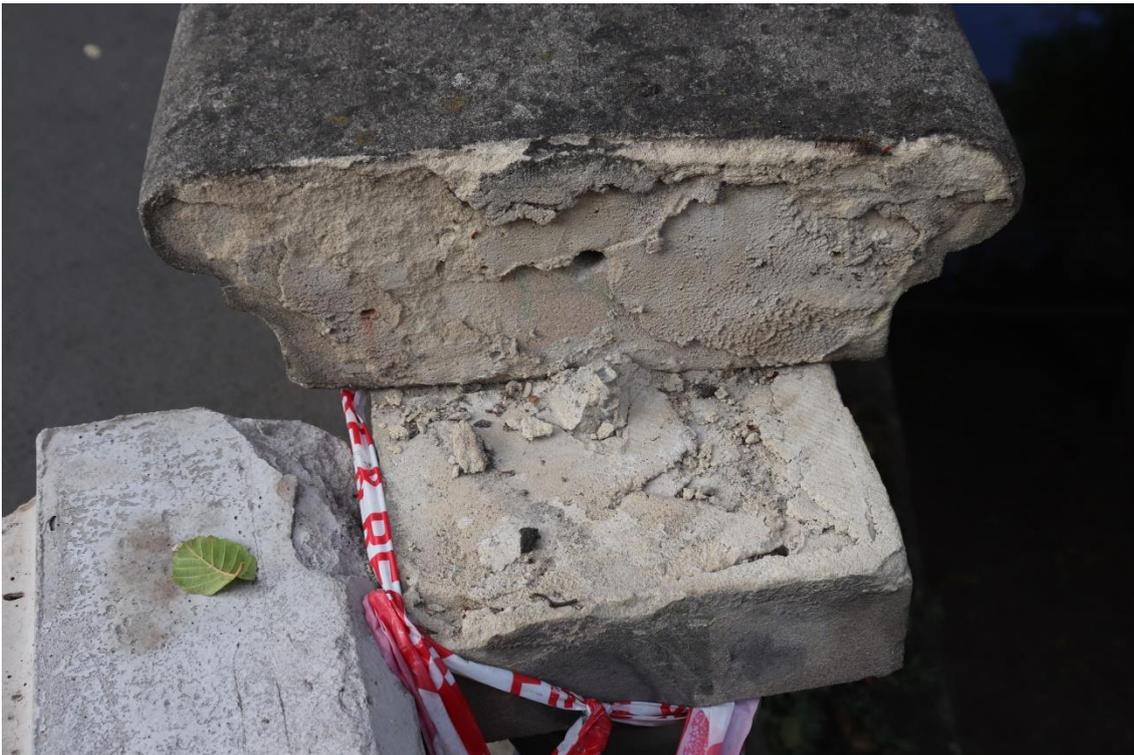
Plate 15 Damaged area of the north parapet, rail detail with central drill hole for a stainless steel dowel and acrylic resin bonding, looking south-west

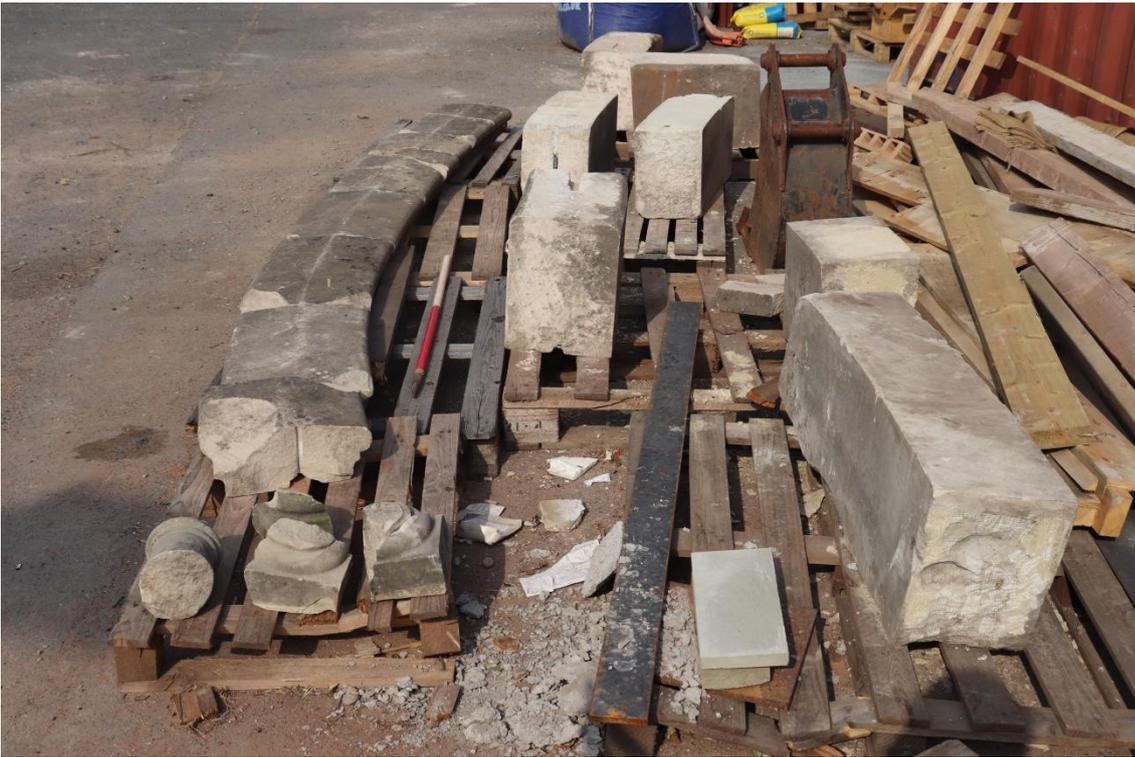
The damaged stonework itself (Plate 16) showed significant evidence for repair and replacement, not only in the form of the slots for the slate dowels as specified in 1993 (Plate 18) but also with stainless steel rods between the stones, bonded with an acrylic resin (Plate 17). These bonded the balusters to the curb stone below and the capping stone above. There is no documentary evidence as to when this took place, but presumably after 1993. This work would have required the parapet to have been taken down from the cornice stone upwards and rebuilt.

Plate 16 Damaged elements of recovered stonework

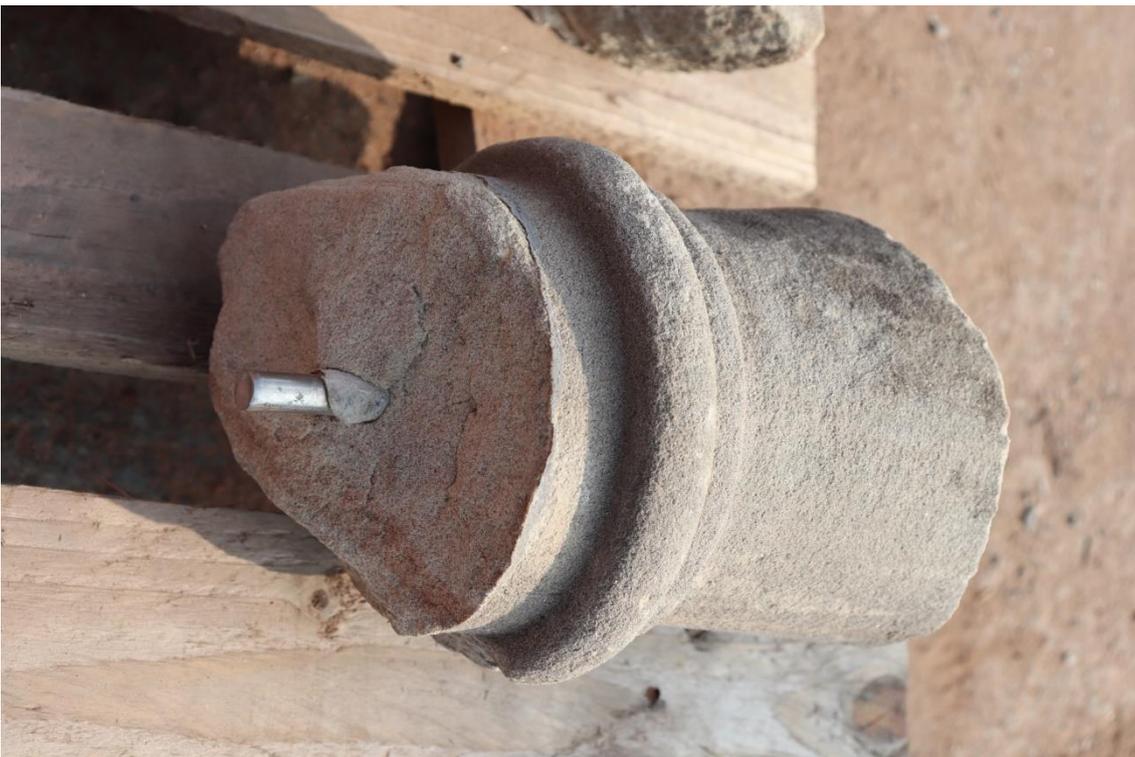
Plate 17 Damaged baluster stainless steel dowel and acrylic resin bonding

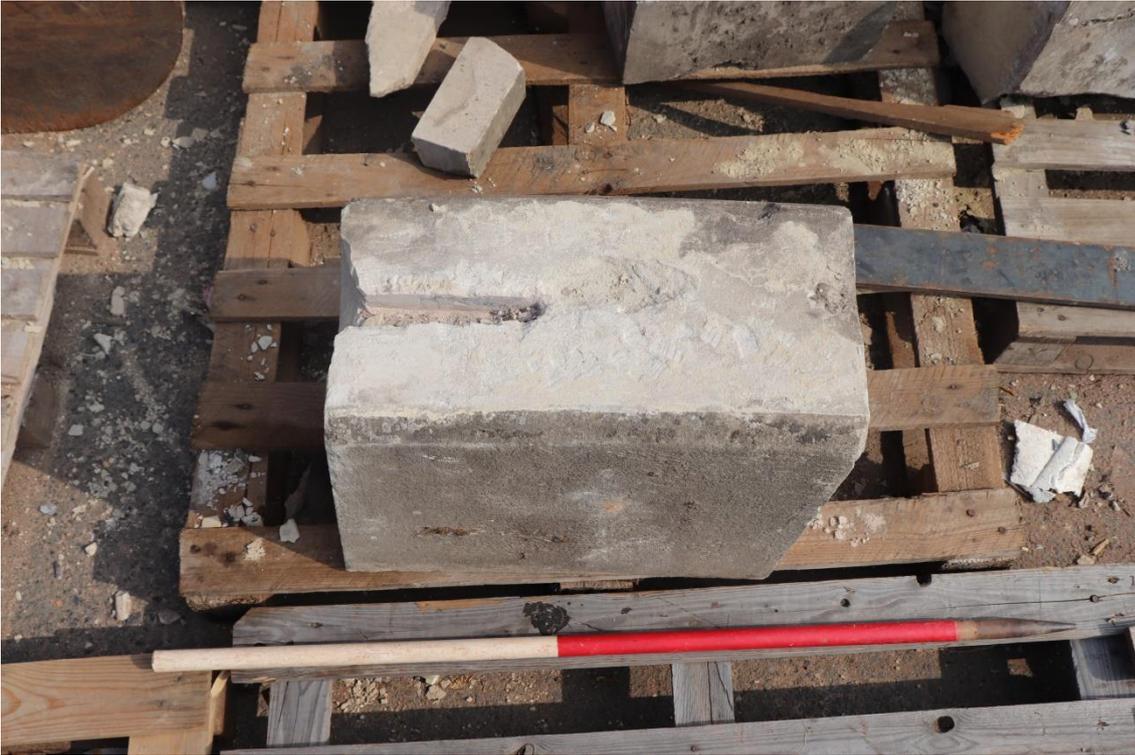
Plate 18 Mortise for a slate dowel as specified in the drawings reapiers of 1993

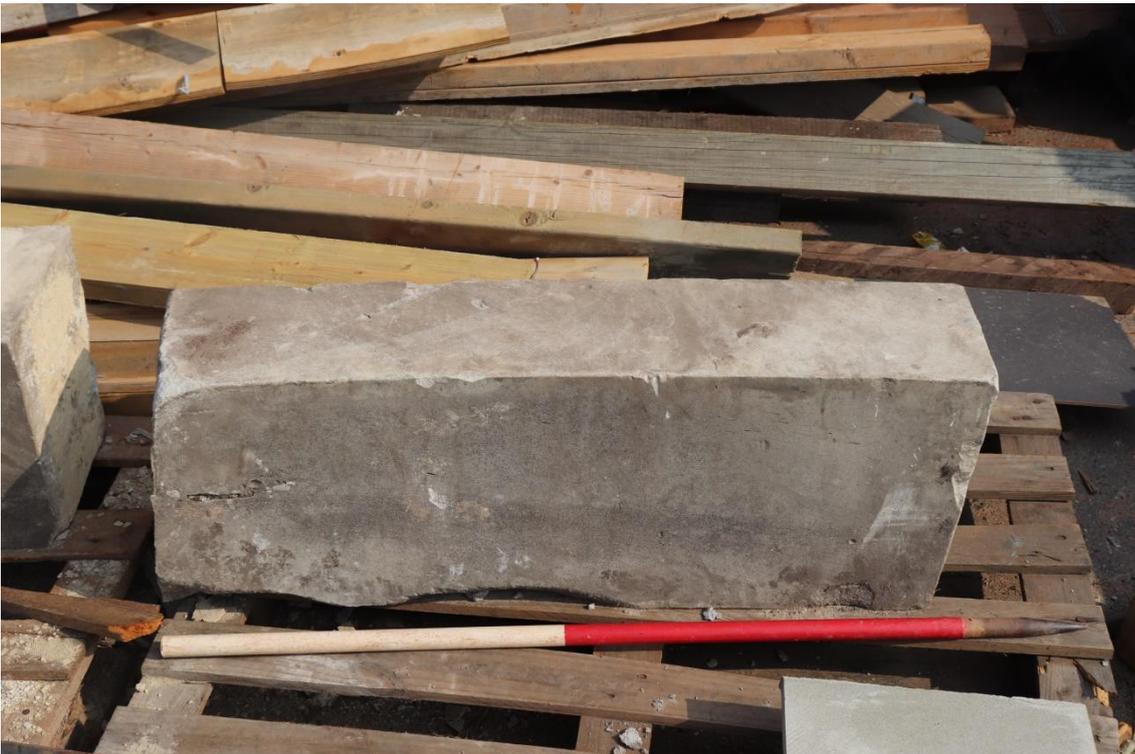
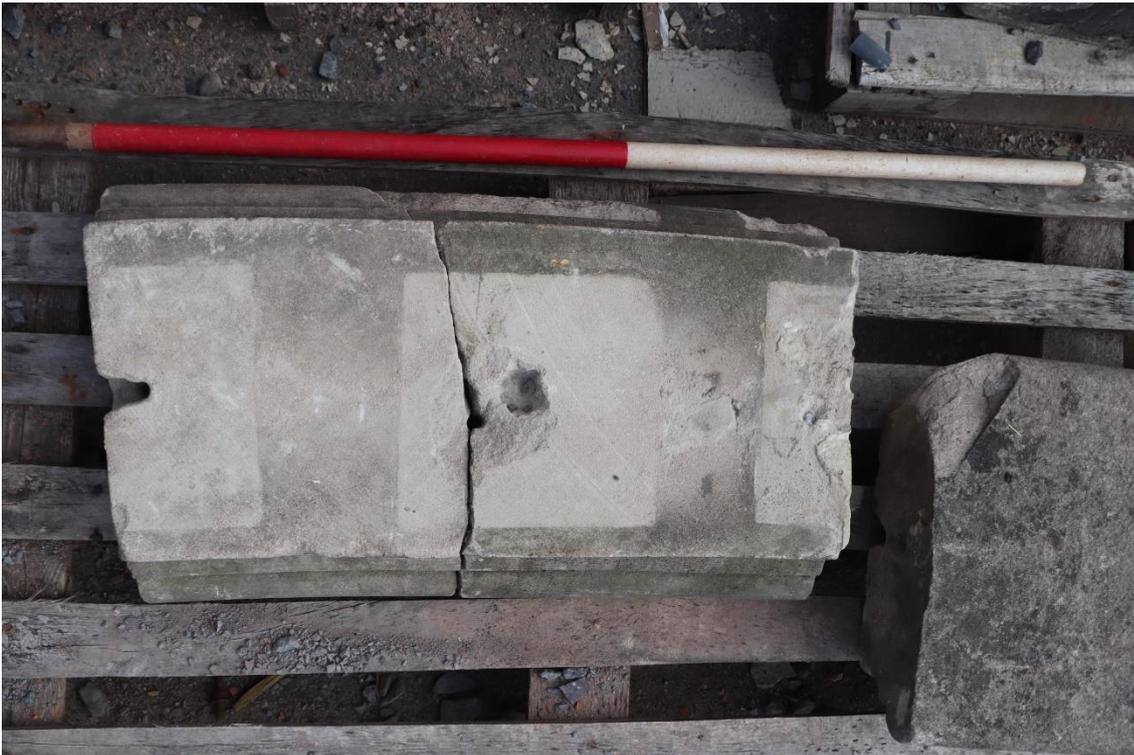
The evidence for the method of stone cutting demonstrated that a circular saw at least 0.76m in diameter was used on the top rail and the pillars (Plate 19 and Plate 20). Whilst the first known patent for a circular saw to cut stone is known from 1777, the larger circular saws for cutting facing and edging were introduced in the last two decades of the 19th century (Jones and Simons 1961), so it is likely that these were cut in the 20th century and therefore replacements. In terms of the stone itself, damaged elements were of light grey sandstone with pinkish red banding consistent with the Halesowen Formation sandstone of the original bridge, though another origin for the stone cannot be ruled out.

Plate 19 Pillar stone with evidence of circular saw conversion

Plate 20 Rail stone underside with evidence of circular saw conversion with drill holes for a stainless steel dowel and acrylic resin bonding
