# Archaeological Watching Brief at St Mary's Church Castle Road, Studley

Worcestershire Archaeology  
*for parochial church council, St Mary's Church*

January 2019

## Archaeological Watching Brief Report

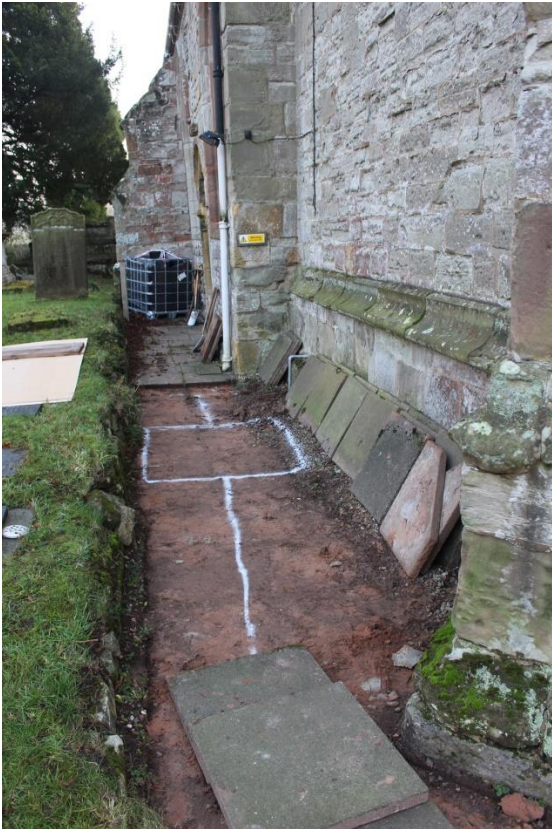
*Plate 1: Pre-excavation view of drainage route on north side of church*

A single pipe trench with associated drainage tank and soakaway pit, approximately 18m in total length, was excavated. The location of the trench is indicated in Figure 2 and Plates 1 and 2.

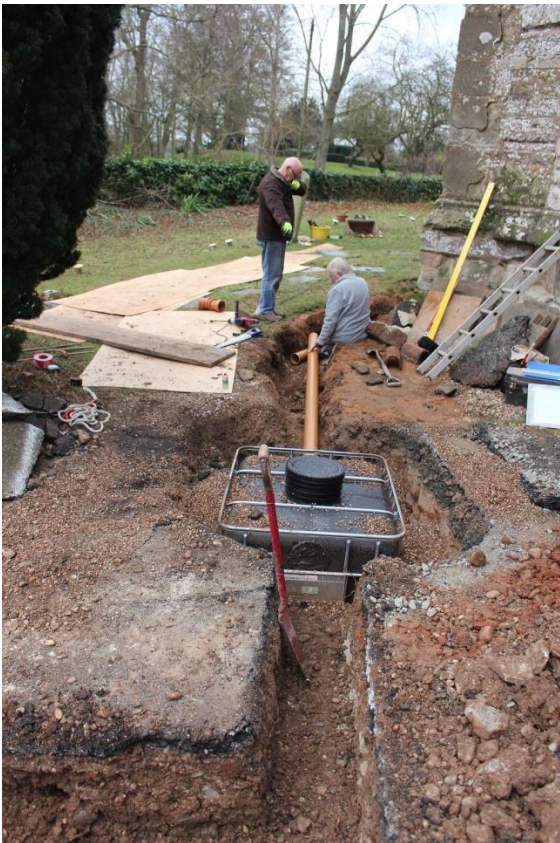
*Plate 2: Working shot of drainage route on west side of church*

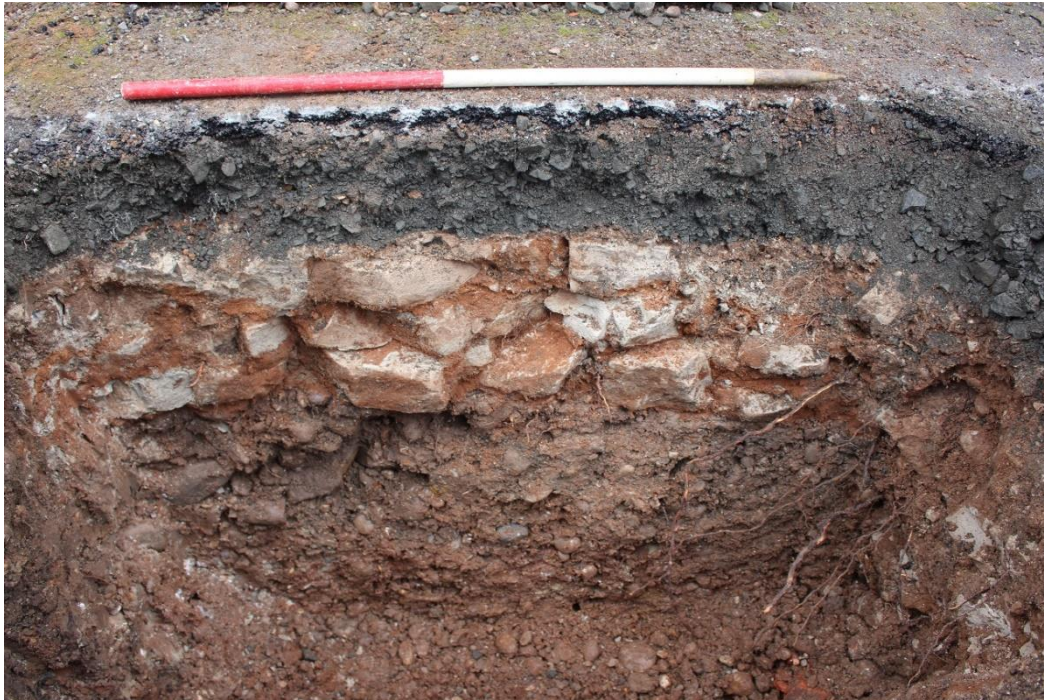
The natural Mercian mudstone geology (105) was encountered in deeper parts of the trench, during excavation of both a drainage tank and soakaway pit. This was overlain by a mixed layer containing numerous cobbles (104), perhaps made ground derived from or associated with construction of the church (Plate 3). Within the excavation area for the drainage tank, a wall foundation was located (103): this survived for three courses and was found 2m west of and parallel to the western wall of the fifteenth century church tower. There was no dating evidence recovered. The wall was sealed by hardcore and tarmac for the current entrance pathway (102).

In addition, parallel to the western wall of the church tower, was an undated wall foundation built with roughly shaped blocks. It is uncertain where this fits in the sequence of construction on the site, but it is possible this is the outer edge of a layer of foundations for the tower, or could be an additional church wall foundation pre- or post-dating this structure. Due to the limited area observed, this remains unclear.

*Plate 3: Wall foundation (103) below tarmac (102) west of church tower, facing east (scale 1m)*

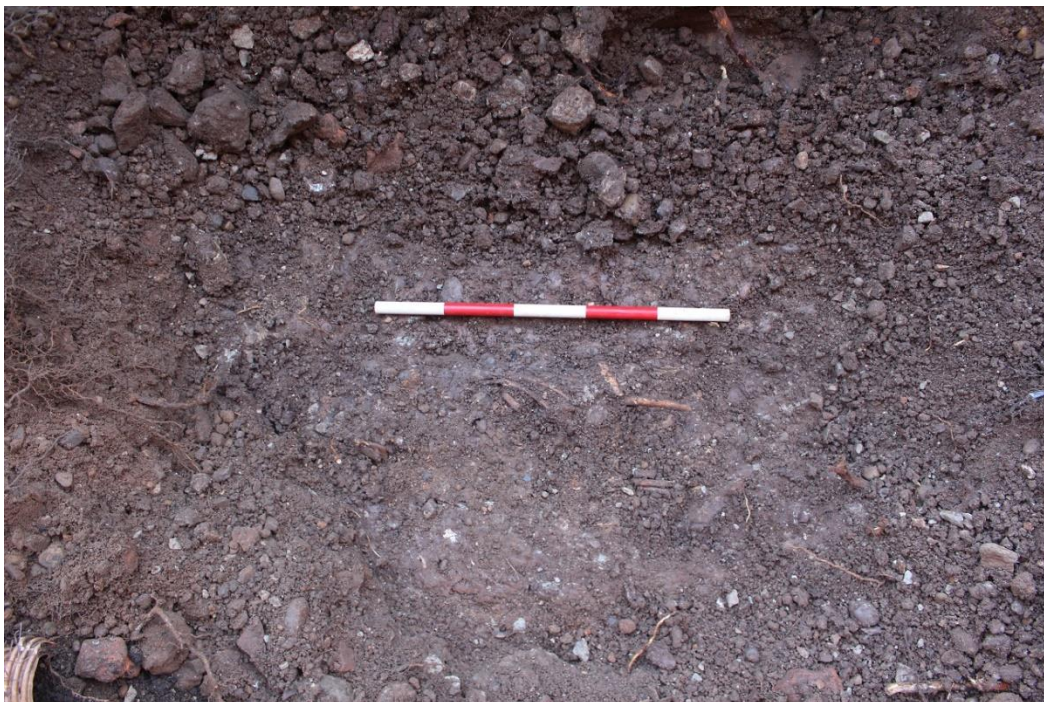
Elsewhere in the trench, excavation for the drainage pipe was less intrusive, but encountered a graveyard soil at only 0.45m below the current surface (101; Plate 4). Within this were disturbed and disarticulated human remains, as well as articulated *in situ* inhumations which were covered and left unexcavated. In one example, corroded iron nails around the edge of the burial were visible. The burials were sealed by a mixed made ground layer of sand and topsoil (100), previously disturbed by a drainage pipe.

Identified below a modern tarmac surface and mixed made ground were *in situ* human remains within a graveyard soil: these were left unexcavated and covered over before installation of a drainage pipe. The presence of corroded nails around the edge of the burial suggested that at least one individual had been placed in a coffin and could potentially be dated to the post-medieval period. Disarticulated human remains were also collected and reburied on site.

*Plate 4: In situ human remains within graveyard soil (101), facing north (scale 0.5m)*
