Building Recording at the former Ice Works, 174, Bromyard Road, Worcester

Worcestershire Archaeology
for JJS Developments

July 2019

Building Recording report

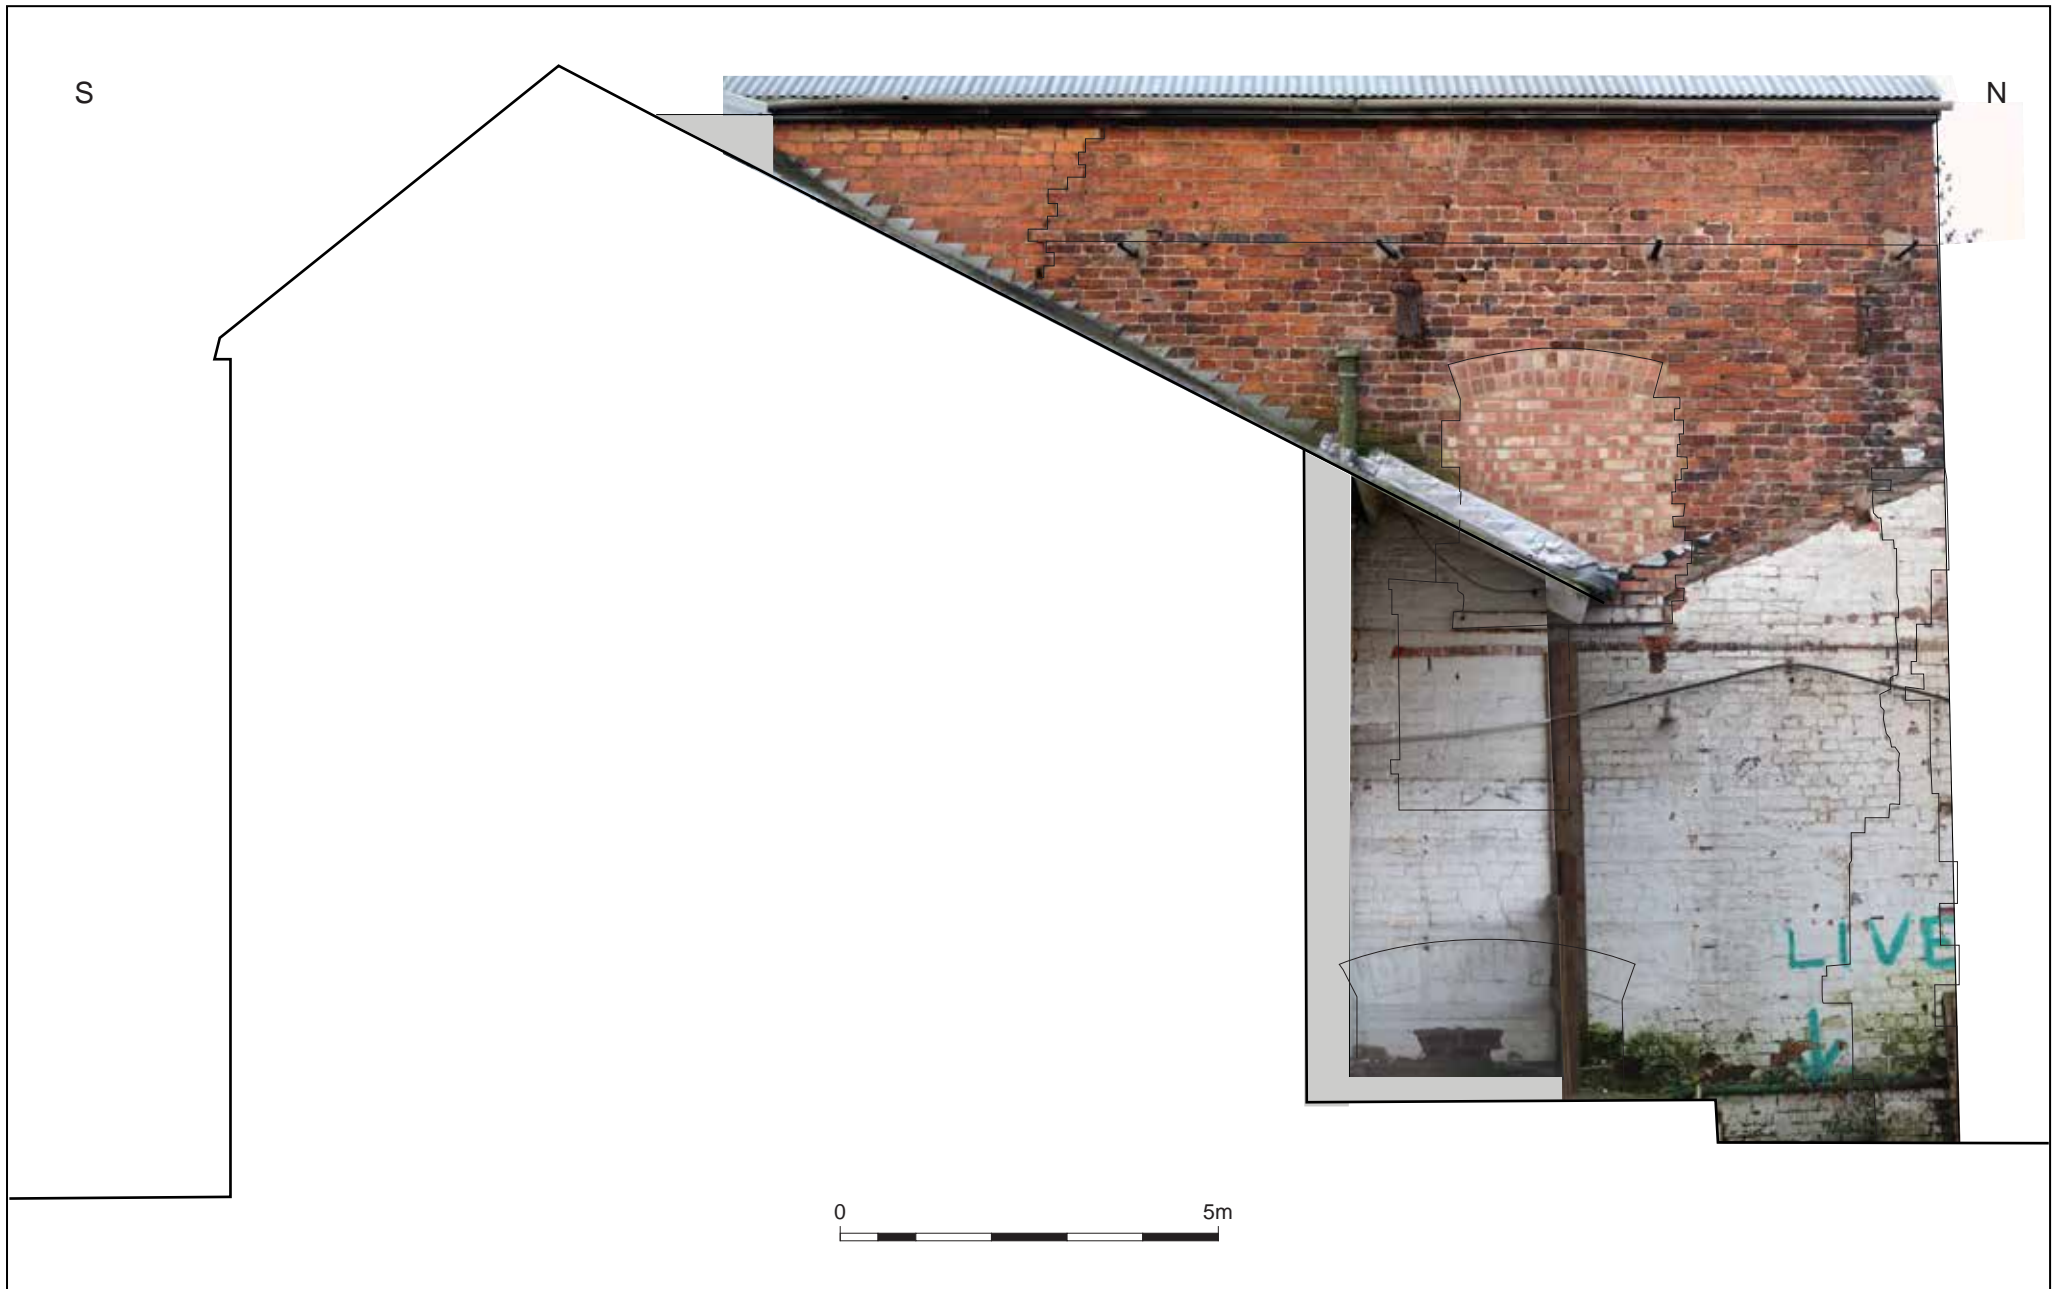
Figure 4

Phase 1 photo elevation

The earliest extant structure was a section of wall on the north east side of **building C** (Plate 3) (Figs 3 to 5). This was aligned north to south, turning a corner to run east to west. The Phase 2 mill was built onto this structure with a straight joint (Plate 4), at which point the structure again turned a corner to form a square or rectangular plan. A rectangular plan is likely as drawings for a proposed structure in 1899, to create what is now building C, shows a rectangular building aligned east to west (Plate 5), presumably with its gables at the east and west ends. These gables have at some point prior to 1899 been partially taken down and a gable erected on its northern end. Its southern wall was demolished at first floor level in 1899, with the rest removed to ground level at a later date. Little can also be said of its character at ground floor level on its northern side due to later alterations (Plate 6) although two blocked segmental arch headed windows are present within this elevation, with a further on its eastern elevation. These can be seen on a pre-1934 photograph of the site (Plate 7). Similarly, little can be said of the structure internally due to coverage by later cladding.

The exposed brickwork of this phase is of English garden wall bond. The bricks are thinner gauge than on any other structure on site, being two and a half inches in width. Whilst not conclusive, this may be indicative of a date earlier than the brick tax of 1784 after which bricks were more typically wider gauge. The building aligns closely with one shown on the tithe map of 1841, so clearly predates this. The east to west alignment of this structure is the same as that sketched on the Doharty map of 1729, though the accuracy of the sketch is questionable.

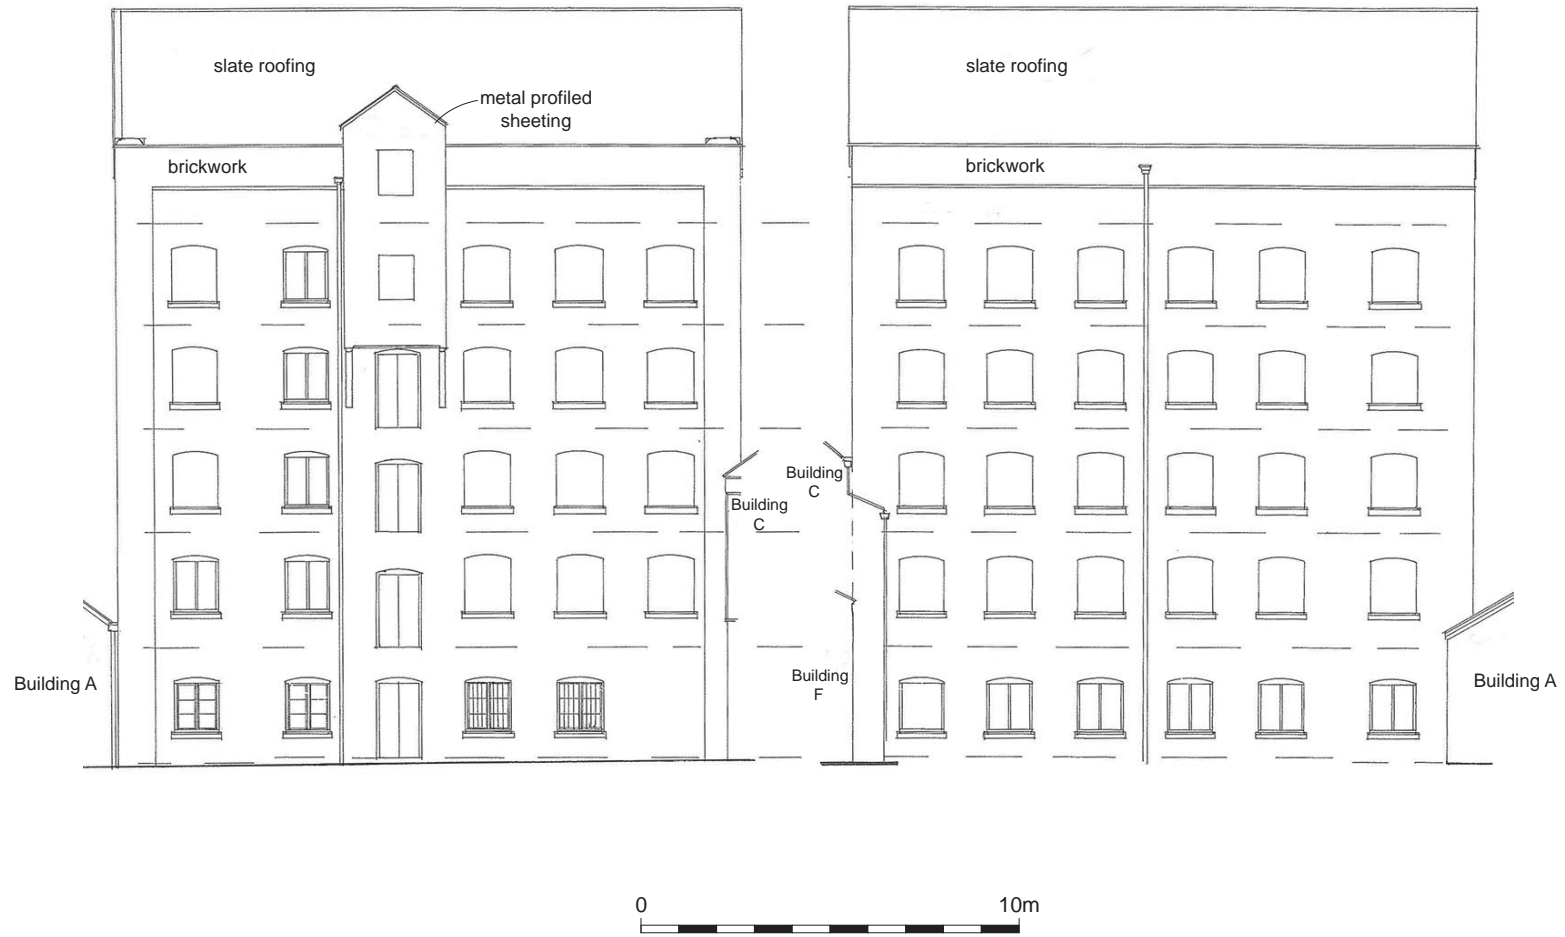
Figure 11

Building B: South and North elevations

The single largest addition of this phase was the mill building itself (Plate 18 and Plate 19). Documentary evidence suggests that this was built between 1868 and 1873 by William Hadley as previously outlined (Cornah 2015) and first seen in a photograph of the site in the 1880s (Plate 20). This building had six storeys, each of which, apart from the sixth floor, was lit by five windows at the front, south facing elevation. An off-centre door on each floor gave access out to the street for loading and offloading directly from each floor. The fifth and sixth floor doors were covered by a clad, projecting timber structure known as a Lucam. The overall layout of the windows and doors of the front elevation is regular, a pattern which is repeated on the rear, north facing elevation. The west facing elevation has two windows on the third, fourth and fifth floors, along with a single round window toward the apex of the gable end on the sixth floor. The east facing elevation has two windows on the fifth floor, along with a round window toward the apex of the gable end on the sixth floor. Other windows at lower levels may have existed but are likely to have been blocked at a later date.

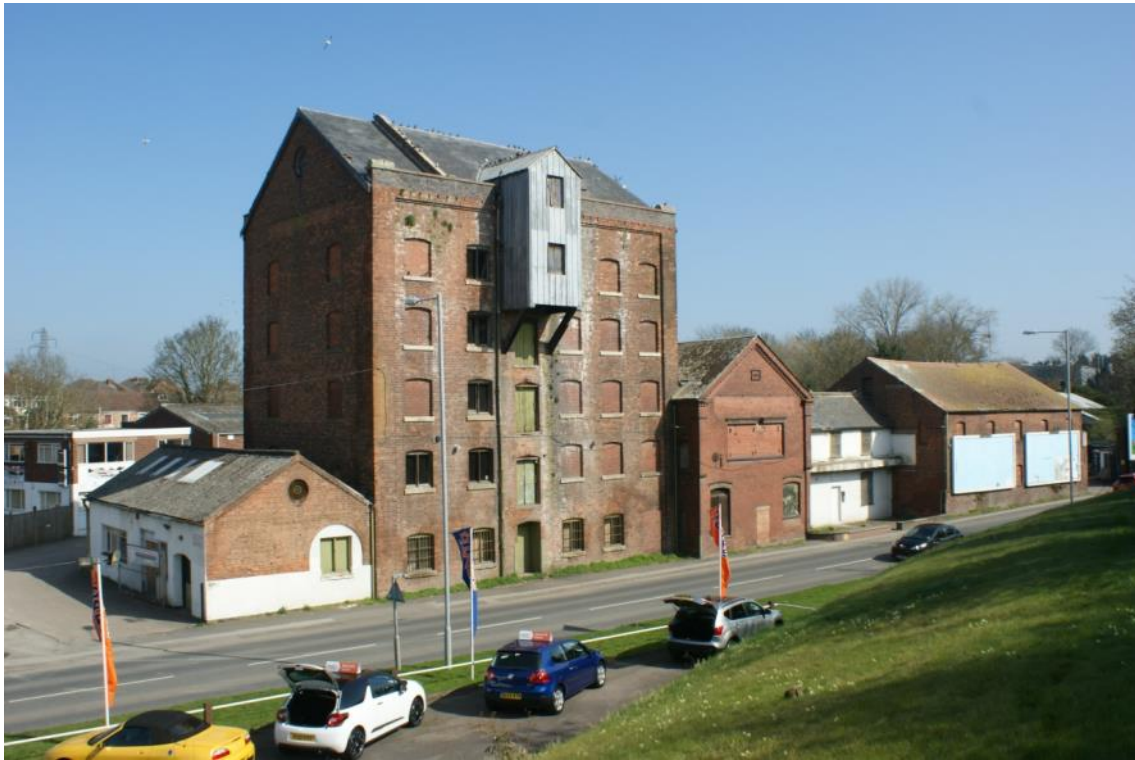
Plate 1 The former Ice Works buildings, looking north-east

The buildings comprised eleven structures, with the earliest being brick built and dominating the road frontage. This is particularly true of the five storey mill structure which is flanked by ancillary structures such as the house and warehouse. To the rear of these are some later brick structures as well as clad steel framed structures added throughout the 20th century. At the time of this recording, some of the ancillary 20th century structures had already been demolished. The buildings can be seen broadly on (Figs 4-17) and (Plate 1 and Plate 2).

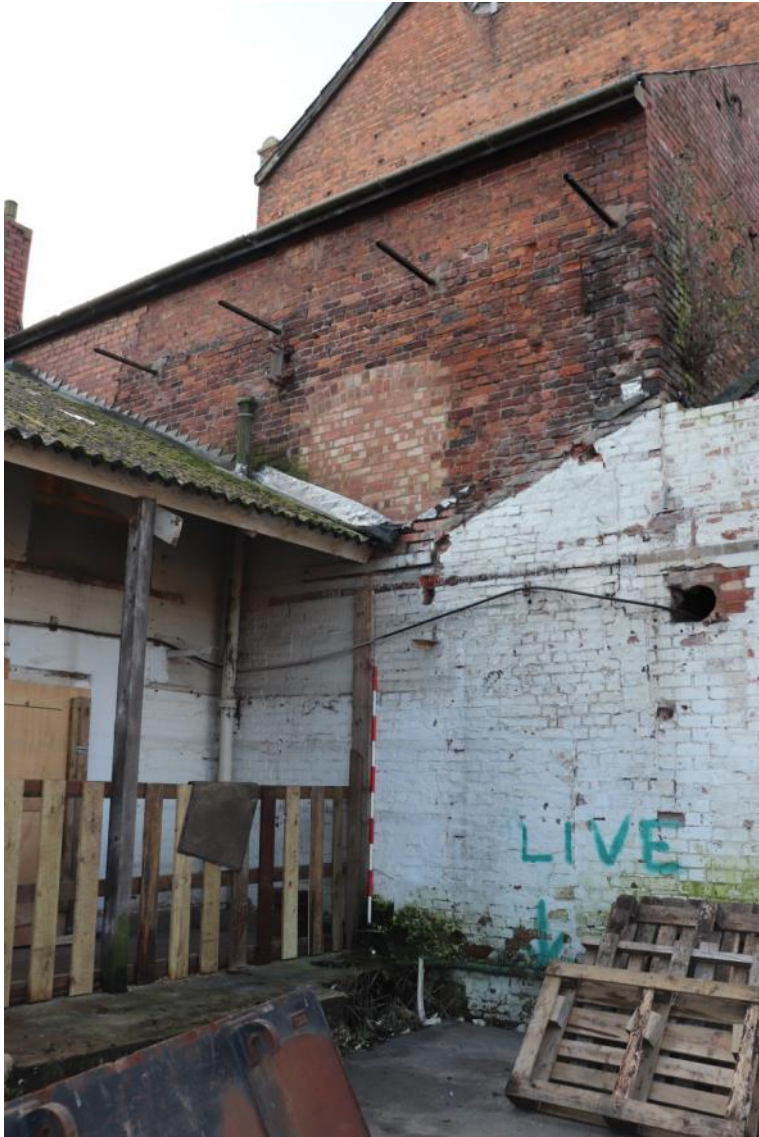
Plate 3 Phase 1 structure, looking south-west

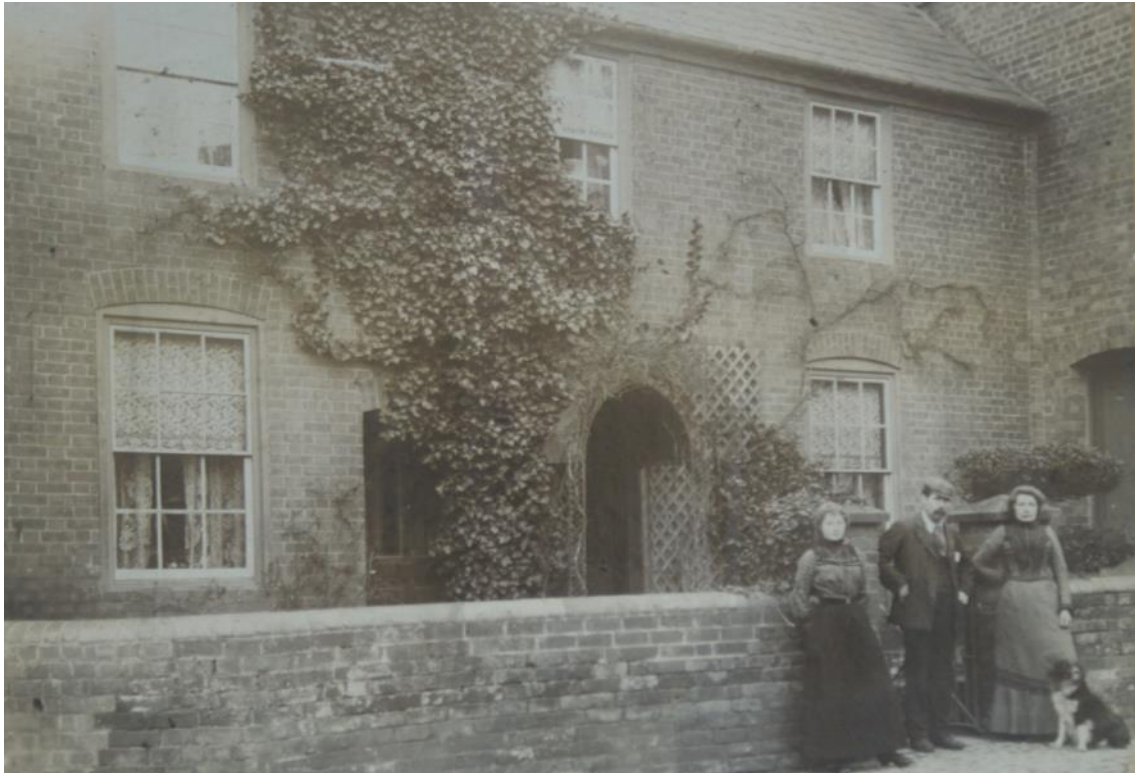
Plate 8 Building D c 1890-1910, looking north-east (reproduced courtesy of Worcester and Midland Coldstores Ltd)

Building D was brick built with a low pitch slate roof with its frontage facing the street with sash windows flanking a central door, with three further sashes above (Plate 8 and Plate 9). It was split up internally into two rooms on each floor which are separated by a passage that contained the staircase (Plate 10 to Plate 12). The front of the house was accessed from an off centre doorway, later blocked, which led into the western ground floor room. Secondary doors to access the western and eastern rooms led off the central passage. The western room on the ground floor was heated by a fireplace, for which a chimney can be seen above the western gable. The first floor rooms continued broadly the same layout (Plate 13 and Plate 14). The overall layout is suggestive of domestic space, an interpretation supported by the front windows being lit by sash windows. A further blocked window position was partially visible its eastern ground floor gable, implying that this house predated building E to its east. The softwood roof structure (Plate 15) confirms the original two room layout of each floor with the original back external wall on the north side of the central staircase.

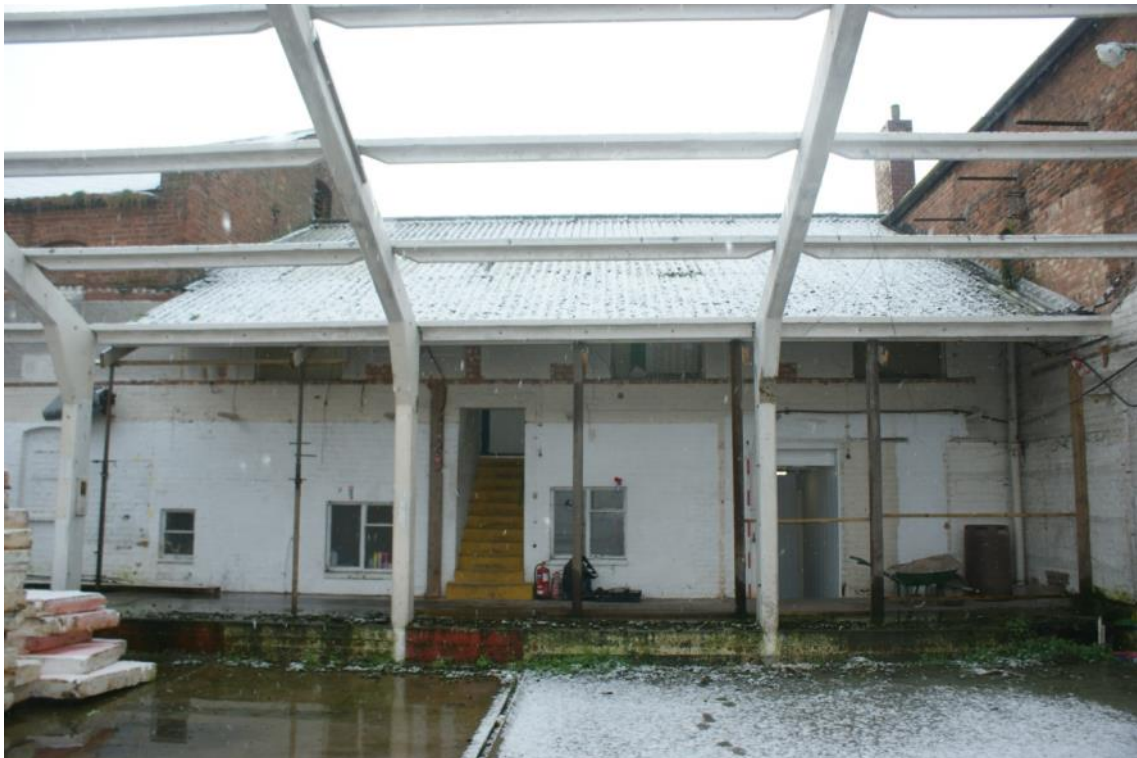
Plate 16 Building D rear extension, looking south

Before the 1885 mapping, the house was extended to the north. This was a ground floor extension only with the first floor added in Phase 4 (Plate 16). It consisted of two rooms, one accessed from the

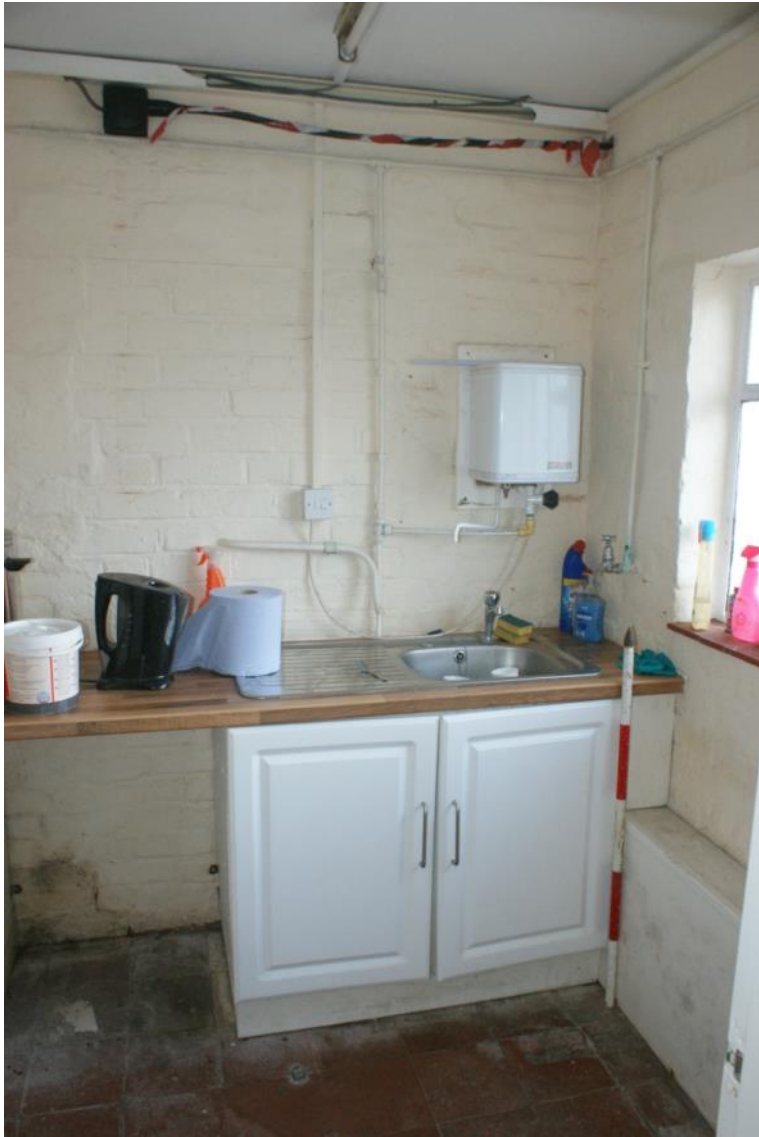
Plate 17 Building D rear extension ground floor, looking west

central passage of the house as well as from the rear, as well a further from the eastern room of the house (Plate 17). These rooms were divided up further in the 20th century.

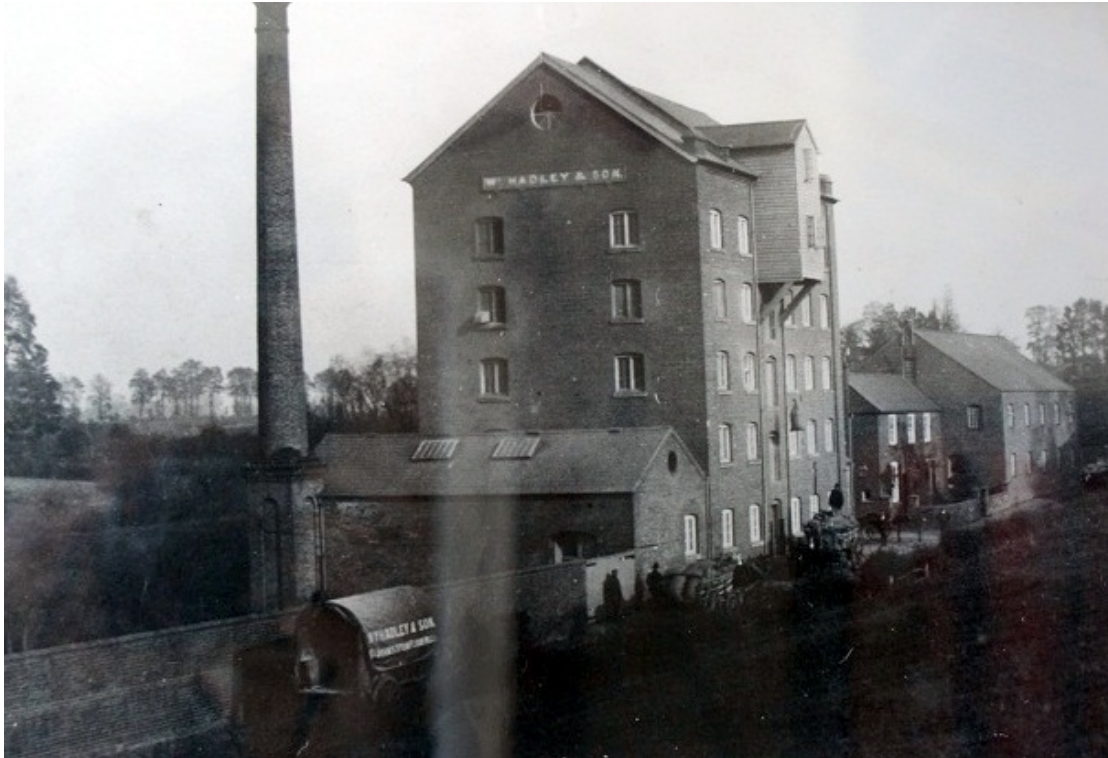
Plate 20 Buildings A, B, D and E in the early 1880s, looking north-east. Note the sack in the process of being lifted below the lucam (reproduced courtesy of Worcester and Midland Coldstores Ltd)

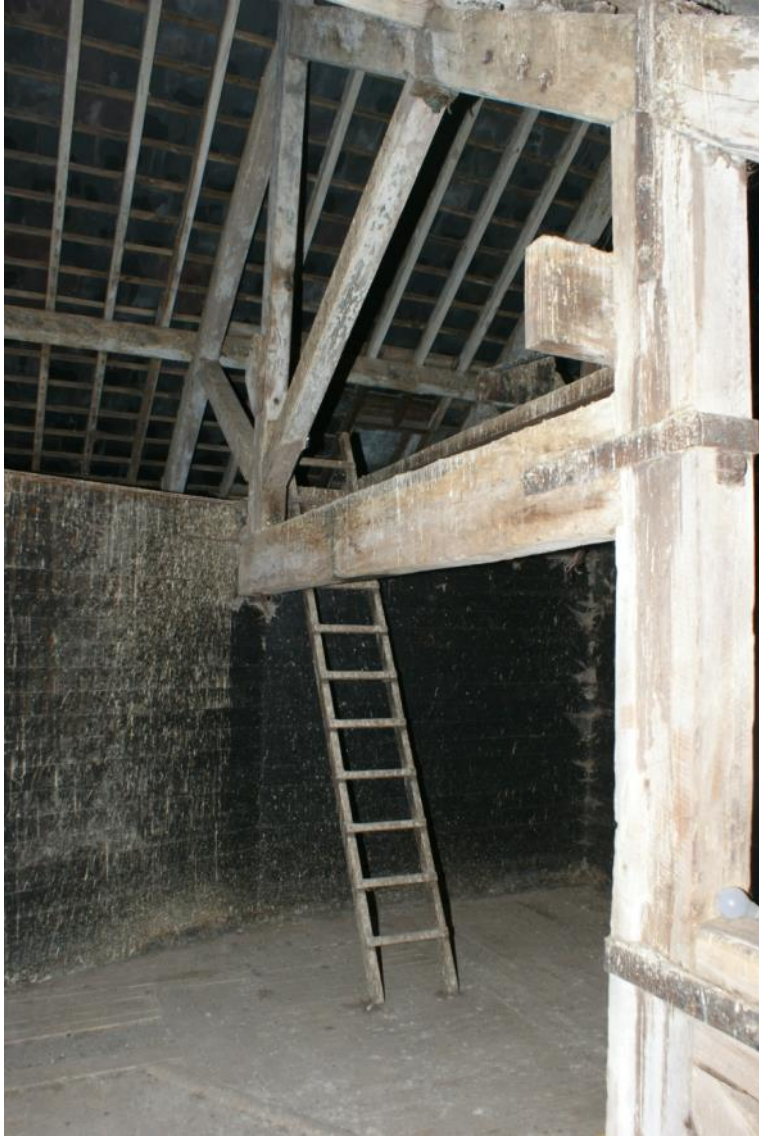
Plate 21 Building B fifth floor roof trusses, looking north

The tile roof of the mill was supported by four softwood king post trusses (Plate 21), the tie beam of which was truncated in order to create space on the sixth floor. These trusses were constructed using iron fixings at all of the appropriate joints, many of which were marked with numbers similar to carpenters marks that correspond to those on the timbers adjacent (Plate 22). On a number of principle timbers such as floor joists, further marks were visible of a type that are considered to have been marks placed on softwood at their port of origin, typically the Baltic (Plate 23). These were most often visible on sides of timber that had been hand converted, the remaining sides converted by circular saw.

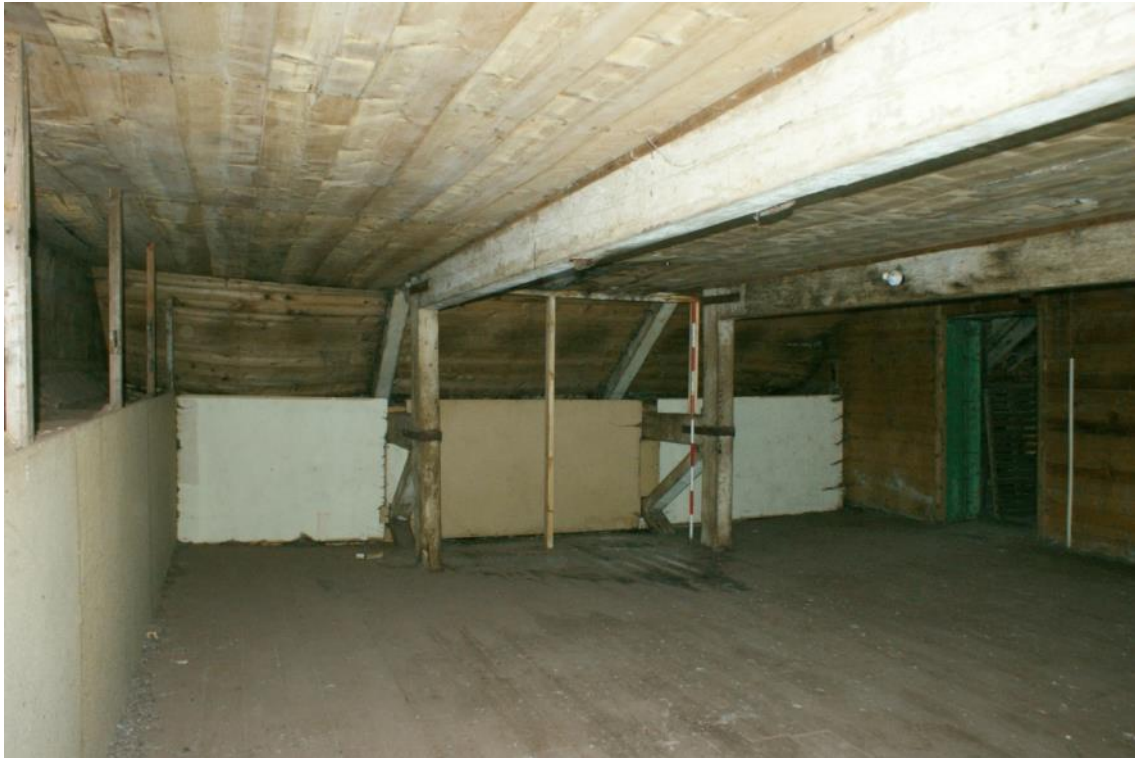
Plate 24 Building B fifth floor, looking south

An internal brick wall ran the entire height of the building, creating two rooms on each floor. The larger of these rooms on the second to fifth floors were further divided for use as cold storage during Phase 4 (Plate 24 to Plate 27). Each floor within this space was supported by four central steel columns, bracketed onto the floor joists above. The exception to this was on the ground floor where four further wooden posts were present beyond the shortened floor joists which did not reach the northern wall and were supported by a cross beam (Plate 28). All of the floors were accessed by a staircase in the south-west corner of the larger room (Plate 29), which was then moved to the smaller room between the ground and first floors (Plate 30). The floor joists have been cut on the second to fourth floors to accommodate the stairs, potentially suggesting it was a later addition despite no other former stair position being evident. It is likely that the stairs were a secondary addition to the original design.

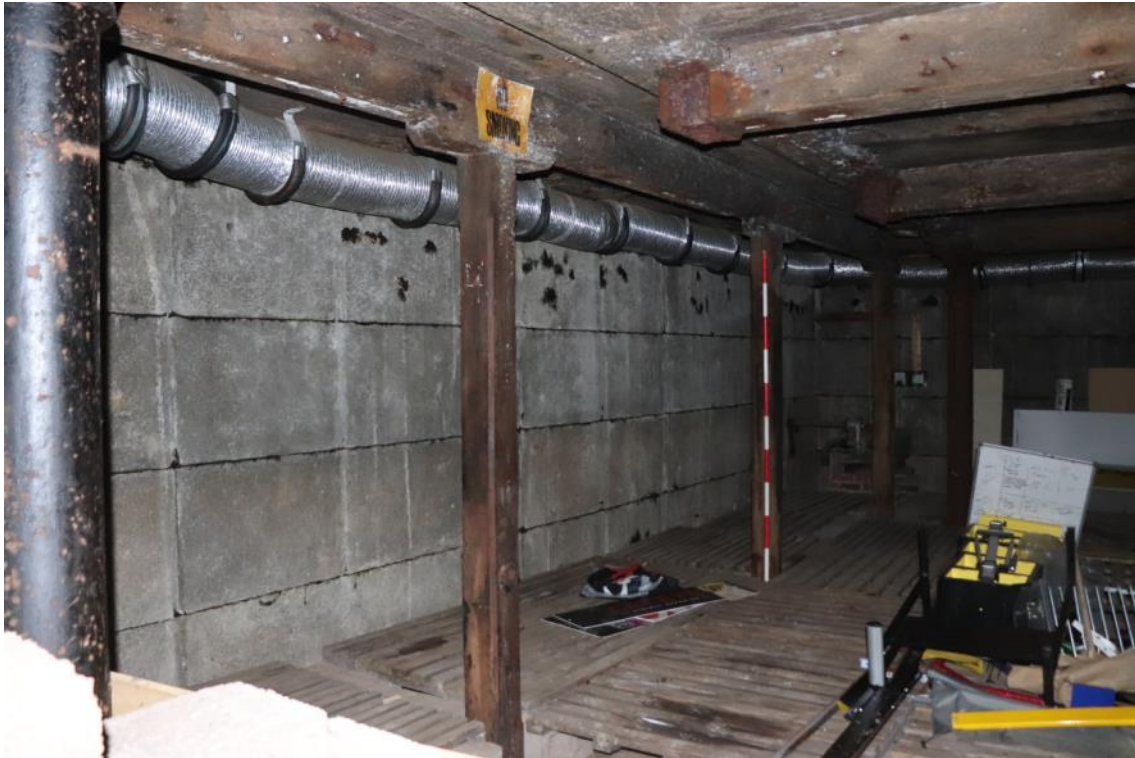
Plate 28 Building B ground floor, looking north-east

It is not clear if there was any means of internally dropping materials such as sacks of grain from the first to ground floors. It is possible that the timber posts supporting the northern section of the ground floor (Plate 28) were later insertions and that this section of floor was originally open. Within this possible later insertion were two former timber column heads with heavy bolting attached (Plate 38),

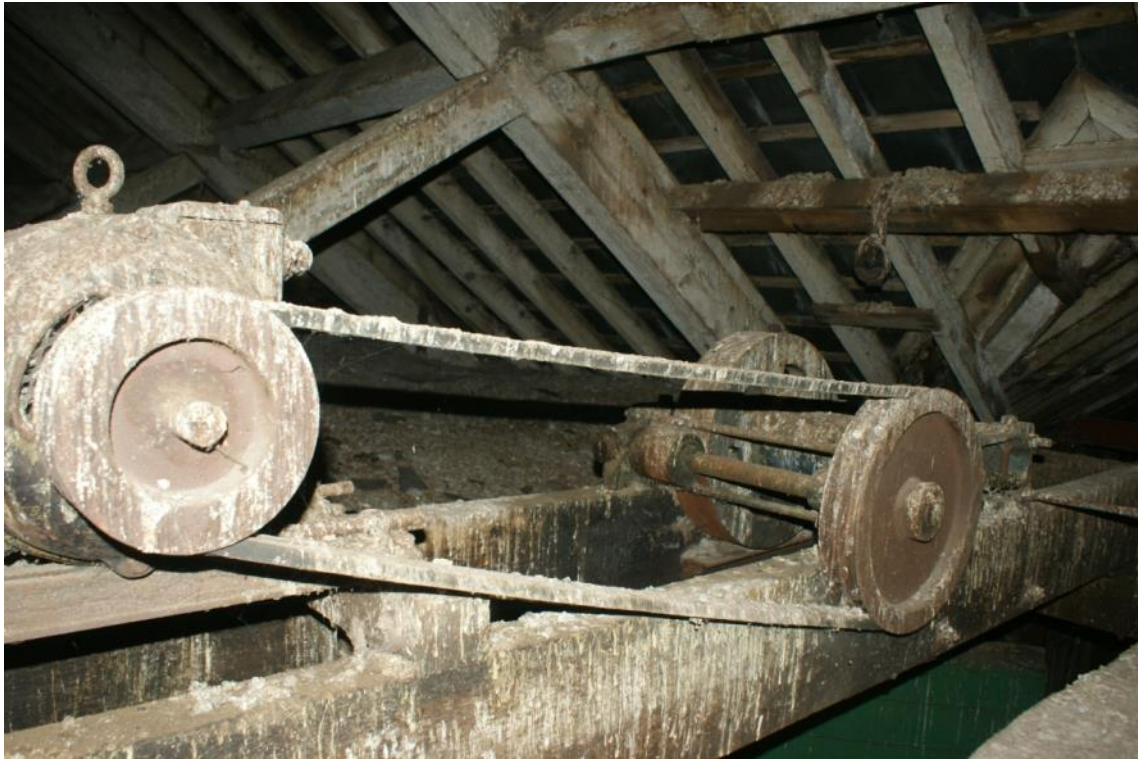
Plate 31 Building B fifth floor hoist machinery, looking south-east

Some idea of the workings of the structure could be suggested from a number of original features. Within the roof space on the fifth floor, a partial mechanism of a winch or pulley system was present that would have lifted materials to all of the floors through door facing onto the frontage (Plate 31). The Lucam created trap door floors on the fourth and fifth floors (Plate 32). A further smaller winch system appears to have been present on the fifth floor to the north of the stairs, as was evident from a blocked attachment to the wall or drive shaft position at this point (Plate 33) along with the same feature and a pattern of ware directly below this on the third floor (Plate 34). Though the evidence was not entirely consistent due to later coverings and modifications, there were two sets of hatches to the east of the internal winch, extending down from the fifth to the first floors (Plate 35). Some ware from the repeated passage of ropes could be seen on the base of these hatches as well as on the banisters of the staircase (Plate 36), strongly suggesting the staircase to have been an original feature. Further wooden hooks were also occasionally present in the vicinity of the staircase (Plate 37).

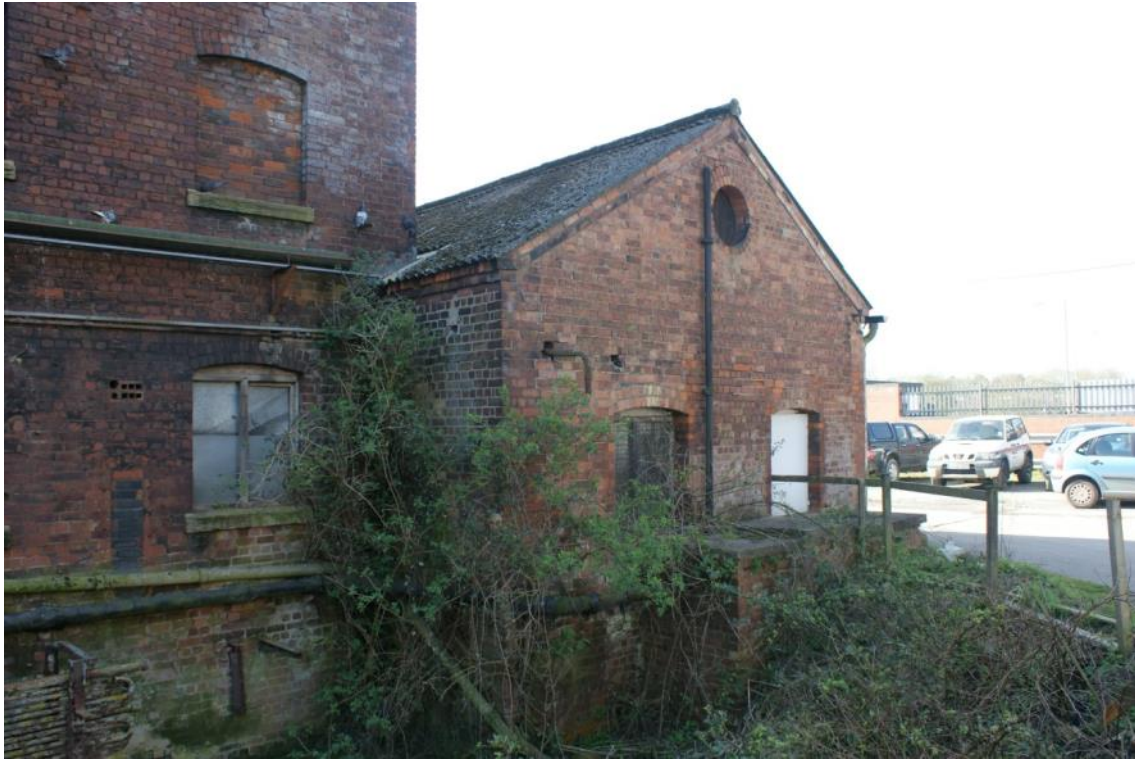
Plate 39 Buildings A and B, looking south- west

A small blocked vertical slot visible on the exterior elevation suggests the probability of drive mechanisms powered from the mill race within the ground floor western room (Plate 39 and Plate 40). The roof in this room was replaced in the 20th century along with elements of the floors above, leaving no evidence of features such as drive shaft or other machinery passing through or within the rooms above (Plate 41 and Plate 42).

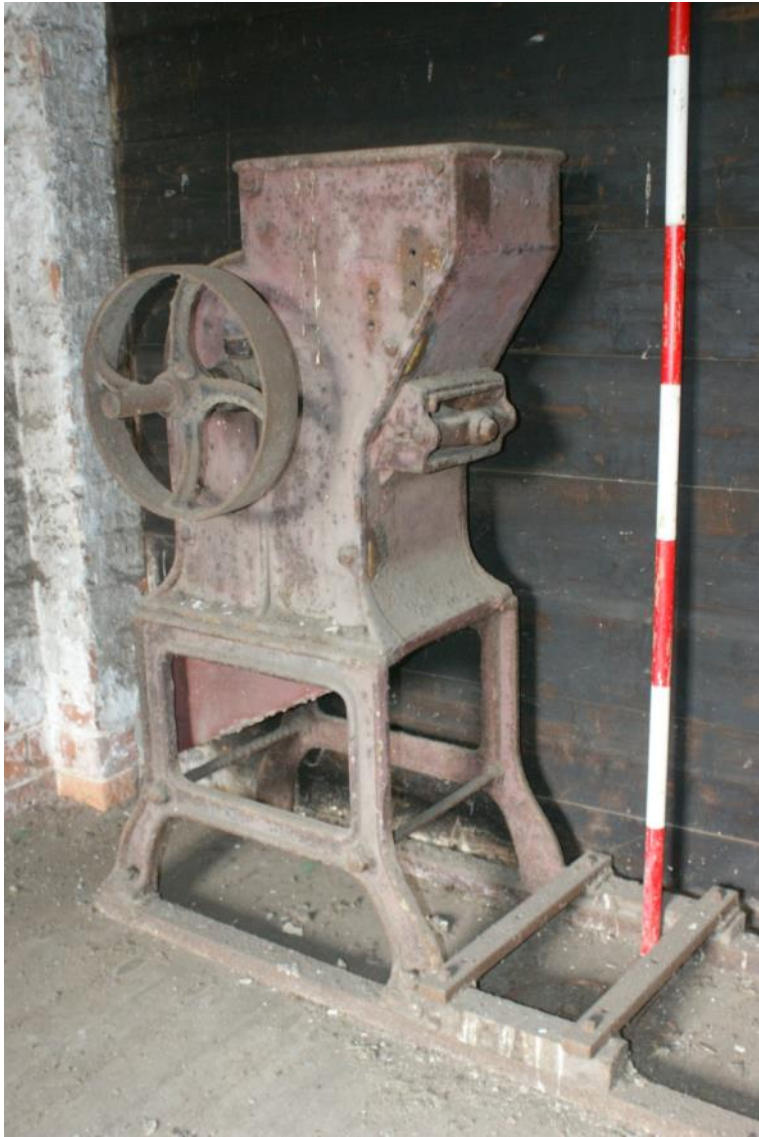
Plate 43 Building B first floor, rolling mill machinery

A single piece of machinery remained that is likely to relate to this phase (Plate 43) though is clearly not in its original position. This is a piece of belt driven roller milling machinery.

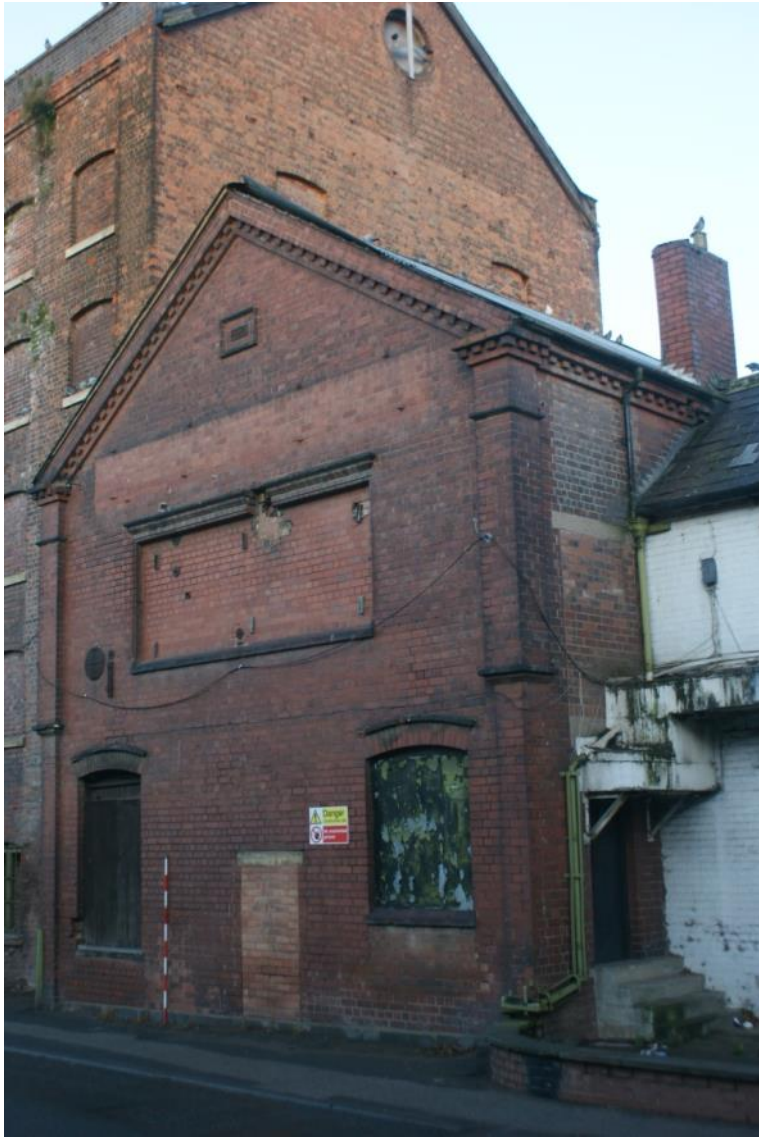
Plate 51 Building C, looking north-west

a date stone below its gable apex (Plate 51). This incorporated and built over the Phase 1 structure as well as being built over and around buildings B and C.

This brick building's gable faced the street and was complete with two segmental arch headed windows with moulded brick hoods. Either side of the gable, brick pilasters extended to wall plate level with a dentilled pediment above. An indented section in the centre of the gable would have held the company name, with a further ware pattern suggesting further signage above at some point. Above this was the date stone.

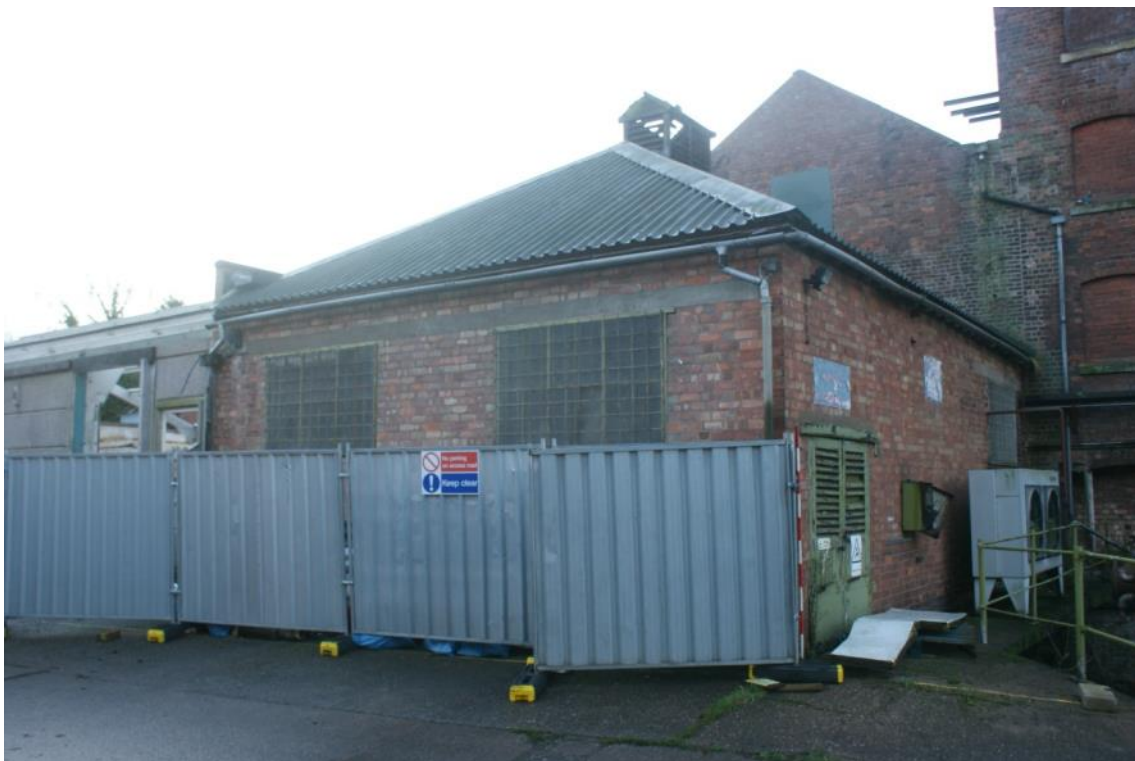
Plate 55 Building F, looking south-east

This phase comprises one building that was added onto the northern side of the Phase 1 element of building C (Plate 55). This is a single storey brick building with a hipped roof which has been replaced in the late 20th century. It has a door and a window facing west and two further windows facing north. The mill race is partly visible underneath this building and it is likely that the heat exchange bars visible to its west to the rear of the mill building (Plate 56), relate to this phase. A number of machine settings were visible within this building (Plate 57).

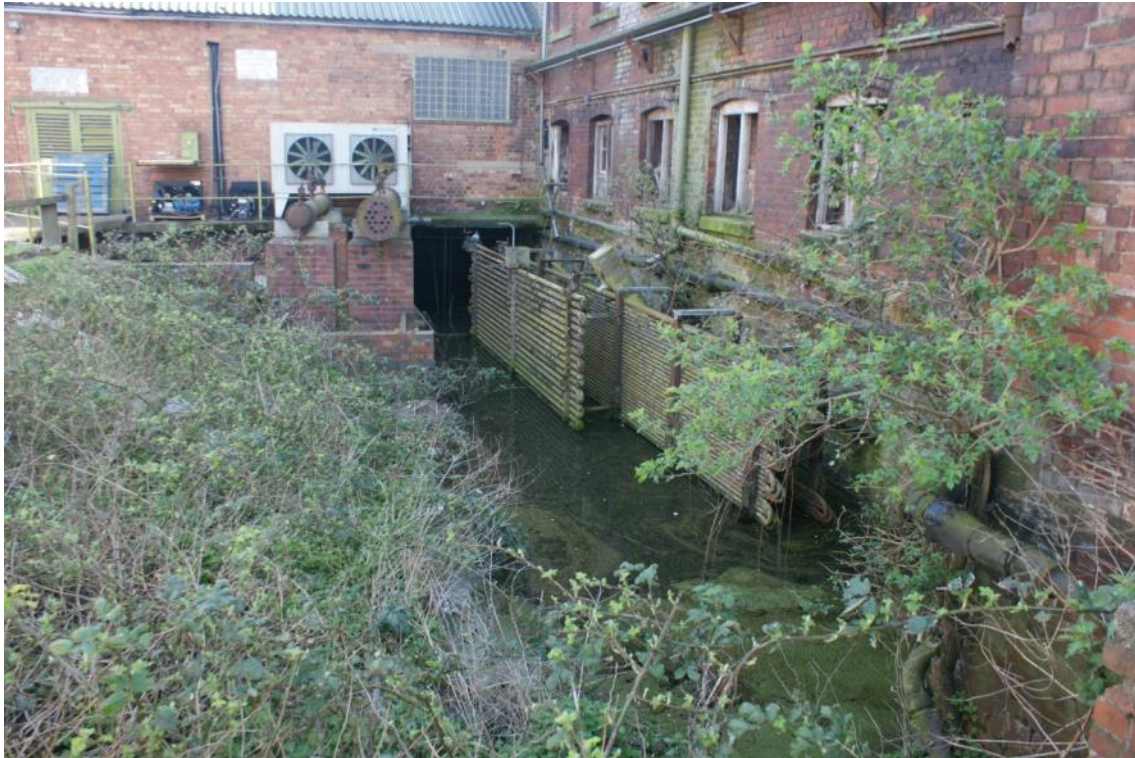
Plate 56 Coolant bars to the west of building F within the former mill race, looking south-east

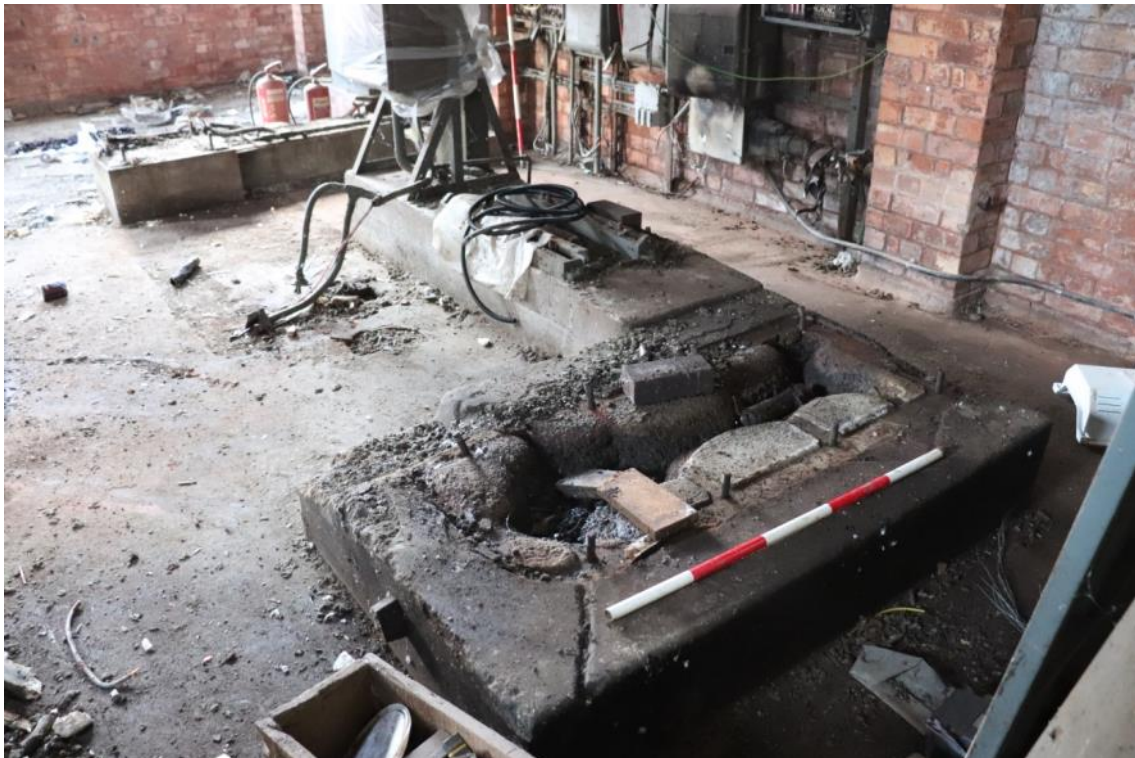
Plate 57 Building F interior machine bases, looking north-east

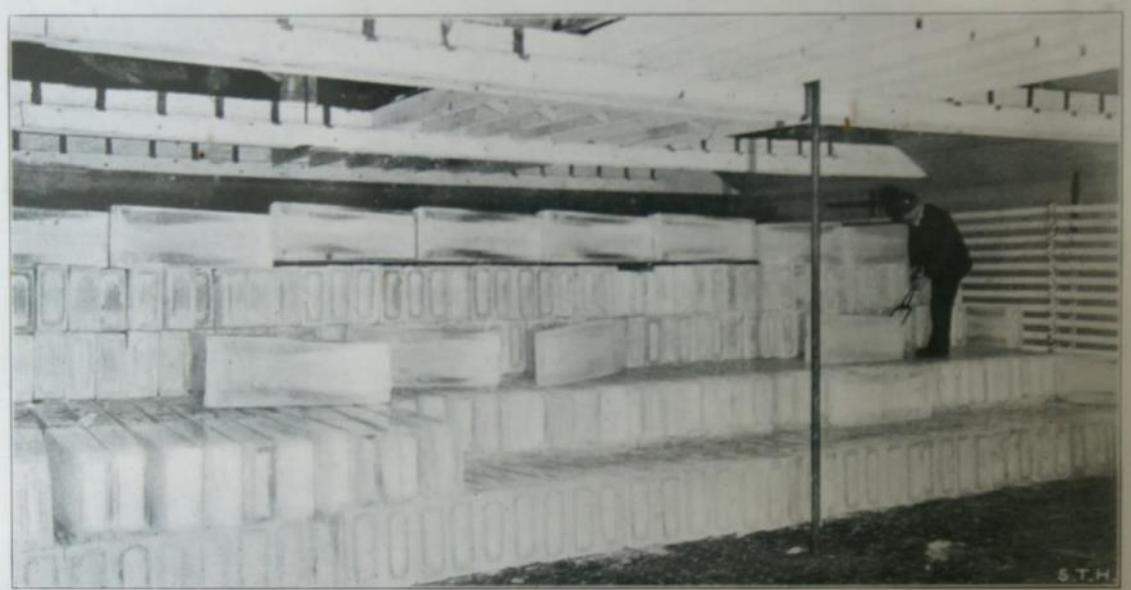
St. John's Works—Ice Warehouse (500 tons reserve kept in this building).

Plate 59 Early 20th century photograph of ice storage within the buildings (reproduced courtesy of Worcester and Midland Coldstores Ltd)

It is likely that many of the internal changes seen through the earlier mill buildings relate to this time when it was converted for use as cold storage and ice works (Plate 25, Plate 26, Plate 41, Plate 42). This is particularly true of most of the floors of **building B** which had its windows bricked up and cladding inserted. The cladding largely took the form of tongue and groove boarding at a distance of approximately ??? from the exterior walls, and the gap filled fibrous material. This was true of all the rooms except the ground and first floor stair well and the smaller ground floor room. On the first to fifth floors, the larger rooms had their south western corners reduced by the addition of insulated walls and similarly insulated doors (Plate 58). Elongated holes cut into the wooden floors demonstrate that chilled air movement was required vertical through the structure. This is shown from a thermometer within building B (Plate 60) with the red lines show a normal range of between 28° to 33° Fahrenheit (-2.2° to 0.5° Celsius). This thermometer is of very close similarity to those shown in a sales catalogue in 1923 (Ultimheat 2018). An earlier 20th century photo shows ice storage within one these buildings (Plate 59).
