Archaeological watching brief of additional service trench works at Hartlebury Castle, Hartlebury, Worcestershire

Status: Version 1
Date: 15th December 2017
Author: Graham Arnold garnold@worcestershire.gov.uk
Contributors: Rob Hedge
Illustrator: Carolyn Hunt
Project reference: P4695 + P5198
Report reference: 2511
HER reference: WSM68500 / WSM69555
Oasis id: Fieldsec1-27661

Archaeological works at Hartlebury Castle, Hartlebury, Worcestershire

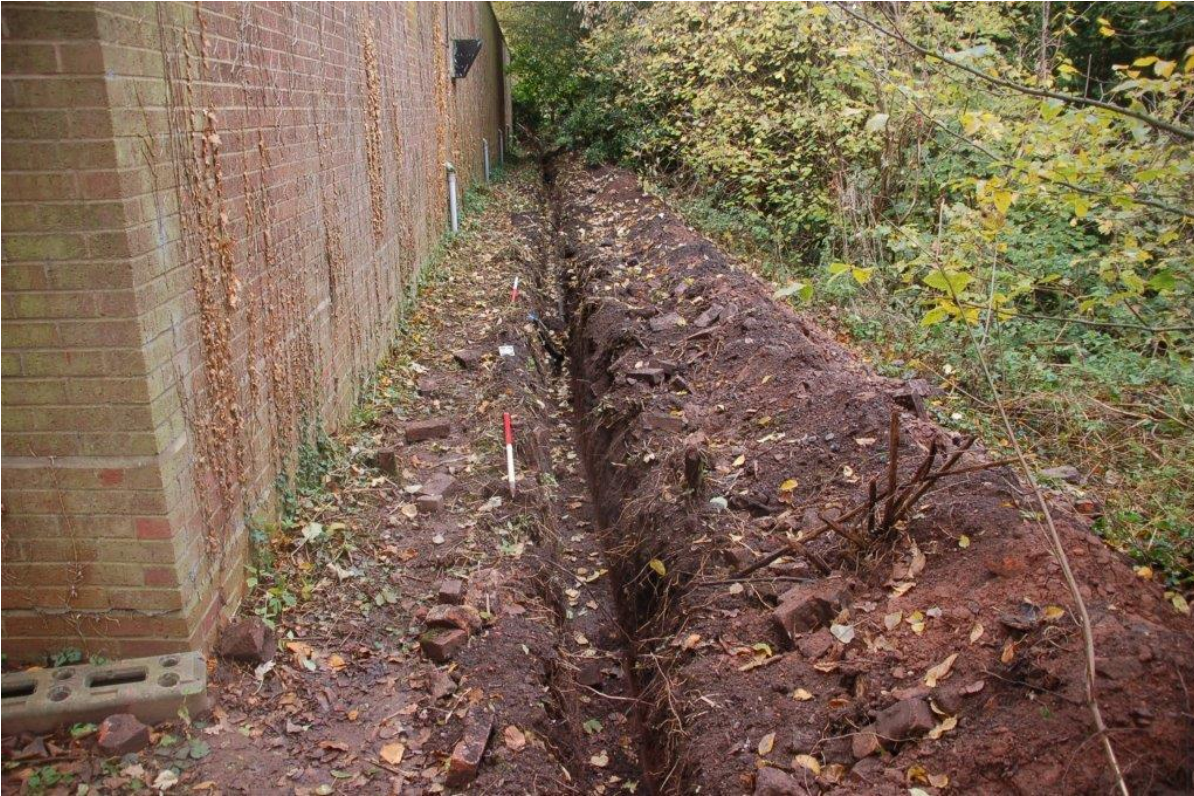
Plate 1 Trench 4 through proposed gas tank location. 2 x1m scales looking west. Gas tank location is at 1m scale in the foreground.

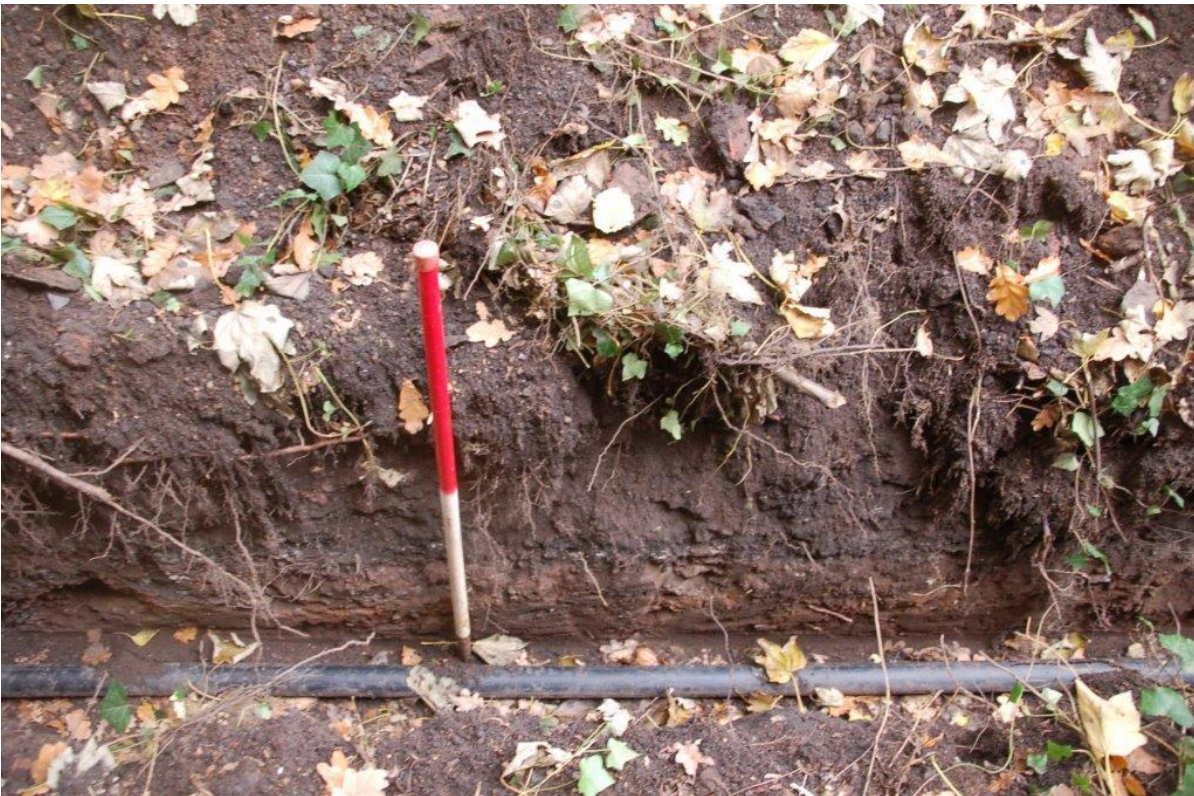
Plate 2 Sample section of trench 4, showing topsoil, clinker demolition deposit and disturbed natural at base.

Context	Classification	Description	Depth below ground surface (b.g.s) – top and bottom of deposits
400	Topsoil	Dark greyish brown friable sandy loam with frequent glass cbm charcoal and vegetation rooting.	0.00 – 0.48m
401	Made ground	Loose dark brownish black ash, clicker layer in a silty sand matrix with frequent bricks from wall, glass, charcoal and porcelain. 20 th Century dump deposit from demolition of brick revetment / retaining wall and buttress.	0.48 – 0.70m
402	Made ground	Compact mid brownish orange clayey sand with frequent charcoal. Made ground or bank material from up cast related to moat in north. Modern disturbance.	0.70 – 1.15m +

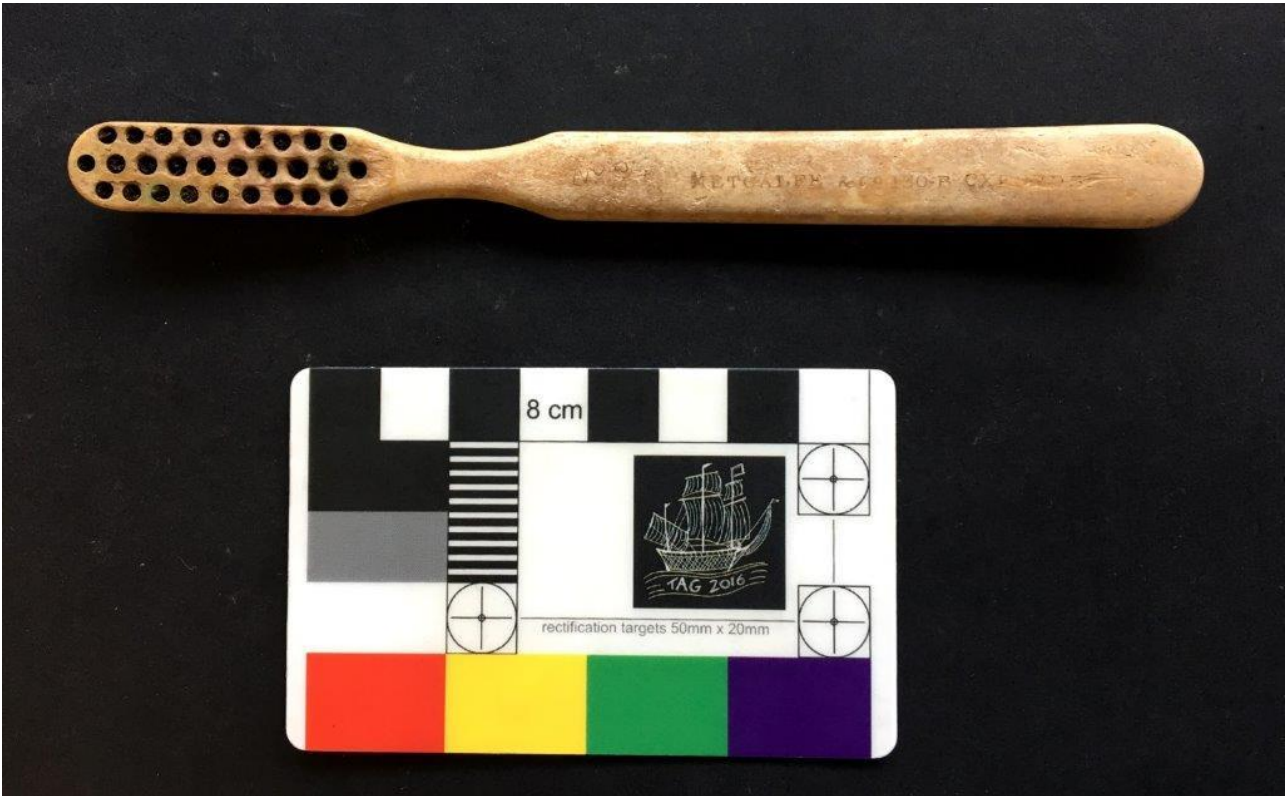
Plate 3 Bone toothbrush retrieved from deposit (401) 8cm scale.

The archaeological monitoring of groundworks in the area of the proposed gas tank indicated that anomalies highlighted on the GPR survey (SUMO 2017 – Appendix 1) related to 20th Century demolition rubble. This is thought to be from an outbuilding in the area first recorded on the 1821 inclosure map (Cornah and Robson-Glyde 2014). This was later replaced by a brick boundary or retaining wall and buttressing by the time of the 1888 OS map and still existed on the 1927 OS map. This suggests an early 20th Century date for the date of demolition. The bricks were machine made with modern mortar and measured 9" x 4 1/2" x 3". Only a sample of artefacts were retained, which included two fragments of blue and white porcelain and an engraved bone toothbrush (Plate 3). These deposits corresponded with the anomalies on the GPR survey (SUMO 2017).

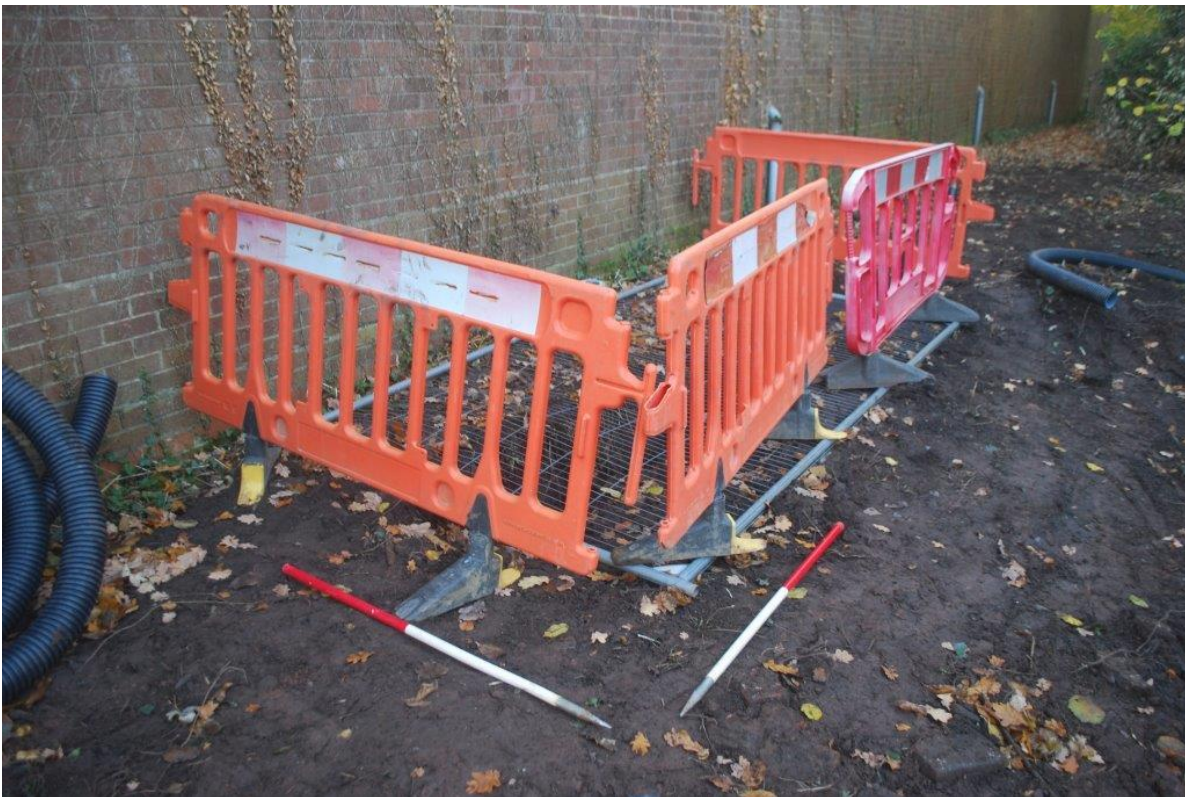
Plate 4 Proposed gas tank location fenced off around trench 4. 2 x 1m scales.

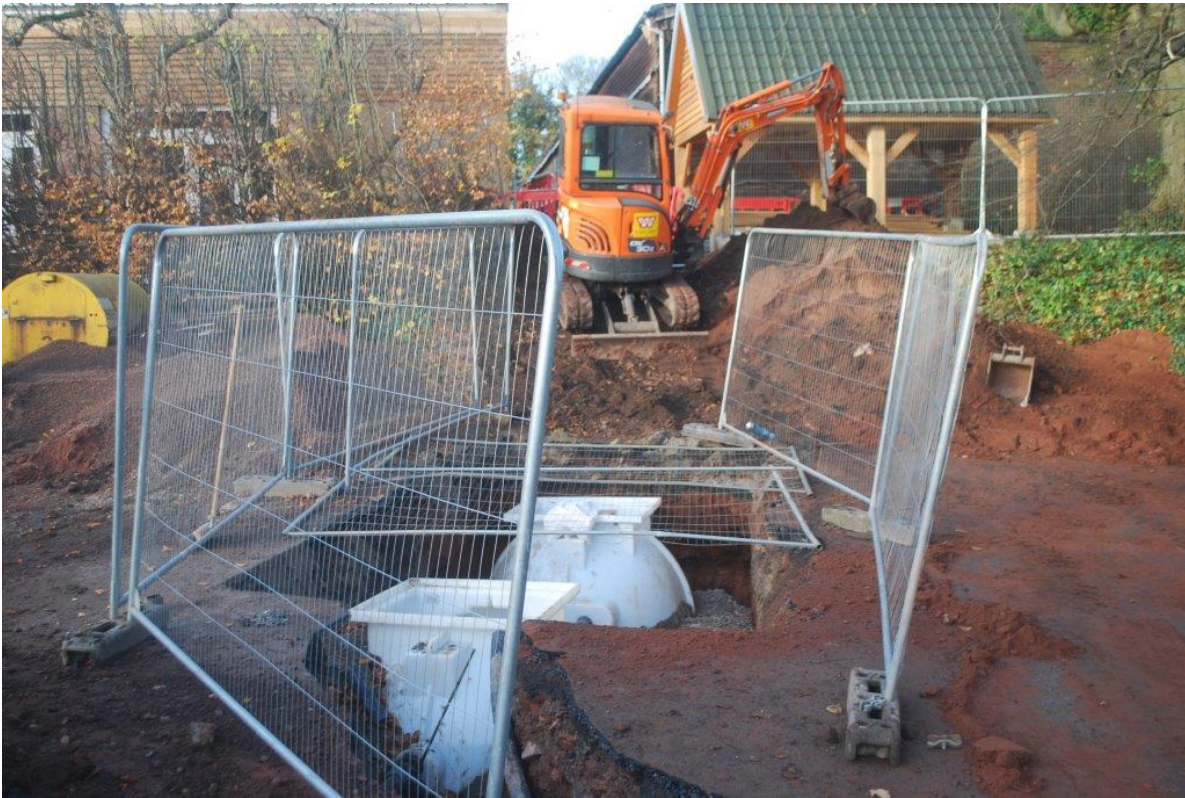
Plate 5 Sewer service trench in carpark with modern hardcore, surfacing and natural sands.

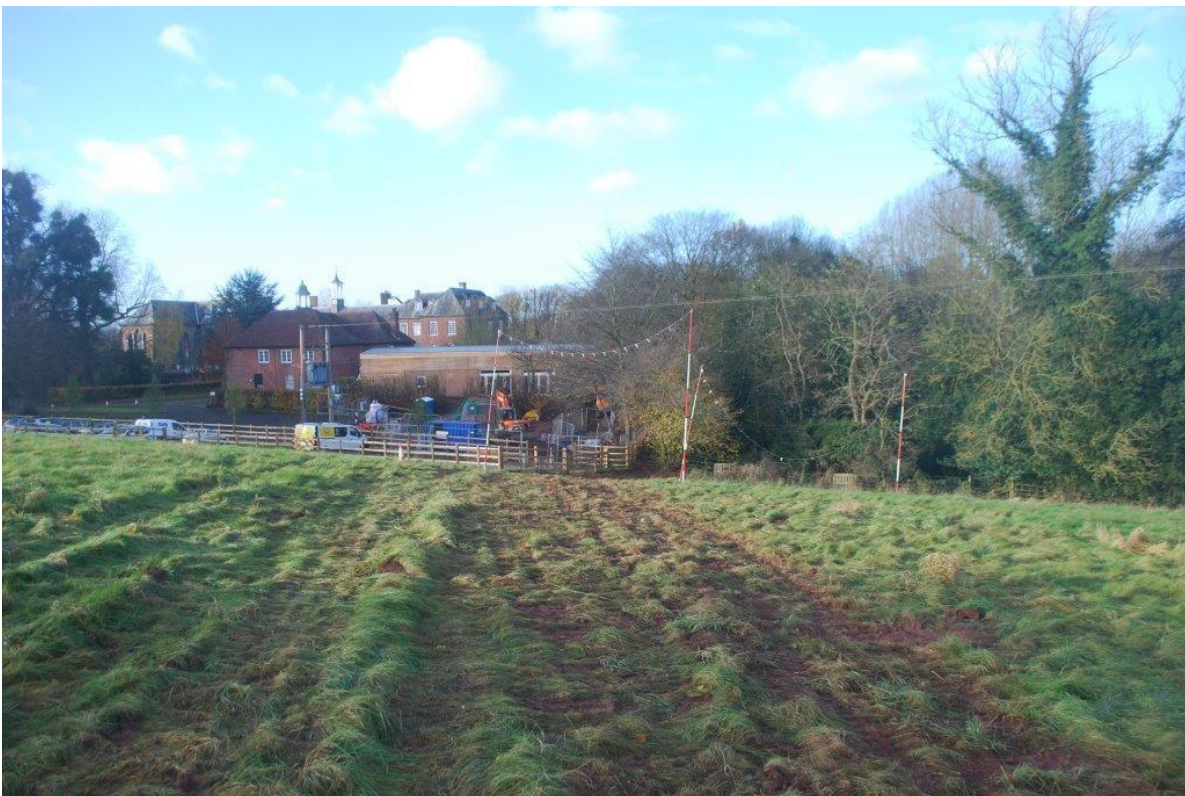
Plate 6 Location of service trench after backfilling. Ran across open field to existing sewer. View Southeast towards Hartlebury Castle.
