Archaeological watching brief at Lawnstone House, High Street, Coleford, Forest of Dean, Gloucestershire

Worcestershire Archaeology
for Forest of Dean District Council

June 2019

Archaeological watching brief report

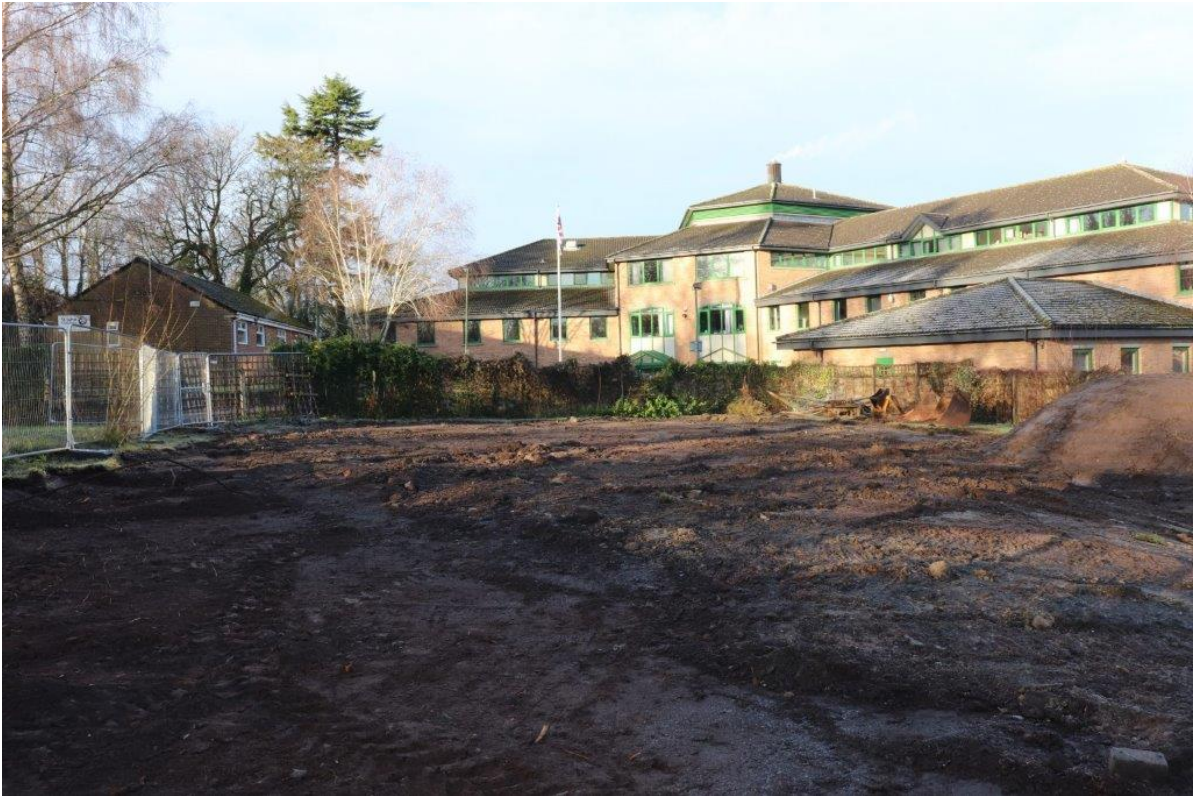
Plate 1: View of southern area prior to groundworks taking place; view west, no scales

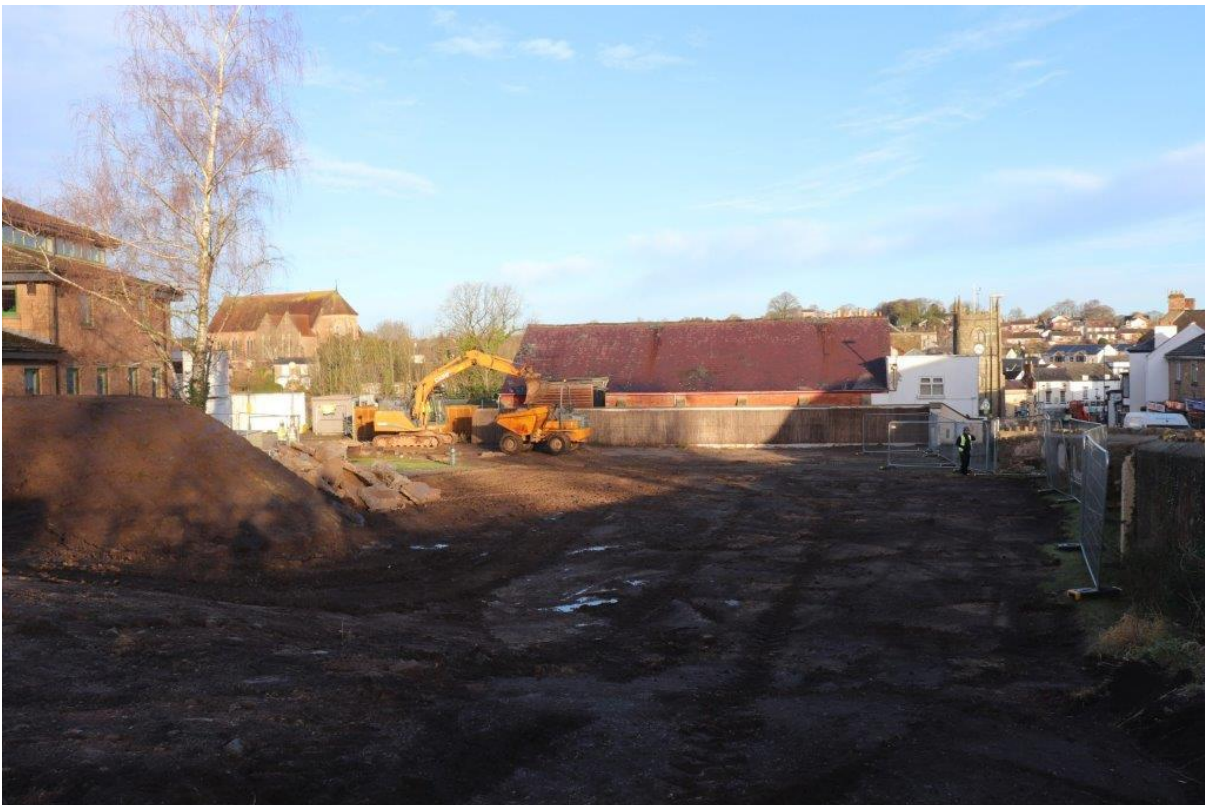
Plate 2: View north of site prior to excavations; machine removing hardstanding in background; no scales

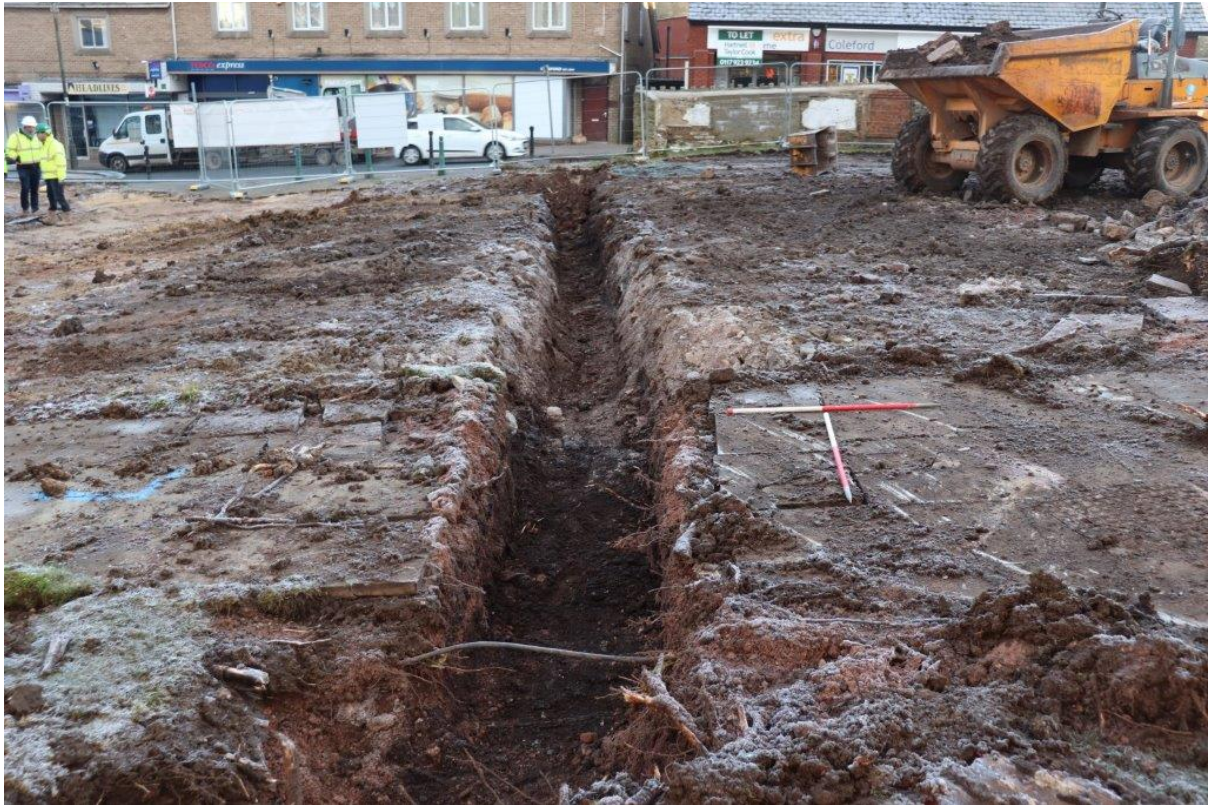
Plate 3: Trench 1 electricity cable, aligned east to west across site; view east; 2x 1m scales

The brick and limestone foundations of Lawnstone House and the adjacent Annex were visible on site prior to excavations taking place. These were recorded in Trench 1 (Plates 3 and 4) and the Trench 3 foundation trenches for the north block, and consisted of limestone blocks with lime mortar bonding and some later brick built foundations.

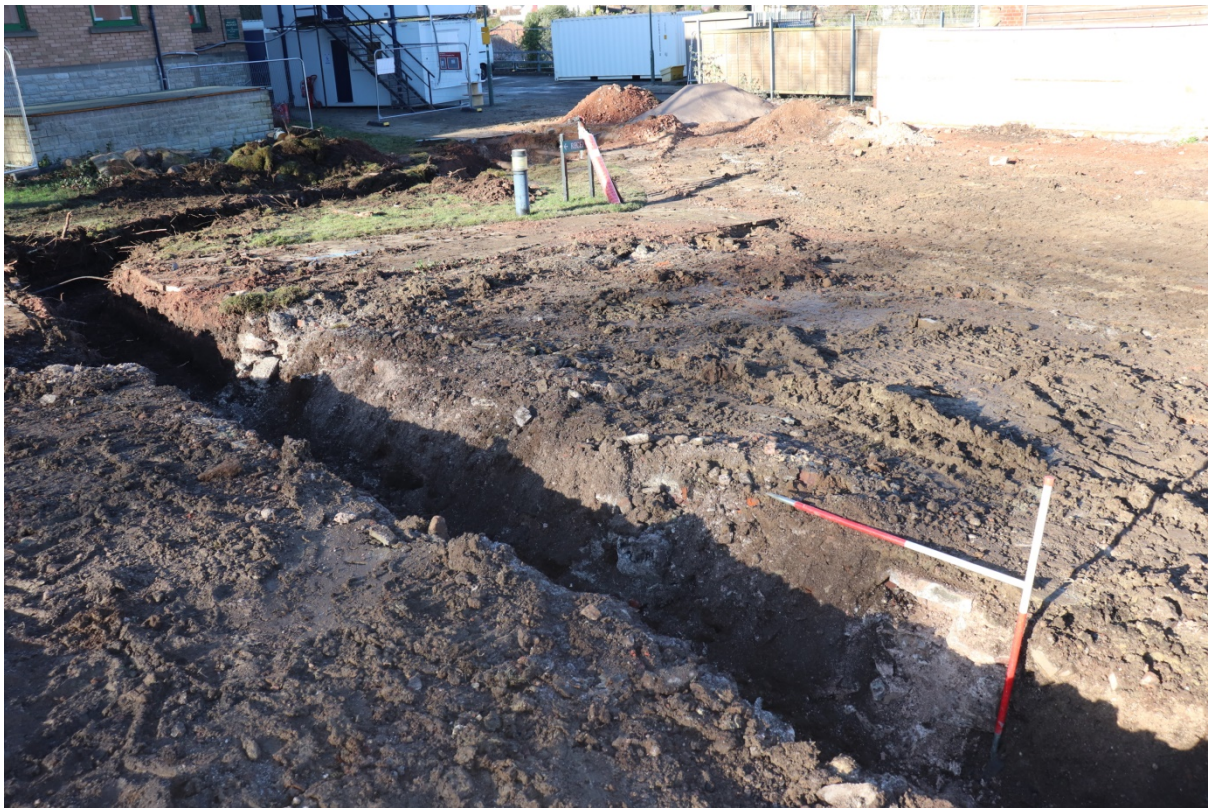
Plate 4: Trench 1, limestone footings from Lawnstone house; view north-west 2x 1m scales

Context	Brief description	Depth from ground surface	Comments
105	Wall foundation	0.00-0.70m	Footing of Lawnstone House North wing made of limestone and green sandstone, with lime mortar bonding
106	Natural substrate	0.70m+	Firm red and yellow clay, with large angular limestone boulders and occasional patches of red gravels. White, yellow and red with depth. Limestone brash and clay geology.

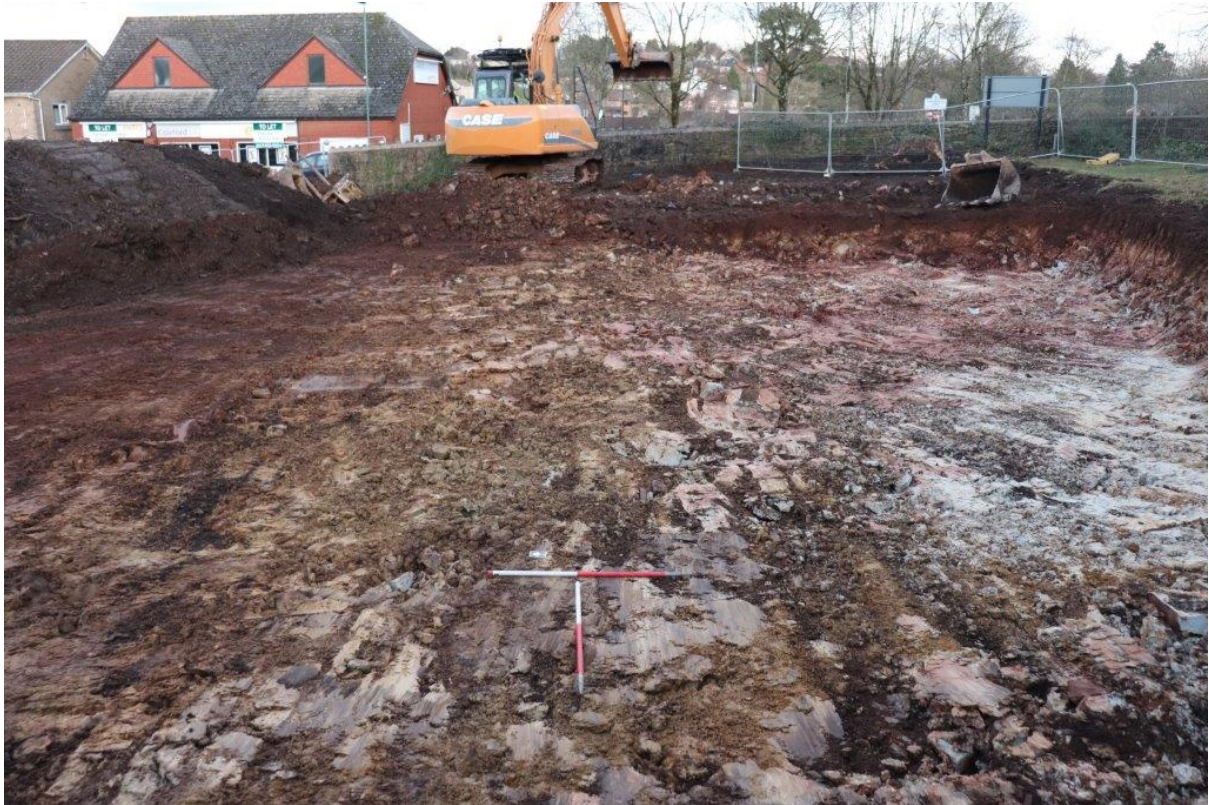
Plate 5: Trench 2, natural substrate in the southern part of site, following reduced dig; view east; 2x 1m scales

In the south block a reduced dig was monitored down to the natural substrates (Trench 2; Plate 5). The strip in the east showed that modern hardstanding, made ground and foundations from the modern bungalow had truncated the ground down to the natural firm clay (Plate 6). In the centre of the area, a limestone slab drainage culvert was recorded, (205), with lime mortar bonding, similar to the foundations for Lawnstones house (Plates 7 and 8). This indicates that it is likely to be

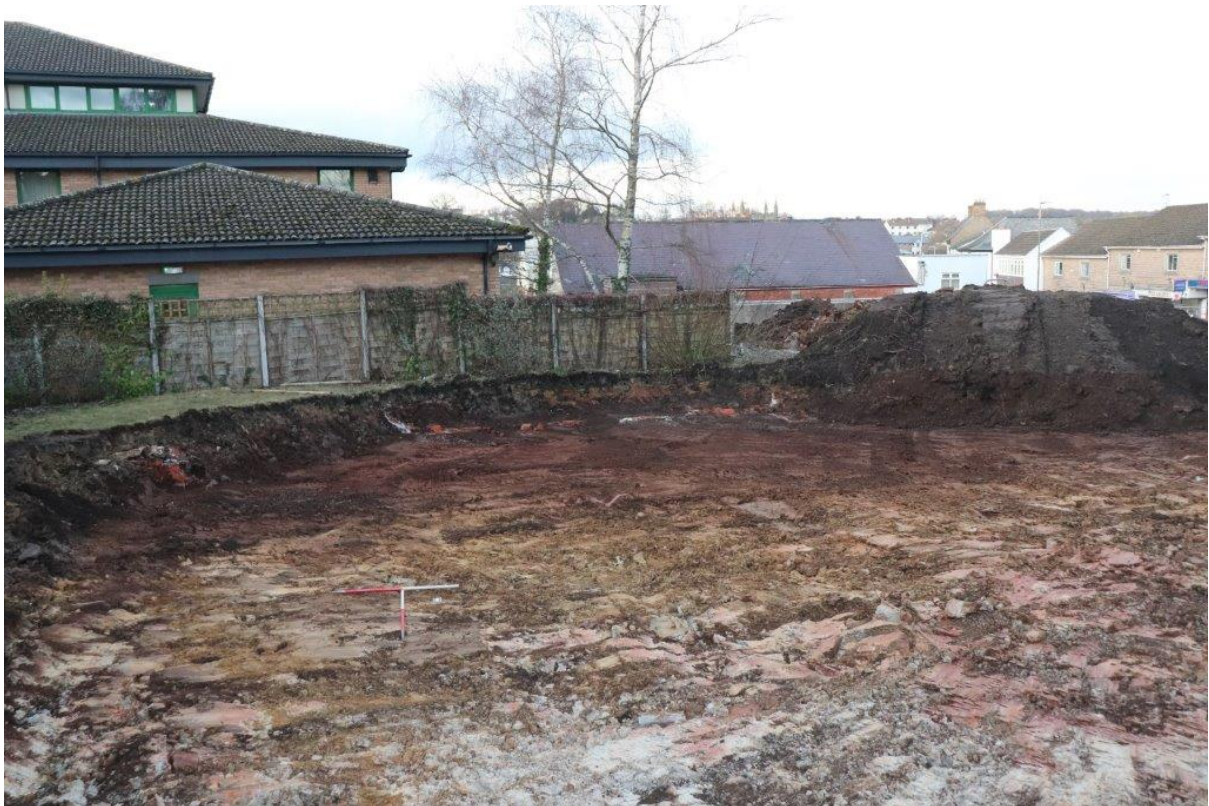
Plate 6: Trench 2, natural substrate in southern area; site of previous bungalow; view north, 2x 1m scales

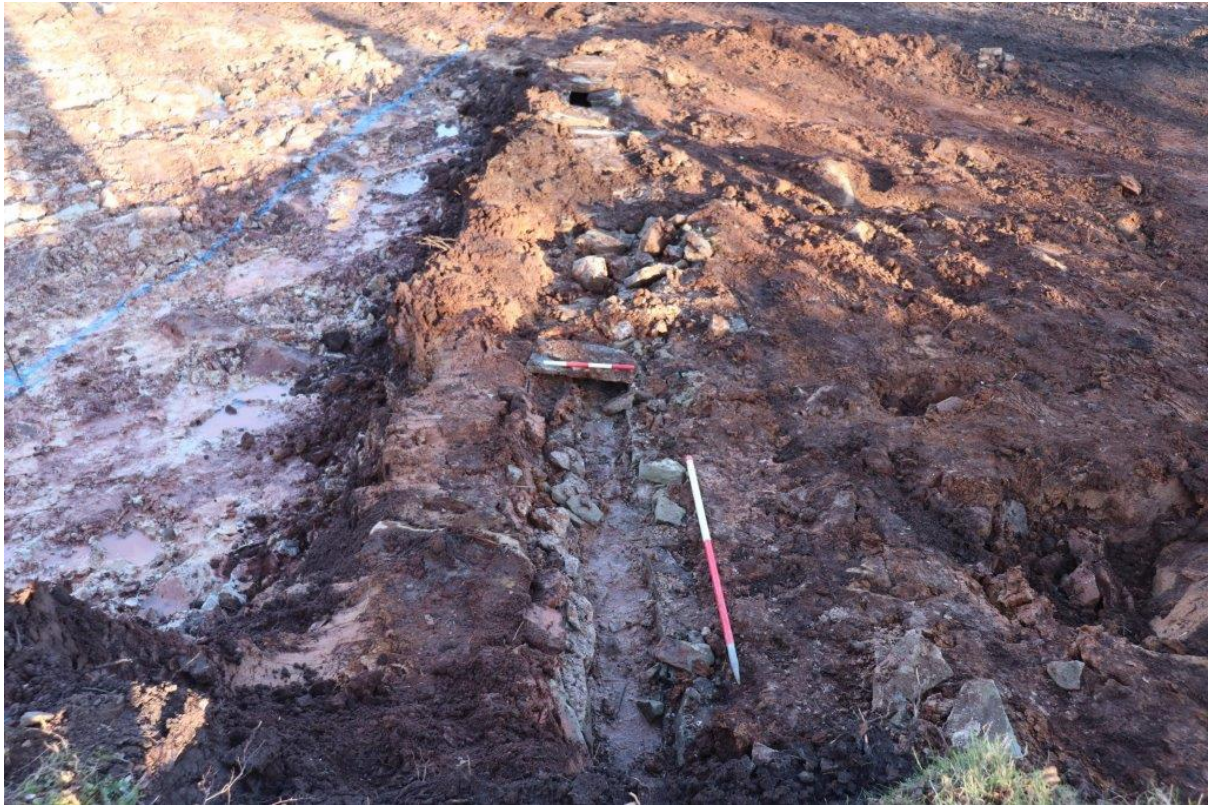
Plate 7: Trench2 stone culvert (205) relating to original Lawnstone building; view north; 0.4m and 1m scales

contemporary with the Lawnstone House building. No dating evidence was otherwise found within the culvert.

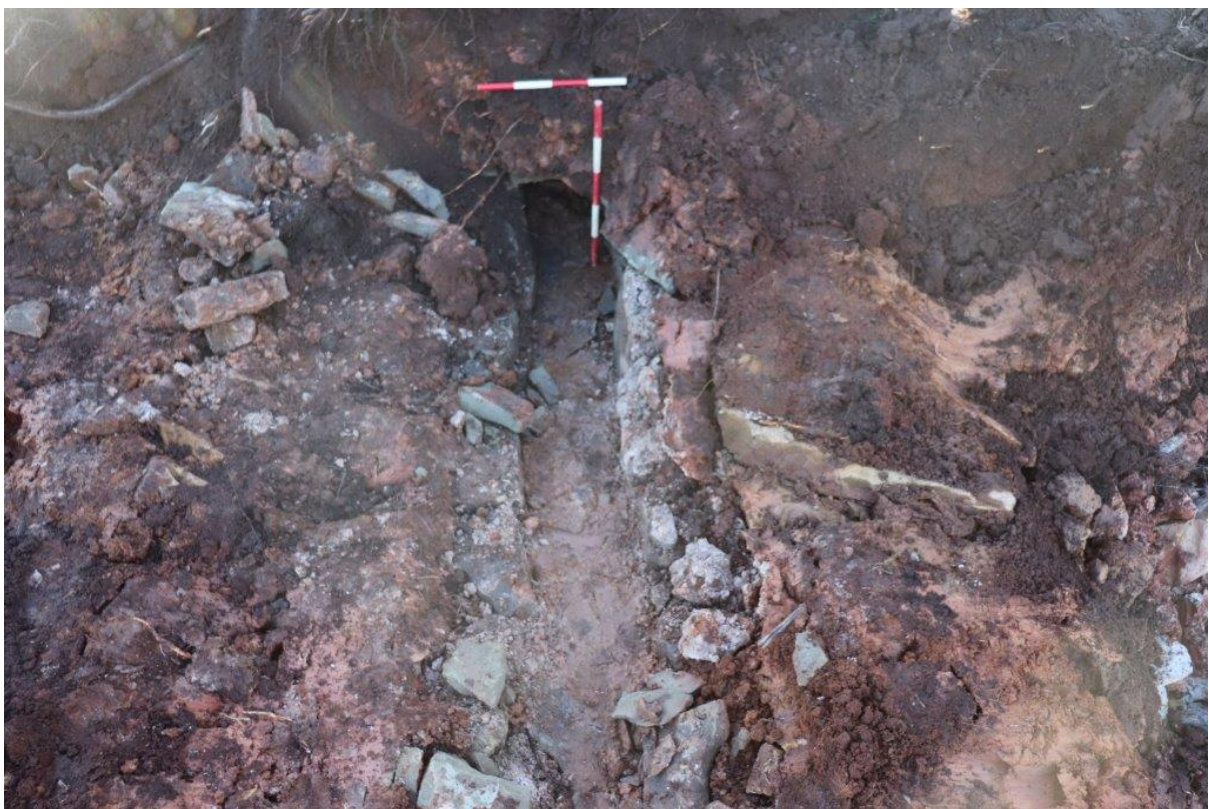
Plate 8: Trench 2, close up of stone culvert (205); view south; 0.4 and 0.5m scales

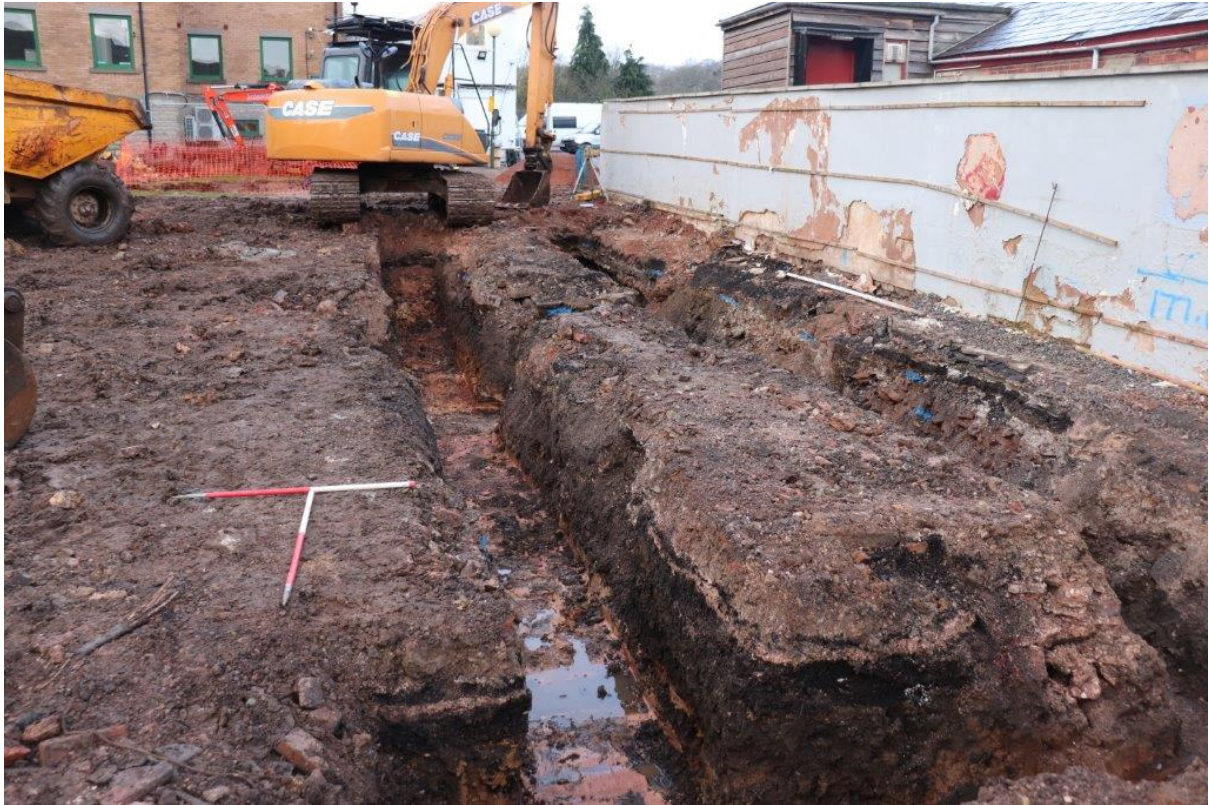
Plate 9: Trench 3, north block footings in progress; view west; 2x 1m scales

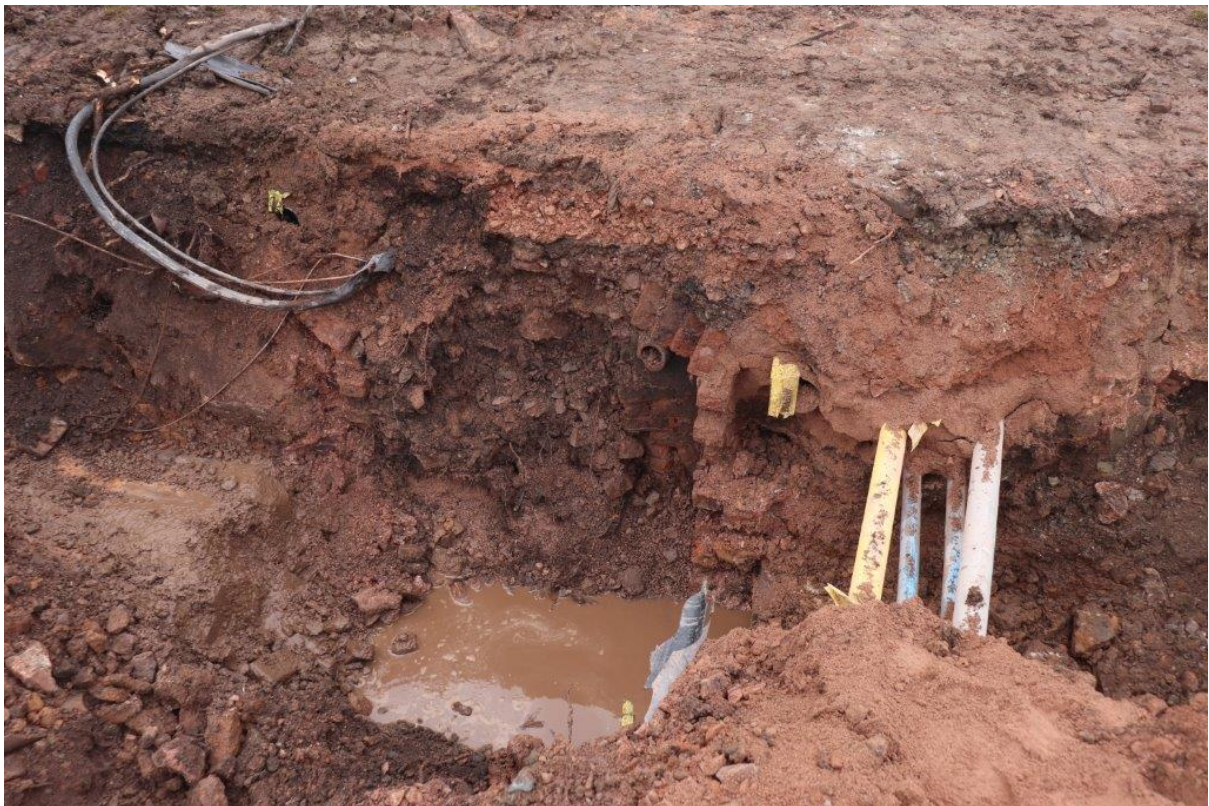
Plate 10: Trench 3, brick water storage drainage chamber structure (312); cut by modern sewer; view west; no scales

A brick chamber observed within the western side of Trench 3 in the north block is thought to be related to the building that was in this location in the early 20th century and had been cut by later services for the council buildings to the west of the site (Plate 10). The northern area of site (Trench 3) had been heavily truncated by a variety of modern utility services and drainage (Plate 11).

A brick chamber in the north of the site dated to the early 20th century, together with further wall foundations and modern disturbance for services and drainage.

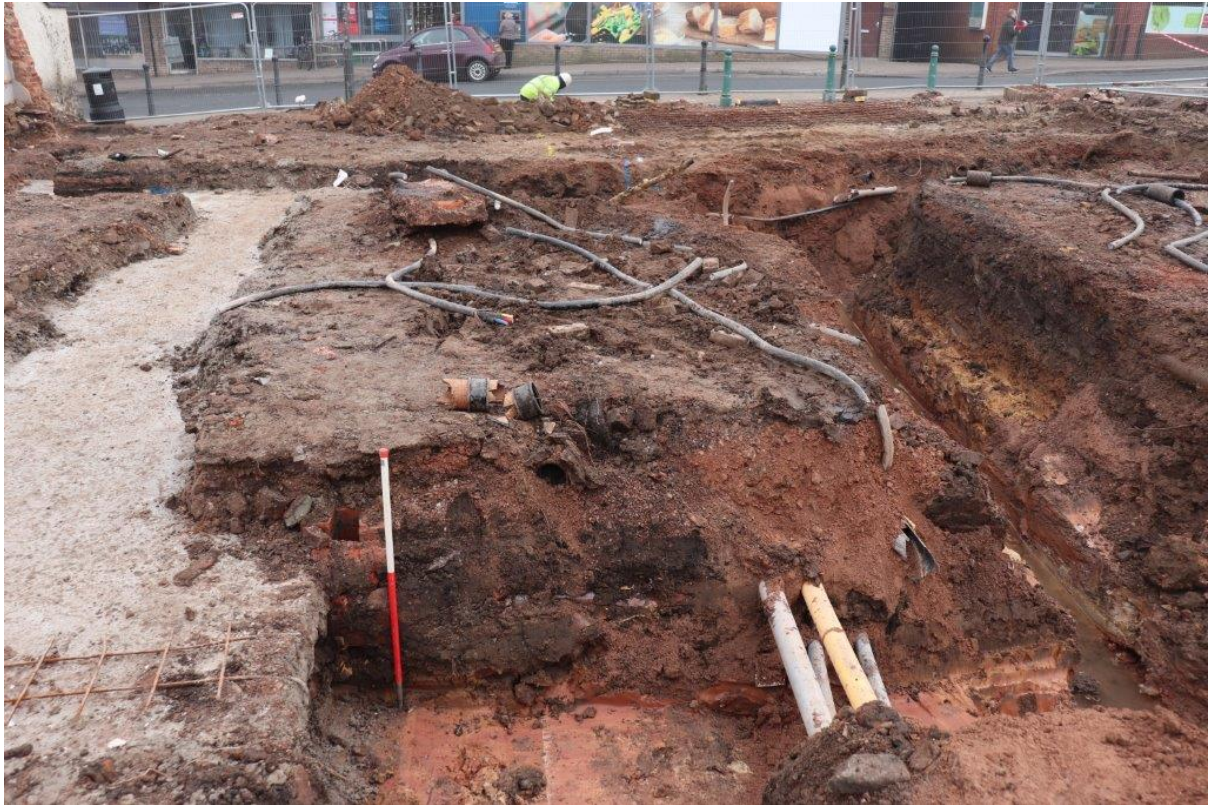
Plate 11: Trench 2 modern service trench, drainage and sewer truncations; view east; 1m scale

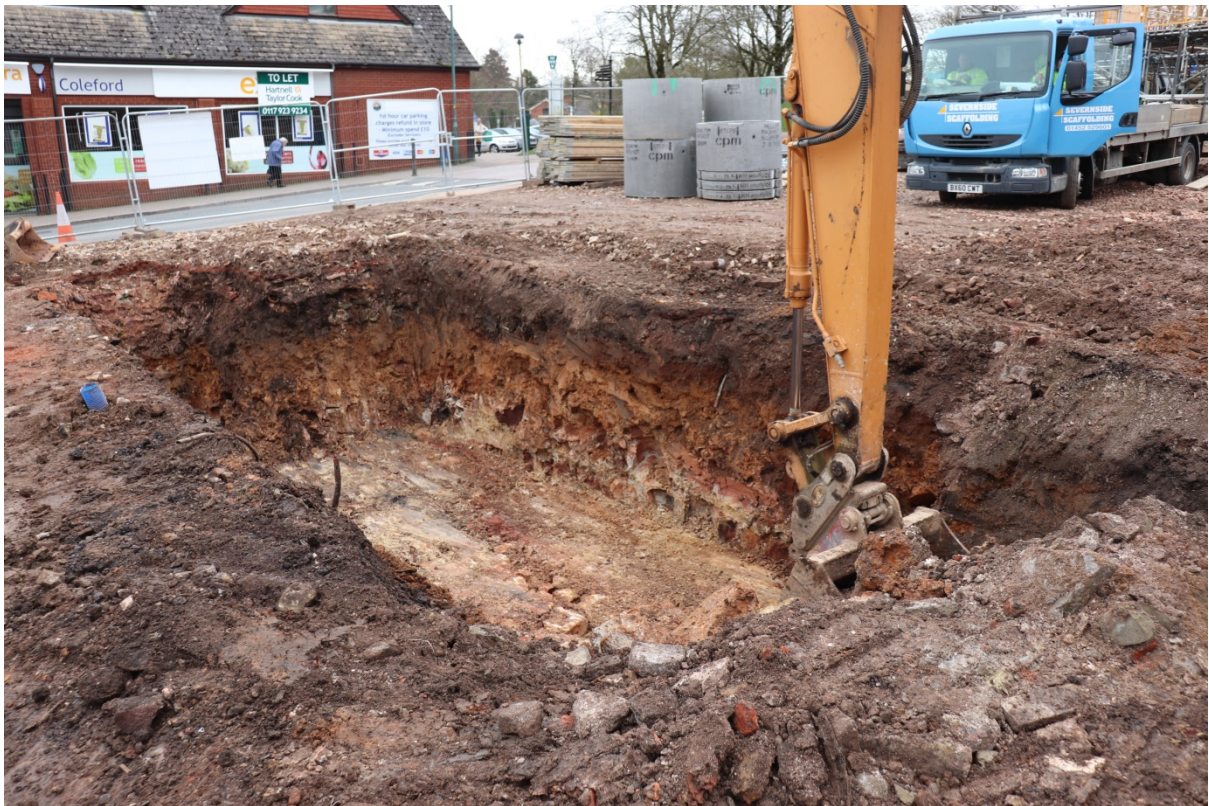
Plate 12: Attenuation tank excavated showing made ground and natural deposits; view south-west; no scales

Context	Brief description	Depth from ground surface	Comments
400	Modern hardstanding	0.00-0.50m	Concrete footings and hardstanding in central area
401	19 th C made ground	0.00-0.70m	Dark blackish brown sandy silty clay with frequent mortar, clinker and brick rubble, cut by modern drainage
402	Natural	0.70-2.70m+	Firm yellow and orange clay with frequent angular limestone boulders. Solid bedrock

Monitoring of the area for an attenuation tank (Trench 4; Plate 12) located at the centre of the site only recorded modern made ground and natural deposits.
