Archaeological Watching Brief at Church Hill Brook Ravensbank Drive, Redditch Worcestershire

Worcestershire Archaeology
for Wyre Forest District Council

March 2019

Archaeological Watching Brief Report

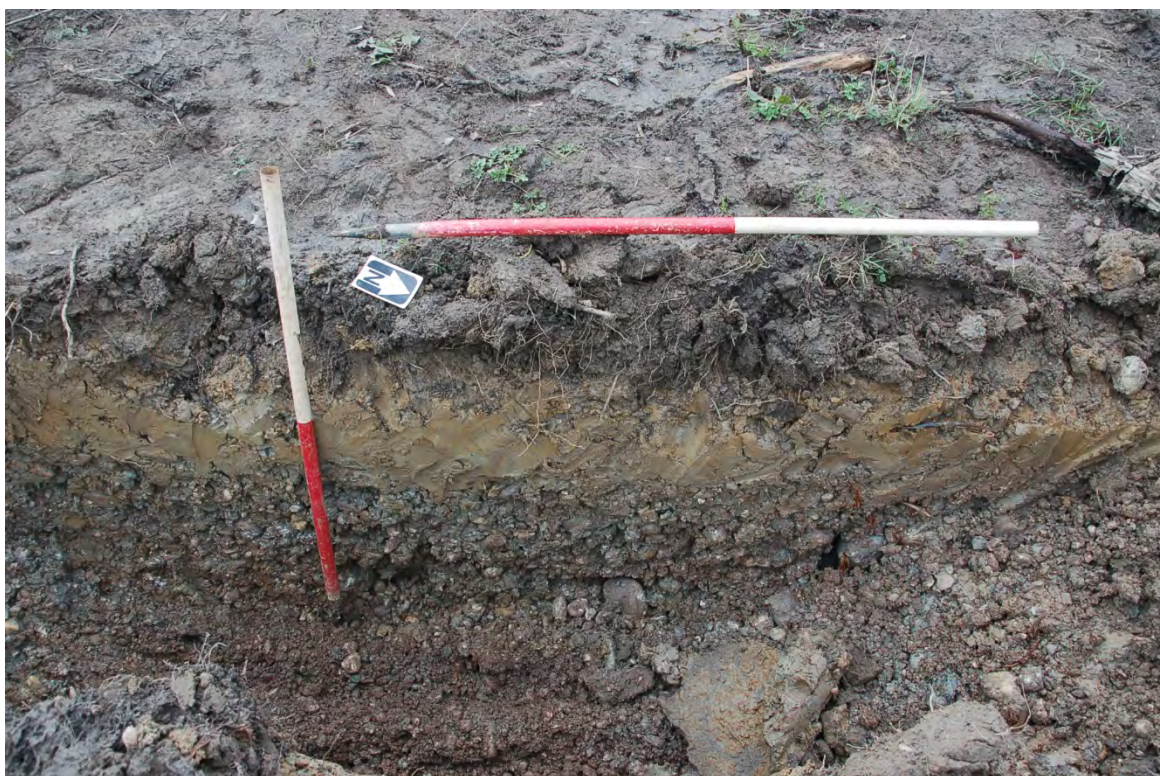
The stratigraphic sequence was simple and consistent across the site. This comprised a thin topsoil (100), overlaying a gleyed clay deposit (101), which overlay the natural geology (102) (Plates 1-2). No archaeological features or deposits were observed. Specifically, no organic-rich pond deposits were encountered.

The gleyed clay deposit (102) comprised a yellow and blue mottled silty-clay which had a maximum thickness of 0.58m, though this was reduced to 0.38m in the north-east of the site. The nature of this deposit could not be discerned within the confines of the groundworks; however a gleyed subsoil or former pond deposit seems likely. The deposit did not contain any organics and in places was just 0.12m below ground surface (*bgs*).

Plate 1: The stratigraphic sequence within the eastern meander of the trench. Topsoil (100) can be seen above gleyed clay (101), which sits above natural gravels (102), 1m scales.

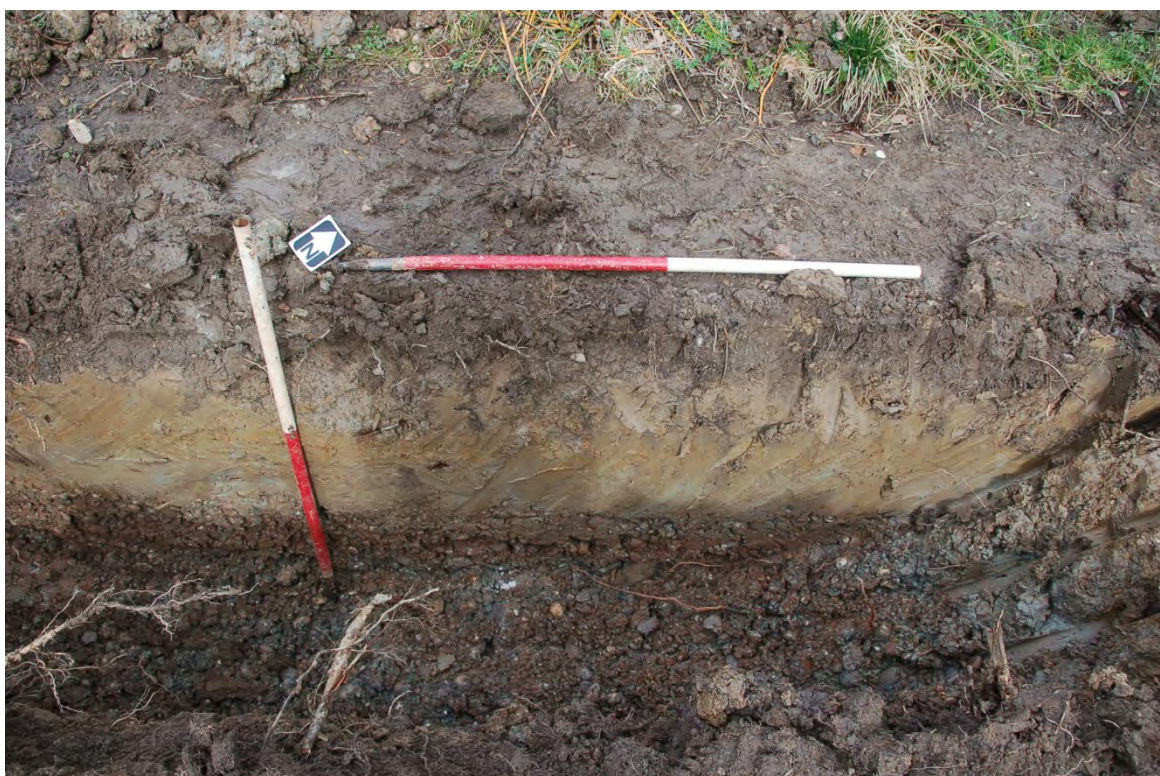
Plate 2: The stratigraphic sequence observed in the northern extent of the stream diversion, scales 1m.

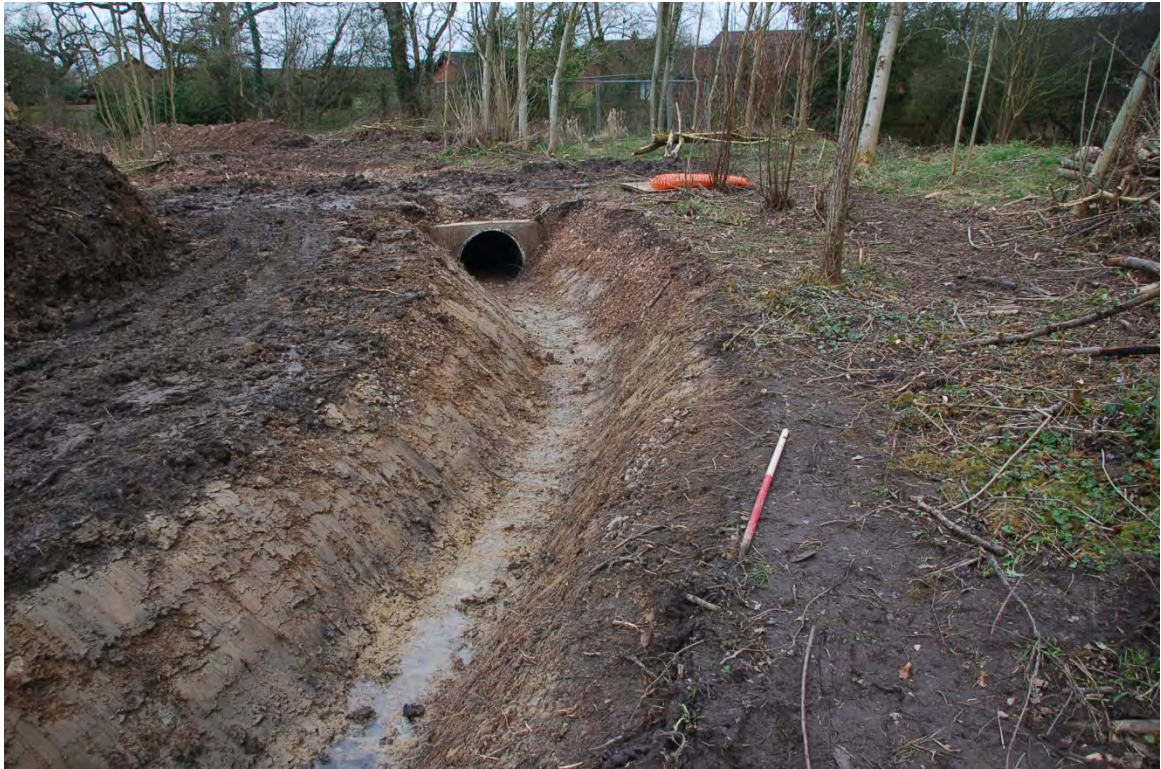
The trench was monitored in five locations across the meander of the diversion in order to provide a sample of the stratigraphic sequence across the site. The area of the meander had previously been identified by the Curator as the having the greatest potential for the presence of organic pond deposits. A control structure and a stretch of the southern stream diversion had previously been completed.

Plate 3: An example of the previously excavated stream diversion in the south of the site. The control structure can be seen towards the rear, 1m scale.
