Archaeological Watching Brief of access works for Upper Norton Farm, Craven Arms, Shropshire

Worcestershire Archaeology for ADS Architects

May 2019

Archaeological Watching Brief Report

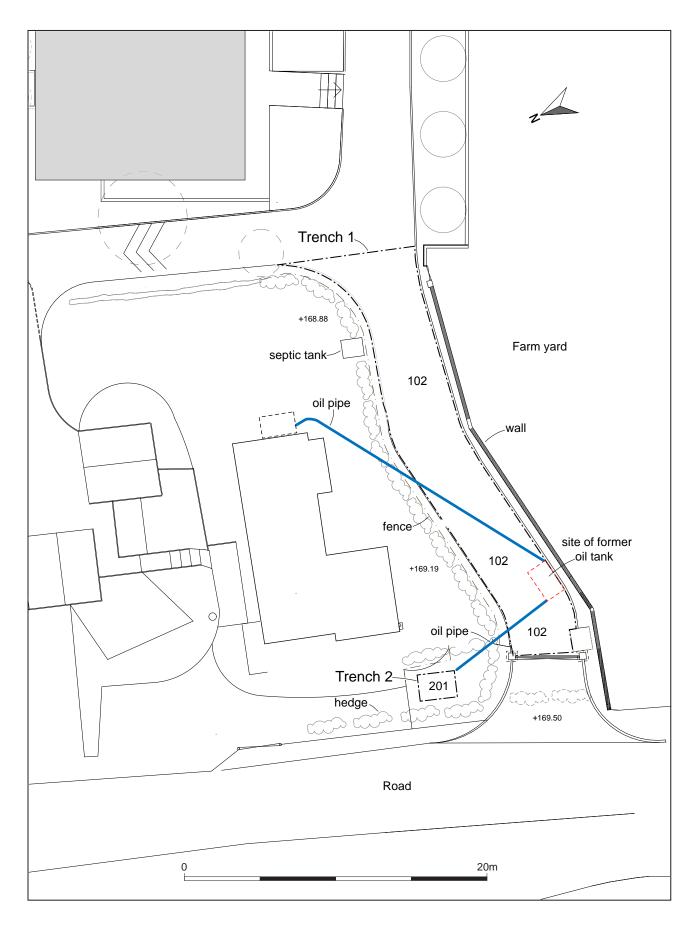
Trench location plan (based upon ADS Architects Limited Dwg. 891-A-01 Rev C)

Observation of two areas was undertaken: Trench 1: ground reduction for the new access road, c 4m wide by 30m long (amounting to c 120m²), and up to 1m deep; and Trench 2: ground reduction for a new oil tank, 1.75m by 2.50m, and 0.15m deep. The location of the trenches is indicated in Figure 2.

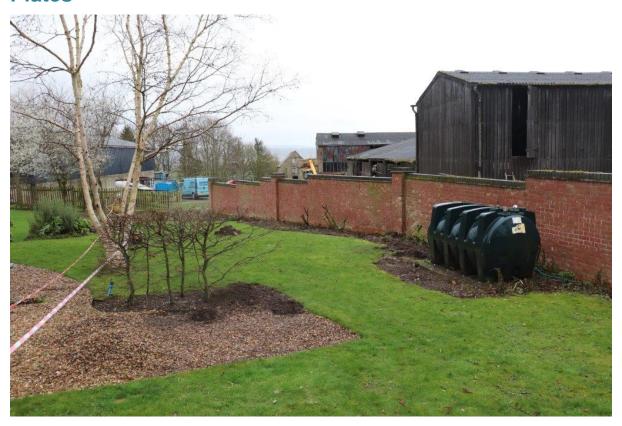
The site was in a garden of an existing property, with the ground sloping to the east towards the farmyard and barns. Ground reduction for the access road was to a maximum of 1.00m below ground level. No significant archaeological deposits, layers, structures or horizons were identified, nor artefacts recovered during the watching brief. The natural undisturbed geology was observed at approximately 0.70m depth across the full depth of the Trench 1 access road. However there was no defined undisturbed subsoil deposit above this. The modern turfed topsoil overlay a mixed made ground deposit of garden soils with occasional later post-medieval rubble and debris, which appeared to relate to previous phase/s of landscaping, and had involved intensive disturbance of the soils down to the natural geology.

Plate 1: General view south-east of the garden before start of groundworks, no scales

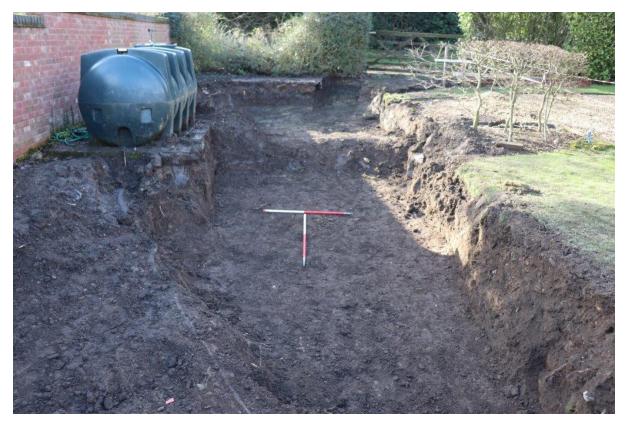
The watching brief of the groundworks revealed the turfed topsoil to overlie a mixed garden soil and made ground deposit cut by a number of modern service pipes, directly over the natural geological deposits.

Plate 2: Trench 1 access road groundworks, west end, view west to B4368 road, 2x 1m scales

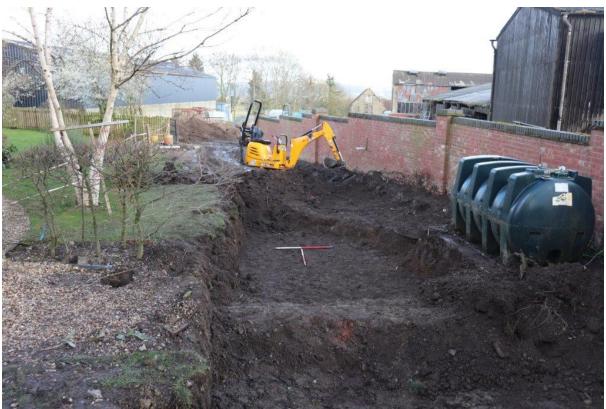
Plate 3: Trench 1 access road, modern oil pipe in foreground, view south-east, 2x 1m scales

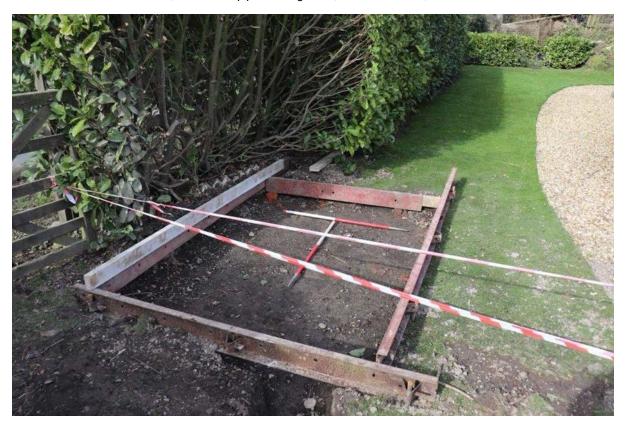
Context	Brief description	Depth from ground surface (m)	Comments
Trench 2 Ground reduction for new oil tank maximum depth 0.15m			
201	Topsoil	0.15m+	Turf and dark blackish brown sandy silt topsoil

Plate 4: Trench 2 base for new oil tank on north-west side of site, view north, 2x 1m scales
