Building Recording at Allesborough Farm, Pershore, Worcestershire

Worcestershire Archaeology
for Clive Petch Architects

August 2019

Building recording report

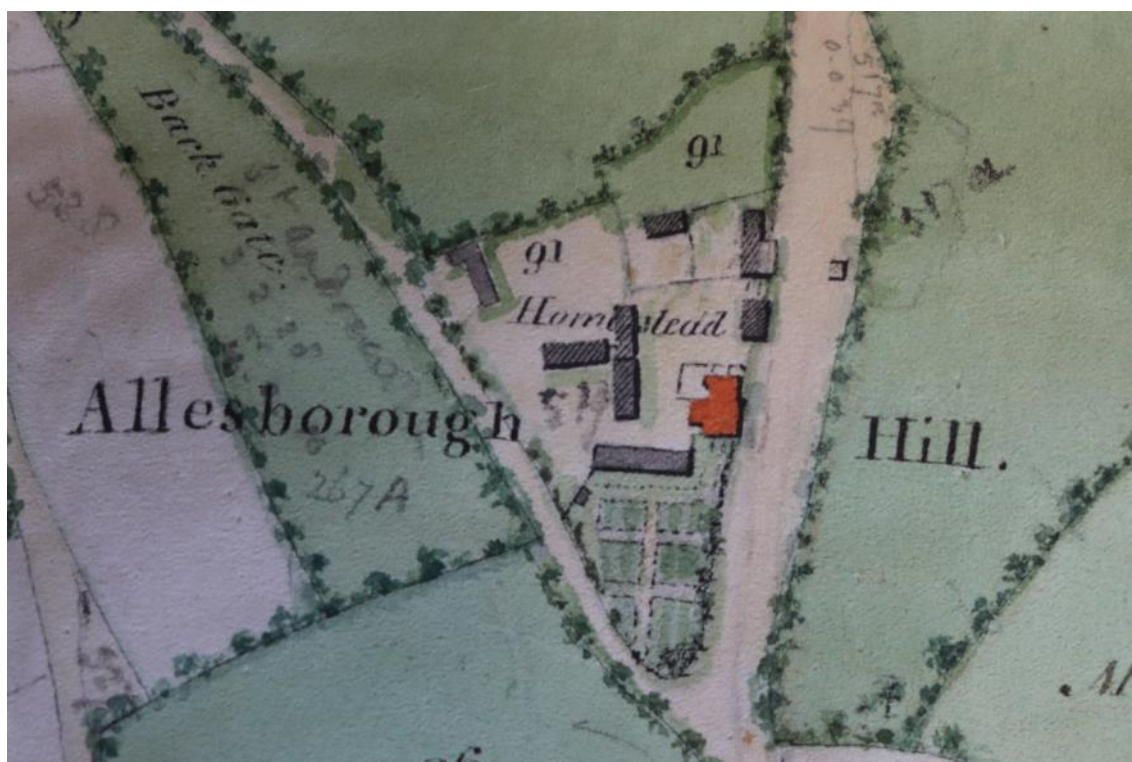
Plate 6 1812 "Map and Survey of the Estates Situate in the Parishes of Holy Cross and St Andrews Pershore" (WRO BA14450/260 s705:73), showing Allesborough Farm. All of the buildings up to the end of Phase 3 are present, with the definition between Phases 1 and 2 also clear.

All of the elements of the buildings up to the end of Phase 3 as outlined below are shown for the first time on a 1812 map of the holdings of the Earl of Coventry of Croome Estate with the parishes of Pershore Holy Cross and St Andrews, of which Allesborough farm was part (WRO BA14450/260 s705:73 Plate 6). A range of buildings is shown close to the middle of the barn to its south-west and running in that direction. A number of small buildings are shown within the farm yard south-west and north-west of the barn which no longer survive. The boundary between the Phases 1 and 2 elements of the barn as discussed below is clear on the map.

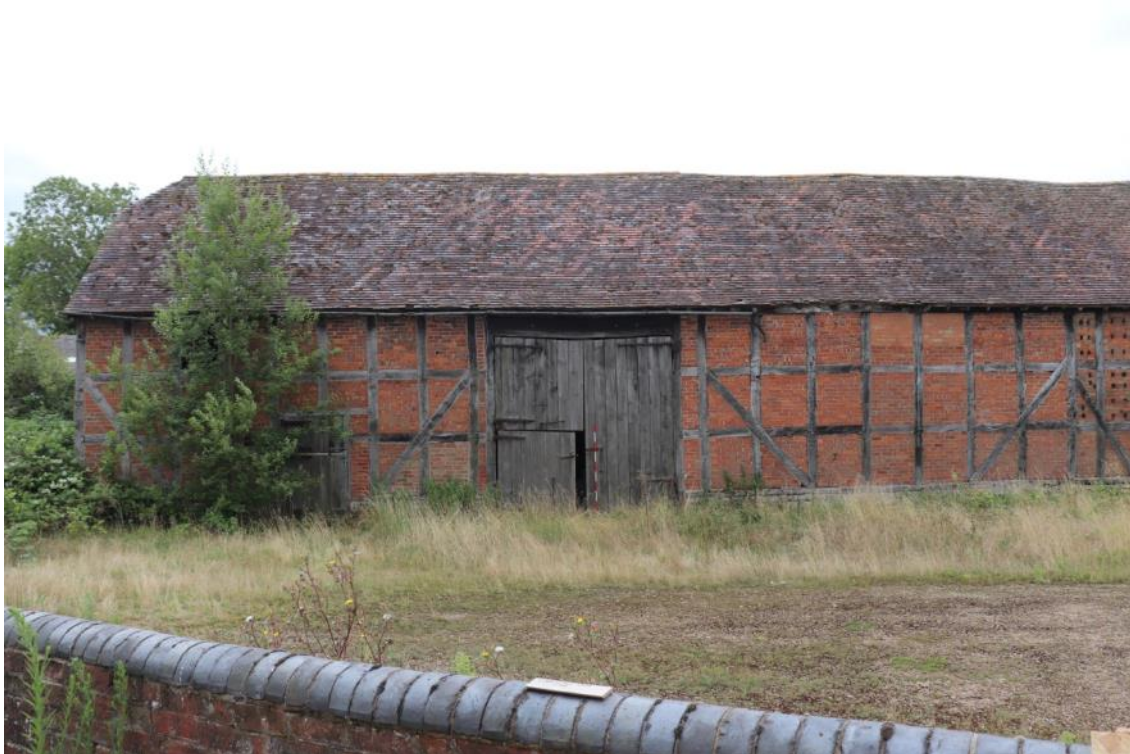
Plate 7 Phase 1 Barn, looking south-west, scale 2m

The earliest phase of the buildings consisted of a five bay timber framed barn 21m in length, 7.5m wide and the ridge apex 8.25m above the ground level. This made up over half of the south-eastern end of the remaining barn (Plate 7 to Plate 9).

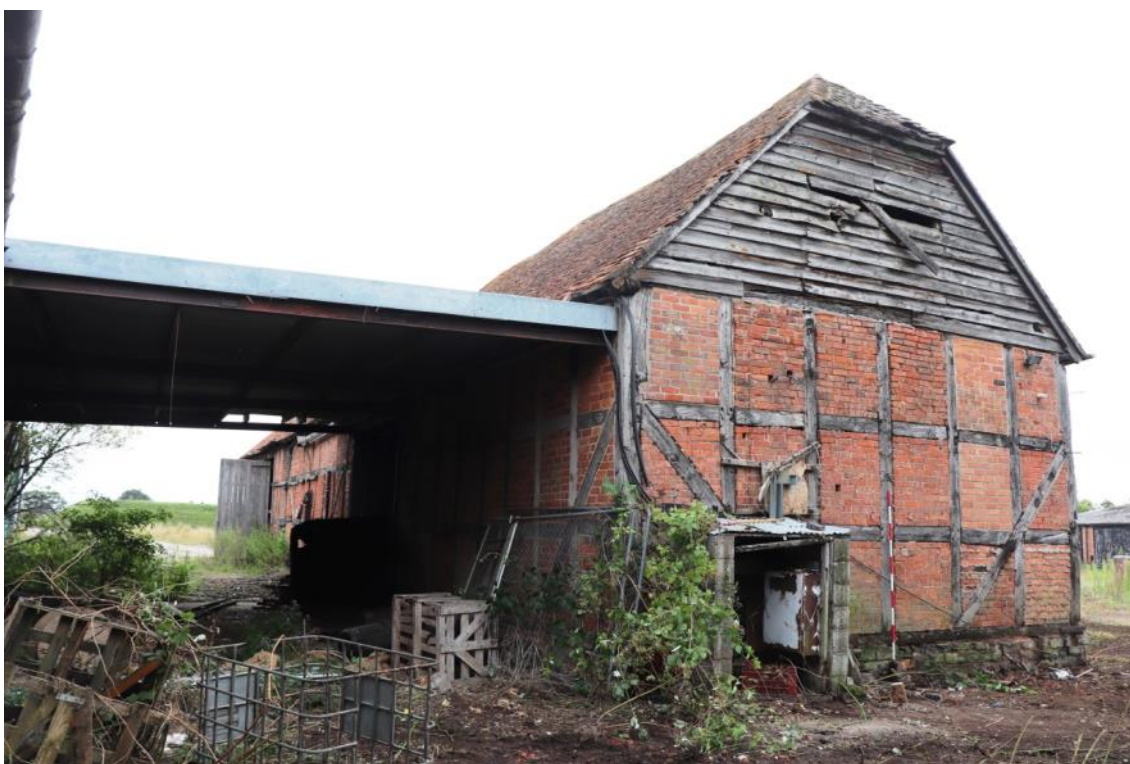
Plate 8 Phase 1 Barn, looking north, scale 2m

sill beam to the posts of the end gable frames and to the cross frames either side of the wide double doors in the position of the threshing floor (Plate 10 and Plate 11). The single remaining gable elevation on the south-east end of the barn (Plate 8) contained the same framing arrangement.

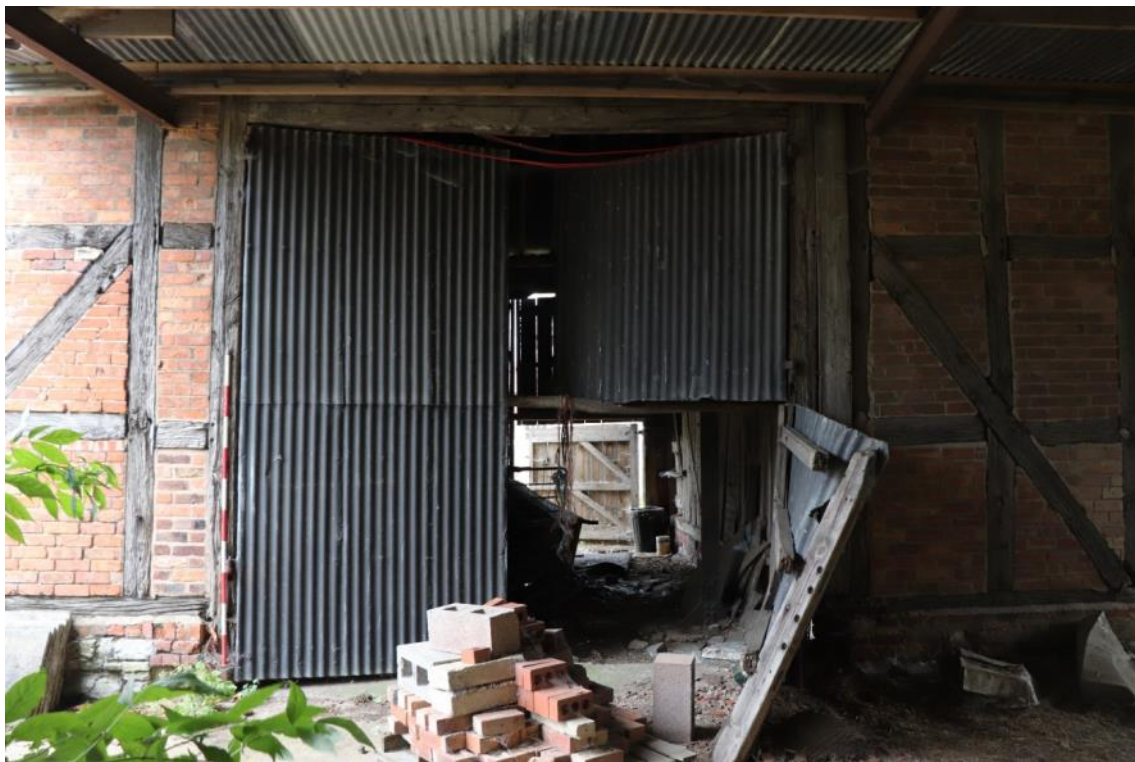
Plate 10 Phase 1 Barn, looking north-east, scale 2m

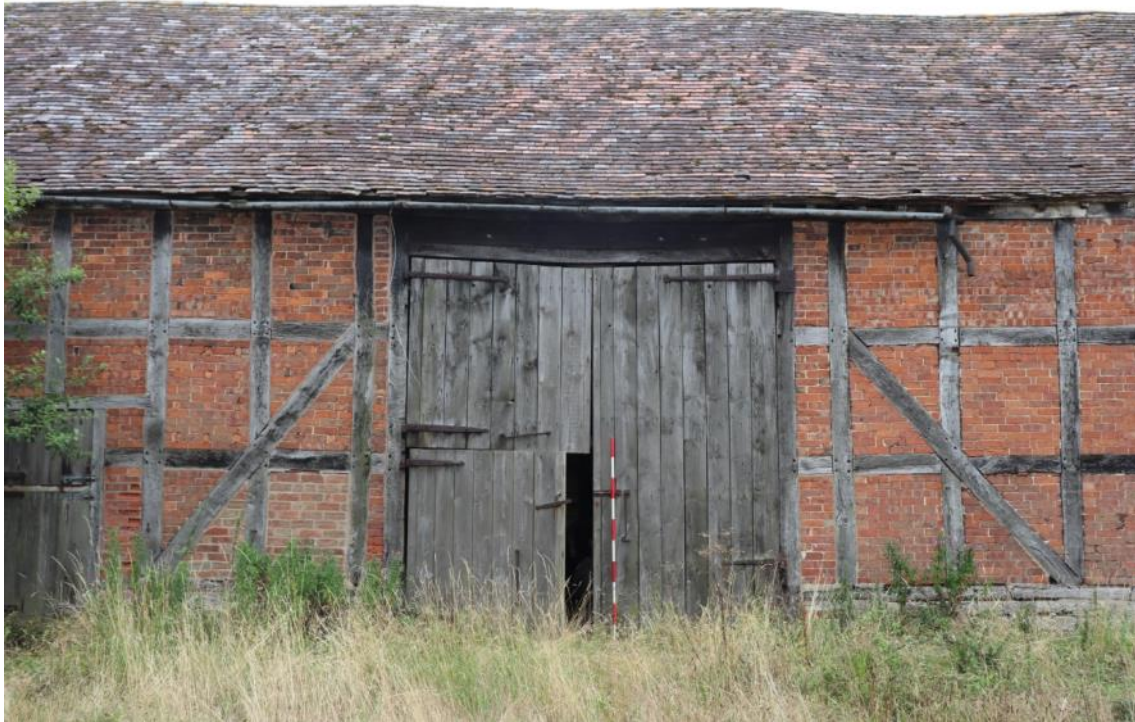
Plate 11 Phase 1 Barn, looking south-west, scale 2m

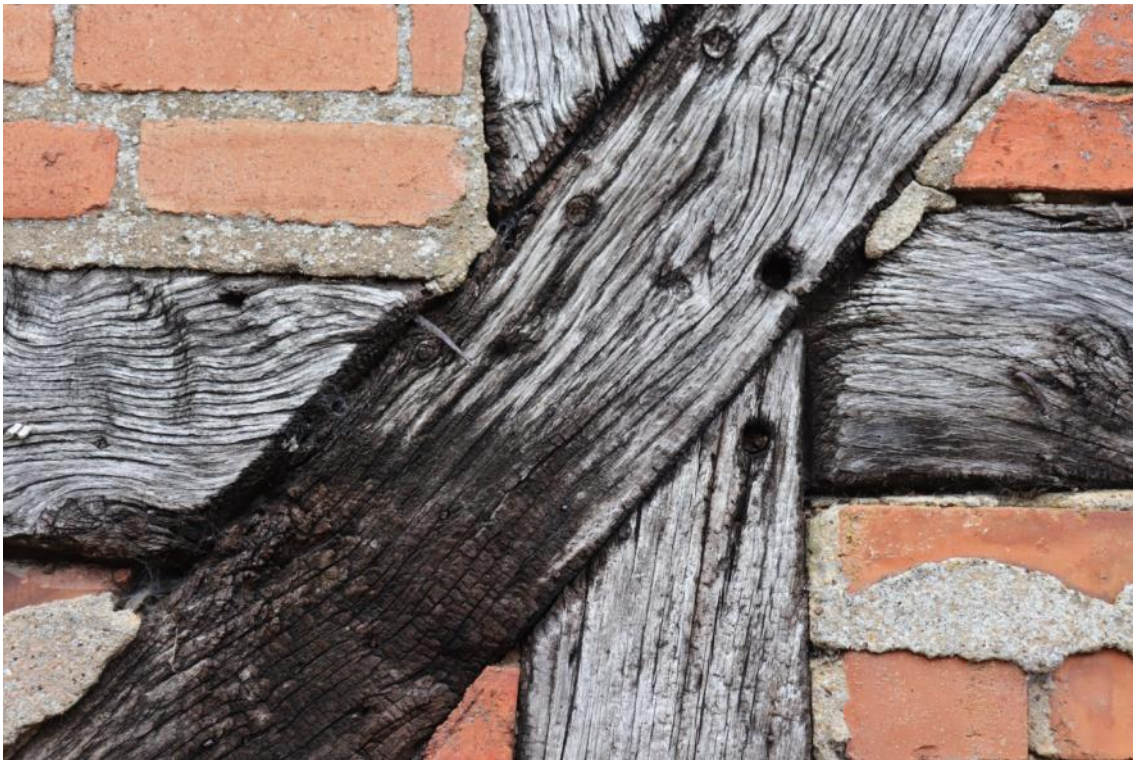
Plate 12 Phase 1 partial use mortice and tenon with peg jointing, and fixing of joints with nails. This method was used exclusively when jointing the rail to the brace.

No exterior details such as carpenters marks were visible due to weathering though some discussion of the jointing method used is useful, particularly when compared to the Phase 2 structure below. For almost all of its joints, wooden pegs have been used to secure the joints into position. This indicates the presence of a mortice and tenon within the joint therefore using an entirely standard and routine method. An exception to this is within some of the horizontal wall timbers which were attached to the passing braces using hand-made square headed nails and apparently without mortice and tenons (Plate 12). This technique was used extensively in Phase 2.

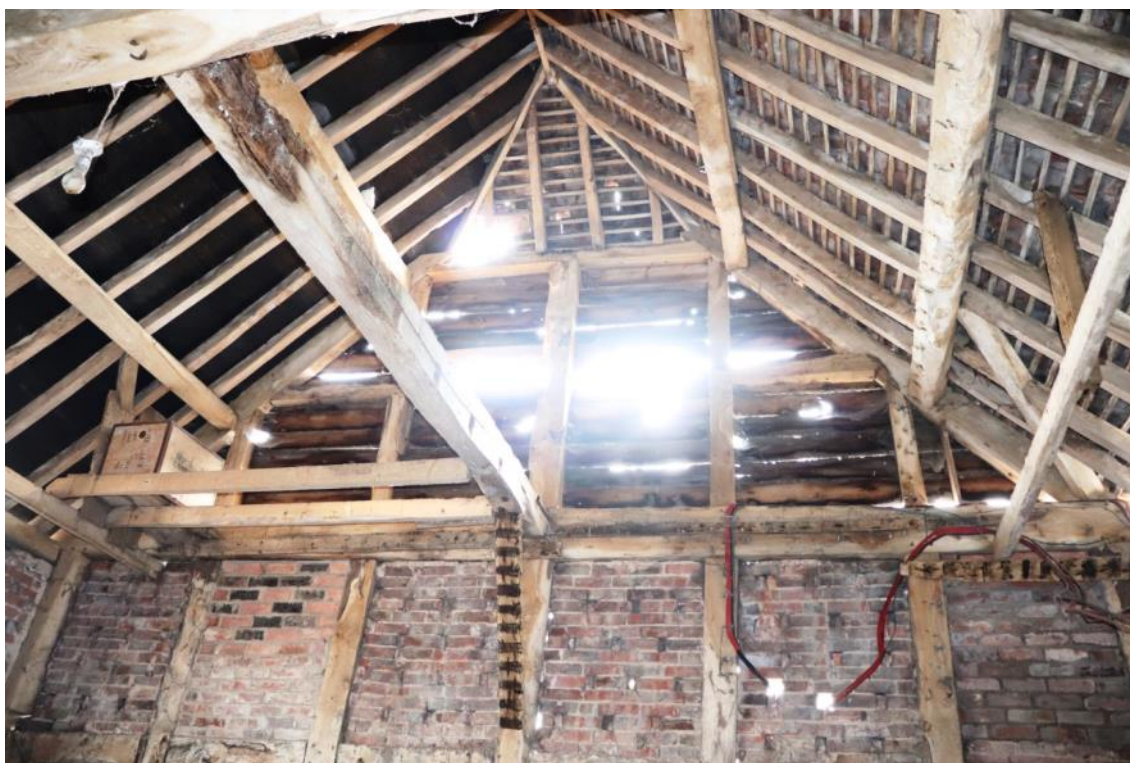
Plate 13 Phase 1 Truss 1, no scale, looking east

The interior of the building was split into five bays by cross frame trusses 1 to 6. Trusses 1 and 6 above tie beam level consisted of two truncated principal rafters jointed together by a high collar which indicates that the building was originally half hipped at both ends. A single central post ran from the tie beam to the collar which interrupted a horizontal rail. This in turn had four further posts above and below, creating a square panel frame (Plate 13 and Plate 14). No wall framing remained below truss 6. This is likely to have been truncated in Phase 5.

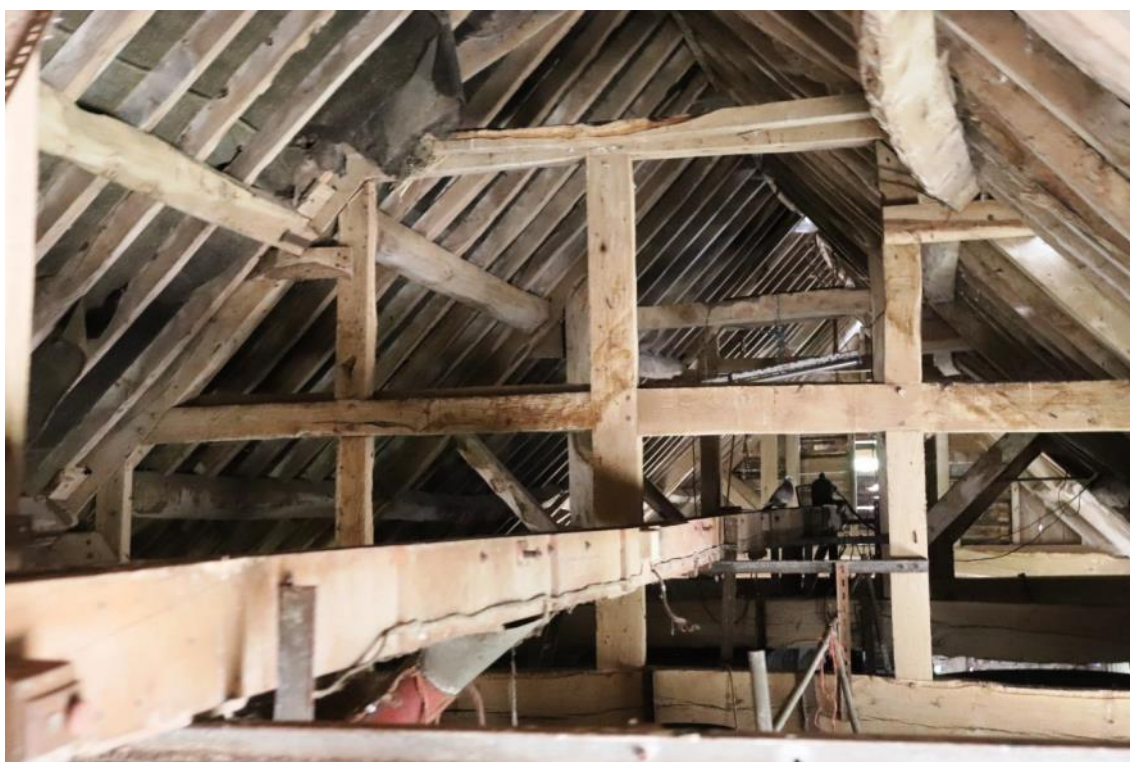
Plate 14 Phase 1 Truss 6 former gable end, no scale, looking east

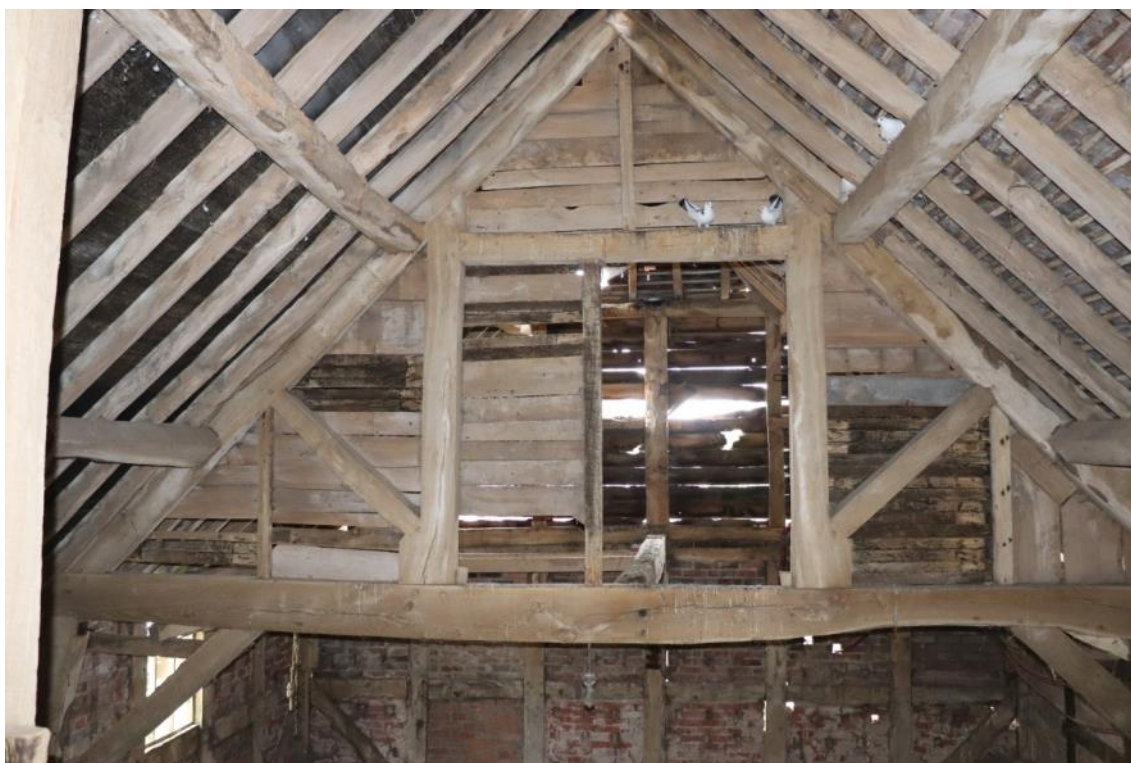
Plate 15 Phase 1 truss 2, no scale, looking east

Trusses 2 to 5 above tie beam level consisted of two queen posts with raking struts facing towards the roof, leaving a gap between the posts that would have allowed access through the trusses, despite no original floor evidence remaining (Plate 15). A high collar was present between the two posts, which in turn supported the principal rafters. This truss type with the raking strut jointed to a step at the base of the post is reminiscent of king post construction, which was first used in Worcestershire in the later 17th century.

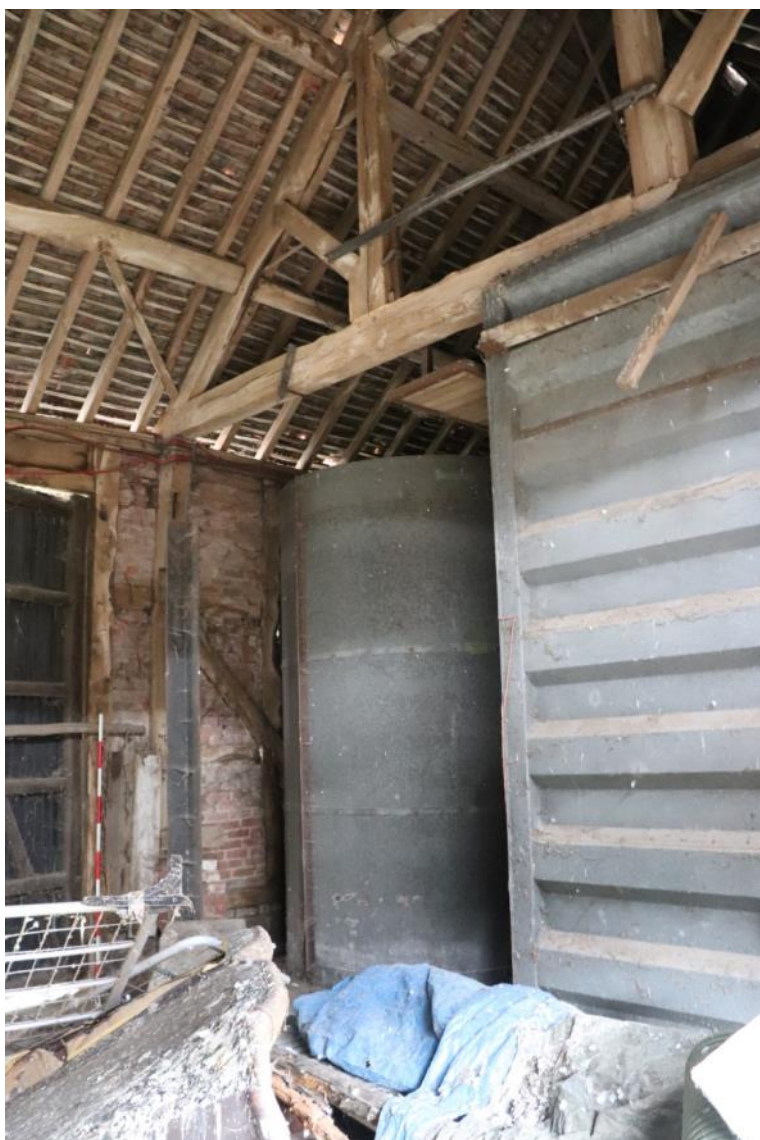
Plate 17 Phase 1 barn with 20thcentury silos obscuring the structure, scale 2m, looking west

The most substantial changes to the Phase 1 and 2 barns occurred from the middle of the 20th century when the north-western gable of the Phase 1 building was largely removed and large silos added, along with associated machinery.

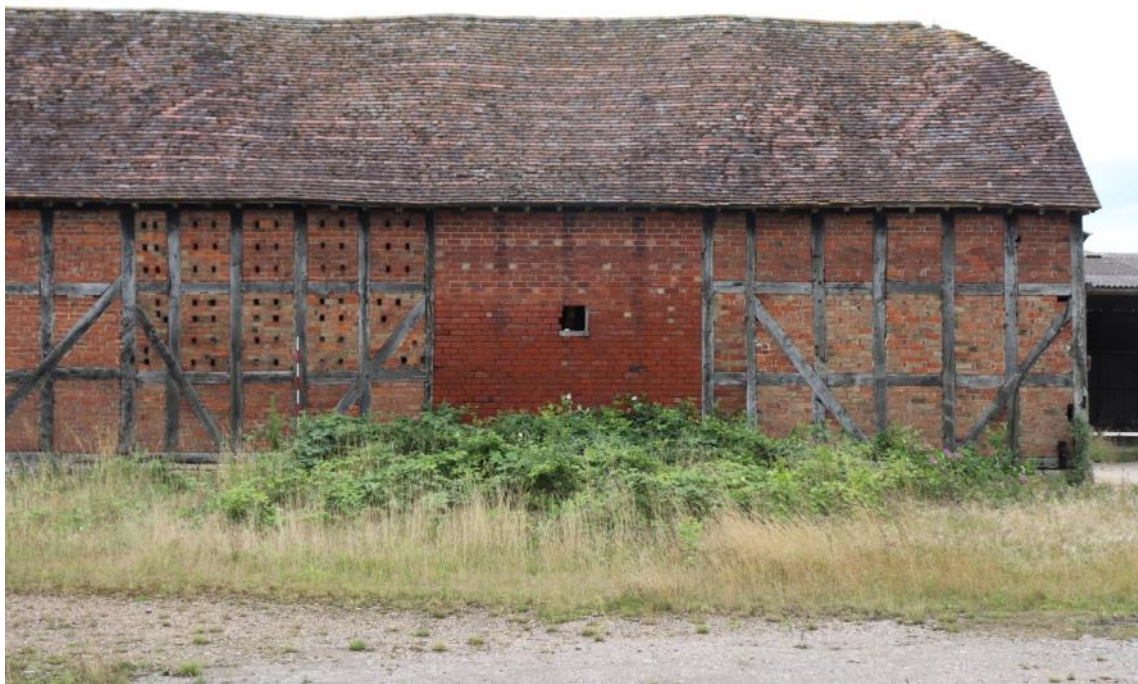
Plate 18 Phase 2 barn, scale 2m, looking south-west

A second barn of broadly the same function and style was constructed on the north-western end of the Phase 1 building (Plate 18 to Plate 20). This consisted of three bays, with only three cross frames, as the building reused the end frame of the Phase 1 structure. The building retained the same general wall plate and ridge height as the earlier structure. Its dimensions were 14m long by 7.25m wide, with its apex at the same height as the previous structure.

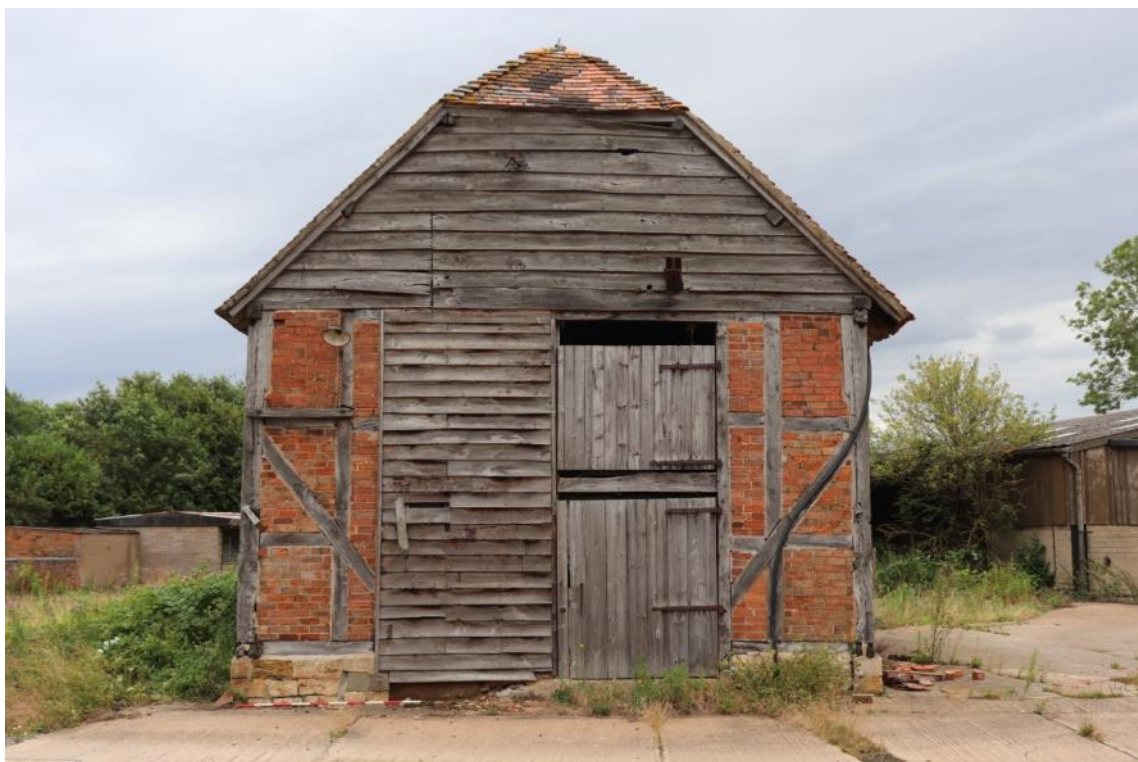
Plate 19 Phase 2 barn, scale 2m, looking south-east

The broad wall framing style remained the same as in Phase 1, with 3 high square panel framing, though with the posts slightly closer together to be vertical set rectangles. The posts again ran from the sill beam to the wall plate, with the horizontal rails between these. The earlier bracing style was also retained, with long straight braces running from the sill beam to the bay frame posts and interrupting the posts and rails. These were visually different in that they were set slightly lower, below the upper horizontal rail, than in the Phase 1 structure. The gable end frame (Plate 19) was built in the same style but truncated by later double doors.

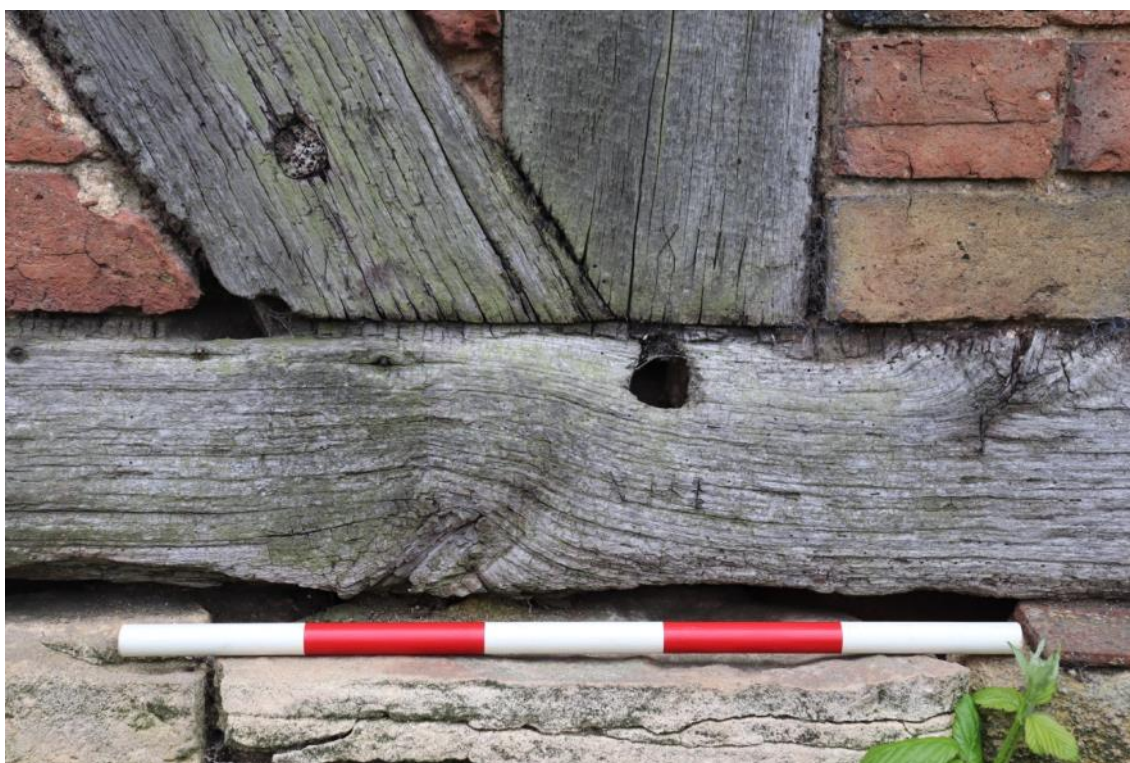
Plate 21 Phase 2 carpenters marks on the northern side of the barn, scale 0.5m, looking south-west

The wall framing of the northern side retained some evidence of the carpenters numbering system on the sill beam and base of posts in Roman numerals. This ran from III on the base of the north-eastern facing base of the northern corner of the building, through to XIV on its eastern corner (Plate 21 and Figure 7). The overall numbering system is consistent, though either side of the blocked double doors, both the numbers VIII and X were repeated on what may well have been a mistake.

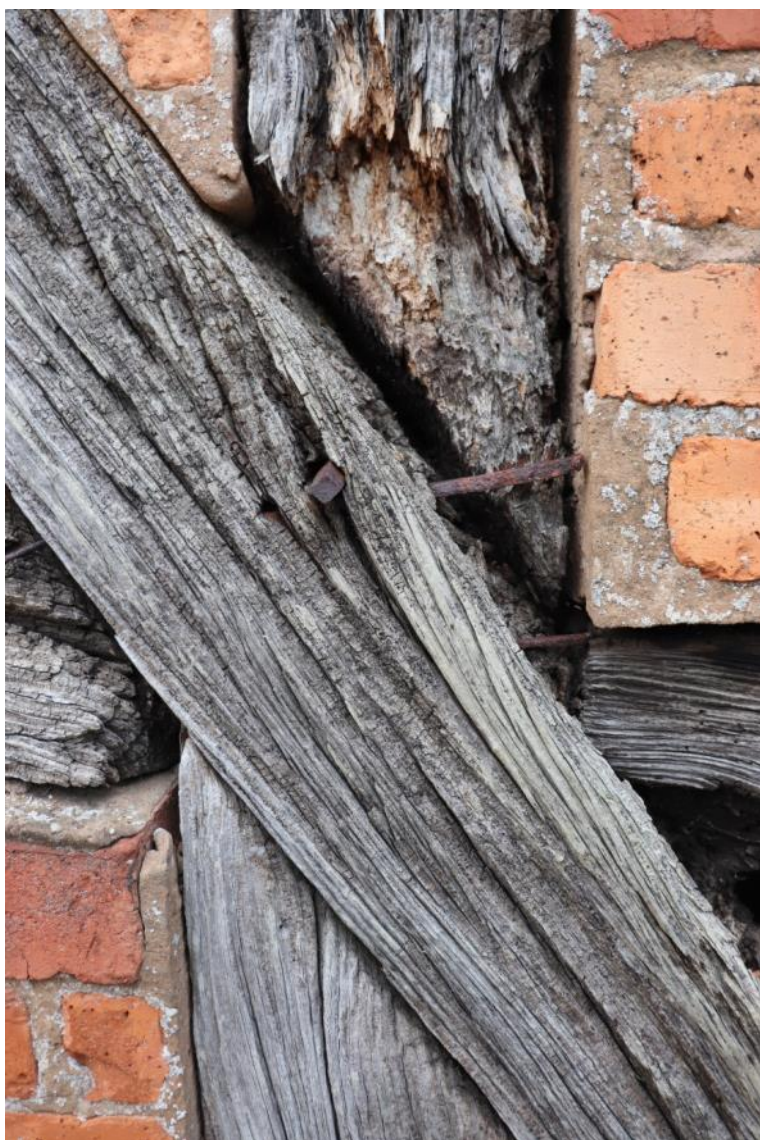
Plate 22 Phase 2, example of nailed together joints without internal mortice and tenons, no scale

As previously suggested, the most notable detail of the wall framing of this structure is its lack of pegging on the majority of joints. Some joints at the base of the posts are pegged to the sill beam, as is occasionally the case with the braces to both the sill beam and posts. The majority of joints were simply butted without mortice and tenon joints and nailed in place (Plate 22). To have this method used so extensively across the building is very unusual.

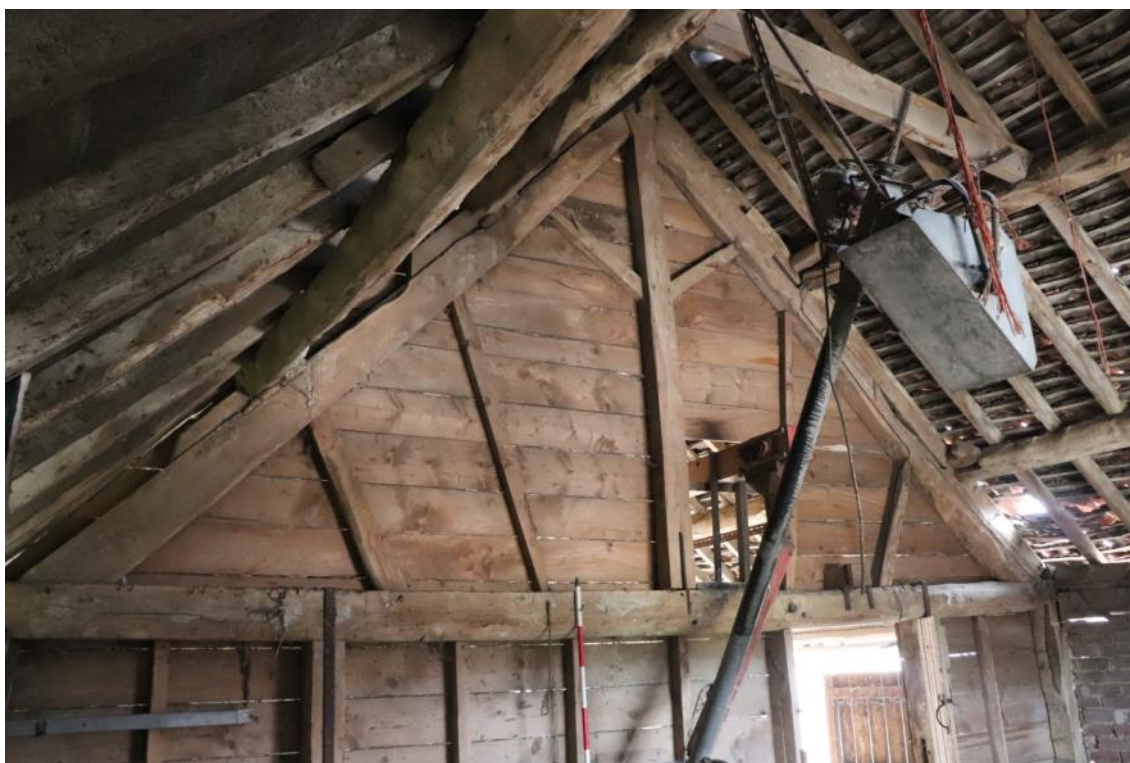
Plate 23 Phase 2 truss 8, scale 1m, looking south

Internal cross frame trusses 7 and 8 were placed either side of a broadly central threshing floor, with double doors from both walls opening onto this. These trusses above tie beam level consisted of a central king post truss with raking struts either side with two varying arrangements on each truss that were attached to the principal rafters (Figure 5 and Plate 23). Two posts extended vertically from floor level to the base of the tie beams and in turn attached to the posts with a horizontal beam and raking struts. Above the tie beam of cross frame truss 9, (Plate 24) were four posts which supported the principal rafters and a collar onto which the half hipped roof was constructed.

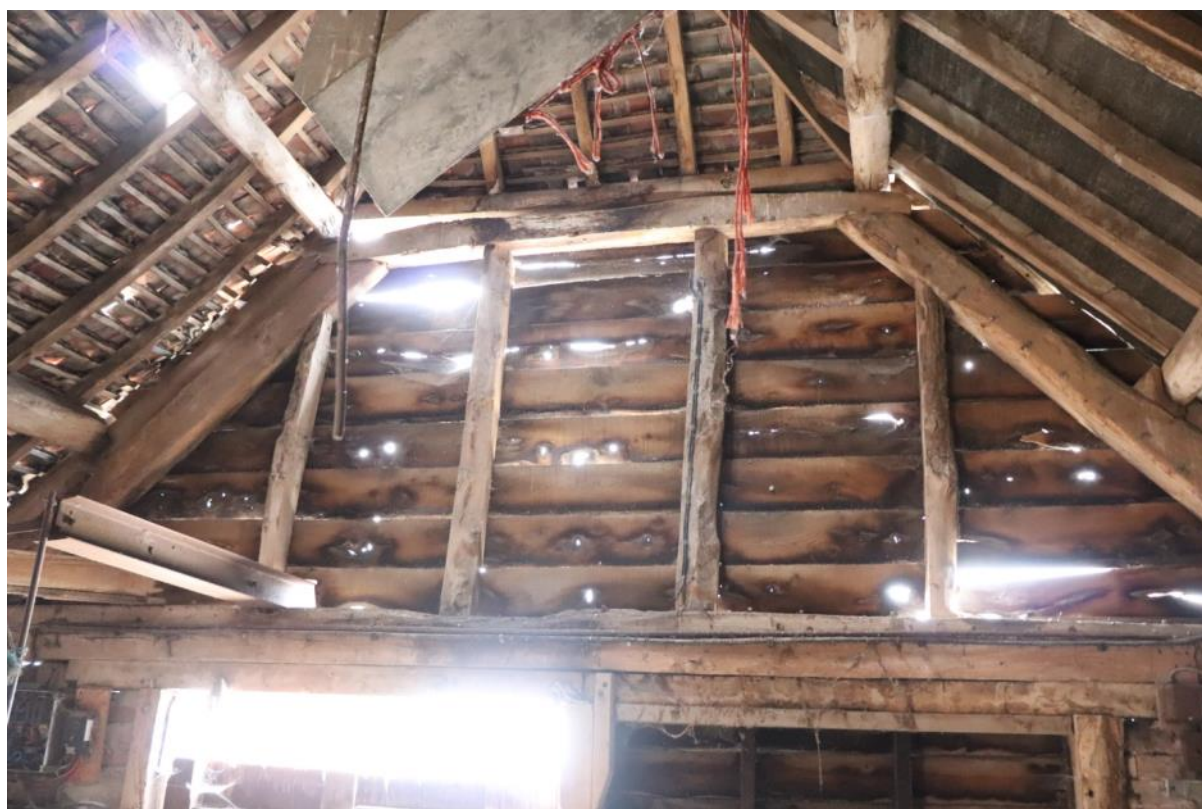
Plate 24 Phase 2 truss 9, no scale, looking west

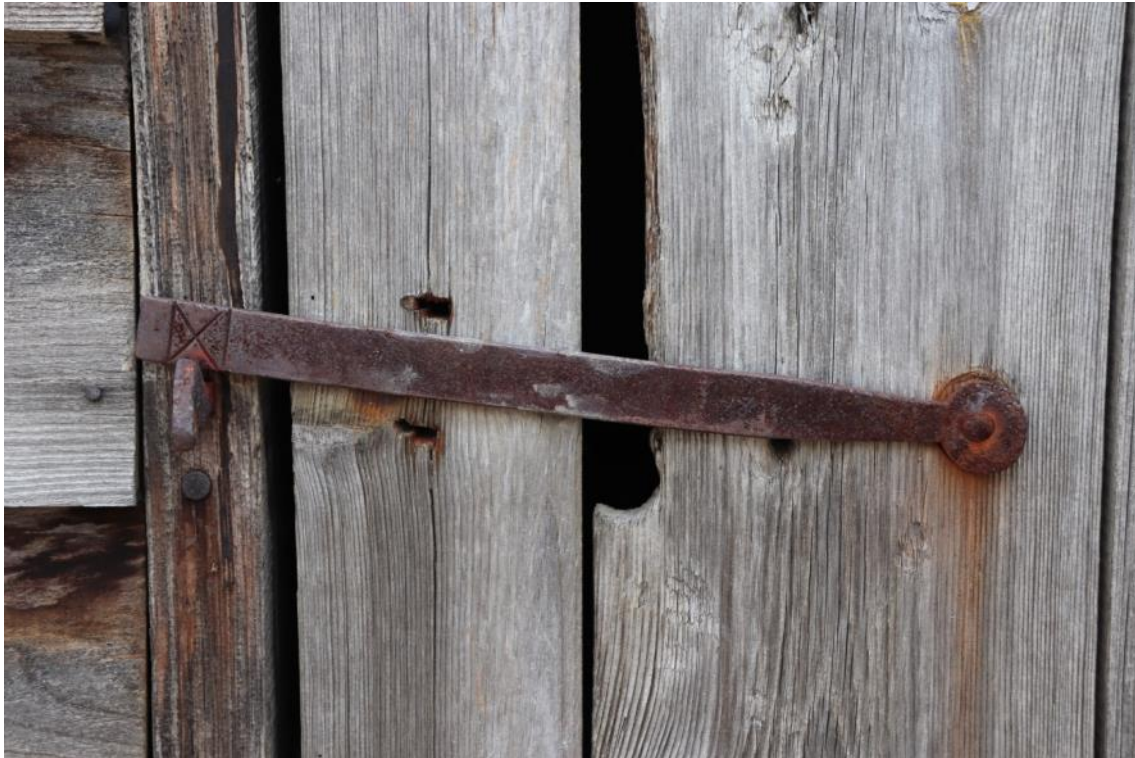
Plate 27 Latch reused on the Phase 2 barn, no scale, looking south-east

The common rafters were supported by double purlins on each side and nailed to a ridge board at the apex. The rafters were braced by long straight braces between the wall plate and ridge board. These were interrupted by, and nailed to, the common rafters. As with the rest of the phase, the use of iron work was extensive, notably in strapping the tie beam ends to the wall plates and the base of the king posts to the tie beams. It is likely that most of the iron work hinges and straps reused on the Phase 4 doors (Plate 27 and Plate 28) are of both this phase and Phase 1.

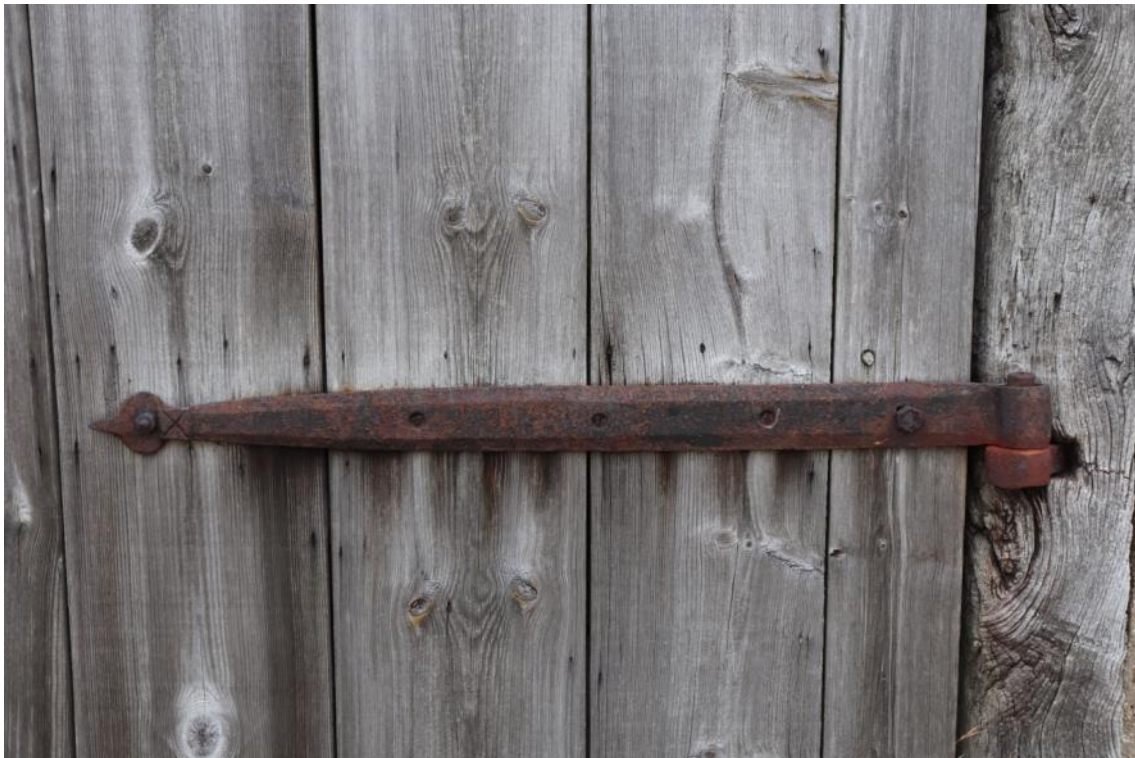
Plate 28 Strap hinge reused on the Phase 2 building, no scale, looking north east

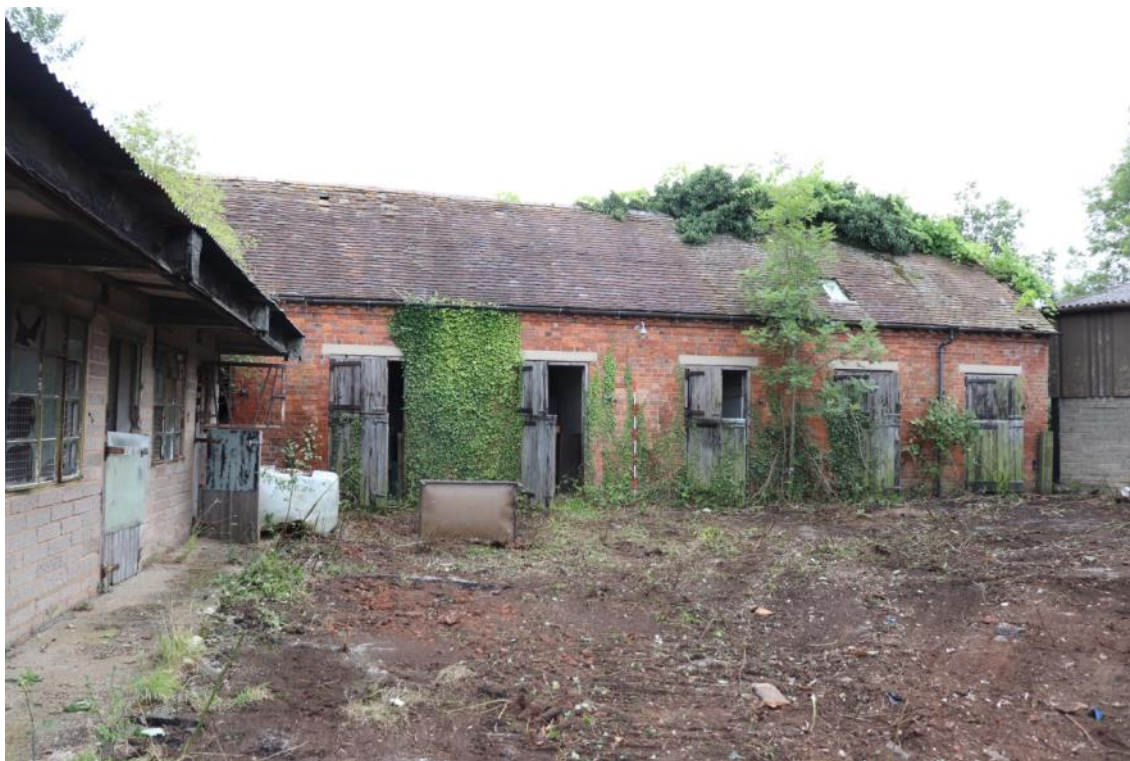
Plate 29 Phase 3 building, 2m scale, looking south-east

To the south east of the Phase 1 barn, a brick range (brick 220 by 110 by 70mm) with dentilled eaves, and half hipped ceramic tile roof aligned north-east to south-west was constructed (Plate 29 to Plate 32).

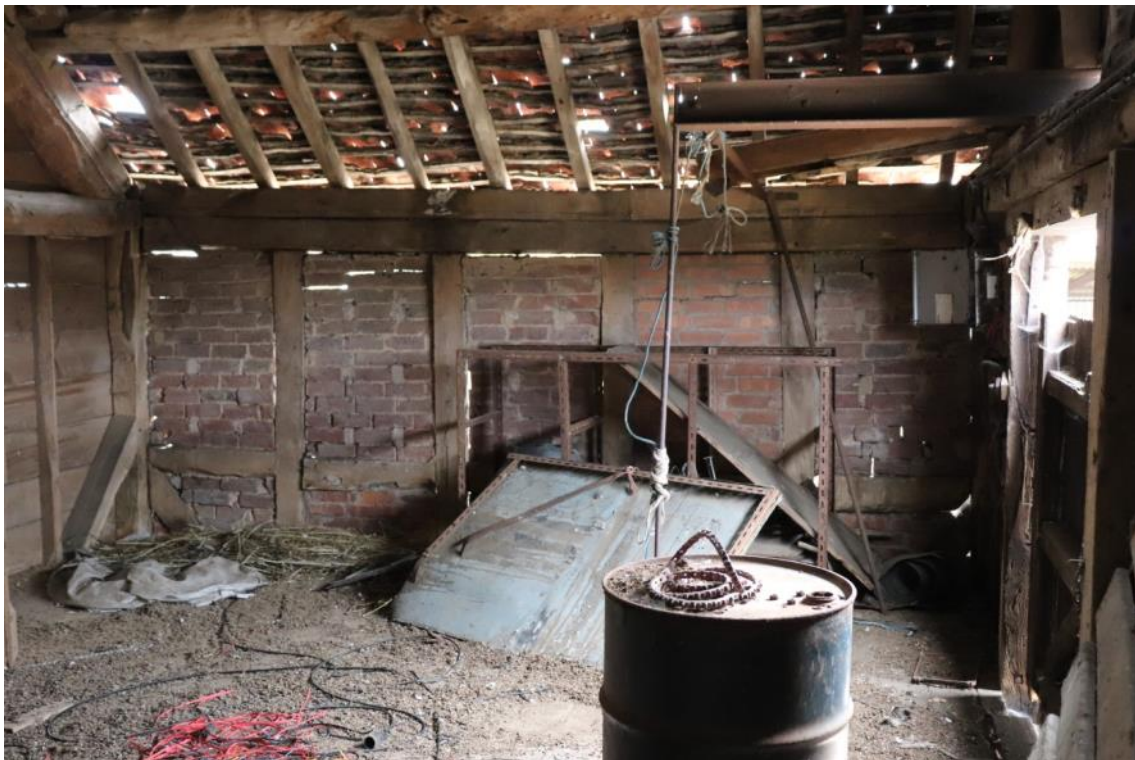
Plate 36 First floor room added into the Phase 2 barn, looking south-west
