Archaeological Watching Brief at Sydney Gardens, Bath

Worcestershire Archaeology
for RPS Consulting

October 2019

Archaeological Watching Brief Report

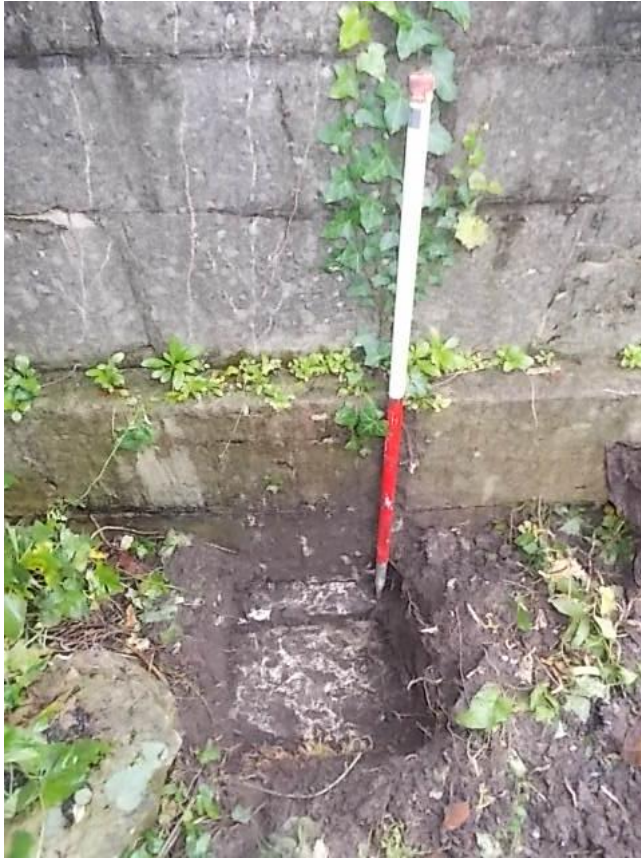
Plate 1. Trial hole 1

Context	Brief description	Max depth (m)	Depth from ground surface (m)	Comments
TH100	Imported topsoil	0.3m	0.00- 0.3m	Loose dark grey clay silt with frequent stone fragments – oolitic limestone, rooting and modern foam.
TH101	Crown of canal bridge	0.4m.	0.3-0.4m	Shaped Bath stone, slight ledge to north adjacent to bridge wall.

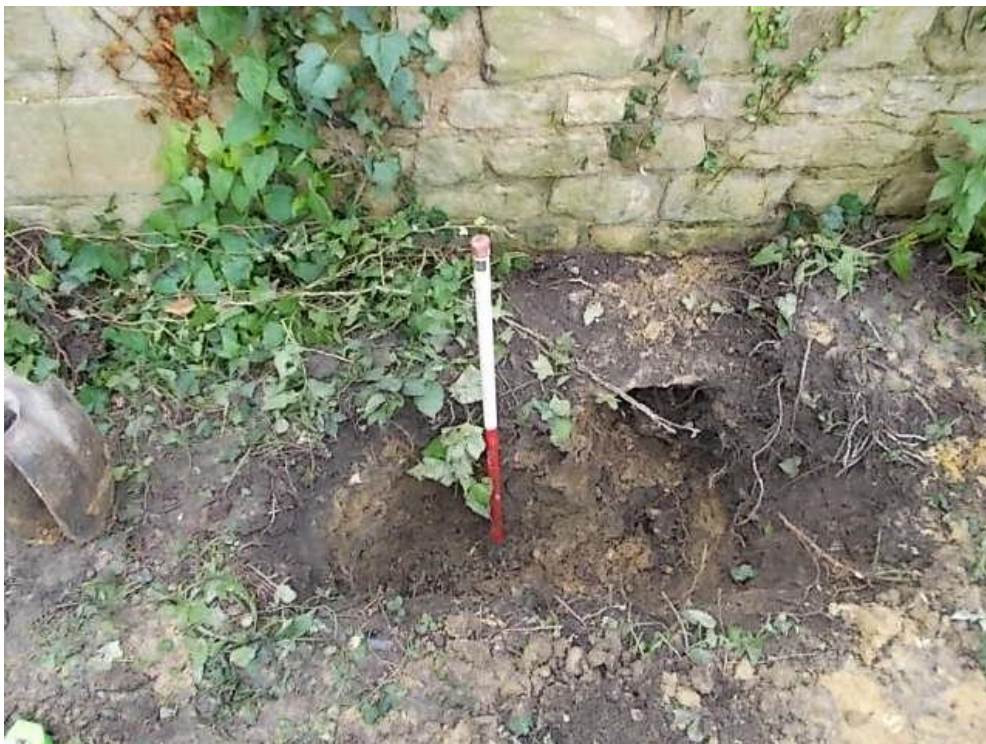
Plate 2. Trial hole 2

Context	Brief description	Max depth (m)	Depth from ground surface (m)	Comments
TH201	Topsoil – modern build up from vegetation	0.3m	0.00- 0.3m	Loose dark brown clay silt with oolitic limestone inclusions – some plastic at base
TH202	Imported clay – probably brought in the shore up edge of canal adjacent to revetment wall	0.25m	0.25m- 0.6m	Firm, homogenous yellow-brown clay

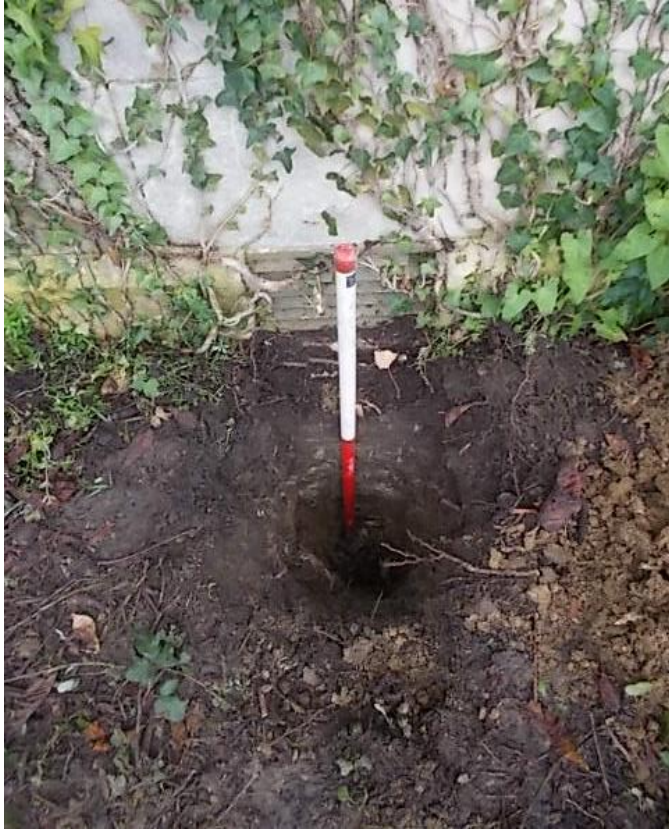
Plate 3. Trial hole 3

Context	Brief description	Max depth (m)	Depth from ground surface (m)	Comments
TH301	Imported topsoil	0.2m	0-0.2m	Loose dark brown clay silt with frequent angular limestone fragments
TH302	Imported clay	0.6m	0.2-0.8m	Firm, homogenous yellow-brown clay

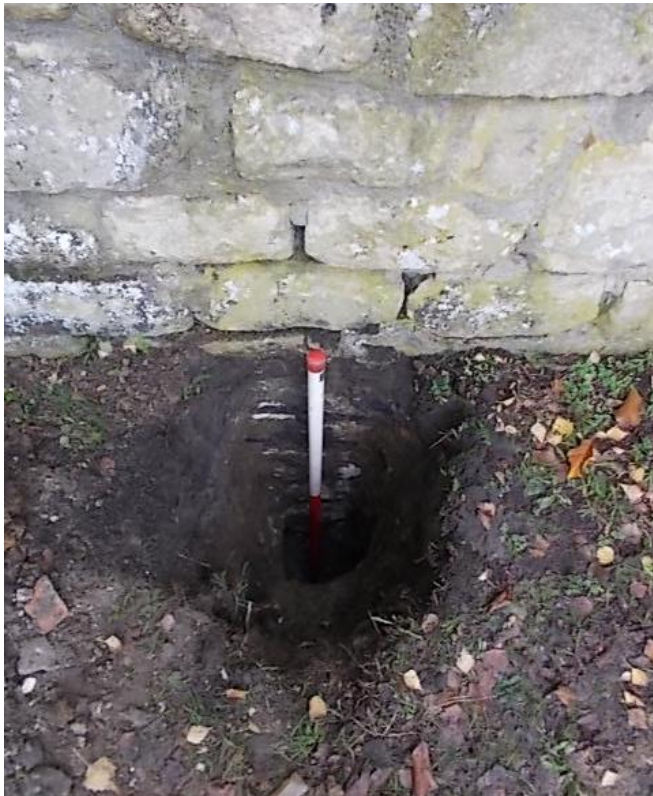
Plate 4 Trial Pit 04

Context	Brief description	Max depth (m)	Depth from ground surface (m)	Comments
TP401	Topsoil	0.25m	0-0.25m	Loose dark brown clay silt with oolitic limestone fragments
TP402	Made ground		0.25-1.15m	Loose light grey silt with frequent stones and cbm including tile and slate –

Note – wall abutting this pit was sooted below the ground surface to full depth

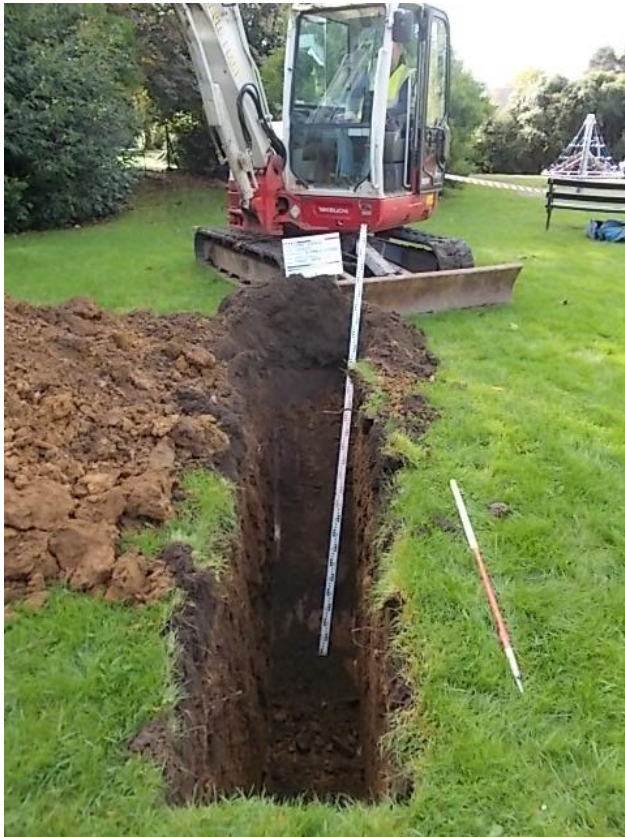
Plate 5. Trial Pit 05

Context	Brief description	Max depth (m)	Depth from ground surface (m)	Comments
TP501	Topsoil		0-0.2m	Loose dark grey silt
TP502	Made ground		0.2-0.7m	Soft light brown sandy clay with brick fragments and shell
TP503	Made ground		0.7-1m	Mid brown homogenous clay

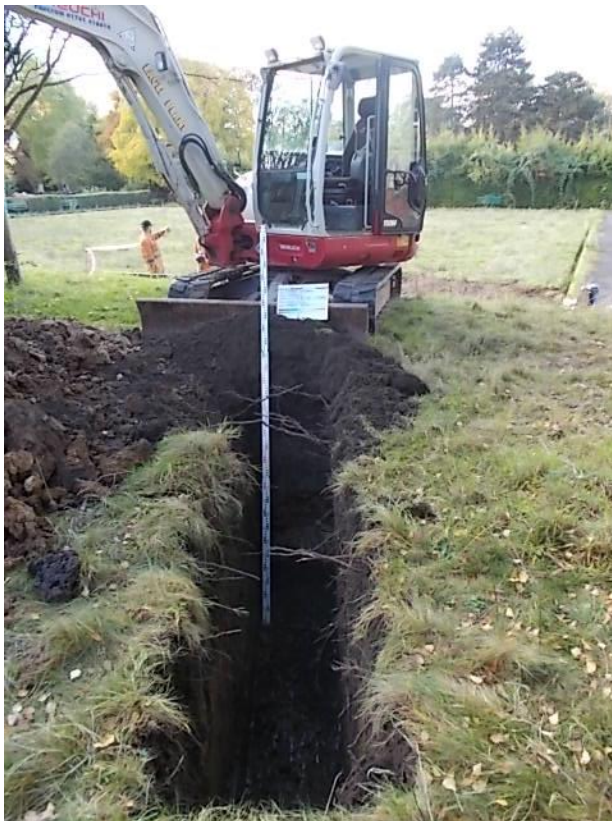
Plate 6. Trial Pit 06

Context	Brief description	Max depth (m)	Depth from ground surface (m)	Comments
TP601	Topsoil		0-0.2m	Loose dark grey silt with ash and charcoal
TP602	Reworked natural ground		0.2-1.2m	Firm mid brown silty clay with sub-angular limestone gravel inclusions charcoal. One shaped and sooted limestone block recovered.
TP603	Lens of imported material		1.2m	Lens of loose light grey silt with brick fragments and oyster shell
TP604	Imported material		1.2m+	Firm mid-brown clay

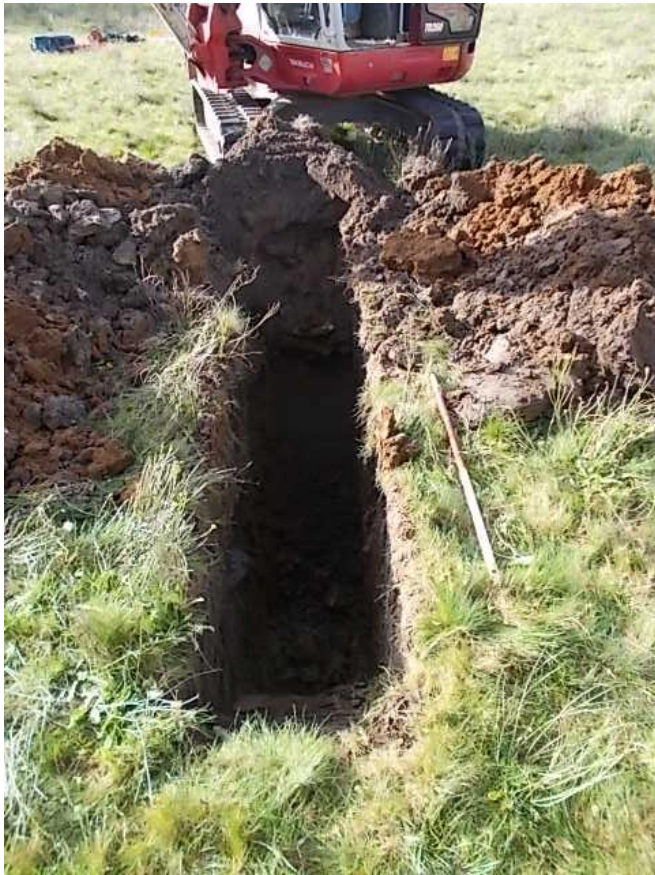
Plate 7. Trial Pit 07

Context	Brief description	Max depth (m)	Depth from ground surface (m)	Comments
TP701	Imported material for base of bowling green		0.0-0.5m	Loose sandy grey silt and clinker
TP702	Imported material for base of bowling green		0.5-0.55m	Layer of clinker
TP703	Made ground		0.55-1.2m	Mixed clay with ash and clinker with large flat limestone blocks at base – some brick inclusions
TP704	Possible natural		1.2m+	Mid brown sandy clay

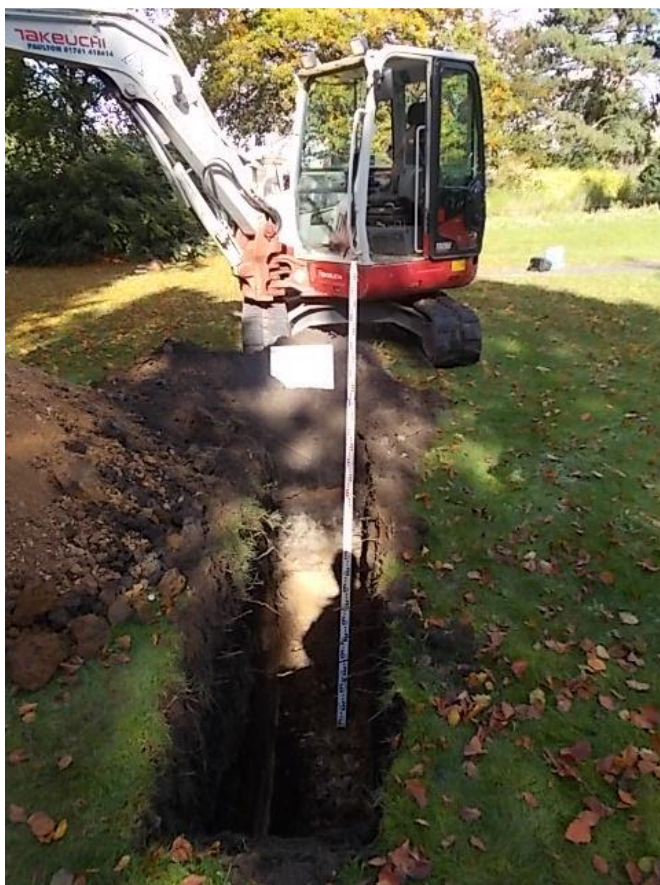
Plate 8. Trial Pit 08

Context	Brief description	Max depth (m)	Depth from ground surface (m)	Comments
TP801			0.03m	Loose mid brown clay stil
TP802			0.3-1m	Dark brown ashy clinker with brick fragments and a lens of light buff clay
TP803			1-1.8m	Firm Mid to light brown-orange clay
TP804			1.8m+	Light brown clay with weathered limestone

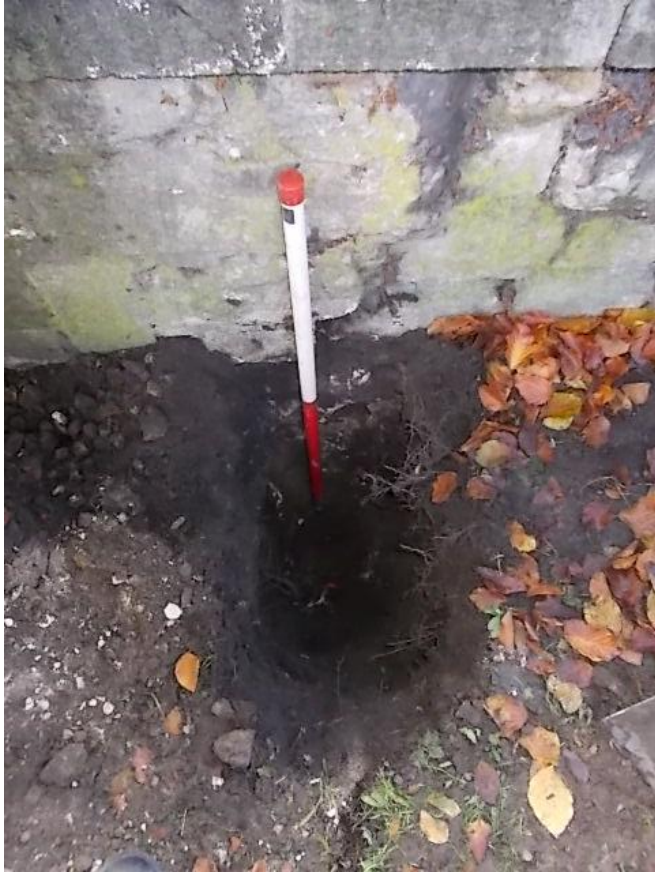
Plate 9. Trial Pit 10

Context	Brief description	Max depth (m)	Depth from ground surface (m)	Comments
TP1001	Topsoil			Loose dark brown clay silt with oolitic limestone fragments
TP1002	Made ground			Loose light grey -brown silty clay with frequent stones
