# Archaeological evaluation at The City Learning Quarter, Bilston Street, Wolverhampton

Worcestershire Archaeology  
*for City of Wolverhampton Council*

February 2020

Archaeological evaluation report

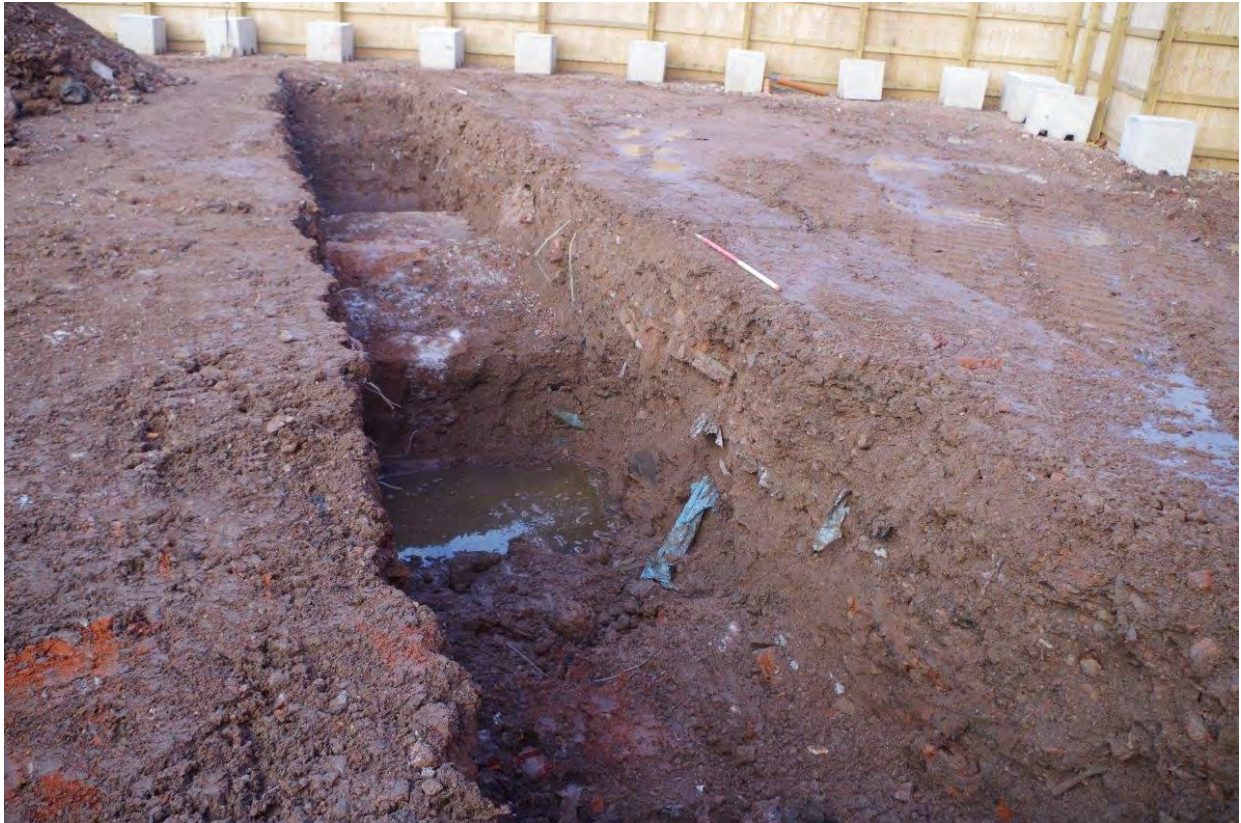
*Plate 1: Sondage in Trench 1 showing demolition material; 1m scale, view north*

The natural undisturbed geology was identified in the northern half of Trench 1, at a depth of c 1.5m below ground surface (BGS). Above this was a possible remnant of subsoil, c 0.2m thick (c 153.85m AOD). Due to the depth of the trench it was not possible to gain access to more closely inspect this deposit. It lay approximately 1m lower than the depth observed for the natural strata across the site as a whole, so it is probable that it was a weathered horizon of natural geology, rather than subsoil. This was covered by a layer of demolition material 102, that was observed in the southern half of the trench to a depth of at least 2.2m BGS. A large concrete block sat in the middle of the trench, at 1m BGS, with 102 overlying it (Plate 1). Sealing this was recent demolition layer 101, c 0.6m thick.

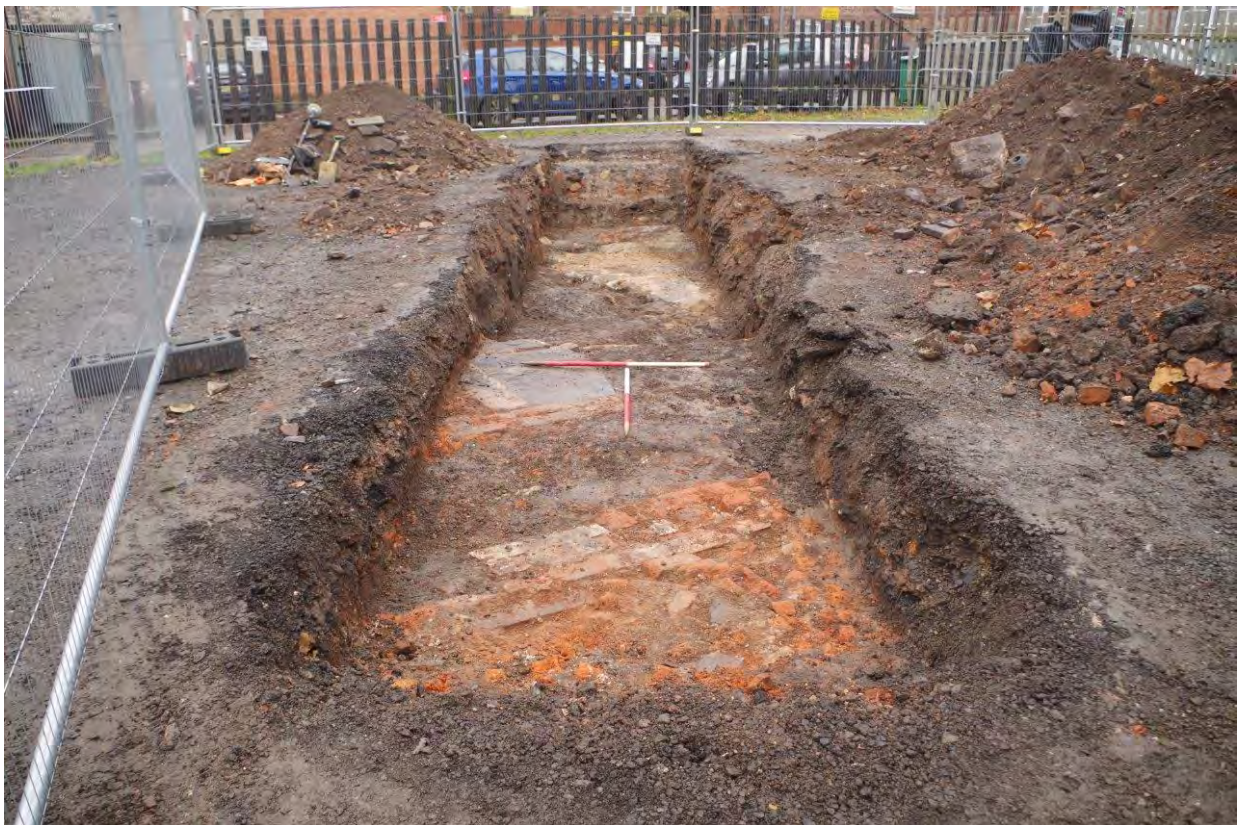
*Plate 2: Trench 3, brick walls and surfaces relating to St Georges School, 1m scales, view south-west*

Layer 326 was cut by construction cuts for walls 319, 306, 309 and 312 at the northern end of the trench (Plate 2). These walls were all constructed of orange machine-made bricks, measuring 240 x 120 x 70mm and bonded with a hard whiteish grey cement. All of the walls with the exception of 309 were laid in stretcher bond, and two bricks wide. Walls 309, 306 and 311 are abutted by floor 310.

The northern part of Trench 3 revealed the remains of what must be the south-west corner of St George's School for Boys, Girls and Infants, at 155.20m AOD, 0.35m below the ground. This was built between 1842 and 1852 and was demolished by 1956.

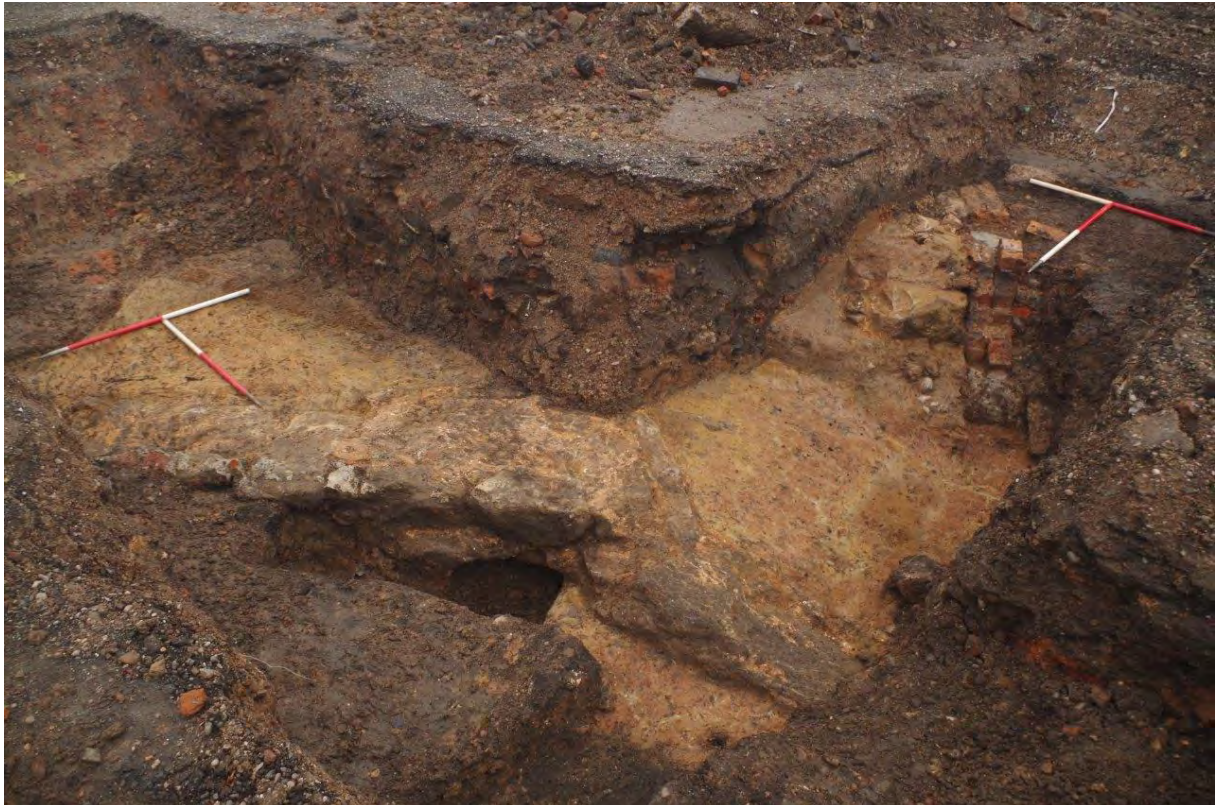
*Plate 3: Trench 3, curtain walls 313, 320 and 321, 1m scales, view north-west*

The natural undisturbed geology was identified at between 0.99 and 1.2m below ground surface. Above this was a remnant subsoil (316), in the south and west of the trench. This was a firm greyish brown silty clay, up to 0.47m thick in places. It was truncated by the construction cut, 322, for three sandstone walls; 313, 320 and 321. Where it was present in the south of the trench, it was as an isolated patch away from the wall, but it was seen in the western trench extension being directly truncated by the construction cut. It sat directly above the natural undisturbed clay. A small sondage was excavated through the material to check if it was redeposited, but it appeared to be *in situ* and undisturbed. Wall 313 was aligned north-west to south-east. It measured 0.85m wide and was 2.8m long within the trench. It was built of roughly hewn green sandstone blocks, up to 0.55 x 0.4 x 0.12m in size, with the external face on the eastern side visible and surviving to two courses. It was bonded with a pink sandy mortar. Concrete and brick remnant 314 was bonded to the south-eastern edge of the wall, which may represent a repair or later addition. The north-western end of the wall was finished with two stones effectively "on edge", and the wall returned to the north-east, as wall 320. This was 0.45m wide and 1.1m long and was bonded with the same pink mortar as 313. To the west of this was wall 321, again constructed of green sandstone and pink mortar. This wall was not dug as deep into the ground, but was otherwise similar in construction. The top of this wall was 0.52m below ground surface (Plates 3-5).

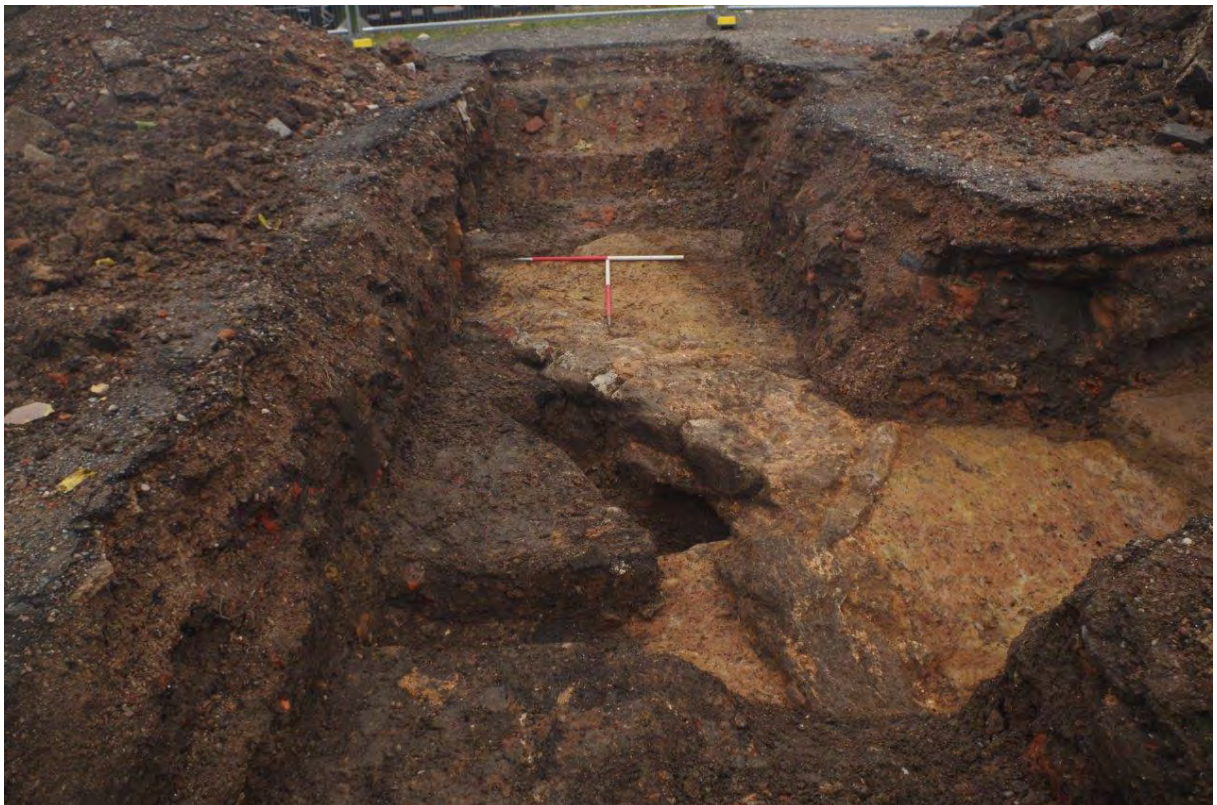
*Plate 4: Trench 3, curtain walls 313 and 320; edge of moat in sondage in foreground, 1m scales, view south-west*

Along the eastern, outer, edge of wall 313 was moat cut 324. This was observed only in the base of a small sondage, but is projected to run parallel to the wall (Plate 4). It was unexcavated, but the deposits seen in plan suggested it was intentionally backfilled, with dark silty sand, rich with domestic and industrial waste. Pottery observed (but not retained) in this fill was of 19<sup>th</sup> century date. Overlying the ditch fill was a made ground of probable 19<sup>th</sup> century date, 326. This was also observed in the western extension of the trench (Plate 6).

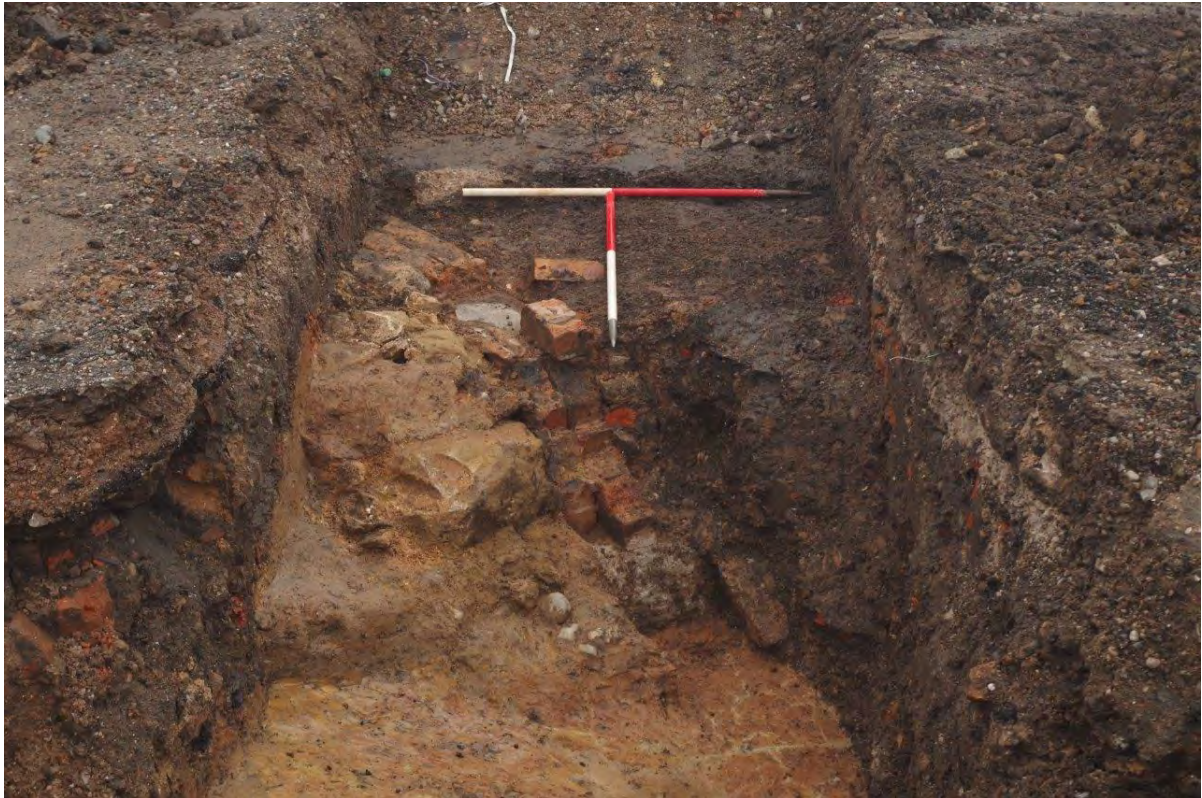
*Plate 5: Trench 3, curtain wall 321, with brick wall 325 built against it, 1m scales, view north-west*

Layer 326 was also truncated by the construction cut (328) for wall 325. This was constructed parallel to and abutting sandstone wall 321, on its northern, outer edge (Plate 5). It was a 20<sup>th</sup> century wall, constructed of orange bricks measuring 235 x 110 x 85mm, and sat on a concrete foundation. The wall survived to six courses on top of the concrete. It was two bricks wide laid in stretcher bond.

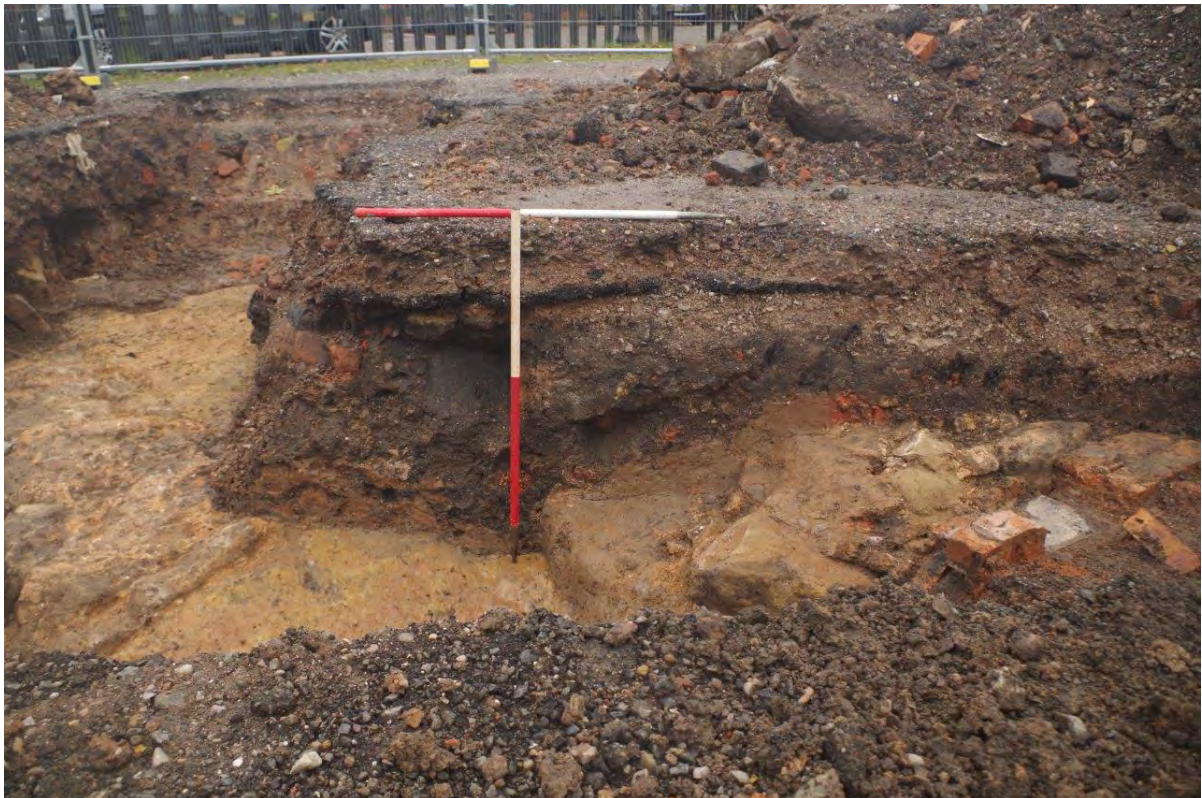
*Plate 6: Trench 3 extension, with cut for 2000 evaluation trench, and made ground deposits over subsoil, 1m scales, view south-west*

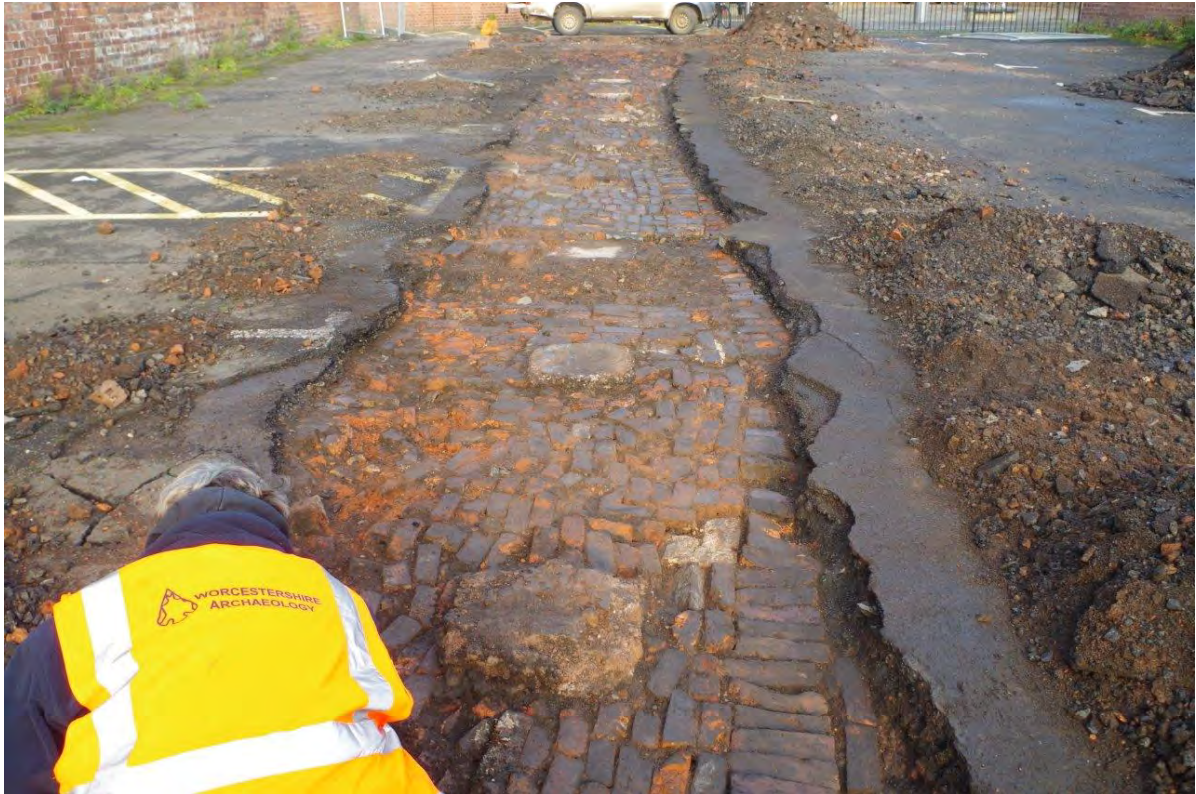
Plate 7: Trench 4, brick surface 404, no scales, view north-east

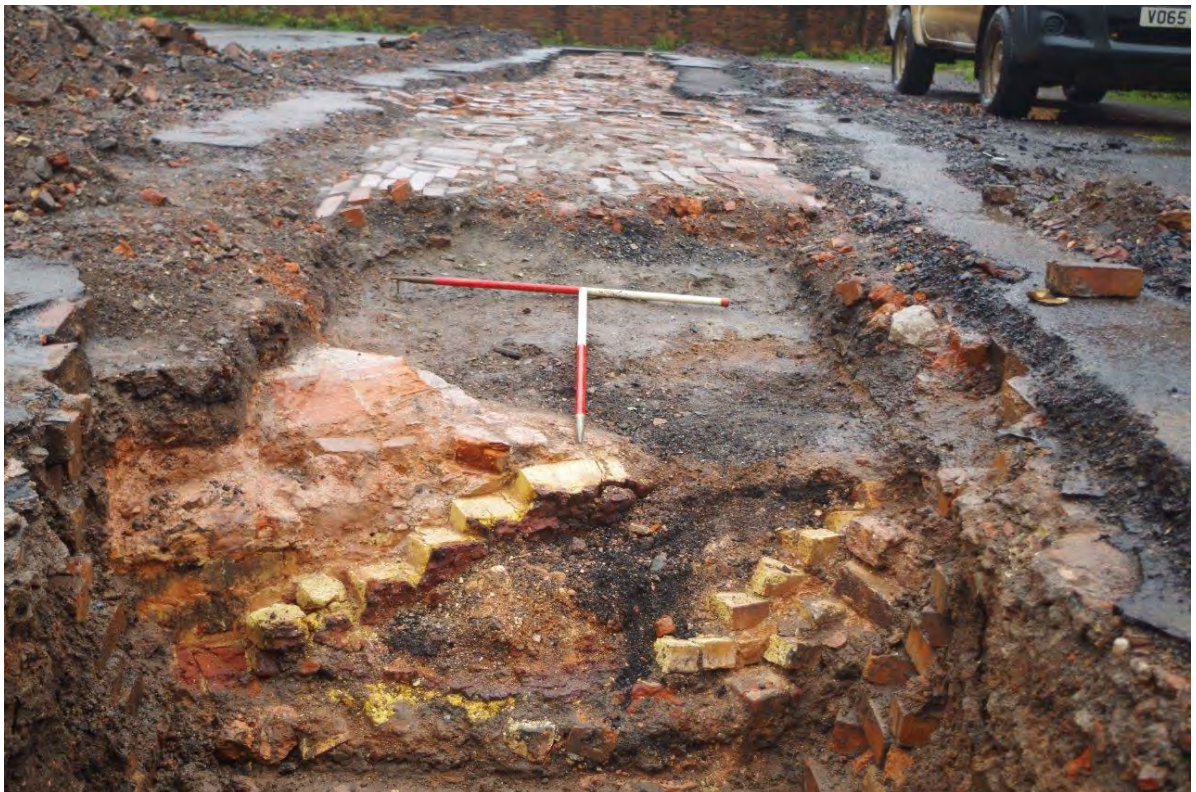
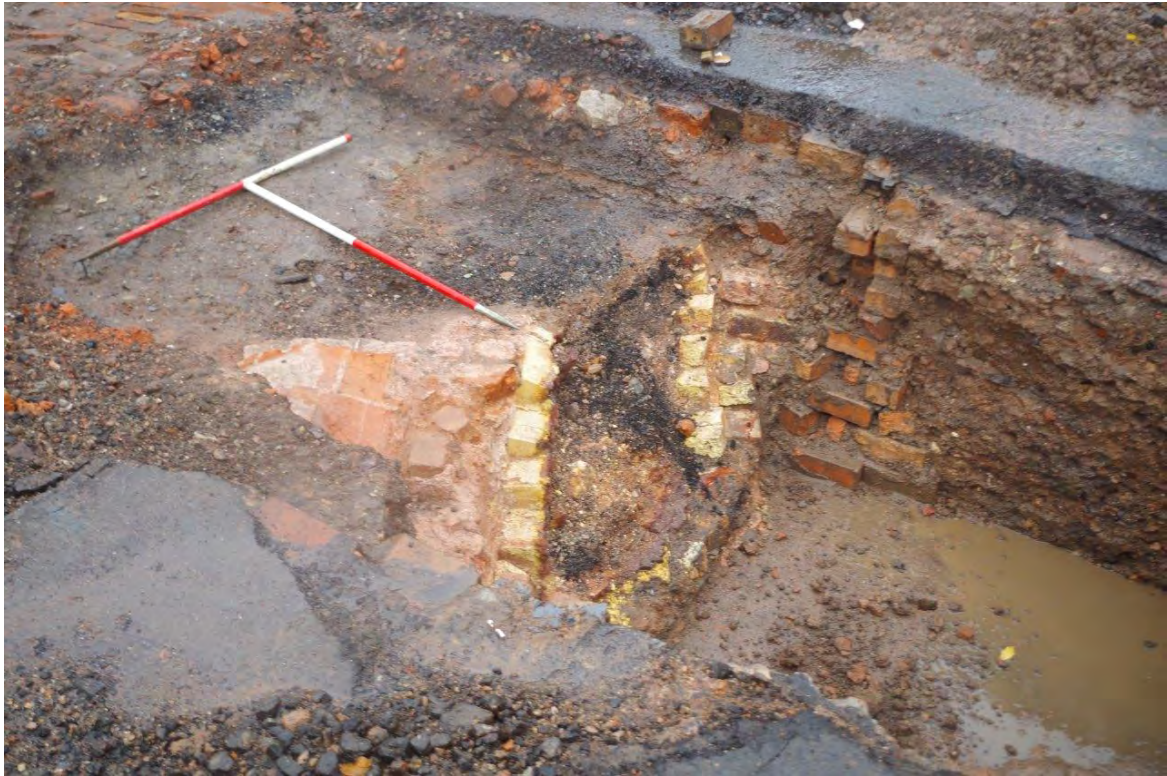
Plate 8: Trench 4, flue 418 and associated deposits, 1m scales, view south-west

*Plate 9: Trench 4, flue 418 and associated deposits, 1m scales, looking west*

Approximately 3m to the north of this structure was a flue (418) constructed of yellow fire bricks, vitrified on their inner faces to a purplish finish (Plates 8-9). It had an internal opening of 0.35m and a

visible length of 2.1m. It was 0.45m deep and was filled with a series of dumped deposits of sand, demolition material and coal (420). These deposits were seen in section following the removal of a later wall that truncated the flue. The flue itself was not excavated during this evaluation. The flue bricks on the southern side were built up against a wall constructed of orange brick (419), which measured 225 x 115 x 95mm. This wall was encountered at 156.43m AOD whilst the bottom of the flue was seen at 155.85m. The flue bricks were 230 x 120 x 70mm, and both walls were bonded with a light pinkish white mortar. Both structures, and the brick tanks, were sealed by mixed demolition layer 421.

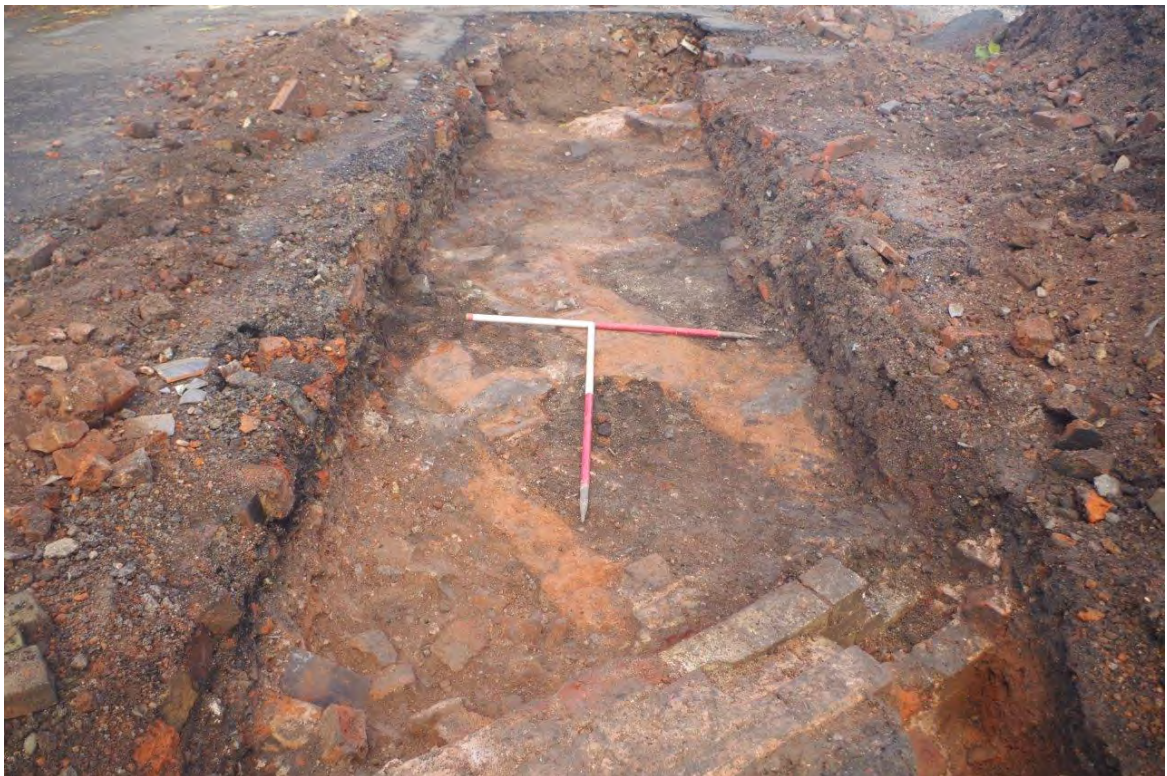
*Plate 10: Trench 4, brick tanks (422) associated with Japanning works, 1m scales, view north-east*

At the northern end of the trench were a series of structures constructed in brick. They formed a series of tanks, but were effectively one structure, 422 (Plate 10). They measured around 1.2m in length and 0.5-0.7m wide. None were excavated, but were backfilled with cinder, clinker and sand, or brick rubble. One of the tanks had two iron spikes, one in the north-west corner, one in the south-west. These appeared to be *in situ*. They were at c 156.38m AOD.

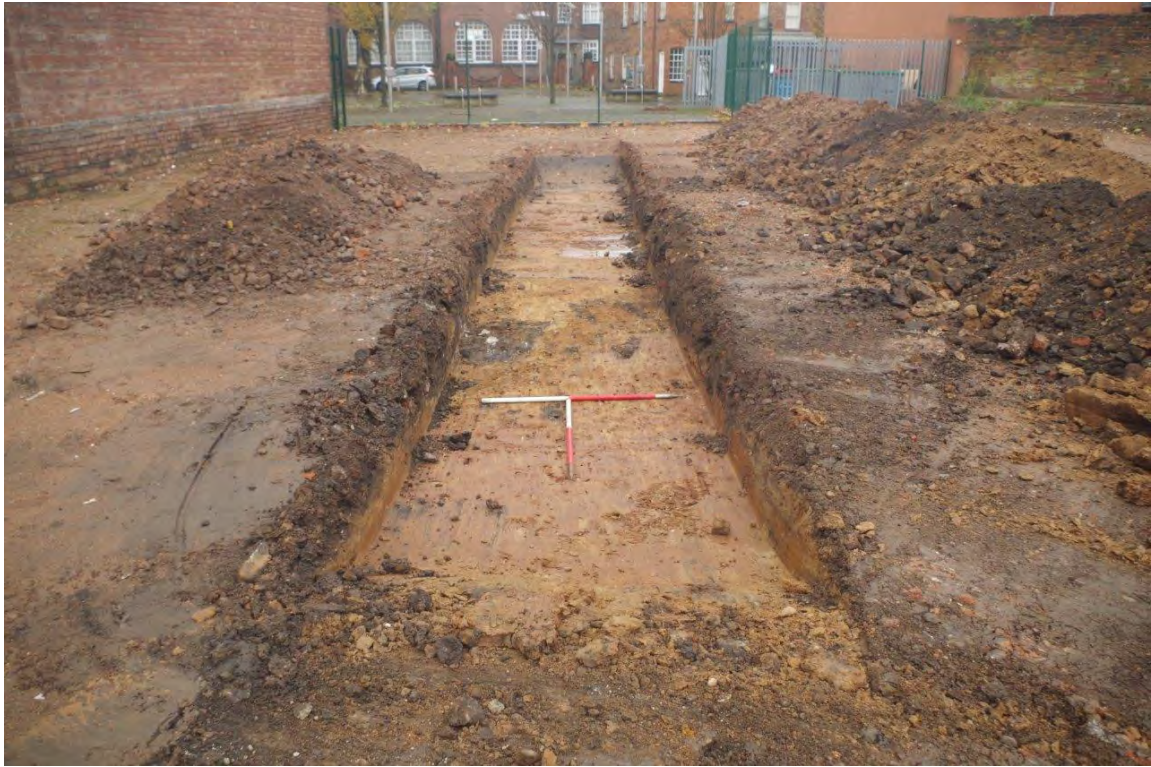
*Plate 11: Trench 5 general shot, 1m scales, view north-east*

The natural ground was encountered at 156.26m AOD at the north end of the trench (0.63m below ground surface) and 156.44m AOD in the south (0.44m below ground surface). A thin remnant of subsoil was identified, up to 0.15m thick. Above that was a dark grey clay silt with frequent brick and charcoal fragments, measuring 0.28m thick. This was a 19<sup>th</sup>-20<sup>th</sup> century made ground. Sealing it was a modern crush layer, derived from the recent demolition of the former building on site (Plate 11).
