Archaeological works at The Wooden Barn, Shelsley Walsh, Worcestershire

THE WOODEN BARN SHELSLEY WALSH WORCESTERSHIRE

Building recording and watching brief report

Site name:	The Wooden Barn, Shelsley Walsh, Worcestershire
Local planning authority:	Wychavon and Malvern Hills District Council
Planning reference:	18/00397/LB
Central NGR:	SO 72162 63045
Commissioning client:	Firlands Developments Ltd on behalf of Midland Automobile Club Ltd
WA project number:	P5353
WA report number:	2792
HER reference:	WSM70502
Oasis reference:	fieldsec1-386315

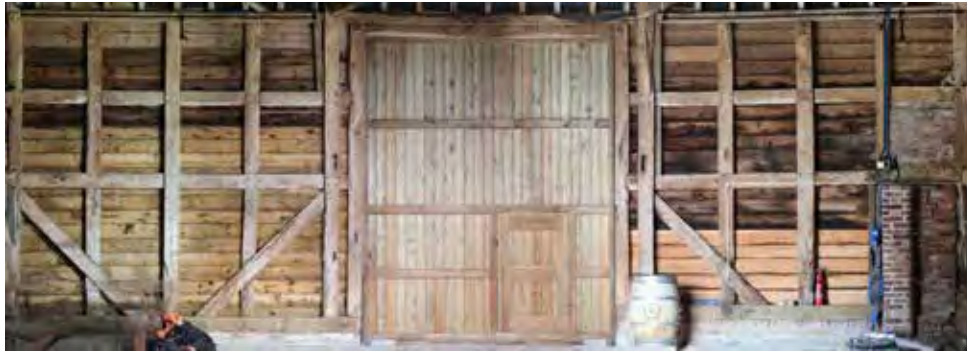
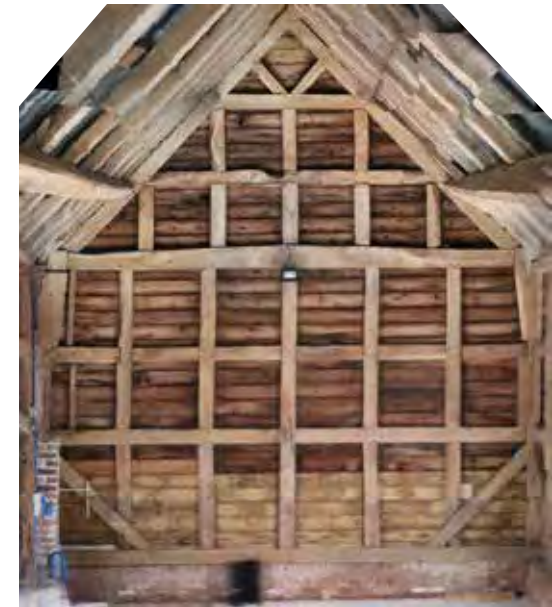
The barn is a timber framed structure of three bays, with its shortest bay in its centre. The wall framing is of three high square framing (Plate 8, Plate 9 and Plate 10 and Figure 2) with relatively short straight braces running between the sill beam and the posts of the cross frames. Above the tie beams of the gable frames, the multiple studs continue the square framing between two collars. Above the upper of the two collars were raking V struts, typical of a style used from the latter half of the 16th century into the early 18th century.

Directly below one of the cross frame trusses, a partial brick and stone plinth wall was present. Its base course (109) was of limestone and 0.56m wide and probably the original wall dividing the end bay from the threshing floor. This was largely replaced in brick from which the upper courses were constructed (108). This wall was 0.24m wide and constructed of 6 by 4 by 3 inch handmade bricks of probable later 18th century to 19th century date.

Plan of barn with elevations (based upon Nigel J Teale Drg No3837A-01)

Excavations within the interior of the building, an area of approximately 13m by 6m, were monitored as the floor level was reduced. The area is indicated in Figure 2 and Plate 16.

A brick pillar with a small area of brick wall was present in the north-west corner (Plate 9) which relates to a possible former shelter shed to the western side of the building (Plate 2; Figure 2).

The features recorded are shown in Figure 2 and Plate 16.

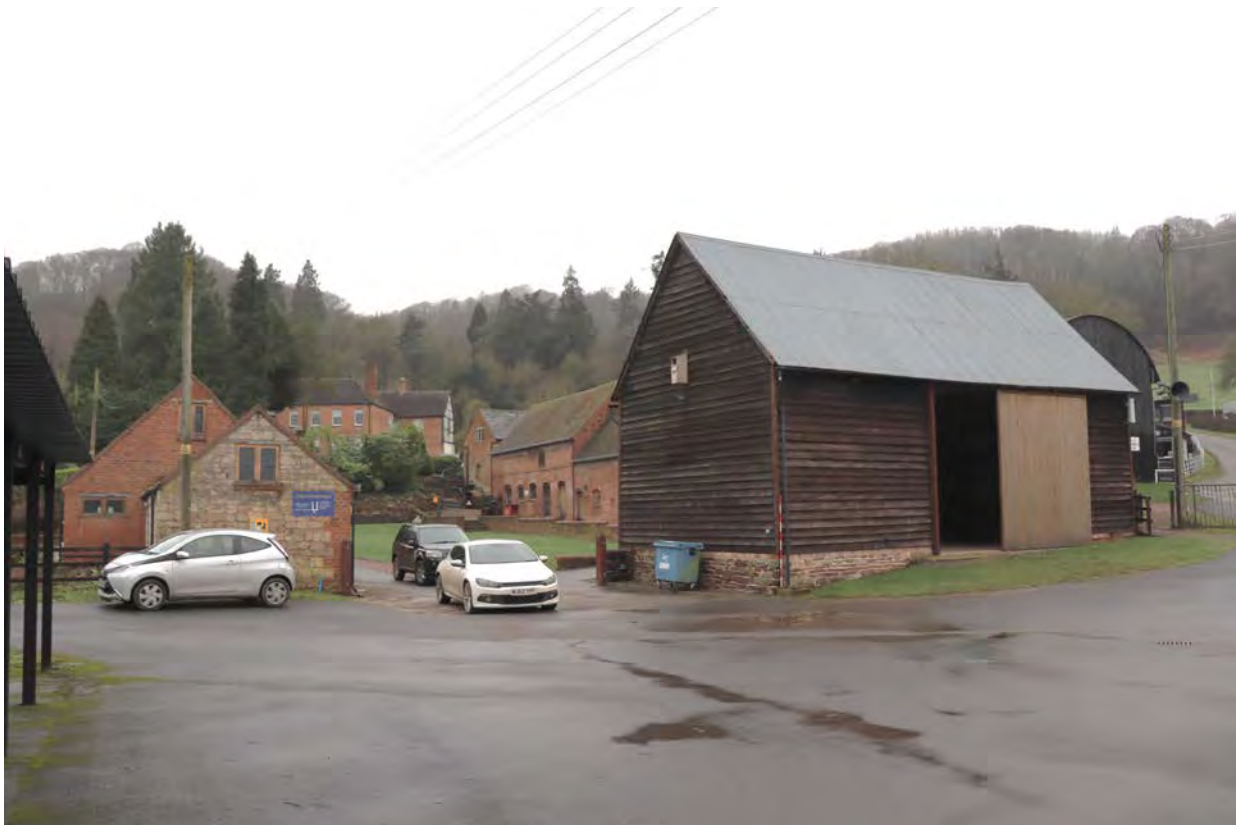
The building currently comprises a rectangular structure aligned north-west to south-east, with a timber frame clad in wood on a sandstone and brick footing, and with its gabled roof clad in corrugated iron. General views of the buildings can be seen on (Plate 1 to Plate 3)

Plate 1 General view of the barn with the farmyard and Court House behind, looking west, 2m scale

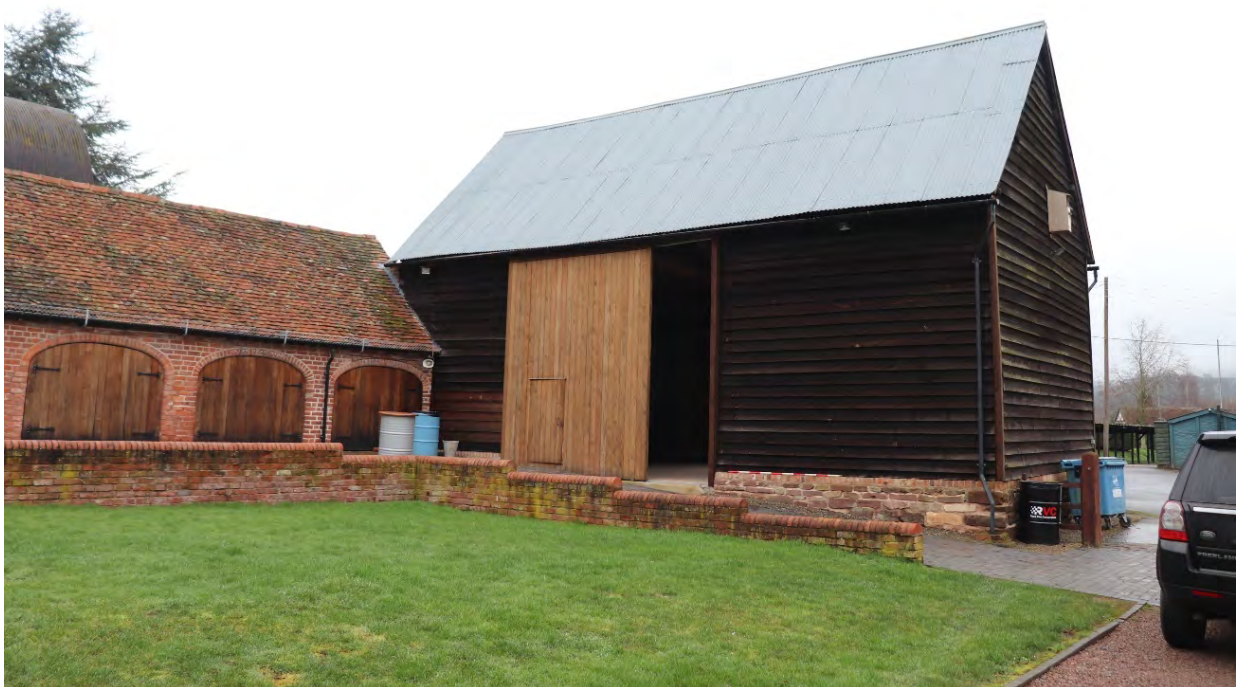
Plate 2 General view of the barn from the farmyard, looking north-east, 2m scale

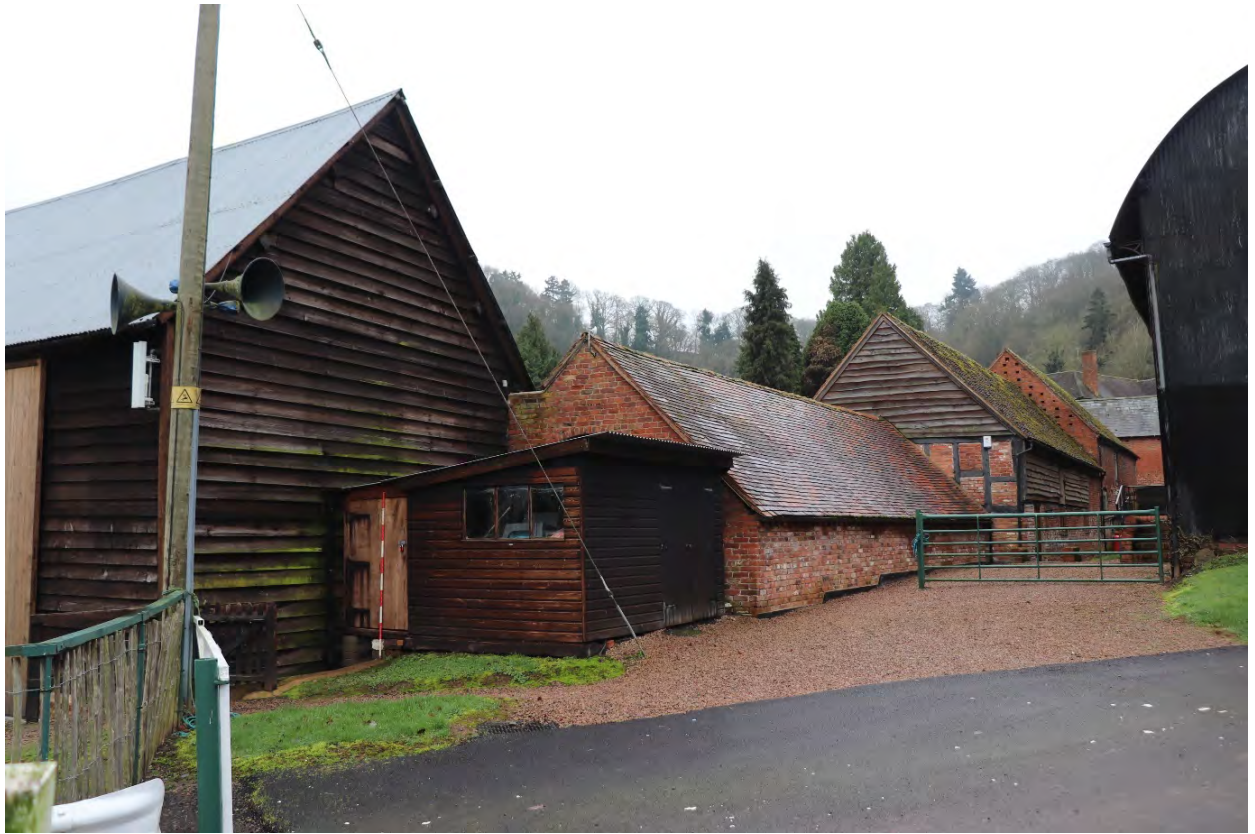
Plate 3 General view of the barn with the farm buildings behind, looking south-west, 2m scale

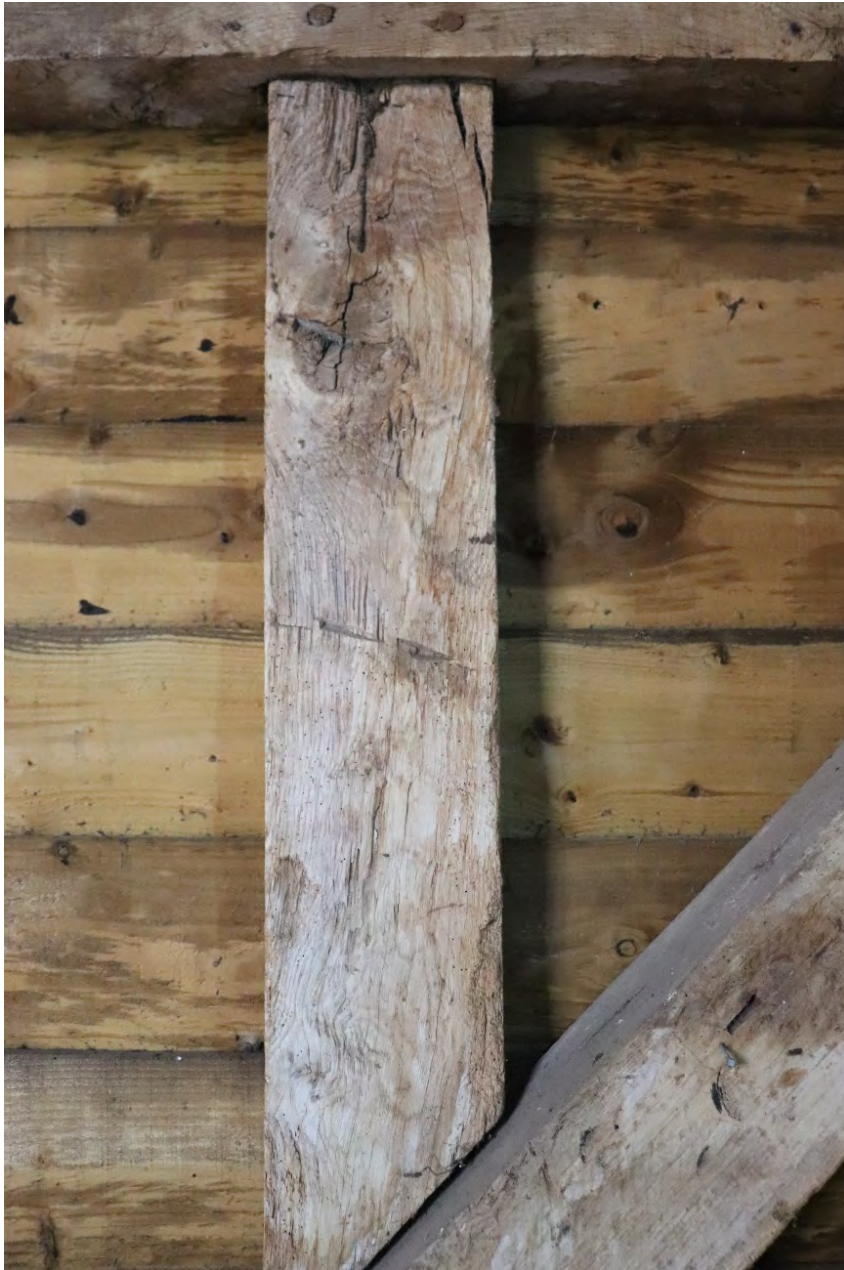
As with most such timber frame structures, the methods of timber conversion are clear within this structure. The majority of timbers have been squared on at least one side by hewing, with notching marks visible (Plate 4), along with marks of a wide axe with a shallow curve typical of a side axe (Plate 5). This method is well documented and fairly typical for squaring of the waney side of the timber (Russel 1995). Some surfaces were also finished using an adze (Plate 6). Subsequent conversion both of some waney edges of the trees and quartering and halving the timbers was undertaken by saw, leaving saw marks a little off 90° as is typical of pit sawing (Plate 7).

Plate 4 Timber with a notch mark cut aligned at 90° to the timber with a short bladed axe, most likely a felling axe, no scale

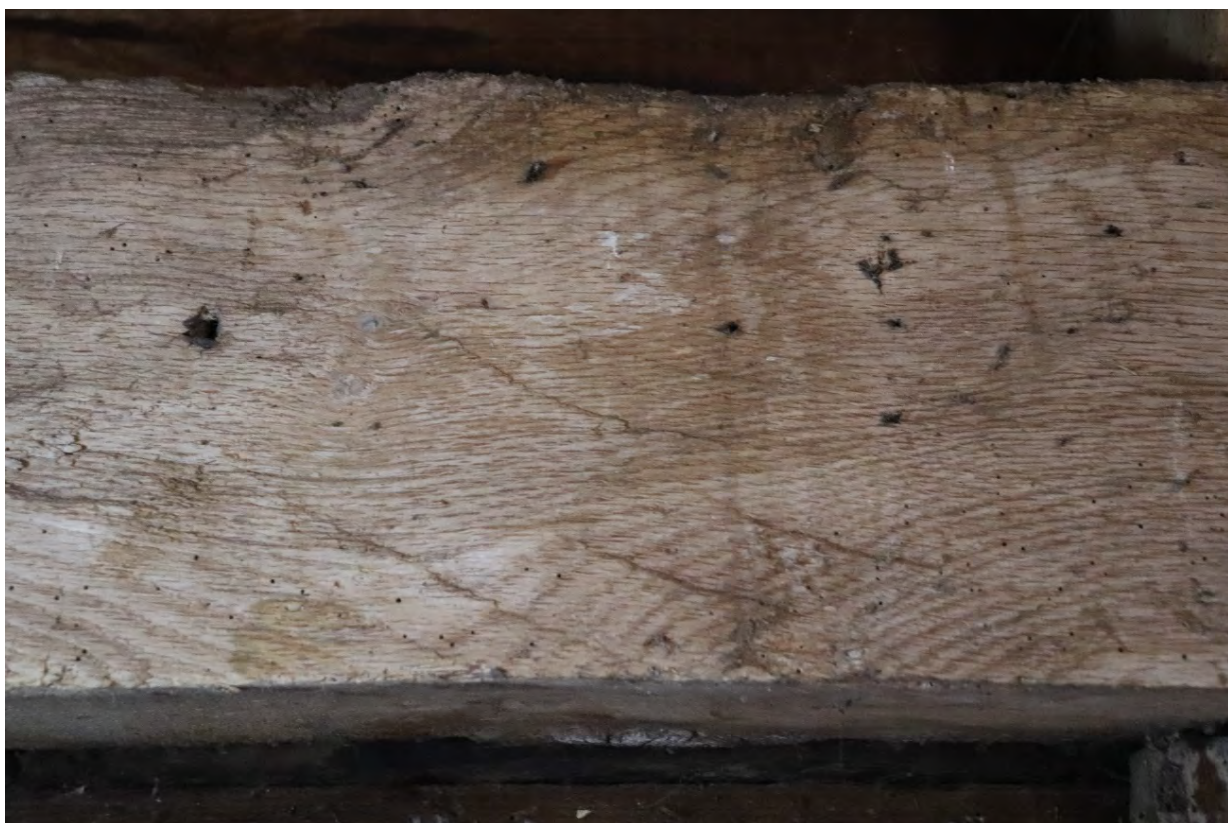
Plate 5 Timber with shallow curved cut marks typical of a side axe, no scale

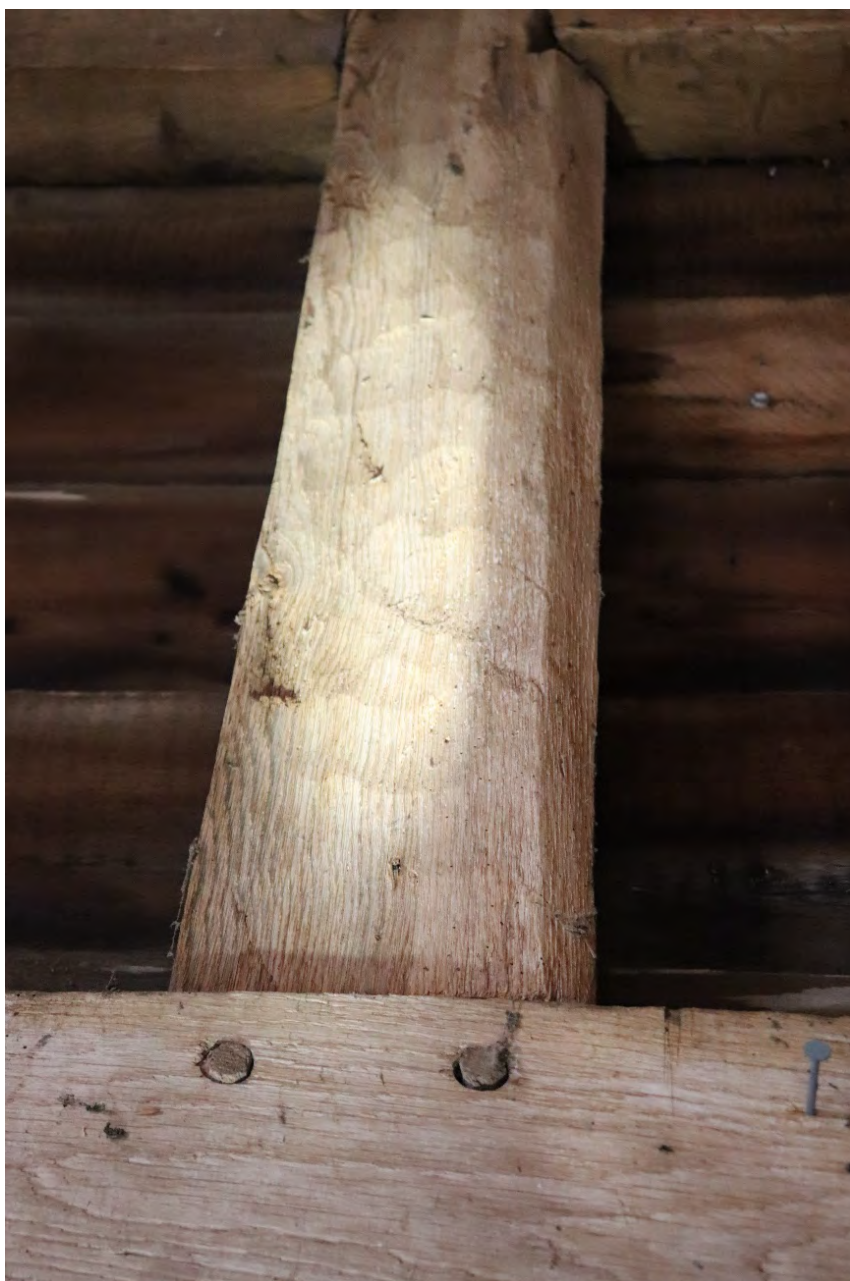
Plate 6 Timber with shallow scalloped marks, typical of an adze, no scale

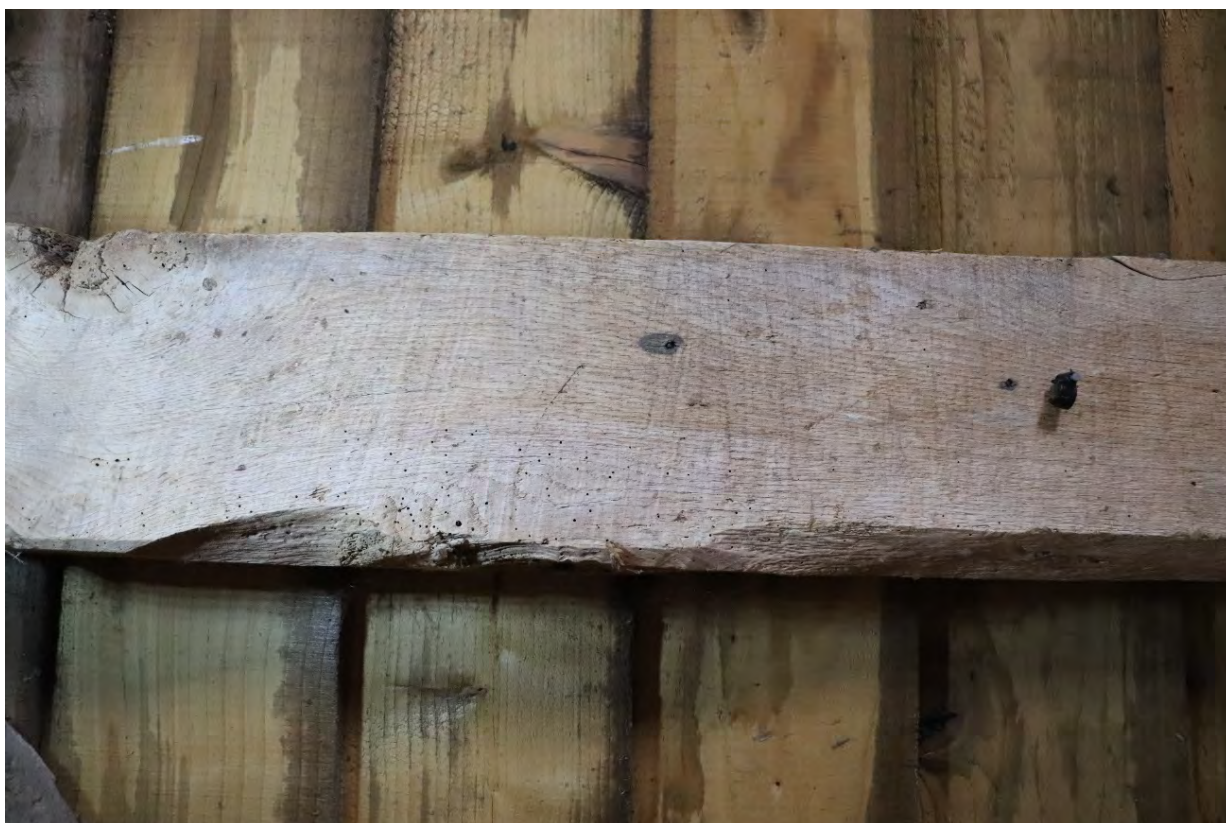
Plate 7 Timber with slightly off 90 degree fairly irregular saw marks, typical of pit or double trestle sawing, no scale

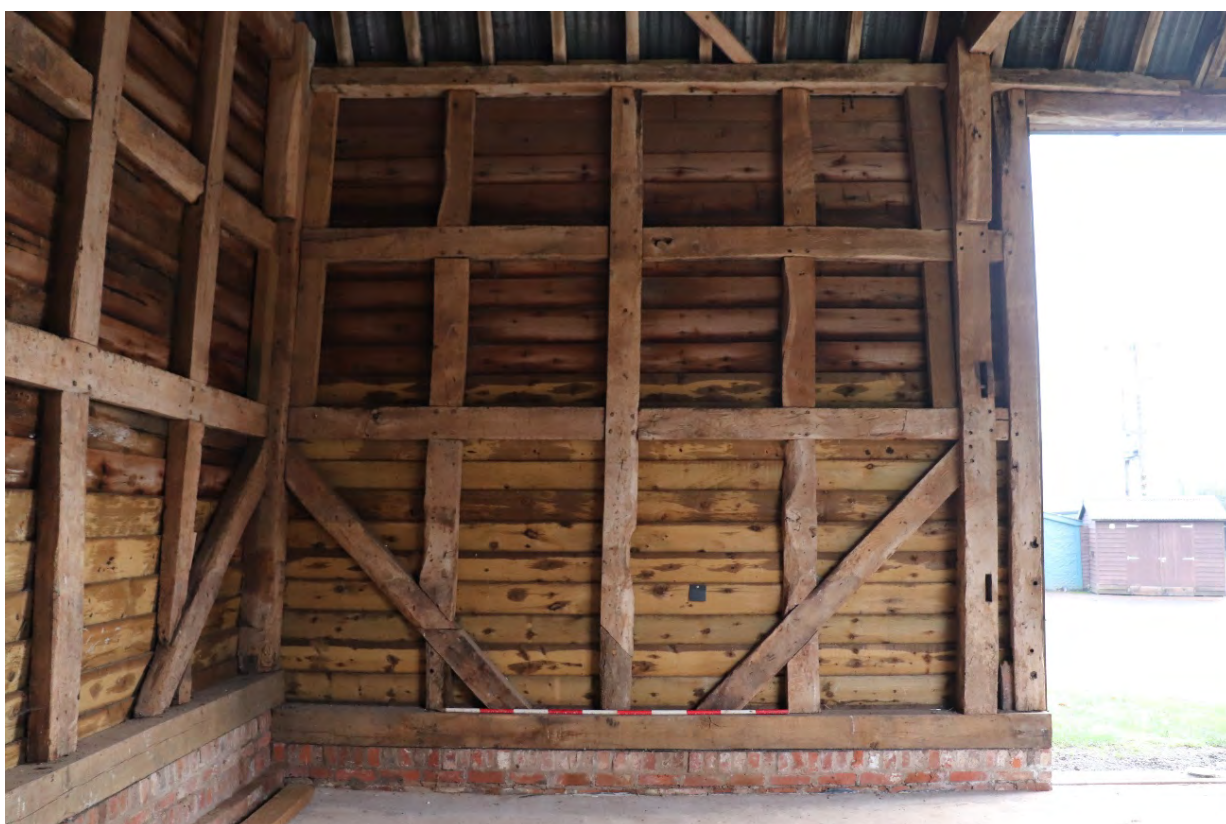
Evidence for partial framing below the tie beams of intermediate frames exists in the form of a central mortice in the base of each tie beam (Plate 9) and two mortices in the posts of the cross frames next

to the doors which would have held bracing (Plate 8). An oddity of carpentry is that at the point where the posts joint to the tie beam, the post runs to the full height of the tie beam at the rear of the frame, whereas it is normal for it to be cut at the base of the tie beam. Some evidence for the reuse of timbers from an earlier structure was also present (Plate 11).

Plate 8 Interior side wall frame, looking north-east, 2m scale

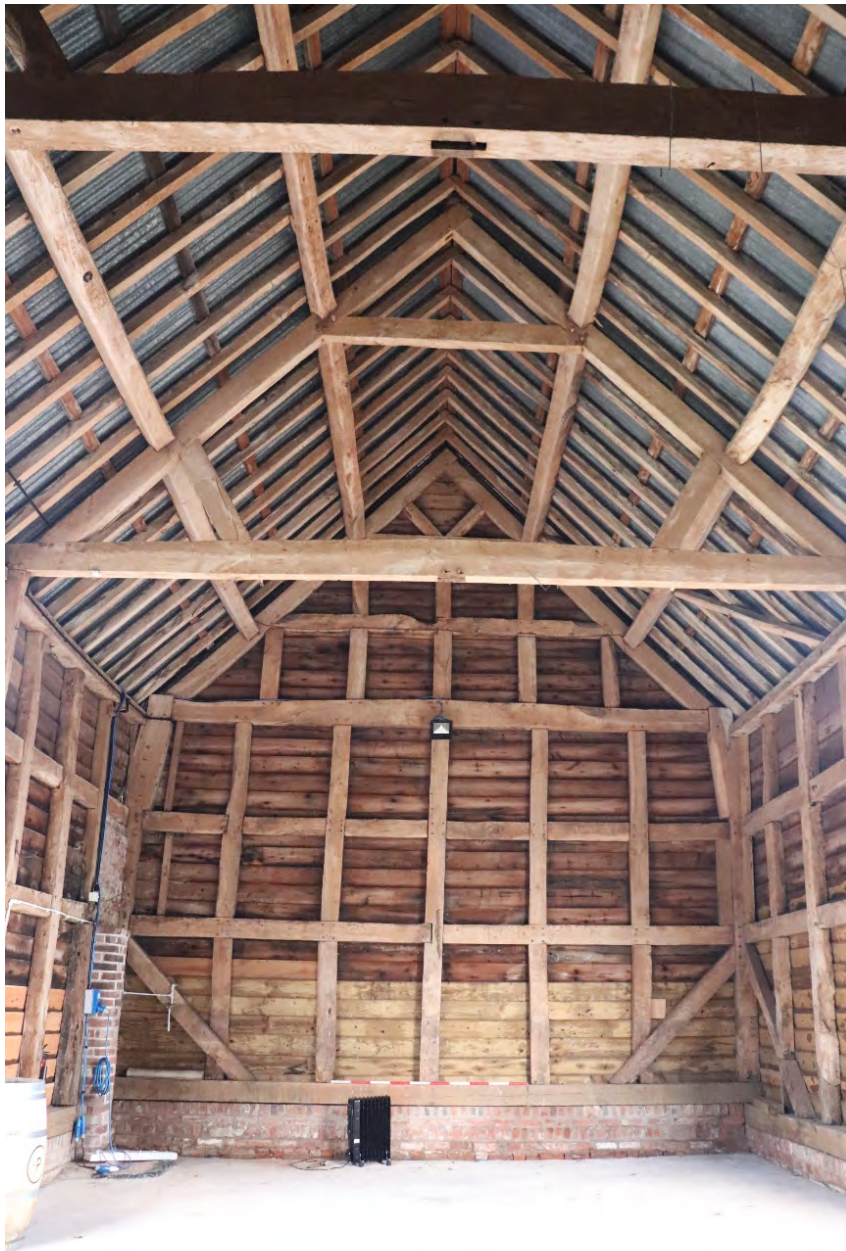
The intermediary two roof trusses (Plate 9) had only a high collar with raking struts between the principle rafters and the tie beams, in a style typical of later 17th century and 18th century roof trusses. The roof structure consisted of two trenched purlins on each side with common rafters above, all pegged at the apex. A single long straight brace ran between the wall plate and principle rafter of gable end frames, located below the common rafters.

Plate 9 Interior end and intermediary cross frames, looking north-west, 2m scale

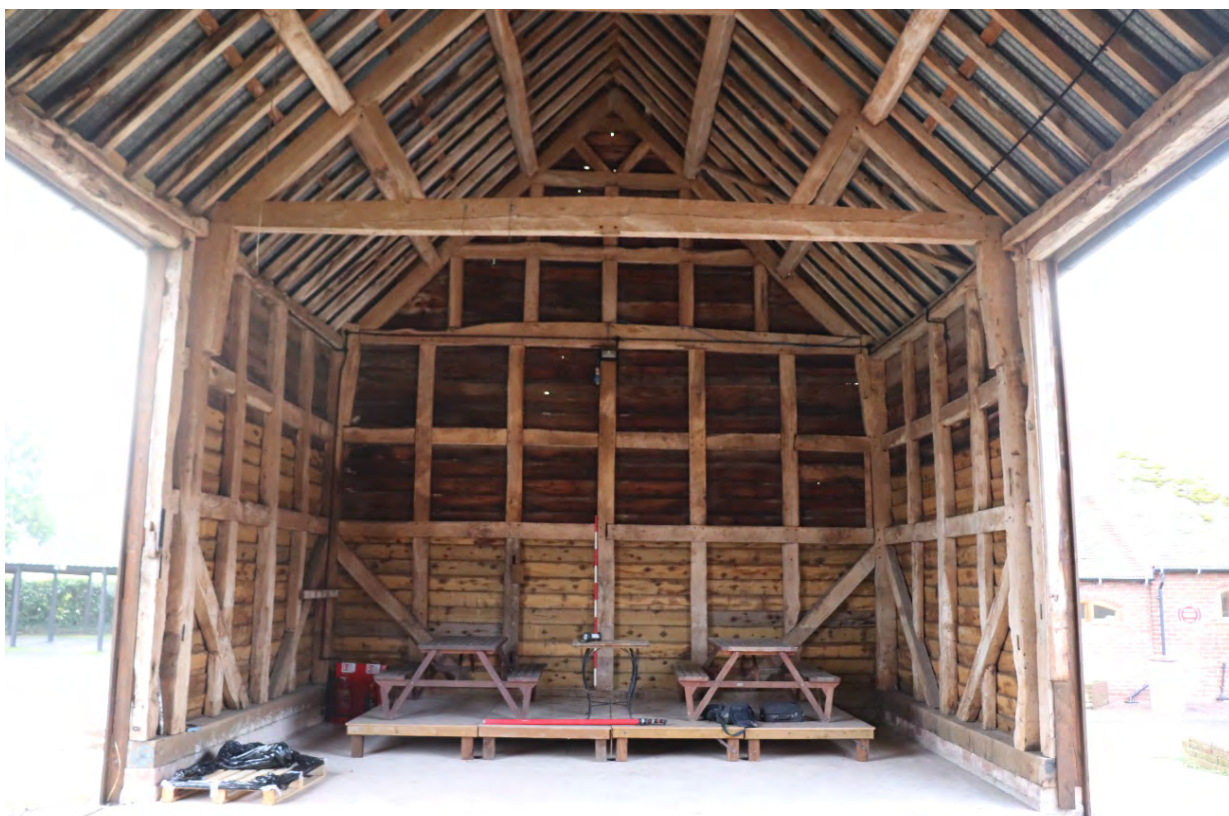
Plate 10 Interior end and intermediary cross frames, looking south-east, 2m scale

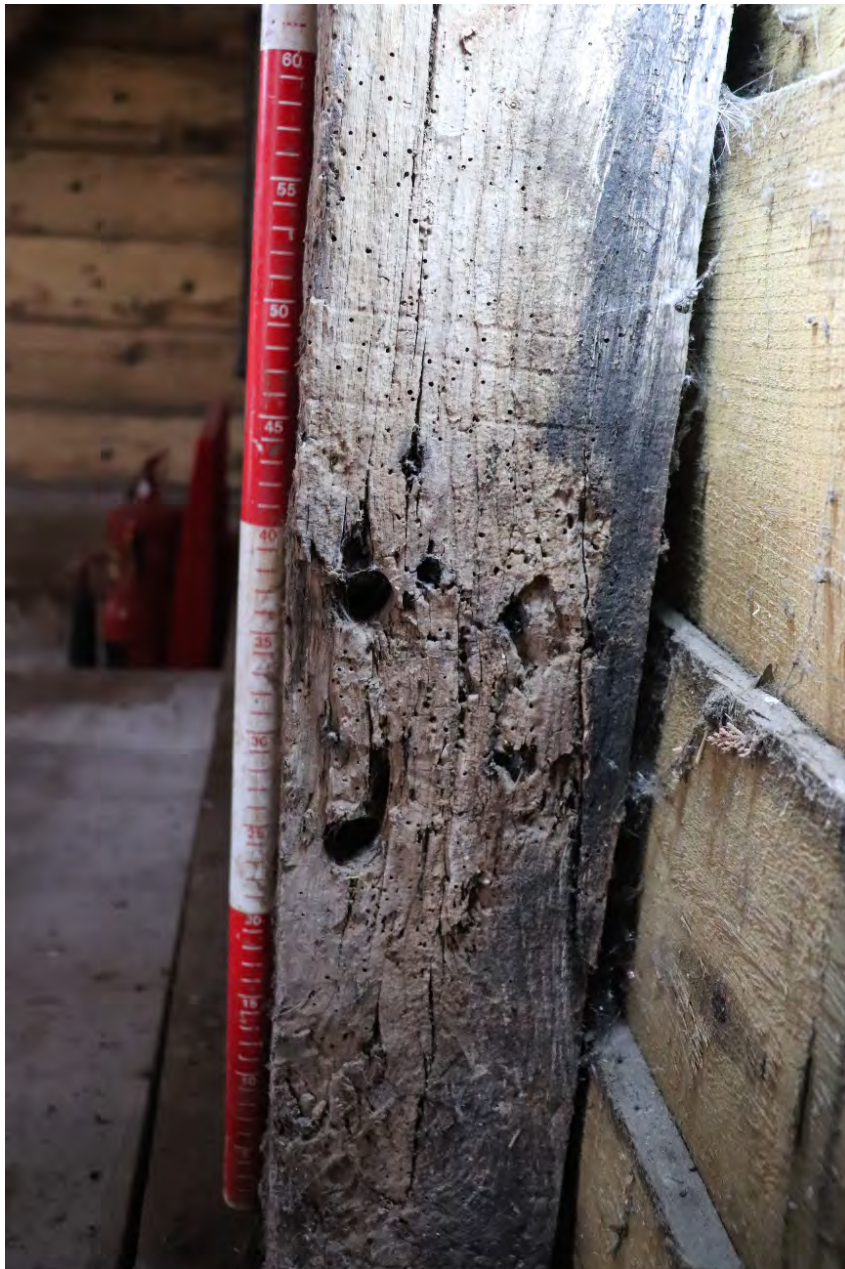
Plate 11 Reused timber next to a redundant pegged mortice joint, with the “III” mark being redundant carpenters marks, looking north-east

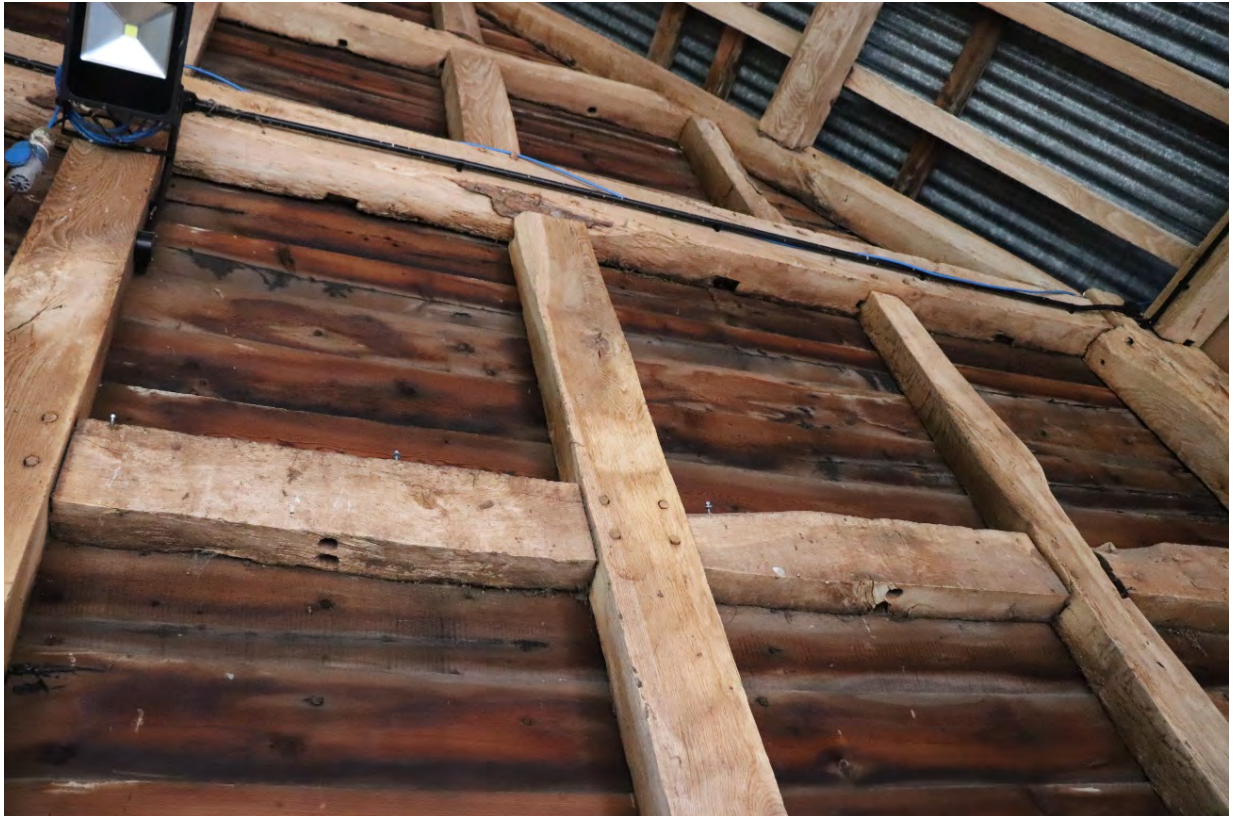
Plate 12 Single and double pegholes as well as small lapped joints central to each panel. Note no such corresponding features at the edge of the panels, as would typically be the case, no scale

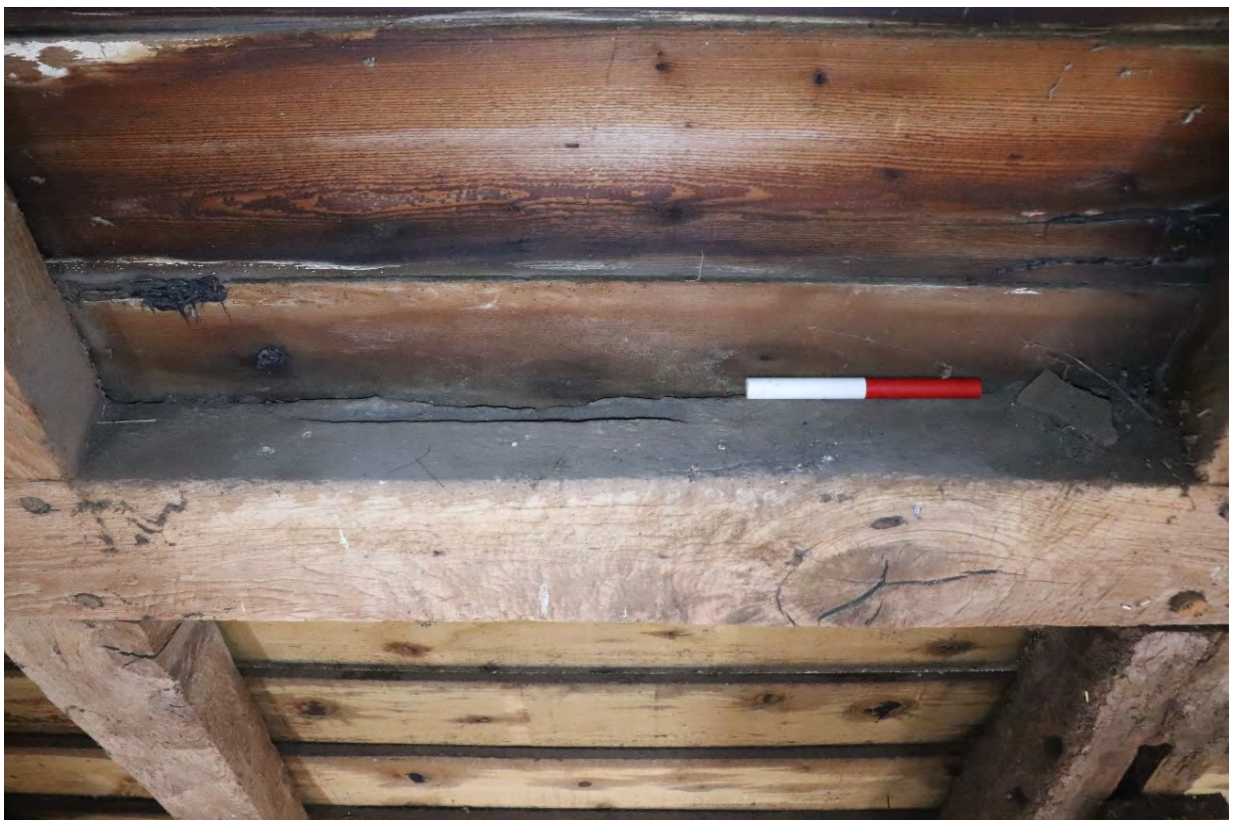
Plate 13 Groove with vertical stop closest to the 0.20m scale that runs out at opposing end

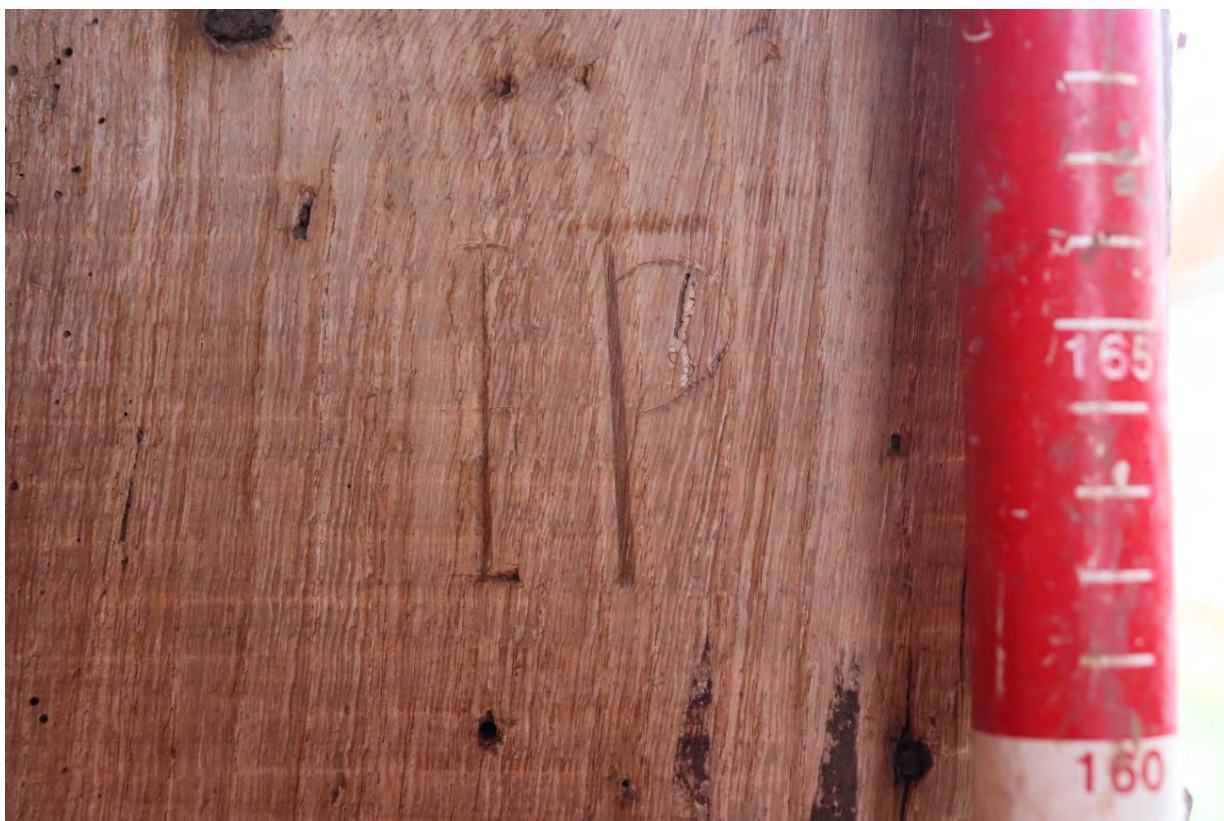
Chiselled into the frame which supported the door on the south-west side of the building was the symbol 'IP' (Plate 14). It is unlikely these were initials but actually derived from the Greek symbols chi-ro more commonly used as a Christogram. This derivation is supported by the 'I' symbol being crossed in the centre. The invocation of Christ in this form is well documented and thought to be for the protection of the stored crops. A further indication of crop protection was present on the first floor in the form of a candle burn on the northern end frame (Plate 15). These marks are also well documented and were considered to afford ritual protection from the presence of the devil (Hoggard 2019).

Plate 14 "IP" mark considered to have been derived from a Christogram, scale showing height from the floor in cm, looking south-west

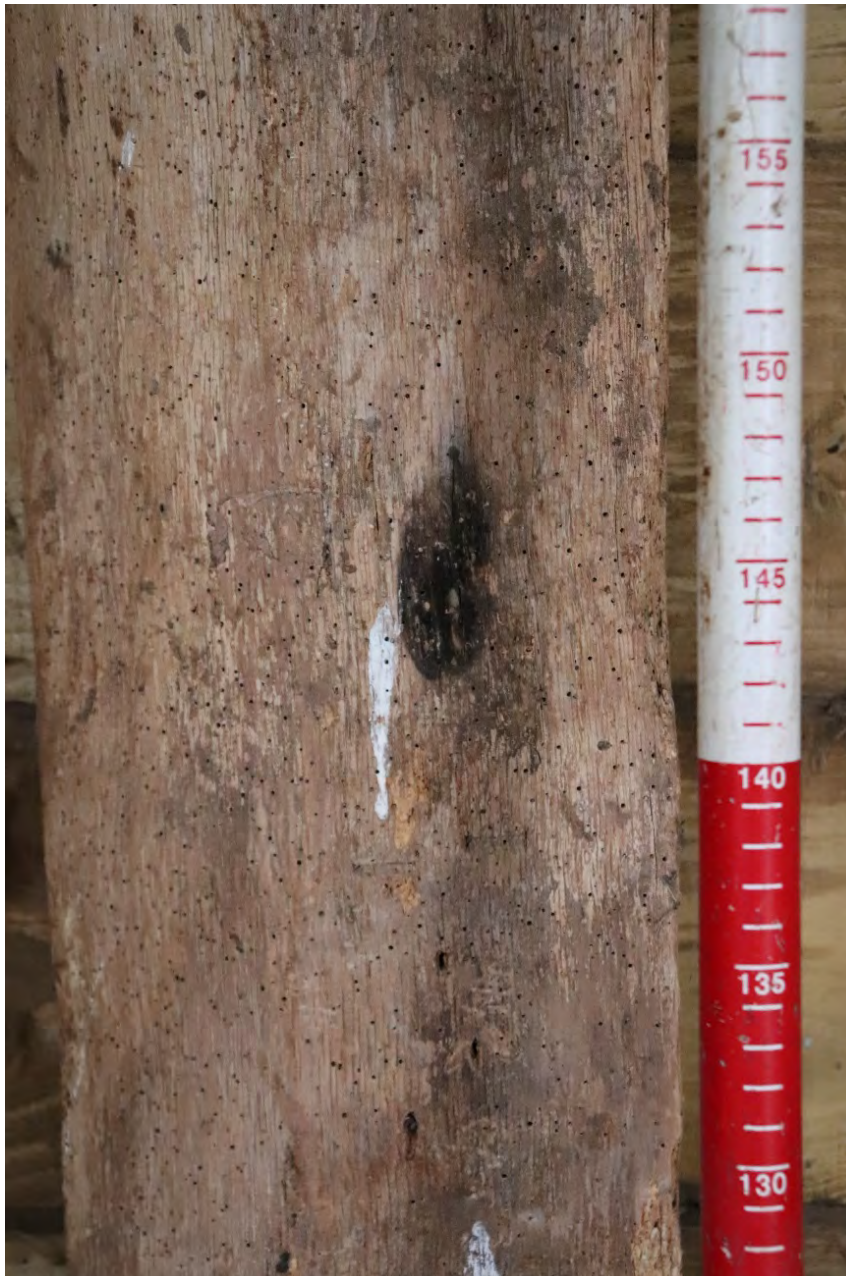
Plate 15 Candle burn mark, scale showing height from the floor in cm, looking north-east

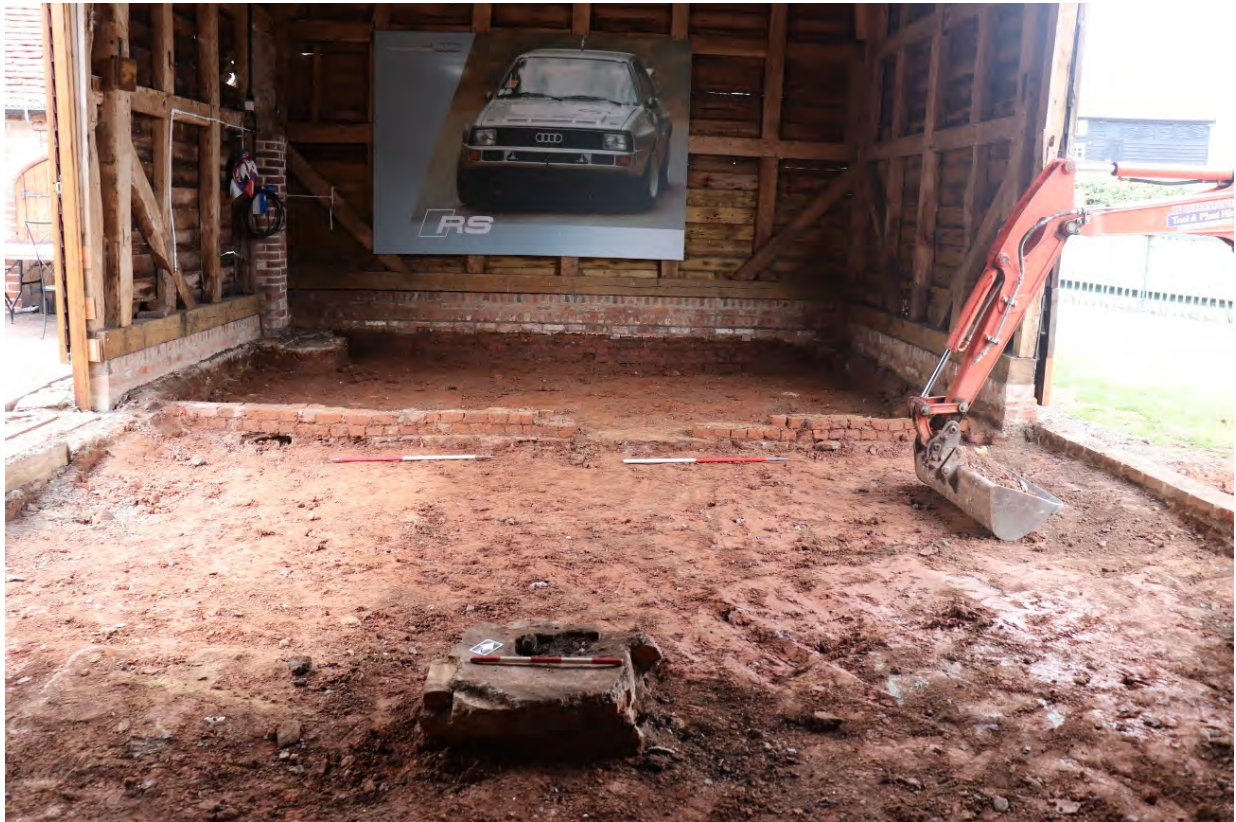
A centrally positioned brick and concrete built post setting was present under the opposing internal cross frame truss (105), of probable 20th century date. Cut [107] was for part of a service, infilled by (106) which contained modern material. An internal cut around the edge of the former threshing floor and south-western part of the barn was cut [104], shuttered and backfilled with concrete in order to support the plinth wall.

Plate 16 The interior of the barn during the watching brief, scales 2x 2m and 1 x 0.50m
